Physical Plant Inspection of Comcast Communications in the City of Bellingham, Washington

May 2010

Inspected by
Kramer.Firm, Inc.

**PHYSICAL PLANT SAFETY INSPECTION
OF COMCAST CABLE COMMUNICATIONS
IN THE CITY OF BELLINGHAM, WASHINGTON**

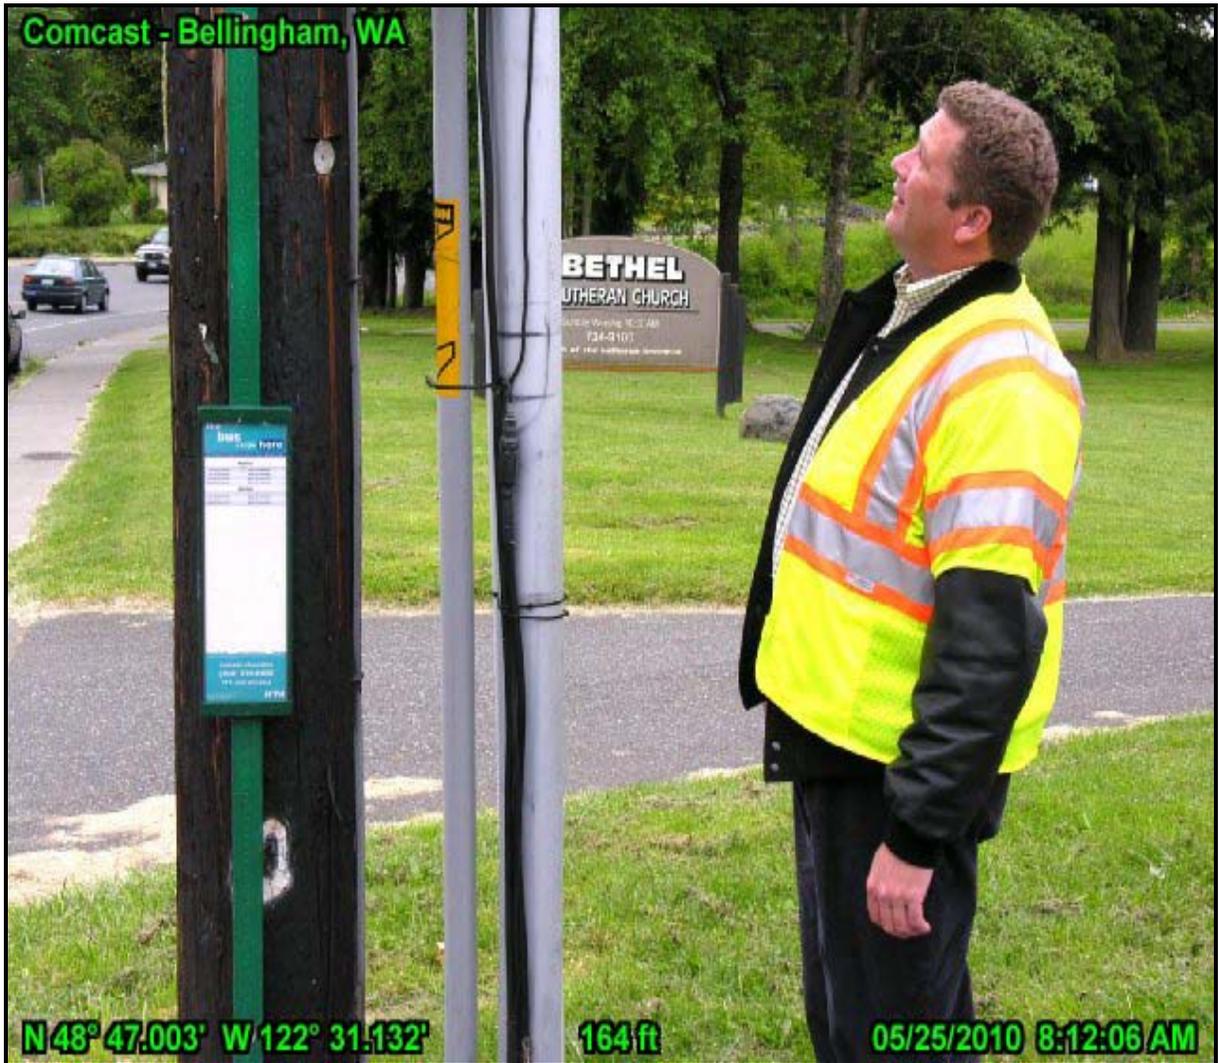
In multiple locations (estimated to exceed 100) around the Comcast service area in the City, we observed riser cables that were either loosely and improperly attached to other utility conduits in violation of the NESC or not attached at all. Examples of loose and improper cable attachments can be found in Figure 2 and 3, below. Additional photographs, including the locations, of the observed cable riser violations can be found in Attachment A1 of this report.

Figure 2: 3615 Bennett Drive. CATV cables tied to power riser conduit. Comcast Tech Ops Manager Lance Ryon shown in this photograph.

Comcast should take steps to correct the attachment problems in their service area. Improper attachment is a significant problem and negatively affects reliability of the network and customer satisfaction. Loose cables move in the wind and eventually become damaged or fail completely.

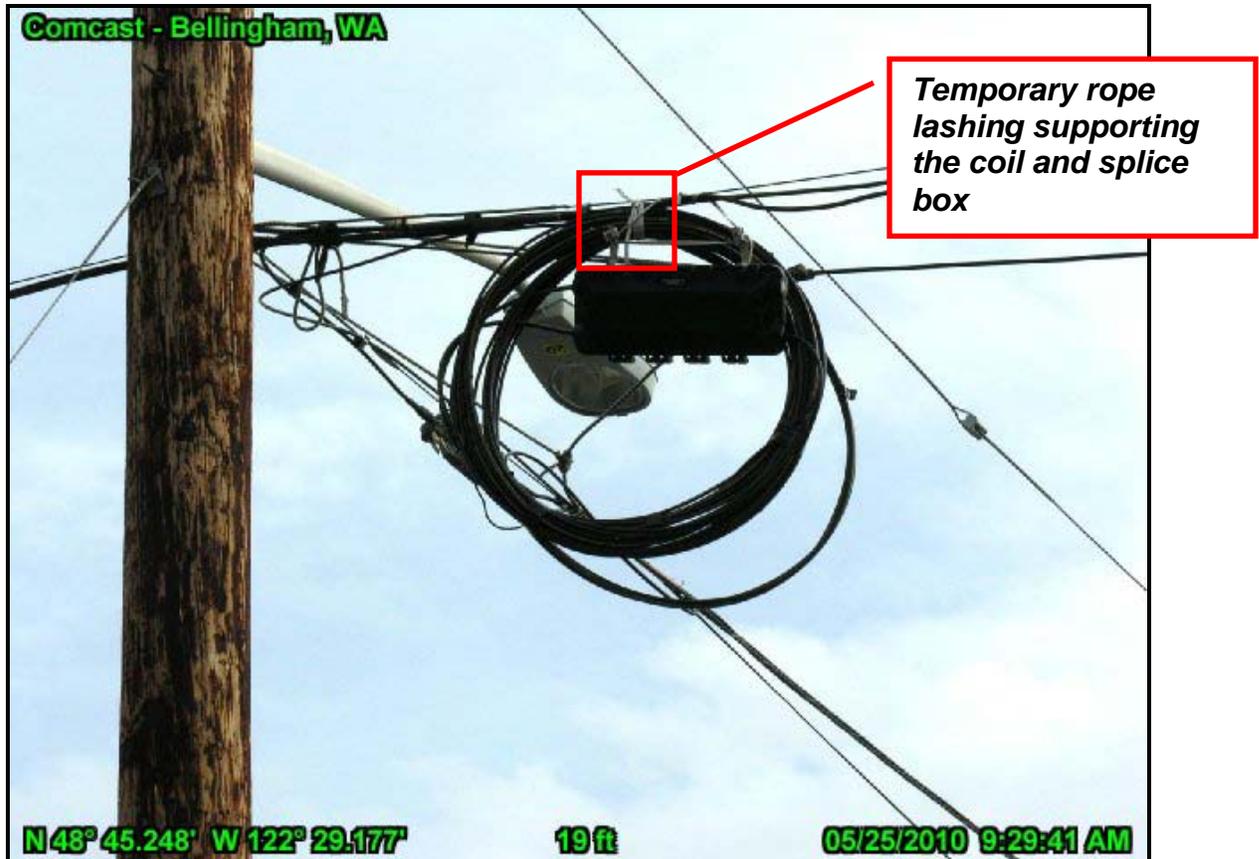
Figure 4: Corner of D Street and Holly Street. Fiber coil and splice box hanging from strand.

Heavy cable coils and splice housings suspended on overhead lines pose a risk to the general public and the integrity of the cable system itself. If the lashings used to attach the temporary equipment to stand should fail, the falling equipment could cause damage to objects and individuals below. Conversely, if the strand is not strong enough to support the equipment, the weight of the hanging equipment may cause the strand to sag or break.

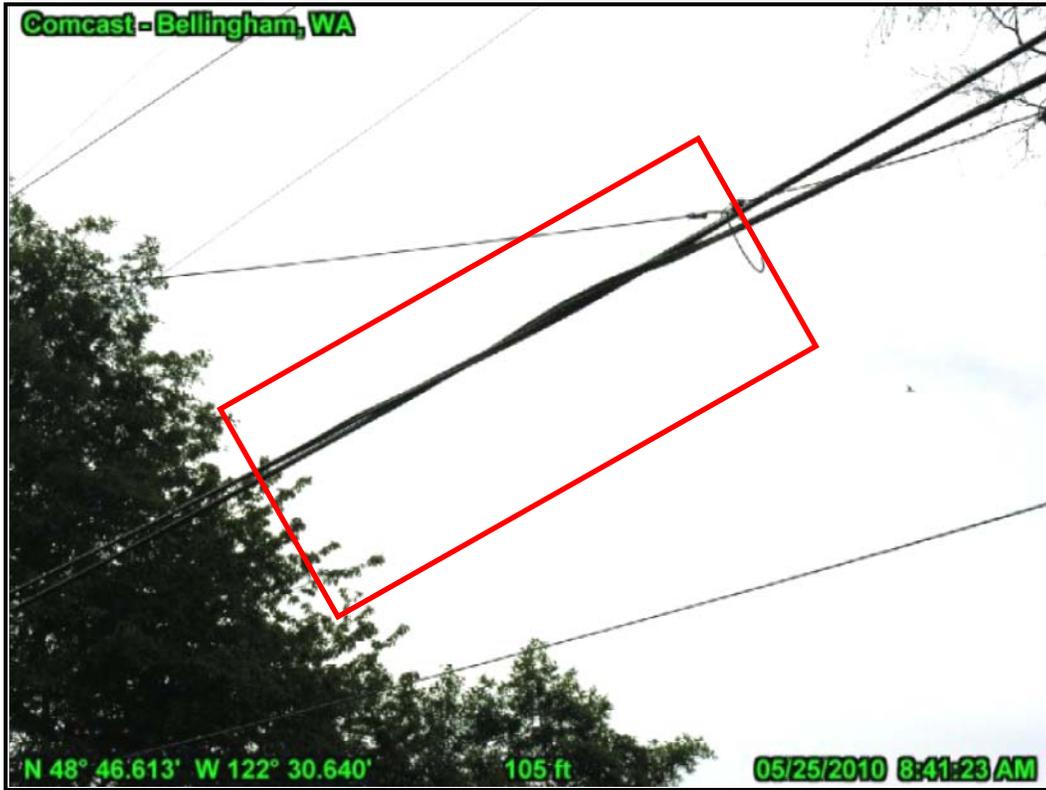
Excessive sag is a violation of the National Electrical Safety Code (Section 235C2b), whereby cable is required to maintain a nominal minimum separation of 12 inches from telephone plant so as to prevent the two plants from rubbing against each other, which could cause shorts and outages. Below is an excerpt from the NESC code regarding sag limits.

Figure 5: 3217 Cottonwood. Sagging cable lines rubbing against and intertwined with telephone cable.

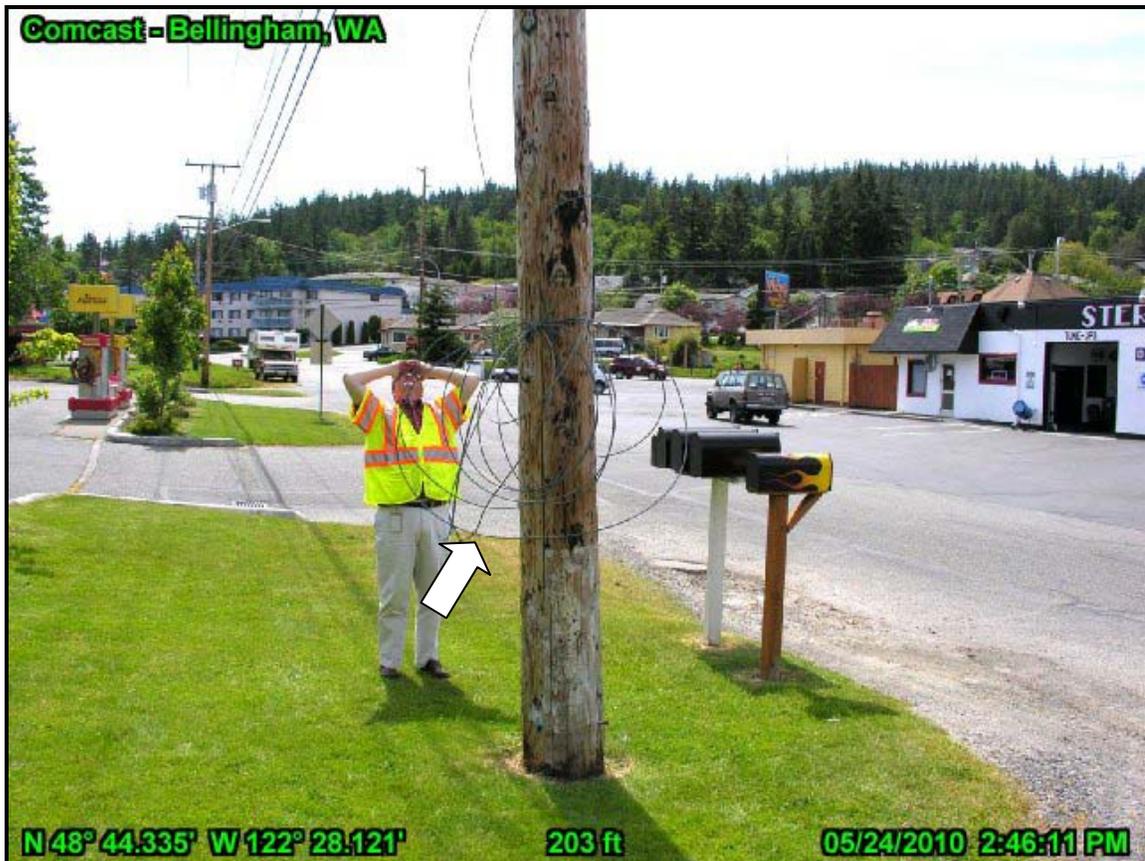
Figure 6: Corner of East Maple and Pasco Streets. Down guy loosely and unsafely wrapped around the base of the pole. Hazard to the public, and to pole line safety. Pole line load not shunted to ground.

Missing down guys and anchors can result in poles leaning in the direction of the tension up to and including collapse. Proper maintenance of required down guys is an essential part of a well maintained system that properly shunts the pole stresses to ground anchors. Shunting pole stresses to ground anchors is necessary to ensure that poles do not lean to one side or another because of unshunted loads as is seen in the next photograph.

Disconnected down guys wrapped around the base of poles presents a clear and obvious hazard to pedestrians and autos.

Missing down guys should have been caught and corrected as part of normal system operations. Furthermore, what was not caught during normal system operations should have been identified and corrected during the recent system upgrade. Comcast should be directed to inspect their entire plant and to promptly correct missing down guys and anchors. They should also be directed to replace missing or broken down guy markers as required.

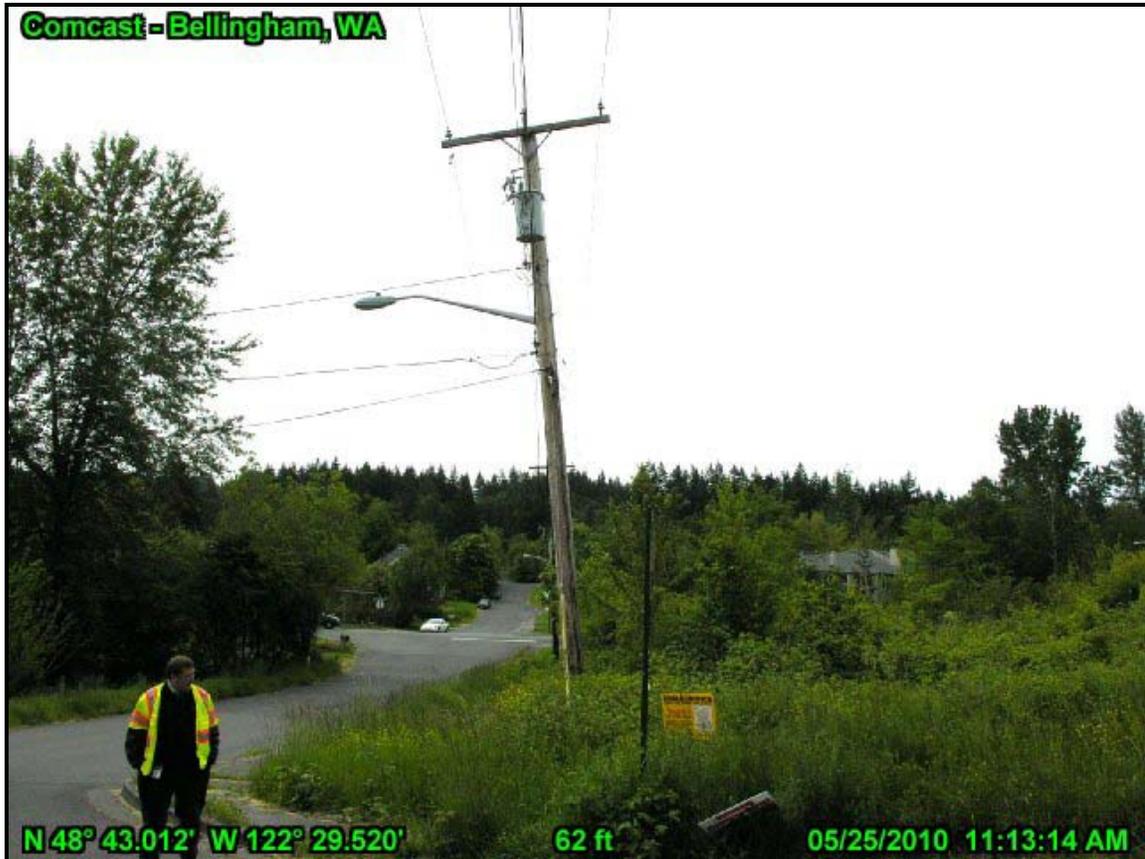
Figure 7: Corner of 20th Street and Wilson Avenue. Missing down guy causing pole to lean in direction of stress (pull).

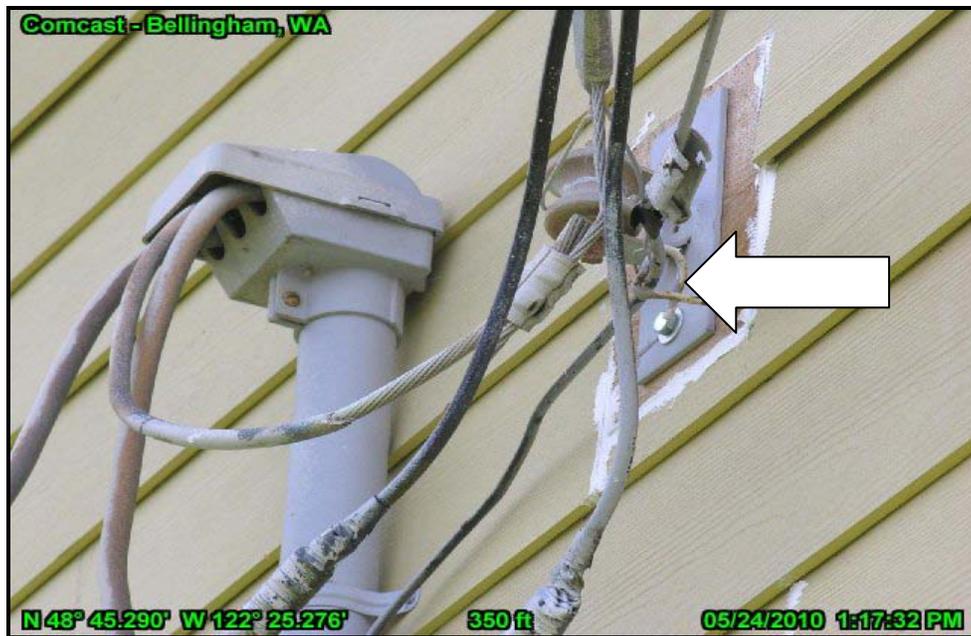
Figure 8: 1901 Ohio Street. Cable drop is installed at same point as power. Clearance violation of separation rules in NEC.

Improper clearances and improper attachments are often the result of inadequate training and/or poor quality control procedures. In this system, we estimate the number of improper clearances and improper attachments to exceed 2,000. Comcast should examine their current training methods and curriculum and take appropriate steps to correct their installation procedures and policies. Comcast should also take immediate steps to audit their system and to identify and correct each and every clearance violation, especially as they relate to proximity to power conductors at the attachment point on the house. Cable employees and contractors are not trained or certified to work in close proximity to power conductors and the NEC requirements are designed to protect them from hazardous exposure to the limitless current potential present at the power mast. In addition to correcting the existing violations, Comcast should concurrently provide remedial training for all of its employees and subcontractors on the requirements of the National Electrical Code regarding permitted attachments and required

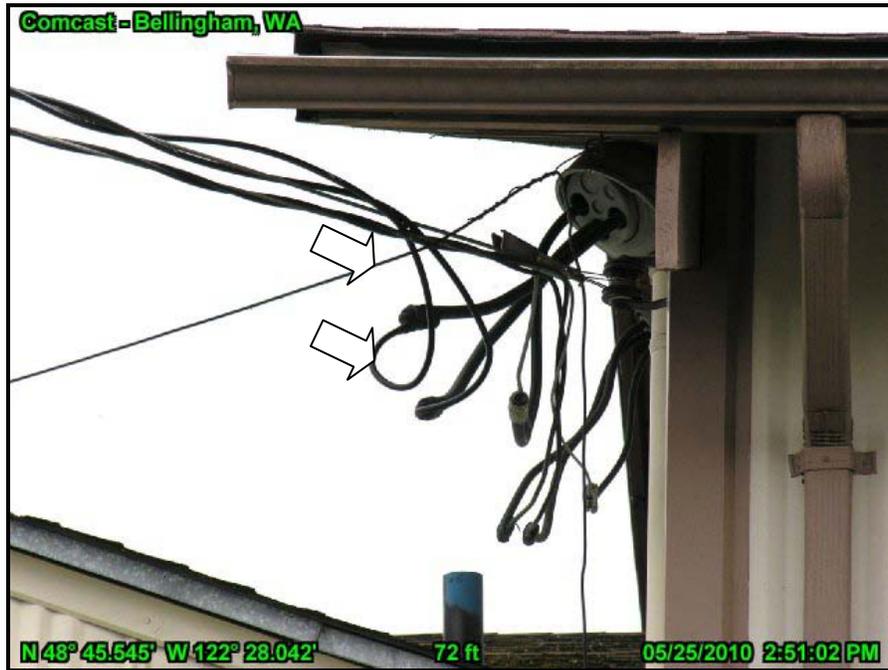
Figure 9: 2138 Virginia Street Cable drop mounted too close to power conductors. Drop wrapped around power utility drop.

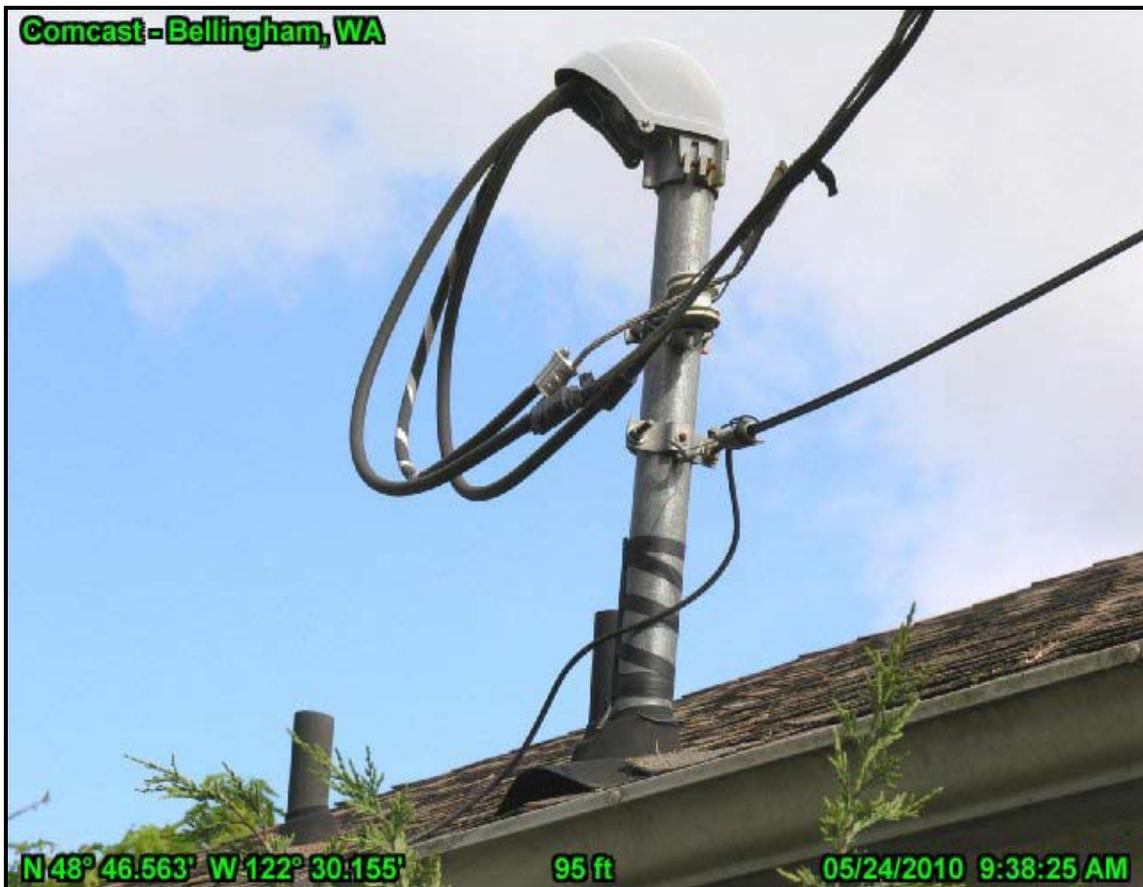
Figure 10: 3235 Firwood Street. Cable drop attached to the power mast above the roof. Cables run over the roof of the building.

This method of attachment is frequently used in order to obtain sufficient height over a roadway, or because it is an easy and inviting point of attachment. As can be seen in the above pictures, telephone drops are also attached to the masts, and their presence is often interpreted as meaning that it is OK, or a recommended practice. It is not an authorized point of attachment, and in these cases, both utilities are in violation of the National Electrical Code.

As can be observed, this practice often violates the required separation from the power drop and places installation personnel in a dangerous position as they try to work in close proximity to the power conductors.

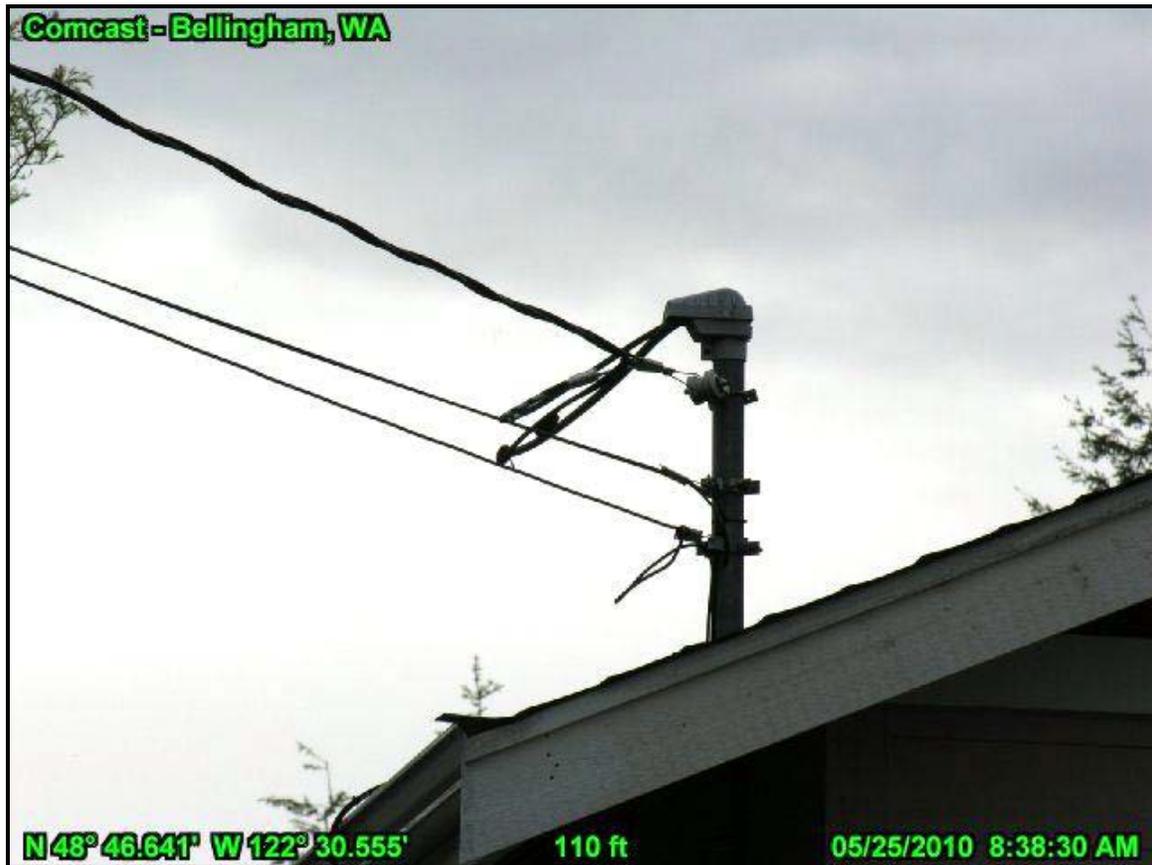
Figure 11: 2904 Cherrywood. Cable drop attached to the power mast above the roof.

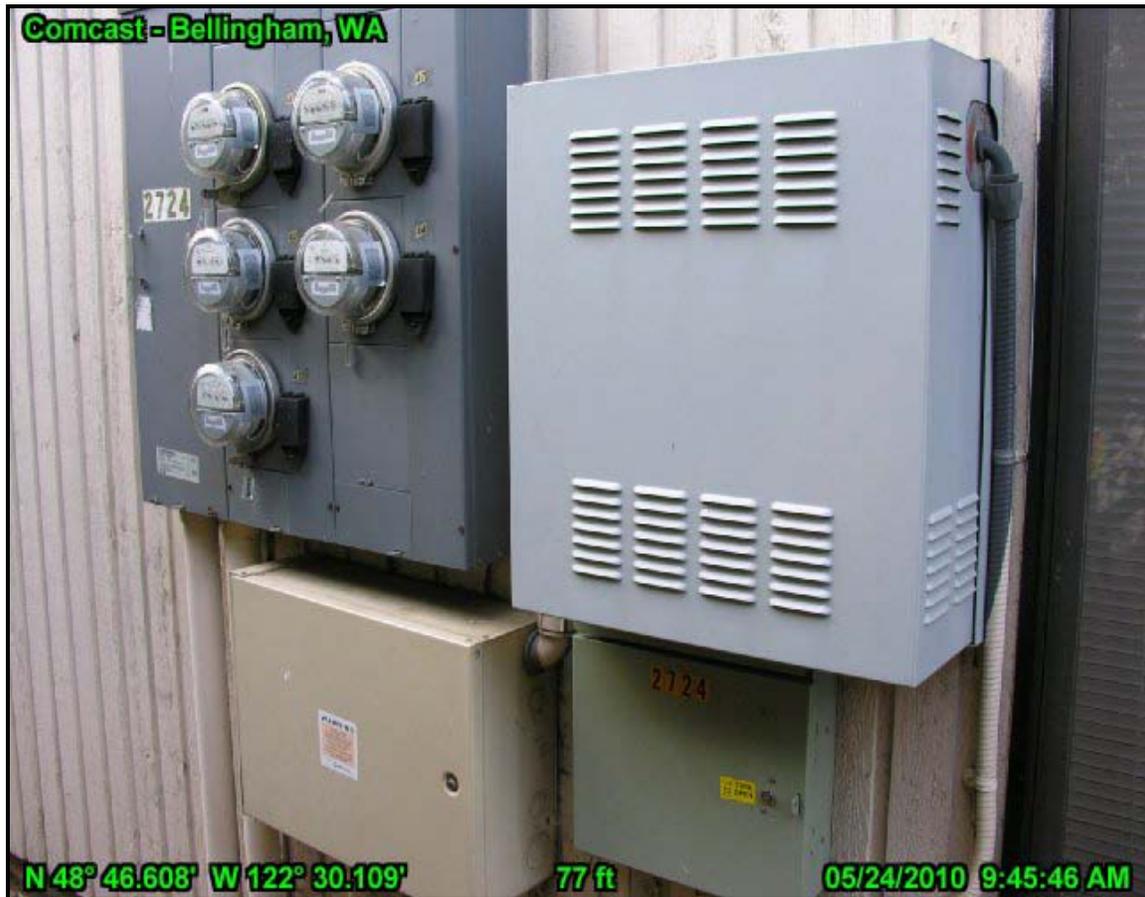
Figure 13: 2724 West Maplewood. Apartment building. Large Gray Box. Arris Apartment MDU Cornerstone multi-customer NIU. Apparently abandoned in place.

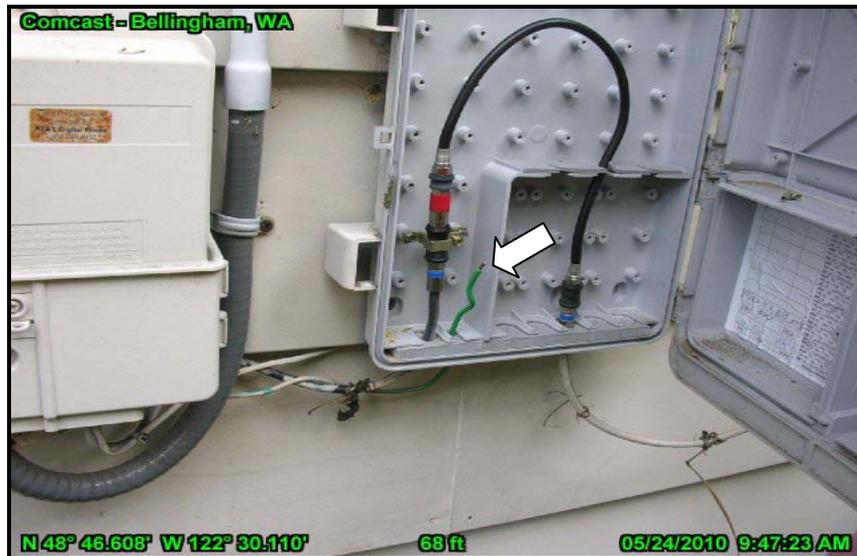
We did find the occasional missing or damaged ground, and those need to be corrected, but for the most part, the grounding of the system is in very good condition.

Figure 14: 2724 Maplewood. Ground wire has broken off of ground block (white arrow).

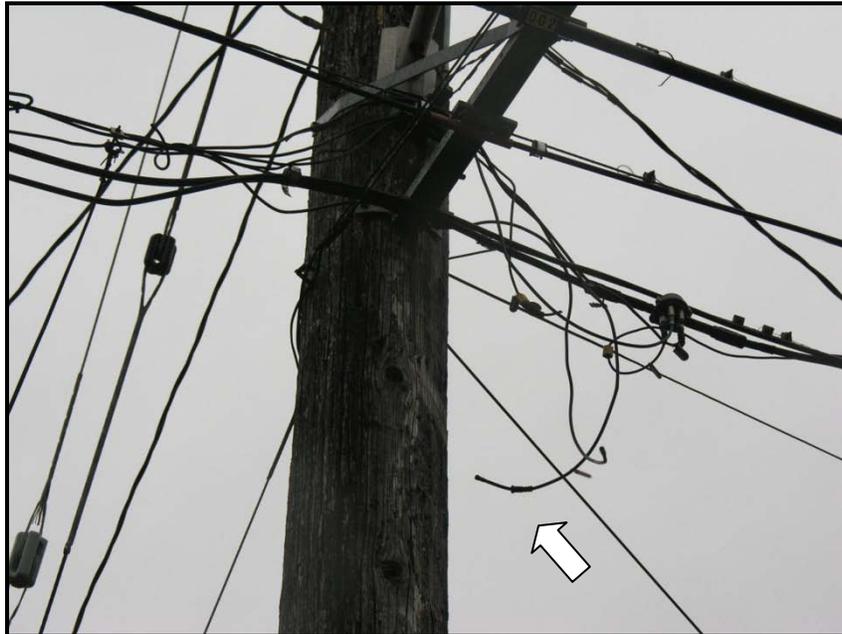
Figure 15: Loose unused cable hanging freely from overhead pole

Comcast should continue to impress upon their staff the importance of high quality installation work as well as the need for high quality maintenance. Constant quality control inspections and notification of observed infractions will help to address this issue.

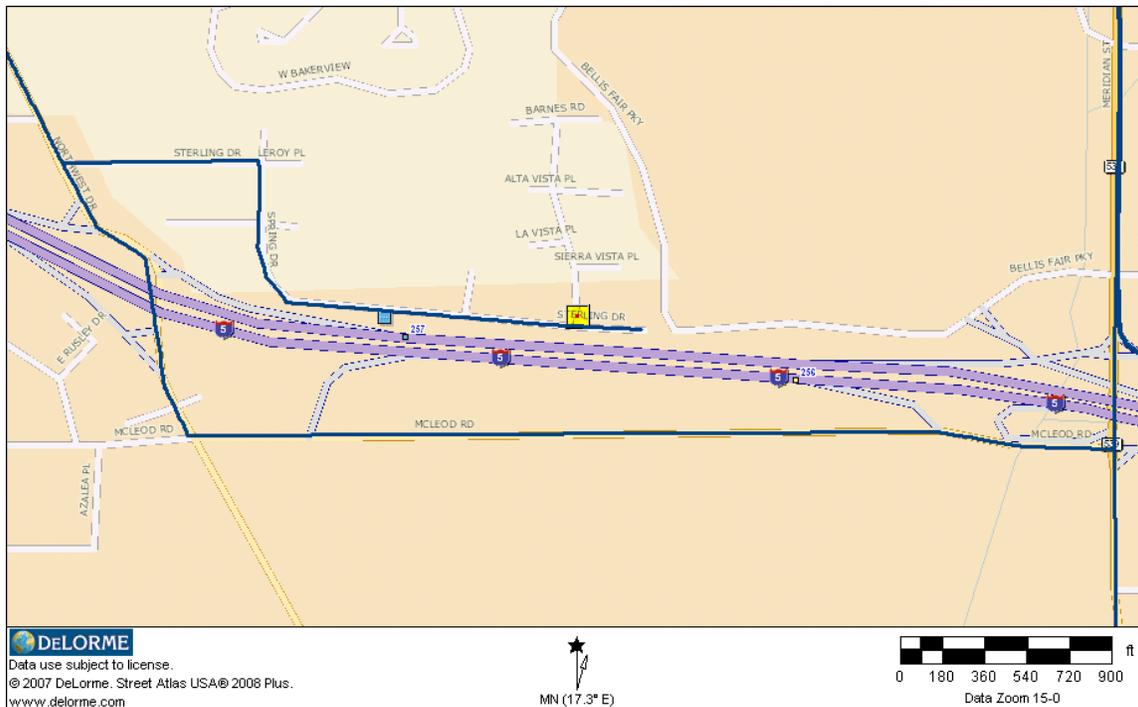
Corner of Pana Vista and Sterling Drive
Distribution cables ty-wrapped to power riser conduit.

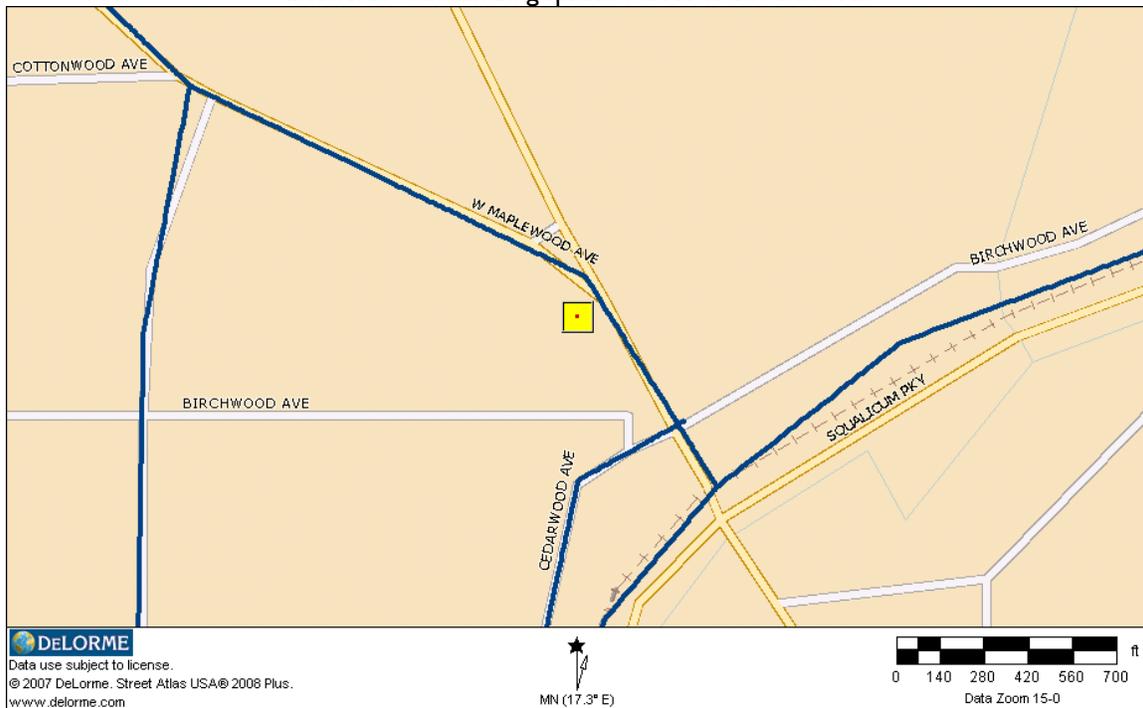
3224 Northwest Avenue. Temporary drop connected to "500 to F" connector. Line is disconnected now. Interferes with climbing space. Needs to be removed.

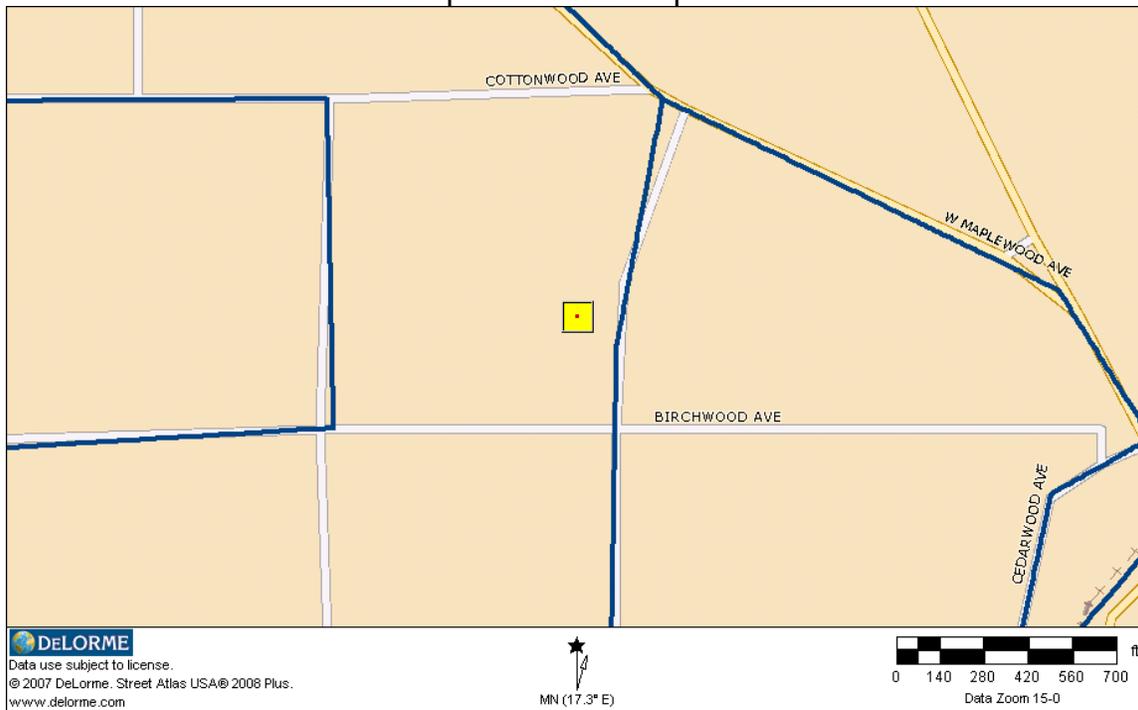
3214 Firwood
Cable drop attached to the power mast.

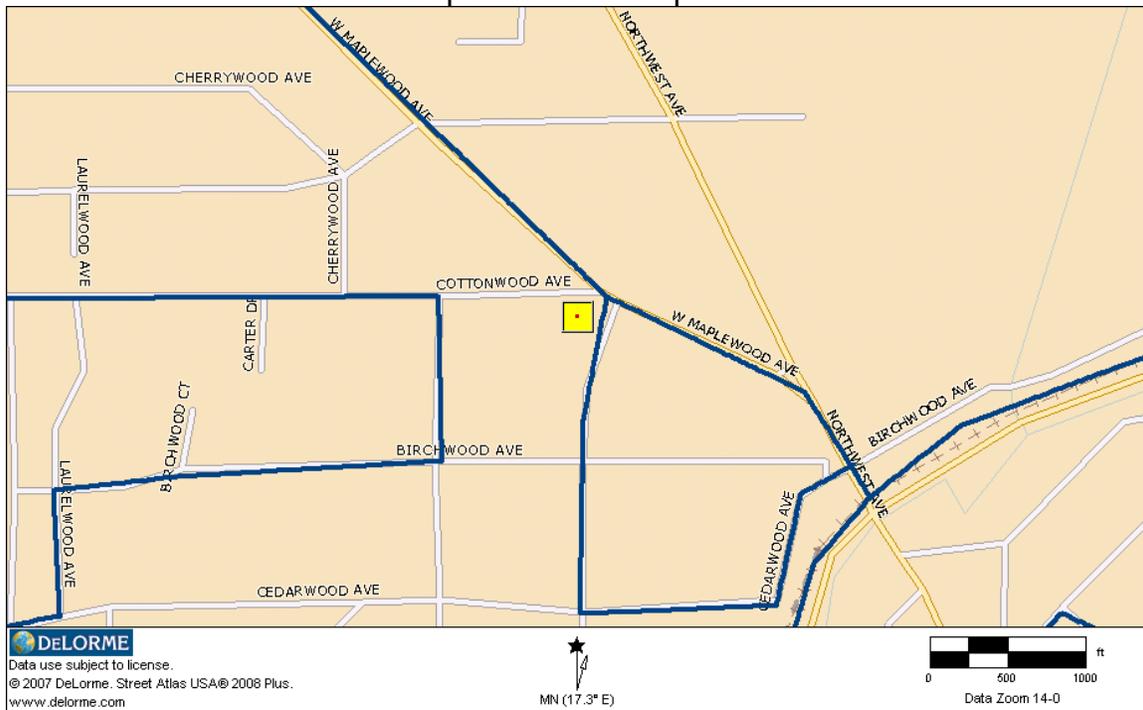
3245 Firwood
Cable drop attached to the power mast.

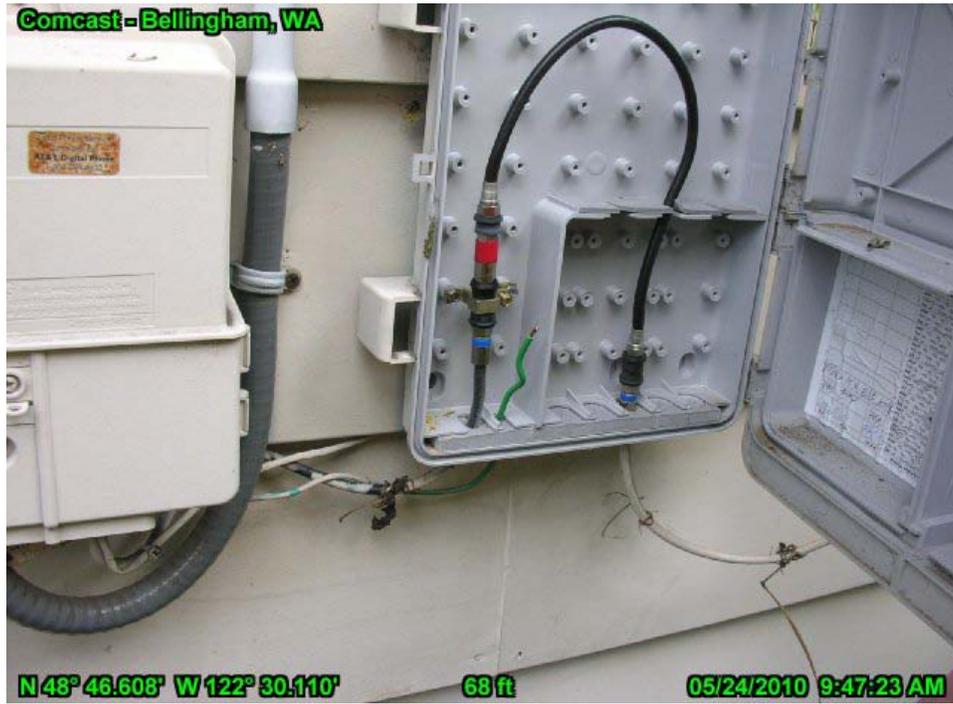
2724 Maplewood
Apparently abandoned Arris Cornerstone MDU telephony unit.

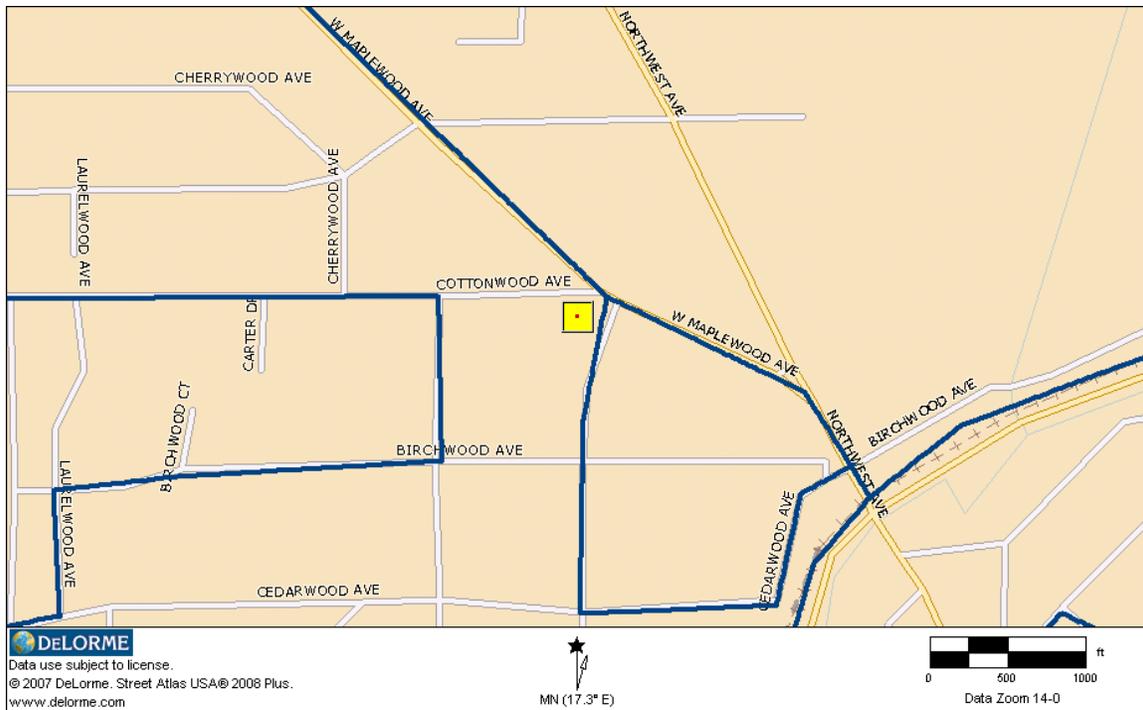
2728 Maplewood Avenue. Ground wire is broken off.

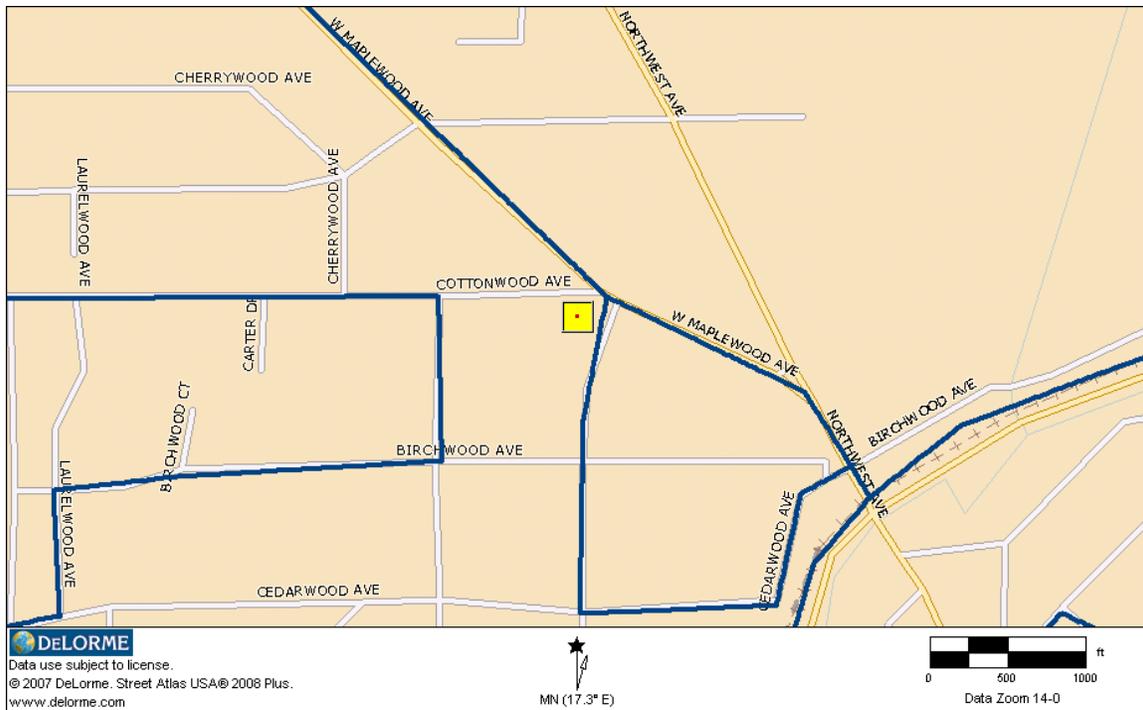
2724 Maplewood Avenue. Ground wire broken at meter clamp.

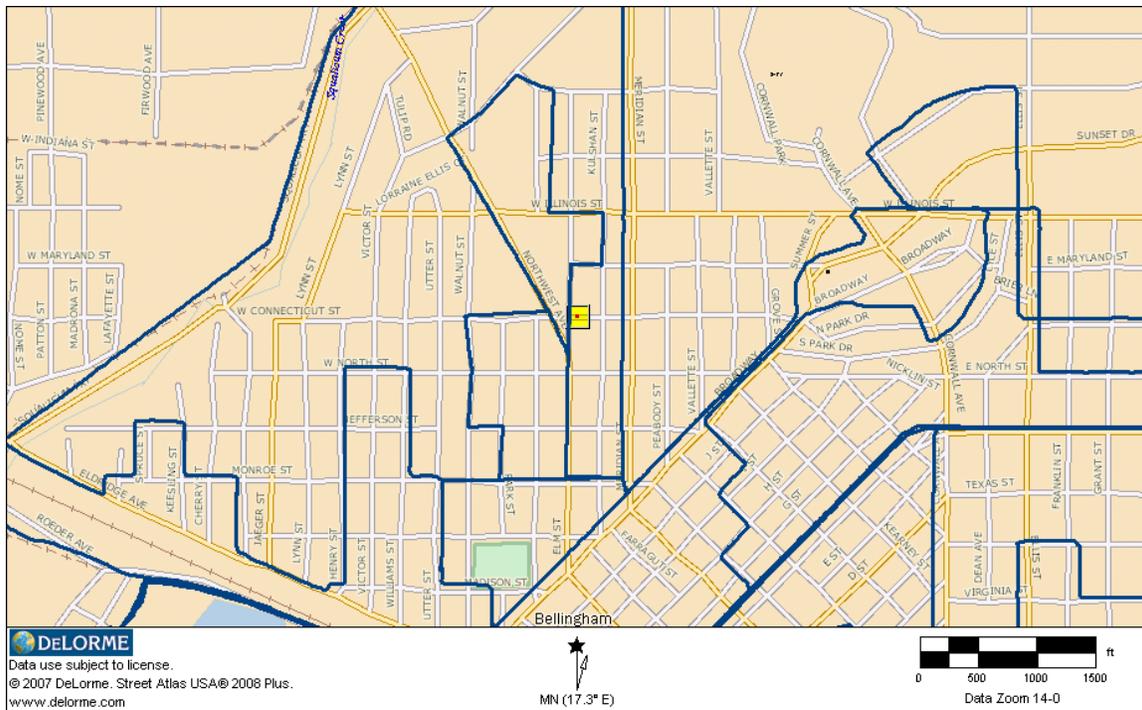
2823 Elm Street. Cable drops hit the power mast, wiring ty-wrapped to the power Mast conduit. Ground wire not secured.

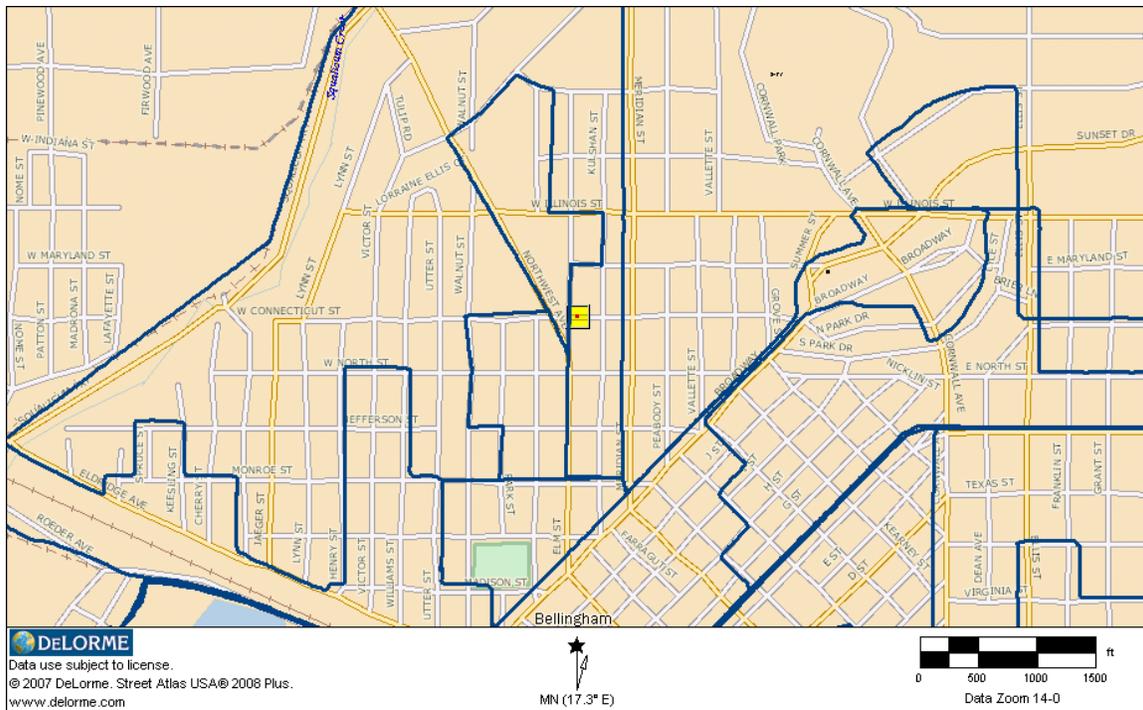
2823 Elm Street. Cable drops hit the power mast, wiring ty-wrapped to the power mast conduit. Ground wire not secured.

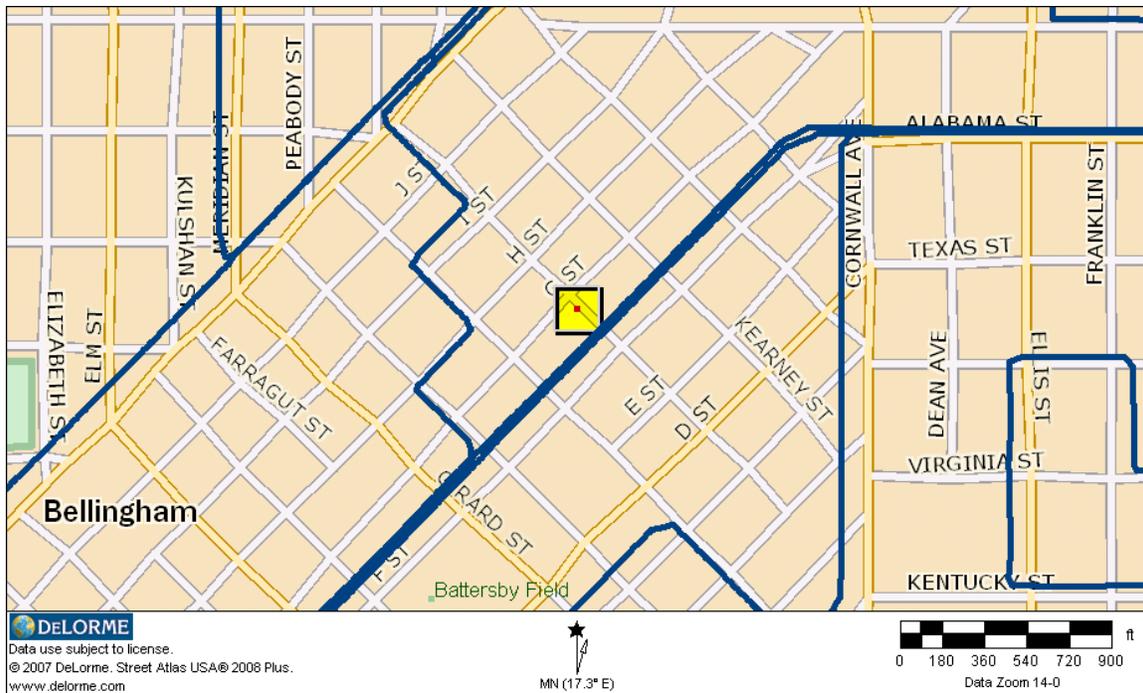
Rear of 2300 G Street. Not grounded.

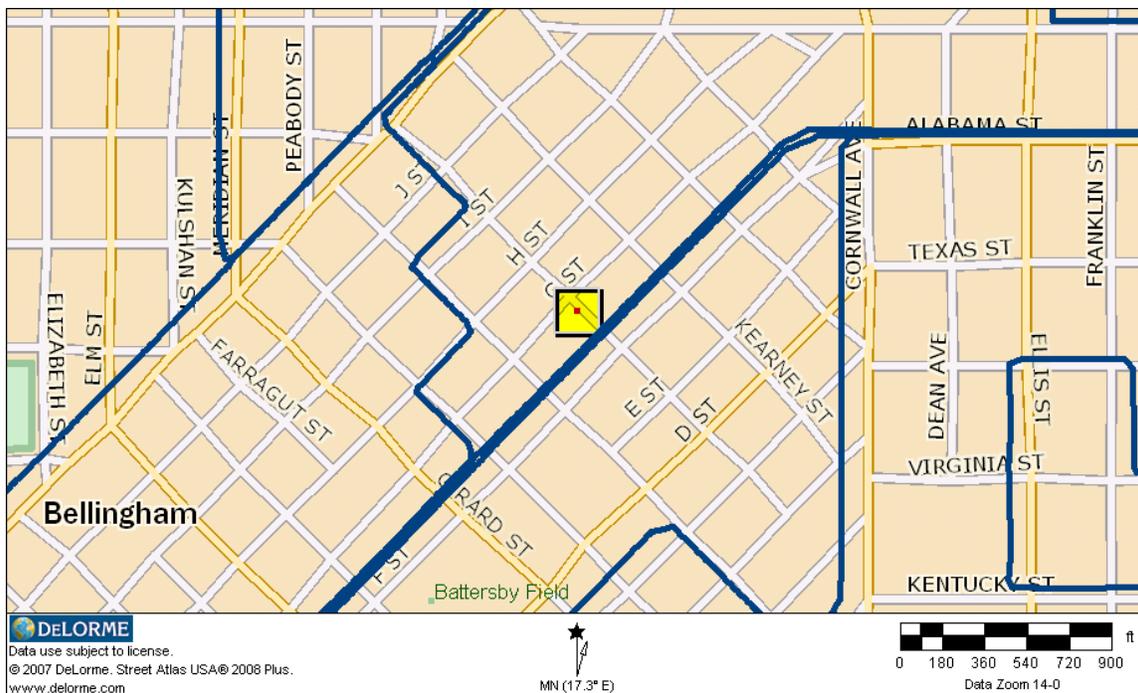
Rear of 2302 G Street. Apartment above Garage. Grounded to the power mast conduit.
Multiple pipe connections between ground and meter.

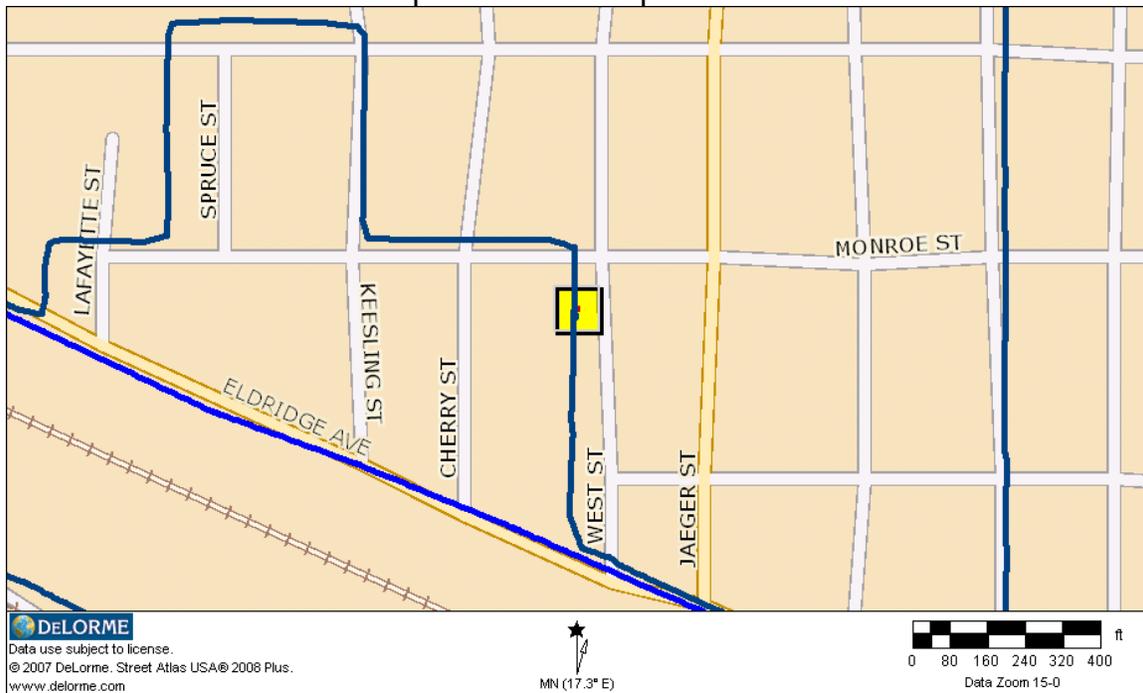
2339 West Street
Drop attached to the power mast

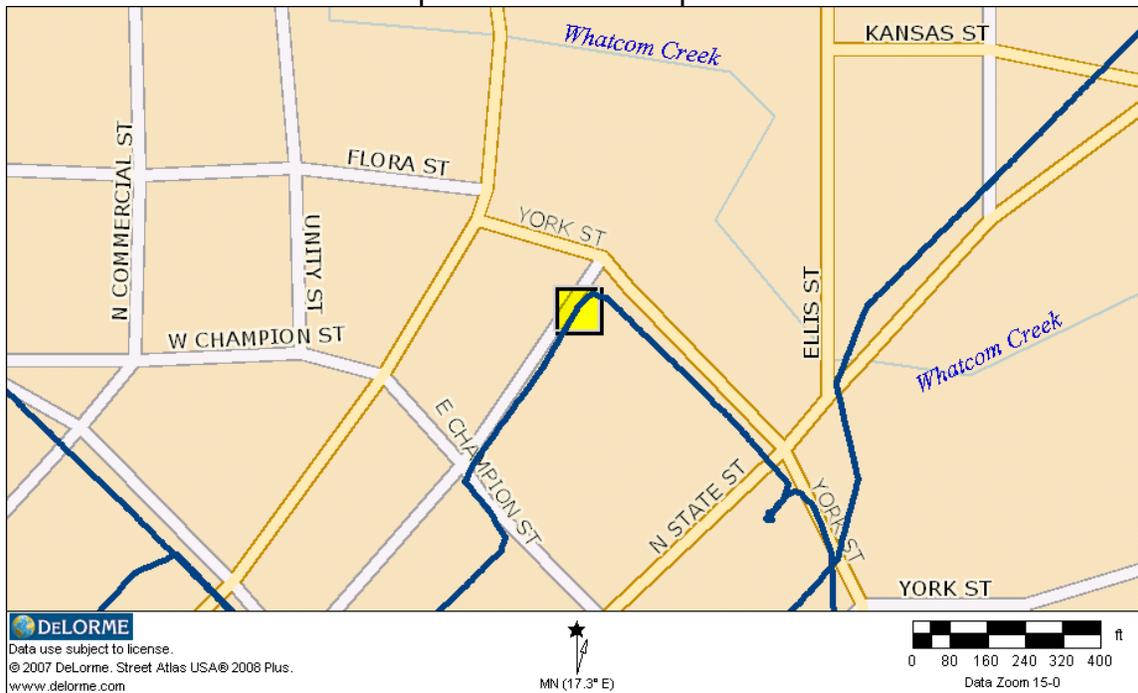
Corner of Railroad Ave and York St
Fiber optic enclosure tied up to strand.
