Physical Plant Inspection of Comcast Communications in the City of Bellingham, Washington

May 2010

Inspected by
Kramer.Firm, Inc.

**PHYSICAL PLANT SAFETY INSPECTION
OF COMCAST CABLE COMMUNICATIONS
IN THE CITY OF BELLINGHAM, WASHINGTON**

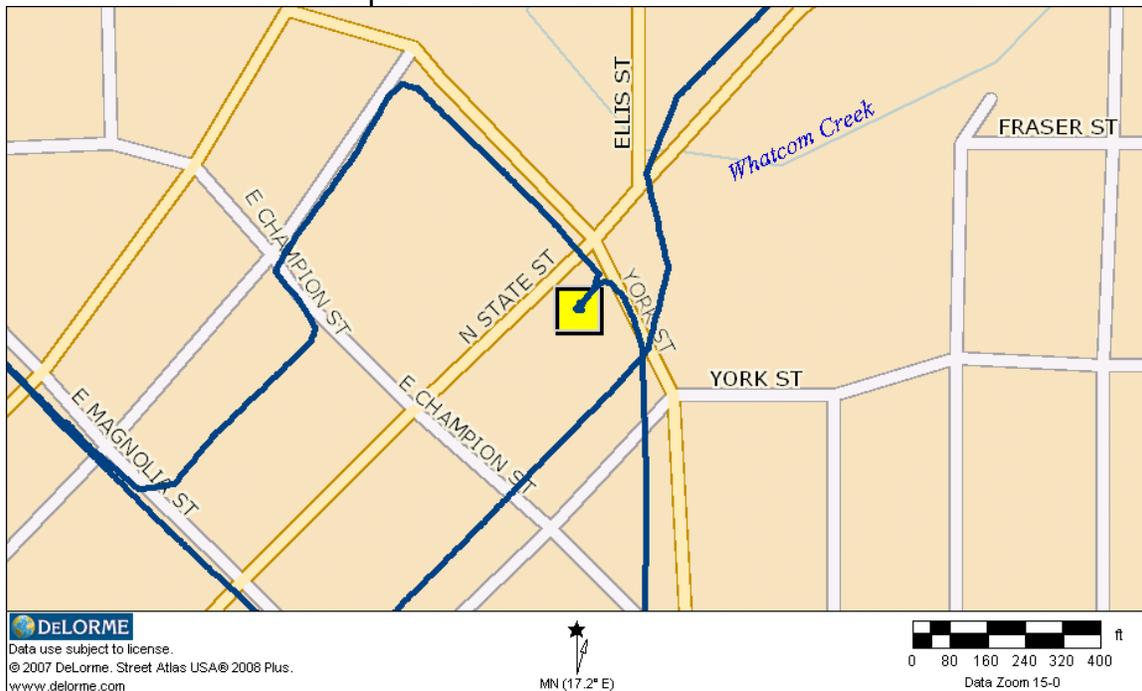
Next to the Firestone store on North State Street.
Fiber optic enclosure and cables tied to strand.

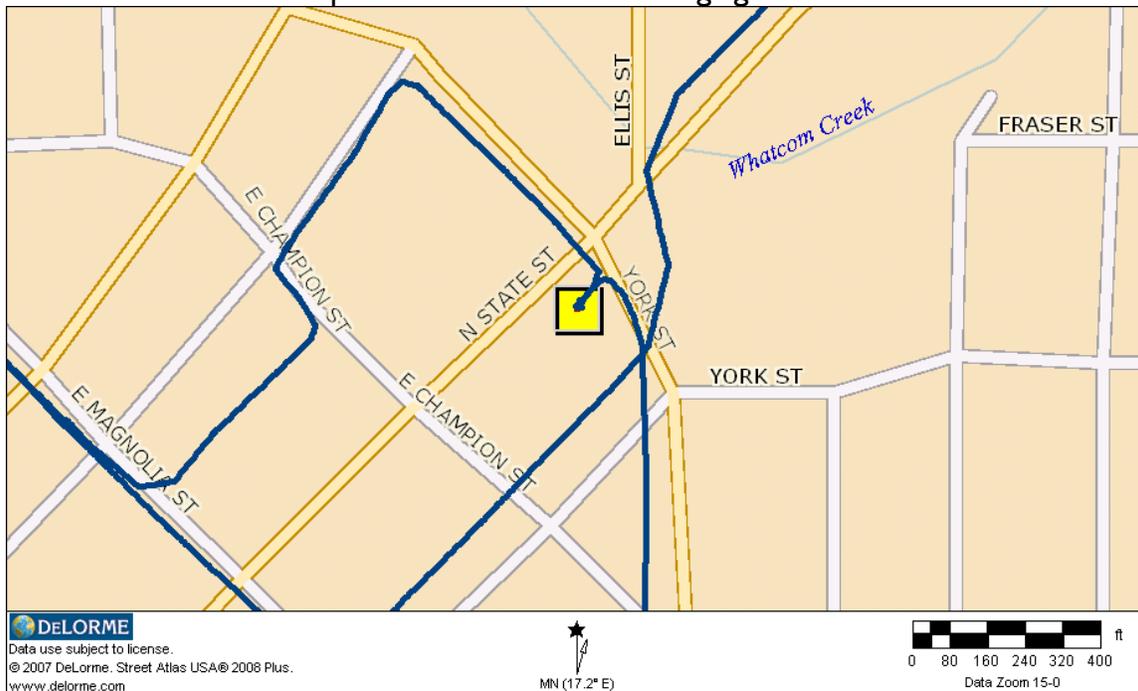
Behind the Firestone store on North State Street.
Fiber optic enclosure and fibers hanging from strand.

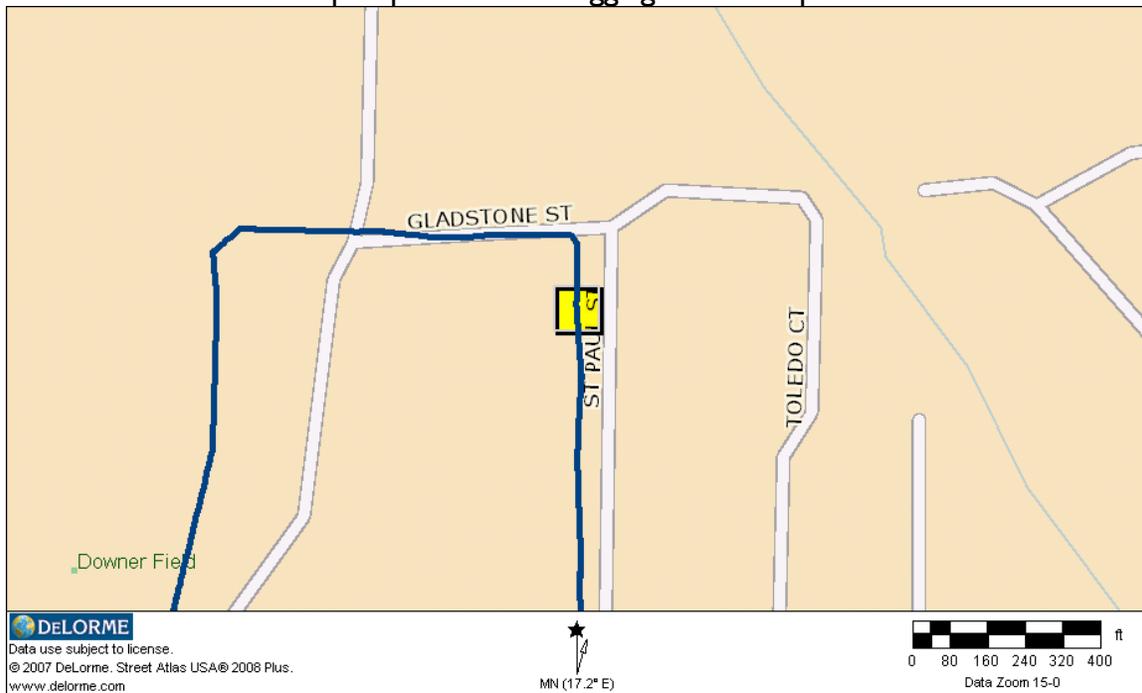
Multiple spans of cable sagging below telephone.

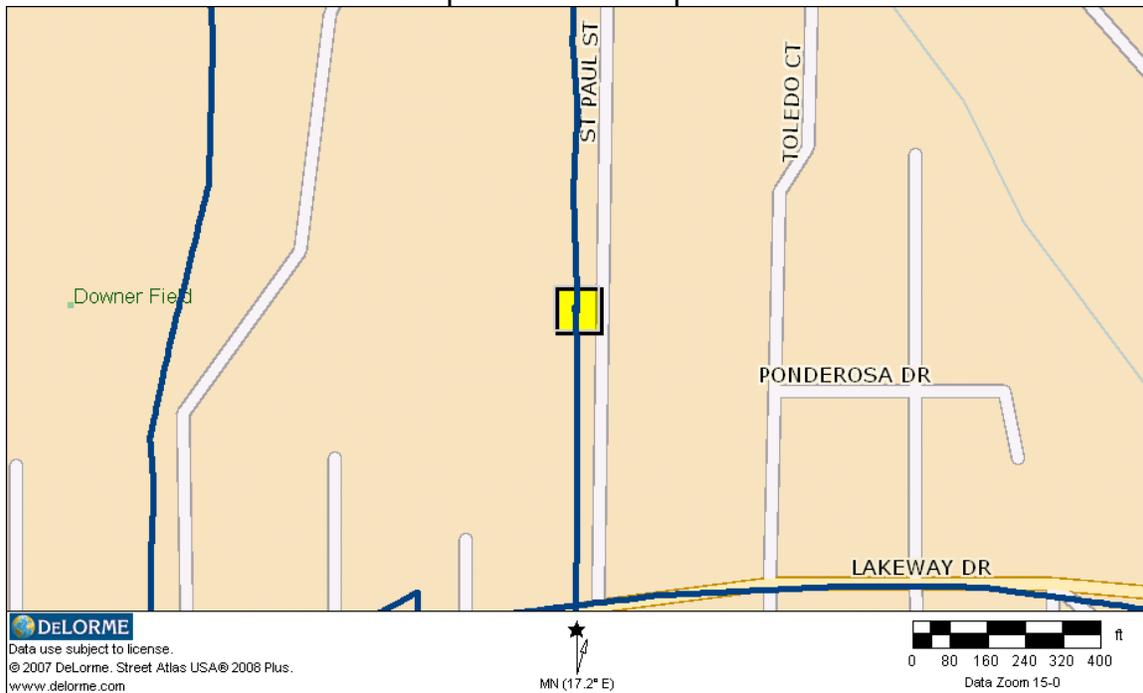
Cable drop attached to the power mast.

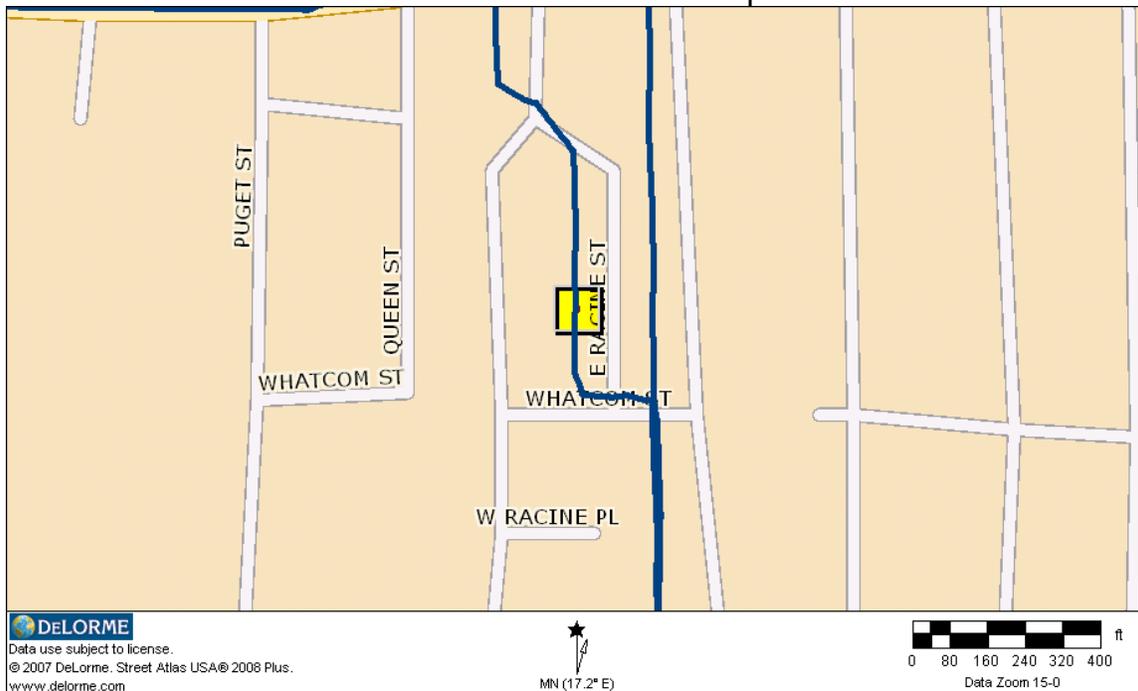
1213 East Racine Street.
Riser cables not secured to the pole.

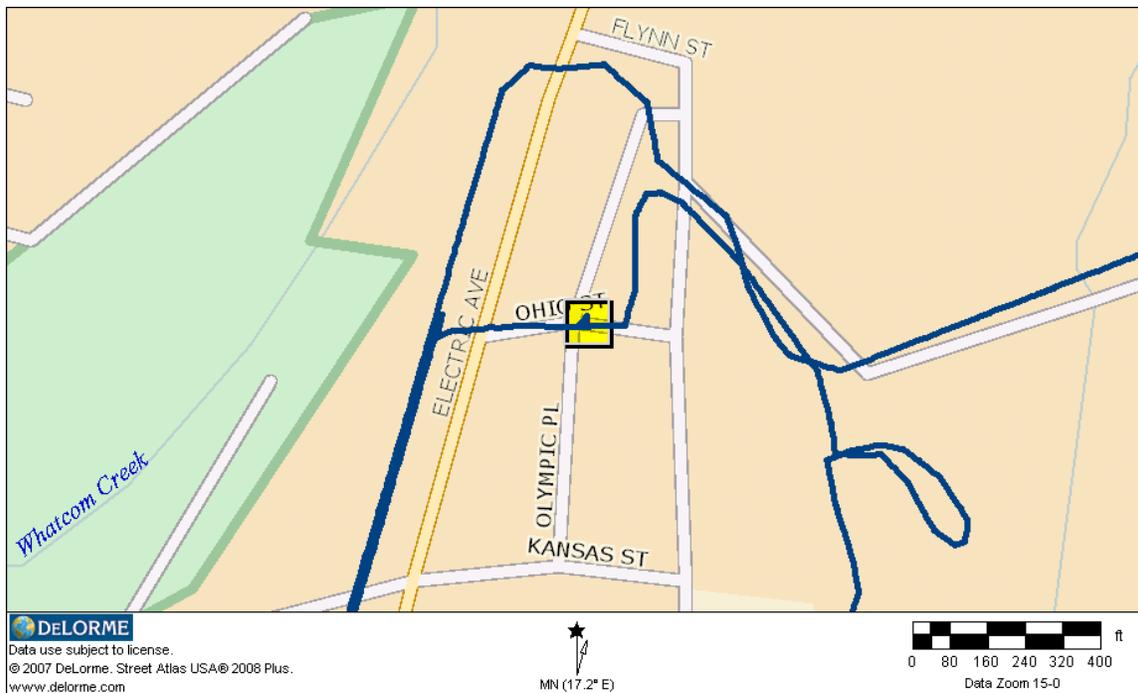
1901 Ohio Street.
Cable drop attached too close to power at the house.

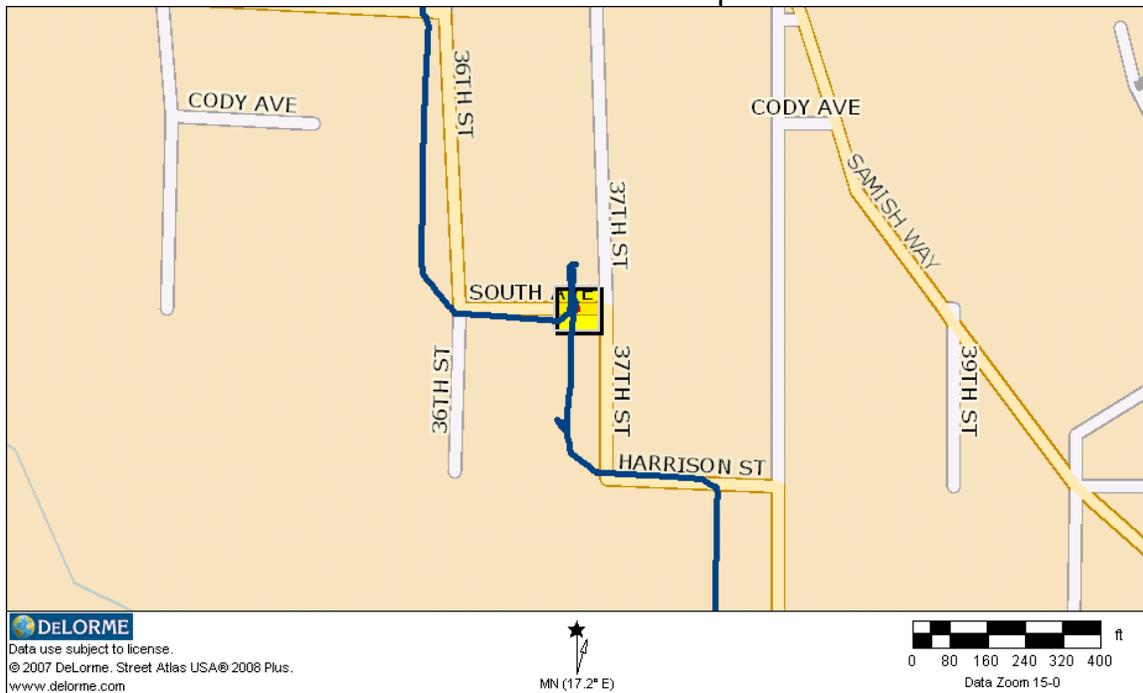
Corner of 37th Street and South Street
Cable riser not secured to pole.

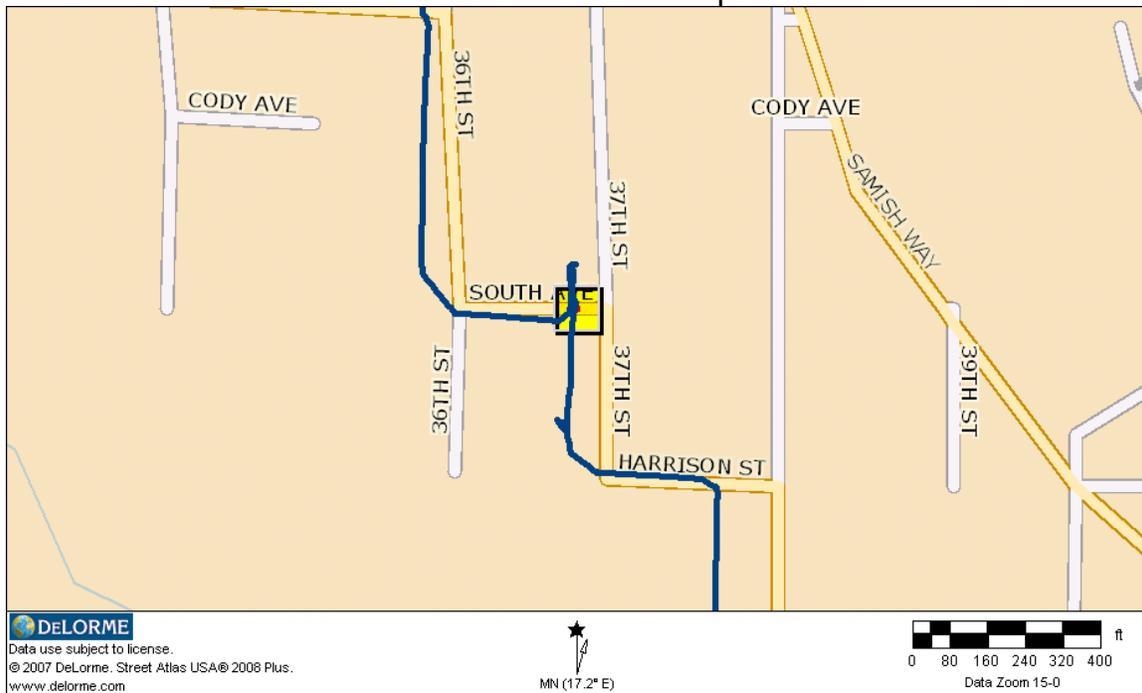
Corner of 37th Street and South Street
Cable riser not secured to pole.

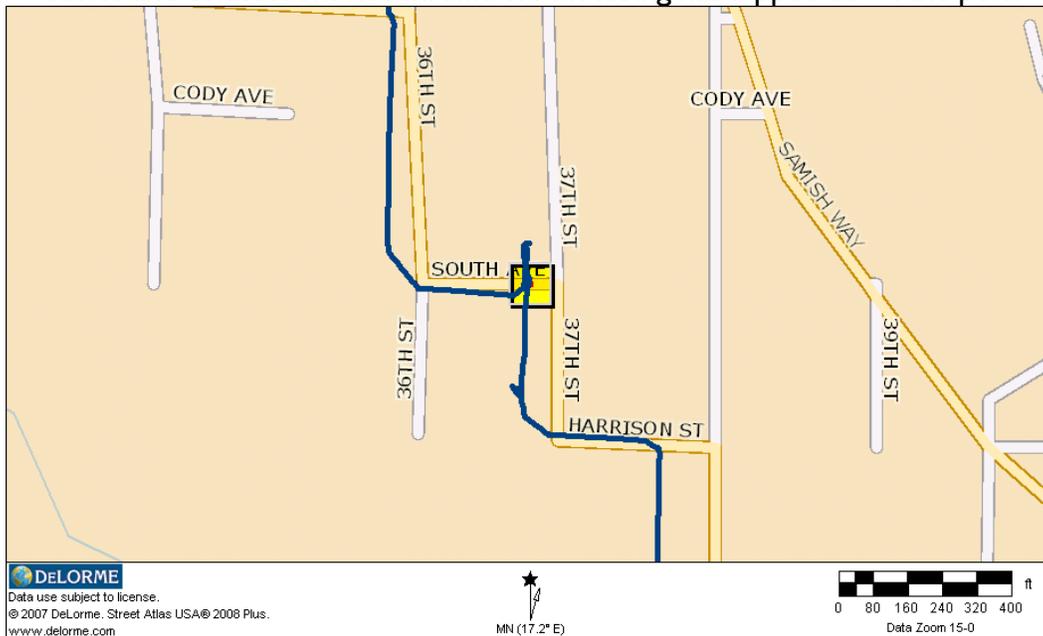
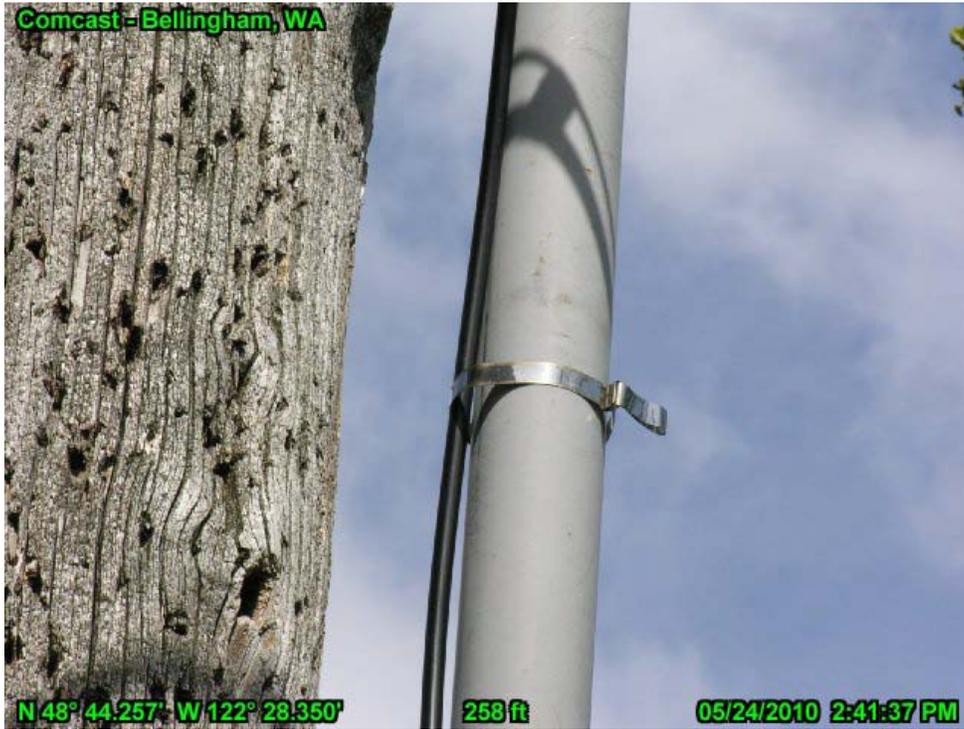
Poor pole change out. "Preforms" and deadens not properly attached.
Cables and connections not shrunk. Shrink tubing has slipped down the pole.

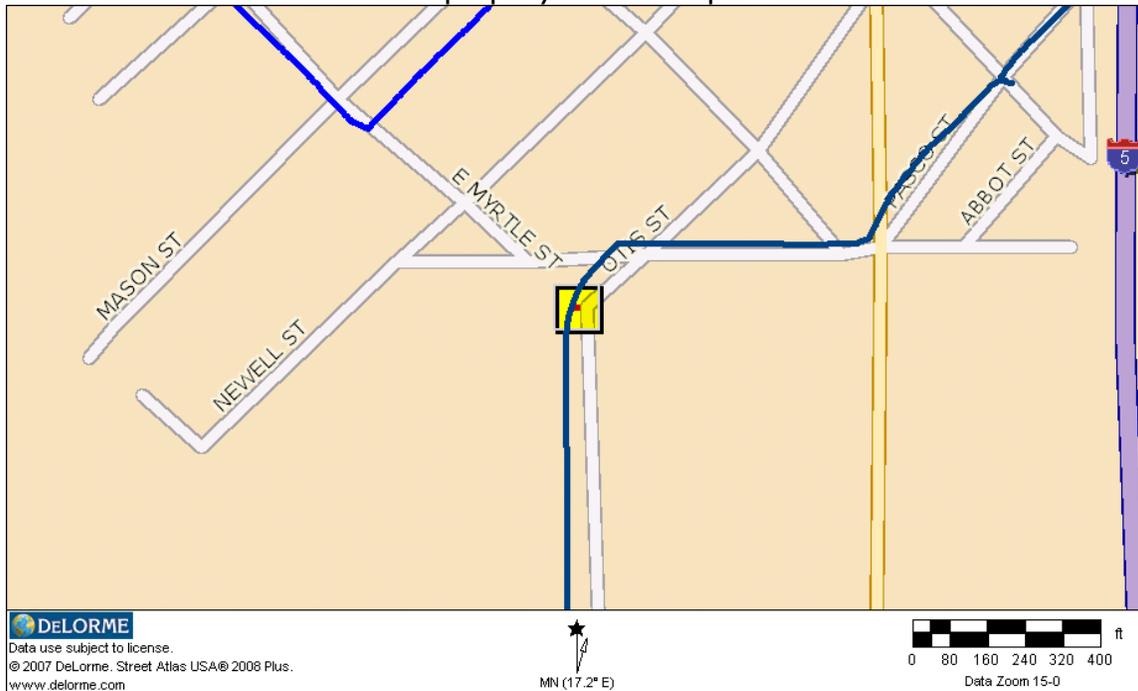
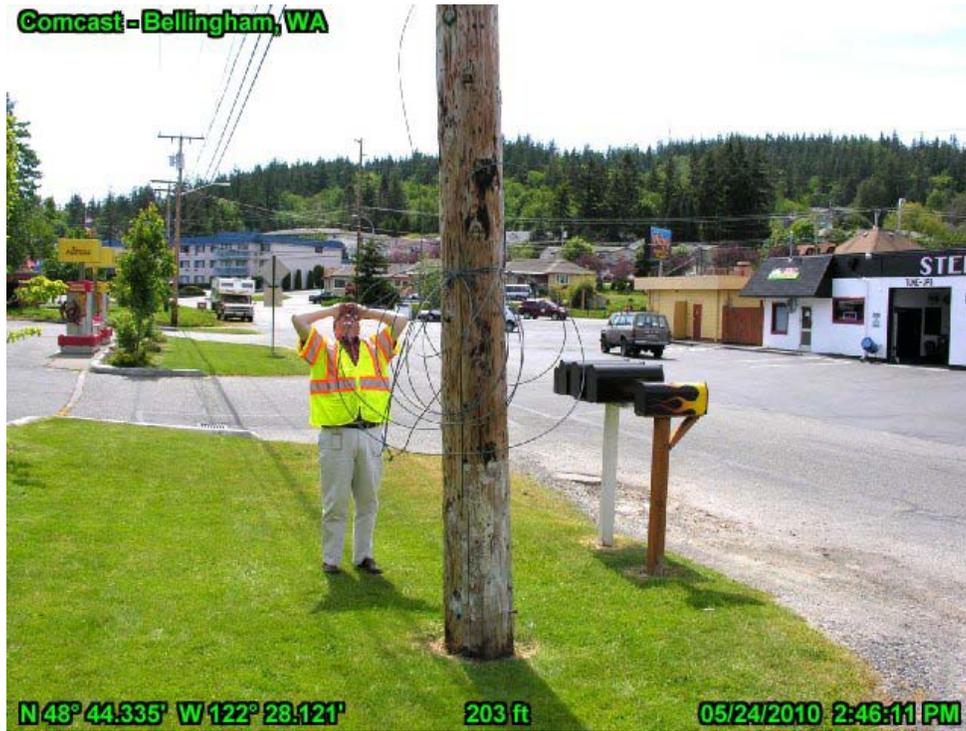
Entrance to 202 North 34th Street
0.500 cable riser improperly secured to power riser conduit

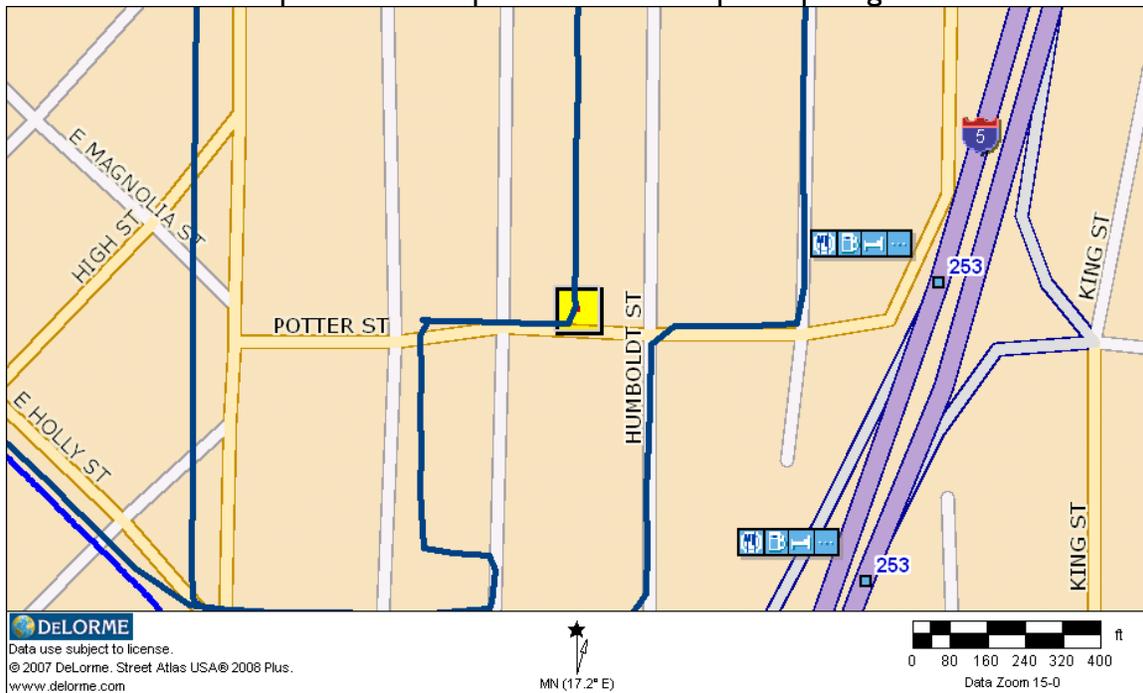
Potter between Humboldt and Grant Streets
Fiber optic coils tied up to strand. Incomplete splicing work.

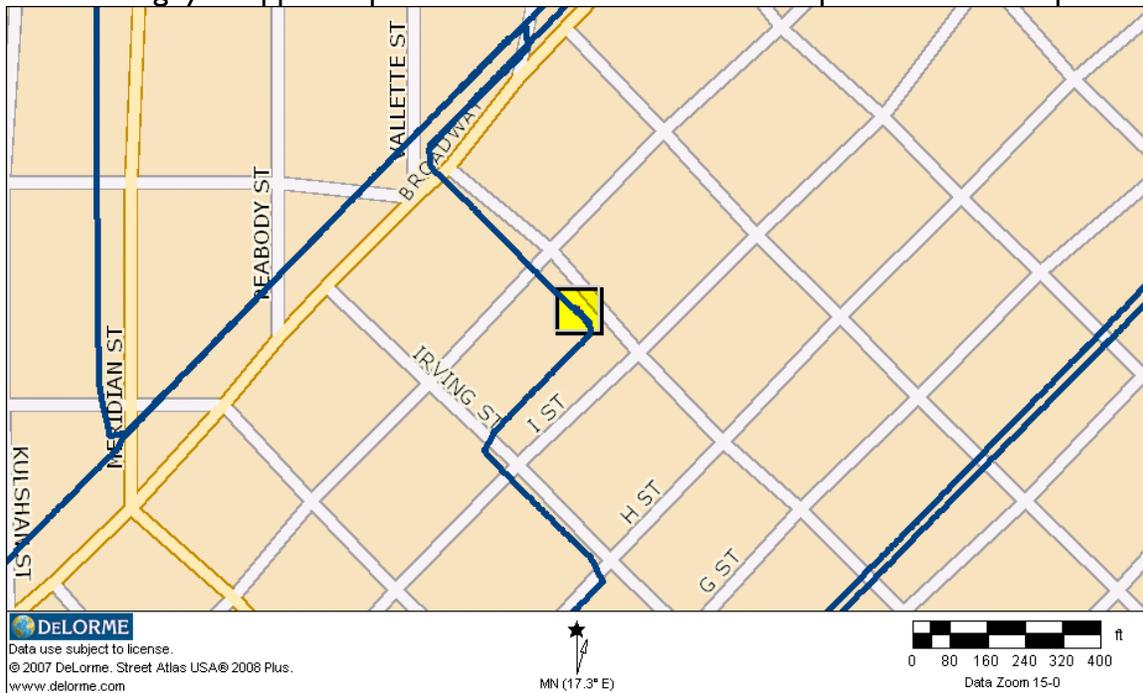
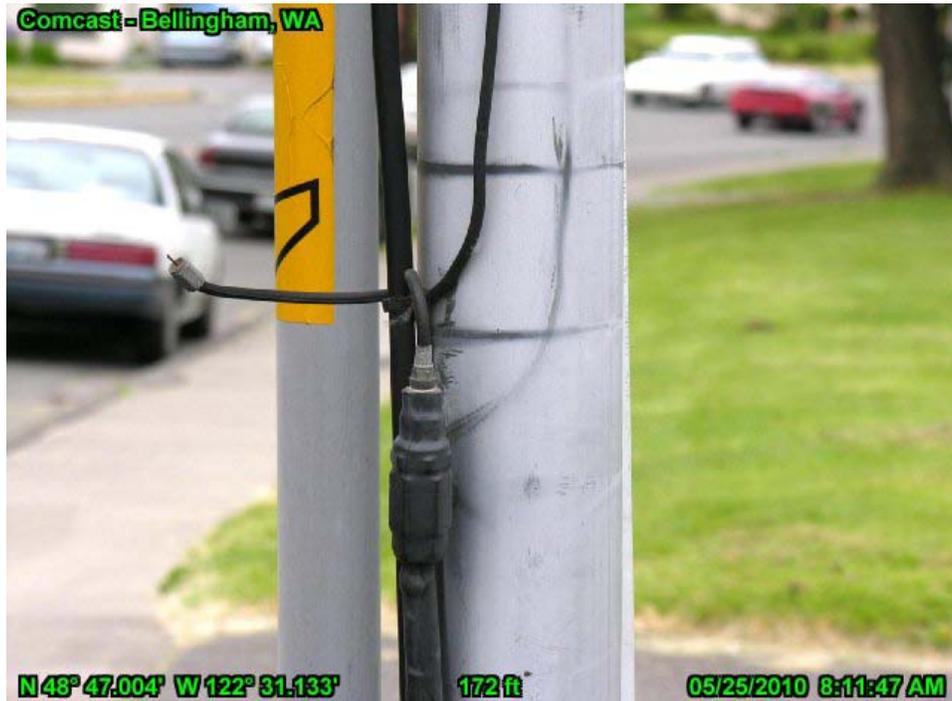
Cable wiring ty-wrapped to power riser conduits. Attachment point too close to power.

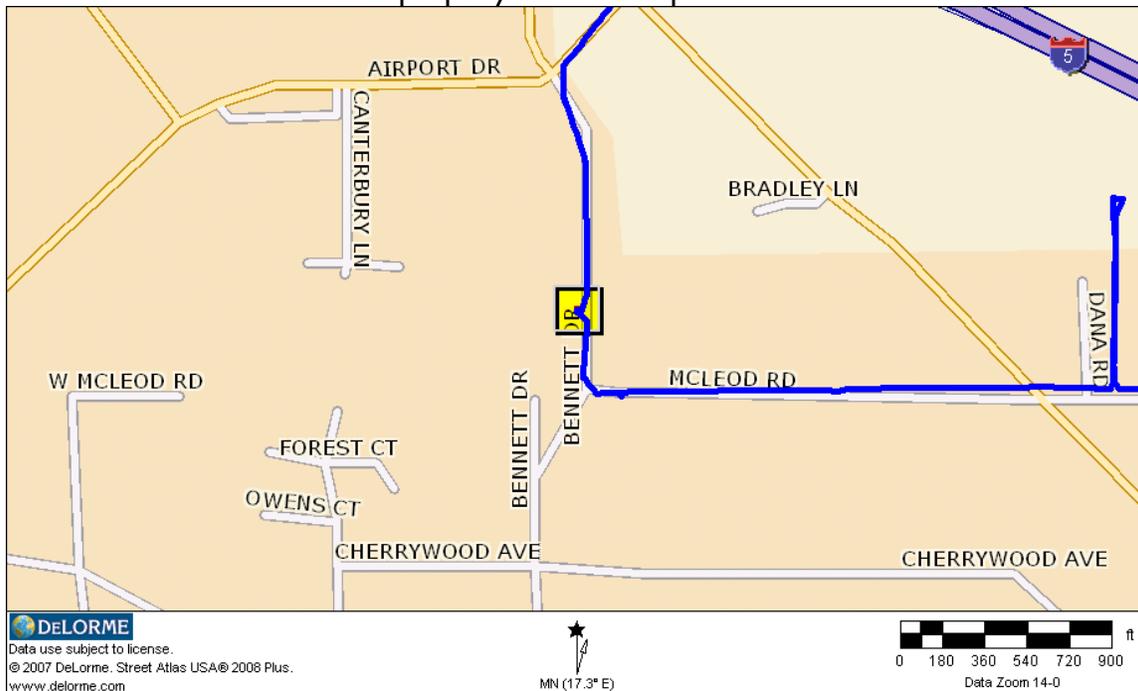
3615 Bennett Drive.

Riser cable improperly attached to power riser conduit.

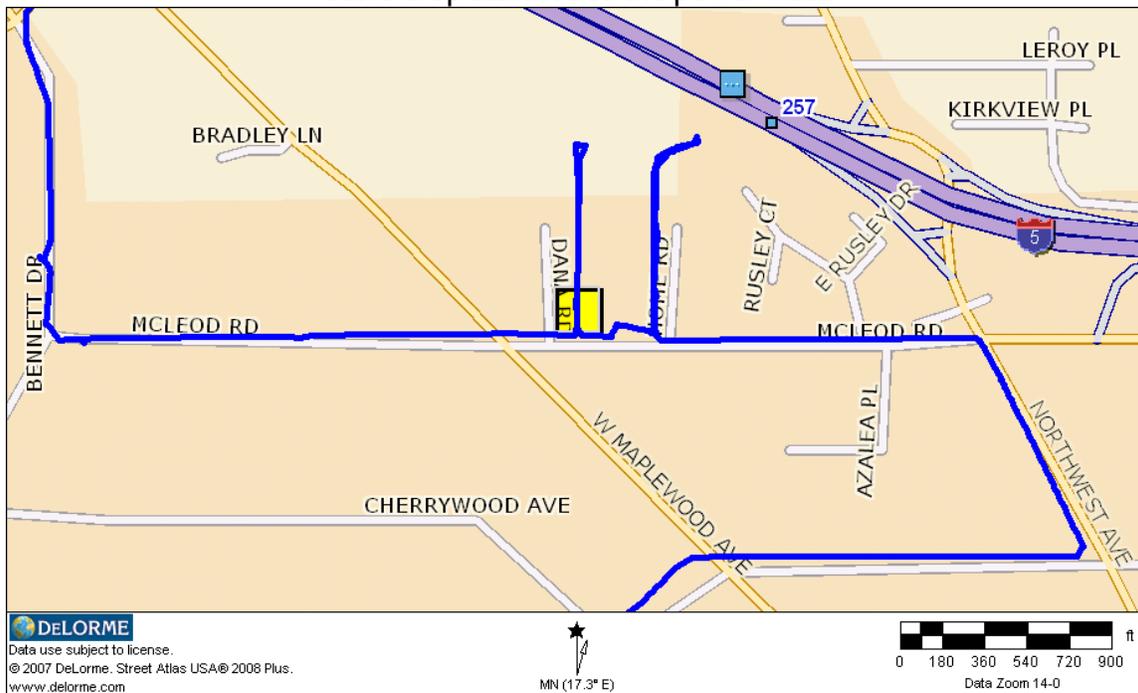
2938 McCleod Road
Cable drop attached to the power mast.

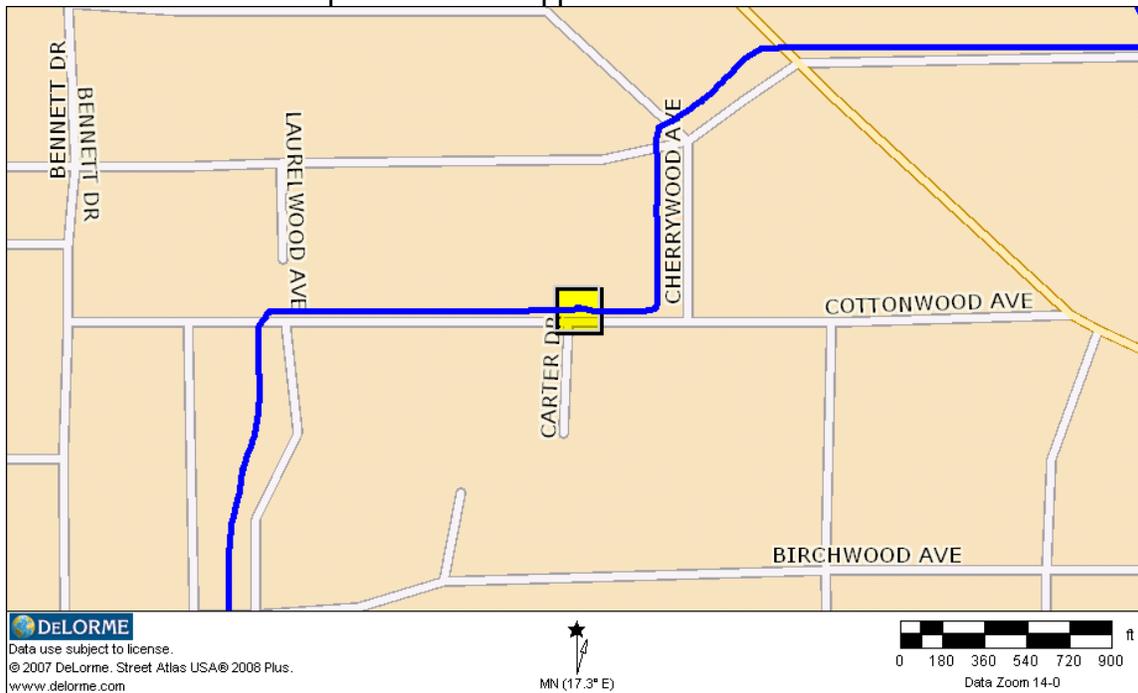
3017 Cottonwood Avenue
Telephone cable wrapped around CATV Cable.

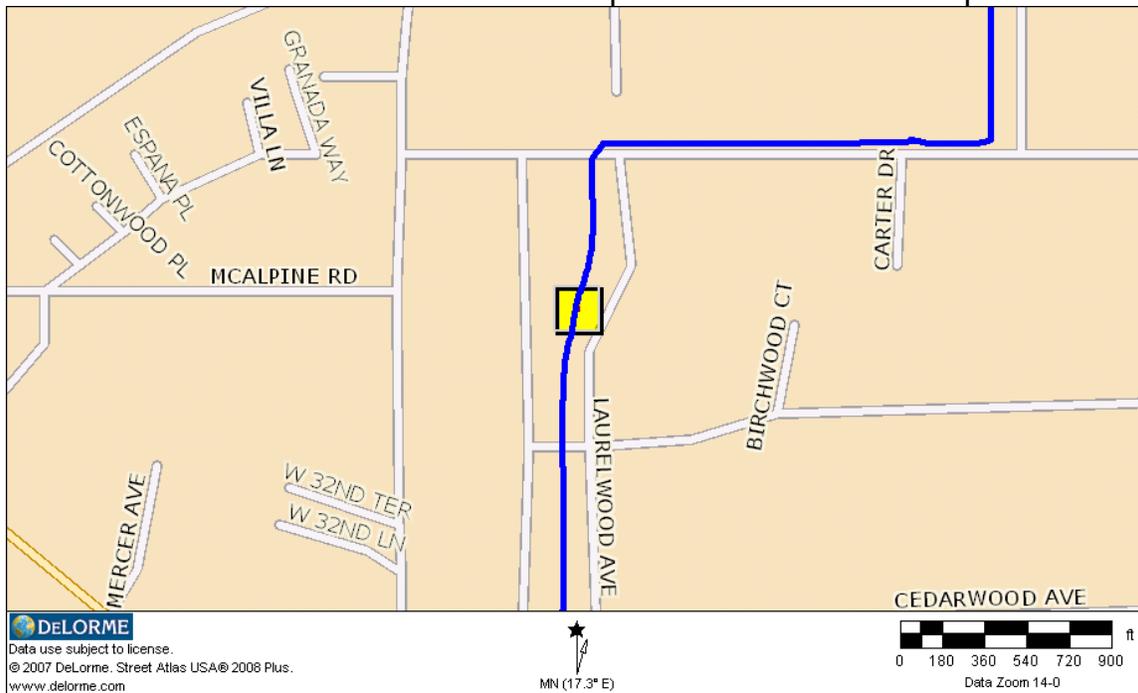
Cable strand mounted too close to power transformer and drops.

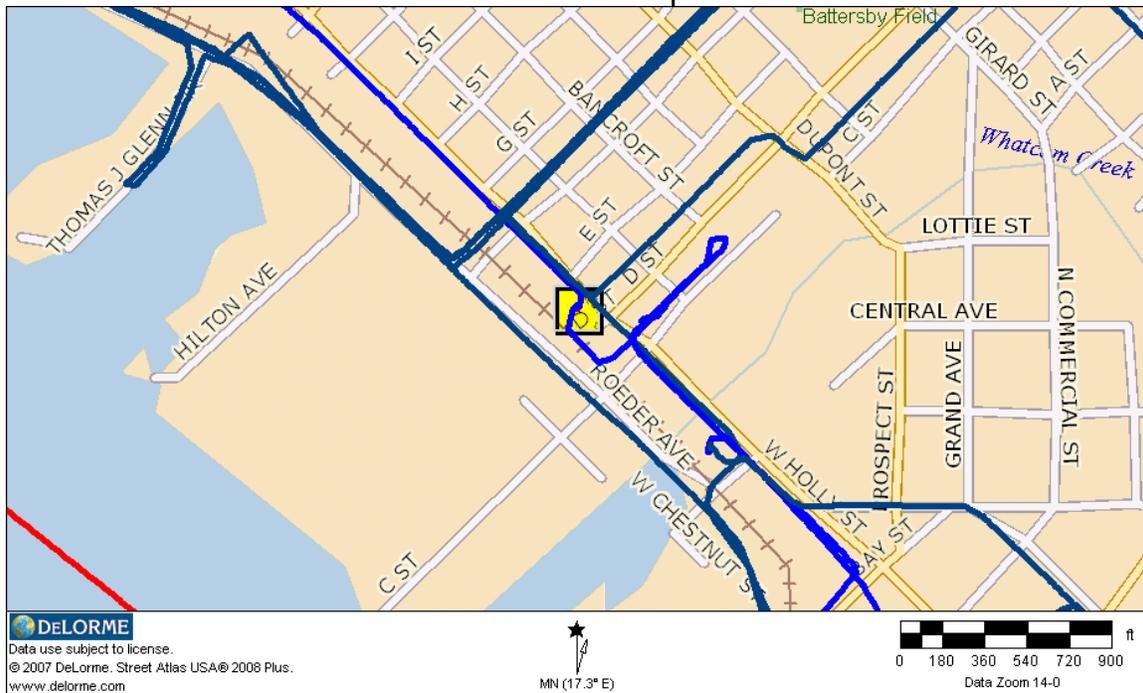
Corner of D Street and Holly Street
Fiber and enclosure tied up to strand.

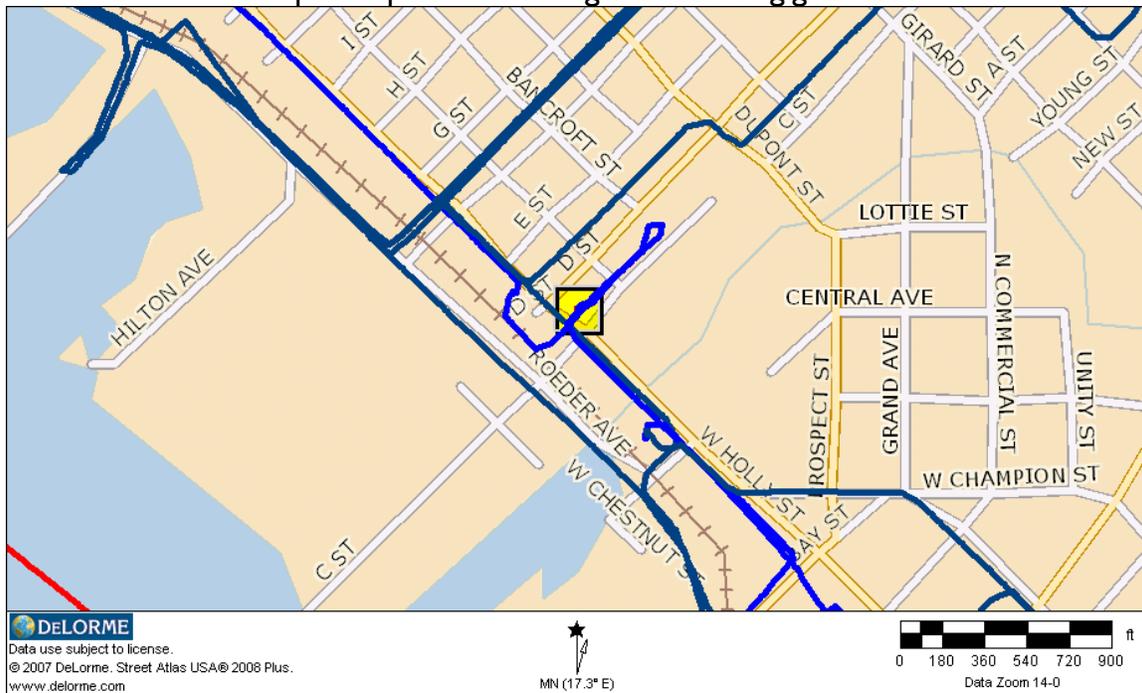
Multiple drops enter building without being grounded.

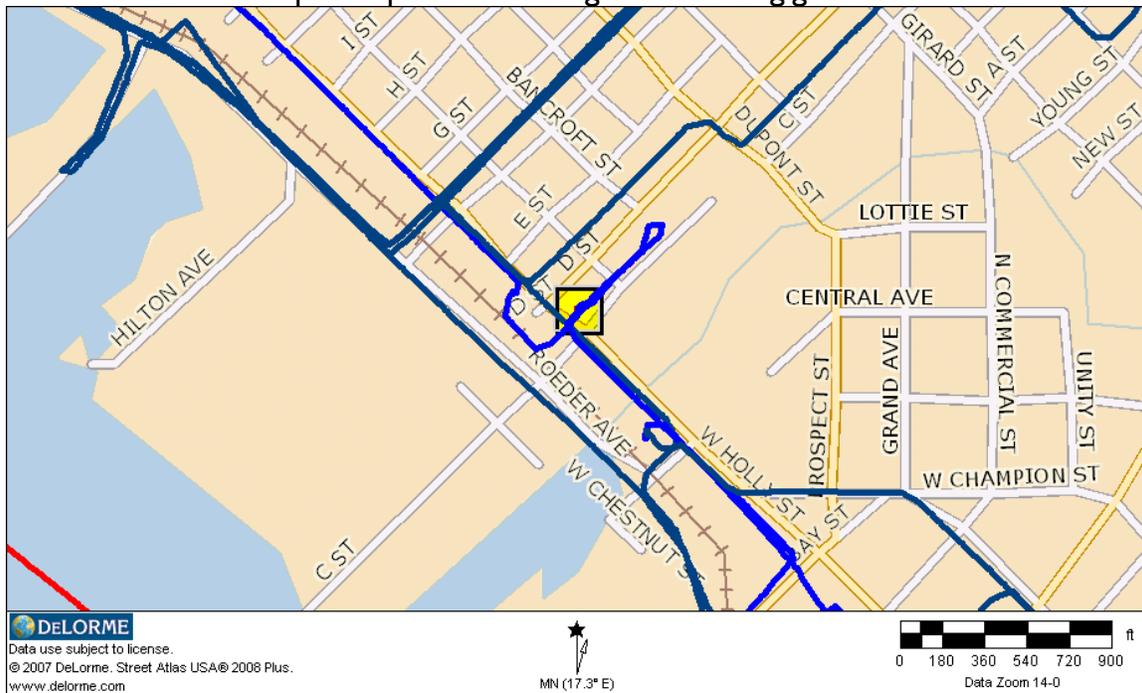
Multiple drops enter building without being grounded.

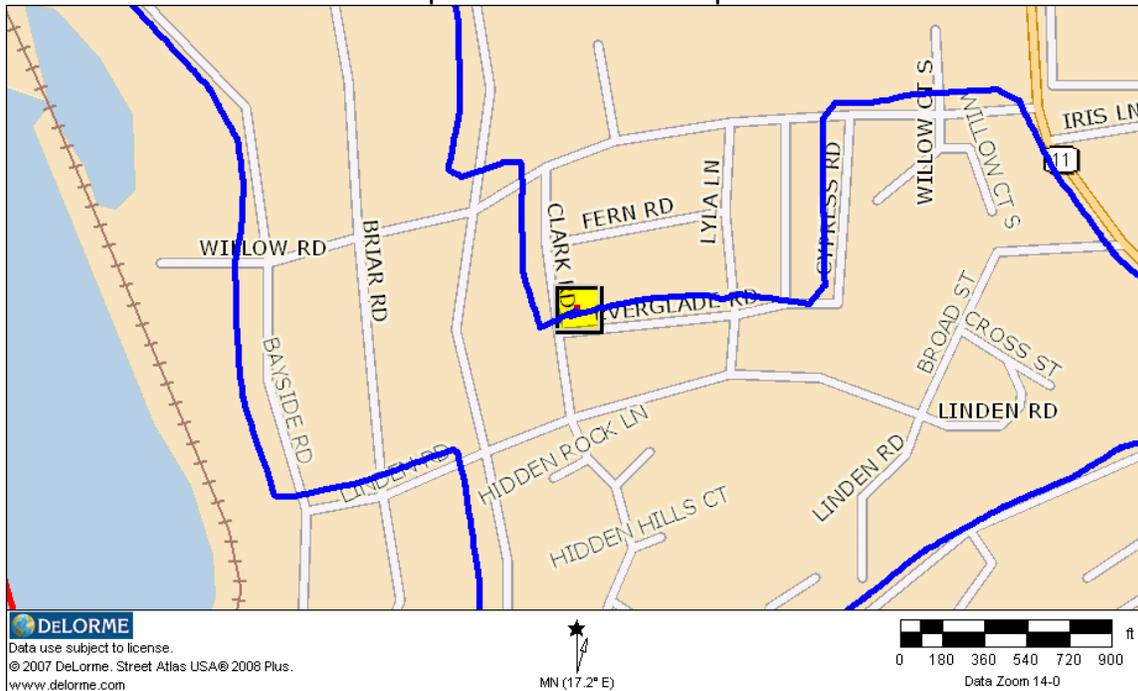
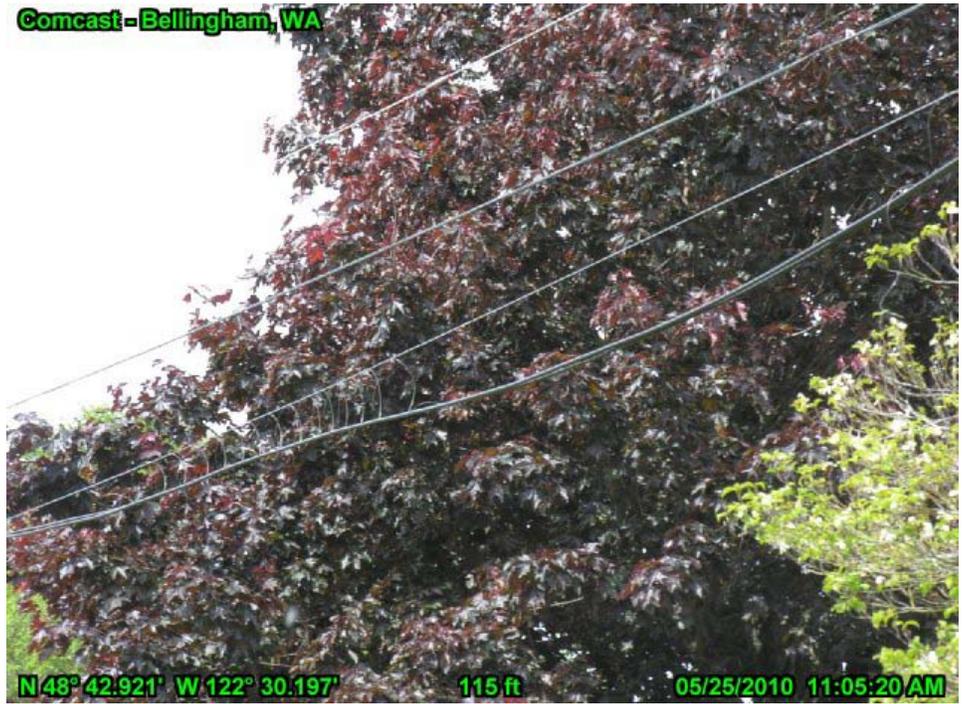
510 Everglade Road
Drop riser not secured to pole.

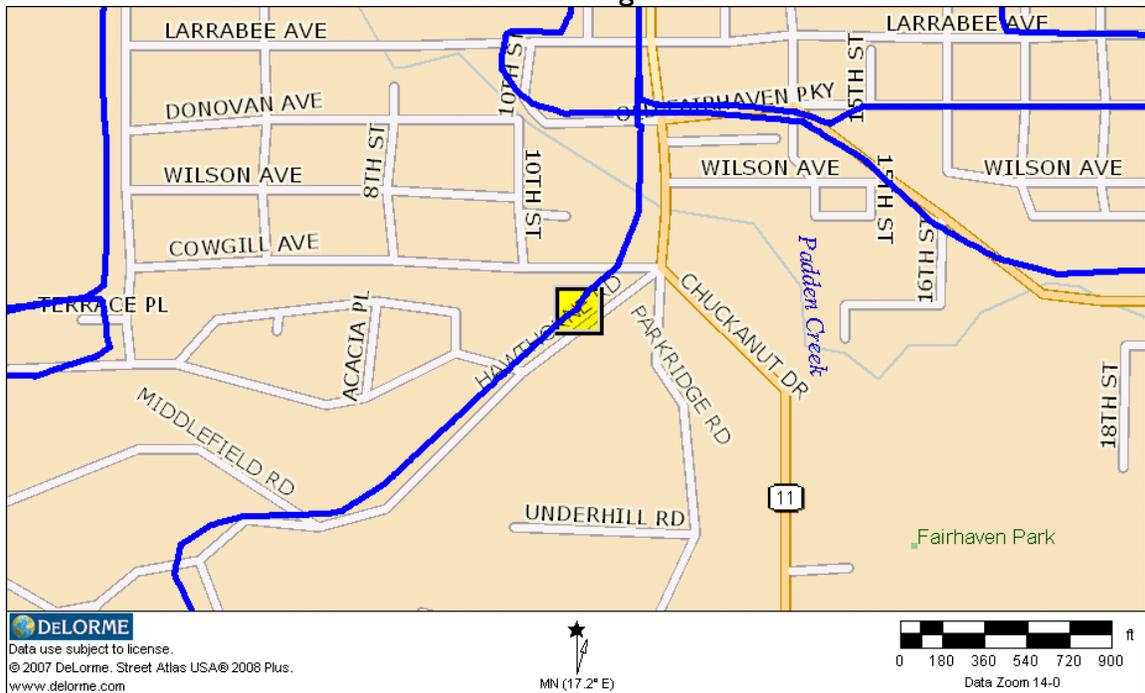
93 Hawthorn Road
Broken lashing wire.

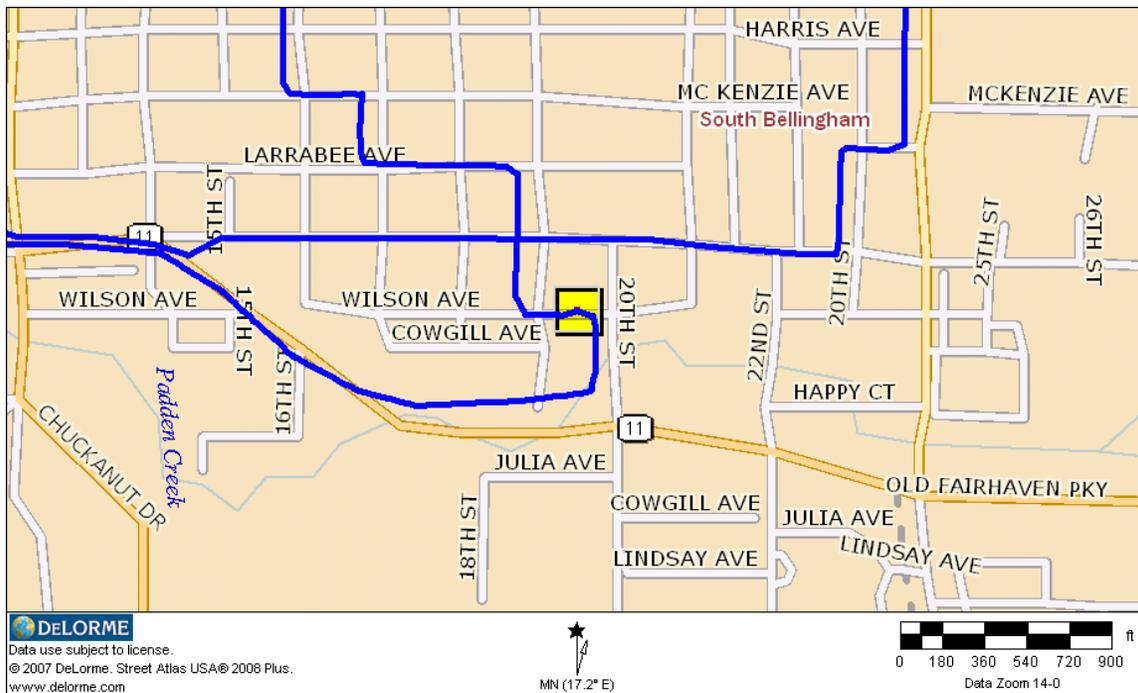
20th and Wilson.
Down guy not anchored. Pole leaning.

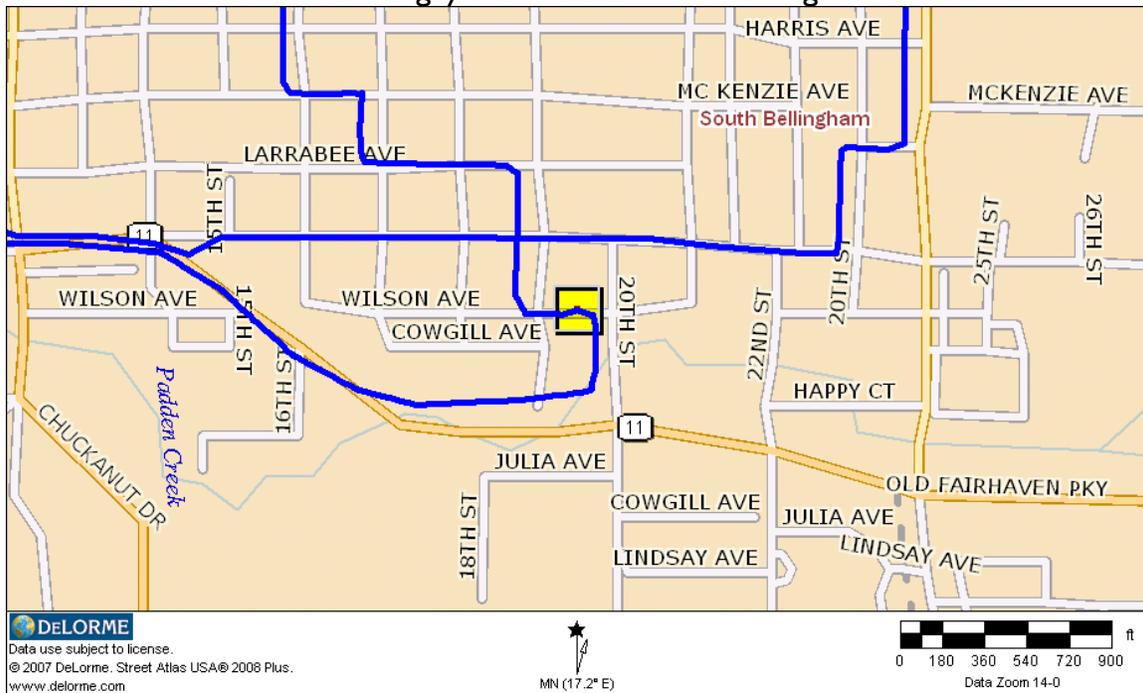
20th and Wilson Rd.
Down guy not anchored. Pole leaning.

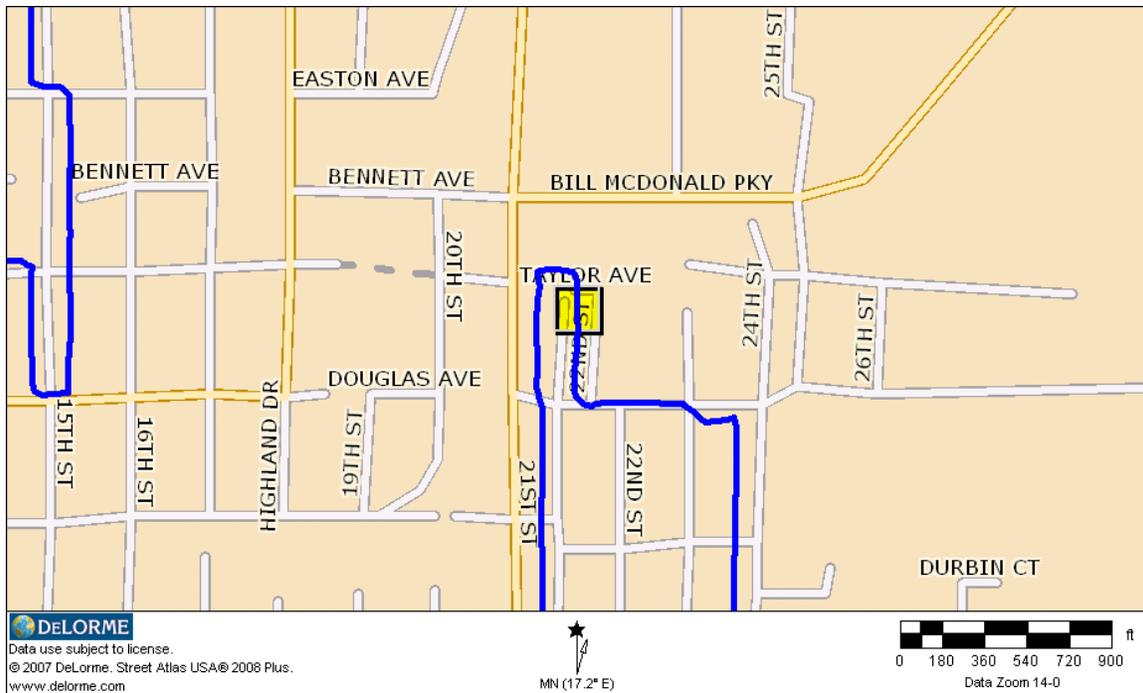
917 to 927 - 22nd Street. Damaged cable sections. Broken cables, lashing, taps.

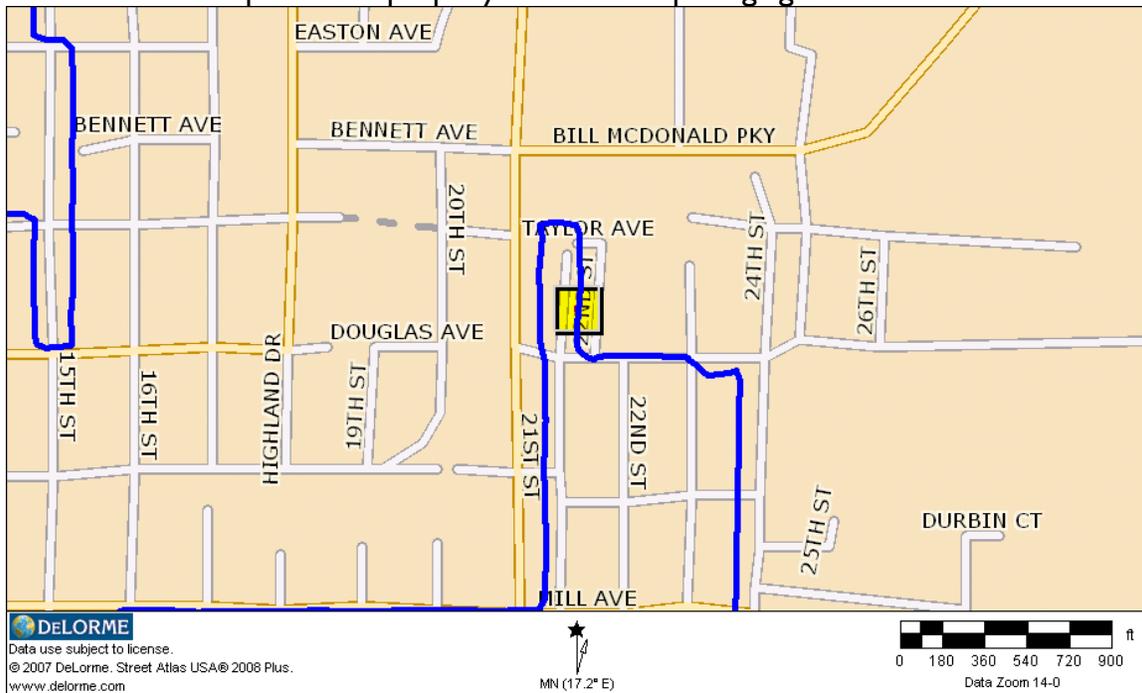
Drop wire not properly attached. Tap hanging from strand.
