Physical Plant Inspection of Comcast Communications in the City of Bellingham, Washington

May 2010

Inspected by
Kramer.Firm, Inc.

**PHYSICAL PLANT SAFETY INSPECTION
OF COMCAST CABLE COMMUNICATIONS
IN THE CITY OF BELLINGHAM, WASHINGTON**

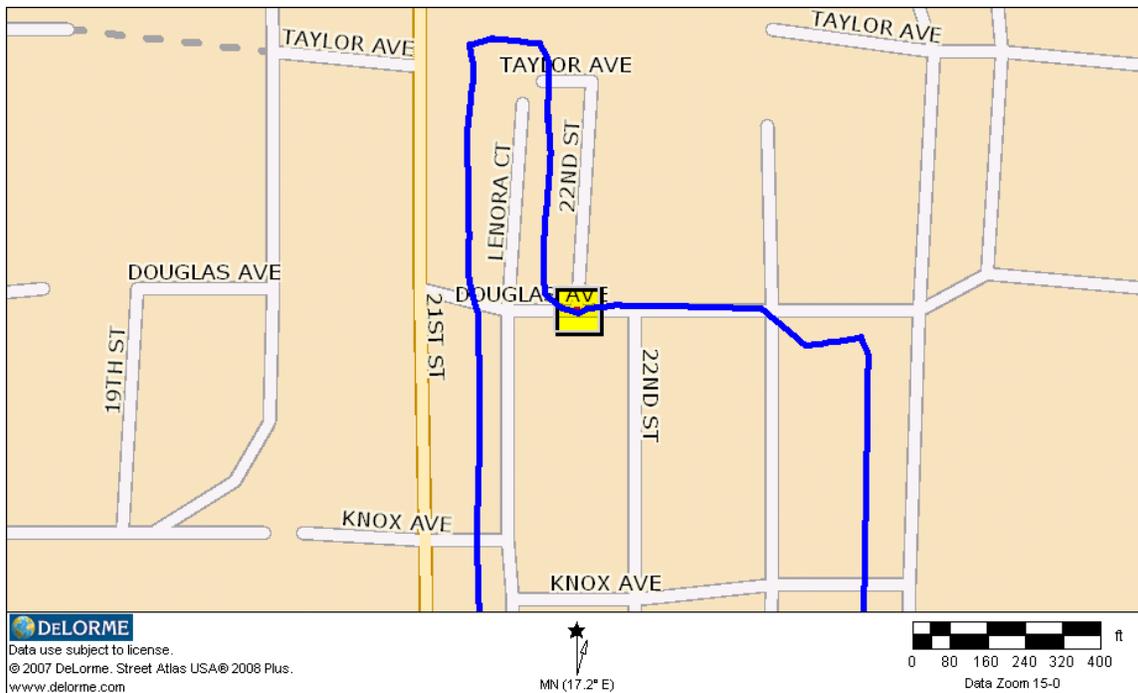
Corner of 22nd and Douglas
Apparently abandoned amplifier can and pole stub.

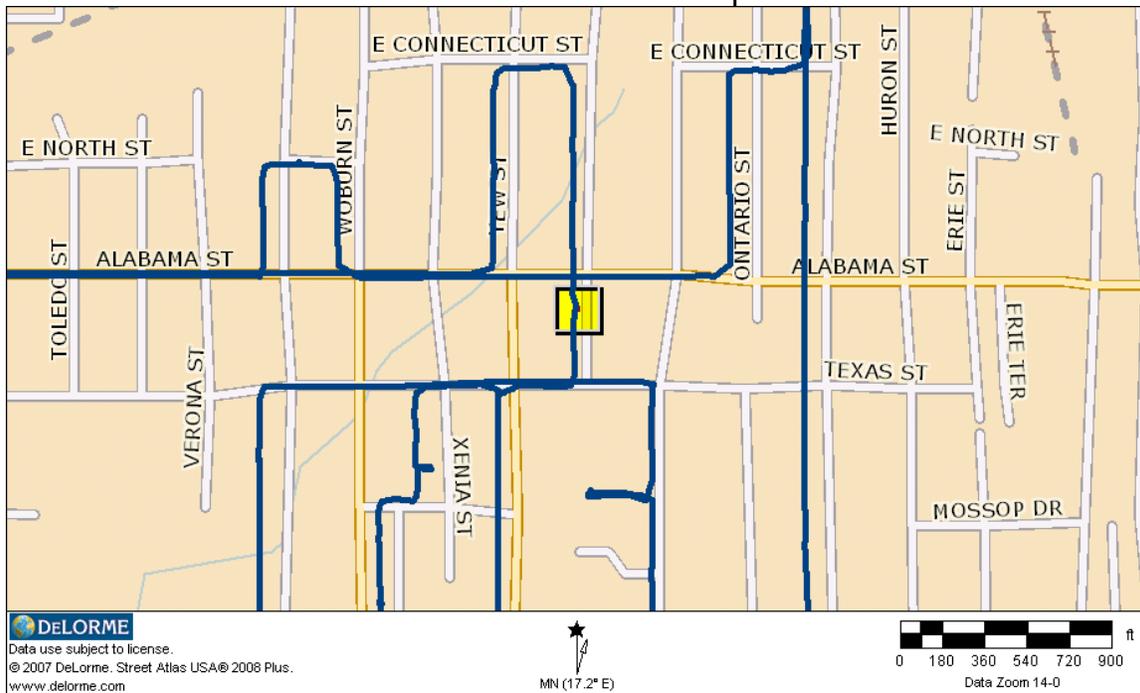
Superior and Alabama Streets.
Cable attachment too close to power.

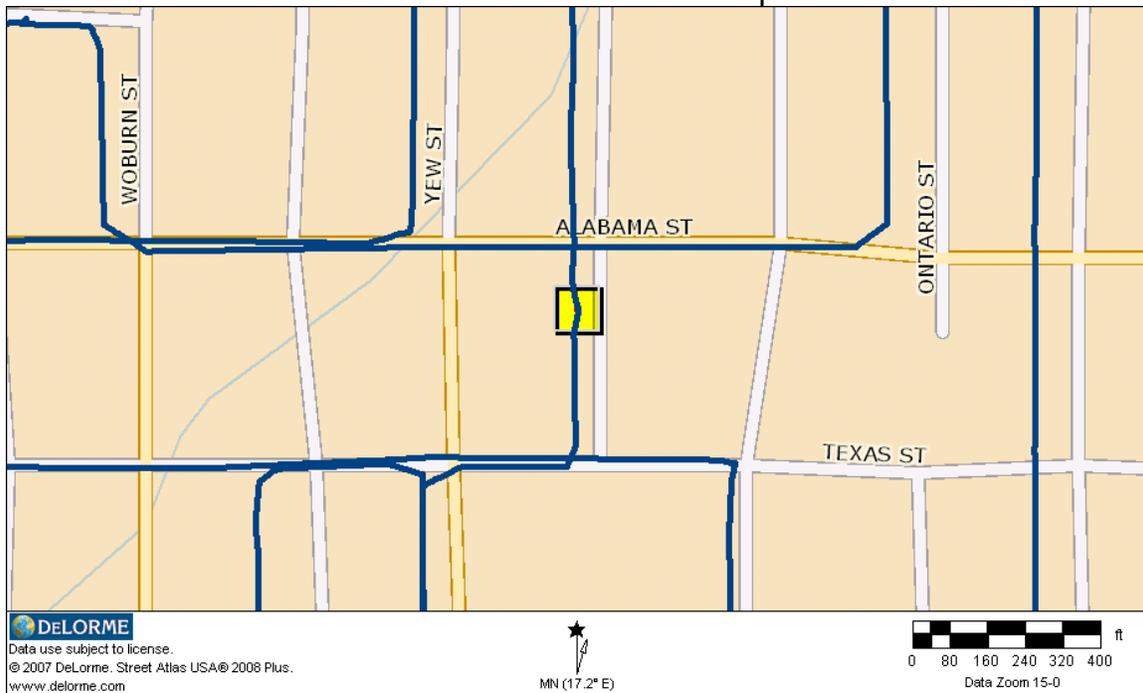
Superior Street just South of Alabama.
Cable strand mounted too close to power.

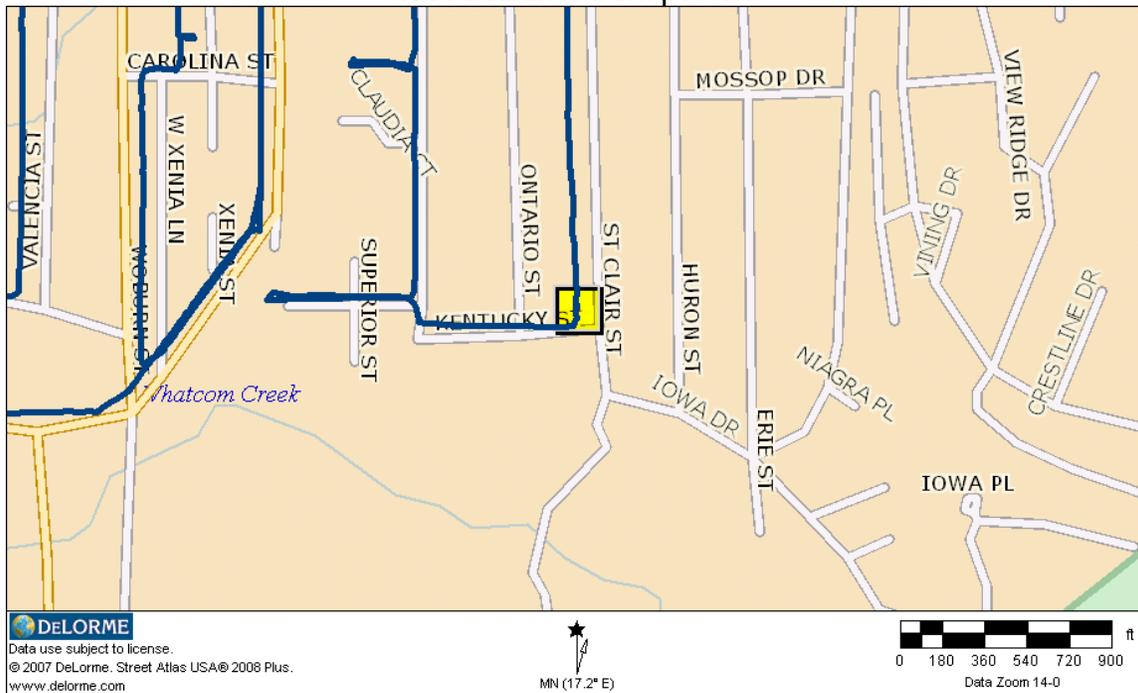
8104 St. Clair Street Cable drop attached to the power mast above the roof. Less than 1 foot clearance from power.

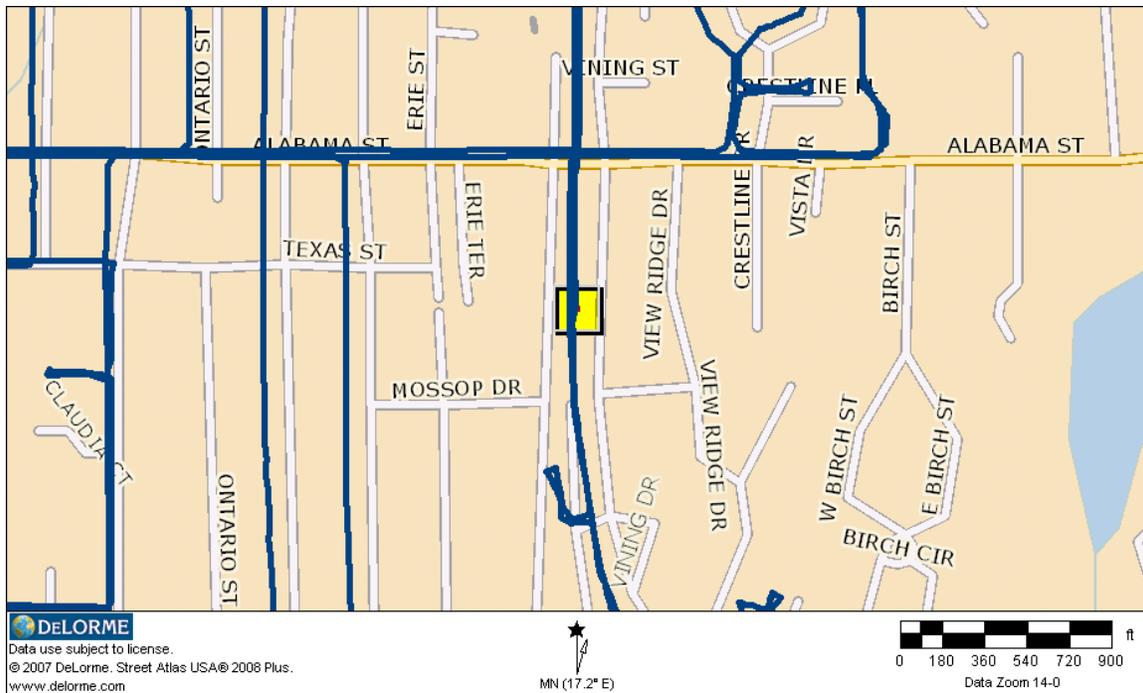
2325 Vining Street. Cable drop risers secured to power conduit

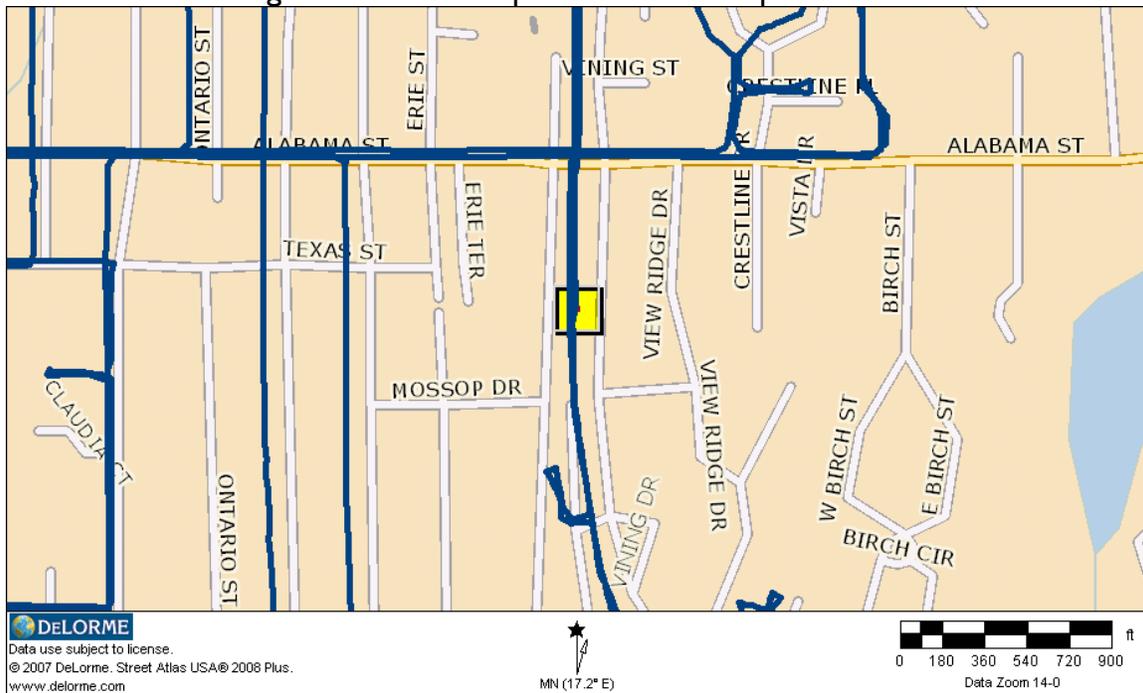
2325 Vining Street. Cable drop risers secured to power riser conduit.

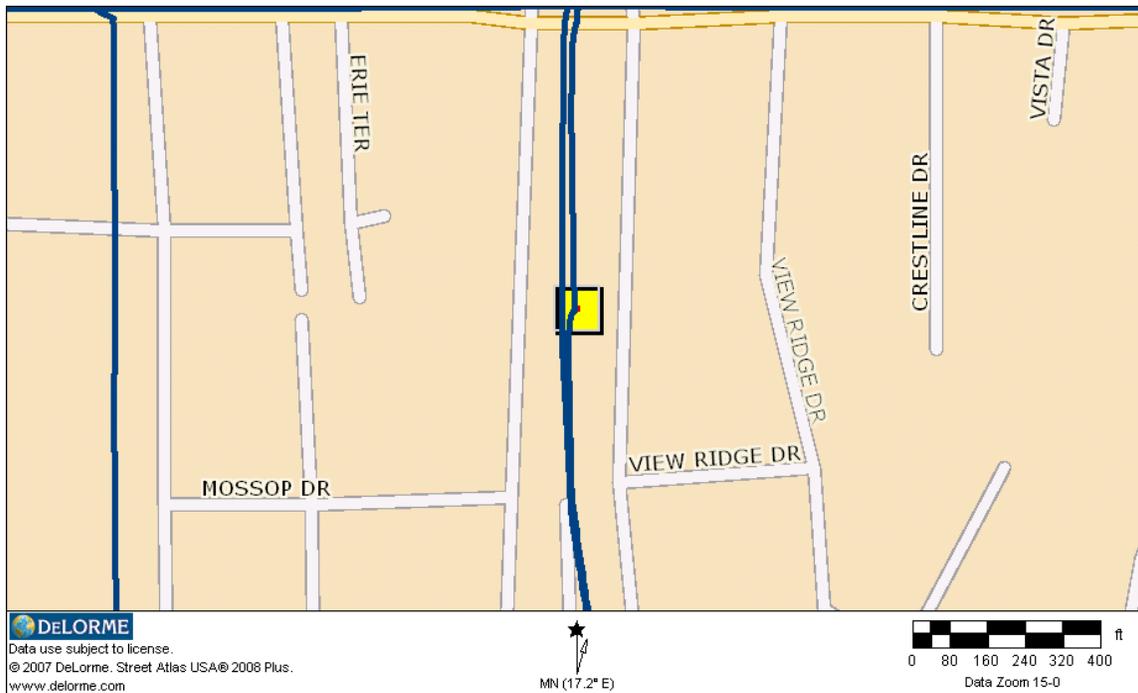
2325 Vining Street. Cable drop attached to the power mast.
