POST POINT WASTEWATER TREATMENT PLANT Pipe Hanger Failure Investigation

Bellingham, Washington

December 7, 2017

WJE No. 2017.3338

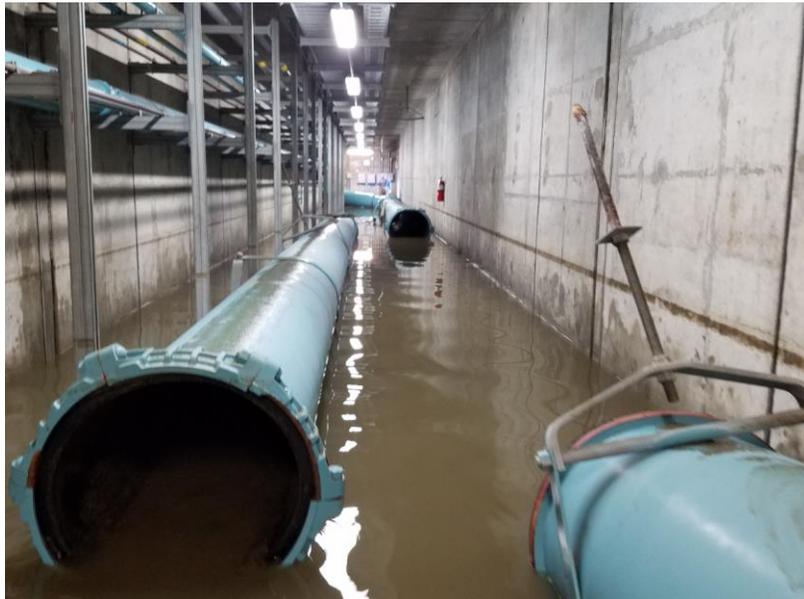
On May 6, 2017, a number of galvanized steel pipe hangers supported from the concrete lid of the below grade tunnel at the PPWWTP failed by pulling through the lid where they were connected, resulting in the collapse of a portion of the suspended steel RAS pipe (Figure 3). A total of thirteen pipe hangers lost their ability to remain connected to the concrete lid and pulled through it. Carollo reported to WJE that the collapsed segments of the RAS pipe had separated at the grooved end pipe joints, and the RAS pipe was slightly deformed to an oval shape from the vertical fall.

Figure 3. May 6, 2017 collapse of RAS pipe. Photo provided to WJE by Carollo.

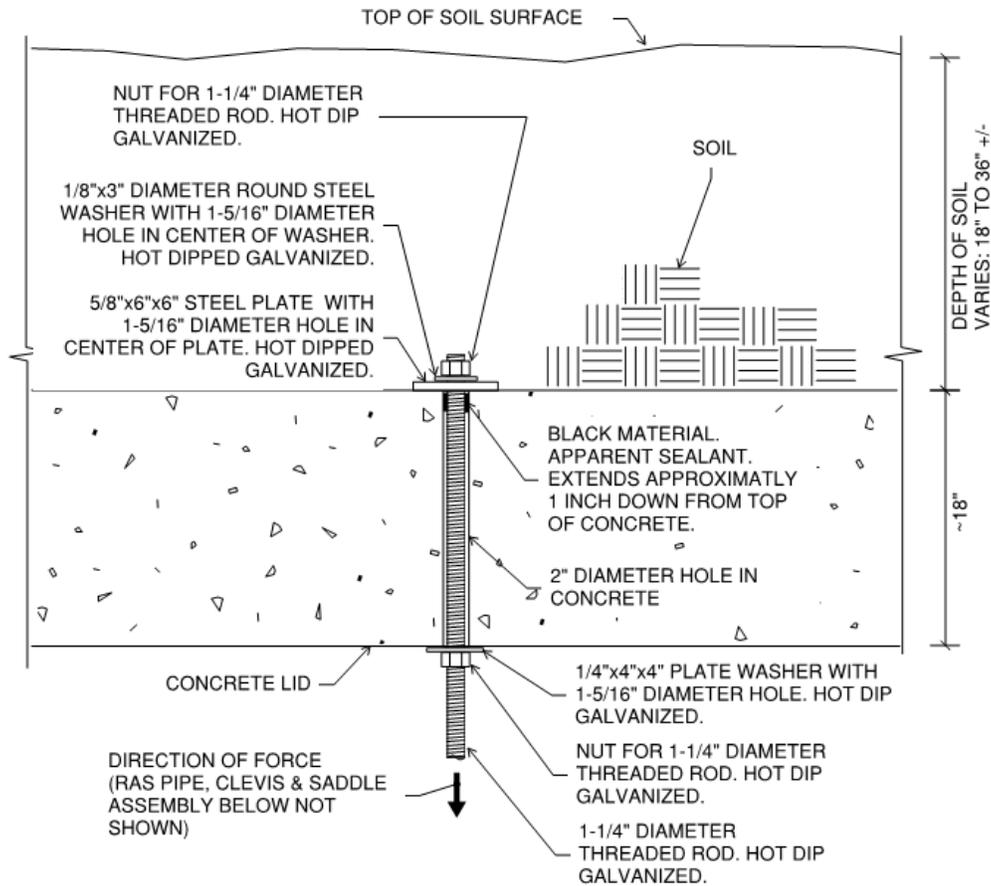
The as-built RAS pipe hanger assembly and connection to the concrete lid do not match the design drawings from August 1990, and, instead, were attached to the concrete lid (Figure 6). As a result, the top of the threaded rod, nut, plate washer, and steel plate on top of the concrete lid were exposed to soil and moisture.

No apparent waterproofing or coatings beyond galvanizing appear to have been applied to the upper end of the threaded rod, nut, washer, and plate where they were in contact with soil. Grouting was not applied to fill the space between the threaded rod and the concrete, except a black material that appeared to be a sealant observed between the threaded rod and concrete surface (Figure 6).

Figure 6. As-built section detail of threaded rod attachment to concrete lid.

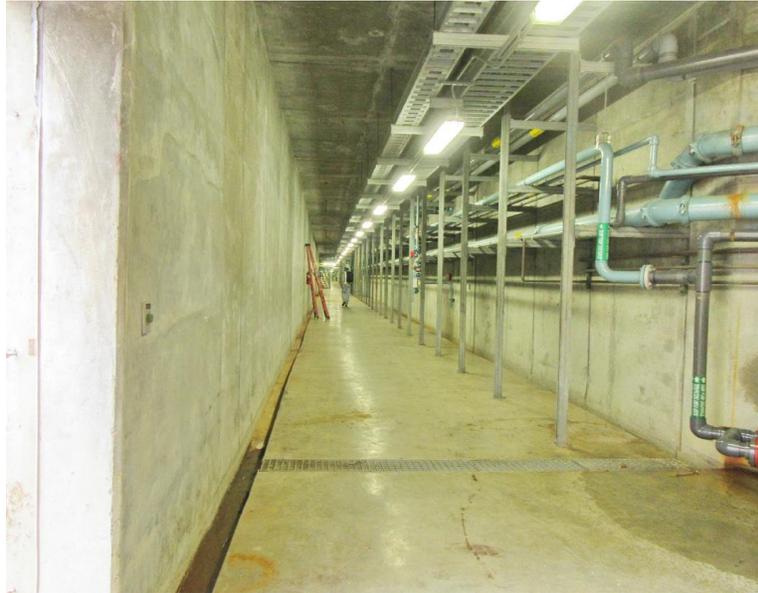
Several weeks prior to WJE's August 31, 2017 site visit, PPWWTP staff and/or a contractor hired by PPWWTP had cleaned the corridor and removed the RAS pipe and the failed hanger elements (Figure 7).

Figure 7. Photo from a location of the corridor during WJE's site visit where the RAS pipe once was suspended but had been removed.

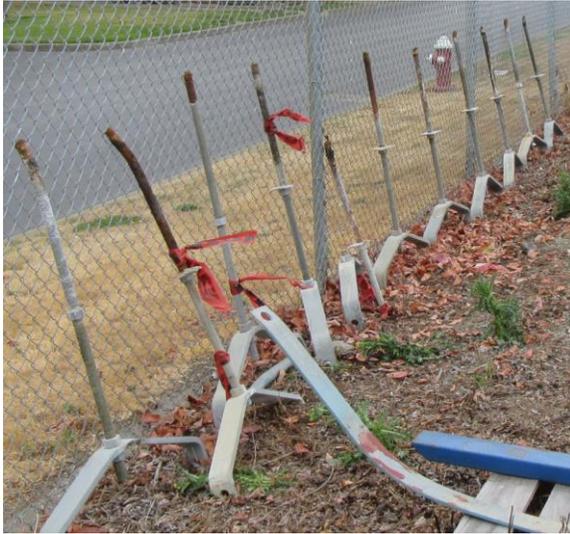
Hanger rods that had lost their connection to the concrete lid, along with associated attached components, were removed from the corridor and placed in a nearby storage yard on the site of the PPWWTP (Figure 8). Within the storage yard, WJE noted the presence of thirteen hanger rods, eight plate saddles, and eleven clevises. PPWWTP staff labeled some of the structural elements with their location in the corridor prior to their removal; other elements were found unlabeled. Five labeled threaded rods were uniquely found marked with 7, 9, 10, 11, and 12, which corresponded to numbers written on the wall in the corridor, which in turn correspond to locations shown in Appendix 1. The other threaded rods found unmarked were labeled onsite by WJE as A, B, C, D, E, F, G, and H.

Figure 8. Failed hanger rods were removed and placed in the PPWWTP storage yard.

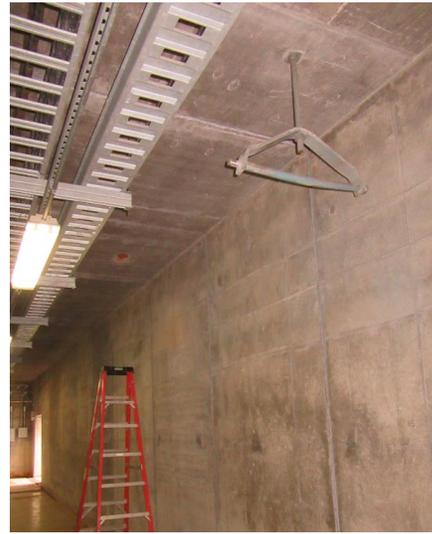
Figure 9. Hanger rod that remains in place.

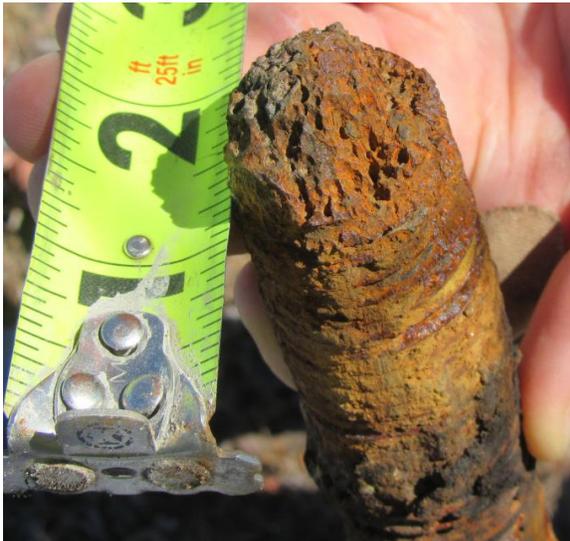
Figure 10. Corroded top of threaded rod. Rod labeled B by WJE.

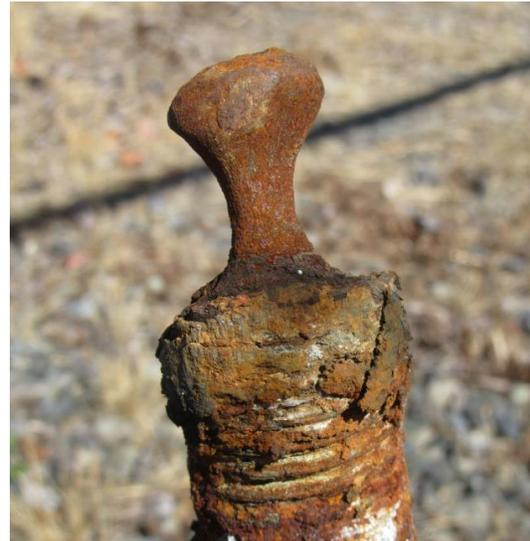
Figure 11. Eroded top of threaded rod. Rod labeled E by WJE.

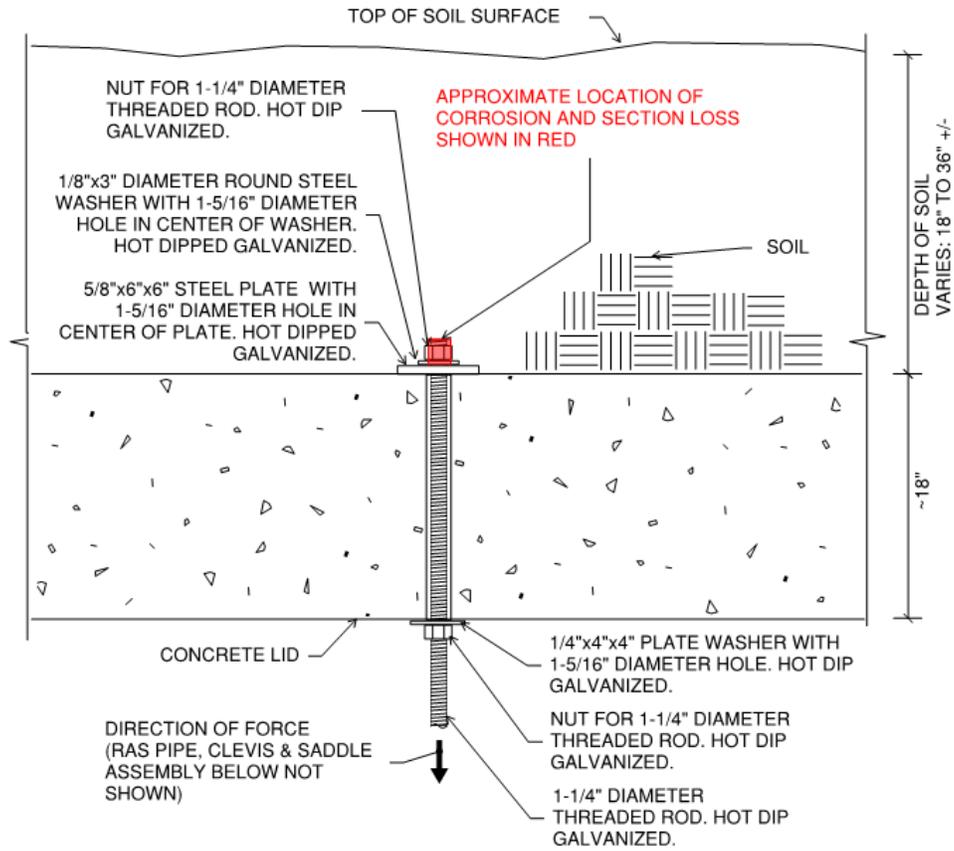
All thirteen hanger rods located in the yard had failed by "pulling through" the concrete lid; other hanger rods that did not pull through the concrete lid remained in place in the corridor (Figure 9). The hanger rods that pulled through the concrete lid and were observed in the yard exhibited signs of severe corrosion on their upper tip that would have protruded above the concrete lid. An example of end of rod corrosion can be seen in Figures 10 and 11. A sketch indicating where the observed rod corrosion occurred in relation to its connection to the concrete lid is shown in Figure 12.

Figure 12. Depiction of approximate extent and location of corrosion and section loss (in red shaded region) observed at all rods that pulled through the lid.

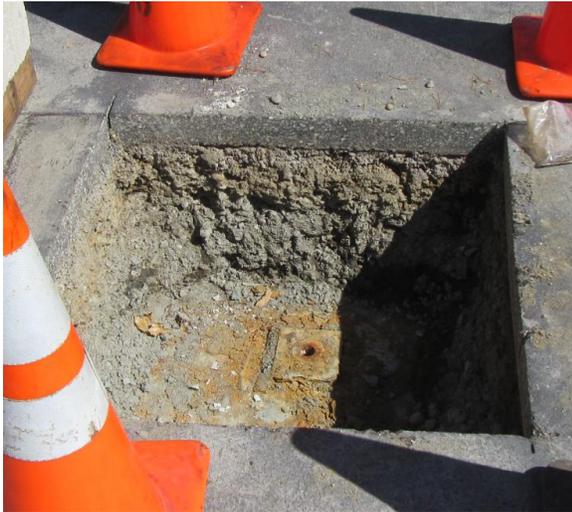
Figure 13. Pothole No. 2 with steel plate washer exposed. Round cut washer remnant of corroded nut removed by WJE prior to photo.

At Pothole No. 2, the hanger rod that pulled through the concrete lid had been relocated to the holding yard with other samples. The plate washers were still in place, and the nut that was holding the threaded rod was found and observed to be corroded with nearly complete section loss. The nut was bagged and collected for laboratory examination (see Appendix 2 for photos of samples sent to the laboratory).

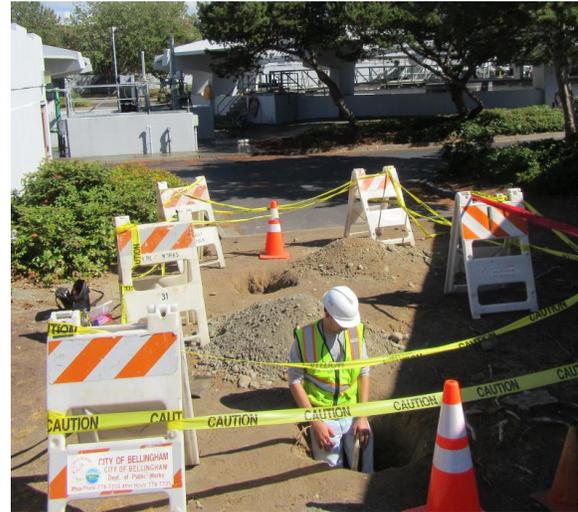
Figure 14. Pothole No. 3 shown with arrow, and WJE's Mr. Stutts standing in Pothole No. 4.

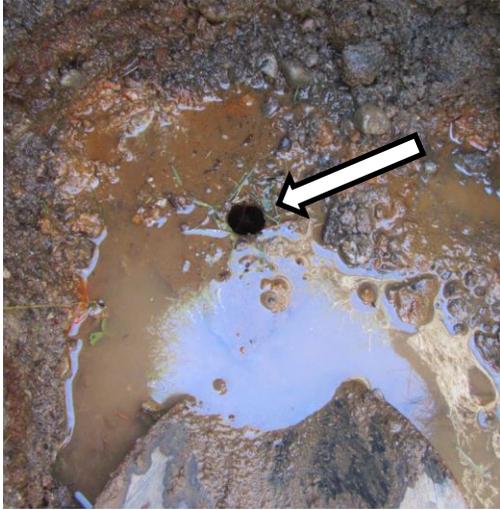
At Pothole No. 1, the hanger rod that pulled through the concrete lid had been relocated to the holding yard with other samples. The plate washers were still in place. However, the nut that was holding the threaded rod was not found or observed, and the bottom of the pothole had water in it presumably from nearby landscape sprinklers (Figure 15).

Figure 15. Pothole No. 1 with water at bottom and opening where threaded rod was once held by nut (arrow).

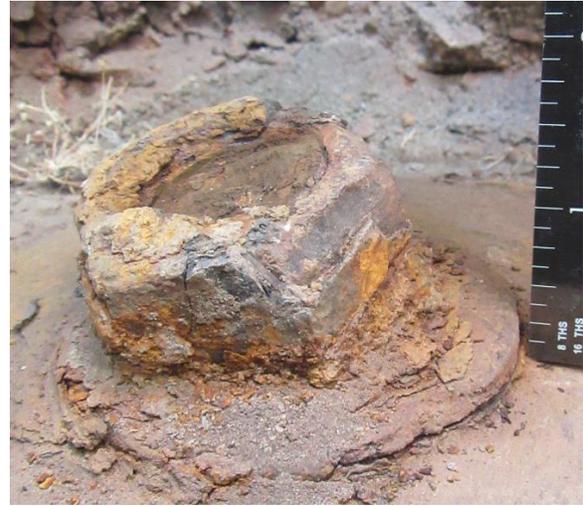
At Pothole Nos. 3 and 4, the entire plate assembly above the concrete lid was still intact, including the threaded hanger rod. Despite being intact, the components, and particularly the exposed nut, exhibited corrosion, including section loss of the nut (Figures 16 and 17). With the assistance of PPWWTP staff at Pothole No. 3, the hanger rod was cut from beneath the concrete lid, and WJE was able to extract the assembly for laboratory examination (Figure 18).

Figure 16. Pothole No. 3 steel washer and nut assembly in place. Note corrosion on nut and washer.

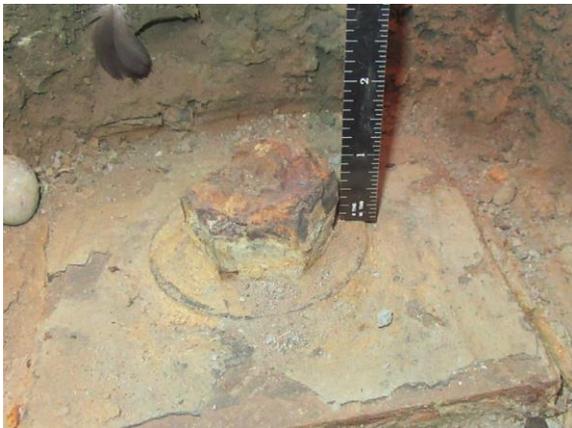
Figure 17. Pothole No. 4 steel washer and nut assembly in place. Note corrosion on nut.

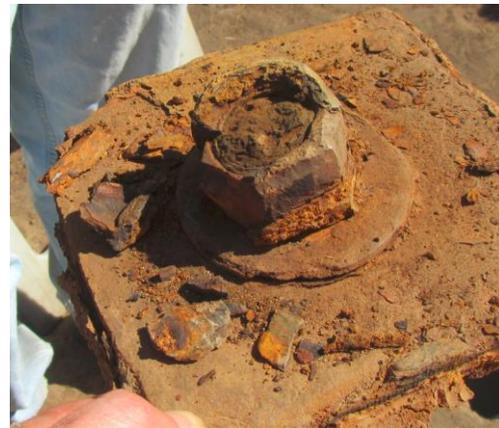
Figure 18. Pothole No. 3 nut and washer rod assembly extracted for laboratory examination.

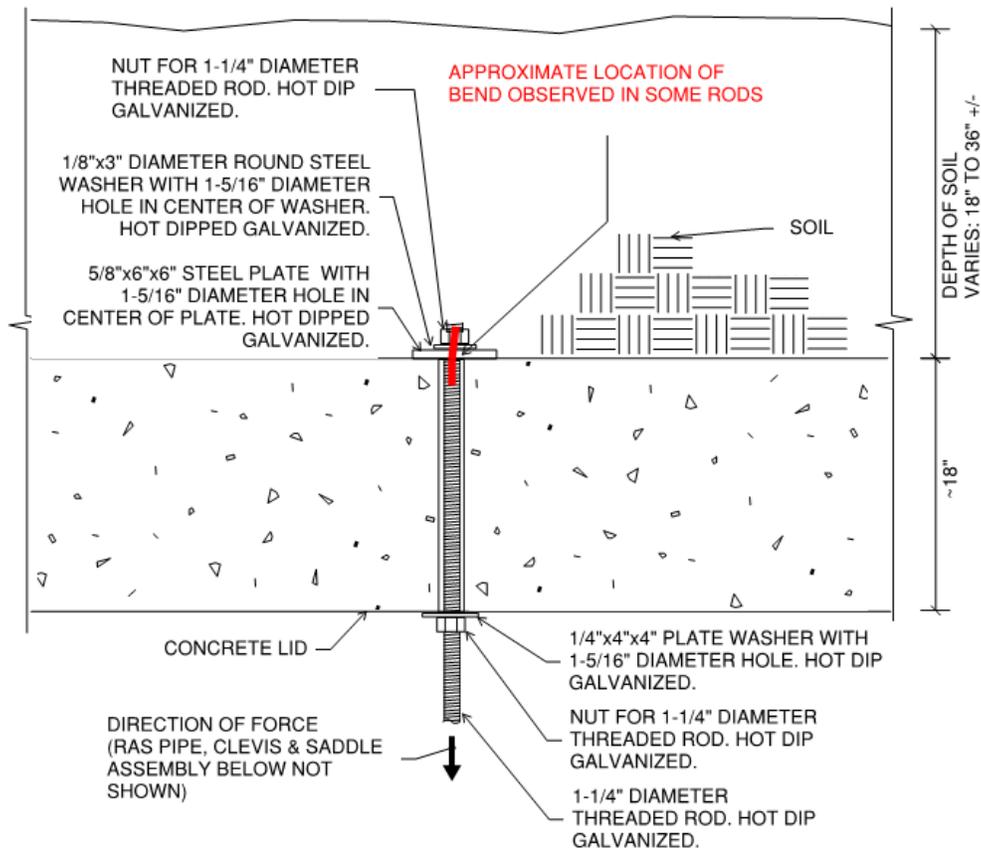
Some threaded rods were observed to have a bend in them near the top of the concrete lid (Figure 19). Bends in the rods can also be seen in Figure 8 and the figures in Appendix 2. The unfailed sample extracted from Location 19 (at Pothole No. 3) also exhibited a bend in the rod, as shown in photographs of that sample in Appendix 2. The magnitude of the bends observed varied. During WJE's site visit, PPWWTP staff reported to WJE that during the original construction of the subject structure, after the concrete lid was constructed and after the threaded rods were installed, but before the concrete lid was covered with soil, they recalled that construction equipment had impacted the portions of the hanger components that extend above the concrete lid surface and hypothesized that the impact caused the bend. The impact described was implied to have imparted a lateral movement to the parts protruding above the concrete lid surface and thought to have maybe caused the bend in the rods.

Figure 19. Depiction of approximate location of bend observed in some rods.

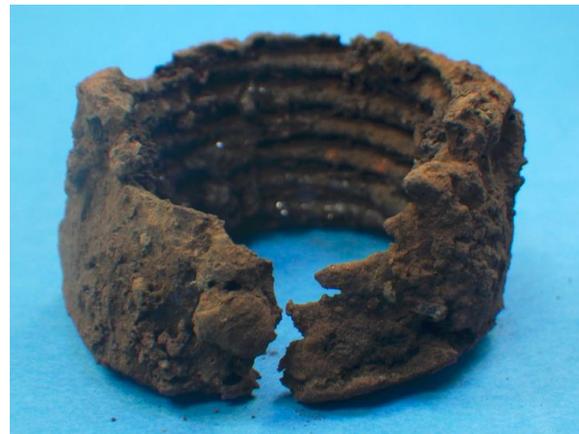
Figure 23. Corroded nut once connected to threaded rod above the concrete lid from Location 2, Pothole No. 2.

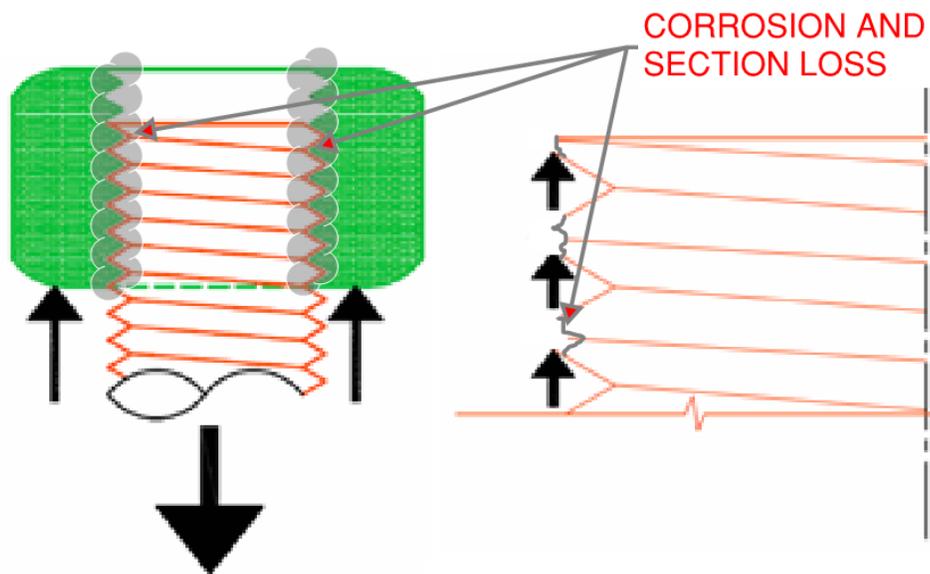
As the nut and threads on the nut or on the rod lose steel due to the corrosion process, their capacity to transfer load is reduced due to the physical change. See a depiction of this mechanism in Figure 24.

Figure 24. As corrosion and section loss occurs, the thread engagement between rod and nut is reduced, as is the capacity of the system to carry load. (Image modified from Figure 20).

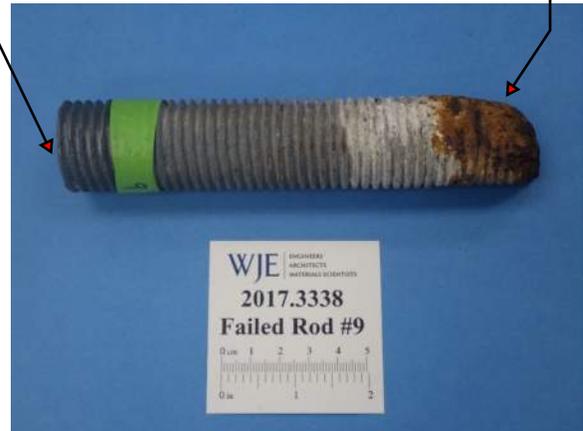
Failed Rod 9_B

Commentary note: corroded end rod was tip in contact with soil.

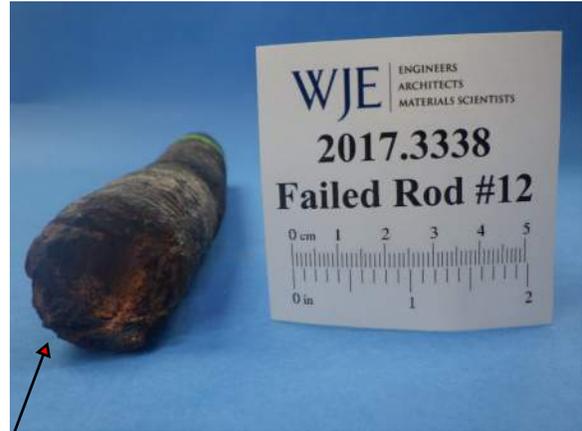
Failed Rod 12_C

Corroded end of rod with section loss was tip in contact with soil.

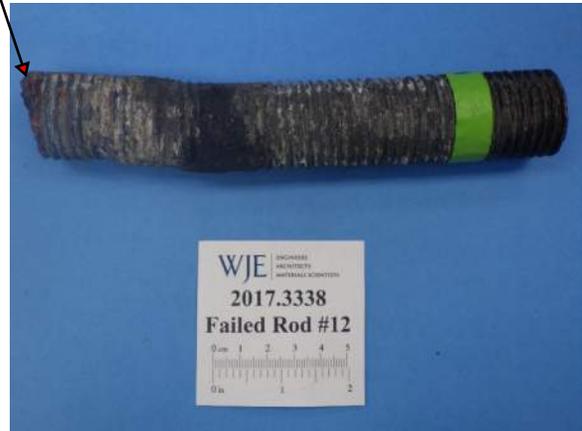
Failed Rod 12_D

Corroded end of rod with section loss was tip in contact with soil.

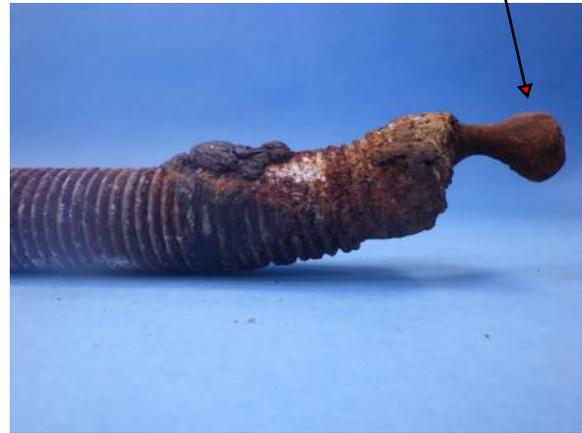
Failed Rod E_H

*Corroded end of rod
with section loss was
tip in contact with soil.*

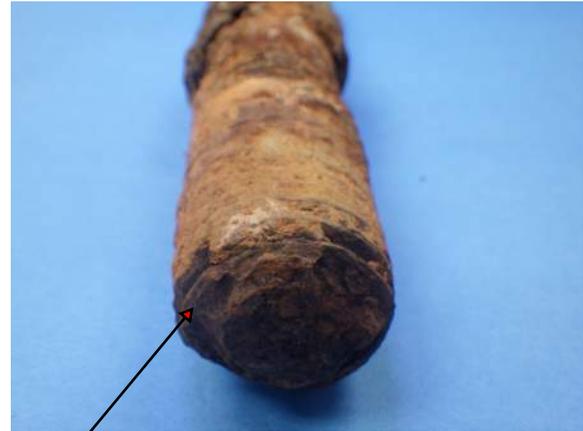
Failed Rod G_D

*Corroded end of rod
with section loss was
tip in contact with soil.*

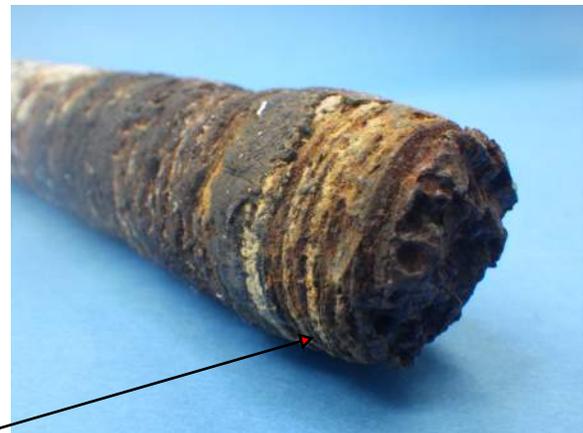
Failed Rod H_E

Corroded end of rod with section loss was tip in contact with soil.

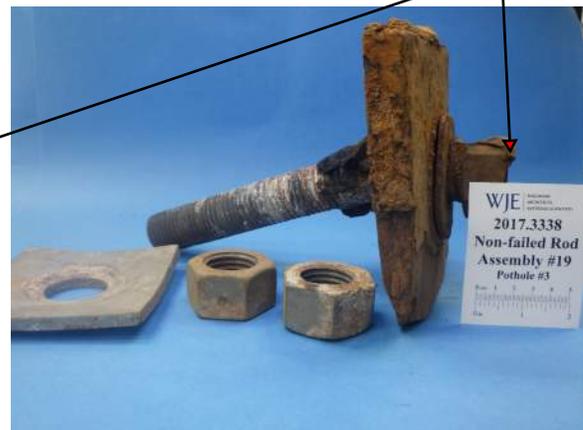
Non-failed Rod Assembly 19

Corroded end of rod with section loss was tip in contact with soil.

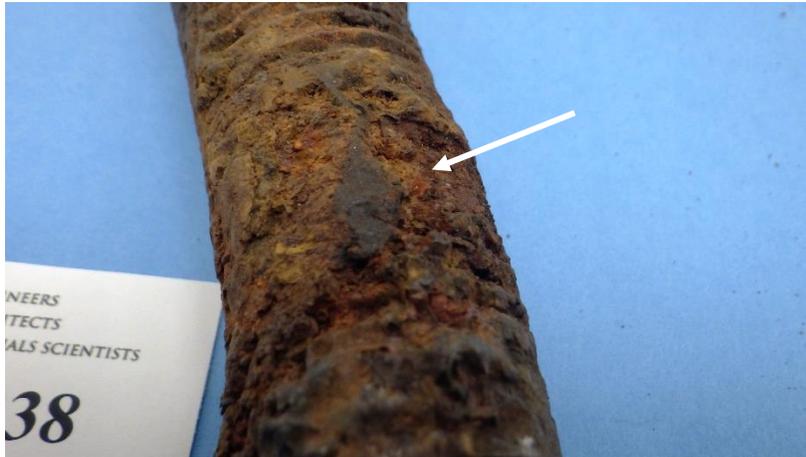
Figure 1. Corrosion product was collected from the indicated area of Sample Rod B for SEM/EDS analysis.

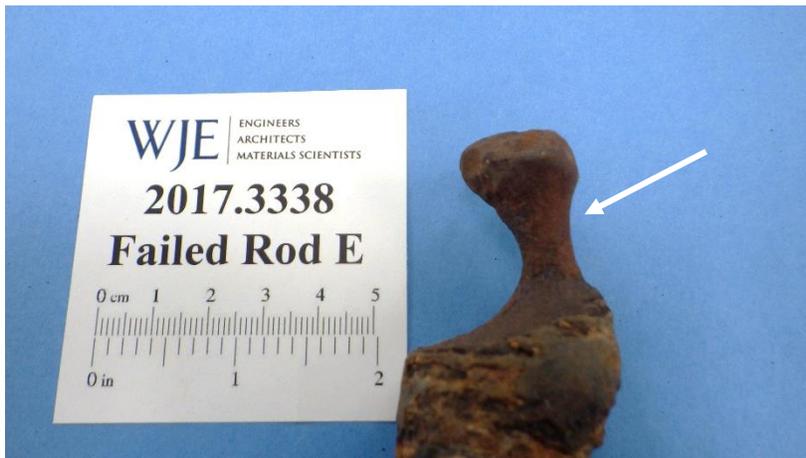
Figure 2. Corrosion product was collected from the indicated area of Rod E for SEM/EDS analysis.

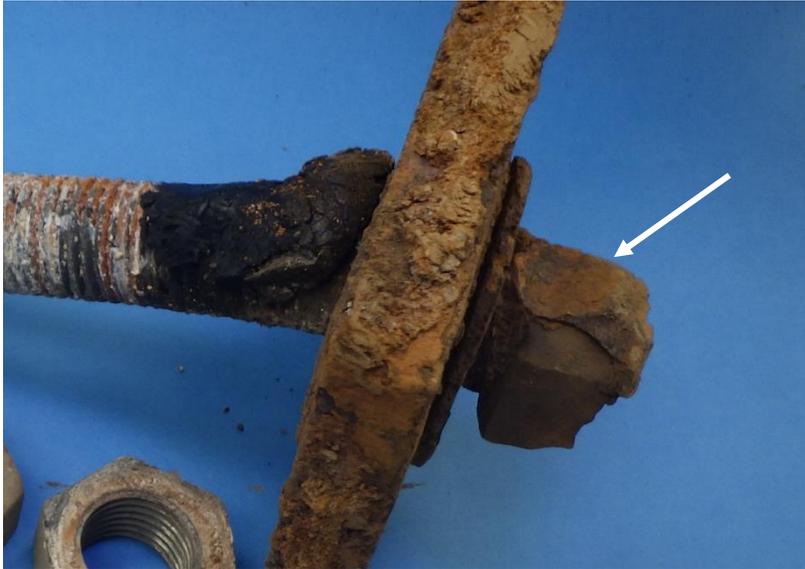
Figure 3. Corrosion product was collected from the indicated area of Assembly #19 for SEM/EDS analysis.
