APPENDIX

Date: January 22, 2020

Subject: City of Bellingham Reservoirs Inspection and Repairs
Marietta Site

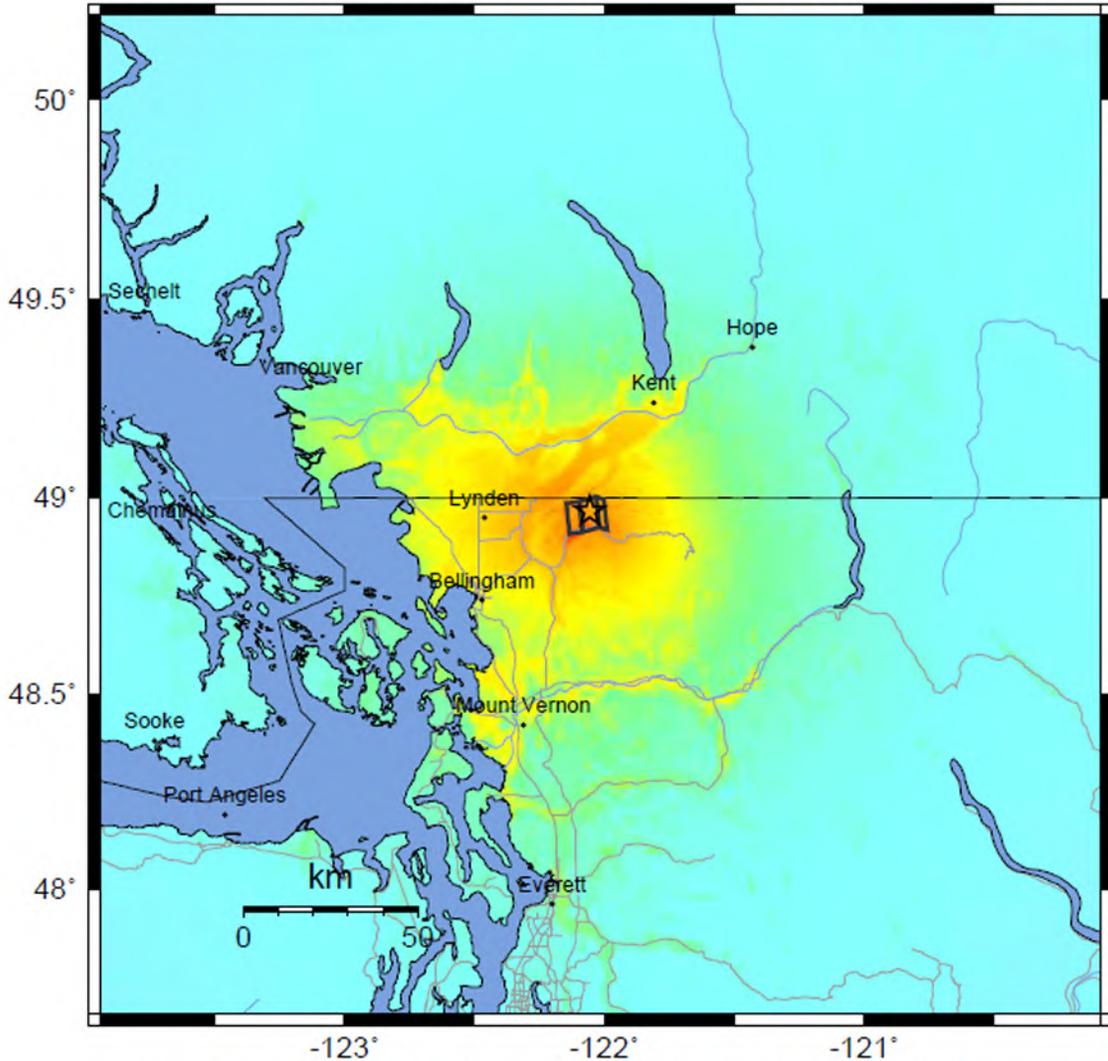
Figure 5 presents the ShakeMap for the Mw 6.8 Boulder Creek fault scenario. The ShakeMap provides the location of the epicenter (star) and rupture area (gray box) for the scenario considered and provides geographic representation of the ground shaking intensity. Shaking (or instrumental) intensity is a qualitative measure ranging from I to X+ that portrays the effects of an earthquake scenario at a particular location. These effects include potential damage, perception of shaking and permanent changes in topography. The instrumental intensity at the site from a Mw 6.8 Boulder Creek fault scenario is VI, which corresponds to strong ground shaking with light potential damage. Some observations may include ground shaking being felt by all, weak plaster and masonry crack, and slight damage in poorly constructed buildings.

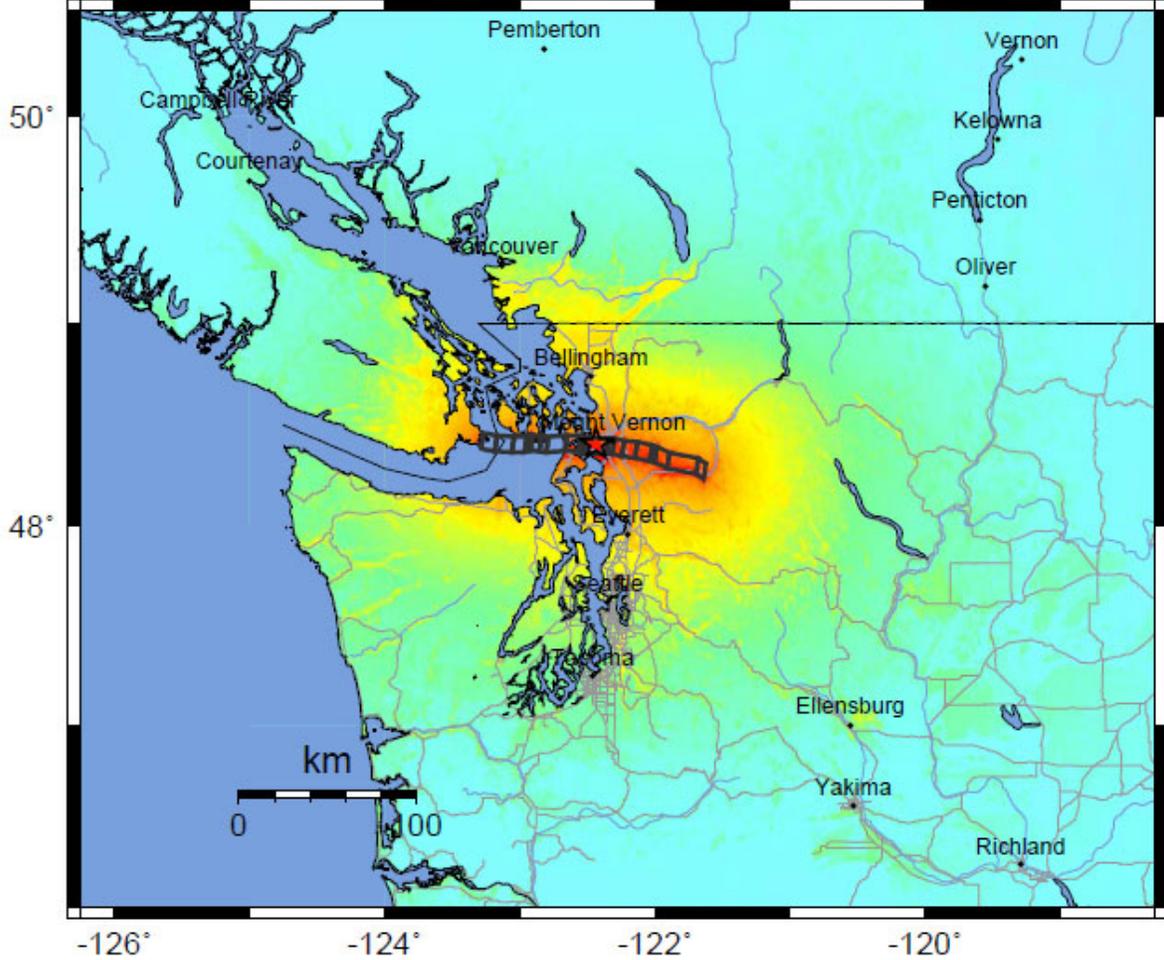
Figure 6 presents the ShakeMap for the Mw 7.5 Devils Mountain fault scenario. The ShakeMap provides the location of the epicenter (star) and rupture area (gray box) for the scenario considered and provides geographic representation of the ground shaking intensity. Shaking (or instrumental) intensity is a qualitative measure ranging from I to X+ that portrays the effects of an earthquake scenario at a particular location.

These effects include potential damage, perception of shaking and permanent changes in topography. The instrumental intensity at the site from a Mw 7.5 Devils Mountain fault scenario is VI, which corresponds to strong ground shaking with light potential damage. Some observations may include ground shaking be felt by all, weak plaster and masonry crack, and slight damage in poorly constructed buildings.

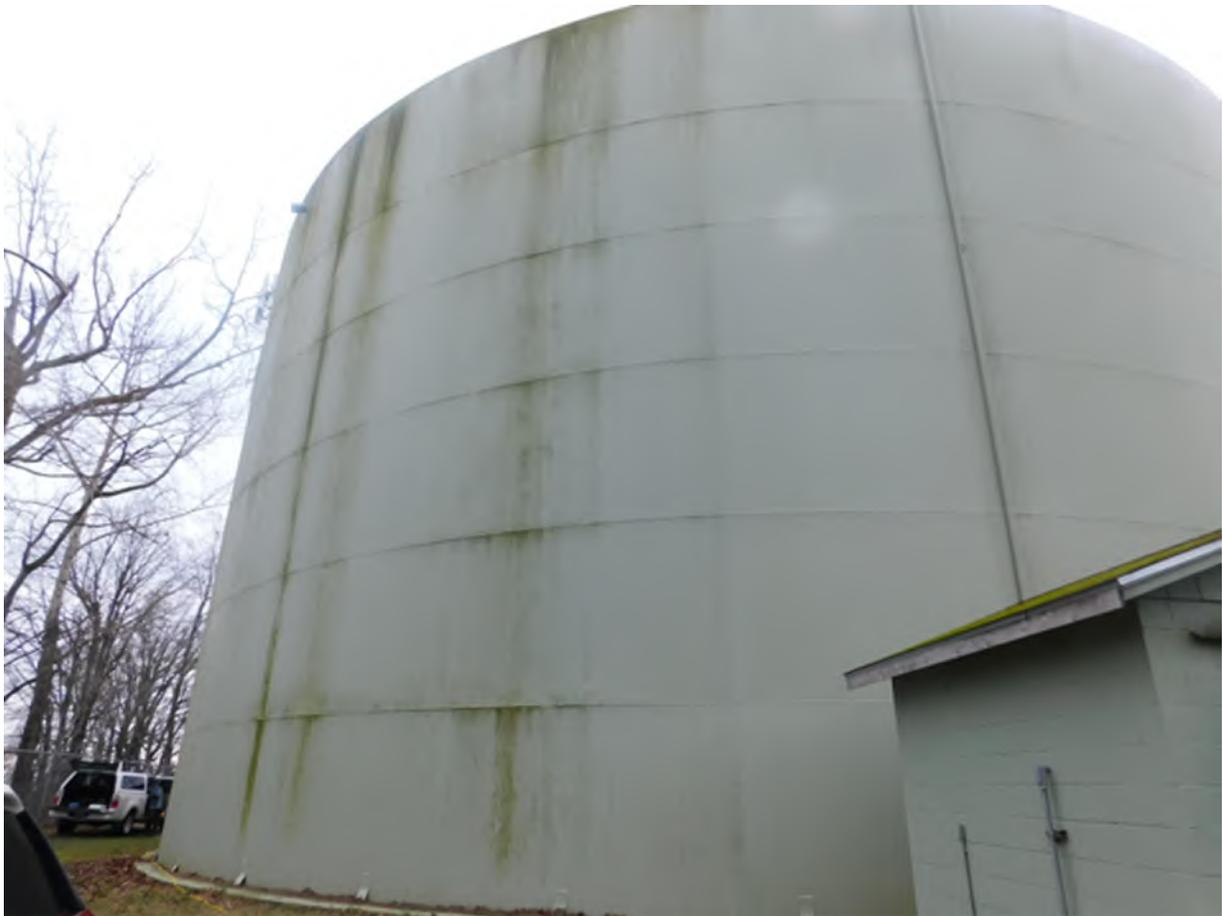
Marietta Tank, exterior surfaces are dirty with area of organic material accumulation

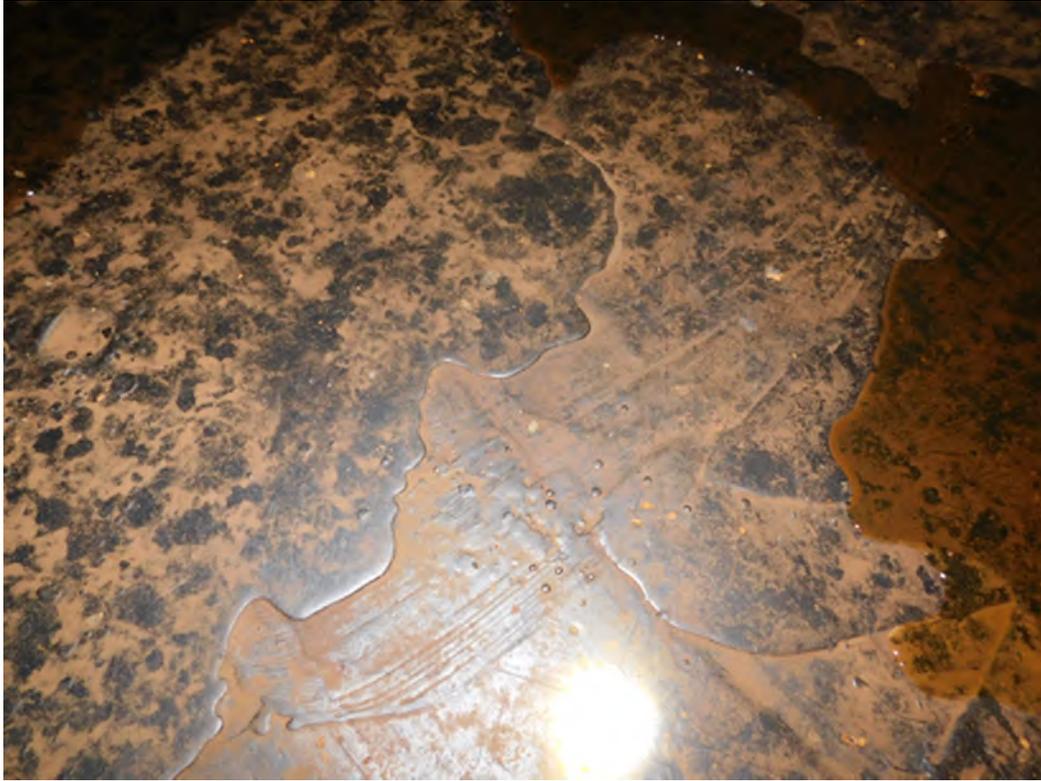
Floor – flood coated, dirt covers much of floor

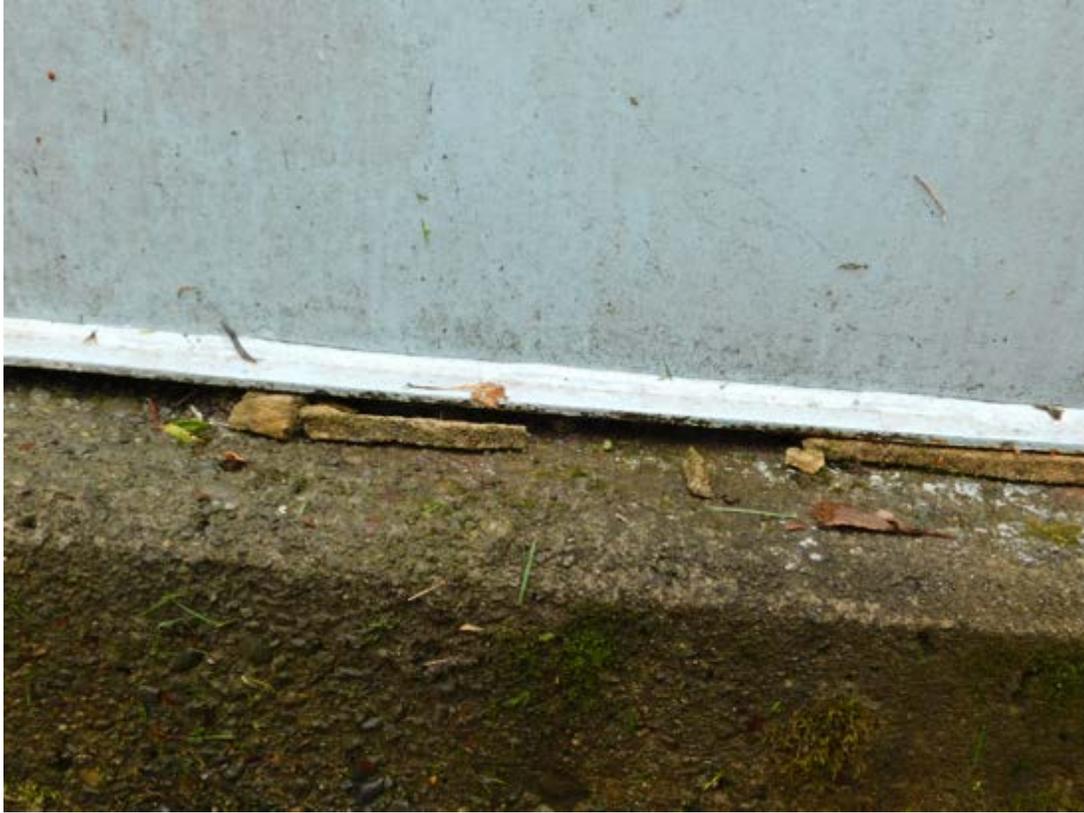
Sealing failure at chime/ring wall transition

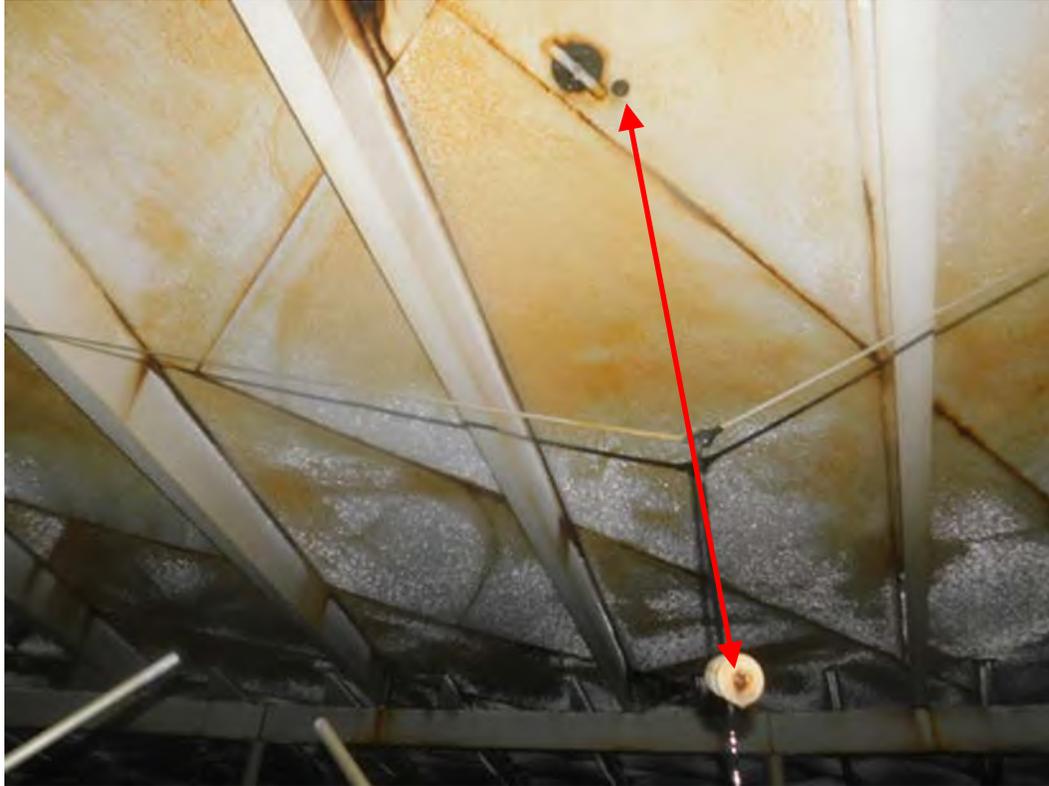
As part of the internal inspection of the Whatcom Falls #1 tank, it was noted that one of the anode support hangers had become detached from the roof. This should be replaced in the near future to ensure that the anode does not electrically short to the bottom of the tank.

Broken anode hanger, should be suspended from the roof

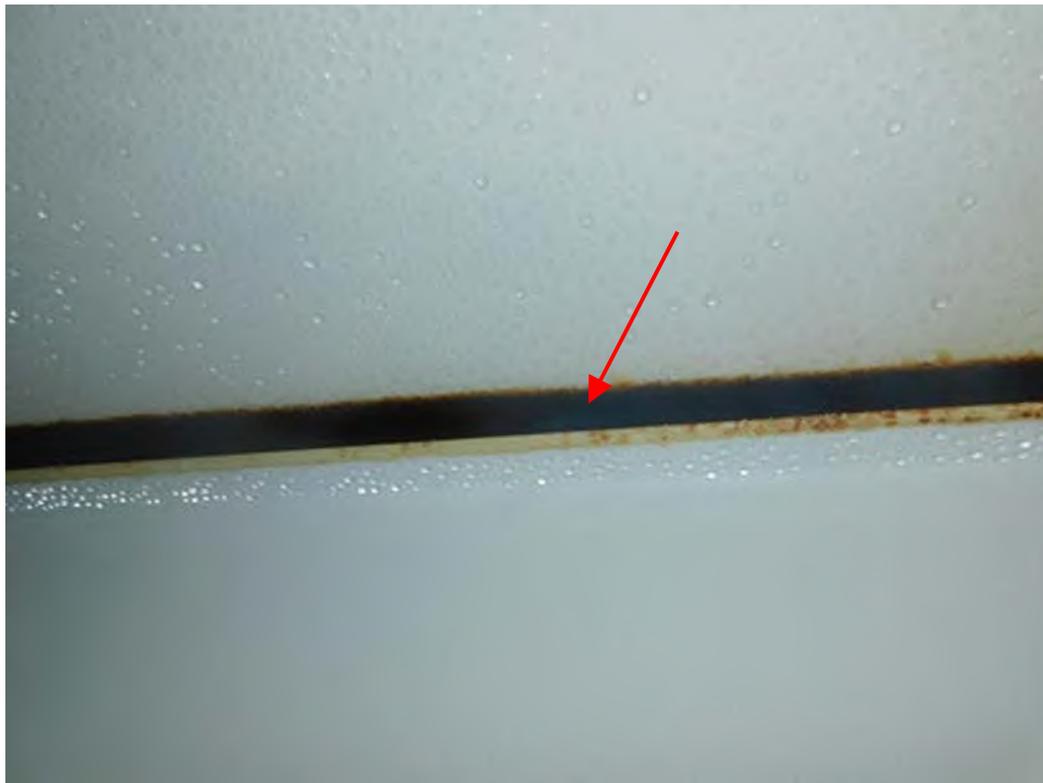
Gap between beam and roof plate, area is not coated, bare steel has surface corrosion

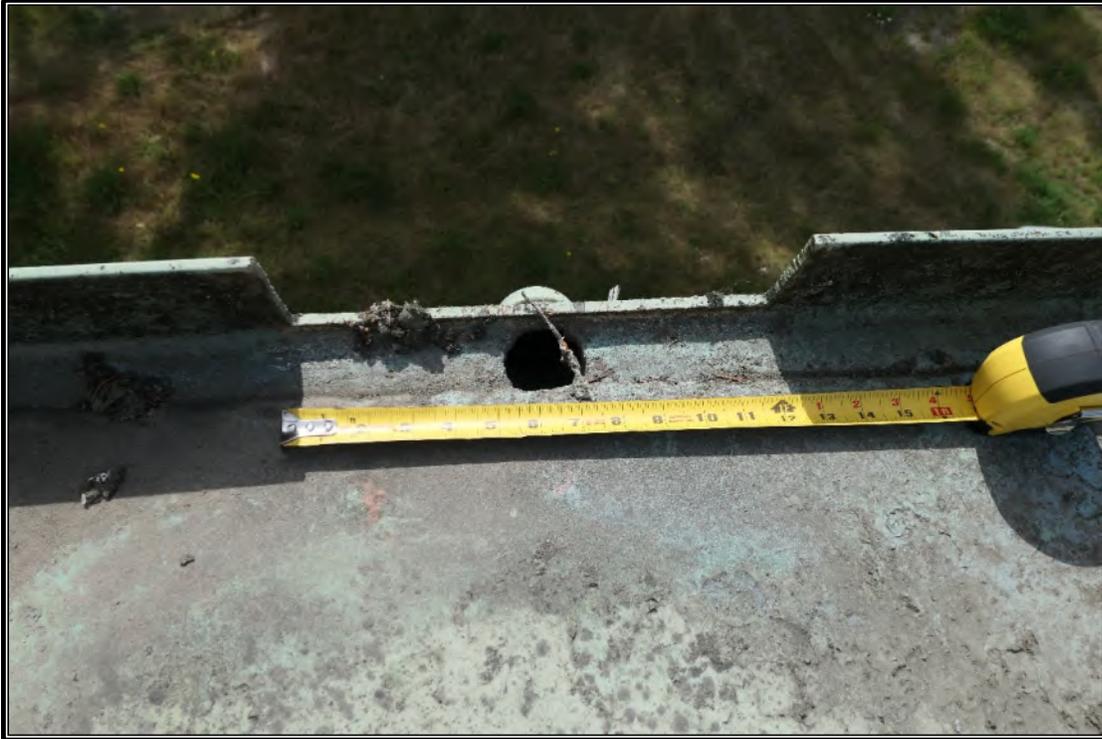
Figure 2-16: Whatcom Falls 1 Reservoir – Roof Drain. Side plate has been notched to facilitate drainage if a pipe is blocked.

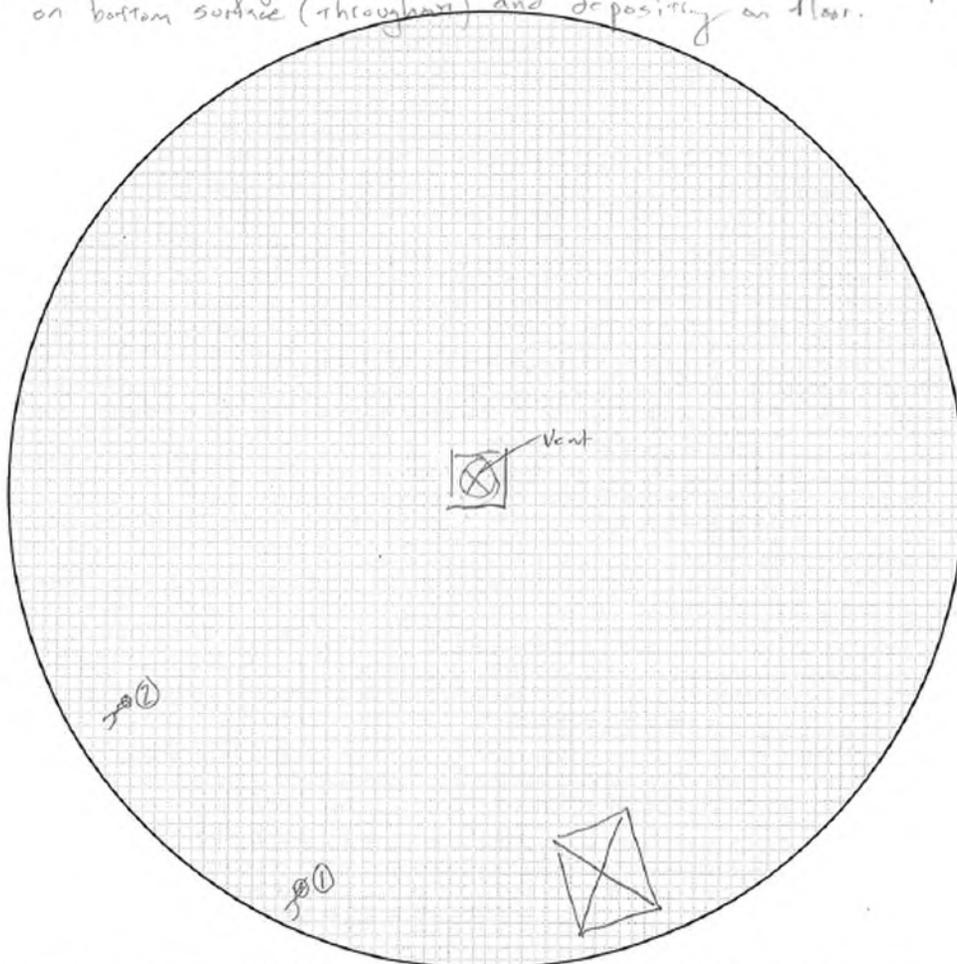
Bottom Surface Roof Slab Condition: Open good, a couple notes (see below).
No major cracking noted. Mineralization seems to be forming
on bottom surface (throughout) and depositing on floor.

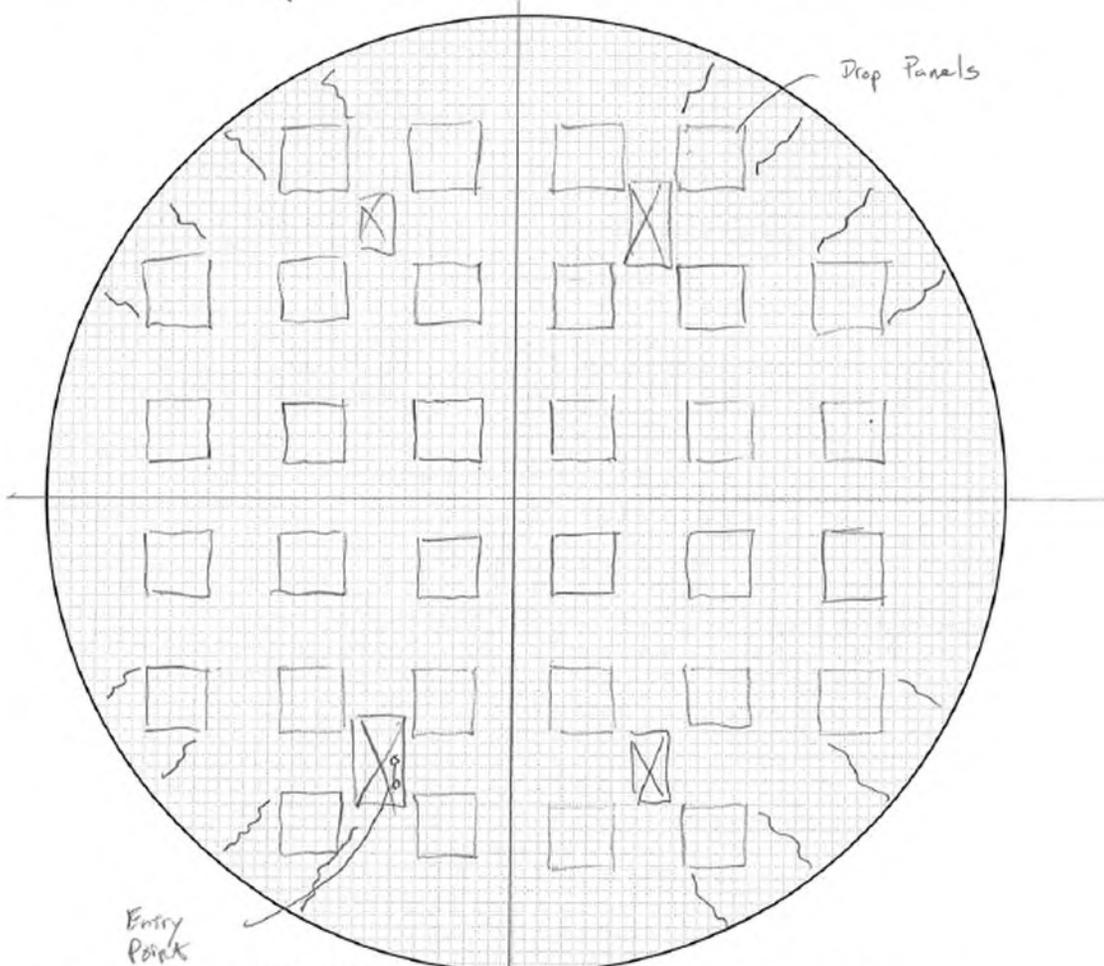
Primary cracking note by drop panels nearest walls

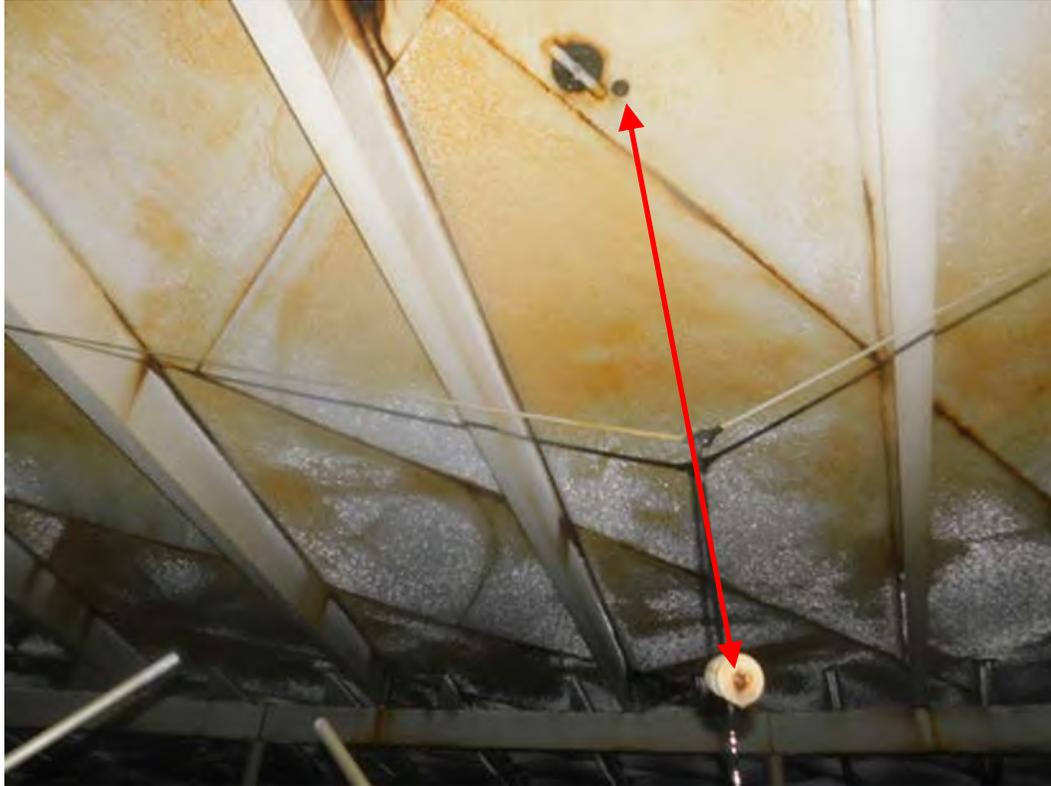
As part of the internal inspection of the Whatcom Falls #1 tank, it was noted that one of the anode support hangers had become detached from the roof. This should be replaced in the near future to ensure that the anode does not electrically short to the bottom of the tank.

Broken anode hanger, should be suspended from the roof

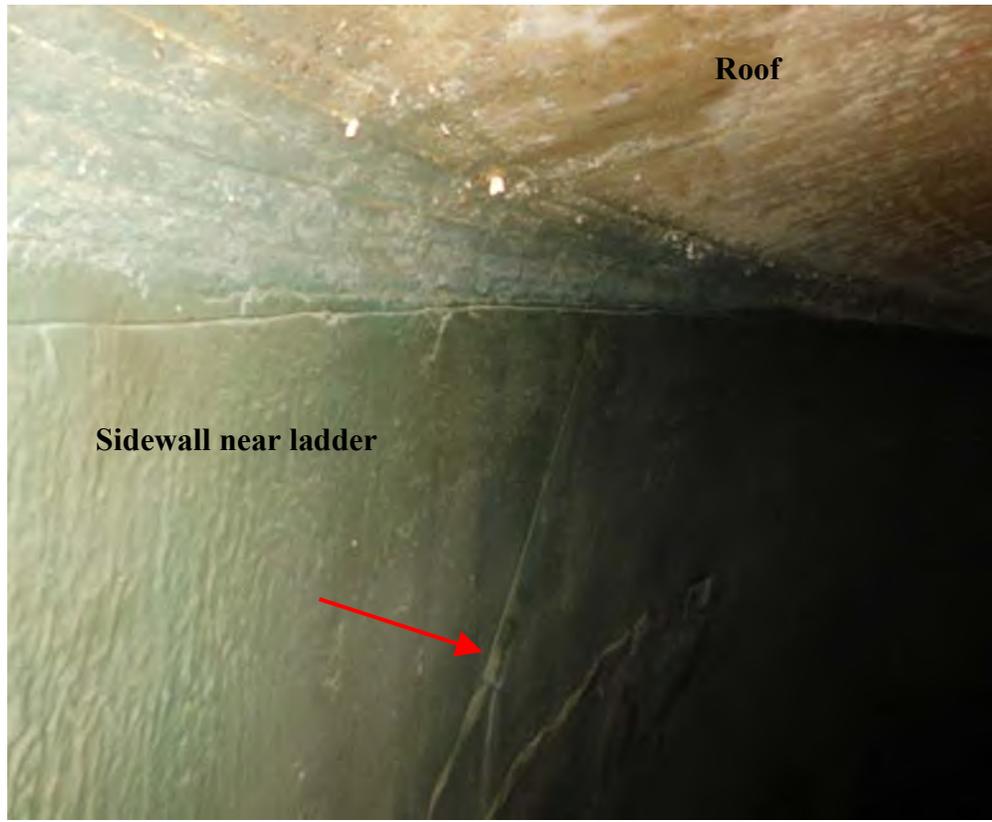
Tape repairs on wall, applied during original coating

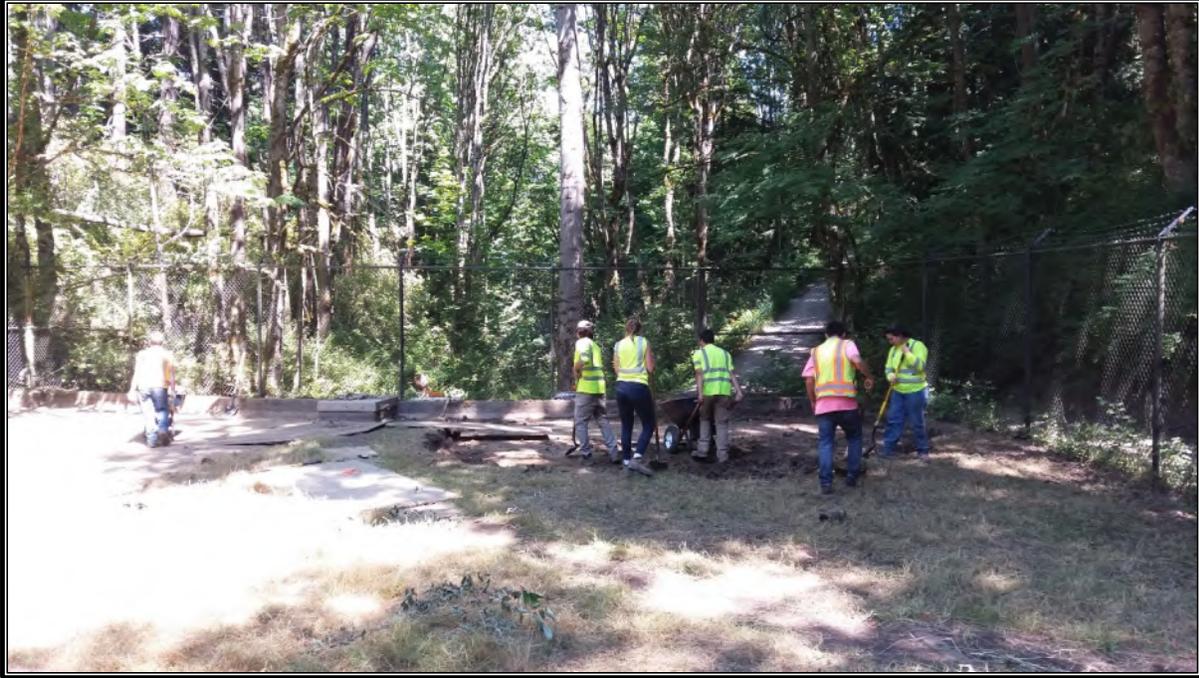
Figure 2-18: Sehome Reservoir – Work crews clearing the soil load from the roof in 2017 (picture provided by the City of Bellingham)
