November 22, 2024

Project: **Proposed 38-Lot Woods at Viewcrest Plat**  
352 Viewcrest Road, Bellingham, WA

Subject: **Geohazard Review Addendum – Stormwater Outfall Plan**

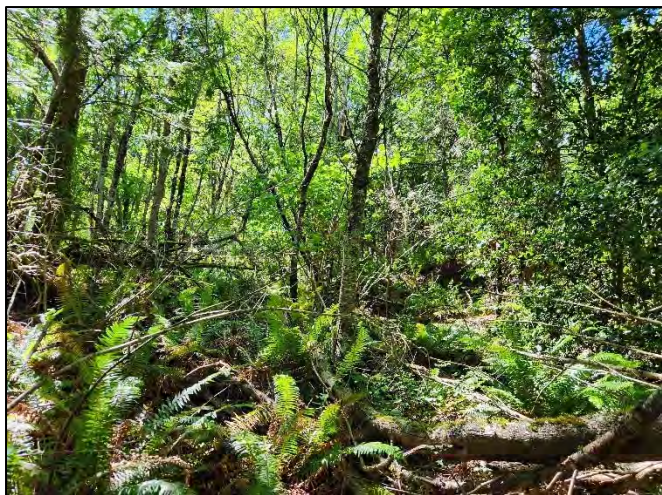
The uphill segment travels over generally gentle to moderate, rolling upland topography. Grades of over 40% on slope faces are interspersed with areas around or under 30%. The topographic variations are likely a reflection of underlying bedrock patterns, although outcrops are minimal in the uphill zone. This area is well vegetated with mature undergrowth and tree canopy (Photos 1 & 2).

**Photo 1:** Upper slope conditions near top of SW outfall path, looking uphill.

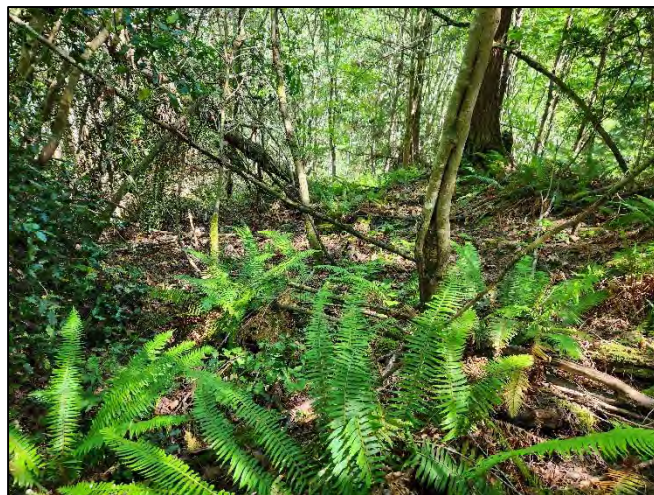
**Photo 2:** Upper slope conditions near top of SW outfall path, looking downhill.

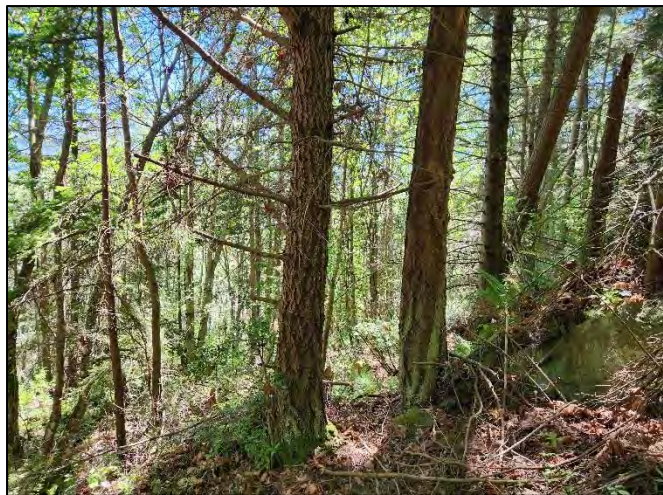
Upon reaching the area of the 90-degree turn in the outfall alignment, conditions change locally and persist for over 100 feet to the southwest. Sandstone outcrops locally, exposed on the order of 5 to 10 feet in height, along "ridges" oriented roughly east-west that cut across the southeast-facing slope (Photos 3 & 4). The outcrops are interspersed with small benches, creating an uneven ground surface that rises and falls in small areas. Overall ground conditions appear to be stable in this area, based on the common presence of large mature trees, although locally loose soils and rock may be found in troughs and directly above/below outcrops.

**Photo 3:** View to southwest from turn in alignment along proposed path with rock outcrop to right.

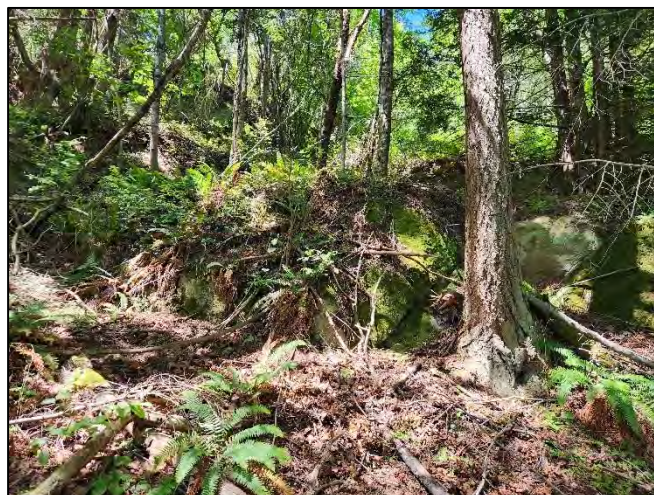
**Photo 4:** Looking uphill toward area of outfall path passing from right to left through extent of outcrop.

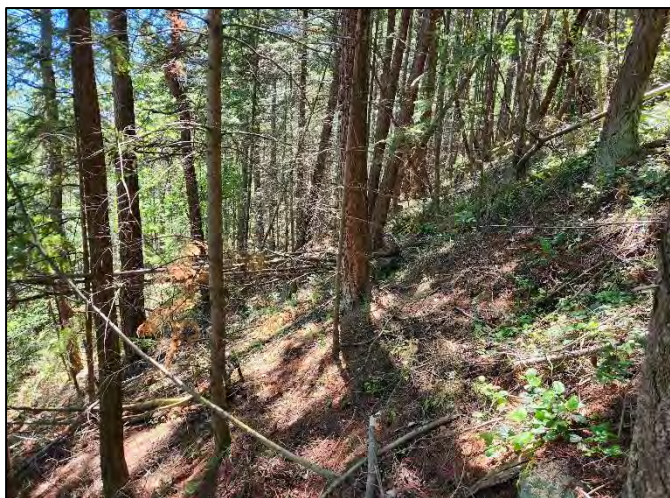
Past the zone of small outcrops, the main southeast slope face is a broadly planar feature with minor local variation. Conditions are typically mature tree cover with varying degrees of underbrush and forest litter (Photos 5 & 6). Trees are generally growing with straight trunks indicating soil creep is not significant, but there is some evidence of leaning or fallen trees that suggests shallow rooting (likely in thin soils over bedrock). No evidence of slope erosion, sloughing, or failures was seen along the proposed alignment or on the slope face above/below. The slope becomes progressively more moderate to the southwest. At the location of the proposed top-of-bluff catch basin, topography is gentle and mature forest vegetation covers the zone between the upland slope face and lower bluff (Photos 7 & 8).

**Photo 5:** View along main outfall path across planar slope. Looking SW. Taken near end of outcrop zone.

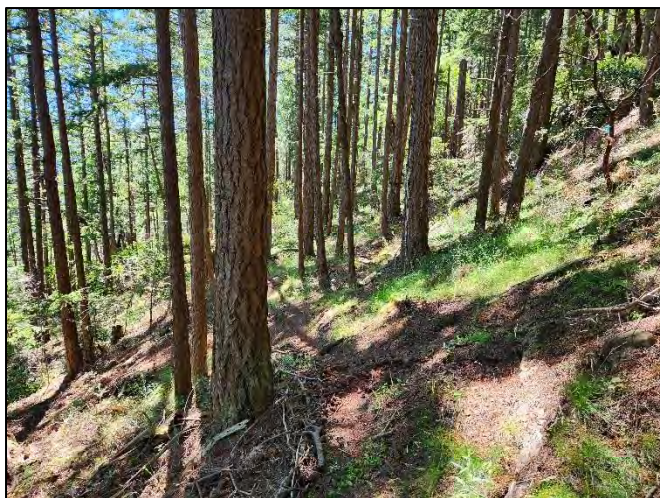
**Photo 6:** View to SW along outfall path across slope face. Location further to west of #5.

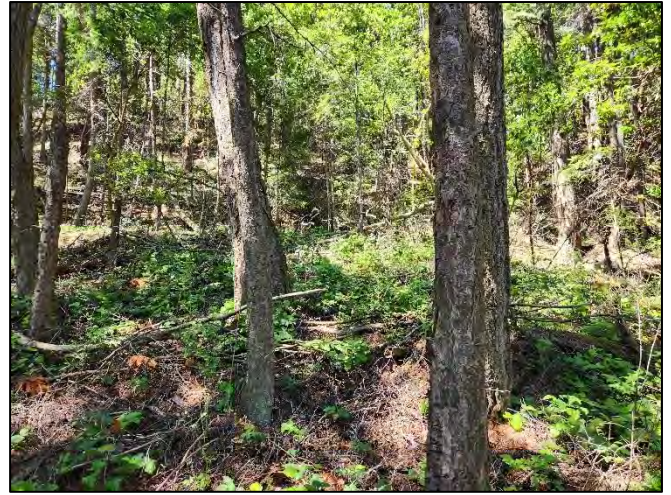
**Photo 8:** View uphill from location of catch basin. No evidence of slope activity and mature vegetation.

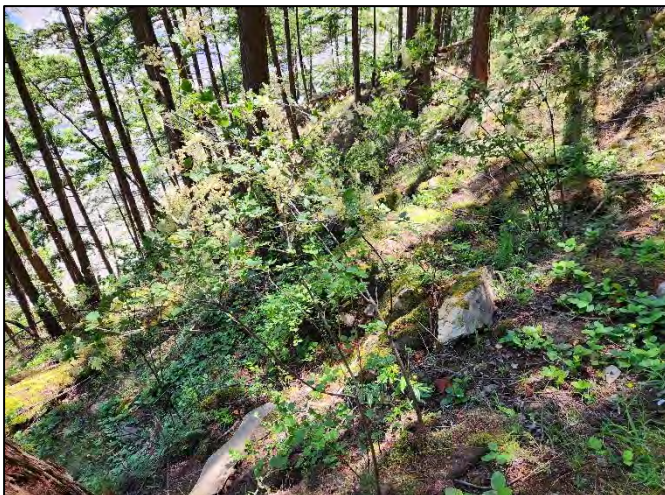
to the west, and wraps around the end of a large sandstone outcrop that appears broadly intact. Near to the east, the outcrop exposure becomes larger and exhibits common fracturing with some loose rock and recent rock fall remains on the ground below (Photos 10 & 11). The slope below the more fractured zone of outcrop has uneven terrain as a function of rock debris of varying sizes, but otherwise appears stabilized based on mature tree cover. The amount and size of rock debris generally dissipates downhill, further away from the outcrop face, with most surface rock observed within approximately 25 to 30 feet of the outcrop base. The outcrop remains exposed and becomes more competent to the east. Large boulders are present on the slope face just below the outcrop, but these appear to have been in place for a long time. The area with most recent rock debris evidence and outcrop fracturing is on the order of 100 feet wide, as estimated in the field, with the adjacent zone of older rock fall evidence and lesser fracturing an additional 100 feet wide (totaling about 200 feet width).

**Bluff Slope Rock Fall Zone:** After descending onto the lower bluff slope, the conveyance piping is proposed near the base of the tall rock exposure. While the eastern majority of this rock face appears intact with a low rock fall risk, the western portion appears prone to occasional rock fall from fractured outcrops. In particular, the first approximately 100 feet along the cliff face displays an elevated risk of incidental rock fall. This is evidenced by common rock talus on the underlying slope which generally dissipates out from the outcrop. The next roughly 100 feet of slope also has common older rock debris but little evidence of recent activity.

**Photo 11:** Slope face below fractured outcrop. Note rock fall debris in foreground.

- One method to mitigate rock fall hazard from the cliff band is to adjust the alignment to traverse across the slope further away from the cliff exposure below elevated hazard areas. The hazard of rock fall directly impacting a downhill pipe generally lessens with distance from the source.

- A downslope shift on the order of 50 feet is interpreted to be sufficient to minimize rock fall impact risk, based on conditions observed during the recent reconnaissance. We recommend an alignment shift below the elevated hazard areas be considered for final design. Site conditions should be re-observed during final design to optimize the outfall path for rock fall protection.

- In addition to the above protective mitigations, shallow burial or inset of the pipe into natural topography will help minimize the potential for dislodged rolling or sliding rock debris to “catch” on the pipe as it travels downslope. We recommend the pipe placement be optimized to minimize a surface debris “catch” hazard by use of shallow embedment.

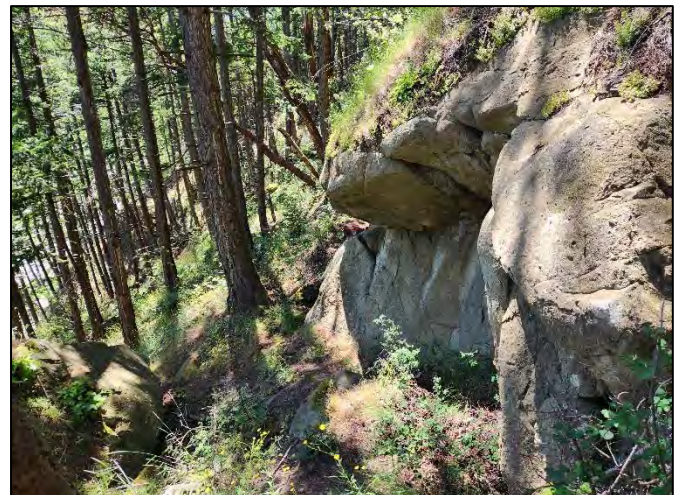
**Photo 12:** Sandstone outcrop becomes more competent / less fractured to east.

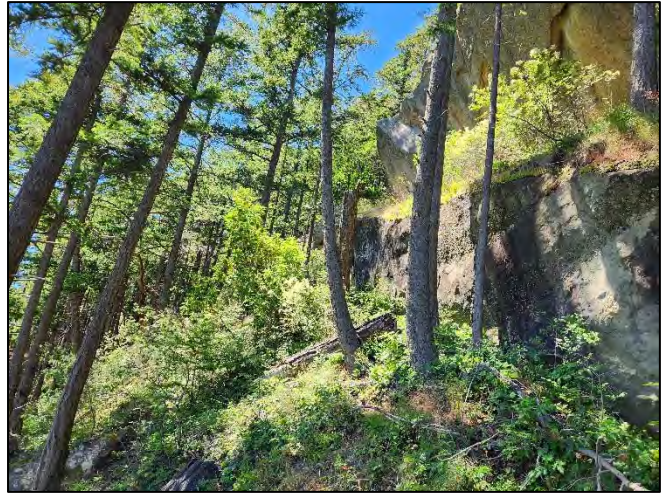
The proposed outfall path continues to follow the base of the sandstone cliff. The exposure grows to the east but becomes notably more competent with little to no evidence of recent rock fall (Photos 13 – 16). The lower slope below the outcrop is well vegetated with undergrowth, patches of grass, and mature pines. The final segment of the outfall travels a short distance down the slope to the proposed dispersion point atop a sandstone plateau at the shoreline (Photo 17). The level of activity in this area is generally low based on the outcrop competency and underlying slope conditions.

**Photo 14:** View of large intact bedrock face with forested slope below. Looking west.

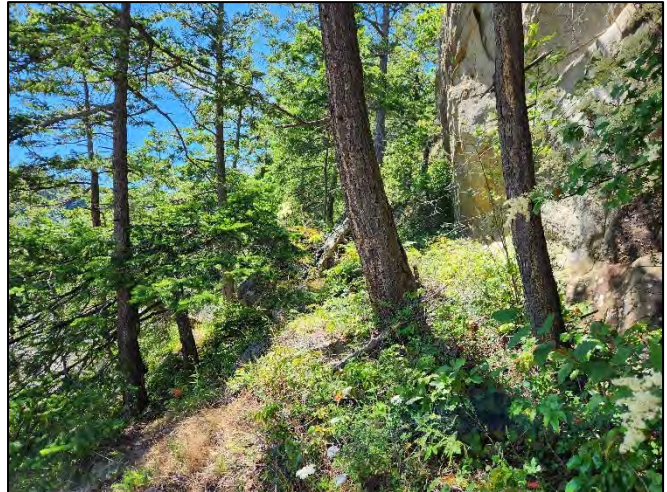
**Photo 16:** View of slope face below large sandstone cliff (near #15).

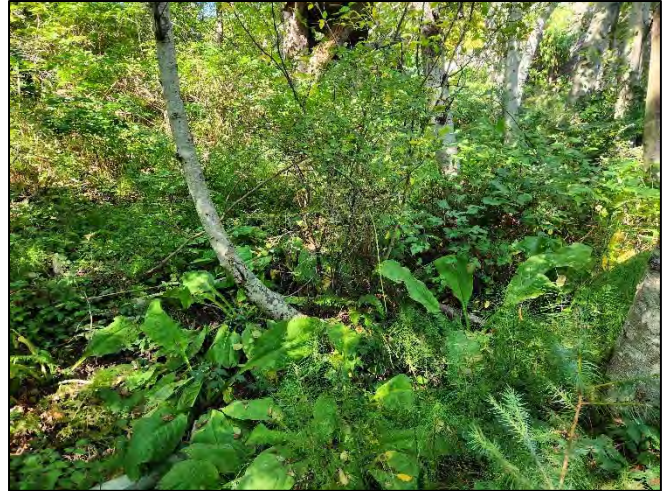
The convergent basin below the LHA slopes consists of lower surface grades leading into the low-lying Wetland “A” area. The transitional lower slope zone was covered in heavy brush and not accessed, but was viewed from within the basin bottom (Photos 11 & 12). We observed ground conditions becoming progressively moist to wet northeastward. Vegetation also changes to wet zone grasses and plants approaching the east site boundary (Photo 14) which is paralleled by a driveway embankment (Photo

**Photo 14:** Wet ground and plants concentrated along East margin of LHA basin. (10-7-24)

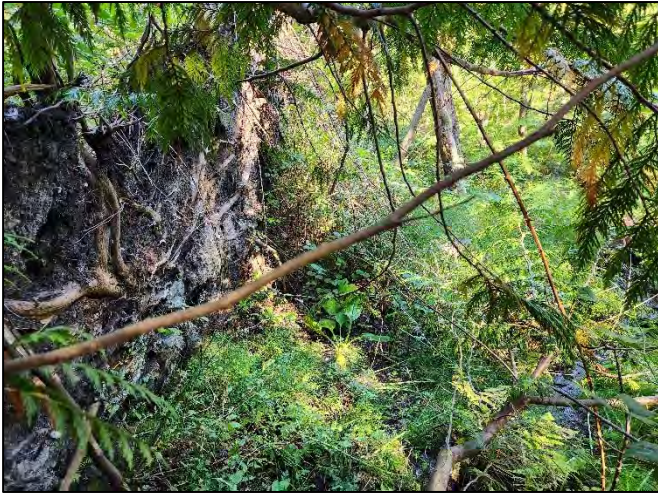
We located the top of the mapped wetland, finding wet ground exposed where a large tree had fallen in the past (Photo 19). Nearby rock exposures suggest bedrock is shallow in this area, limiting root depth and contributing to perched water conditions. We followed the upper half of the feature downhill until heavy brush became impassable. The feature was slightly lower compared to flanking slope areas, confining its extent. The feature typically had dark, moist to wet organic soils amid wet zone plants (Photo 20). Minor free water was present, although there was no consistent flow or channelization seen at the time of our visit. The lower end of Wetland "D" was found from below. At its terminus, the wet zone flora ends abruptly into typical brushy undergrowth approaching the lower slope (Photo 21). Along the nearby bluff slope crest, bedrock is exposed and patchy cover soils did not have signs of erosion from excess water flow (Photo 22). We interpret that any excess wet conditions emanating from the Wetland "D" feature are reabsorbed into the ground along the gentle upland grades before reaching the rocky bluff crest.

**Photo 19:** Uphill end of Wetland "D" with fallen tree remains and wet ground below. (10-7-24)

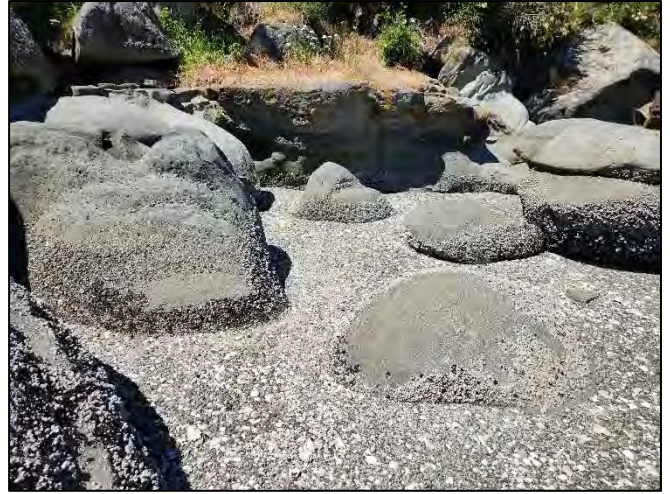
**Photo 2:** Dispersion is proposed atop the flat "table" outcrop situated among a rocky area.

- Design the shoreline Dispersion Tee so that it is sufficiently secured and resistant to damage from storm surge wave events.
  - Anchor the Dispersion Tee directly to the rock shelf by use of epoxied dowels and collars to the extent that it is not at risk of loss or dislodgement from a maximum potential storm wave magnitude.

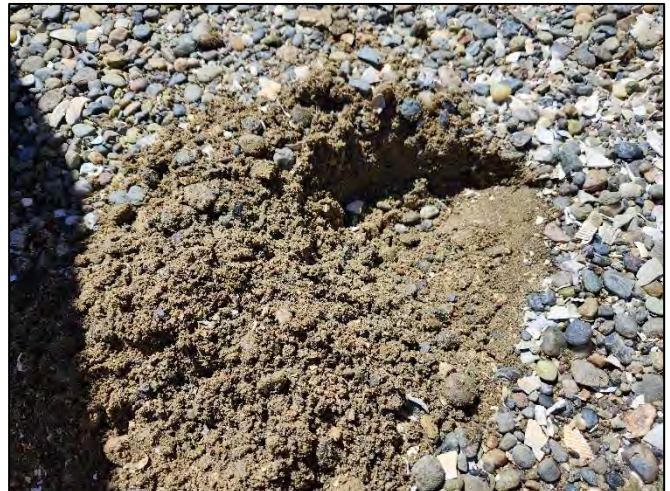
**Photo 4:** Upper tidal sediments consist of coarse-grained sand and gravel.
