November 22, 2024

Project: **Proposed 38-Lot Woods at Viewcrest Plat**  
352 Viewcrest Road, Bellingham, WA

Subject: **Geohazard Review Addendum – Stormwater Outfall Plan**

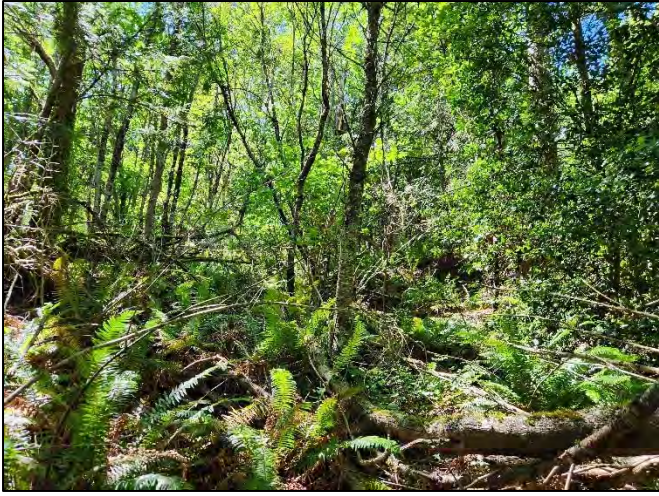
The uphill segment travels over generally gentle to moderate, rolling upland topography. Grades of over 40% on slope faces are interspersed with areas around or under 30%. The topographic variations are likely a reflection of underlying bedrock patterns, although outcrops are minimal in the uphill zone. This area is well vegetated with mature undergrowth and tree canopy (Photos 1 & 2).

**Photo 1:** Upper slope conditions near top of SW outfall path, looking uphill.

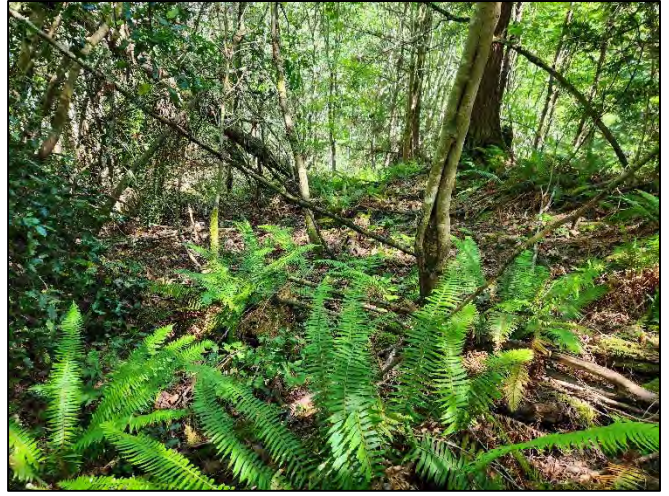
**Photo 2:** Upper slope conditions near top of SW outfall path, looking downhill.

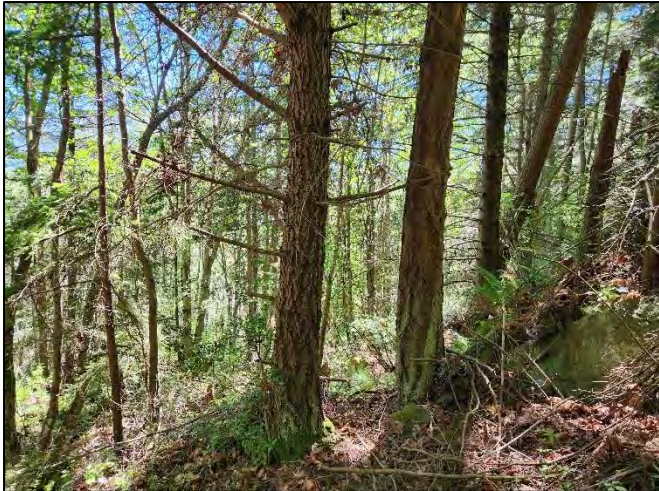
Upon reaching the area of the 90-degree turn in the outfall alignment, conditions change locally and persist for over 100 feet to the southwest. Sandstone outcrops locally, exposed on the order of 5 to 10 feet in height, along "ridges" oriented roughly east-west that cut across the southeast-facing slope (Photos 3 & 4). The outcrops are interspersed with small benches, creating an uneven ground surface that rises and falls in small areas. Overall ground conditions appear to be stable in this area, based on the common presence of large mature trees, although locally loose soils and rock may be found in troughs and directly above/below outcrops.

**Photo 3:** View to southwest from turn in alignment along proposed path with rock outcrop to right.

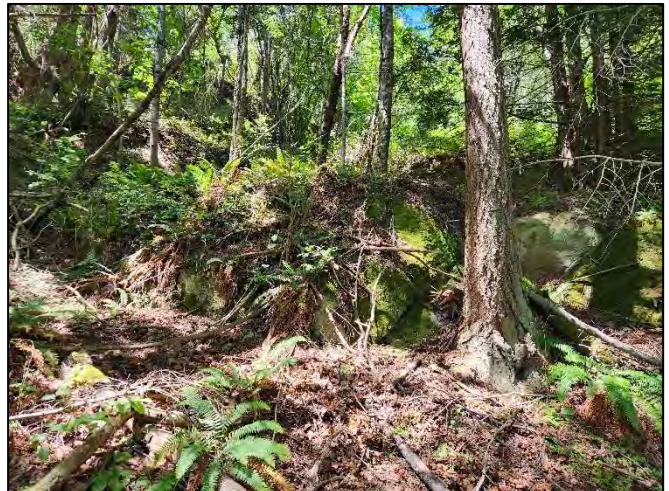
**Photo 4:** Looking uphill toward area of outfall path passing from right to left through extent of outcrop.

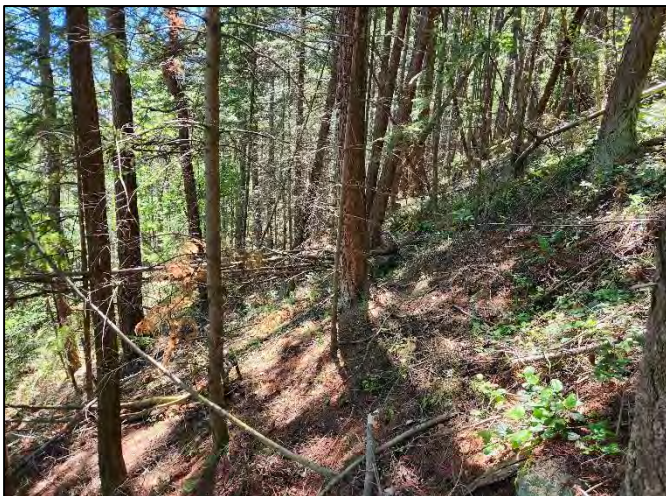
Past the zone of small outcrops, the main southeast slope face is a broadly planar feature with minor local variation. Conditions are typically mature tree cover with varying degrees of underbrush and forest litter (Photos 5 & 6). Trees are generally growing with straight trunks indicating soil creep is not significant, but there is some evidence of leaning or fallen trees that suggests shallow rooting (likely in thin soils over bedrock). No evidence of slope erosion, sloughing, or failures was seen along the proposed alignment or on the slope face above/below. The slope becomes progressively more moderate to the southwest. At the location of the proposed top-of-bluff catch basin, topography is gentle and mature forest vegetation covers the zone between the upland slope face and lower bluff (Photos 7 & 8).

**Photo 5:** View along main outfall path across planar slope. Looking SW. Taken near end of outcrop zone.

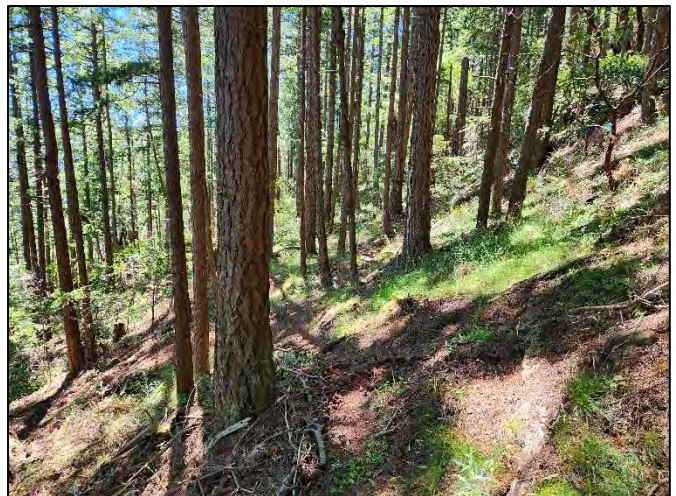
**Photo 6:** View to SW along outfall path across slope face. Location further to west of #5.

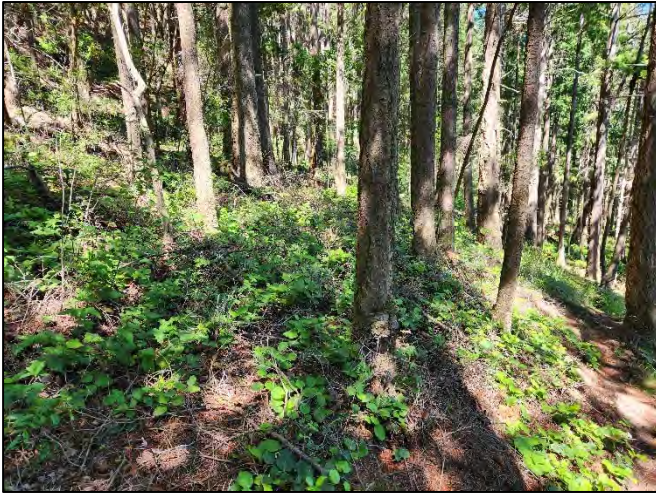
**Photo 7:** Looking at location of catch basin proposed near top of bluff (out of photo to right).

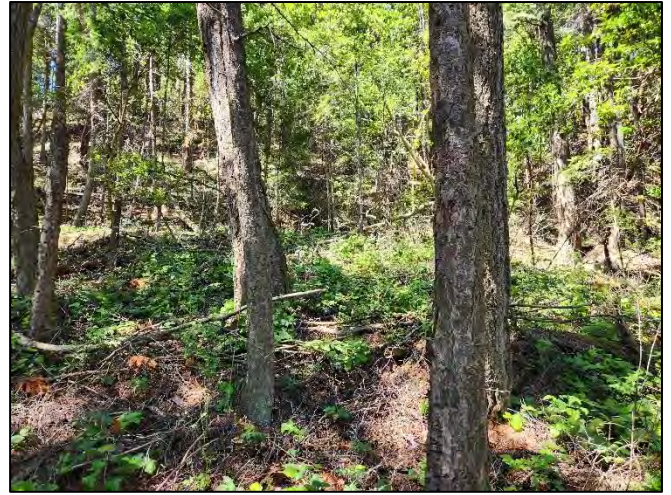
**Photo 8:** View uphill from location of catch basin. No evidence of slope activity and mature vegetation.

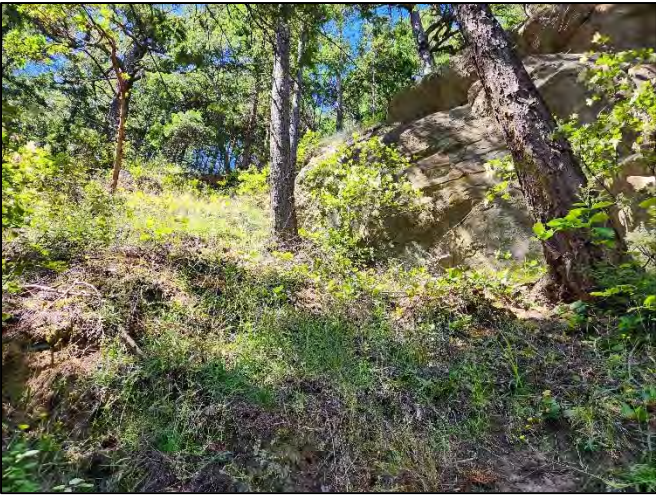
The location of the pipe entry onto the bluff slope is a planar section with little brush, grassy ground-cover, and several mature trees (Photo 9). The proposed alignment avoids a steeper erosion-prone area

**Photo 9:** Looking up at slope face at entry of outfall onto lower bluff.

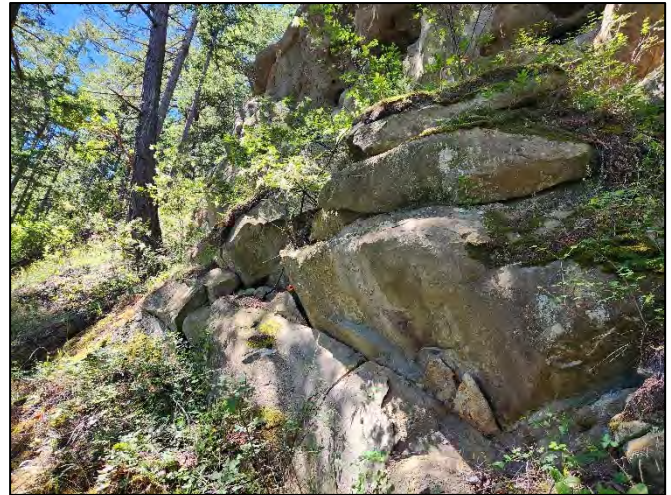
to the west, and wraps around the end of a large sandstone outcrop that appears broadly intact. Near to the east, the outcrop exposure becomes larger and exhibits common fracturing with some loose rock and recent rock fall remains on the ground below (Photos 10 & 11). The slope below the more fractured zone of outcrop has uneven terrain as a function of rock debris of varying sizes, but otherwise appears stabilized based on mature tree cover. The amount and size of rock debris generally dissipates downhill, further away from the outcrop face, with most surface rock observed within approximately 25 to 30 feet of the outcrop base. The outcrop remains exposed and becomes more competent to the east. Large boulders are present on the slope face just below the outcrop, but these appear to have been in place for a long time. The area with most recent rock debris evidence and outcrop fracturing is on the order of 100 feet wide, as estimated in the field, with the adjacent zone of older rock fall evidence and lesser fracturing an additional 100 feet wide (totaling about 200 feet width).

**Bluff Slope Rock Fall Zone:** After descending onto the lower bluff slope, the conveyance piping is proposed near the base of the tall rock exposure. While the eastern majority of this rock face appears intact with a low rock fall risk, the western portion appears prone to occasional rock fall from fractured outcrops. In particular, the first approximately 100 feet along the cliff face displays an elevated risk of incidental rock fall. This is evidenced by common rock talus on the underlying slope which generally dissipates out from the outcrop. The next roughly 100 feet of slope also has common older rock debris but little evidence of recent activity.

**Photo 10:** Fractured area of sandstone outcrop with loose rock exposed.

- One method to mitigate rock fall hazard from the cliff band is to adjust the alignment to traverse across the slope further away from the cliff exposure below elevated hazard areas. The hazard of rock fall directly impacting a downhill pipe generally lessens with distance from the source.

- A downslope shift on the order of 50 feet is interpreted to be sufficient to minimize rock fall impact risk, based on conditions observed during the recent reconnaissance. We recommend an alignment shift below the elevated hazard areas be considered for final design. Site conditions should be re-observed during final design to optimize the outfall path for rock fall protection.

- In addition to the above protective mitigations, shallow burial or inset of the pipe into natural topography will help minimize the potential for dislodged rolling or sliding rock debris to “catch” on the pipe as it travels downslope. We recommend the pipe placement be optimized to minimize a surface debris “catch” hazard by use of shallow embedment.

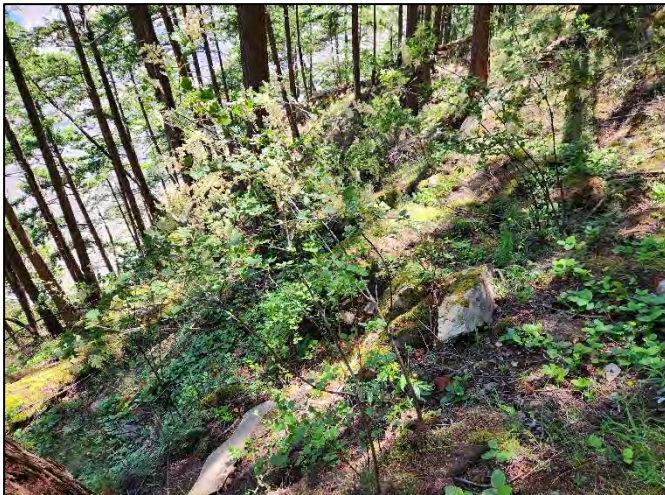
**Photo 11:** Slope face below fractured outcrop. Note rock fall debris in foreground.

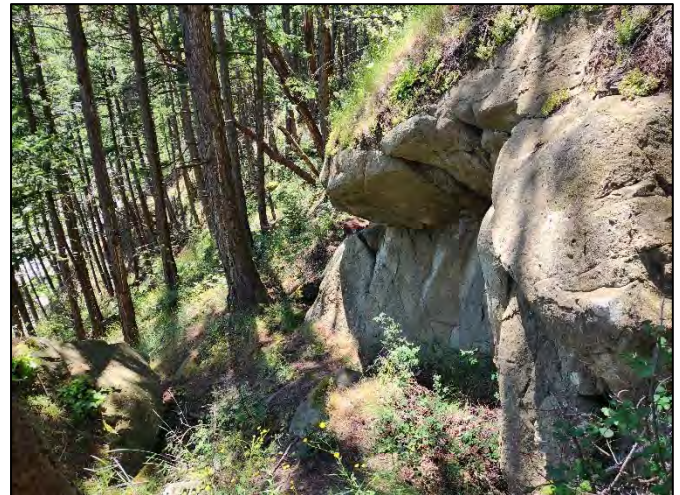
**Photo 12:** Sandstone outcrop becomes more competent / less fractured to east.

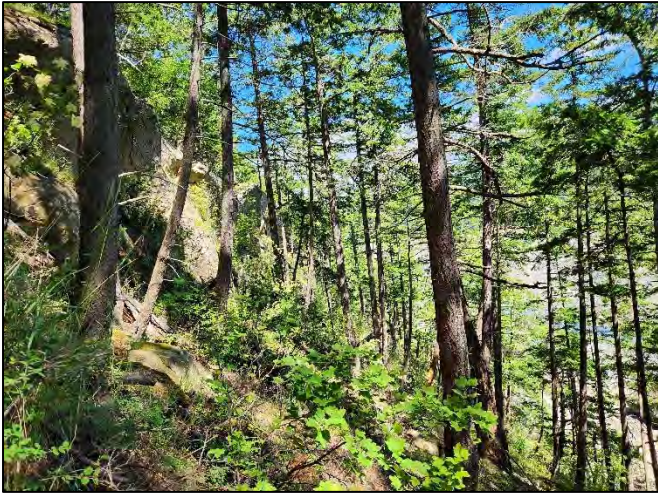
The proposed outfall path continues to follow the base of the sandstone cliff. The exposure grows to the east but becomes notably more competent with little to no evidence of recent rock fall (Photos 13 – 16). The lower slope below the outcrop is well vegetated with undergrowth, patches of grass, and mature pines. The final segment of the outfall travels a short distance down the slope to the proposed dispersion point atop a sandstone plateau at the shoreline (Photo 17). The level of activity in this area is generally low based on the outcrop competency and underlying slope conditions.

**Photo 13:** View across lower slope below large sandstone outcrop. Looking east.

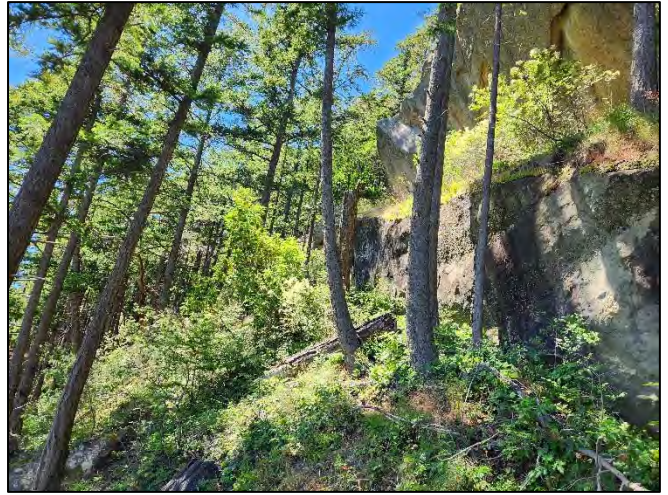
**Photo 14:** View of large intact bedrock face with forested slope below. Looking west.

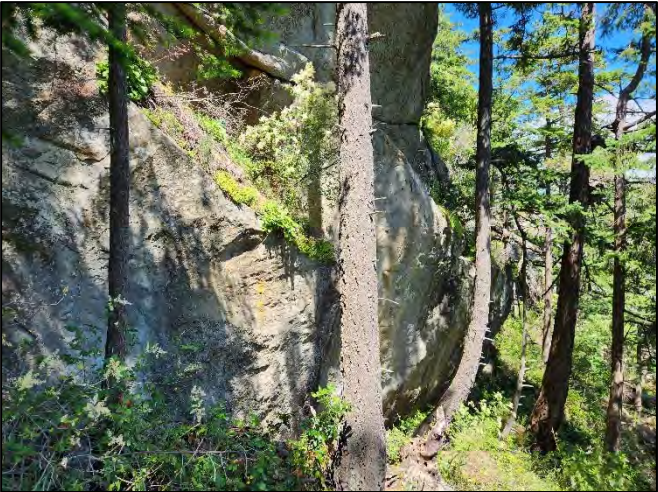
**Photo 15:** Large intact sandstone bedrock face near east end of conveyance alignment. Looking east.

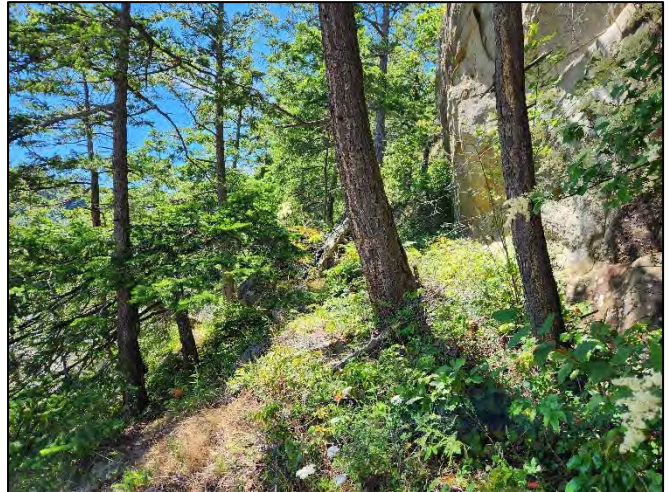
**Photo 16:** View of slope face below large sandstone cliff (near #15).

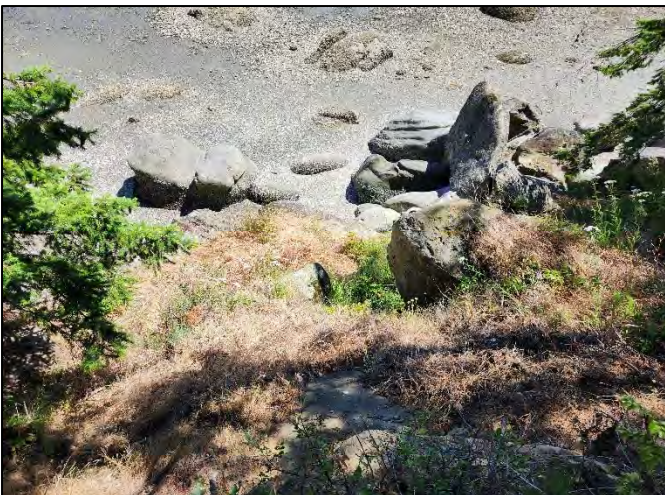
**Photo 17:** Looking down slope at proposed outfall release location above tidal beach.

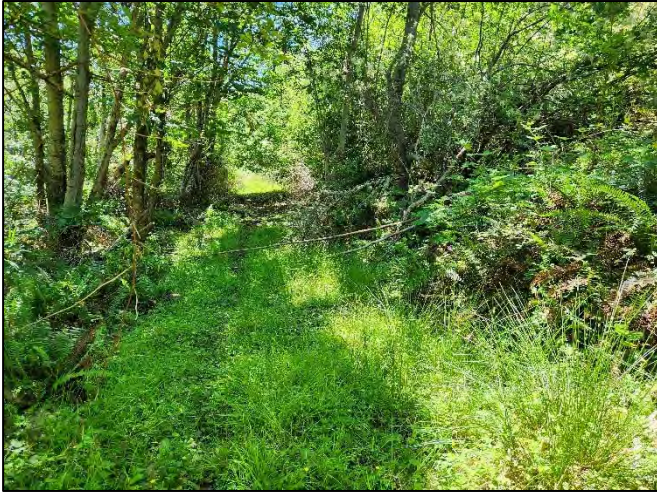
**Photo 1:** View along area of proposed dispersion spreader at west edge of Lot 38. (6-24-24)

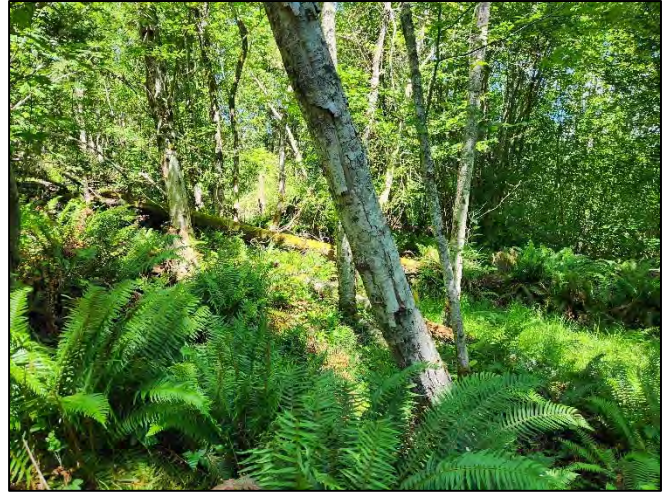
**Photo 2:** View to North across Wetland "B" area downhill to east of planned dispersion area. (6-24-24)

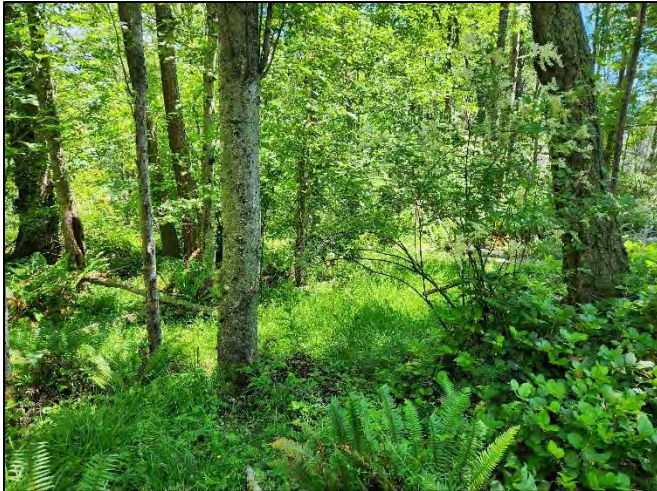
**Photo 3:** View to East downhill from Wetland "B" toward small Wetland "C" and forest area. (6-24-24)

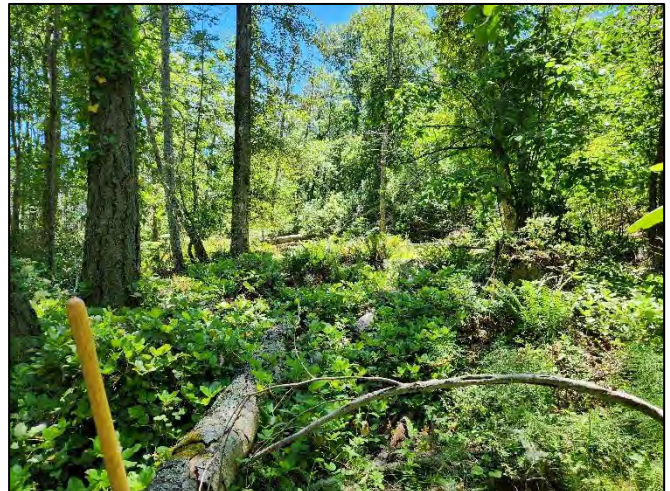
**Photo 4:** Gentle forested upland area to south of Wetland "B". (6-24-24)

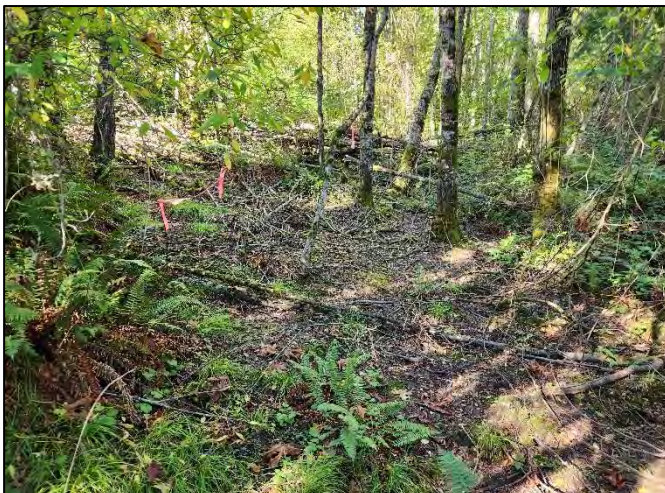
**Photo 5:** Small Wetland "C" area, looking to northwest. (10-7-24)

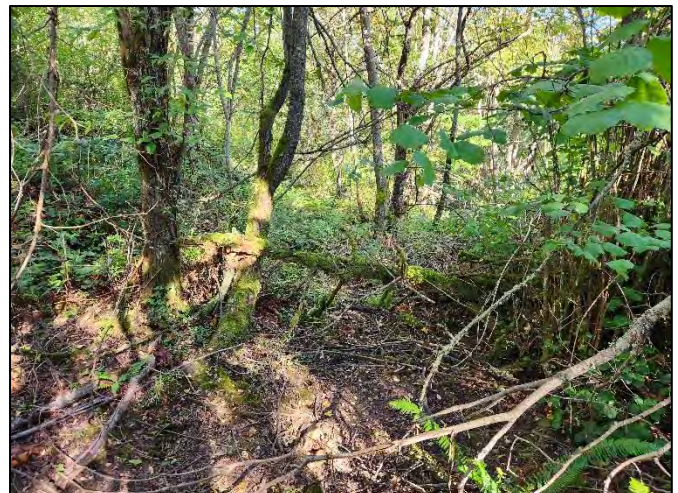
**Photo 6:** Small Wetland "C" area, looking downhill to east along minor convergence in grades. (10-7-24)

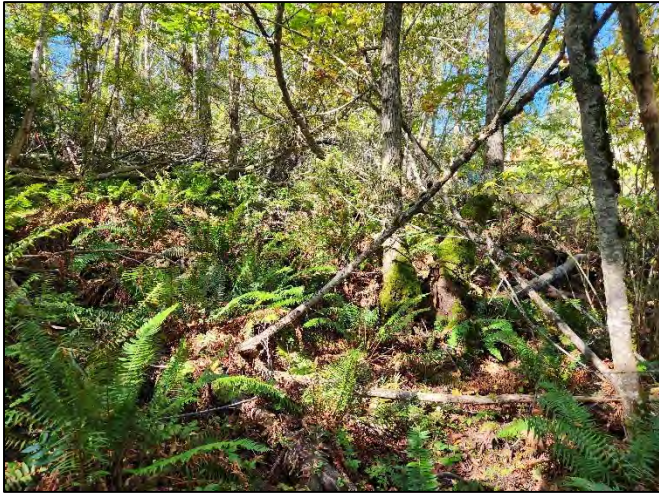
**Photo 7:** Upper slope leading into LHA area from off-site lots. Looking North from site boundary. (10-7-24)

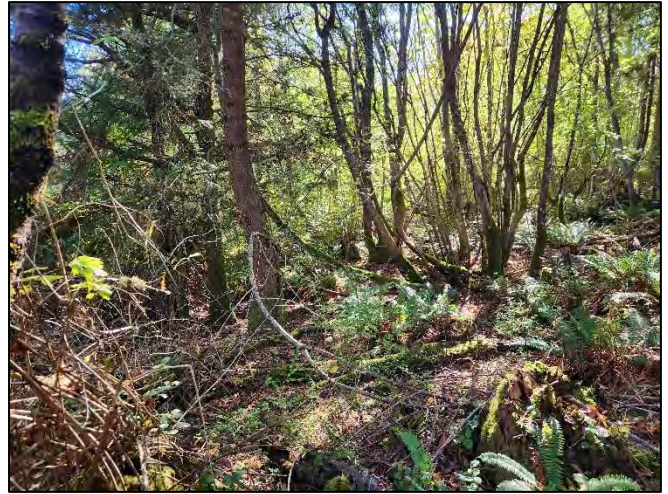
**Photo 8:** Typical upland forest conditions approaching LHA slope crest within site, looking East. (10-7-24)

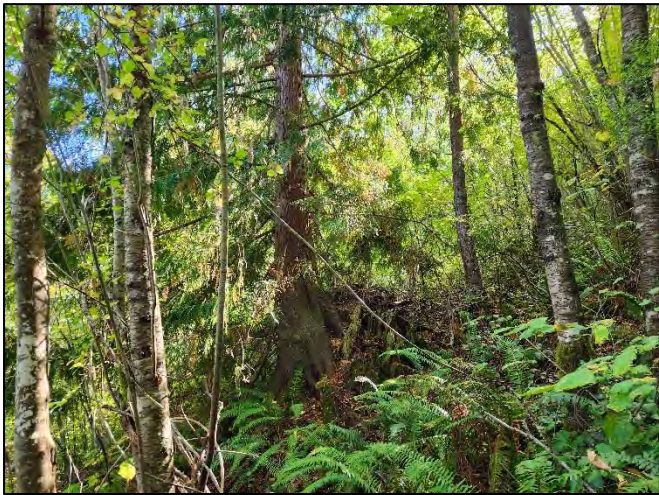
**Photo 9:** LHA slope crest along south area of slope, looking South downhill of proposed Lot 38. (10-7-24)

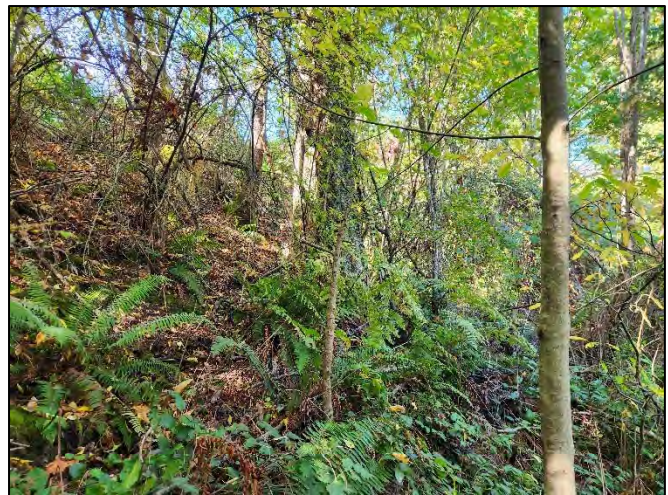
**Photo 10:** LHA slope face. Looking North toward middle of slope. (10-7-24)

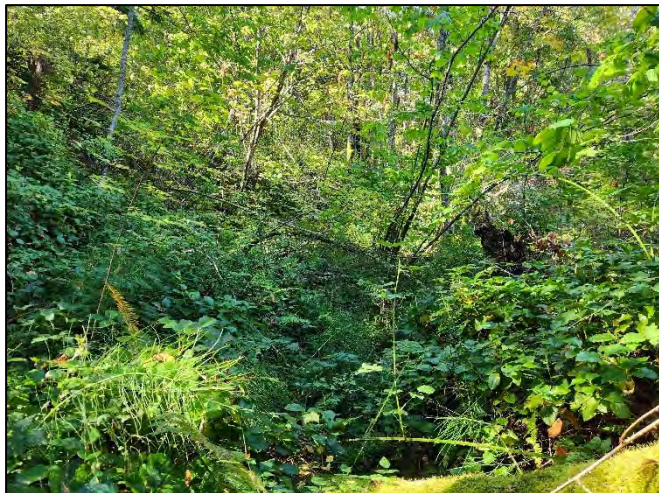
**Photo 11:** View Northwest through LHA basin / Wetland "A" area from South end. (10-7-24)

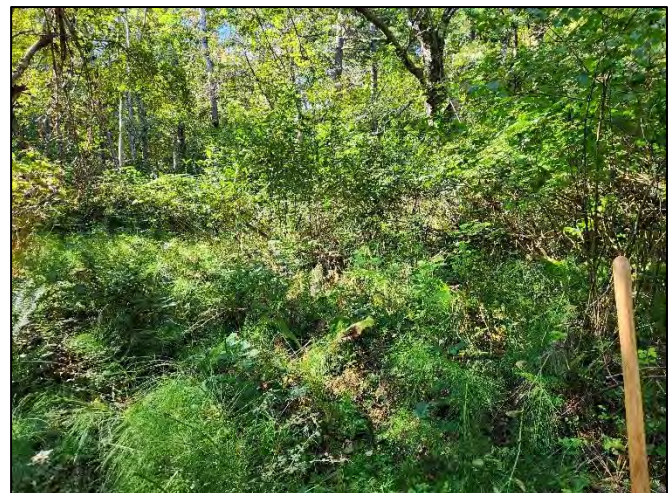
**Photo 12:** Conditions in middle of LHA basin / Wetland "A" area. (10-7-24)

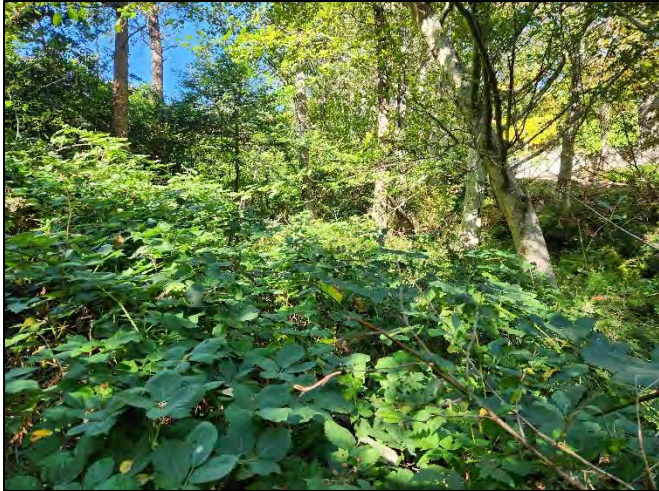
**Photo 13:** Within middle of LHA basin, looking North up brushy slope toward mapped SD outfall. (10-7-24)

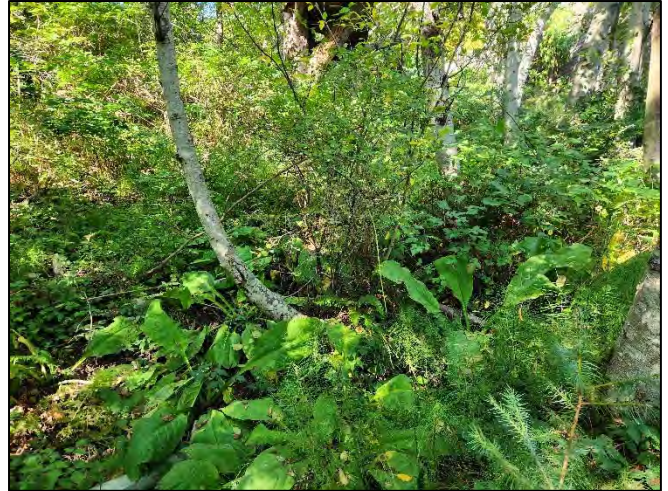
**Photo 14:** Wet ground and plants concentrated along East margin of LHA basin. (10-7-24)

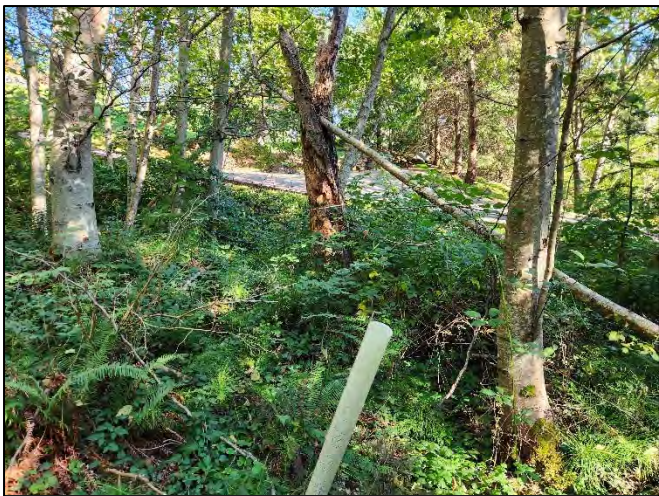
**Photo 15:** Within east side of LHA basin, looking east toward SFR driveway embankment. (10-7-24)

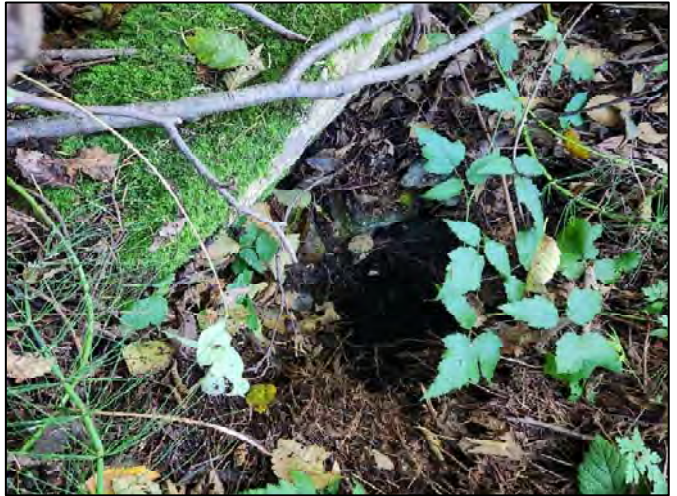
15) that effectively confines the basin on that side. At the low-point east margin of the basin, we found the mapped public Storm Drain inlet that leads into the Sea Pines Road system (Photo 16). City of Bellingham maps indicate an outfall for a public storm drain system from Viewcrest Drive located just uphill from the site's northeast corner (shown on Figure 2). We could not access this area from within the site (Photo 13). The presence of the mapped wetland extending well up the slope toward this outfall suggests the conditions are related. It is plausible, if not likely, that the SD outfall is a primary contributor to Wetland "A", and that the accumulation of water in this basin is controlled by the downhill inlet. We did not find or directly observe other seeps in the area.

**Photo 16:** Found SD inlet at East edge of LHA basin and site, leads to Sea Pines Road utility. (10-7-24)

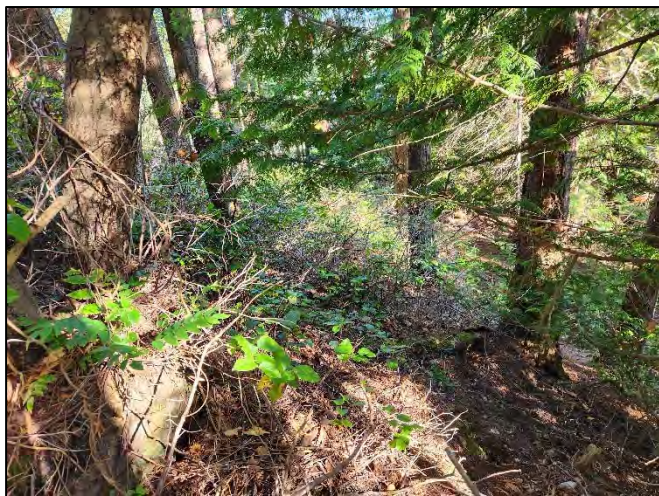
**Photo 17:** Moderate forested slope conditions at Lot 37 building zone, looking West. (10-7-24)

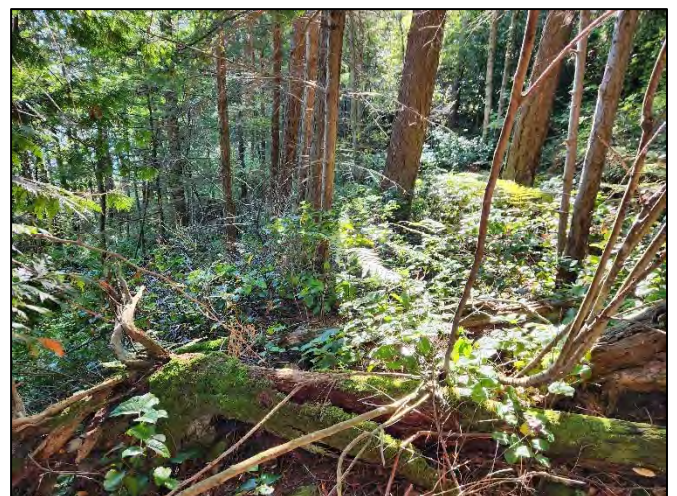
**Photo 18:** Moderate forested slope conditions at Lot 37 building zone, looking Southeast. (10-7-24)

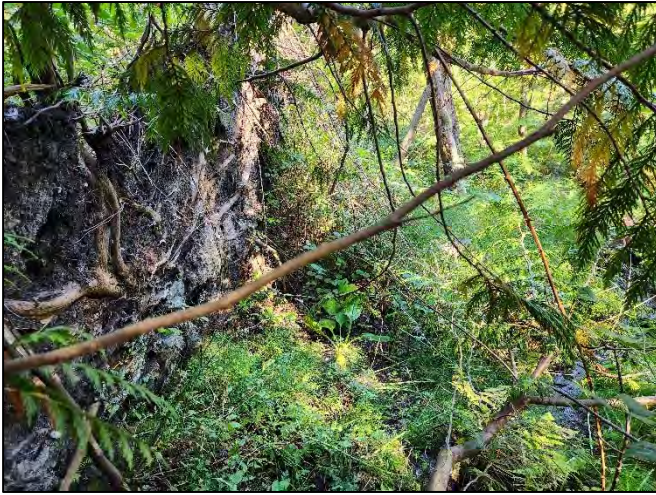
We located the top of the mapped wetland, finding wet ground exposed where a large tree had fallen in the past (Photo 19). Nearby rock exposures suggest bedrock is shallow in this area, limiting root depth and contributing to perched water conditions. We followed the upper half of the feature downhill until heavy brush became impassable. The feature was slightly lower compared to flanking slope areas, confining its extent. The feature typically had dark, moist to wet organic soils amid wet zone plants (Photo 20). Minor free water was present, although there was no consistent flow or channelization seen at the time of our visit. The lower end of Wetland "D" was found from below. At its terminus, the wet zone flora ends abruptly into typical brushy undergrowth approaching the lower slope (Photo 21). Along the nearby bluff slope crest, bedrock is exposed and patchy cover soils did not have signs of erosion from excess water flow (Photo 22). We interpret that any excess wet conditions emanating from the Wetland "D" feature are reabsorbed into the ground along the gentle upland grades before reaching the rocky bluff crest.

**Photo 19:** Uphill end of Wetland "D" with fallen tree remains and wet ground below. (10-7-24)

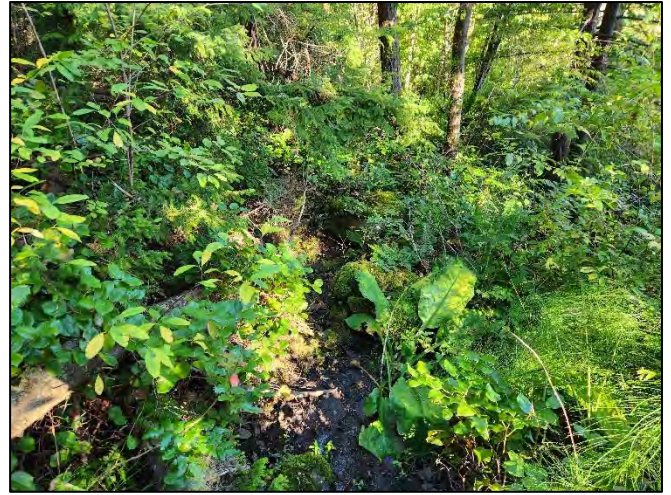
**Photo 20:** View down-gradient along strip of Wetland "D". (10-7-24)

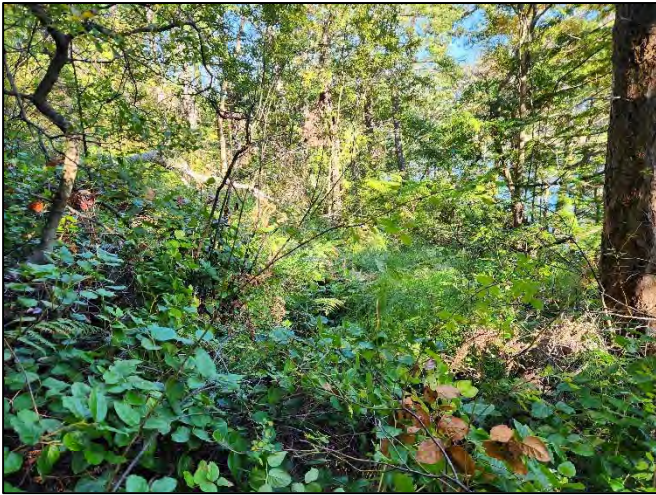
**Photo 21:** Downhill terminus of Wetland "D" above bluff slope. (10-7-24)

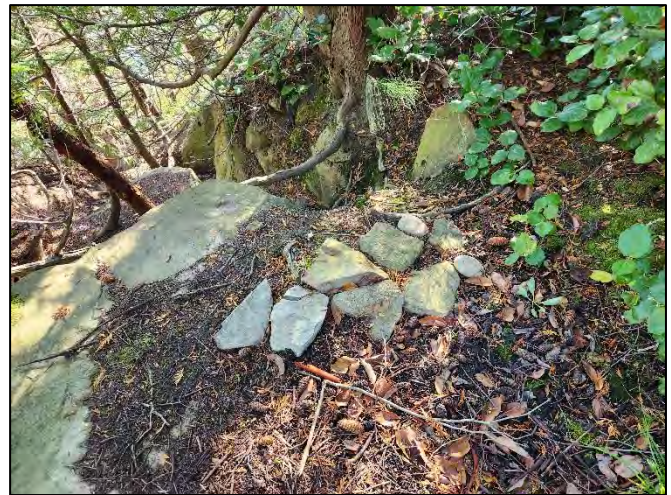
**Photo 22:** Rocky bluff slope crest near end of Wetland "D". (10-7-24)

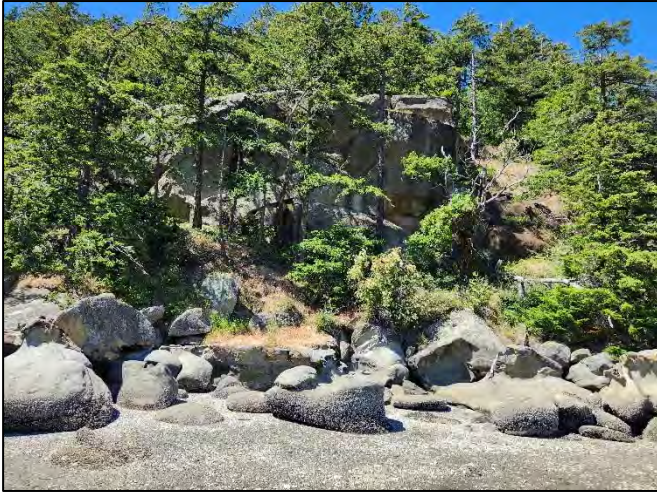
**Photo 1:** View of site shoreline from tidal zone at proposed dispersion area.

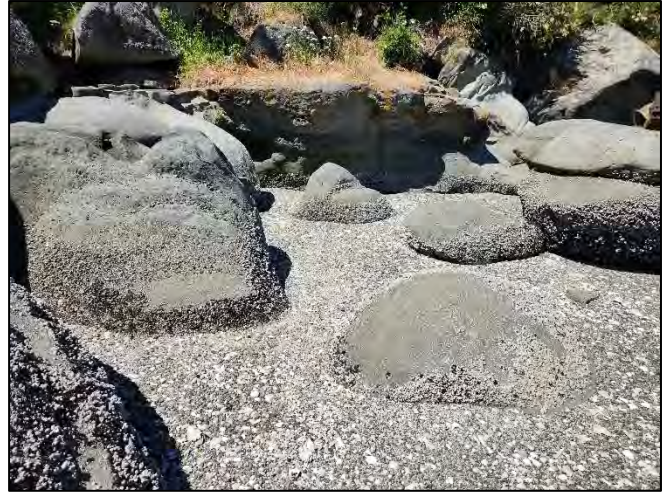
**Photo 2:** Dispersion is proposed atop the flat "table" outcrop situated among a rocky area.

- Design the shoreline Dispersion Tee so that it is sufficiently secured and resistant to damage from storm surge wave events.
  - Anchor the Dispersion Tee directly to the rock shelf by use of epoxied dowels and collars to the extent that it is not at risk of loss or dislodgement from a maximum potential storm wave magnitude.

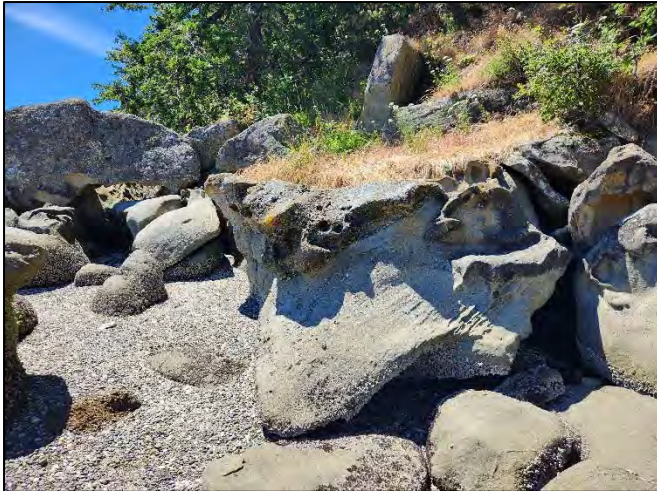
**Photo 3:** Profile view of dispersion outcrop and upper tidal conditions below.

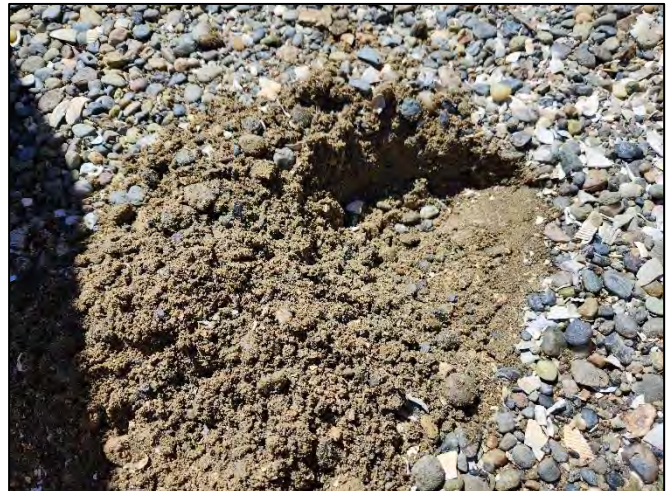
**Photo 4:** Upper tidal sediments consist of coarse-grained sand and gravel.

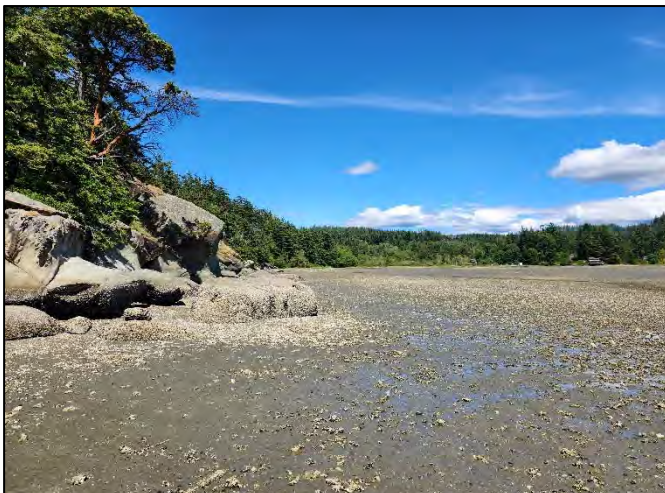
**Photo 5:** View to east from near dispersion area showing lower tidal conditions

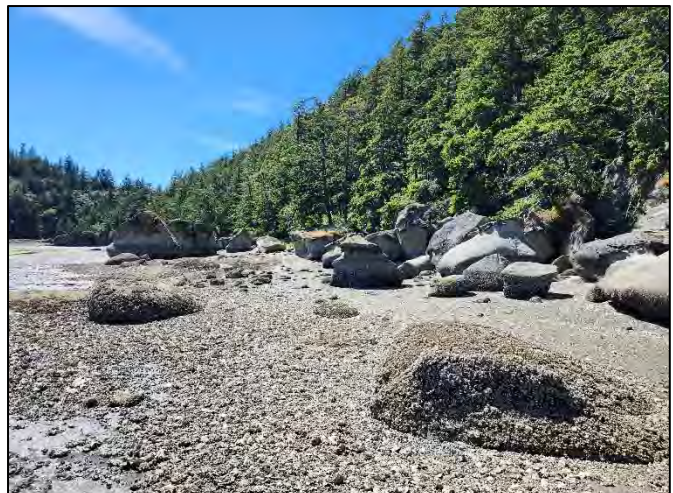
**Photo 6:** View to southwest from near dispersion area showing transition zone between upper and lower tidal areas.

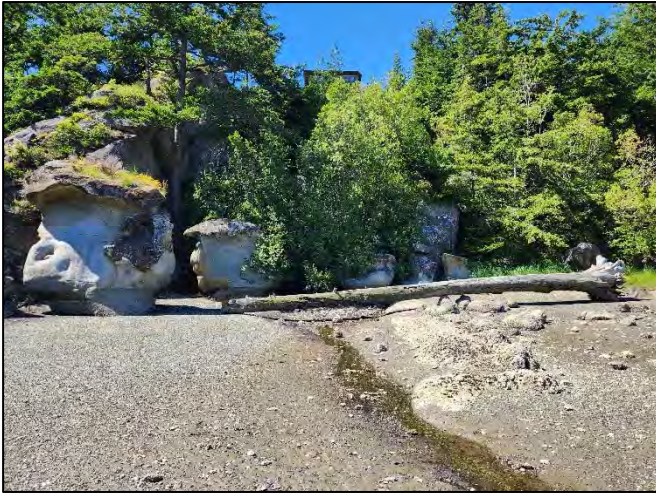
**Photo 7:** View of shoreline at location of existing stormwater release below Arbutus Place.

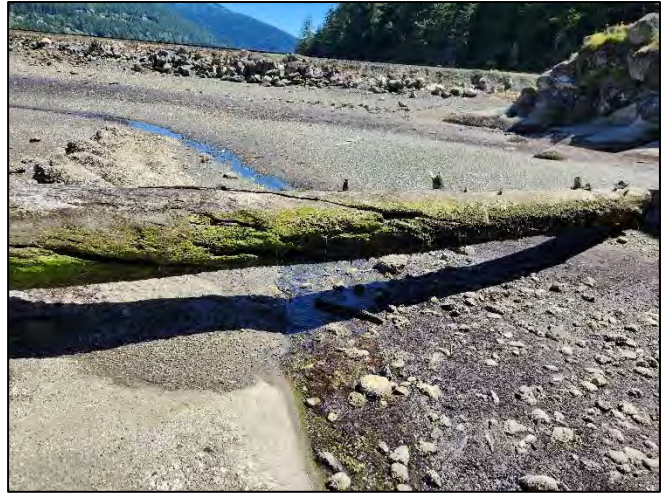
**Photo 8:** View out from shoreline next to emergence point of existing release.

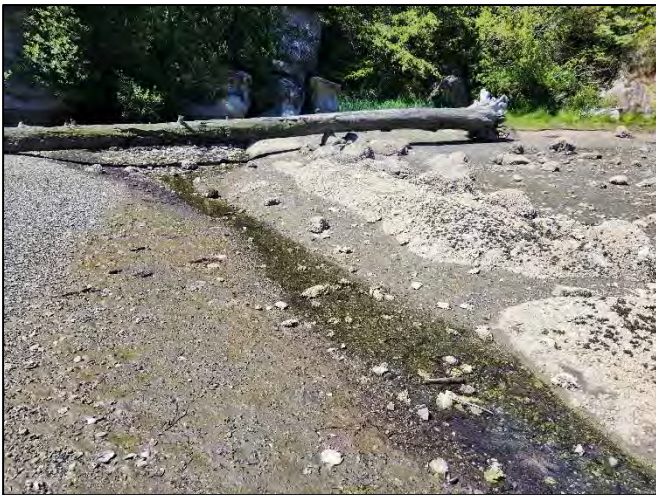
**Photo 9:** Closer view of flow channel conditions through upper tidal area.

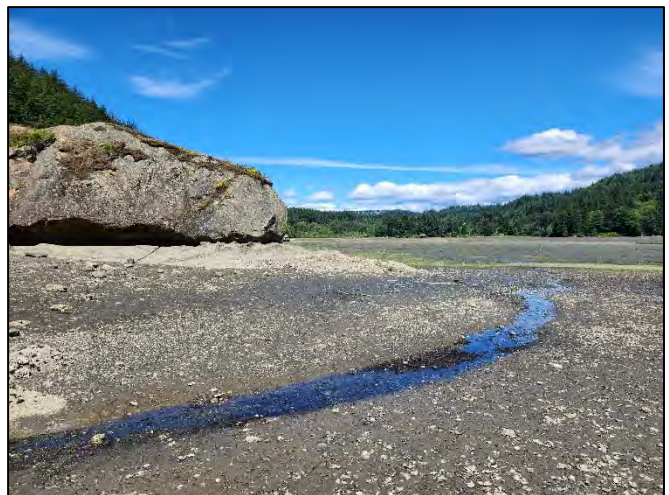
**Photo 10:** View of channel through transitional zone heading into lower tidal area where it becomes indistinguishable.
