Summary of Woodstock Barn Engineering Assessments to Date

WOODSTOCK FARM BUILDING FOUNDATION

REPORT FOR STRUCTURAL CONDITION ASSESSMENT

VECO Document No.: 1000-10-100-01

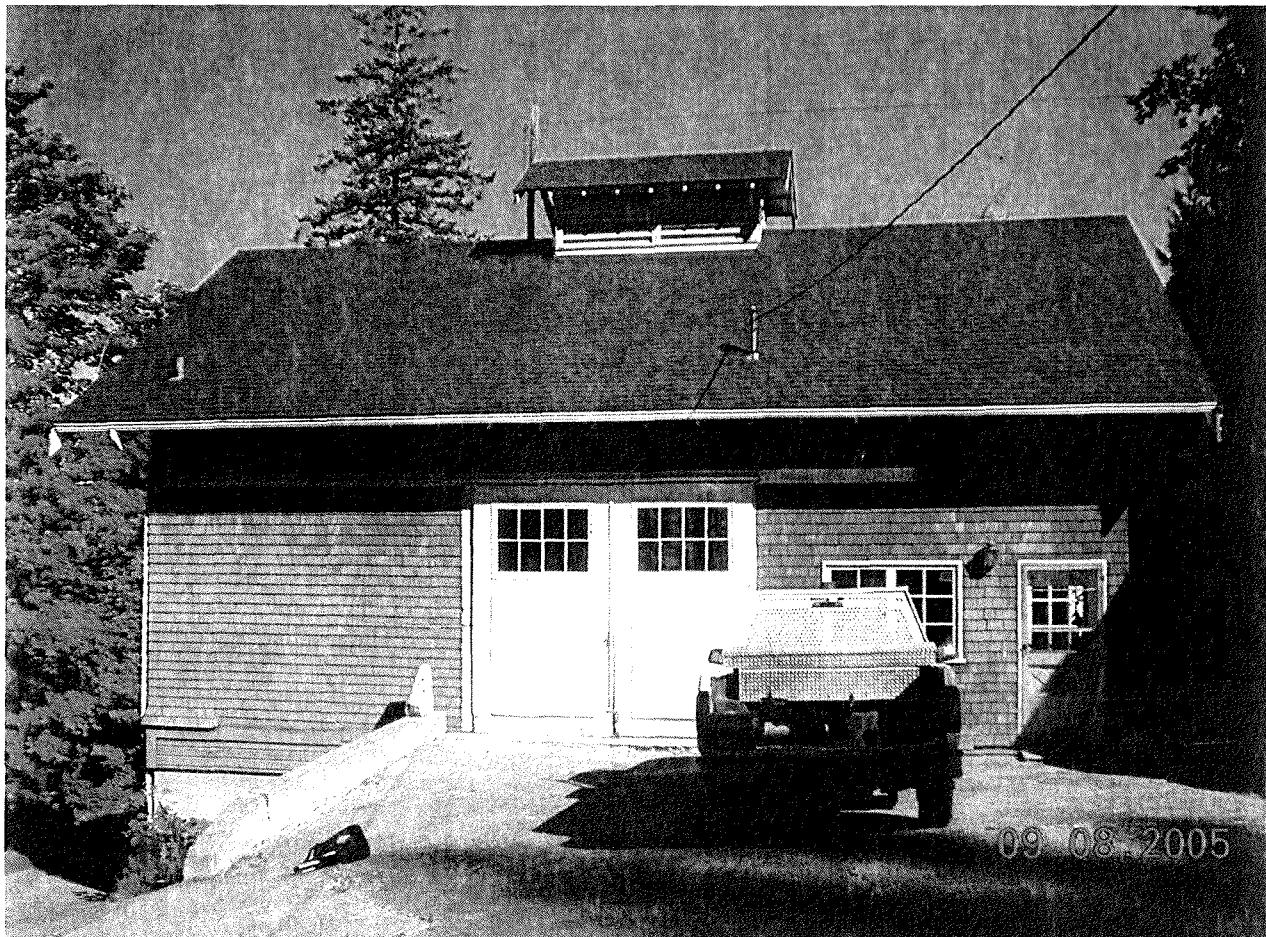
South Wall Elevation

The south concrete basement wall has failed structurally as evidenced by the vertical cracks through the wall and the horizontal crack located about 18 inches above the floor. A full inspection of the wall was not possible due to the items stored in the southwest end of the basement.

Measurements indicate that the wall has deflected at the top up to 3 inches. In addition the interior columns have deflected up to 2 inches. This indicates that the entire building has racked about 2 inches to the north.

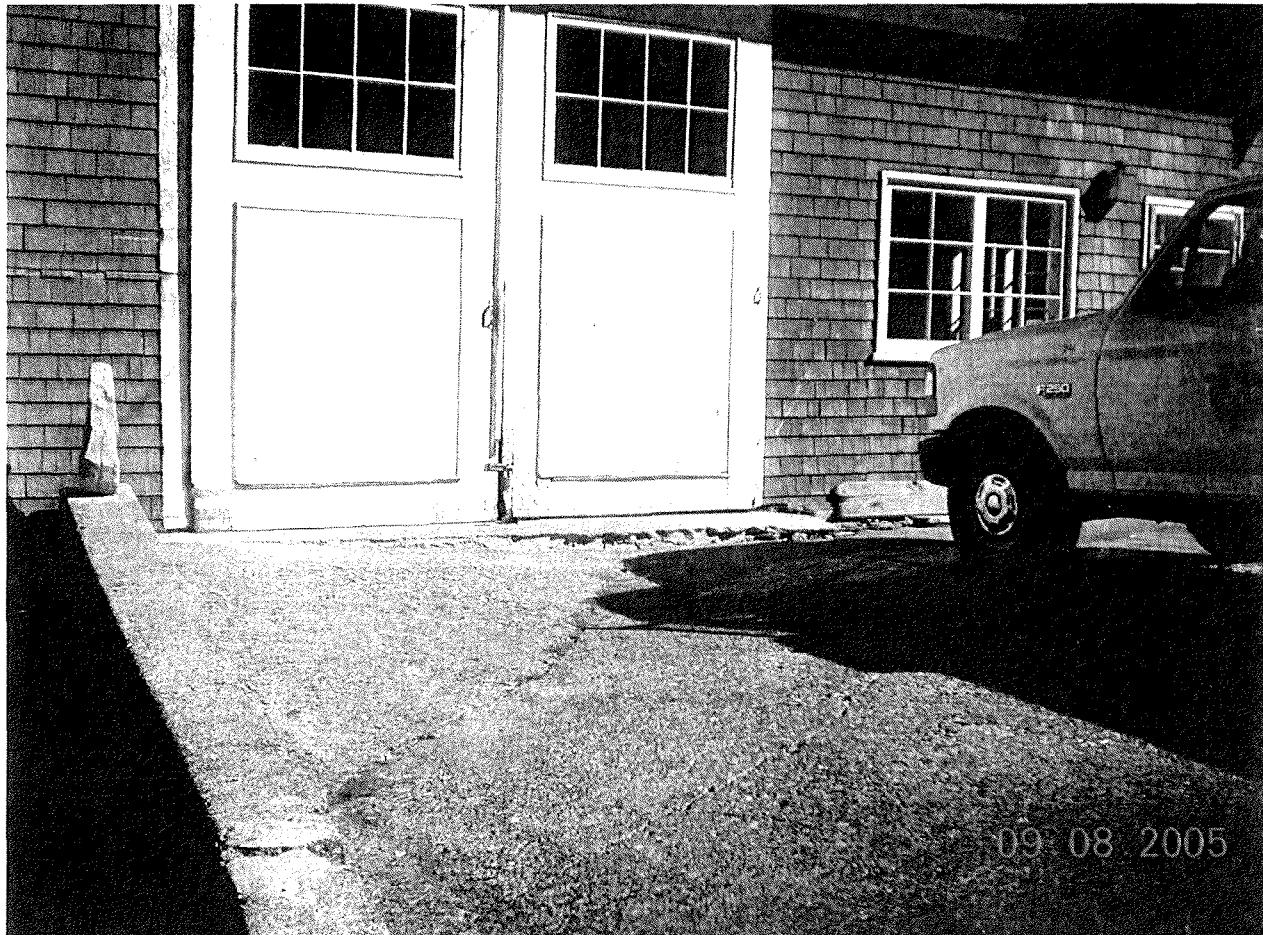
The paving on the south side is cracked and slopes toward the building draining into large cracks along the wall. A fairly large area of paving drains toward the building and may be compounded if the existing catch basin along the road is plugged.

Cracked paving and opening below door.

1. Replace existing paving so the water is directed away from the building. A conceptual plan was discussed with Tom Slack and Carl Clark of the Parks Department. This plan included installation of a trench drain, rerouting of the downspouts and inspection of the existing catch basins and drains for functionality.

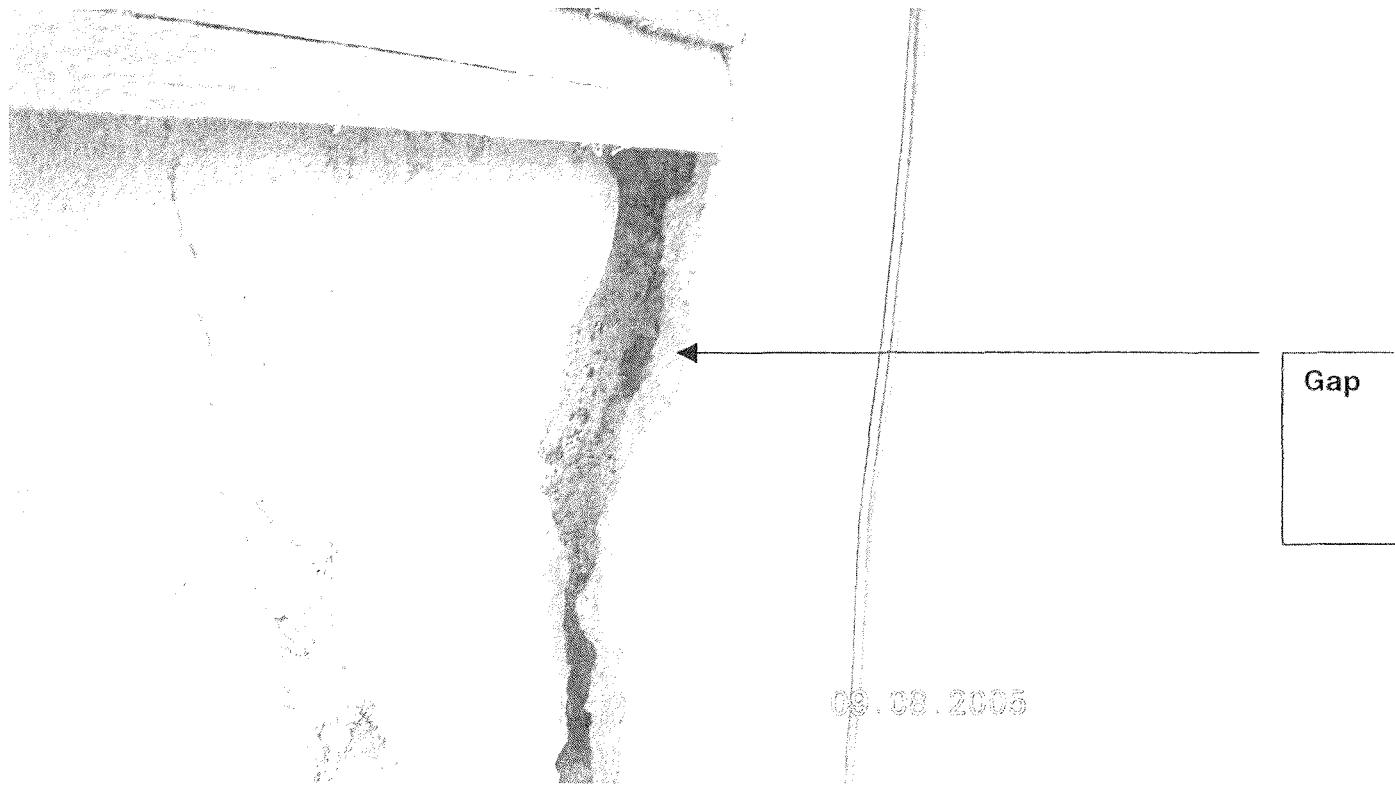
Crack in basement wall with gap where wall has pulled away from the retaining wall.

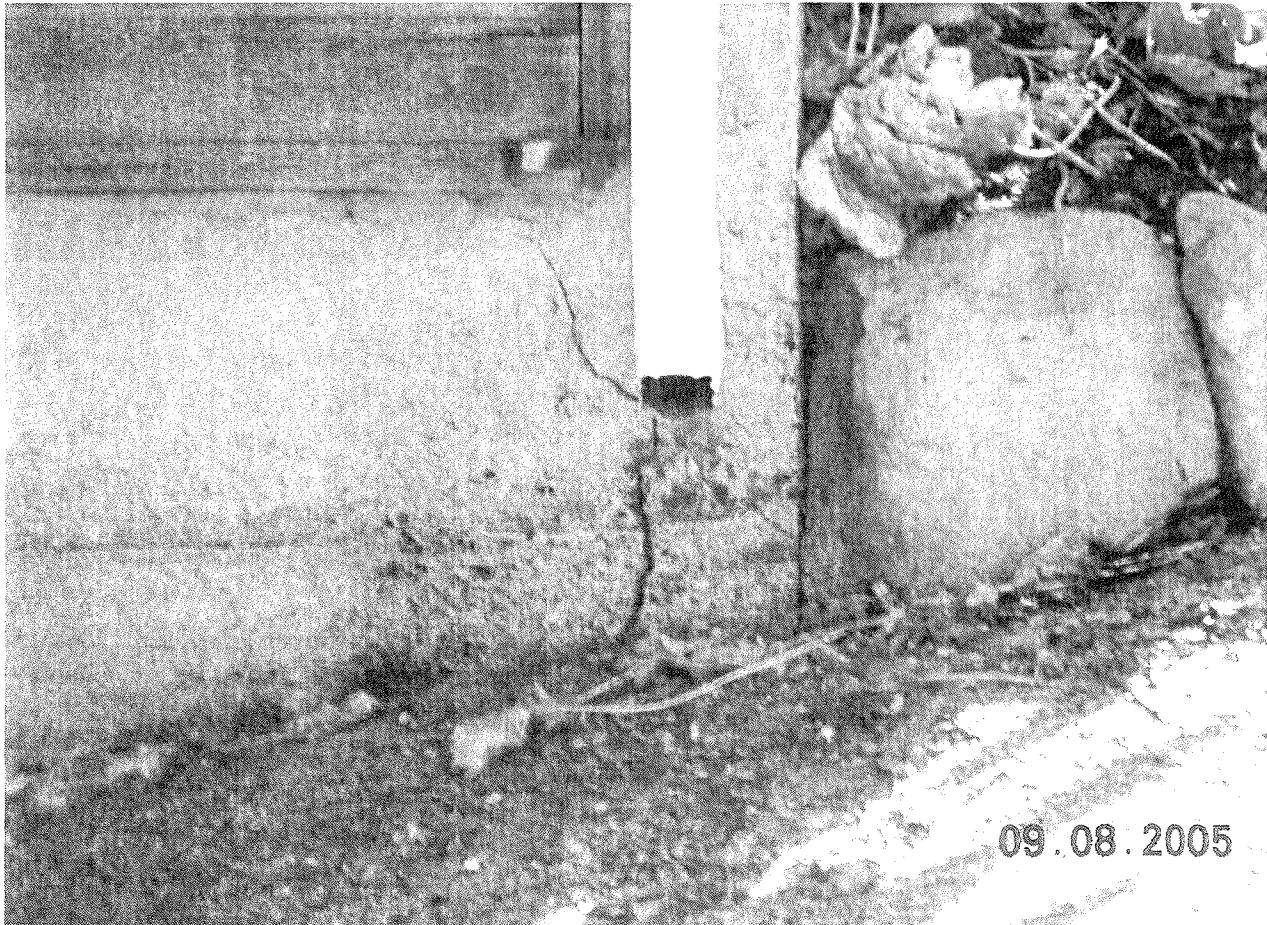
A failed cantilevered wall would exhibit horizontal cracks on the soil side whereas a braced wall would begin cracking on the inside. It appears that the wall started in the later condition as indicated by the interior crack and then overcame friction and failed on the outside. These interior cracks are quite subtle since the wall has rotated north and compressed the cracks.

SW corner. Vertical crack in foundation from wall rotation. Note horizontal crack turns the corner and heads south. Elevation lines up with interior horizontal crack.

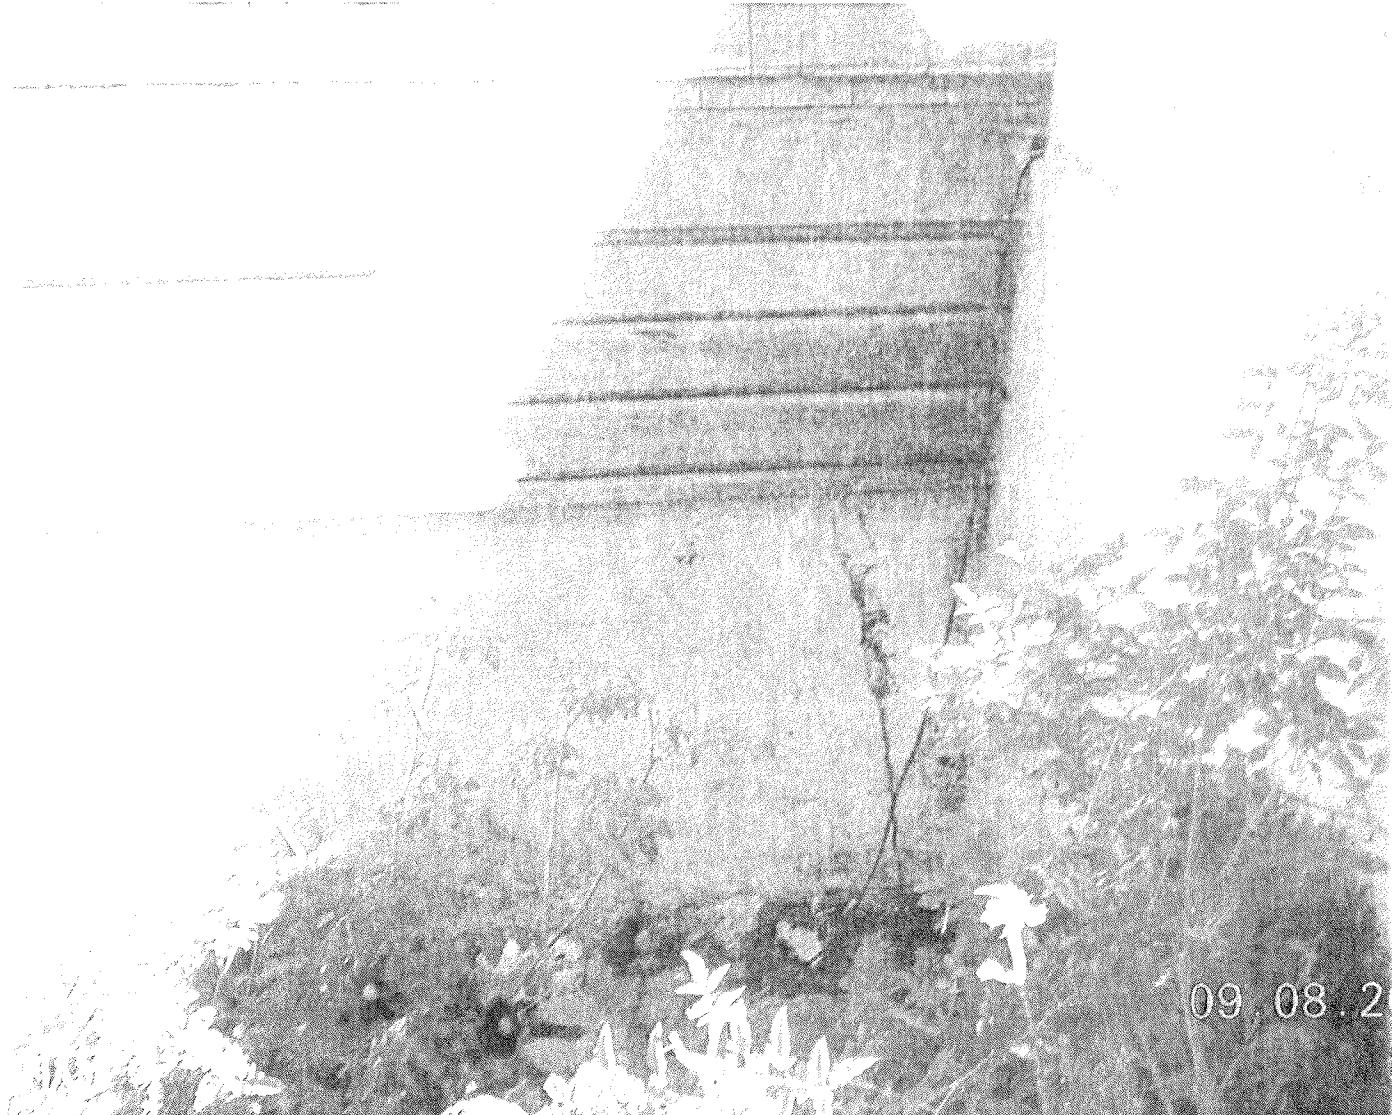
Another shot of exterior crack and driveway retaining wall.

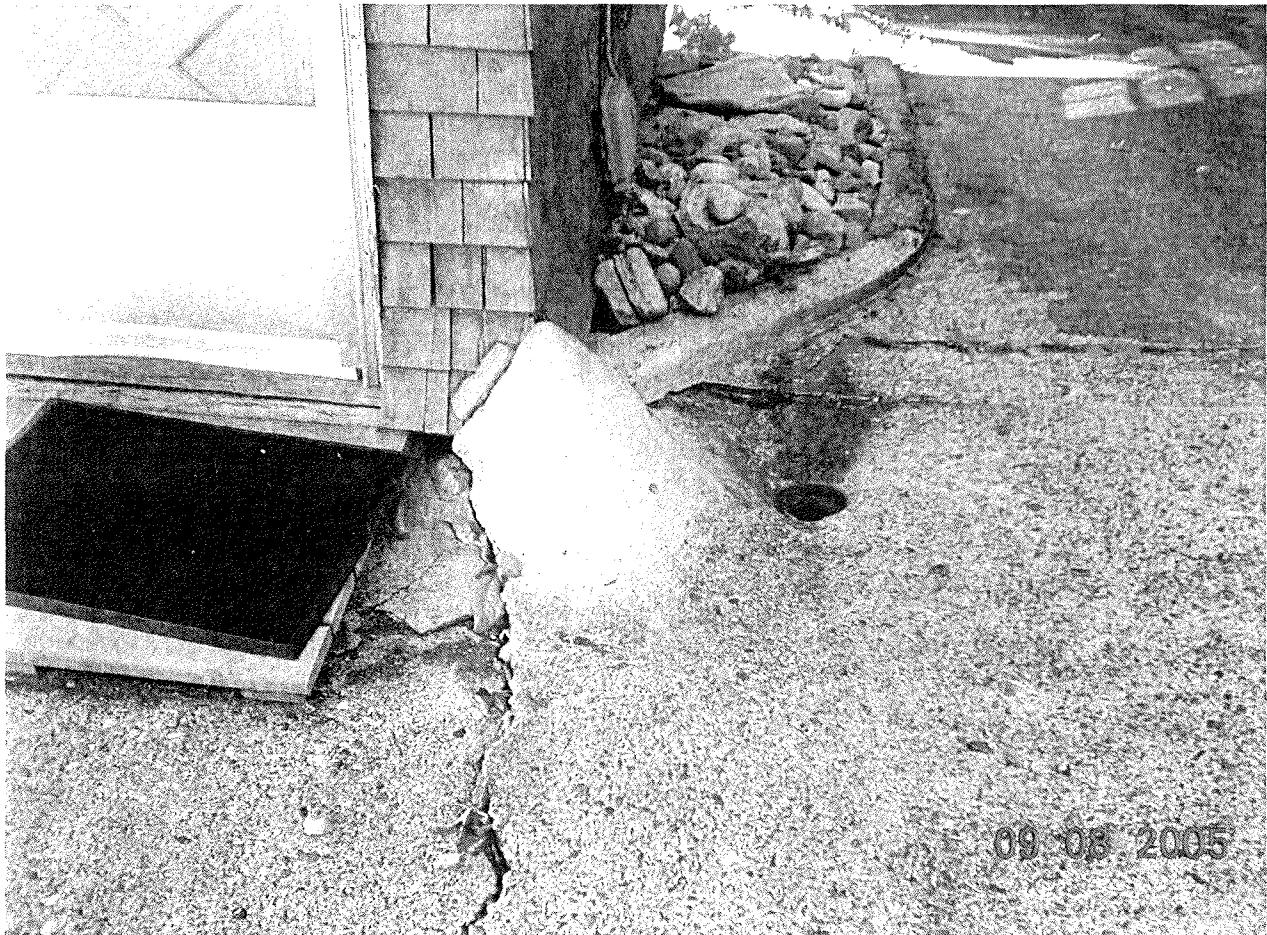
Settlement due to the wall rotation and erosion of the soil along the wall have caused the paving to settle and compound the problem.

More cracks in paving at SE corner looking north.

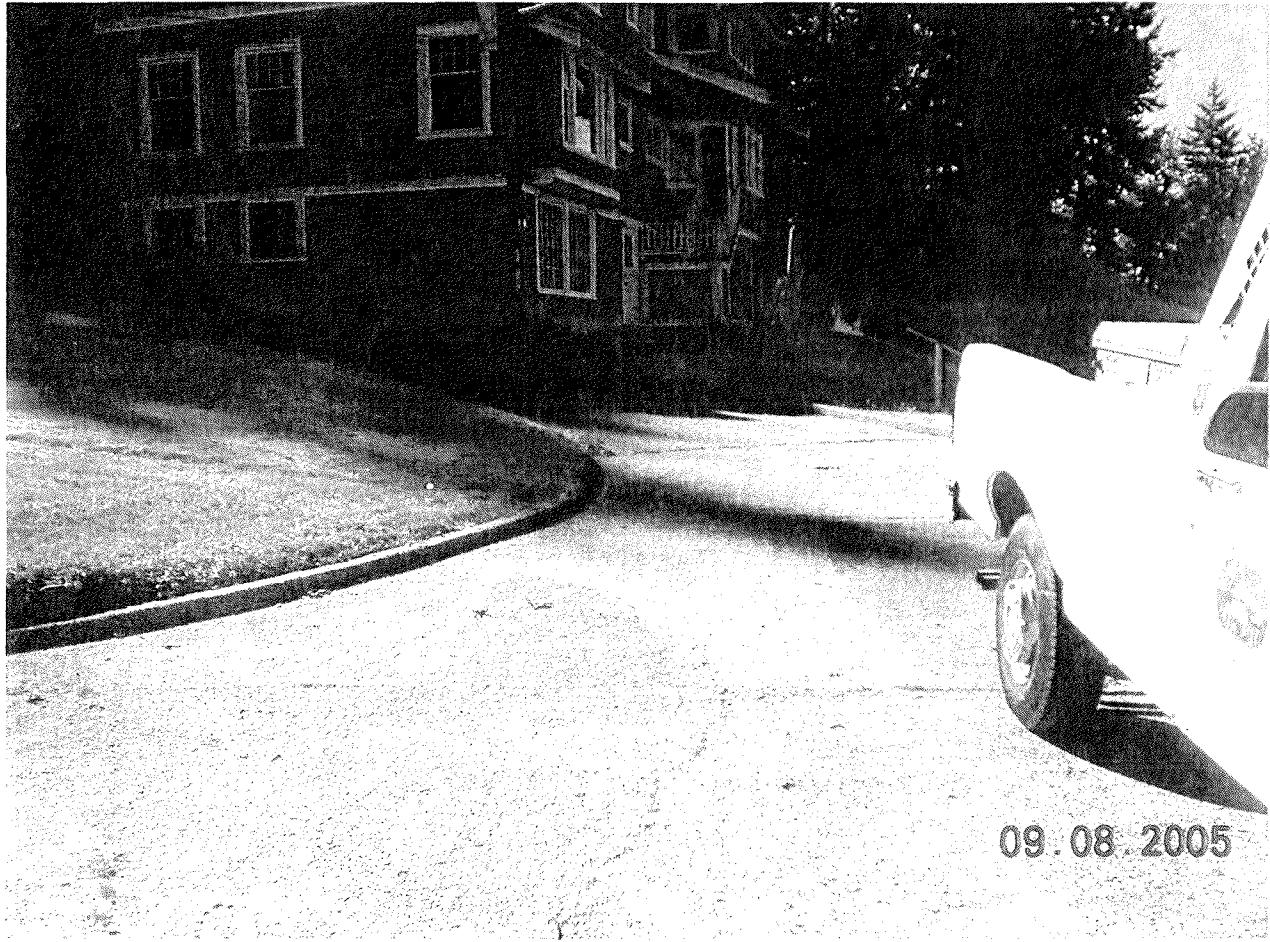
Looking south. Note driveway slope to the front of the building.
