**Tree Retention Plan  
'Cityview'  
4413 Consolidation Ave., Bellingham WA  
Township 38N, Range 3E, Section 32  
Bellingham, WA 98225**

Prepared by:  
Tree Guys Incorporated  
Patrick J. Sullivan  
International Society of Arboriculture  
Certified Arborist # PN-7123A  
Certified Tree Risk Assessor  
Bellingham, WA  
(360)920-6285  
February 15, 2020

\*\*\*REVISED JANUARY 25<sup>TH</sup>, 2021\*\*\*

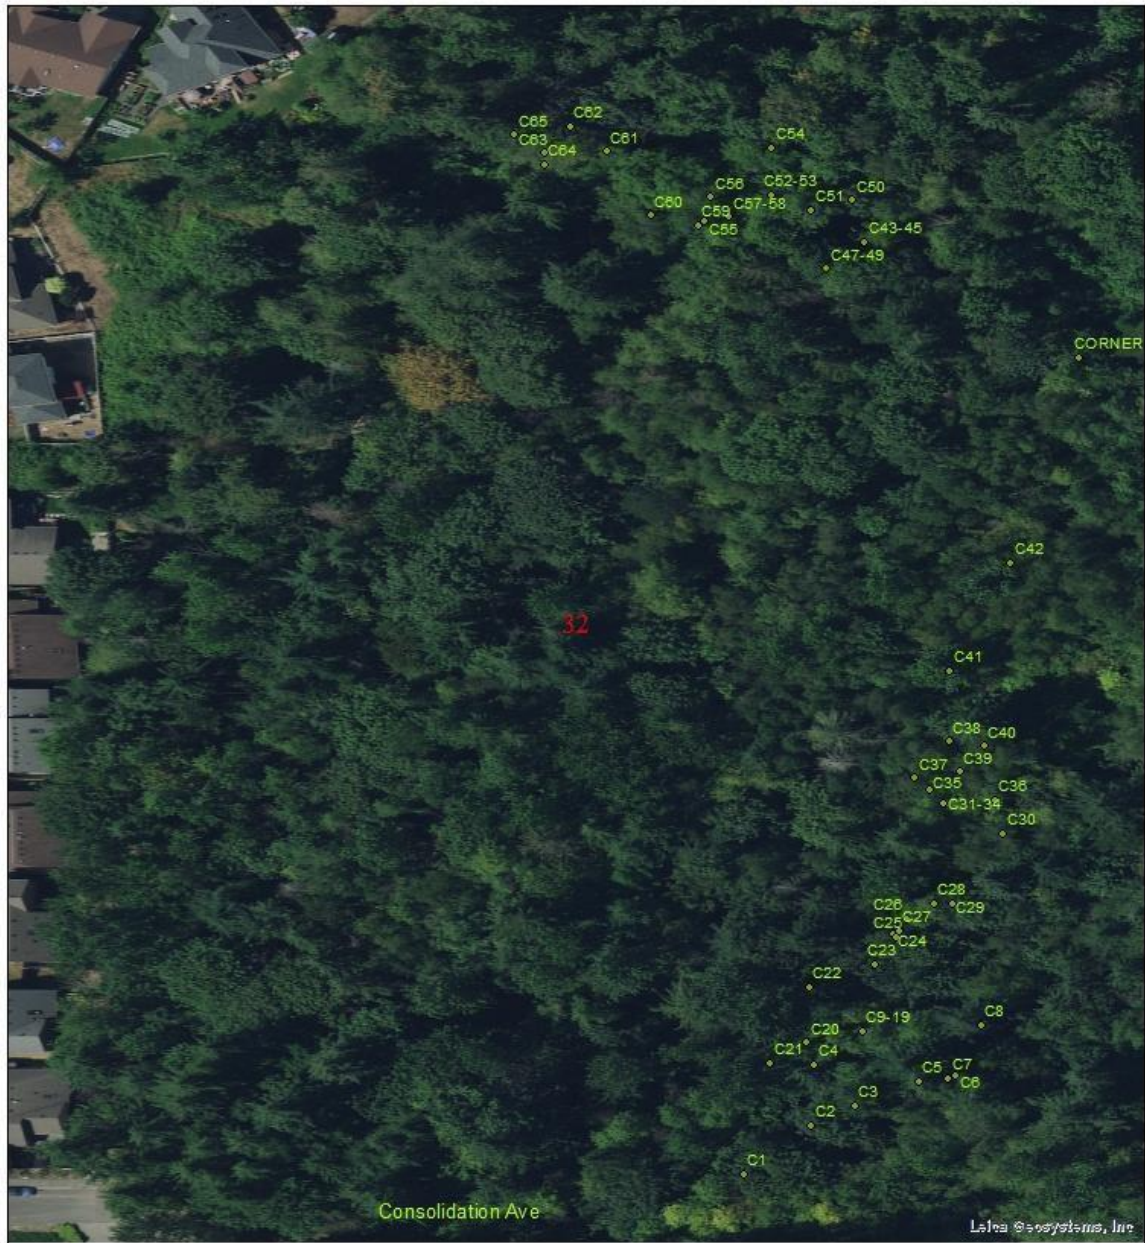
Appendix 1  
Consolidation Ave Tree Risk Map  
1:1200  
Febraury 2020

Finally, 23 trees (C43-65) within Wetland B and/or it's buffer are listed as 'Possible, Probable, or Imminent' for failure. Per Table 1, I recommend removal of these trees and a replacement ratio of 2:1 per Page 3 of this report. Replacement trees should be planted outside of the wetland/buffer.
