City of Bellingham Wood-Stave Intake Pipeline: Condition Assessment (Task 2.1.5)

PREPARED FOR: City of Bellingham Project Team
PREPARED BY: CH2M HILL Project Team
DATE: November 7, 2014

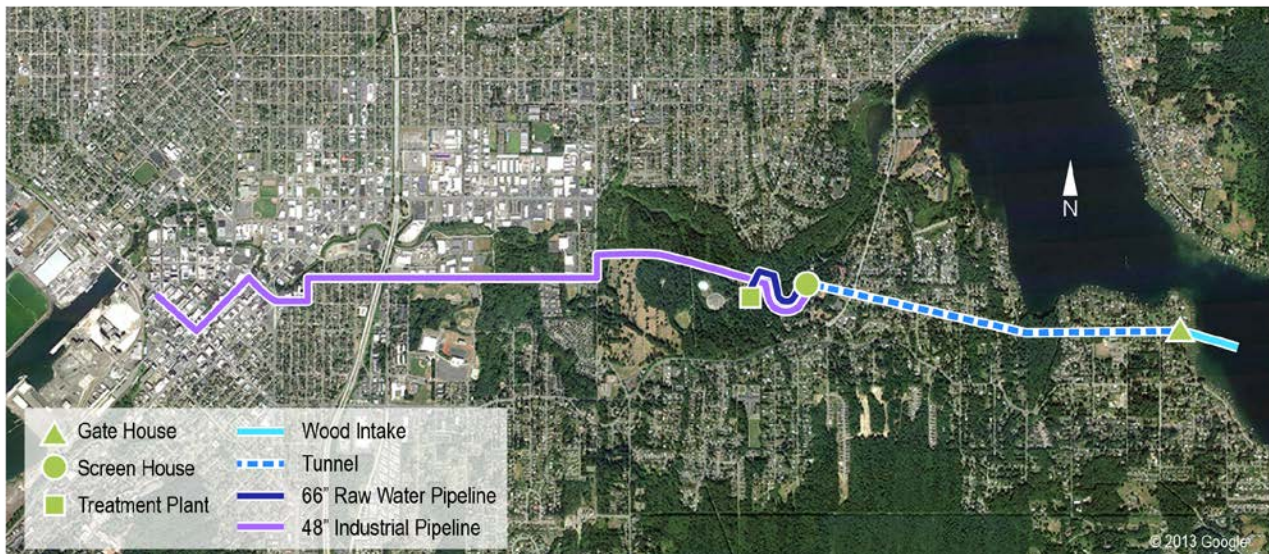
Exhibit 2-1. City of Bellingham Water Supply Facilities

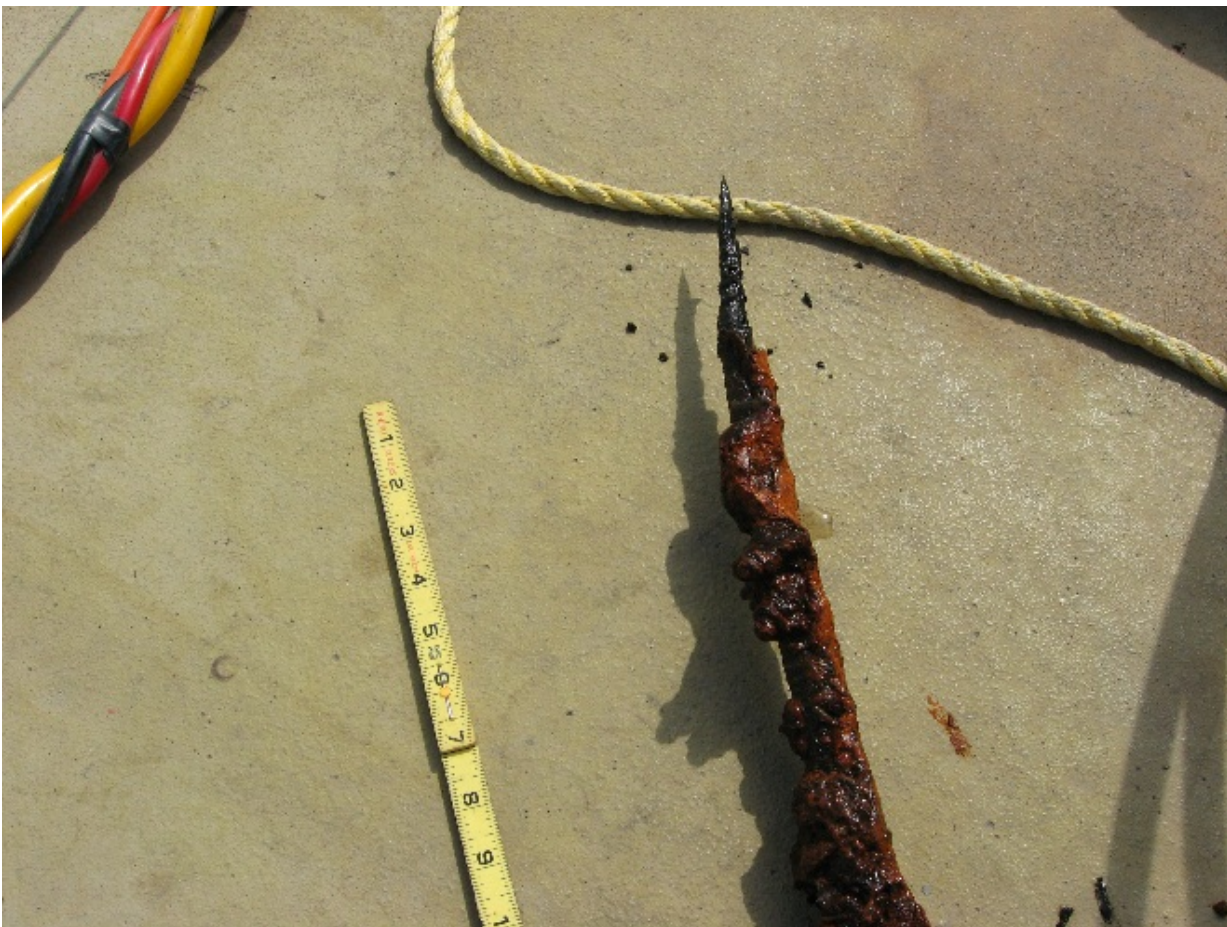
Photograph No. 1 – Failure of Original Pipe Band

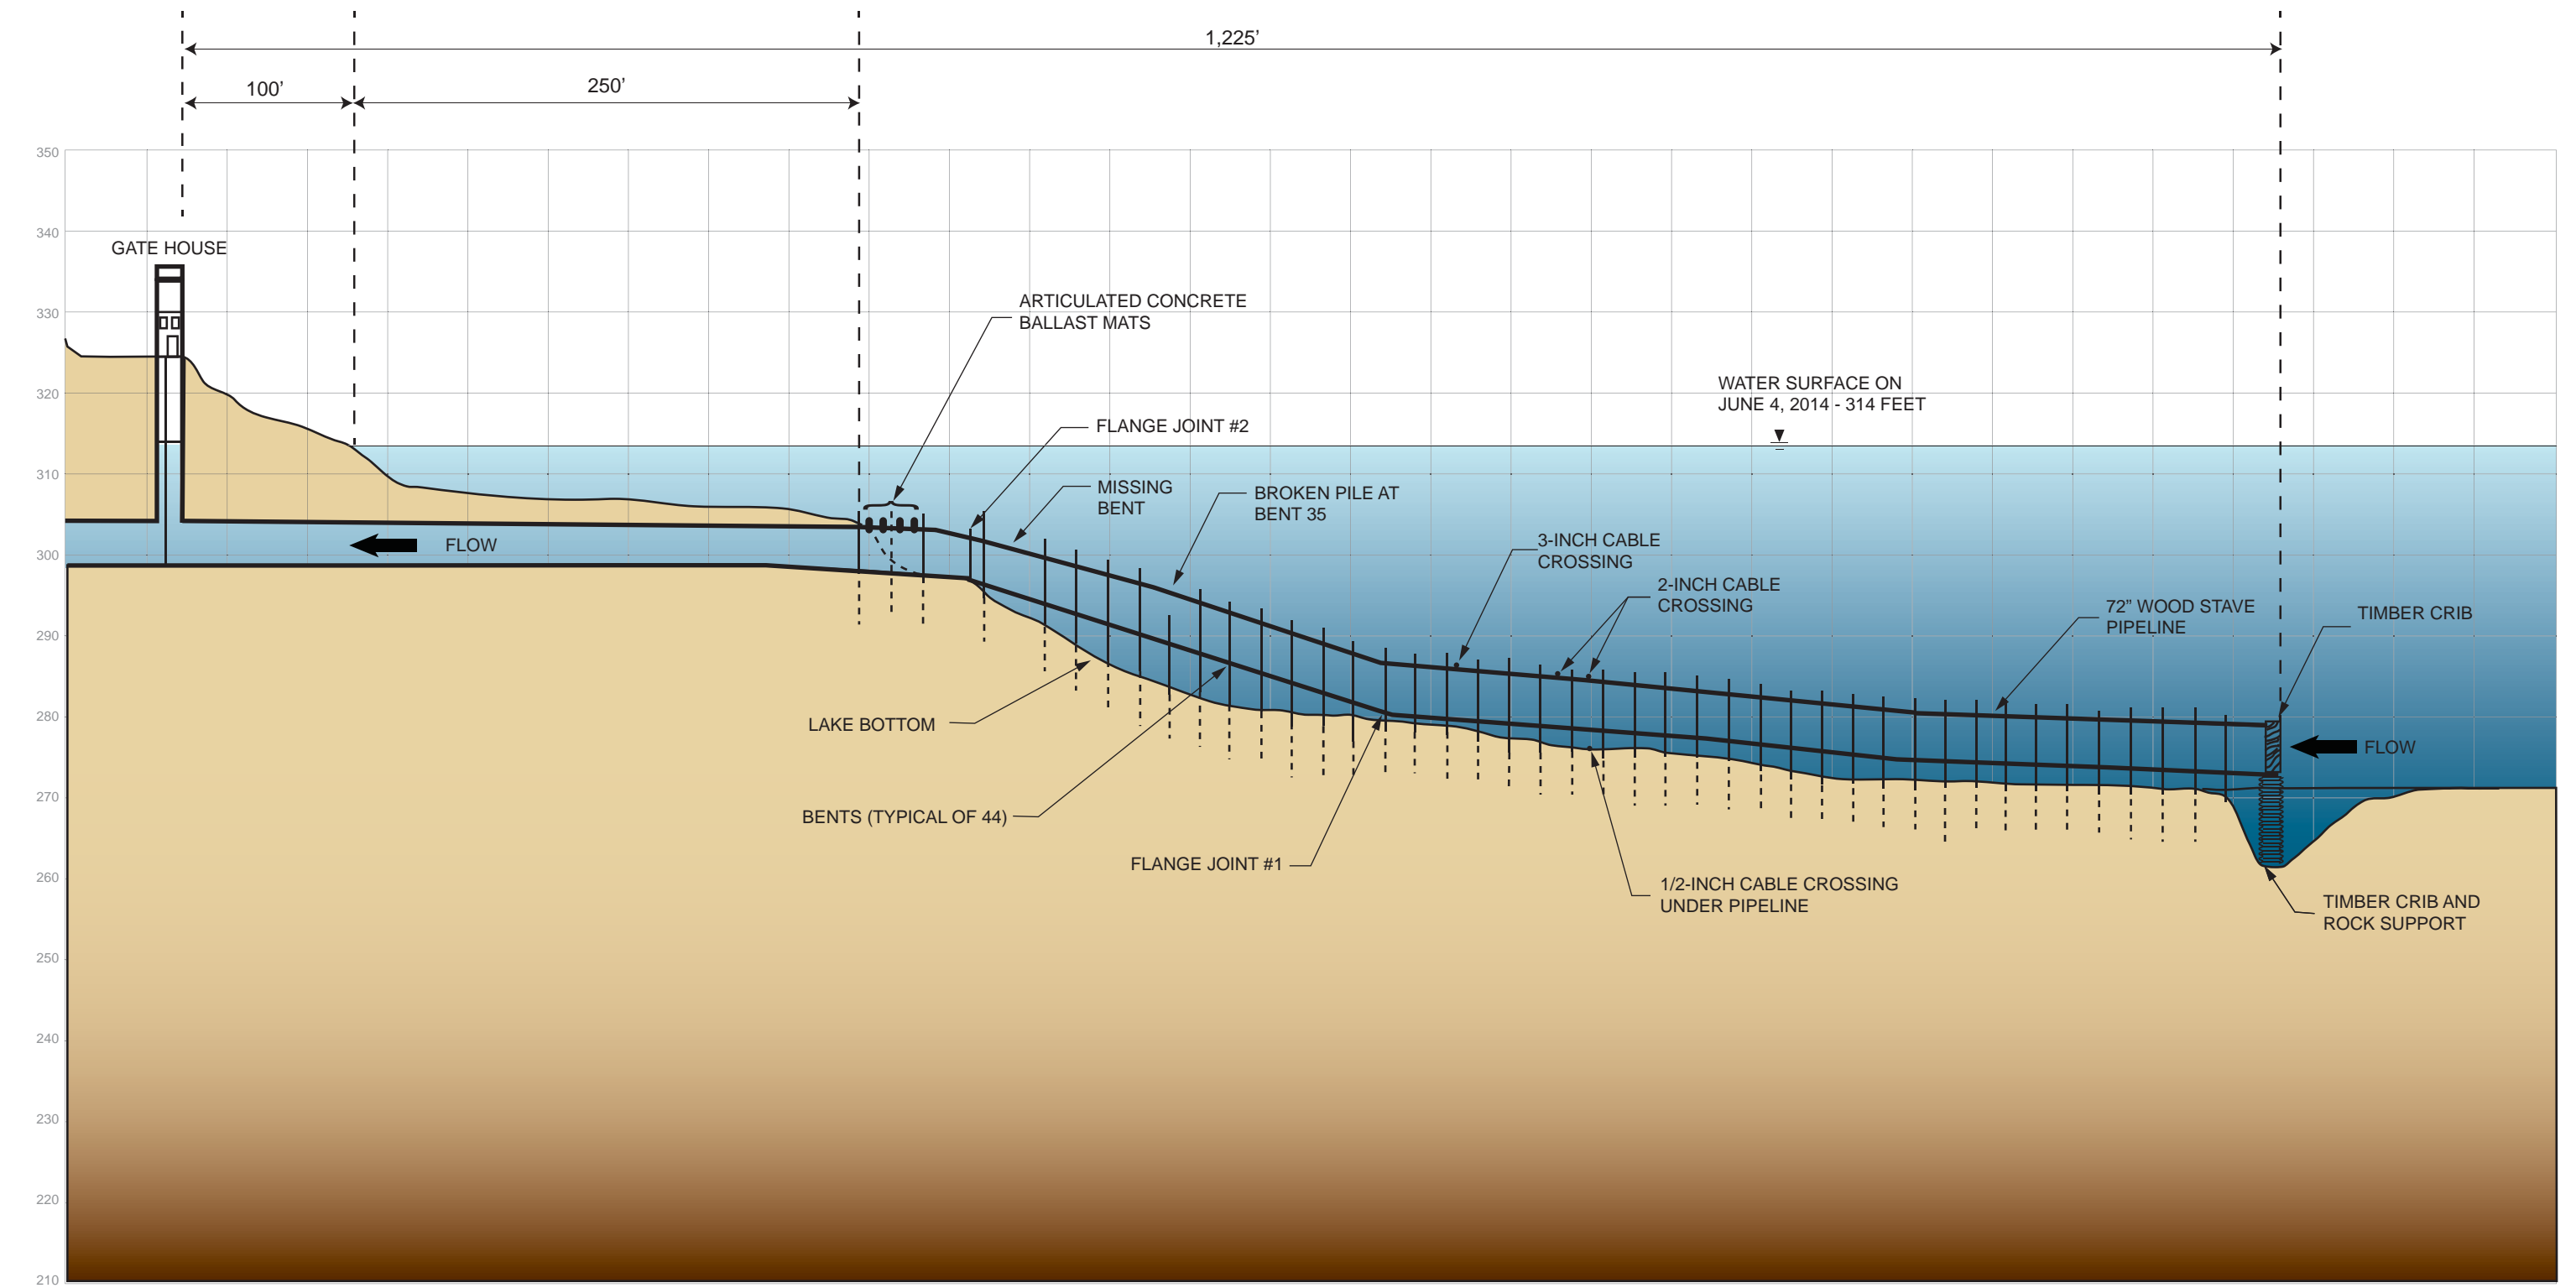
0 100 200
Approximate scale in feet

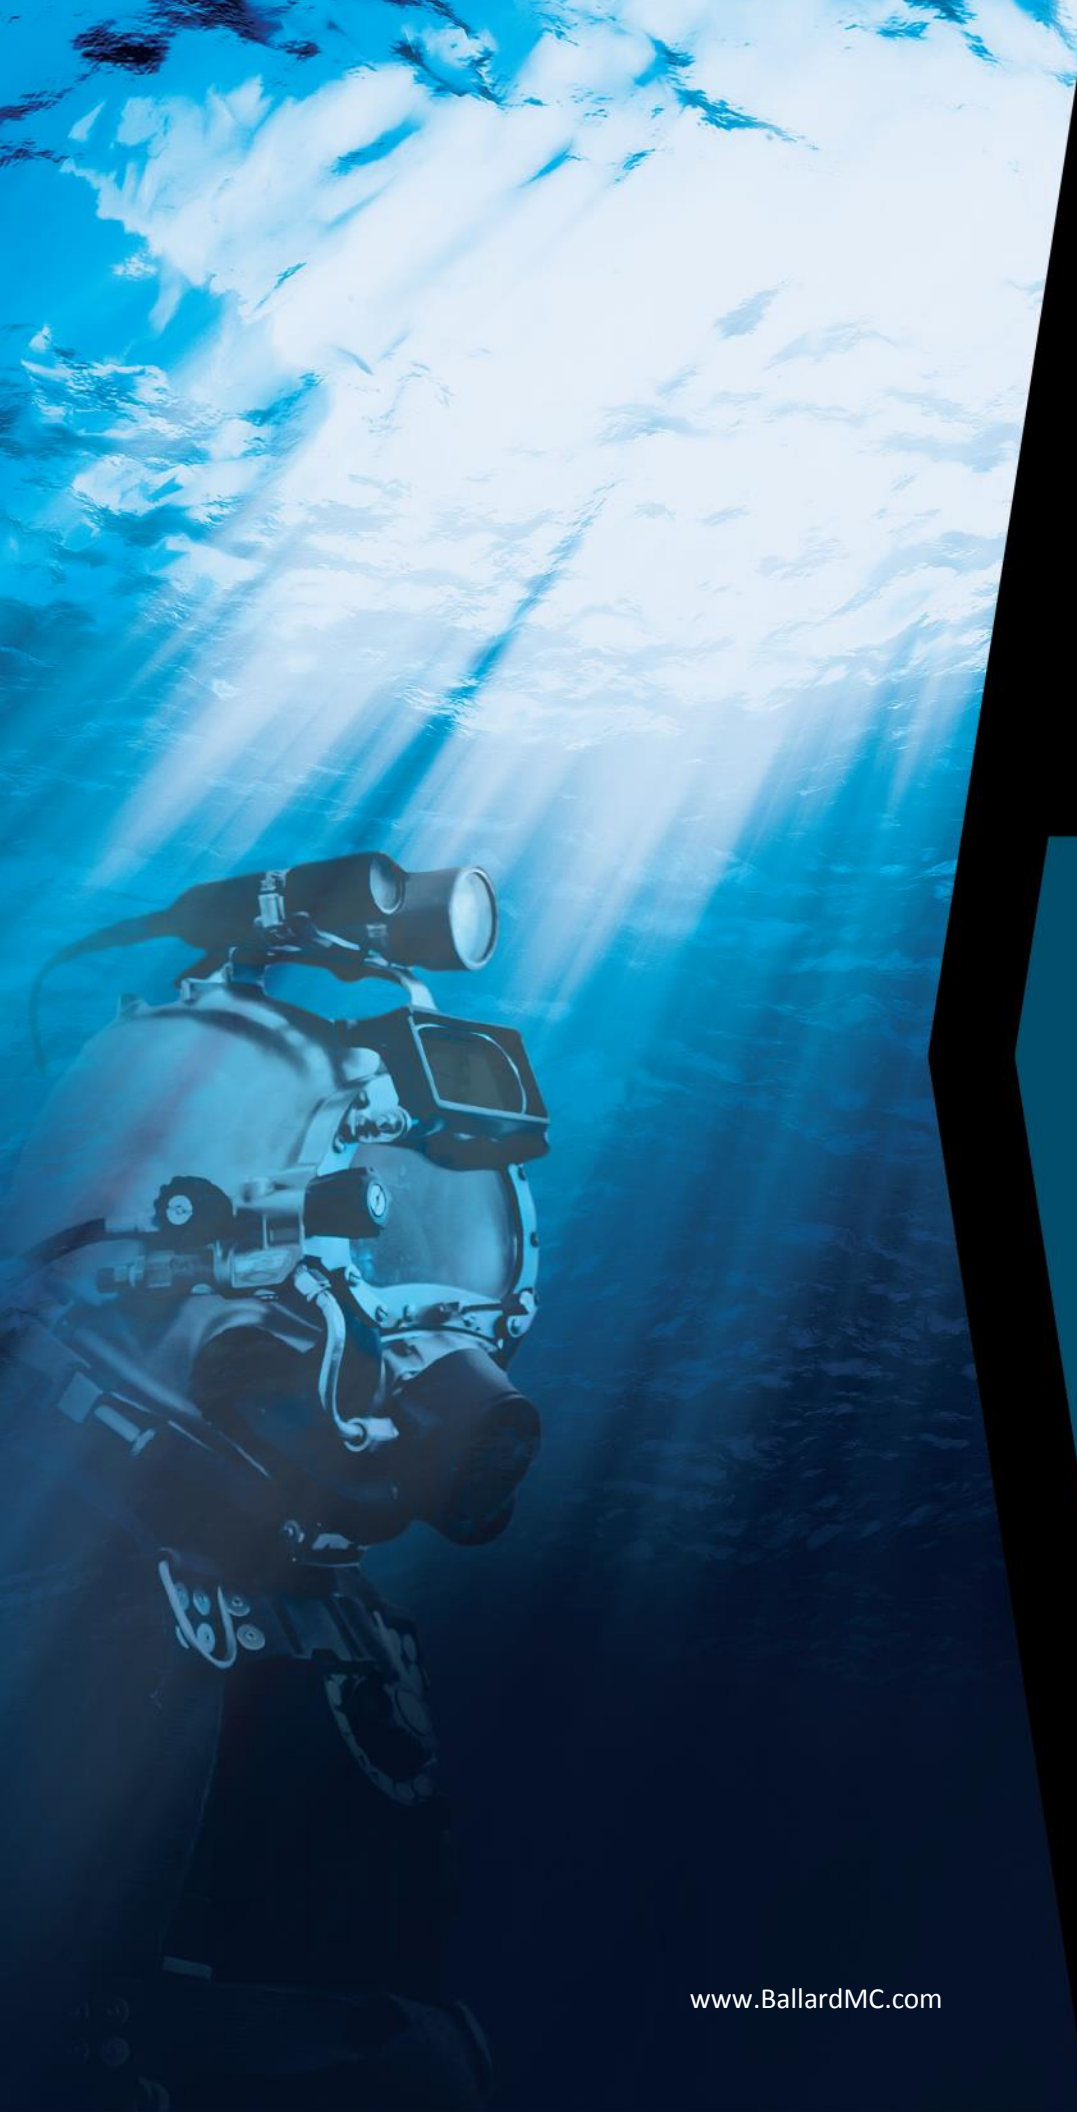
Appendix A
Ballard Marine Construction Report: Lake
Whatcom Wood Stave Intake Inspection

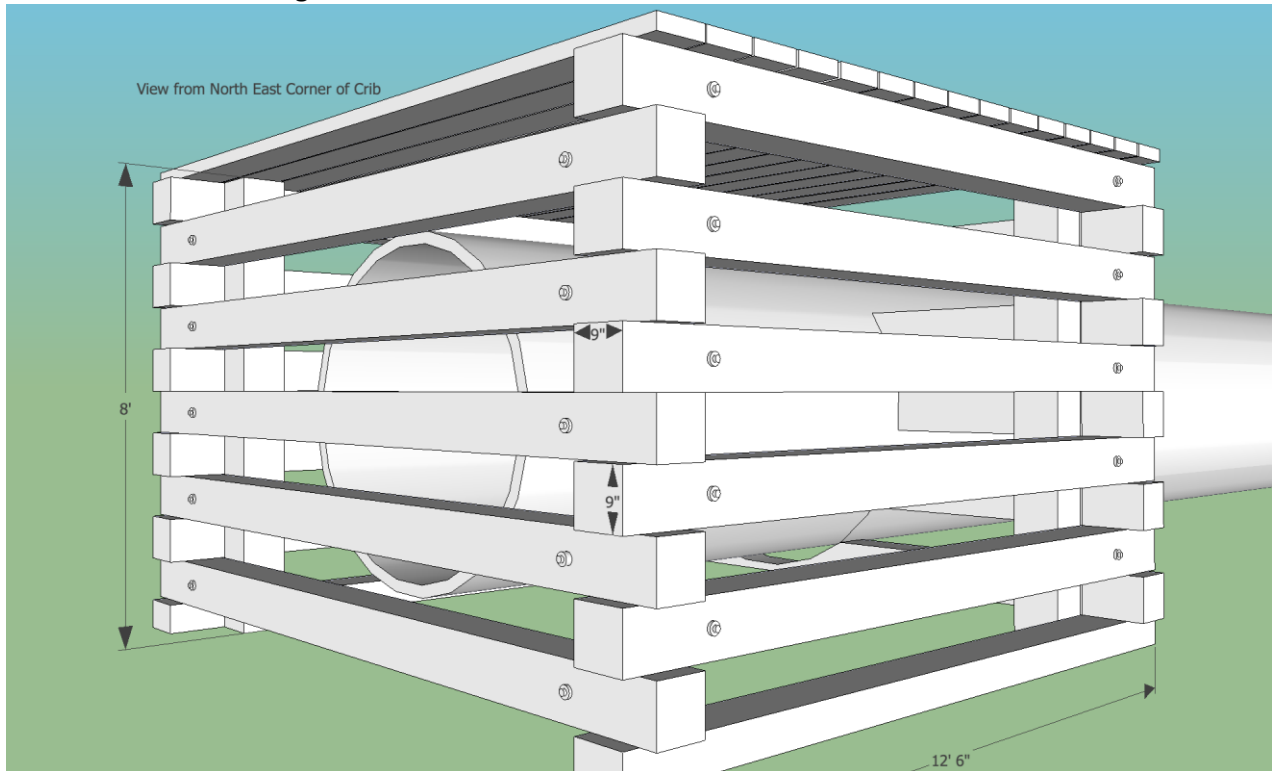
Figure 4: View of Intake Crib from the North West Corner

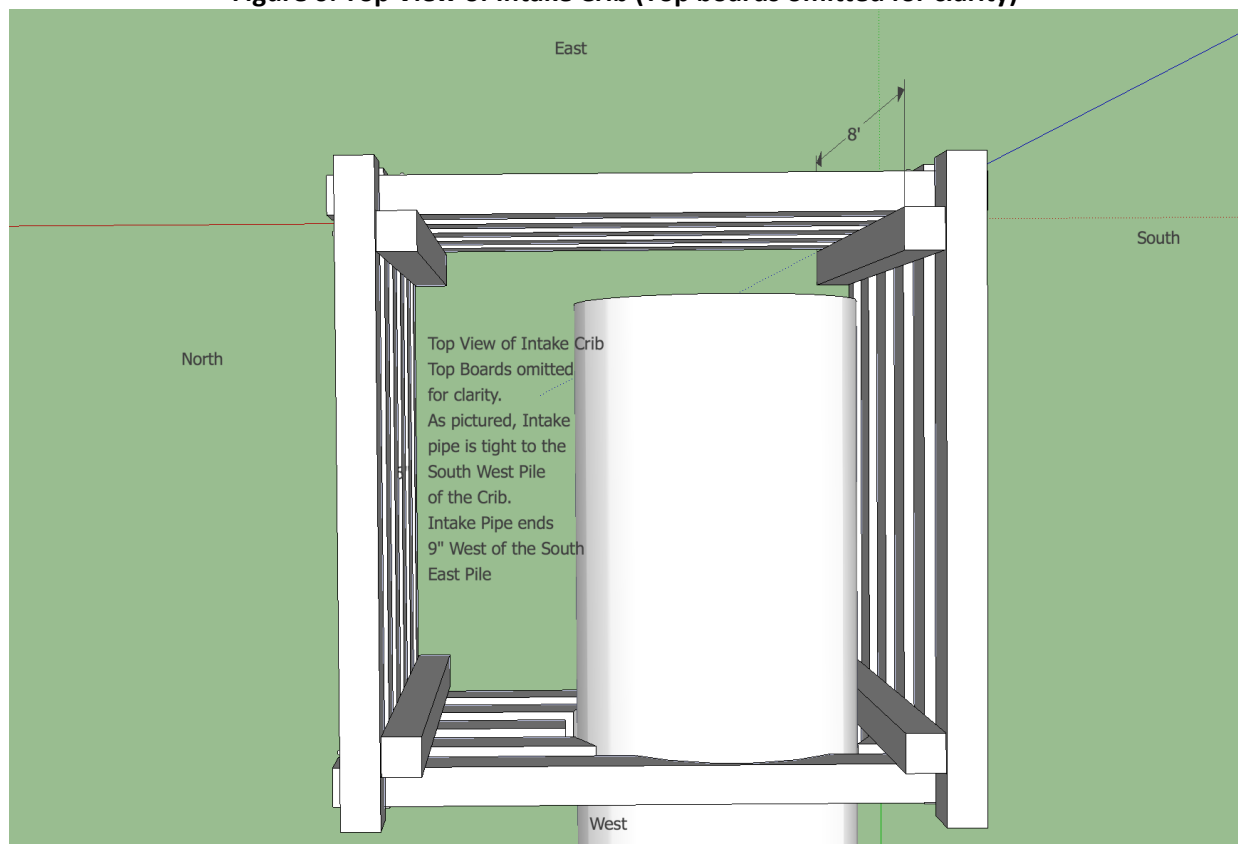
-External Intake Pipe and Pile Bents

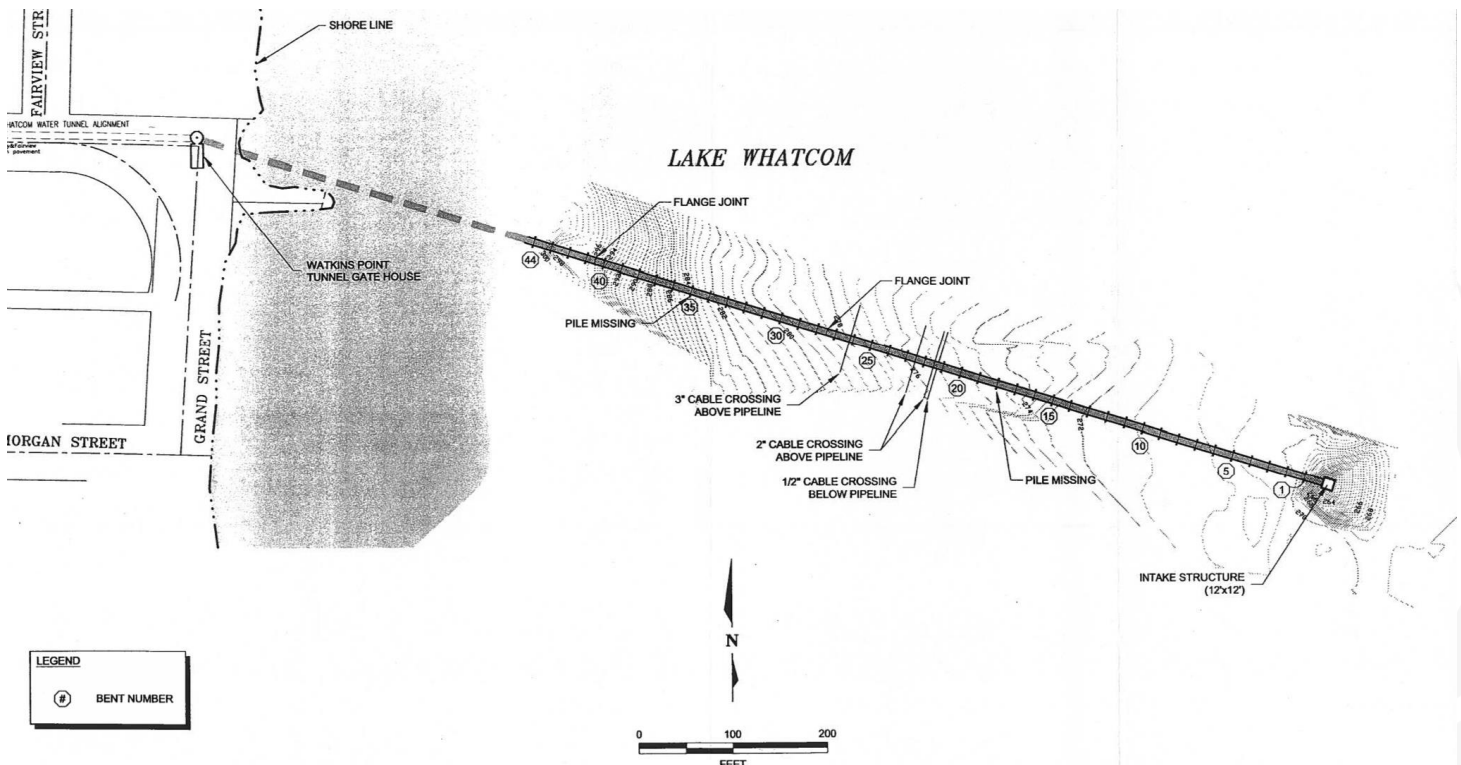
Figure 8: Cross Section of Typical Bent from Original Record Drawings

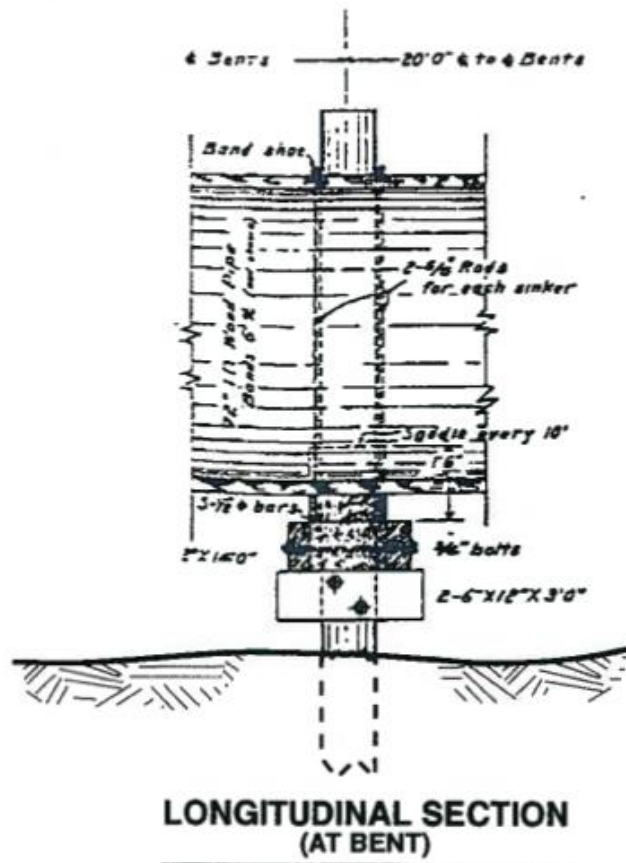
Pipe Condition Intake Crib to Bent 1

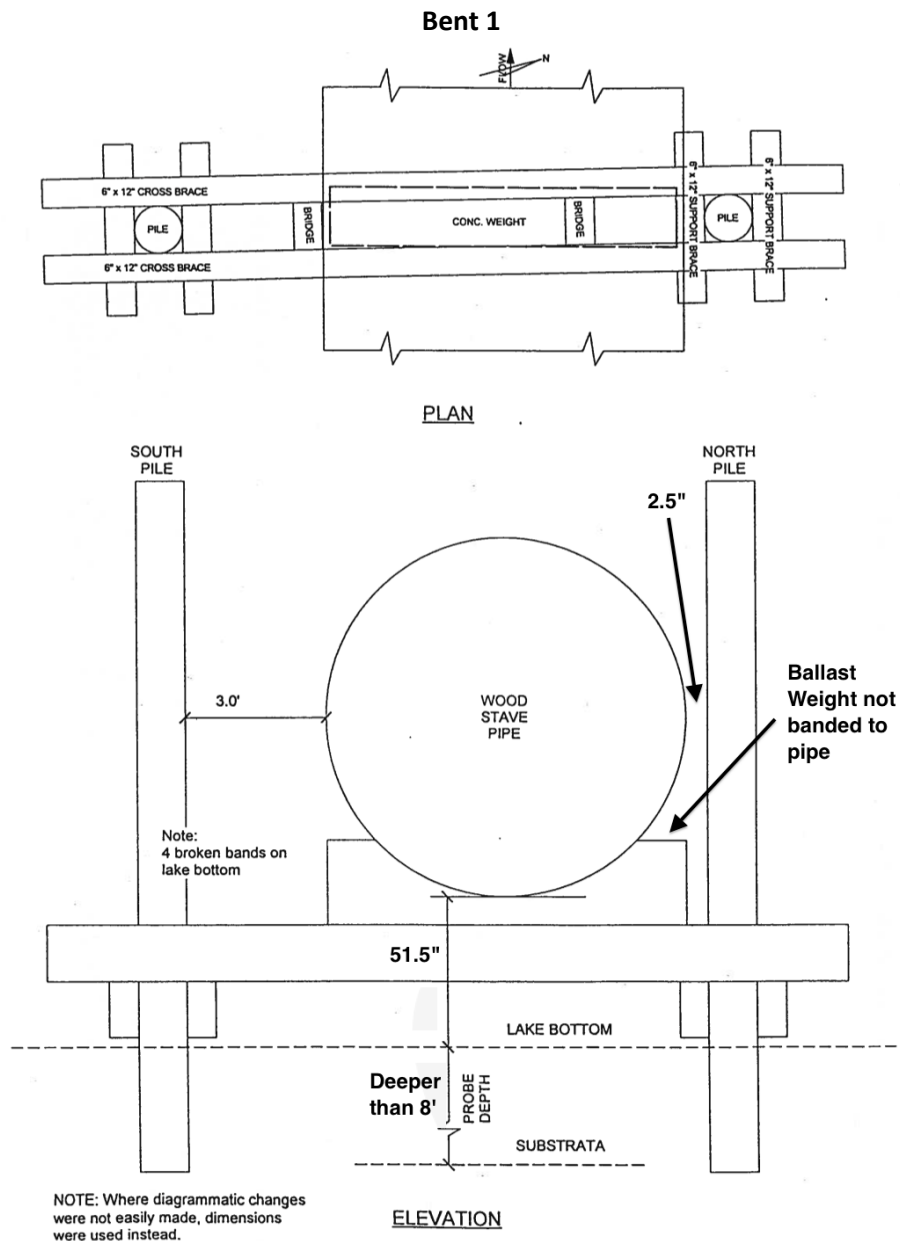
Pipe Condition Bent 1 to Bent 2					
Wood Condition	Marine Growth	Carbon Steel Component condition	Stainless Component Condition	Broken/Missing Bands Evident	Intermediate Ballast Weight Present
Very good	Light to Moderate Algae growth	Heavily Corroded	Tight, not corroded	None evident	No
Notes: Bent 2 Piles are not in the typical location. As shown in the top view, they are inshore of the cross braces. An extra broken pile is leaning against the South side of the bent.

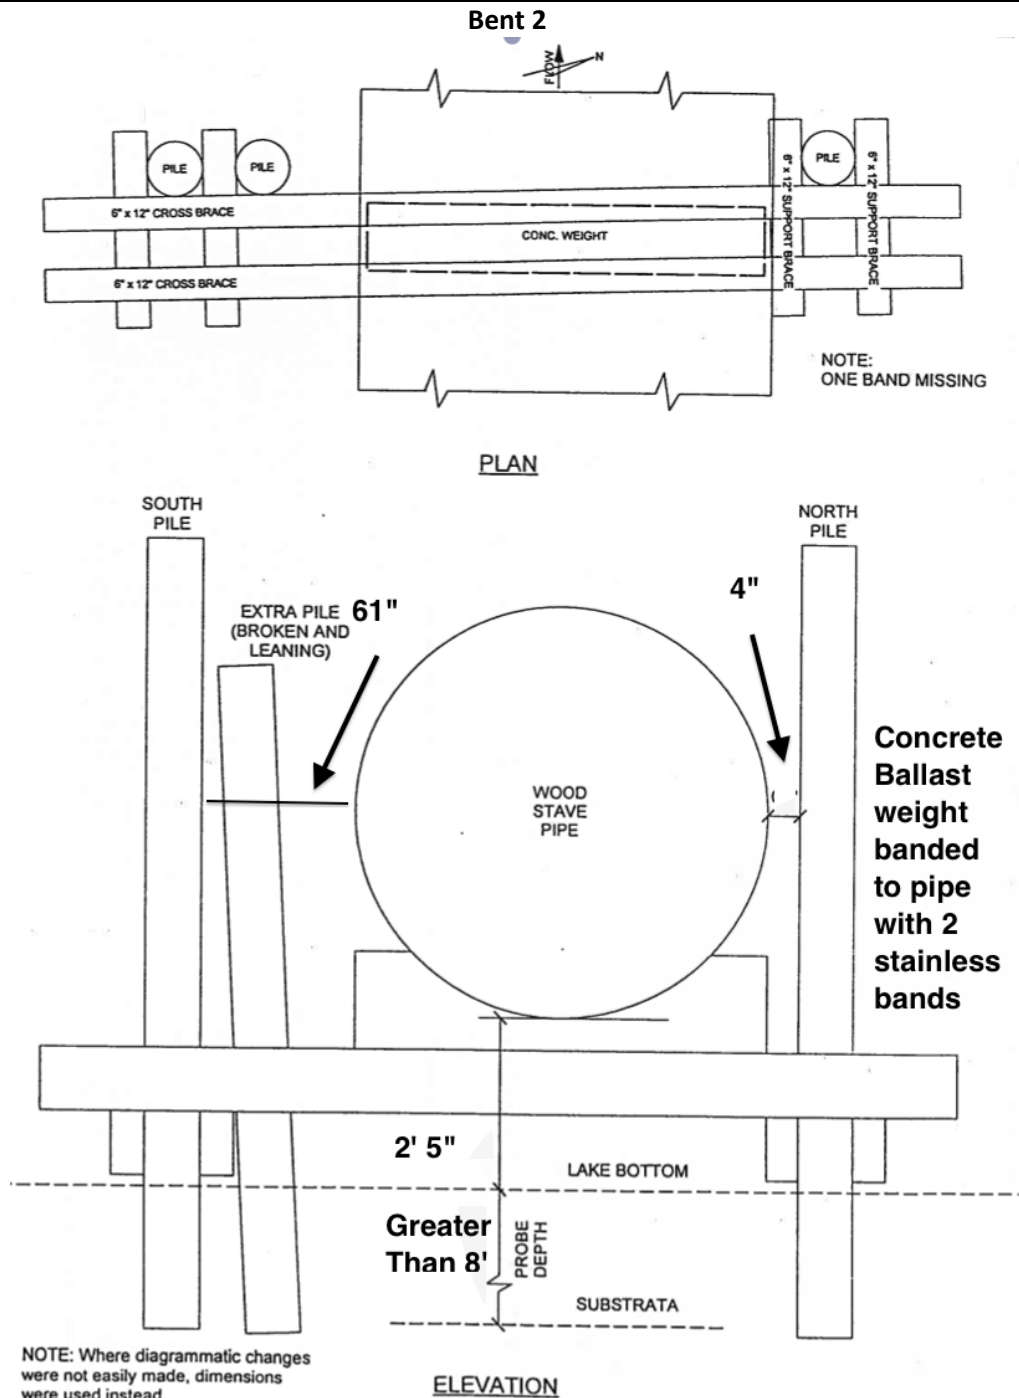
Pipe Condition Bent 2 to Bent 3					
Wood Condition	Marine Growth	Carbon Steel Component condition	Stainless Component Condition	Broken/Missing Bands Evident	Intermediate Ballast Weight Present
Very good	Light to Moderate Algae growth	Heavily Corroded	Tight, not corroded	None evident	No

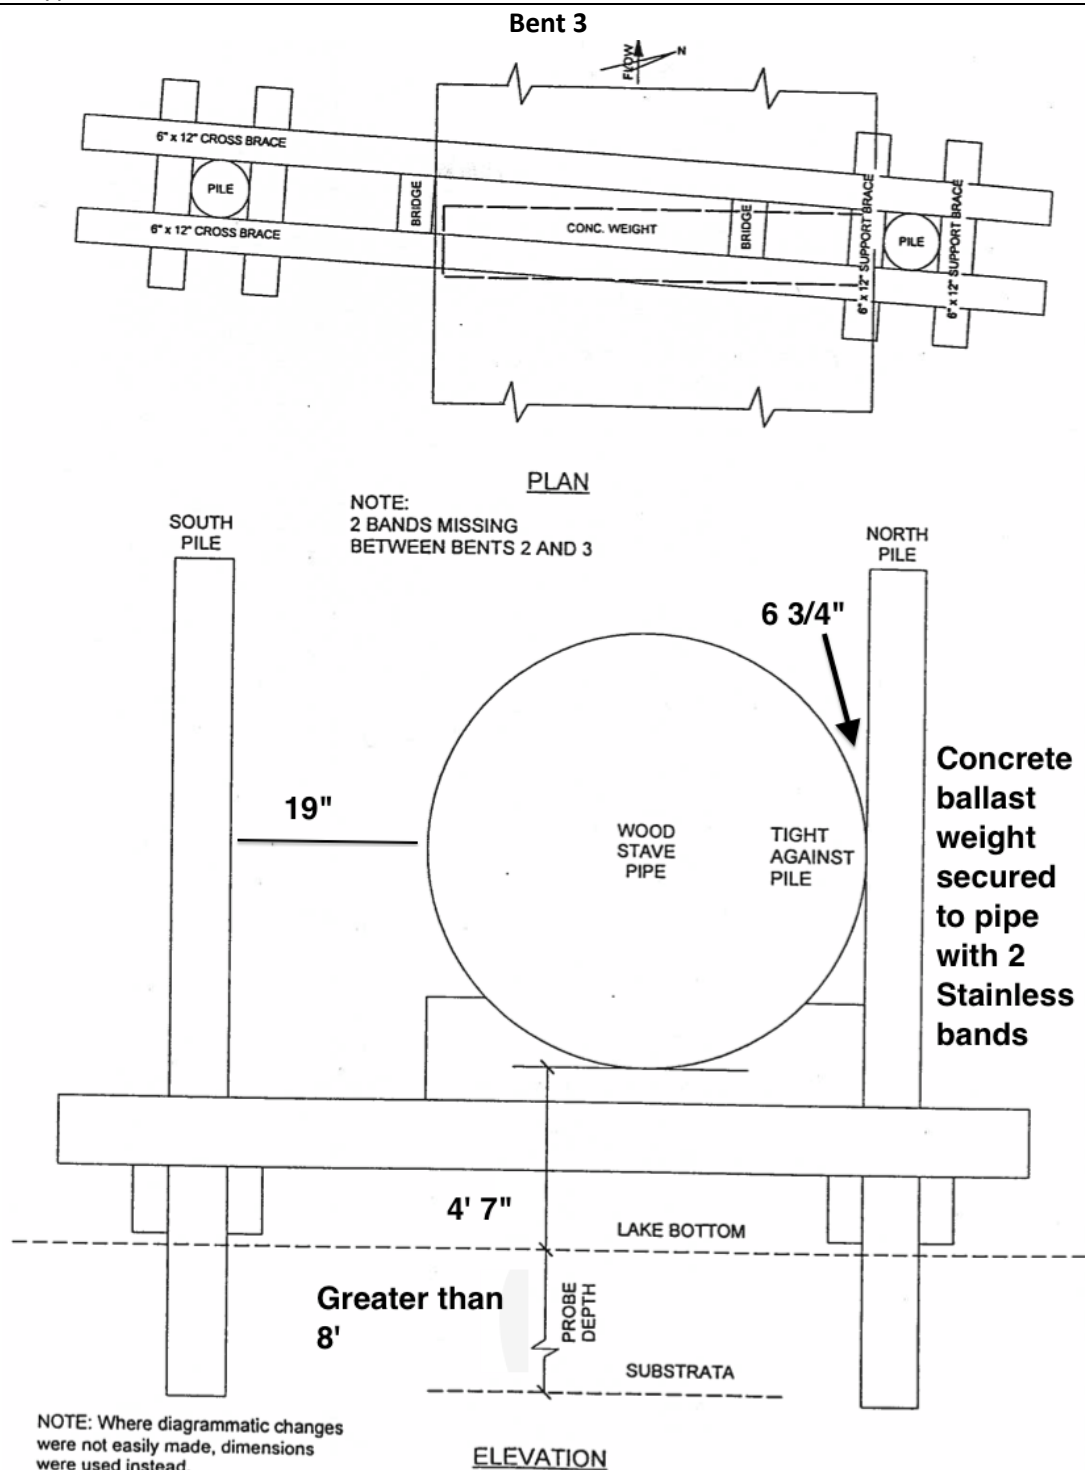
Pipe Condition Bent 3 to Bent 4					
Wood Condition	Marine Growth	Carbon Steel Component condition	Stainless Component Condition	Broken/Missing Bands Evident	Intermediate Ballast Weight Present
Very good	Light to Moderate Algae growth	Heavily Corroded	Tight, not corroded	None evident	No

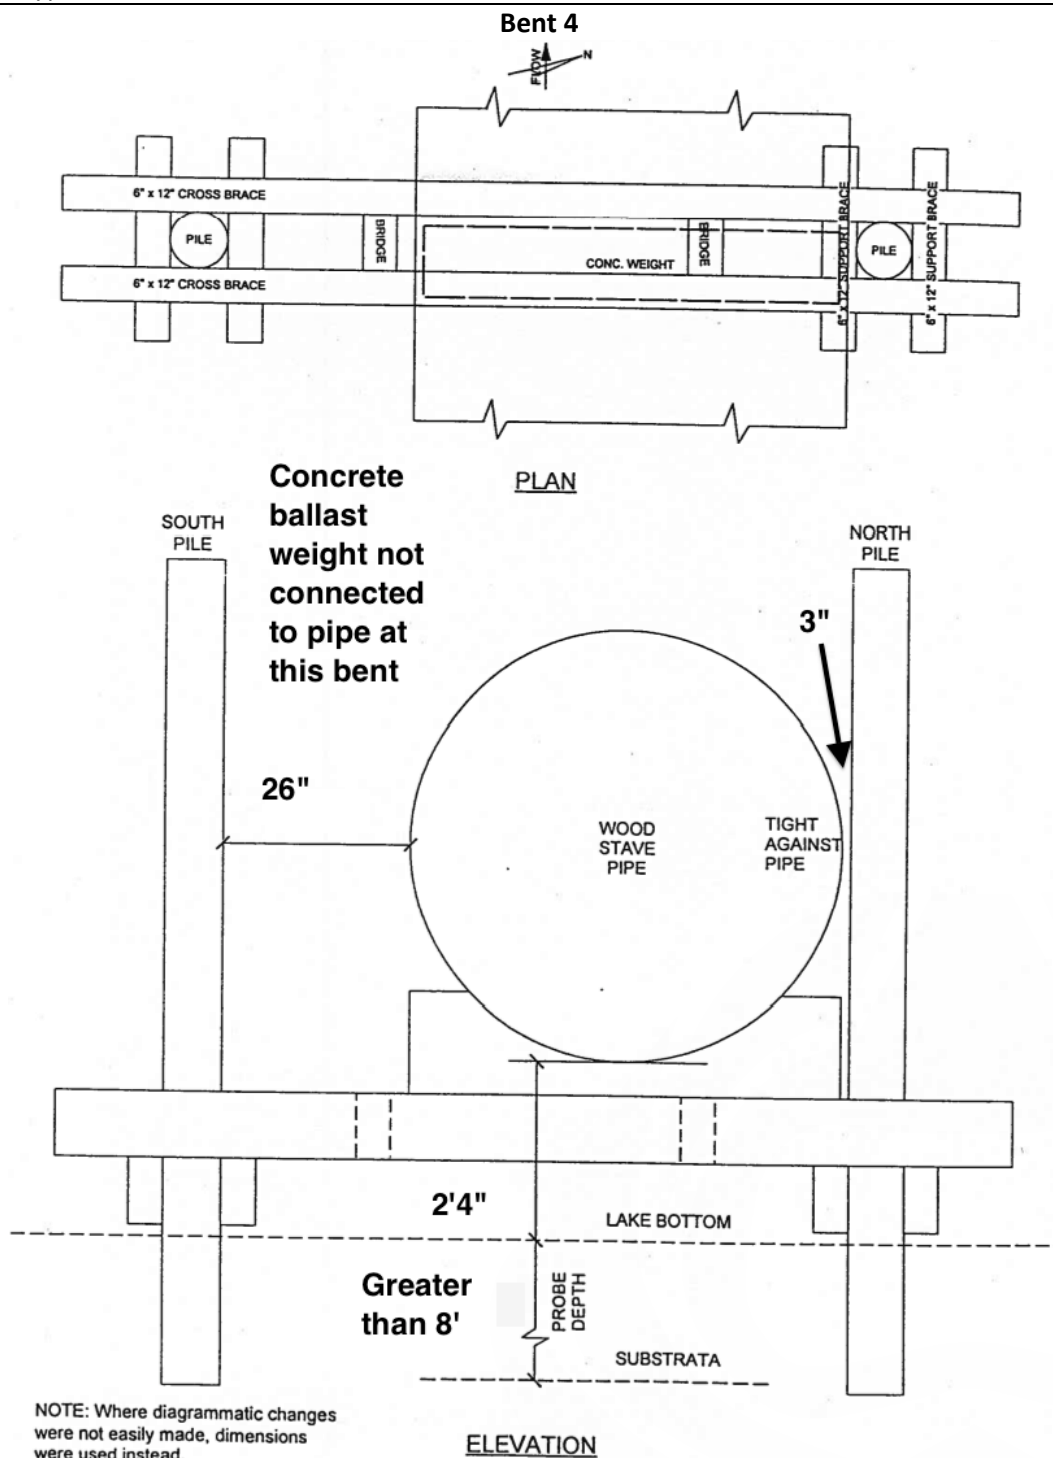
Pipe Condition Bent 4 to Bent 5					
Wood Condition	Marine Growth	Carbon Steel Component condition	Stainless Component Condition	Broken/Missing Bands Evident	Intermediate Ballast Weight Present
Very good	Light to Moderate Algae growth	Heavily Corroded	Tight, not corroded	Band on bottom at bent 5	No
Notes:					
See Photo #3 for typical condition of Stainless and Carbon bands.

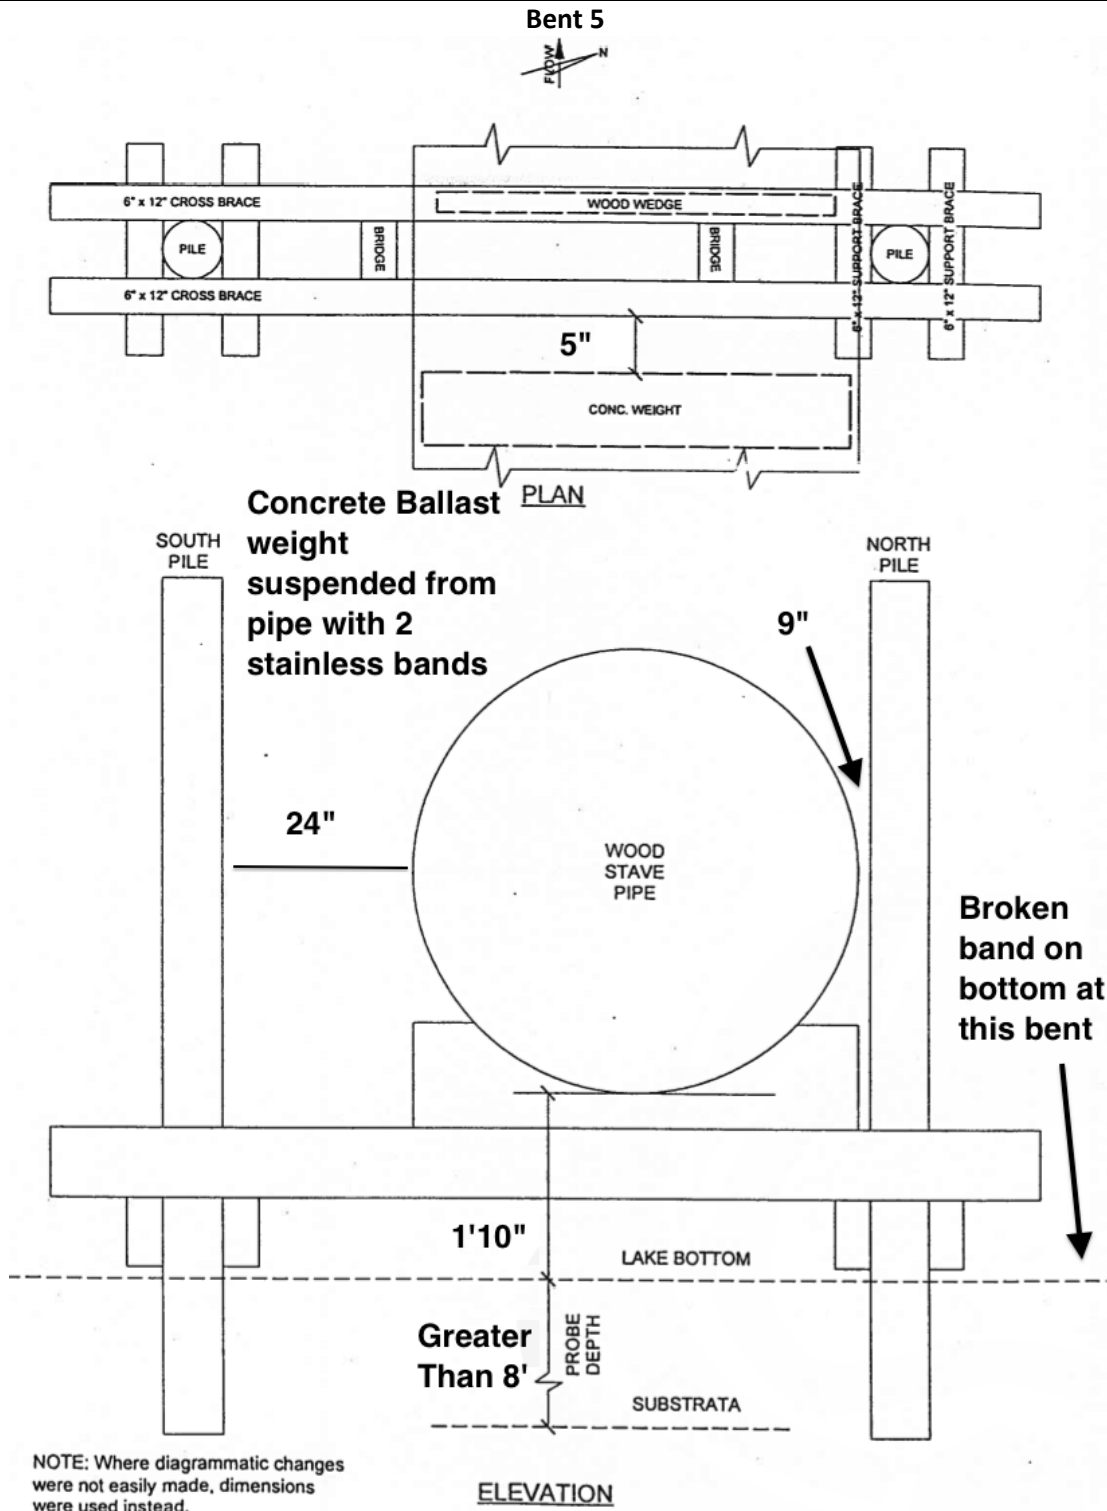
Pipe Condition Bent 5 to Bent 6					
Wood Condition	Marine Growth	Carbon Steel Component condition	Stainless Component Condition	Broken/Missing Bands Evident	Intermediate Ballast Weight Present
Very good	Light to Moderate Algae growth	Heavily Corroded	Tight, not corroded	No	Yes, 2 bands, stainless, tight
Notes: See Photo #3 for typical condition of Stainless and Carbon bands. First section of pipe with intermediate ballast weight.

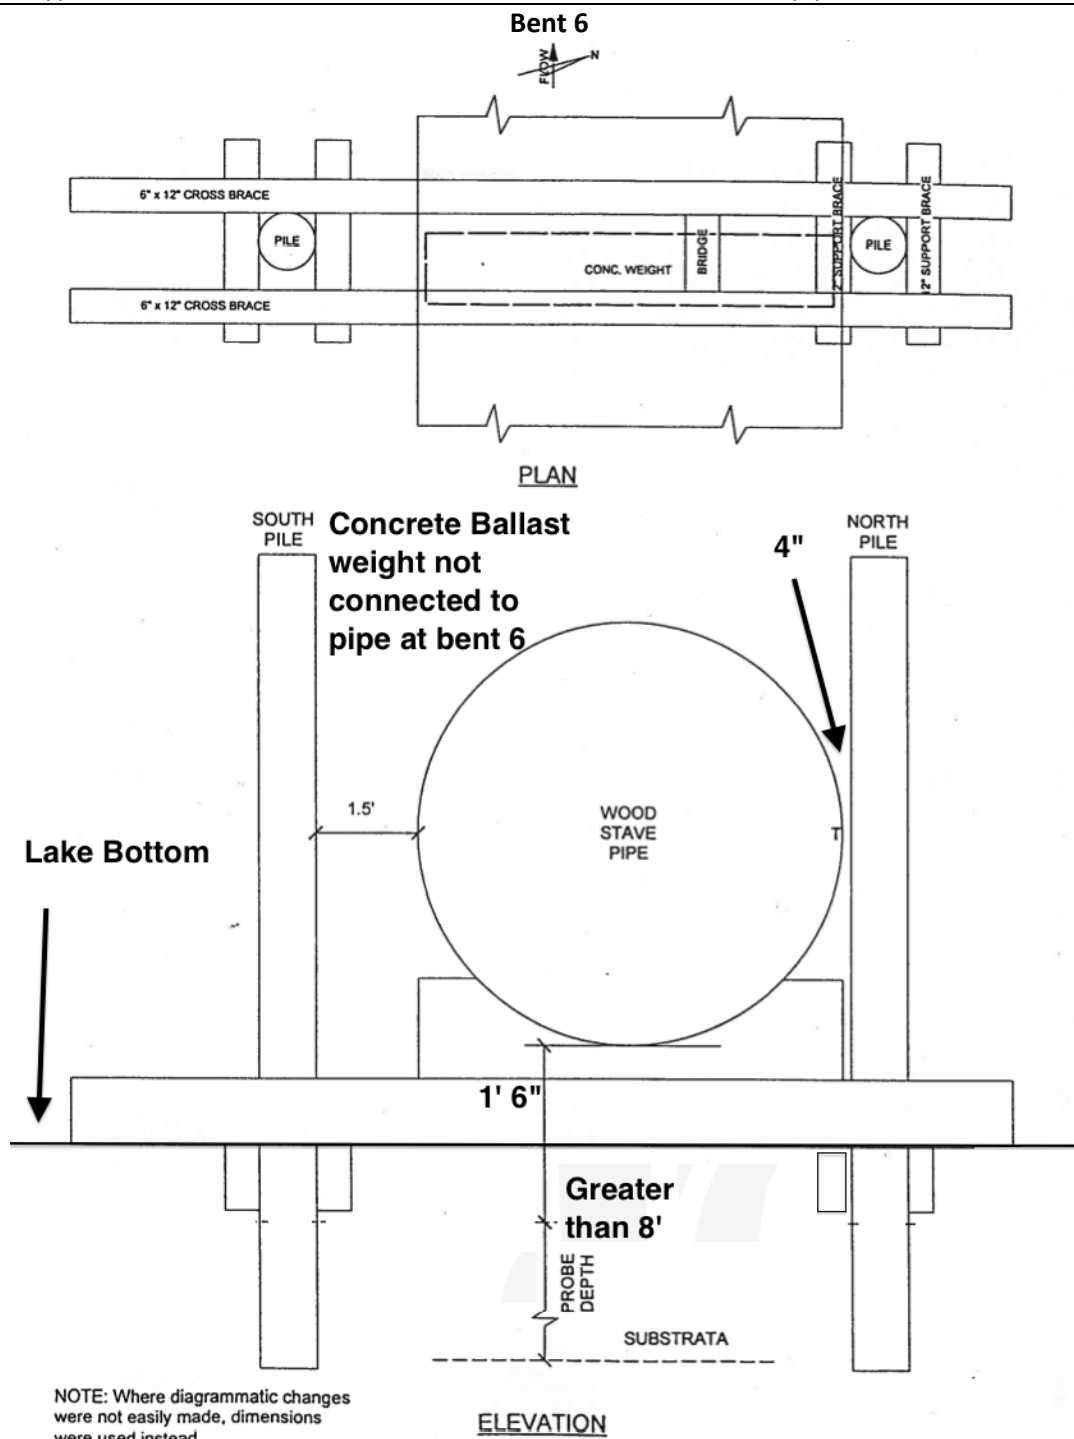
Pipe Condition Bent 6 to Bent 7					
Wood Condition	Marine Growth	Carbon Steel Component condition	Stainless Component Condition	Broken/Missing Bands Evident	Intermediate Ballast Weight Present
Very good	Light to Moderate Algae growth	Heavily Corroded	Not corroded, tight	Broken bands on bottom at bent 7	Yes, 2 bands, stainless, tight
Notes:					
See Photo #3 for typical condition of Stainless and Carbon bands. Ballast weight not secured to pipe at bent 7.

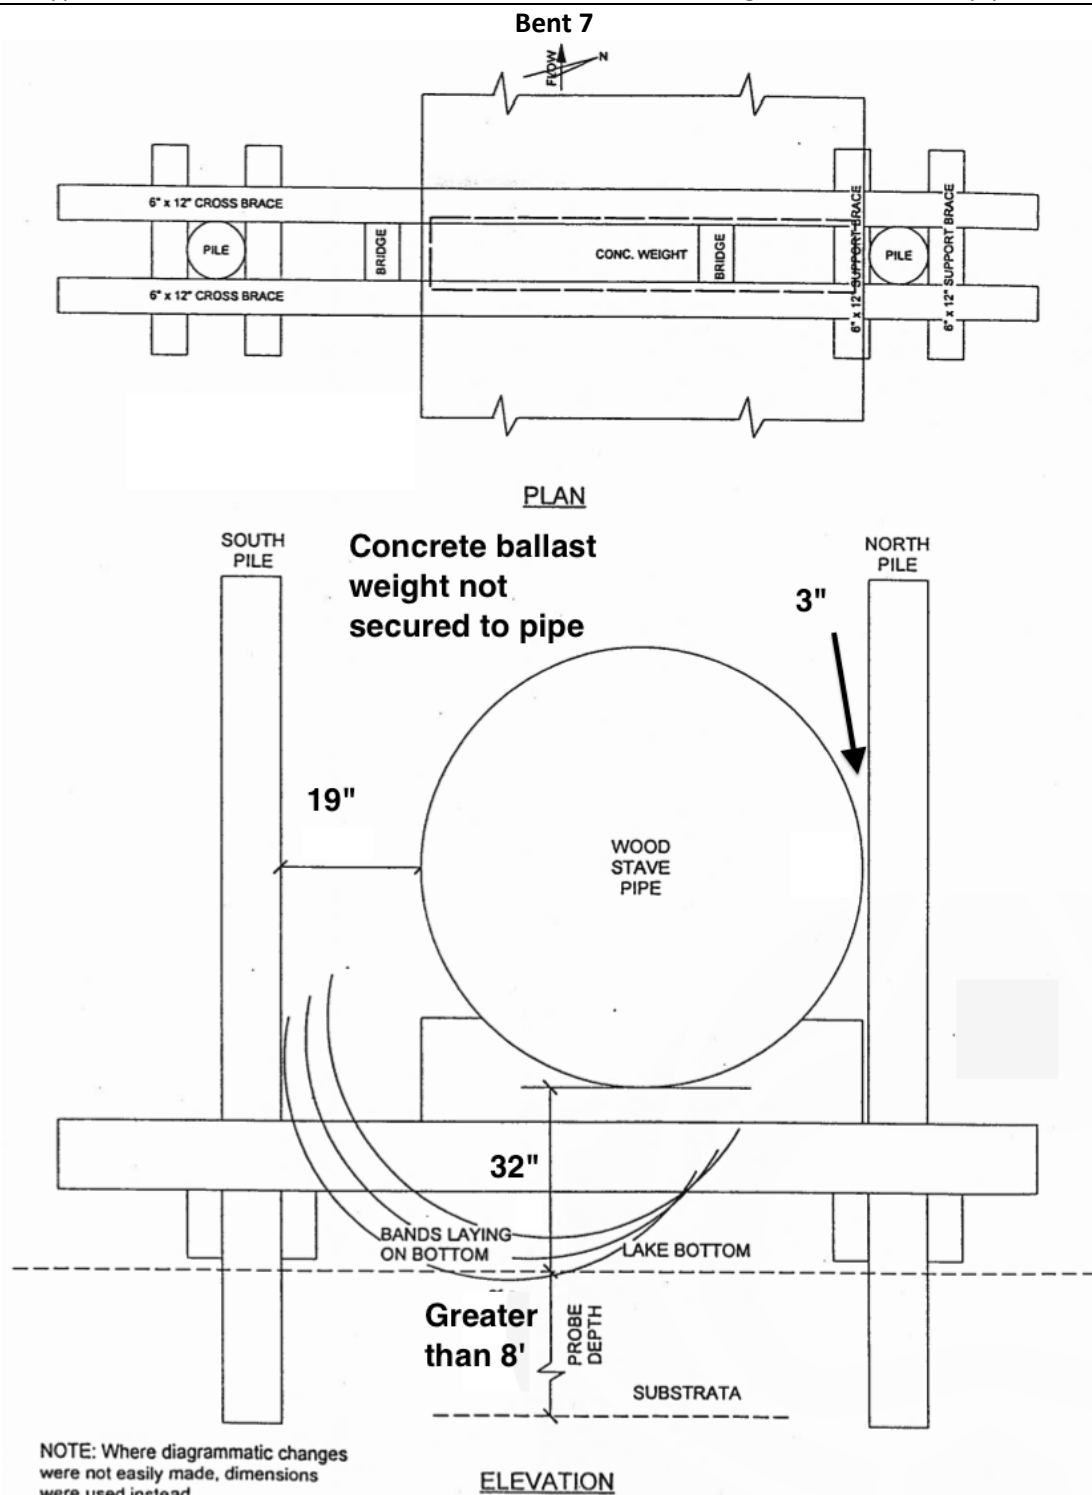
Pipe Condition Bent 7 to Bent 8					
Wood Condition	Marine Growth	Carbon Steel Component condition	Stainless Component Condition	Broken/Missing Bands Evident	Intermediate Ballast Weight Present
Very good	Light to Moderate Algae growth	Heavily Corroded	Not corroded, tight	Broken bands on bottom at bent 7	Yes, 2 bands, stainless, tight
Notes:					
See Photo #3 for typical condition of Stainless and Carbon bands.
