City of Bellingham Wood-Stave Intake Pipeline: Condition Assessment (Task 2.1.5)

PREPARED FOR: City of Bellingham Project Team
PREPARED BY: CH2M HILL Project Team
DATE: November 7, 2014

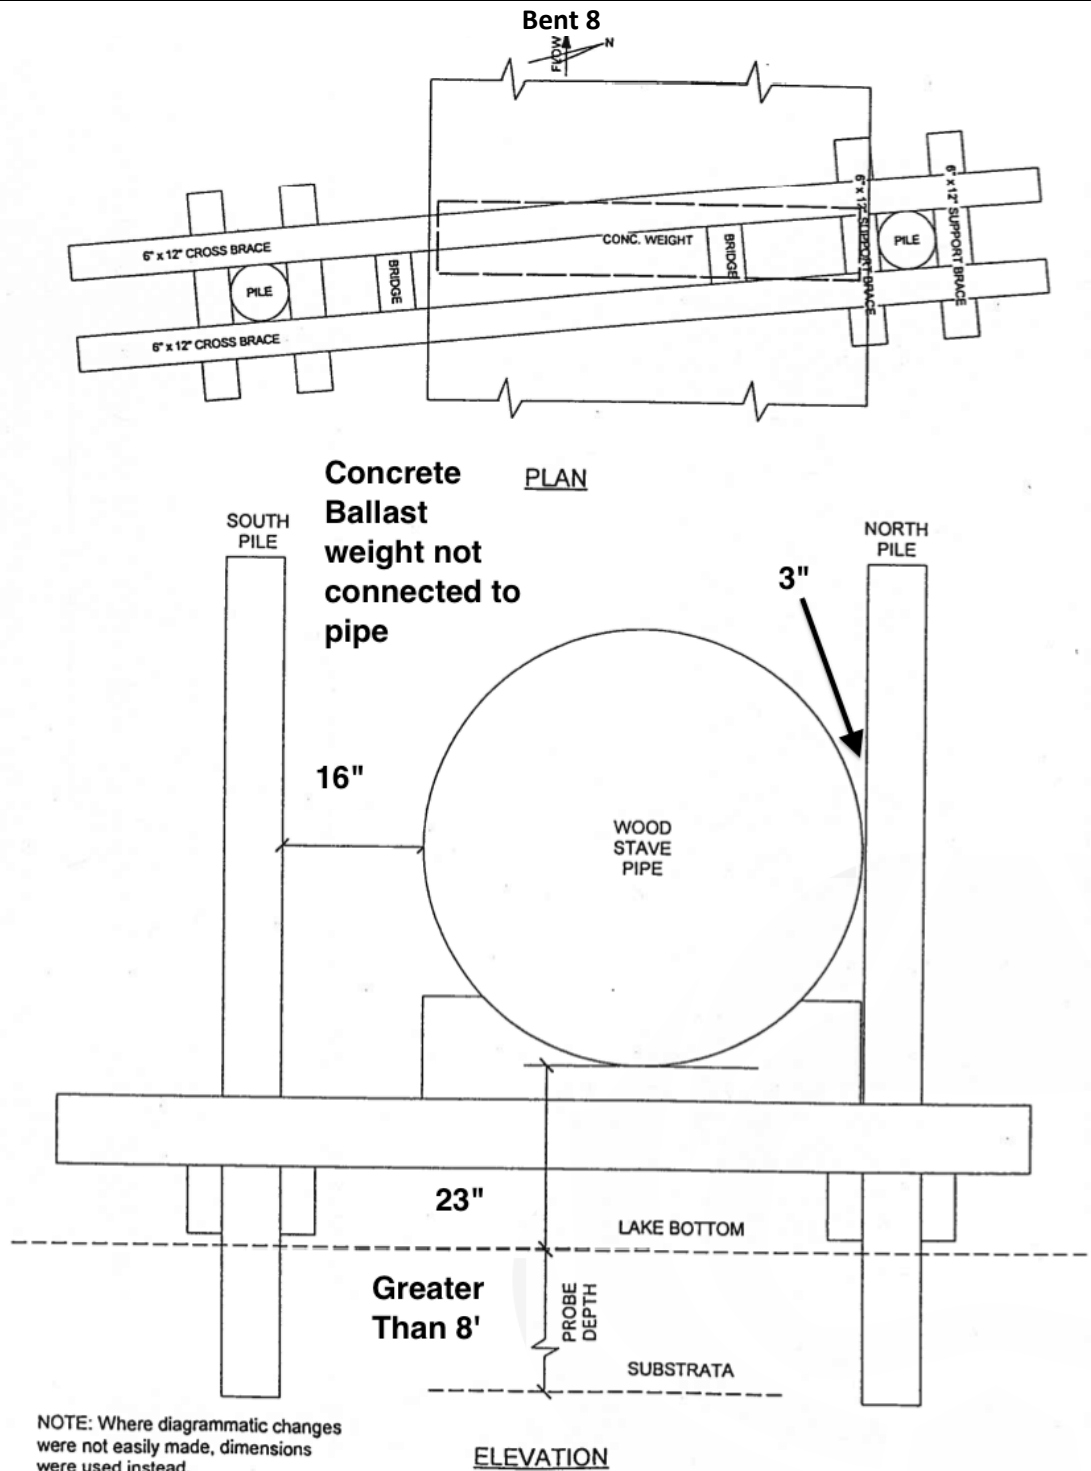
Pipe Condition Bent 8 to Bent 9					
Wood Condition	Marine Growth	Carbon Steel Component condition	Stainless Component Condition	Broken/Missing Bands Evident	Intermediate Ballast Weight Present
Very good	Light to Moderate Algae growth	Heavily Corroded	Not corroded, tight	None Seen	Yes, 2 bands, stainless, tight
Notes: See Photo #3 for typical condition of Stainless and Carbon bands.

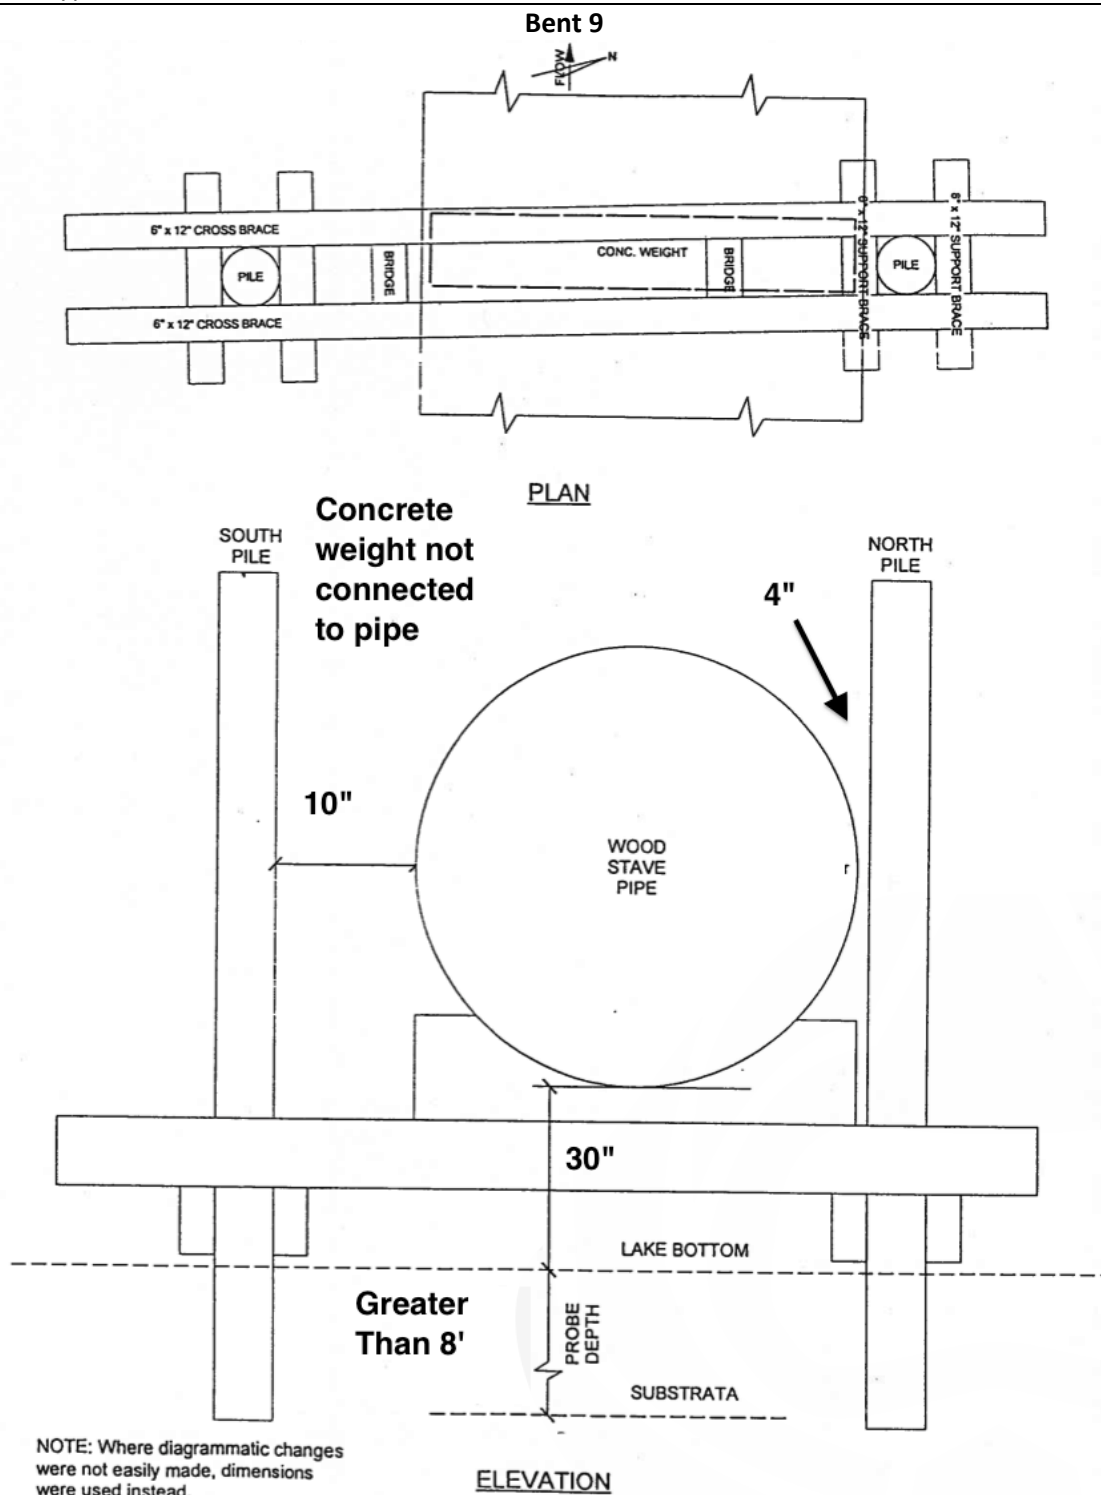
Pipe Condition Bent 9 to Bent 10					
Wood Condition	Marine Growth	Carbon Steel Component condition	Stainless Component Condition	Broken/Missing Bands Evident	Intermediate Ballast Weight Present
Very good	Light to Moderate Algae growth	Heavily Corroded	Not corroded, tight	None Seen	Yes, 2 bands, stainless, tight
Notes: See Photo #3 for typical condition of Stainless and Carbon bands.

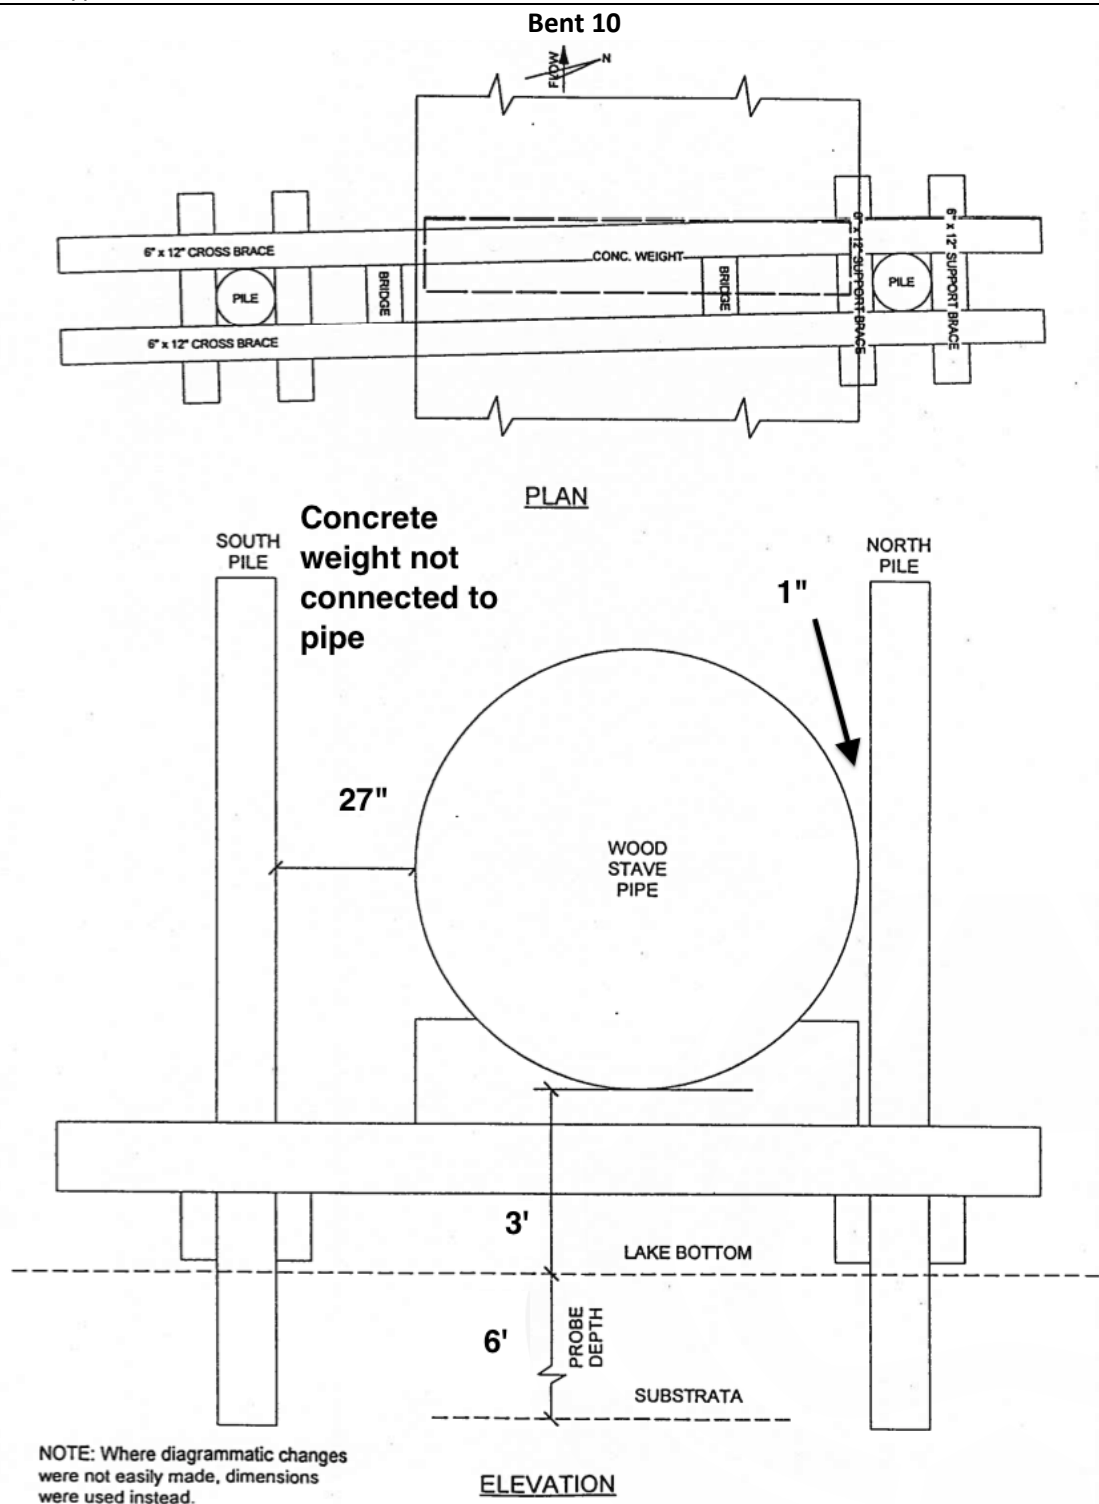
Pipe Condition Bent 10 to Bent 11					
Wood Condition	Marine Growth	Carbon Steel Component condition	Stainless Component Condition	Broken/Missing Bands Evident	Intermediate Ballast Weight Present
Very good	Light to Moderate Algae growth	Heavily Corroded	One corroded band at bent 11	None Seen	Yes, 2 bands, stainless, tight
Notes:					
See Photo #3 for typical condition of Stainless and Carbon bands. See Photo #5 for detail of corroded stainless band at bent #11

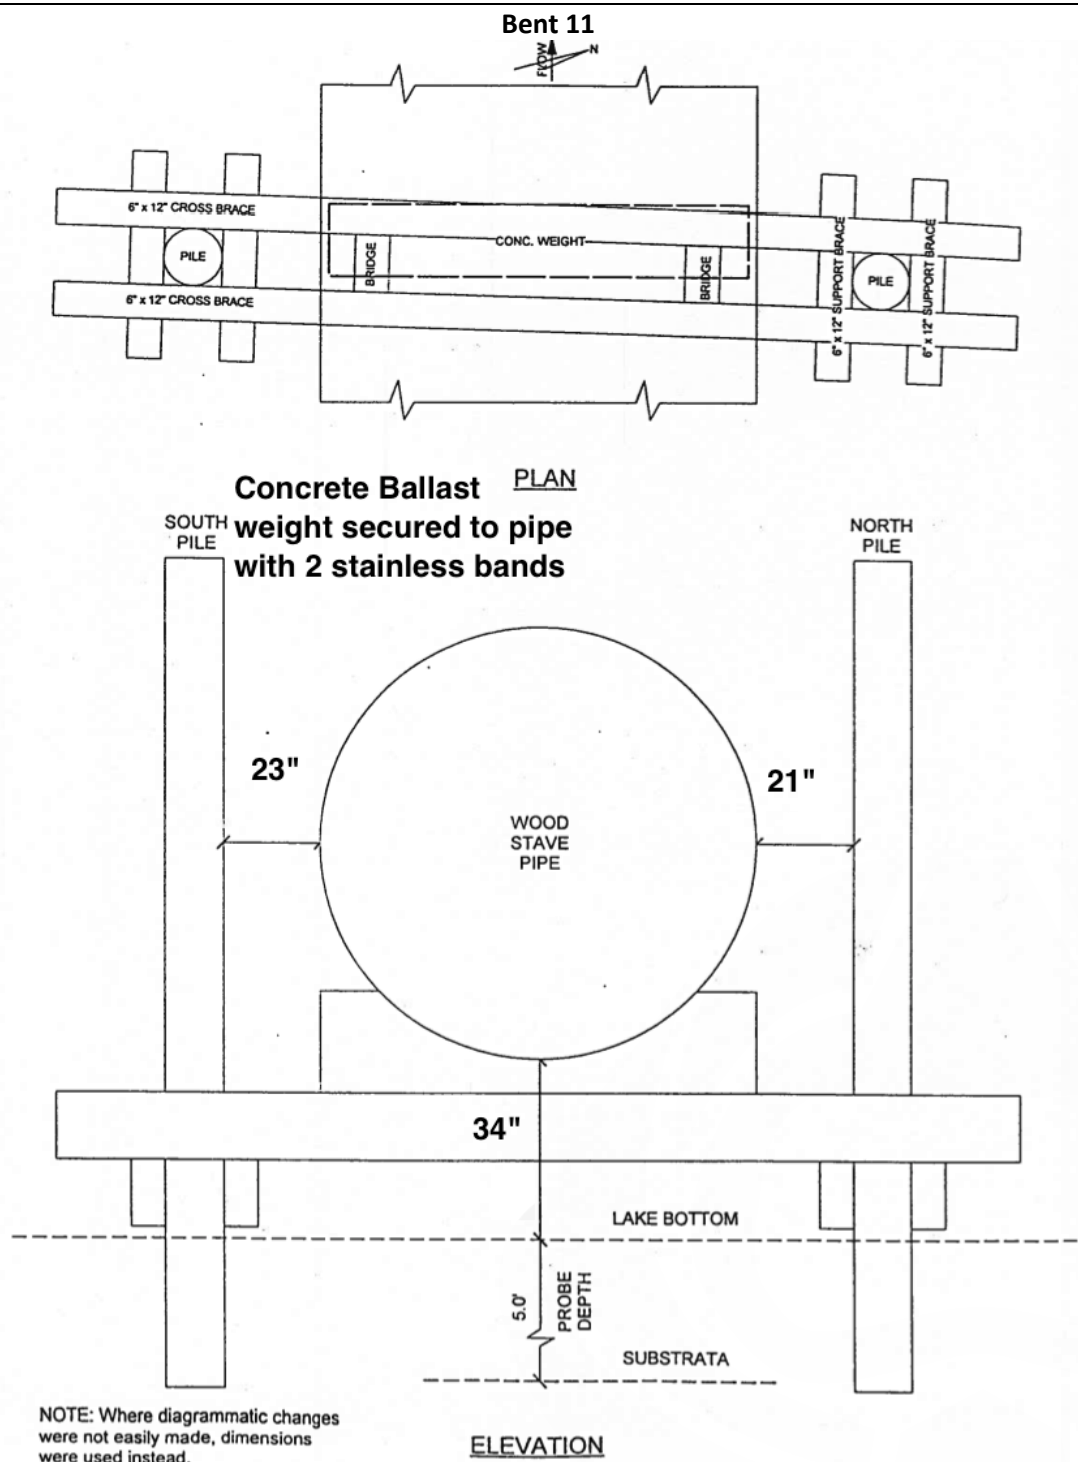
Pipe Condition Bent 11 to Bent 12					
Wood Condition	Marine Growth	Carbon Steel Component condition	Stainless Component Condition	Broken/Missing Bands Evident	Intermediate Ballast Weight Present
Very good	Light to Moderate Algae growth	Heavily Corroded	One corroded band at bent 11	None Seen	Yes, 2 bands, stainless, tight
Notes: See Photo #3 for typical condition of Stainless and Carbon bands. See Photo #5 for detail of corroded stainless band at bent #11

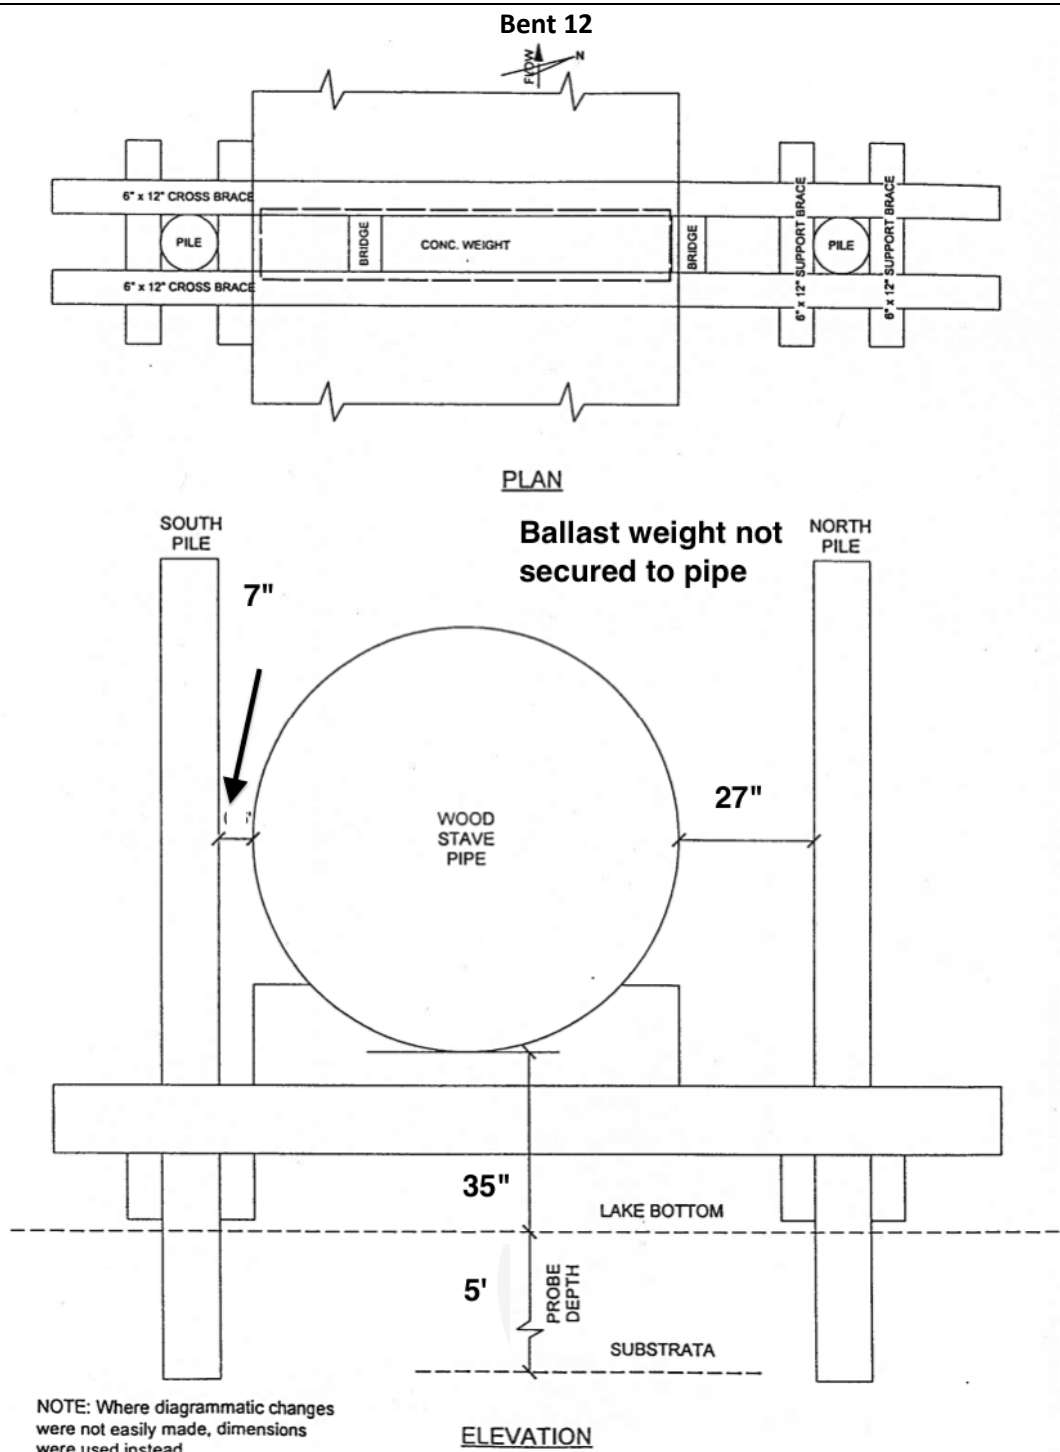
Pipe Condition Bent 12 to Bent 13					
Wood Condition	Marine Growth	Carbon Steel Component condition	Stainless Component Condition	Broken/Missing Bands Evident	Intermediate Ballast Weight Present
Very good	Light to Moderate Algae growth	Heavily Corroded	Not Corroded, Tight	None Seen	Yes, 2 bands, stainless, tight
Notes:					
See Photo #3 for typical condition of Stainless and Carbon bands.

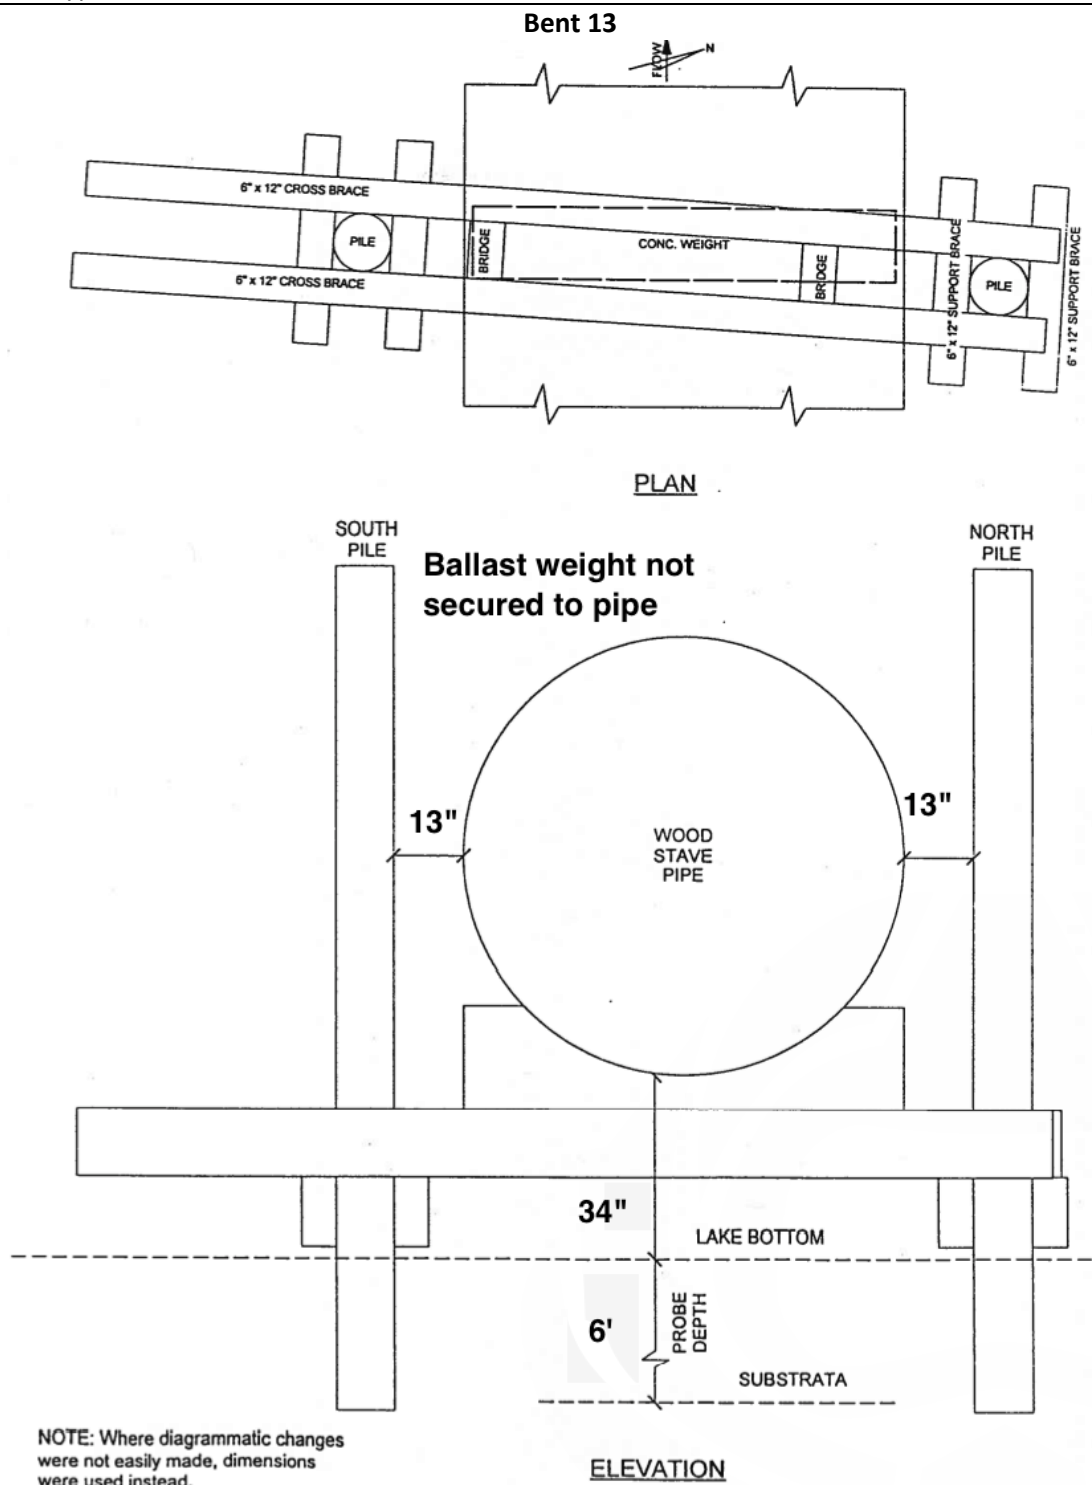
Pipe Condition Bent 13 to Bent 14					
Wood Condition	Marine Growth	Carbon Steel Component condition	Stainless Component Condition	Broken/Missing Bands Evident	Intermediate Ballast Weight Present
Very good	Light to Moderate Algae growth	Heavily Corroded	Not Corroded, Tight	None Seen	Yes, 2 bands, stainless, tight
Notes:					
See Photo #3 for typical condition of Stainless and Carbon bands.

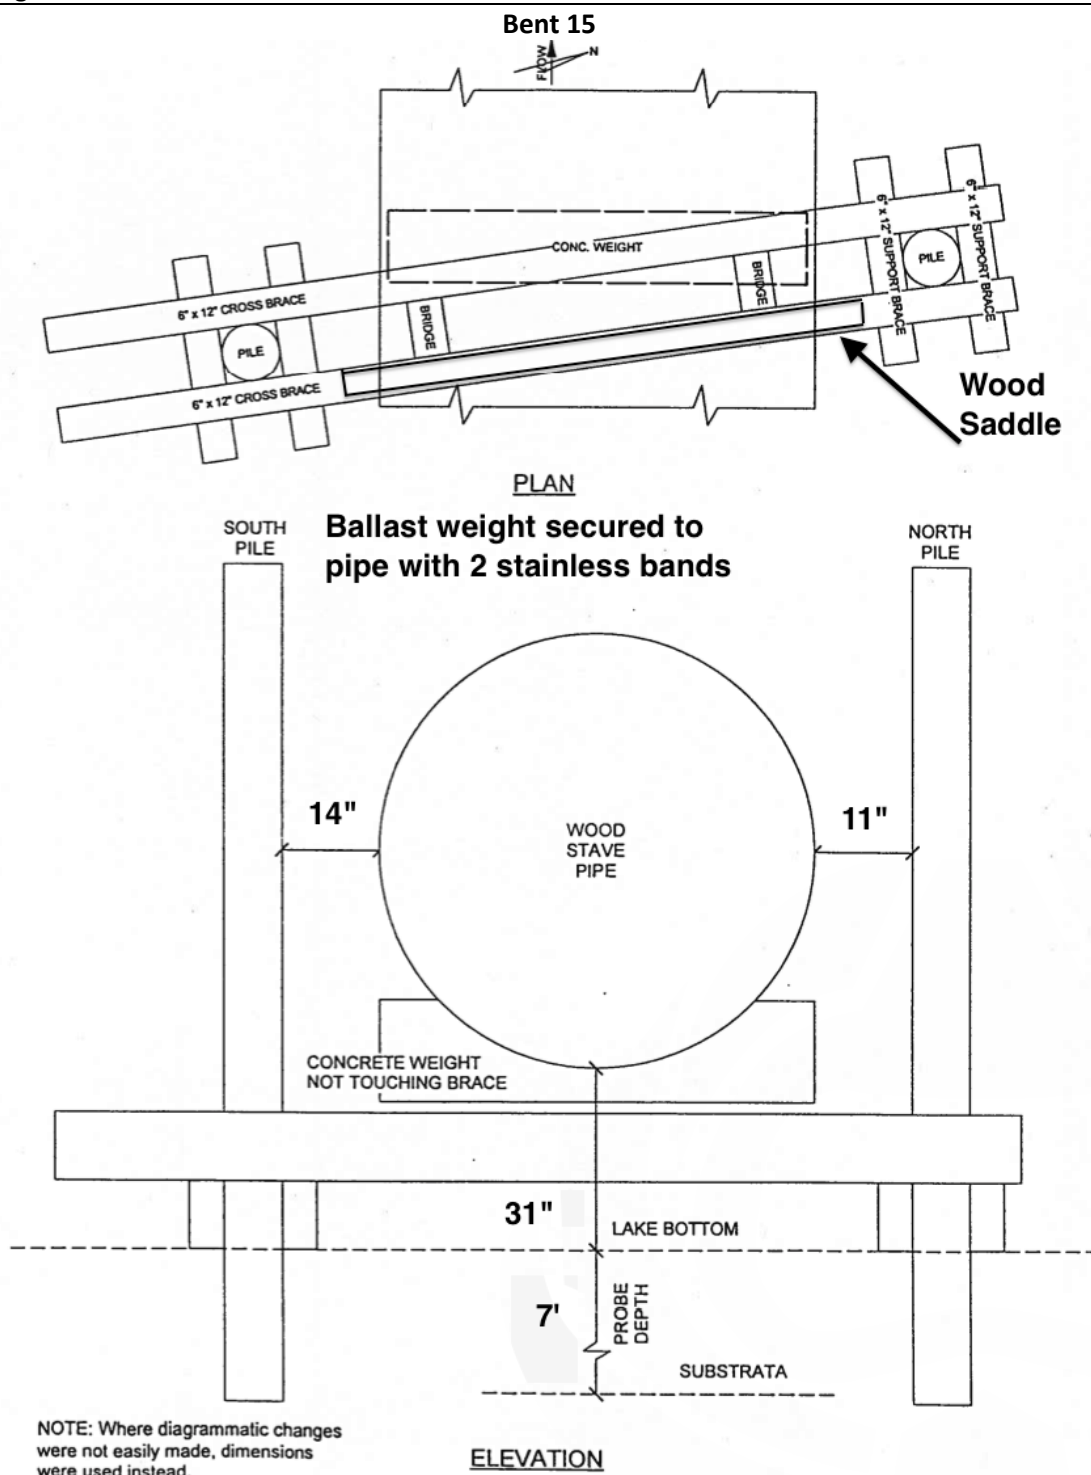
Pipe Condition Bent 15 to Bent 16					
Wood Condition	Marine Growth	Carbon Steel Component condition	Stainless Component Condition	Broken/Missing Bands Evident	Intermediate Ballast Weight Present
Very good	Light to Moderate Algae growth	Heavily Corroded	Not Corroded, Tight	Broken band offshore of 16	Yes, 2 bands, stainless, tight
Notes:					
See Photo #3 for typical condition of Stainless and Carbon bands. Broken Band Just offshore of Bent 16

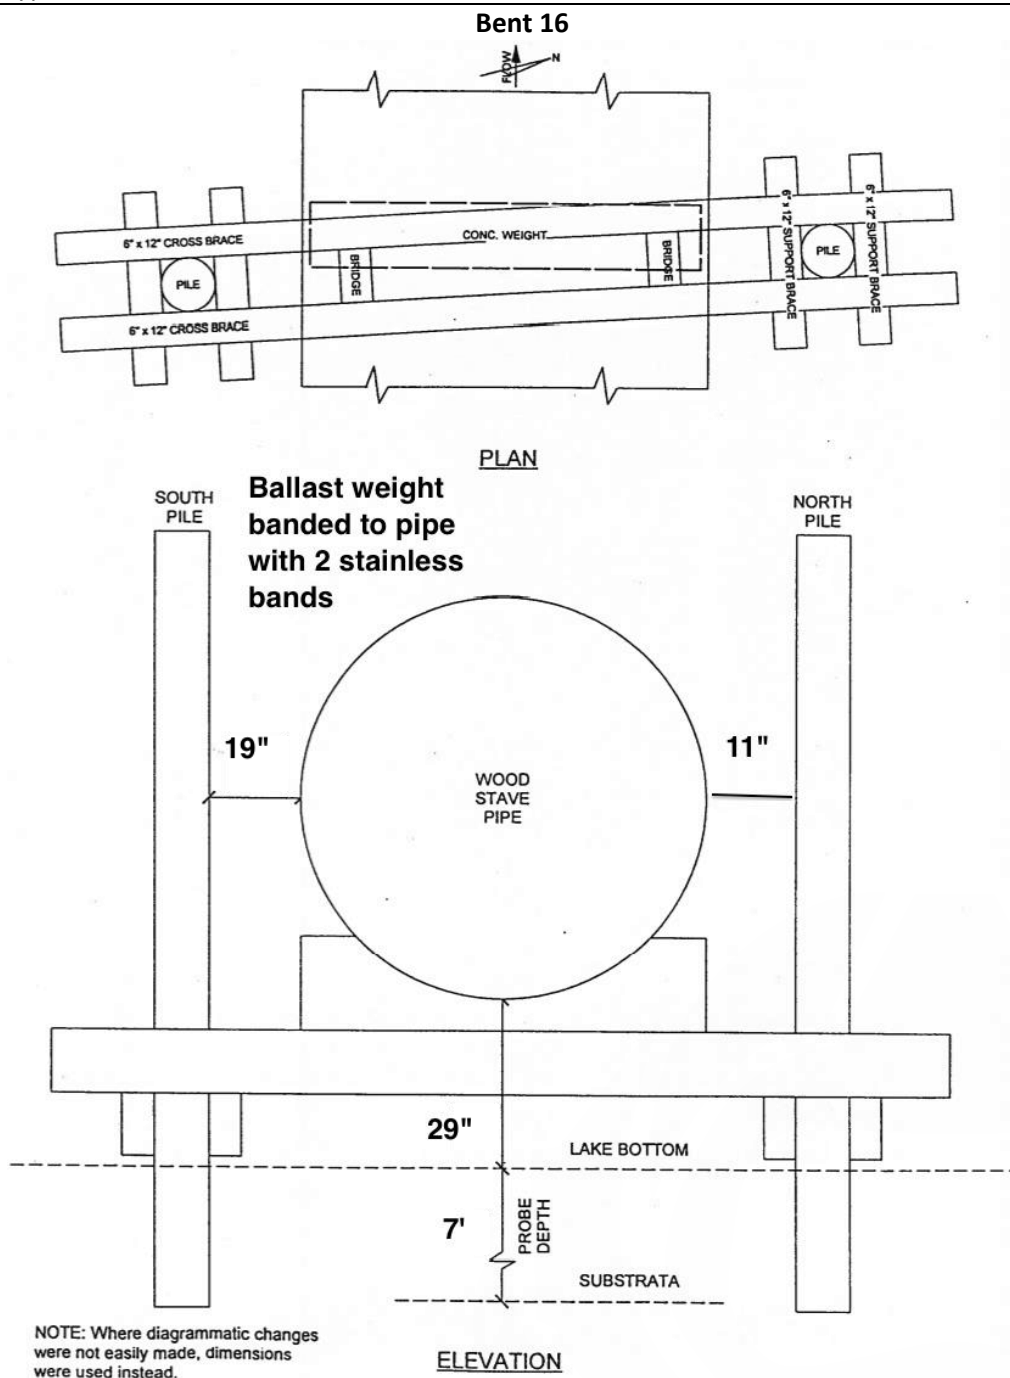
Pipe Condition Bent 16 to Bent 17					
Wood Condition	Marine Growth	Carbon Steel Component condition	Stainless Component Condition	Broken/Missing Bands Evident	Intermediate Ballast Weight Present
Very good	Light to Moderate Algae growth	Heavily Corroded	Not Corroded, Tight	None Seen	Yes, 2 bands, stainless, tight
Notes: See Photo #3 for typical condition of Stainless and Carbon bands.

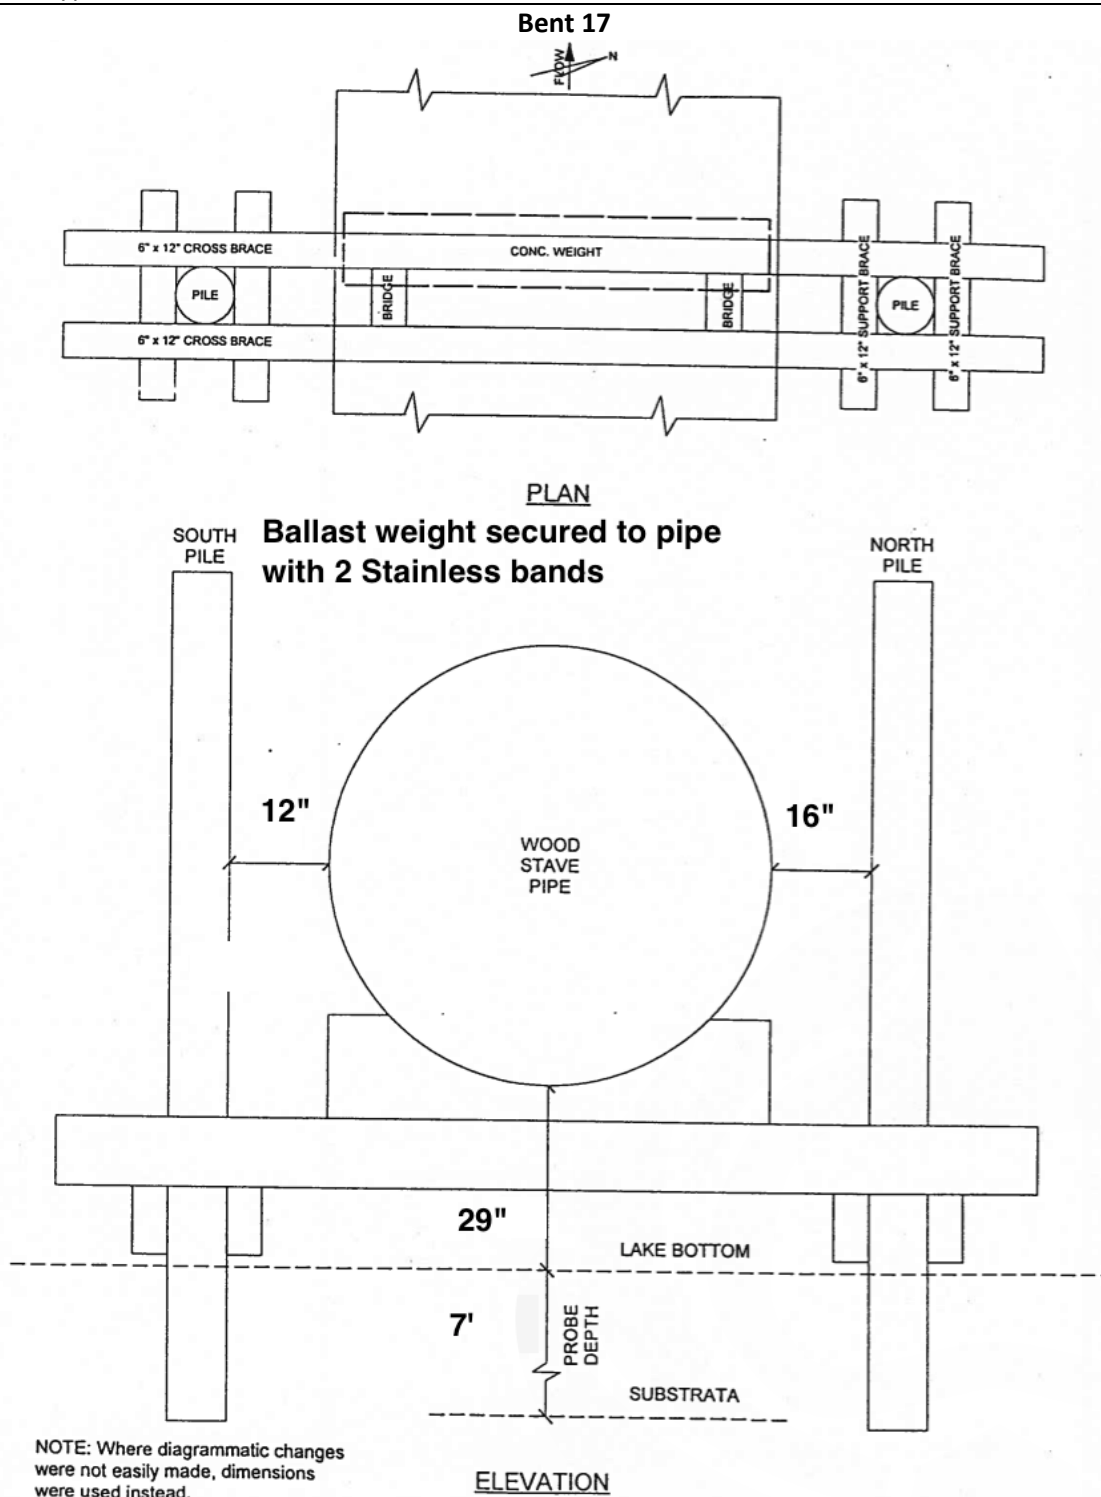
Pipe Condition Bent 17 to Bent 18					
Wood Condition	Marine Growth	Carbon Steel Component condition	Stainless Component Condition	Broken/Missing Bands Evident	Intermediate Ballast Weight Present
Very good	Light to Moderate Algae growth	Heavily Corroded	Not Corroded, Tight	None Seen	Yes, 2 bands, stainless, tight
Notes: See Photo #3 for typical condition of Stainless and Carbon bands. South Pile has been replaced at bent 18, so new support brace hardware was installed. See photo #7 for detail of new hardware.

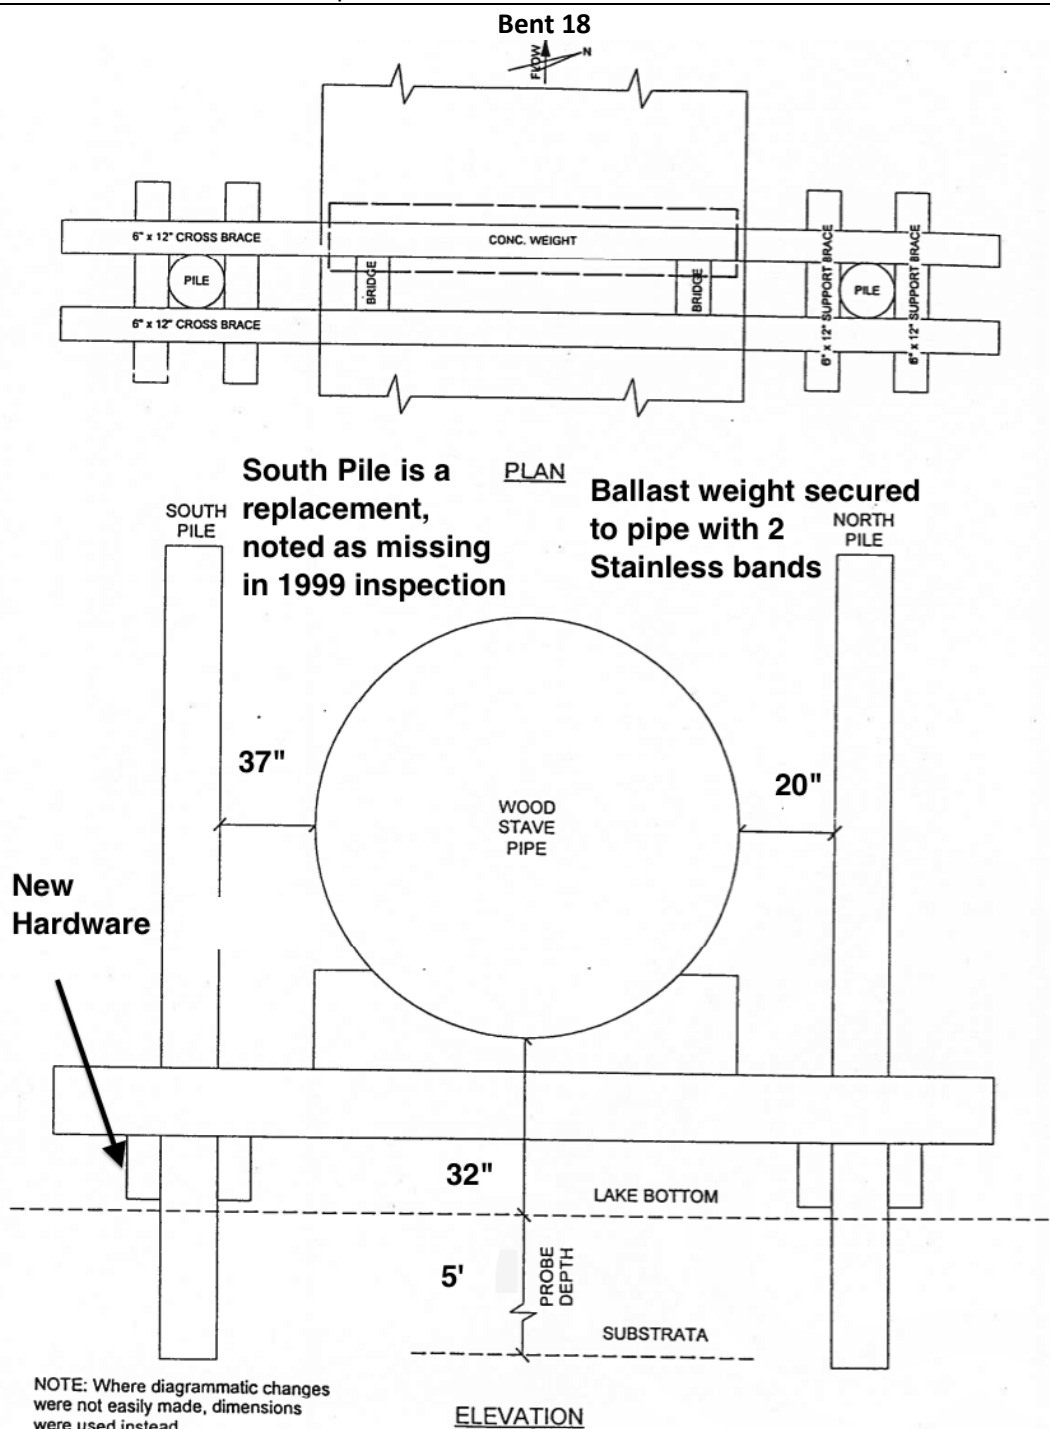
Pipe Condition Bent 18 to Bent 19					
Wood Condition	Marine Growth	Carbon Steel Component condition	Stainless Component Condition	Broken/Missing Bands Evident	Intermediate Ballast Weight Present
Very good	Light to Moderate Algae growth	Heavily Corroded	Not Corroded, Tight	carbon band missing 1' offshore of bent 19	Yes, 2 bands, stainless, tight
Notes: See Photo #3 for typical condition of Stainless and Carbon bands.

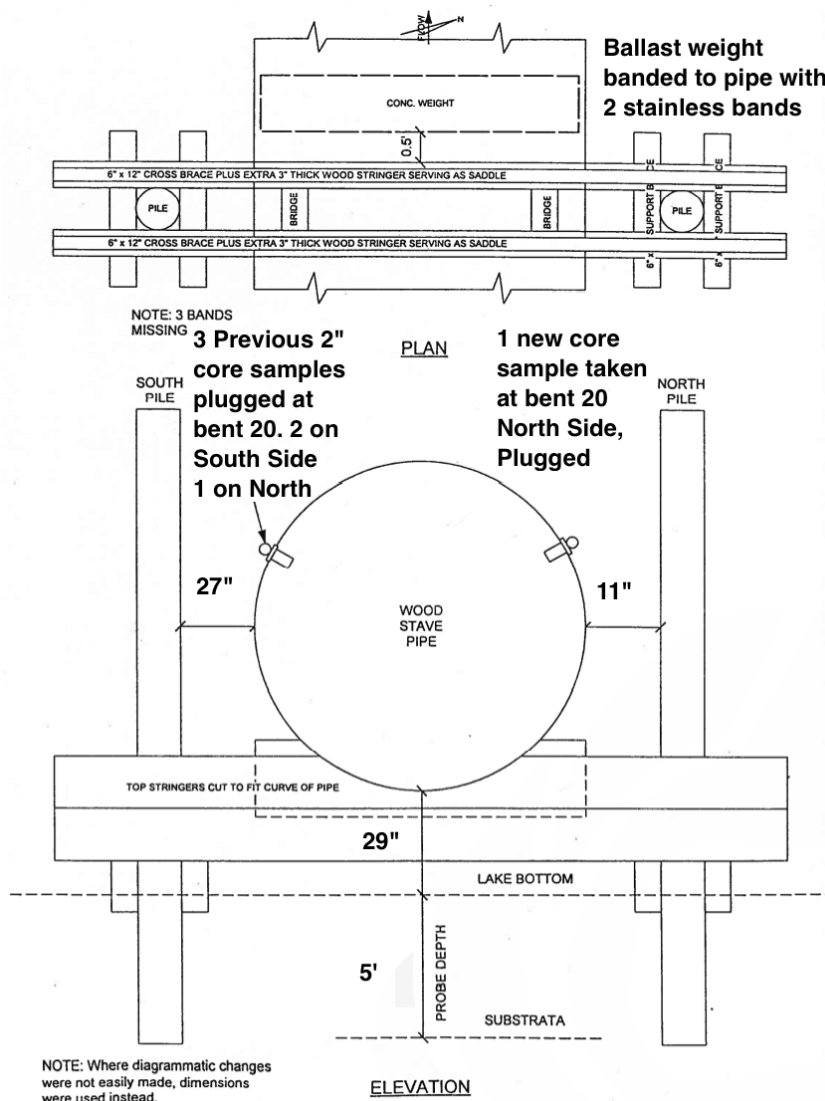
Pipe Condition Bent 20 to Bent 21					
Wood Condition	Marine Growth	Carbon Steel Component condition	Stainless Component Condition	Broken/Missing Bands Evident	Intermediate Ballast Weight Present
Very good	Light to Moderate Algae growth	Heavily Corroded	Not Corroded, Tight	None seen	Yes, 2 bands, stainless, tight
Notes:					
See Photo #3 for typical condition of Stainless and Carbon bands.

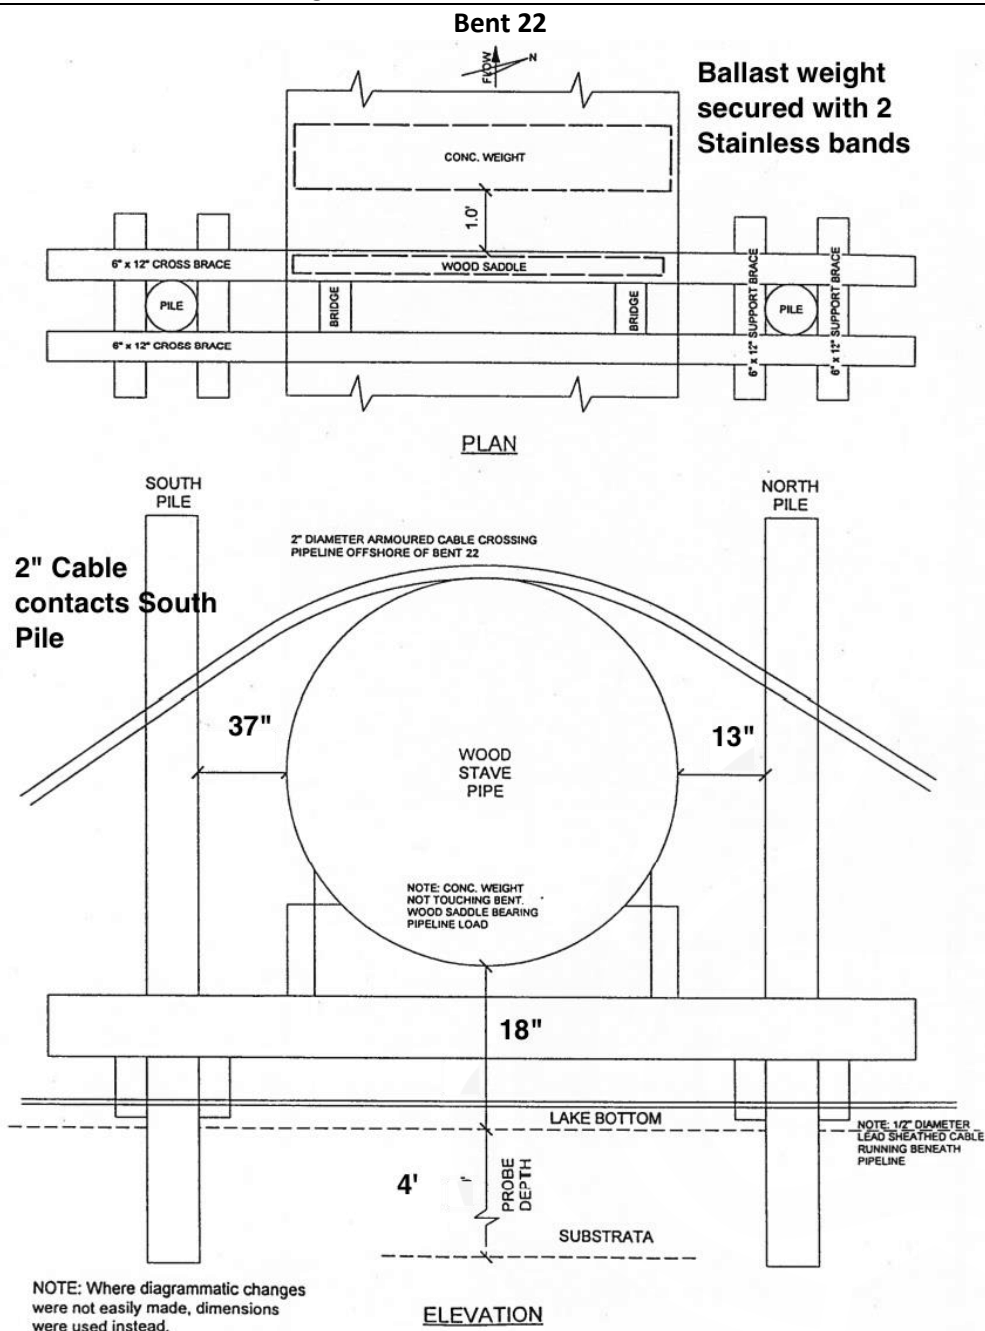
Pipe Condition Bent 22 to Bent 23					
Wood Condition	Marine Growth	Carbon Steel Component condition	Stainless Component Condition	Broken/Missing Bands Evident	Intermediate Ballast Weight Present
Very good	Light to Moderate Algae growth	Heavily Corroded	Not Corroded, Tight	None seen	Yes, 2 bands, stainless, tight

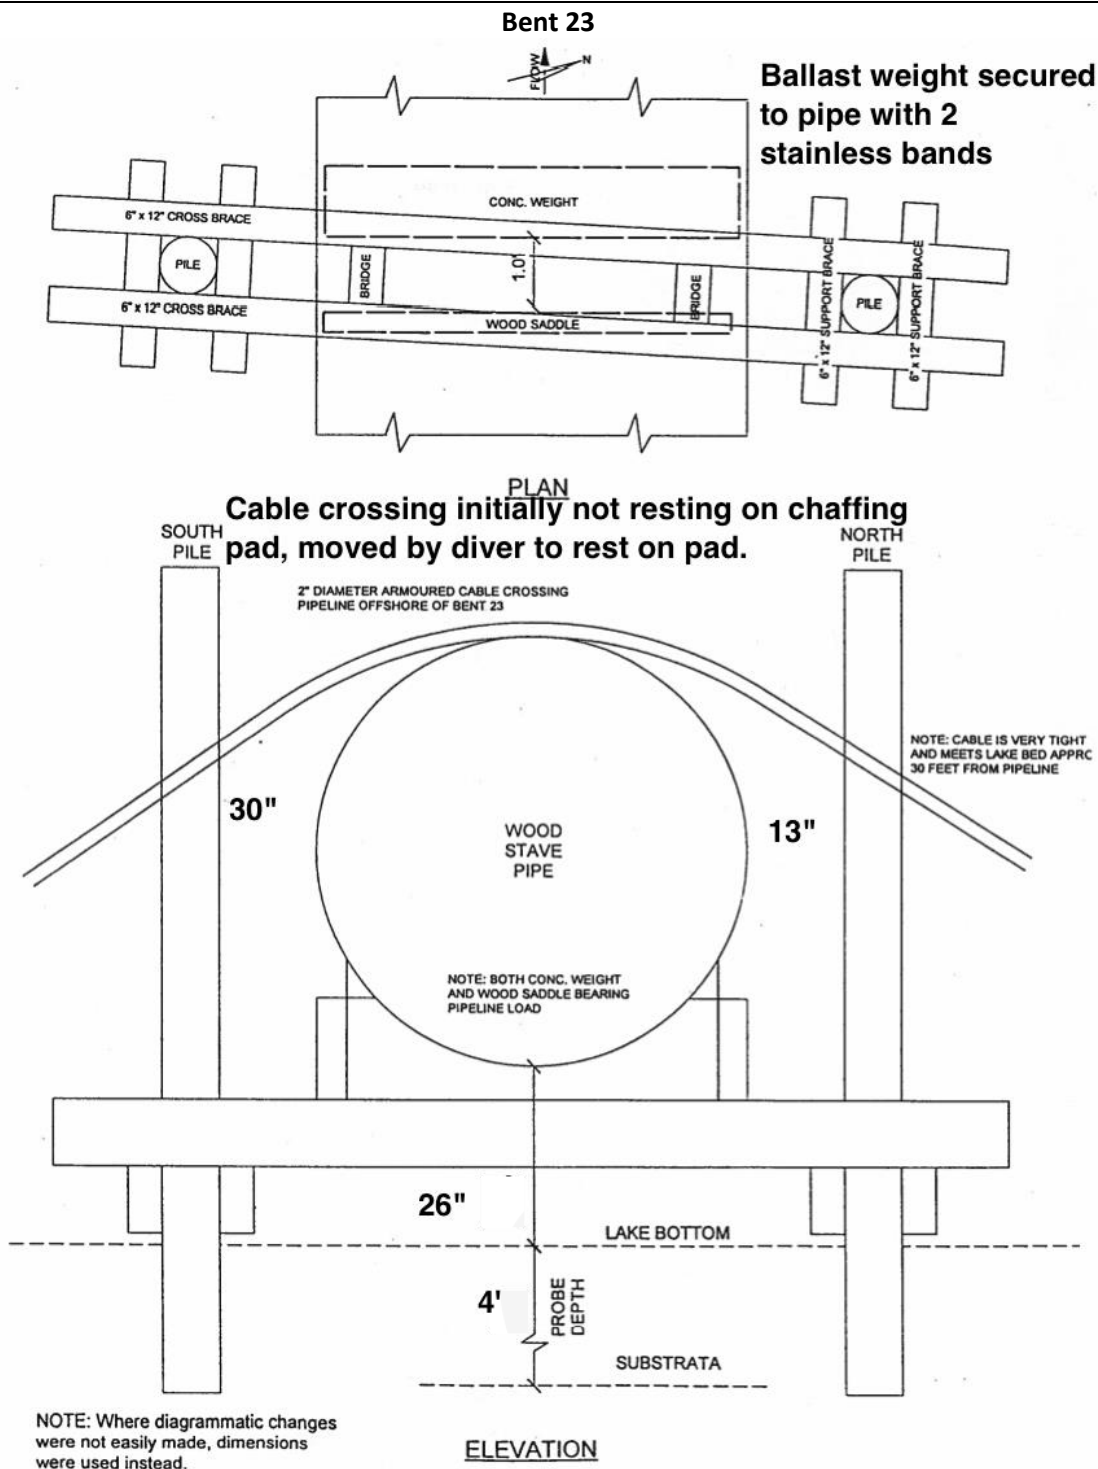
Pipe Condition Bent 23 to Bent 24					
Wood Condition	Marine Growth	Carbon Steel Component condition	Stainless Component Condition	Broken/Missing Bands Evident	Intermediate Ballast Weight Present
Very good	Light to Moderate Algae growth	Heavily Corroded	Not Corroded, Tight	None seen	Yes, 2 bands, stainless, tight
Notes:					
See Photo #3 for Typical condition of stainless and carbon bands.

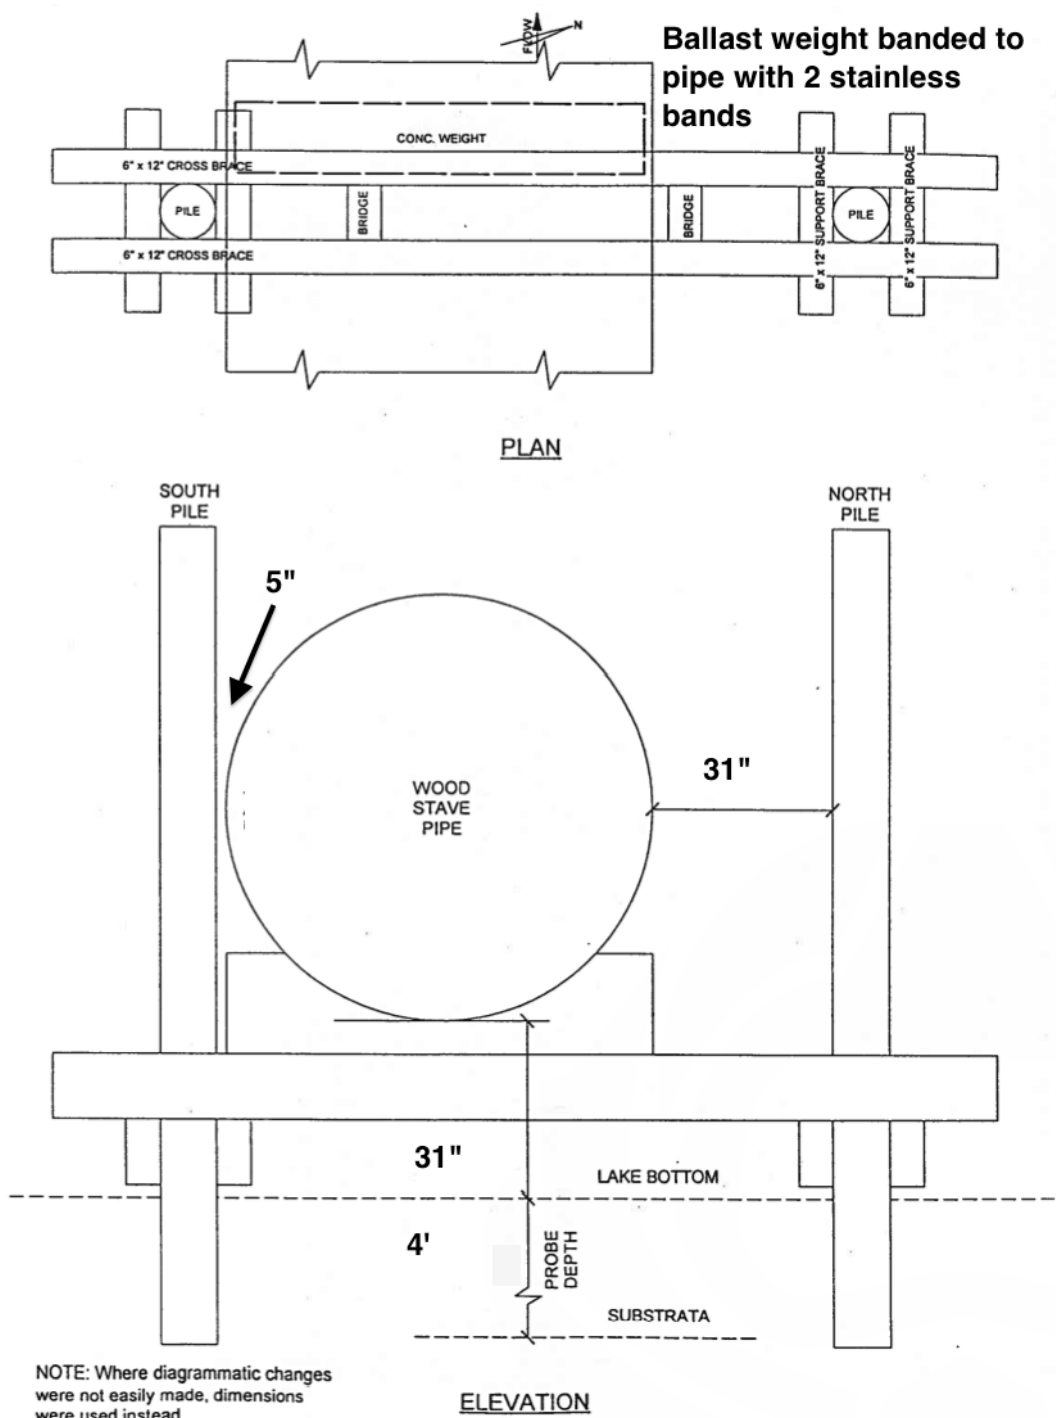
Pipe Condition Bent 24 to Bent 25					
Wood Condition	Marine Growth	Carbon Steel Component condition	Stainless Component Condition	Broken/Missing Bands Evident	Intermediate Ballast Weight Present
Very good	Light to Moderate Algae growth	Heavily Corroded	Not Corroded, Tight	None seen	Yes, 2 bands, stainless, tight
Notes: See Photo #3 for Typical condition of stainless and carbon bands.
