City of Bellingham Wood-Stave Intake Pipeline: Condition Assessment (Task 2.1.5)

PREPARED FOR: City of Bellingham Project Team
PREPARED BY: CH2M HILL Project Team
DATE: November 7, 2014

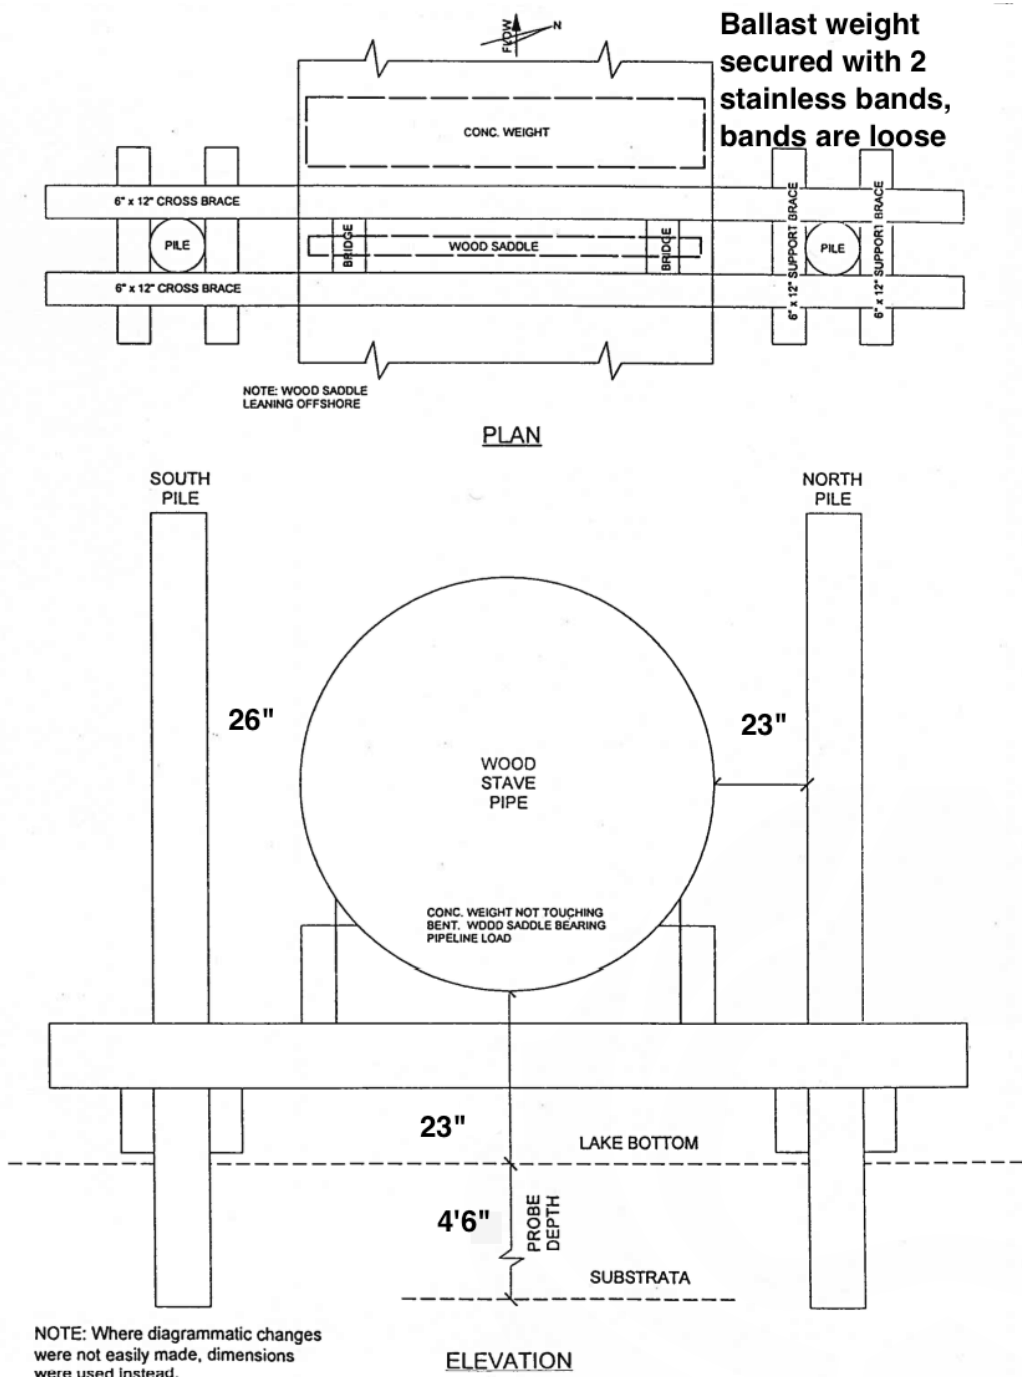
Pipe Condition Bent 25 to Bent 26					
Wood Condition	Marine Growth	Carbon Steel Component condition	Stainless Component Condition	Broken/Missing Bands Evident	Intermediate Ballast Weight Present
Very good	Light to Moderate Algae growth	Heavily Corroded	Not Corroded, Tight	3 rd carbon band offshore of bent 26 broken	Yes, 2 bands, stainless, tight
Notes: See Photo #3 for Typical condition of stainless and carbon bands. 3 rd band offshore of bent 26 broken 3.5" cable crossing inshore of bent 26

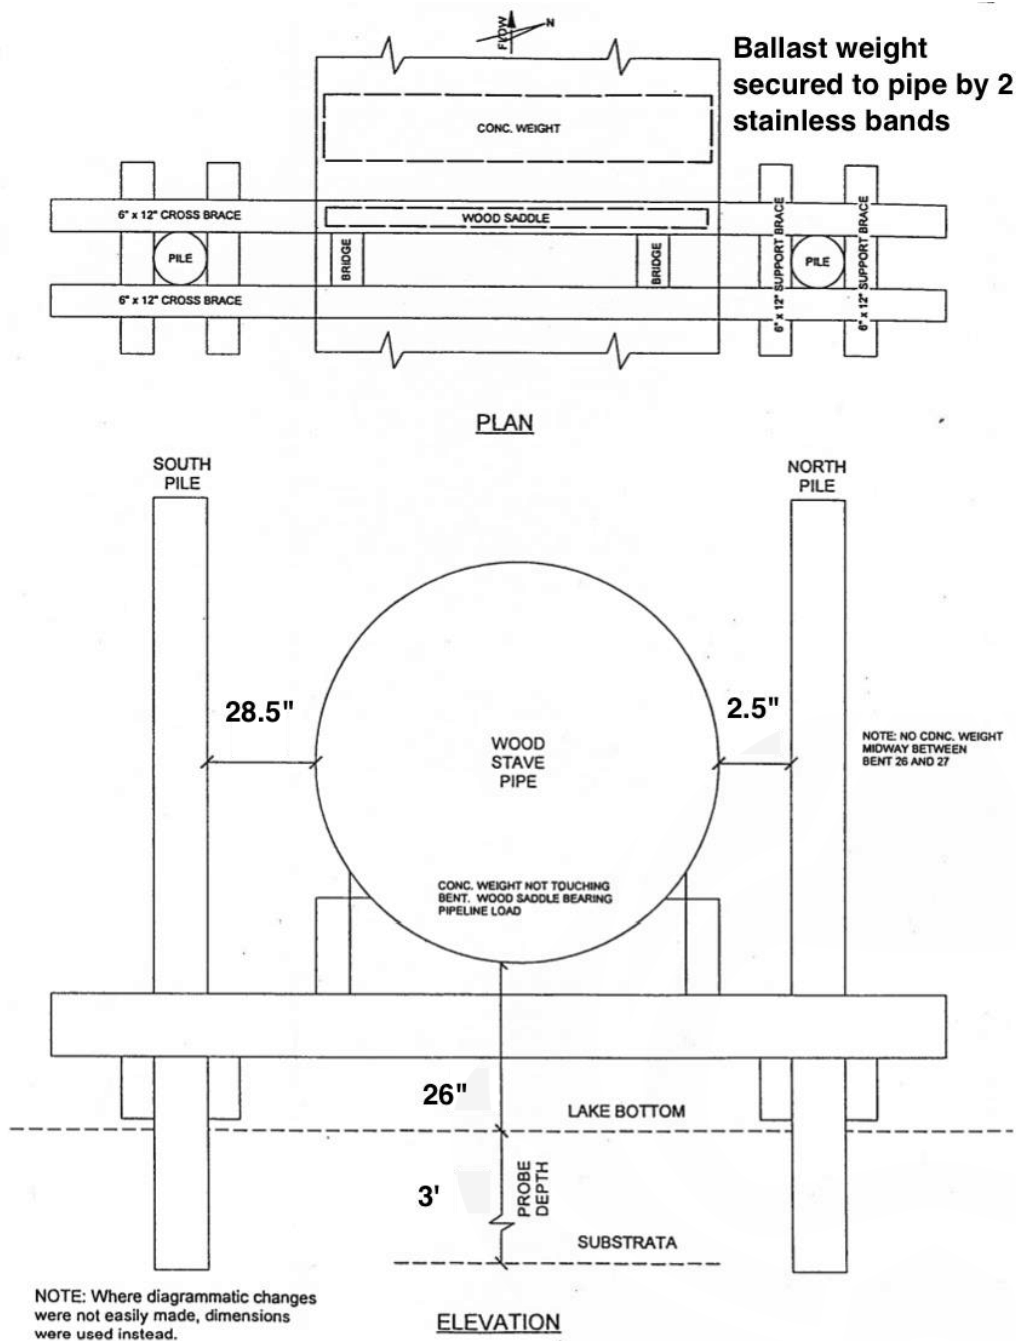
Pipe Condition Bent 26 to Bent 27					
Wood Condition	Marine Growth	Carbon Steel Component condition	Stainless Component Condition	Broken/Missing Bands Evident	Intermediate Ballast Weight Present
Very good	Light to Moderate Algae growth	Heavily Corroded	Not Corroded, Tight	None seen	Yes, 2 bands, stainless, tight
Notes: See Photo #3 for Typical condition of stainless and carbon bands. 3.5" Cable crossing sitting on chaffing guard just offshore of pile bent 27. See Photo# 17 Articulated concrete ballast mat laying over top of intake pipe at bent 27. See Photo #18

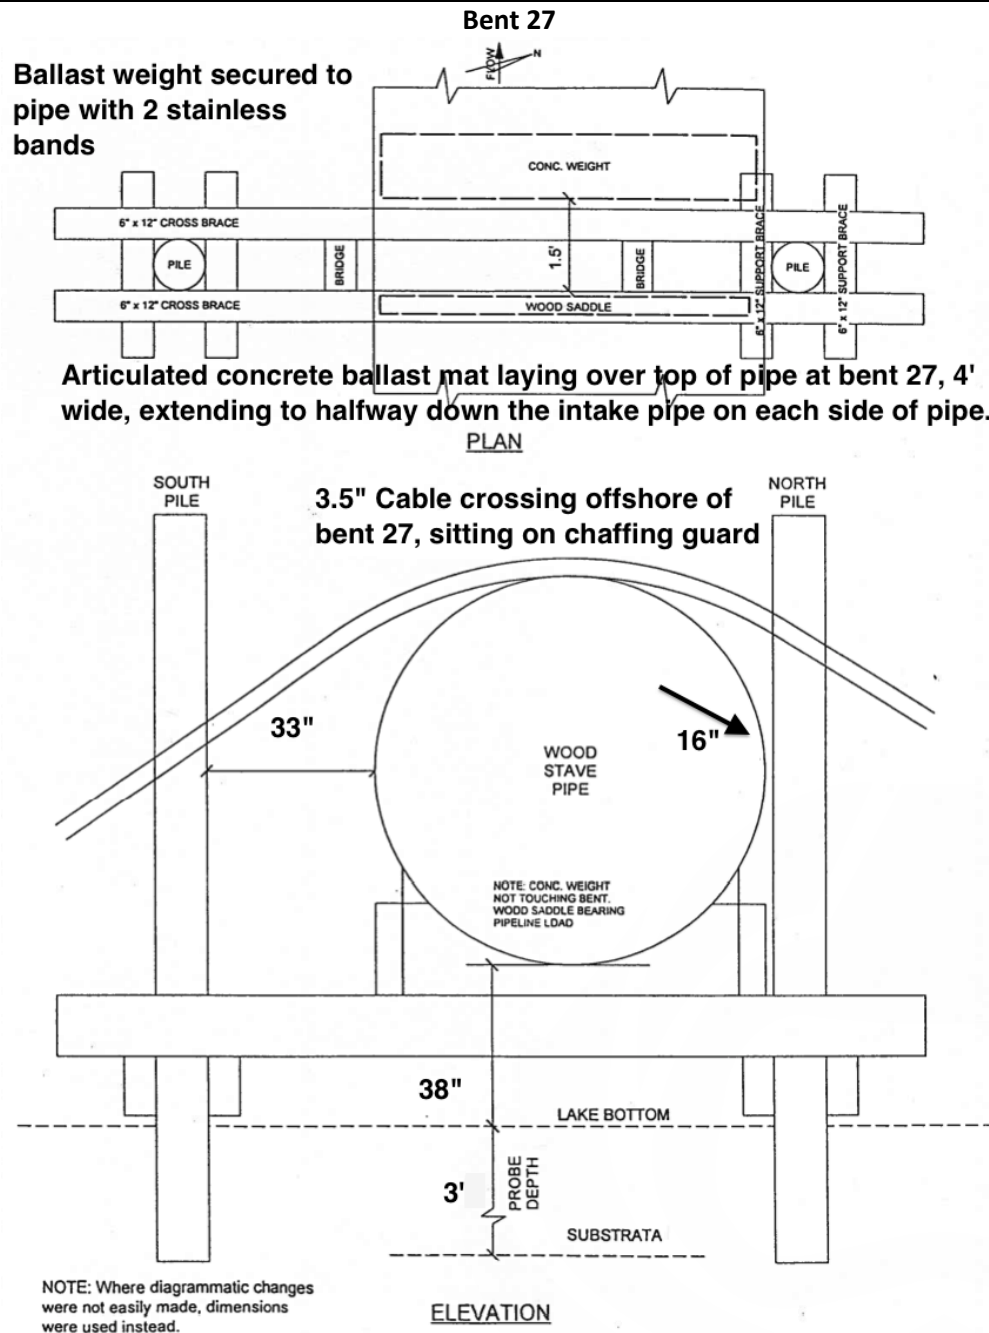
Pipe Condition Bent 27 to Bent 28

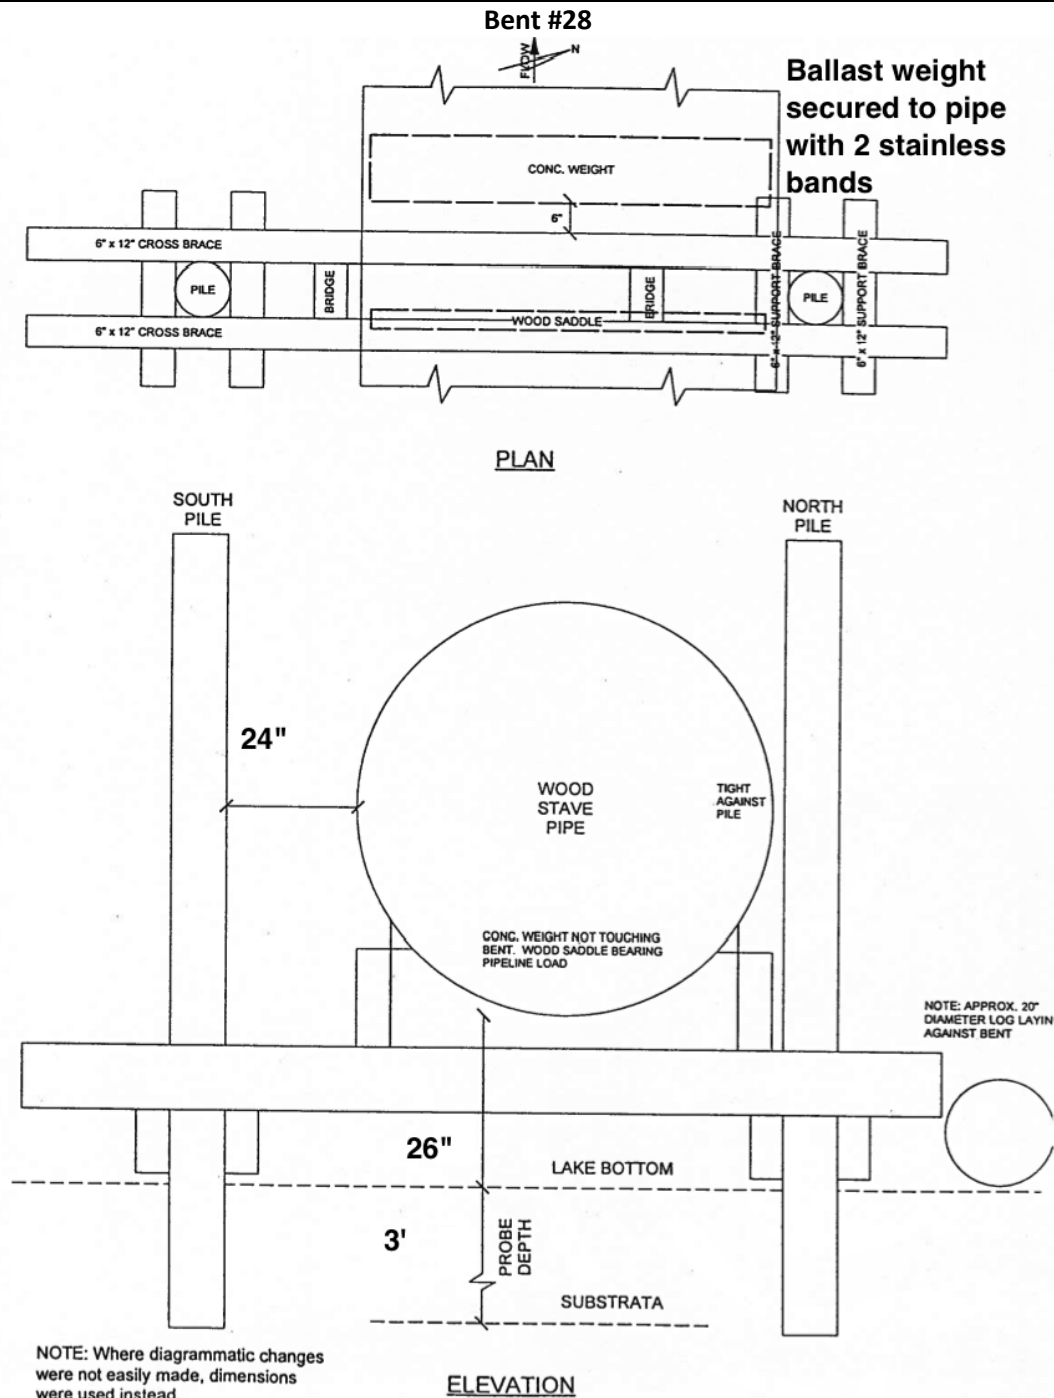
Pipe Condition Bent 28 to Bent 29					
Wood Condition	Marine Growth	Carbon Steel Component condition	Stainless Component Condition	Broken/Missing Bands Evident	Intermediate Ballast Weight Present
Very good	Light to Moderate Algae growth	Heavily Corroded	Not Corroded, Tight	None seen	Yes, Stainless bands not corroded, tight
Notes: Articulated concrete ballast weight laying over top of pipe 4' inshore of bent 28, 4' wide, typical of previous concrete mat noted at bent 27. See Photo #3 for Typical condition of stainless and carbon bands.

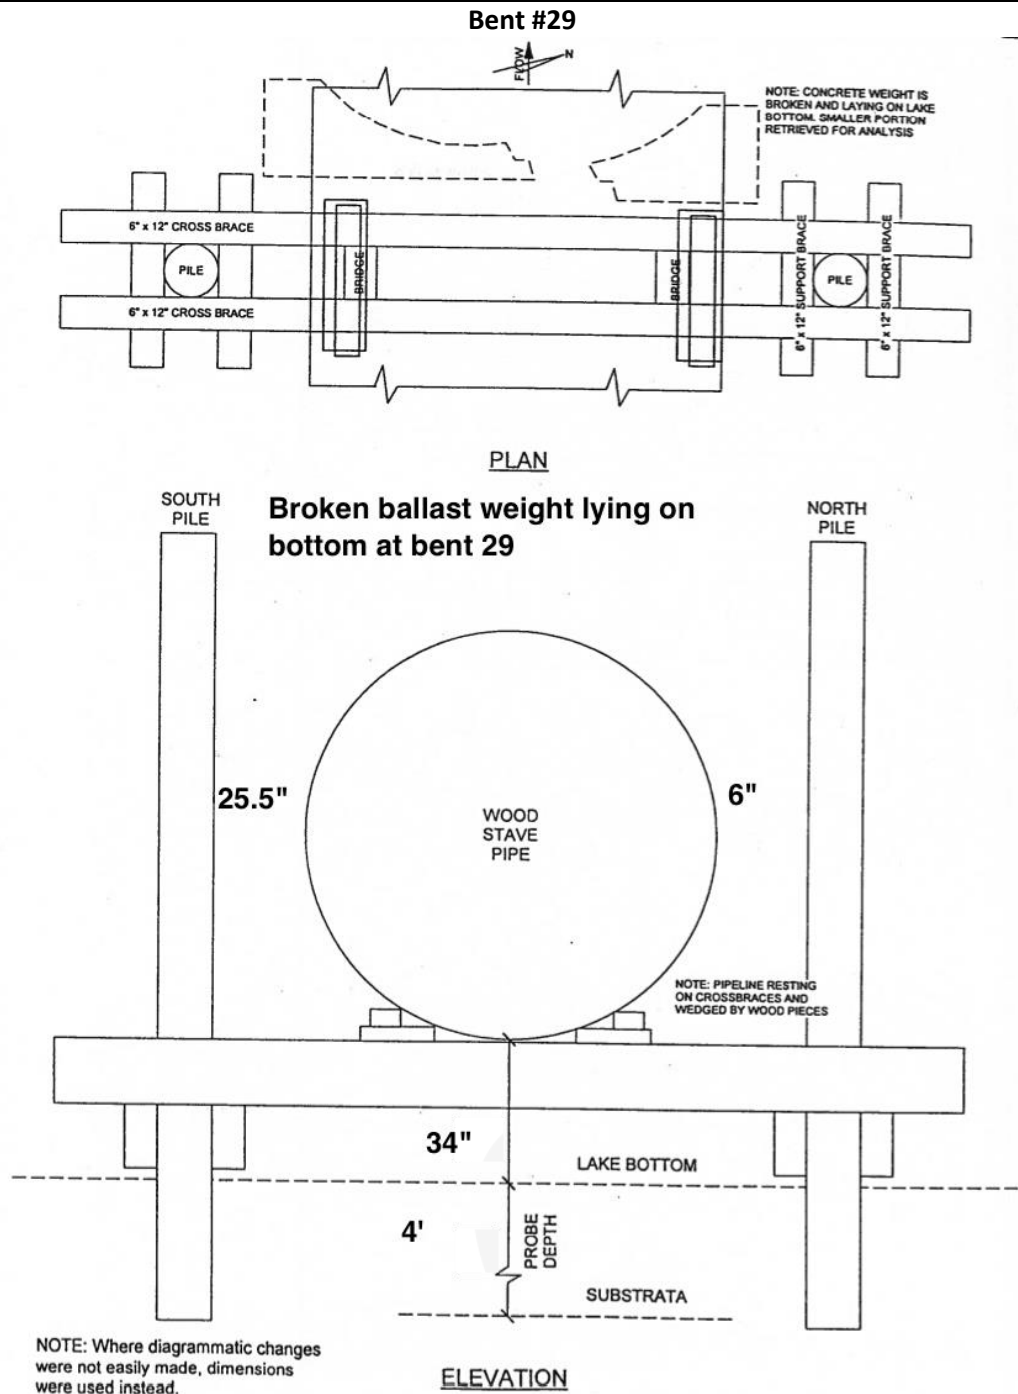
Pipe Condition Bent 29 to Bent 30					
Wood Condition	Marine Growth	Carbon Steel Component condition	Stainless Component Condition	Broken/Missing Bands Evident	Intermediate Ballast Weight Present
Very good	Light to Moderate Algae growth	Heavily Corroded	Not Corroded, Tight	None seen	Yes, Stainless bands not corroded, tight
Notes: Previous cores taken at bent 30 and plugged, plugs typical of those noted at bent 20 and pictured in photo #9. See Photo #3 for Typical condition of stainless and carbon bands.

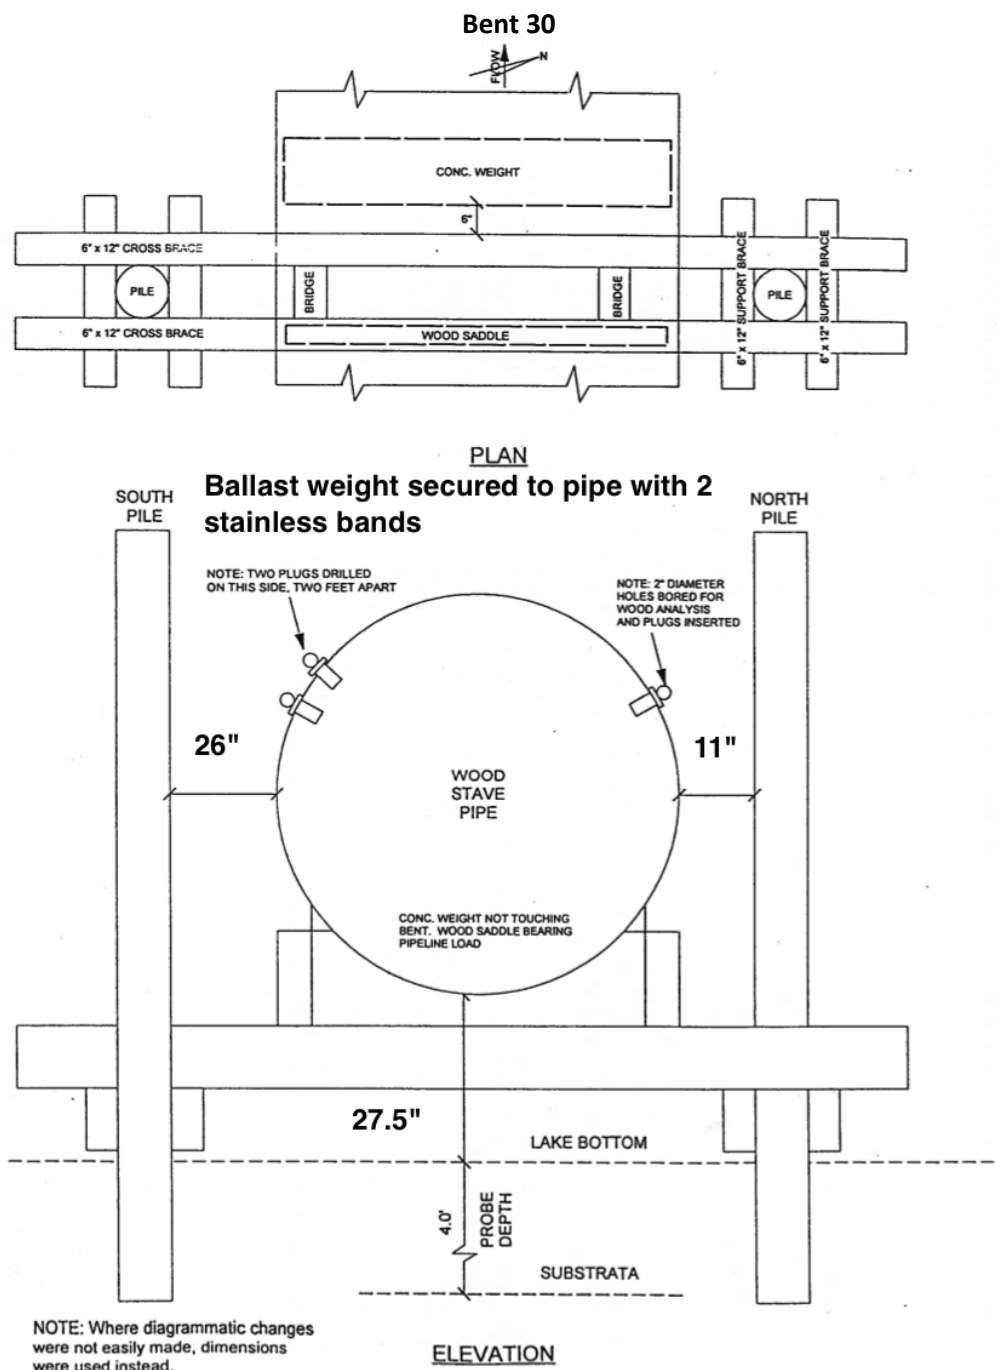
Pipe Condition Bent 30 to Bent 31					
Wood Condition	Marine Growth	Carbon Steel Component condition	Stainless Component Condition	Broken/Missing Bands Evident	Intermediate Ballast Weight Present
Very good	Light to Moderate Algae growth	Heavily Corroded	Not Corroded, Tight	None seen	Yes, Stainless bands not corroded, tight
Notes: See Photo #3 for Typical condition of stainless and carbon bands.

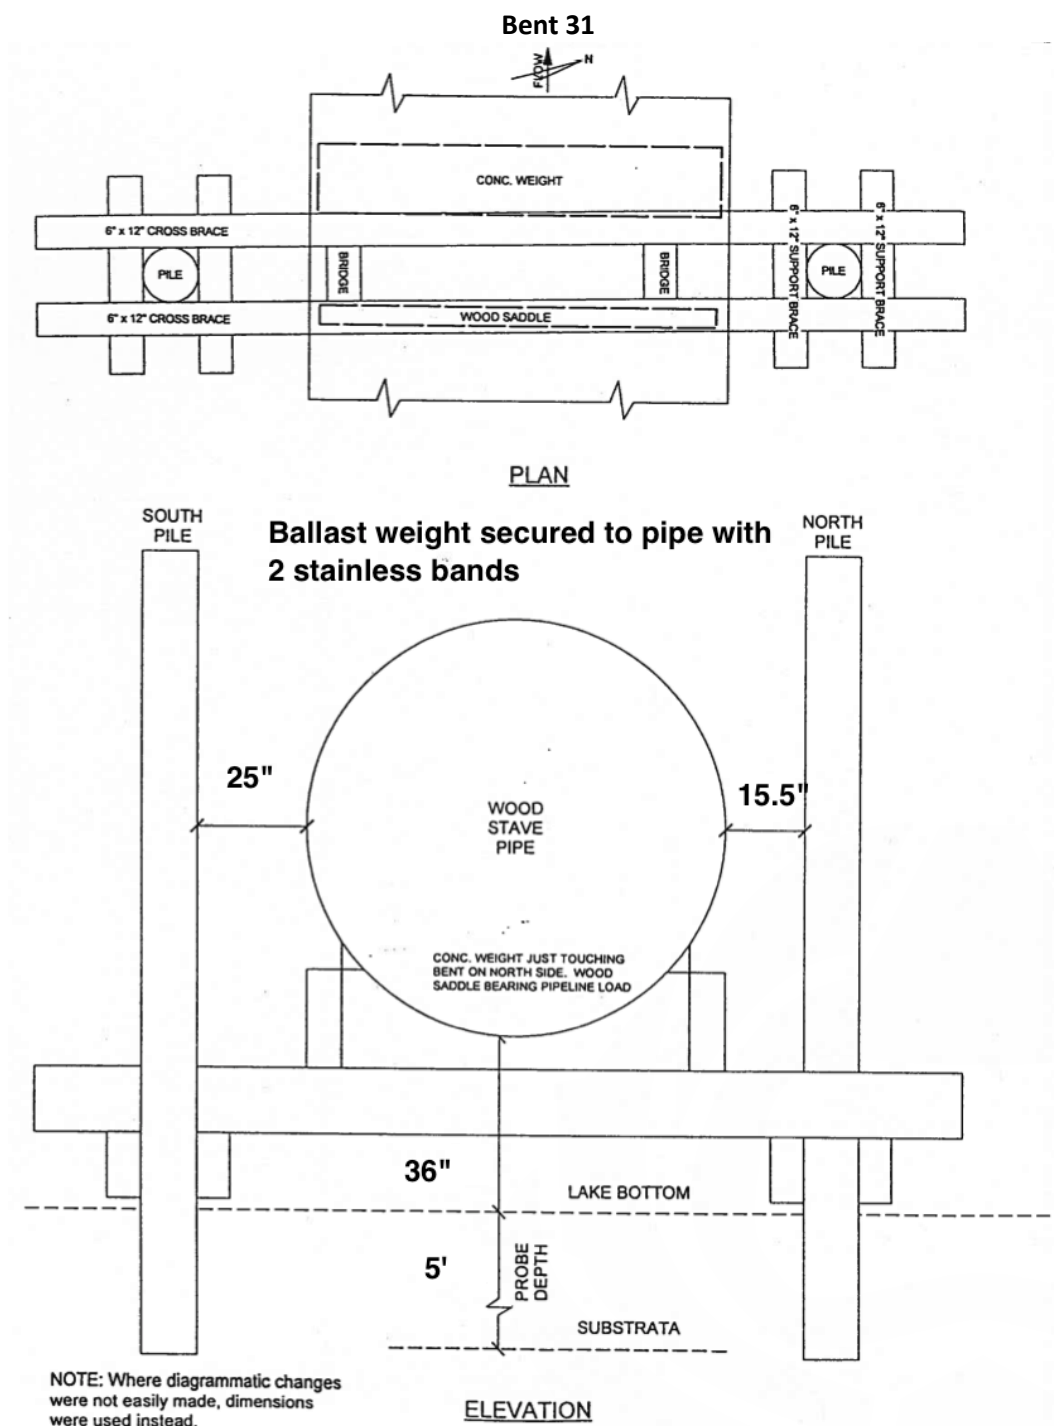
Pipe Condition Bent 31 to Bent 32					
Wood Condition	Marine Growth	Carbon Steel Component condition	Stainless Component Condition	Broken/Missing Bands Evident	Intermediate Ballast Weight Present
Very good	Light to Moderate Algae growth	Heavily Corroded	Not Corroded, Tight	None seen	Yes, Stainless bands not corroded, tight
Notes: See Photo #3 for Typical condition of stainless and carbon bands.

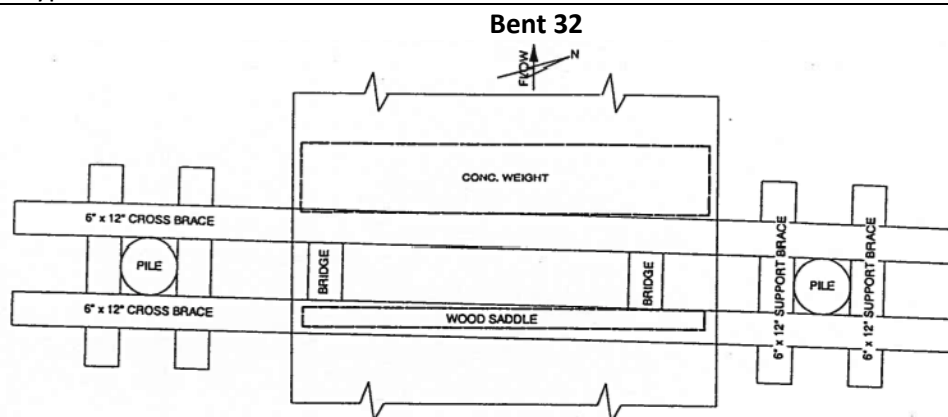
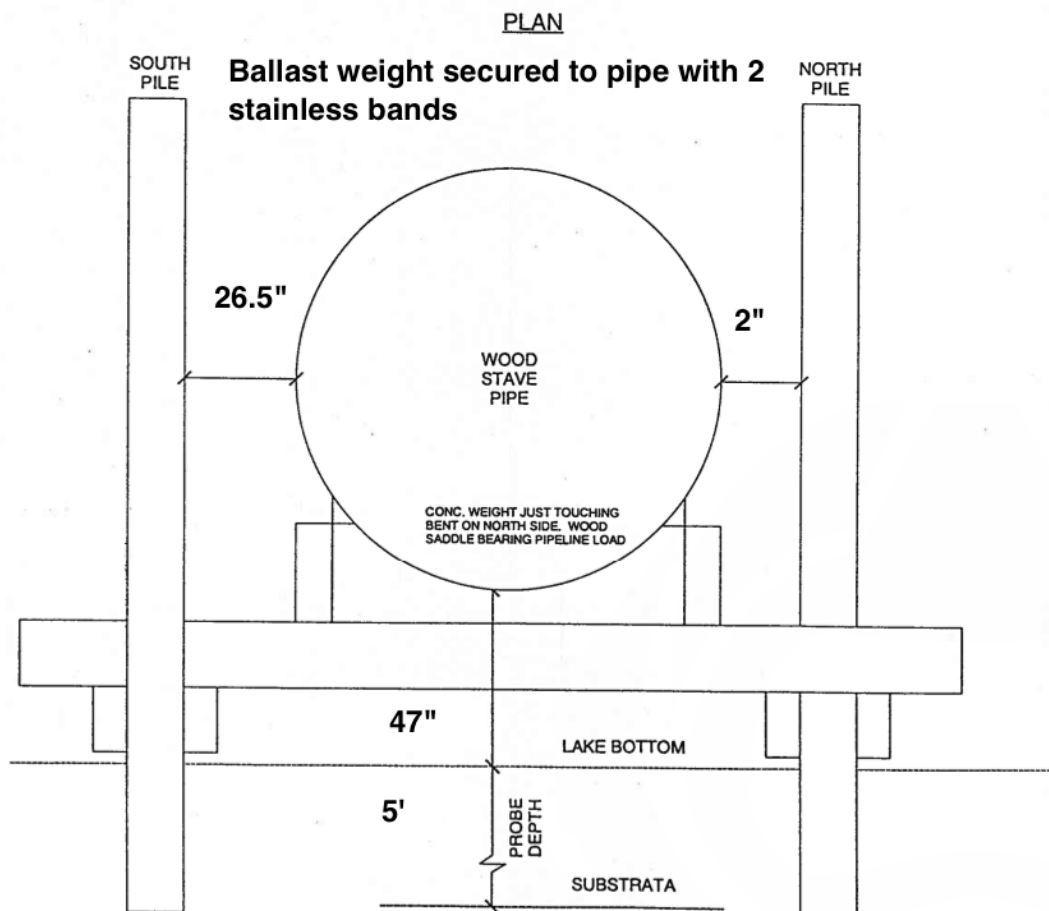
NOTE: Where diagrammatic changes were not easily made, dimensions were used instead.

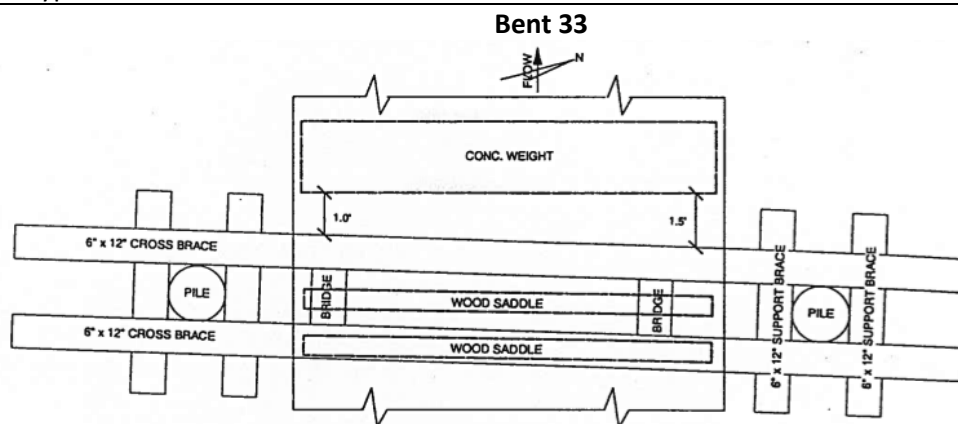
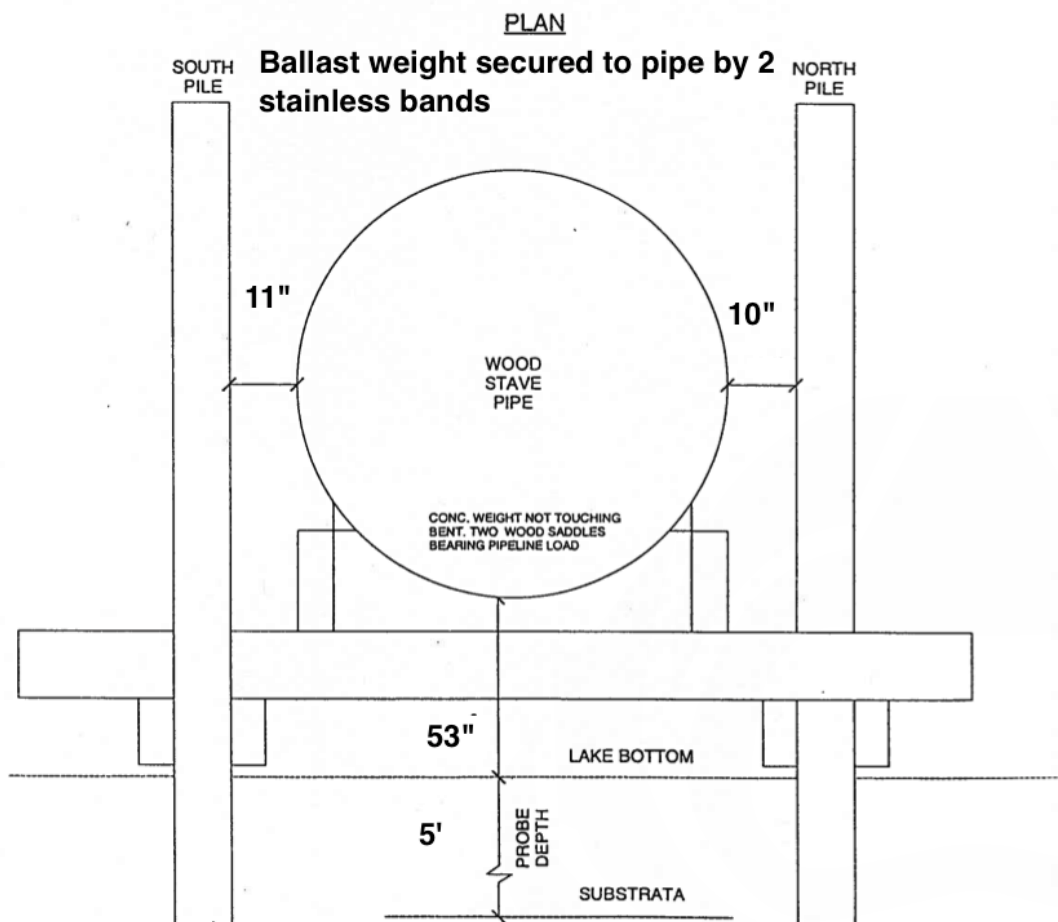
NOTE: Where diagrammatic changes were not easily made, dimensions were used instead.

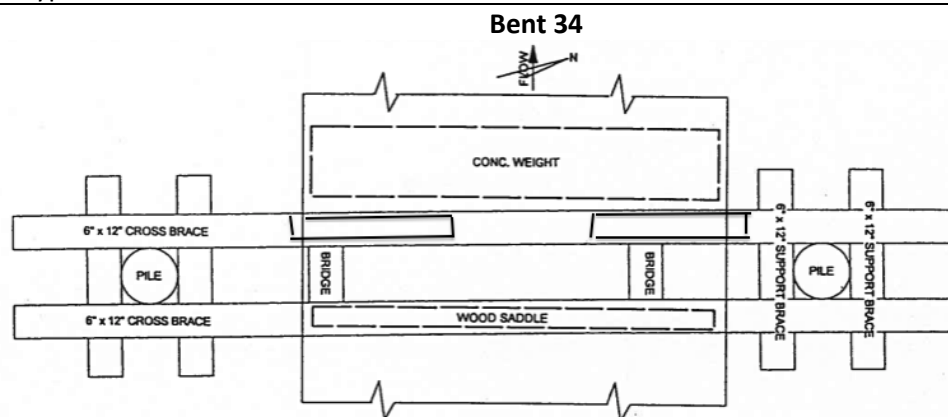
Pipe Condition Bent 33 to Bent 34					
Wood Condition	Marine Growth	Carbon Steel Component condition	Stainless Component Condition	Broken/Missing Bands Evident	Intermediate Ballast Weight Present
Very good	Light to Moderate Algae growth	Heavily Corroded	Not Corroded, Tight	None seen	Yes, Stainless bands not corroded, tight
Notes:					
See Photo #3 for Typical condition of stainless and carbon bands.

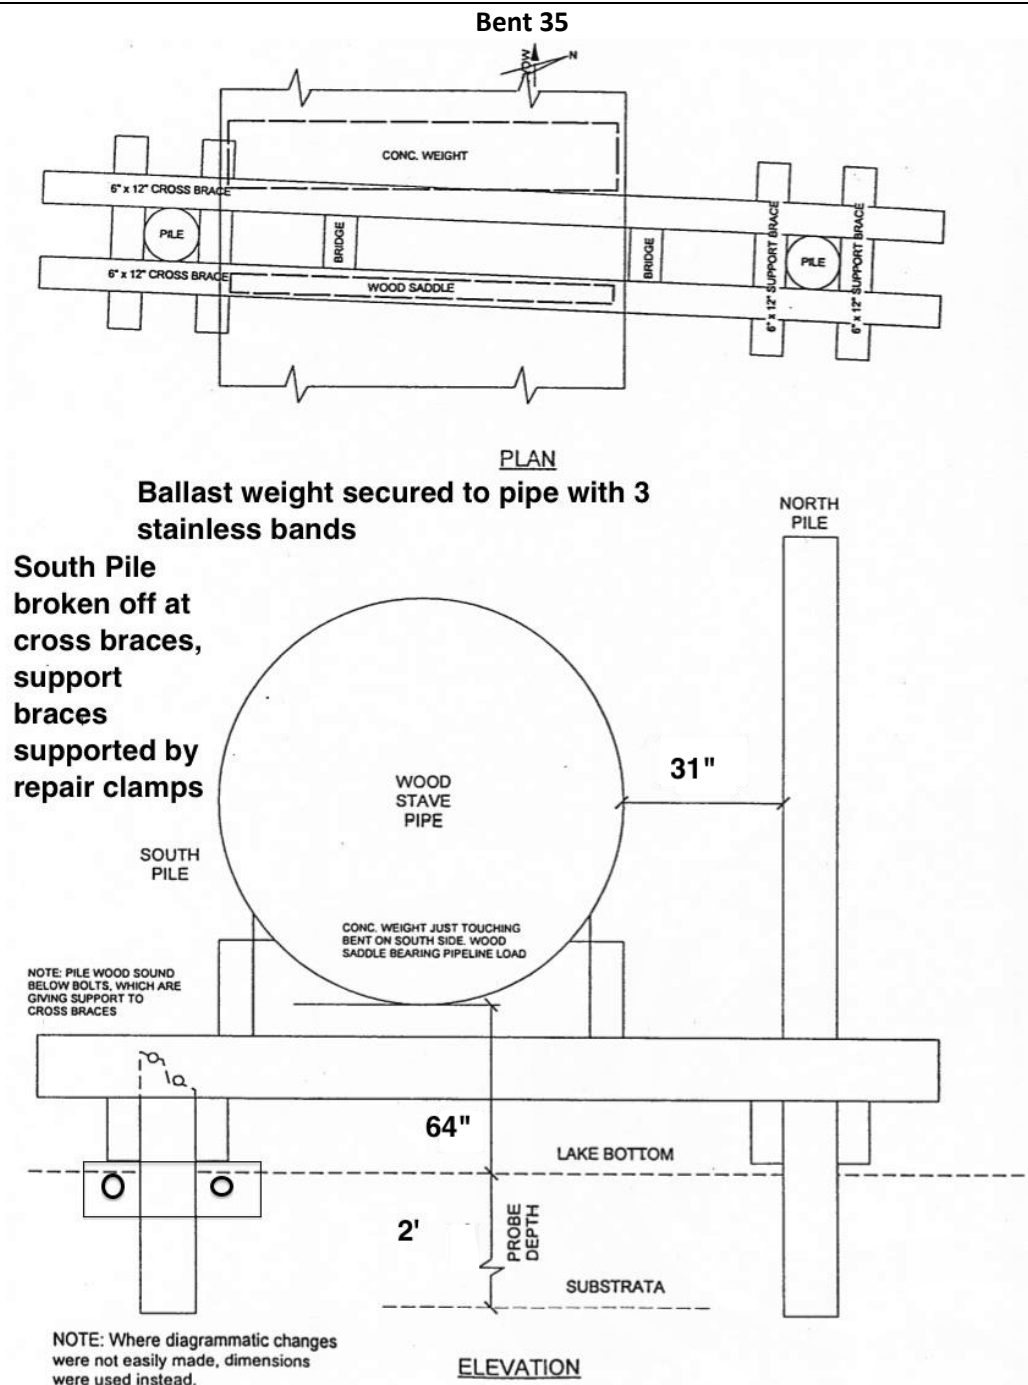
Pipe Condition Bent 35 to Bent 36					
Wood Condition	Marine Growth	Carbon Steel Component condition	Stainless Component Condition	Broken/Missing Bands Evident	Intermediate Ballast Weight Present
Very good	Light to Moderate Algae growth	Heavily Corroded	Not Corroded, Tight	None seen	Yes, Stainless bands not corroded, tight
Notes: See Photo #3 for Typical condition of stainless and carbon bands.

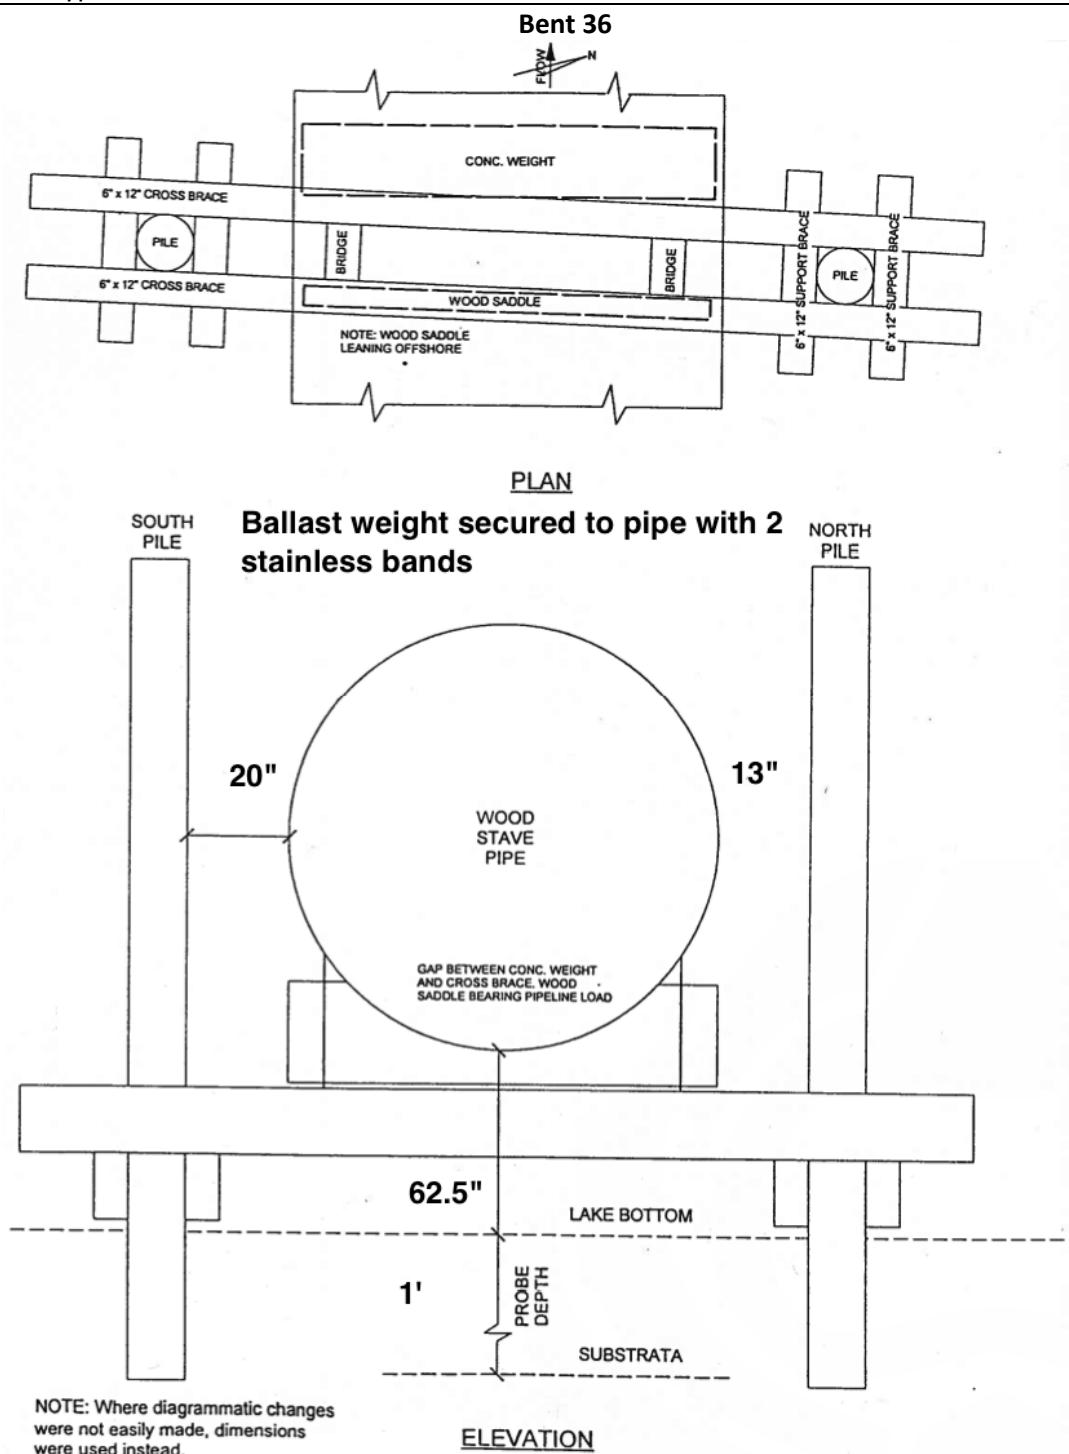
Pipe Condition Bent 36 to Bent 37					
Wood Condition	Marine Growth	Carbon Steel Component condition	Stainless Component Condition	Broken/Missing Bands Evident	Intermediate Ballast Weight Present
Very good	Light to Moderate Algae growth	Heavily Corroded	Not Corroded, Tight	None seen	Yes, Stainless bands not corroded, tight
Notes: See Photo #3 for Typical condition of stainless and carbon bands.

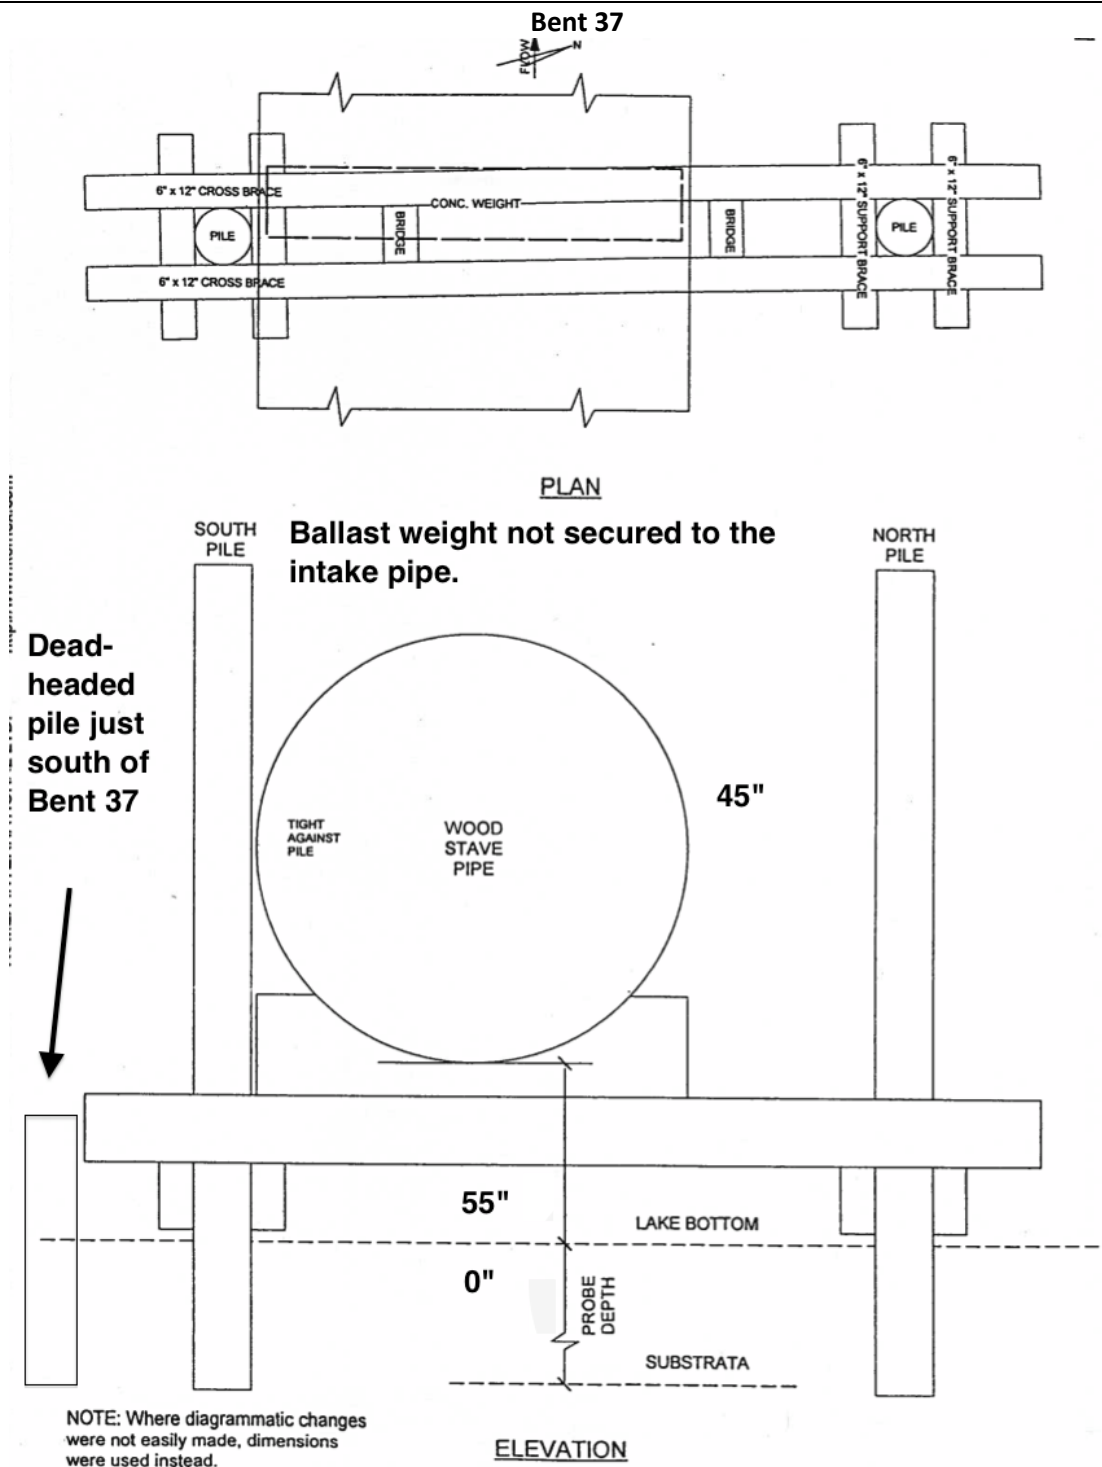
Pipe Condition Bent 37 to Bent 38					
Wood Condition	Marine Growth	Carbon Steel Component condition	Stainless Component Condition	Broken/Missing Bands Evident	Intermediate Ballast Weight Present
Very good	Light to Moderate Algae growth	Heavily Corroded	Not Corroded, Tight	None seen	Yes, Stainless bands not corroded, tight
Notes: Intermediate concrete ballast weight broken, secured together with a third stainless band running horizontally around the weight. See Photo #3 for Typical condition of stainless and carbon bands.

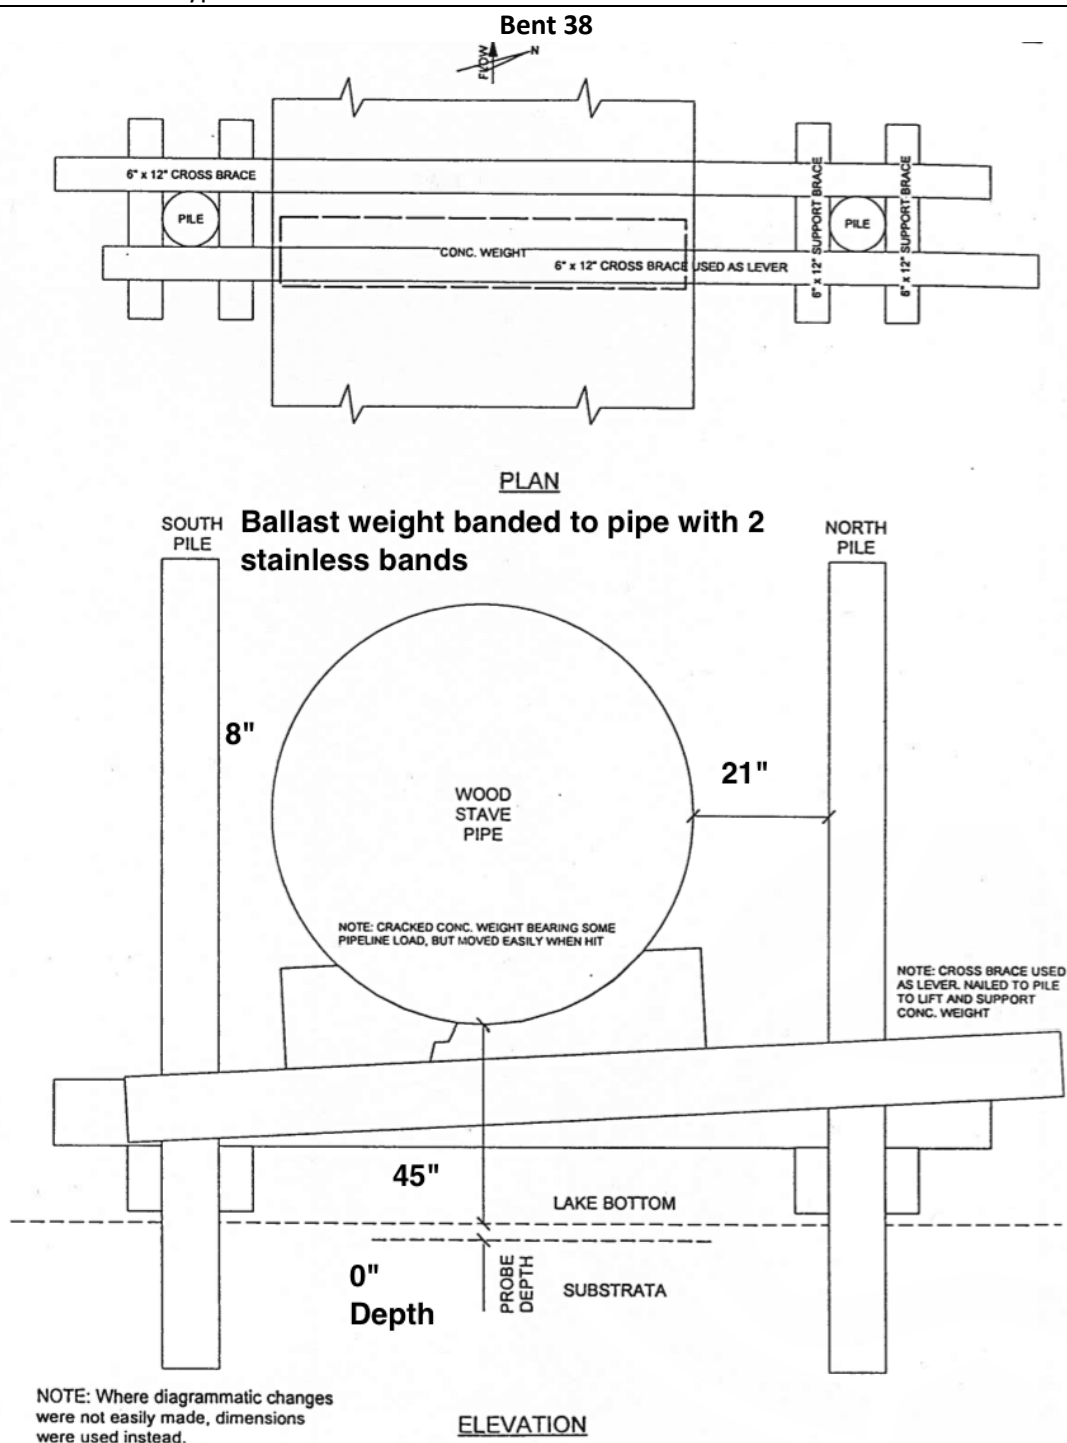
Pipe Condition Bent 38 to Bent 39					
Wood Condition	Marine Growth	Carbon Steel Component condition	Stainless Component Condition	Broken/Missing Bands Evident	Intermediate Ballast Weight Present
Very good	Light to Moderate Algae growth	Heavily Corroded	Not Corroded, Tight	5' Inshore of bent 38, carbon band missing band missing at bent 39	Yes, Stainless bands not corroded, tight
Notes: Intermediate concrete ballast weight broken, secured together with a third stainless band running horizontally around the weight. See Photo #3 for Typical condition of stainless and carbon bands.

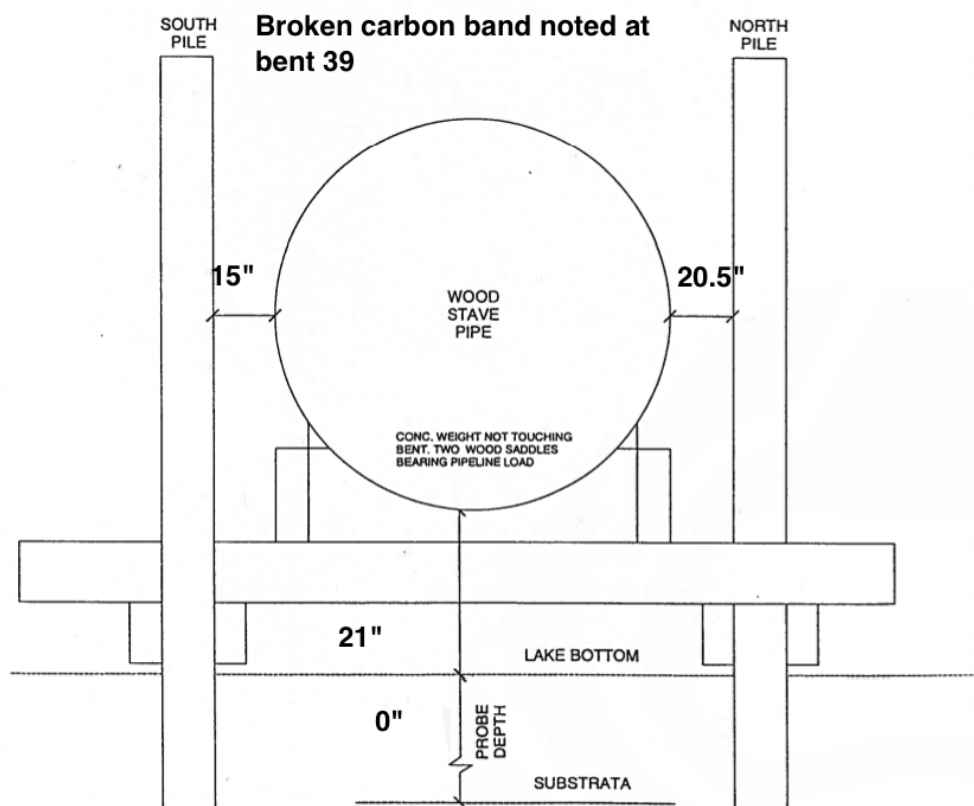
Broken carbon band noted at bent 39

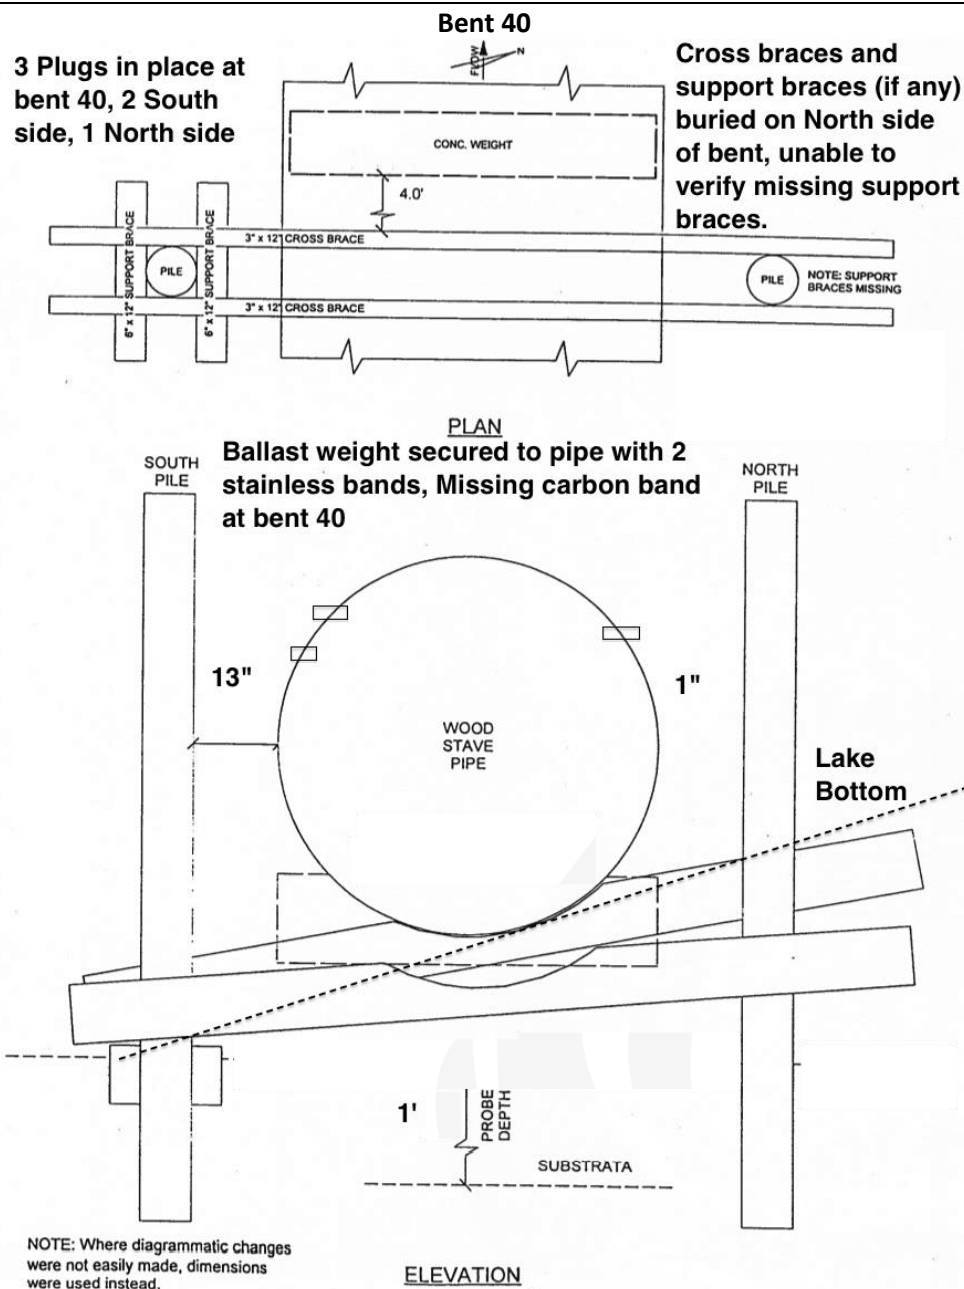
Pipe Condition Bent 39 to Bent 40					
Wood Condition	Marine Growth	Carbon Steel Component condition	Stainless Component Condition	Broken/Missing Bands Evident	Intermediate Ballast Weight Present
Very good	Light to Moderate Algae growth	Heavily Corroded	Not Corroded, Tight	Band broken at bent 39, band broken 5' inshore of bent 39 missing band at bent 40	Yes, 5 each Stainless bands not corroded, tight
Notes: Pipe span between bent 39 and 40 is longer than previously 20' spaced bents. There are 5 intermediate ballast weights between bent 39 and 40, spaced approximately 10' apart. See Photo #3 for Typical condition of stainless and carbon bands. 3 Mechanical plugs from previous cores at bent 40. 2 on South side, 1 on North side.
