City of Bellingham Wood-Stave Intake Pipeline: Condition Assessment (Task 2.1.5)

PREPARED FOR: City of Bellingham Project Team
PREPARED BY: CH2M HILL Project Team
DATE: November 7, 2014

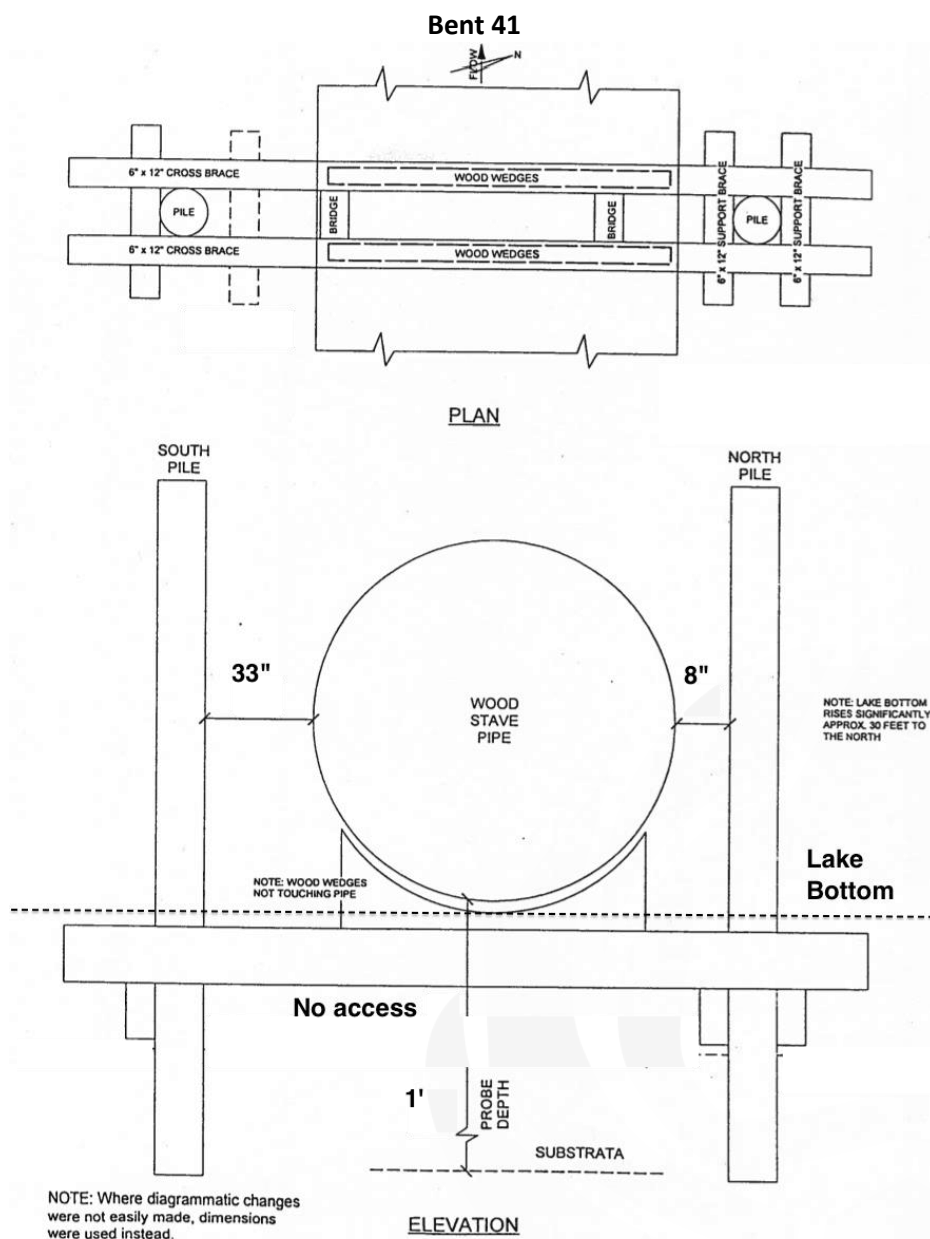
Pipe Condition Bent 41 to Bent 42					
Wood Condition	Marine Growth	Carbon Steel Component condition	Stainless Component Condition	Broken/Missing Bands Evident	Intermediate Ballast Weight Present
Very good	Light to Moderate Algae growth	Heavily Corroded	Not Corroded, Tight	Broken Band at bent 41, carbon	Yes, Stainless bands not corroded, tight
Notes: Cross braces on bent 42 are bolted to piles, no support braces evident. See Photo #3 for Typical condition of stainless and carbon bands

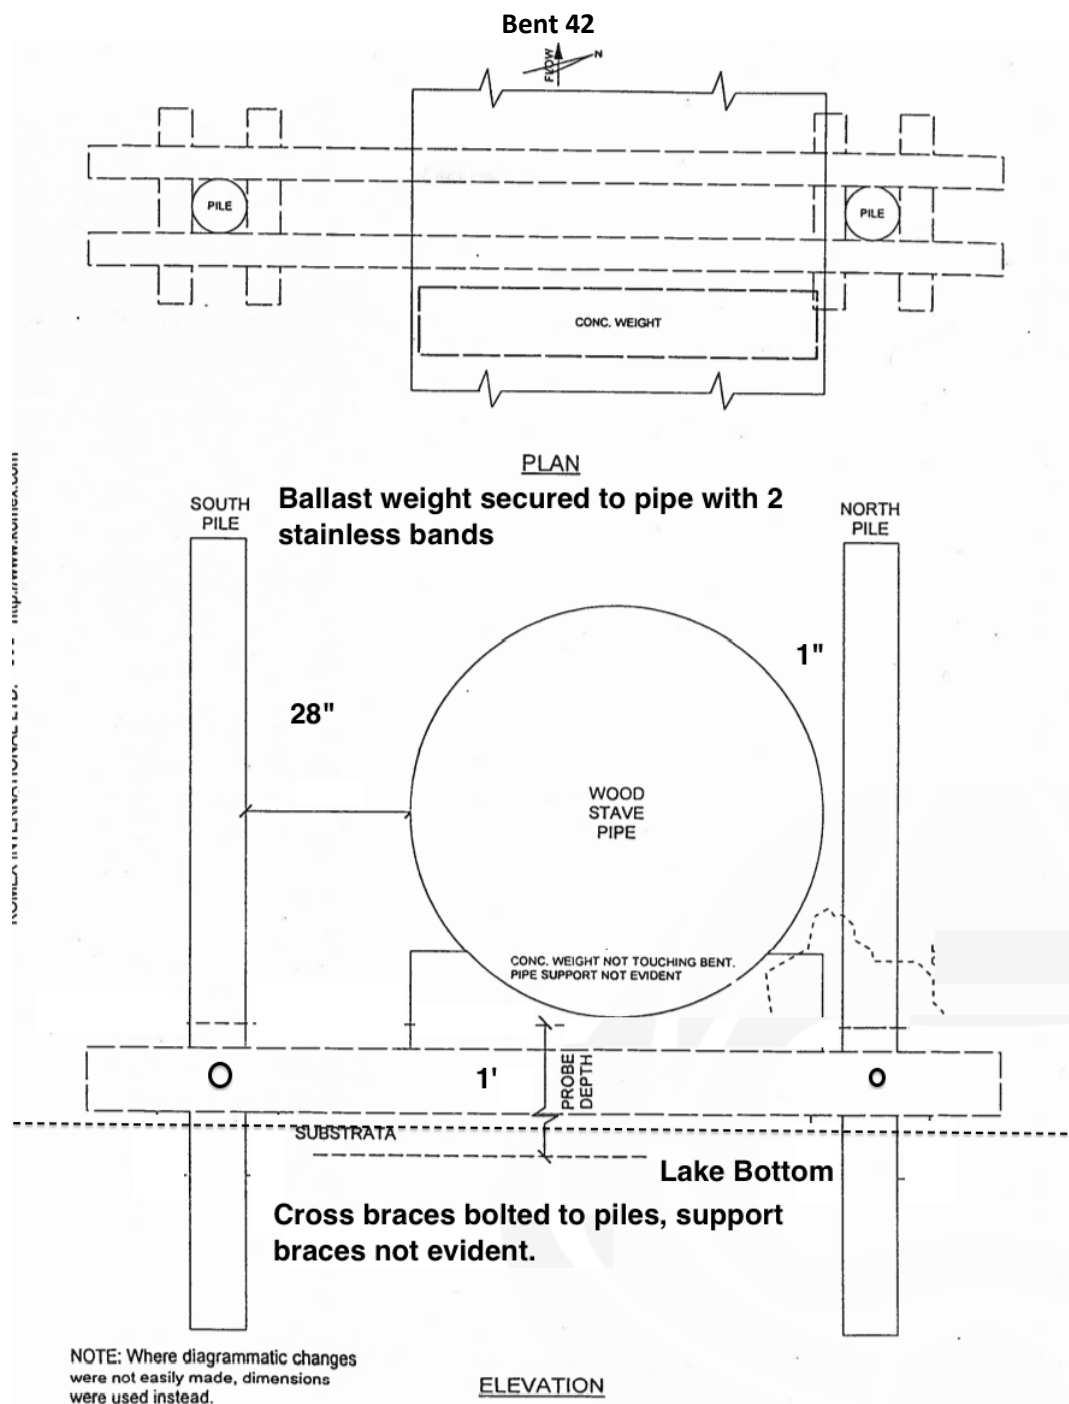
Pipe Condition Bent 42 to Bent 43					
Wood Condition	Marine Growth	Carbon Steel Component condition	Stainless Component Condition	Broken/Missing Bands Evident	Intermediate Ballast Weight Present
Very good	Light to Moderate Algae growth	Heavily Corroded	Not Corroded, Tight	None seen	2 Articulated concrete mats
Notes: Concrete ballast mat 4' inshore of bent 42, 4' wide, 4' past 1 st mat, there is a second concrete mat 4' wide. Concrete mats are typical of the articulated concrete mats seen previously and pictured in photo 18 See Photo #3 for Typical condition of stainless and carbon bands

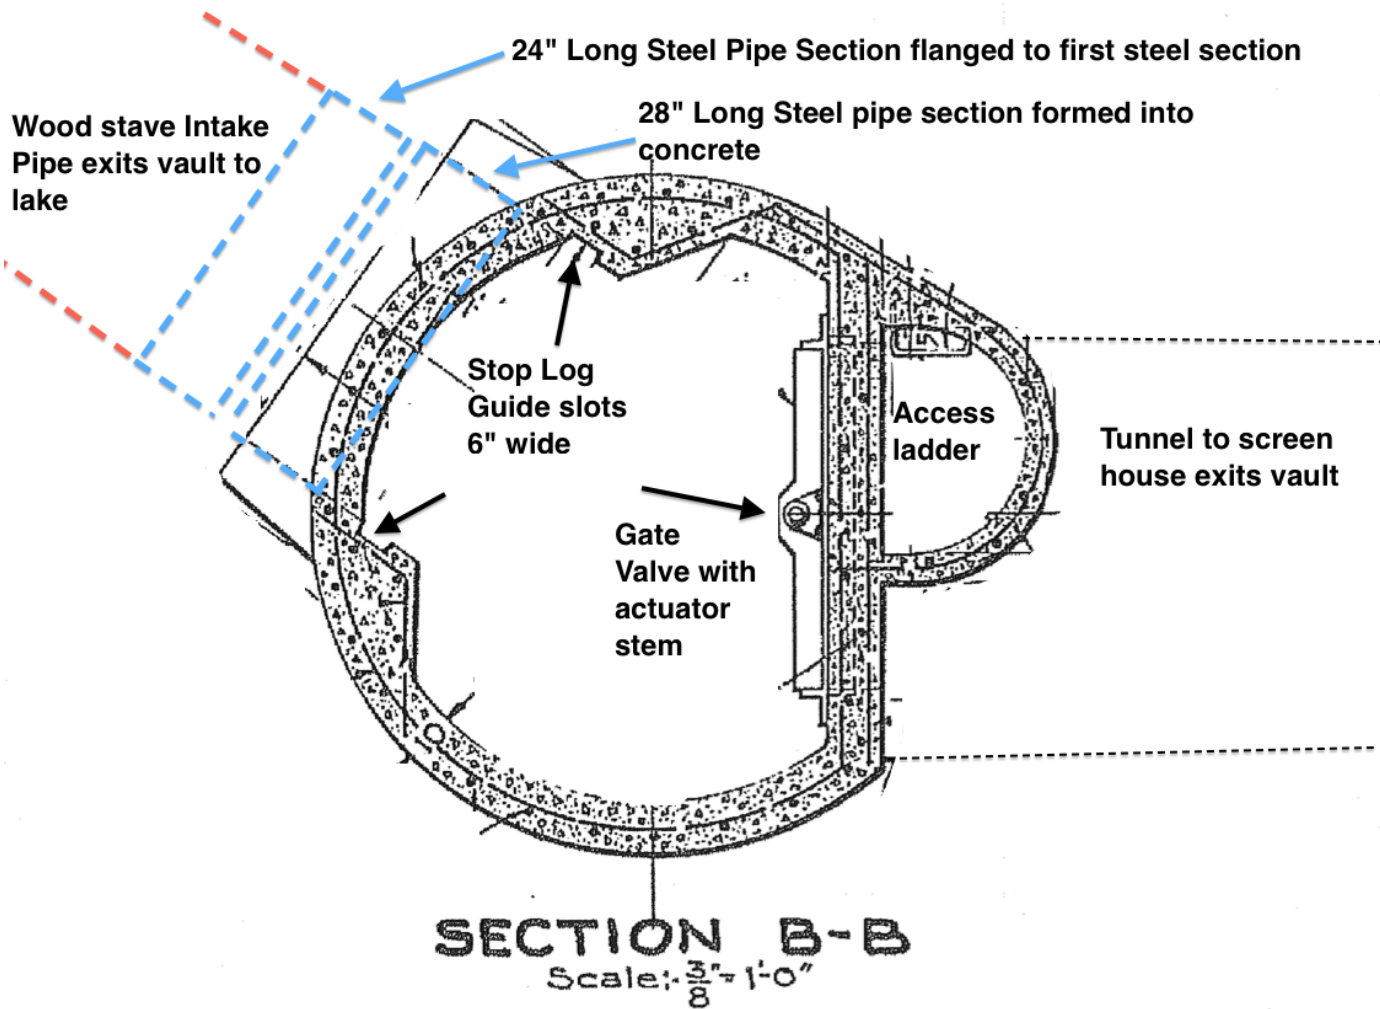
Access ladder condition:

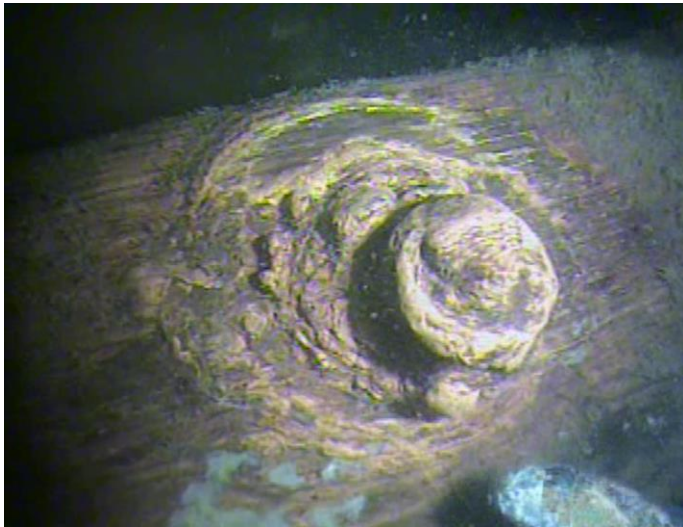
Photo #1: Typical Condition of Hardware of Intake Crib

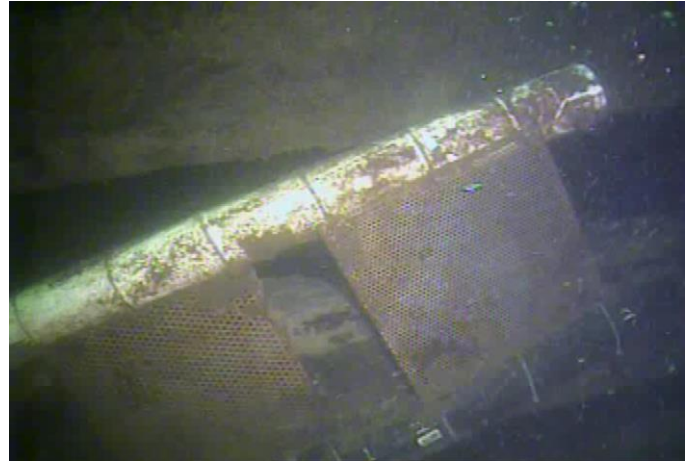
Photo #2: PVC and Steel Screen 3'x9" bolted to Crib

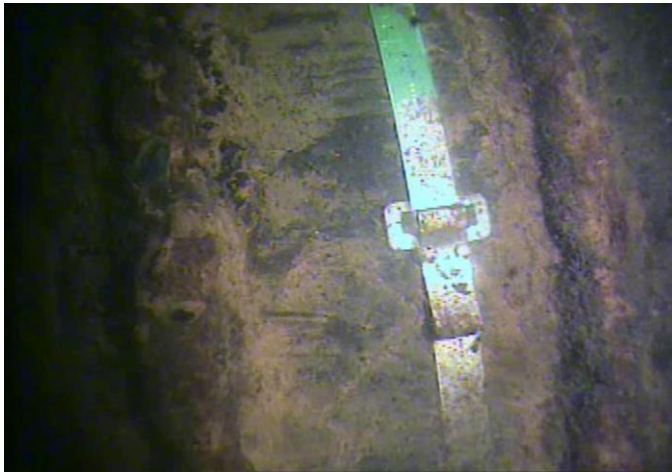
Photo #3: Typical Condition of Stainless and Carbon bands

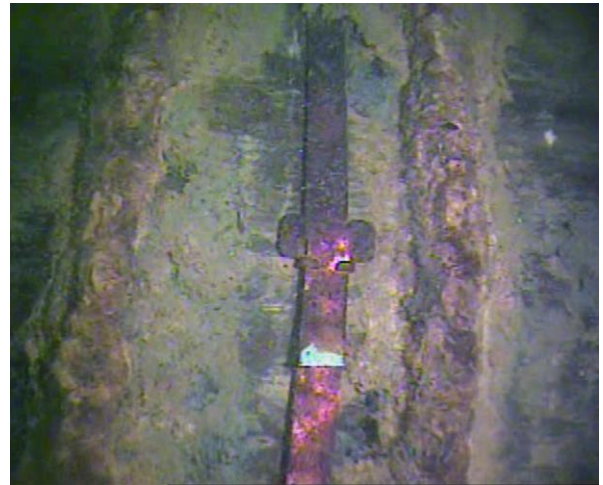
Photo #4: Corroded and Loose Stainless band between intake crib and bent #1

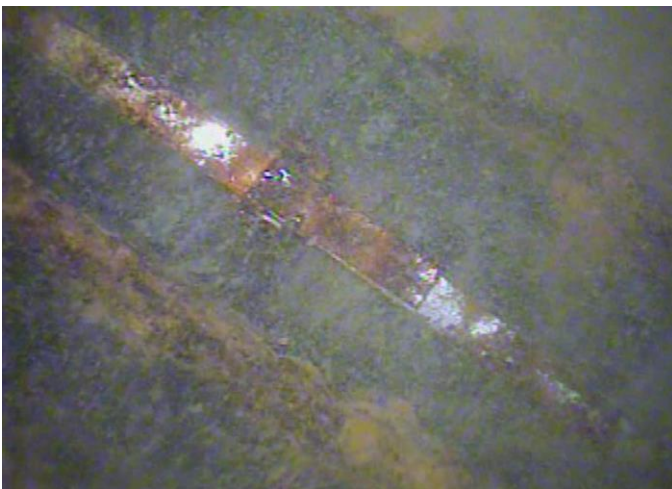
Photo #5: Corroded Stainless band at Bent 11

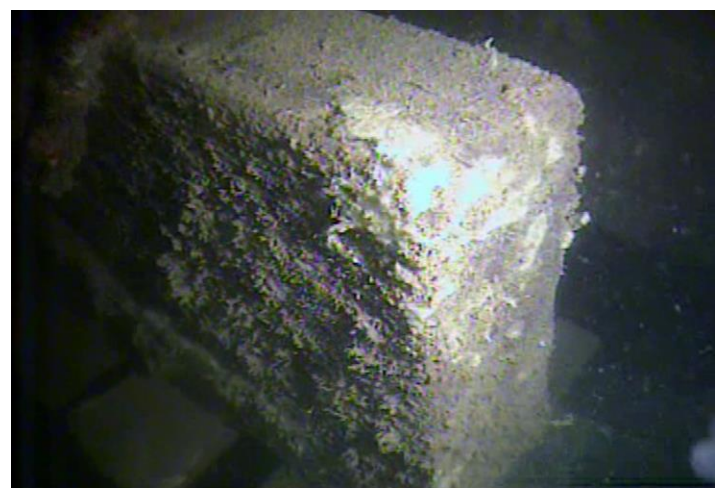
Photo #6: Wood Saddle Support at bent 15

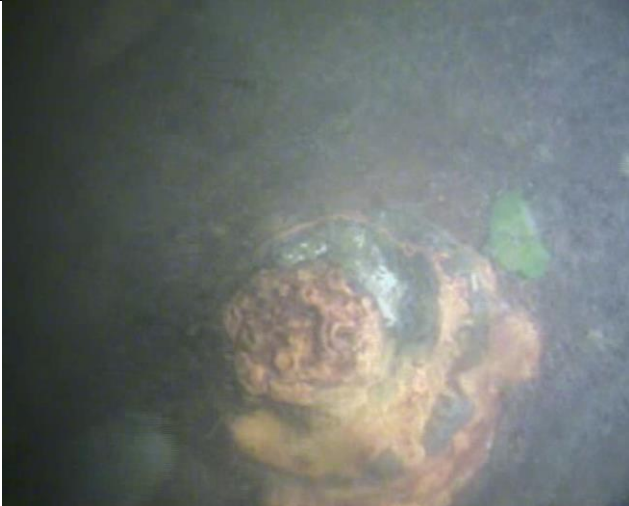
Photo #7: Newer Hardware at replaced pile at Bent 18

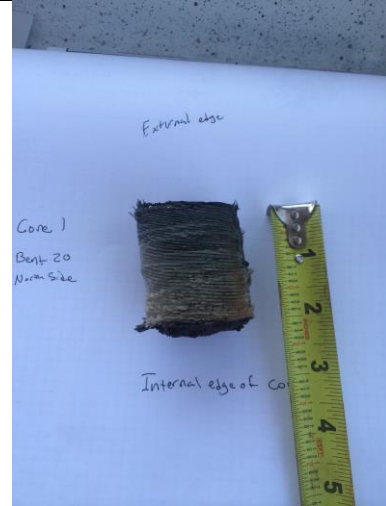
Photo #8: Core Sample from North side of pipe, bent 20

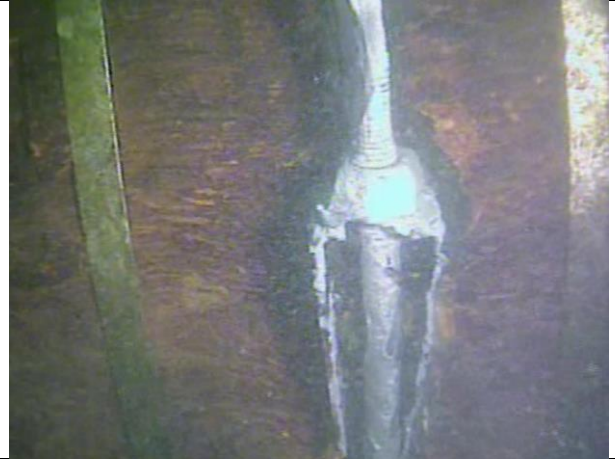
Photo #14: Carbon steel hardware with scale removed showing severe deterioration of fastener

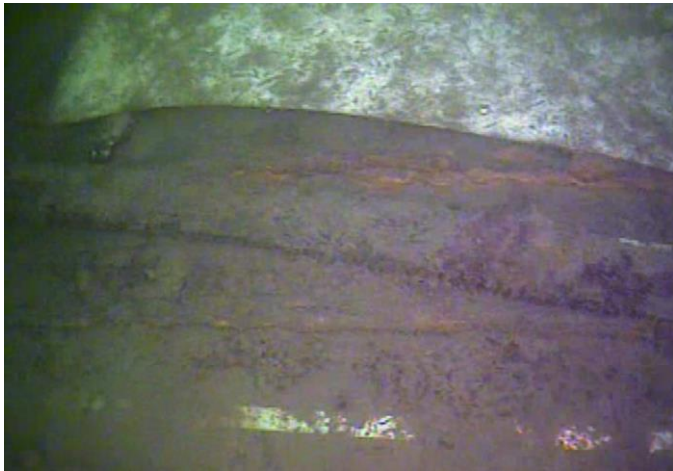
Photo #15: Cable crossing at bent 23 off of pad

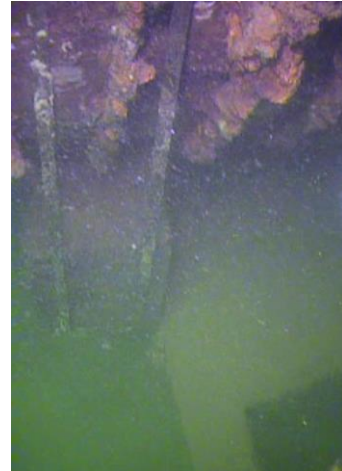
Photo #16: Typical stainless banded concrete ballast weight at bent

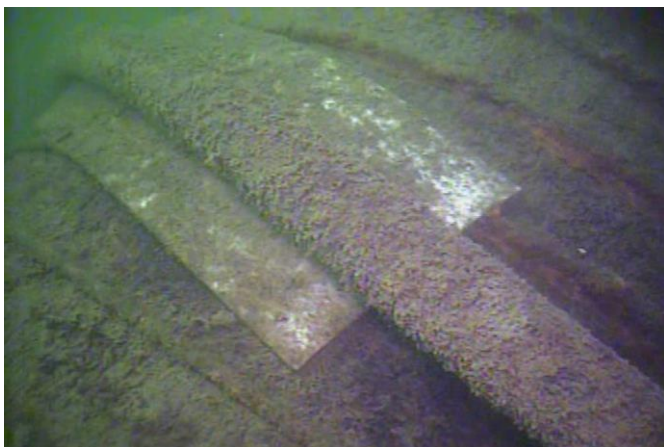
Photo #17: 3.5" Cable crossing offshore of bent 27

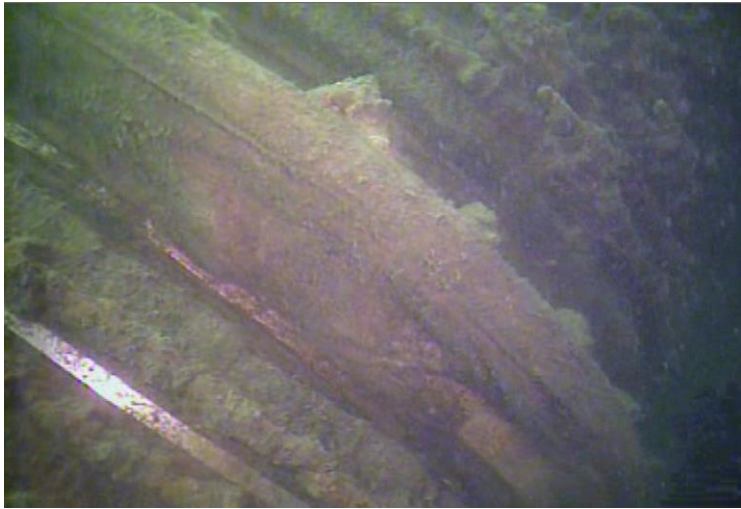
Photo #19: Flange between bents 27 and 28 covered in Denso wax tape secured by stainless bands

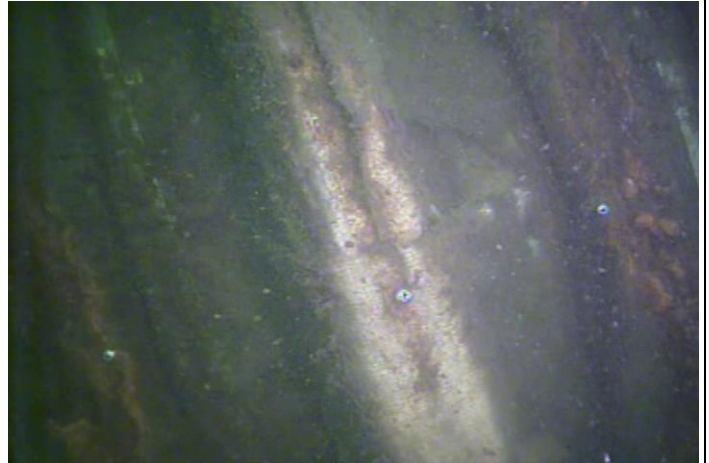
Photo #20: Top View of Flange between 27-28, alignment screws visible at 12 o'clock position in line.

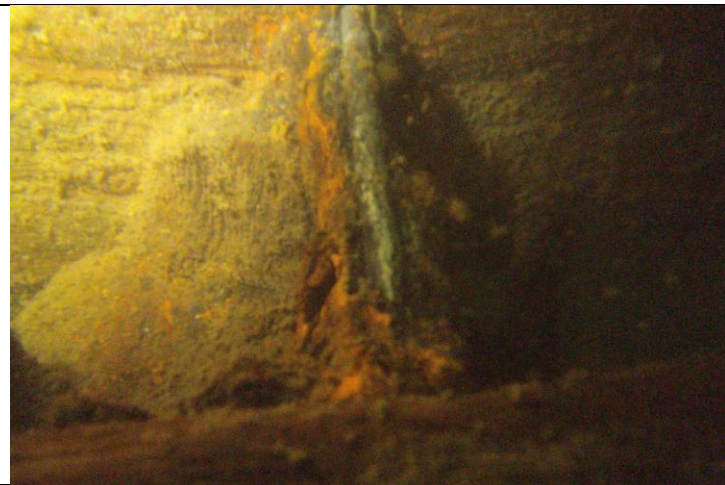
Photo #21: Through pile hardware exposed at broken pile #35

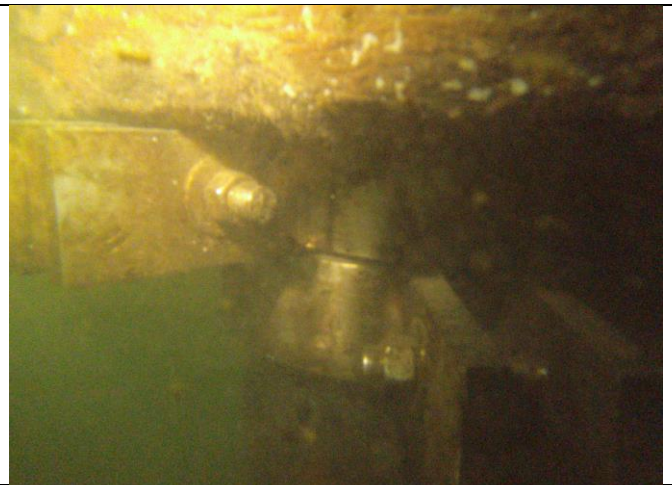
Photo #22: Repair Clamps at South Pile Bent 35 beneath support braces

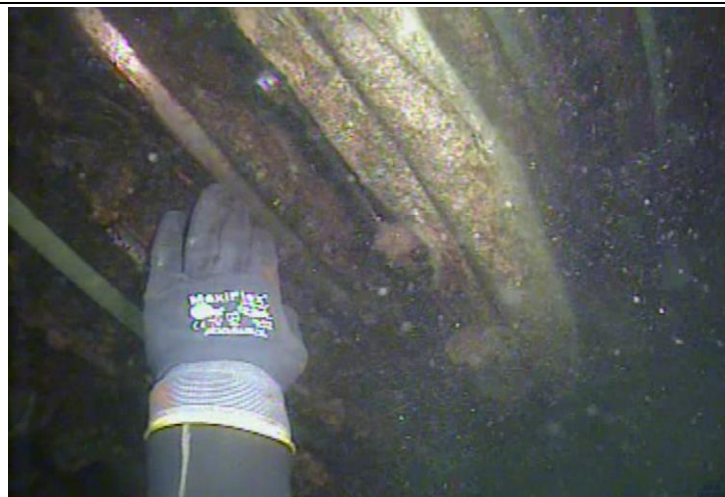
Photo #23: Flange between bent 40 and 41

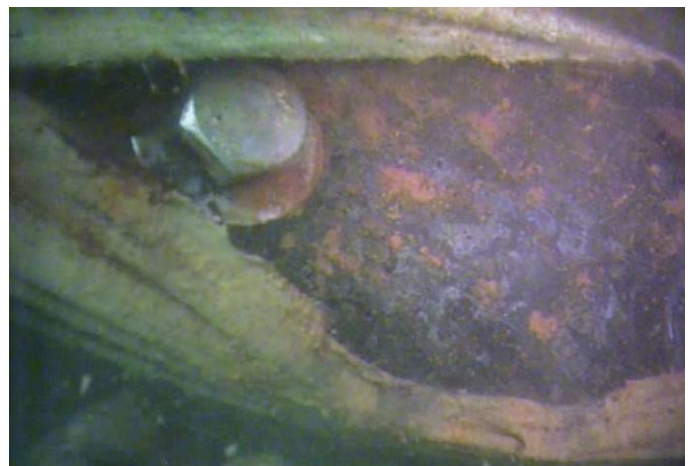
Photo #24: Flange surface exposed by diver at bent 40-41, showing condition of steel flange/stainless hardware

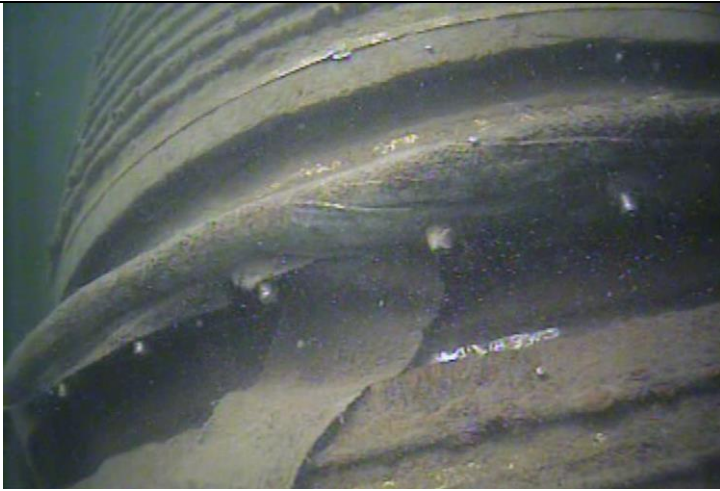
Photo #25: Flange at Bents 40-41 showing 12 o clock position alignment screws

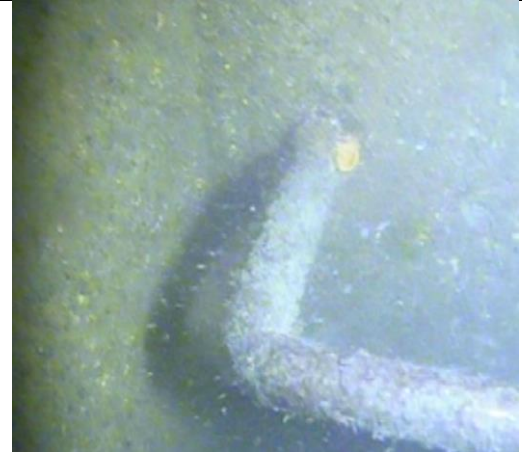
Photo #28: Ladder rung underwater condition

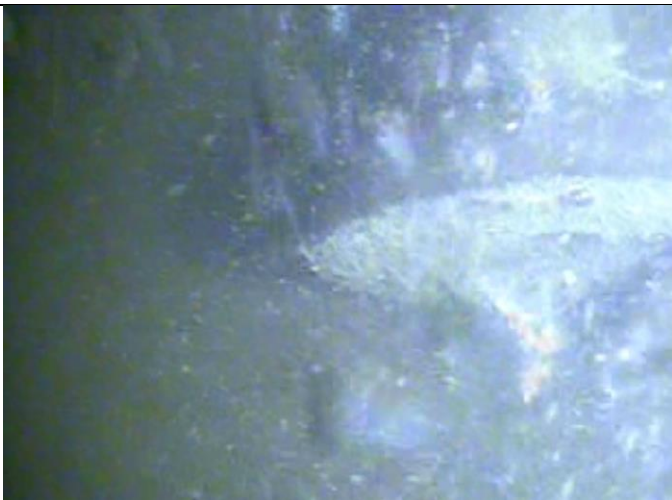
Photo #29: Bottom flange of 2" riser where it terminates in the access ladder shaft.

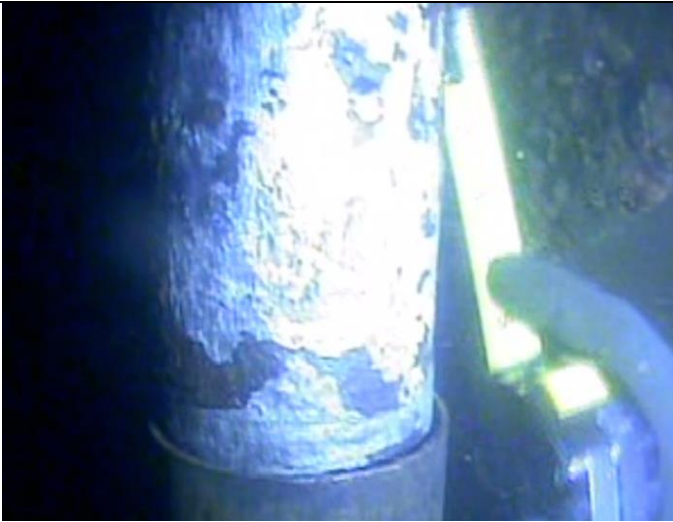
Photo #31 Gate Valve Actuator shaft cleaned by diver to show corrosion and pitting to a depth of 1/8"

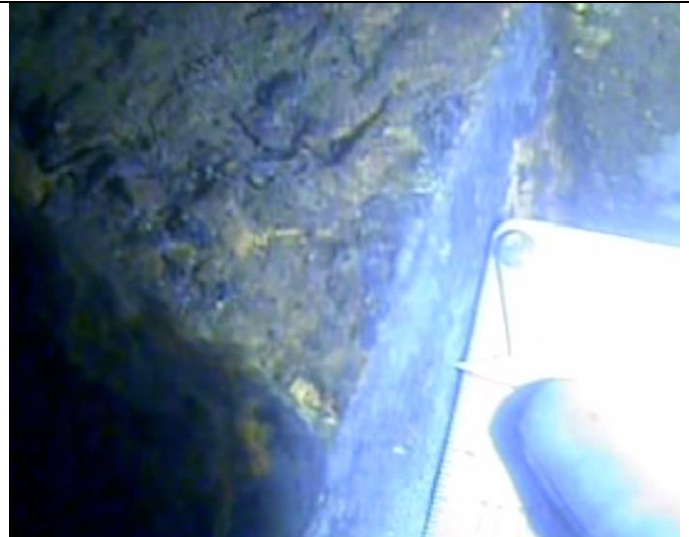
Photo #32 Diver using pit gauge to check depth of pitting on actuator bracket

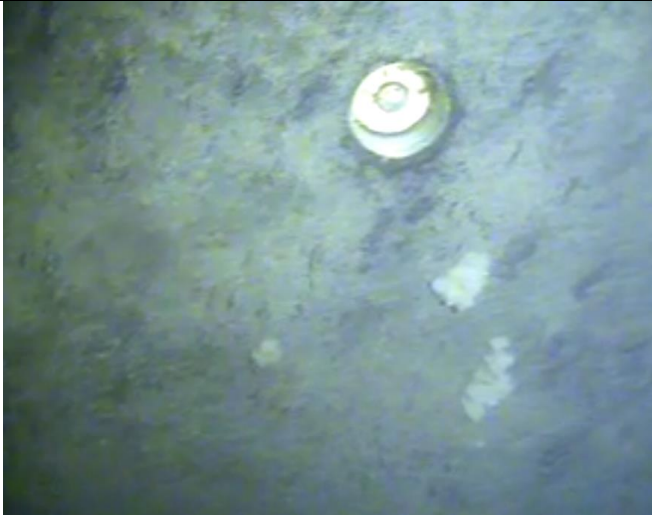
Photo #43 Mechanical plug installed in place of core observed at 280' from gate house

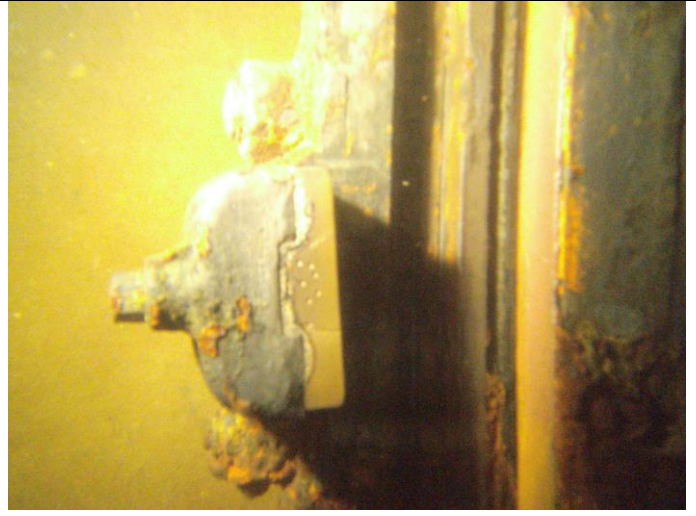
Photo # 44 Detail of Wedge block on gate valve frame

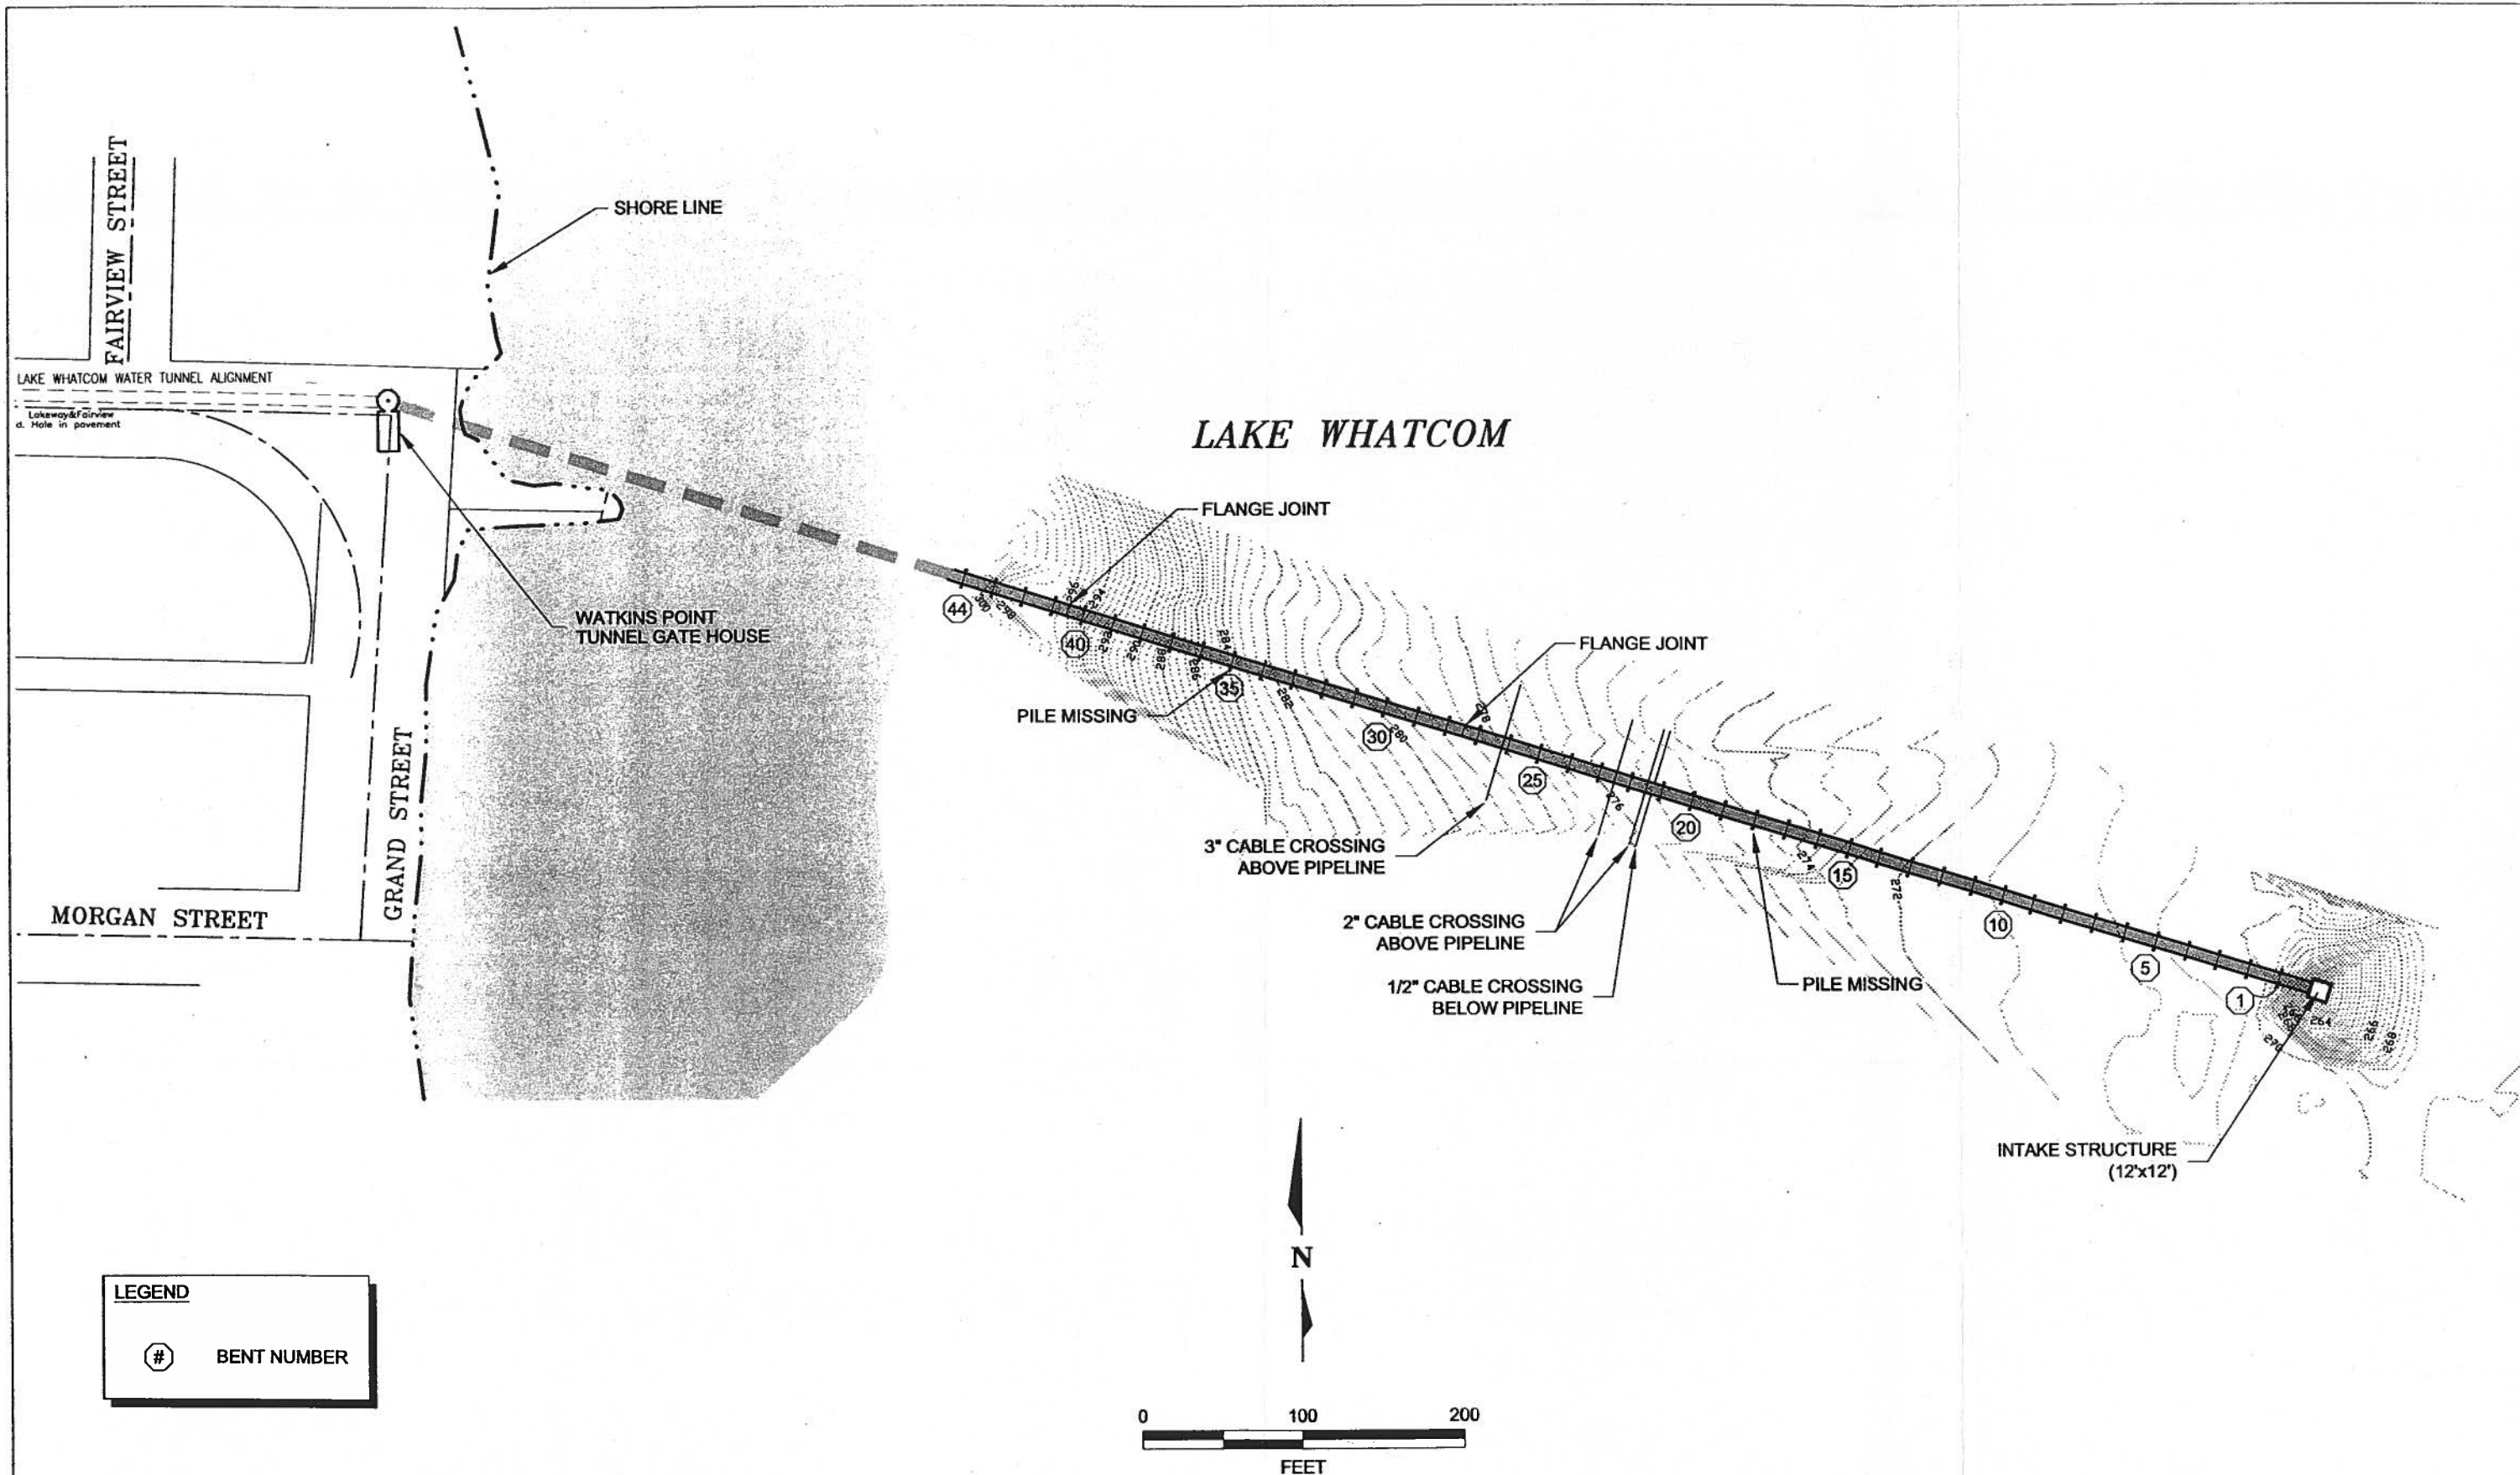
Appendix C
Drawings of the Intake Pipeline from September
2000 Golder and Associates Inspection Report

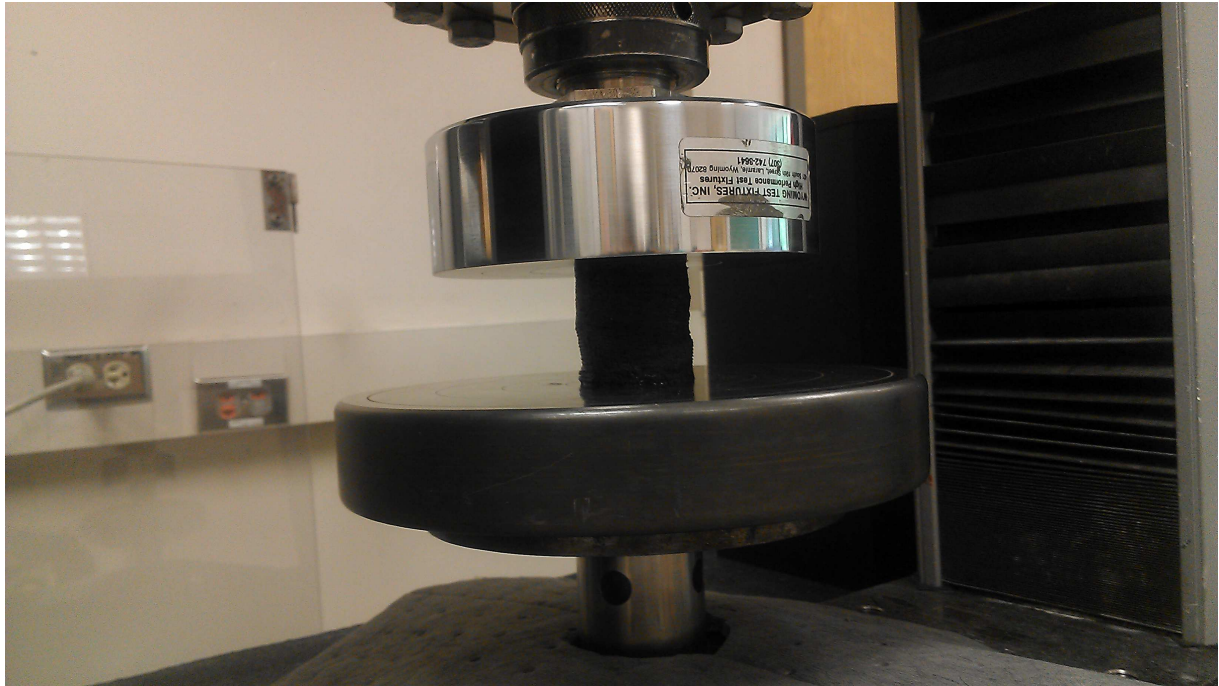
Figure 3: Sample 1 prior to initiation of the test

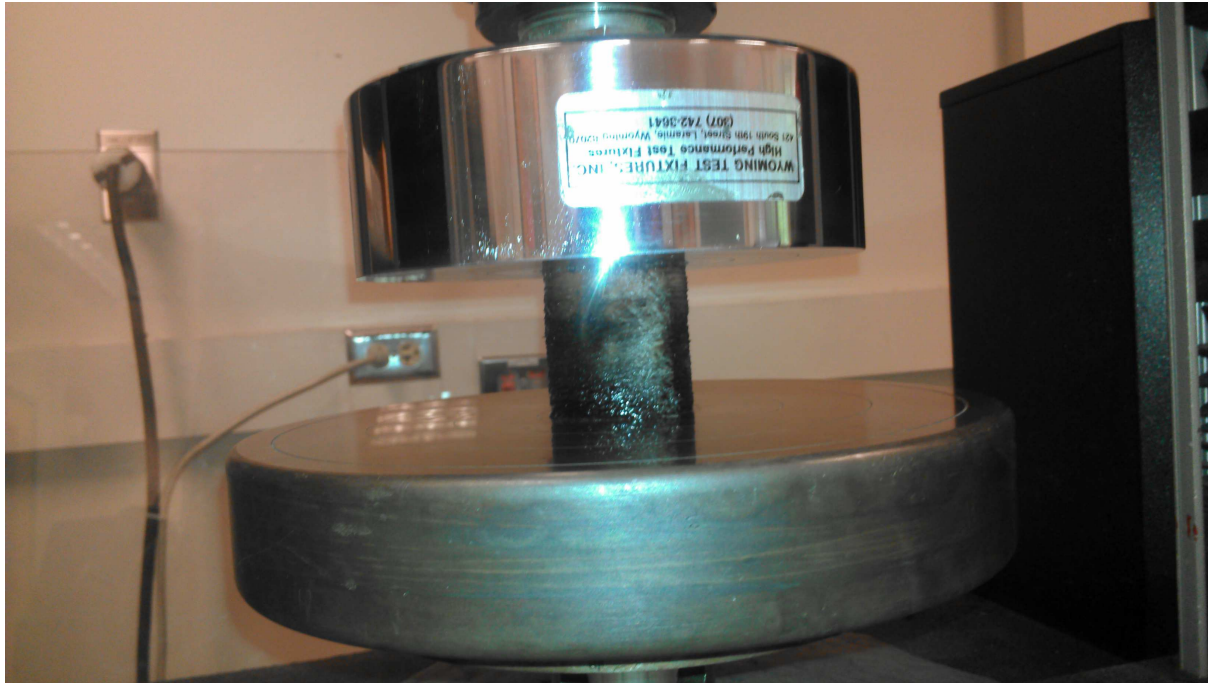
Figure 7: Sample 2 prior to initiation of the test
