# Part 2: Table of Contents

## Part 2: Conditions Assessment

# Conditions Assessment Results

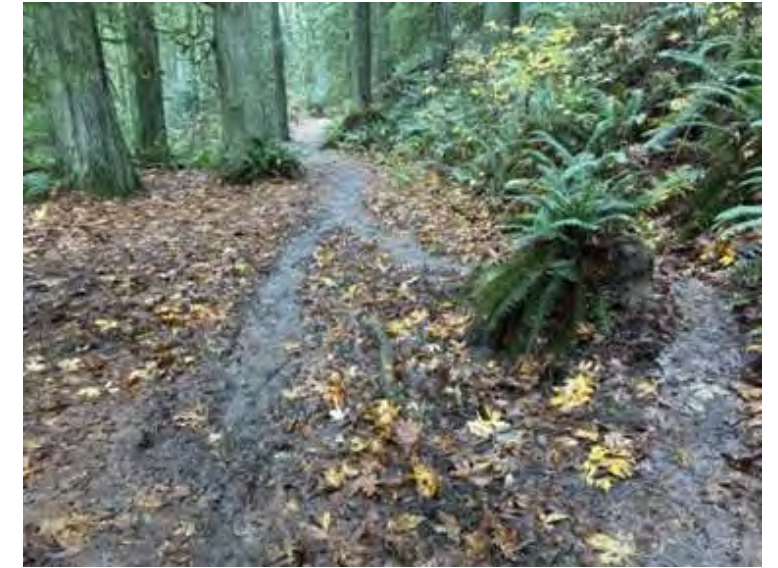
Figure 27. Main loop trail segment with drainage issues in Zone 4.

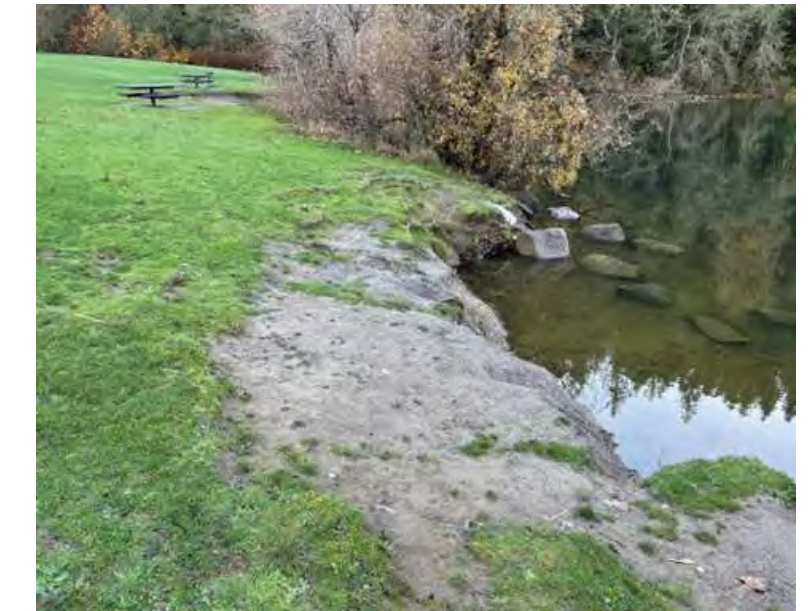
Figure 28. Eroded shoreline at the “swim beach” area at the north end of the lake in Zone 5.

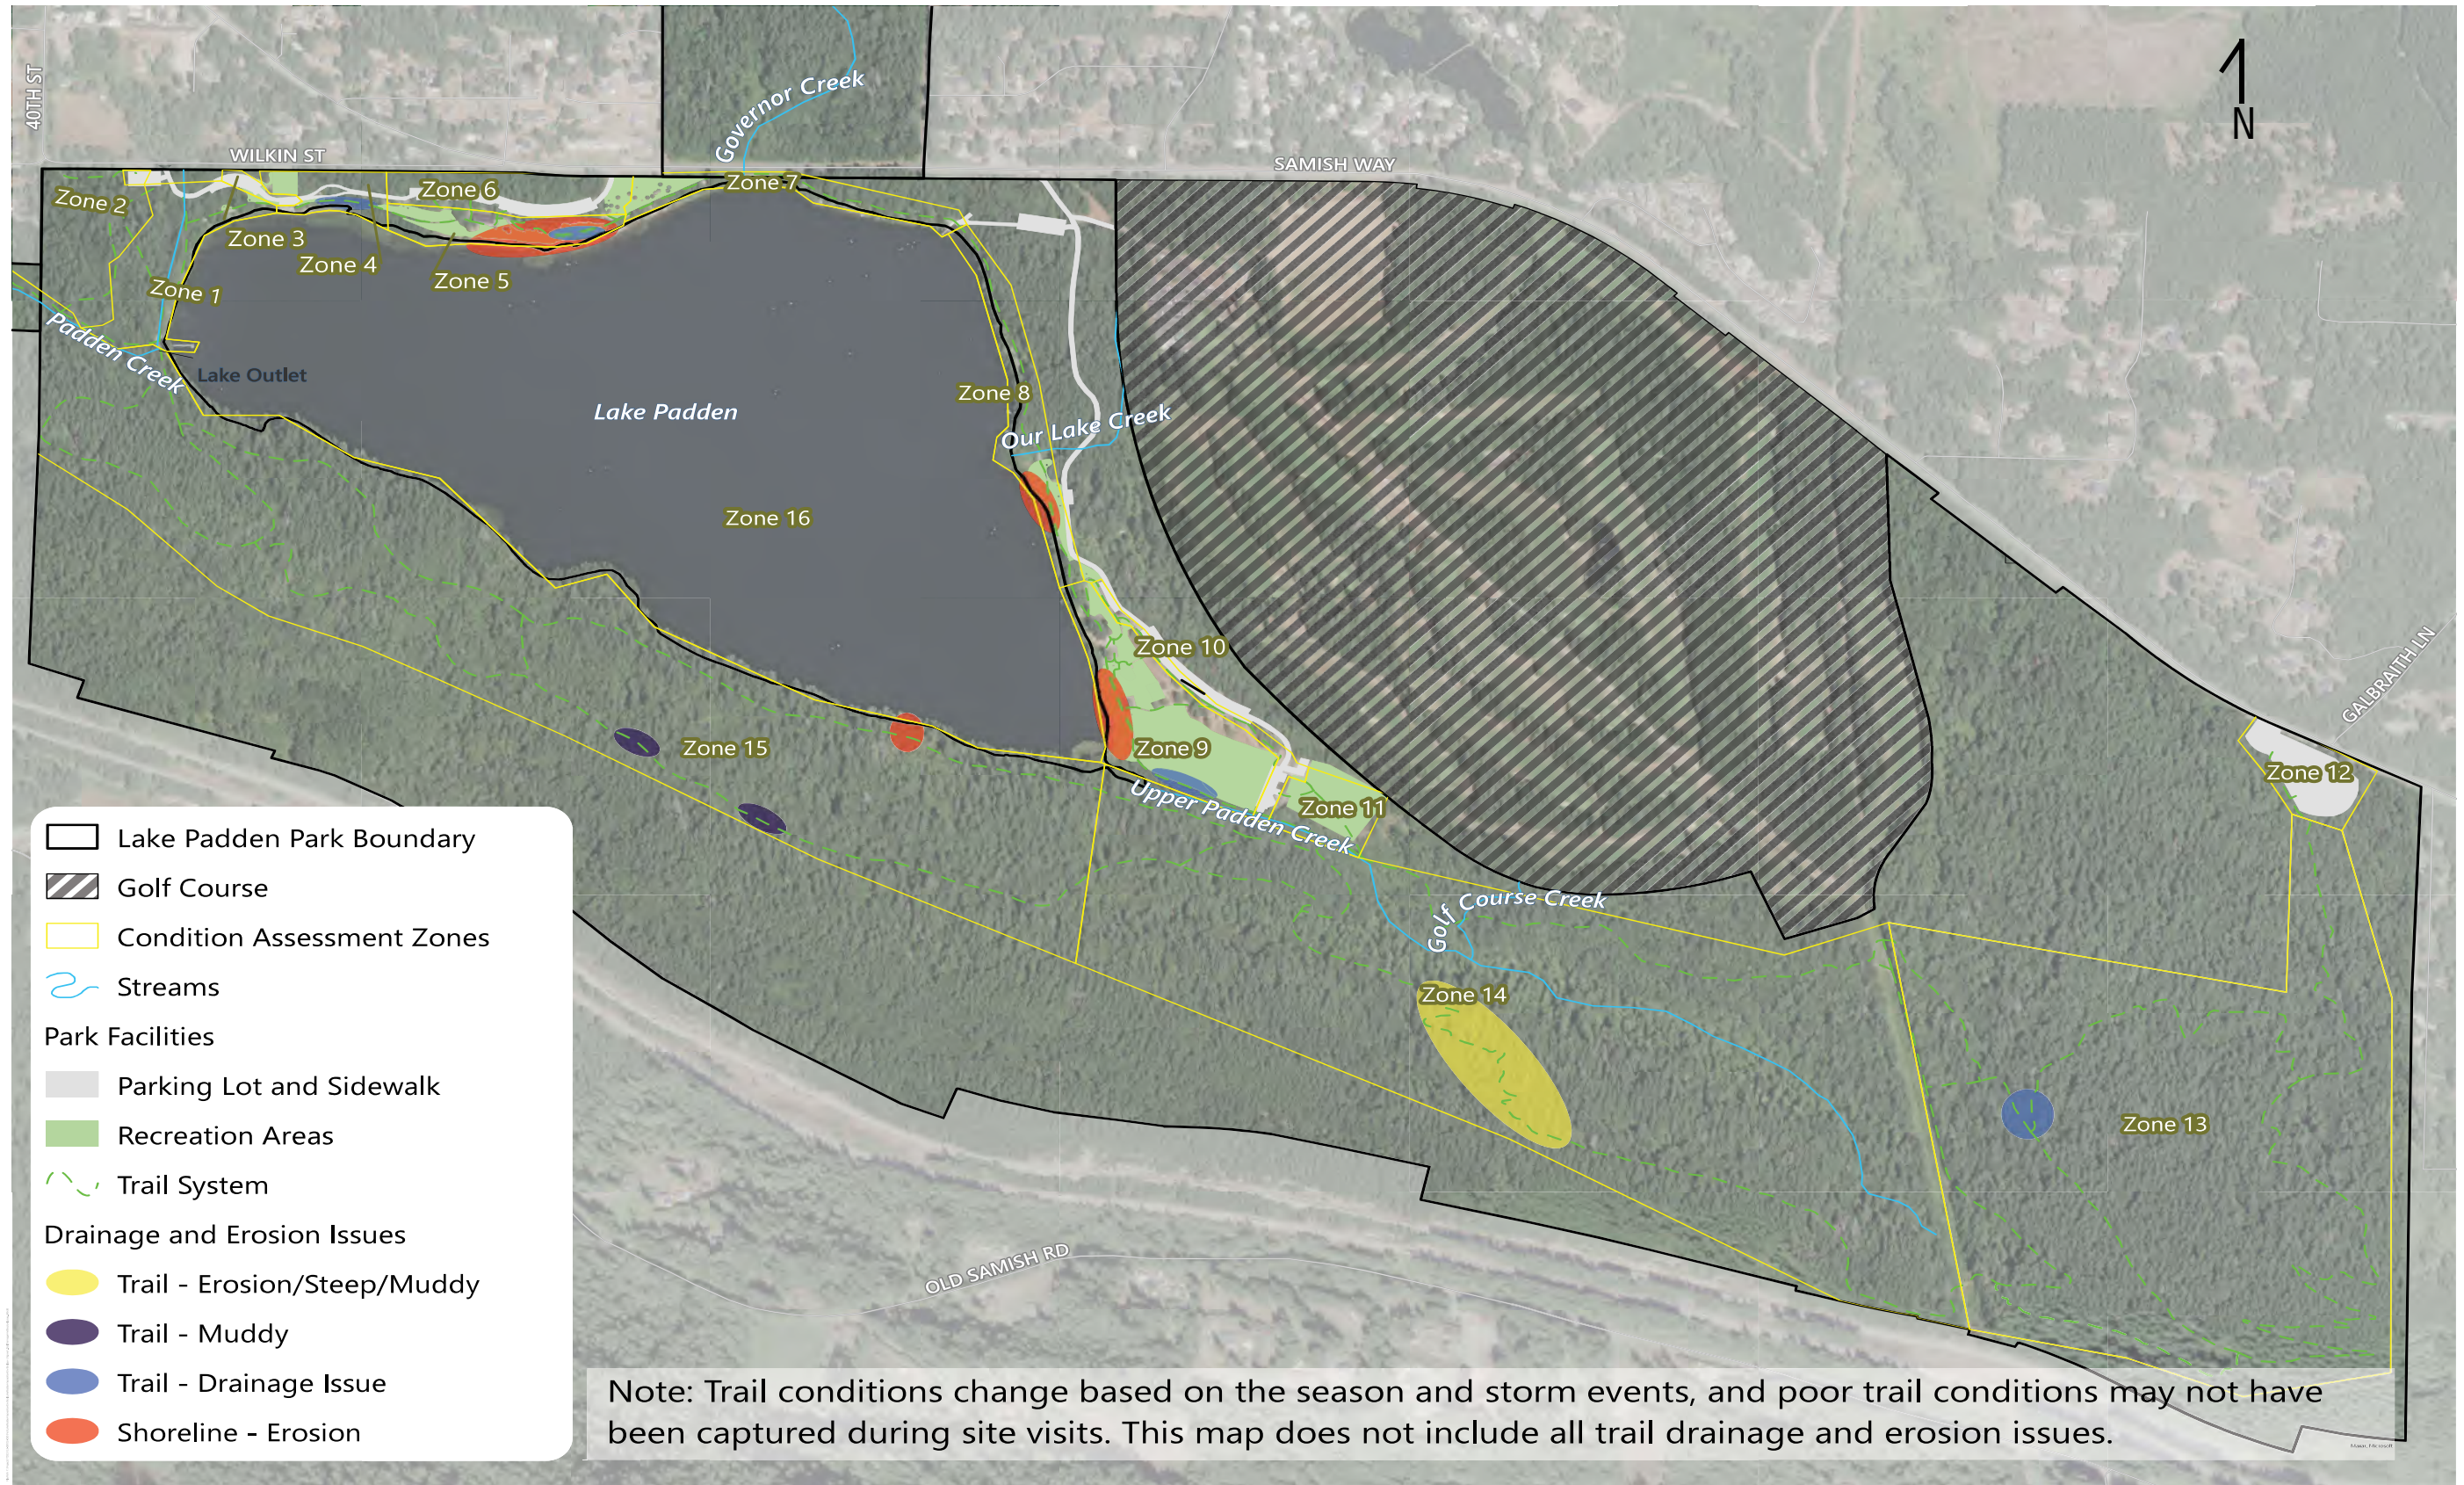
Figure 30. Eroded shoreline at the south end of the lake in Zone 9.

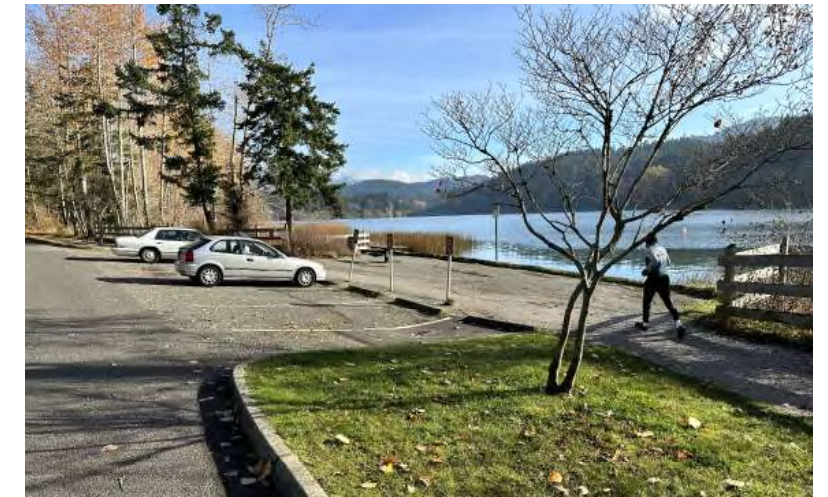
Fishing area parking lot- condition rating 4.

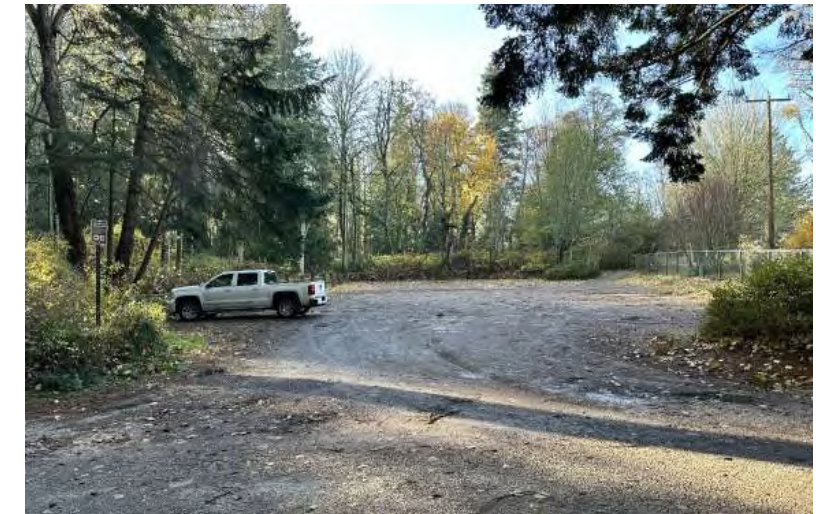
Horse trailer parking lot- condition rating 3.

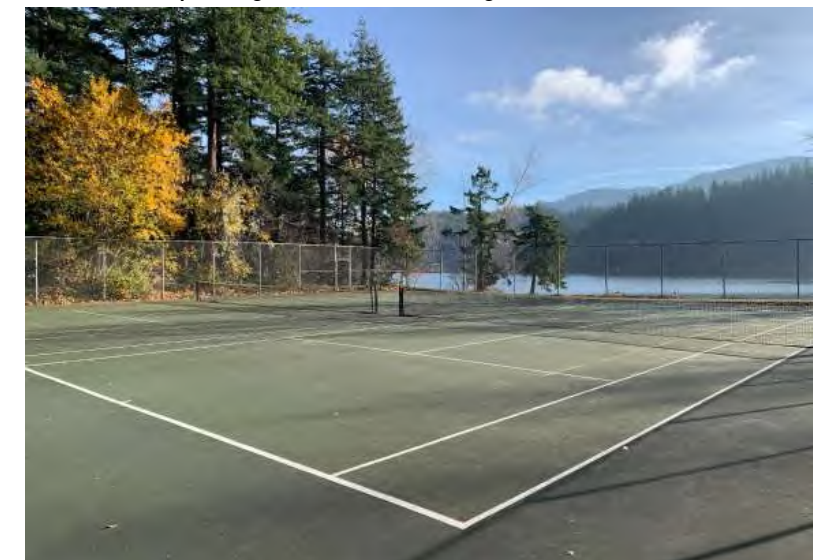
Tennis court- surface condition rating 3. Fence rating condition 2.

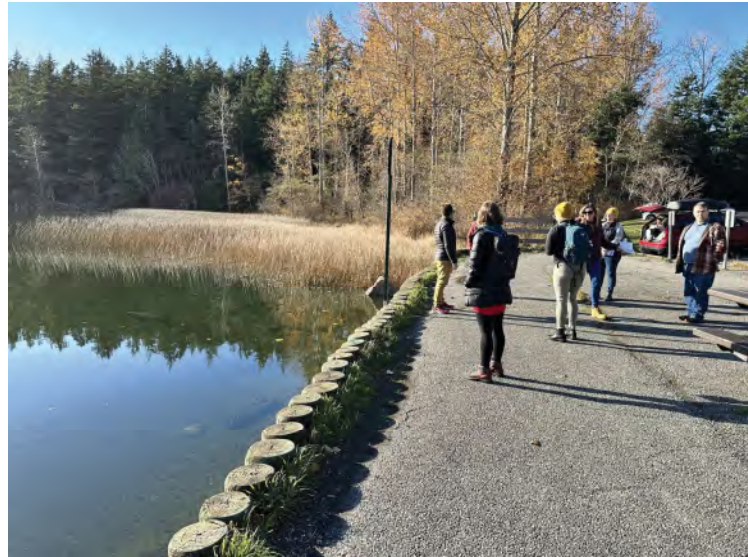
Fishing area bulkhead- condition rating 4.

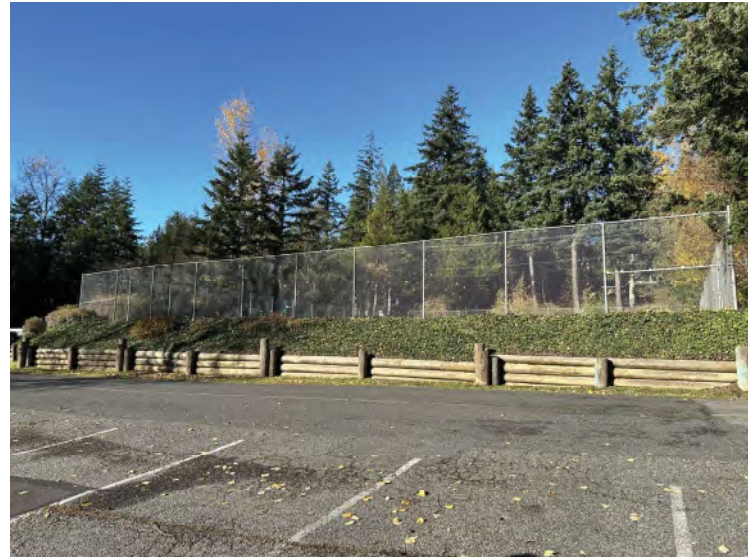
Tennis court as seen from parking lot. Condition rating 2.

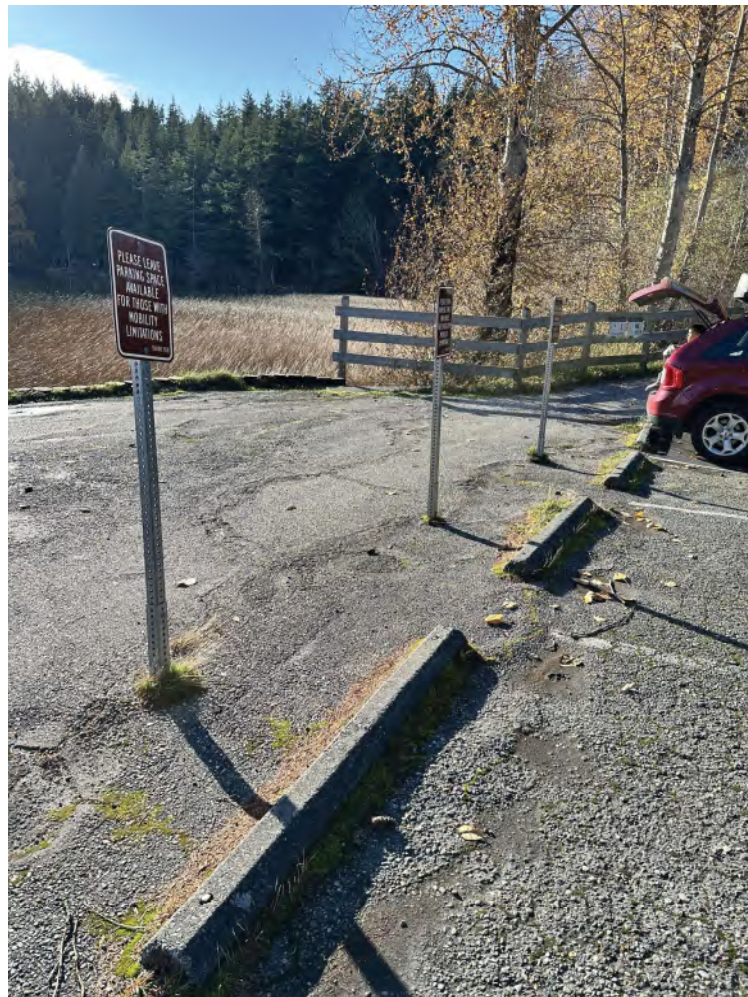
Fishing area accessible parking- condition rating 5.

- Accessible parking at fishing area is not ADA-compliant. Recommend upgrading to current ADA standards.

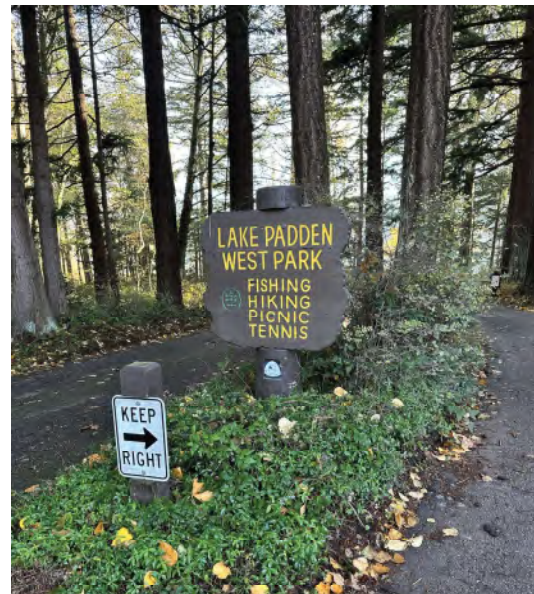
Entrance sign- condition rating 3.

- Entrance sign and entrance is difficult to see from Wilkin Street. Recommend more signage before entrance (this applies to all) to allow drivers time to adjust speed and prepare to entire park.
- Park entrance drive and parking lot asphalt surface is cracked and worn- recommend grinding and repaving
- Horsetrailer parking area is unpaved. Look to opportunities to convert to regular parking based on future equestrian access.
- Consider adding a fishing dock and removing treated timber pilings in the lake.
- Replace wood retaining wall at base of tennis court with a more durable material.
- Replace wood curbing with more durable materials.

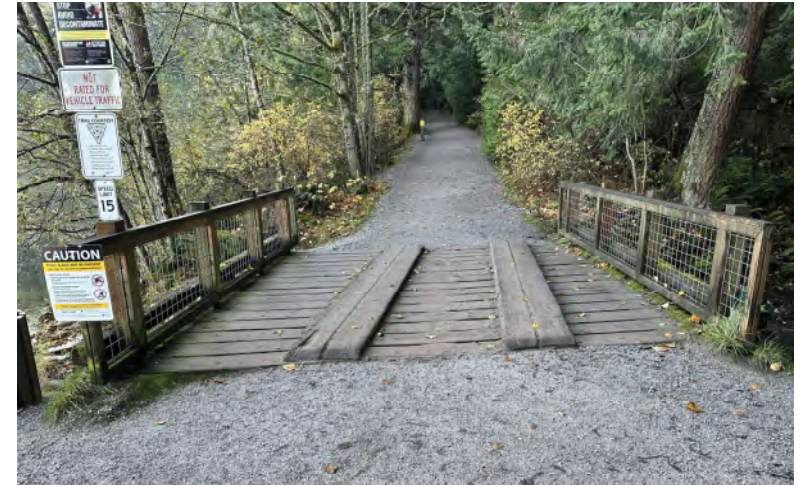
Bridge over lake outfall- condition rating 3.

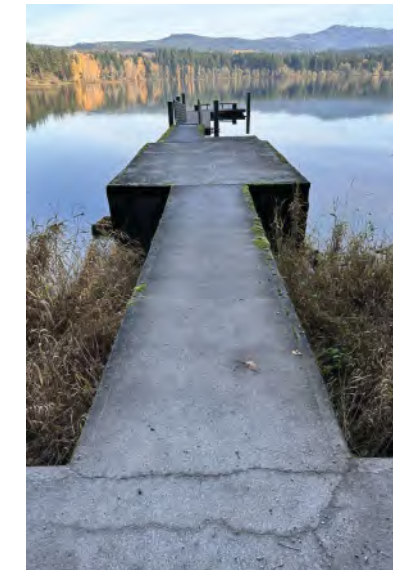
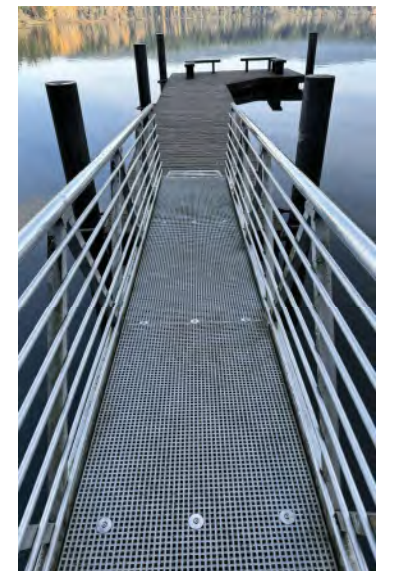
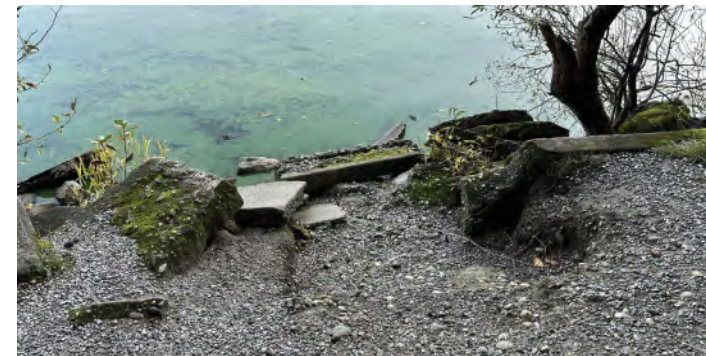
Shoreline edge erosion and historic debris- condition rating 4.

- ADA upgrades to fishing dock.
- Enhance shoreline erosion protection.
- Improve erosion control structures on unimproved trails or consider restricting access/ closing trails on steeper slopes.
- Address fish barrier at lake outlet.

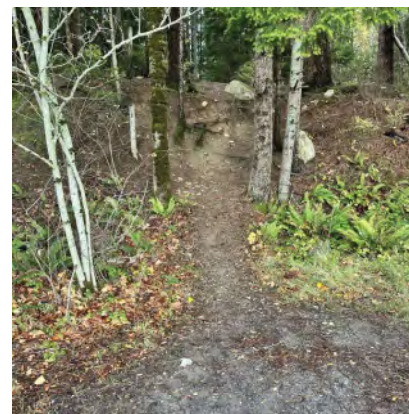
Unimproved trails showing erosion- condition rating 4.

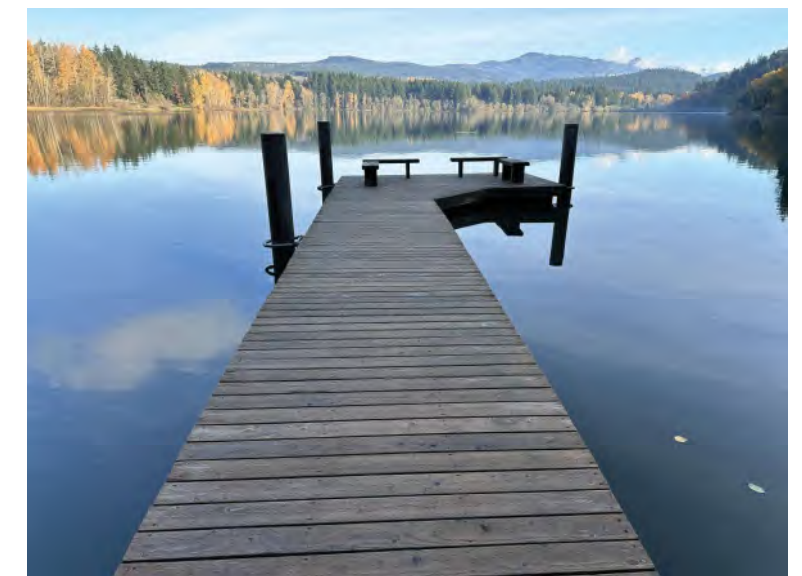
Fishing dock- condition rating 4.

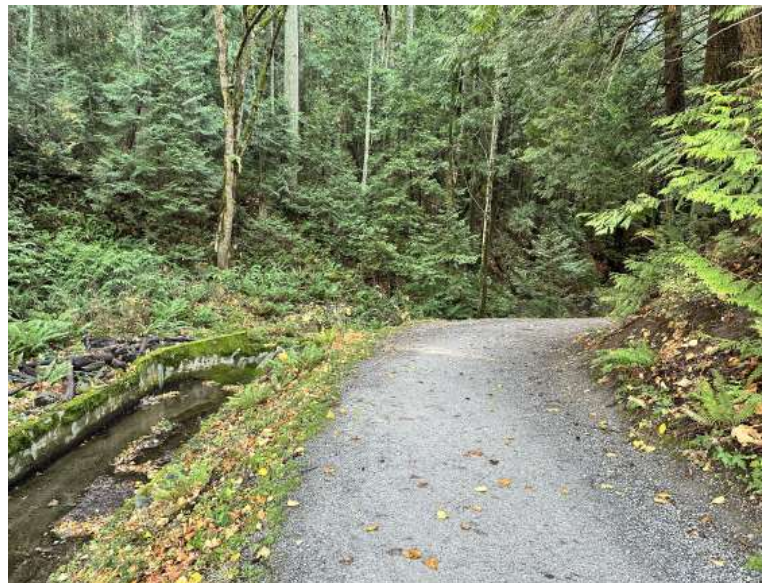
Trail- condition rating 2.

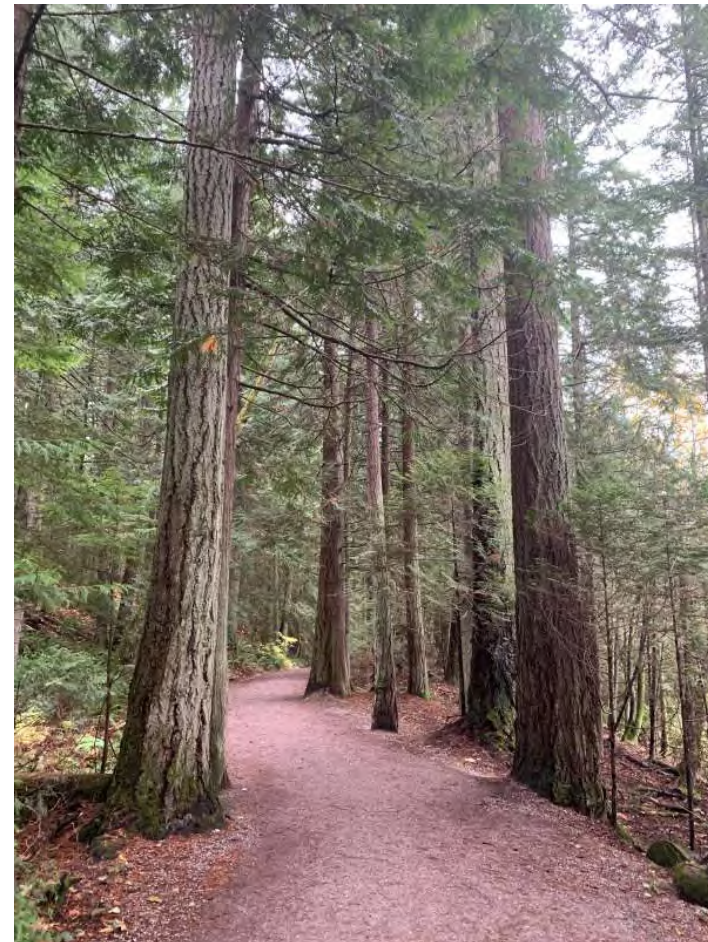
Improved trail- condition rating 2.

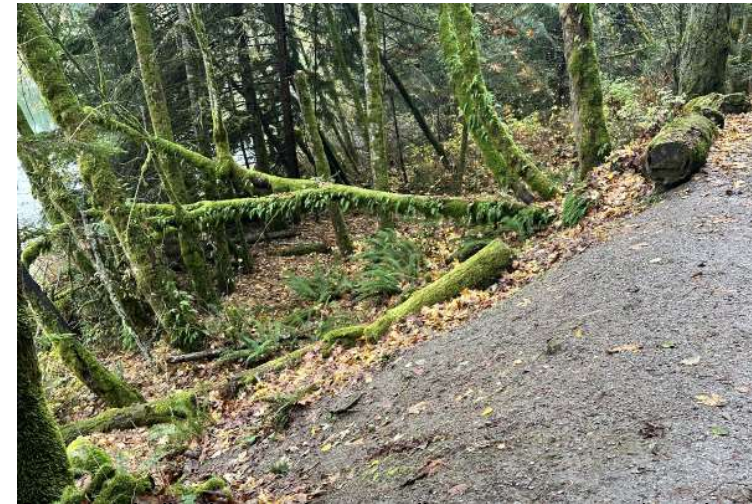
One area indicating erosion on trail- suggests users (mostly dogs) are accessing lake shore in this area.

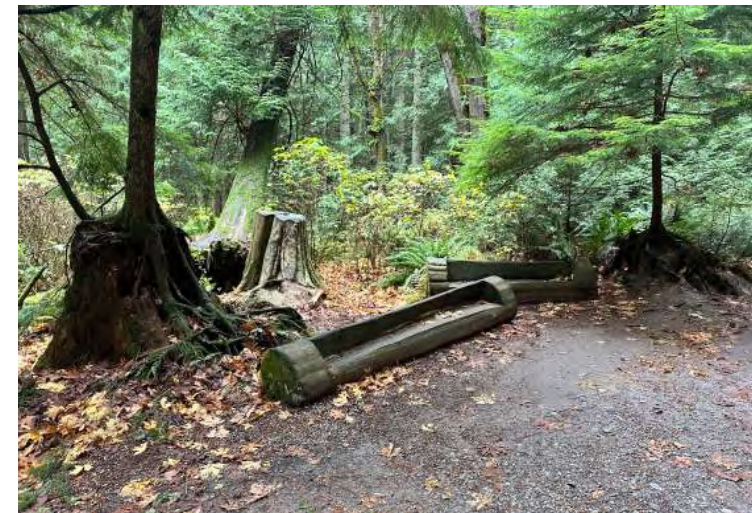
Rustic benches should be repositioned for easier access- provide ADA seating area adjacent.

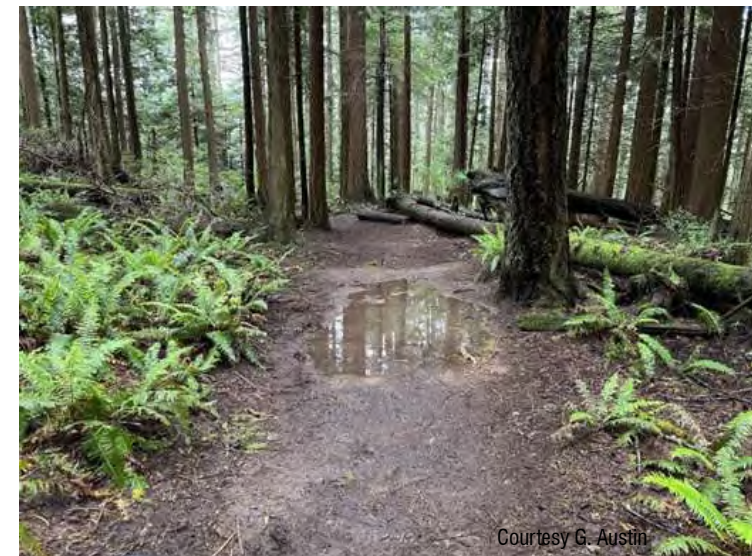
Standing water in unimproved trails- condition rating 4.

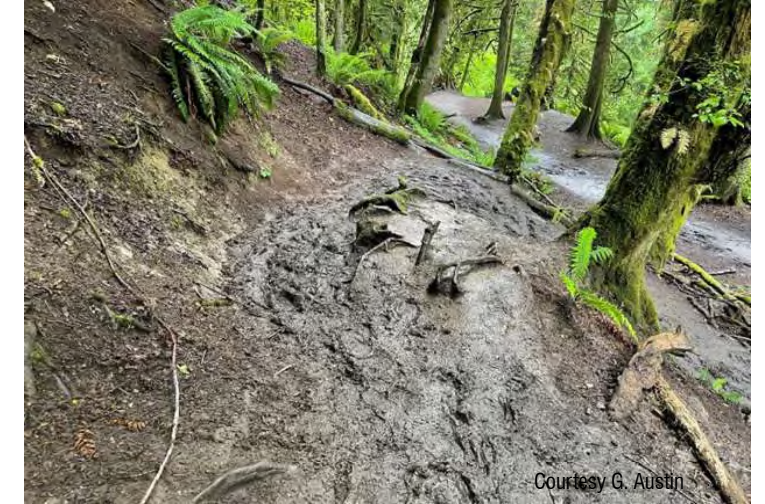
Unimproved trail with steep, muddy conditions with exposed roots- condition rating 5.

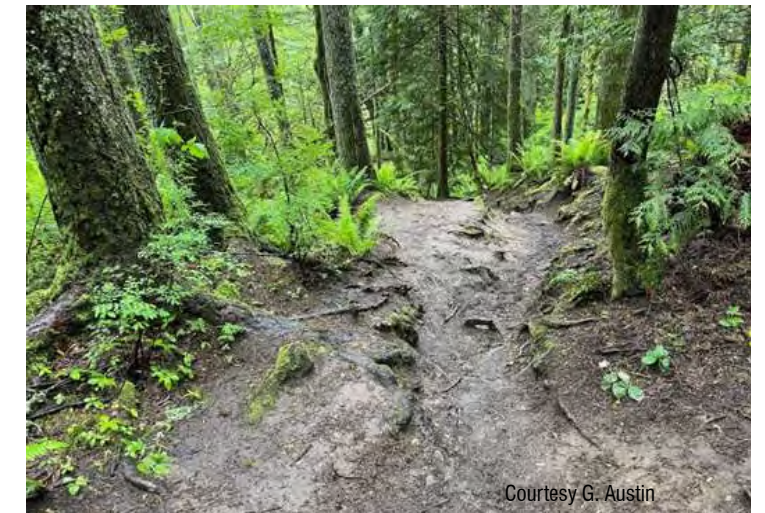
Unimproved trail with steep, muddy conditions with exposed roots- condition rating 5.

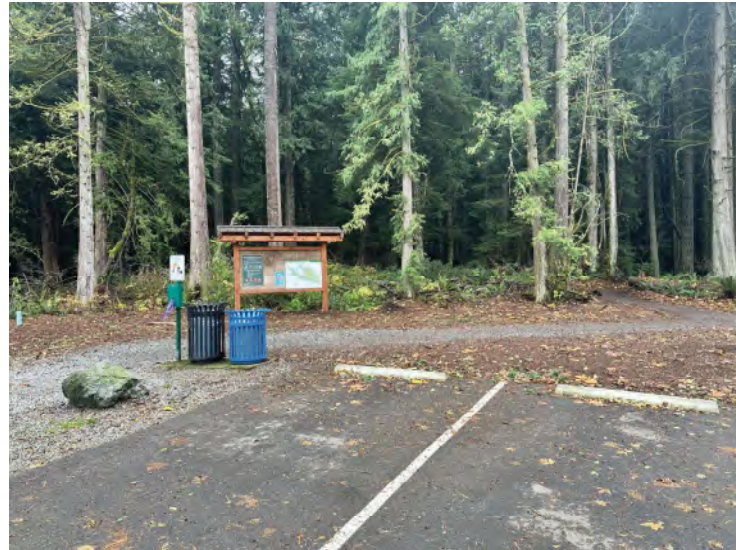
Galbraith parking lot trail head condition rating 1.

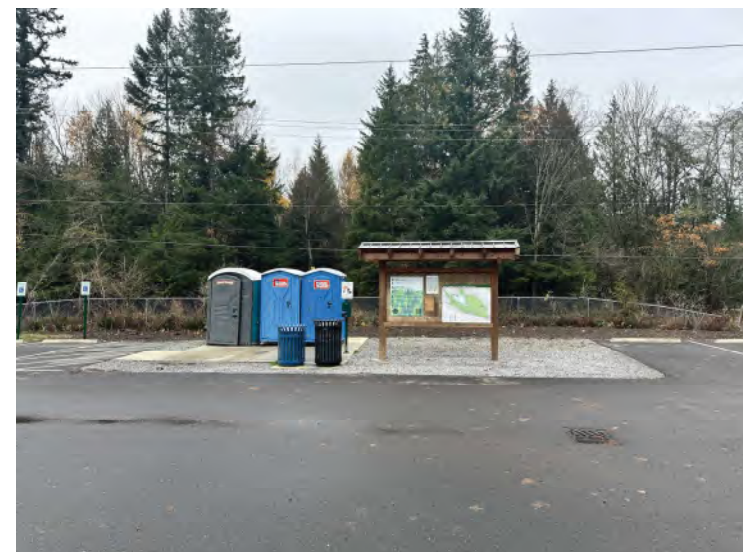
Galbraith parking lot signage and porta-toilets- condition rating 1.

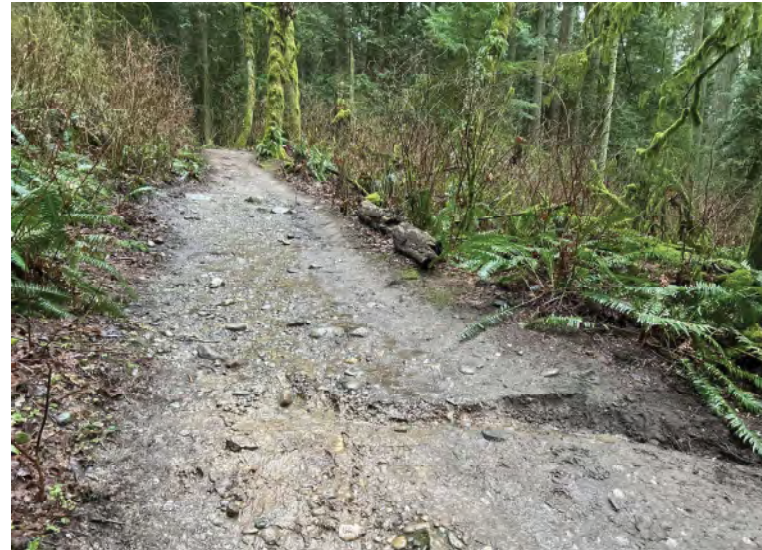
Erosion on unimproved trail- condition rating 4.

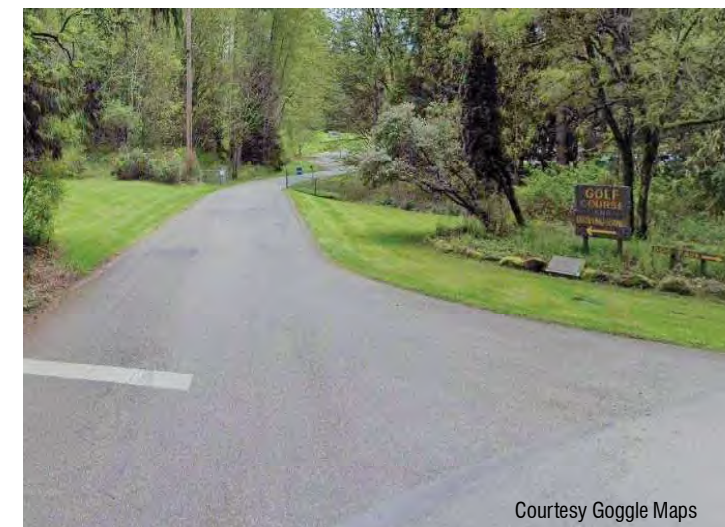
Lake Padden Golf Course Road intersection- signage condition rating 3.

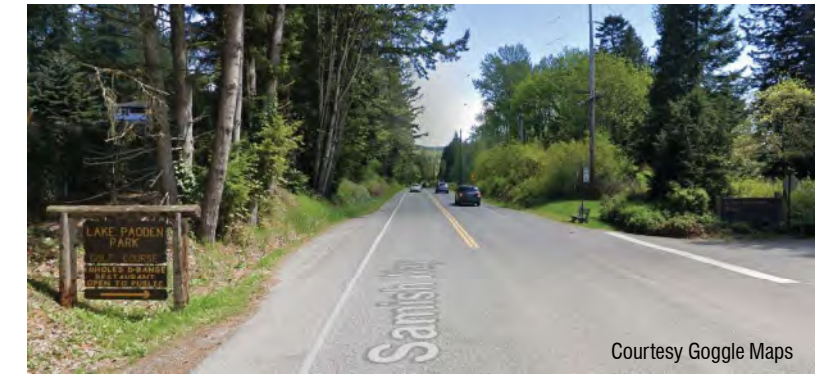
East park entrance signage- condition rating 3.

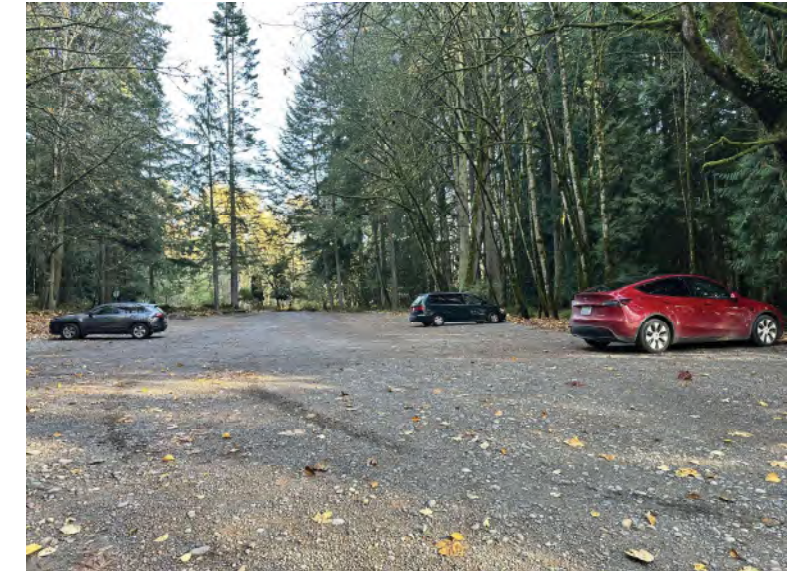
Boat launch parking lot- condition rating 4.

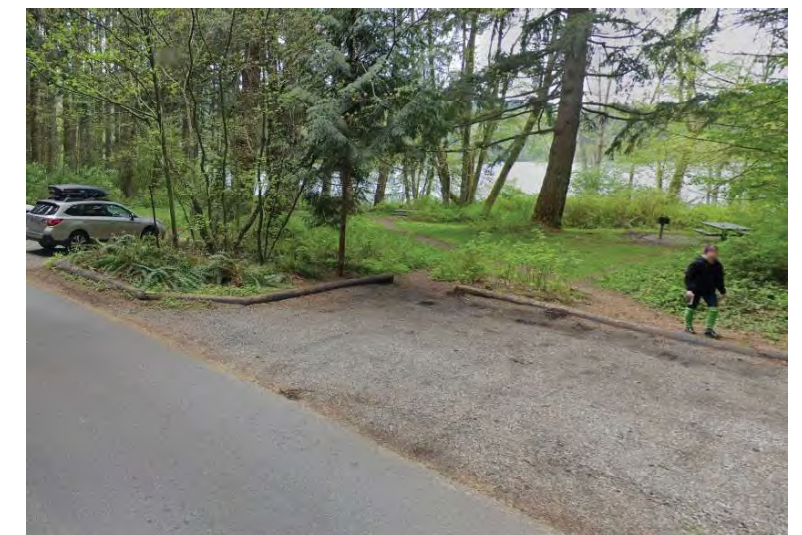
Satellite parking areas- improve accessible paths to adjacent amenities.

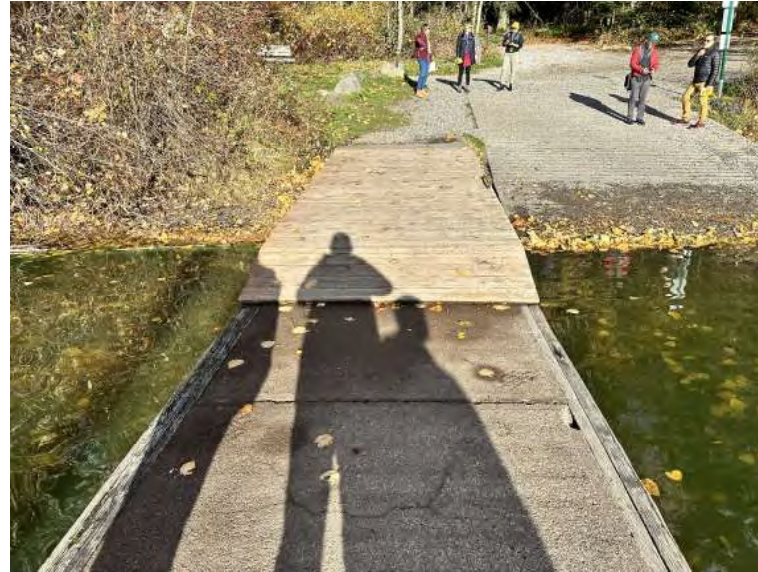
Boat launch ramp and dock- transition is not ADA accessible. Dock lacks toe kick rails.

- Upgrade/ replace dock. Add ADA-compliant features such as railings and toe-kicks, and a smoother ramp transition.
- Update submerged portion of ramp to be less steep

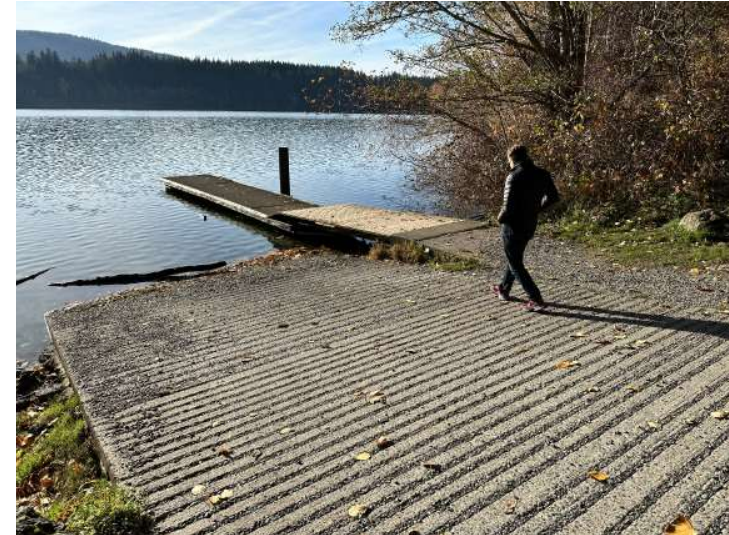
Boat launch ramp and dock- condition rating 3.

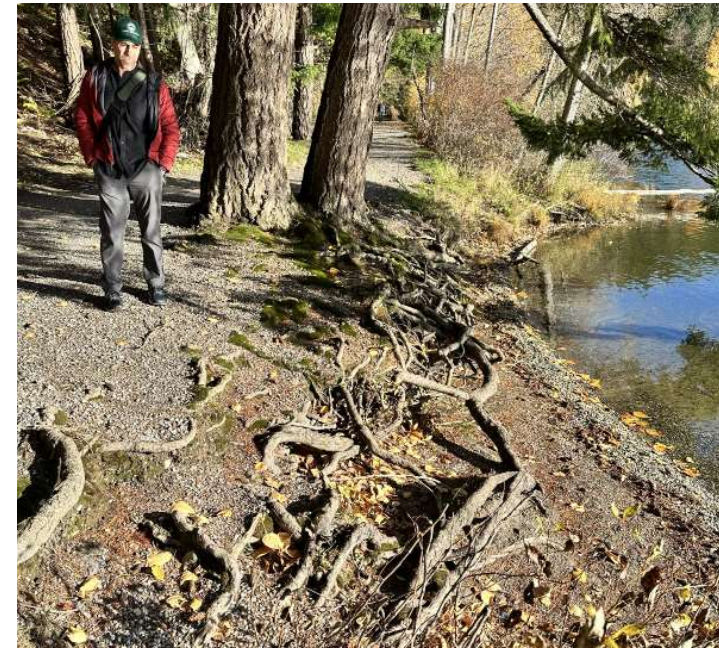
Bank erosion on east shoreline.

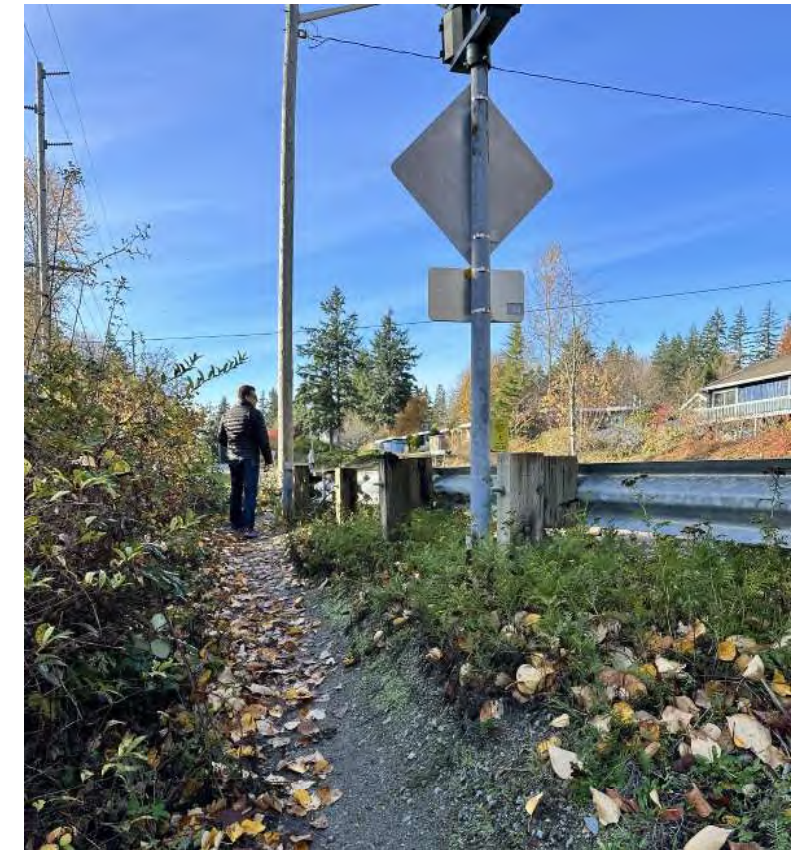
Informal pedestrian access from trail to Samish Way.

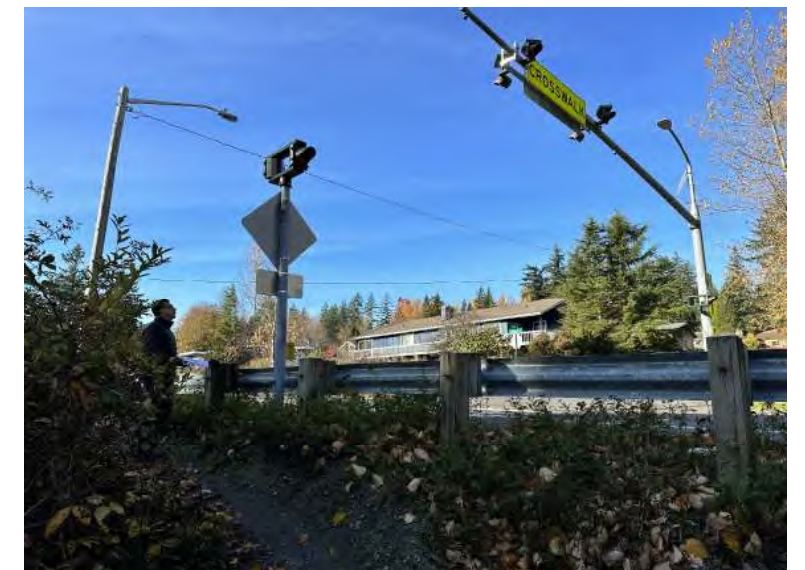
Informal pedestrian access from trail to Samish Way ties into pedestrian crossing. There is inadequate space for pedestrians to wait at crossing at the top of the trail.

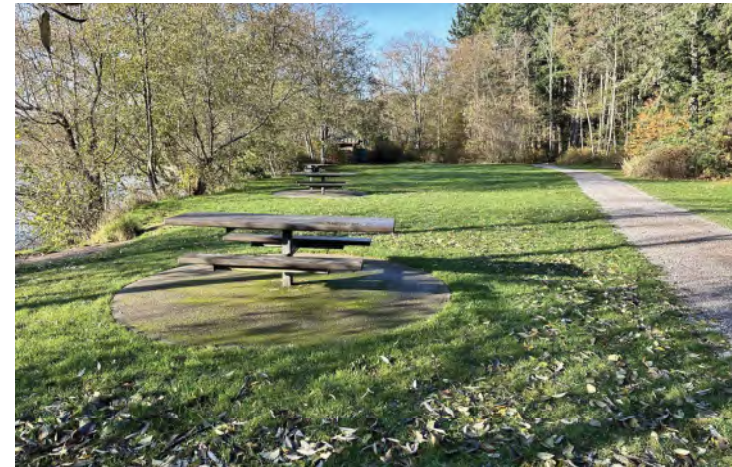
Picnic tables and concrete pads are not ADA compliant. Adjacent improved path is in good condition.

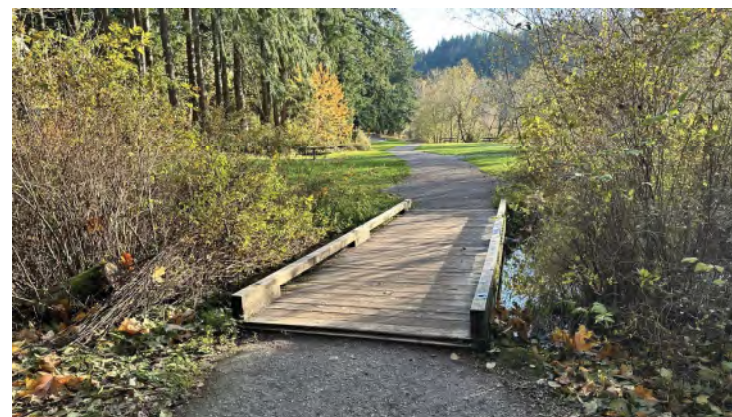
Pedestrian bridge transition is not ADA compliant.

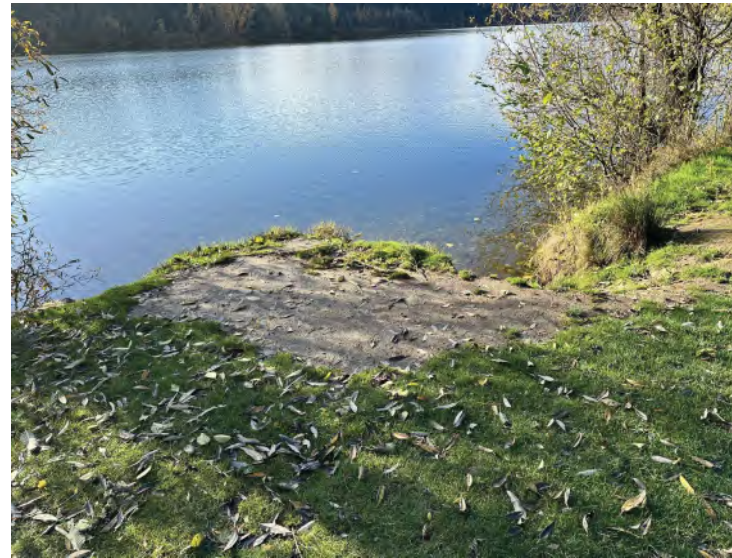
Bank erosion and compaction.

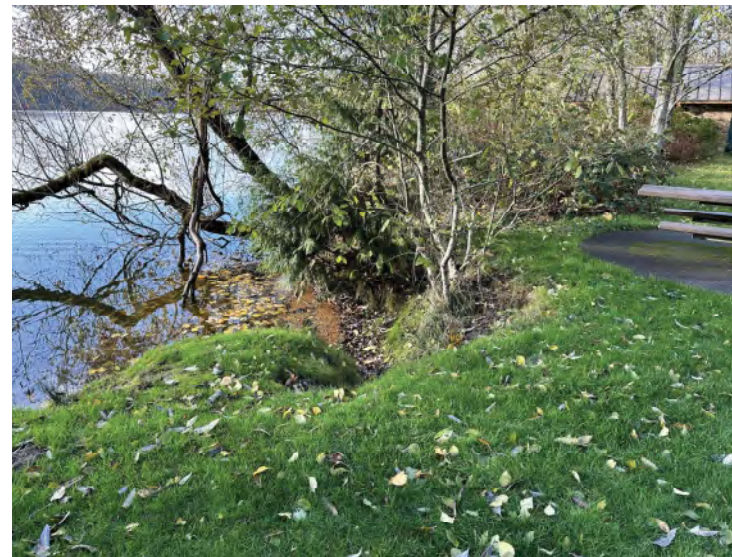
Bank erosion adjacent to picnic spot.

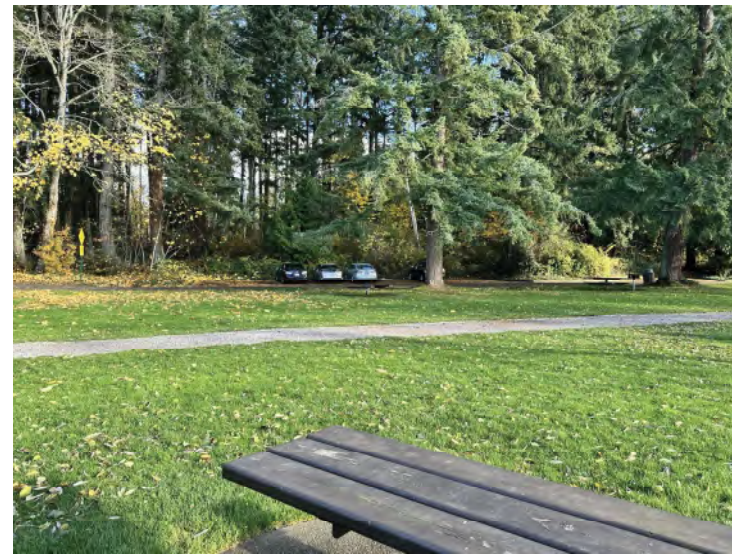
Turf is well-maintained. There is a lack of accessible paths from parking area to the picnic table spots.

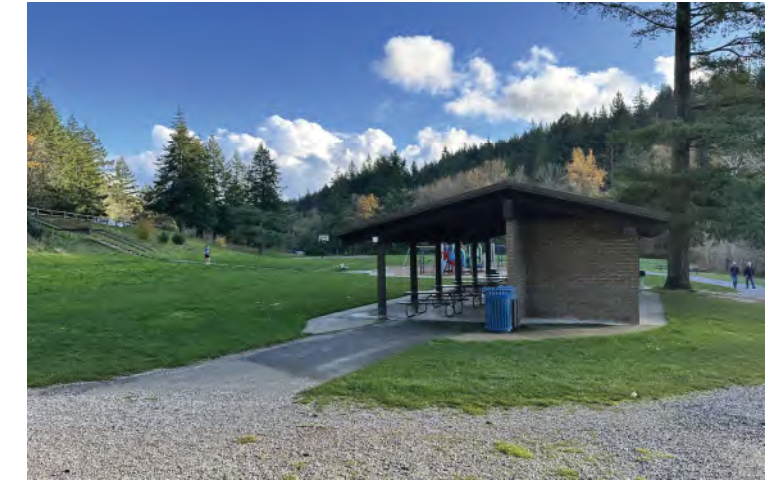
Typical picnic shelter- condition rating 3.

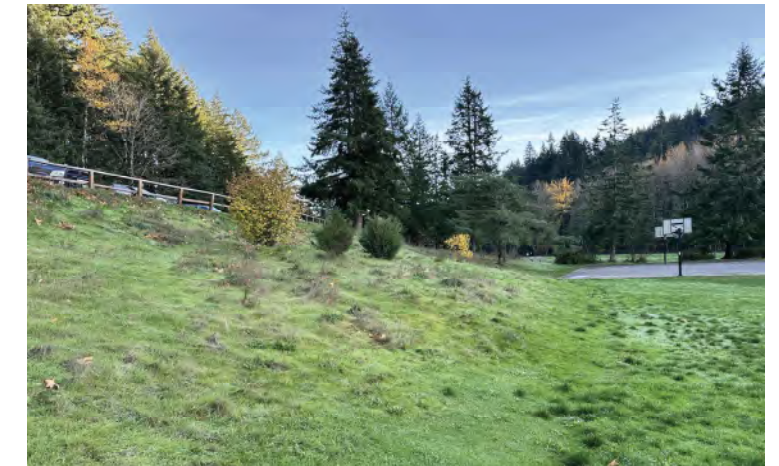
- The slope between the northern parking area and the multi-use field is poorly vegetated and is contributing to area drainage issues as it sheds water to the field. Worn trails down the slope are contributing to erosion of the slope. There is no direct access from the highest portion of the parking area to the field and play activity area below. Slope is unsightly and does not contribute to the overall character of the site.

Slope separating parking and activity area.

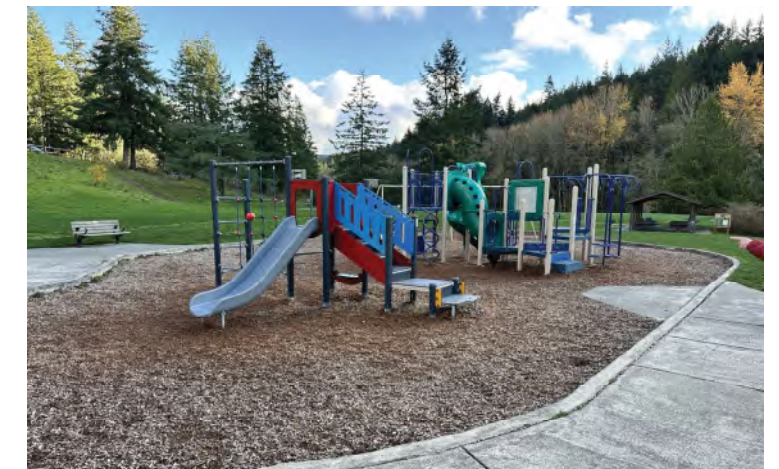
Play area equipment- condition rating 3.

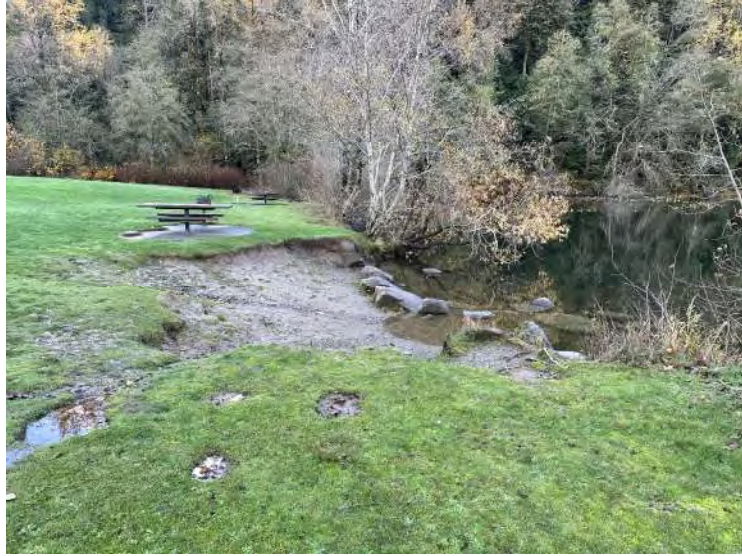
Shoreline erosion limiting water access.

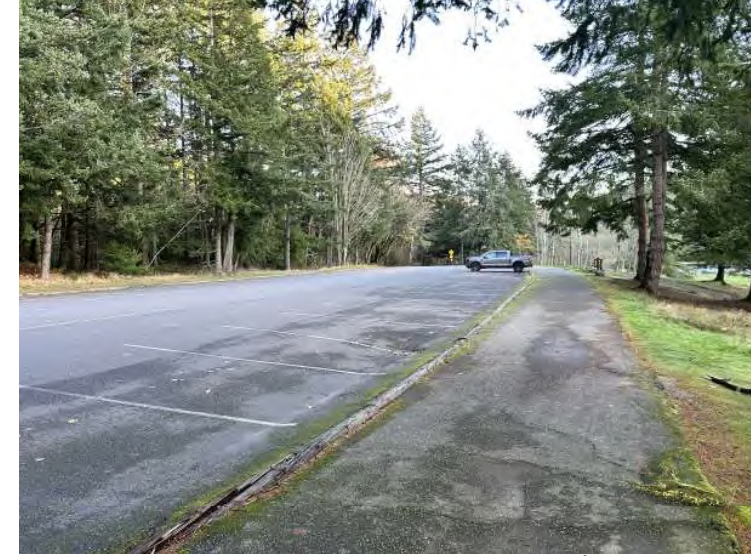
Pavement and sidewalk in poor condition rating 4.

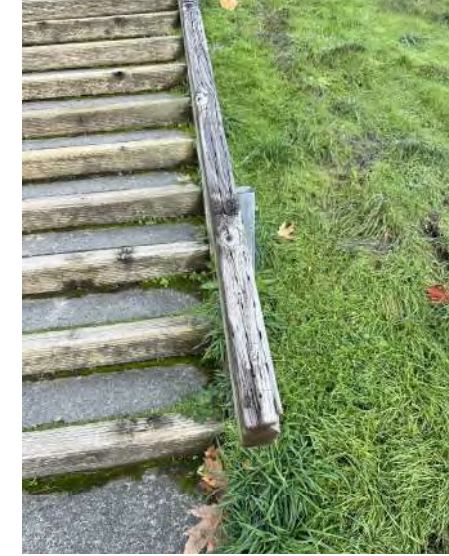
Wood handrails in poor repair on parking lot stairs- condition rating 4.
