# Part 2: Table of Contents

## Part 2: Conditions Assessment

# Conditions Assessment Results

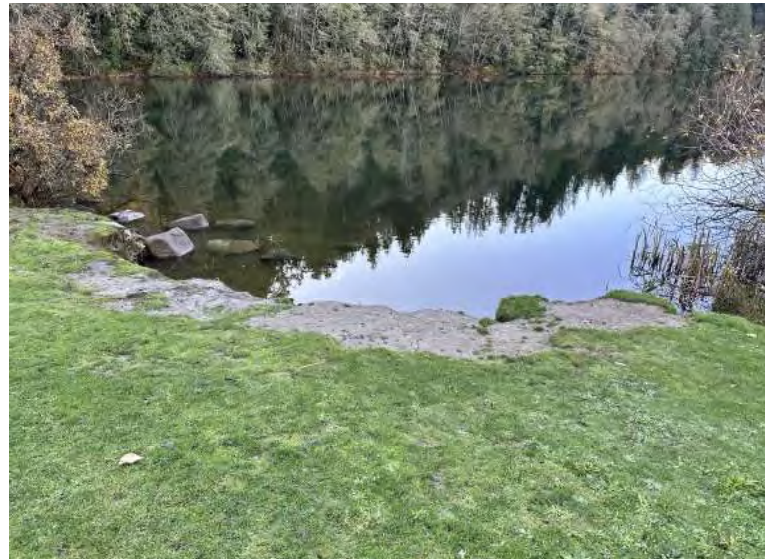
Shoreline erosion limiting water access.

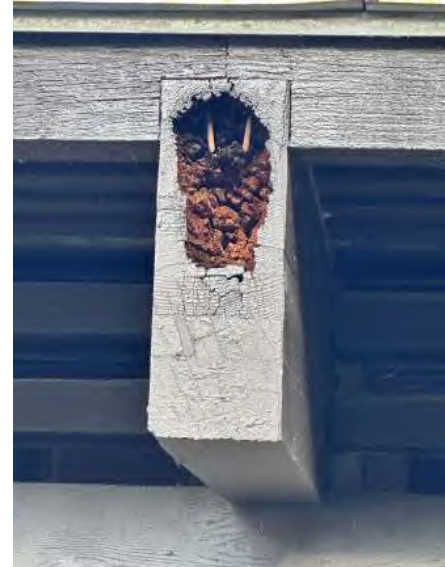
- Parking area above main activity area is in fair condition- requires resurfacing and re-striping.
- Bathroom is in good condition with the exception of visible rot in front of one roof beam.

Decay in roof beam.

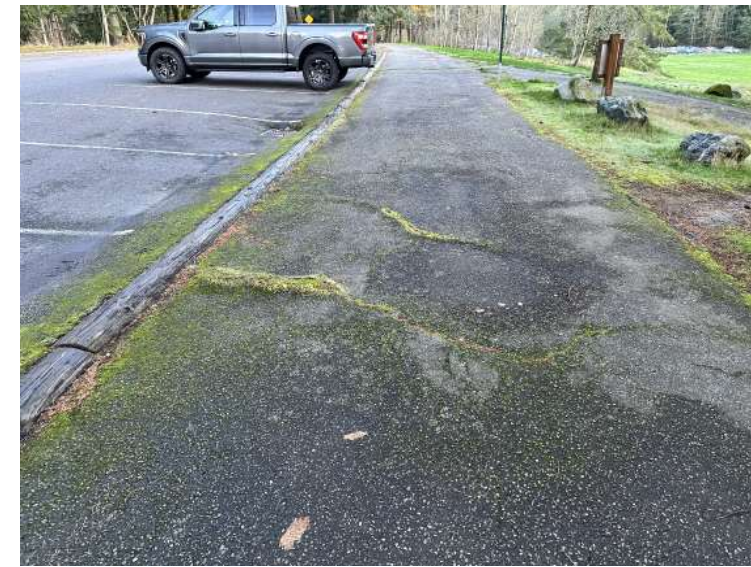
Wood edging presents barrier to movement between parking and sidewalk.

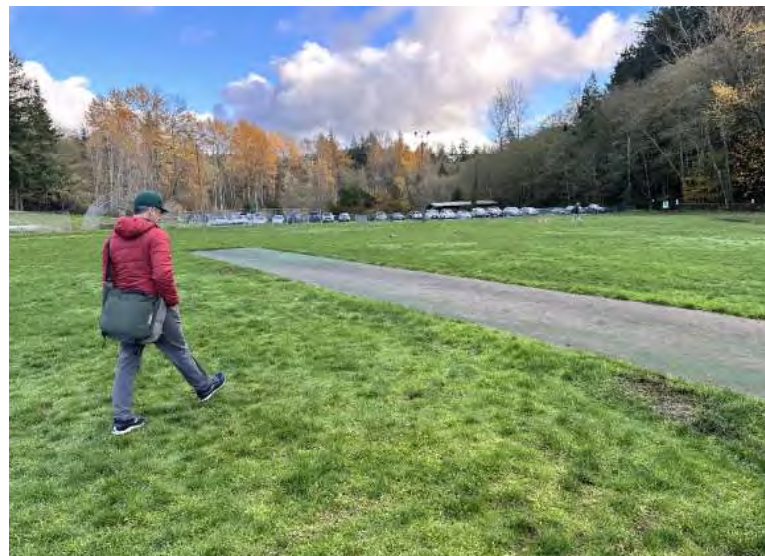
- Sewer lift station requires intensive maintenance due to user misuse of bathrooms.
- Multi-use field suffers from poor drainage and standing water. This condition has led to soil compaction, producing patchy and uneven turf growth that could present injury risks.

Multi-use field.

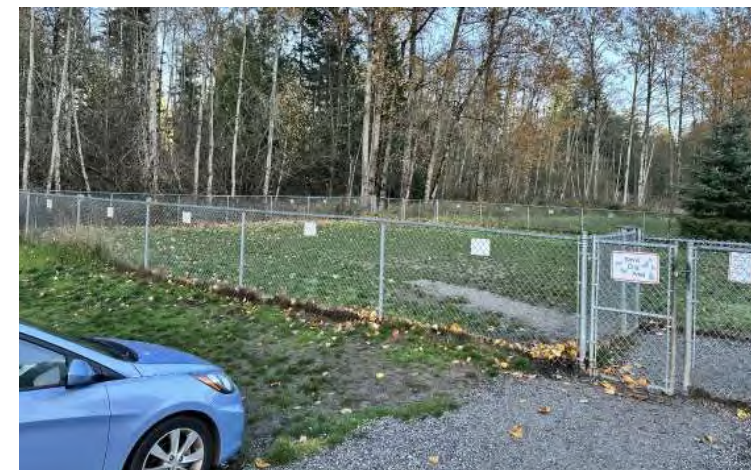
Dog park parking and fencing- condition rating 3.

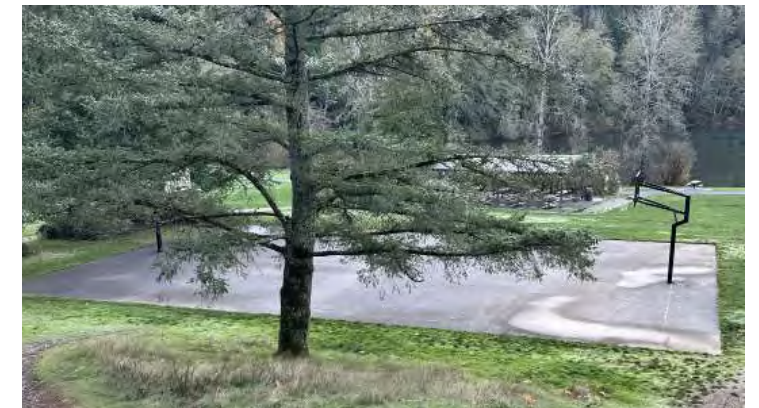
Basketball court- striping is very faded and concrete has numerous cracks- condition rating 4.

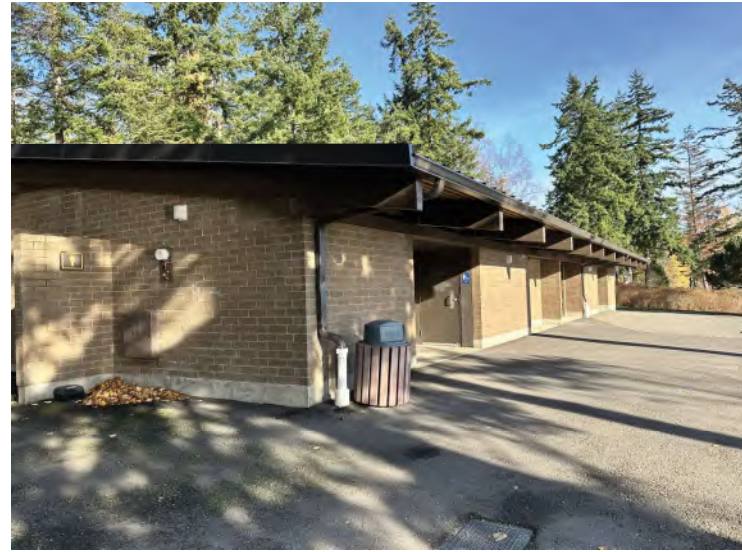
Bath house- condition rating 3.

- Bath house is over-sized for current use- consider decreasing footprint to better accommodate circulation around it.
- Sewer service must be fixed before showers can be repaired/ building upgraded.
- Improve beach access by regrading/ improving beach front that will also protect shoreline.
- Resurface and repaint parking area.
- Consider expanded picnic opportunities south of bath house.

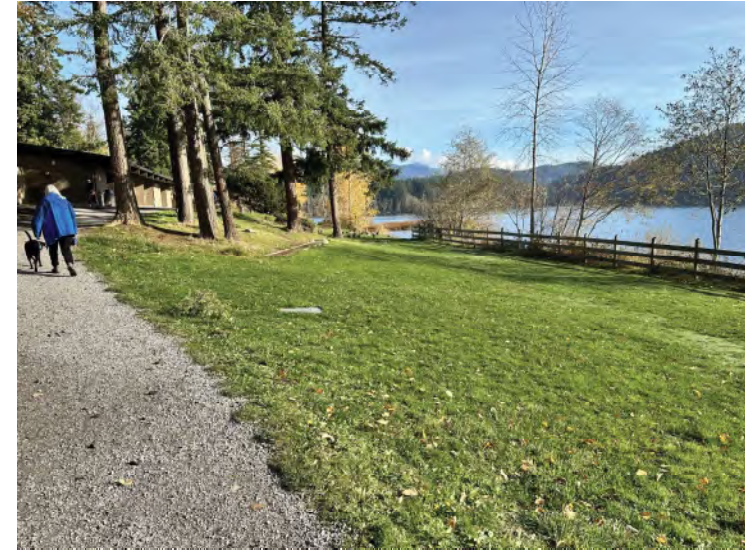
Improved trail- condition rating 3.

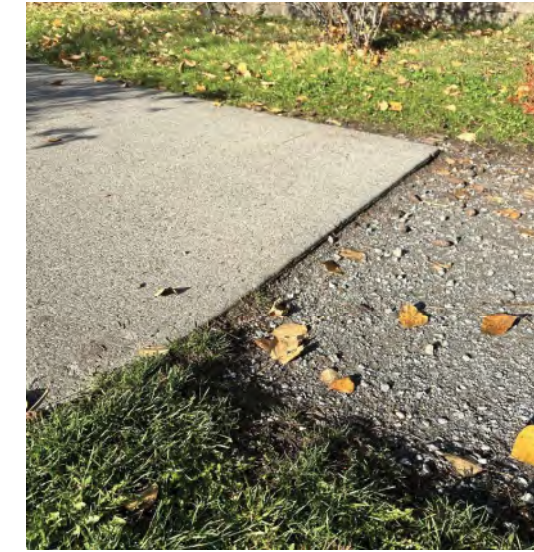
Transition between improved trail and concrete pathways not-ADA compliant.

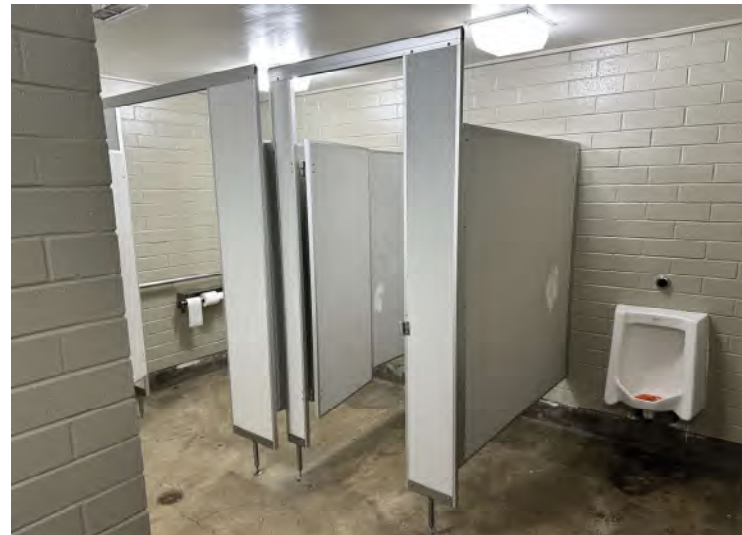
Bath house interior- condition rating 3.

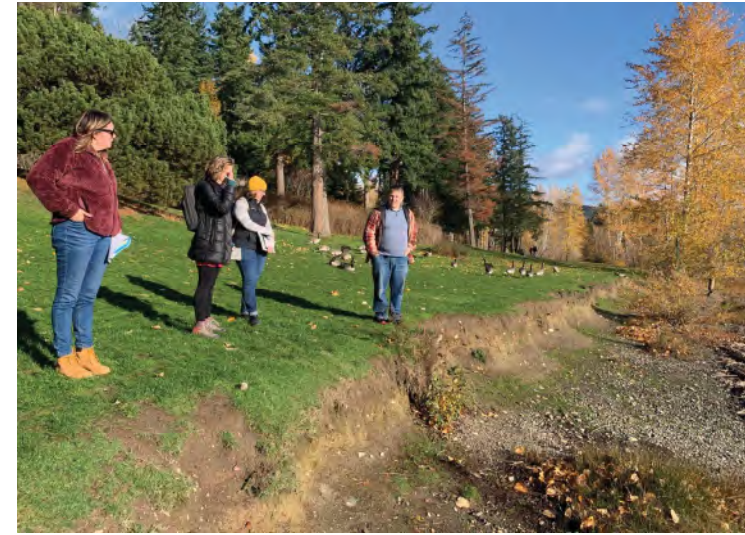
Pronounced bank erosion at shoreline.

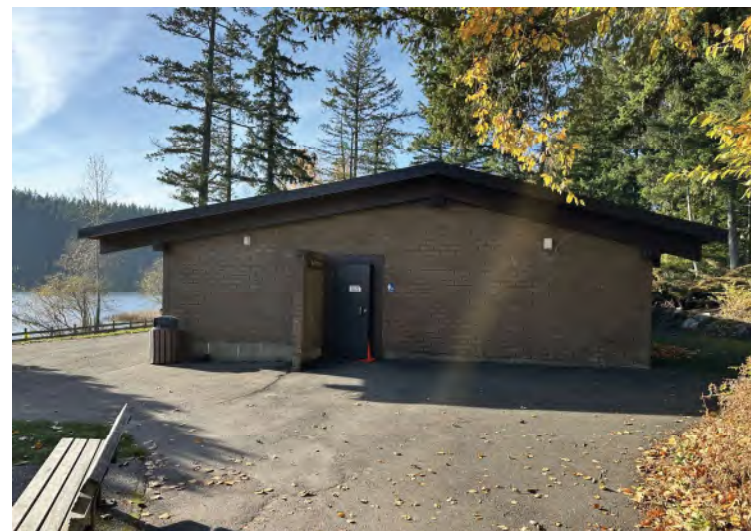
Bath house- condition rating 3.

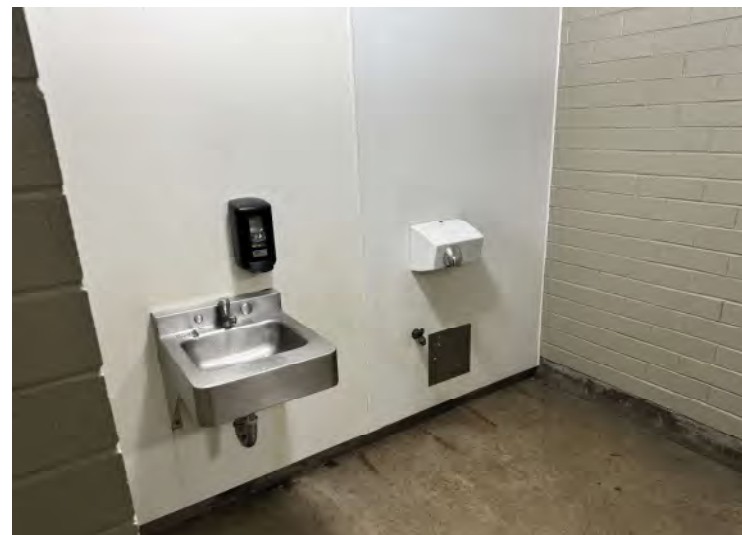
Bath house interior- condition rating 3.

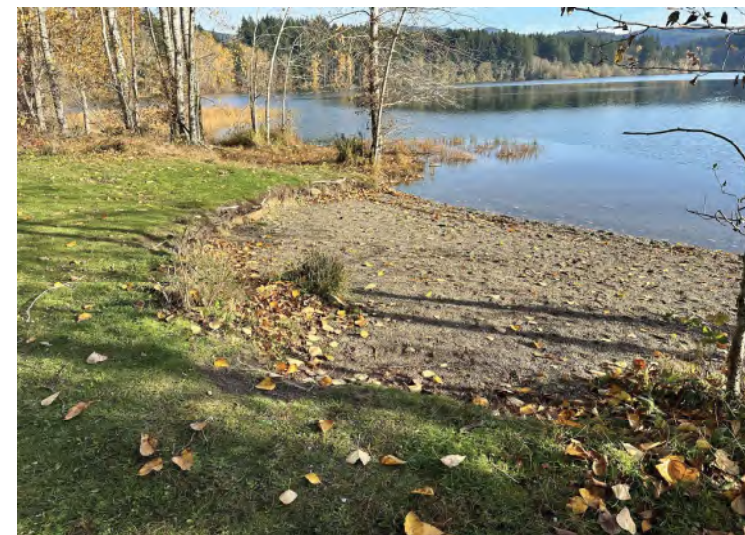
Pronounced bank erosion at shoreline.

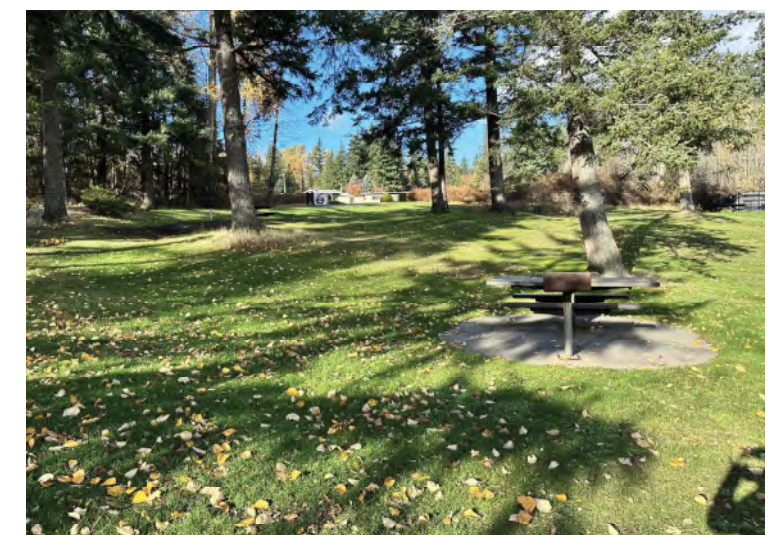
Picnic tables are not ADA compliant nor are the concrete pads.
