# MF Nooksack Channel Monitoring & Adaptive Management As Built Monitoring

Final Report, Rev. 1

NHC Reference 2005776

**City of Bellingham Public Works**

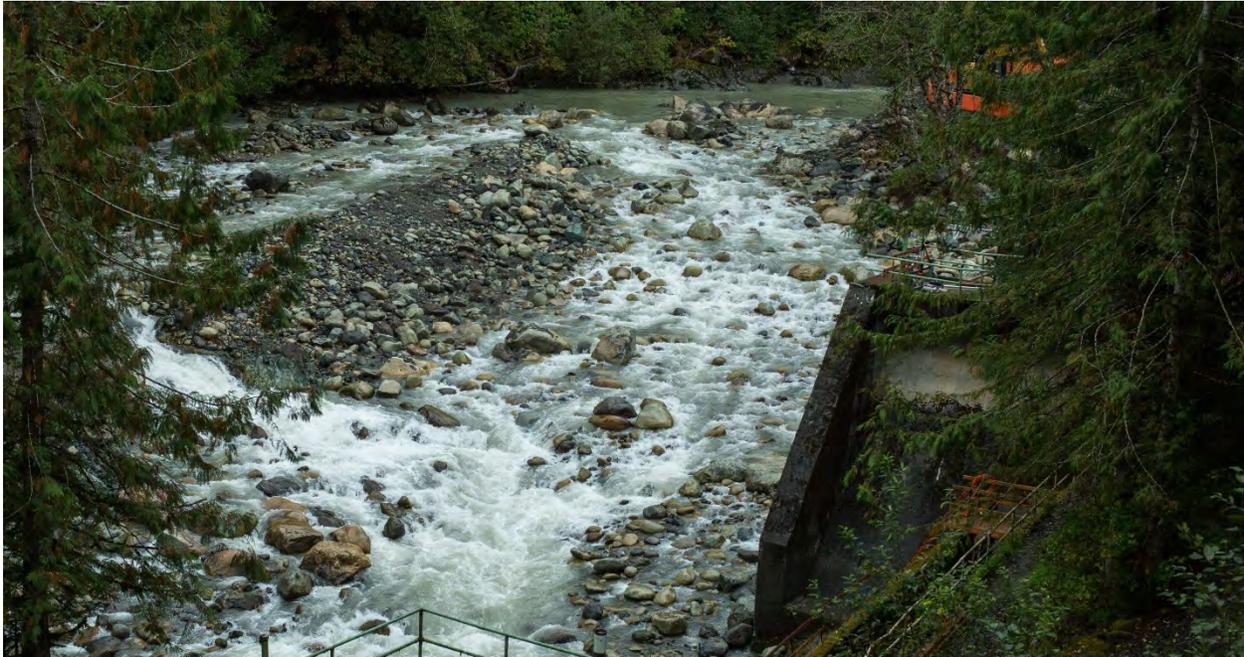
**Photo 2.1** Image from September 23, 2020 at 7:31 AM PDT showing a flow of approximately 170 cfs used to aid development of the as-built topographic surface and for hydraulic model calibration. Photo provided by American Rivers.

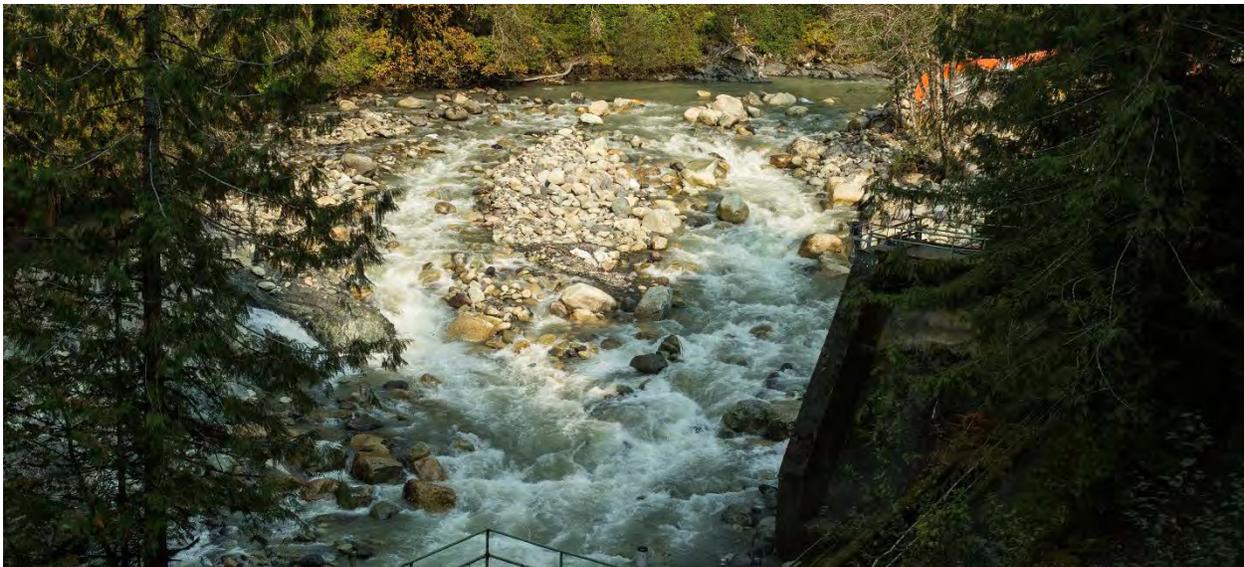
The domain where each of these data sources was used is shown in Figure 2.2. The north portion of the mid-channel bar, between station 240 and 340, was outside of the extent of the dewatered as-built TLS scans, but changed appreciably in the first flow pulse before the Oct 8<sup>th</sup> UAV overflight. Therefore, no data were available to represent the topography of this area. This hole was filled with simple interpolation unless this interpolation indicated an elevation above the 2013 LiDAR, in which case the lower LiDAR elevation was used. This qualitatively matches topography visible in the reference photo (Photo 2.1) for conditions just before the first high flow pulse, which adjusted the channel morphology (Photo 2.2).

**Photo 2.2** Image from September 30, 2020 at 2:16 PM PDT showing a flow of approximately 275 cfs and development of new mid-river channel. Photo provided by American Rivers.

The avulsion of the right bank channel to form the right bank flow pathways (compare Photo 2.1 and Photo 2.2 and see Figure 3.1) has shifted most of the flow in that pathway away from the large shallow and high-velocity step into a much lower slope channel not reflected in the as-built conditions hydraulic model. Although hydraulic conditions in this channel are now precisely known, we interpret—based on the wider channel cross section, lower slope, and higher bed roughness (due to a channel boundary change from rock to boulder)—that hydraulic conditions along the new avulsion pathway of the right bank flowpath are more suitable for fish passage than in the design condition.

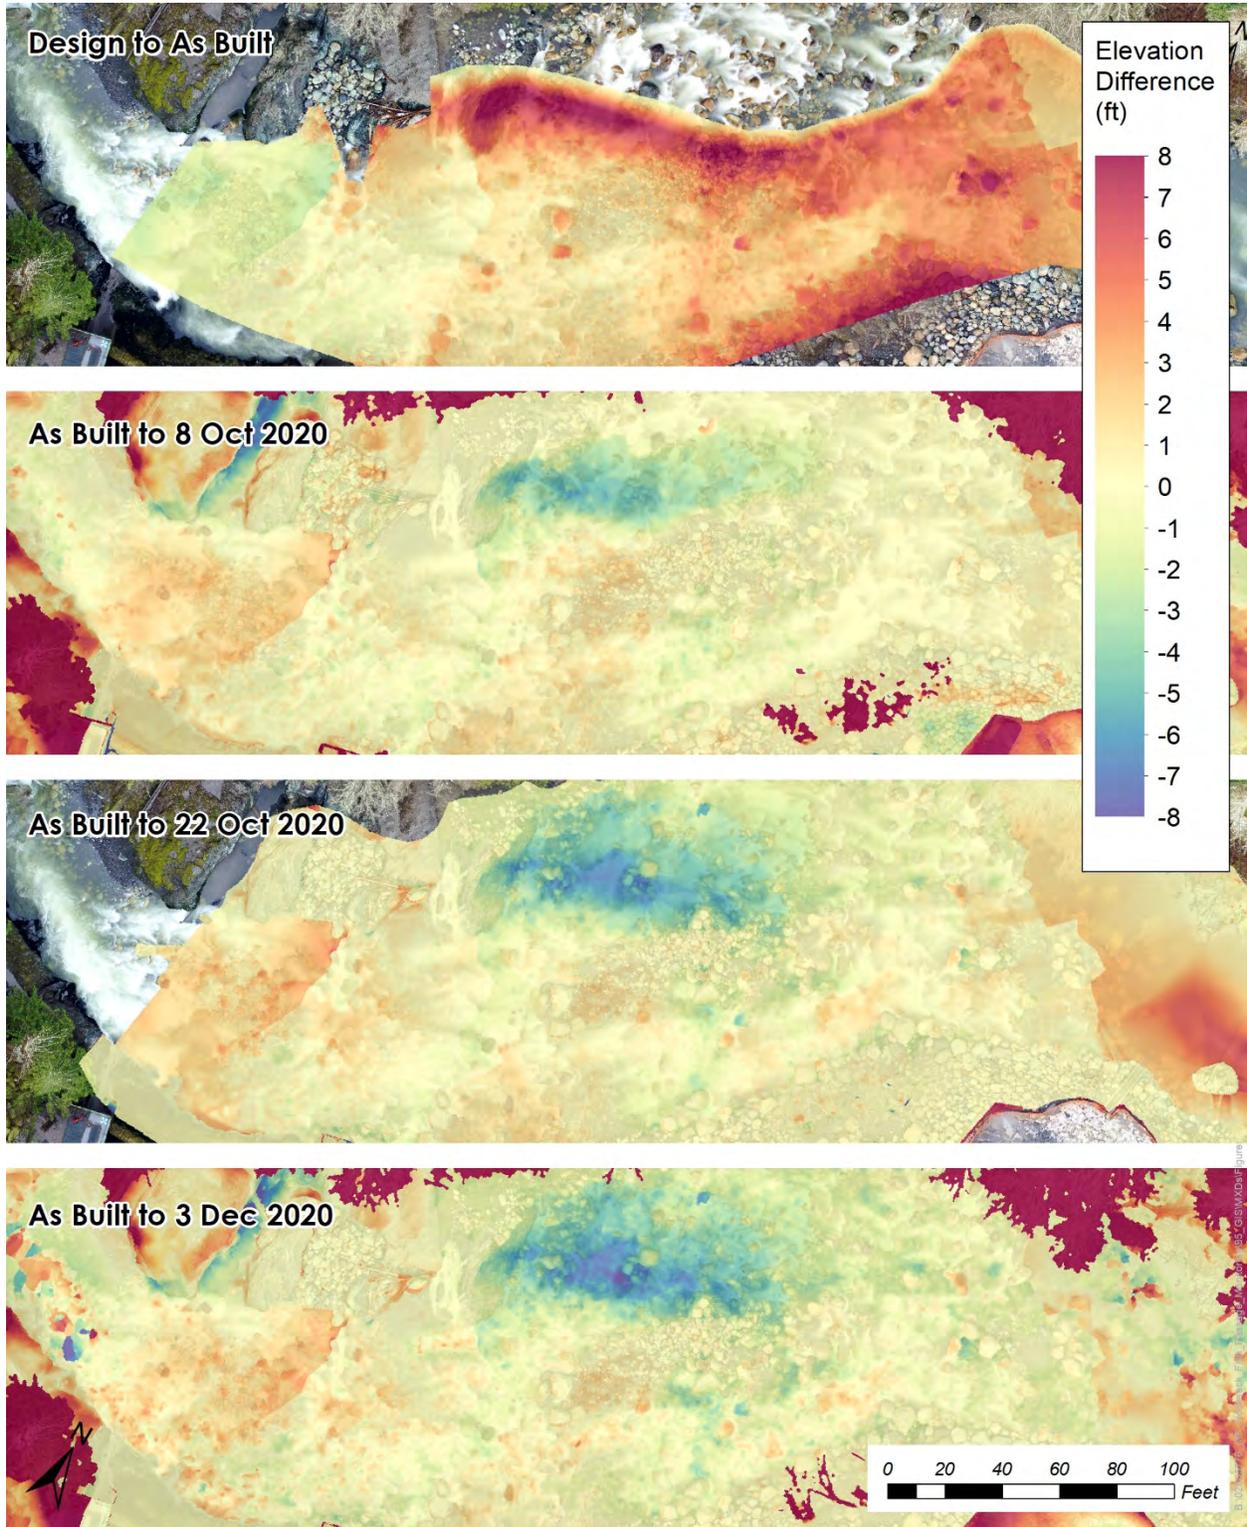
Comparison of the integrated as-built surface with the design channel grading for the project (Figure 3.1 top) indicates that the upstream portion of the channel was built 3 to 4 ft higher than the design and that less material was removed from the right bank portion of the design cut across the mid channel bar than indicated in the design surface. These channel grading revisions performed during construction were made under the direct authorization and observation of the channel design engineer (Paul DeVries).

High flows during autumn 2020 resulted in significant changes in the channel condition through the regraded reach and in the channel immediately downstream of the regraded reach (Figure 3.1). The first flow pulse resulted in scour of a new mid-river channel (Compare Photo 2.1 and Photo 2.2 and changes to 8 October in Figure 3.1), and subsequent flows resulted in continuing deepening of that channel where scour is concentrated in front of a large rock spur and headcutting erosion along the course of the channel towards the fish bypass return pool (compare changes to 8 October, 22 October, and 3 December in Figure 3.1). This channel lowering has removed some of the material along the right bank portion of the design cut that was not removed during construction, but has also removed material from outside (to the north) of the planned excavation area.

**Figure 3.1 DEM surface comparisons showing differences between the design surface and as-built surface (top) and between the as-built surface and subsequent topographic surfaces.**

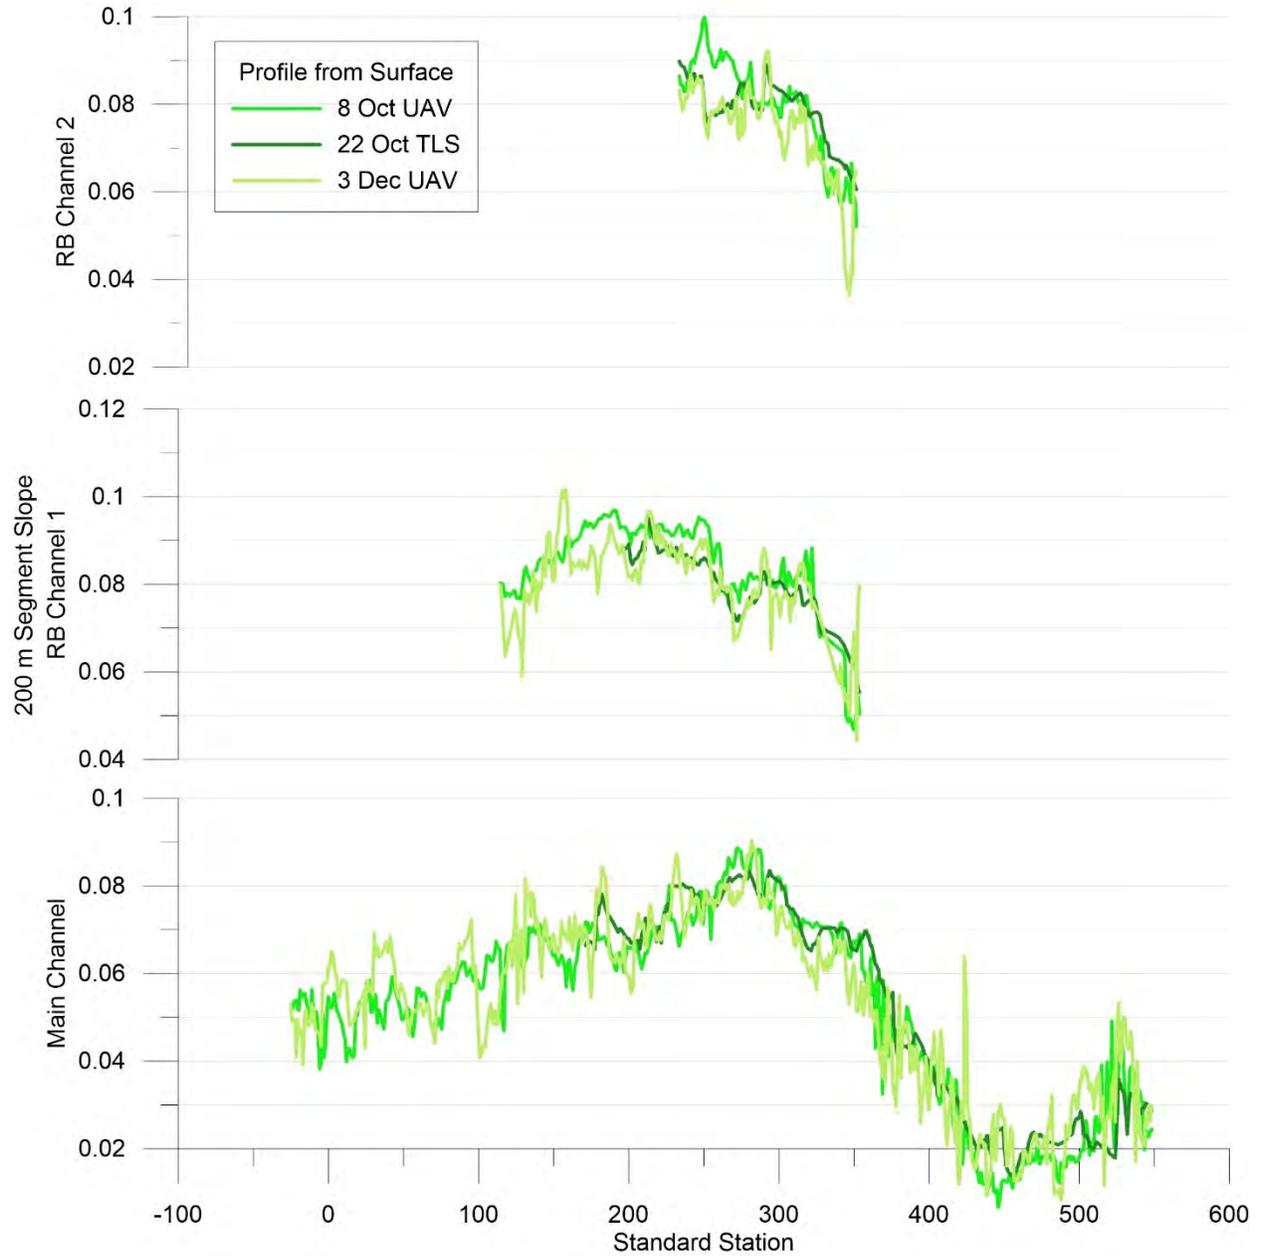
Slopes for 200 ft segments were extracted along each profile path outlined in Figure 2.1 and are plotted in Figure 4.1. Along the main channel, the slope is consistently below 8%, except a small area near station 275 that is between 8 and 9%. The right bank flow paths are slightly steeper, with localized areas between 9 and 10%. The upstream left bank split is less than 200 ft long, but the average slope along that split is 5%. All segments are below the action threshold of a 12% slope (Table 1.1) and below the 2b decision pathway threshold of a 10% slope; but several are above the 7% 2b decision pathway indicating continuing monitoring is needed.

**Figure 4.1** Plots showing 200 ft segment average slopes for each monitoring DEM.

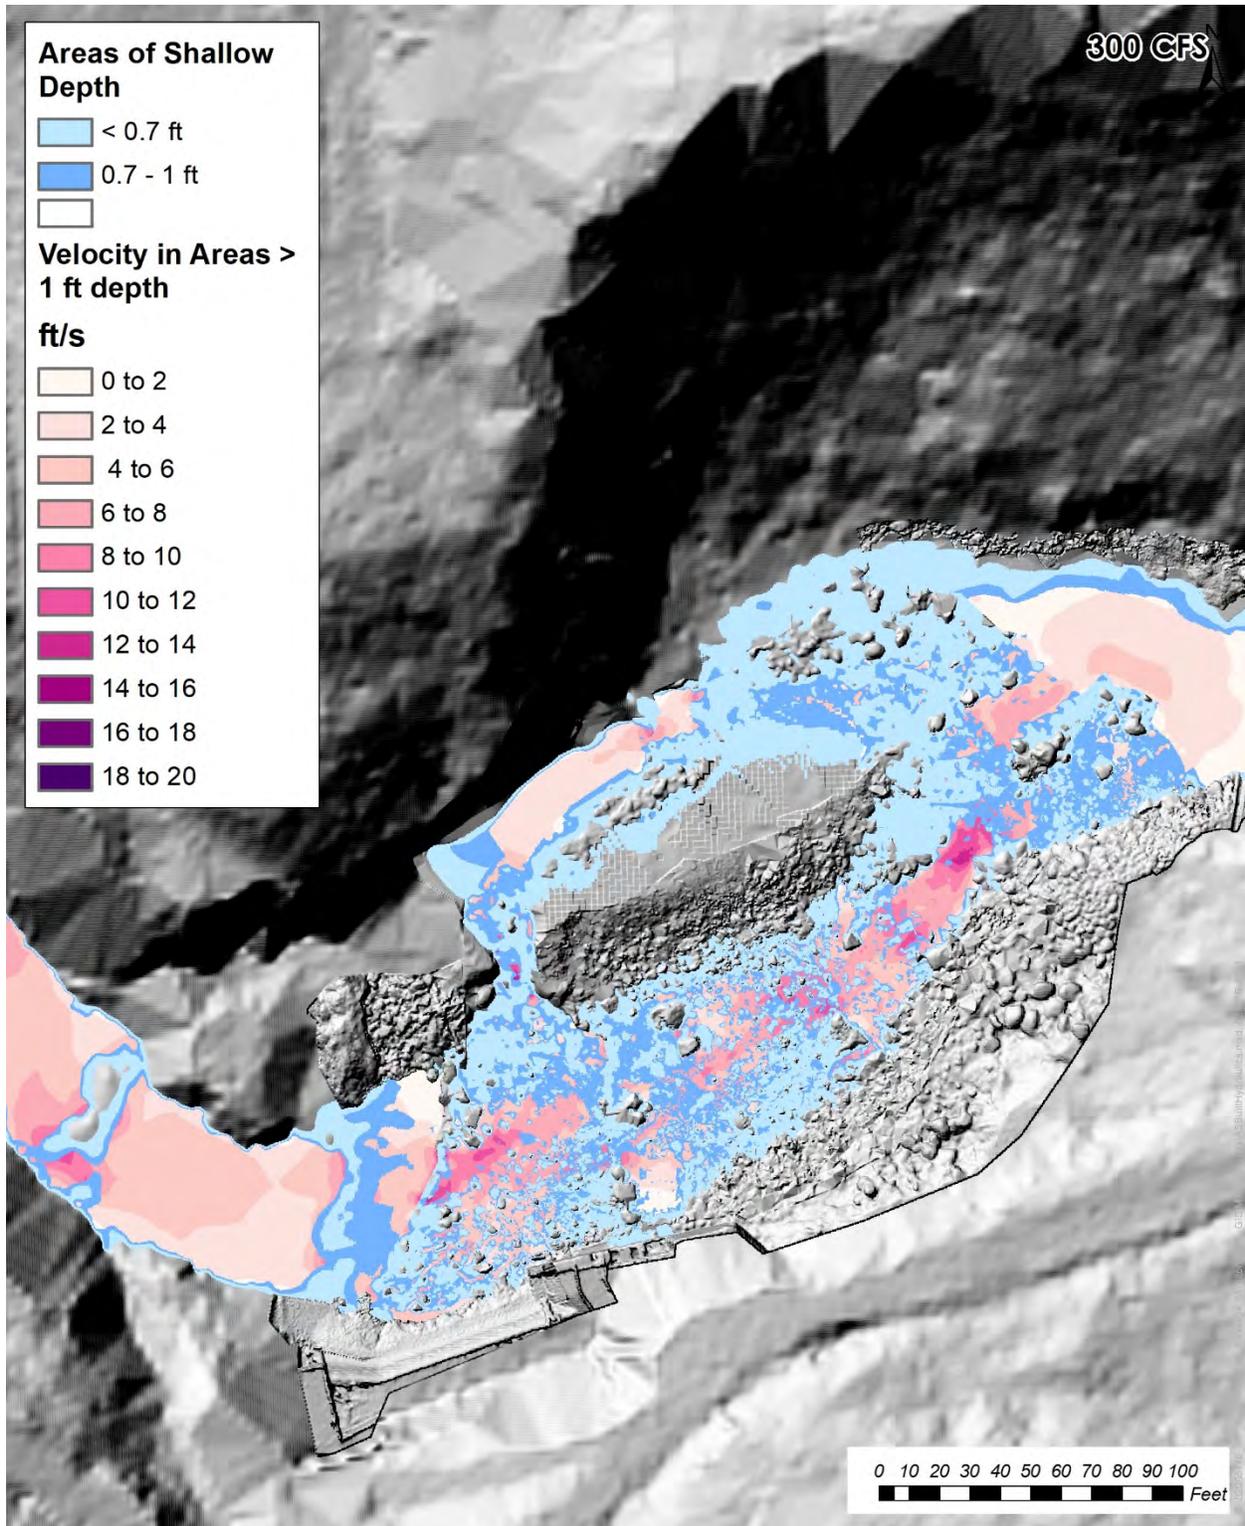
Figure 4.2 through Figure 4.5 depict depth and velocity distributions predicted by the model for the approximate as-built terrain in the river regrade reach, over a similar range of flows assessed during design (DeVries, 2018). The velocities are depth averaged and are generally representative of velocities encountered by the target species adults in shallower water and may be higher than encountered by fish swimming along the bottom in deeper water.

Overall, there appears to be hydraulic longitudinal connectivity along both sides of the design channel with periodic refugia of lower velocity along the viable length at all flows modeled (Figure 4.2 through Figure 4.5). Based on depth, passage opportunities presently appear to be available over a wider section of flow for Steelhead than Chinook, and Chinook Salmon upstream passage may be more limited by depth over the 300-600 cfs flow range than at higher flows. There are two steeper locations that presently represent constrained, but passable sections along the Main Channel, and along the actively regrading secondary right bank flow pathways to the North. Both locations will continue to be monitored through the Spring and evaluated in greater detail after their adjustments appear to have completed for the season.

Figure 4.2 As-built hydraulic model results showing areas of shallow inundation and velocity in areas of deeper inundation for a discharge of 300 cfs.
