# MF Nooksack Channel Monitoring & Adaptive Management As Built Monitoring

May 7, 2021  
Final Report, Rev. 1

NHC Reference 2005776

**City of Bellingham Public Works**  
104 W. Magnolia Street, Suite 109  
Bellingham, WA 98225

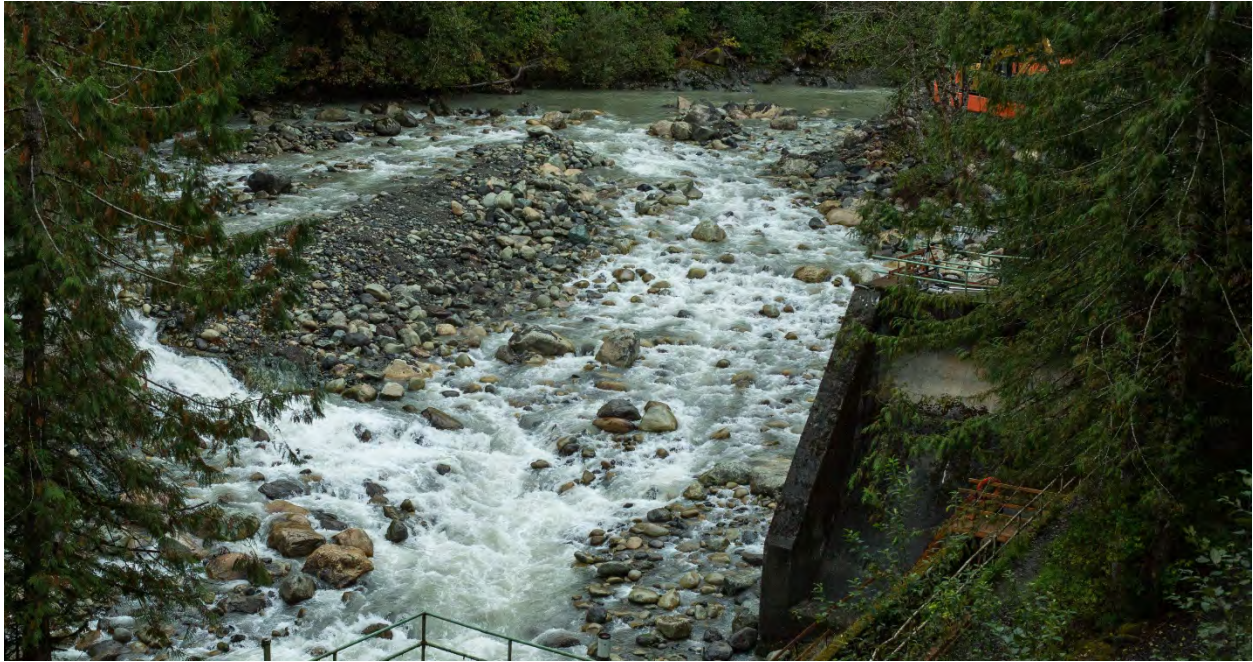
**Photo 2.1** Image from September 23, 2020 at 7:31 AM PDT showing a flow of approximately 170 cfs used to aid development of the as-built topographic surface and for hydraulic model calibration. Photo provided by American Rivers.

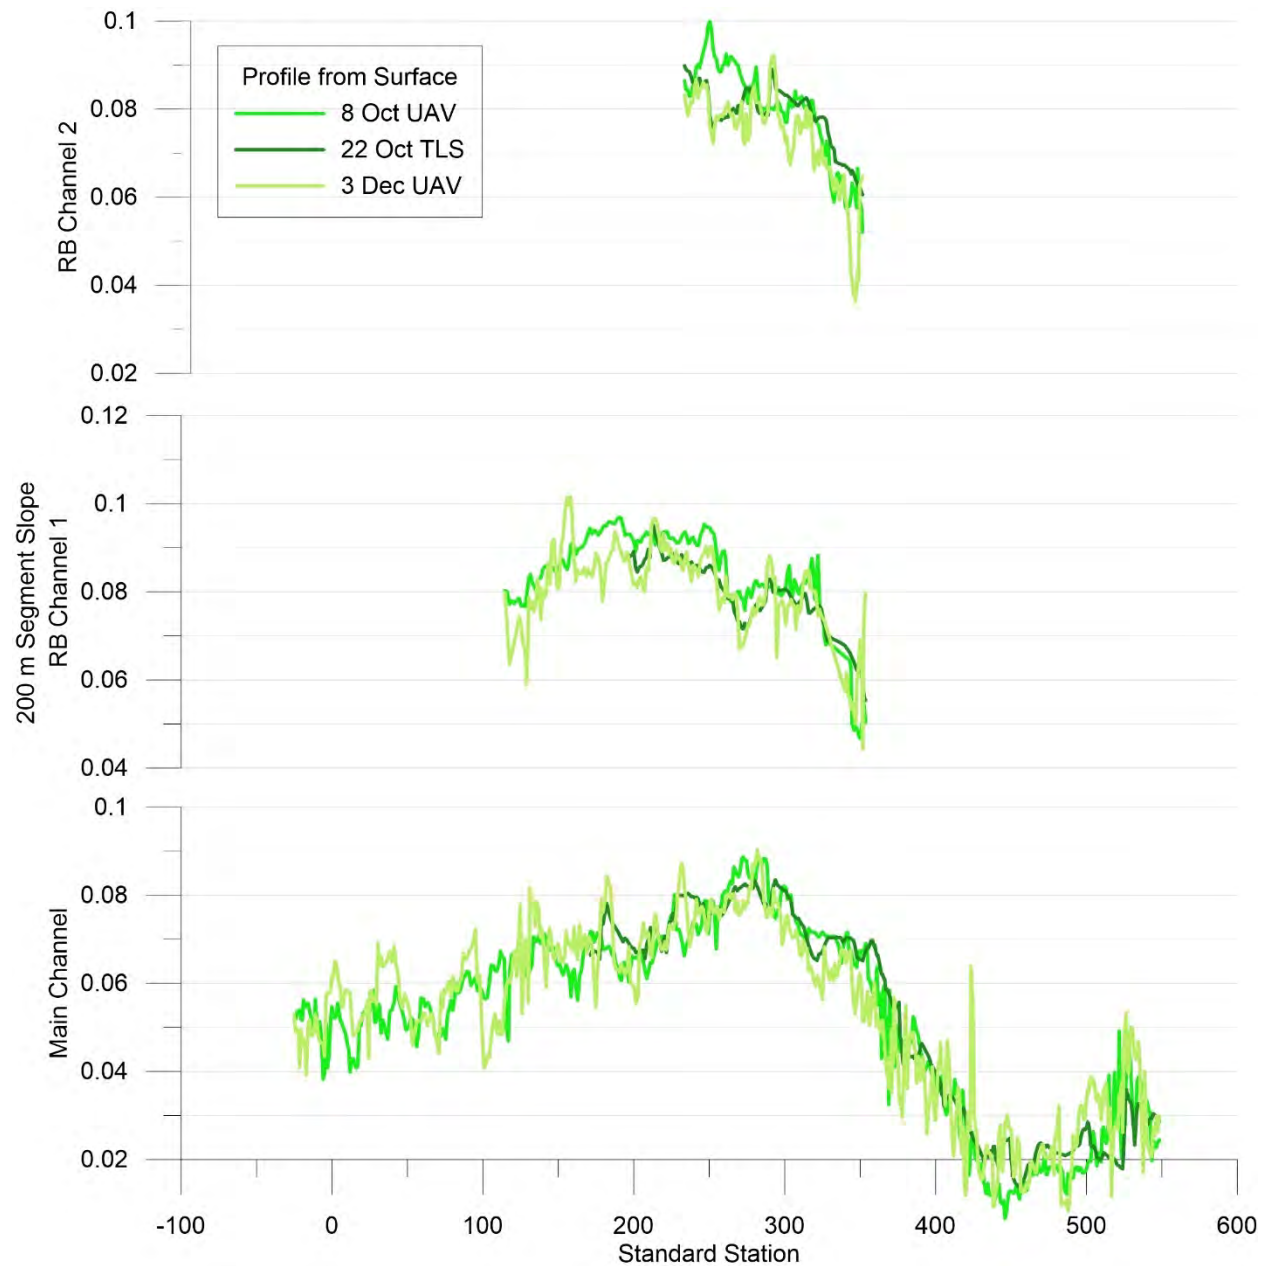
**Figure 4.1** Plots showing 200 ft segment average slopes for each monitoring DEM.

Slopes for 200 ft segments were extracted along each profile path outlined in Figure 2.1 and are plotted in Figure 4.1. Along the main channel, the slope is consistently below 8%, except a small area near station 275 that is between 8 and 9%. The right bank flow paths are slightly steeper, with localized areas between 9 and 10%. The upstream left bank split is less than 200 ft long, but the average slope along that split is 5%. All segments are below the action threshold of a 12% slope (Table 1.1) and below the 2b decision pathway threshold of a 10% slope; but several are above the 7% 2b decision pathway indicating continuing monitoring is needed.
