# MF Nooksack Channel Monitoring & Adaptive Management As Built Monitoring

May 7, 2021  
Final Report, Rev. 1

NHC Reference 2005776

**City of Bellingham Public Works**  
104 W. Magnolia Street, Suite 109  
Bellingham, WA 98225

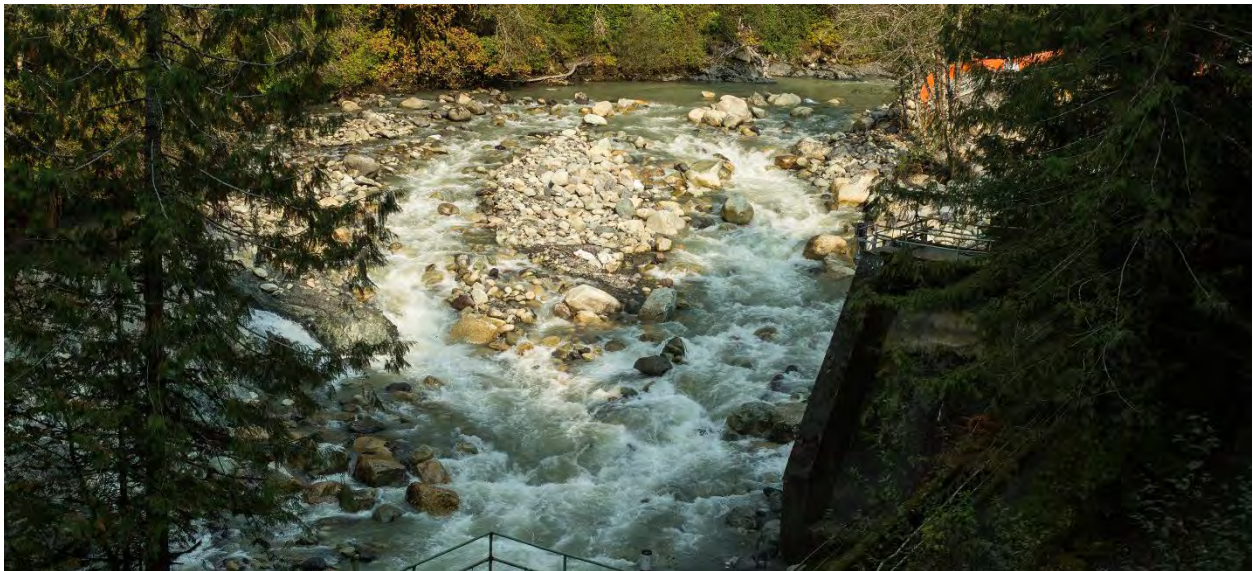
The domain where each of these data sources was used is shown in Figure 2.2. The north portion of the mid-channel bar, between station 240 and 340, was outside of the extent of the dewatered as-built TLS scans, but changed appreciably in the first flow pulse before the Oct 8<sup>th</sup> UAV overflight. Therefore, no data were available to represent the topography of this area. This hole was filled with simple interpolation unless this interpolation indicated an elevation above the 2013 LiDAR, in which case the lower LiDAR elevation was used. This qualitatively matches topography visible in the reference photo (Photo 2.1) for conditions just before the first high flow pulse, which adjusted the channel morphology (Photo 2.2).

**Photo 2.2** Image from September 30, 2020 at 2:16 PM PDT showing a flow of approximately 275 cfs and development of new mid-river channel. Photo provided by American Rivers.

The avulsion of the right bank channel to form the right bank flow pathways (compare Photo 2.1 and Photo 2.2 and see Figure 3.1) has shifted most of the flow in that pathway away from the large shallow and high-velocity step into a much lower slope channel not reflected in the as-built conditions hydraulic model. Although hydraulic conditions in this channel are now precisely known, we interpret—based on the wider channel cross section, lower slope, and higher bed roughness (due to a channel boundary change from rock to boulder)—that hydraulic conditions along the new avulsion pathway of the right bank flowpath are more suitable for fish passage than in the design condition.

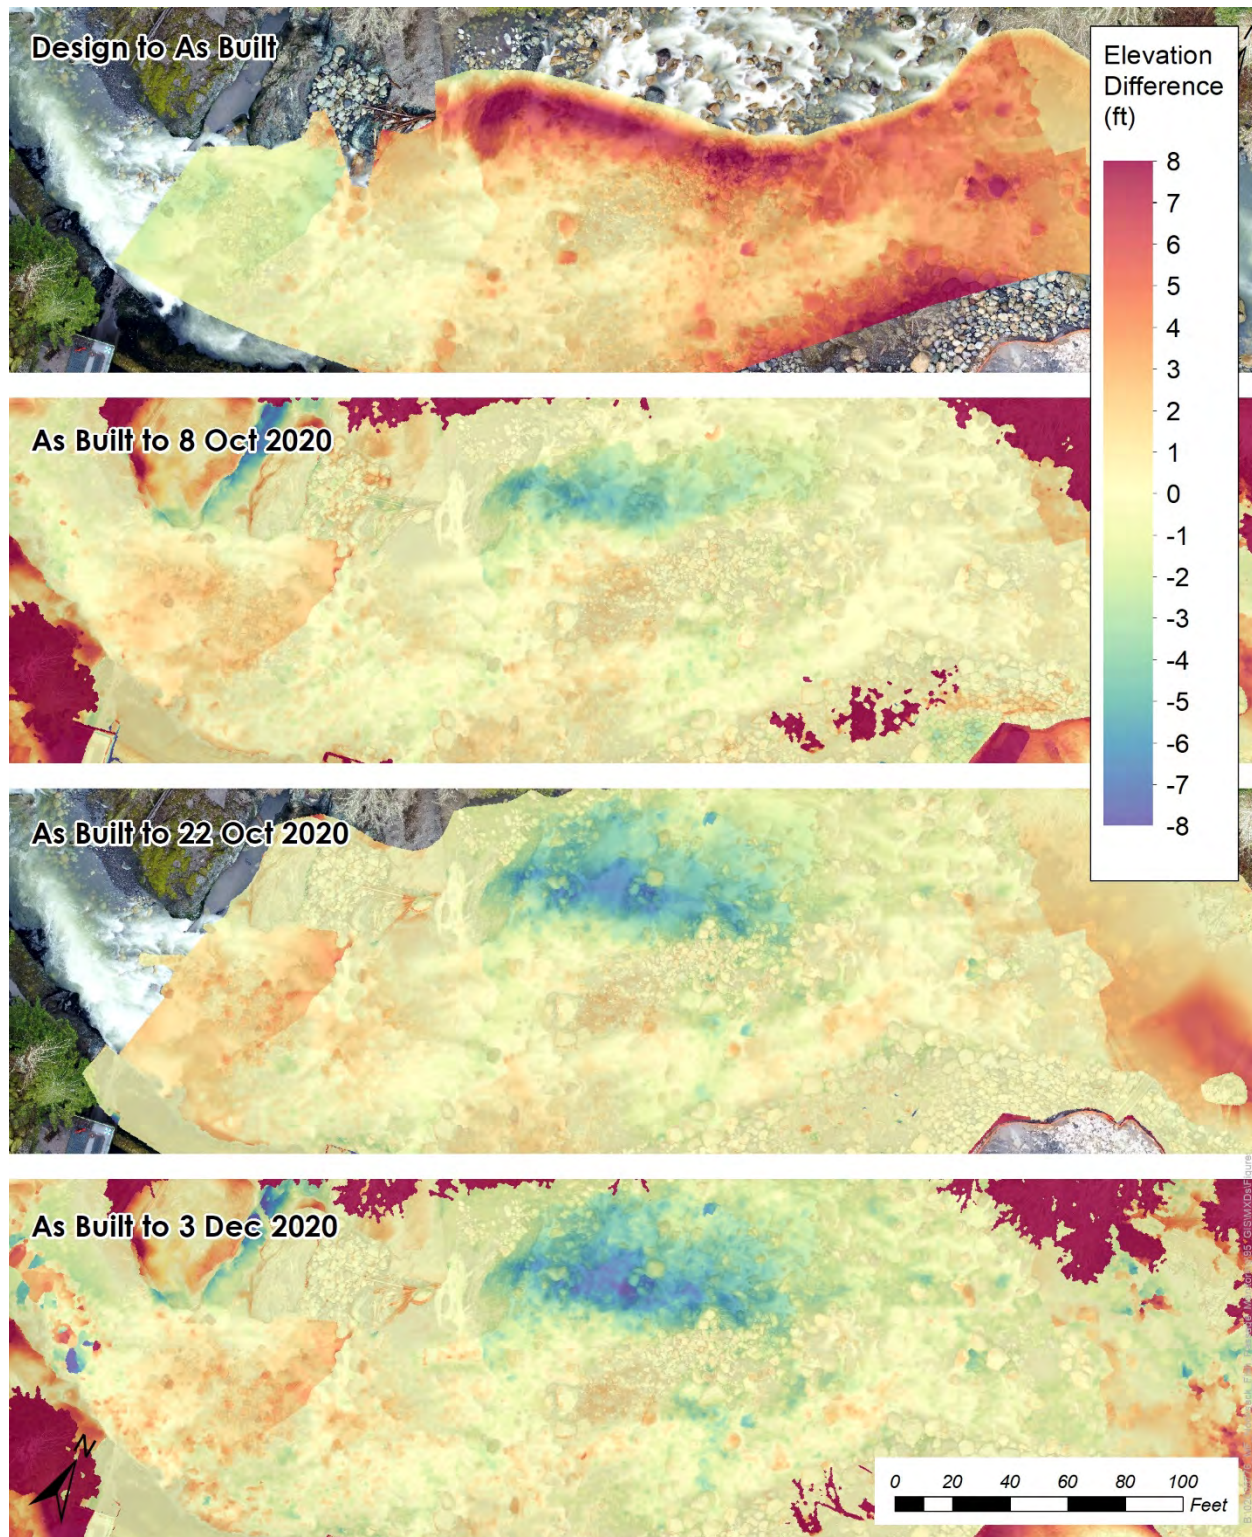
Comparison of the integrated as-built surface with the design channel grading for the project (Figure 3.1 top) indicates that the upstream portion of the channel was built 3 to 4 ft higher than the design and that less material was removed from the right bank portion of the design cut across the mid channel bar than indicated in the design surface. These channel grading revisions performed during construction were made under the direct authorization and observation of the channel design engineer (Paul DeVries).

High flows during autumn 2020 resulted in significant changes in the channel condition through the regraded reach and in the channel immediately downstream of the regraded reach (Figure 3.1). The first flow pulse resulted in scour of a new mid-river channel (Compare Photo 2.1 and Photo 2.2 and changes to 8 October in Figure 3.1), and subsequent flows resulted in continuing deepening of that channel where scour is concentrated in front of a large rock spur and headcutting erosion along the course of the channel towards the fish bypass return pool (compare changes to 8 October, 22 October, and 3 December in Figure 3.1). This channel lowering has removed some of the material along the right bank portion of the design cut that was not removed during construction, but has also removed material from outside (to the north) of the planned excavation area.

Much subtle changes have occurred along the dominant left bank channel where boulder jams were installed to control the grade. The boulder jams have remained stable, though individual overexposed boulders up to 2 m in diameter have shifted and moved short distances (e.g. 3 to 12 m).

**Figure 3.1** DEM surface comparisons showing differences between the design surface and as-built surface (top) and between the as-built surface and subsequent topographic surfaces.

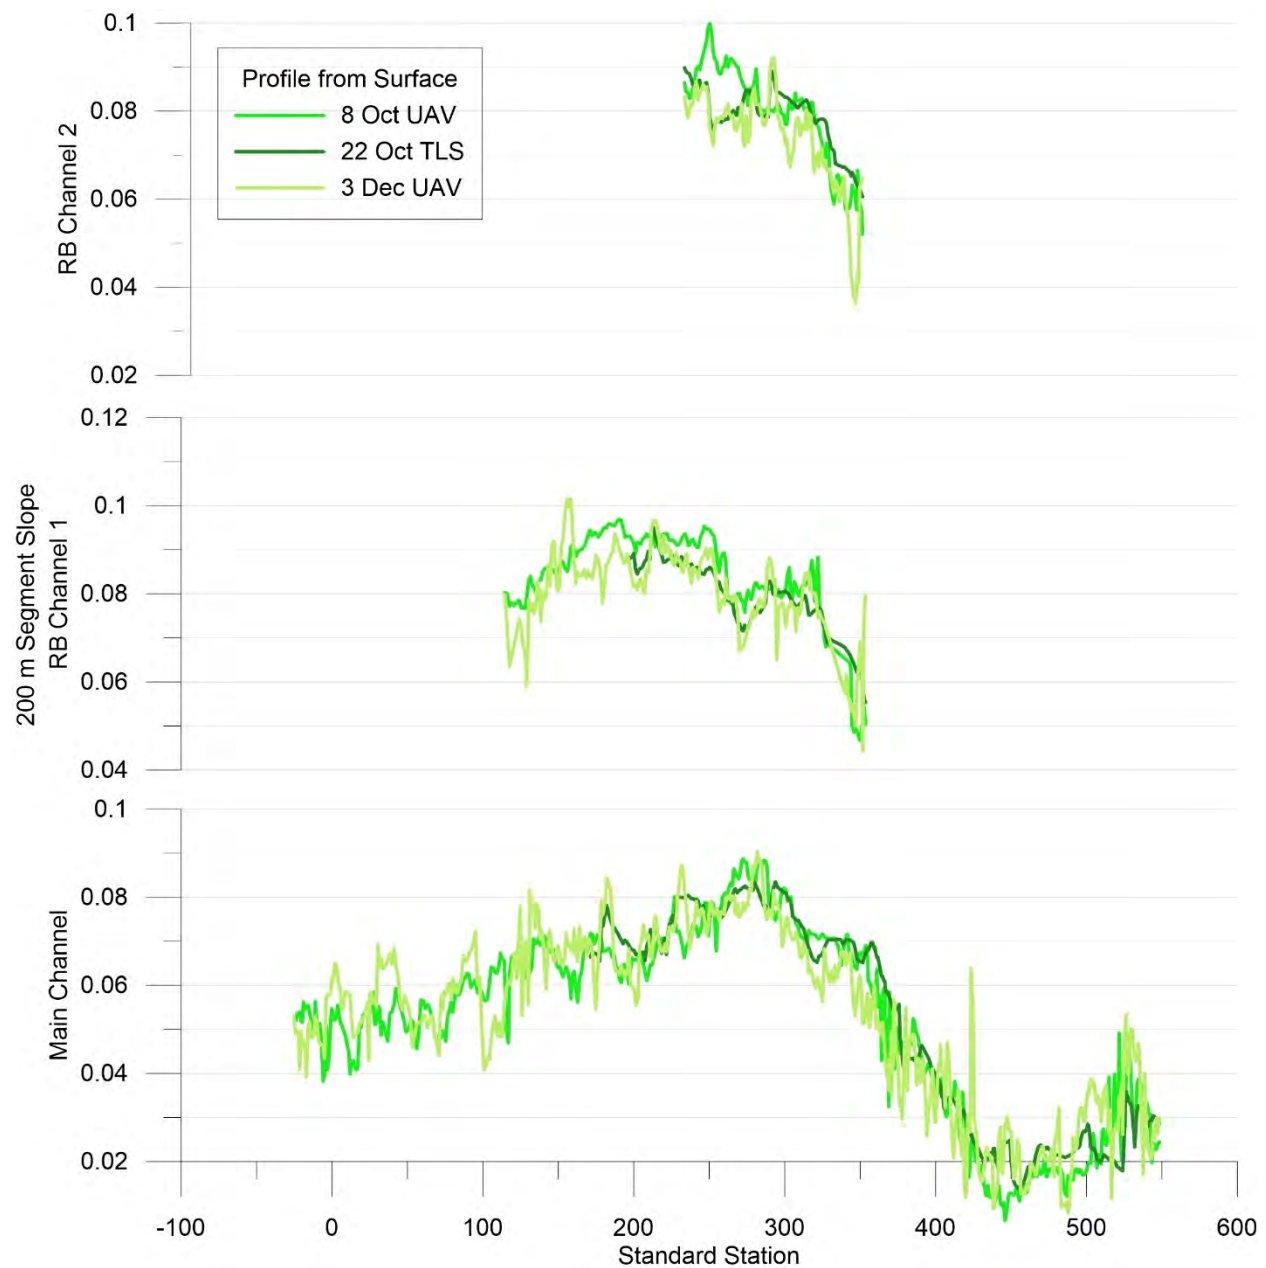
Slopes for 200 ft segments were extracted along each profile path outlined in Figure 2.1 and are plotted in Figure 4.1. Along the main channel, the slope is consistently below 8%, except a small area near station 275 that is between 8 and 9%. The right bank flow paths are slightly steeper, with localized areas between 9 and 10%. The upstream left bank split is less than 200 ft long, but the average slope along that split is 5%. All segments are below the action threshold of a 12% slope (Table 1.1) and below the 2b decision pathway threshold of a 10% slope; but several are above the 7% 2b decision pathway indicating continuing monitoring is needed.

**Figure 4.1** Plots showing 200 ft segment average slopes for each monitoring DEM.

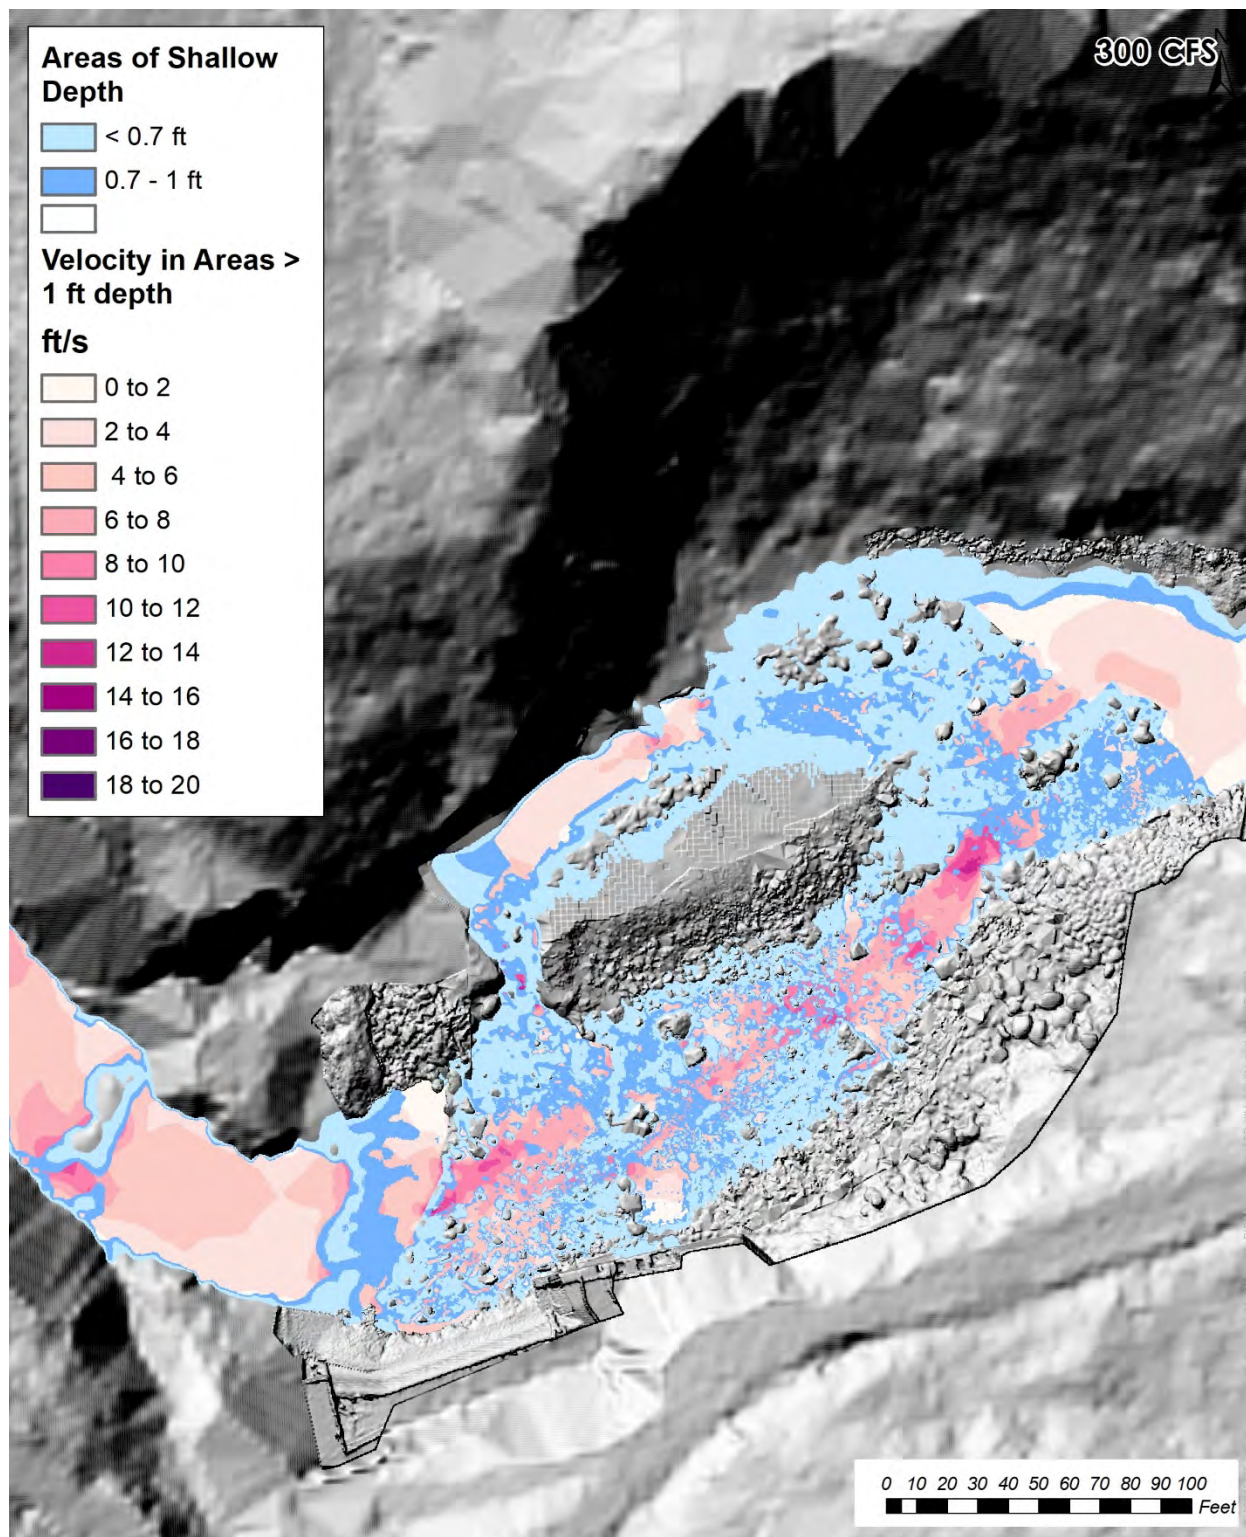
Figure 4.2 through Figure 4.5 depict depth and velocity distributions predicted by the model for the approximate as-built terrain in the river regrade reach, over a similar range of flows assessed during design (DeVries, 2018). The velocities are depth averaged and are generally representative of velocities encountered by the target species adults in shallower water and may be higher than encountered by fish swimming along the bottom in deeper water.

**Figure 4.2** As-built hydraulic model results showing areas of shallow inundation and velocity in areas of deeper inundation for a discharge of 300 cfs.

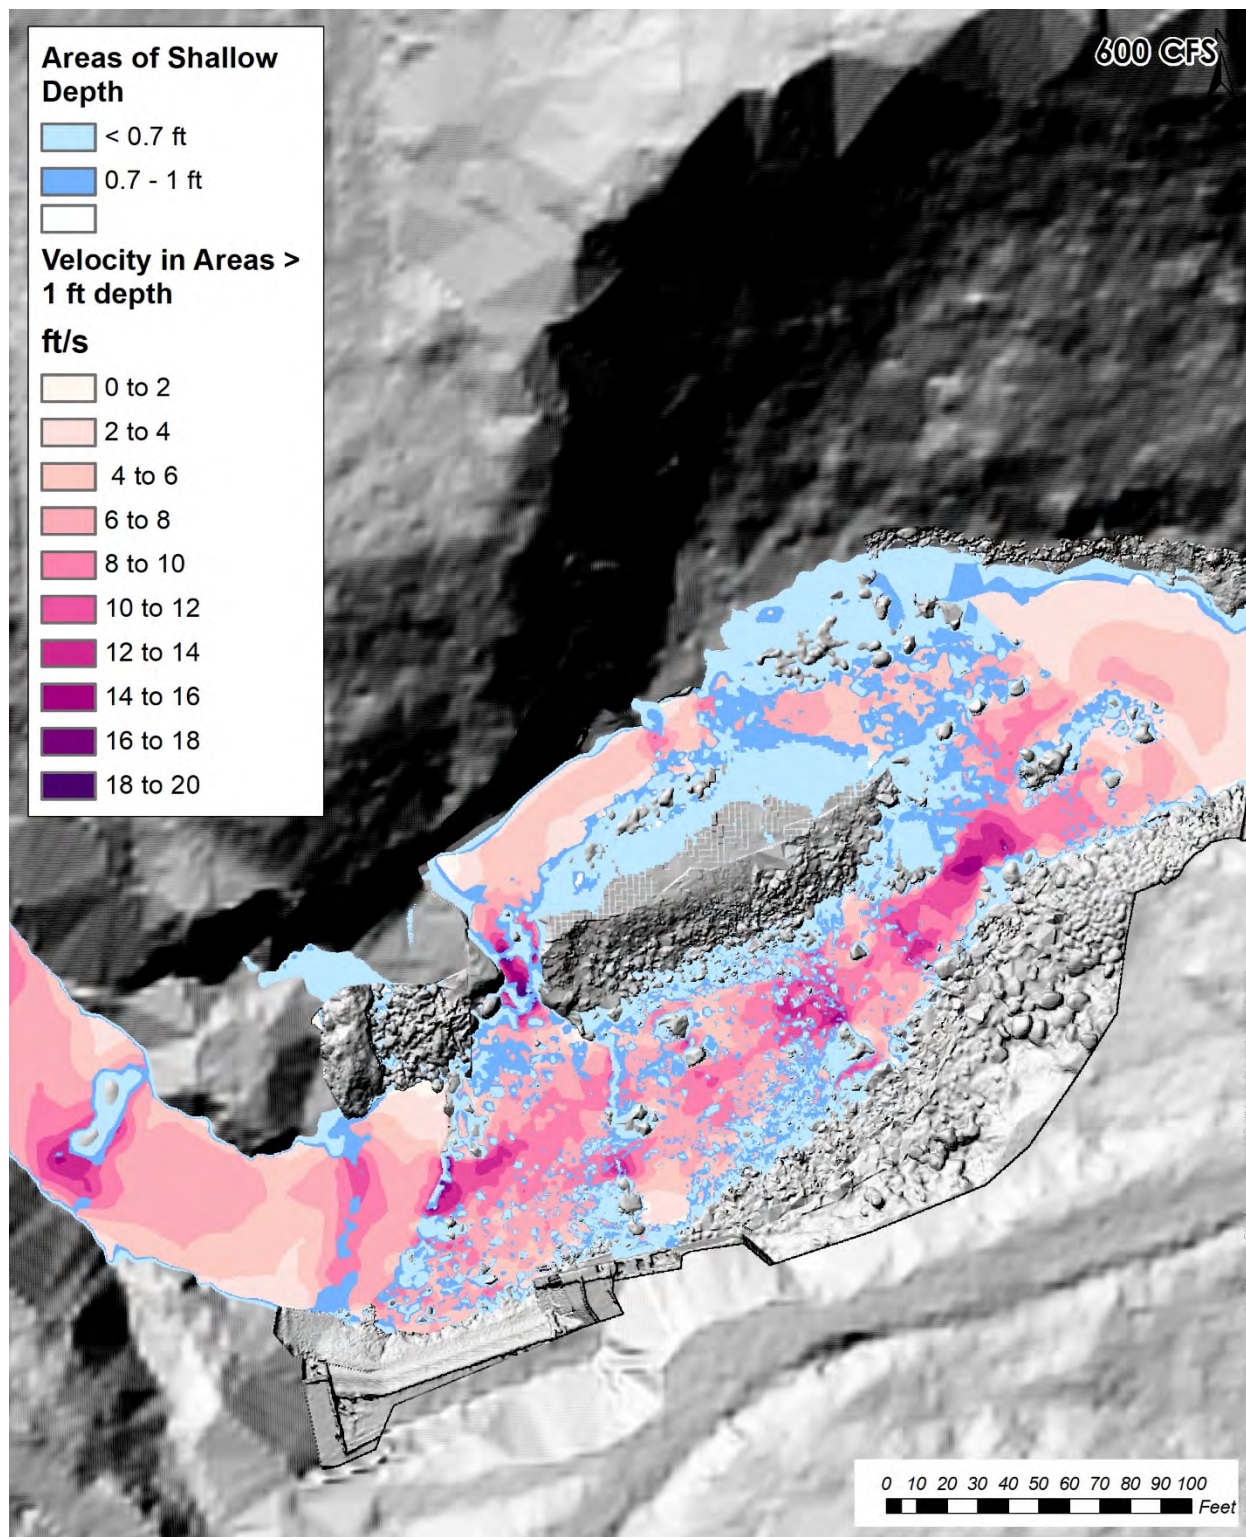
**Figure 4.3** As-built hydraulic model results showing areas of shallow inundation and velocity in areas of deeper inundation for a discharge of 600 cfs.

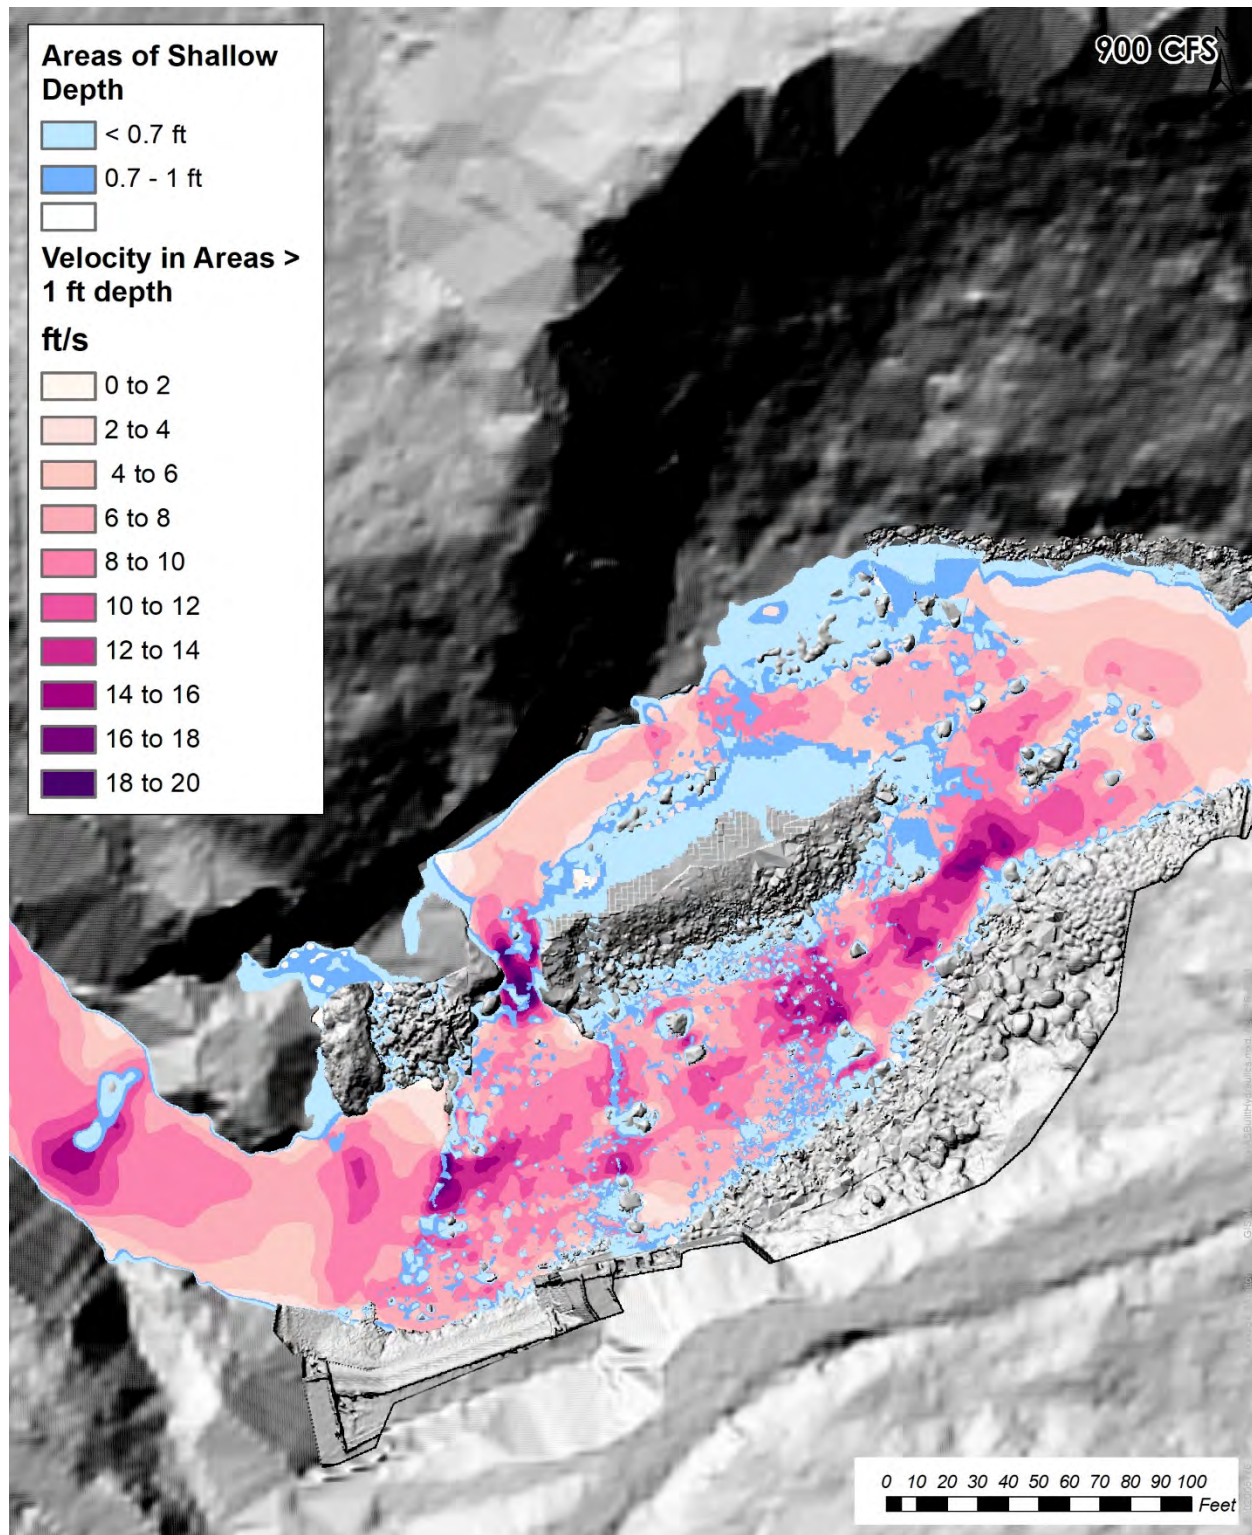
**Figure 4.4** As-built hydraulic model results showing areas of shallow inundation and velocity in areas of deeper inundation for a discharge of 900 cfs.

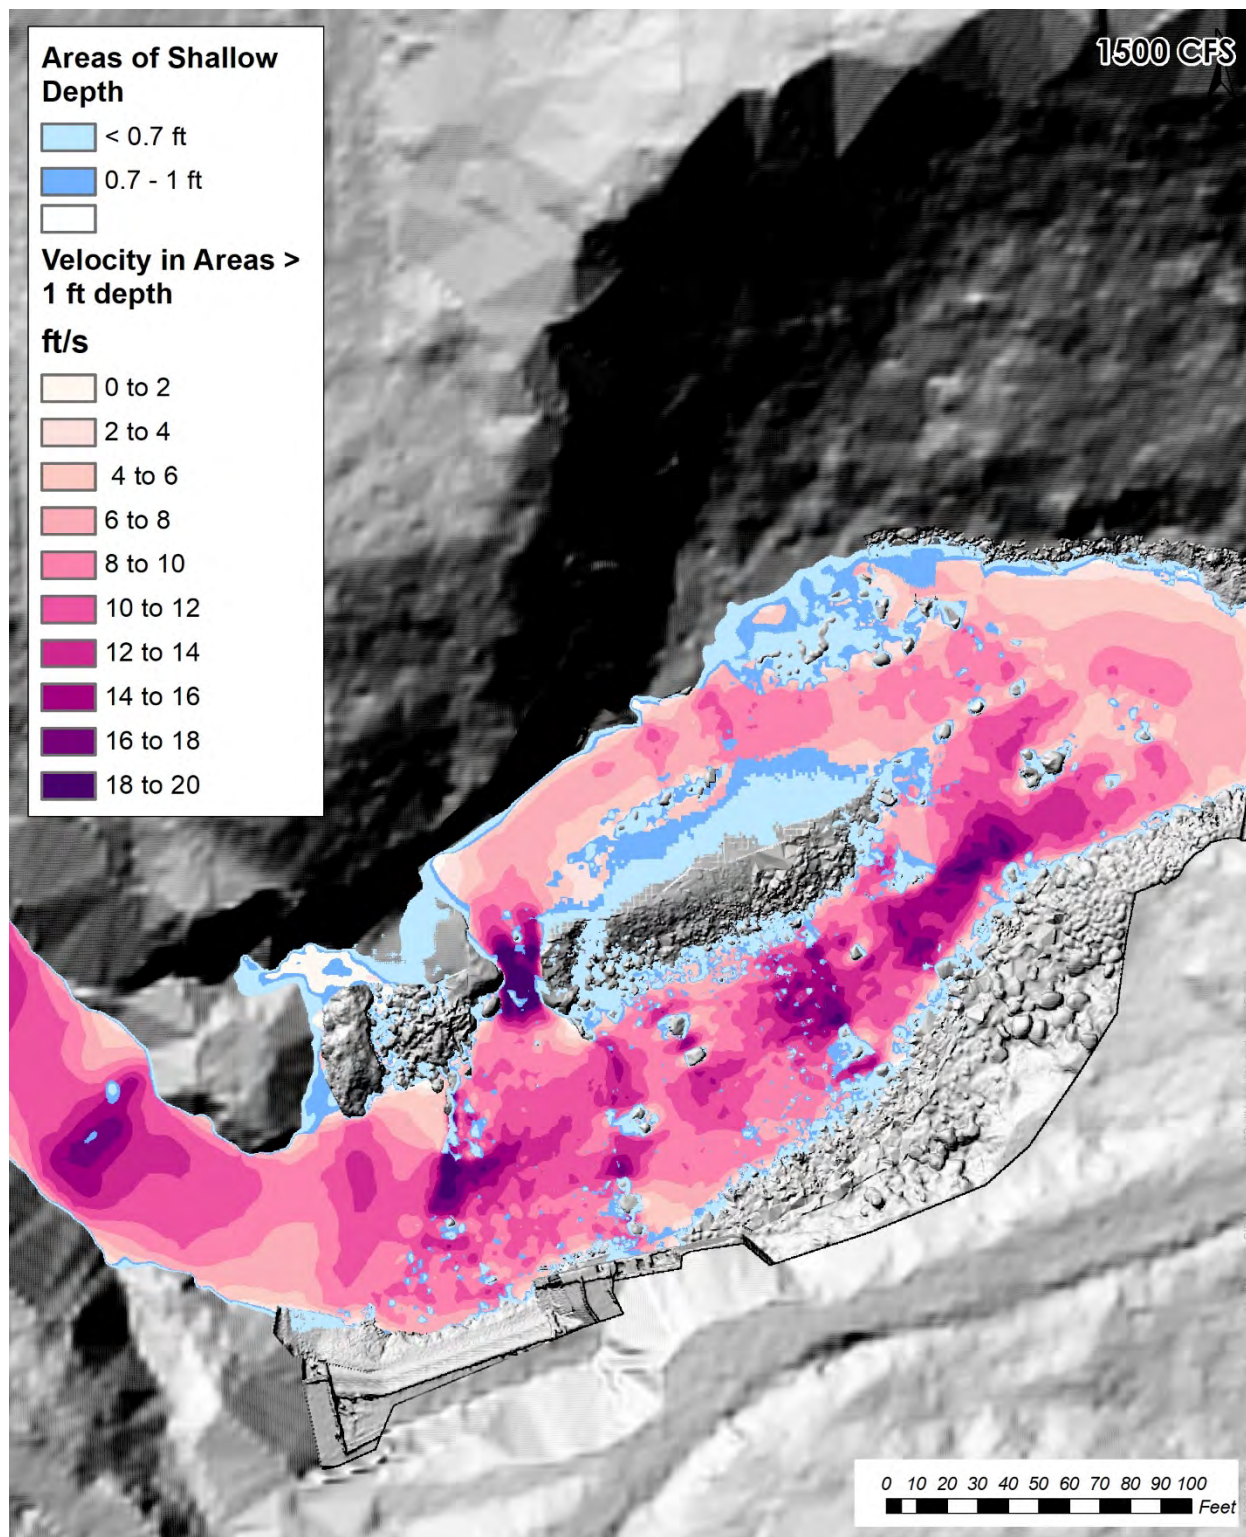
**Figure 4.5** As-built hydraulic model results showing areas of shallow inundation and velocity in areas of deeper inundation for a discharge of 1500 cfs.
