MF Nooksack Channel Monitoring & Adaptive Management Year 1 Monitoring

June 6, 2022
Final Report, Rev. 1

NHC Reference 2005776

City of Bellingham Public Works
104 W. Magnolia Street, Suite 109
Bellingham, WA 98225

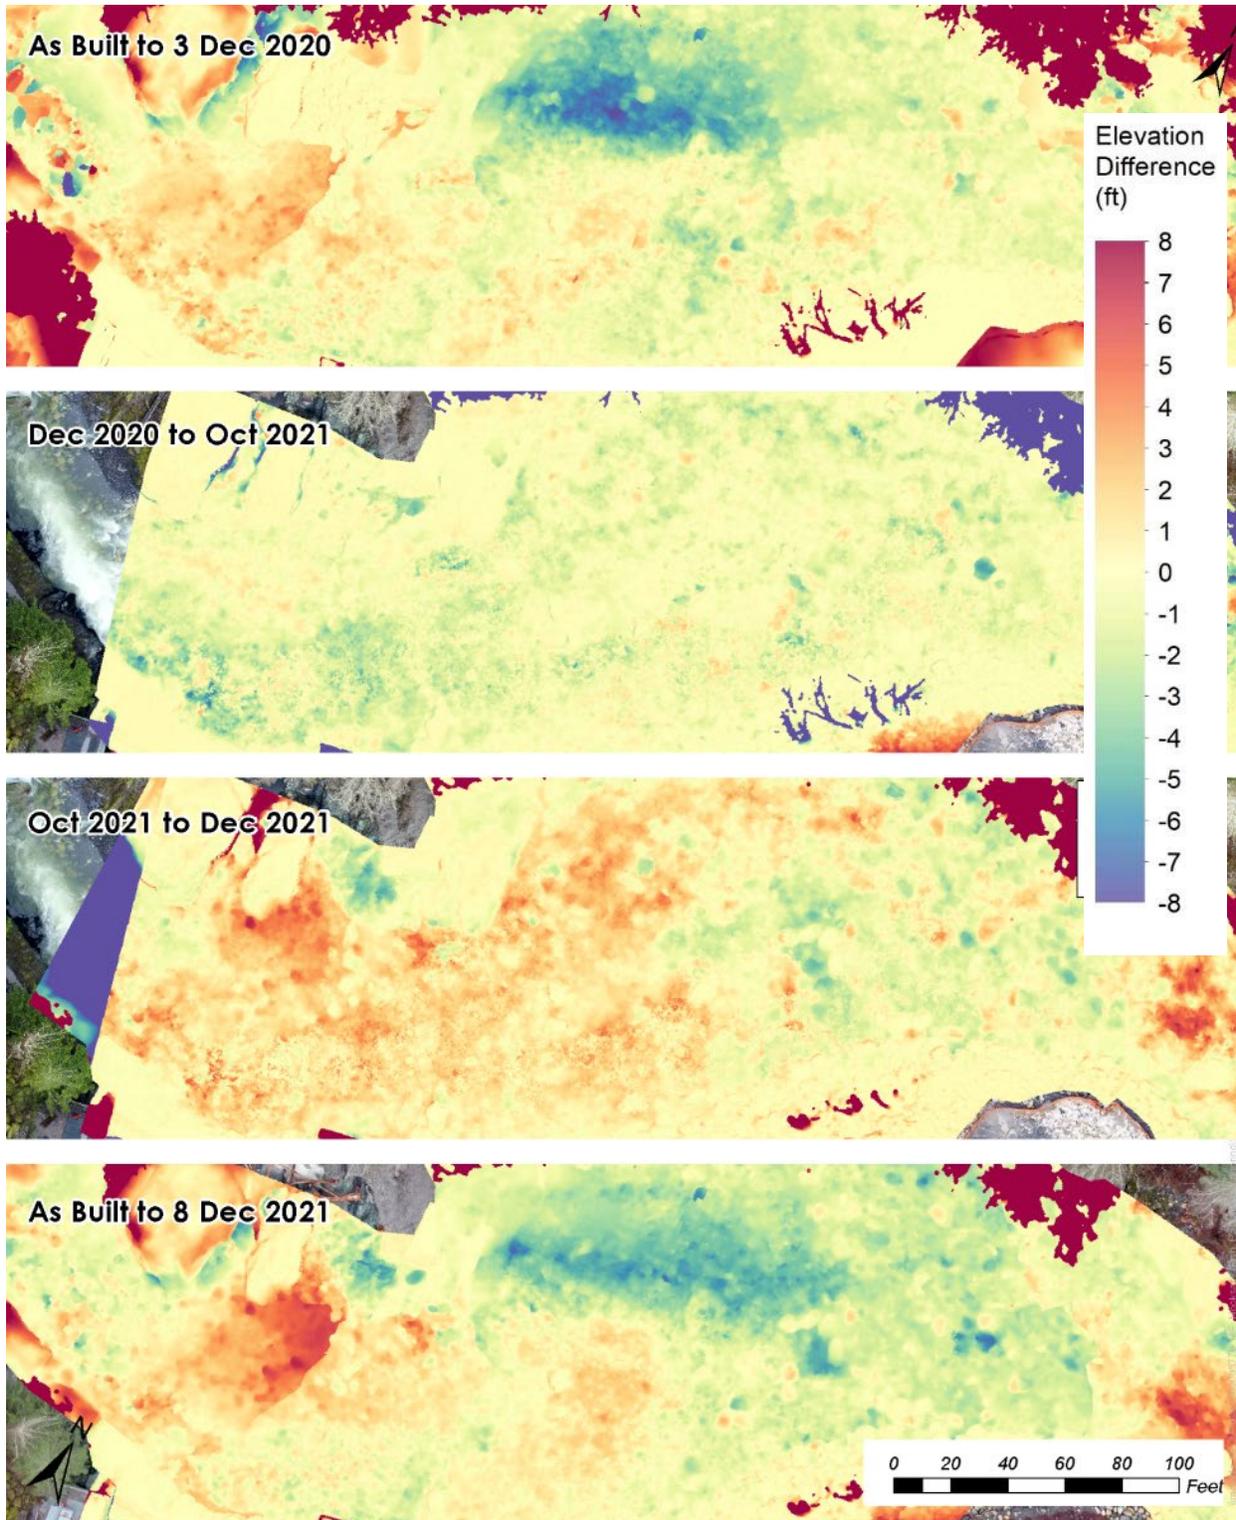
The regraded reach was extremely stable between December 2020 and October 2021, when only subtle changes occurred to the bed along the dominant left and right bank channels (Figure 3.1 and Figure 3.2). This is particularly true of the left bank channel where boulder jams were installed to control the grade. The boulder jams have remained stable, though individual overexposed boulders up to 2 m in diameter shifted and moved short distances (e.g., 3 to 10 m). Small boulders have also shifted in similar extents in the right bank channel where fewer boulder jamming structures exist.

Figure 3.1 DEM surface comparisons showing differences between the design surface and as-built surface (top) and between the as-built surface and subsequent topographic surfaces. Red colors indicate aggradation and blue colors degradation.

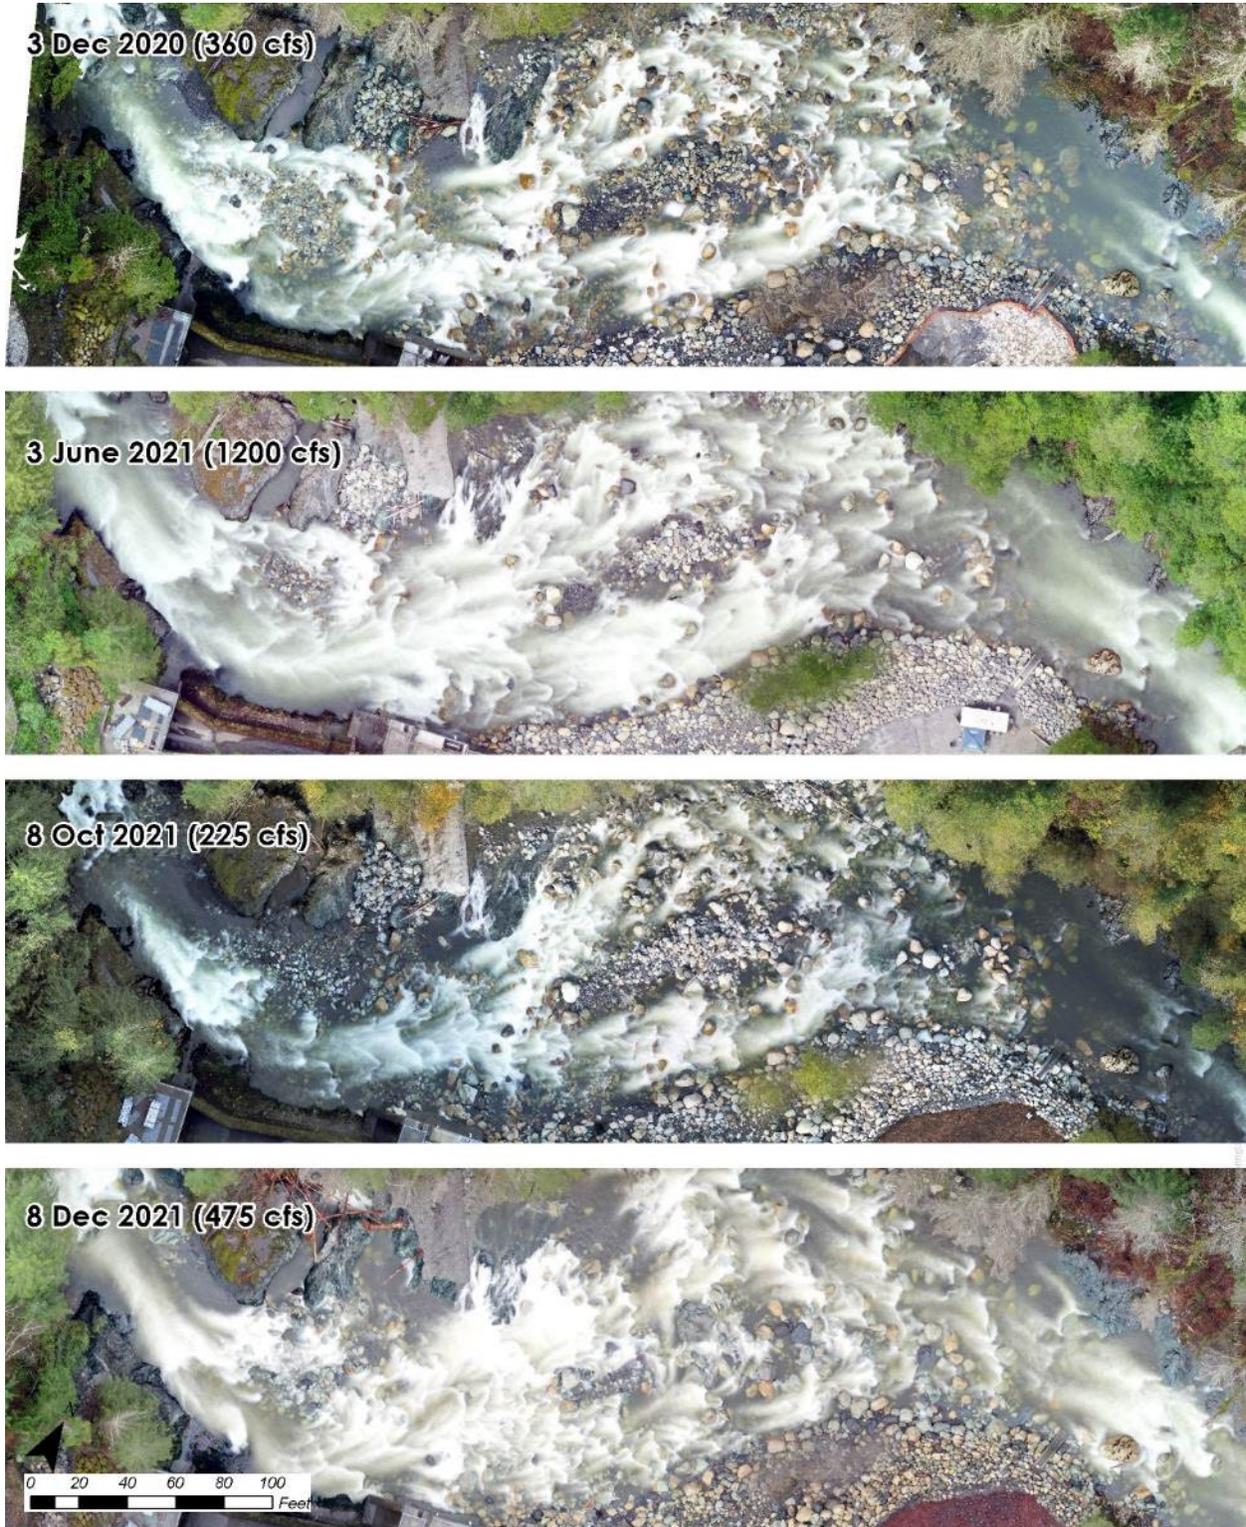
Figure 3.2 Orthomosaic comparisons showing observed channel conditions during monitoring site visits between December 2020 to December 2021.

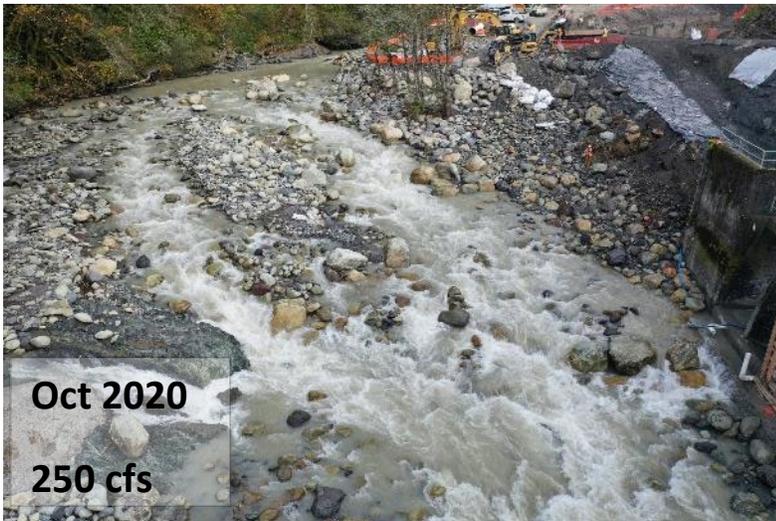
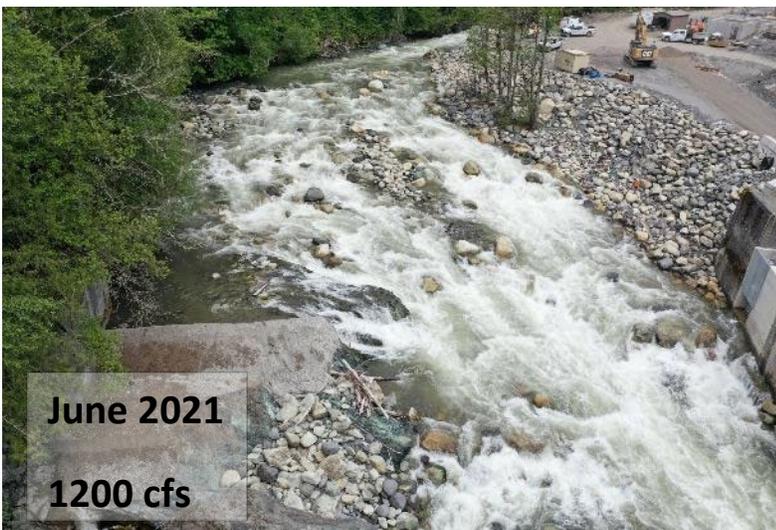
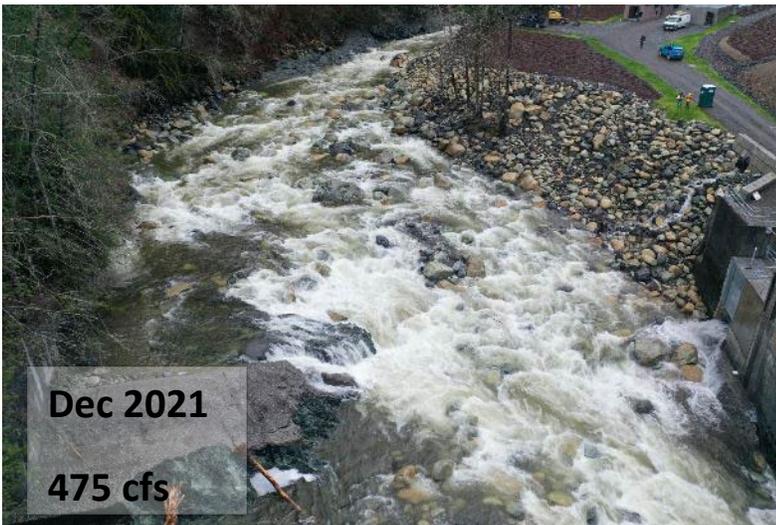
Observations of the channel during high flow conditions (1200 cfs) in June 2021 did not identify any concerns related to fish passage through the regraded reach. At this discharge, the hydraulic steps between boulder lines are generally backwatered, reducing the height of the steps relative to low flow conditions. The lack of channel confinement through the regraded section allows moderately higher flows to expand in width, diffusing the hydraulic energy and preventing the development of velocity barriers. Margins of both the right and left-bank flow paths, especially around the mid-channel boulder-cobble bar where boulder-scale roughness reduces velocity, include areas with adequate depth for adult salmon passage (typically > 1ft) and lower velocities than along the thalweg of each flow path.

Figure 3.3 compares flow conditions of the right and left bank flow split during the June 3 high flow monitoring visit, as compared to as-built low flow conditions (October 2020) as well as the most recently observed conditions in December 2021.

Figure 3.3 UAV oblique photos showing channel evolution at the flow split between the restored left bank channel and right bank pathways in October 2020 (top), June 2021 (middle), and December 2021 (bottom).

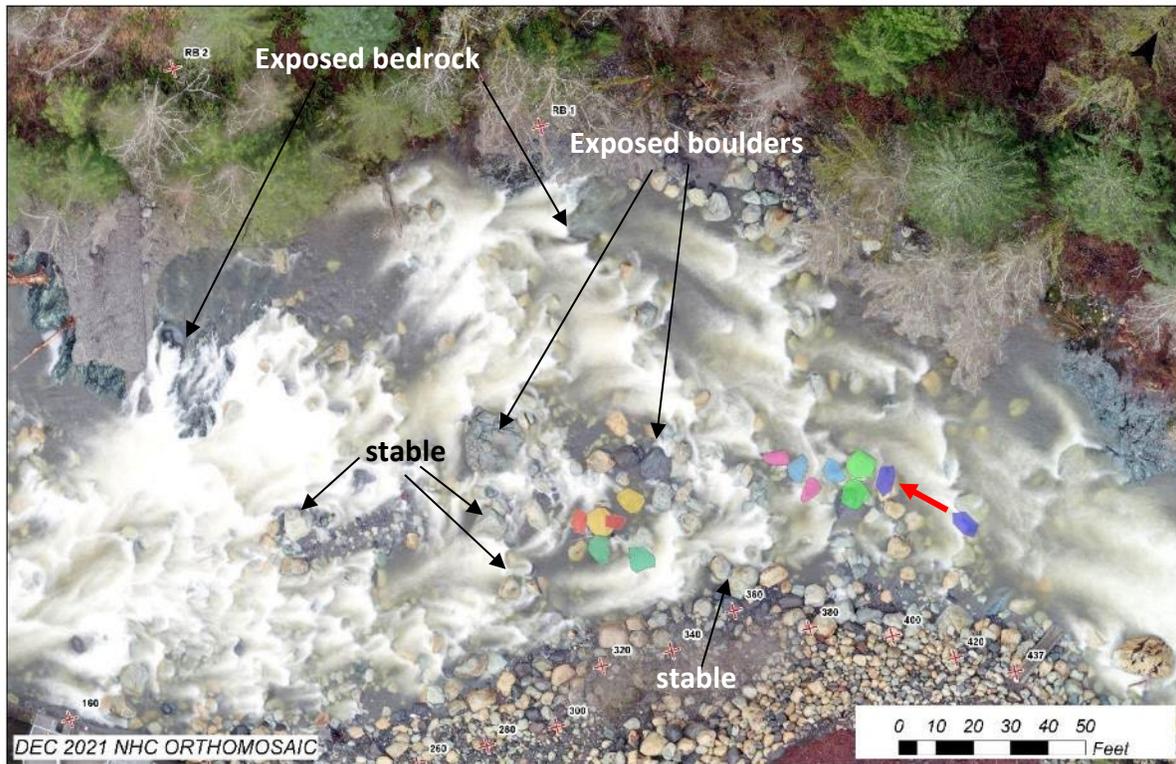
Individual boulder movements are difficult to track in the right bank pathways due to over-topping flow obscuring the boulders and bed, but qualitative comparisons of the October 2021 and December 2021 orthomosaics show large scale reorganization of the channel bed in the post-flood photographs. Prior to the large flow event, boulders outside of the restored flow path were not organized in stable morphologies such as boulder clusters or jamming arches, resulting in widespread mobilization during the flood. Boulder transport of some of the largest grains (estimated D_{84} and above) in the November flood appears to have restructured the bed into a more stable jammed state characteristic of an organized step-pool morphology, increasing the overall stability of the bed compared to the less-organized state present along the right bank flow path before the November 2021 flood (Church and Zimmermann, 2007; Zimmermann et al., 2010). Some of these step features are composed of bedrock near the right bank (Figure 4.1). It is currently unknown how widespread bedrock exposures are in this right bank channel due to high flows obscuring the channel bed at the time of the December 2021 observations. Future monitoring visits at wadable low flows that do not obscure the bed will be necessary to document how the bedrock controls evolve over time. If the bedrock continues to erode unevenly, slots and chutes may develop, providing alternative fish passage routes through the bedrock-controlled reaches. The discontinuous exposure of bedrock on the channel bed within this reach also provides the opportunity for pools to develop downstream.

Figure 4.1 shows some channel bed changes within the flow split between station 180 and the fishway at 437 feet. Overall, minor adjustments occurred in the restored left bank pathway due to boulder cluster stability, which prevented the same degree of bed mobility and large-scale reorganization as observed in the right bank channel. Boulder cluster instability appears to increase upstream with proximity to the pool outlet, between stations 320 and 437, but the bed has since reorganized into a more stable arched step-pool morphology. Select boulder movements can be seen in Figure 4.1, where displacements range from 12 to 25 feet.

Figure 4.1 December 2021 orthomosaic documenting relative instability in the restored channel. Boulder transport during the November 2021 flood is symbolized by colored boulders, where each pair of colored boulders represent an individual boulder’s location in October 2021 and December 2021. Boulders that did not move in the November 2021 flood are labeled as “stable” or “exposed” if bed lowering around the boulders exposed them to the surface. (Photo: NHC)

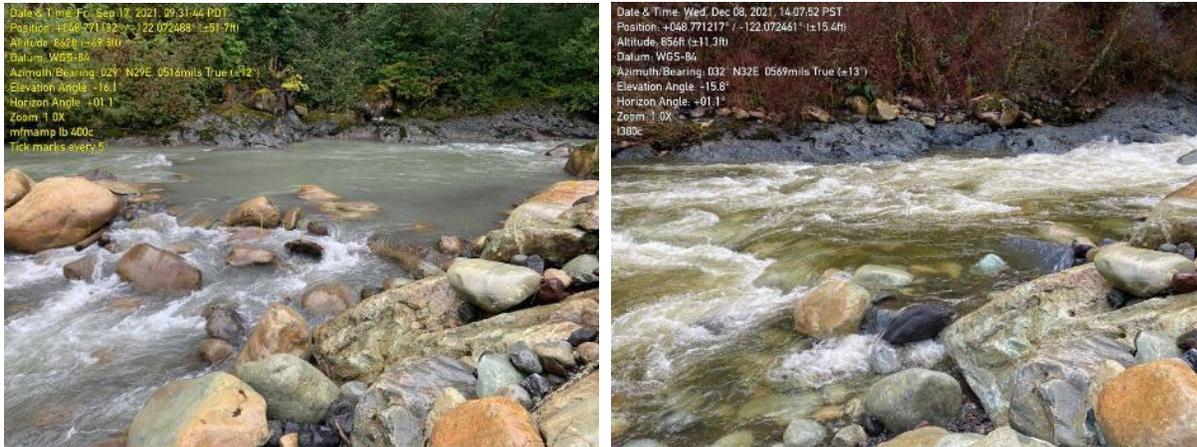
Sediment transport during the November 2021 flood also resulted in the exposure of large boulders in the mid channel bar as well as the dewatering and roughening of the Fish Bypass outlet pool upstream of the flow split. Lowering of the midchannel bar has created wider flow pathways in the right bank channel. Most of the midchannel bar was submerged during the December 2021 site visit, suggesting that these previously distinct channels are now connected during relatively low flows (475 cfs). As predicted, the channel has regraded through the Fish Bypass outlet pool as transport and reorganization of the pool outlet boulders has significantly roughened the channel upstream in the previously backwatered pool reach (Figure 4.2). Observation of this location during low flow conditions will be important to discern that depths in front of the Fish Bypass outlet remain adequate to prevent injury.

Figure 4.2 Pool outlet comparison at Transect 400c between September 2021 (left) and December 2021 (right)

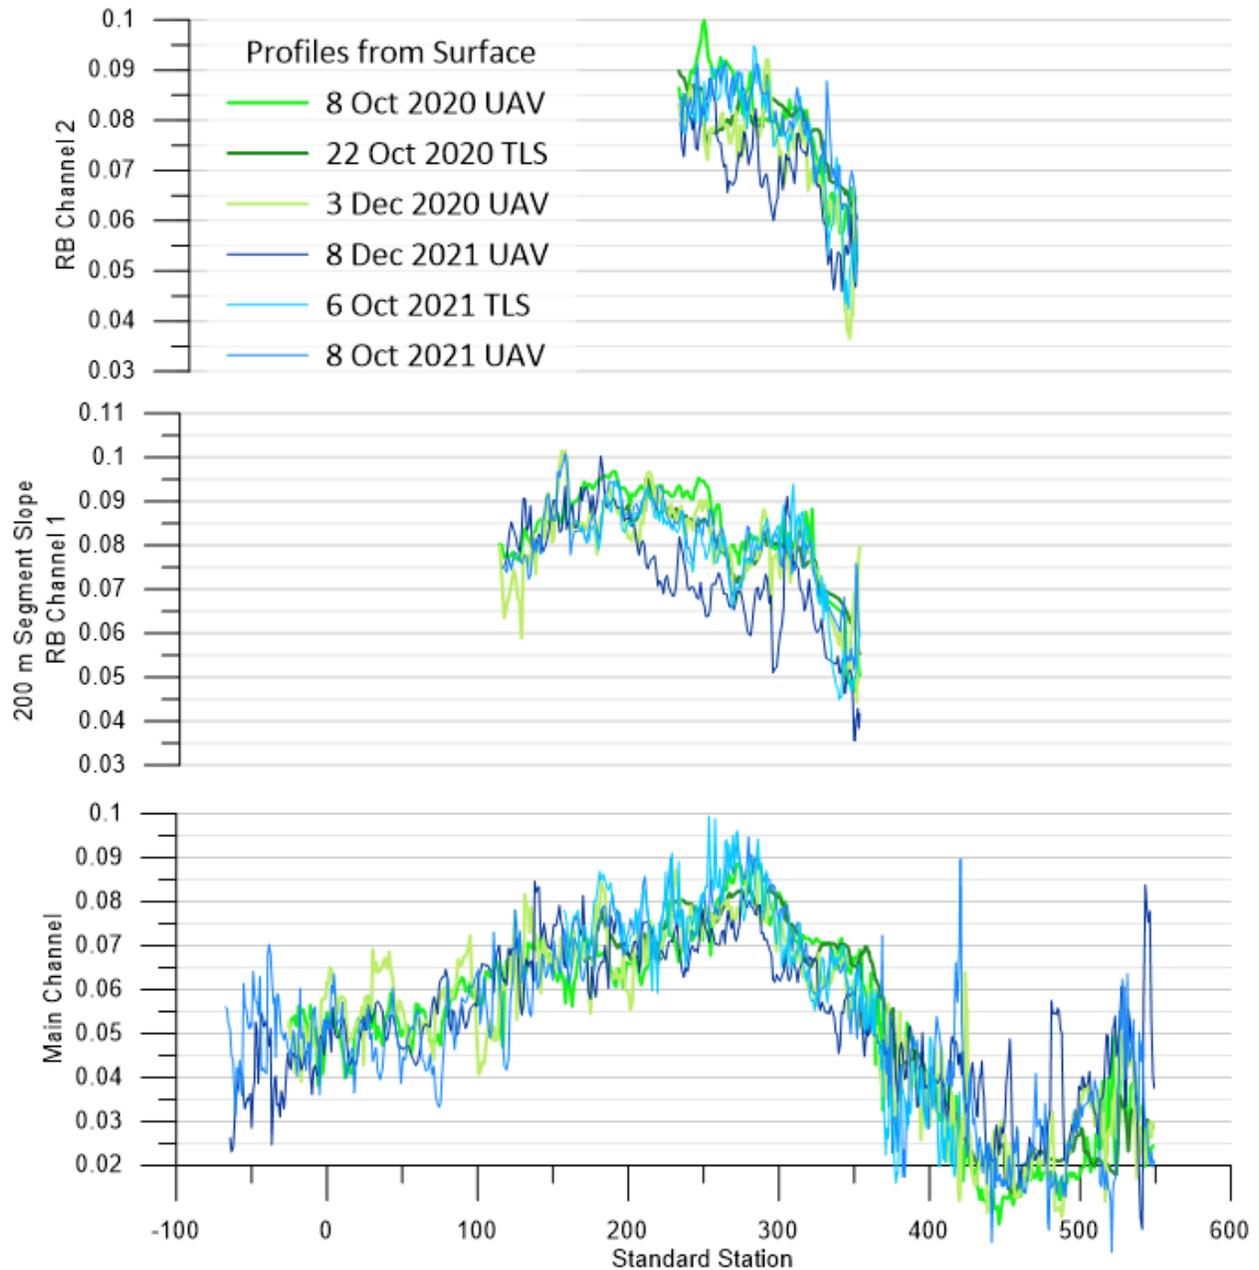
Slopes for 200 ft segments were extracted along each profile path outlined in Figure 2.1 and are plotted in Figure 5.1. Along the main channel, the October 2021 slopes are consistently below 8%, except the reach between the 200 and 300-ft stationing that is between 8 and 10%. The right bank flow paths have lower average slope, but localized areas that are slightly steeper, with slopes between 9 and 10%. The upstream left bank split is less than 200 ft long, but the average slope along that split is 5%. There are no major changes to the channel slope from October 2020 to October 2021 apart from the channel steepening shown in the main channel between the 200 and 300-ft stationing.

Figure 5.1 Plots showing 200 ft segment average slopes for each monitoring DEM.

Along the main channel, the December 2021 slopes are more consistently below 8%, including the reach between the 200 and 300-ft stationing. There is one steeper reach around station 130 ft that exceeds an 8 percent slope, as well as steeper slopes starting at the 420-ft stationing in the bypass return pool and extending upstream. The main channel is less steep between the 280-ft stationing and the 420-ft stationing in December 2021 than previously. This reach of the restored channel coincides with boulder displacement observed in Figure 4.1, and therefore reflects channel regrade following bed mobilization and reorganization during the autumn 2021 floods. The first and second right bank flow paths (RB

Channel 1 and RB Channel 2) are both less steep in December 2021 than previously, with much of the channel upstream of the 200-ft stationing below 8%. Development and regrading of the right bank flow pathways to a lower slope opens a valuable secondary fish passage route through the regraded reach of channel.

All segments are below the action threshold of a 12% slope (Table 1.1) and below the 2b decision pathway threshold of a 10% slope; but several are above the 7% 2b decision pathway indicating continuing monitoring is needed.
