MF Nooksack Channel Monitoring & Adaptive Management

Year 1 Monitoring

June 6, 2022
Final Report, Rev. 1

City of Bellingham Public Works
104 W. Magnolia Street, Suite 109
Bellingham, WA 98225

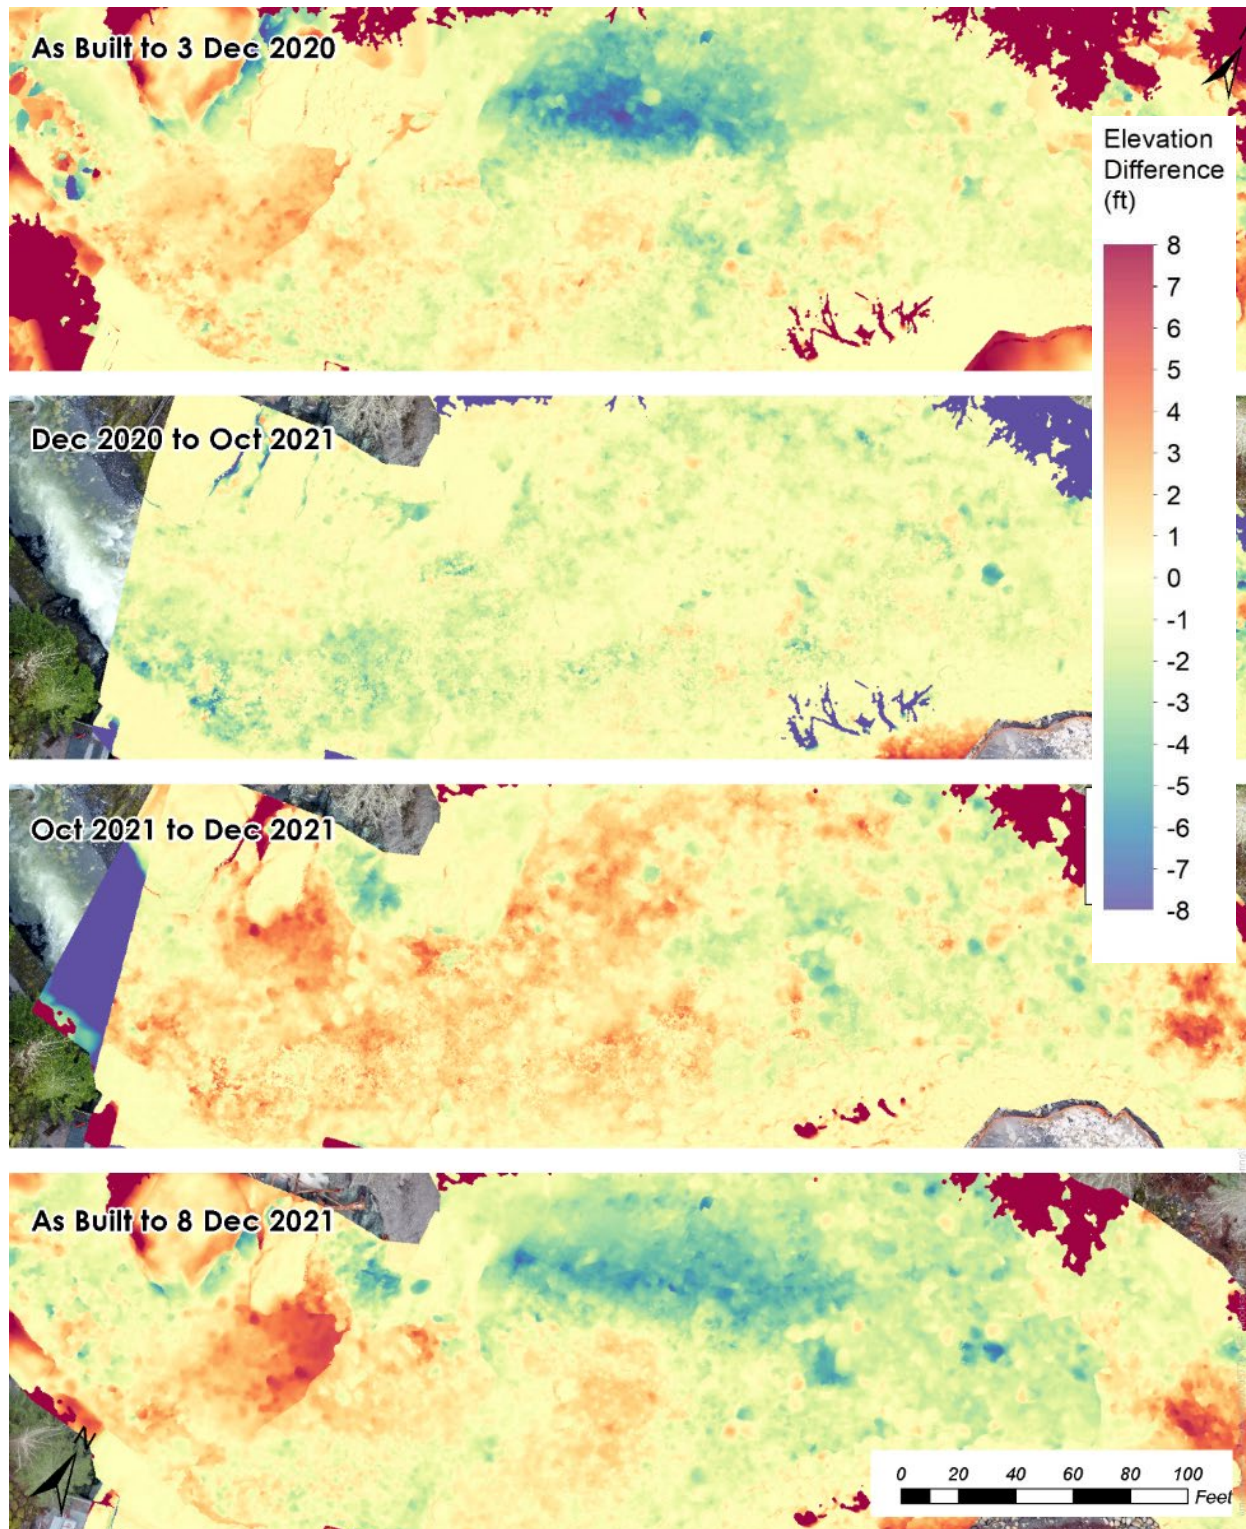
Figure 3.1 DEM surface comparisons showing differences between the design surface and as-built surface (top) and between the as-built surface and subsequent topographic surfaces. Red colors indicate aggradation and blue colors degradation.

The regraded reach was extremely stable between December 2020 and October 2021, when only subtle changes occurred to the bed along the dominant left and right bank channels (Figure 3.1 and Figure 3.2). This is particularly true of the left bank channel where boulder jams were installed to control the grade. The boulder jams have remained stable, though individual overexposed boulders up to 2 m in diameter shifted and moved short distances (e.g., 3 to 10 m). Small boulders have also shifted in similar extents in the right bank channel where fewer boulder jamming structures exist.

Lack of any major bed change between December 2020 and October 2021 is not surprising, considering that the post-construction channel had already been conditioned by substantially larger flow events during autumn of 2020 (Figure 1.1).

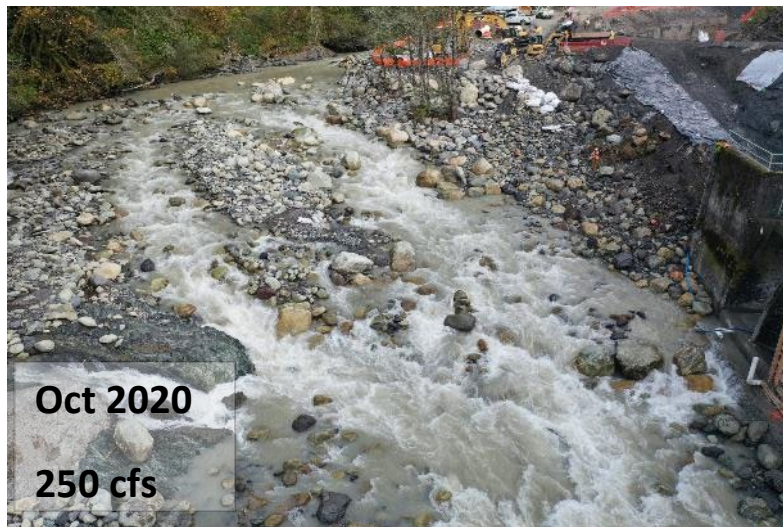
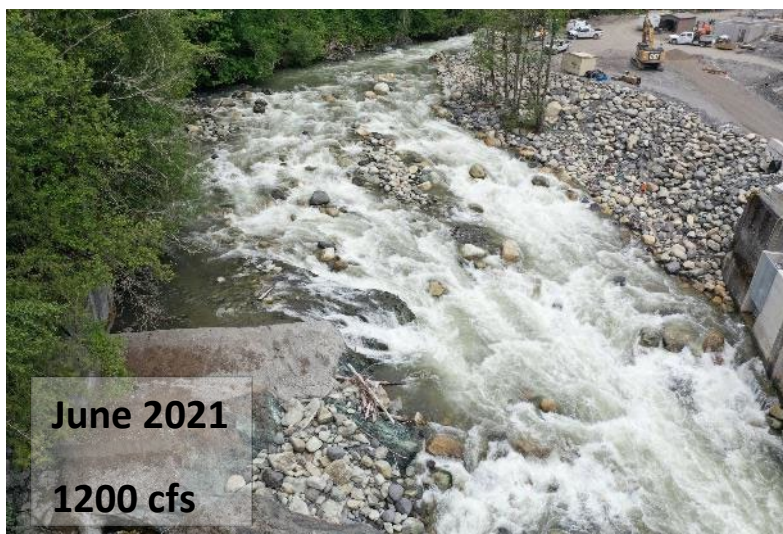
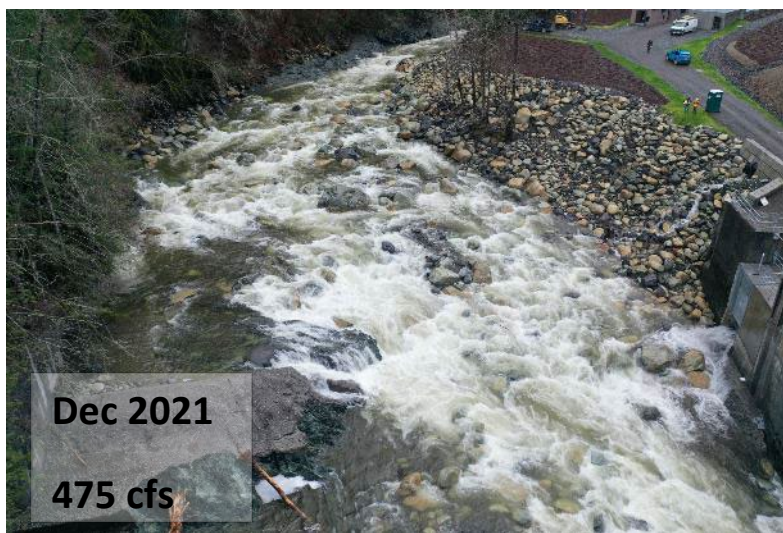
Figure 3.3 UAV oblique photos showing channel evolution at the flow split between the restored left bank channel and right bank pathways in October 2020 (top), June 2021 (middle), and December 2021 (bottom).

Observations of the channel during high flow conditions (1200 cfs) in June 2021 did not identify any concerns related to fish passage through the regraded reach. At this discharge, the hydraulic steps between boulder lines are generally backwatered, reducing the height of the steps relative to low flow conditions. The lack of channel confinement through the regraded section allows moderately higher flows to expand in width, diffusing the hydraulic energy and preventing the development of velocity barriers. Margins of both the right and left-bank flow paths, especially around the mid-channel boulder-cobble bar where boulder-scale roughness reduces velocity, include areas with adequate depth for adult salmon passage (typically > 1ft) and lower velocities than along the thalweg of each flow path.

Figure 3.3 compares flow conditions of the right and left bank flow split during the June 3 high flow monitoring visit, as compared to as-built low flow conditions (October 2020) as well as the most recently observed conditions in December 2021.

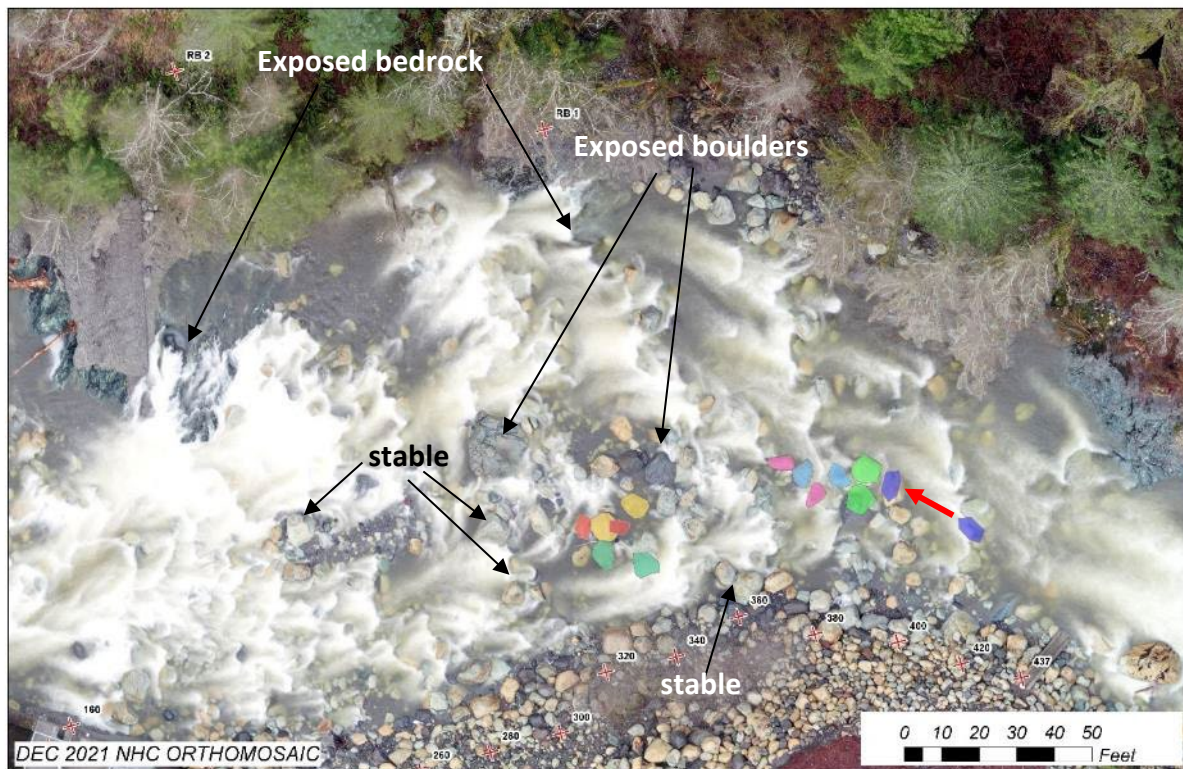
Significant changes occurred to the channel bed during the November 2021 floods, which exceeded the threshold expected to mobilize boulders not part of the boulder jams. These changes are evident in Figure 3.1, Figure 3.2 and Figure 3.3. Boulder transport has notably altered the right bank pathways, midchannel bar and the facility Fish Bypass outlet pool upstream of the main channel and right bank pathway flow split. In particular, as anticipated in NHC (2021), headcutting has continued along the right bank flow pathway, resulting in mobilization of boulders forming the hydraulic control for the Fish Bypass outlet pool and converting that feature from a pool to a rapid. This has also, likely, reduced the proportion of the flow following the designed left bank flow path during lower flow conditions. Relatively minor changes have occurred in the restored left bank pathway in comparison, suggesting that the boulder jams effectively held the designed channel in place during the flood.

Individual boulder movements are difficult to track in the right bank pathways due to over-topping flow obscuring the boulders and bed, but qualitative comparisons of the October 2021 and December 2021 orthomosaics show large scale reorganization of the channel bed in the post-flood photographs. Prior to the large flow event, boulders outside of the restored flow path were not organized in stable morphologies such as boulder clusters or jamming arches, resulting in widespread mobilization during the flood. Boulder transport of some of the largest grains (estimated D_{84} and above) in the November flood appears to have restructured the bed into a more stable jammed state characteristic of an organized step-pool morphology, increasing the overall stability of the bed compared to the less-organized state present along the right bank flow path before the November 2021 flood (Church and Zimmermann, 2007; Zimmermann et al., 2010). Some of these step features are composed of bedrock near the right bank (Figure 4.1). It is currently unknown how widespread bedrock exposures are in this right bank channel due to high flows obscuring the channel bed at the time of the December 2021 observations. Future monitoring visits at wadable low flows that do not obscure the bed will be necessary to document how the bedrock controls evolve over time. If the bedrock continues to erode unevenly, slots and chutes may develop, providing alternative fish passage routes through the bedrock-controlled reaches. The discontinuous exposure of bedrock on the channel bed within this reach also provides the opportunity for pools to develop downstream.

Figure 4.1 shows some channel bed changes within the flow split between station 180 and the fishway at 437 feet. Overall, minor adjustments occurred in the restored left bank pathway due to boulder cluster stability, which prevented the same degree of bed mobility and large-scale reorganization as observed in the right bank channel. Boulder cluster instability appears to increase upstream with proximity to the pool outlet, between stations 320 and 437, but the bed has since reorganized into a more stable arched step-pool morphology. Select boulder movements can be seen in Figure 4.1, where displacements range from 12 to 25 feet.

Figure 4.1 December 2021 orthomosaic documenting relative instability in the restored channel. Boulder transport during the November 2021 flood is symbolized by colored boulders, where each pair of colored boulders represent an individual boulder's location in October 2021 and December 2021. Boulders that did not move in the November 2021 flood are labeled as "stable" or "exposed" if bed lowering around the boulders exposed them to the surface. (Photo: NHC)

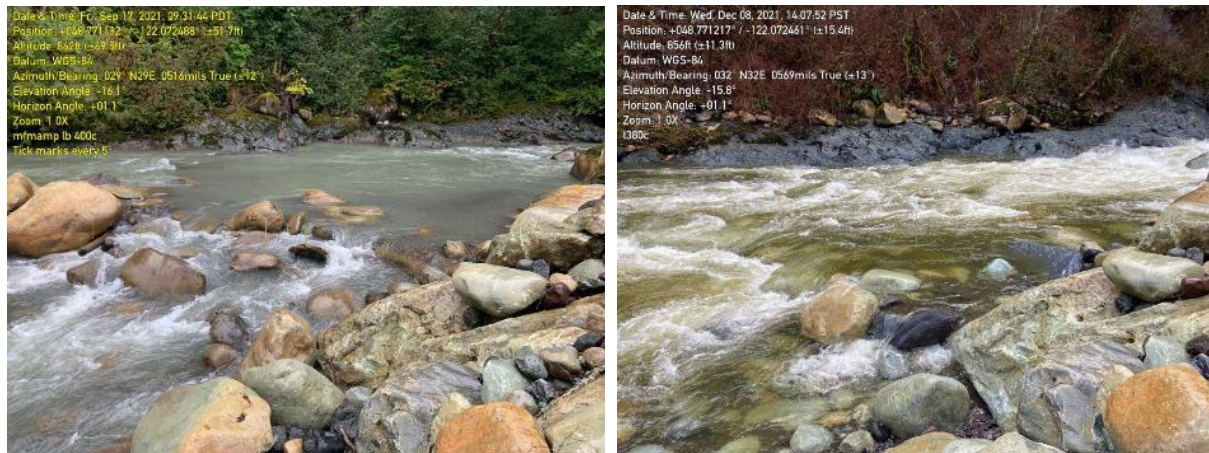
Figure 4.2 Pool outlet comparison at Transect 400c between September 2021 (left) and December 2021 (right)

Sediment transport during the November 2021 flood also resulted in the exposure of large boulders in the mid channel bar as well as the dewatering and roughening of the Fish Bypass outlet pool upstream of the flow split. Lowering of the midchannel bar has created wider flow pathways in the right bank channel. Most of the midchannel bar was submerged during the December 2021 site visit, suggesting that these previously distinct channels are now connected during relatively low flows (475 cfs). As predicted, the channel has regraded through the Fish Bypass outlet pool as transport and reorganization of the pool outlet boulders has significantly roughened the channel upstream in the previously backwatered pool reach (Figure 4.2). Observation of this location during low flow conditions will be important to discern that depths in front of the Fish Bypass outlet remain adequate to prevent injury.

The flood-induced geomorphic regrade changes to the right bank channel appear to have partially dewatered the restored left bank main channel. This change in flow inputs at the top of the main channel is, however, partially compensated by the new flow inputs across the now-connected midchannel bar.

A final significant change that occurred during the November 2021 floods was deposition of boulders on the right bank bar at approximately station 125, downstream of the primary regrade area (Figure 3.1). The December 2021 SfM surface covering this area is approximate, due to the presence of turbulent water over the bed in much of the area; comparison of water surface elevations against stable bedrock in the right bank pool between bedrock features upstream of the bar (Figure 3.2) shows the water surface has substantially increase in this area, qualitatively confirming the presence of aggradation on the bar. This deposition appears to have increased the elevation of the hydraulic control at the base of the regrade reach, which would lower the average slope through the regrade area.

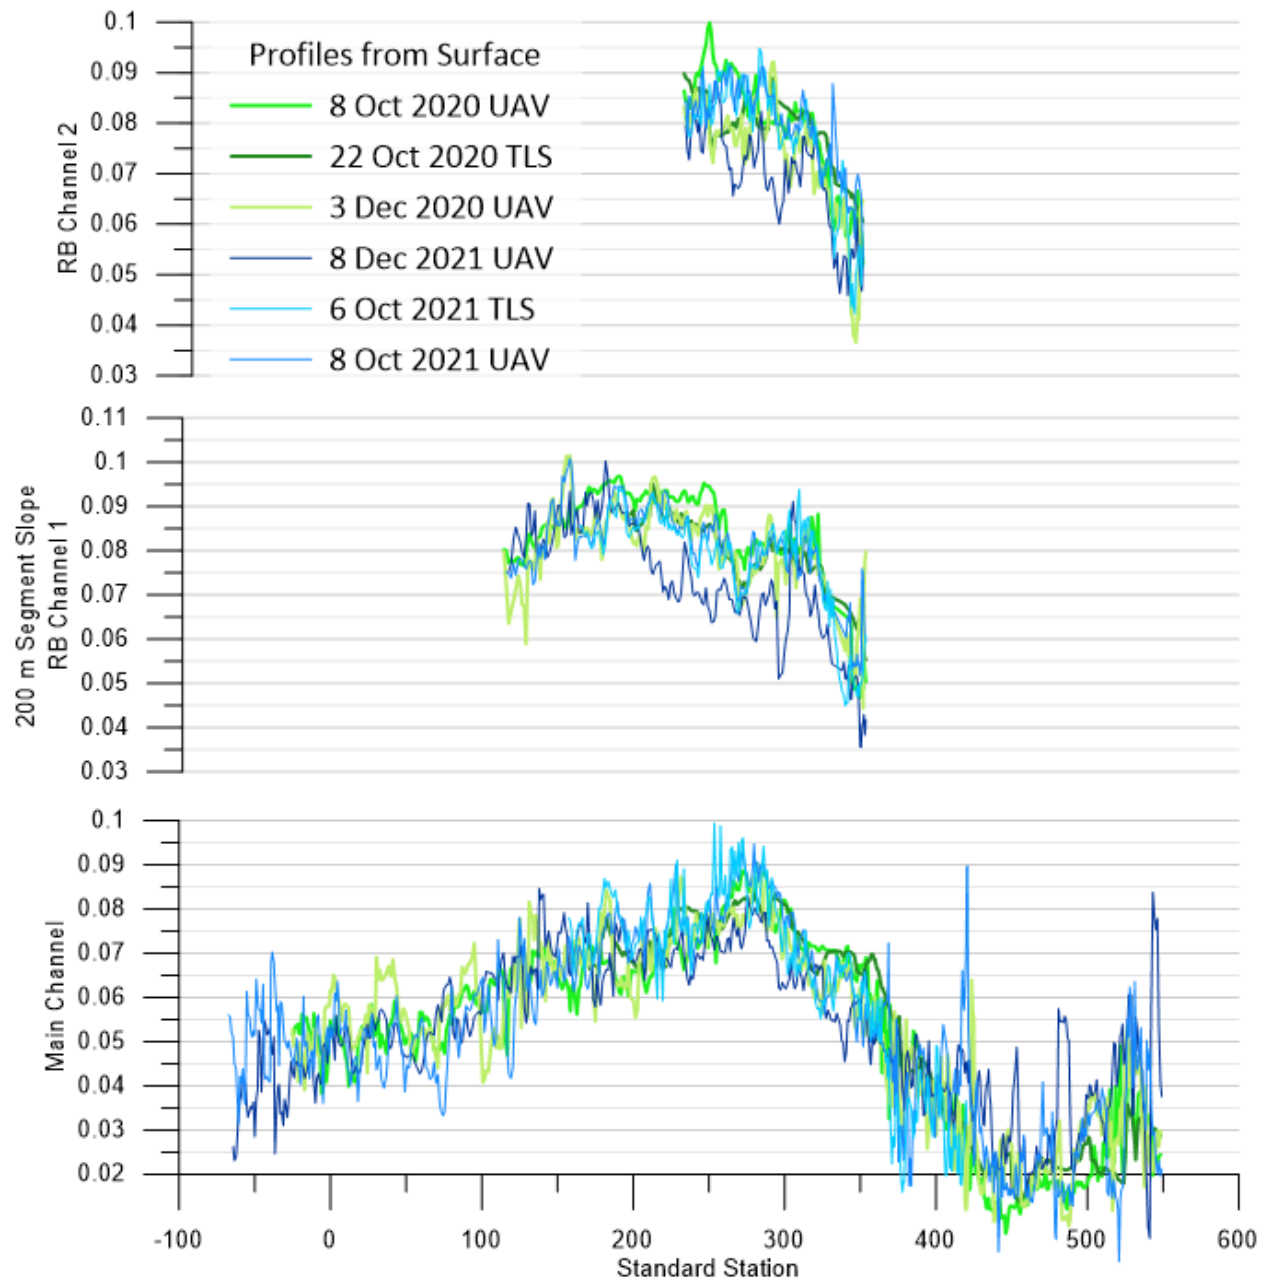
Figure 5.1 Plots showing 200 ft segment average slopes for each monitoring DEM.

Slopes for 200 ft segments were extracted along each profile path outlined in Figure 2.1 and are plotted in Figure 5.1. Along the main channel, the October 2021 slopes are consistently below 8%, except the reach between the 200 and 300-ft stationing that is between 8 and 10%. The right bank flow paths have lower average slope, but localized areas that are slightly steeper, with slopes between 9 and 10%. The upstream left bank split is less than 200 ft long, but the average slope along that split is 5%. There are no major changes to the channel slope from October 2020 to October 2021 apart from the channel steepening shown in the main channel between the 200 and 300-ft stationing.

Along the main channel, the December 2021 slopes are more consistently below 8%, including the reach between the 200 and 300-ft stationing. There is one steeper reach around station 130 ft that exceeds an 8 percent slope, as well as steeper slopes starting at the 420-ft stationing in the bypass return pool and extending upstream. The main channel is less steep between the 280-ft stationing and the 420-ft stationing in December 2021 than previously. This reach of the restored channel coincides with boulder displacement observed in Figure 4.1, and therefore reflects channel regrade following bed mobilization and reorganization during the autumn 2021 floods. The first and second right bank flow paths (RB

Channel 1 and RB Channel 2) are both less steep in December 2021 than previously, with much of the channel upstream of the 200-ft stationing below 8%. Development and regrading of the right bank flow pathways to a lower slope opens a valuable secondary fish passage route through the regraded reach of channel.

All segments are below the action threshold of a 12% slope (Table 1.1) and below the 2b decision pathway threshold of a 10% slope; but several are above the 7% 2b decision pathway indicating continuing monitoring is needed.
