# MF Nooksack Channel Monitoring & Adaptive Management

## Year 2 Monitoring

NHC Reference 2005776

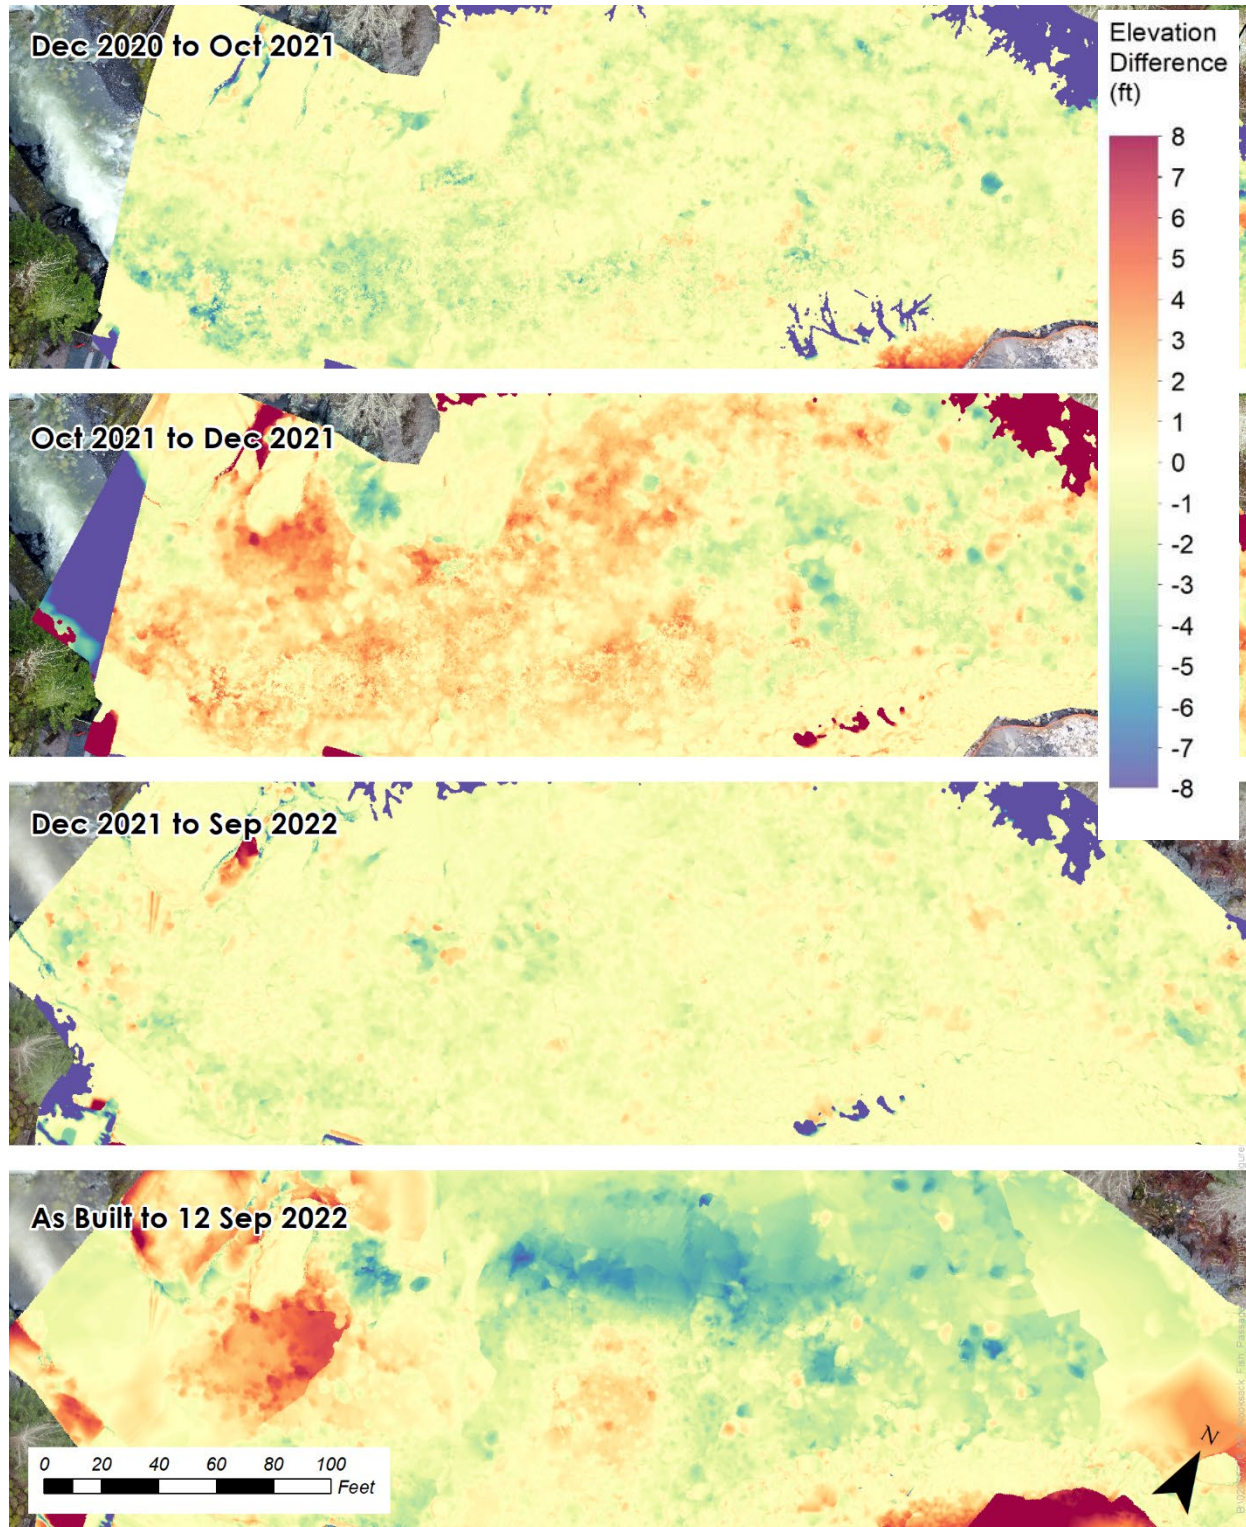
A final significant change that occurred during the November 2021 floods was deposition of boulders on the right bank bar at approximately station 125, downstream of the primary regrade area (Figure 3.1). This deposition was likely facilitated by the most downstream boulder jam (Jam 1) and the large boulders placed in the riffle downstream. There was uncertainty in the December 2021 topographic

surface, where overtopping water can cause errors in the SfM processing, but these visual observations were later confirmed in the September 2022 low-flow topographic surface, suggesting that aggradation of 5 feet or more has occurred since As-Built conditions. This deposition appears to have increased the elevation of the hydraulic control at the base of the regrade reach, which would lower the average slope through the regrade area. See Section 5.4 for more information on the magnitude of localized channel lowering and aggradation.

**Figure 3.1** DEM surface comparisons showing differences between the design surface and as-built surface (top) and between the as-built surface and subsequent topographic surfaces. Red colors indicate aggradation and blue colors degradation.

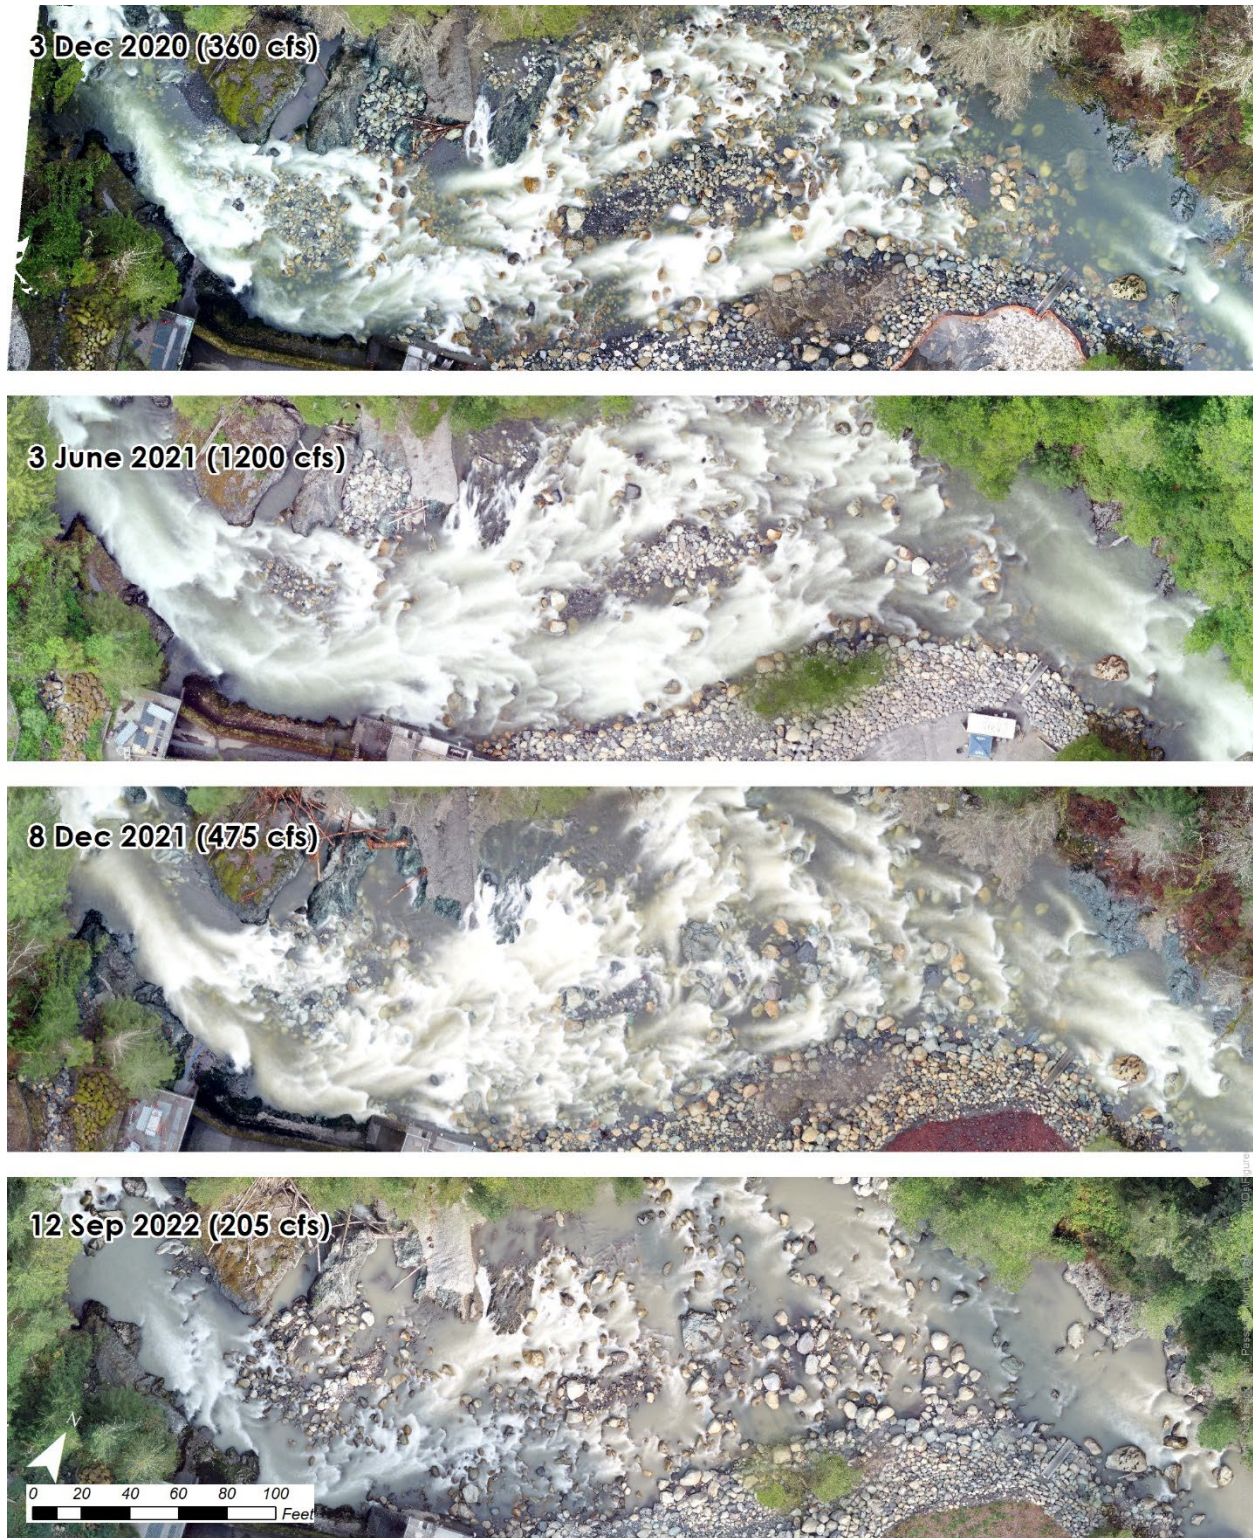
Qualitative comparisons of the October 2021 and December 2021 orthomosaics show large scale reorganization of the channel bed in the post-flood photographs. Prior to the large flow event, boulders outside of the restored flow path were not organized in stable morphologies such as boulder clusters or jamming arches, resulting in widespread mobilization during the flood. Boulder transport of some of the largest grains (estimated  $D_{84}$  and above) in the November flood appears to have restructured the bed into a more stable jammed state characteristic of an organized step-pool morphology, increasing the overall stability of the bed compared to the less-organized state present along the right bank flow paths before the November 2021 flood (Church and Zimmermann, 2007; Zimmermann et al., 2010). Some of these step features are composed of bedrock near the right bank (Figure 4.1). If the bedrock continues to erode unevenly, slots and chutes may develop, providing alternative fish passage routes through the bedrock-controlled reaches. The discontinuous exposure of bedrock on the channel bed within this reach also provides the opportunity for pools to develop downstream.

**Figure 3.2** Orthomosaic comparisons showing observed channel conditions during monitoring site visits between December 2020 to September 2022.

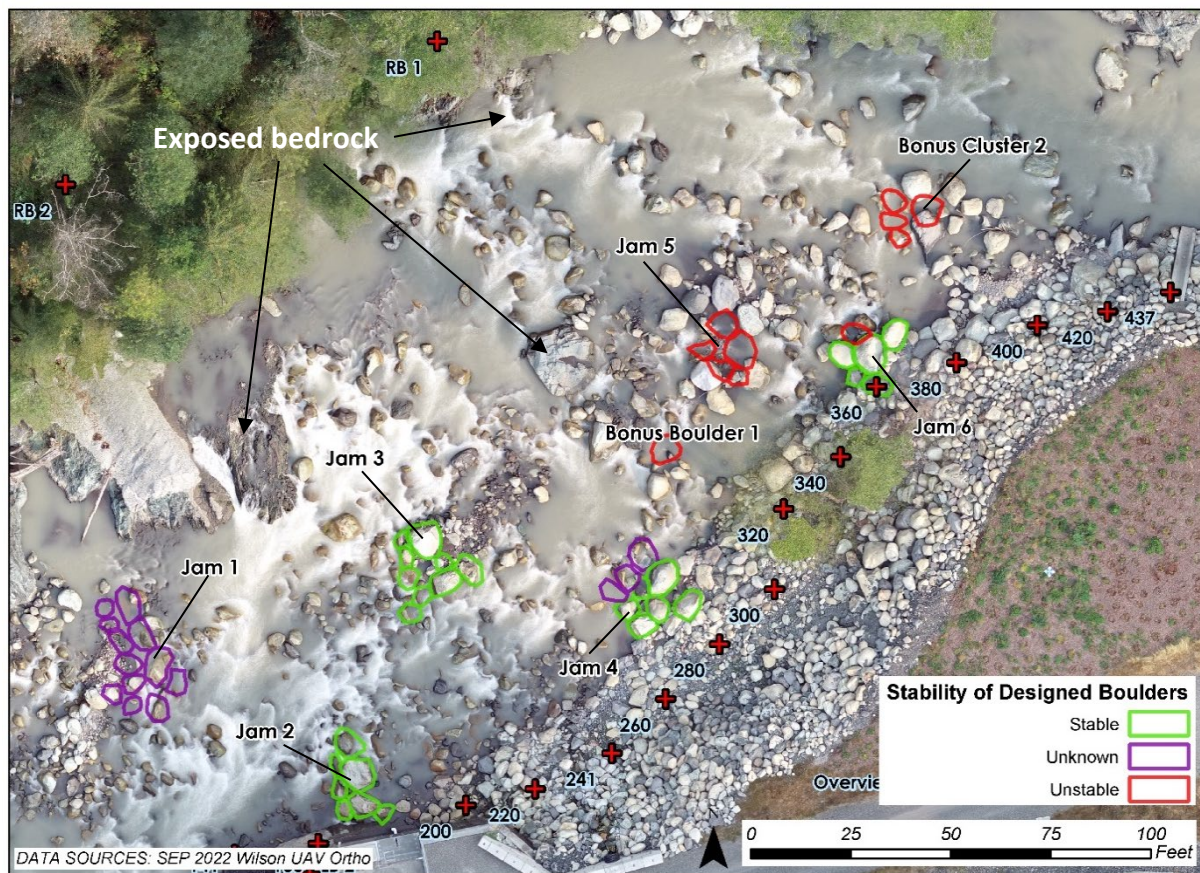
Readjustment of the main channel has increased the complexity of the reach. During the flood, mobile small boulders and cobble being transported from upstream locked into place newly configured arched step-pool morphologies in the restored main channel, increasing the total number of pools in the reach. Therefore, the designed jams worked to not only maintain passable slopes, but they also added stable roughness, both on the left bank and along the lowering midchannel bar, from which networks of new jamming features of transported cobbles and boulders could form. This observation supports the findings from the step-pool flume experiments of Zimmerman (2010), which argues that bank roughness has a stronger effect on bed stability than either the flow or sediment supply.

**Figure 3.3** September 2022 (205 cfs) orthomosaic documenting relative instability in the restored channel, with engineered boulder cluster jams labeled. Areas of exposed bedrock on the channel bed are also labeled. (Photo: Wilson Engineering)

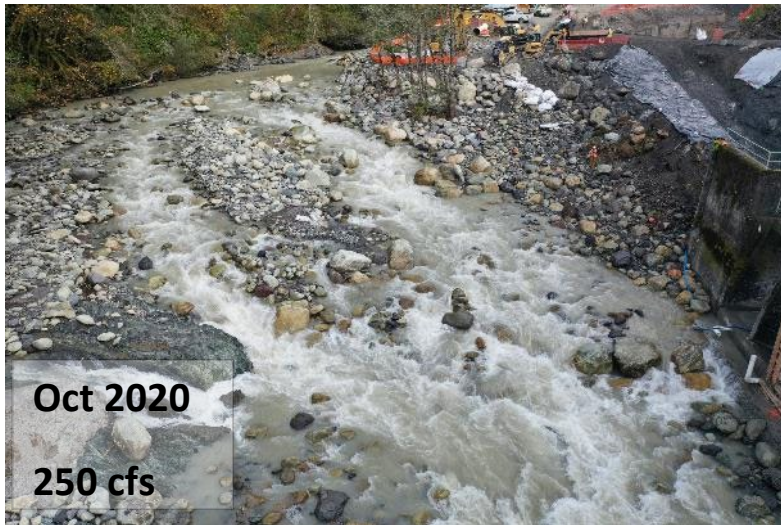
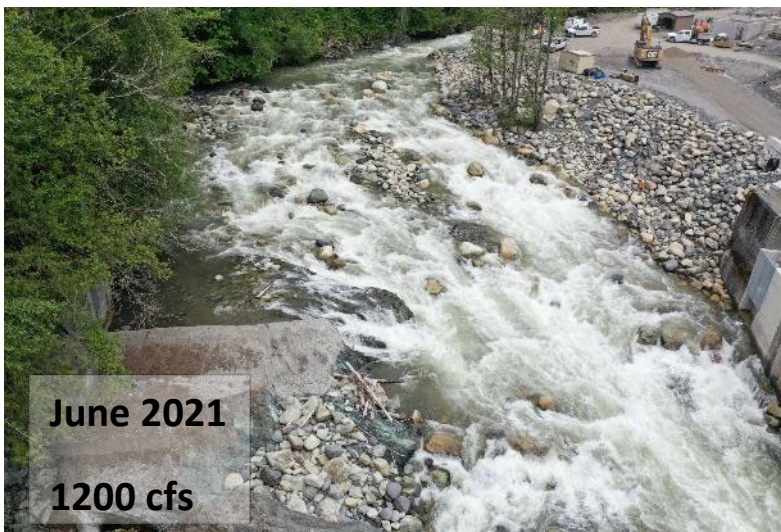
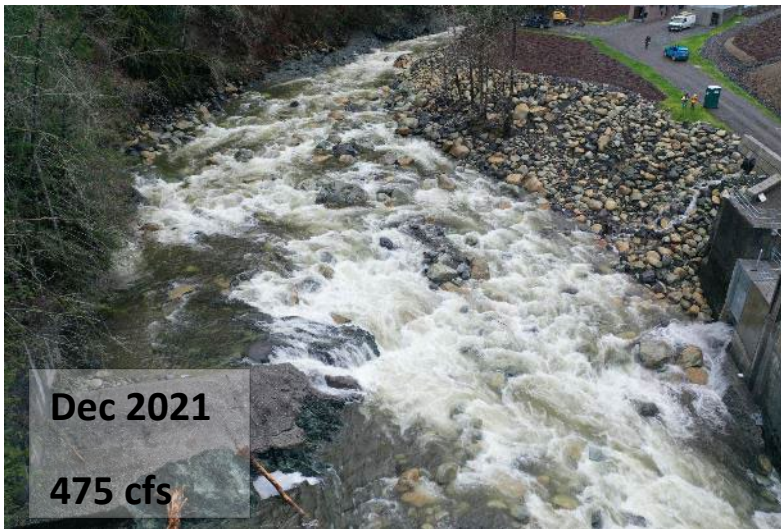
High flow observations were conducted during the December 2021 site visit (475 cfs). In an effort not to duplicate work, an additional high flow site visit was not conducted in the spring given the relatively stable hydrograph and absence of large channel-forming flows (10-yr or greater) between December and the spring of 2022. Reorganization of the entire bed into more stable step-pool arches has created numerous pathways for fish. At this discharge, the hydraulic steps between boulder lines are generally backwatered, reducing the height of the steps relative to low flow conditions. Reorganization across the channel, including the mid-channel bar, has also widened the active channel at high flows. The lack of confinement in both the right bank pathways and regraded main channel allows moderately higher flows to expand in width. This, in addition to the overall increase in the number of moderate size step-pool units and pockets diffuses the hydraulic energy and prevents the development of velocity barriers. Margins of both the right and left-bank flow paths, especially across the now-submerged mid-channel boulder-cobble bar, present areas with adequate depth for adult salmon passage (typically > 1ft) and lower velocities than along the thalweg of each flow path.

**Figure 3.4** UAV oblique photos showing channel evolution at the flow split between the restored left bank channel and right bank pathways in October 2020 (top), June 2021 (middle), and December 2021 (bottom).

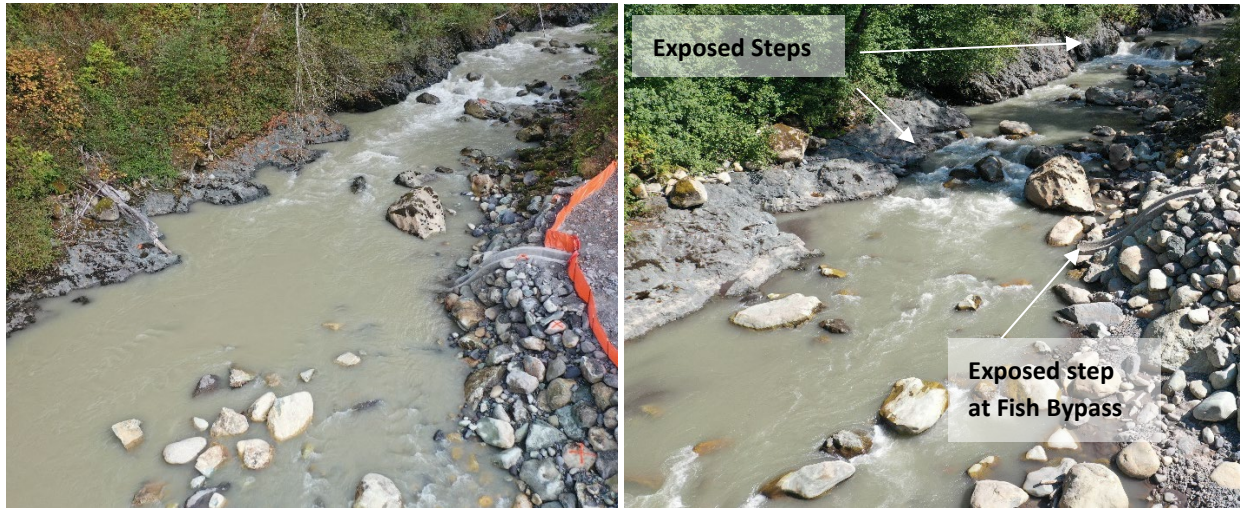
As mentioned in the high flow observational discussion, the reorganization of small to medium-sized boulders across the channel has resulted in the diversification and unification of flow pathways in the previously separated main channel and right flow paths, and remain connected at low flows of at least 300 cfs. Previously held concerns about the dewatering of the main channel in response to channel regrade in the right flow pathways have been reduced after visual observation and topographic confirmation that the main channel and right flow paths have regraded simultaneously. Therefore, the engineered boulder clusters have worked as designed by adjusting with the lowering channel, maintaining passable slopes in the main channel, and creating stable roughness from which small step arches can build and form new jamming features and pools. The abundance of available pools provides ample resting areas for migrating fish. Flows along the upstream left bank flow split, which continues to feed water into the main channel, will be monitored at future low-flow observation visits to assess its risk for dewatering as this reach further adjusts. Another potential concern from the December 2021 site visit was the unknown bedrock exposure extents along the right bank channel. The degree of exposure is still largely unknown due to fine deposition along the right bank, high turbidity, and lack of safe access to this bank.

**Figure 4.1** Oblique aerial view of pool outlet comparison near Transect 400c between October 2020 (left, 225 cfs) and September 2022 (right, 152 cfs).

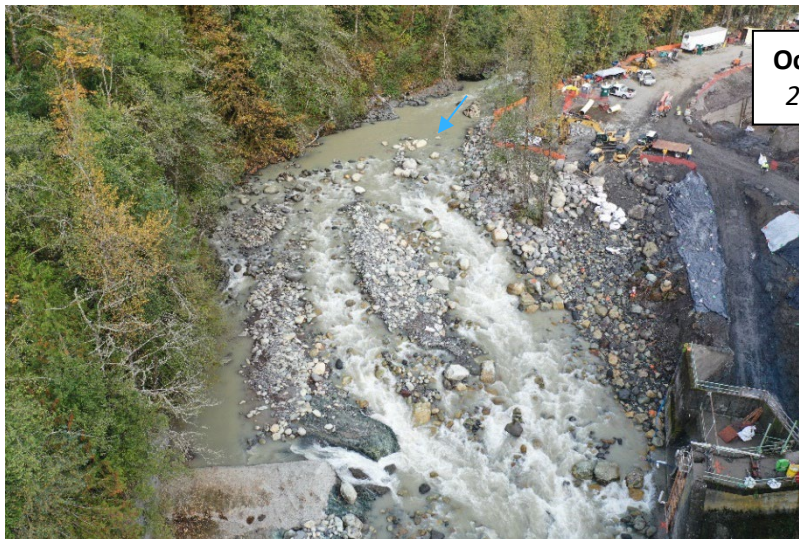
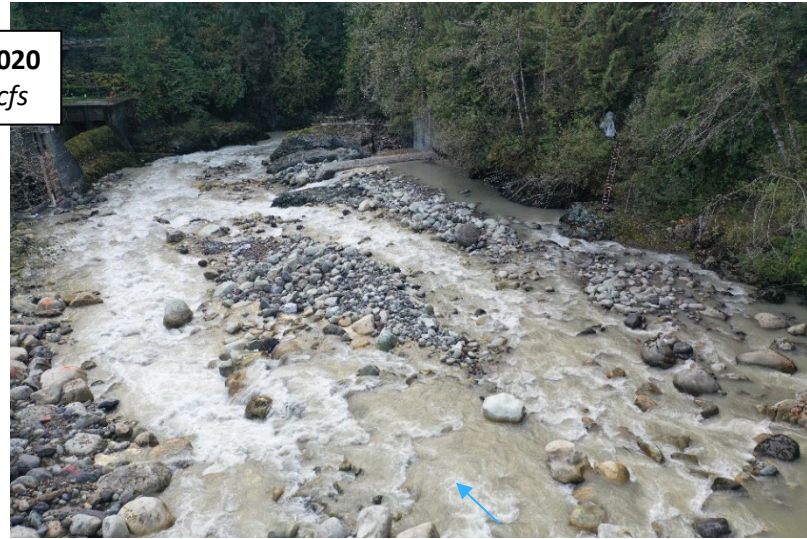
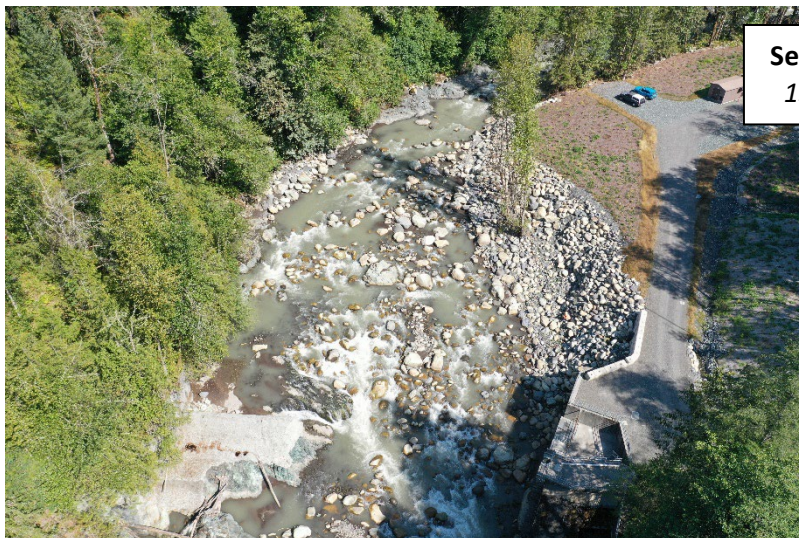
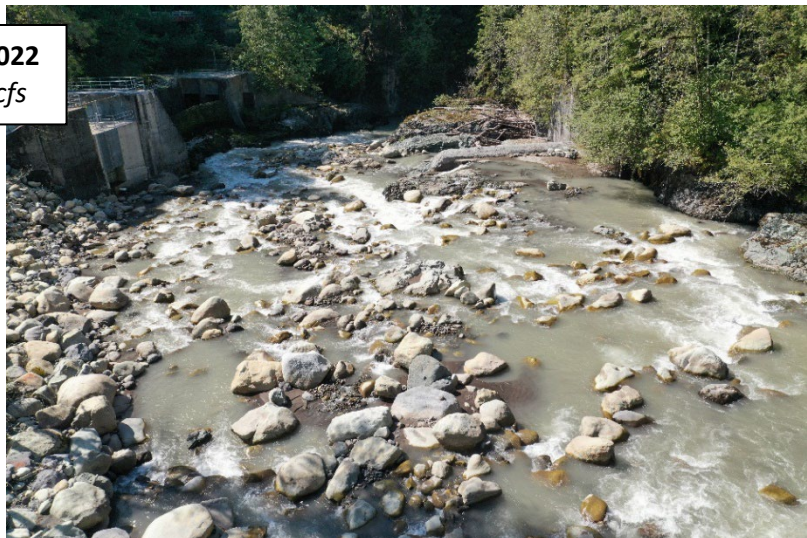
**Figure 4.2** Repeat UAV imagery showing low-flow channel comparisons between October 2020 (top) and September 2022 (bottom)

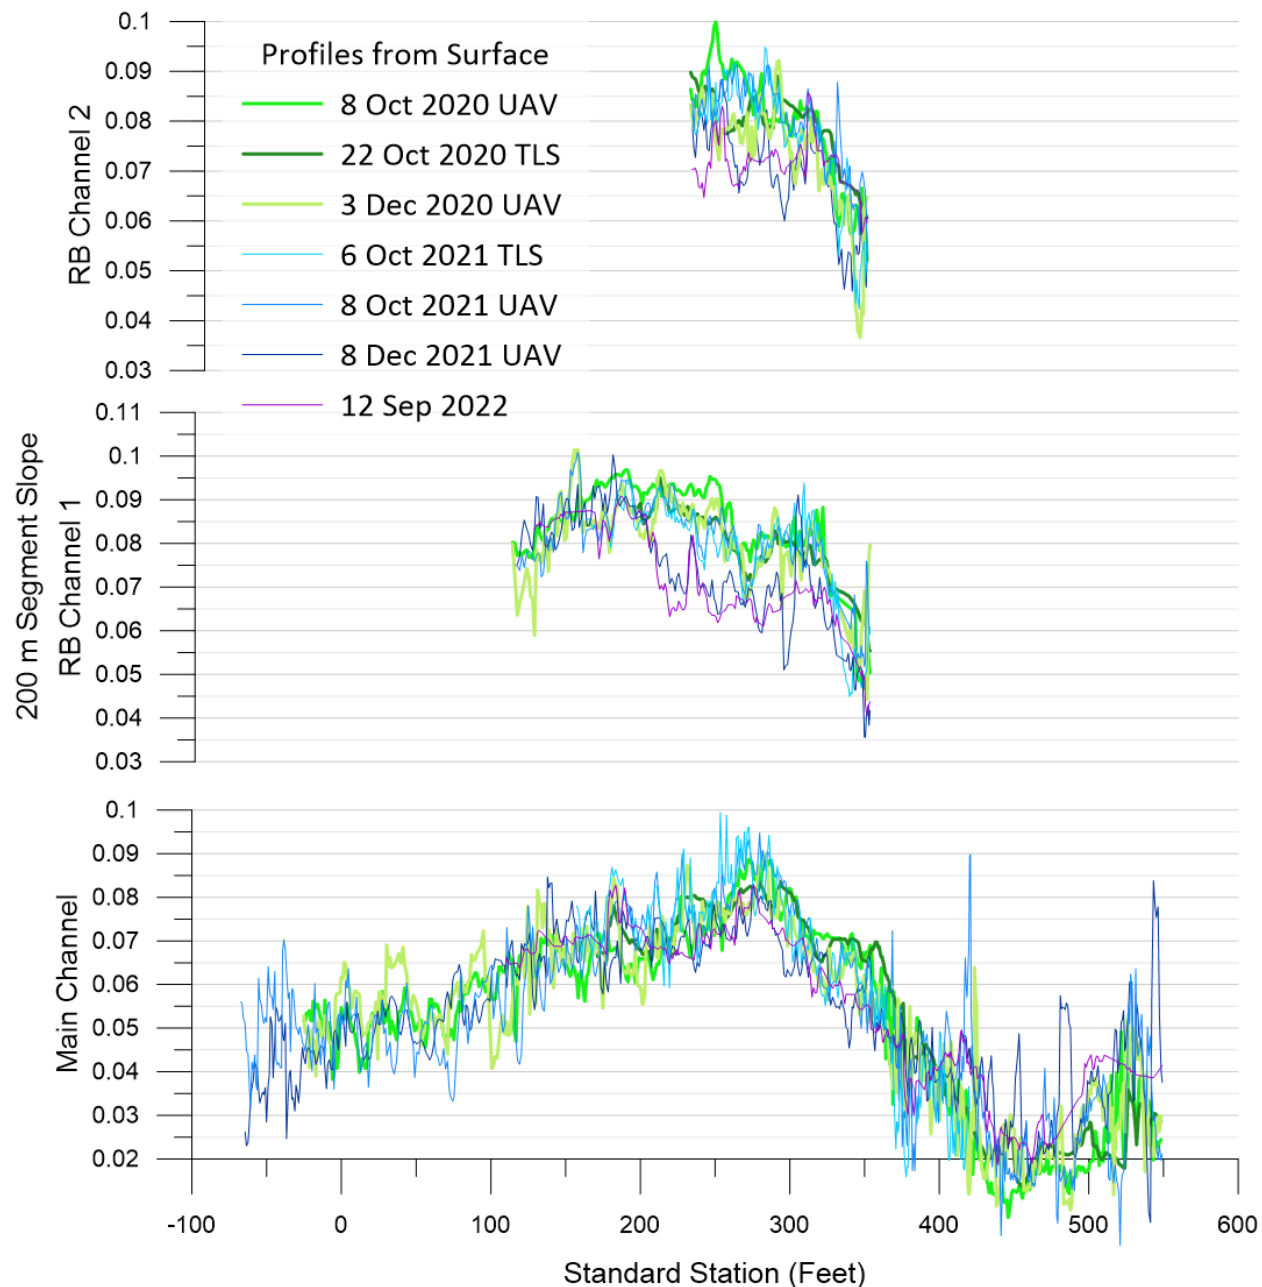
Slopes for 200 ft segments were extracted along each profile path outlined in Figure 2.1 and are plotted in Figure 5.1. Along the main channel, the September 2022 slopes are consistently below 8%, except for one small reach at the 175-ft stationing that is between 8 and 8.5%. The right bank flow paths (RB 1 and RB 2) have a lower average slope compared to previous monitoring periods, and no longer exceed 9%. The upstream left bank split is less than 200 ft long, but the average slope along that split is 5%. There are no major changes to the channel slope from October 2020 to September 2022 apart from the regrade in the right bank flow paths trending in the direction of shallower overall slopes.

**Figure 5.1** Plots showing 200 ft segment average slopes for each monitoring DEM.

Along the main channel, the December 2021 slopes are more consistently below 8%, including the reach between the 200 and 300-ft stationing. The main channel is less steep between the 280-ft stationing and the 420-ft stationing in December 2021 than previously. This reach of the restored channel coincides with boulder displacement observed in Figure 3.3, and therefore reflects channel regrade following bed mobilization and reorganization during the autumn 2021 floods. Just upstream of this reach in the fish bypass return pool the stream is steeper than as built conditions but still within 2 and 5%. The first and second right bank flow paths (RB 1 and RB 2) are both less steep in December 2021 than previously, with

much of the channel upstream of the 200-ft stationing below 8%. Development and regrading of the right bank flow pathways to a lower slope opens a valuable secondary fish passage route through the regraded reach of channel.

All segments are below the action threshold of a 12% slope (Table 1.1) and below the 2b decision pathway threshold of a 10% slope; but several are above the 7% 2b decision pathway indicating continuing monitoring is needed.

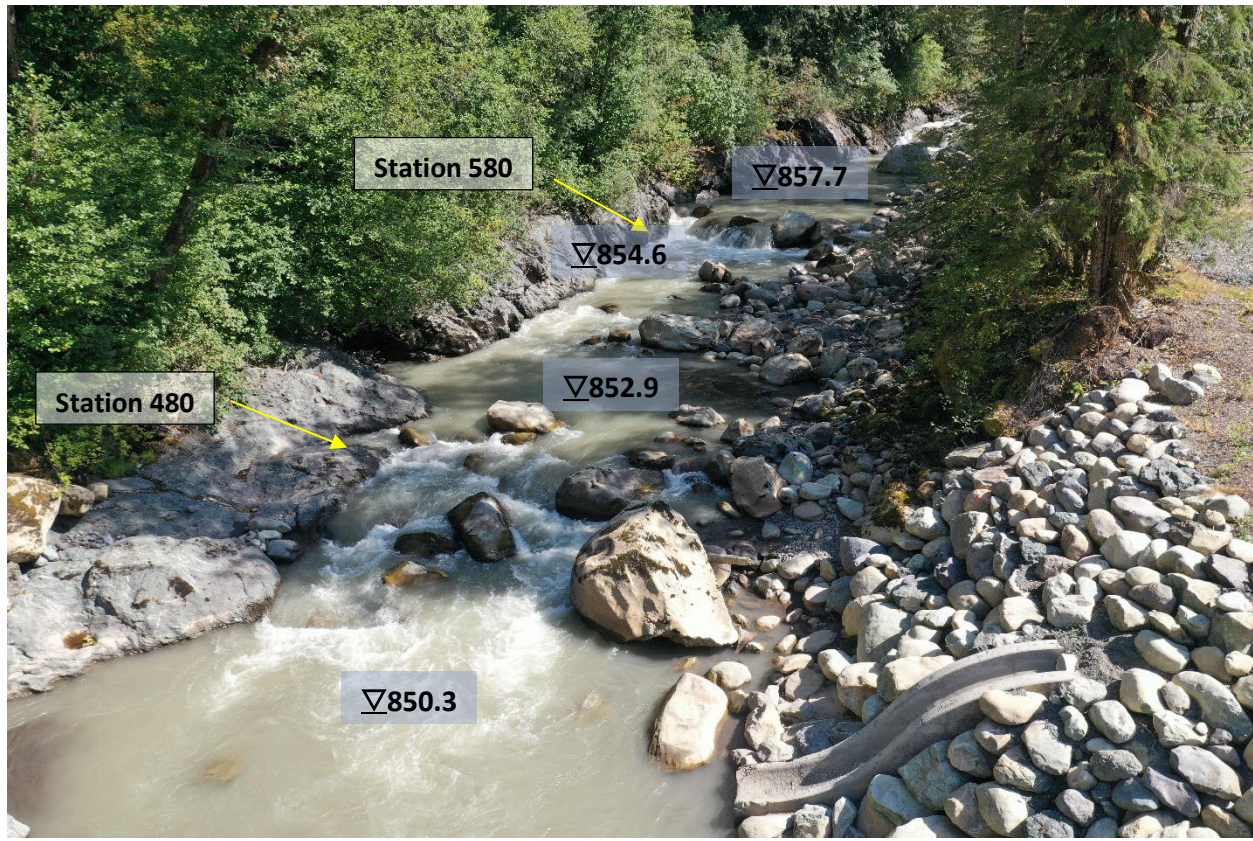
Overall, the moderate degradation of the regrade reach is reducing the average slope and presumably increasing fish passability, however the regrade is increasing the slope of the channel upstream as a result. In particular, the regrade has exposed a boulder step at Transect 480 (step 1), immediately upstream of the fish bypass slide. A new step formed at Station 580 during the November 2021 flood events (step 2), likely due to a combination of channel bed reorganization and dropping of the low flow water surface elevation. Two prominent steps upstream have remained mostly unchanged in morphology at Station 729 (step 3) and Station 760 (step 4) (Figure 4.1, Figure 5.2, Figure 5.3). To provide a quantitative assessment in addition to the qualitative observations from photos, head drop and average slopes over 20-ft segments were calculated for the reach using both the September 2022 and October 2020 TLS topographic surfaces. At both steps, local slopes approach 15% in the 2022 surface as compared to the 2020 topographic surface, where slopes remain below 10%. These steep steps are separated by long pools. The average slope of this reach between Station 440 and Station 600 is 7%. The head drops, rounded to the nearest 0.5 feet, were approximately 2.5 feet, 3 feet, 4 feet, and 3 feet across steps 1 through 4, respectively. These drops do not exceed the 5-ft threshold as outlined in the MAMP.

**Figure 5.2** View of channel conditions between the fish outlet (Station 437) and Station 580 with water surface elevations extracted from the TLS scan on Sep. 12, 2022 at prominent channel steps (205 cfs).

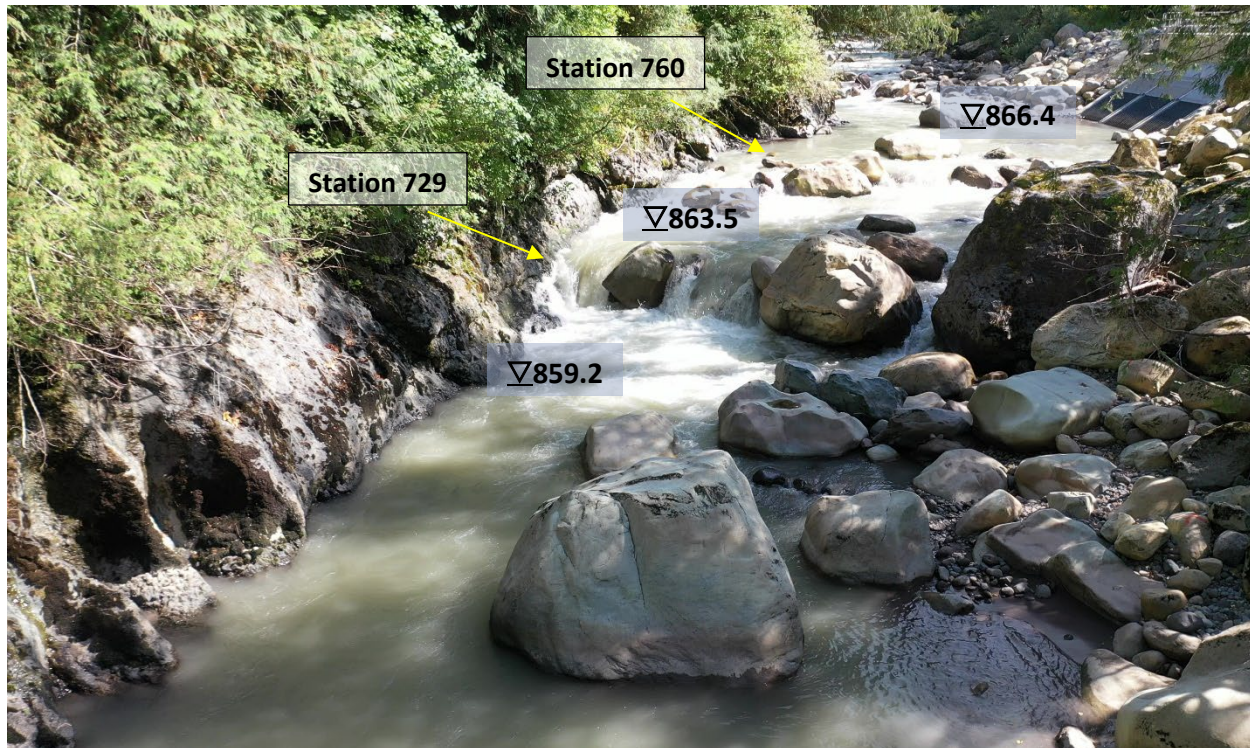
**Figure 5.3** View of channel conditions between Station 663 (downstream photo extent) to the water intake structure upstream with water surface elevations extracted from the TLS scan on Sep. 12, 2022 at prominent channel steps (205 cfs).

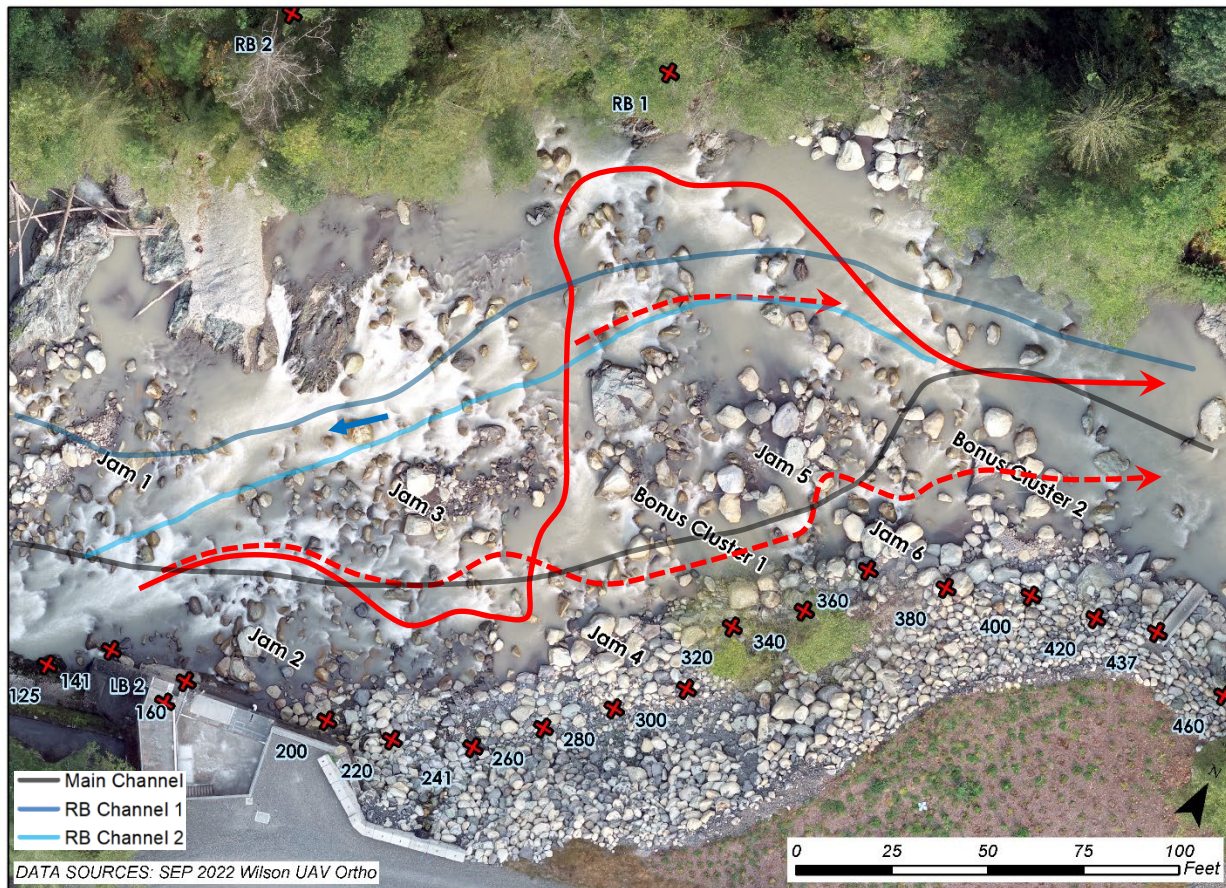
Degradation continued along the right side of the channel, with greater passability than before along the upstream section. However, the downstream section of RB 1 appears to continue to be highly turbulent and aerated and is less likely to be negotiated by upstream migrants than the left side. As noted as a potential outcome in the previous report, the right bank flow path has degraded further and has exposed more of the underlying bedrock. However, it appears from the channel profiles in the appendix that the regrading rate is slowing down, where the right side may be approaching a more stable grade in the future. As such, this route could be potentially passable at higher flows when flow conditions in the left side of the channel become more turbulent and faster.

**Figure 5.4** Potential upstream passage routes overlaid on September 2022 orthomosaic and relevant monitoring pathways (main channel, RB 1 and RB 2). Solid line = expected primary pathway during lower to mid-flow range; dashed lines = additional routes during mid- and higher flow range. (Photo: Wilson Engineering)

While our qualitative interpretation does not identify any major concerns for fish passage through the site, we still recommend confirming fish movement through the site on the basis of biological monitoring. It is understood that the implementation of biological monitoring for this reach of the river is beyond the scope of the MAMP, and responsibility for such activity rests with the WRIA 1 Fishery Co-Managers. NHC and the City are aware of planning efforts for these agencies to implement biological monitoring for this difficult-to-access reach of river in the future.

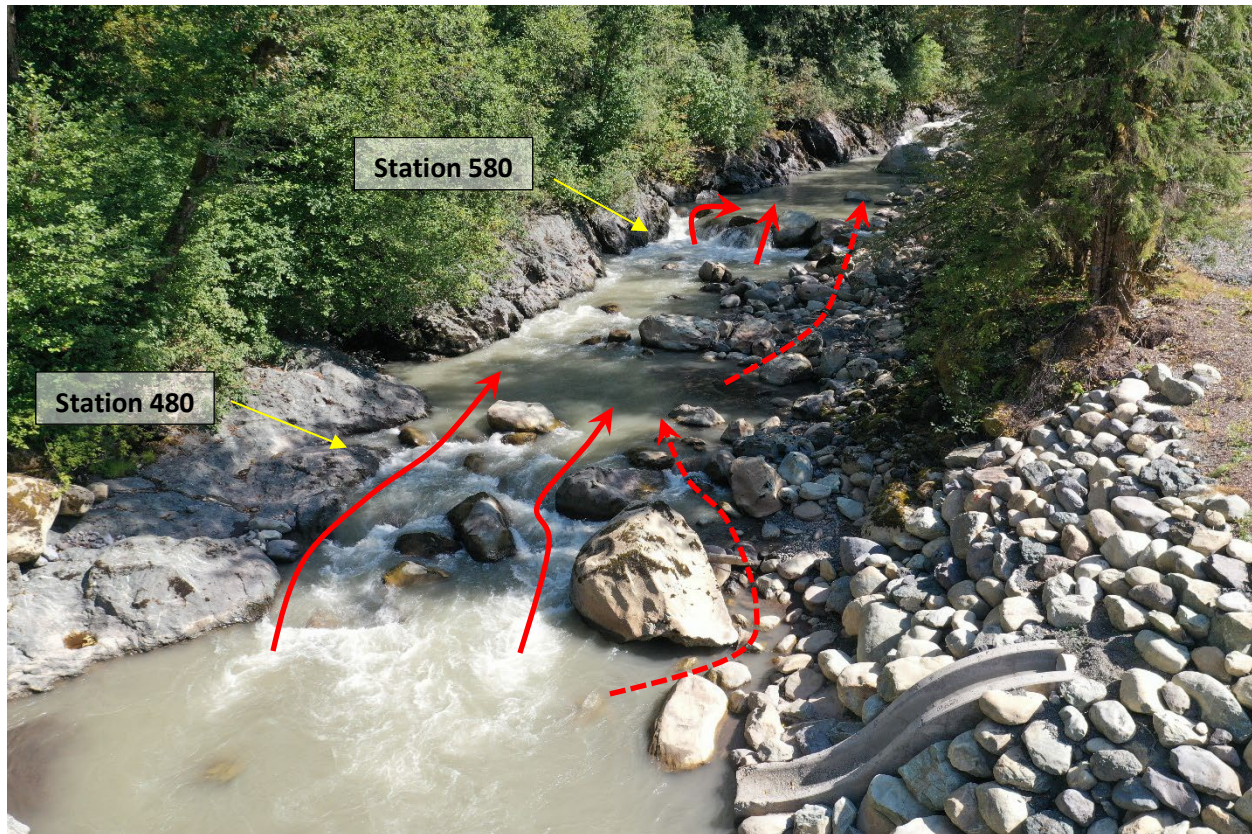
Although the regraded reach experienced meaningful geomorphic changes since before November 2021, in some cases approaching thresholds in the MAMP triggering consideration of adaptive management actions, there were no hydraulics within the channel that appeared to preclude volitional passage at the flows observed, including upstream. Connectivity for adult passage appeared to be highly likely, and different potential swimmable pathways appeared possible for transit of the regraded reach at different flow levels (Figure 5.4). Lowering of the low flow water surface at the upstream end of the regraded reach led to development of larger head drops at existing steps upstream at around stations 480 and 580, but the increased head drops and velocities at the steps were lower than in the unaffected reach between there and the intake, and multiple routes appear passable via a combination of swimming and small leaps (Figure 5.5).

**Figure 5.5** Likely passage routes at the observed flow at steps upstream of the fish outlet slide (September 2022). Solid lines = expected primary pathway during lower to mid-flow range; dashed lines = additional routes during mid- and higher flow range.
