# MF Nooksack Channel Monitoring & Adaptive Management

## Year 2 Monitoring

NHC Reference 2005776

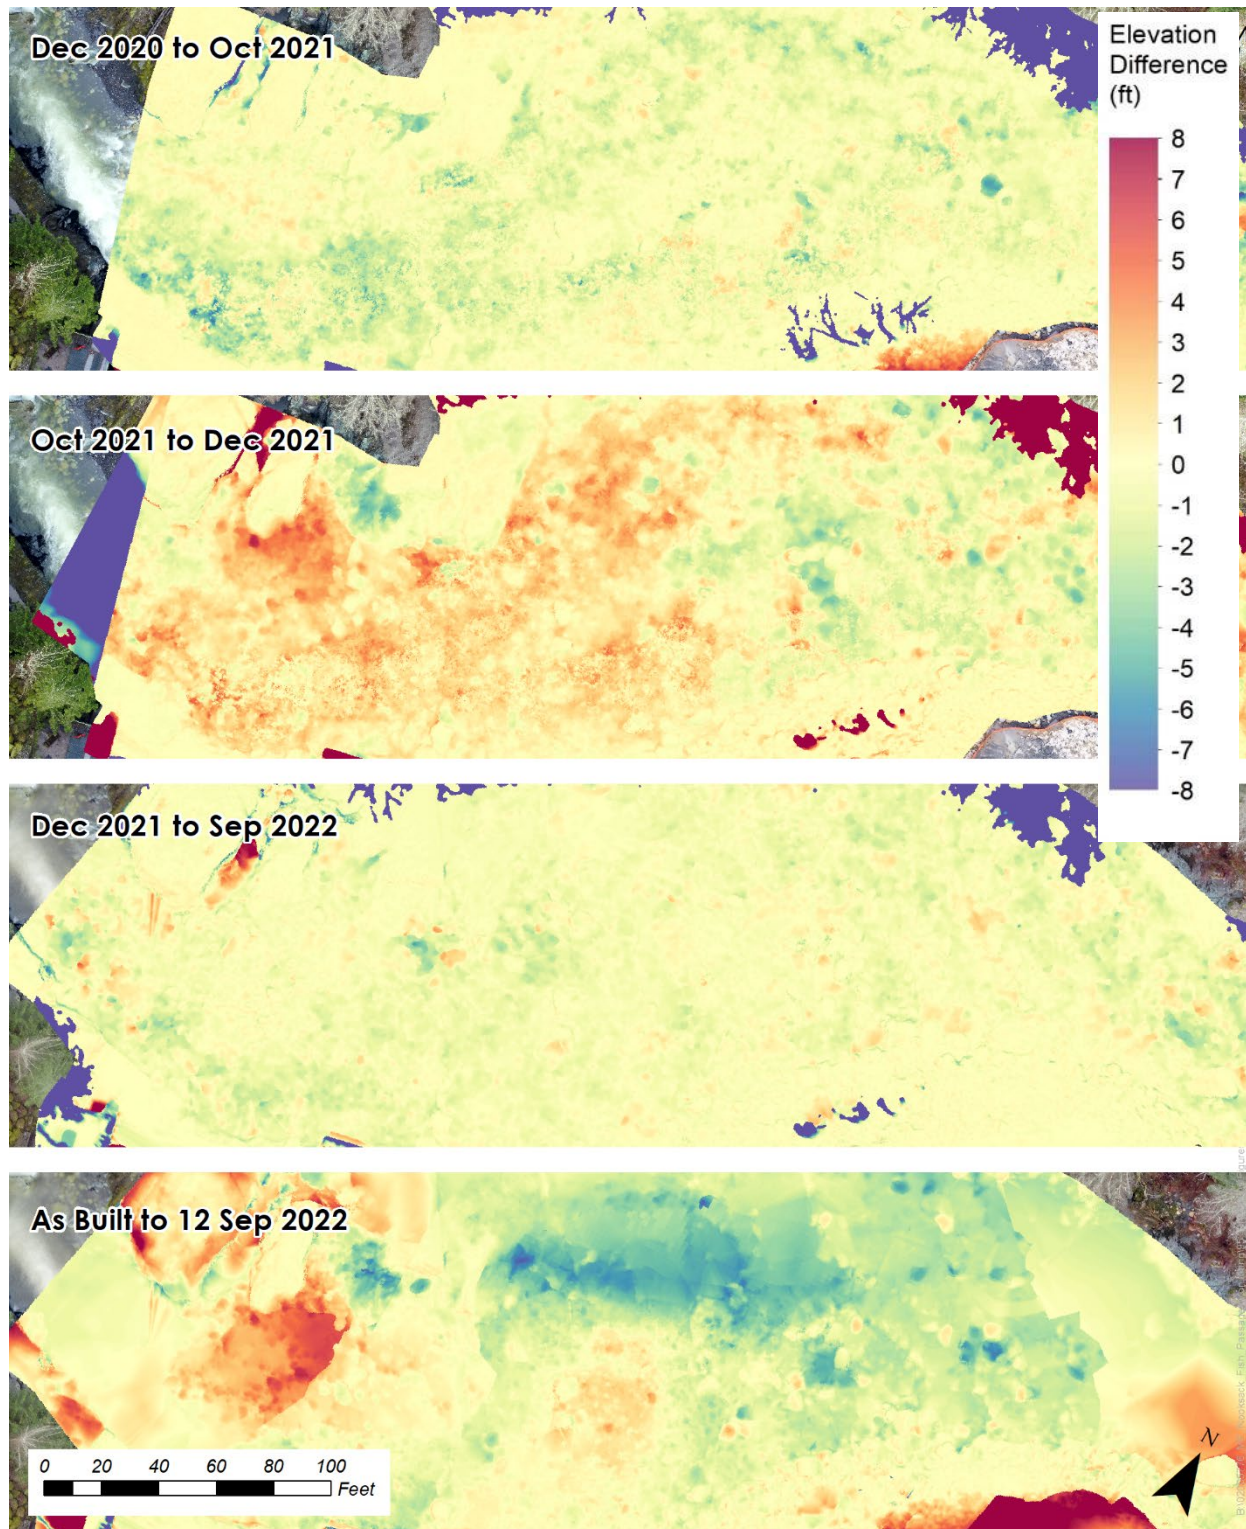
**Figure 3.1** DEM surface comparisons showing differences between the design surface and as-built surface (top) and between the as-built surface and subsequent topographic surfaces. Red colors indicate aggradation and blue colors degradation.

The November 2021 floods provided an early opportunity to test the stability and adaptability of the designed channel during a large magnitude event (approaching 50-yr recurrence). Figure 3.3 displays channel bed changes within the flow split between station 140 and the fishway at 437 feet. Despite widespread channel lowering, the designed boulder clusters remained mostly stable during the November 2021 flood, preventing the same degree of bed mobility and large-scale reorganization as observed in the right bank channels. Only two of the boulder clusters destabilized from their jammed state during the floods, Jam 5 and Bonus Cluster 2. These clusters (outlined in red in Figure 3.3) are located at the upstream extent of the design channel, suggesting that boulder cluster instability increases upstream with proximity to the pool outlet, between stations 320 and 437. Select boulder movements can be seen in Figure 3.3, where displacements (shown as colored polygons) range from 12 to 25 feet.

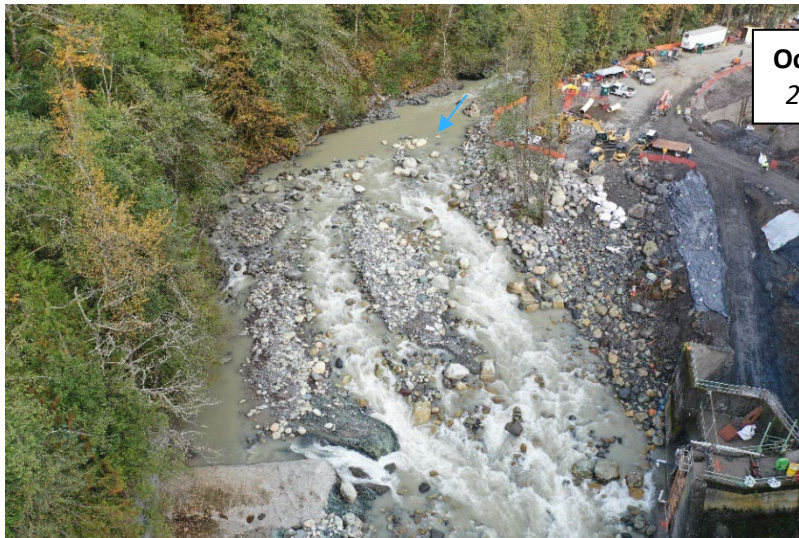
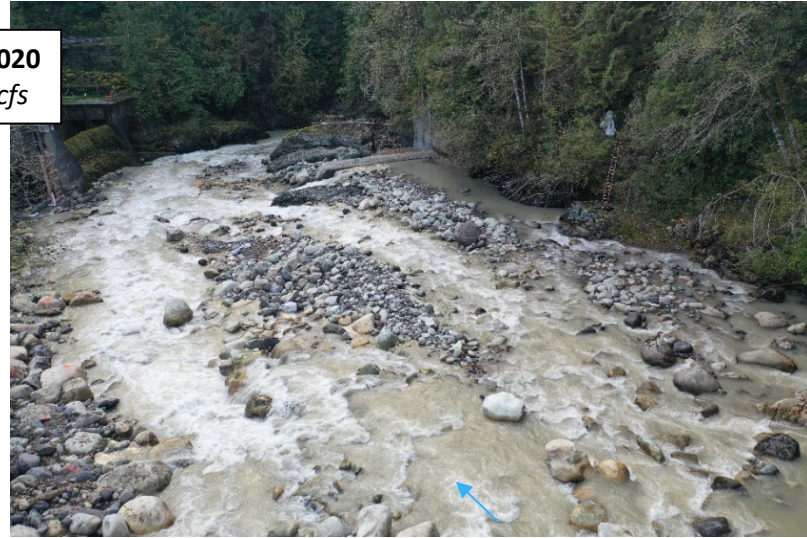
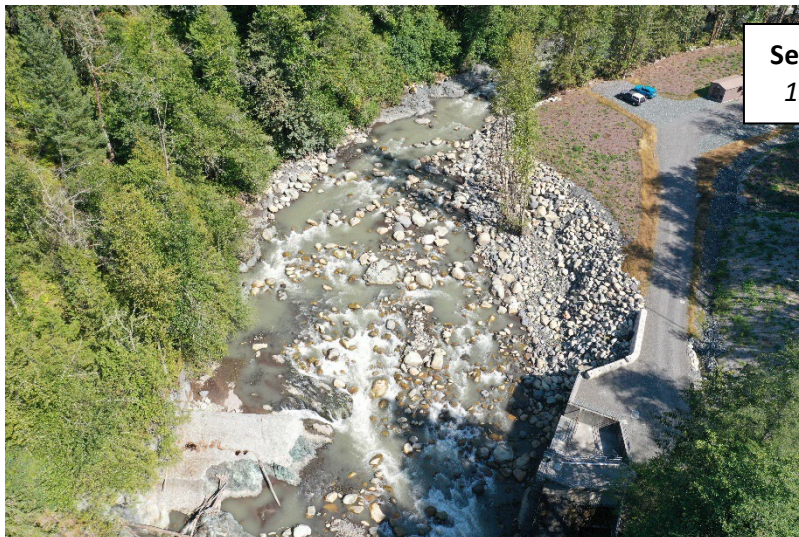
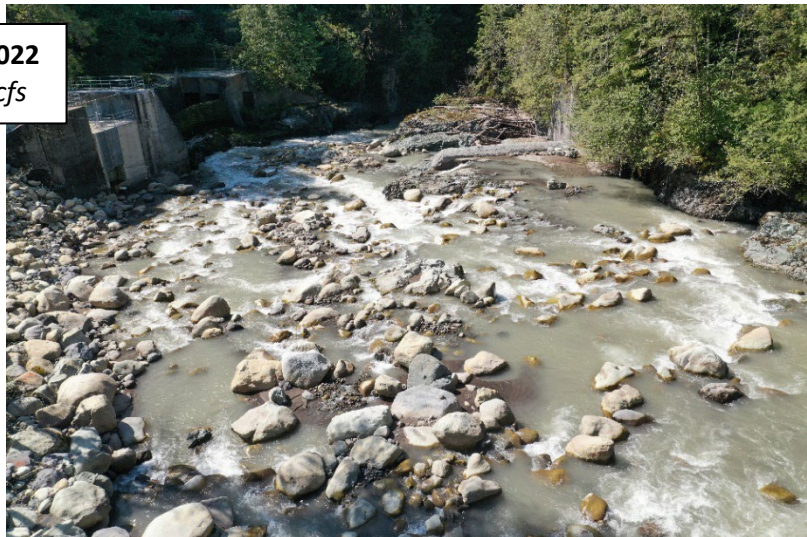
**Figure 4.2** Repeat UAV imagery showing low-flow channel comparisons between October 2020 (top) and September 2022 (bottom)

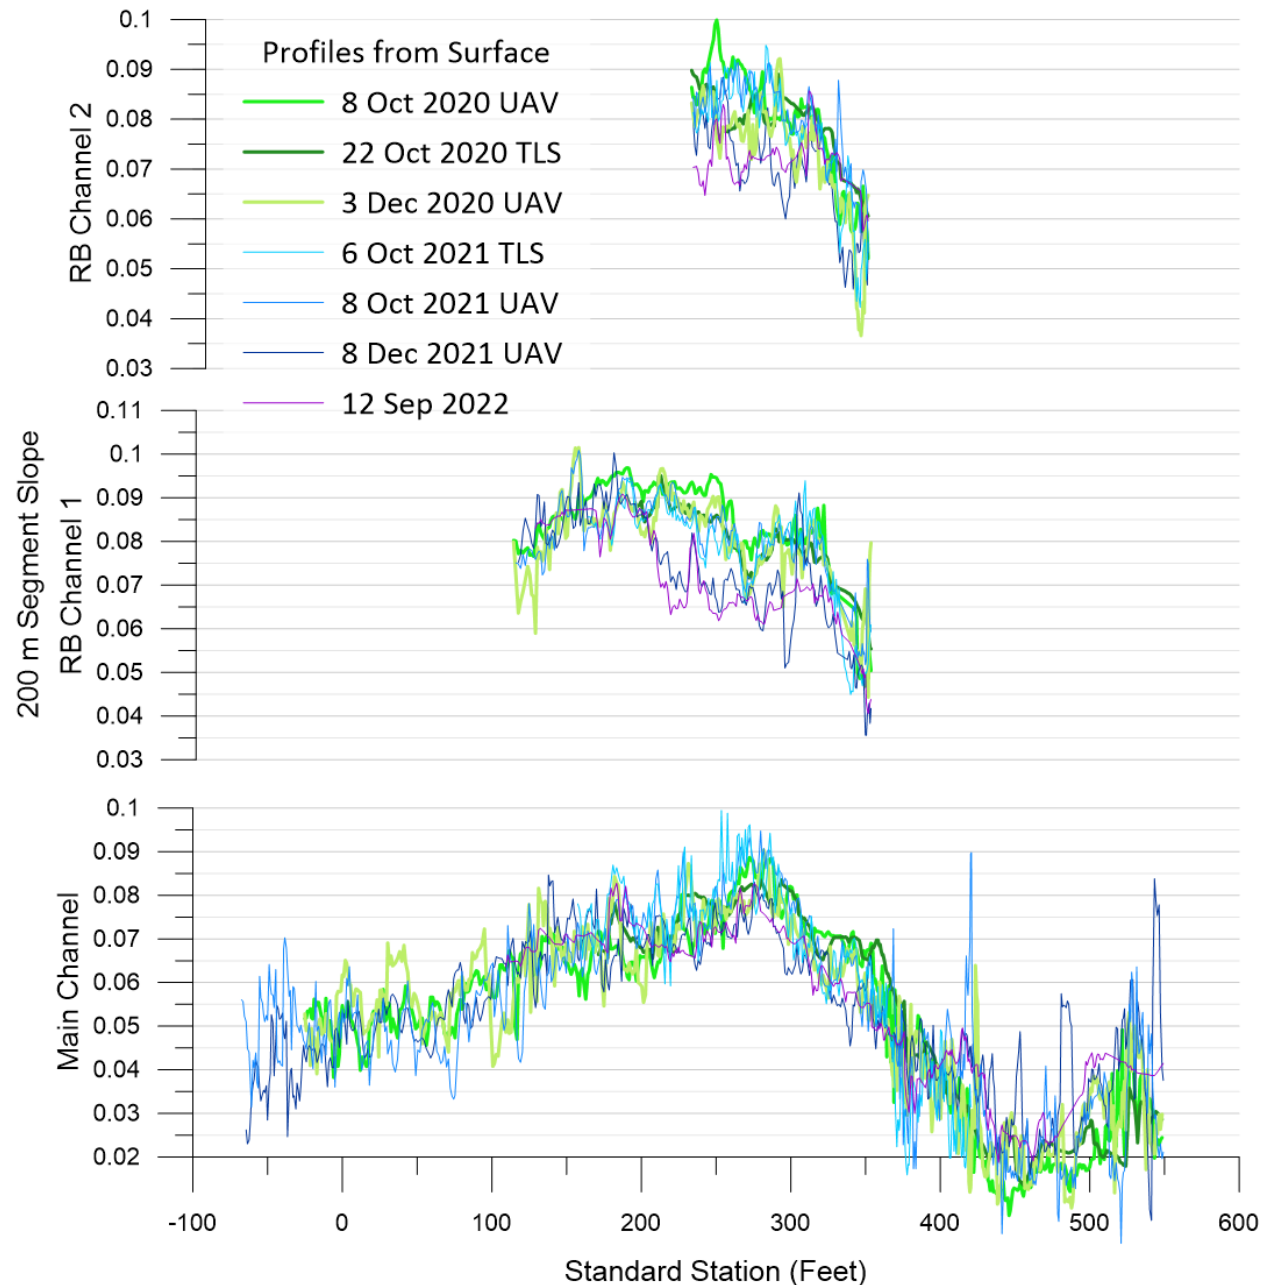
Slopes for 200 ft segments were extracted along each profile path outlined in Figure 2.1 and are plotted in Figure 5.1. Along the main channel, the September 2022 slopes are consistently below 8%, except for one small reach at the 175-ft stationing that is between 8 and 8.5%. The right bank flow paths (RB 1 and RB 2) have a lower average slope compared to previous monitoring periods, and no longer exceed 9%. The upstream left bank split is less than 200 ft long, but the average slope along that split is 5%. There are no major changes to the channel slope from October 2020 to September 2022 apart from the regrade in the right bank flow paths trending in the direction of shallower overall slopes.

**Figure 5.1** Plots showing 200 ft segment average slopes for each monitoring DEM.

Along the main channel, the December 2021 slopes are more consistently below 8%, including the reach between the 200 and 300-ft stationing. The main channel is less steep between the 280-ft stationing and the 420-ft stationing in December 2021 than previously. This reach of the restored channel coincides with boulder displacement observed in Figure 3.3, and therefore reflects channel regrade following bed mobilization and reorganization during the autumn 2021 floods. Just upstream of this reach in the fish bypass return pool the stream is steeper than as built conditions but still within 2 and 5%. The first and second right bank flow paths (RB 1 and RB 2) are both less steep in December 2021 than previously, with

All segments are below the action threshold of a 12% slope (Table 1.1) and below the 2b decision pathway threshold of a 10% slope; but several are above the 7% 2b decision pathway indicating continuing monitoring is needed.

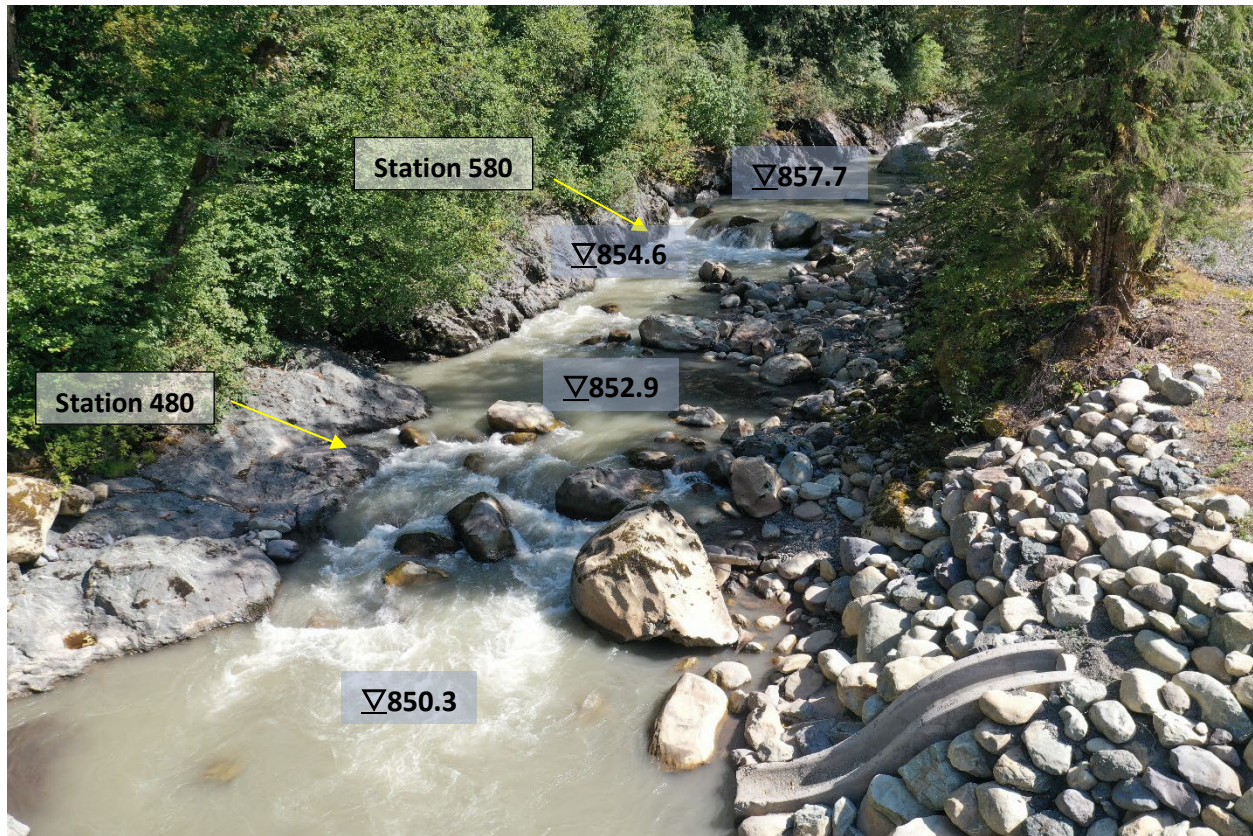
Overall, the moderate degradation of the regrade reach is reducing the average slope and presumably increasing fish passability, however the regrade is increasing the slope of the channel upstream as a result. In particular, the regrade has exposed a boulder step at Transect 480 (step 1), immediately upstream of the fish bypass slide. A new step formed at Station 580 during the November 2021 flood events (step 2), likely due to a combination of channel bed reorganization and dropping of the low flow water surface elevation. Two prominent steps upstream have remained mostly unchanged in morphology at Station 729 (step 3) and Station 760 (step 4) (Figure 4.1, Figure 5.2, Figure 5.3). To provide a quantitative assessment in addition to the qualitative observations from photos, head drop and average slopes over 20-ft segments were calculated for the reach using both the September 2022 and October 2020 TLS topographic surfaces. At both steps, local slopes approach 15% in the 2022 surface as compared to the 2020 topographic surface, where slopes remain below 10%. These steep steps are separated by long pools. The average slope of this reach between Station 440 and Station 600 is 7%. The head drops, rounded to the nearest 0.5 feet, were approximately 2.5 feet, 3 feet, 4 feet, and 3 feet across steps 1 through 4, respectively. These drops do not exceed the 5-ft threshold as outlined in the MAMP.

**Figure 5.2** View of channel conditions between the fish outlet (Station 437) and Station 580 with water surface elevations extracted from the TLS scan on Sep. 12, 2022 at prominent channel steps (205 cfs).

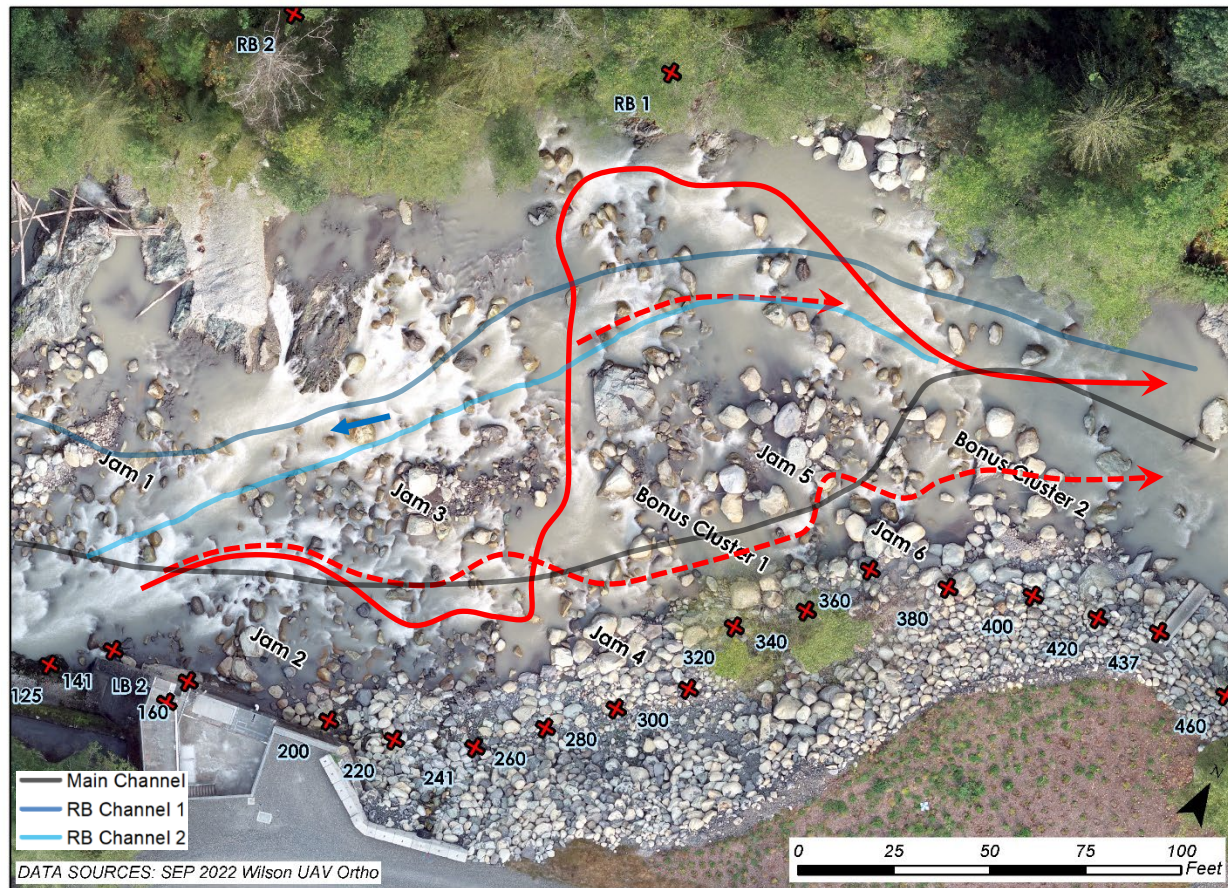
Degradation continued along the right side of the channel, with greater passability than before along the upstream section. However, the downstream section of RB 1 appears to continue to be highly turbulent and aerated and is less likely to be negotiated by upstream migrants than the left side. As noted as a potential outcome in the previous report, the right bank flow path has degraded further and has exposed more of the underlying bedrock. However, it appears from the channel profiles in the appendix that the regrading rate is slowing down, where the right side may be approaching a more stable grade in the future. As such, this route could be potentially passable at higher flows when flow conditions in the left side of the channel become more turbulent and faster.

**Figure 5.4** Potential upstream passage routes overlaid on September 2022 orthomosaic and relevant monitoring pathways (main channel, RB 1 and RB 2). Solid line = expected primary pathway during lower to mid-flow range; dashed lines = additional routes during mid- and higher flow range. (Photo: Wilson Engineering)

While our qualitative interpretation does not identify any major concerns for fish passage through the site, we still recommend confirming fish movement through the site on the basis of biological monitoring. It is understood that the implementation of biological monitoring for this reach of the river is beyond the scope of the MAMP, and responsibility for such activity rests with the WRIA 1 Fishery Co-Managers. NHC and the City are aware of planning efforts for these agencies to implement biological monitoring for this difficult-to-access reach of river in the future.
