MF Nooksack Channel Monitoring & Adaptive Management Year 3 Monitoring

Northwest Hydraulic Consultants Inc.

City of Bellingham Public Works

NHC Reference 2005776

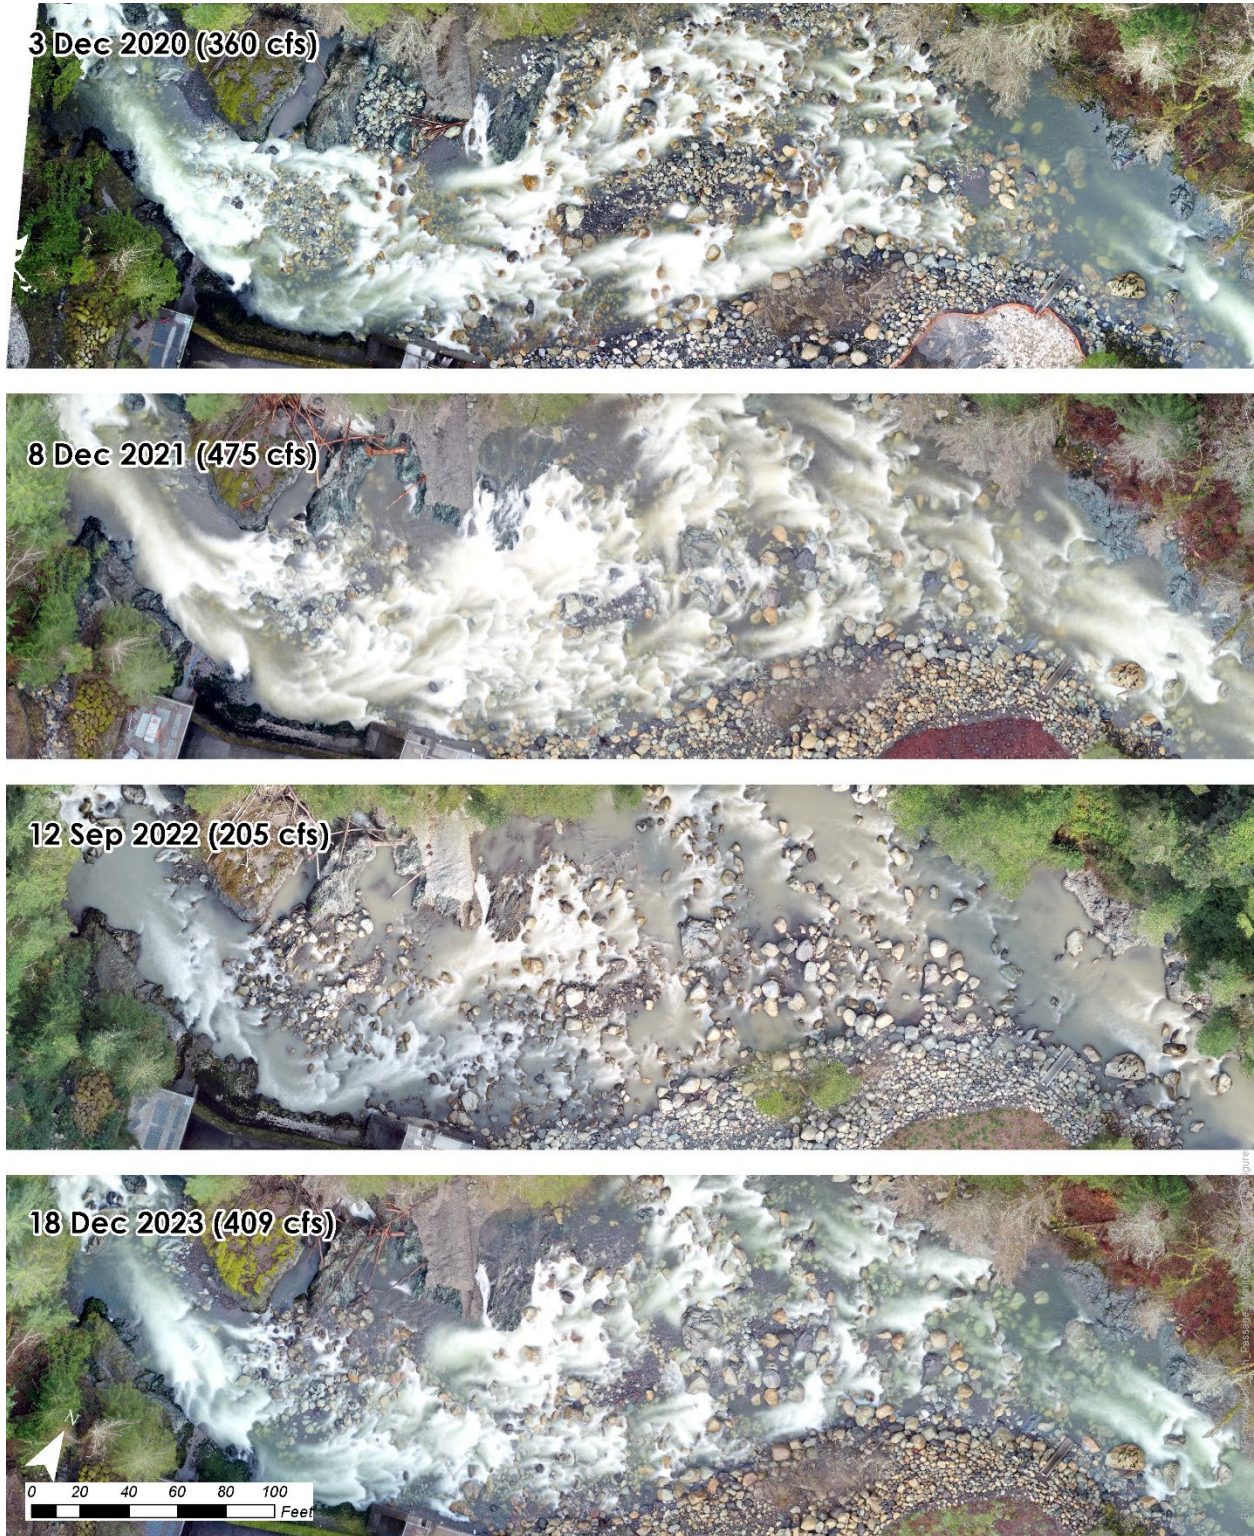
Figure 3.1 Orthomosaic comparisons showing observed channel conditions during monitoring site visits between December 2020 to December 2023.

Qualitative comparisons of the September 2022 and December 2023 orthomosaic photographs show that very little has changed in the structure of the channel bed, which can be attributed to the stability of the jamming features formed in the November 2021 floods (Figure 3.1). Prior to the November 2021 event, boulders outside of the restored flow path were not organized in stable morphologies such as boulder clusters or jamming arches, resulting in widespread mobilization during the flood. Boulder transport of some of the largest grains (estimated D_{84} and above) in the November flood have restructured the bed into a more stable jammed state characteristic of an organized step-pool morphology, increasing the overall stability of the bed compared to the less-organized state present along the right bank flow paths before the November 2021 flood (Church and Zimmermann, 2007; Zimmermann et al., 2010).

Readjustment of the main channel has increased the complexity of the reach, increasing the total number of pools and flow pathways. Therefore, the designed jams continue to not only maintain passable slopes, but add stable roughness along the perimeter of the left flow pathway from which new step pool lines can form over time. Additionally, reworking of the previously exposed mid-channel bar now connects the right and main channels at a range of flows, which increases the number of potential fish migration routes. Section 4 discusses the ongoing adjustments of the main channel, as well as the minor changes in the primary fish pathways outlined in NHC (2023).

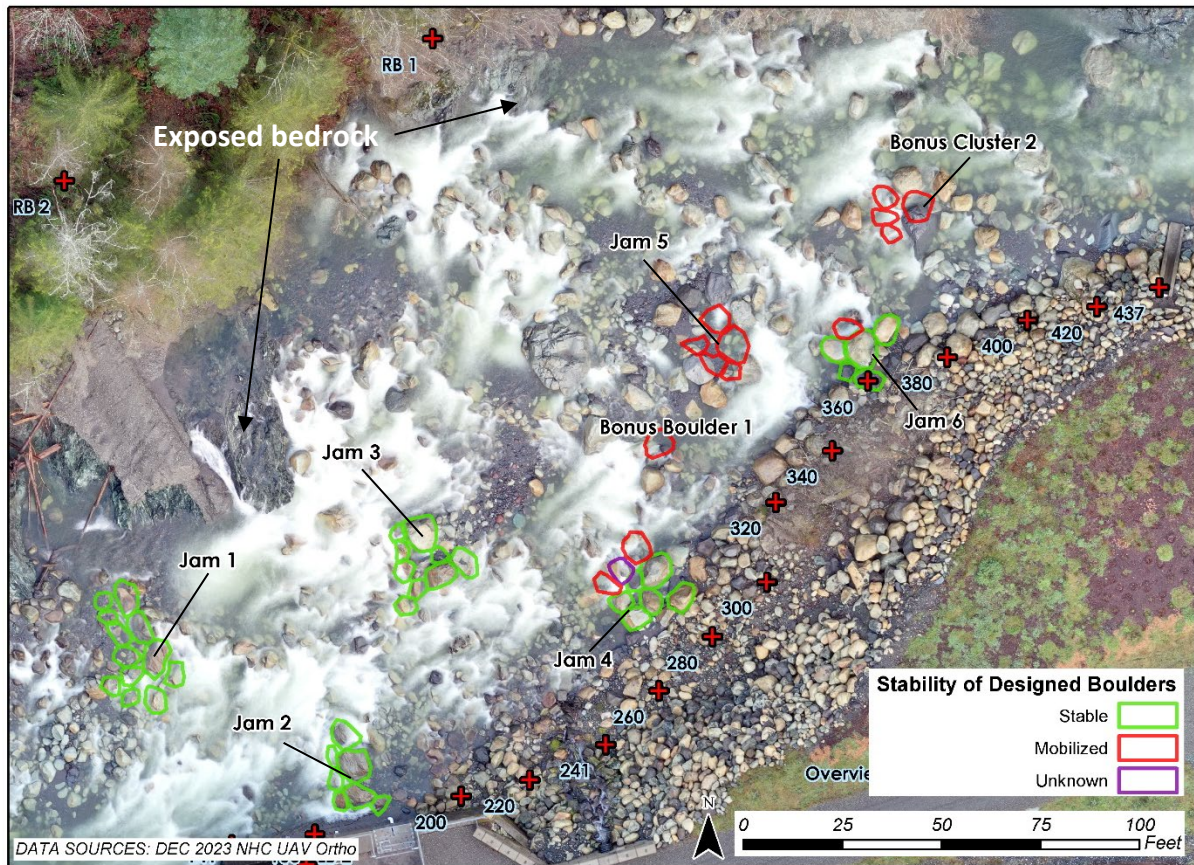
Figure 3.2 December 2023 (410 cfs) orthomosaic documenting relative instability in the restored channel, with engineered boulder cluster jams labeled. Areas of exposed bedrock on the channel bed are also labeled. (Photo: NHC)

The relative stability and locations of the designed boulder jams did not change between 2022 and 2023, although some designations have been changed from “unknown” after clear-water photographs were collected at low flows in December 2023. As discussed in NHC (2023), the November 2021 floods provided an early opportunity to test the stability and adaptability of the designed channel during a large magnitude event (approaching 50-yr recurrence). Figure 3.2 displays channel bed changes within the flow split between station 140 and the fishway at 437 feet. Despite widespread channel lowering, the designed boulder clusters remained mostly stable during the November 2021 flood, preventing the same degree of bed mobility and large-scale reorganization as observed in the right bank channels. Only two of the boulder clusters completely destabilized from their jammed state during the floods, Jam 5 and Bonus Cluster 2. These clusters (outlined in red in Figure 3.2) are located at the upstream extent of the design channel, suggesting that boulder cluster instability increases upstream with proximity to the pool outlet, between stations 320 and 437. Depth to bedrock also increases in the downstream direction, highlighting the importance of downstream buried stabilizing or bracing boulders that could not be constructed in jams over shallow bedrock. It should be noted that since initial mobilization in 2021, most of the mobilized boulders in Jam 5 have reorganized into a new stable jam.

The status of Jam 1 and Jam 4, which previously had some degree of unknown boulder stability, have since been verified in the clear water photographs from December 2023. The stability of Jam 1 was previously described as “unknown” in NHC (2023) due to high turbidity in the site photographs, but clear water conditions in December 2023 reveal that the boulders have remained stable, with the bottom/downstream line of boulders presumably buried under other rocks. The three boulders closest to the thalweg of Jam 4 were previously designated as unknown, but closer examination of the most recent photographs suggests that at least two of the three boulders had partially or fully destabilized. However, their displacement was minimal and they are currently in a stable position.

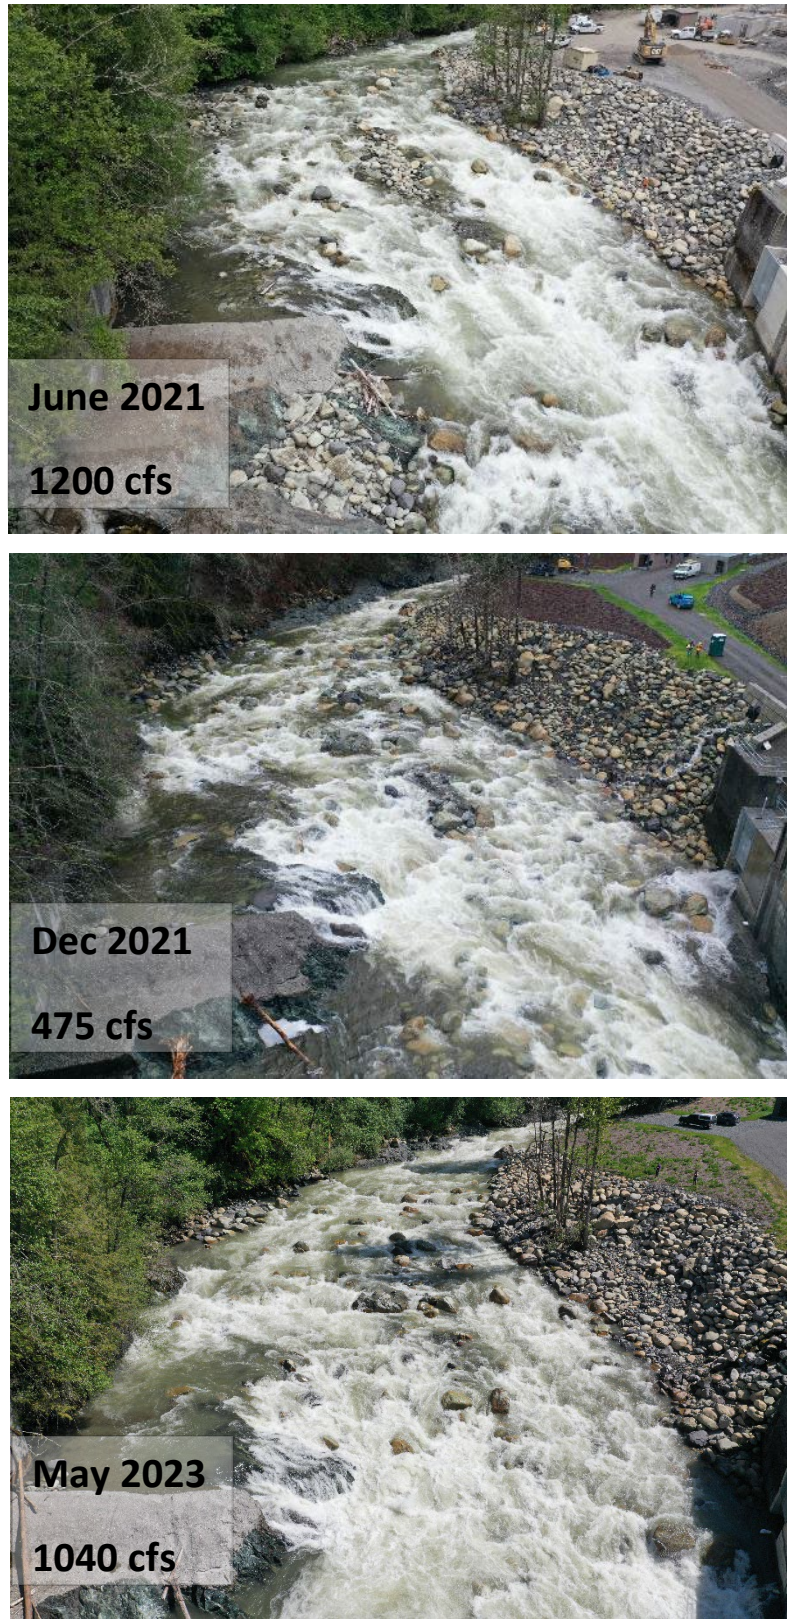
Figure 3.3 UAV oblique photos showing channel evolution at the flow split between the restored left bank channel and right bank pathways in June 2021 (top), December 2021 (middle), and May 2023 (bottom).

High flow observations were conducted during the May 2023 site visit (1,040 cfs). Reorganization of the entire bed during the November 2021 floods into more stable step-pool arches has created numerous pathways for fish, as seen in the progression of photos in Figure 3.1. There were no notable changes in the flow pathways between the December 2021 high flow site visit and the May 2023 site visit apart from the higher discharge in May, resulting in a wider active channel from greater flow connection across the right and main channels. At this discharge (1,040 cfs), the hydraulic steps between boulder lines are generally backwatered, reducing the height of the steps relative to low flow conditions. The wider active flow area and large number of moderate size step-pool units and pockets diffuse the hydraulic energy overall and prevent the development of velocity barriers. Margins of both the right and left-bank flow paths present areas with adequate depth for adult salmon passage (typically > 1ft) and lower velocities than along the thalweg of each flow path.

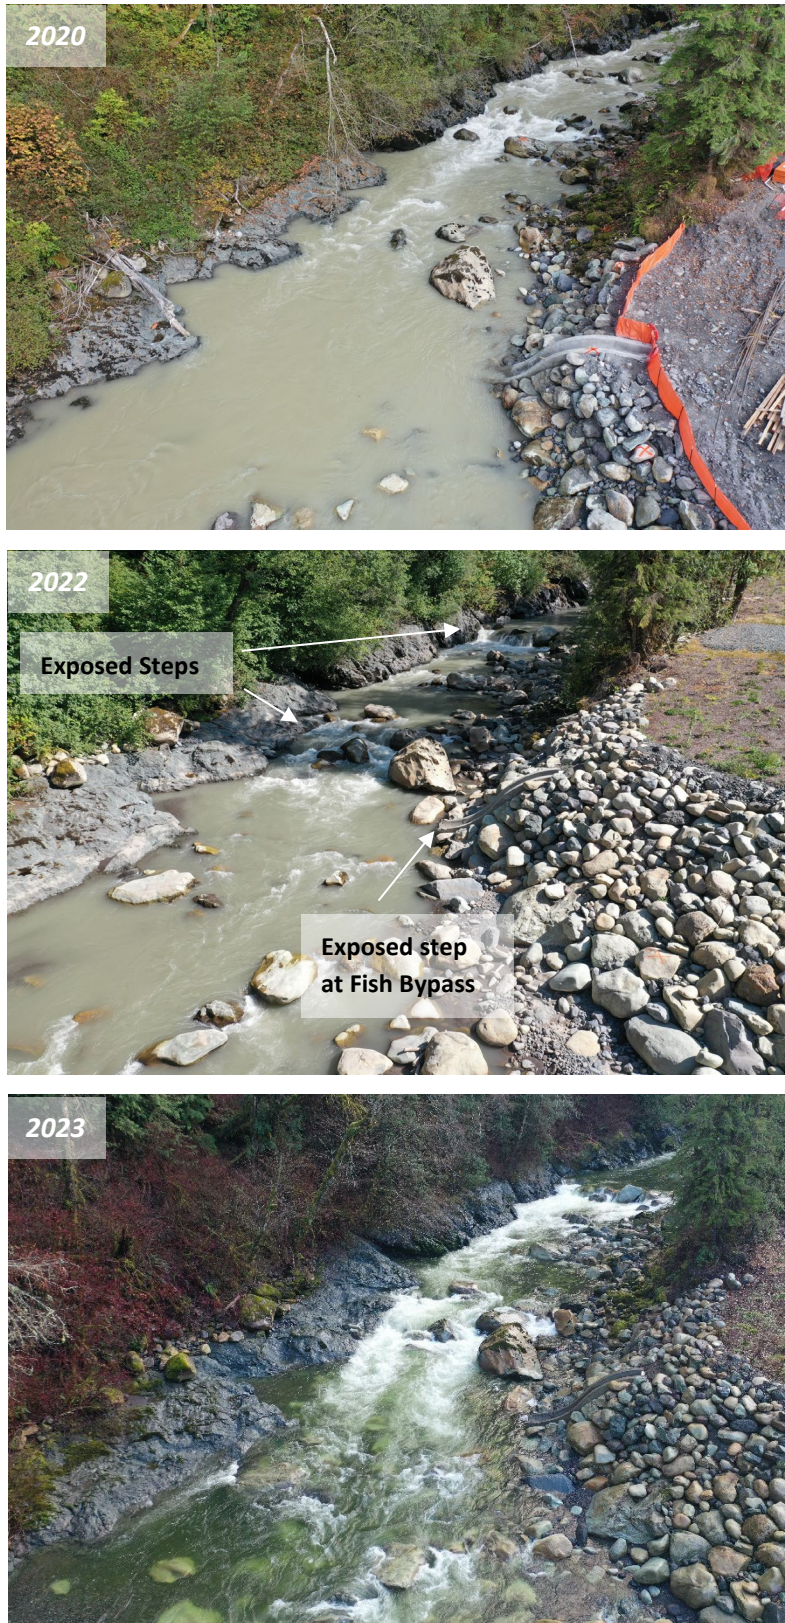
Figure 3.4 UAV oblique photos showing channel evolution at the pool outlet near Transect 400c between October 2020 (top, 225 cfs), September 2022 (middle, 152 cfs), and December 2023 (bottom, 410 cfs).

Low flow observations took place in December 2023, several weeks after a flood event (greater than a 2-yr based on provisional data). Following the site visit, there were no major concerns regarding fish passage through the observational pathways. The channel bed structure has remained largely stable and unchanged since the December 2021 observations. The relatively high amounts of fine sediment observed in September 2022 were absent during the December 2023 site visit, and flows were generally clear. The widespread regrade and channel lowering through the Fish Bypass outlet pool was still apparent during low flows, but does not appear to have downcut any further (Figure 3.4), due to the prolonged stability of the boulder line that formed at the downstream end of the bypass pool in November 2021. In its current configuration, the slide outlet remained perched above the water surface during the visit (410 cfs), which is within the range of operable flows for the bypass. Abrasion of the concrete slide has also exposed rebar near the base of slide near the water's edge. Lowering of the pool resulted in the emergence of a step that had previously been backwatered prior to November 2021, as noted in Figure 3.4. This step has not increased in prominence since September 2022, and similar to steps present along the reach upstream, is not interpreted to adversely affect fish passage, as discussed in Section 4.

One unresolved concern from the 2022 monitoring was the degree of bedrock exposure along the right flow pathway's channel bed. After review of the UAV photos and videos, most of the exposed bedrock appears to be along the right bank of the channel. Whereas previous concerns noted possibilities of extensive lateral bedrock notches, most of the steps in the photographs appear to be composed of boulders and pools filled with gravel and cobble. Future bedrock exposures will be monitored as the channel continues to evolve, as the depth to bedrock varies across the channel.

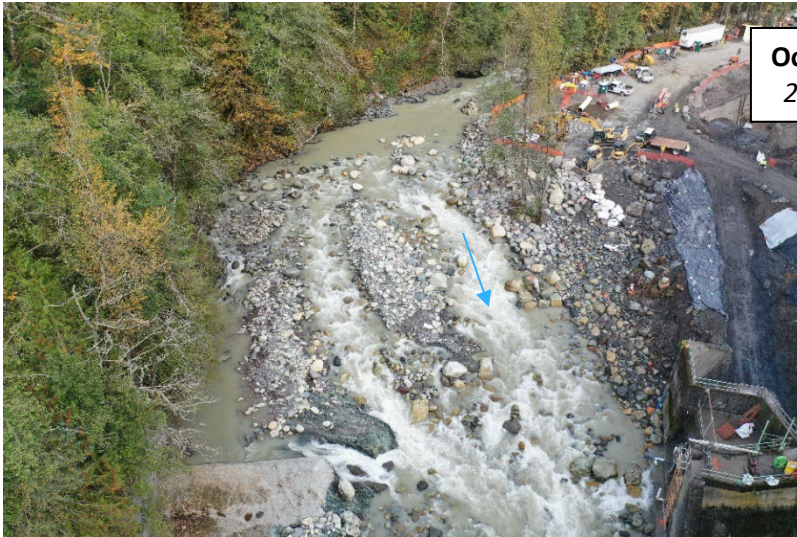
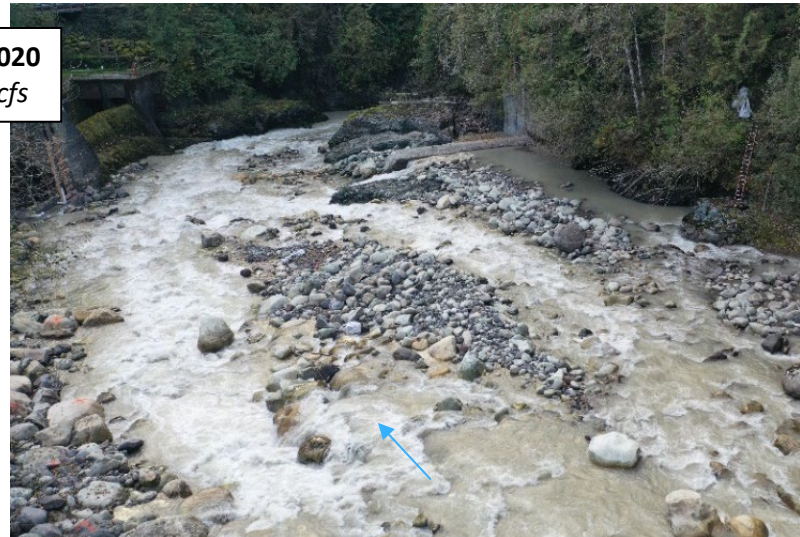
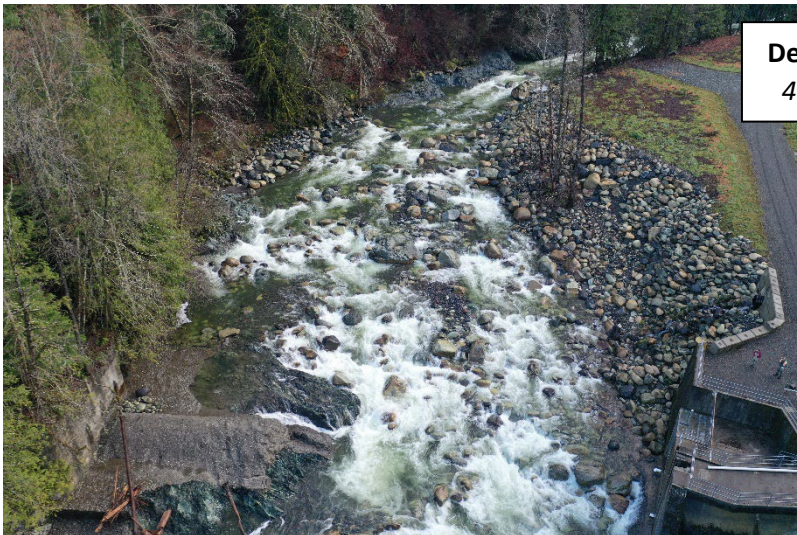
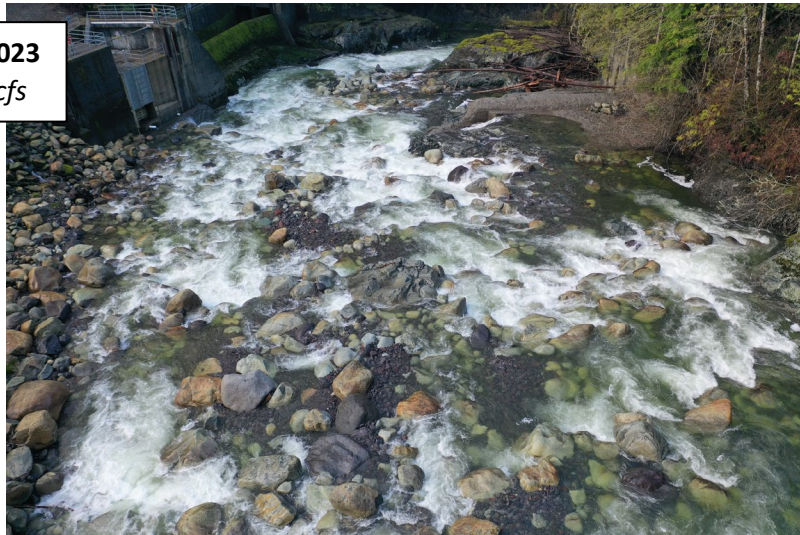
Figure 3.5 Repeat UAV imagery showing low-flow channel comparisons between October 2020 (top) and December 2023 (bottom)

As mentioned in Section 3.3 and NHC (2023), the reorganization of small to medium-sized boulders across the channel has resulted in the diversification and unification of flow pathways in the previously separated main channel and right flow paths, which remain connected at low flows of at least 410 cfs (Figure 3.5). The simultaneous regrade of both main channel and right channels has prevented the main channel from dewatering at low flows. Therefore, the engineered boulder clusters have worked as designed by adjusting with the lowering channel, maintaining passable slopes in the main channel, and creating stable roughness from which small step arches can build and form new jamming features and pools. The abundance of available pools provides ample resting areas for migrating fish. Boulders near the top of the main channel near the left bank flow split continue to adjust in a favorable way that is allowing more water into the main channel, whereas previous observations in NHC (2023) raised the concern of main channel dewatering. Section 4 discusses the evolution of the fish passage routes in this area in more detail. Flows along the upstream left bank flow split, which continues to feed water into the main channel, will be monitored at future low-flow observation visits to assess its risk for dewatering as this reach further adjusts.

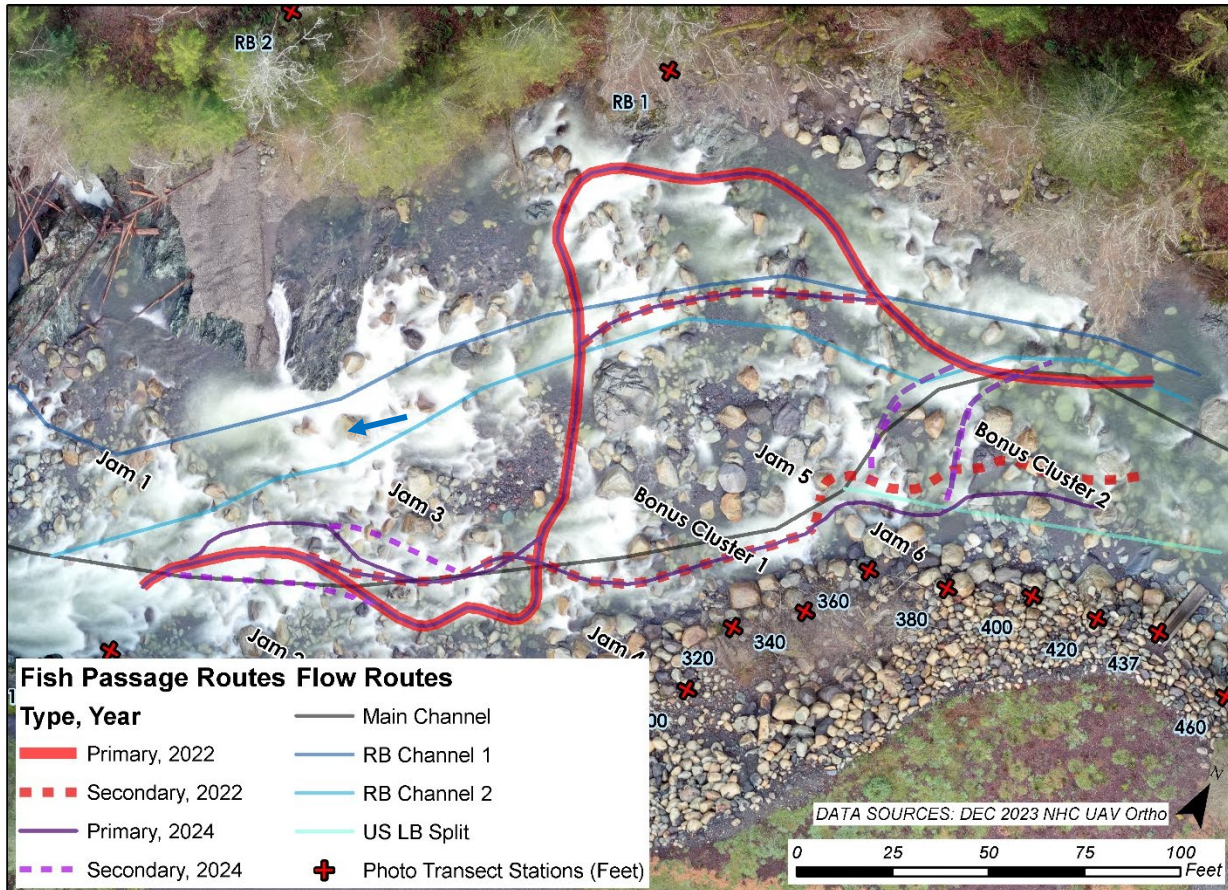
Figure 4.1 Potential upstream passage routes overlaid on December 2023 orthomosaic and relevant monitoring pathways (main channel, RB 1 and RB 2). Solid line = expected primary pathway during lower to mid-flow range; dashed lines = additional routes during mid- and higher flow range. (Photo: NHC)

Degradation continued along the right side of the channel, with greater potential for upstream passage along the upstream section than in prior years. However, the downstream section of RB 1 appears to continue to be highly turbulent and aerated and is less likely to be negotiated by upstream migrants than the left side, or main channel. As noted as a potential outcome in the previous report, the right bank flow path has degraded further and has exposed more of the underlying bedrock. However, it appears from the channel profiles in the appendix of NHC (2023) that the regrading rate is slowing down, where the right side may be approaching a more stable grade in the future. As such, this route could be potentially passable at higher flows when flow conditions in the left side of the channel become more turbulent and faster.

While our qualitative interpretation does not identify any major concerns for fish passage through the site, we still recommend confirming fish movement through the site on the basis of biological monitoring. It is understood that the implementation of biological monitoring for this reach of the river is beyond the scope of the MAMP, and responsibility for such activity rests with the WRIA 1 Fishery Co-Managers. NHC and the City are aware of planning efforts for these agencies to implement biological monitoring for this difficult-to-access reach of river in the future.

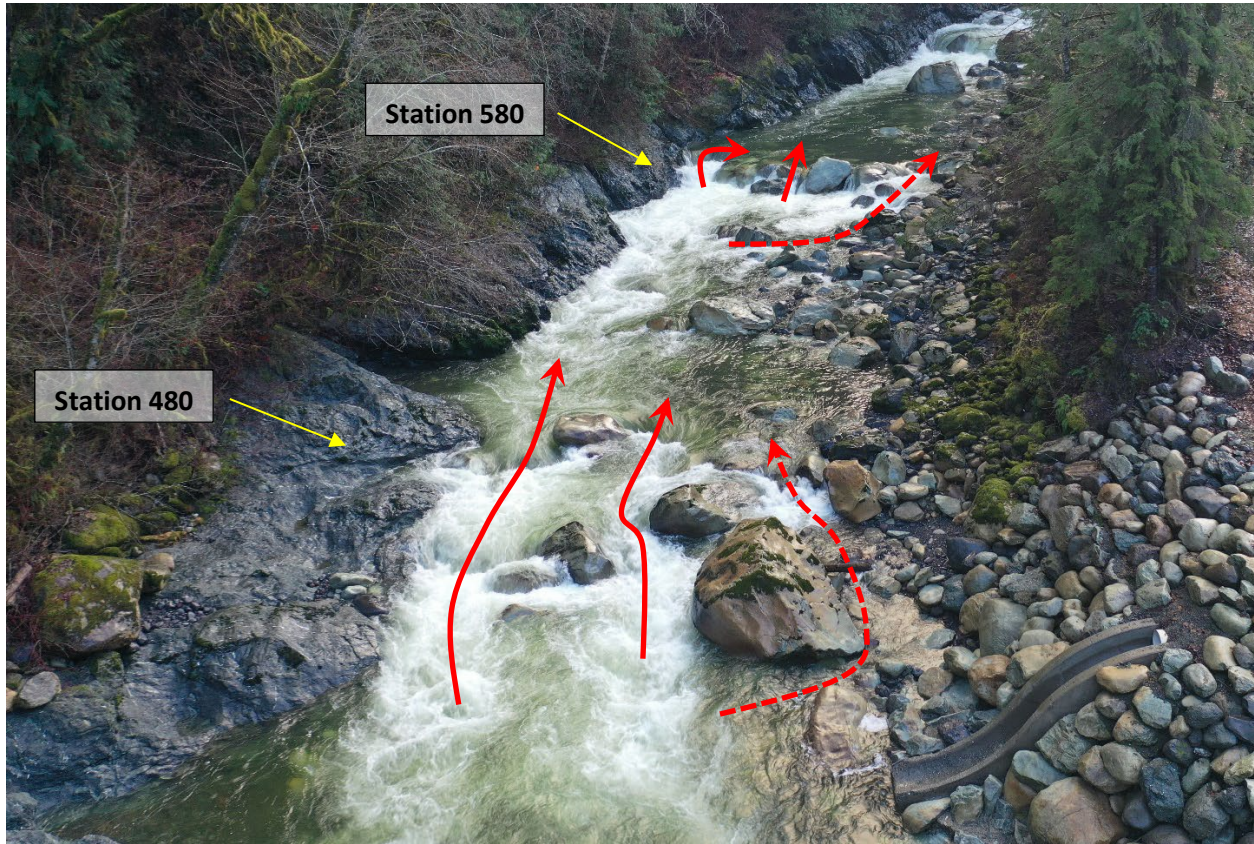
Figure 4.2 Likely passage routes at the observed flow at steps upstream of the fish outlet slide (December 2023). Solid lines = expected primary pathway during lower to mid-flow range; dashed lines = additional routes during mid- and higher flow range.

The site was visited to further evaluate fish passage conditions in April 2024 when flow at the USGS gage was around 250 cfs. Although the regraded reach experienced meaningful geomorphic changes since before November 2021, in some cases approaching thresholds in the MAMP triggering consideration of adaptive management actions, there were no hydraulics within the channel that appeared to preclude volitional upstream passage when flows were higher, with favorable conditions judged to occur at around 400-500 cfs. The same general routes appeared passable as depicted in the Year 2 report, with a few additional connecting pathways apparent (Figure 4.1). Connectivity for adult passage appeared to be highly likely, and different potential swimmable pathways appeared possible for transit of the regraded reach at different flow levels. Lowering of the low flow water surface at the upstream end of the regraded reach led to development of larger head drops at existing steps upstream at around stations 480 and 580, but the increased head drops and velocities at the steps were lower than in the unaffected reach between there and the intake, and multiple routes appear passable via a combination of swimming and small leaps (Figure 4.2).
