# MF Nooksack Channel Monitoring & Adaptive Management

## Year 3 Monitoring

NHC Reference 2005776

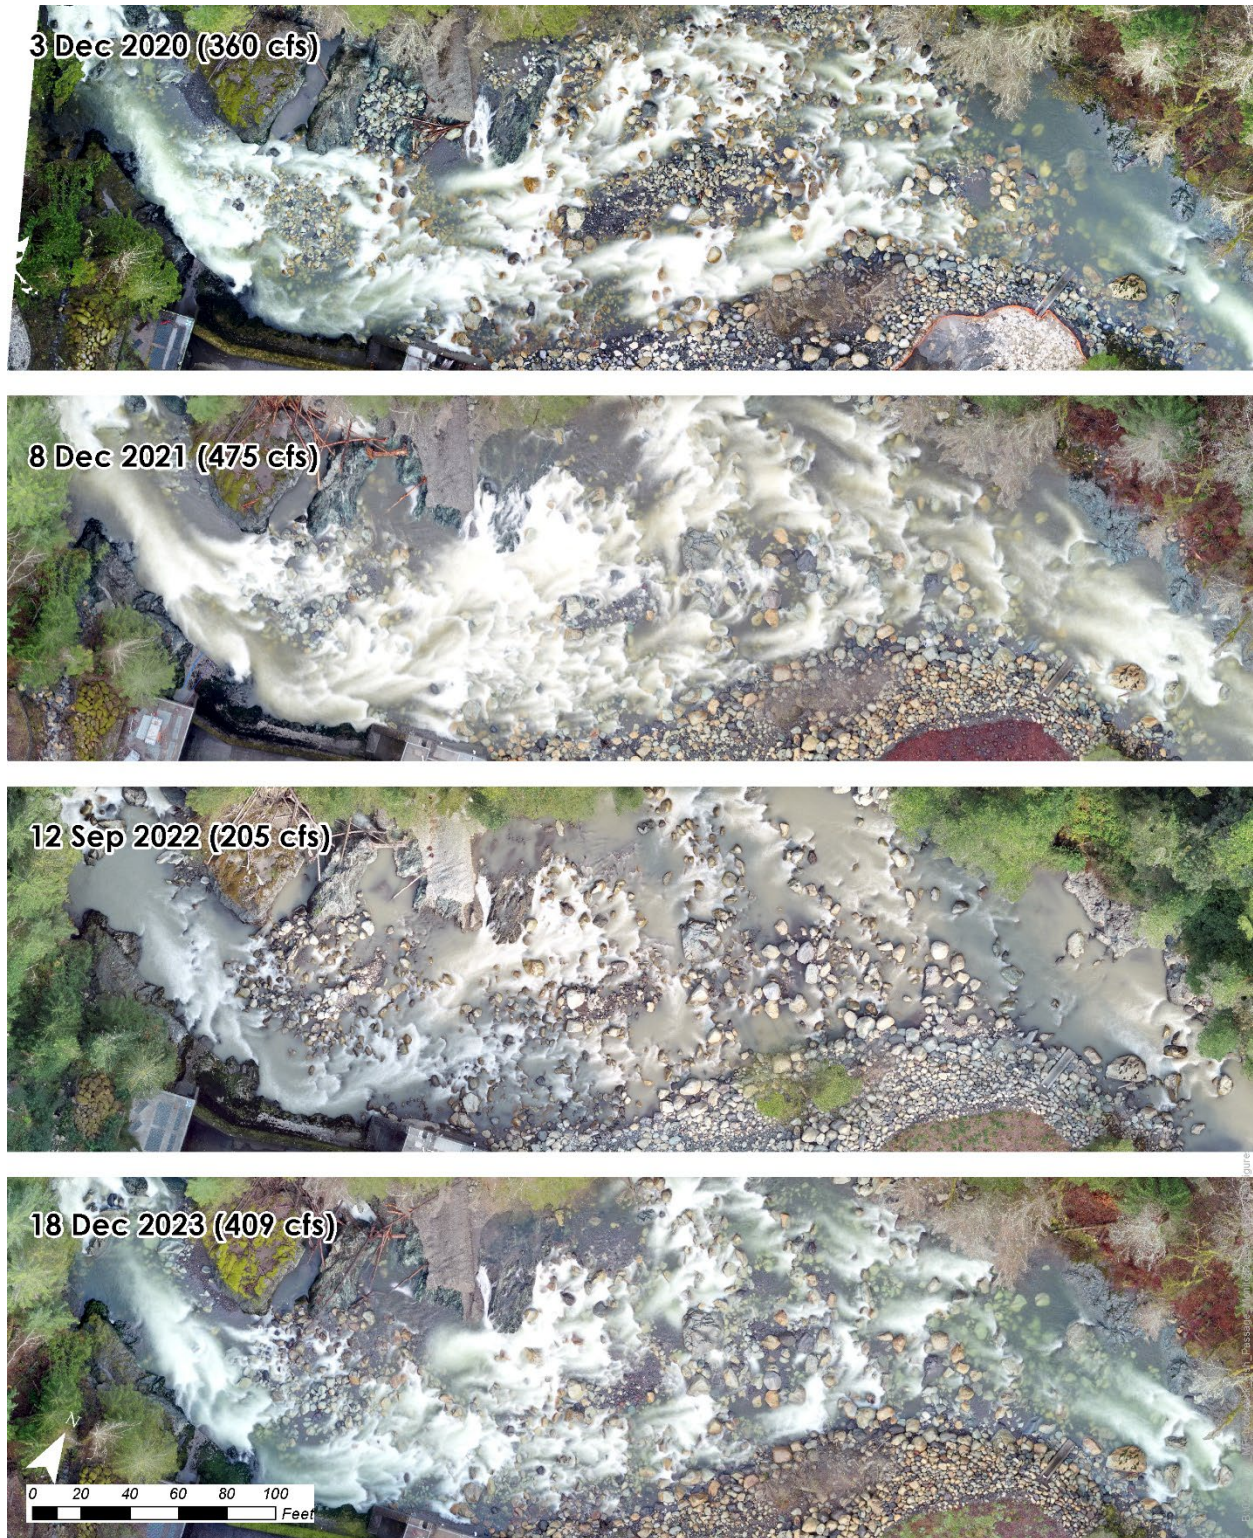
Qualitative comparisons of the September 2022 and December 2023 orthomosaic photographs show that very little has changed in the structure of the channel bed, which can be attributed to the stability of the jamming features formed in the November 2021 floods (Figure 3.1). Prior to the November 2021 event, boulders outside of the restored flow path were not organized in stable morphologies such as boulder clusters or jamming arches, resulting in widespread mobilization during the flood. Boulder transport of some of the largest grains (estimated  $D_{84}$  and above) in the November flood have restructured the bed into a more stable jammed state characteristic of an organized step-pool morphology, increasing the overall stability of the bed compared to the less-organized state present along the right bank flow paths before the November 2021 flood (Church and Zimmermann, 2007; Zimmermann et al., 2010).

Readjustment of the main channel has increased the complexity of the reach, increasing the total number of pools and flow pathways. Therefore, the designed jams continue to not only maintain passable slopes, but add stable roughness along the perimeter of the left flow pathway from which new step pool lines can form over time. Additionally, reworking of the previously exposed mid-channel bar now connects the right and main channels at a range of flows, which increases the number of potential fish migration routes. Section 4 discusses the ongoing adjustments of the main channel, as well as the minor changes in the primary fish pathways outlined in NHC (2023).

**Figure 3.1** Orthomosaic comparisons showing observed channel conditions during monitoring site visits between December 2020 to December 2023.

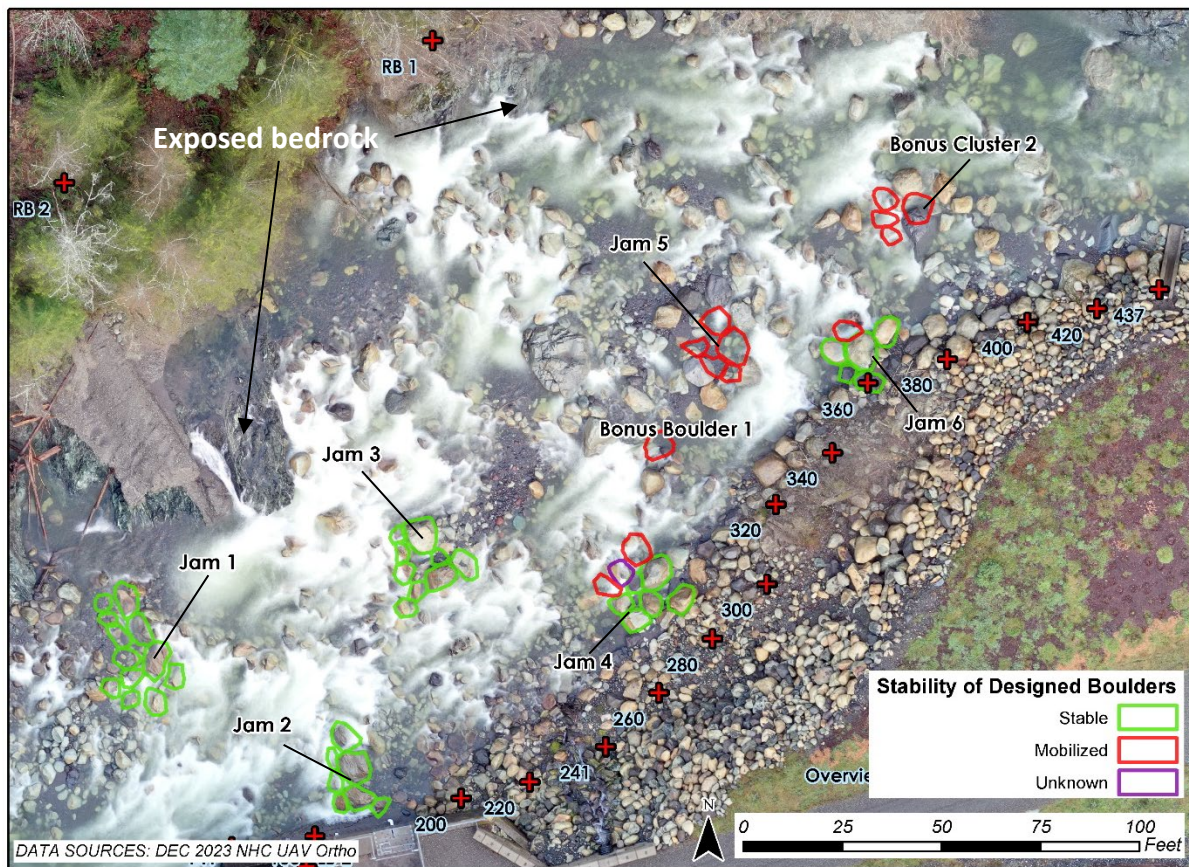
The relative stability and locations of the designed boulder jams did not change between 2022 and 2023, although some designations have been changed from “unknown” after clear-water photographs were collected at low flows in December 2023. As discussed in NHC (2023), the November 2021 floods provided an early opportunity to test the stability and adaptability of the designed channel during a large magnitude event (approaching 50-yr recurrence). Figure 3.2 displays channel bed changes within the flow split between station 140 and the fishway at 437 feet. Despite widespread channel lowering, the designed boulder clusters remained mostly stable during the November 2021 flood, preventing the same degree of bed mobility and large-scale reorganization as observed in the right bank channels. Only two of the boulder clusters completely destabilized from their jammed state during the floods, Jam 5 and Bonus Cluster 2. These clusters (outlined in red in Figure 3.2) are located at the upstream extent of the design channel, suggesting that boulder cluster instability increases upstream with proximity to the pool outlet, between stations 320 and 437. Depth to bedrock also increases in the downstream direction, highlighting the importance of downstream buried stabilizing or bracing boulders that could not be constructed in jams over shallow bedrock. It should be noted that since initial mobilization in 2021, most of the mobilized boulders in Jam 5 have reorganized into a new stable jam.

The status of Jam 1 and Jam 4, which previously had some degree of unknown boulder stability, have since been verified in the clear water photographs from December 2023. The stability of Jam 1 was previously described as “unknown” in NHC (2023) due to high turbidity in the site photographs, but clear water conditions in December 2023 reveal that the boulders have remained stable, with the bottom/downstream line of boulders presumably buried under other rocks. The three boulders closest to the thalweg of Jam 4 were previously designated as unknown, but closer examination of the most recent photographs suggests that at least two of the three boulders had partially or fully destabilized. However, their displacement was minimal and they are currently in a stable position.

**Figure 3.2 December 2023 (410 cfs) orthomosaic documenting relative instability in the restored channel, with engineered boulder cluster jams labeled. Areas of exposed bedrock on the channel bed are also labeled. (Photo: NHC)**

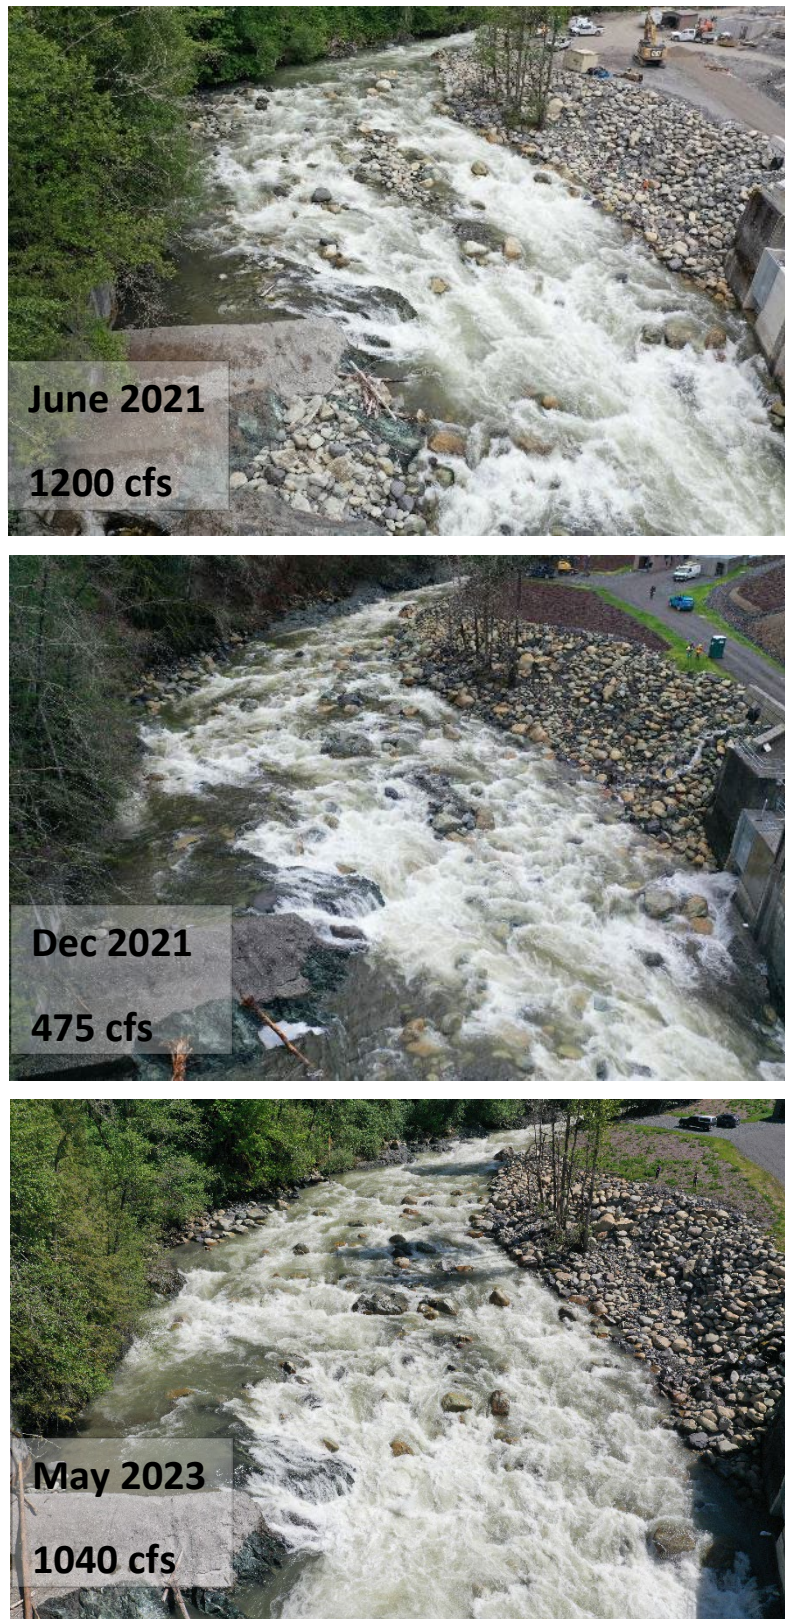
High flow observations were conducted during the May 2023 site visit (1,040 cfs). Reorganization of the entire bed during the November 2021 floods into more stable step-pool arches has created numerous pathways for fish, as seen in the progression of photos in Figure 3.1. There were no notable changes in the flow pathways between the December 2021 high flow site visit and the May 2023 site visit apart from the higher discharge in May, resulting in a wider active channel from greater flow connection across the right and main channels. At this discharge (1,040 cfs), the hydraulic steps between boulder lines are generally backwatered, reducing the height of the steps relative to low flow conditions. The wider active flow area and large number of moderate size step-pool units and pockets diffuse the hydraulic energy overall and prevent the development of velocity barriers. Margins of both the right and left-bank flow paths present areas with adequate depth for adult salmon passage (typically > 1ft) and lower velocities than along the thalweg of each flow path.

**Figure 3.3** UAV oblique photos showing channel evolution at the flow split between the restored left bank channel and right bank pathways in June 2021 (top), December 2021 (middle), and May 2023 (bottom).

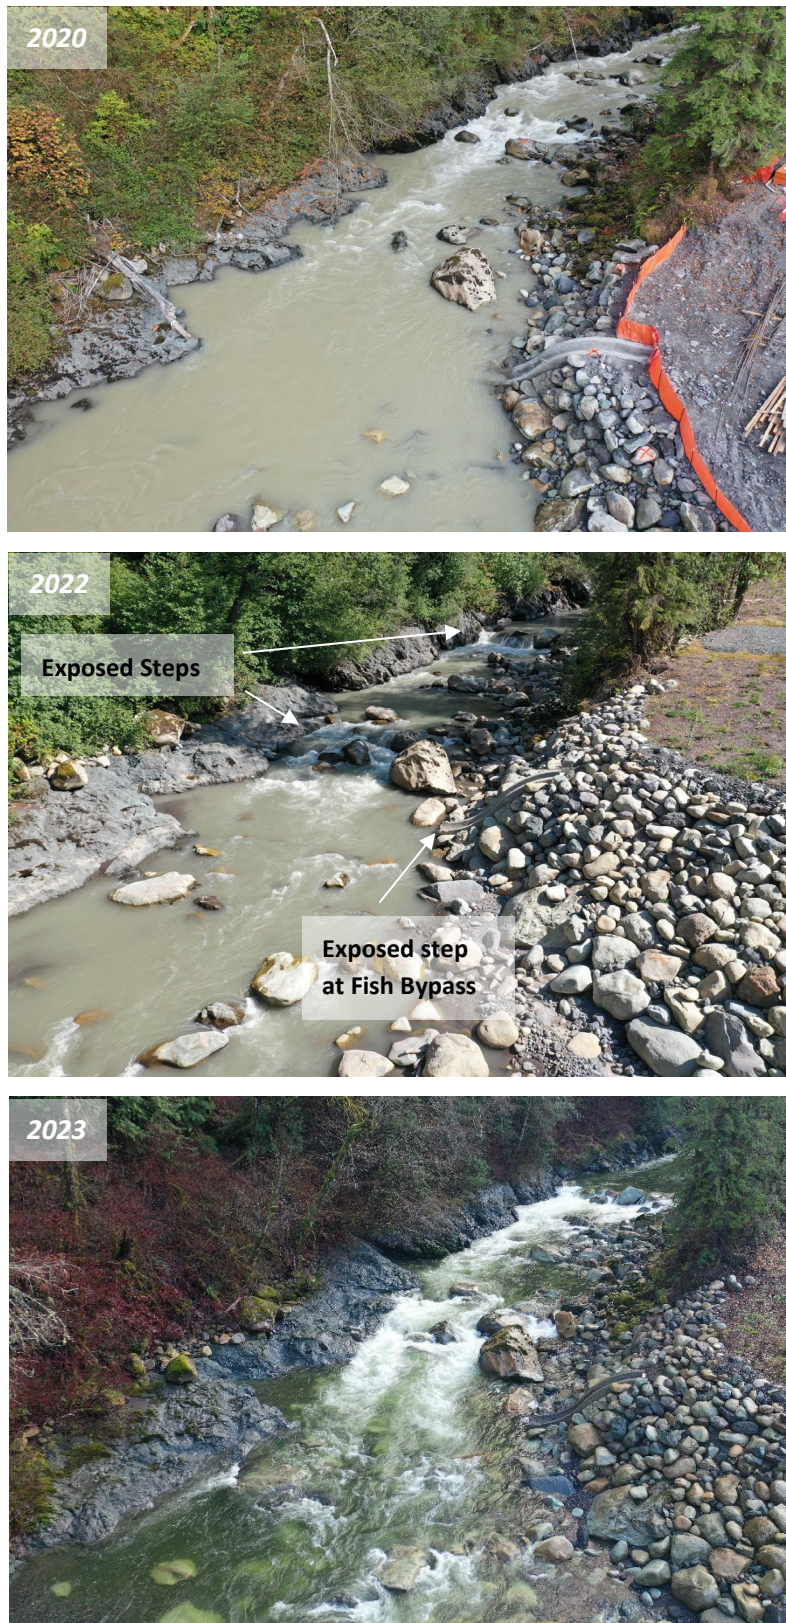
**Figure 3.4** UAV oblique photos showing channel evolution at the pool outlet near Transect 400c between October 2020 (top, 225 cfs), September 2022 (middle, 152 cfs), and December 2023 (bottom, 410 cfs).

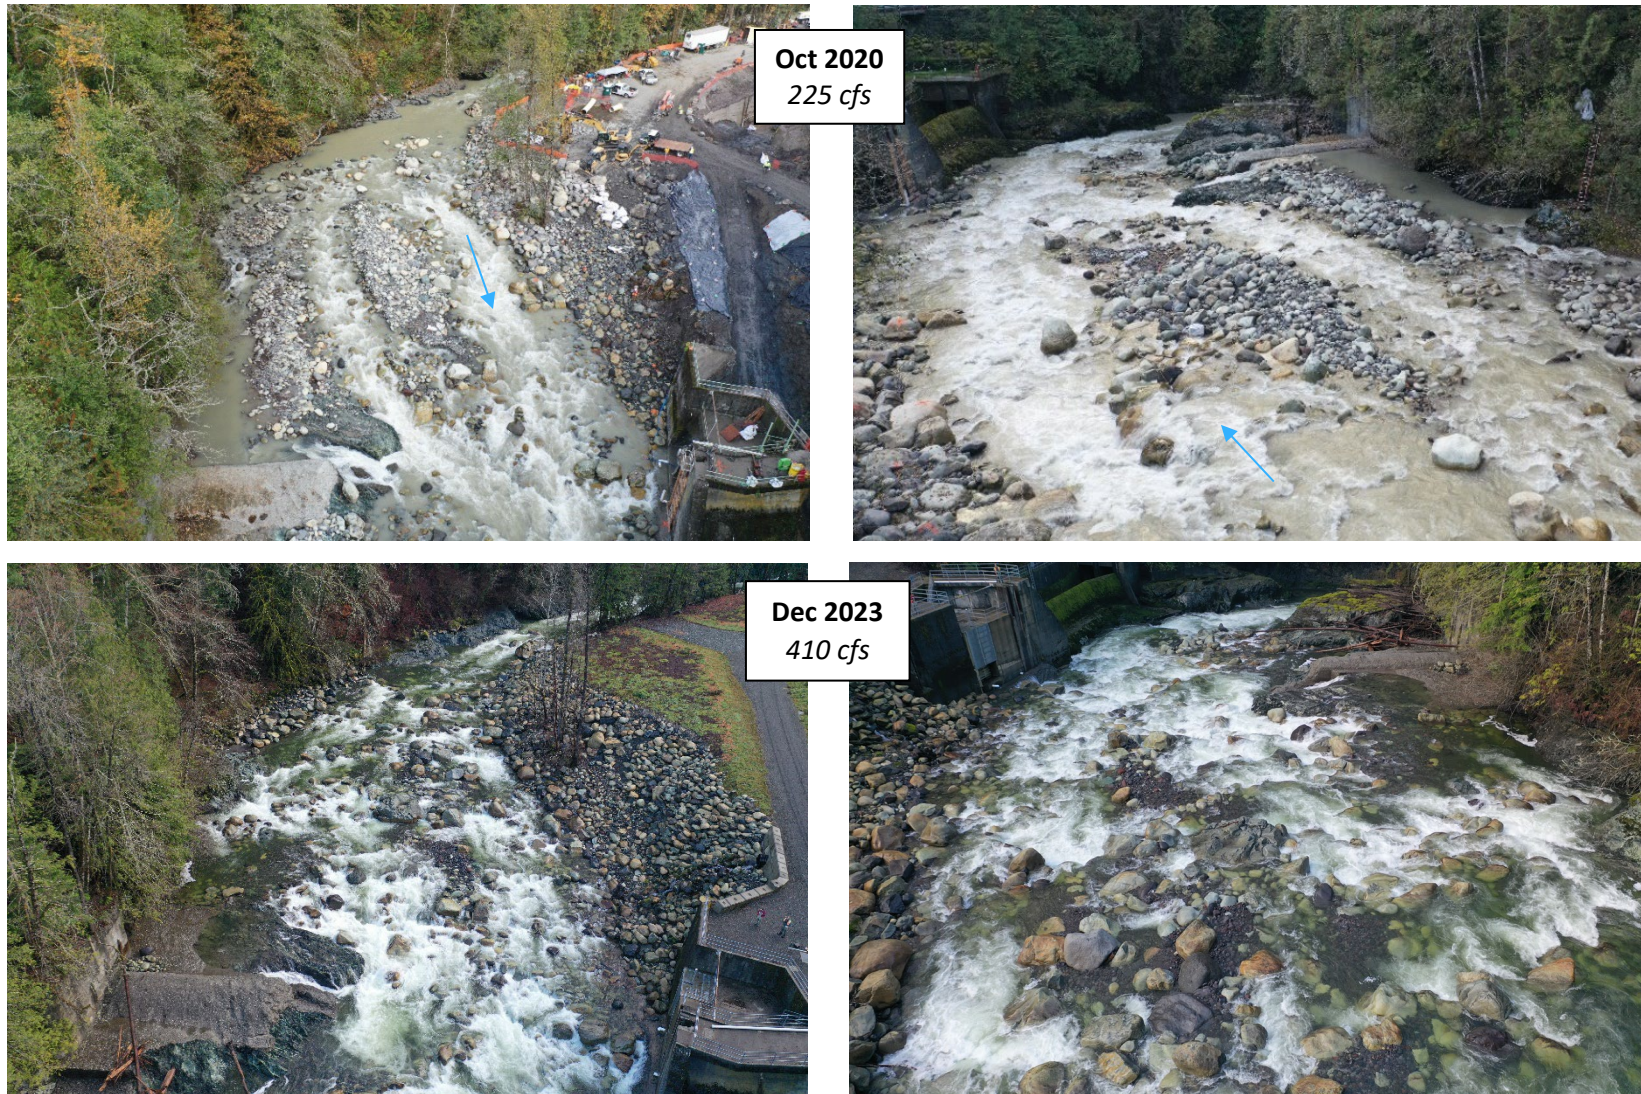
As mentioned in Section 3.3 and NHC (2023), the reorganization of small to medium-sized boulders across the channel has resulted in the diversification and unification of flow pathways in the previously separated main channel and right flow paths, which remain connected at low flows of at least 410 cfs (Figure 3.5). The simultaneous regrade of both main channel and right channels has prevented the main channel from dewatering at low flows. Therefore, the engineered boulder clusters have worked as designed by adjusting with the lowering channel, maintaining passable slopes in the main channel, and creating stable roughness from which small step arches can build and form new jamming features and pools. The abundance of available pools provides ample resting areas for migrating fish. Boulders near the top of the main channel near the left bank flow split continue to adjust in a favorable way that is allowing more water into the main channel, whereas previous observations in NHC (2023) raised the concern of main channel dewatering. Section 4 discusses the evolution of the fish passage routes in this area in more detail. Flows along the upstream left bank flow split, which continues to feed water into the main channel, will be monitored at future low-flow observation visits to assess its risk for dewatering as this reach further adjusts.

**Figure 3.5 Repeat UAV imagery showing low-flow channel comparisons between October 2020 (top) and December 2023 (bottom)**

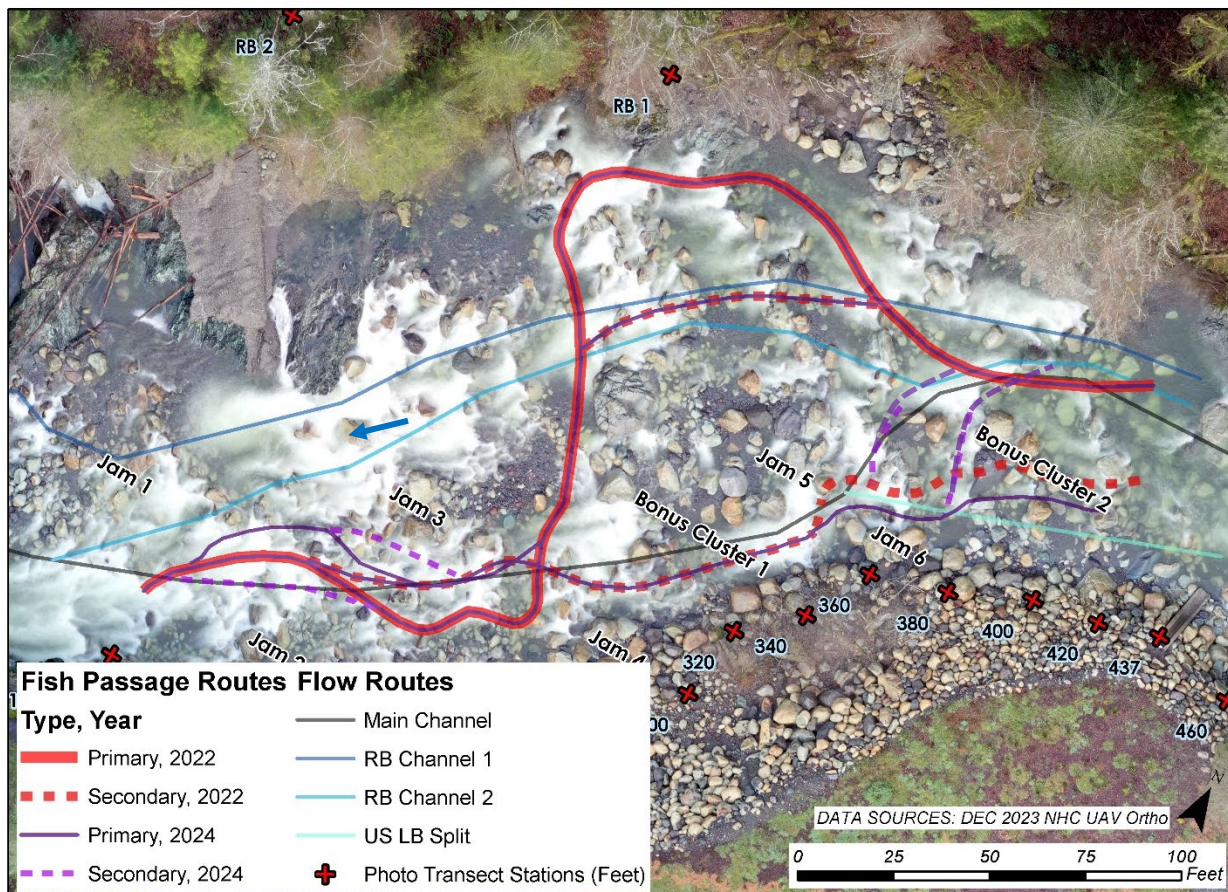
Degradation continued along the right side of the channel, with greater potential for upstream passage along the upstream section than in prior years. However, the downstream section of RB 1 appears to continue to be highly turbulent and aerated and is less likely to be negotiated by upstream migrants than the left side, or main channel. As noted as a potential outcome in the previous report, the right bank flow path has degraded further and has exposed more of the underlying bedrock. However, it appears from the channel profiles in the appendix of NHC (2023) that the regrading rate is slowing down, where the right side may be approaching a more stable grade in the future. As such, this route could be potentially passable at higher flows when flow conditions in the left side of the channel become more turbulent and faster.

**Figure 4.1** Potential upstream passage routes overlaid on December 2023 orthomosaic and relevant monitoring pathways (main channel, RB 1 and RB 2). Solid line = expected primary pathway during lower to mid-flow range; dashed lines = additional routes during mid- and higher flow range. (Photo: NHC)

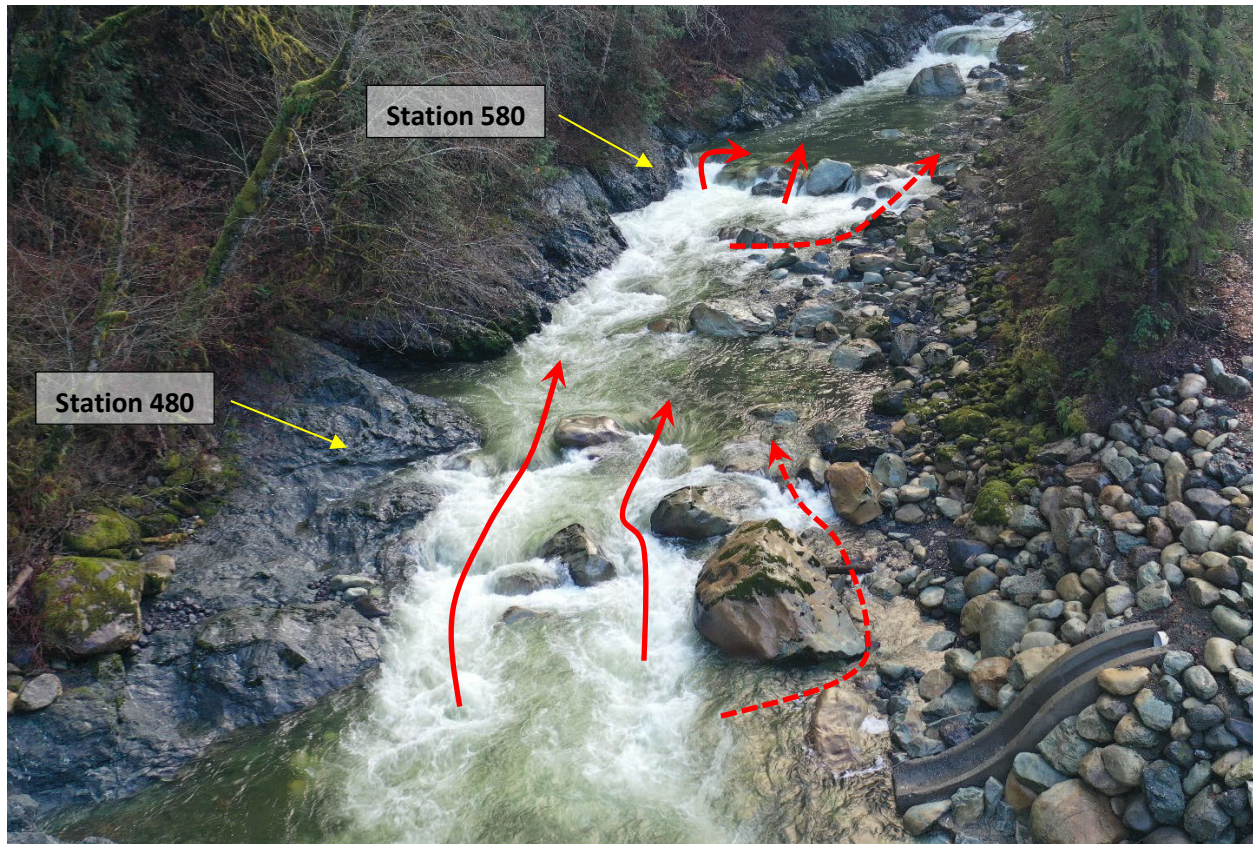
The site was visited to further evaluate fish passage conditions in April 2024 when flow at the USGS gage was around 250 cfs. Although the regraded reach experienced meaningful geomorphic changes since before November 2021, in some cases approaching thresholds in the MAMP triggering consideration of adaptive management actions, there were no hydraulics within the channel that appeared to preclude volitional upstream passage when flows were higher, with favorable conditions judged to occur at around 400-500 cfs. The same general routes appeared passable as depicted in the Year 2 report, with a few additional connecting pathways apparent (Figure 4.1). Connectivity for adult passage appeared to be highly likely, and different potential swimmable pathways appeared possible for transit of the regraded reach at different flow levels. Lowering of the low flow water surface at the upstream end of the regraded reach led to development of larger head drops at existing steps upstream at around stations 480 and 580, but the increased head drops and velocities at the steps were lower than in the unaffected reach between there and the intake, and multiple routes appear passable via a combination of swimming and small leaps (Figure 4.2).

**Figure 4.2** Likely passage routes at the observed flow at steps upstream of the fish outlet slide (December 2023). Solid lines = expected primary pathway during lower to mid-flow range; dashed lines = additional routes during mid- and higher flow range.
