MF Nooksack Channel Monitoring & Adaptive Management

Year 4 Monitoring

Northwest Hydraulic Consultants Inc.
301 W. Holly Street, Suite U3
Bellingham, WA 98225
Tel: (206) 241-6000
www.nhcweb.com

City of Bellingham Public Works
104 W. Magnolia Street, Suite 109
Bellingham, WA 98225

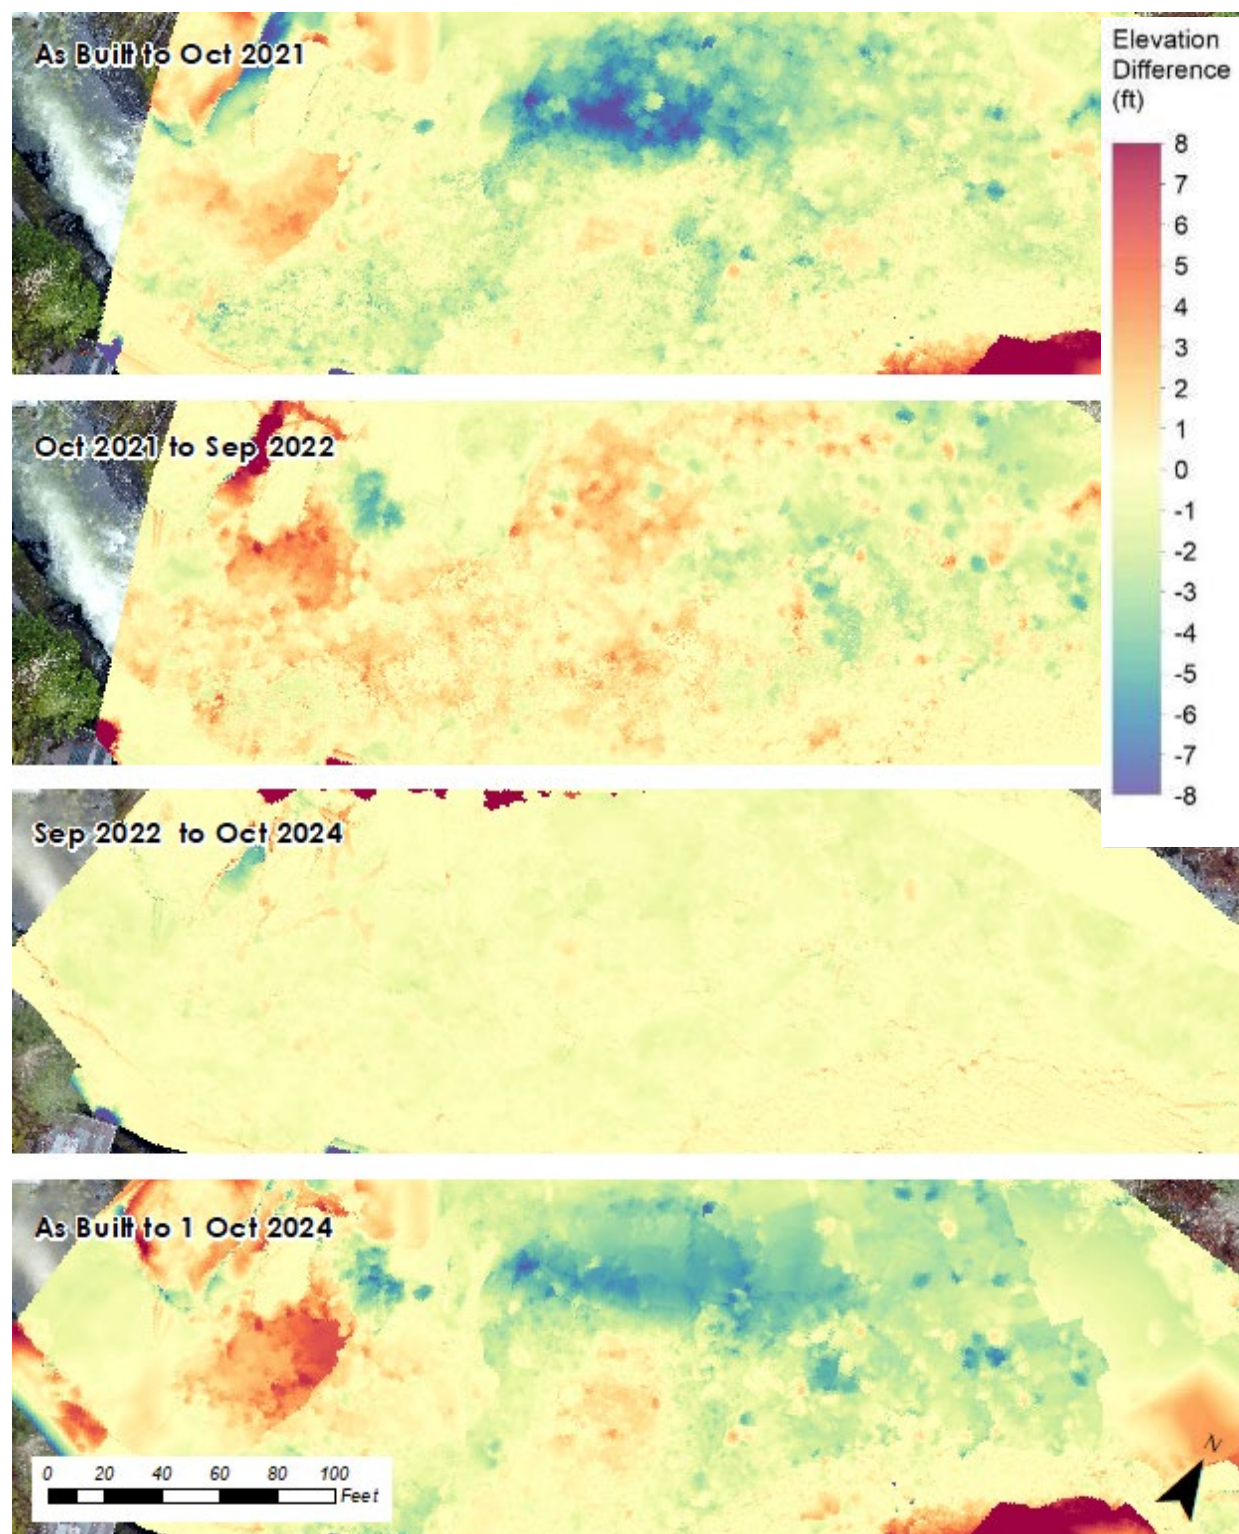
Quantitative metrics derived from the Year 4 (October 1, 2024) TLS survey data show that minimal change has occurred in the structure of the channel bed, which can be attributed to the stability of the jamming features formed in the November 2021 floods (Figure 3.1, Figure 3.2). Prior to the November 2021 event, boulders outside of the restored flow path were not organized in stable morphologies such as boulder clusters or jamming arches, which led to the widespread mobilization. Boulder transport of some of the largest grains (estimated D_{84} and above) in the November flood have restructured the bed into a more stable jammed state characteristic of an organized step-pool morphology, increasing the overall stability of the bed compared to the less-organized state present along the right bank flow paths before the November 2021 flood (Church and Zimmermann, 2007; Zimmermann et al., 2010). Minor changes since 2022 can be attributed to small boulder transport from boulders that were not incorporated in the more stable channel-spanning jams and boulder clusters. Errant boulder transport is expected to occur in the treads between step lines until they are stabilized in future jamming configurations.

Figure 3.1 DEM surface comparisons showing differences between the design surface and as-built surface (top) and between the as-built surface and subsequent topographic surfaces. Red colors indicate aggradation and blue colors degradation.

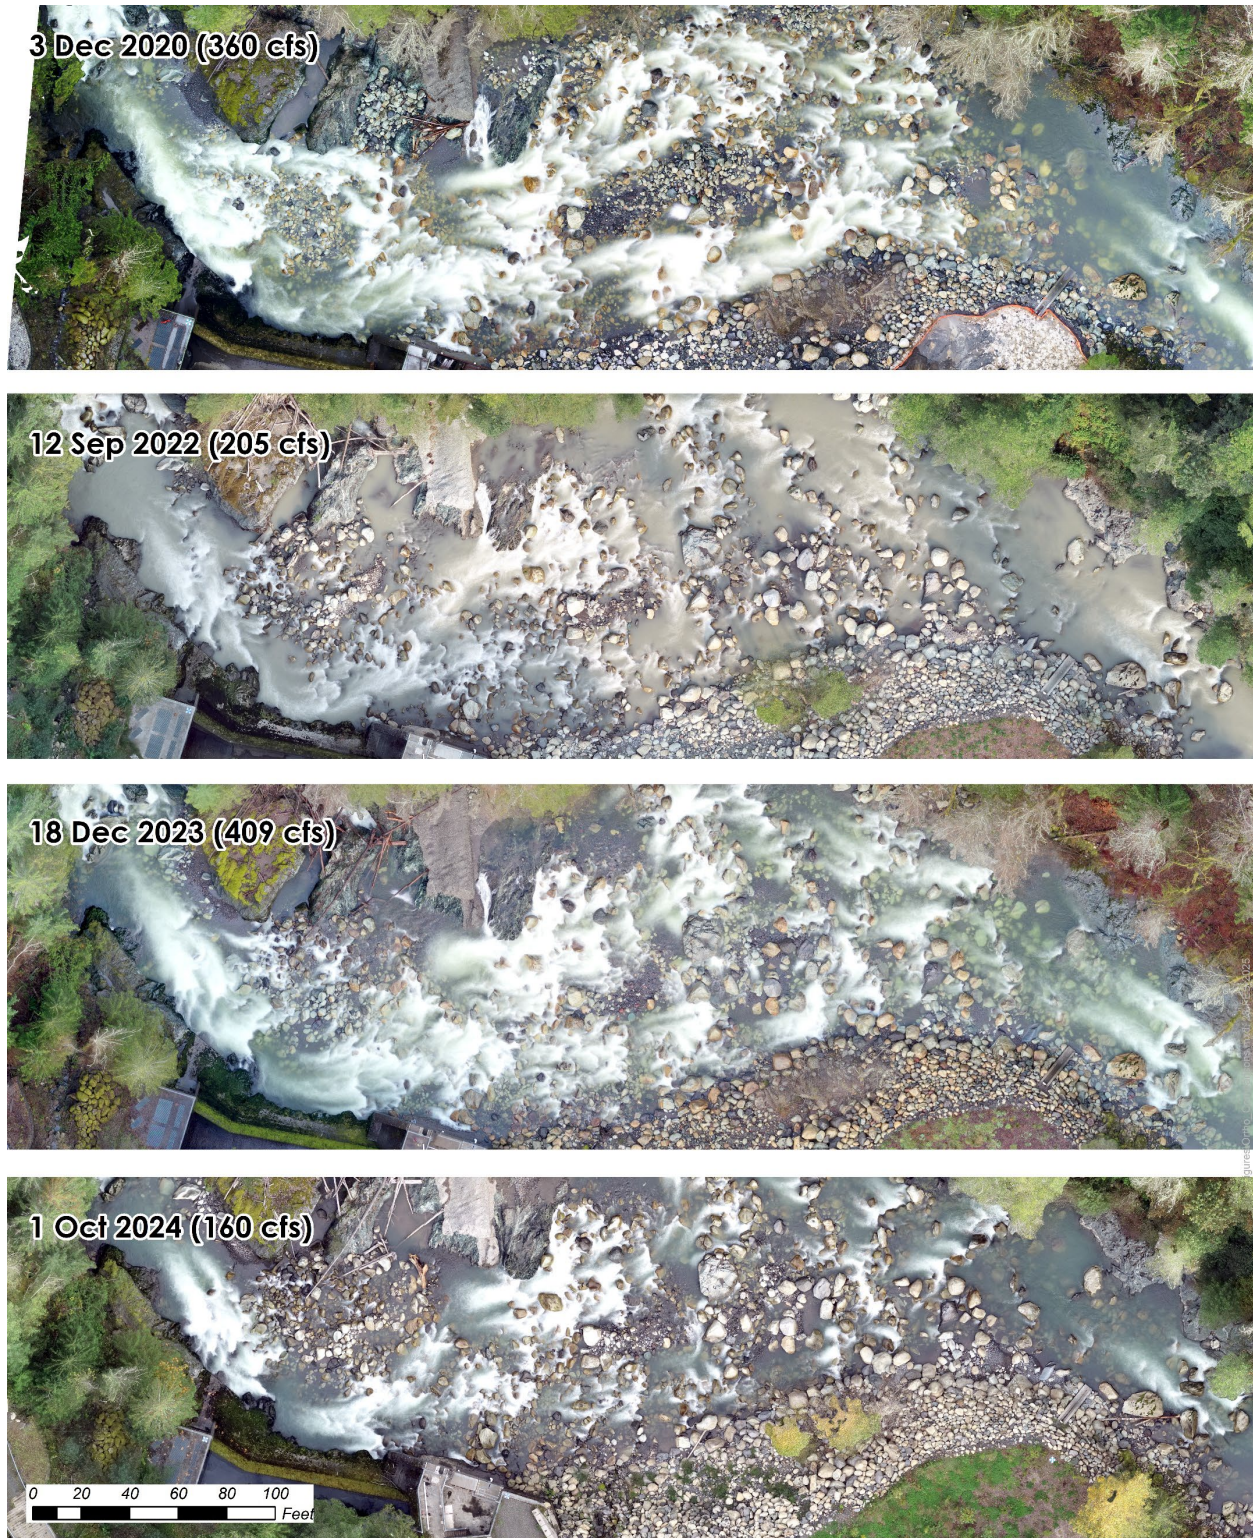
Figure 3.2 Orthomosaic comparisons showing observed channel conditions during monitoring site visits between December 2020 to October 2024.

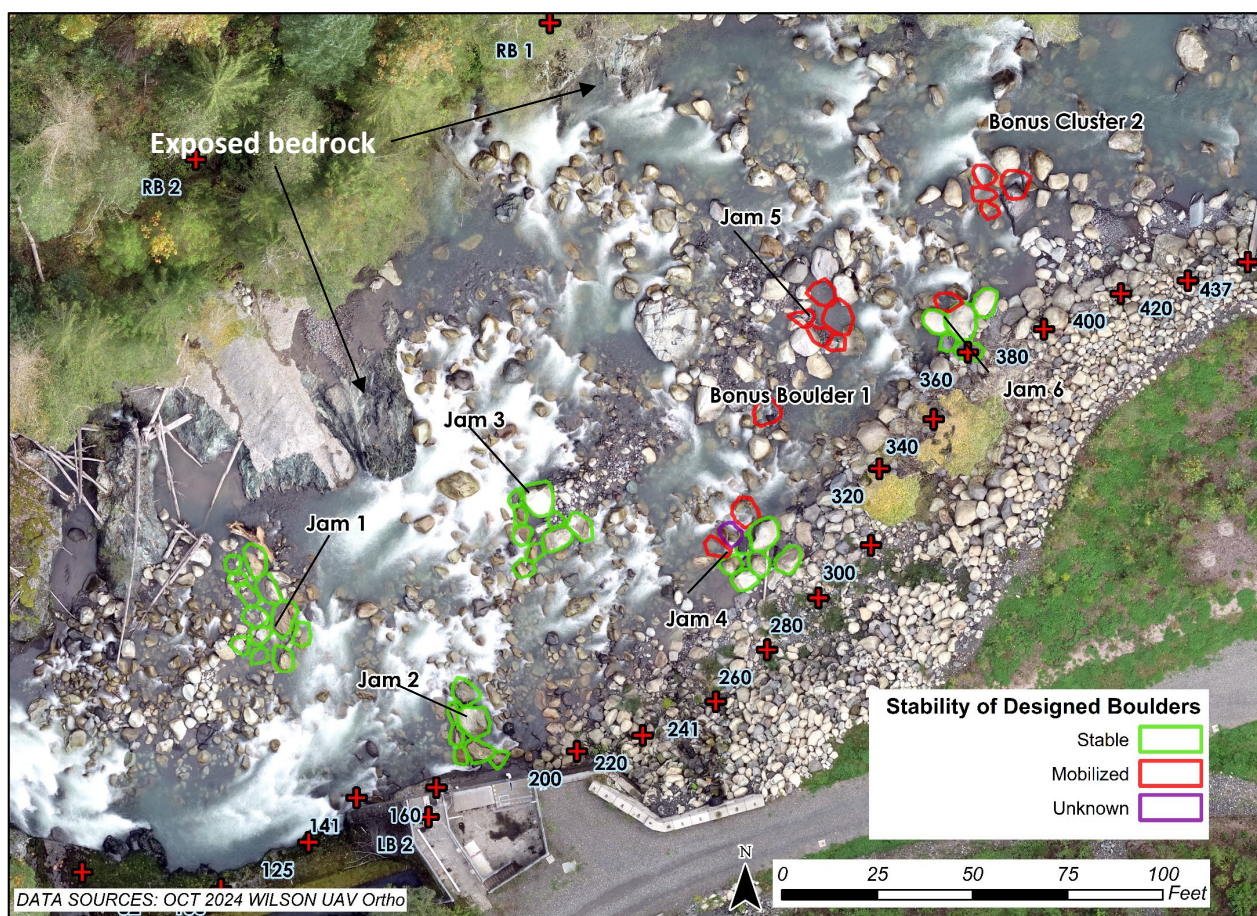
The relative stability and locations of the designed boulder jams did not change between 2023 and 2024 based on aerial and in-field observations. As discussed in NHC (2023, 2024), the November 2021 floods provided an early opportunity to test the stability and adaptability of the designed channel during a large magnitude event (approaching 50-yr recurrence). Figure 3.3 displays boulder cluster changes within the flow split between station 140 and the fishway at 437 ft. As described in NHC (2023), only two of the boulder clusters completely destabilized from their jammed state during the floods, Jam 5 and Bonus Cluster 2. These clusters (outlined in red in Figure 3.3) are located at the upstream extent of the design channel, suggesting that boulder cluster instability increases upstream with proximity to the pool outlet, between stations 320 and 437. Depth to bedrock increases in the downstream direction, highlighting the importance of downstream buried stabilizing or bracing boulders that could not be constructed in jams over shallow bedrock at the upstream clusters. It should be noted that since initial mobilization in 2021, most of the mobilized boulders in Jam 5 have reorganized into a new stable jam.

Figure 3.3 October 2024 (160 cfs) orthomosaic documenting relative instability in the restored channel, with engineered boulder cluster jams labeled. Areas of exposed bedrock on the channel bed are also labeled. (Photo: Wilson Engineering)

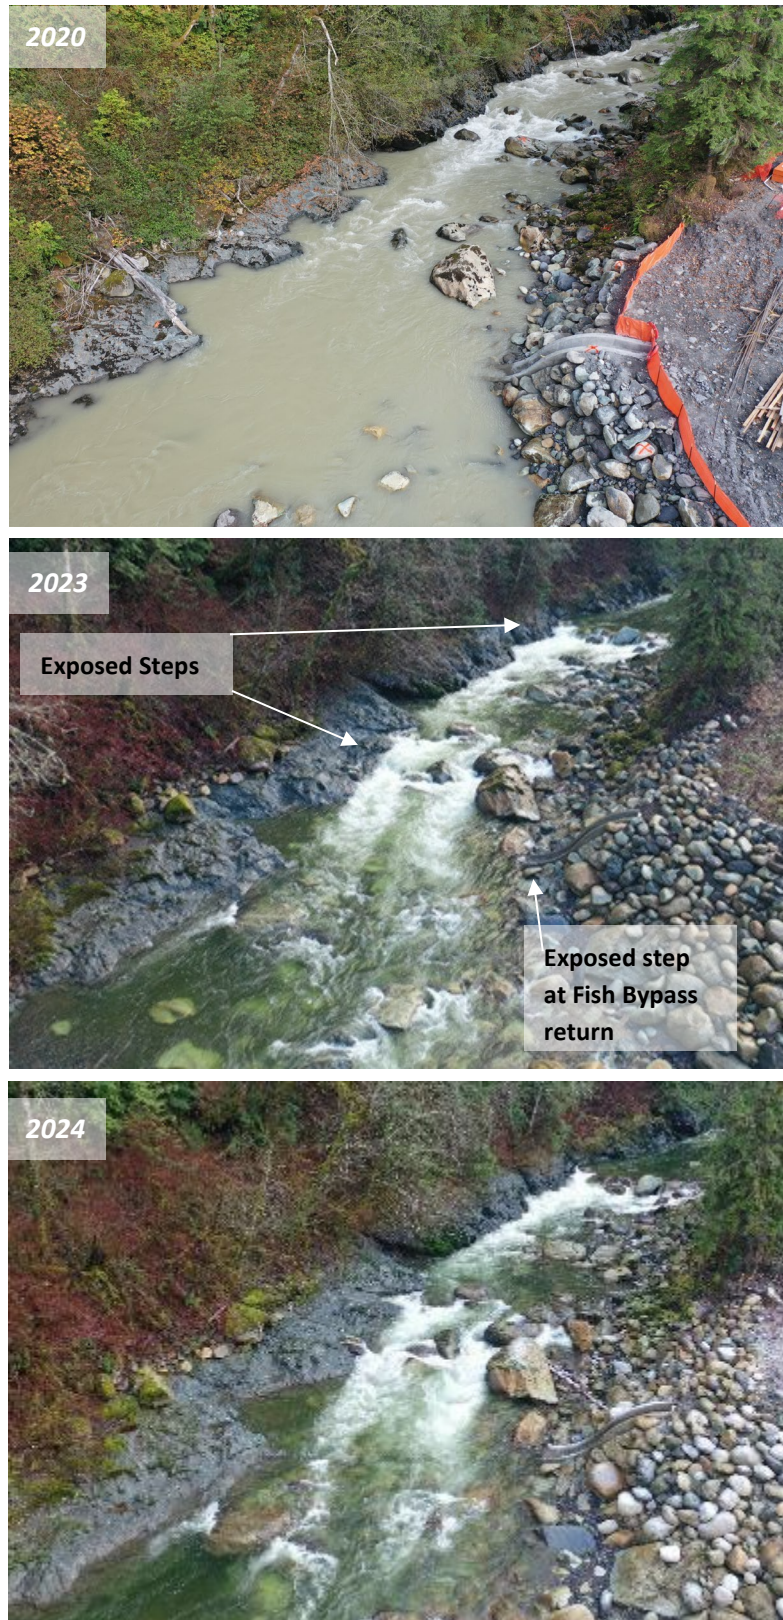
As mentioned in Section 3.2 and NHC (2003, 2024), the reorganization of small to medium-sized boulders across the channel has resulted in the diversification and unification of flow pathways in the previously separated main channel and right flow paths, which remain connected at low flows of at least 300 cfs (Figure 4.2). The simultaneous regrade of both main channel and right channels has prevented the main channel from dewatering at low flows. Therefore, the engineered boulder clusters have worked as designed by adjusting with the lowering channel, maintaining passable slopes in the main channel, and creating stable roughness from which small step arches can build and form new jamming features and pools. The abundance of available pools provides ample resting areas for migrating fish. Boulders near the top of the main channel near the left bank flow split continue to adjust in a favorable way that is allowing more water into the main channel, whereas previous observations in NHC (2023) raised the concern of main channel dewatering. The next section (Section 4) uses quantitative metrics to describe the evolution of the fish passage routes in this area through 2024. Flows along the upstream left bank flow split, which continues to feed water into the main channel, will be monitored at future low-flow observation visits to assess its risk for dewatering as this reach further adjusts.

Figure 3.4 UAV oblique photos showing channel evolution at the pool outlet near Transect 400c between October 2020 (top, 225 cfs), December 2023 (middle, 410 cfs), and December 2024 (bottom, 300 cfs).

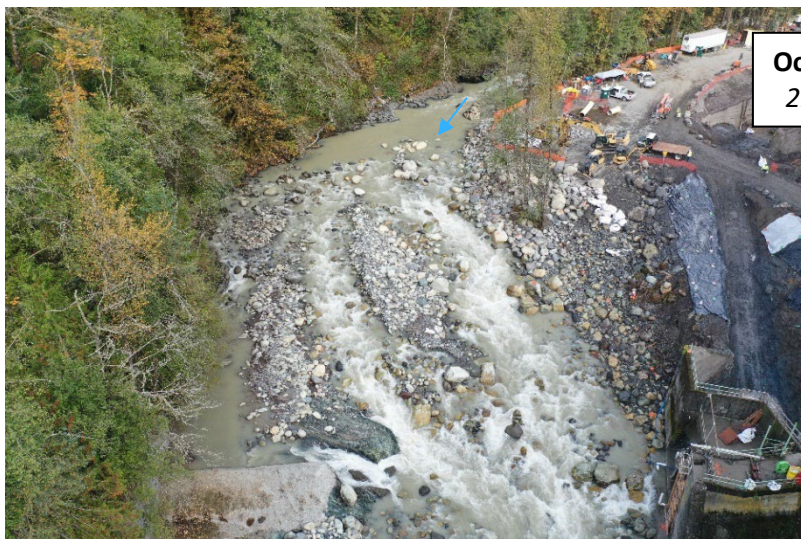
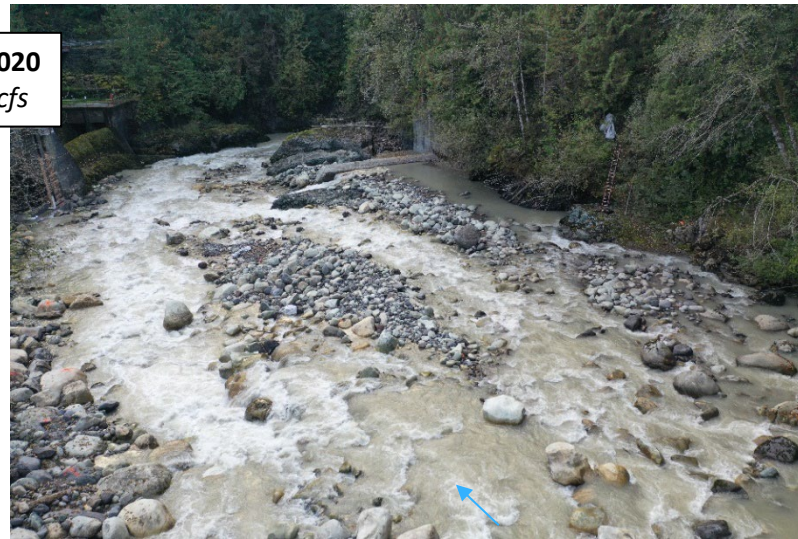
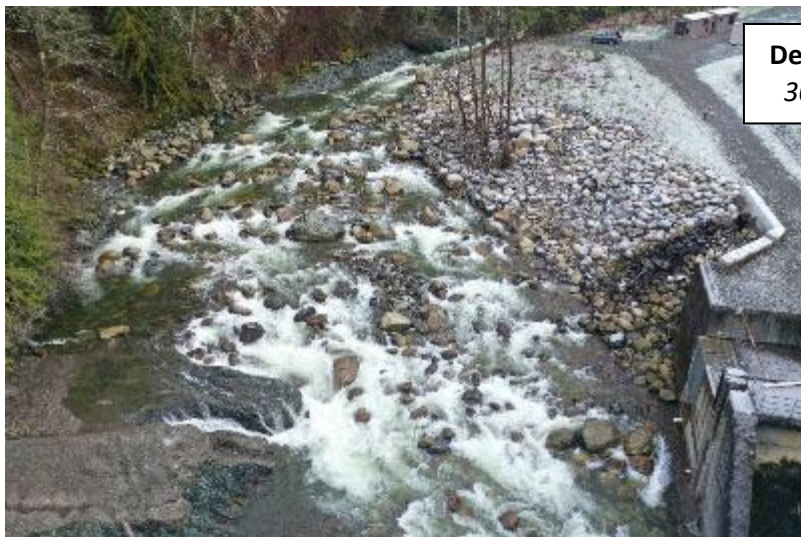
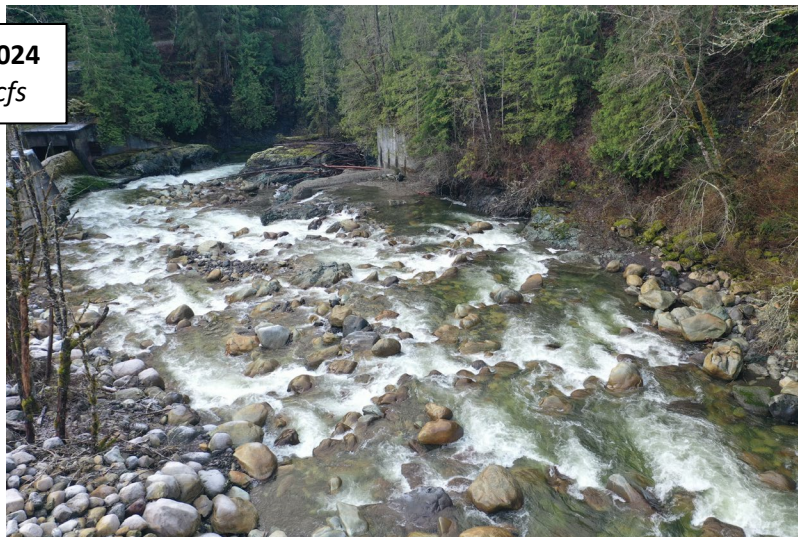
Figure 4.5 Repeat UAV imagery showing low-flow channel comparisons between October 2020 (top) and September 2022 (bottom)

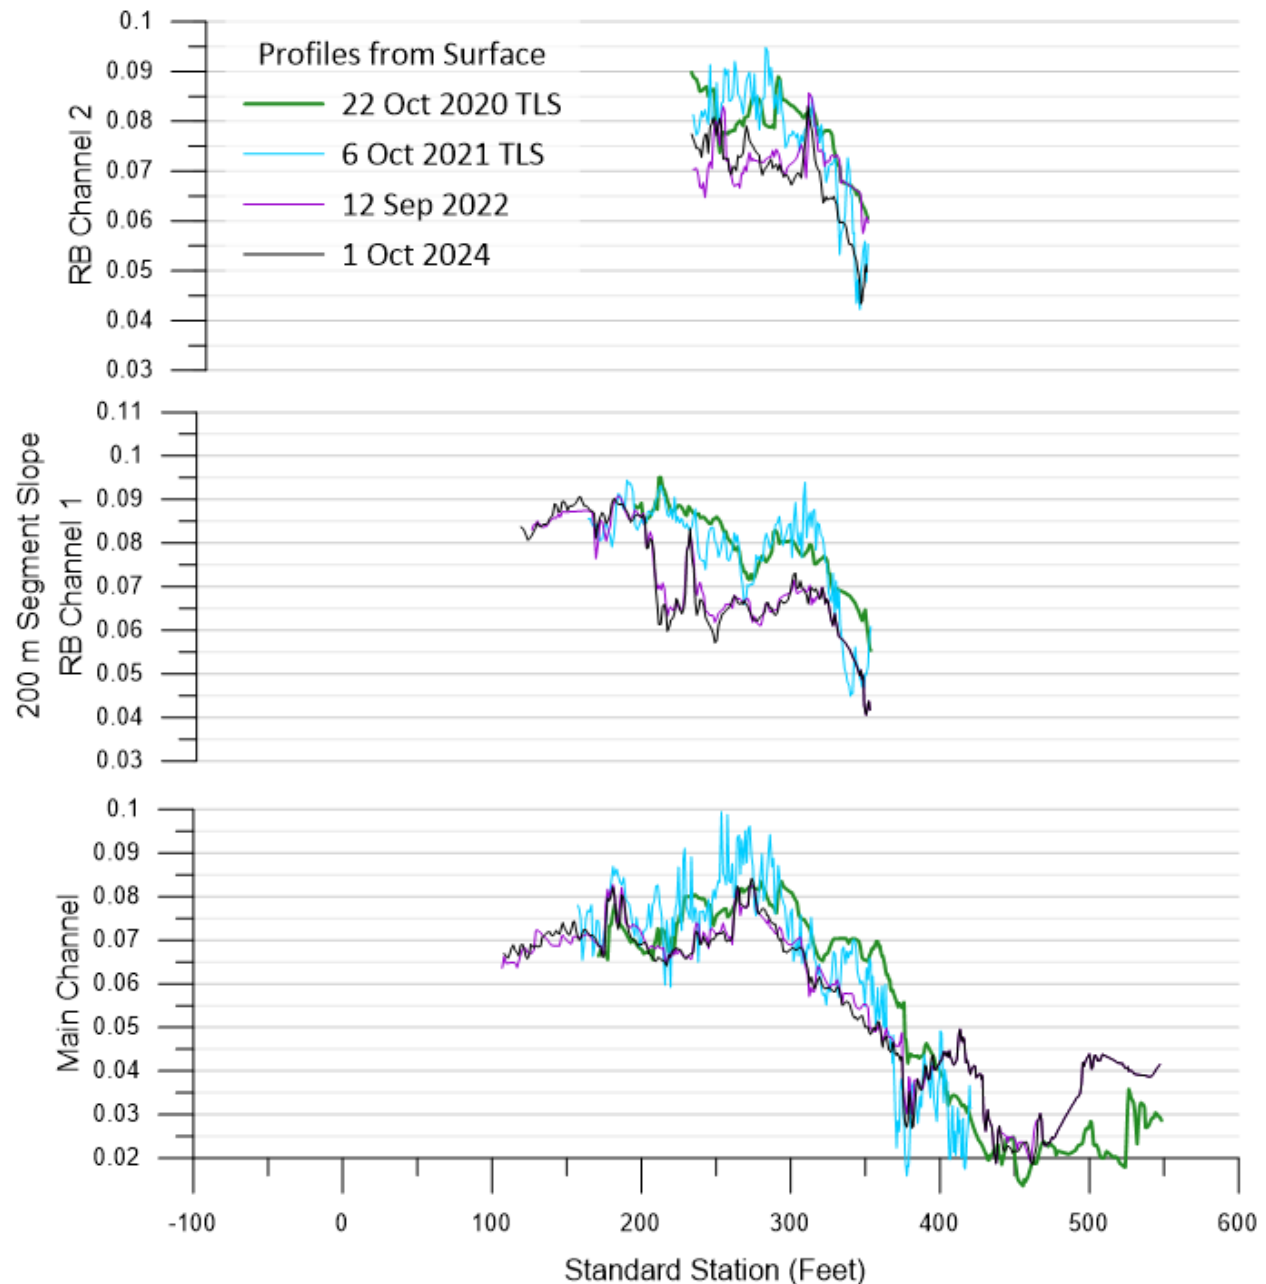
Slopes for 200 ft segments were extracted along each profile path outlined in Figure 2.1 and are plotted in Figure 5.1. Overall, the channel slopes have stabilized since 2022, apart from some deviation in RB 2. Along the main channel, the September 2024 slopes are below 8% for most of its length and similar to the 2022 slopes. The right bank flow paths (RB 1 and RB 2) have remained under 9%, with 2022 and 2024 slopes lower than the previous monitoring periods. The upstream left bank split is less than 200 ft long, but the average slope along that split is 5%. There are no major changes to the channel slope from September 2022 to October 2024 apart from the regrade in the right bank flow paths trending in the direction of shallower overall slopes. The development and regrading of the right bank flow pathways to a lower slope opens a valuable secondary fish passage route through the regraded reach of channel.

Figure 5.1 Plots showing 200 ft segment average slopes for each monitoring DEM.

The main channel is trending towards shallower slopes between the 280-ft stationing and the 420-ft stationing. This reach of the restored channel coincides with boulder displacement observed in Figure 3.3, and therefore reflects continued channel regrade following bed mobilization and reorganization during the autumn 2021 floods. Just upstream of this reach in the fish bypass return pool the stream is steeper than as-built conditions but still within 2 and 5%. This reach is steeper due to downstream channel bed lowering.

All segments are below the action threshold of a 12% slope (Table 1.1) and below the 2b decision pathway threshold of a 10% slope; but several are above the 7% 2b decision pathway indicating continuing monitoring is needed.

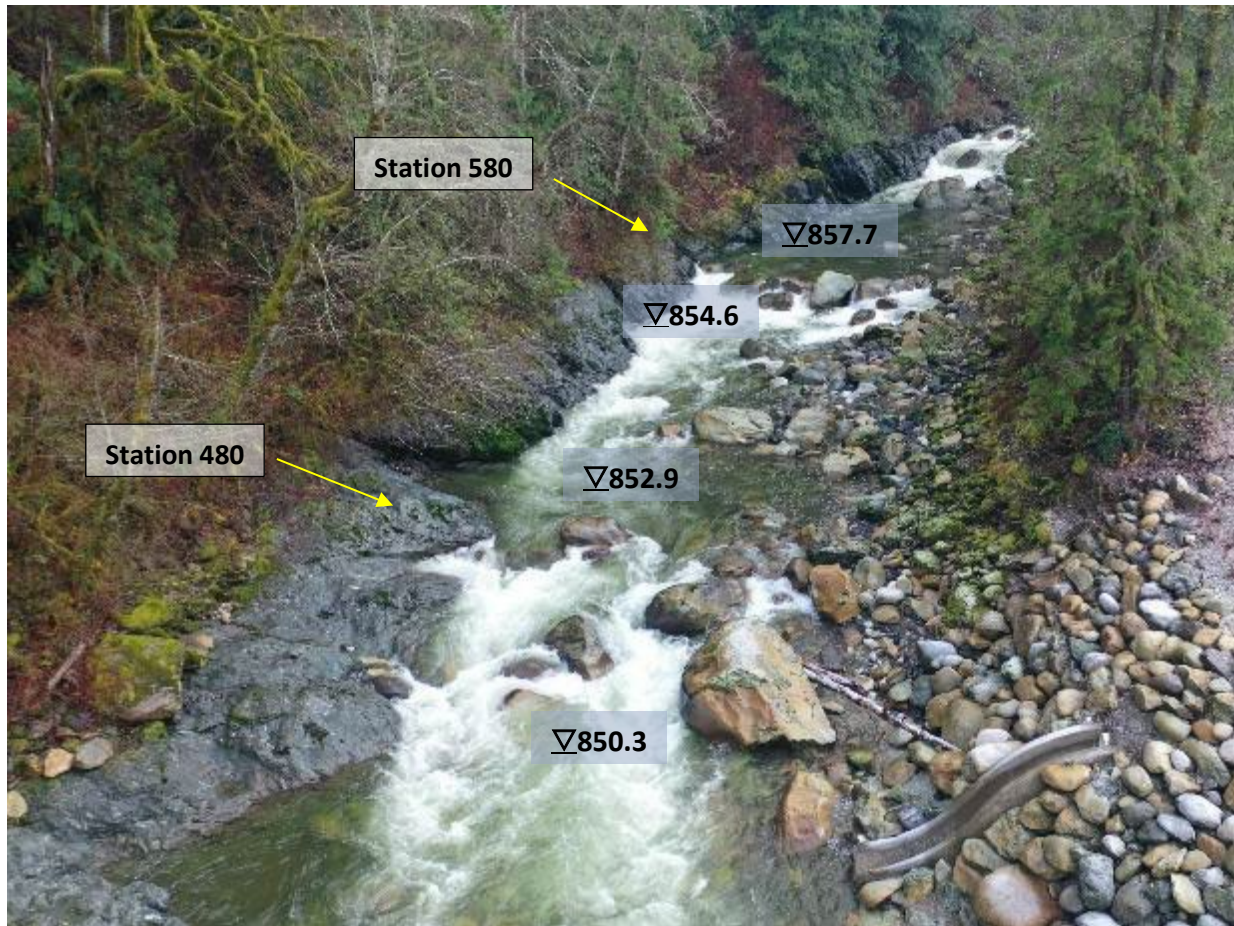
Overall, the moderate degradation of the regrade reach is reducing the average slope and presumably increasing fish passability throughout the project reach (downstream of the fish bypass slide). Given the adjustments, more detailed observations began upstream of the fish bypass to assess potential upstream effects (NHC, 2023). A combination of downstream lowering and sediment transport during the November 2021 floods exposed a boulder step at Transect 480 (step 1), immediately upstream of the fish bypass slide (Figure 5.2). Another step was exposed at Station 580 during the November 2021 flood events (step 2), likely due to a combination of channel bed reorganization and dropping of the low flow water surface elevation (Figure 5.2). Two prominent steps upstream have remained mostly unchanged in morphology at Station 729 (step 3) and Station 760 (step 4) (Figure 4.1, Figure 5.3). To provide a quantitative assessment in addition to the qualitative observations from photos, head drop and average slopes over 20-ft segments were calculated for the reach using both the October 2024 and October 2020 TLS topographic surfaces. At both steps, local slopes approach 15% in the 2024 surface as compared to the 2020 topographic surface, where slopes remain below 10%. These steep steps are separated by long pools and have multiple pathways for fish passage. The average slope of this reach between Station 440 and Station 600 is 7%. The head drops, rounded to the nearest 0.5 ft, were approximately 2.5 ft, 3 ft, 4 ft, and 3 ft across steps 1 through 4, respectively, consistent with the September 2022 values. These drops do not exceed the 5-ft threshold as outlined in the MAMP.

Figure 5.2 View of channel conditions between the fish outlet (Station 437) and Station 580 with water surface elevations extracted from the 2024 TLS scan at prominent channel steps (160 cfs).

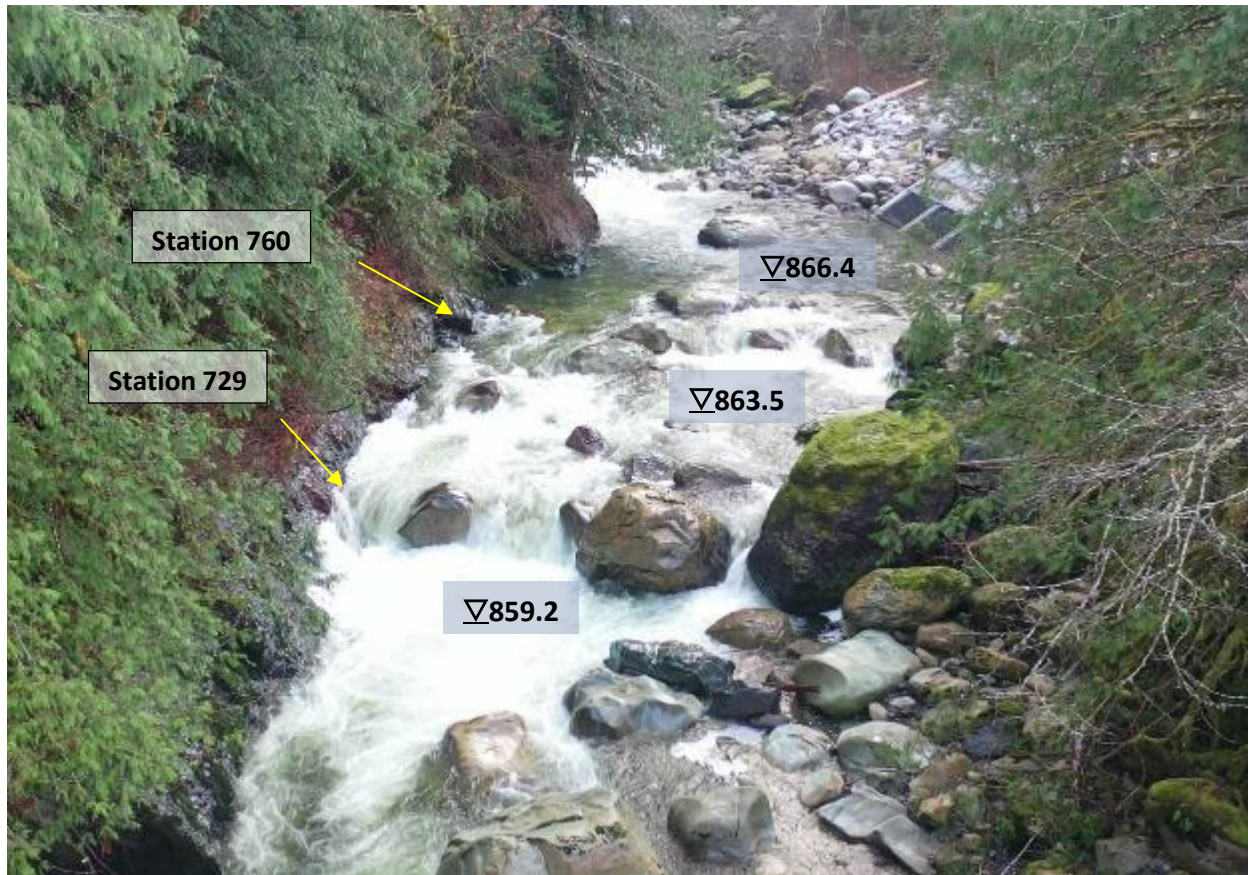
Figure 5.3 View of channel conditions between Station 663 (downstream photo extent) to the water intake structure upstream with water surface elevations extracted from 2024 TLS scan at prominent channel steps (160 cfs).

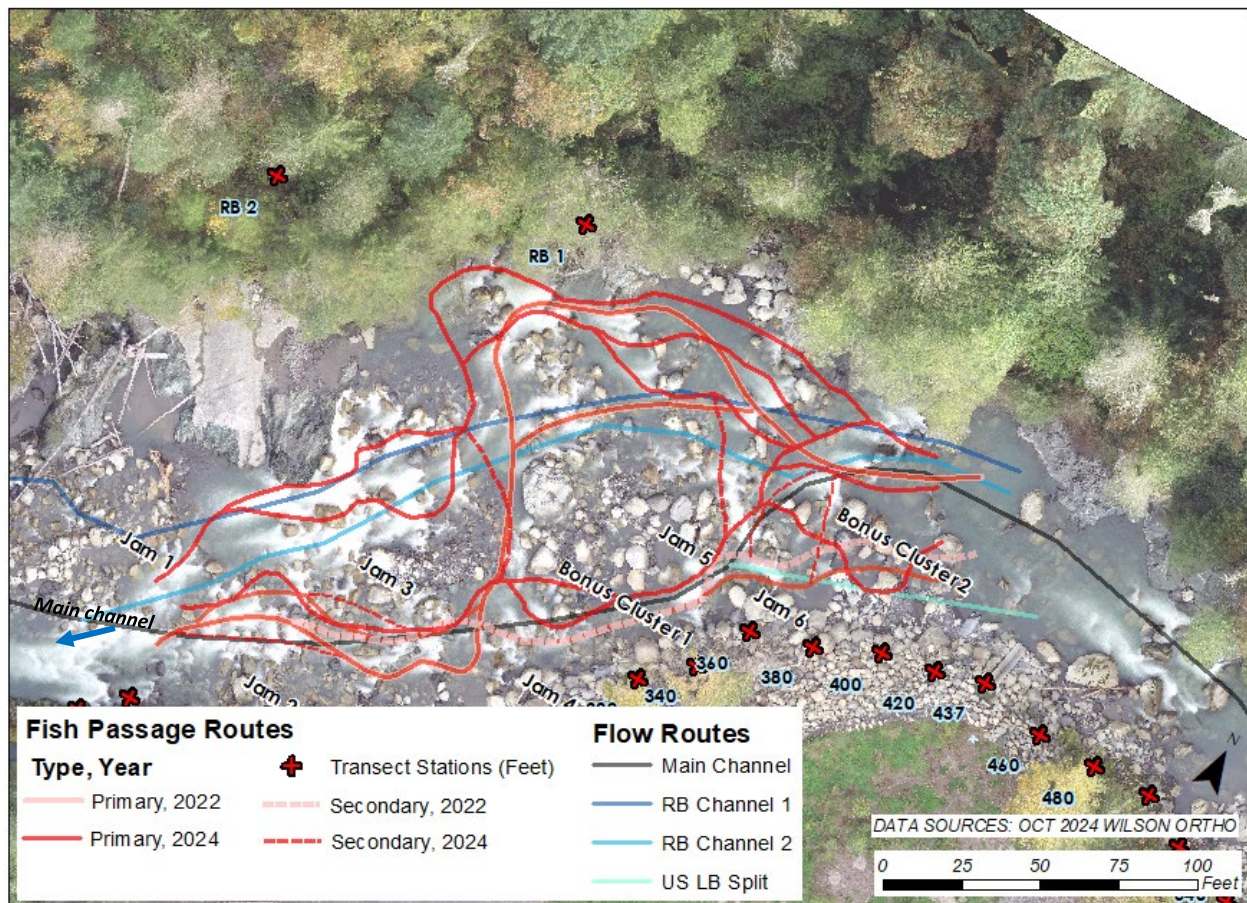
During optimal fish passage flows (300 to 500 cfs), the right bank pathways (RB 1) become fish passable. Prior observations from NHC (2023) made during low flows indicated that turbulent flows along the downstream section of RB 1 were unlikely to be negotiated by upstream migrants as compared to the main channel. During the 2025 site assessment at 350 cfs, the right bank pathways became viable, opening up alternative routes for passage (Figure 5.4). Previously, degradation along the upper portion of both right and left channels had improved fish passage upstream by locally lowering slopes and increasing pool frequency. As noted as a potential outcome in previous reports, the right bank flow path has degraded further and has exposed more of the underlying bedrock. However, it appears from the change detection provided throughout Section 4 that the regrading rate is slowing down, where the right side may be approaching a more stable grade in the future.

Figure 5.4 Potential upstream passage routes overlaid on October 2024 orthomosaic and relevant monitoring pathways (main channel, RB 1 and RB 2). Solid line = expected primary pathway during lower to mid-flow range; dashed lines = additional routes during mid- and higher flow range. (Photo: Wilson Engineering, 2024)

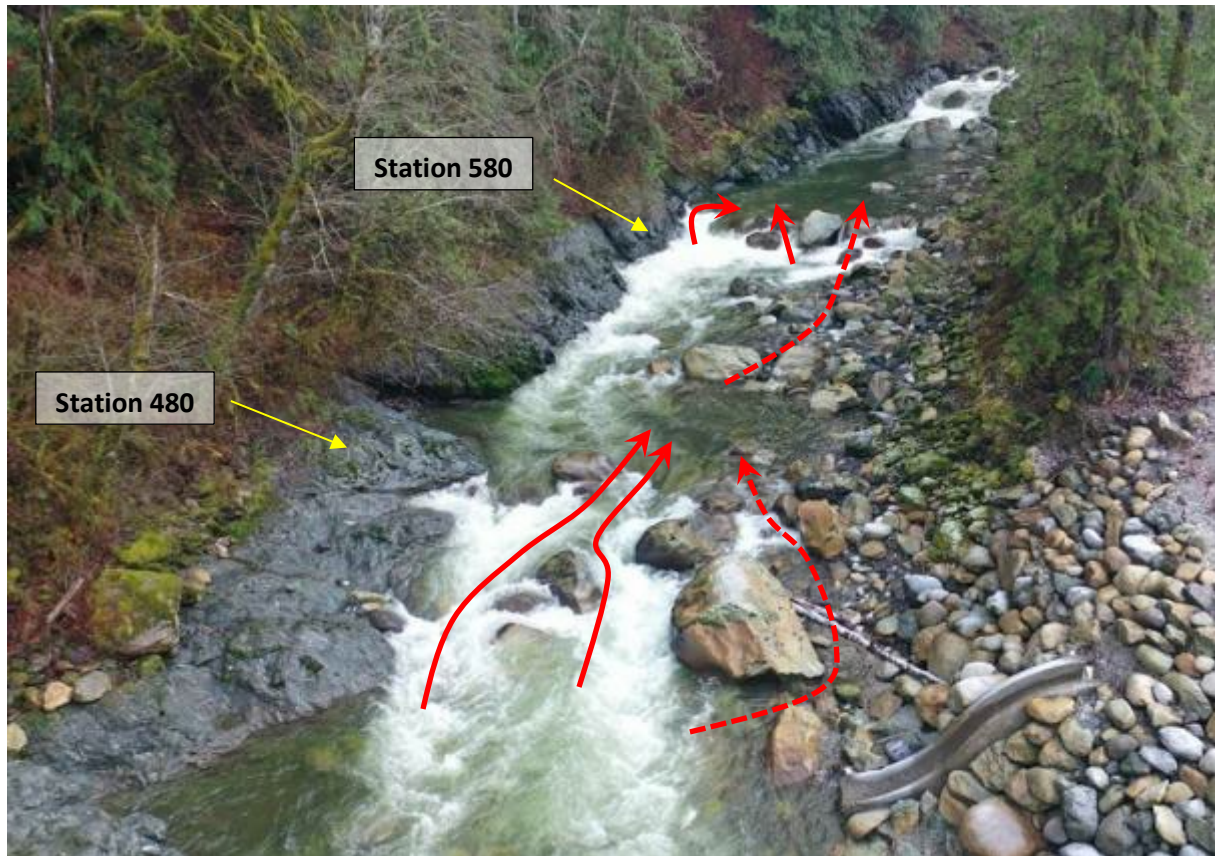
The site was visited to further evaluate fish passage conditions in April 2024 and February 2025 when flow at the USGS gage was around 250 cfs and 350 cfs, respectively. NHC (2024) outlines how there were no hydraulics within the channel that appeared to preclude volitional upstream passage despite widespread regrade approaching thresholds in the MAMP triggering consideration of adaptive management actions. This was confirmed during the 2025 site assessment during more optimal fish passage flows, which is believed to occur between 300 and 500 cfs. The same general routes appeared passable as depicted in the Year 2 and Year 3 reports (Figure 5.4). Connectivity for adult passage appeared to be highly likely, and different potential swimmable pathways appeared possible for transit of the regraded reach at different flow levels. None of the local head drops were more than about 2 ft in height, with sufficiently deep water at base that steelhead, Chinook, & bull trout could partially swim up the nappe as well. Lowering of the low flow water surface at the upstream end of the regraded reach led to development of larger head drops at existing steps upstream at around stations 480 and 580, but the increased head drops and velocities at the steps were lower than in the unaffected reach between there and the intake, and multiple routes appear passable via a combination of swimming and small leaps (Figure 5.5).

Figure 5.5 Likely passage routes at the observed flow at steps upstream of the fish outlet slide (December 2024, 300 cfs). Solid lines = expected primary pathway during lower to mid-flow range; dashed lines = additional routes during mid- and higher flow range.
