# MF Nooksack Channel Monitoring & Adaptive Management Year 5 Monitoring

NHC Reference 2005776

**MF NOOKSACK CHANNEL MONITORING  
& ADAPTIVE MANAGEMENT  
APPENDIX A  
COMPLETE PHOTO DOCUMENTATION**

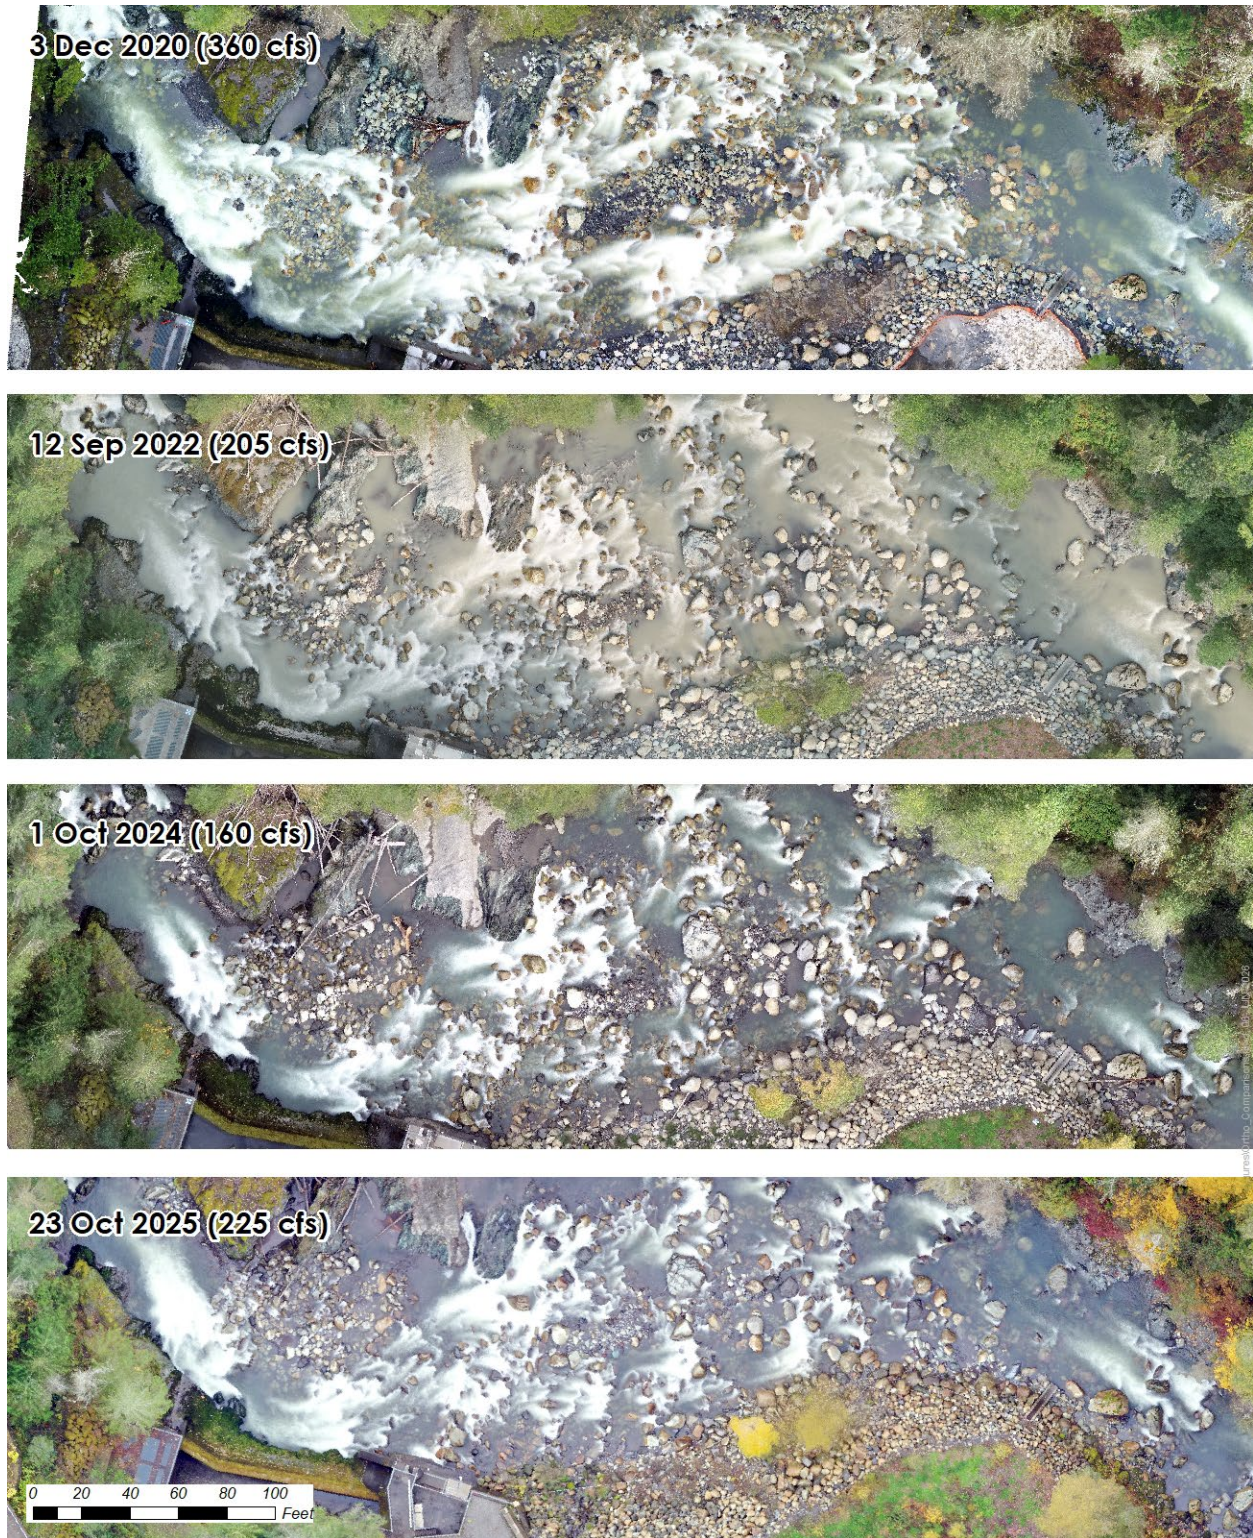
Detailed low flow observations took place in October 2025 after a relatively calm year (no notable runoff events, Figure 1.1) and before the December flood (observations from after that flood are described in the next section). Observations were conducted at 225 cfs. During the visit, it was concluded that the channel bed structure has remained largely stable and unchanged since the December 2024 observations (Figure 3.1). The widespread regrade and channel lowering through the fish bypass outlet pool was still apparent during low flows but does not appear to have downcut any further (Figure 3.2), due to the prolonged stability of the boulder line that formed at the downstream end of the bypass pool in November 2021. As anticipated, the fish bypass slide outlet remains perched above the water surface. However, more abrasion of the concrete slide has occurred since 2024, exposing additional rebar. The exposed rebar is bent against and generally flush with the concrete surface such that it does not protrude from the slide, minimizing the current risk of injury to passing fish. The slide appears to remain structurally sound but should be monitored following future sediment transport events for evidence of additional erosion near the slide outlet. The simultaneous regrade of both main channel and right channels has prevented the main channel from dewatering at low flows. Therefore, the engineered boulder clusters have worked as designed by adjusting with the lowering channel, maintaining passable slopes in the main channel (assumed to be largely unchanged since the 2024 topographic survey), and creating stable roughness from which small step arches can build and form new jamming features and pools (Figure 3.3).

**Figure 3.1** Orthomosaic comparisons showing observed channel conditions during monitoring site visits between December 2020 to October 2025.

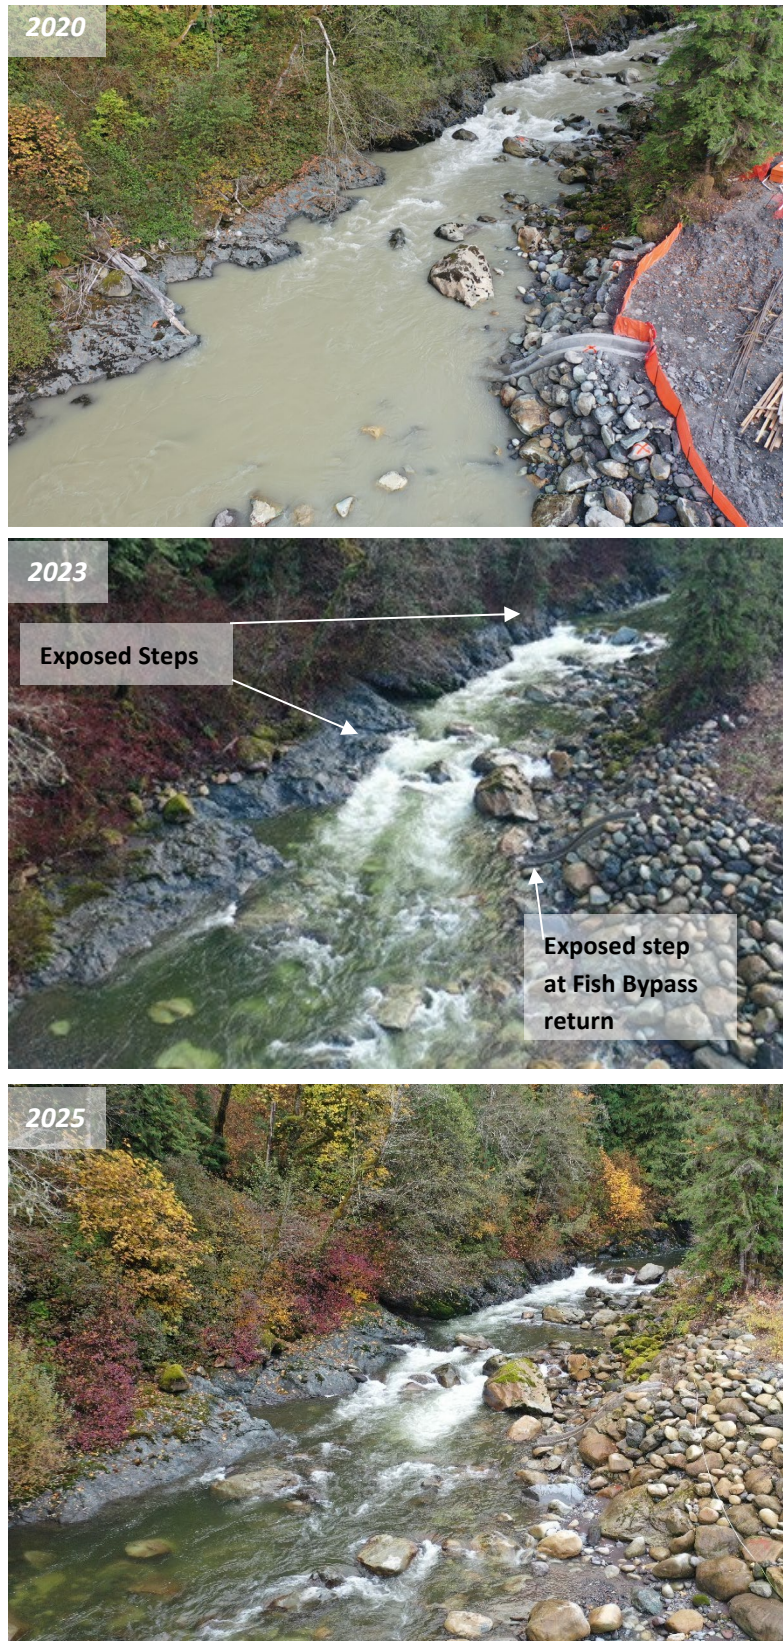
**Figure 3.2** UAV oblique photos showing channel evolution at the pool outlet near Transect 400c between October 2020 (top, 225 cfs), December 2023 (middle, 410 cfs), and October 2025 (bottom, 225 cfs).

Closer monitoring of the larger head drops of several steps upstream of the regrade area, specifically stations 480 and 580, has been a focus of each report as downstream lowering of the water surface in

the regrade area has increased the relative heights of these step features upstream (Figure 3.2). Multiple routes appear passable via a combination of swimming and small leaps (Figure 4.2).

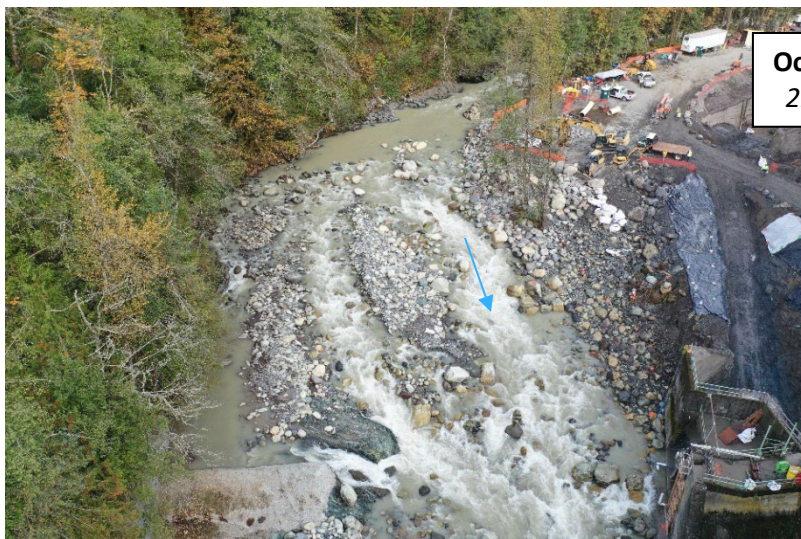
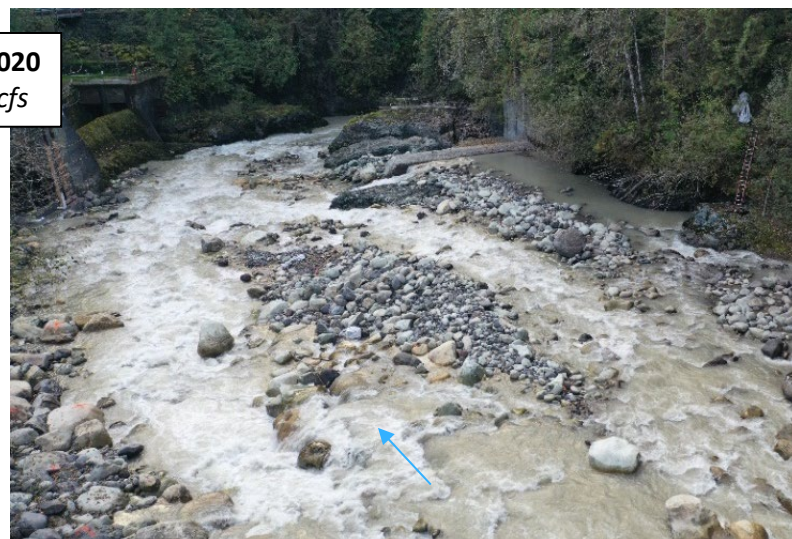
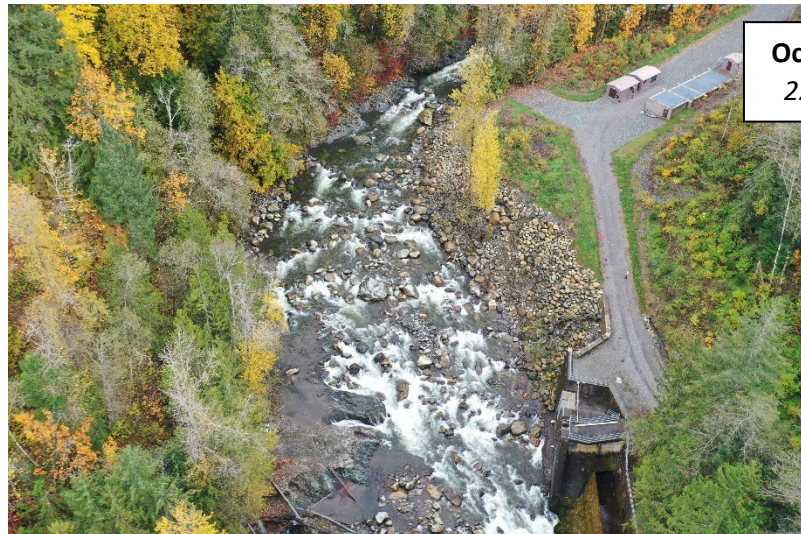
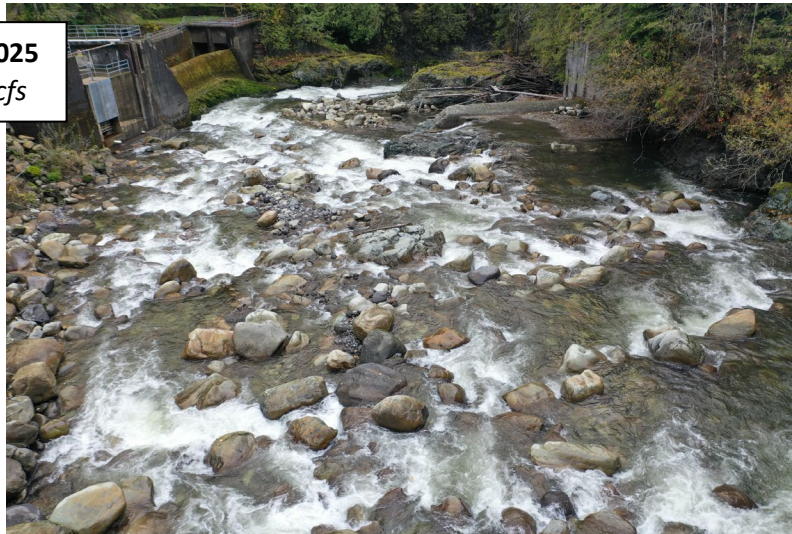
**Figure 3.3 Repeat UAV imagery showing low-flow channel comparisons between October 2020 (top) and October 2024 (bottom)**

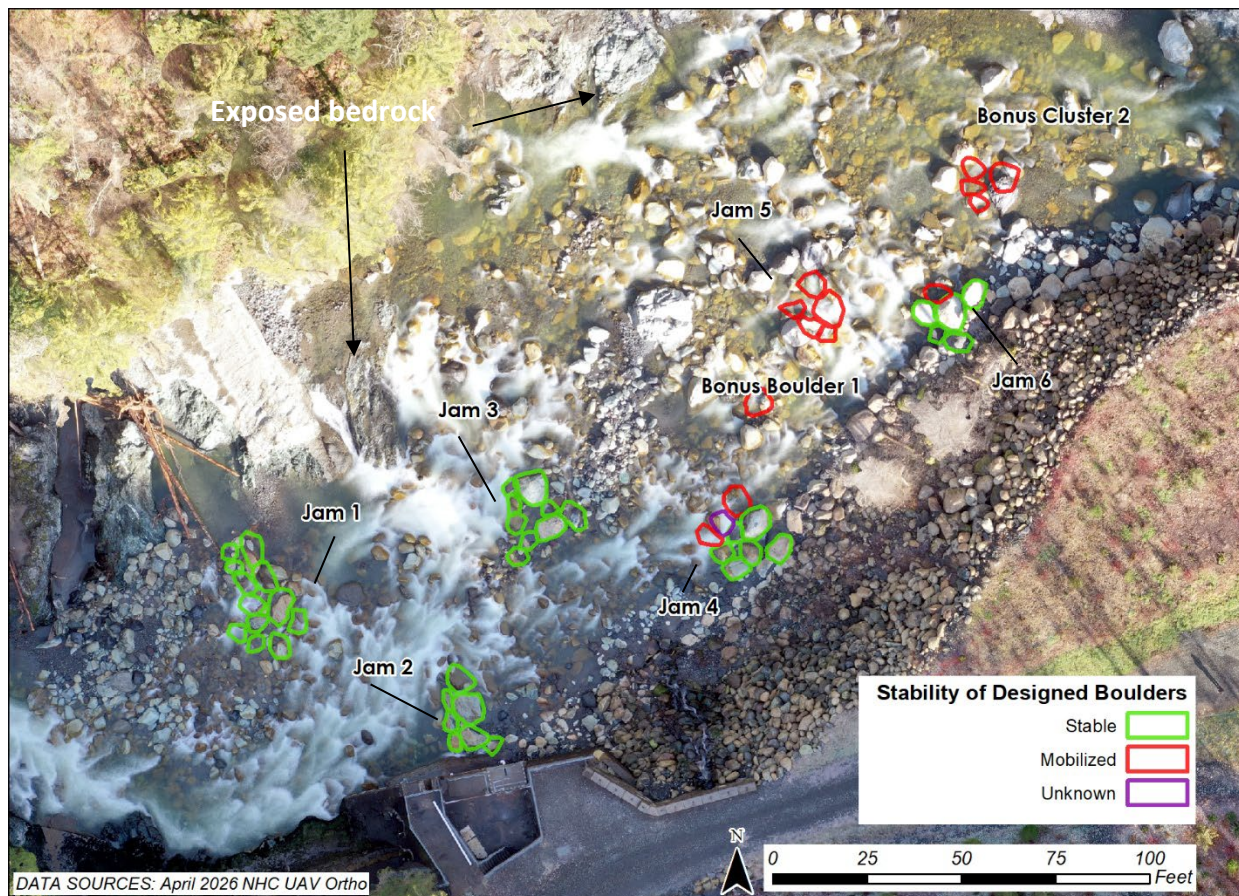
An atmospheric river in December 2025 caused widespread flooding in the region, the flood peak on the MF Nooksack was just slightly higher (20,100 cfs) than the peak of the November 2021 flood (17,200 cfs). The December 2025 event was below the 100-yr trigger that would require additional survey and a full report, but NHC completed reconnaissance observations to evaluate whether substantial changes to the site had occurred that would trigger the mobilization for an additional topographic survey and full monitoring report. This site visit was completed on April 22, 2026. No major changes were observed in the monitoring reach that caused concern for fish passage. All boulder cluster locations were visually observed and found to be stable relative to the October 2025 conditions (as described in Section 3.2; Figure 3.4). The smaller boulders that had formed force chains across the design boulder clusters and channel banks have reorganized into new bed structures, but any lowering that has occurred in the left bank pathways has occurred simultaneously in the main restoration pathway as well, alleviating concerns about dewatering for the existing channel bed conditions.

**Figure 3.4** April 2026 (300 cfs) orthomosaic documenting relative instability in the restored channel, with engineered boulder cluster jams labeled. Areas of exposed bedrock on the channel bed are also labeled. (Photo: NHC)

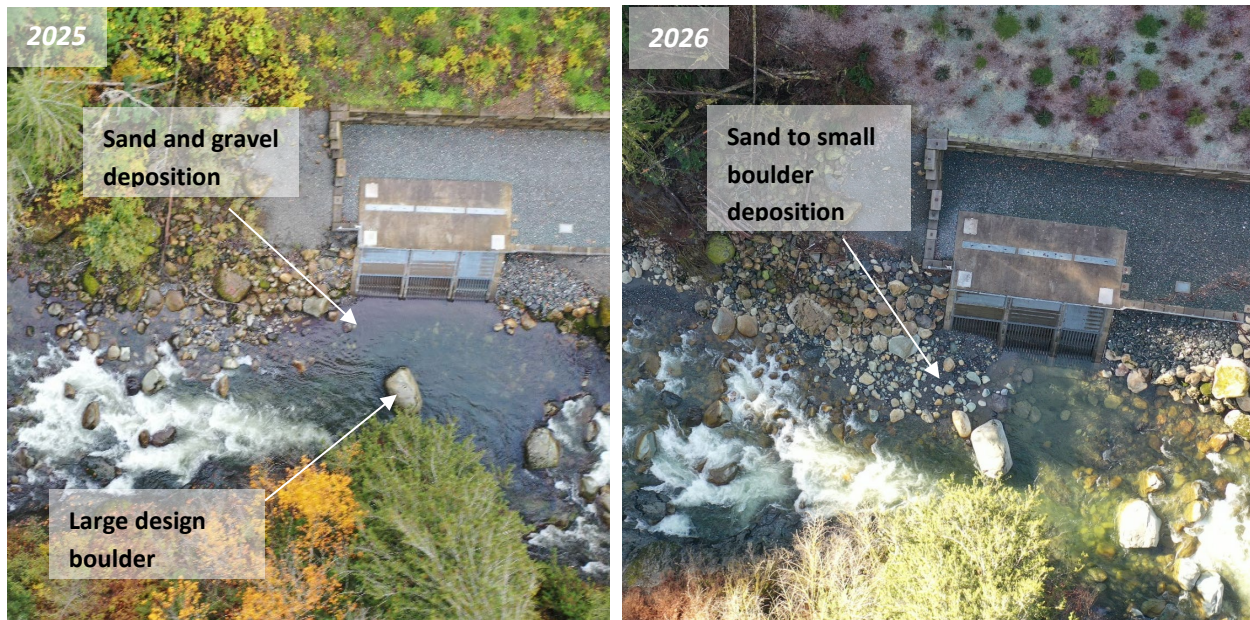
Sediment deposition was observed near the inlet of the diversion, associated with growth of a coarse bar immediately upstream (Figure 3.5). While sediment between sand and small boulders were blocking some of the upstream diversion, the downstream gates remained mostly clear and flowing. Sediment will likely continue to deposit here until local hydraulics change. This location will continue to be monitored in the future to confirm whether bar growth continues, or if the location of the bar and existing large boulder create sufficient scouring flows at the downstream gates to prevent flow loss to the diversion. Placement of an additional large boulder upstream of the existing large boulder could mitigate the issue if placed closer to the left bank to facilitate scour around and downstream of it.

**Figure 3.5 Comparison of the diversion structure in fall of 2025 (left) and spring of 2026 (right)**  
(Photos: NHC)

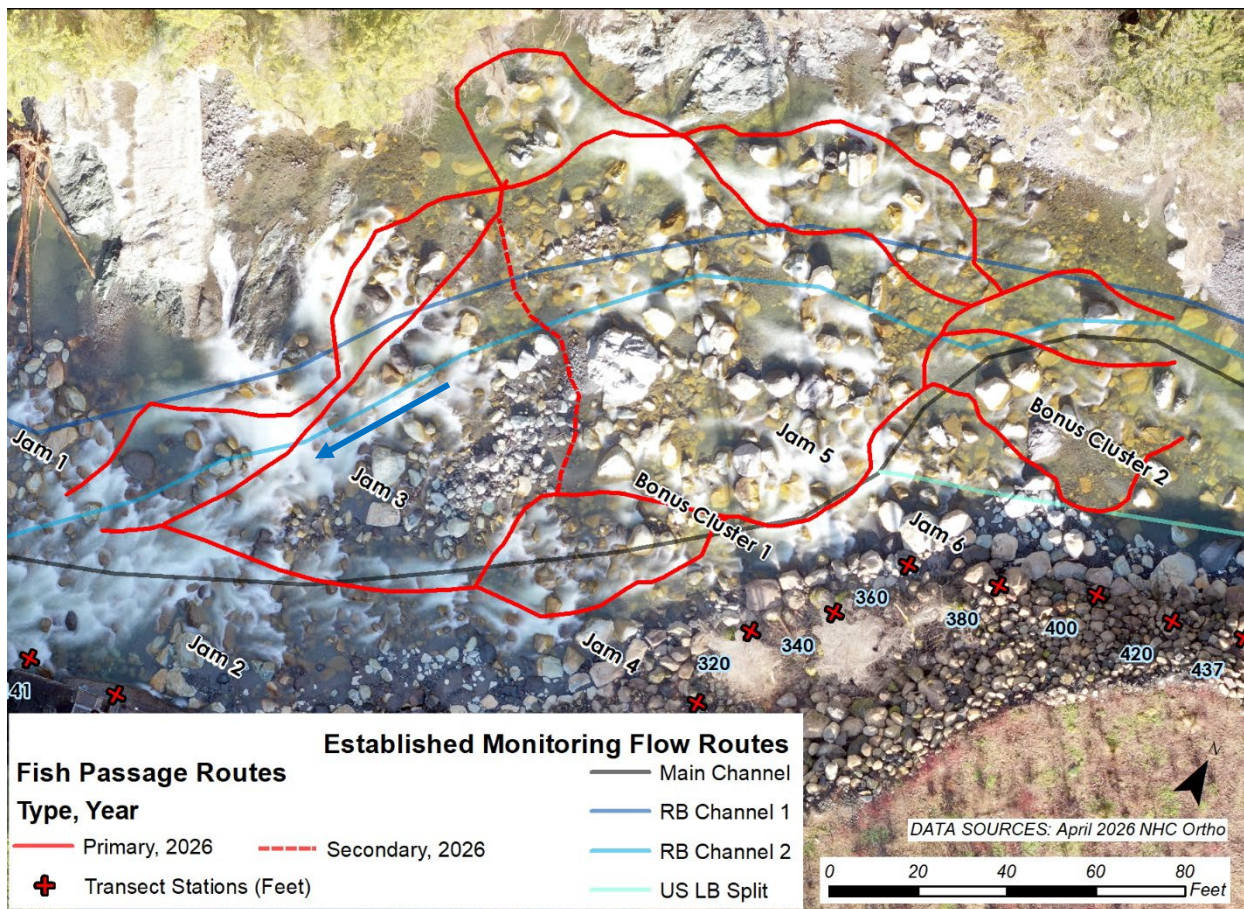
Previously, degradation along the upper portion of both right and left channels had improved fish passage upstream by locally lowering slopes and increasing pool frequency. During optimal fish passage flows (300 to 500 cfs), the right bank pathways (RB 1) become fish passable, creating routes across the channel that have shifted over time, but have not decreased in number (Figure 4.1). As noted as a potential outcome in previous reports, the right bank flow path has degraded further and has exposed more of the underlying bedrock near the bankline but is not widespread.

**Figure 4.1** Potential upstream passage routes overlaid on October 2026 orthomosaic and relevant monitoring pathways (main channel, RB 1 and RB 2). Solid line = expected primary pathway during lower to mid-flow range; dashed lines = additional routes during mid- and higher flow range. (Photo: NHC)

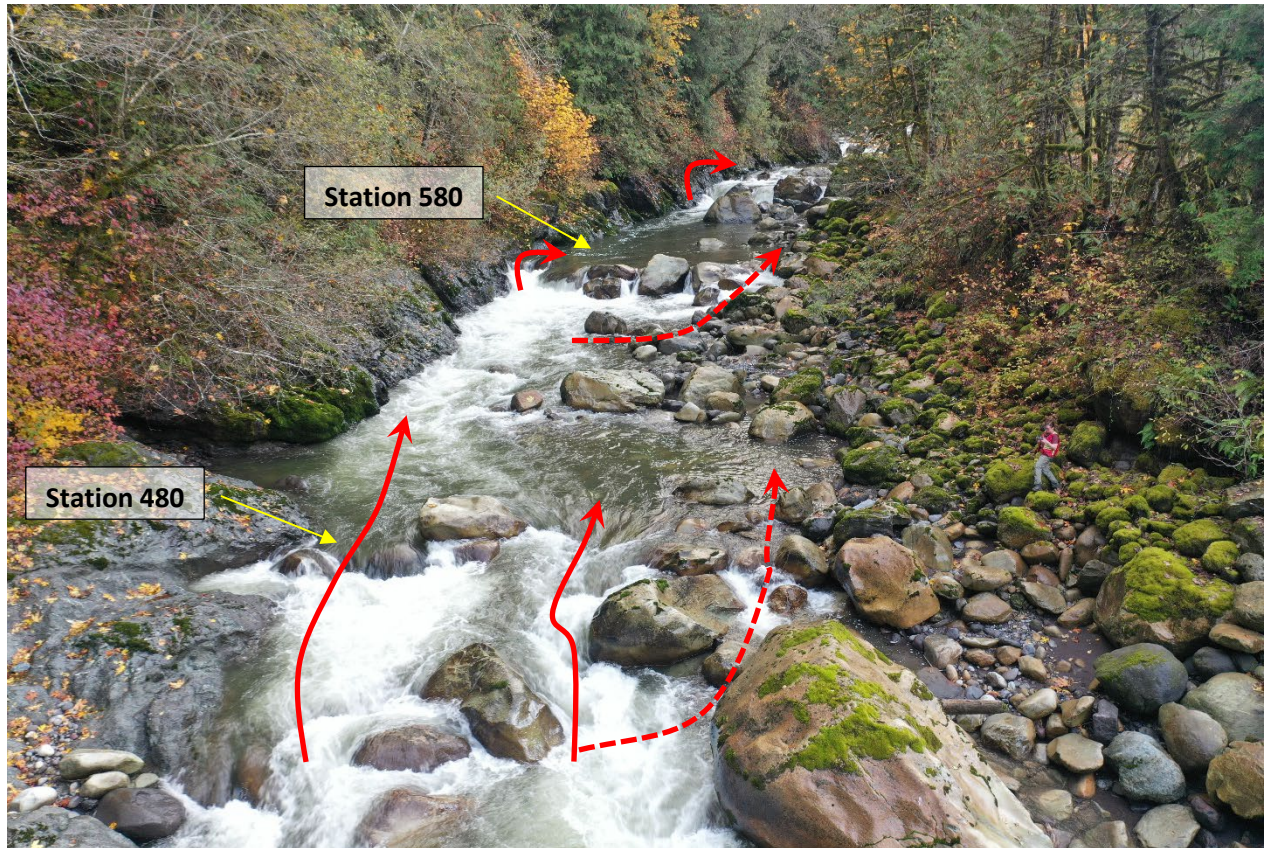
**Figure 4.2** Likely passage routes at the observed flow at steps upstream of the fish outlet slide (October, 2025). Solid lines = expected primary pathway during lower to mid-flow range; dashed lines = additional routes during mid- and higher flow range.
