ROOFING ALTERNATIVES FOR THE BELLINGHAM SPORTSPLEX

Roofing Alternatives for the Sportsplex
Bellingham Parks & Recreation Department
Bellingham, Washington

Final Sportsplex Roof Report

This report is based on a site visit performed on August 2nd, 2016. Gregory Minaker, Architect, Ken Levesque, Designer at Minaker Architecture and Greg Guillen, SE CG Engineering inspected the roof. The following observations and recommendations are the opinions of Minaker Architecture and do not constitute any requirements for client.

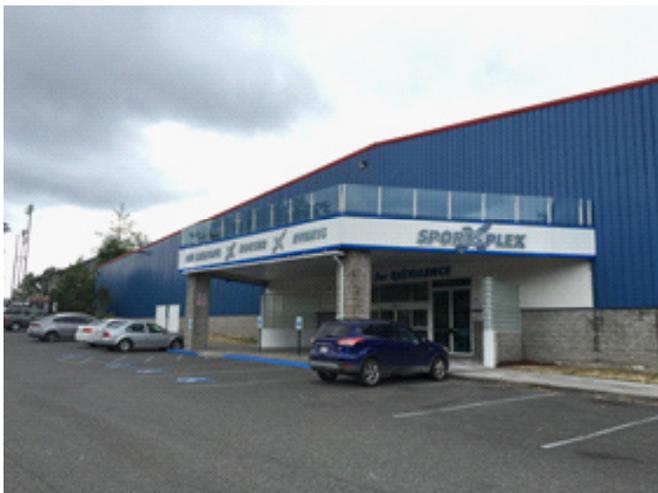
1

Front elevation of structure.
Note water flows over edge into added gutter system.
The canopy roof needs to be reworked and develop a downspout system that will bring water within the boundaries of the structure.

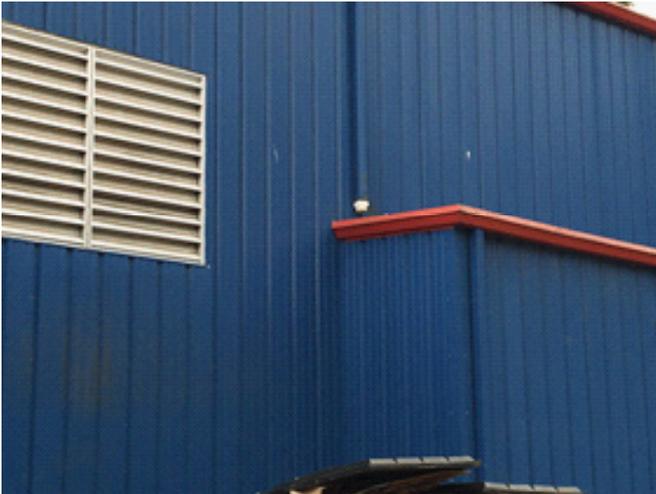
2

On the North elevation at the east bump out off the main structure, there are down spouts that discharge directly onto a lower roof of the bump out; this provides an opportunity for large amounts of moisture to spill adjacent to the structure. To avoid this condition, down spouts should be installed where the discharge is directed away from the structure.

Downspout spills onto another roof.
Recommend moving away from lower roof.

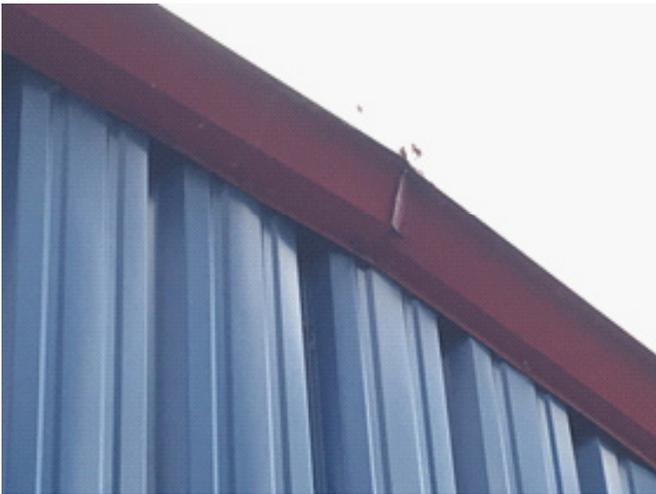
3

There is an opening in the edge metal; this condition can allow moisture into the roof system.
The gutters are incorrectly mounted and need to be lowered approximately 3" for ice and snow to slide off.

Remove and reset Gutters to be 1/2” lower the roof edge.

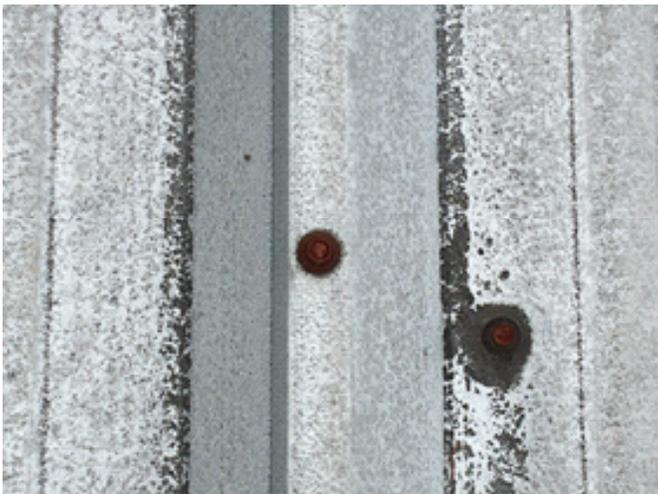
4

Many of the fasteners on the roof are rusted and will likely fail soon.

Continue to apply silicone sealant over failing fasteners.

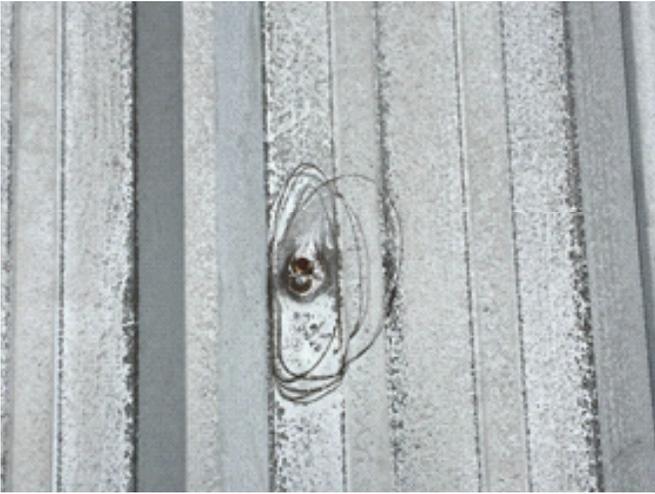
5

Some areas have two fasteners in one location, this can make it difficult to keep weather tight.

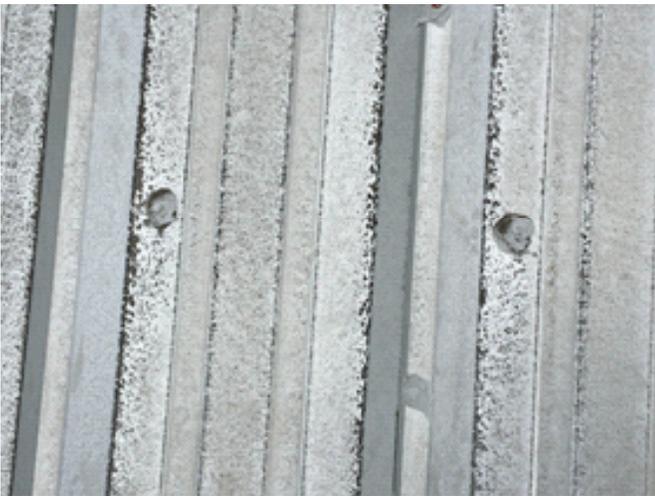
6

Many fasteners are coated with sealant.

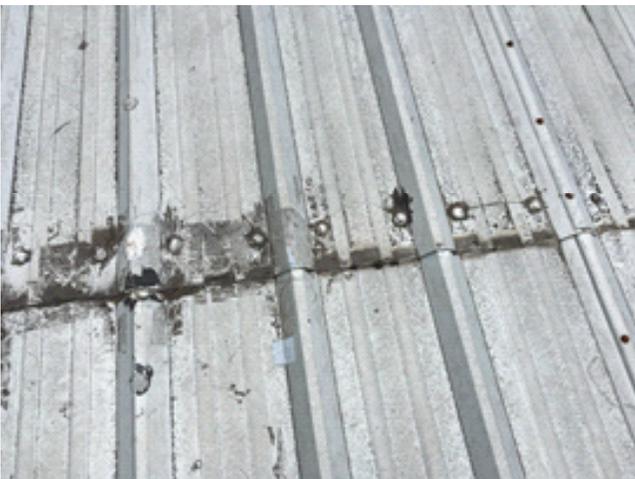
7

The laps in the roofing are not staggered, this can lead to moisture intrusion.

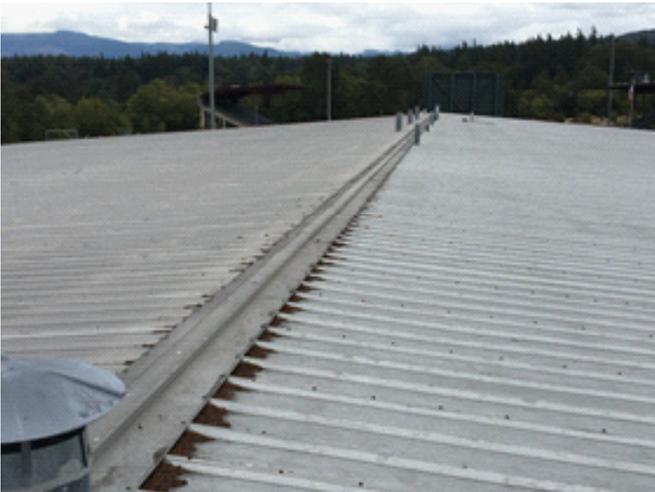
8

Debris has collected at both sides of the ridge. This condition can lead to moisture intrusion.

Remove the debris from the ridge. Remove and replace failing gaskets' line the perimeter of the gasket with a flexible sealant.

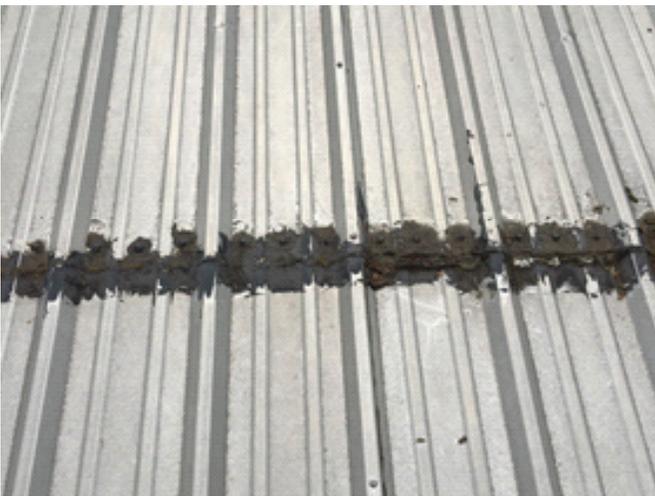
9

Sealant has been applied to some of the laps of the roofing

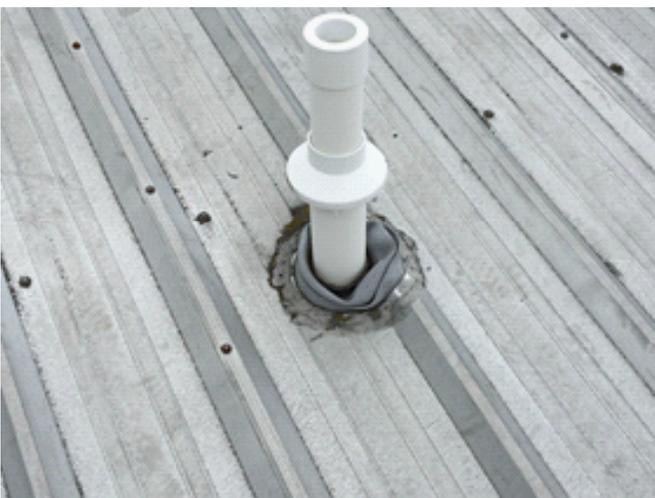
10

A majority of the pipe boots are sagging and collection of moisture, these conditions can lead to failure.

Replace pipe boots where failing. Raise the existing pipe boots top upward, to avoid a location where moisture may collect, then install a stainless steel collar around near the top of the boot followed with a bead of sealant at the top of the boot.

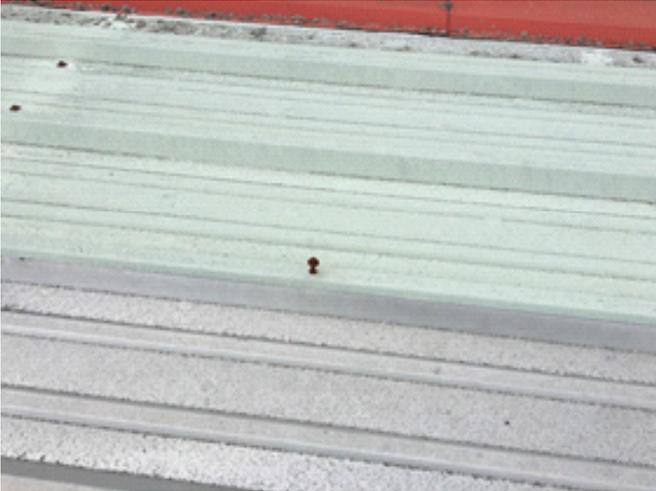
11

Some fasteners are backing out on the Northwest portion of the roof.

Replace missing fasteners with new that include a neoprene washer.

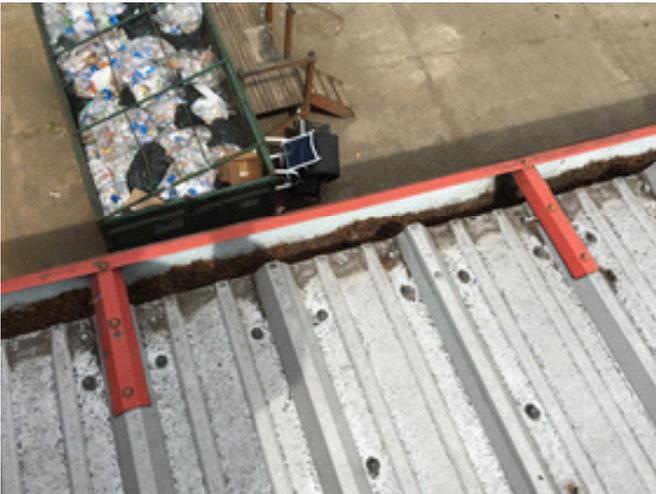
12

There are some miscellaneous areas to note. At a number of pipe boot locations, the sealant is failing. The standoffs for the metal gutter are fastened and installed upslope of the roofing and provide an upslope lap, where moisture can collect and migrate through the opening provided by the fasteners.

The standoffs for the gutter are installed over the roofing, creating an upslope lap. Combined with the hole from the fasteners, moisture will likely enter.

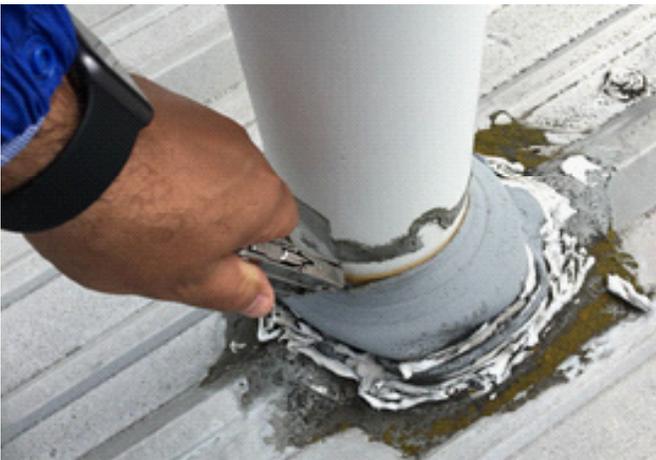
13

Sealant at pipe boots have failed, providing an inlet for moisture

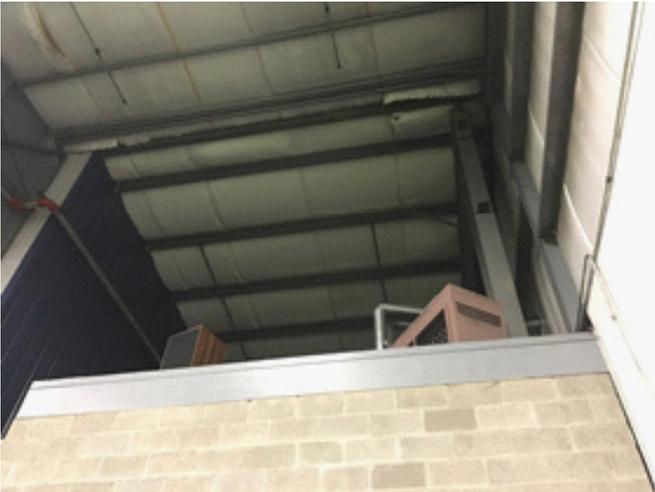
14

The insulation at the ridge on the West side of the building appears to be intact.

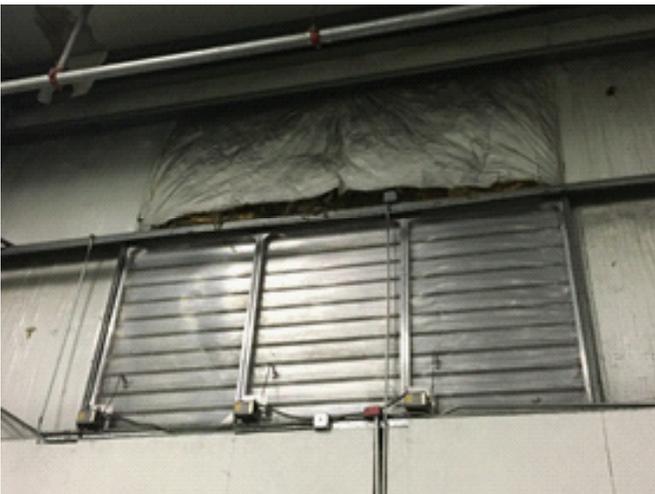
15

There is damage to insulation above some of the louvers.

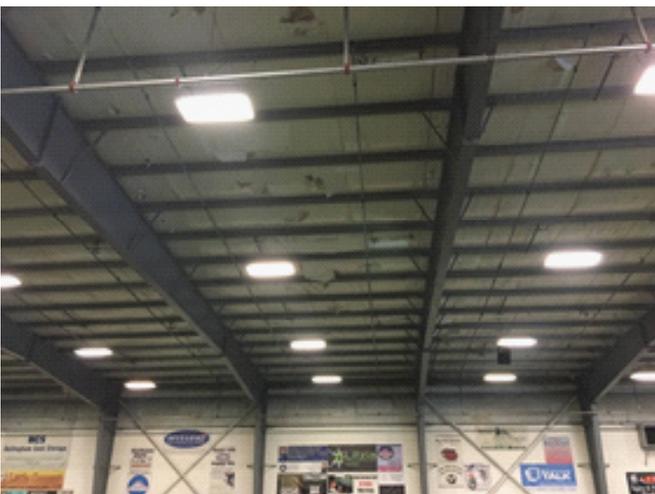
16

On the soccer side of the building, there are numerous locations where the insulation has failed.

Patch existing vapor barrier in the ice room and the soccer room.

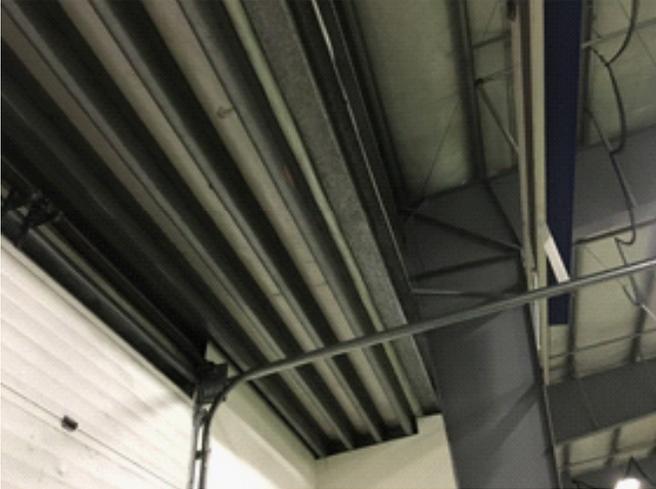
17

There does not appear to be insulation at the roll-up door locations.

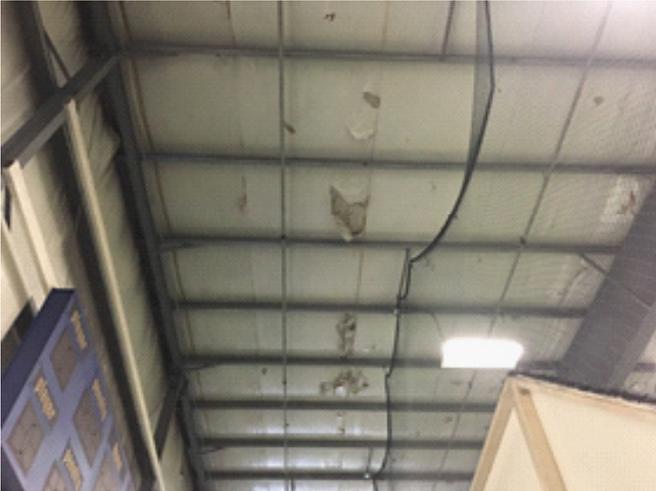
18

There are multiple locations of damage insulation in hockey side of the building.

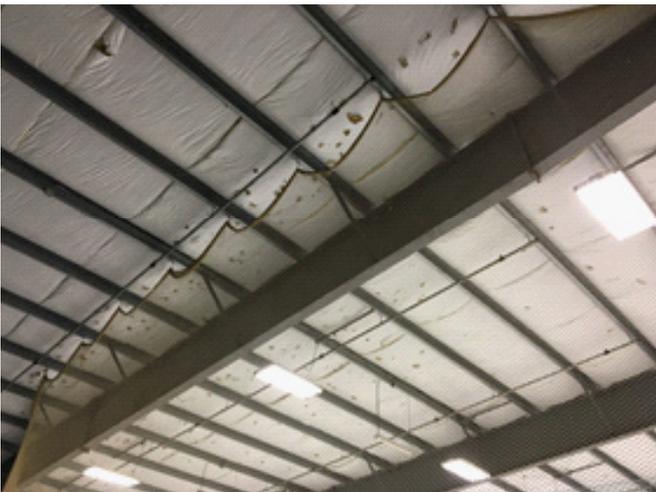
19

Within the interior there are many penetrations in the insulation on both north and south sides of the building. On the side of the hockey rink, most of the penetrations are reported to be from pucks hitting the goal and then embedding themselves. There appears to be a few that show signs from failure in the vapor barrier, which may have been from moisture damage. On the side of the soccer fields, there are significant amounts of openings in the vapor barrier and insulation; some where the underside of the metal roofing is exposed. It was reported that a majority of these are from moisture damage this could be from both water intrusion and condensation

On both sides of the hockey rink, the insulation is damaged, it is from the hockey pucks as reported by staff.
