ROOFING ALTERNATIVES FOR THE BELLINGHAM SPORTSPLEX

Roofing Alternatives for the Sportsplex
Bellingham Parks & Recreation Department
Bellingham, Washington

September 14, 2016

Final Sportsplex Roof Report

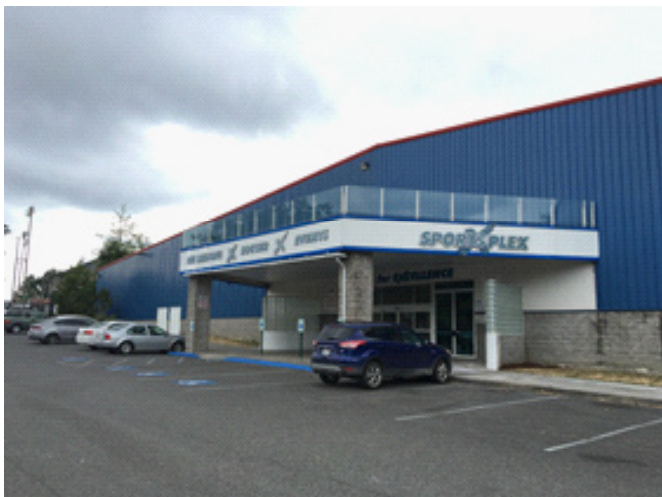
Front elevation of structure.
Note water flows over edge into added gutter system.
The canopy roof needs to be reworked and develop
a downspout system that will bring water within the
boundaries of the structure.

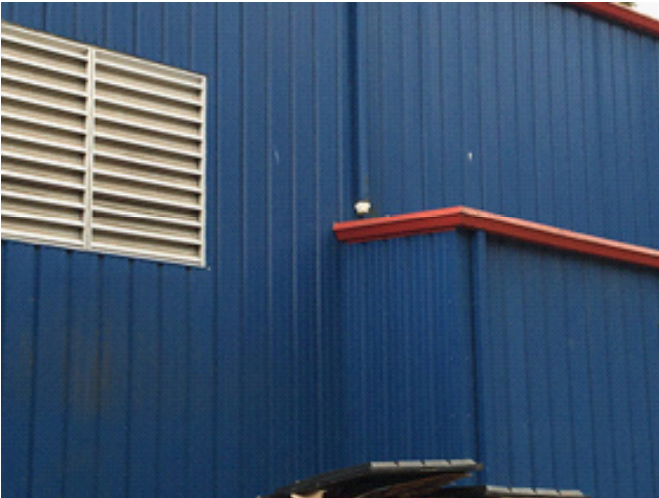
2

On the North elevation at the east bump out off the main structure, there are down spouts that discharge directly onto a lower roof of the bump out; this provides an opportunity for large amounts of moisture to spill adjacent to the structure. To avoid this condition, down spouts should be installed where the discharge is directed away from the structure.

Downspout spills onto another roof.
Recommend moving away from lower roof.

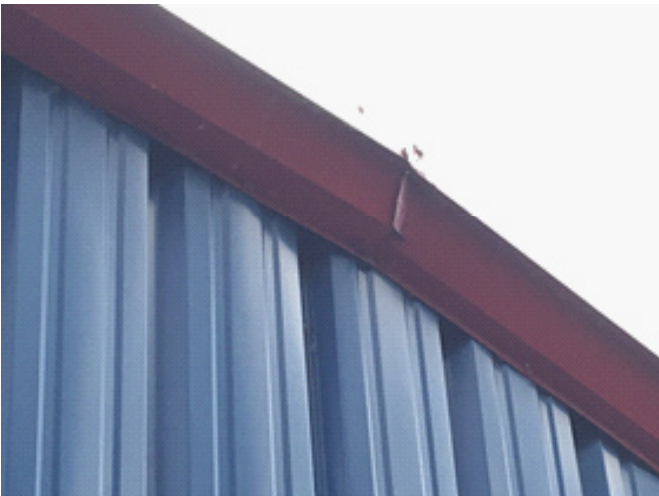
3

There is an opening in the edge metal; this condition
can allow moisture into the roof system.
The gutters are incorrectly mounted and need to be lowered
approximately 3" for ice and snow to slide off.

Remove and reset Gutters to be 1/2" lower the roof edge.

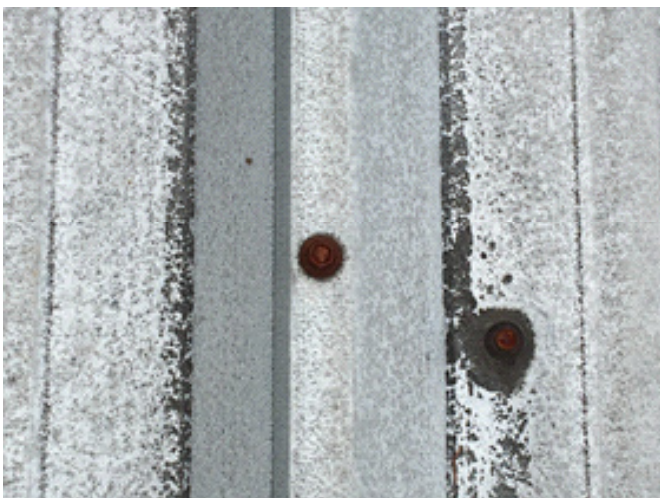
4

Many of the fasteners on the roof are rusted and will likely
fail soon.

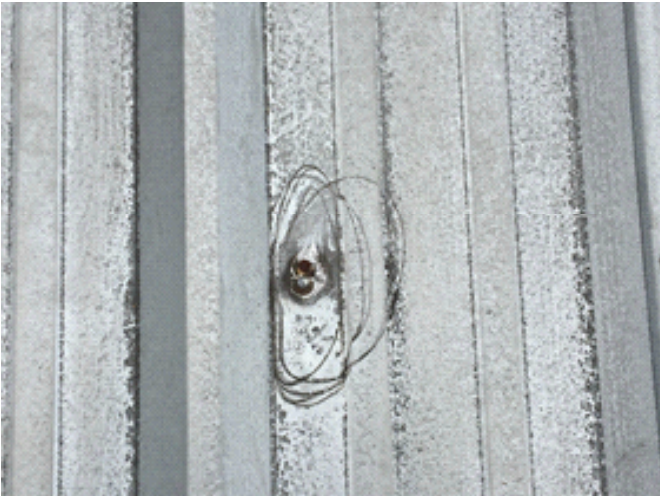
5

Some areas have two fasteners in one location, this can make it difficult to keep weather tight.

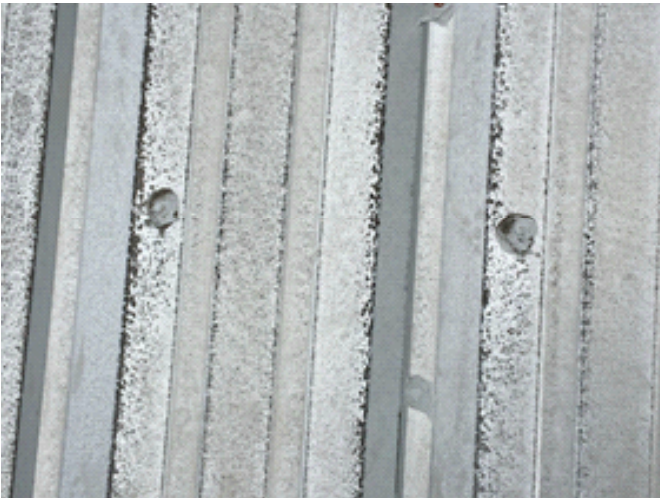
6

Many fasteners are coated with sealant.

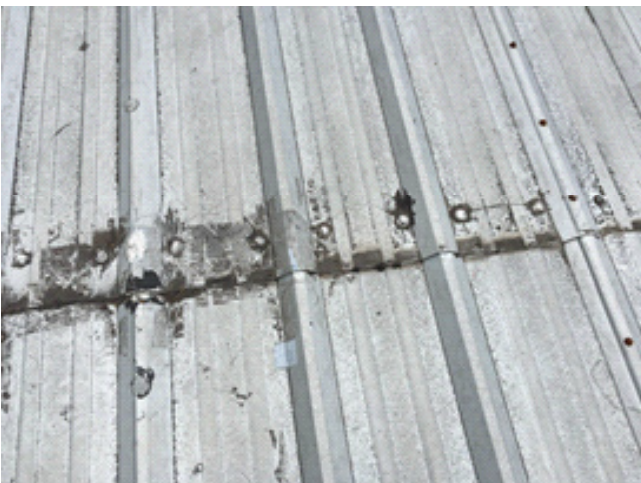
7

The laps in the roofing are not staggered, this can lead to moisture intrusion.

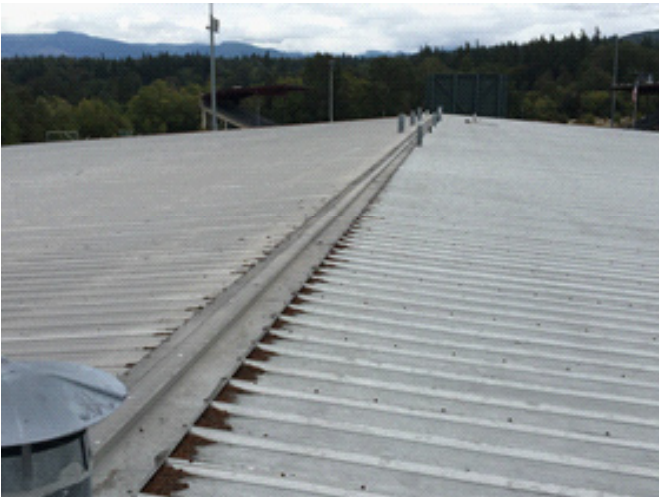
8

Debris has collected at both sides of the ridge. This condition can lead to moisture intrusion.

Remove the debris from the ridge. Remove and replace failing gaskets' line the perimeter of the gasket with a flexible sealant.

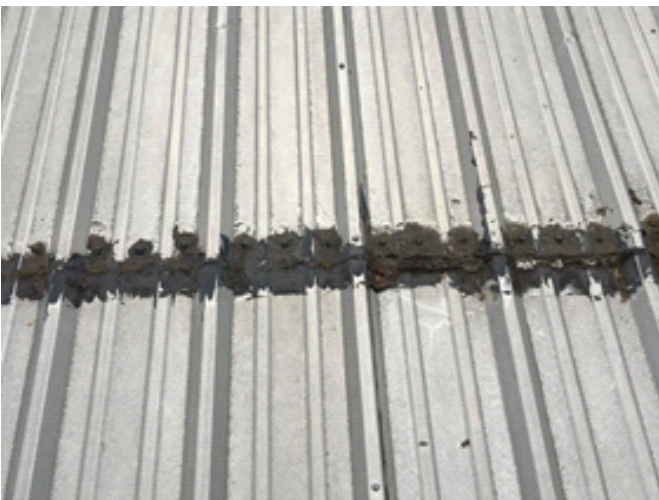
9

Sealant has been applied to some of the laps of the roofing

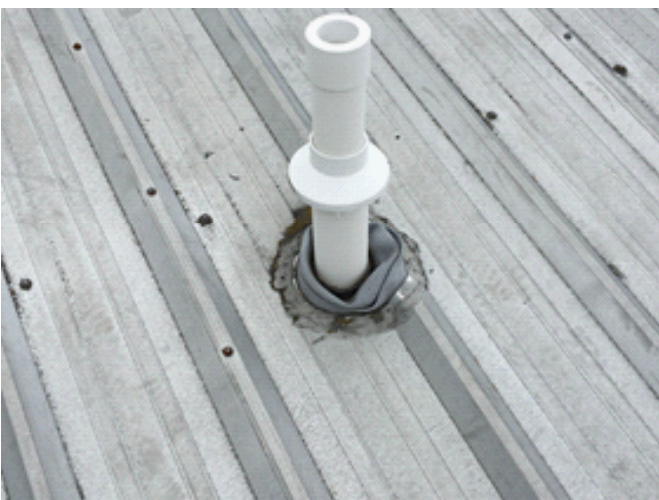
10

A majority of the pipe boots are sagging and collection of moisture, these conditions can lead to failure.

Replace pipe boots where failing. Raise the existing pipe boots top upward, to avoid a location where moisture may collect, then install a stainless steel collar around near the top of the boot followed with a bead of sealant at the top of the boot.

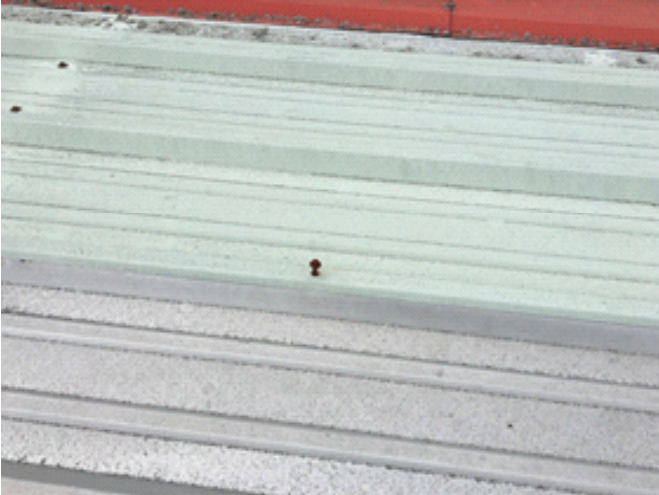
11

Some fasteners are backing out on the Northwest portion of the roof.

Replace missing fasteners with new that include a neoprene washer.

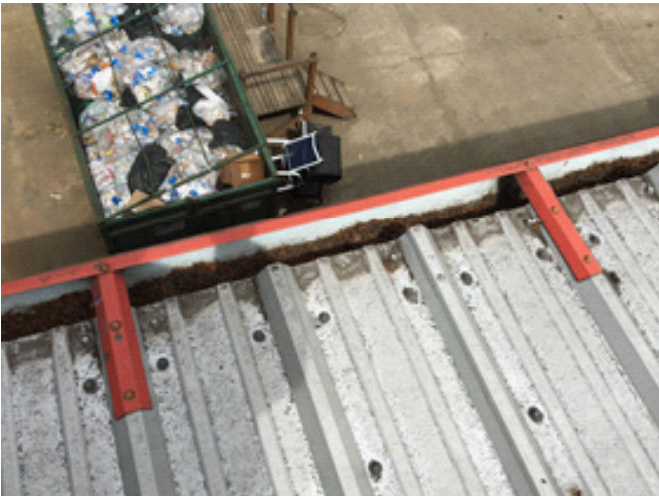
12

There are some miscellaneous areas to note. At a number of pipe boot locations, the sealant is failing. The standoffs for the metal gutter are fastened and installed upslope of the roofing and provide an upslope lap, where moisture can collect and migrate through the opening provided by the fasteners.

The standoffs for the gutter are installed over the roofing, creating an upslope lap. Combined with the hole from the fasteners, moisture will likely enter.

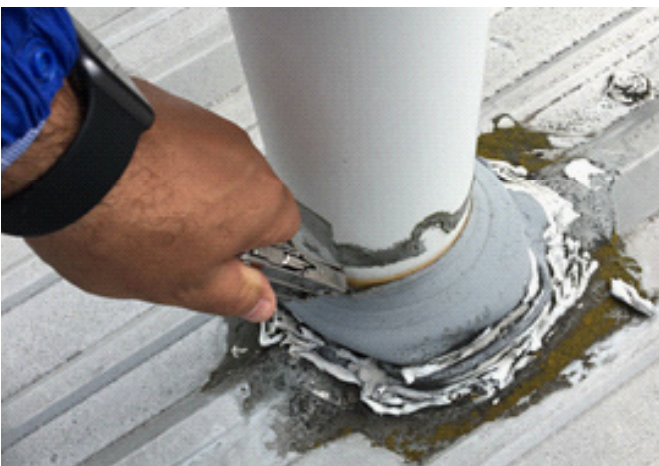
13

Sealant at pipe boots have failed, providing an inlet for moisture

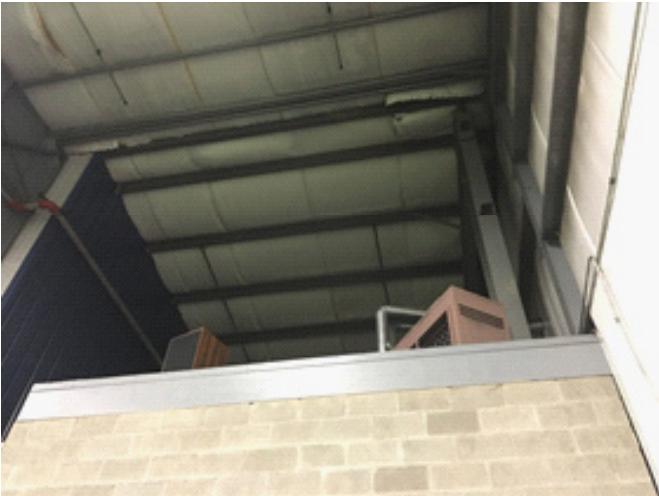
14

The insulation at the ridge on the West side of the building appears to be intact.

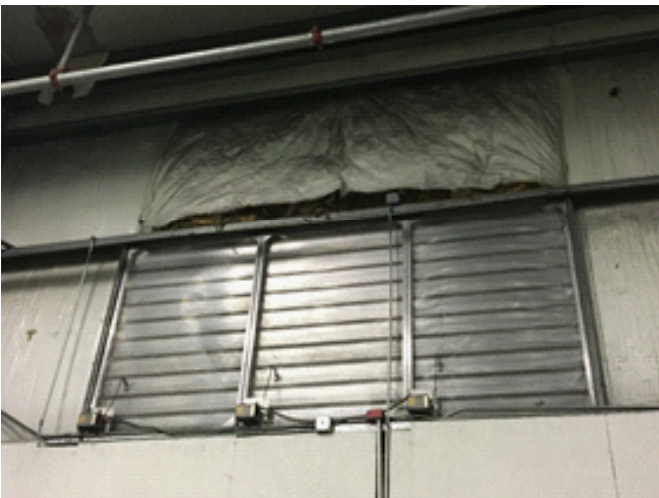
15

There is damage to insulation above some of the louvers.

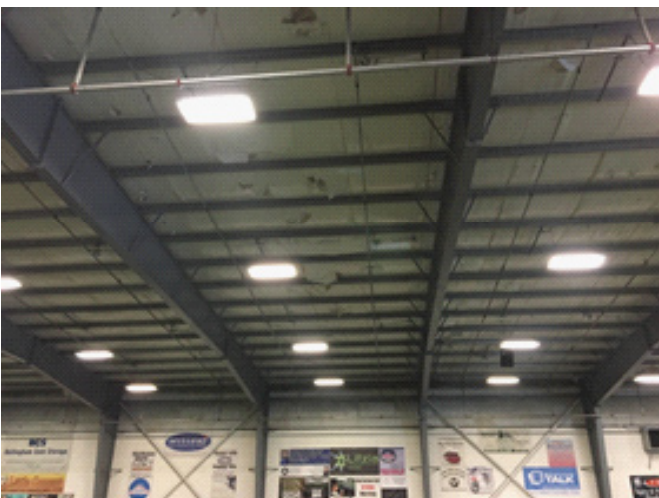
16

On the soccer side of the building, there are numerous locations where the insulation has failed.

Patch existing vapor barrier in the ice room and the soccer room.

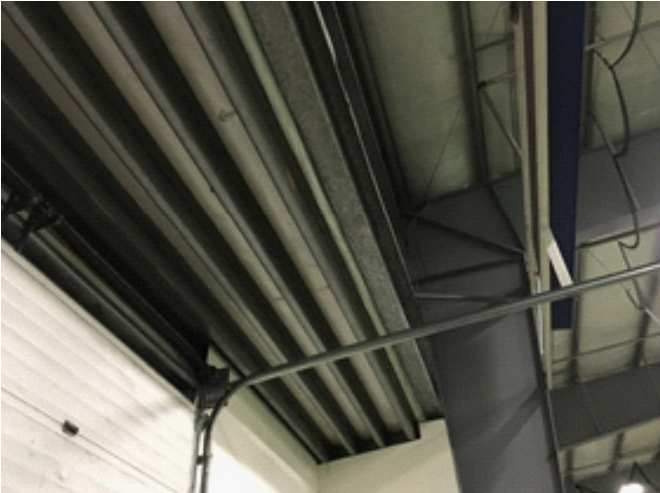
17

There does not appear to be insulation at the roll-up door locations.

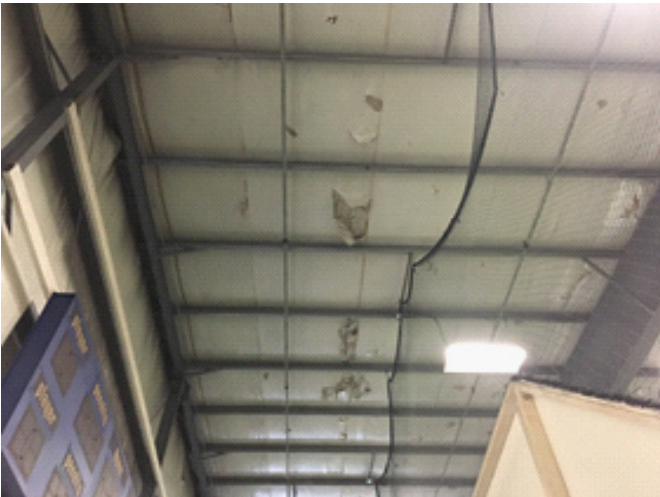
18

There are multiple locations of damage insulation in hockey side of the building.

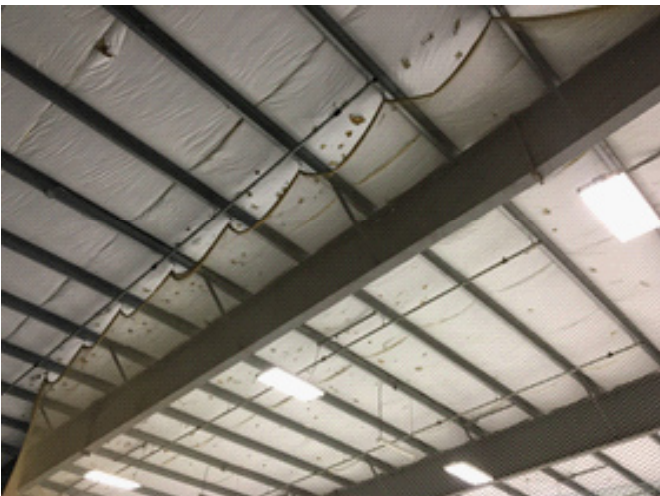
19

On both sides of the hockey rink, the insulation is damaged, it is from the hockey pucks as reported by staff.
