# City of Bellingham Screen House: Condition Assessment and Improvement Report (Task 3.8)

PREPARED FOR: City of Bellingham Project Team  
PREPARED BY: CH2M HILL Project Team  
DATE: November 7, 2014

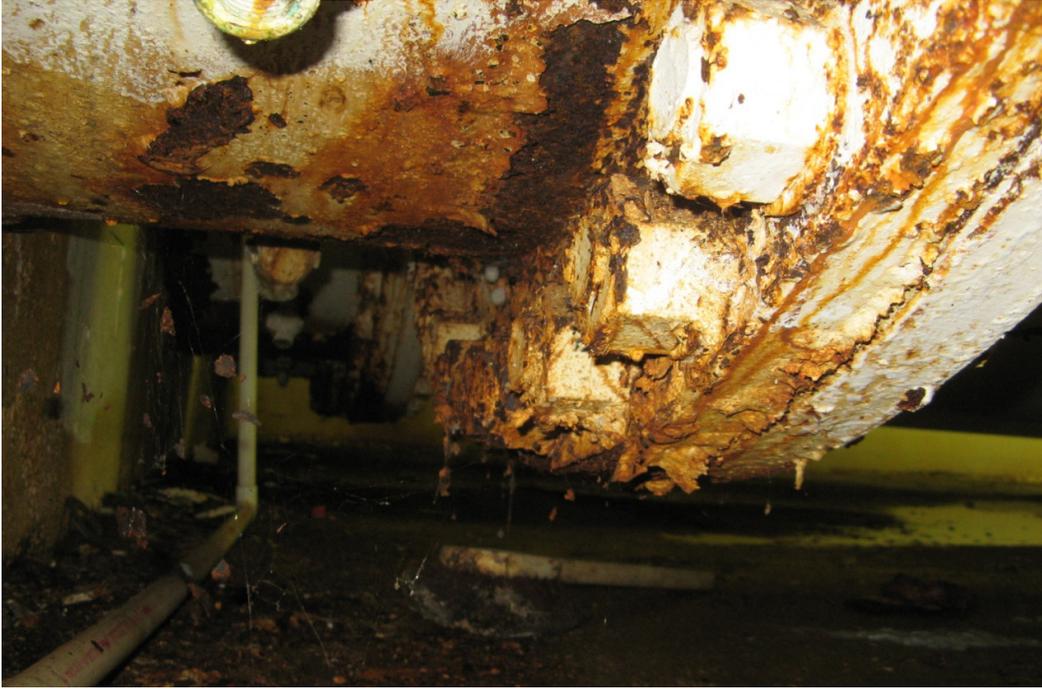
**Figure 1 - View of bottom of Pipe 1 at the Flange Showing Extensive Corrosion and Delamination of the Pipe Barrel**

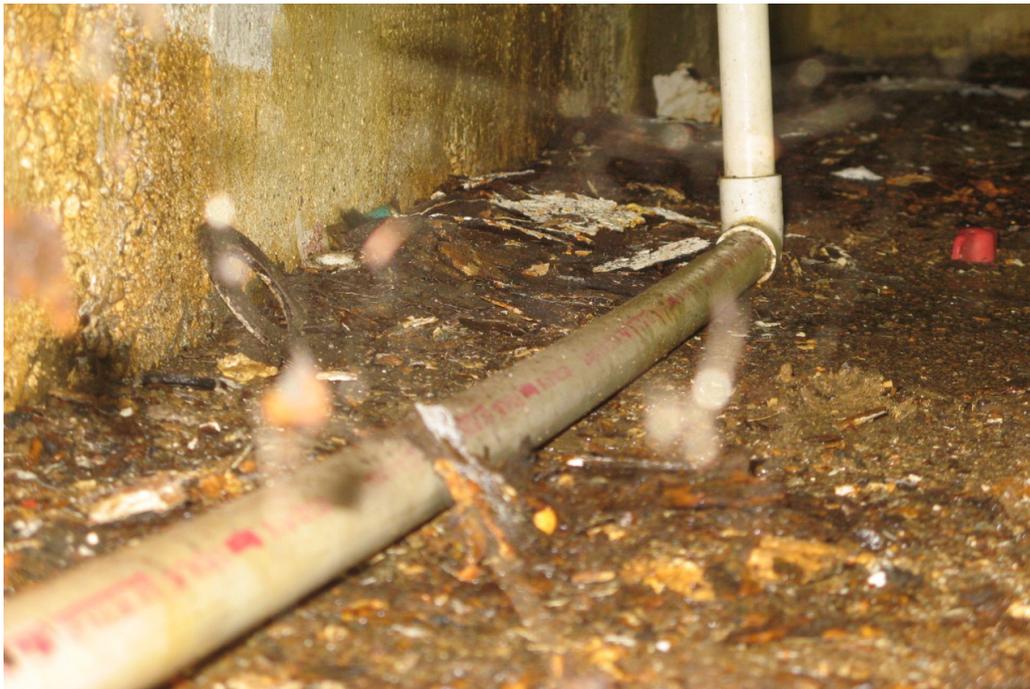
**Figure 2 - Accumulation of Corrosion Scale and Corrosion by Products on the Floor Below Pipe 1**

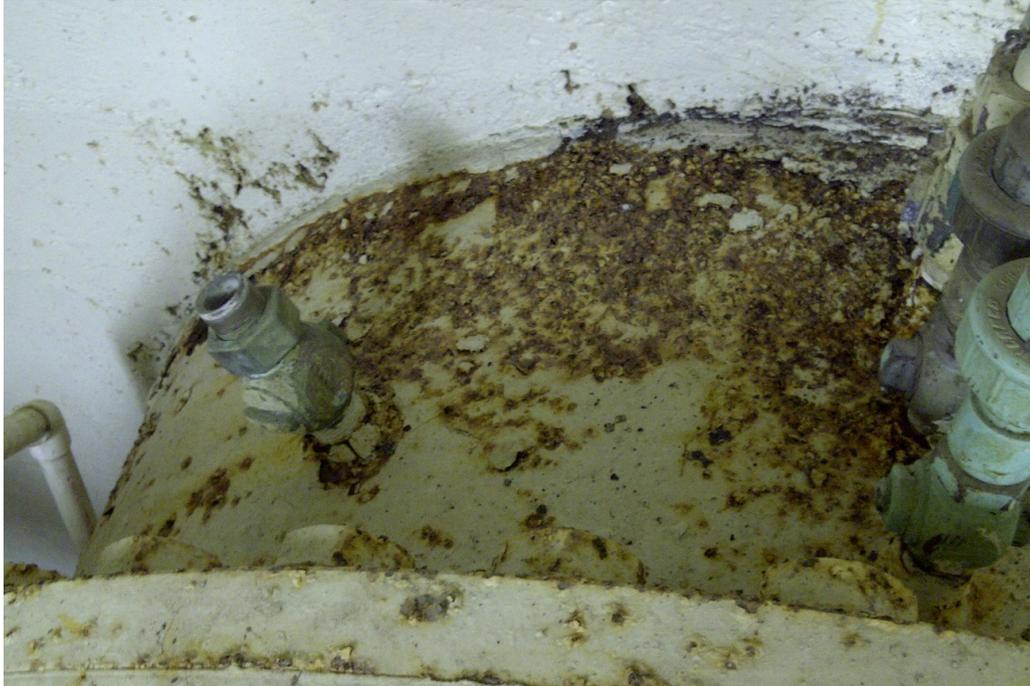
**Figure 3 - Crown of Pipe 1 Shows Some Evidence of Corrosion Near Contact with the Chlorine House Foundation Wall**

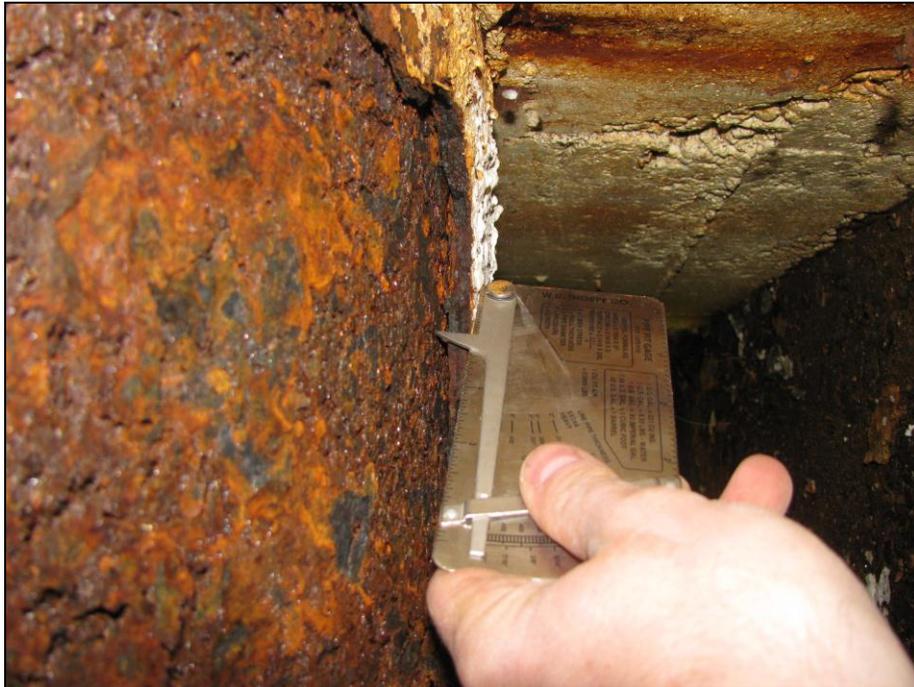
Image 1: Corrosion product after removal of an adjacent segment. As found on the bottom of the center pipe. Corrosion product found was approximately a half-inch thick.

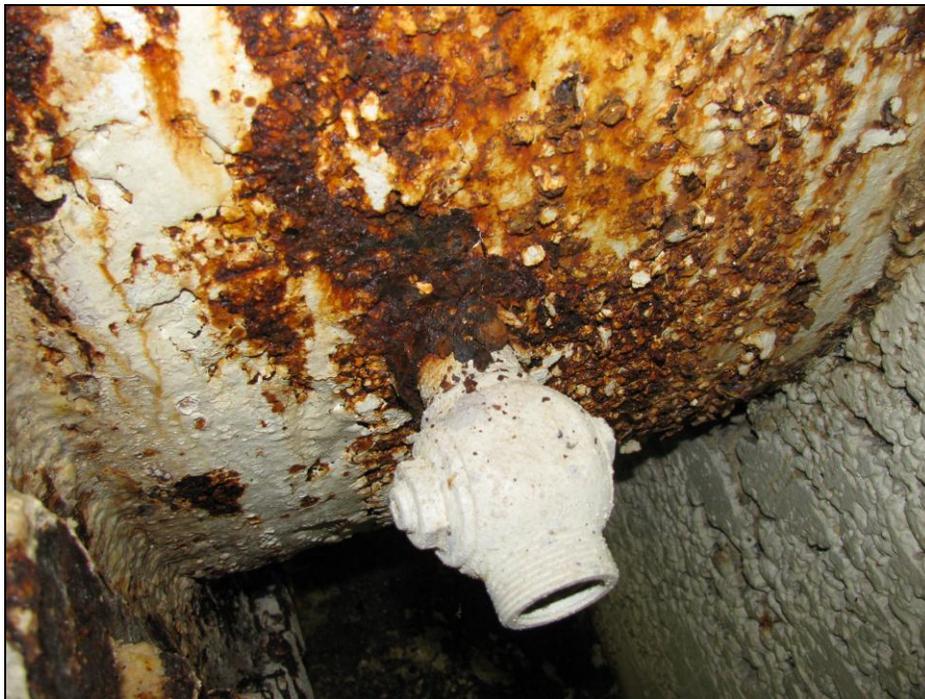
Image 2: Corrosion damage to the weld surrounding the nipple.

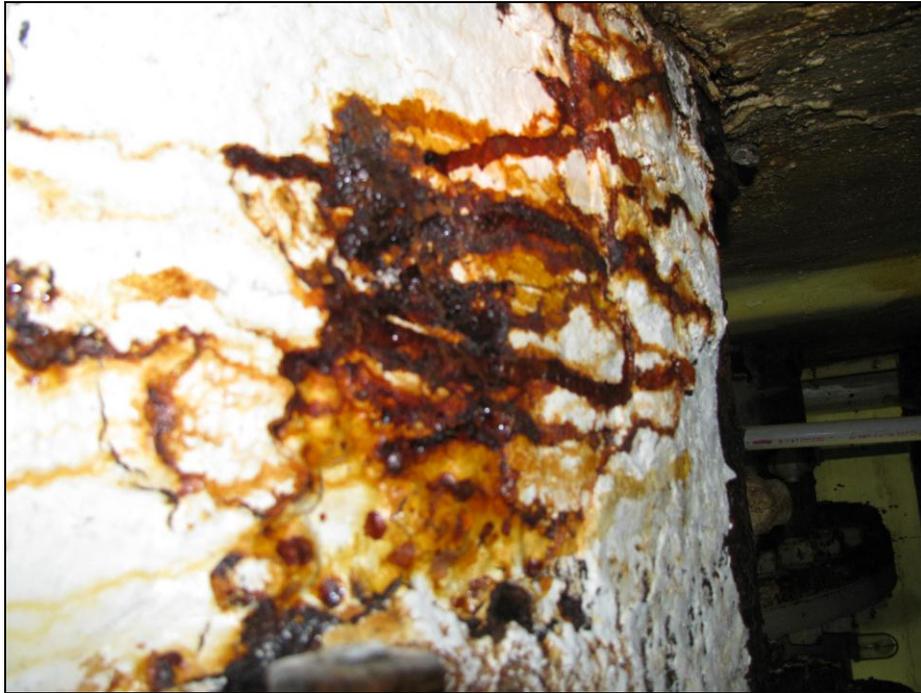
Image 3: Moisture present on the surface of the pipe.

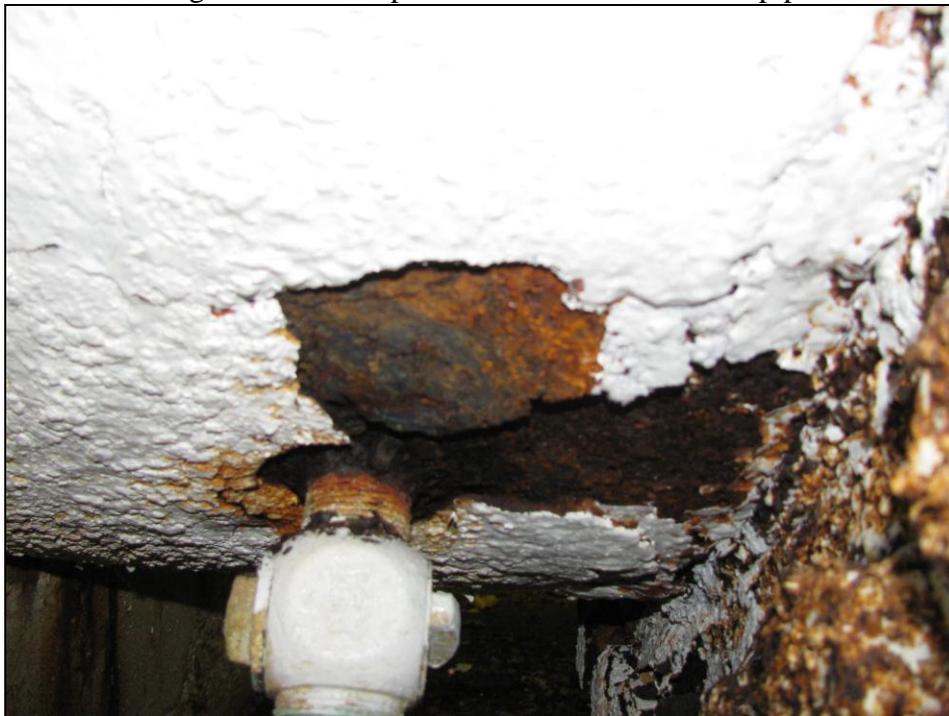
Image 4: Corrosion damage, after removing a segment of metal adjacent to the nipple.  
Located on the southernmost pipe

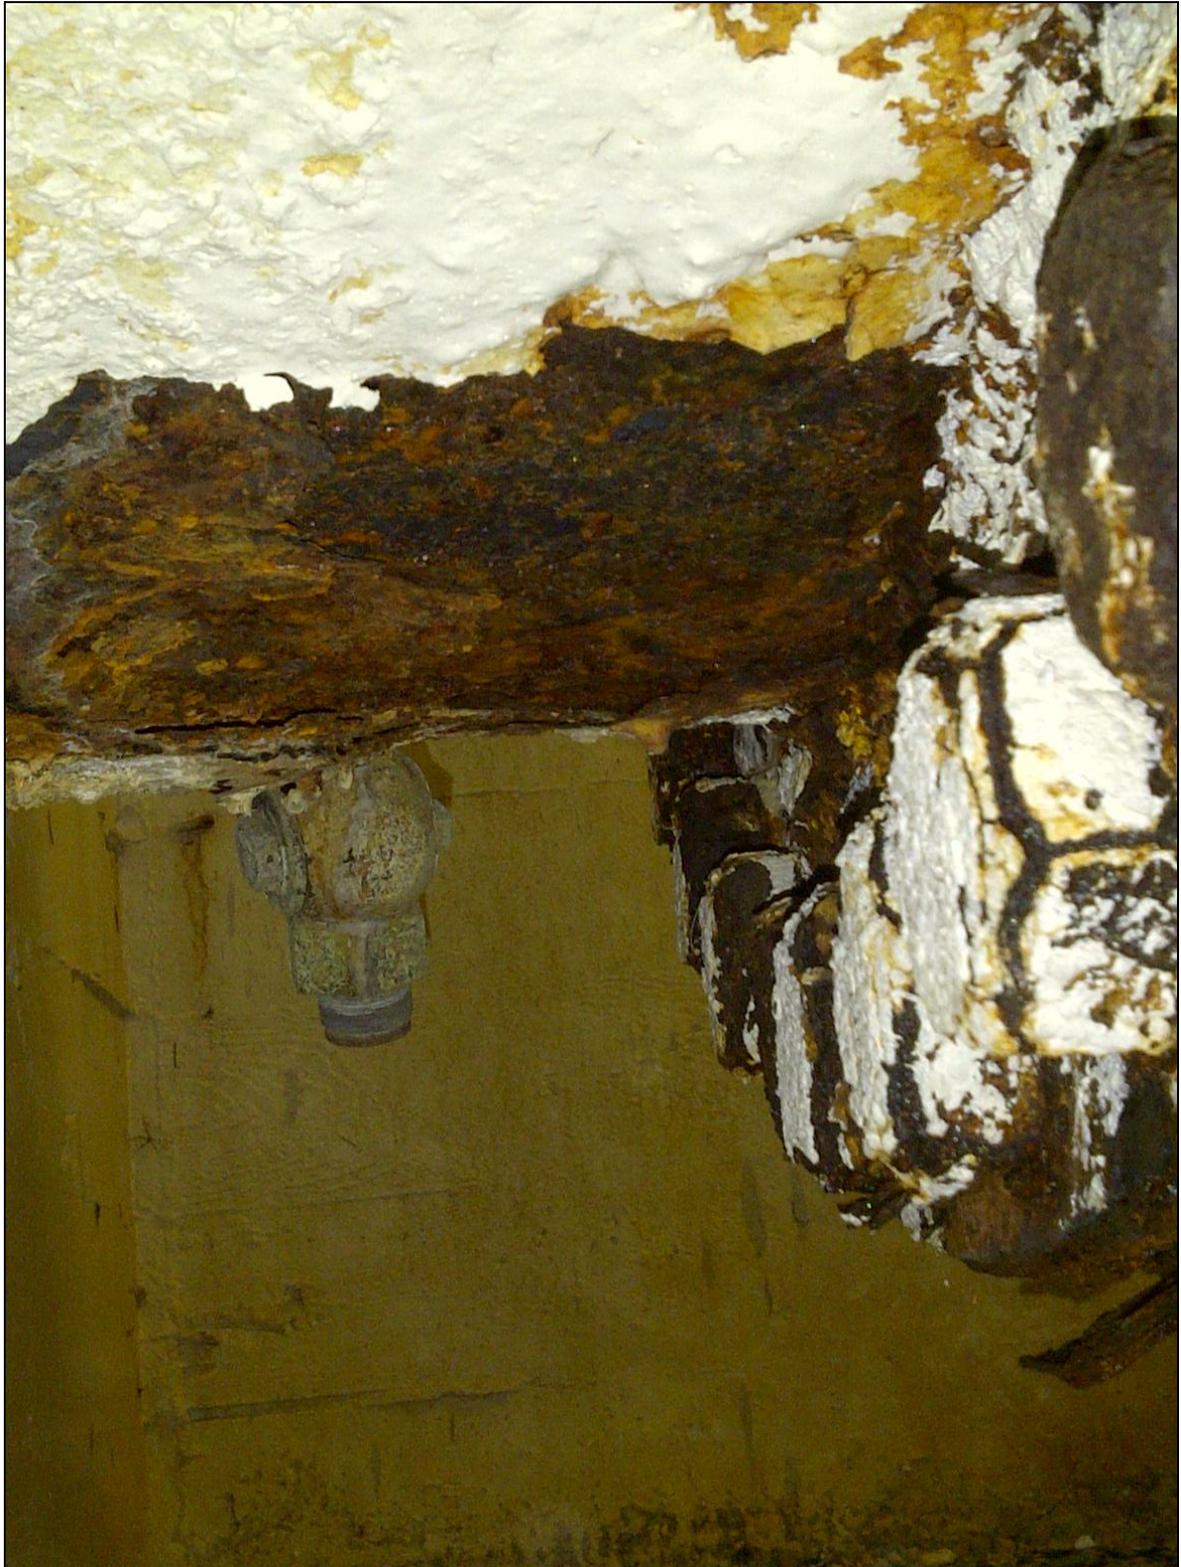
Image 5: Corrosion damage as found on the bottom of the southernmost pipe.

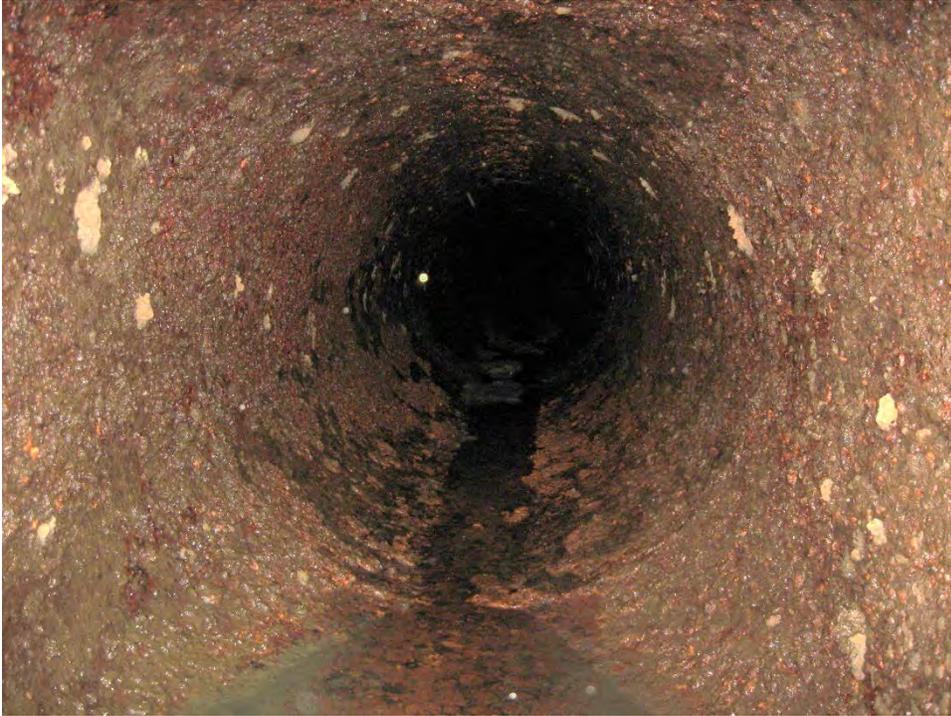
Rust tubercles were extensive inside each of the three 20-foot-long pipeline sections. Approximately 2 inches of sediment was present on the bottom of the industrial pipeline, which is believed the result of low and water velocities and extended period of zero flow in this pipeline. No significant sediment was observed in the two pipelines conveying water to the WTP. The general condition of the interior of each of the outlet pipelines is shown in Photographs B-1 to B-3 (Appendix B).

Photo B-1. IMG\_4624. General condition of the south 48-inch industrial pipeline. The project team observed approximately 2-inches of sediment in the bottom, and a constant trickle of water from the pipe to the downstream chamber. Photo date: 4-23-2014.

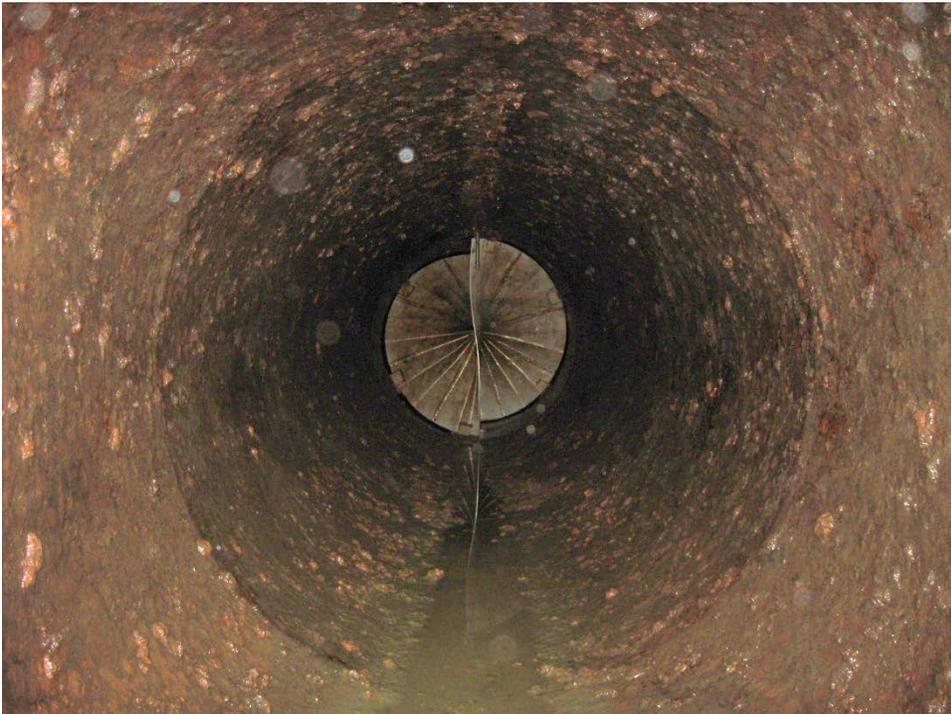
Photo B-2. IMG\_4627. General condition of the center 48-inch diameter raw water pipeline. No significant sediment was observed. The stainless steel mixer is visible in the background. Photo date: 4-23-2014.

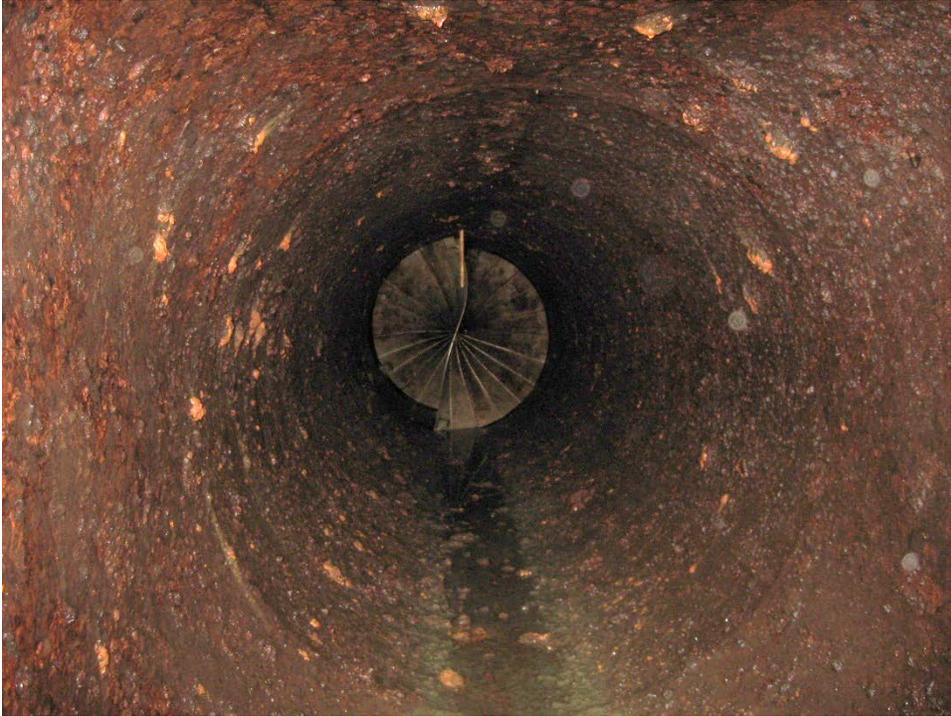
Photo B-3. IMG\_4629. General condition of the north 48-inch diameter raw water pipeline. No significant sediment was observed. The stainless steel mixer is visible in the background. Photo date: 4-23-2014.

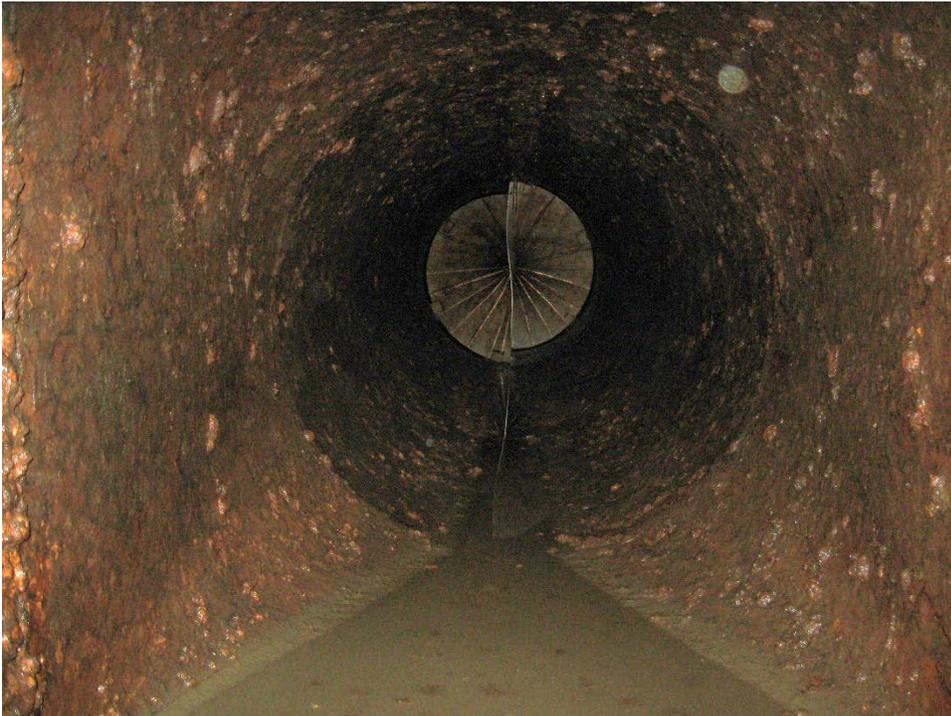
Even though the coal-tar lining is intact, it no longer provides significant corrosion protection to the metal surface. Water permeation through the lining is allowing corrosion of the underlying steel. Rust tubercles (mounds of corrosion product) are present inside all three outlet pipelines, as shown in Photographs B-4 and B-5 (Appendix B).

Photo B-4. IMG\_3642. Rust tuberculation on steel transition between outlet well wall and pipe (center 48-inch raw water). Photo date: 4-23-2014.

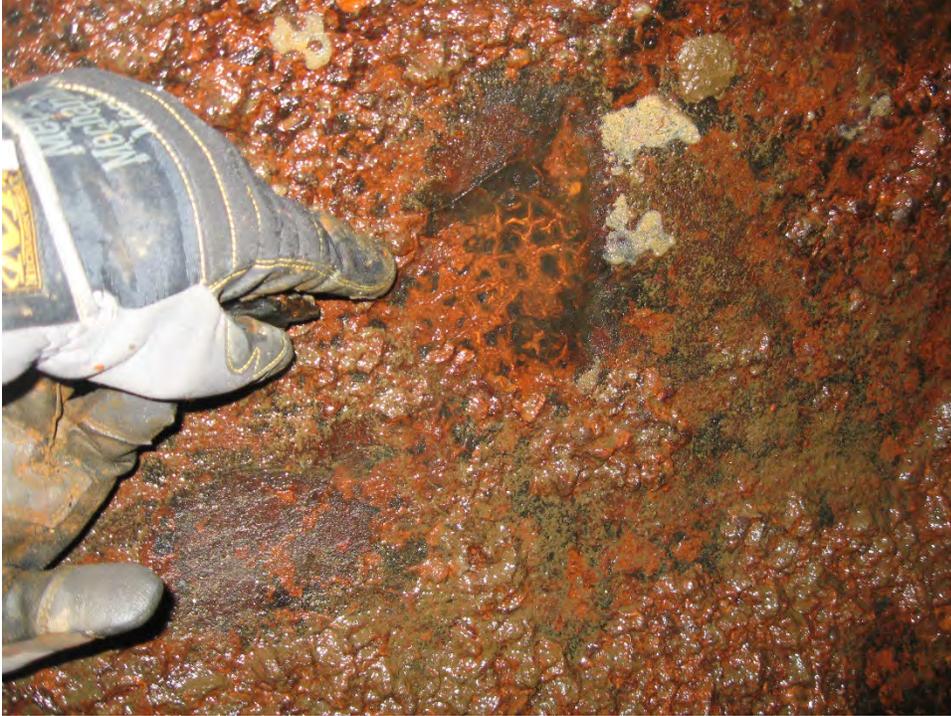
Photo B-5. IMG\_3670. Close-up view of the condition of the pipe wall in the center 48-inch diameter pipeline. Coal tar enamel lining is intact, but is checked and cracked. The lining material is brittle and relatively easy to remove from the pipe wall. Extensive rust and tuberculation was observed at the surface. Photo date: 4-23-2014.

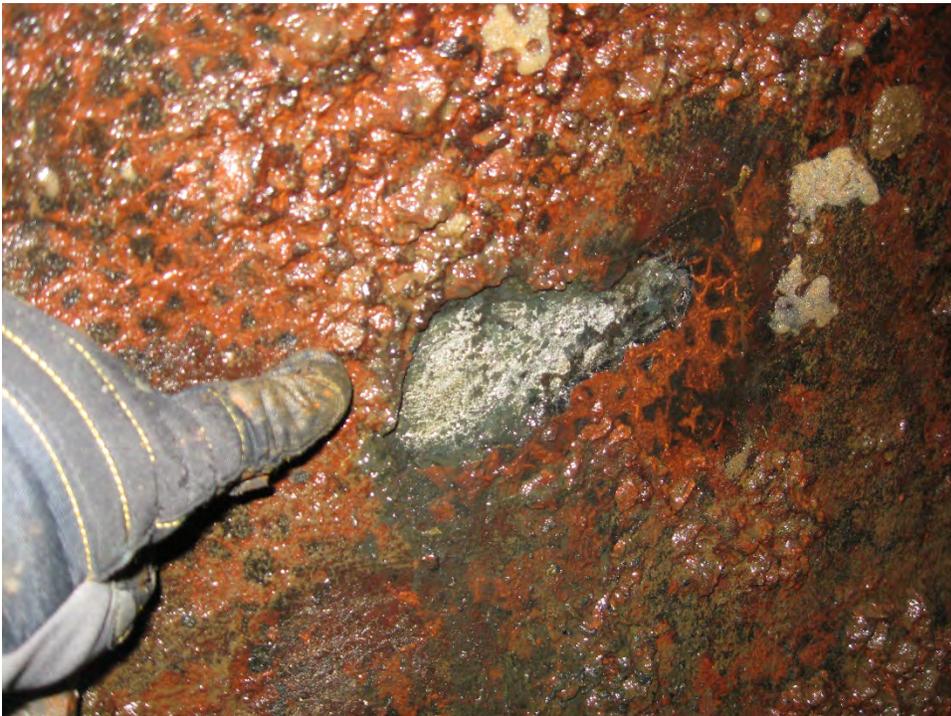
Small sections of the lining and corrosion products were removed to allow inspection and testing of the pipe wall. The pipe wall was found to have a moderate amount of uniform corrosion with some relatively shallow pitting. The maximum measured pit depth was 0.05-inch. The condition of the underlying steel is shown in Photographs B-6 to B-9 (Appendix B).

Photo B-6. IMG\_3673. Condition of the pipe wall after removal of coal tar enamel lining and corrosion products. Pitting (localized corrosion) up to 0.05 inch was measured. Photo date: 4-23-2014.

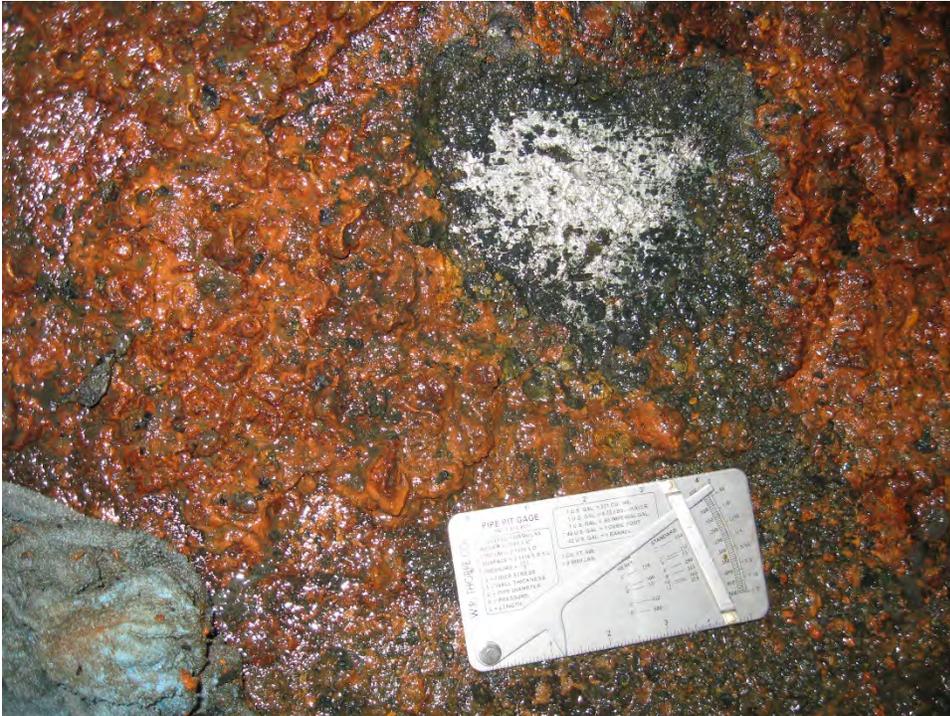
Photo B-7. IMG\_3676. Condition of the pipe wall in the south 48-inch diameter raw water pipeline was similar to that observed in the center pipeline. Remnants of coal tar enamel lining are visible around the exposed metal. Photo date: 4-23-2014.

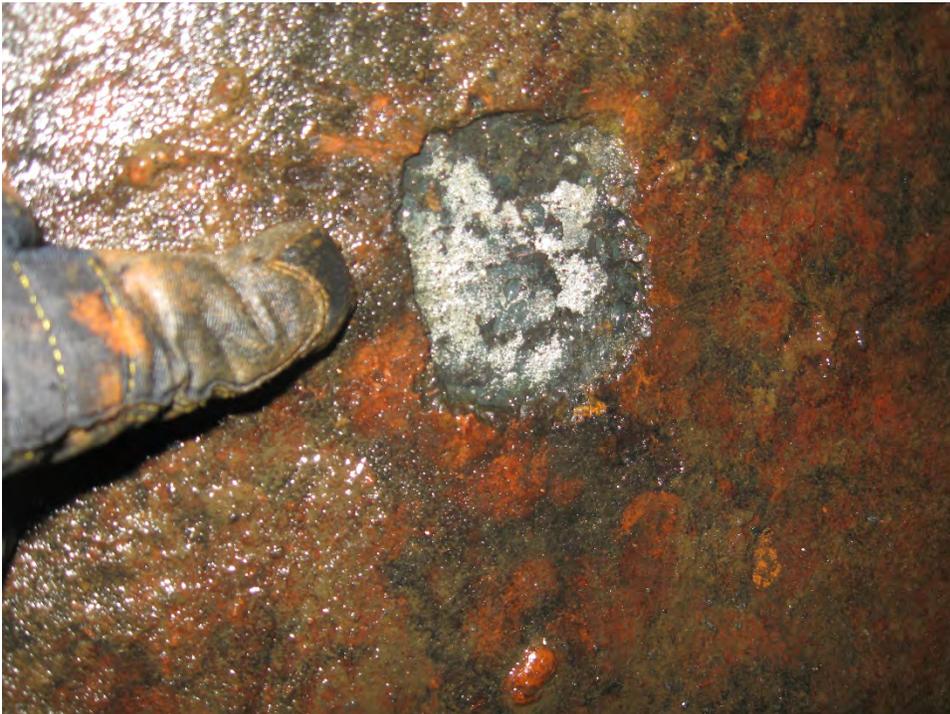
Photo B-8. IMG\_3688. Condition of the pipe wall at the third inspection point shows the same corrosion pattern as the previous two inspection points (Photos B-6 and B-7). Photo date: 4-23-2014.

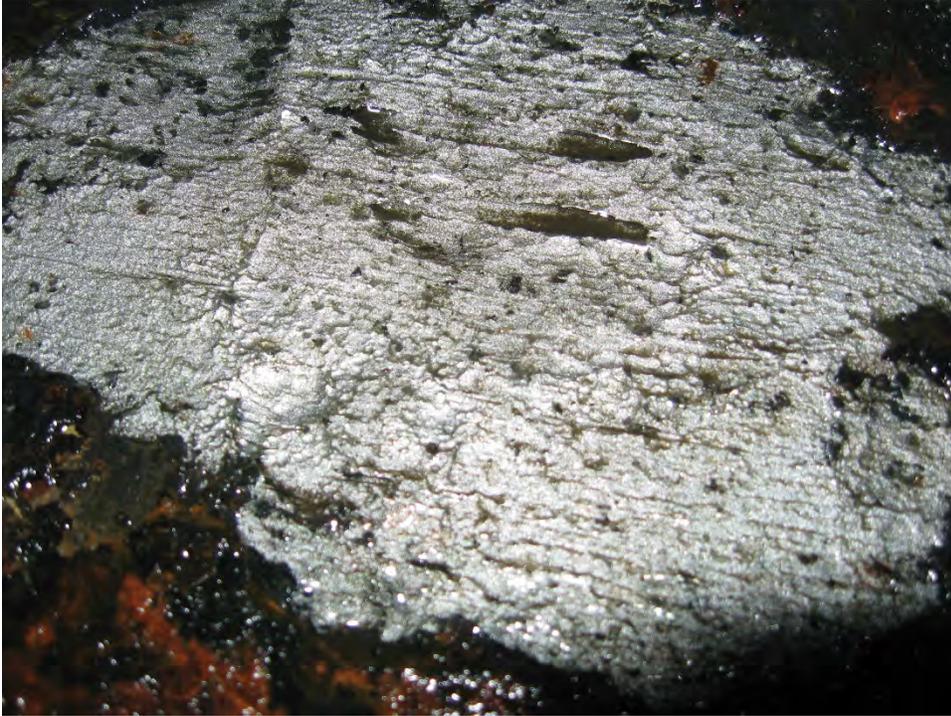
Photo B-9. IMG\_3715. Close-up view of corrosion at the fourth inspection point. The metal loss at this location was slightly more uniform (i.e., fewer pits) than the location shown in Photos B-6 and B-7. Photo date: 4-23-2014.

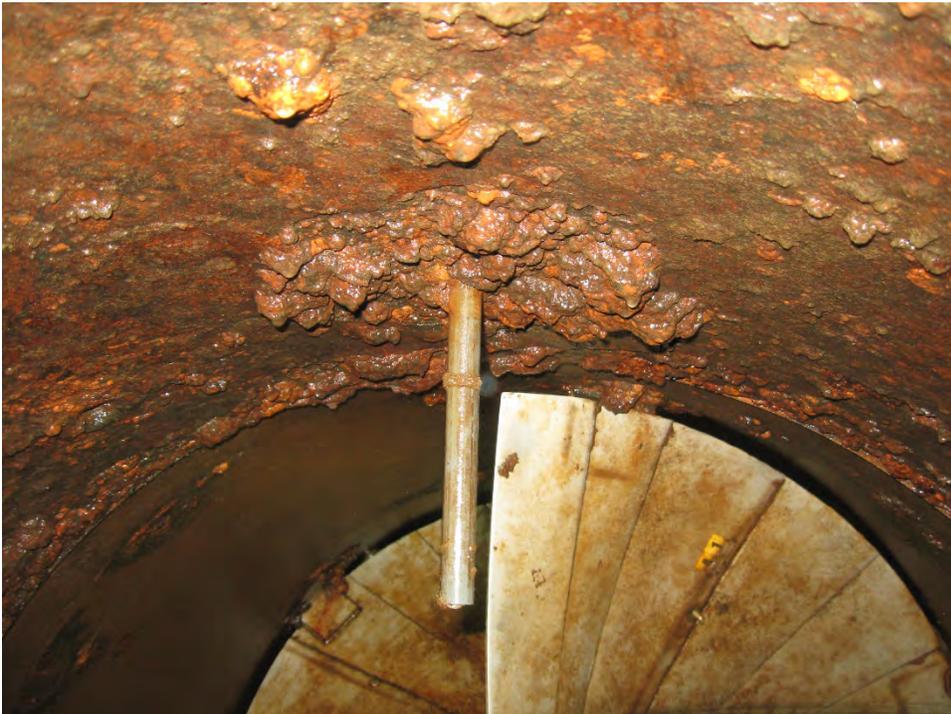
Each of the three parallel deteriorated pipe sections connects downstream to newer sections of cement-mortar-lined steel pipe. Observations were extended to these newer sections. The cement mortar lining and stainless steel mixer components inside the newer (1980) steel pipe in the Chlorine Injection Room is in good condition. The cement mortar lining is mainly intact. Some localized rust staining was observed at the stainless steel static mixer connection points to the two municipal supply pipelines. As stated previously, the static mixers are only installed in the two municipal supply pipelines. See Photographs B-10 and B-11 (Appendix B).

Photo B-10. IMG\_3679. Heavy rust tuberculation at the injection pipe presentation. Note the rust spots on the surface of the cement mortar lining (left and at attachment point). Photo date: 4-23-2014.

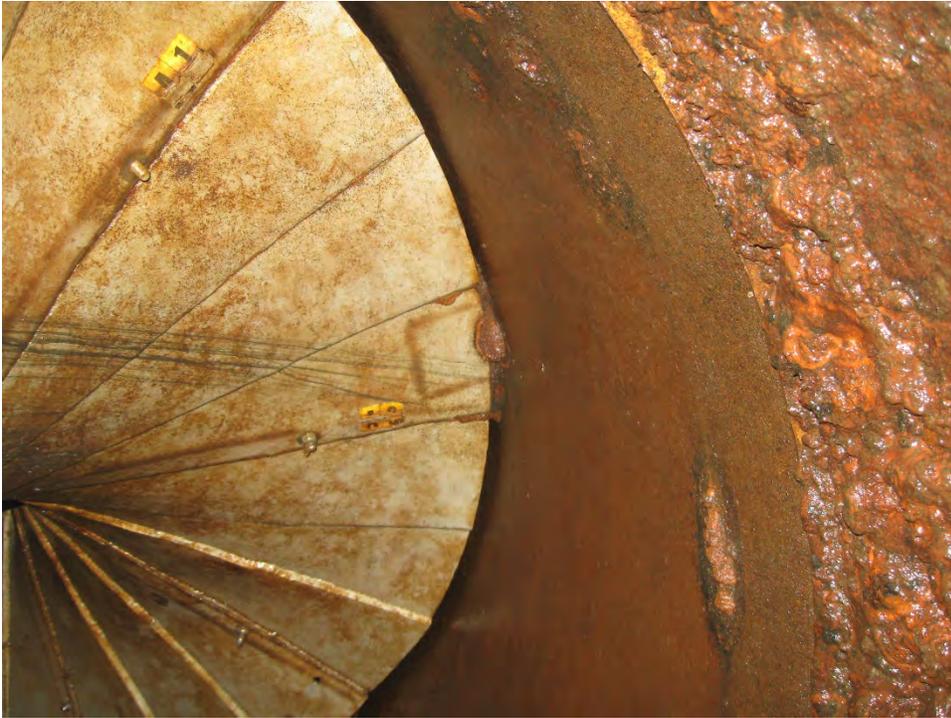
Photo B-11. IMG\_3681. Corrosion product at the stainless steel mixer attachment point (center of photo). Rust staining of the cement mortar was also observed (just to the right of photo's center). Photo date: 4-23-2014.

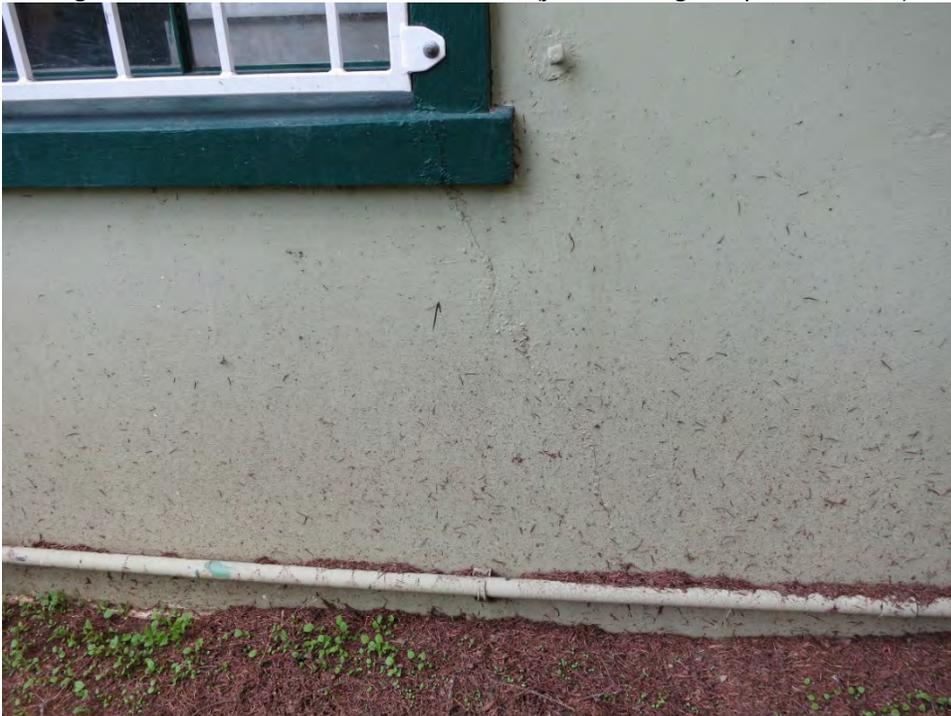
Photo B-12. IMG\_1702 : Hairline crack below window on south elevation. Crack width is 0.005-0.007". Photo date: 4-15-2014.

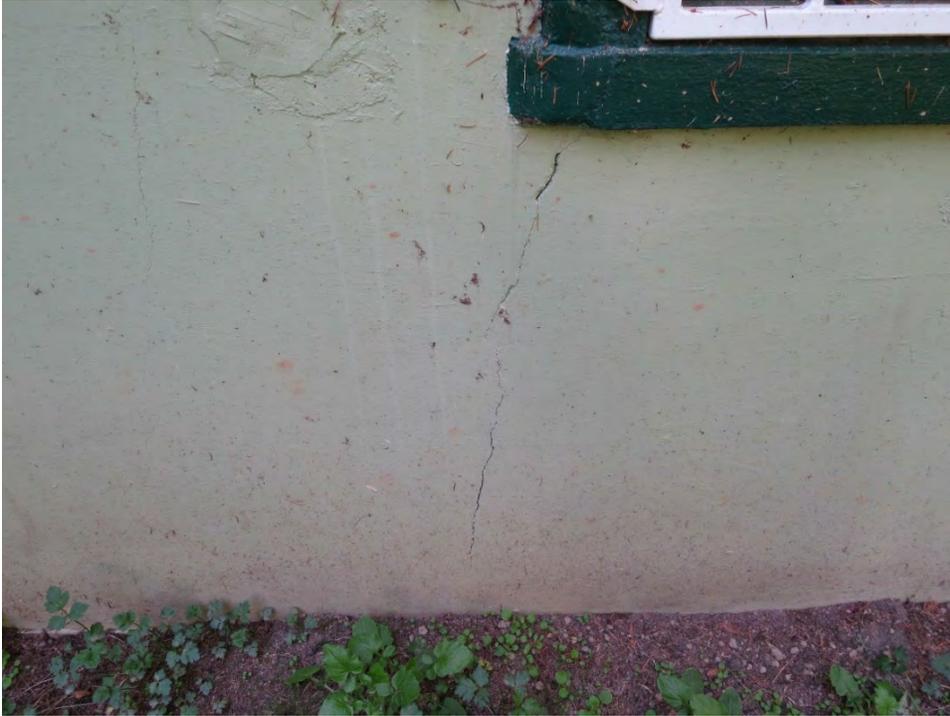
Photo B-13. IMG\_1710: Hairline crack below window on the north elevation. Crack width is 0.005-0.05". This crack was also observed in the interior of the building. Photo date: 4-15-2014.

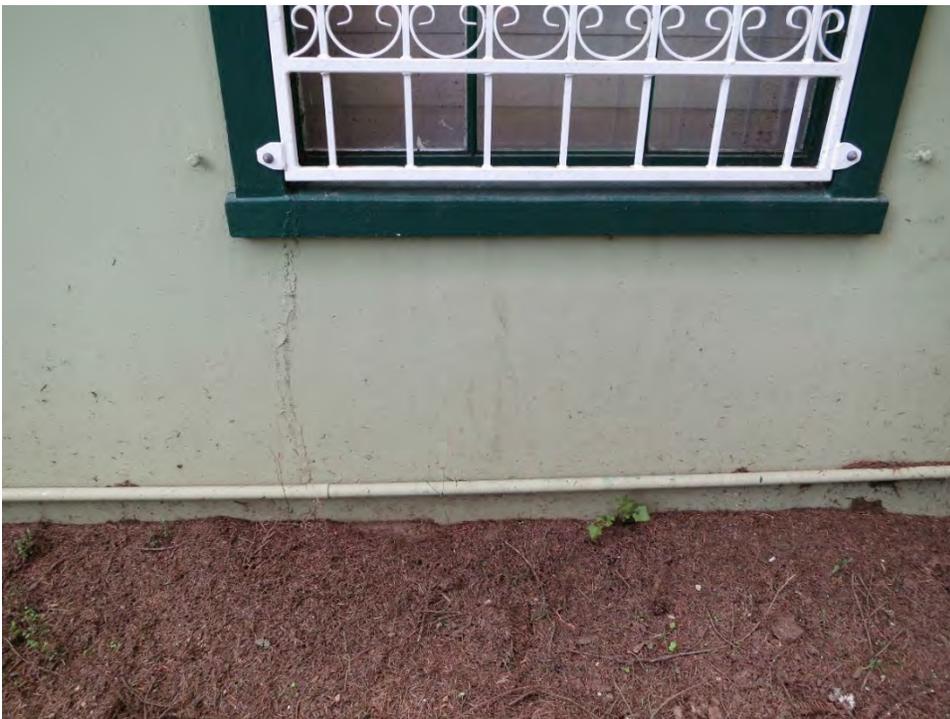
Photo B-14. IMG\_1703: Hairline cracks below window on each side. Crack was previously patched but has since re-opened. Crack width is 0.003-0.005 inches. Photo date: 4-15-2014.

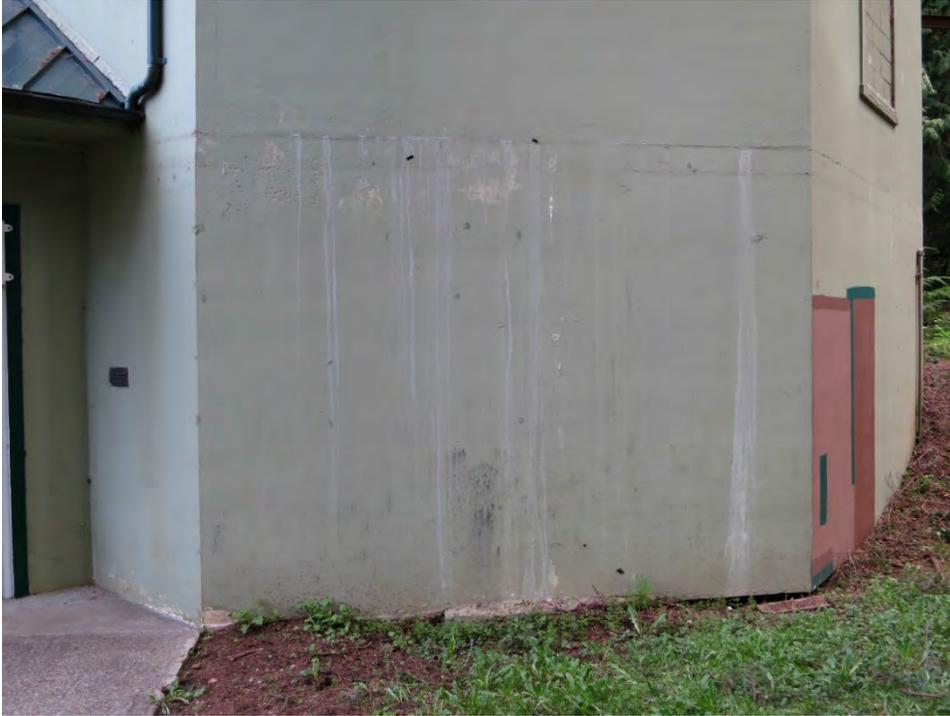
Hairline cracks were also observed on the east elevation of the exterior wall below a construction joint (Photo B-15). There is evidence of previous (no longer active) water leakage through this horizontal construction joint. Given that construction of the Screen House was in 1940, it is unlikely that waterstops of any type were incorporated into the design. A vertical crack below the construction joint has also re-opened through the coating and has a hairline crack measuring 0.005-0.007 inches (Photo B-16). These cracks are not a structural concern.

Photo B-15. IMG\_1704: Hairline cracks on the exterior southeast corner shows previous leakage at a construction joint but this leakage is not currently active. Photo date: 4-15-2014.

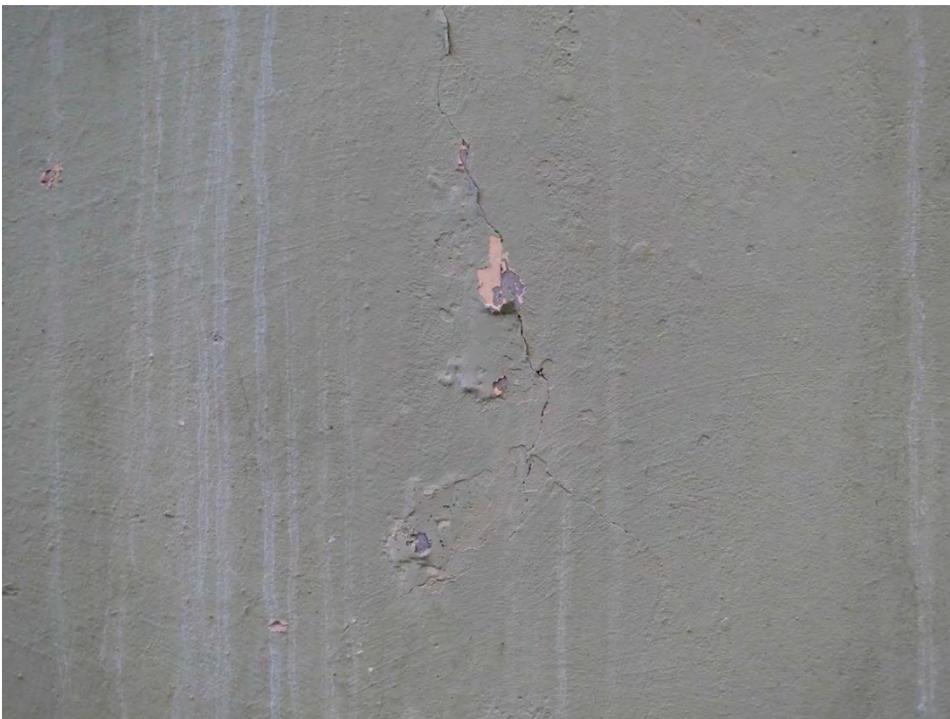
Photo B-16. IMG\_1705: Hairline crack on the exterior southeast corner where the crack has opened after wall was painted. Crack width is 0.005-0.007 inches. Photo date: 4-15-2014.

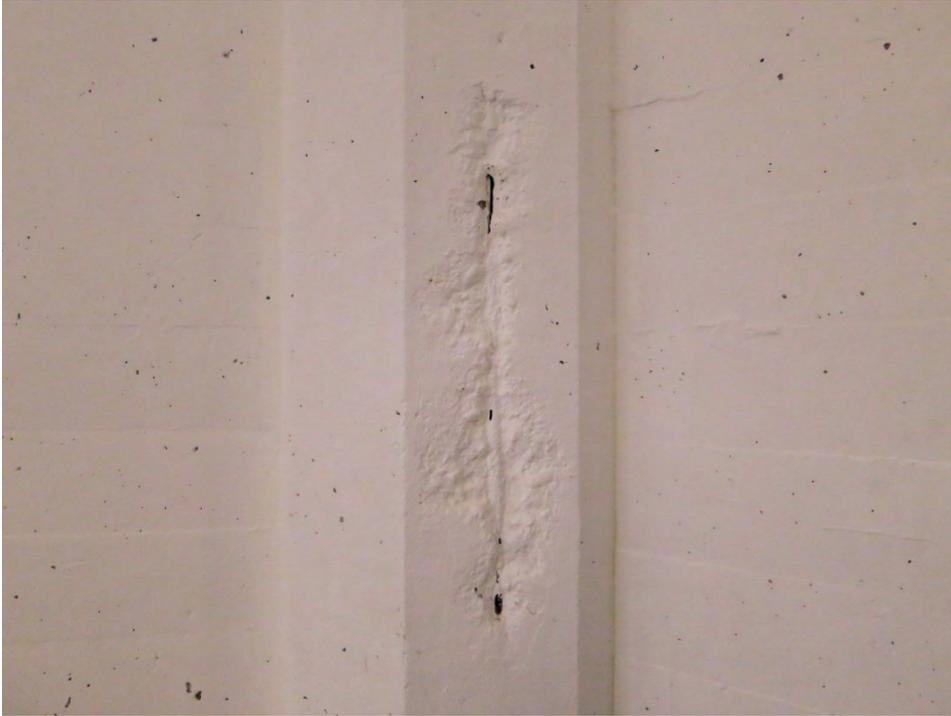
A pilaster on the external wall of the Screen House structure, viewed from inside the building on the second floor, where the traveling screens are installed exhibited spalled concrete along a vertical reinforcing bar. Photo B-17a shows this location at the time of the April 15, 2014 inspection after it had been painted. Two photos (B-17b and B-17c) from several months before (prior to the re-painting) show this same location. There is a void in the concrete around the vertical reinforcing bar and much of the reinforcing bar itself at this location is corroded away. The reason this bar corroded is unclear, but it appears there was insufficient concrete coverage over the bar. There likely was a moisture source that no longer exists. The condition appears to have stabilized and this location can easily be patched to stop further corrosion. This location does not present a structural concern because it is localized, relatively high within the structure, and representative of only a fraction of the building structure. No repair is necessary, but patching of this area would help to ensure further corrosion is terminated. Overall, the walls of the superstructure appear to be in satisfactory condition with no structural concerns.

Photo B-17a. IMG\_1751: Spalled concrete and void around an exposed column longitudinal reinforcing bar. No evidence of corrosion, however, this may have been covered by the coating. Photo date: 4-15-2014.

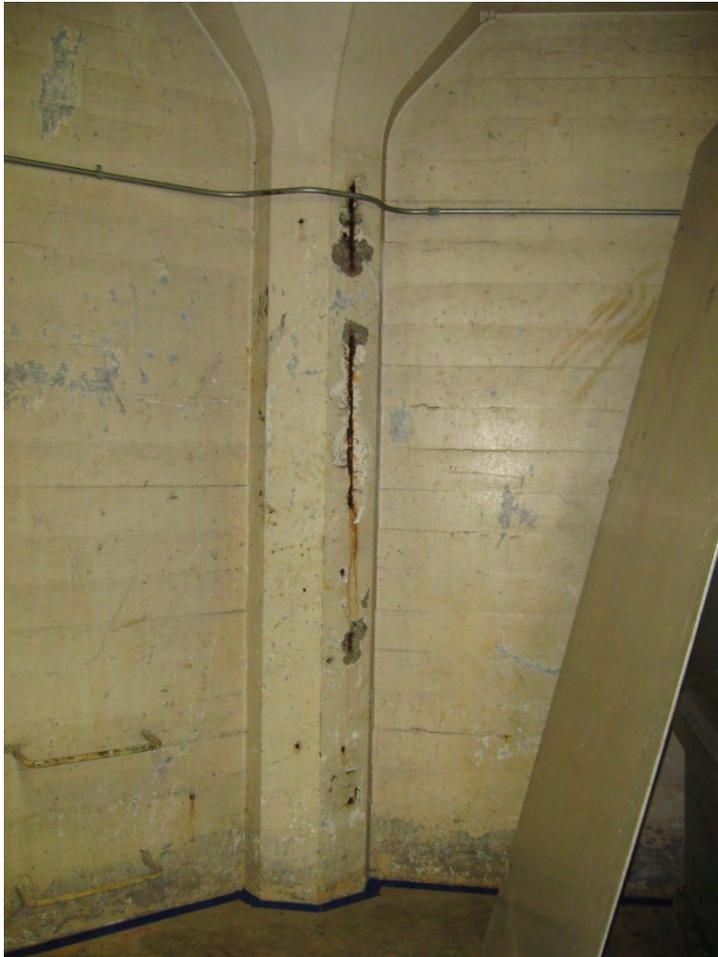
Photo B-17b. PM 131: Same location as shown in Photo B-17a, prior to painting. Photo date: 9-24-2013.

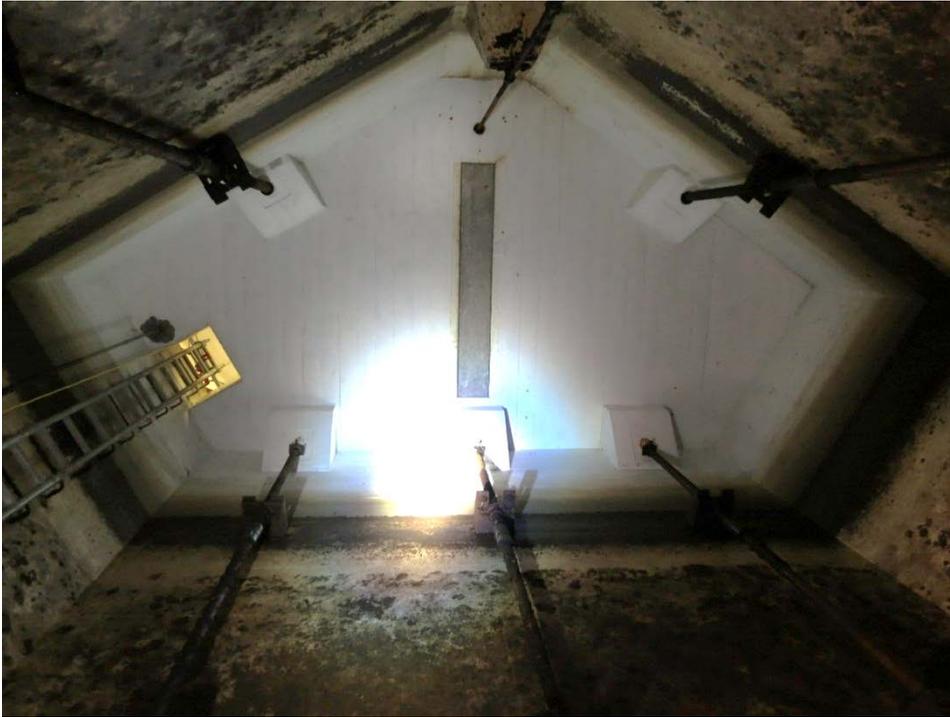
Photo B-18. IMG\_1767: Outlet well roof underside showing a white coating with only minor spot corrosion marks. Photo date: 4-23-2014.

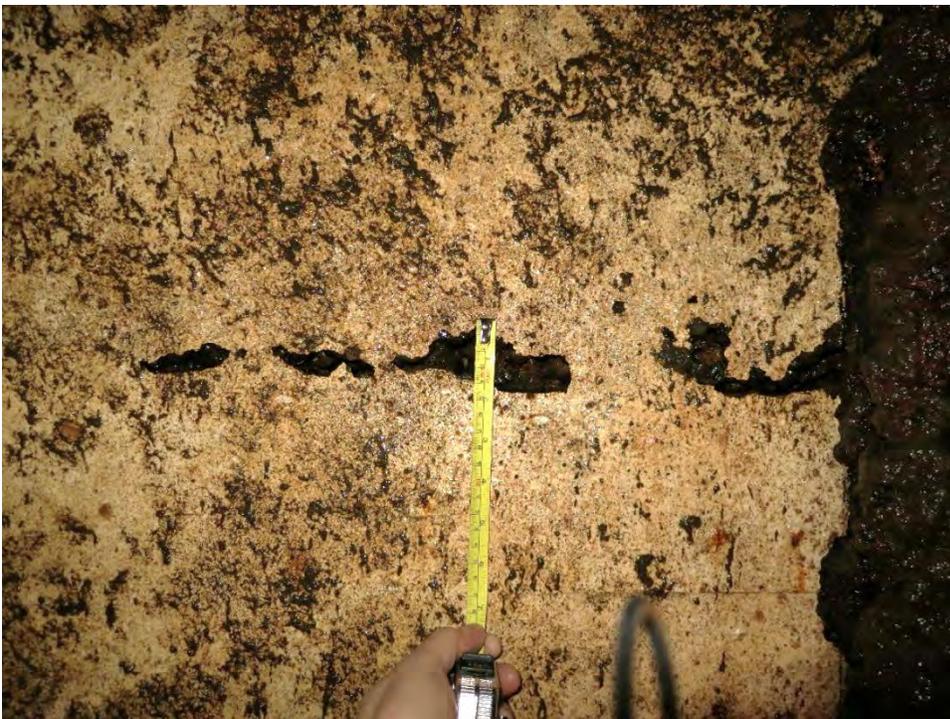
Photo B-19a. IMG\_1776 Outlet well cold joint line where voids in concrete from 1.5" -2" deep have formed. Photo date: 4-23-2014.
