# City of Bellingham Screen House: Condition Assessment and Improvement Report (Task 3.8)

PREPARED FOR: City of Bellingham Project Team  
PREPARED BY: CH2M HILL Project Team  
DATE: November 7, 2014

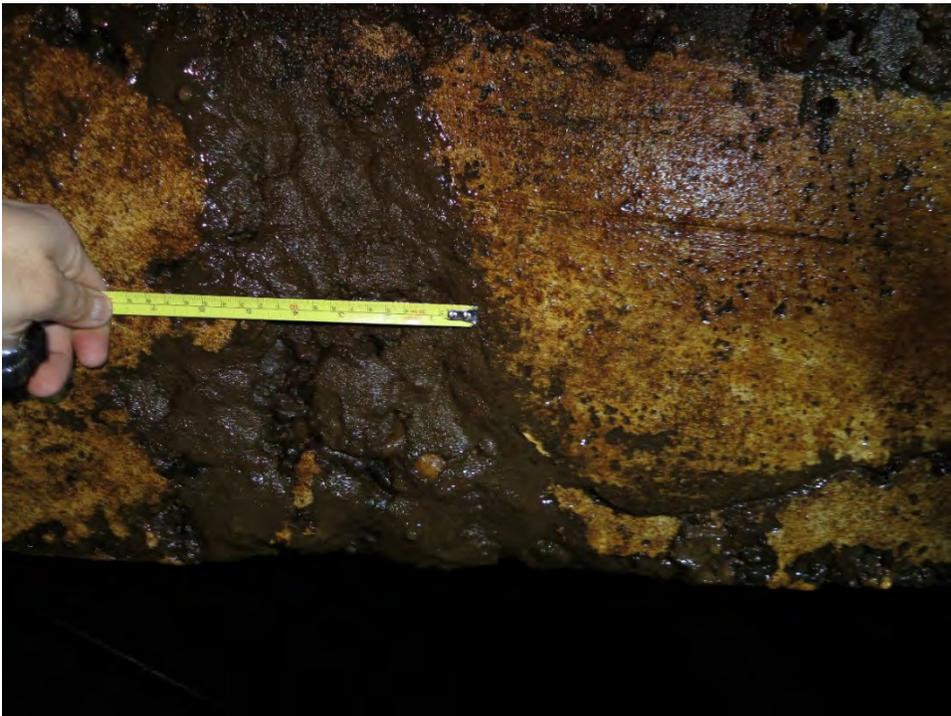
Some minor erosion or spalled concrete was observed at the top of the 5 ft opening that leads to the screen well (Photo B-20). Other areas exhibited some minor void formation or “pop-out” of concrete (Photo B-21). One concrete core was taken from the outlet well for testing and yielded a high compressive strength of 5,220 psi. The outlet well structure is in satisfactory condition based on areas that could be viewed or accessed.

Photo B-20. IMG\_1779: Outlet well eroded or spalled concrete at top of opening in the wall. Photo date: 4-23-2014.

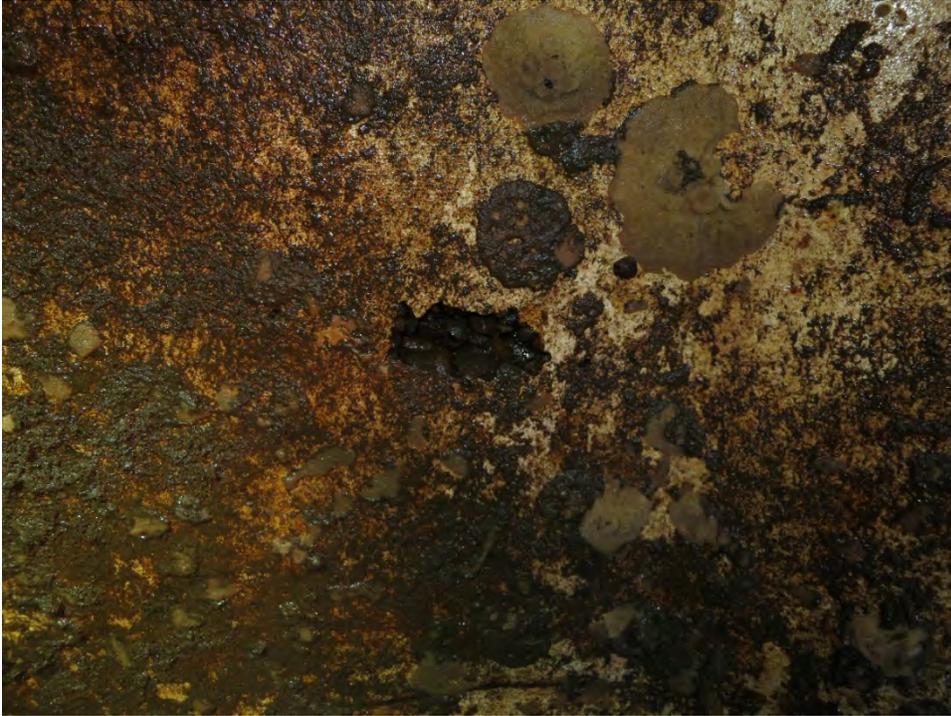
Photo B-21. IMG\_1783: Outlet well small voids in the wall. Photo date: 4-23-2014.

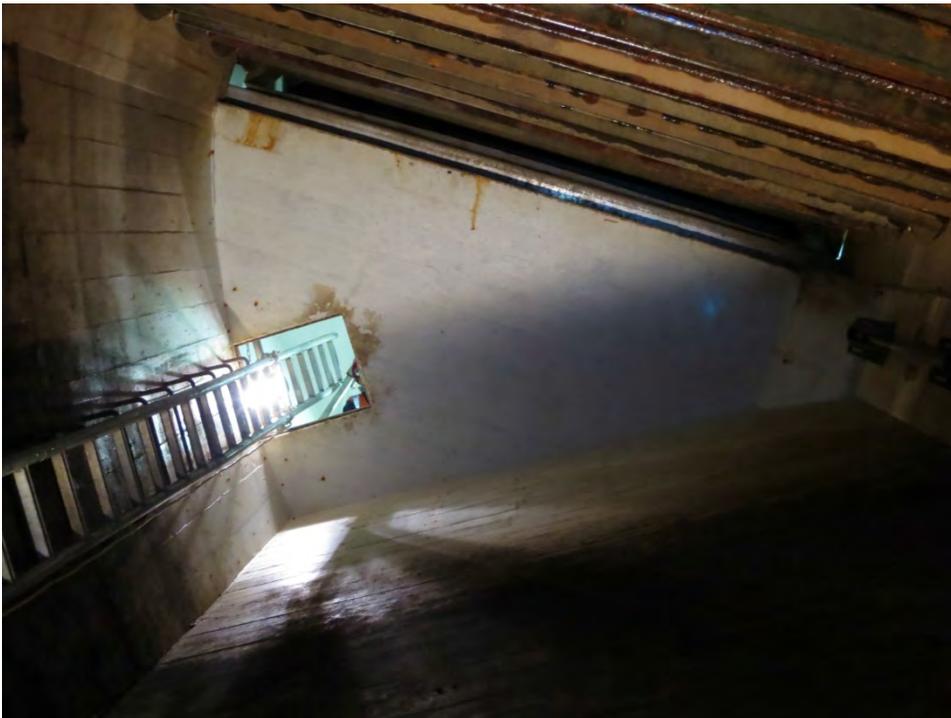
Photo B-22. IMG\_1795: Screen well (North side) roof underside showing a white coating with only minor spot corrosion marks. Photo date: 4-23-2014.

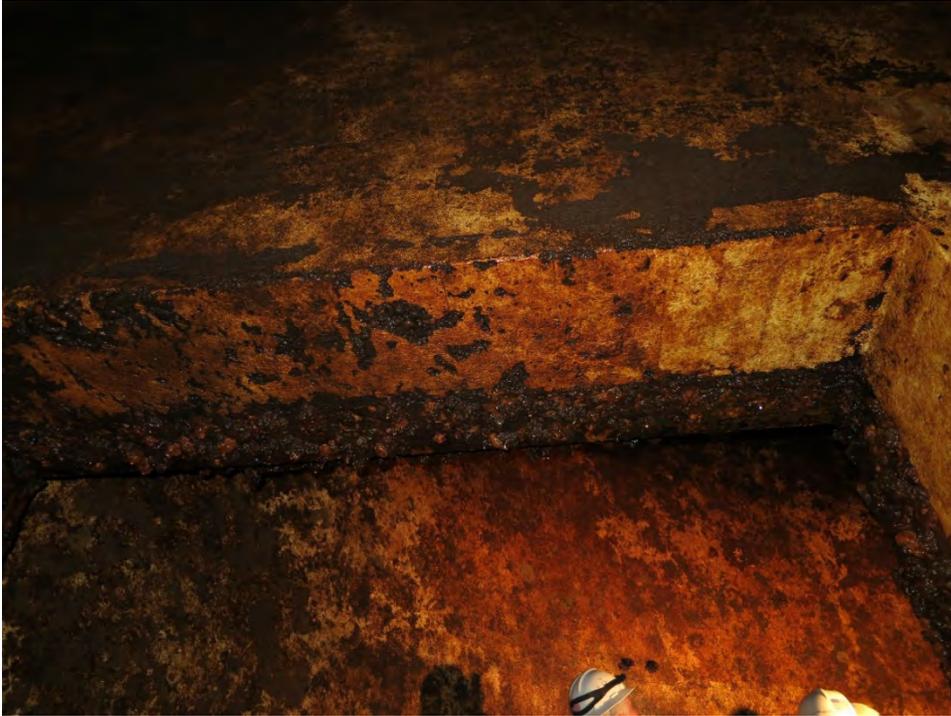
Photo B-23. IMG\_1789: Screen well (North side) eroded concrete in top of opening that leads to the intake well. Photo date: 4-23-2014.

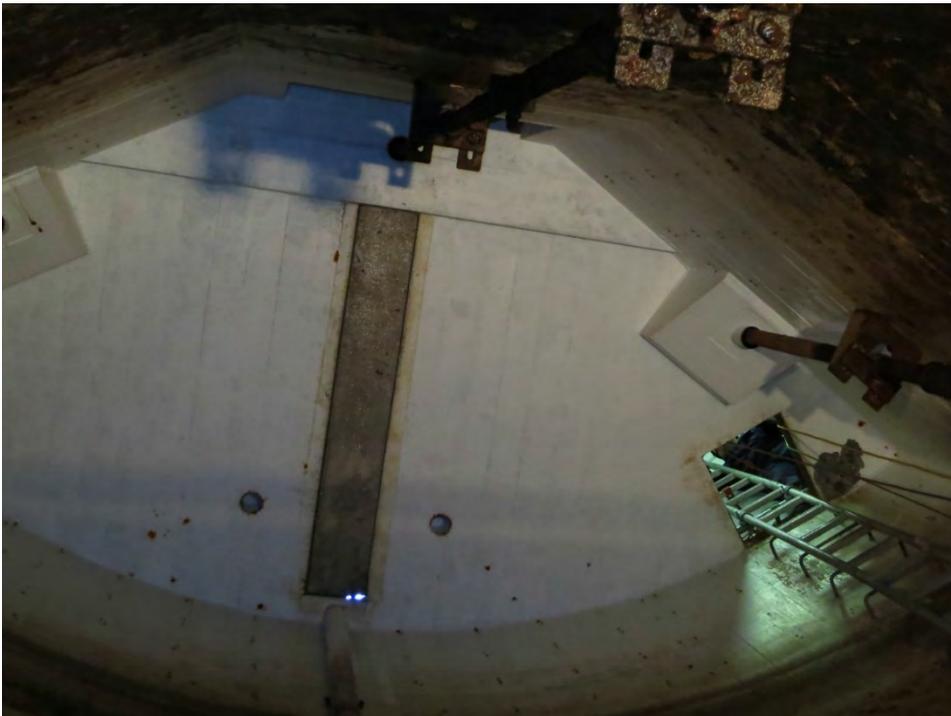
Photo B-26. IMG\_1819: Intake well roof underside showing a white coating with only minor spot corrosion marks. Photo date: 4-23-2014.

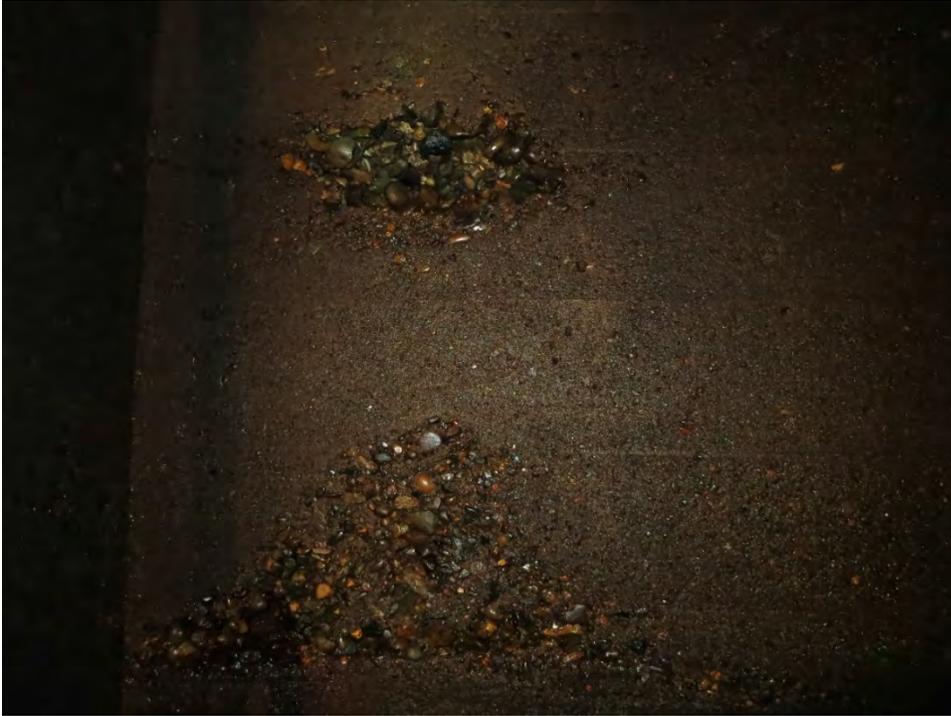
Photo B-27. IMG\_1826: Waste well voids or eroded concrete in the wall. Photo date: 4-23-2014.

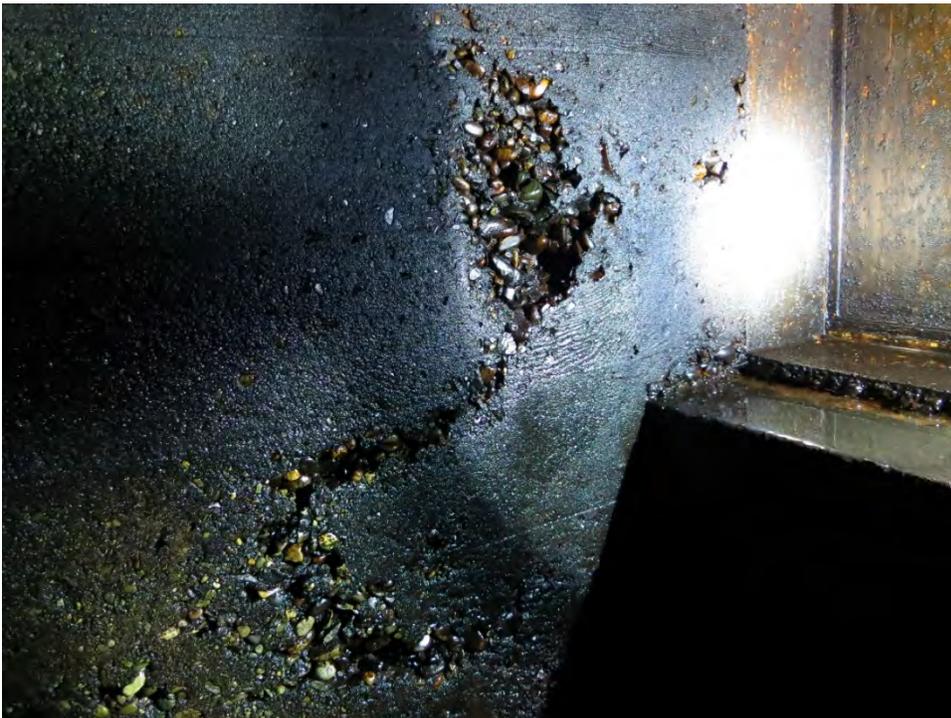
Photo B-28. IMG\_1853: Waste well voids in wall near 4'x4' gate caused by erosion of weak or insufficiently consolidated concrete. Photo date: 4-23-2014.

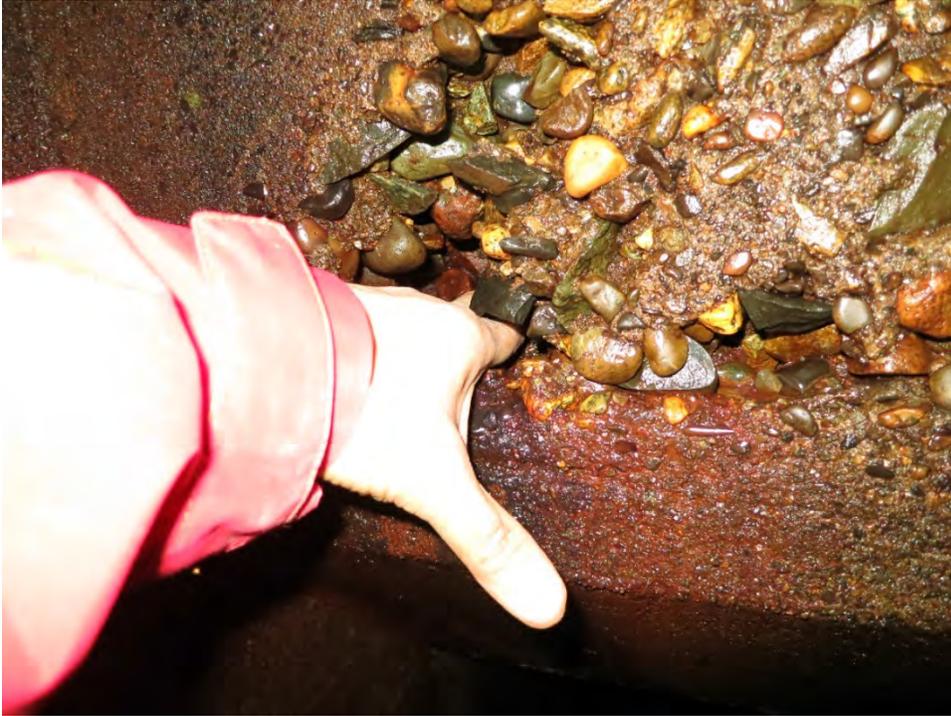
Photo B-29. IMG\_1842: Waste well eroded concrete above outlet. Photo date: 4-23-2014.

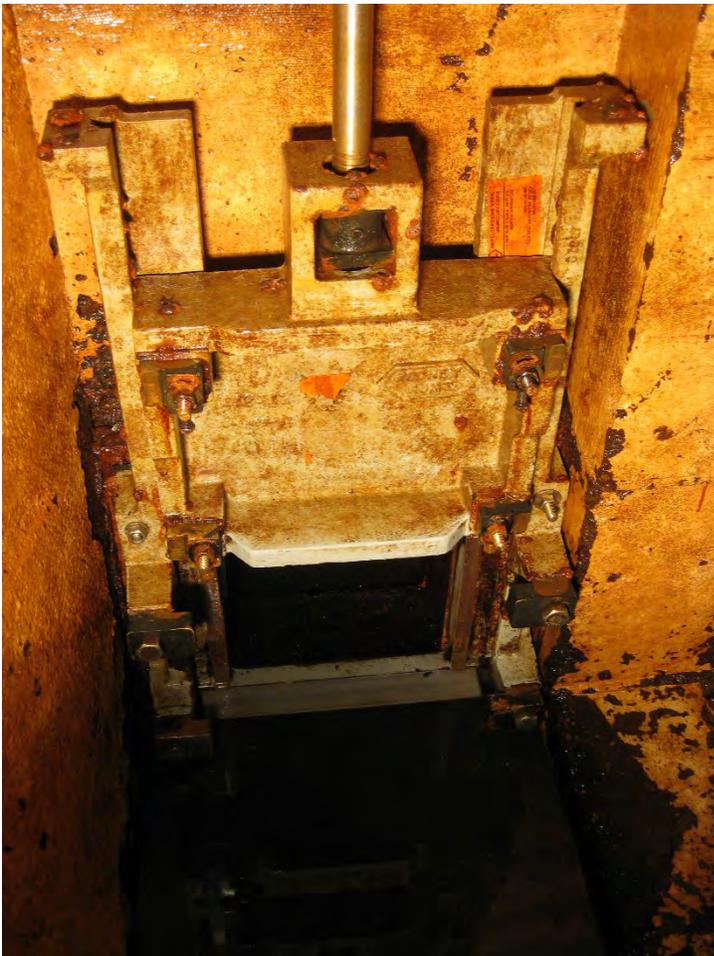
Photo B-37. Slide gate (5) in screen well in good condition. Photo date: 4-23-2014.

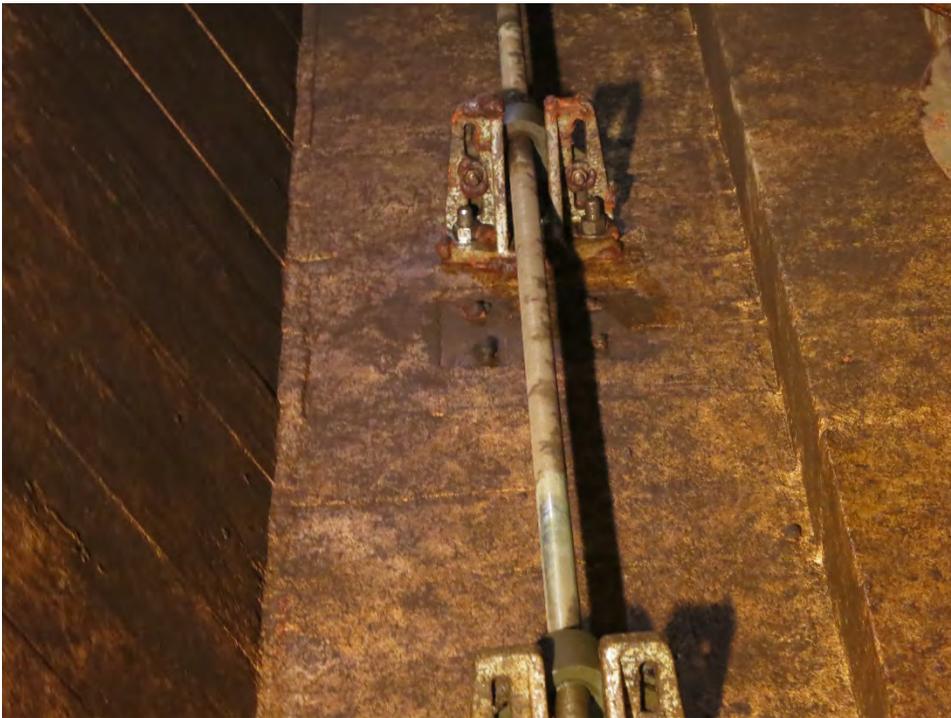
Photo B-38. Slide gate (5) operating stem and guides. Photo date: 4-23-2014.
