Technical Memorandum

Subject Lake Whatcom Screenhouse Condition Assessment Report (Task 4.2) (Final)

Project Name Raw Water Intake Condition Assessment and Intertie Pipeline Design

Date August 23, 2024

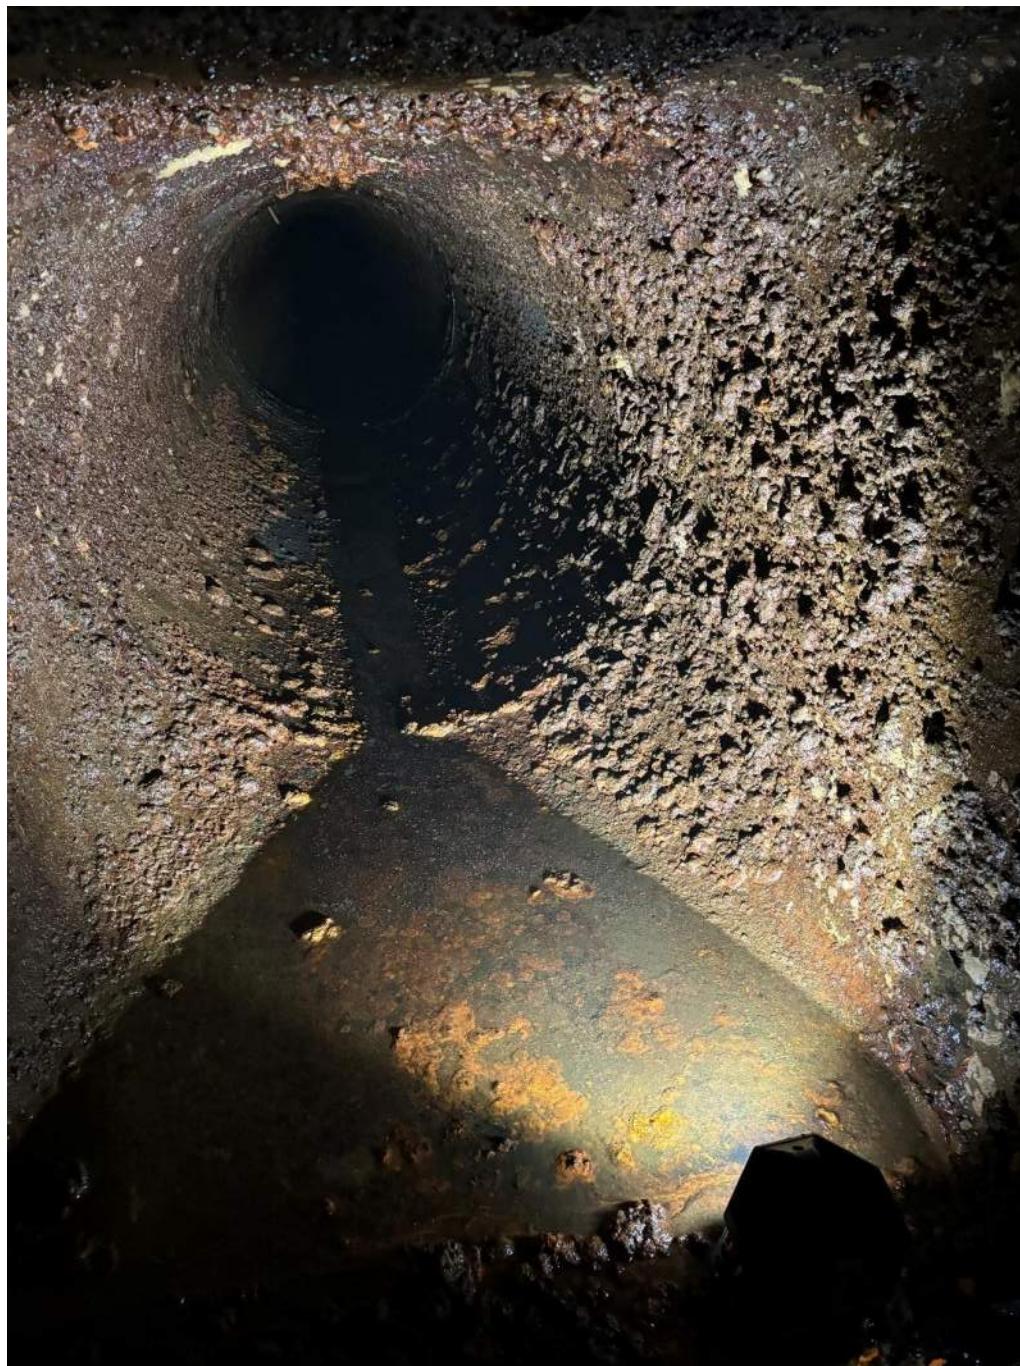
Rust tubercles and corrosion were extensive inside each of the three 20-foot-long pipeline sections as shown in Exhibit 4-1. Fine sediment measuring one to three inches was present on the bottom of the industrial pipeline, which is believed to be the result of low water velocities and extended periods of zero flow in this pipeline. No significant sediment was observed in the two pipelines conveying water to the WTP.

Exhibit 4-1. Tuberculation and Corrosion Product on South (Industrial) 48-inch Diameter Pipeline

Each of the three pipeline sections are lined with a relatively thick, black material that appears to be coal-tar based. Coal-tar was commonly used to line and coat steel pipelines during the timeframe when the Screenhouse was constructed. The lining is essentially intact, but with fair to poor adhesion to the pipe surface. The coal tar thickness was measured to be approximately 0.15 to 0.20-inch thick during the 2014 inspection. Observations during the 2024 inspection indicate negligible change to the lining material from what was observed in 2014. Even though the coal-tar lining is intact, it no longer provides significant

corrosion protection to the metal surface. Water permeation through the lining is presumably allowing corrosion of the underlying steel.

Small sections of the lining and corrosion product were removed to allow inspection and testing of the pipe wall. The pipe wall was found to have a moderate amount of uniform corrosion with some relatively shallow pitting. Wall thickness measurements of the underlying steel were performed using an ultrasonic thickness (UT) gauge. A summary table of observed readings is provided in Table 4-1.

Previous investigations identified implementation of a fully structural fiber reinforced polymer (FRP) renewal (internal liner) strategy. This strategy remains the recommended approach, as it has a history of successful implementation. Recently, there have been advancements within the industry for other NSF 61 approved structural liner systems that could also potentially be implemented for these applications, including a geopolymer spray-applied lining. This system and potentially others could be considered for implementation, as advancements in these structural lining systems continue to be brought to market.

FRP is a renewal option that uses the existing pipe as a form. When designed and installed as a fully structural system, which is the recommendation at this site, the FRP acts as a standalone pipe following curing. Pipe strength is achieved by applying the FRP wrap in both the horizontal (hoop strength) and longitudinal (length strength) in alternating layers that are bound to each other by the impregnating resins. FRP options include both carbon (CFRP), glass (GFRP), or a combination of these two. CFRP is more expensive, but also stronger, than GFRP. Installation of the FRP is completed manually after a thorough blasting and cleaning of the existing pipe lining to expose bare metal. The installed material is NSF 61 approved for water service, is corrosion resistant, and provides service comparable to new pipe installation.

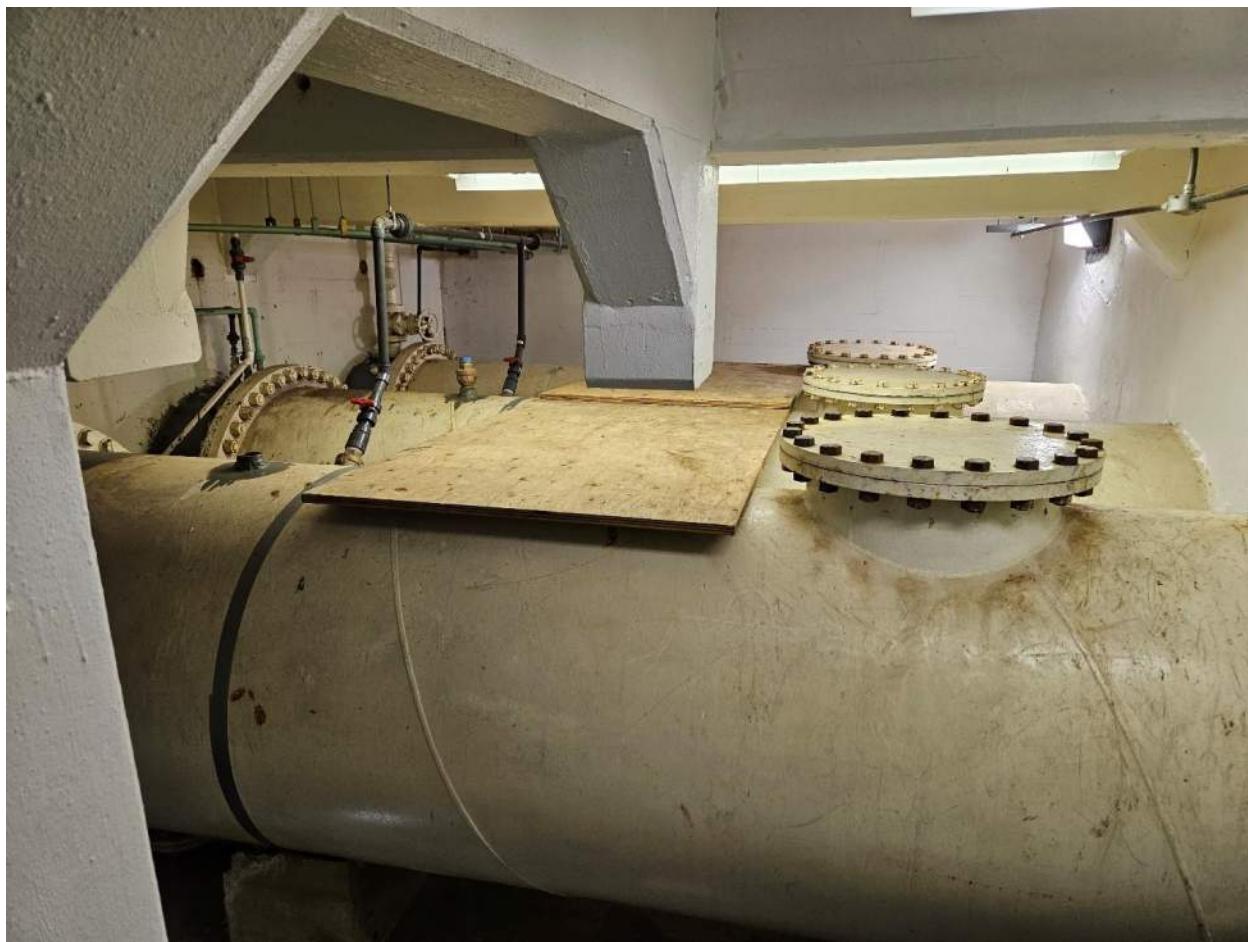
The corroded and deeply pitted short (18-inch length) downstream sections of each of the three 48-inch outlet pipes in question were not inspected externally because of the thick coating system applied in 2013. The condition of these short section is described in Appendix A of the 2014 Condition Assessment Report. Progression of the underlying external corrosion is not known. An image of the discharge pipelines, including the flanged connection, is present in Exhibit 4-2.

Removing the external coating is risky and is not recommended without installing permanent or temporary isolation within each pipe. The potential to damage and/or pierce the pipe wall is considerable. It is not feasible to accurately assess the progression or change in these external pits with UT measurements from the pipe interior. Regardless of the progression of corrosion-induced pitting (whether continued or stopped) these short sections should be rehabilitated and not left in their current condition. This path-forward conclusion remains the same as presented in the 2014 Condition Assessment Report.

The 18-feet of each of these three degraded pipes, just upstream of these three short externally-pitted segments, does not appear to have general wall loss due to corrosion as observed and measured from the pipe interior. The presence and extent of external corrosion-induced pitting of each of these sections of pipe is not known and cannot reasonably be discovered. Consequently, the path-forward conclusion to include these segments of pipe in a combined rehabilitation strategy with the 18-inch, externally-corroded segments, remains the same as presented in the 2014 Condition Assessment Report.

Exhibit 4-2. Discharge Pipelines in Chlorine Injection Room

To rehabilitate the area of known concern and risk associated with the three deteriorated outlet pipelines (the short 18-inch segments with deep external corrosion-induced pitting), the recommended approach is to proceed with implementing a fully structural liner of the entire 20-foot long, 1940-vintage pipe segments. Doing so effectively addresses risk associated with potential failure of these pipe segments.

That stated, given the primary known area of concern with respect to these pipes is the short 18-inch segment that is accessible within the Chlorine Injection Room, the City may consider a strategy that can be implemented sooner. Such a strategy would be to implement an external FRP system on the three short 18-inch segments in the Chlorine Injection Room. This would be a targeted, but less-holistic strategy that focuses on the known area of severe corrosion pitting and can be implemented without the benefit of a bypass supply to the City's WTP. Doing so would reduce risk. If implemented, it should be considered as an interim strategy, and not as a full-replacement, to the more-complete internal lining system described above.

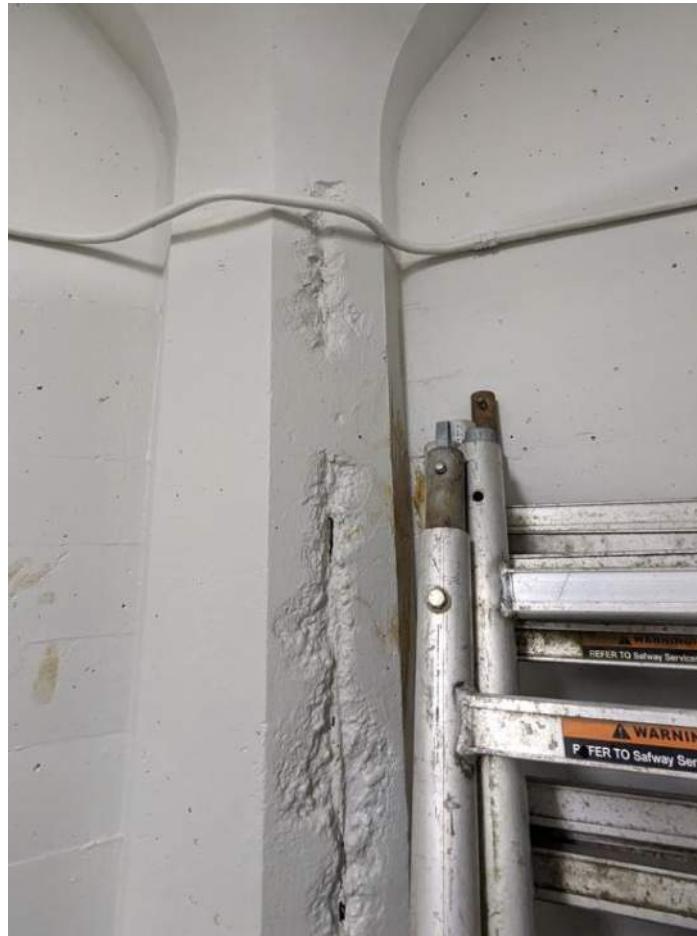
A pilaster on the external wall of the Screenhouse structure, viewed from inside the building on the second floor, where the traveling screens are installed, exhibited spalled concrete along a vertical reinforcing bar, as shown in Exhibit 4-3. There is a void in the concrete around the vertical reinforcing bar and much of the reinforcing bar itself at this location is corroded away. The condition appears to have stabilized and this location can easily be patched to stop further corrosion. This location does not present a structural concern because it is localized, relatively high within the structure, and representative of only a fraction of the building structure. No repair is necessary, but patching of this area would help to ensure further corrosion is terminated. Overall, the walls of the superstructure appear to be in satisfactory condition with no structural concerns.

Exhibit 4-3. Spalled Concrete and Void Around the Exposed Reinforcing Bar

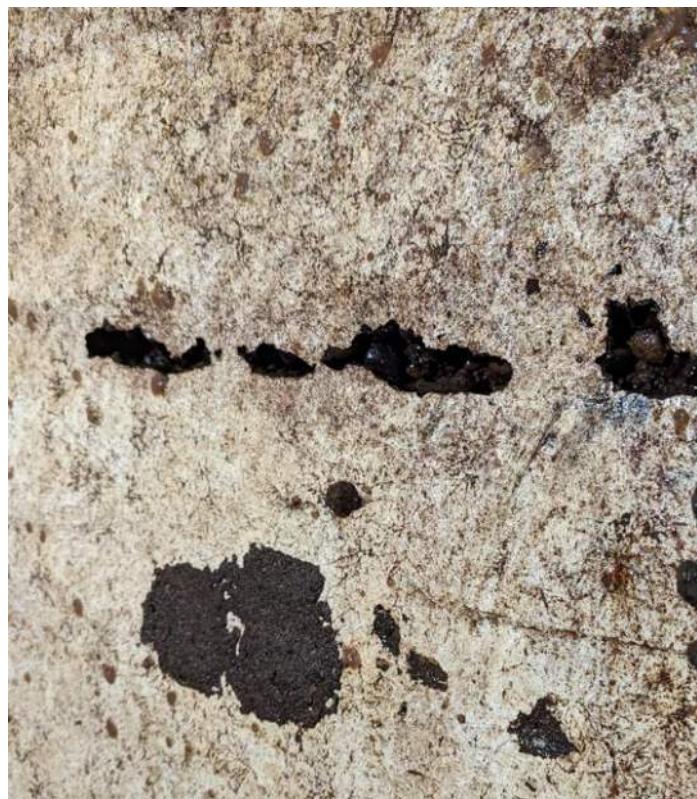
In the Outlet Well, the bottom slab was covered in sludge; therefore, it was not possible to confirm its condition. The underside of the roof appears from a distance to be in good condition with only minor spot corrosion marks showing through the coating from what appear to be form ties. The walls were all in relatively good condition. In the outlet well, there was one area where there was a horizontal void line several feet in length where the voids extended 1.5-2 inches into the concrete, as shown in Exhibit 4-4. This void line most likely appeared at a construction or cold joint line where the interface at the joint was weaker and subject to the eroding action of the water.

Exhibit 4-4. Outlet Well Cold Joint Line where Voids in Concrete Have Formed

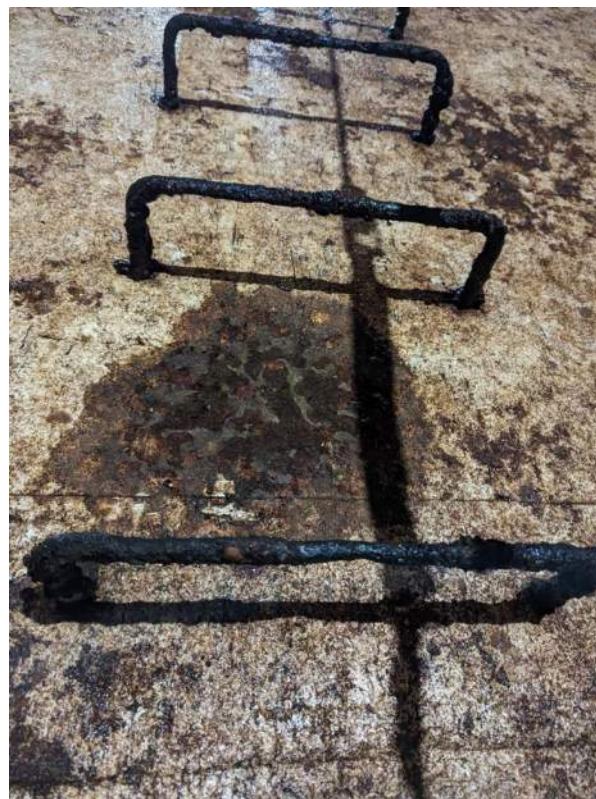
Some of the original embedded ladder access rungs in the wet well caisson are severely corroded, as shown in Exhibit 4-5. This is a safety concern and these embedded ladders should be replaced or removed. A final decision on whether to replace or remove could be made closer to the time of implementing this improvement with input from key City management and staff at the time.

Exhibit 4-5. Ladder Access Rungs Show Severe Corrosion

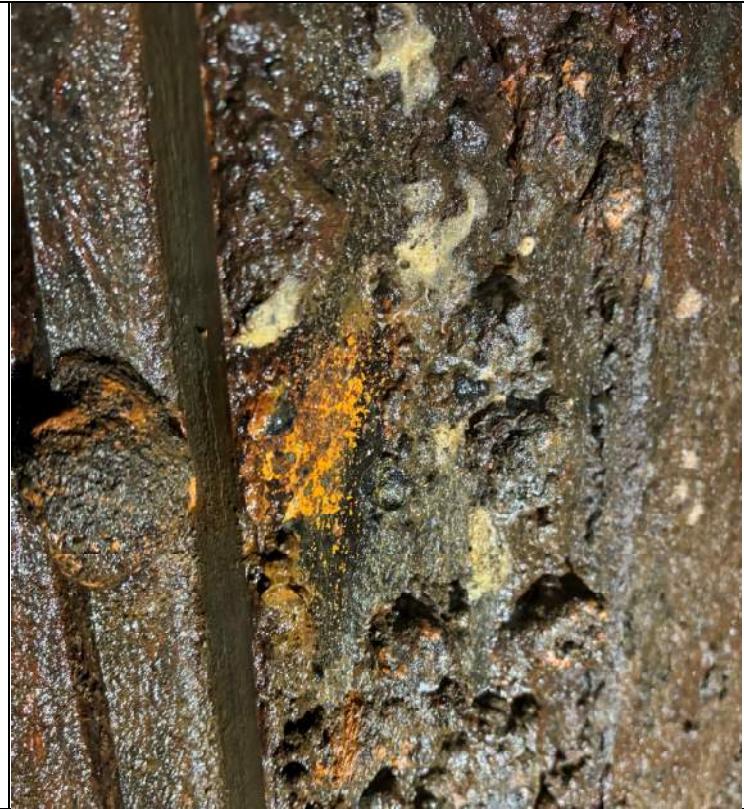
Photo #2: Tuberculation on Gate Frame at South (Industrial) Discharge Pipeline

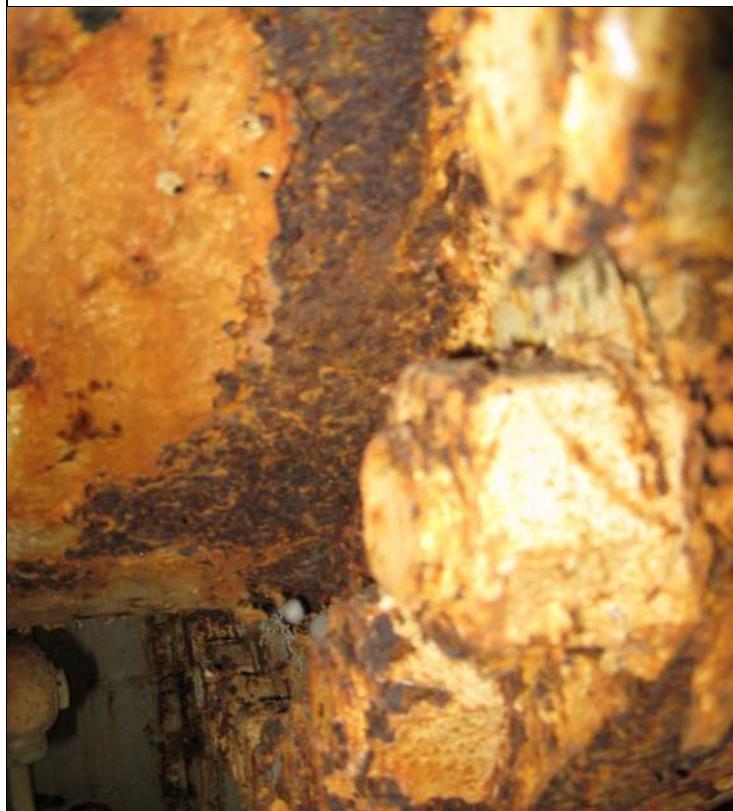
Photo #7: Corrosion on Discharge Pipeline Exterior and Flange in Chlorine Injection Room prior to Coating (Legacy Photo circa 2012)

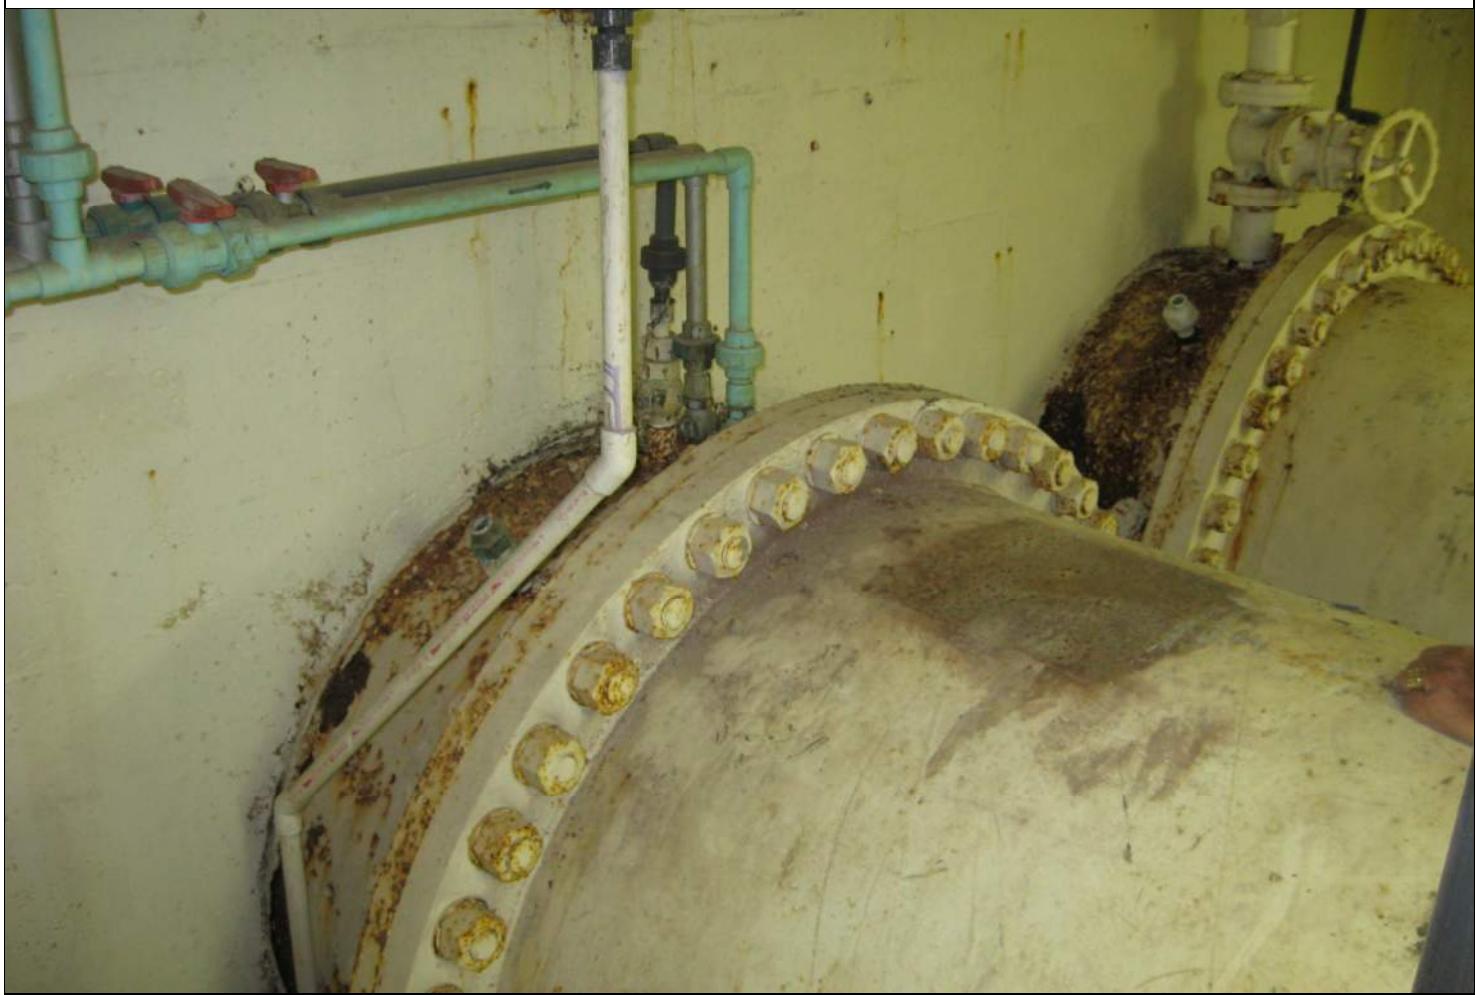
Photo #9: Discharge Pipelines in Chlorine Injection Room, Prior to Application of Coating System (Legacy Photo Circa 2012), Showing Extensive External Corrosion on Short Sections of 1940-Vintage Pipes.

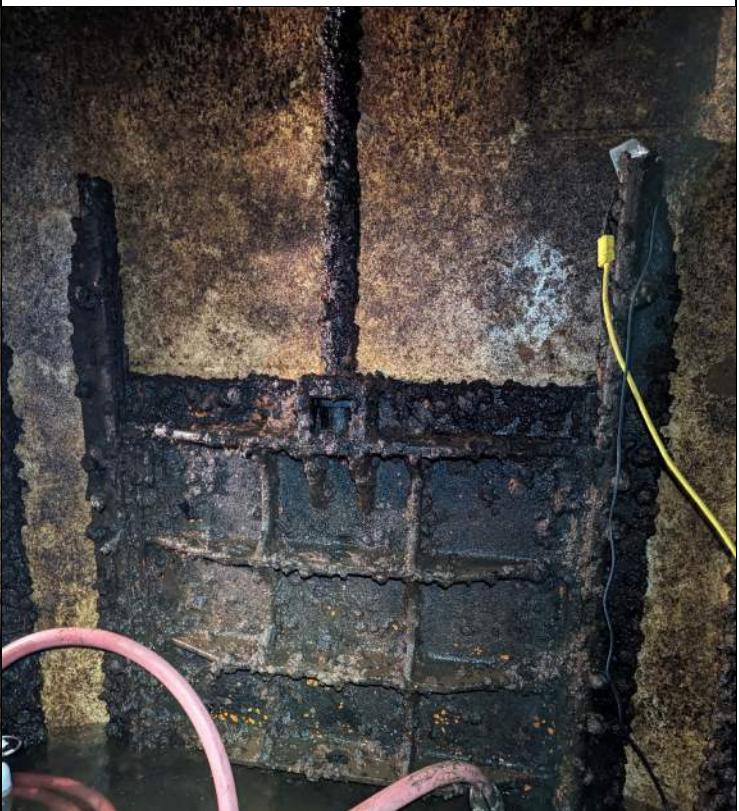
Photo #4: Intake Waste Well Slide Gate (Seized in Closed Position)

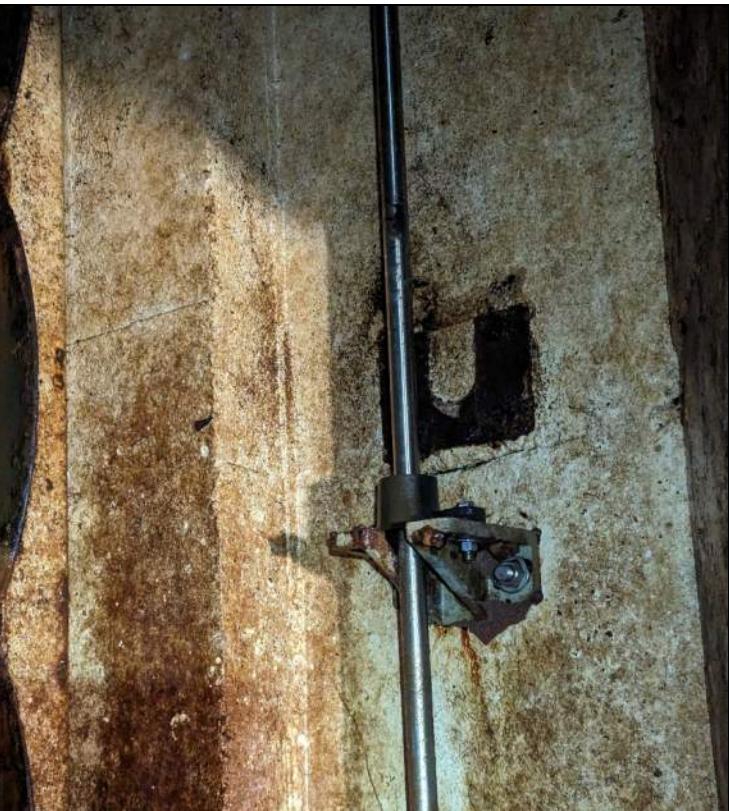
Photo #6: South Waste Well Gate Stem (Replaced early 2000s, Minimal Corrosion)
