Technical Memorandum

Subject Lake Whatcom Tunnel Condition Assessment Report (Task 5.2) (Final)

Project Name Raw Water Intake Condition Assessment and Intertie Pipeline Design

Date June 14, 2024

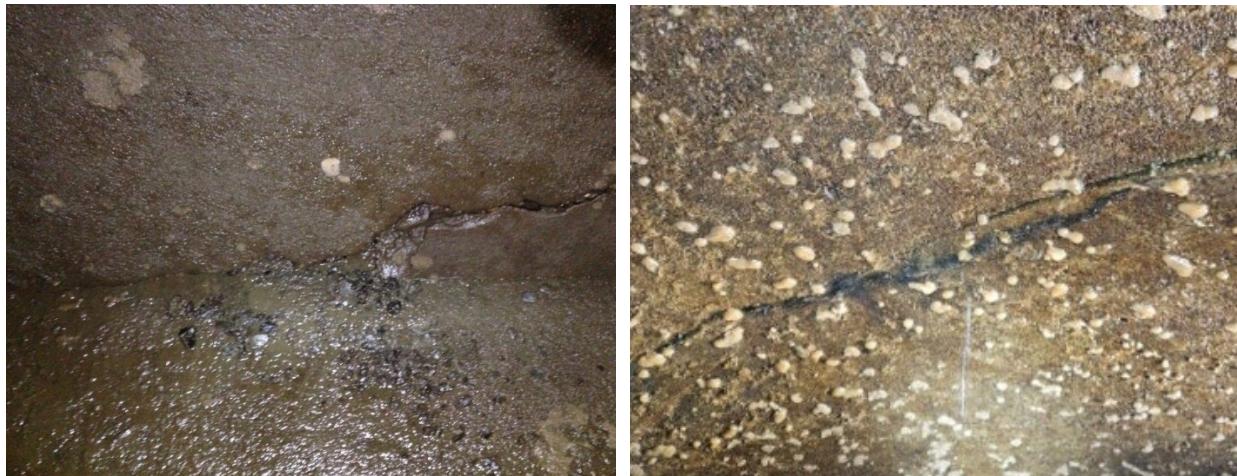
EXHIBIT 4

In 2015, 103 locations with longitudinal fracturing of the concrete tunnel liner were identified. In 2024, 115 locations with longitudinal fracturing of the concrete tunnel liner were identified. Five of these fractures had offsets of up to 0.19 inches during the 2015 inspection, which were observed to be up to 0.22 inches during the 2024 inspection as presented in Exhibit 4. Longitudinal fracturing is a significant structural defect that suggests the lack of support between the liner and the excavated surface. The importance of these fractures is dependent on the extent to which there is change in their size and offset. In this instance there is evidence of movement of the liner suggesting external pressure is displacing the concrete liner.

Offset Longitudinal Fracture in Tunnel Liner Comparison from 2015 on the left to 2024 on the right

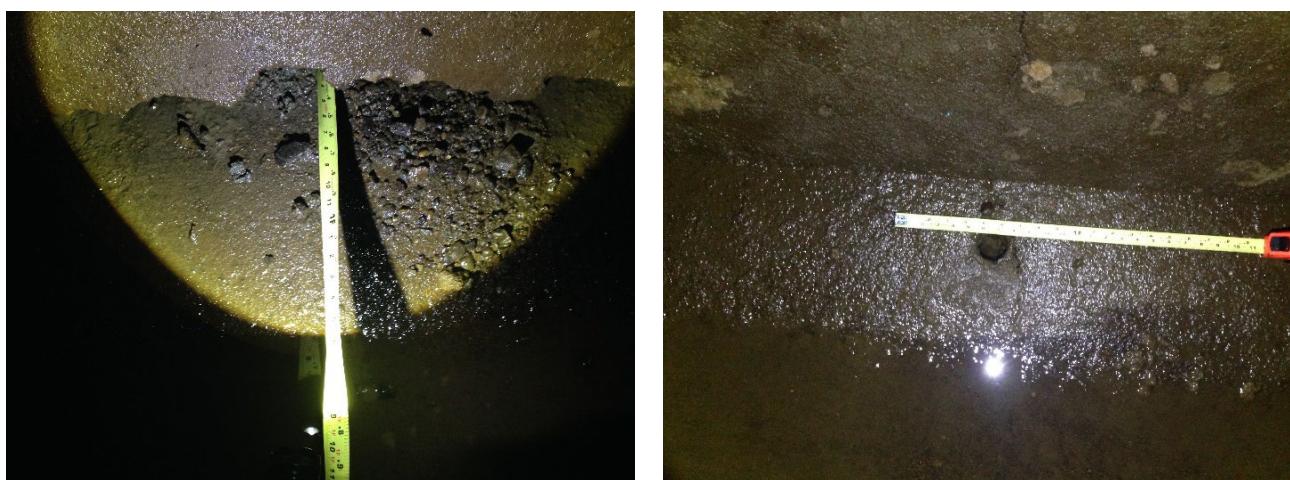
EXHIBIT 5

Typical Holes Found in the Tunnel Liner

As noted above, there were 56 locations in the tunnel liner where holes were identified. Left unrepaired, these holes will allow for the continued migration of fine grained material and the growth of voids behind the concrete tunnel liner. The result could be instability of the liner and potentially collapse.

Following completion of the preceding recommended investigative and alternative supply actions, repairs to address structural defects in the liner and voids behind the line can be implemented. Quantification and scoping of these repairs can be completed after the invasive investigations described above are completed.

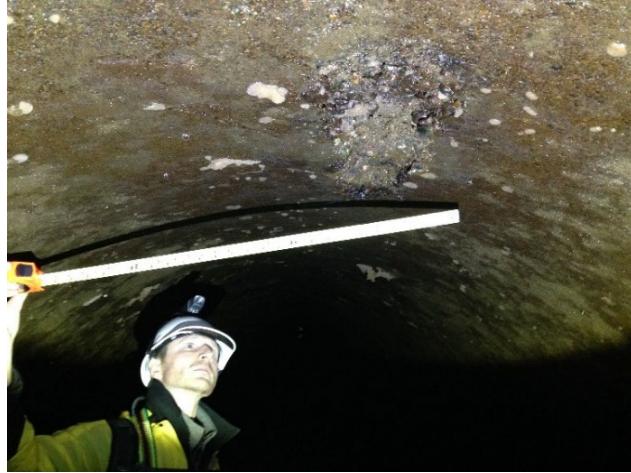
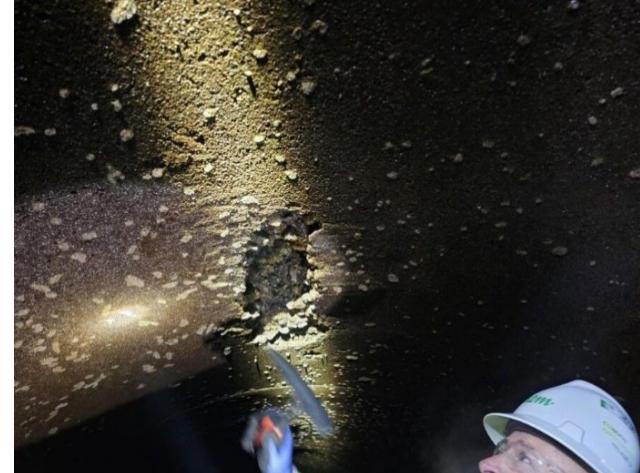
EXHIBIT 6

There were several tunnel liner locations (5+47 to 5+49, 30+45, 33+01 to 33+02, and 33+06 to 33+07) where the liner was thin or deteriorating to a point where the concrete could easily be scraped away at the surface. One notable example of this deterioration is presented in Exhibit 6 showing a comparison from 2015 to 2024 where the liner has continued to move approximately 0.06 inches since 2015.

Deteriorated Concrete Tunnel Liner from 2015 on the left to 2024 on the right

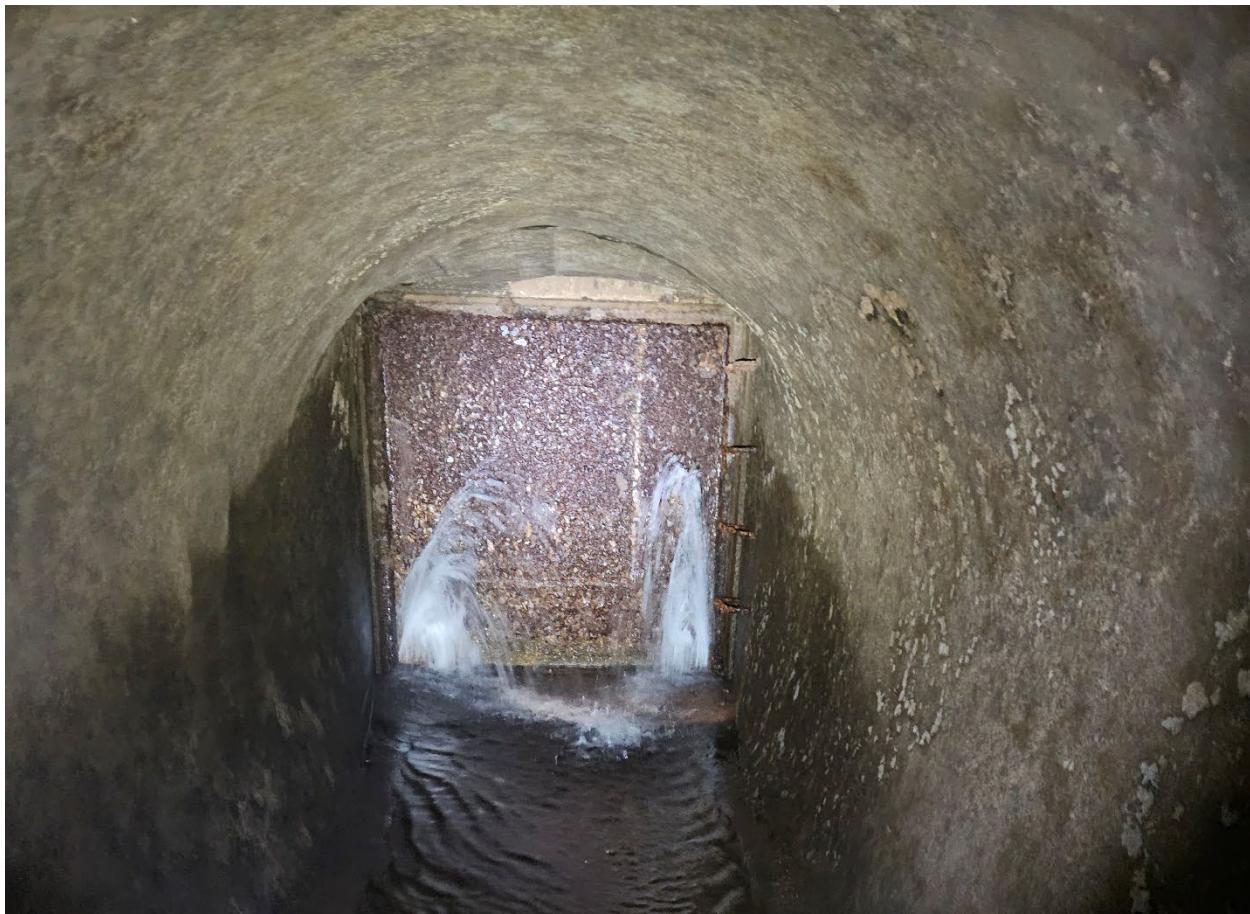
In addition to developing an alternative water intake strategy to take the tunnel out of service, the leakage through the slide gate in the Gatehouse will need to be reduced, if not eliminated. Reducing or eliminating leakage could be done via slide gate replacement, which is already being contemplated by the City. Other methods for addressing leakage could be considered, such as removing corrosion product or other means of plugging the gaps between the slide gate and gate frame. Refer to Exhibit 7 below for the slide gate leakage observed during the March 2024 tunnel inspection.

EXHIBIT 7**Seepage through Gate at Gatehouse (Non- PACP code)**

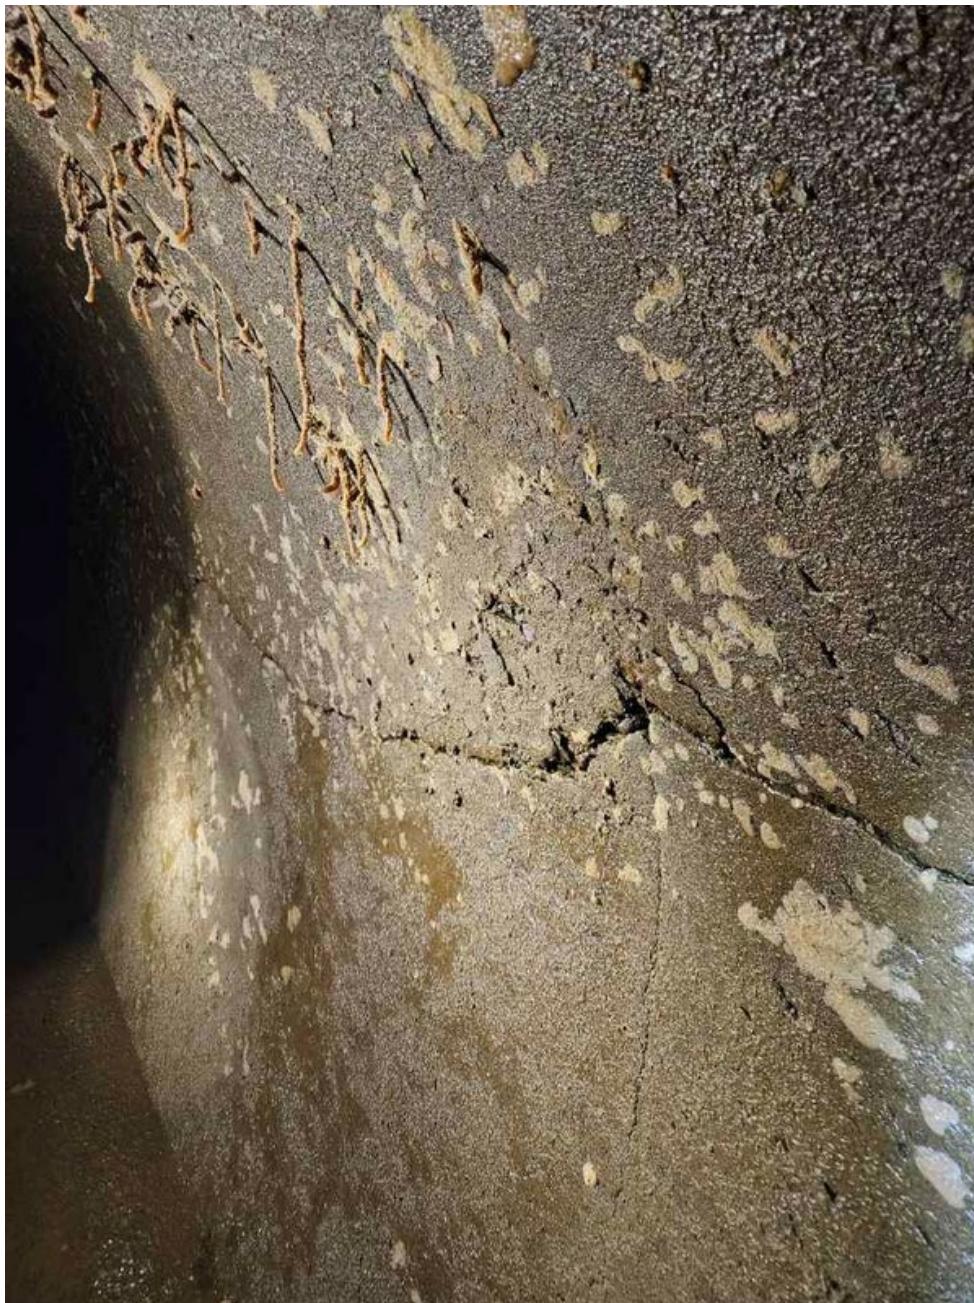
EXHIBIT 8

Fracture Multiple (Approx Sta 50+90 @ 3 o'clock position in pipe)

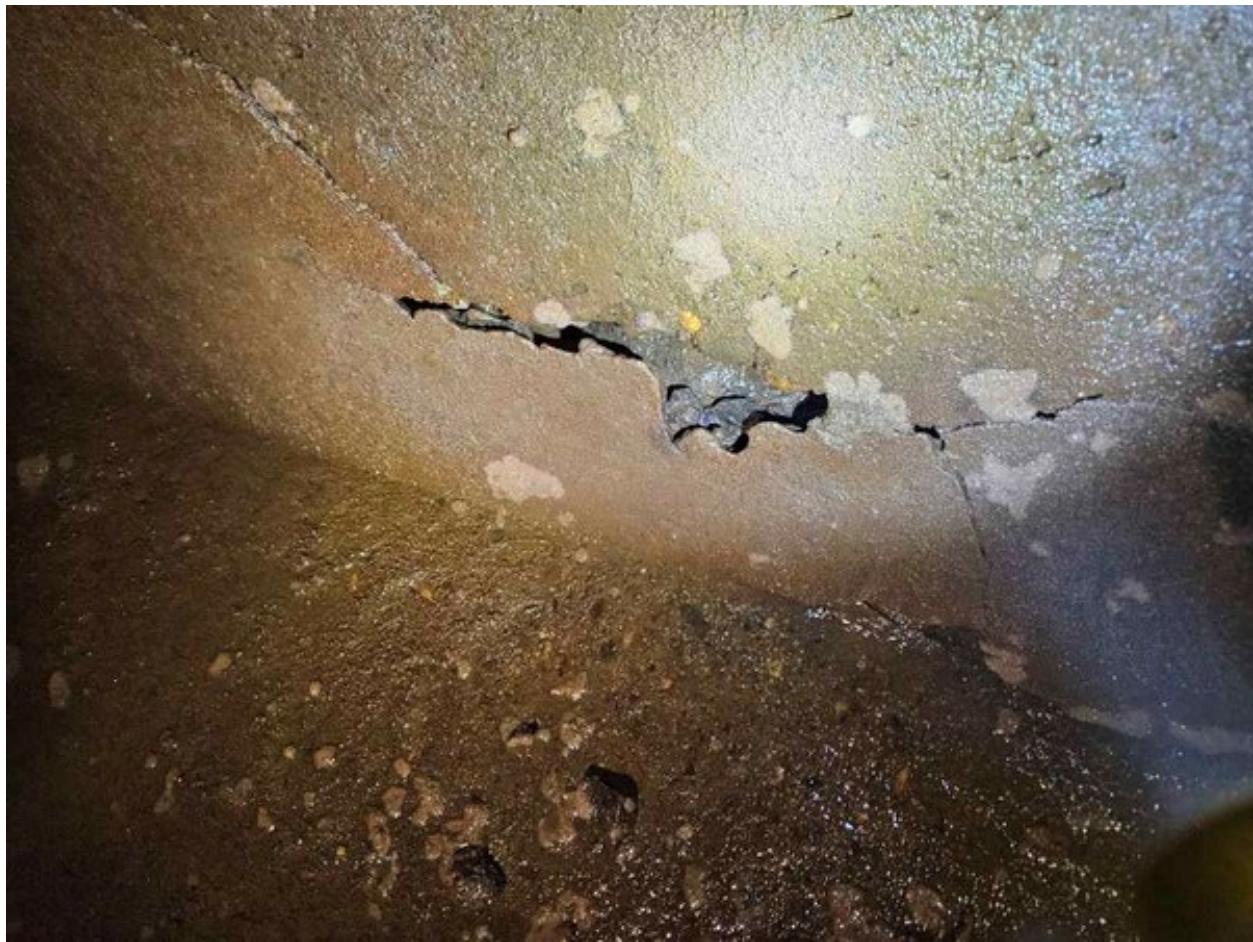
EXHIBIT 9

Hole Soil Visible (Approx Sta 51+10 @ 5 o'clock position in pipe)

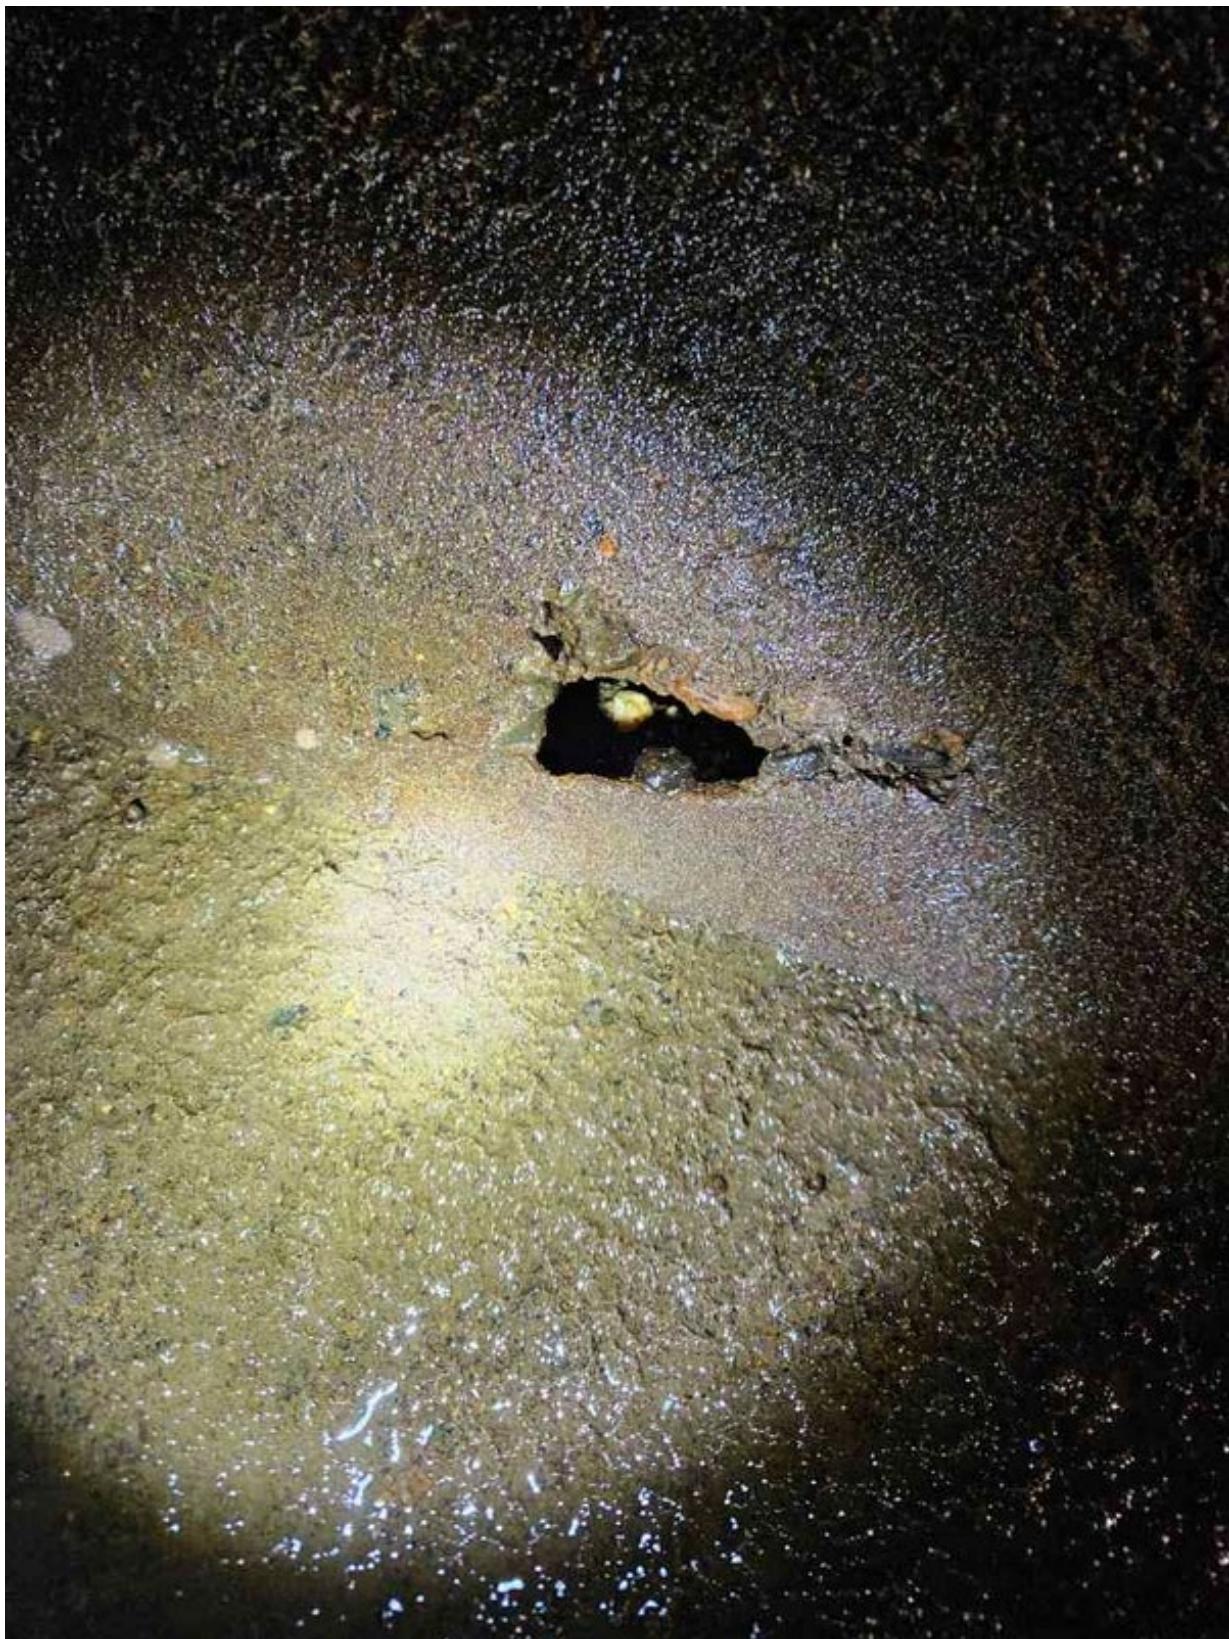
EXHIBIT 10

Hole Soil Visible (Approx Sta 53+40 @ 5 o'clock position in pipe)

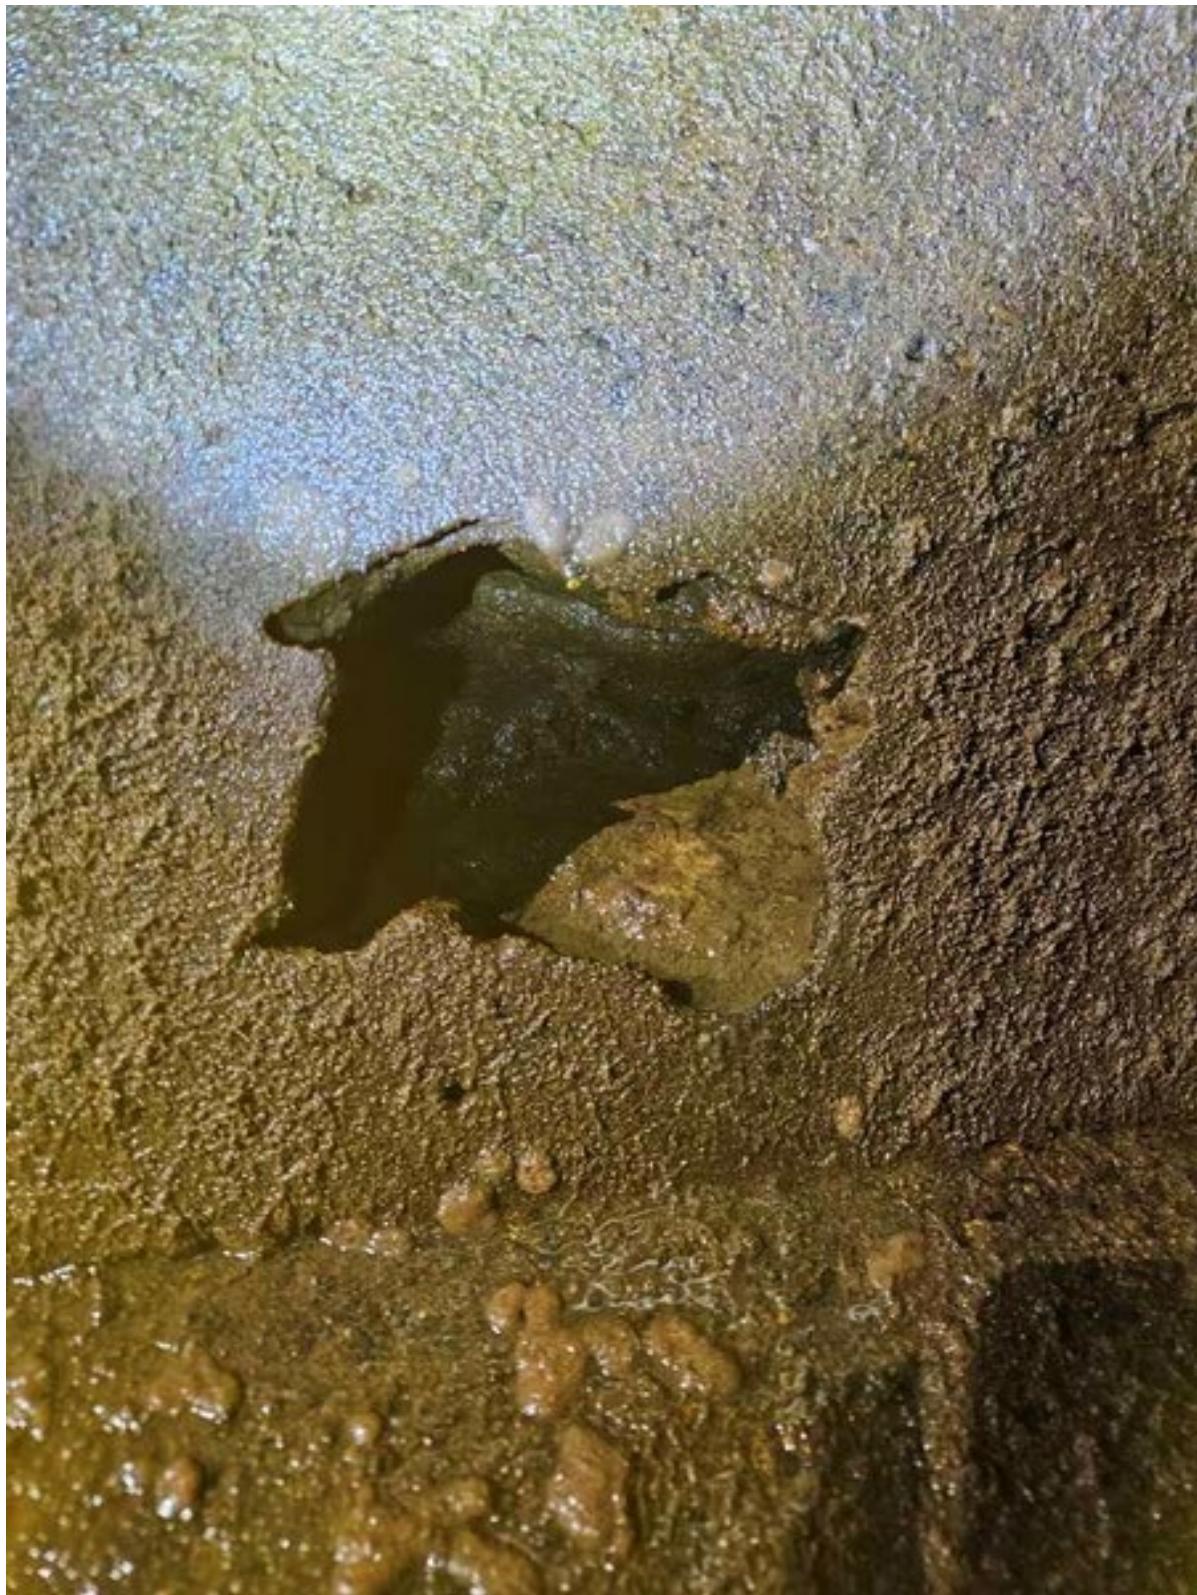
EXHIBIT 11

Hole Soil Visible (Approx Sta 59+60 @ 7 o'clock position in pipe)

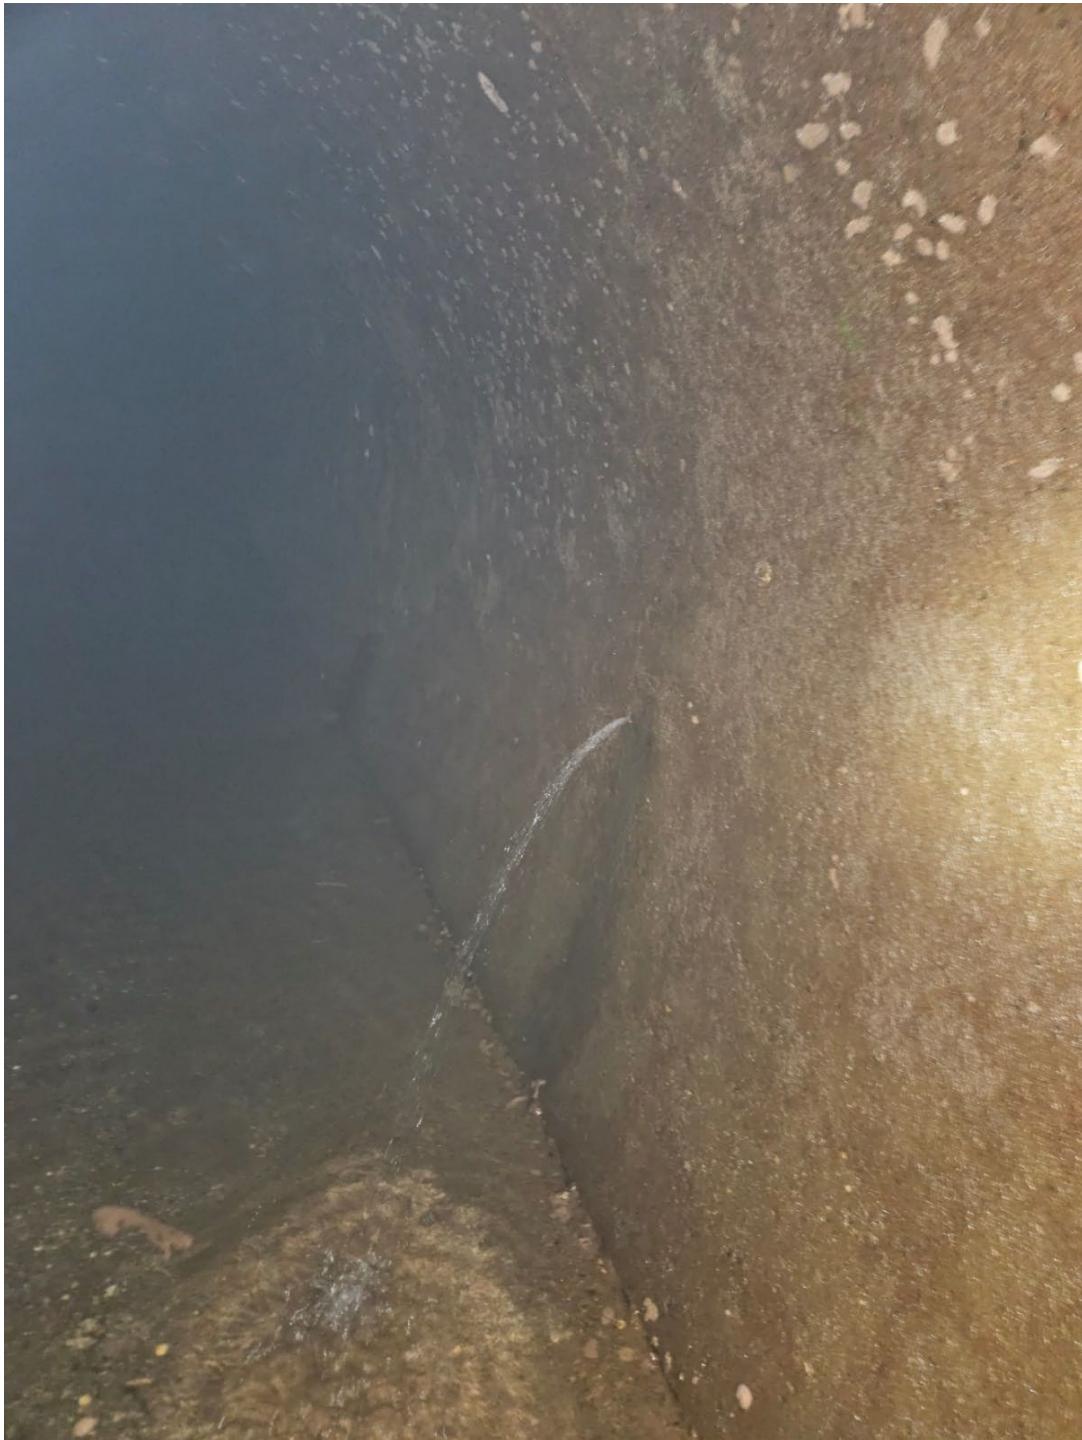
EXHIBIT 12

Infiltration Runner Barrel @ 4 o'clock position in pipe

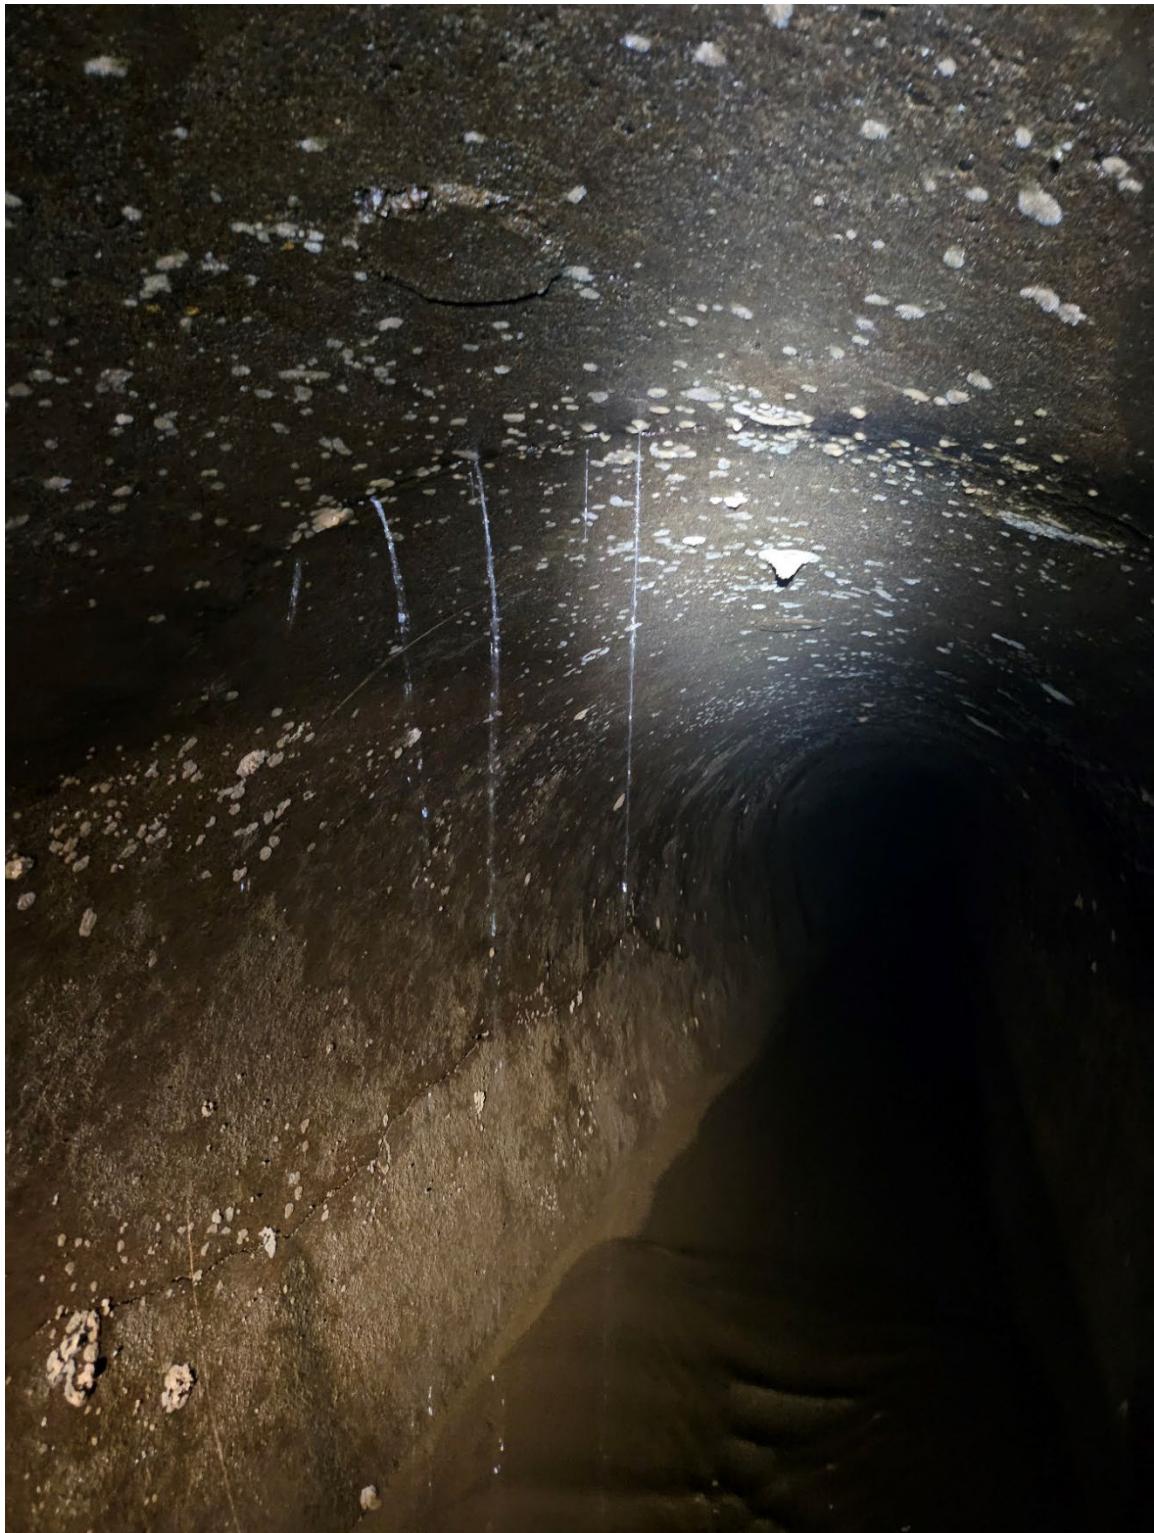
EXHIBIT 13
Infiltration Runner Barrel (Multiple) @ 12 o'clock position in pipe
