**GEOTECHNICAL INVESTIGATION  
& GEOHAZARD REPORT  
JONES EDGEMOOR ESTATE  
PROPOSED 38-LOT PLAT DEVELOPMENT  
VIEWCREST ROAD, BELLINGHAM, WA**

Subject: **Geotechnical Investigation & Geohazard Assessment**  
**Proposed 38-Lot Plat - Jones Edgemoor Estate**  
Viewcrest Road, Bellingham, WA

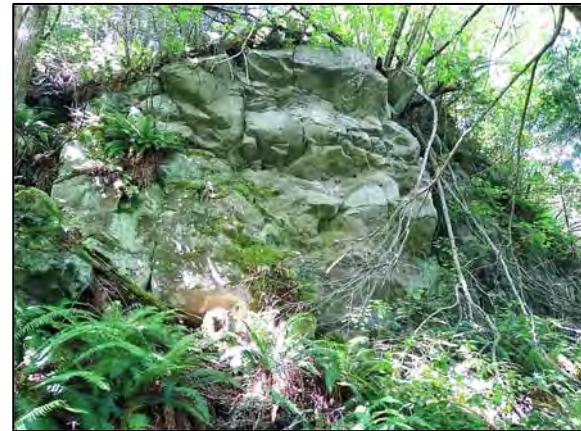
**Photo 1: Bedrock Cliff Face; Northwest Slope**

The cliff area along the northwest hill represents the greatest exposure and highest hazard potential for associated rock-fall (Photo 1, above). At its steepest point, the elevation drops about 37 feet over a horizontal distance of ~25 feet for an average slope ratio approaching 1:1.5 (H:V) along the cliff face. Grades range up to approximately vertical, and are locally overhanging on the variable outcrop faces. We observed these features to be highly influenced by the regularity and orientation of rock structures dictating their stability and character. Section 4.3 below provides a review of bedrock features and structures.

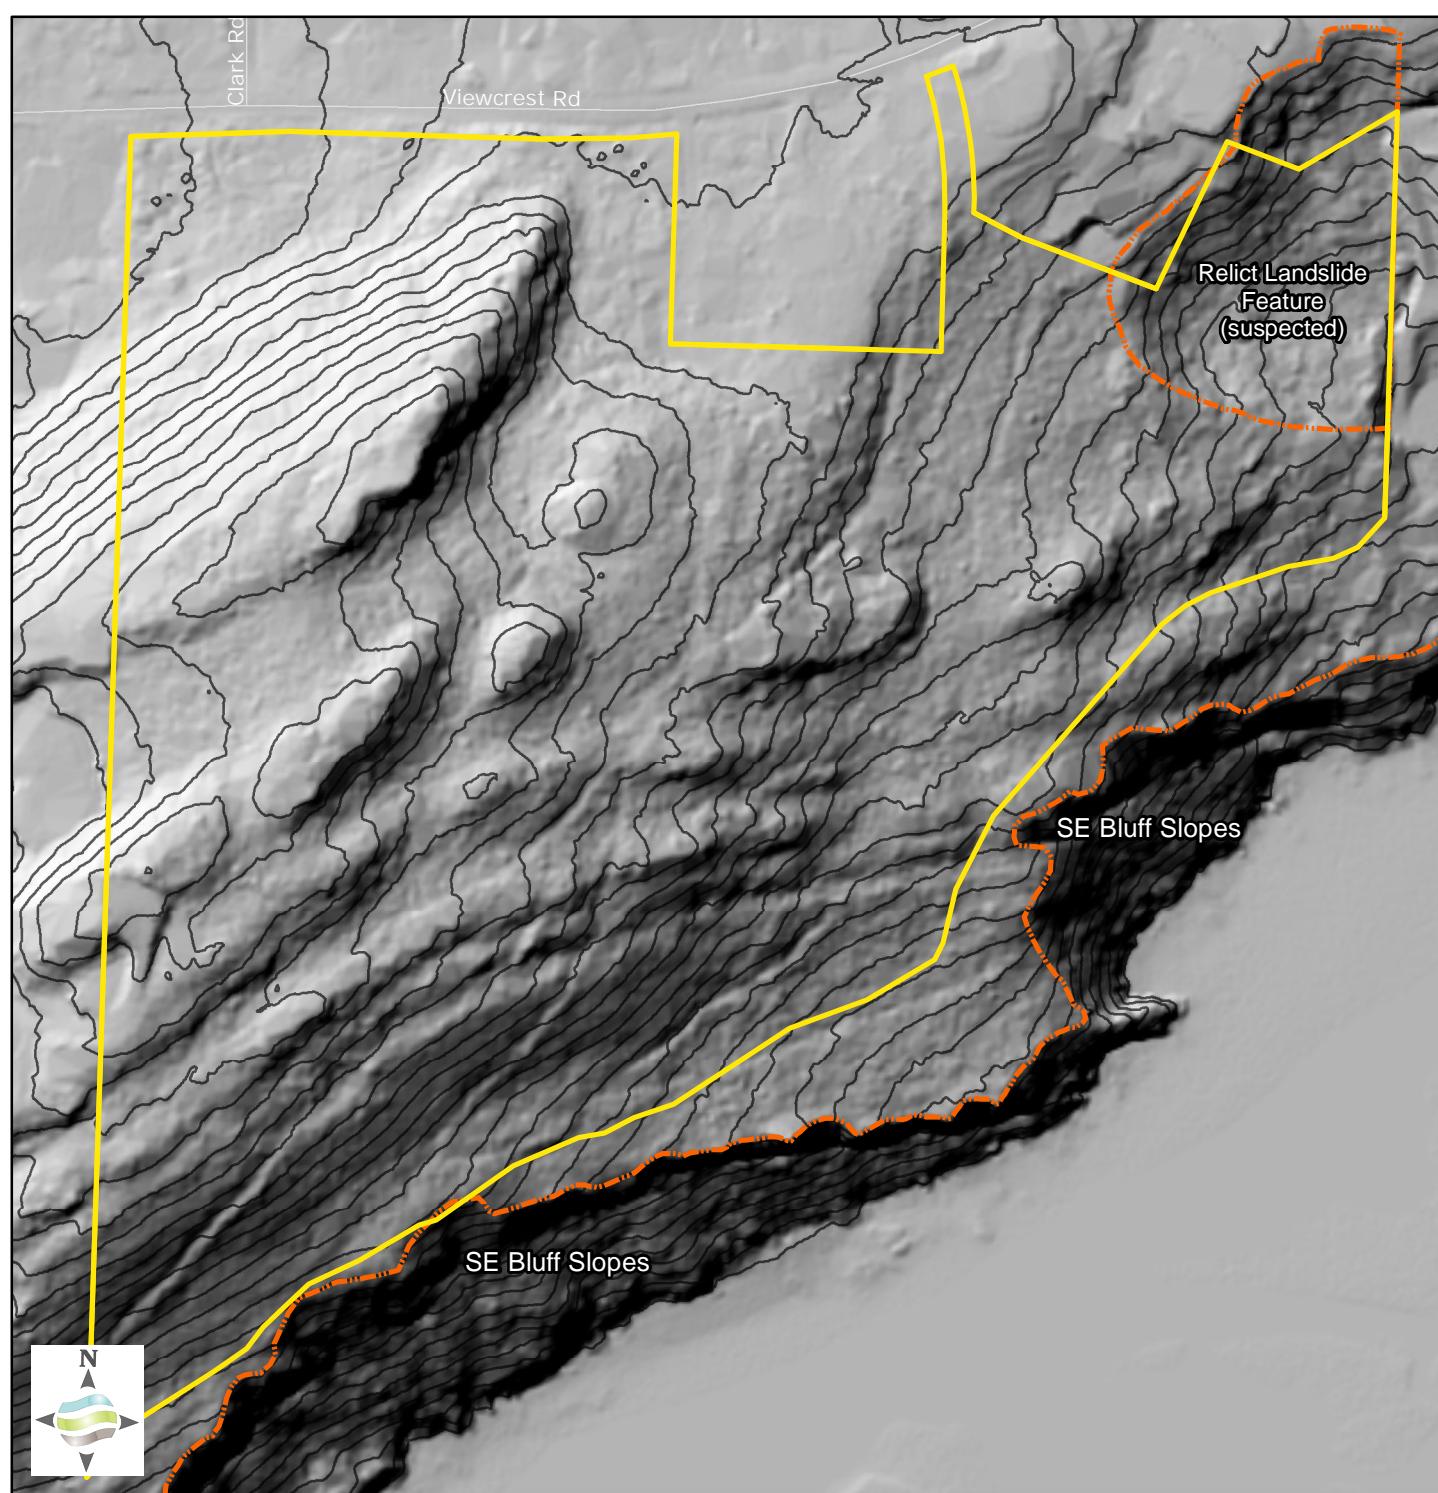
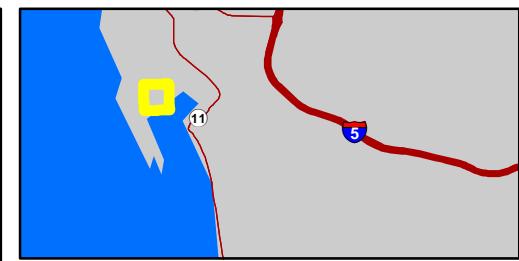
**Figure 4**  
 Jones - Edgemoor Estate  
 LiDAR Overview w/ Feature Annotation

Two features of special significance were evident in initial image review. These include: 1) the main southeast shoreline bluff slope, and 2) an area of bowl-shaped topography at the northeast corner of the property. Figure 4 presents site-wide LiDAR imagery including delineation and annotation of the areas noted below.

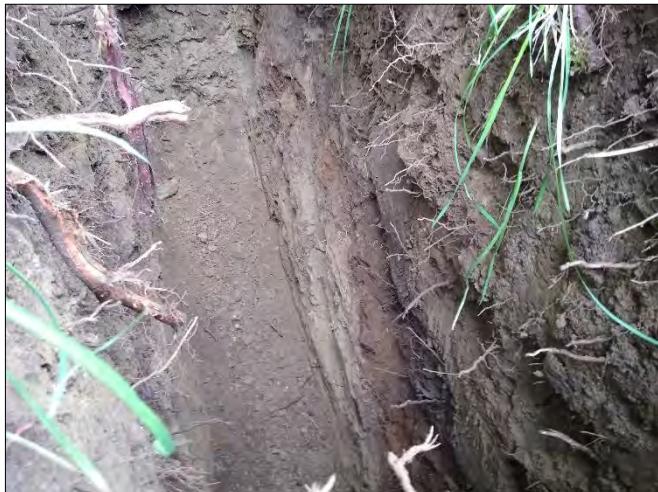
**Uncontrolled Fill:** Shallow materials, interpreted as non-native uncontrolled fill were found at one location (TP1, northeastern margin area) to approximately 3.5 feet bgs. The location coincides with an area of somewhat raised grade at the northern extent of the “East Road”, currently a primitive and overgrown off-road feature. Based on topographic indications, we suspect that similar fills may extend into the properties located to the east and west of TP1. The fill consisted of silt with sand (USCS Classification: ML) containing approximately 50% to 60% fines, was soft to medium stiff with depth, cohesive with low plasticity, and damp in the early summer season. The fill contained some chunks of asphalt, and was capped with about 0.7 feet of topsoil. A band of dark orange oxidation staining was observed from about 3.0 to 3.5 feet bgs near the base of the fill material.

Photo 1: TP1 Subsurface; Fill over Glacial Drift and Till

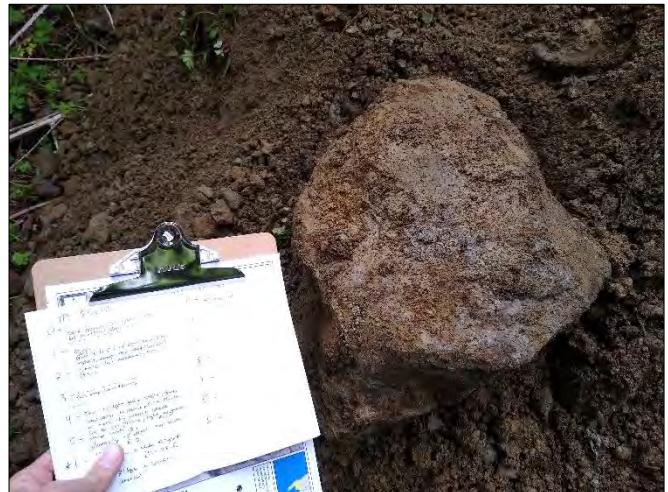
Photo 2: TP2; Excavated Boulder

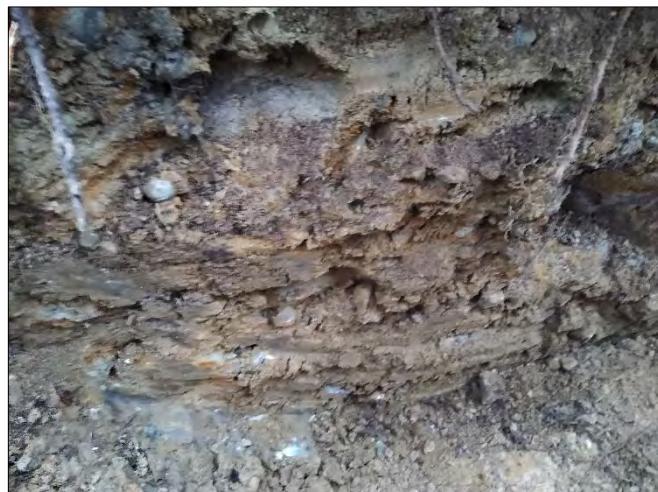
Photo 3: TP5; Redox Staining in Shallow Soil

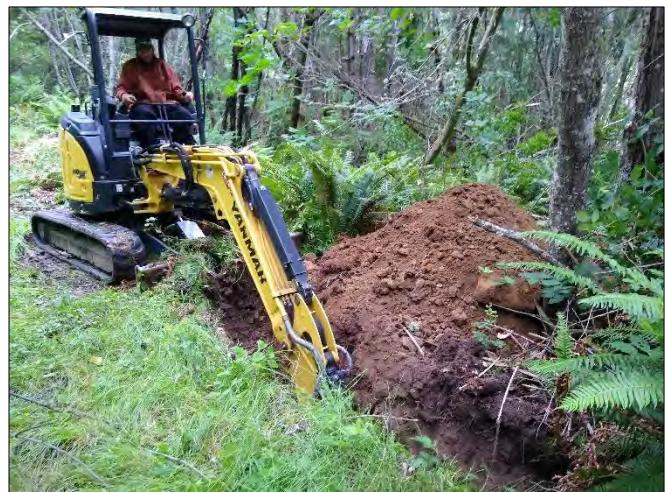
Photo 4: TP8 Location; Excavated Glacial Drift

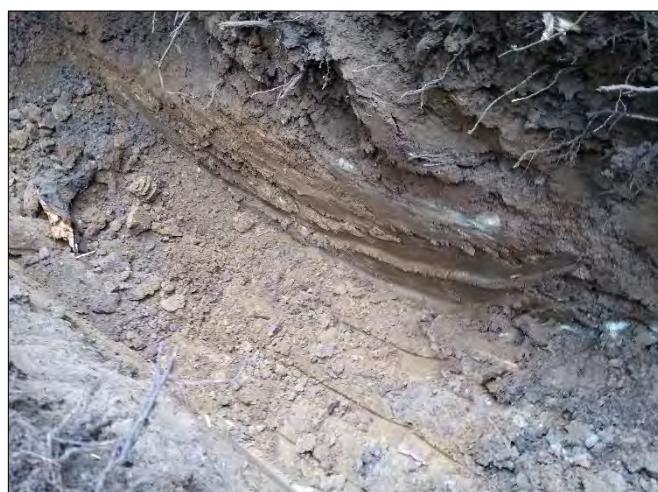
Photo 5: TP9; Oxidized Soil Horizon

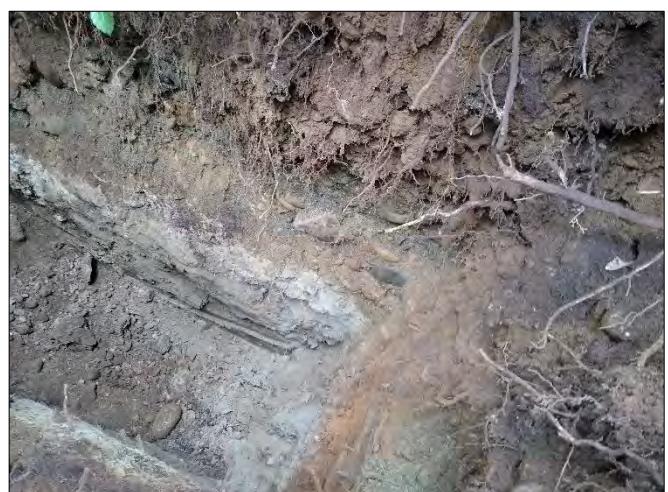
Photo 6: TP13; Thick Organic over Glacial Outwash and Dense Till

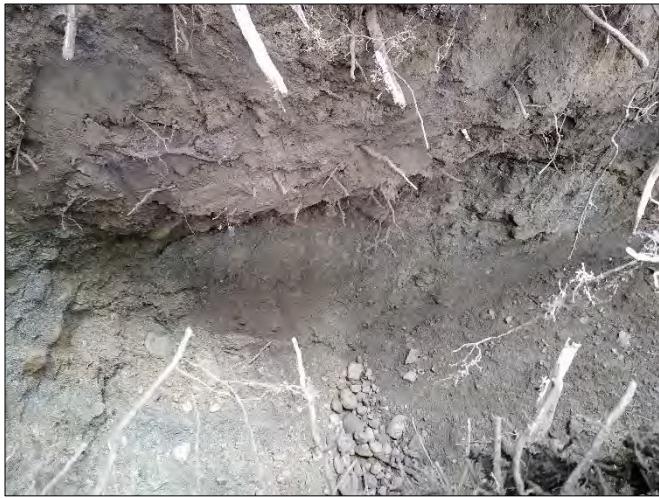
**Photo 7:** TP15; Thick Organic over Glacial Outwash

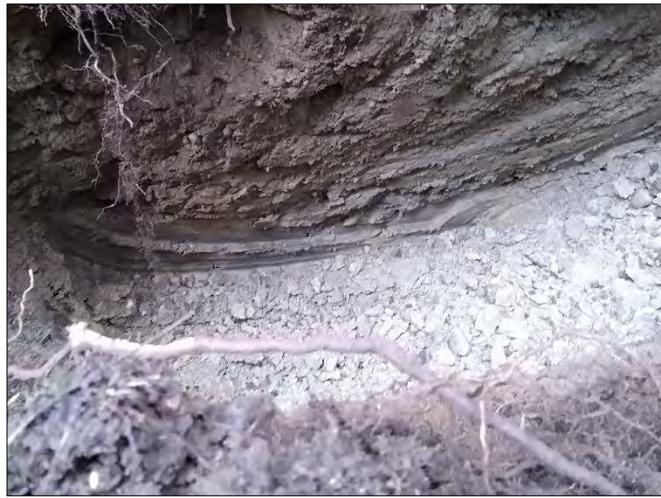
**Photo 8:** TP17; Dense Glacial Till at Base of Pit

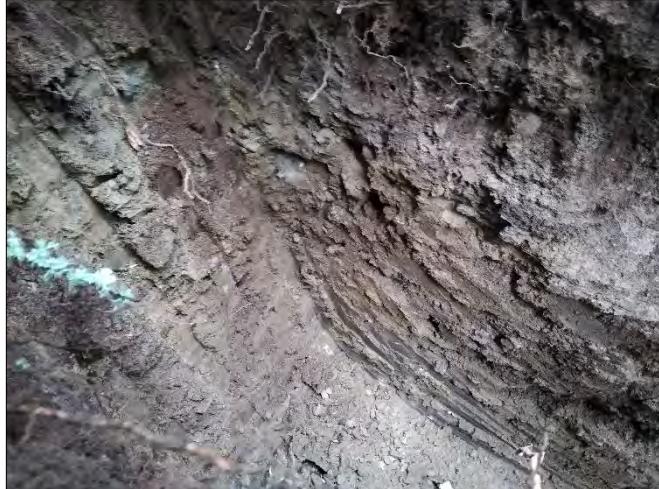
**Photo 9:** TP23; Glacial Drift over Dense Till

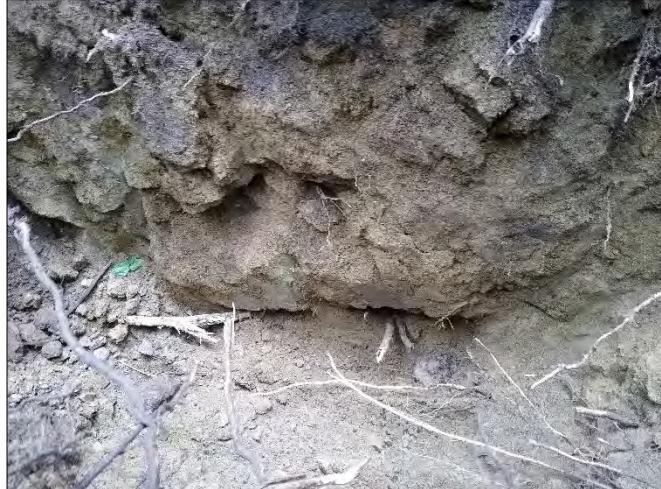
**Photo 10:** TP25; Sandy Eluvium Over Dense Sandstone Bedrock

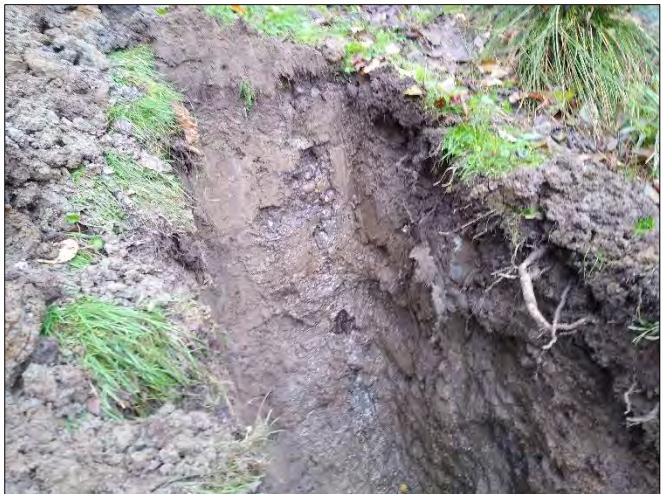
**Photo 3: TP2 Seepage from North Pit-Wall**

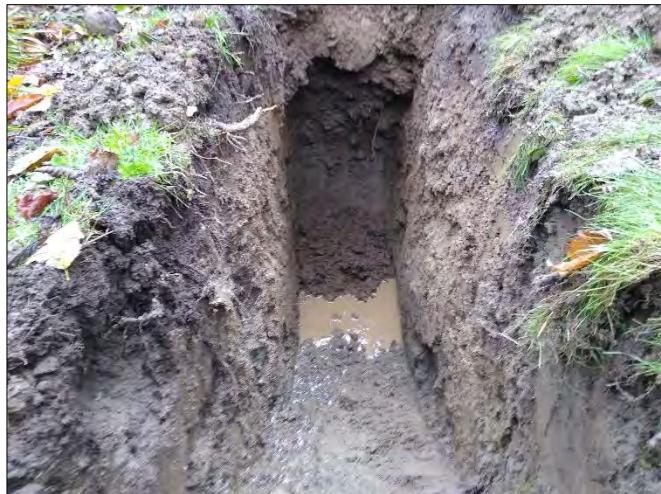
**Photo 4: TP2 Caving on South Pit-Wall**
