**GEOTECHNICAL INVESTIGATION  
& GEOHAZARD REPORT  
JONES EDMOOR ESTATE  
PROPOSED 38-LOT PLAT DEVELOPMENT  
VIEWCREST ROAD, BELLINGHAM, WA**

Subject: **Geotechnical Investigation & Geohazard Assessment**  
**Proposed 38-Lot Plat - Jones Edgemoor Estate**  
Viewcrest Road, Bellingham, WA

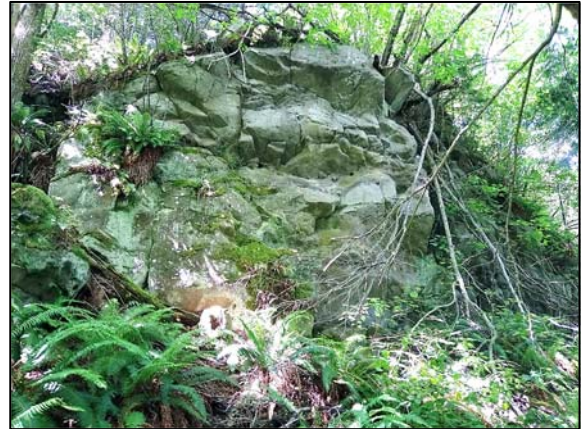
**Photo 1: Bedrock Cliff Face; Northwest Slope**

The cliff area along the northwest hill represents the greatest exposure and highest hazard potential for associated rock-fall (Photo 1, above). At its steepest point, the elevation drops about 37 feet over a horizontal distance of ~25 feet for an average slope ratio approaching 1:1.5 (H:V) along the cliff face. Grades range up to approximately vertical, and are locally overhanging on the variable outcrop faces. We observed these features to be highly influenced by the regularity and orientation of rock structures dictating their stability and character. Section 4.3 below provides a review of bedrock features and structures.

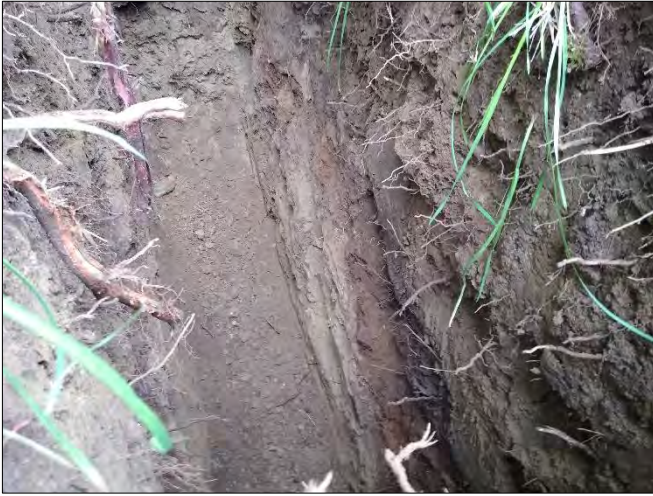
**Uncontrolled Fill:** Shallow materials, interpreted as non-native uncontrolled fill were found at one location (TP1, northeastern margin area) to approximately 3.5 feet bgs. The location coincides with an area of somewhat raised grade at the northern extent of the “East Road”, currently a primitive and overgrown off-road feature. Based on topographic indications, we suspect that similar fills may extend into the properties located to the east and west of TP1. The fill consisted of silt with sand (USCS Classification: ML) containing approximately 50% to 60% fines, was soft to medium stiff with depth, cohesive with low plasticity, and damp in the early summer season. The fill contained some chunks of asphalt, and was capped with about 0.7 feet of topsoil. A band of dark orange oxidation staining was observed from about 3.0 to 3.5 feet bgs near the base of the fill material.

**Photo 1:** TP1 Subsurface; Fill over Glacial Drift and Till

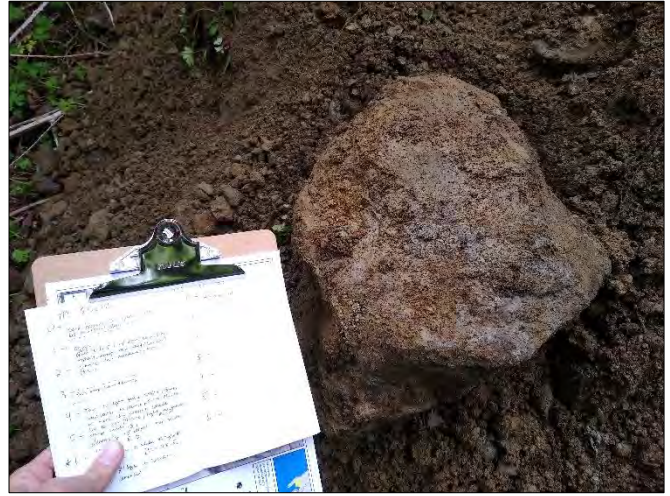
**Photo 2:** TP2; Excavated Boulder

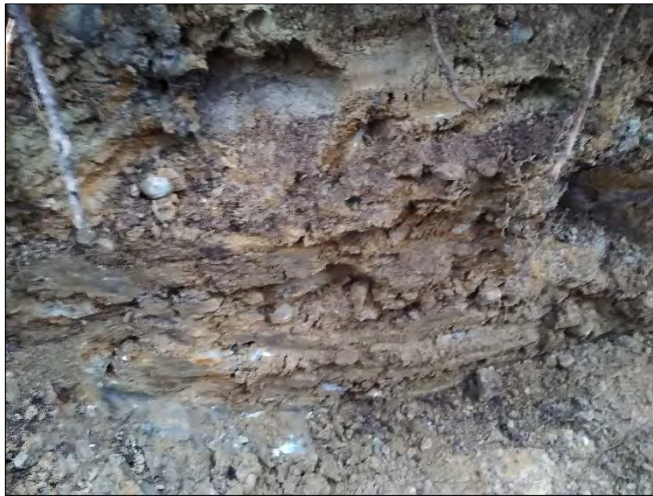
**Photo 3:** TP5; Redox Staining in Shallow Soil

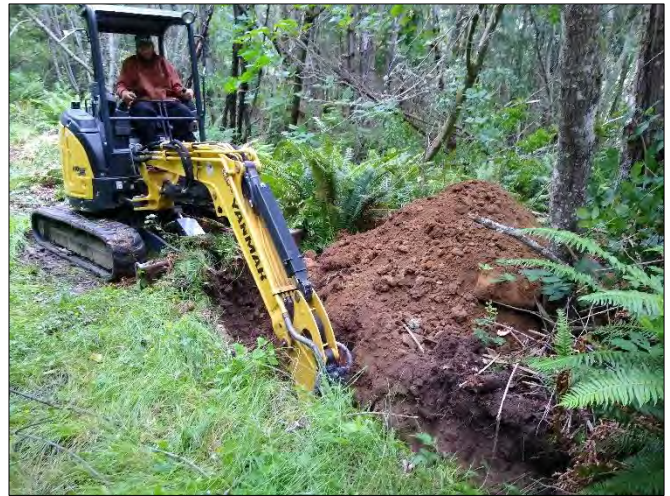
**Photo 4:** TP8 Location; Excavated Glacial Drift

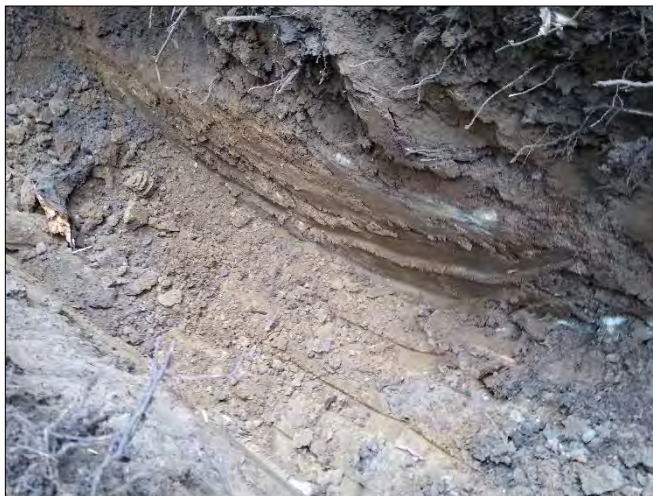
**Photo 5:** TP9; Oxidized Soil Horizon

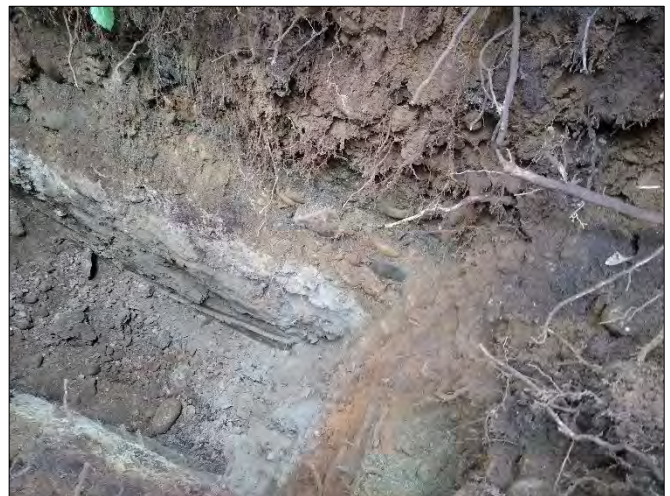
**Photo 6:** TP13; Thick Organic over Glacial Outwash and Dense Till

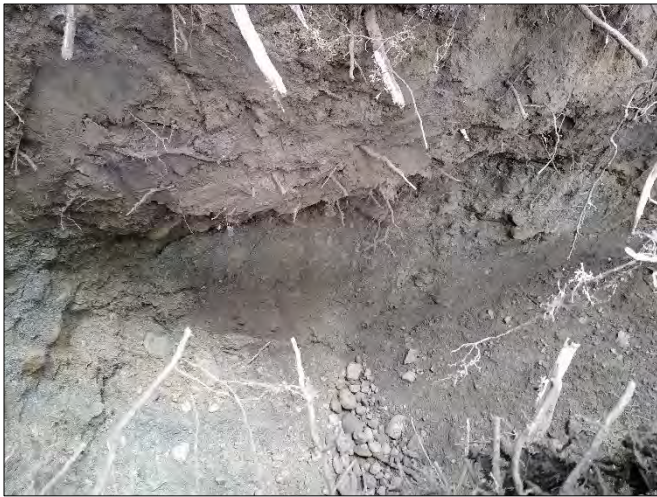
**Photo 7:** TP15; Thick Organic over Glacial Outwash

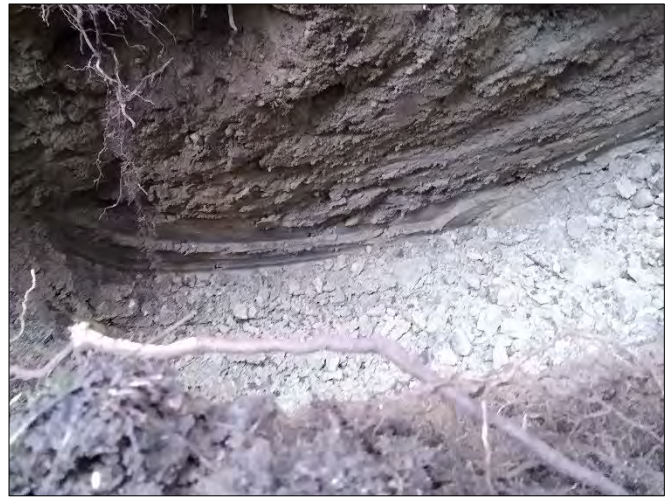
**Photo 8:** TP17; Dense Glacial Till at Base of Pit

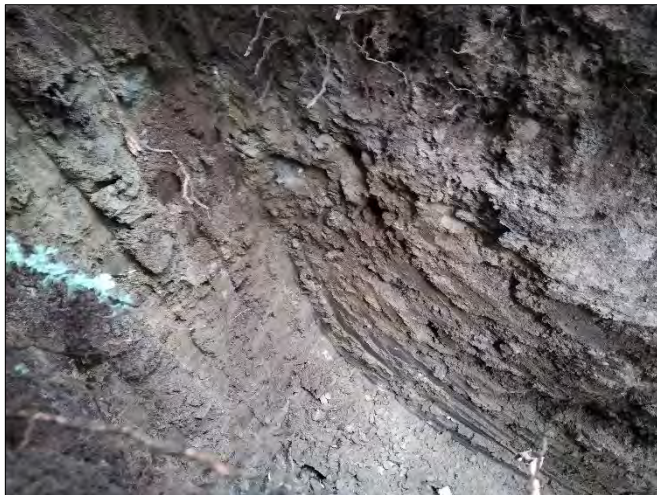
**Photo 9:** TP23; Glacial Drift over Dense Till

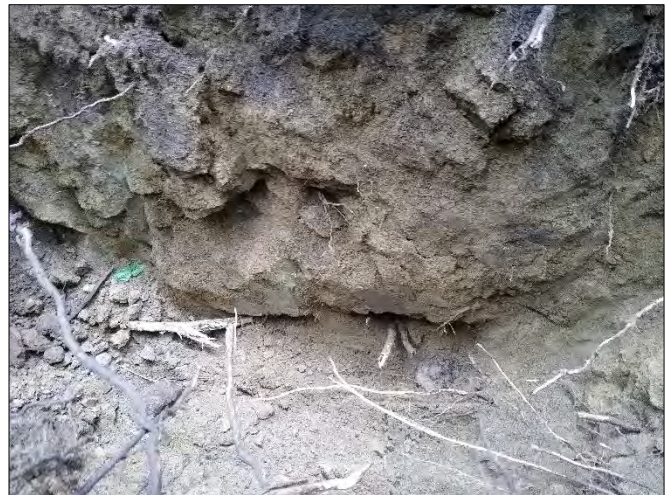
Soils that appeared to have been weathered-in-place (eluvium) were observed at the top of the outcrop in the northwest region of the site (TP25 and TP26). These soils appeared similar in character to the more frequently observed colluvium, but were made up almost entirely of poorly-graded medium sand (USCS Classification: SP), containing less than 5% fines. The SP soil was yellowish brown, non-plastic, non-cohesive, damp to moist, and loose to medium dense in the upper 3.5 feet before transitioning to the underlying weathering rind and bedrock at 4.0 feet bgs.

**Photo 10:** TP25; Sandy Eluvium Over Dense Sandstone Bedrock

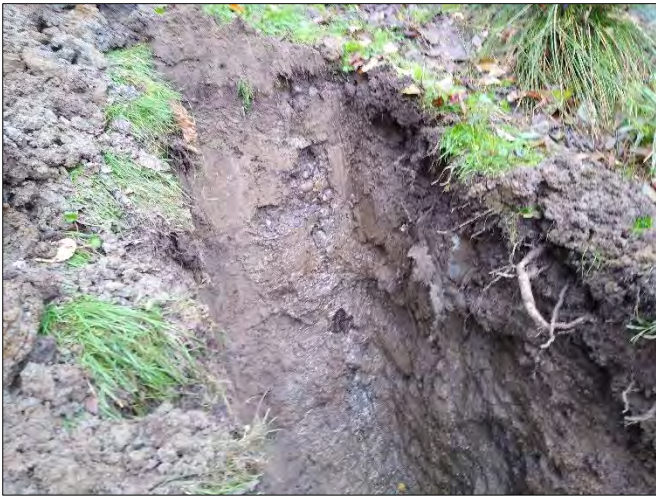
**Photo 3: TP2 Seepage from North Pit-Wall**

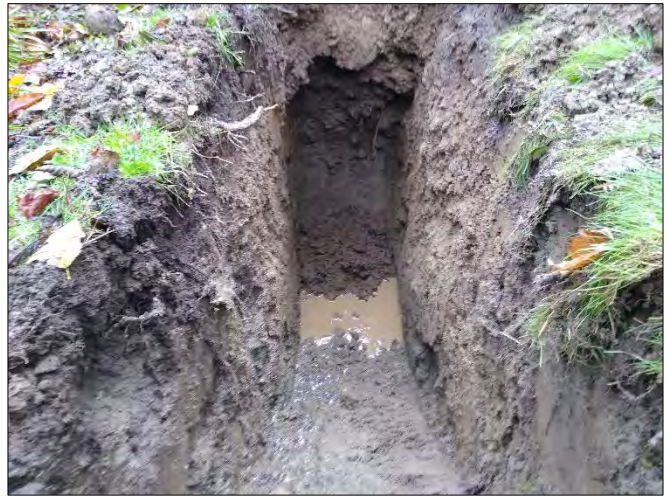
**Photo 4: TP2 Caving on South Pit-Wall**

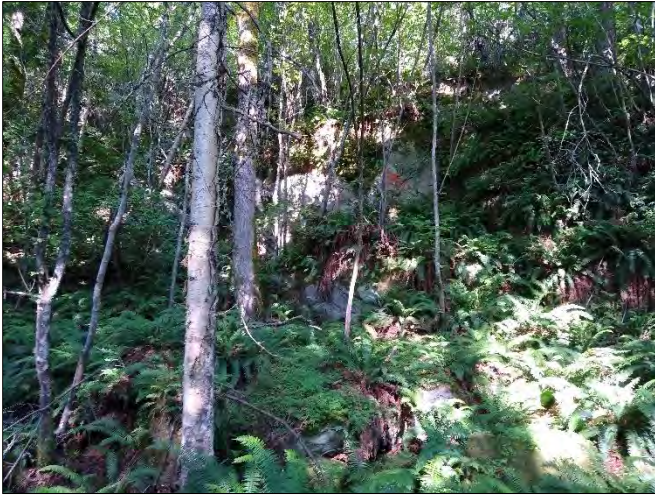
**Photo 1:** Northern Part of NW Bedrock Face

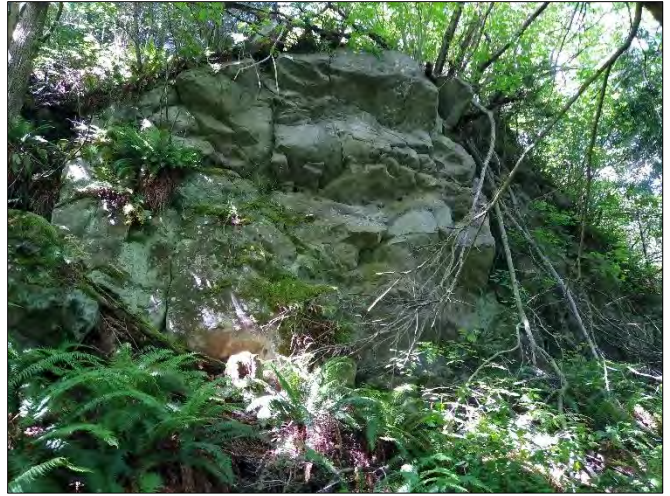
**Photo 2:** Southern Part of NW Bedrock Face

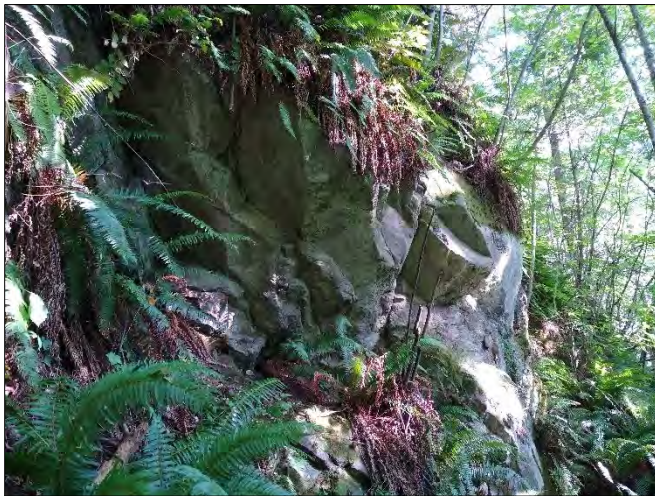
**Photo 3:** Northern Part of NW Bedrock Face

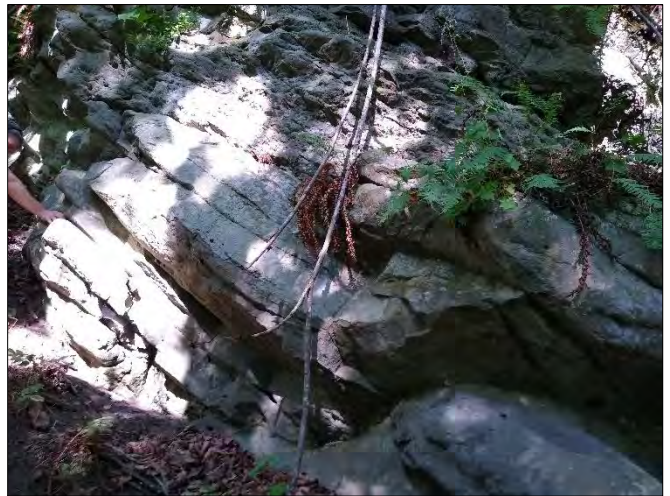
**Photo 4:** Northern Part of NW Bedrock Face

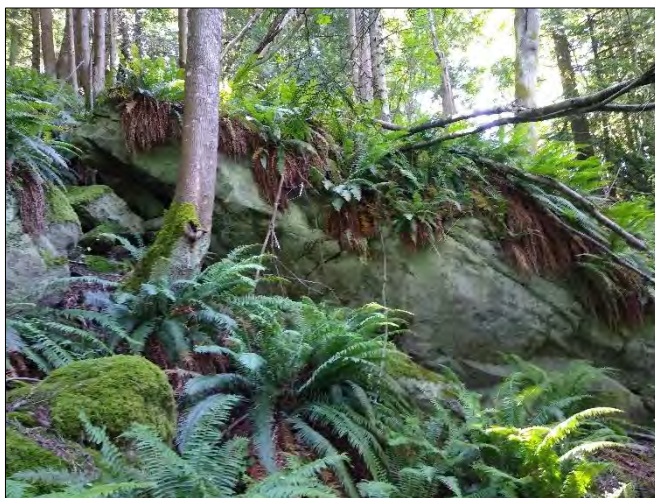
**Photo 5:** NW Forested Slope

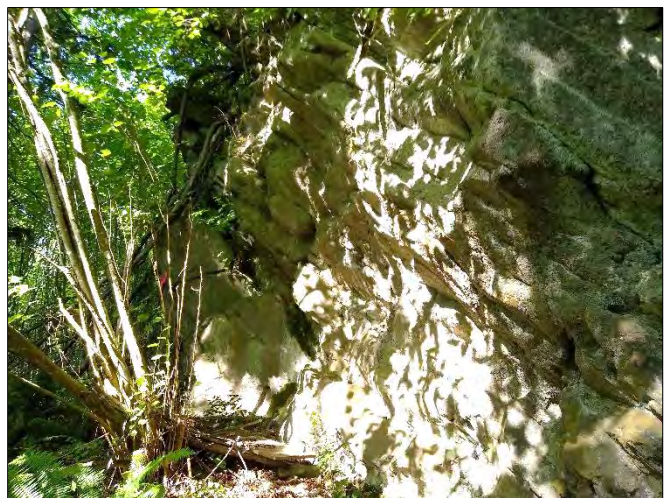
**Photo 6:** Central Area of NW Bedrock Face

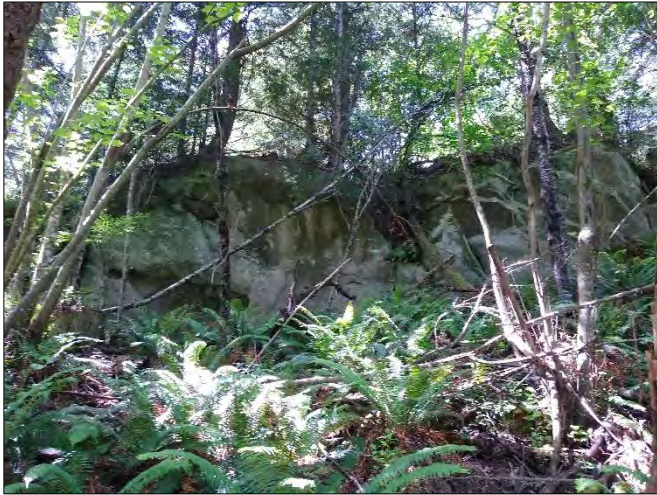
**Photo 7:** West-Central Bedrock Faces; West Outcrop

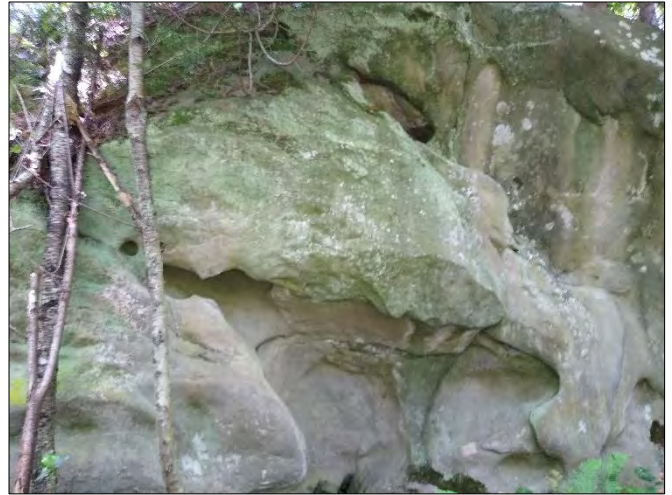
**Photo 8:** West-Central Bedrock Faces; West Outcrop

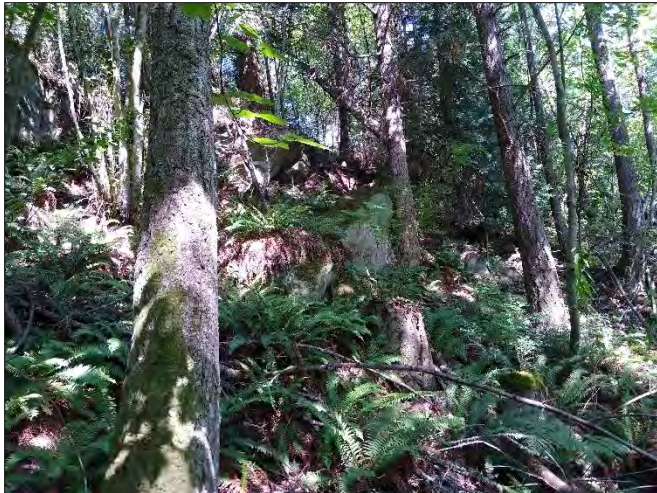
**Photo 9:** West-Central Bedrock Faces; West Outcrop, Northern Slope Area

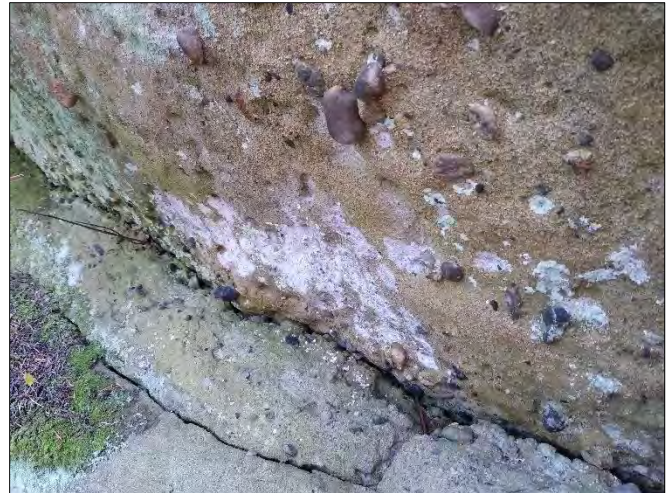
**Photo 10:** Conglomerate Bedrock Exposure; SW Project Area
