November 22, 2024

Project: **Proposed 38-Lot Woods at Viewcrest Plat**  
352 Viewcrest Road, Bellingham, WA

Subject: **Geohazard Review Addendum – Stormwater Outfall Plan**

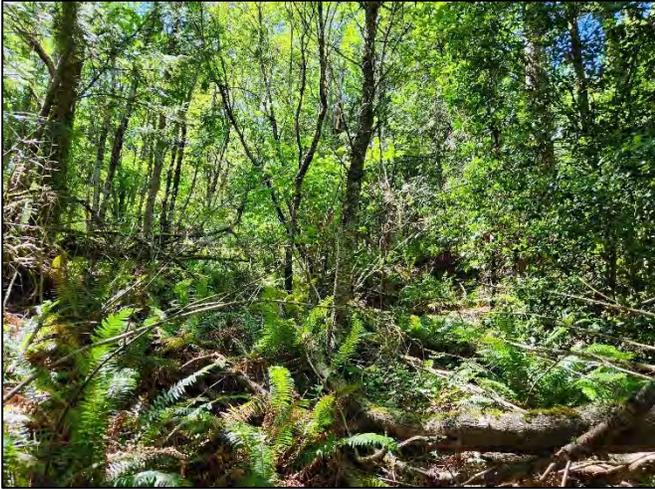
**Photo 1:** Upper slope conditions near top of SW outfall path, looking uphill.

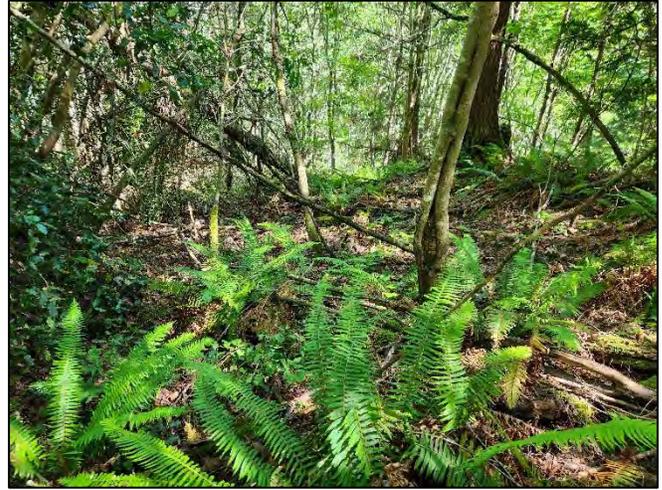
**Photo 2:** Upper slope conditions near top of SW outfall path, looking downhill.

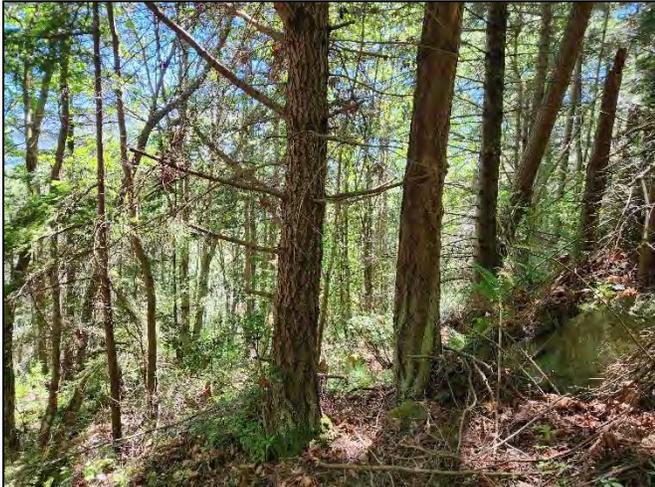
Upon reaching the area of the 90-degree turn in the outfall alignment, conditions change locally and persist for over 100 feet to the southwest. Sandstone outcrops locally, exposed on the order of 5 to 10 feet in height, along "ridges" oriented roughly east-west that cut across the southeast-facing slope (Photos 3 & 4). The outcrops are interspersed with small benches, creating an uneven ground surface that rises and falls in small areas. Overall ground conditions appear to be stable in this area, based on the common presence of large mature trees, although locally loose soils and rock may be found in troughs and directly above/below outcrops.

**Photo 3:** View to southwest from turn in alignment along proposed path with rock outcrop to right.

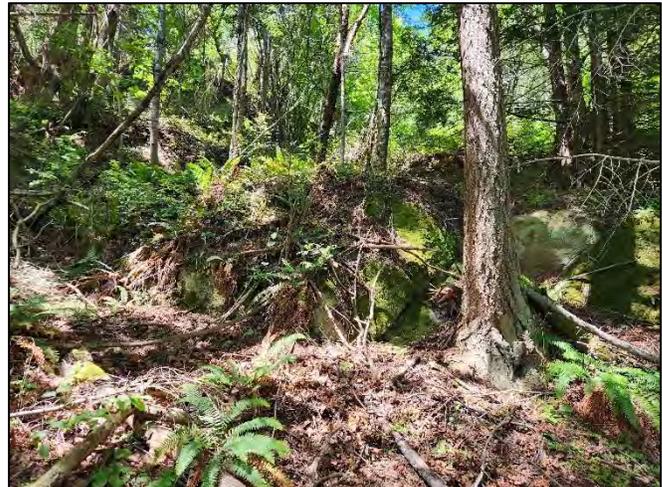
**Photo 4:** Looking uphill toward area of outfall path passing from right to left through extent of outcrop.

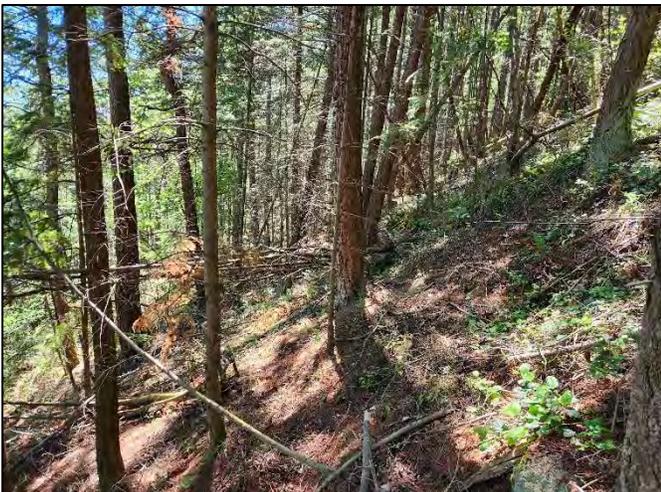
Past the zone of small outcrops, the main southeast slope face is a broadly planar feature with minor local variation. Conditions are typically mature tree cover with varying degrees of underbrush and forest litter (Photos 5 & 6). Trees are generally growing with straight trunks indicating soil creep is not significant, but there is some evidence of leaning or fallen trees that suggests shallow rooting (likely in thin soils over bedrock). No evidence of slope erosion, sloughing, or failures was seen along the proposed alignment or on the slope face above/below. The slope becomes progressively more moderate to the southwest. At the location of the proposed top-of-bluff catch basin, topography is gentle and mature forest vegetation covers the zone between the upland slope face and lower bluff (Photos 7 & 8).

**Photo 5:** View along main outfall path across planar slope. Looking SW. Taken near end of outcrop zone.

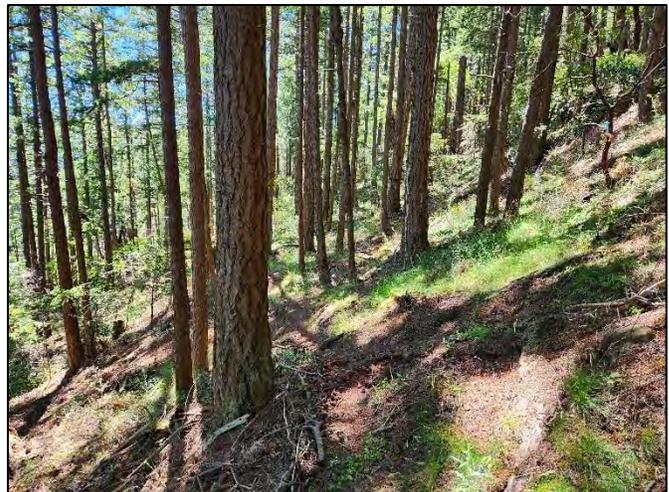
**Photo 6:** View to SW along outfall path across slope face. Location further to west of #5.

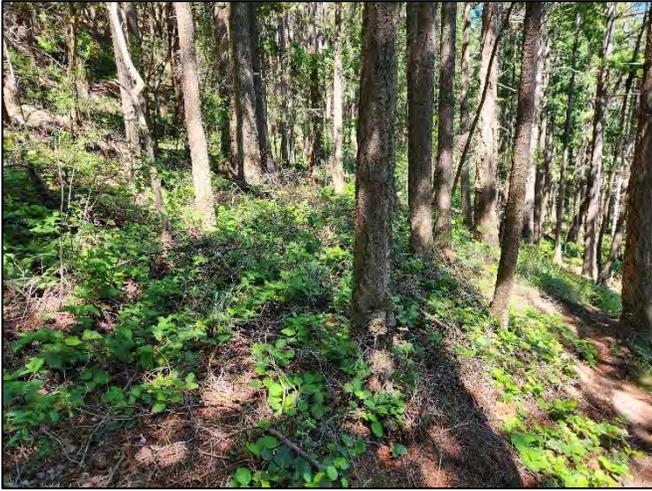
**Photo 7:** Looking at location of catch basin proposed near top of bluff (out of photo to right).

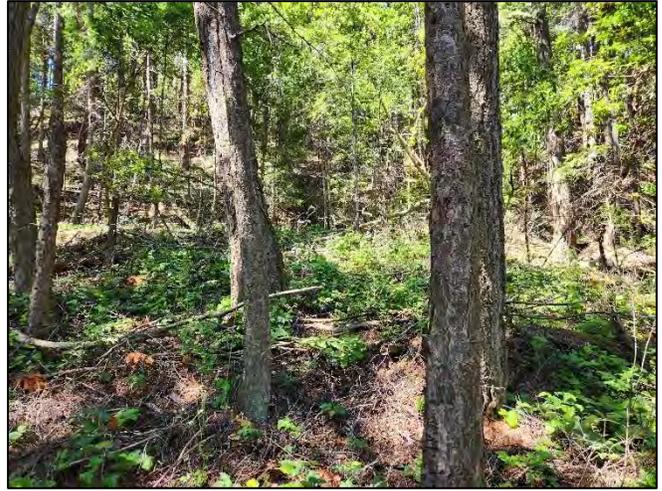
**Photo 8:** View uphill from location of catch basin. No evidence of slope activity and mature vegetation.

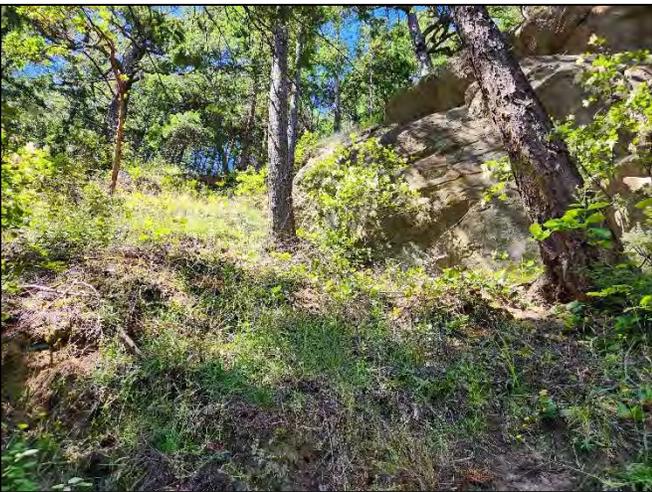
**Photo 9:** Looking up at slope face at entry of outfall onto lower bluff.

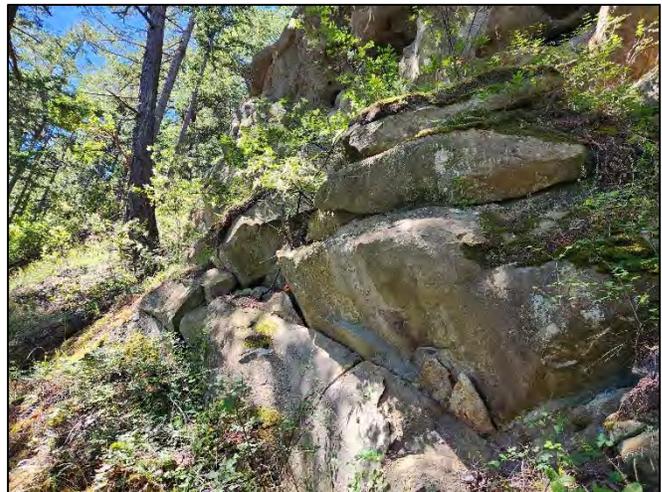
to the west, and wraps around the end of a large sandstone outcrop that appears broadly intact. Near to the east, the outcrop exposure becomes larger and exhibits common fracturing with some loose rock and recent rock fall remains on the ground below (Photos 10 & 11). The slope below the more fractured zone of outcrop has uneven terrain as a function of rock debris of varying sizes, but otherwise appears stabilized based on mature tree cover. The amount and size of rock debris generally dissipates downhill, further away from the outcrop face, with most surface rock observed within approximately 25 to 30 feet of the outcrop base. The outcrop remains exposed and becomes more competent to the east. Large boulders are present on the slope face just below the outcrop, but these appear to have been in place for a long time. The area with most recent rock debris evidence and outcrop fracturing is on the order of 100 feet wide, as estimated in the field, with the adjacent zone of older rock fall evidence and lesser fracturing an additional 100 feet wide (totaling about 200 feet width).

**Bluff Slope Rock Fall Zone:** After descending onto the lower bluff slope, the conveyance piping is proposed near the base of the tall rock exposure. While the eastern majority of this rock face appears intact with a low rock fall risk, the western portion appears prone to occasional rock fall from fractured outcrops. In particular, the first approximately 100 feet along the cliff face displays an elevated risk of incidental rock fall. This is evidenced by common rock talus on the underlying slope which generally dissipates out from the outcrop. The next roughly 100 feet of slope also has common older rock debris but little evidence of recent activity.

**Photo 10:** Fractured area of sandstone outcrop with loose rock exposed.

- One method to mitigate rock fall hazard from the cliff band is to adjust the alignment to traverse across the slope further away from the cliff exposure below elevated hazard areas. The hazard of rock fall directly impacting a downhill pipe generally lessens with distance from the source.

- A downslope shift on the order of 50 feet is interpreted to be sufficient to minimize rock fall impact risk, based on conditions observed during the recent reconnaissance. We recommend an alignment shift below the elevated hazard areas be considered for final design. Site conditions should be re-observed during final design to optimize the outfall path for rock fall protection.

- In addition to the above protective mitigations, shallow burial or inset of the pipe into natural topography will help minimize the potential for dislodged rolling or sliding rock debris to “catch” on the pipe as it travels downslope. We recommend the pipe placement be optimized to minimize a surface debris “catch” hazard by use of shallow embedment.

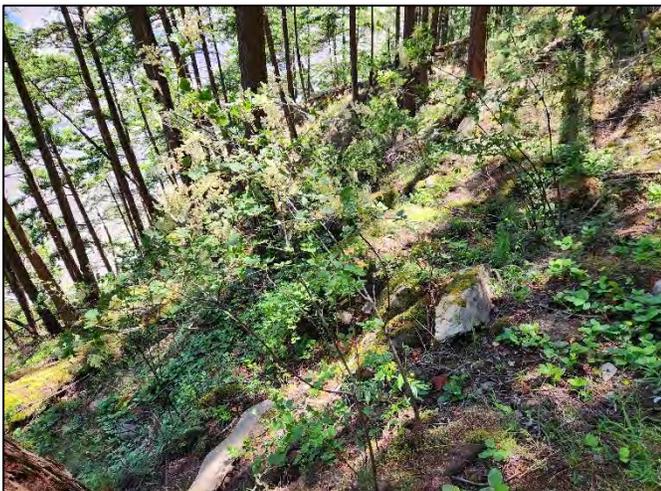
**Photo 11:** Slope face below fractured outcrop. Note rock fall debris in foreground.

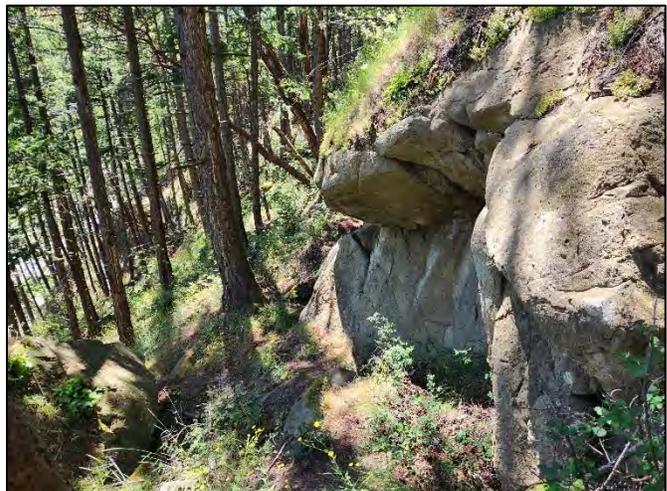
**Photo 12:** Sandstone outcrop becomes more competent / less fractured to east.

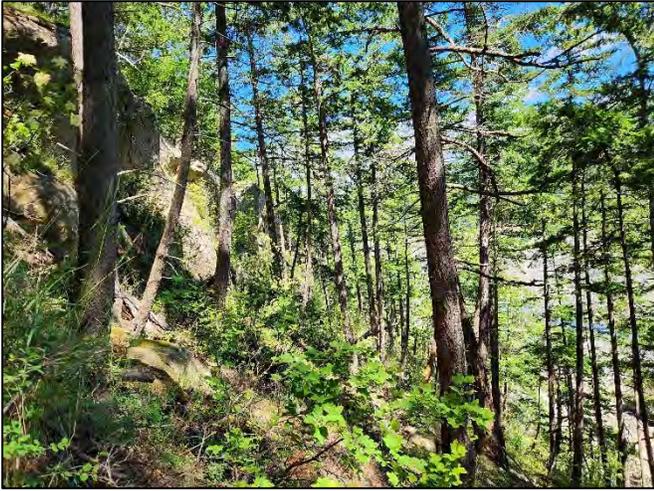
The proposed outfall path continues to follow the base of the sandstone cliff. The exposure grows to the east but becomes notably more competent with little to no evidence of recent rock fall (Photos 13 – 16). The lower slope below the outcrop is well vegetated with undergrowth, patches of grass, and mature pines. The final segment of the outfall travels a short distance down the slope to the proposed dispersion point atop a sandstone plateau at the shoreline (Photo 17). The level of activity in this area is generally low based on the outcrop competency and underlying slope conditions.

**Photo 13:** View across lower slope below large sandstone outcrop. Looking east.

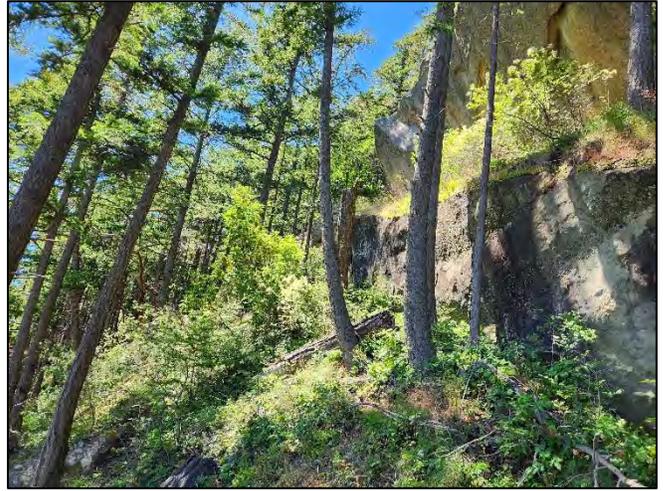
**Photo 14:** View of large intact bedrock face with forested slope below. Looking west.

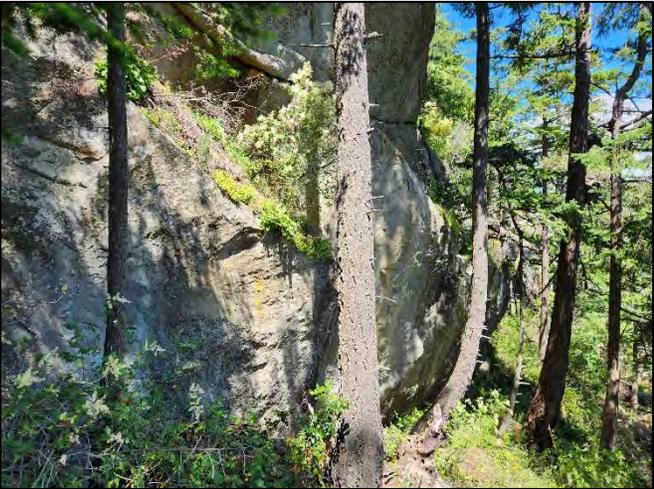
**Photo 15:** Large intact sandstone bedrock face near east end of conveyance alignment. Looking east.

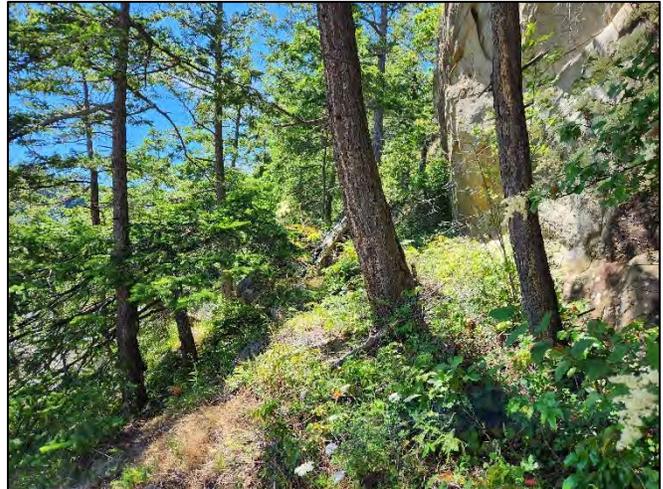
**Photo 16:** View of slope face below large sandstone cliff (near #15).

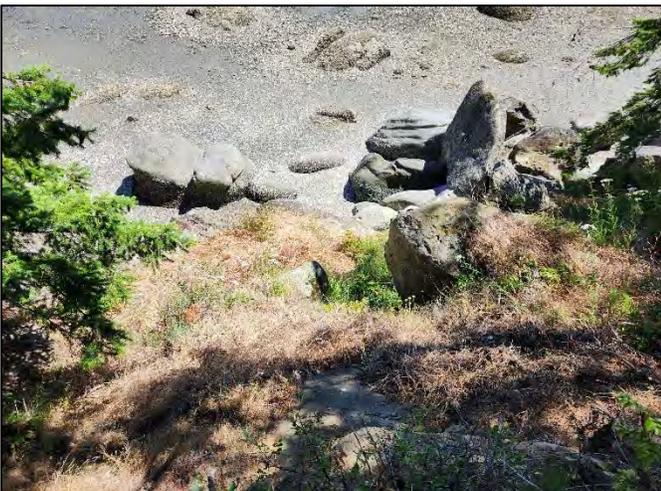
**Photo 17:** Looking down slope at proposed outfall release location above tidal beach.

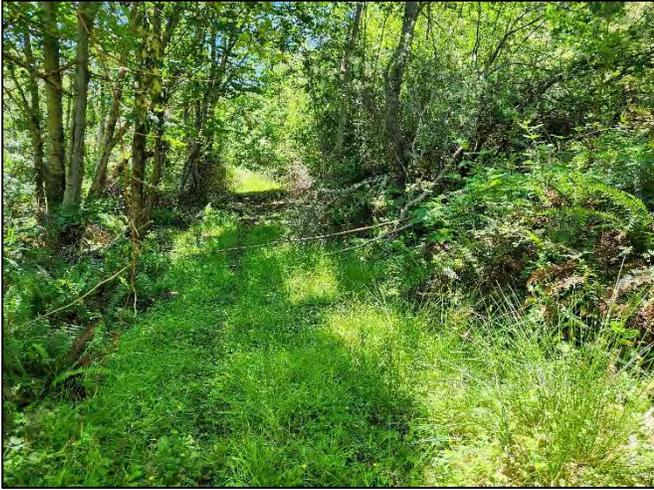
**Photo 1:** View along area of proposed dispersion spreader at west edge of Lot 38. (6-24-24)

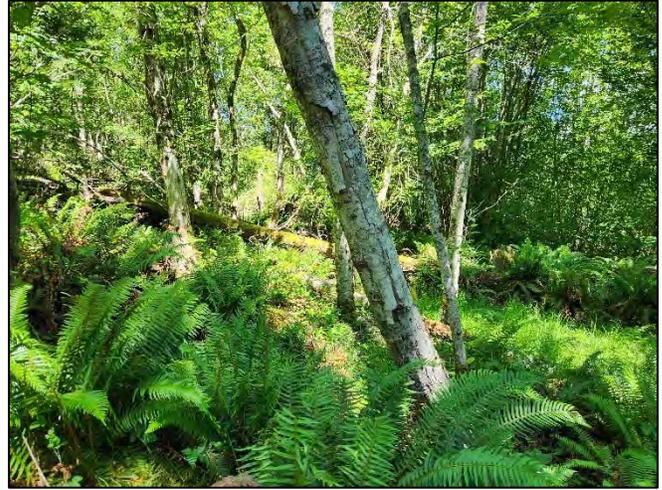
**Photo 2:** View to North across Wetland "B" area downhill to east of planned dispersion area. (6-24-24)

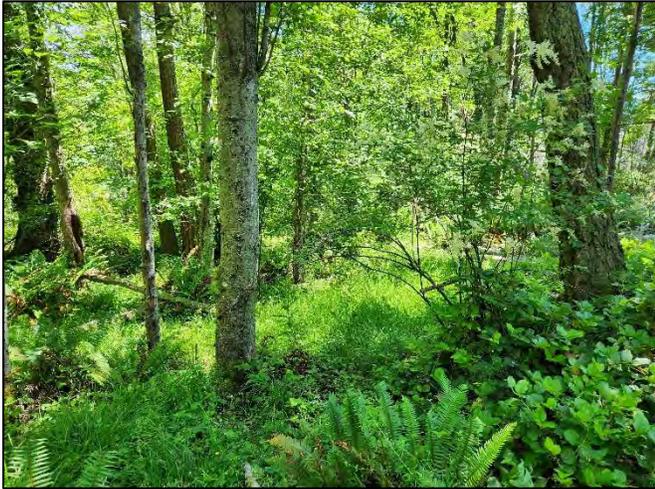
**Photo 3:** View to East downhill from Wetland "B" toward small Wetland "C" and forest area. (6-24-24)

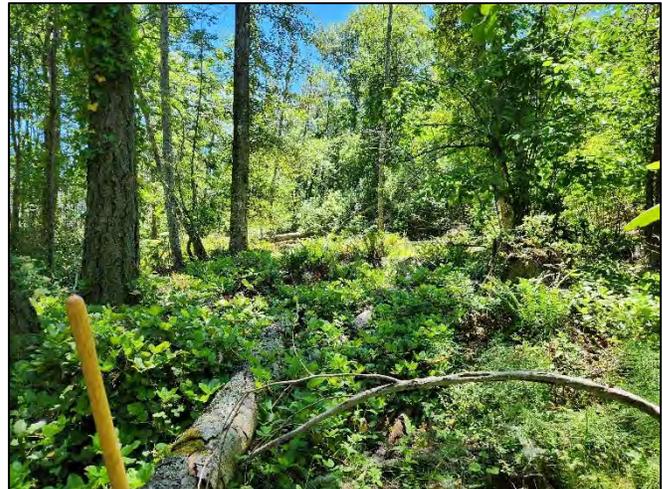
**Photo 4:** Gentle forested upland area to south of Wetland "B". (6-24-24)

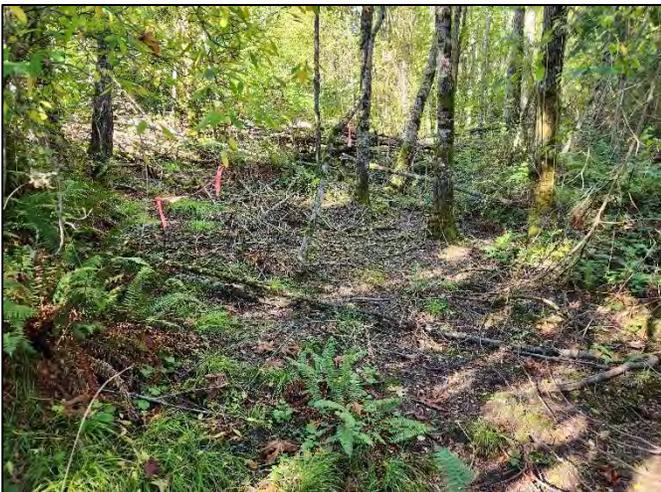
**Photo 5:** Small Wetland "C" area, looking to northwest. (10-7-24)

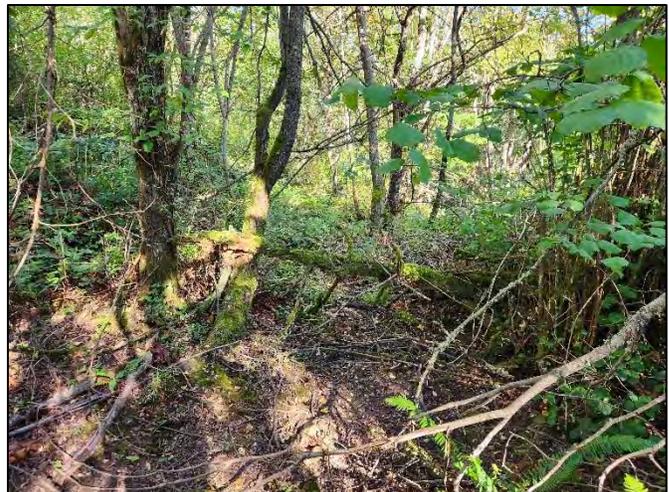
**Photo 6:** Small Wetland "C" area, looking downhill to east along minor convergence in grades. (10-7-24)

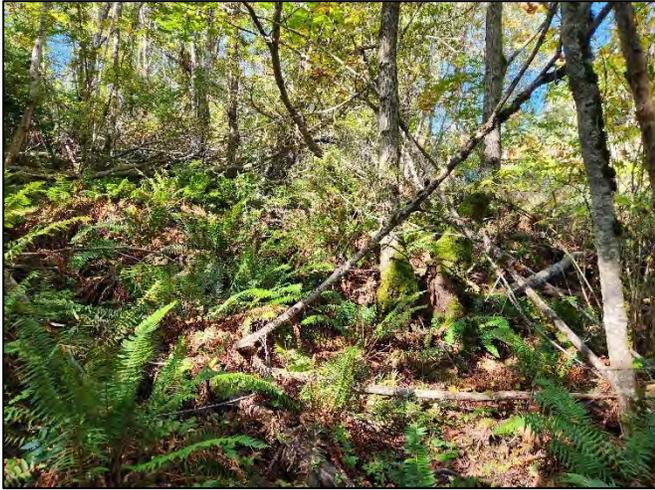
**Photo 7:** Upper slope leading into LHA area from off-site lots. Looking North from site boundary. (10-7-24)

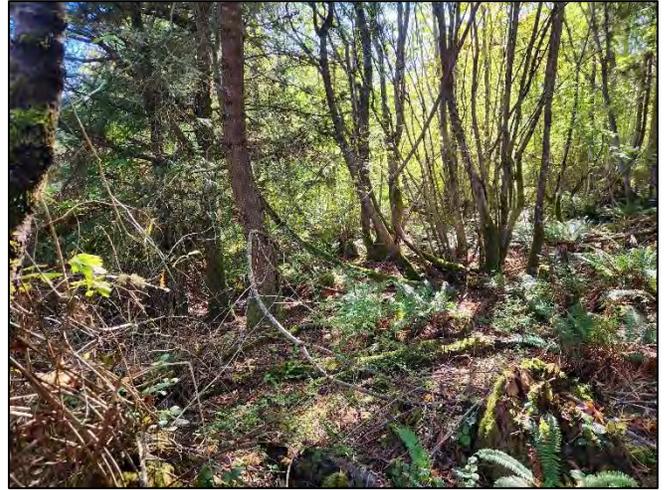
**Photo 8:** Typical upland forest conditions approaching LHA slope crest within site, looking East. (10-7-24)

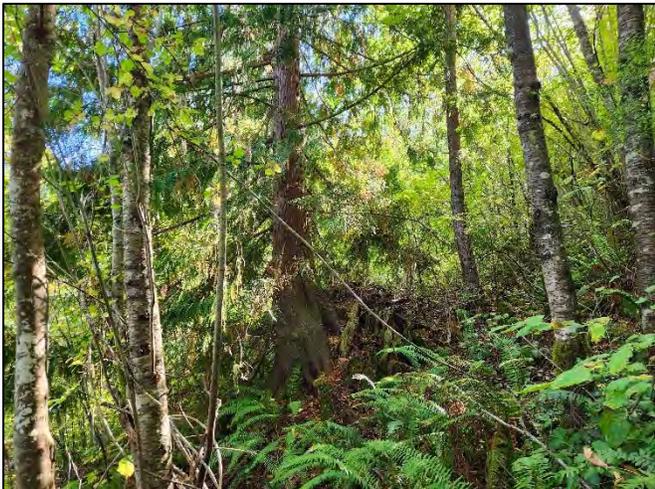
**Photo 9:** LHA slope crest along south area of slope, looking South downhill of proposed Lot 38. (10-7-24)

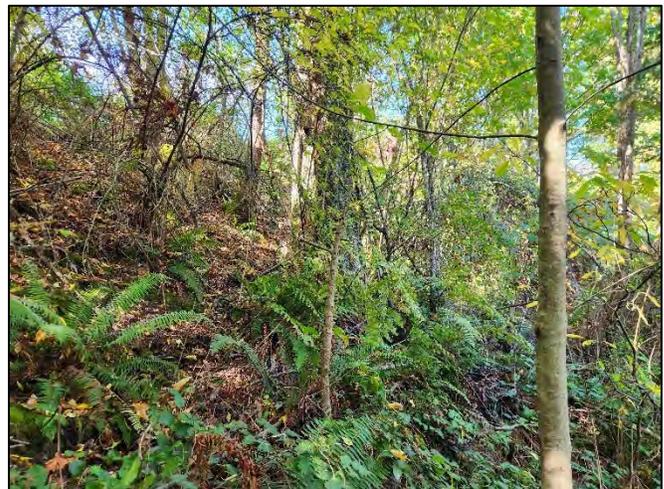
**Photo 10:** LHA slope face. Looking North toward middle of slope. (10-7-24)

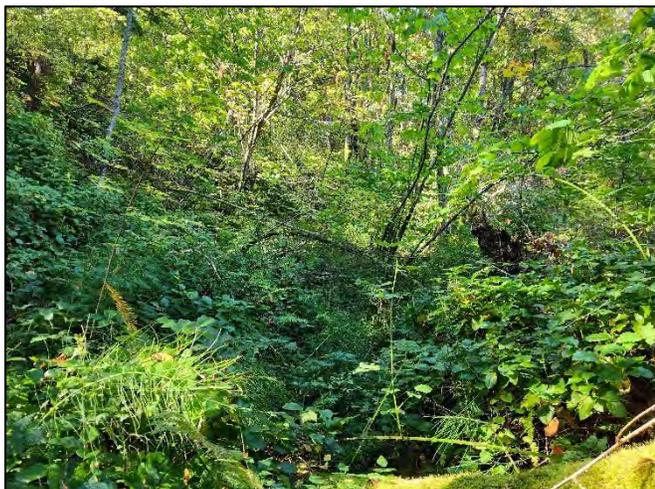
**Photo 11:** View Northwest through LHA basin / Wetland "A" area from South end. (10-7-24)

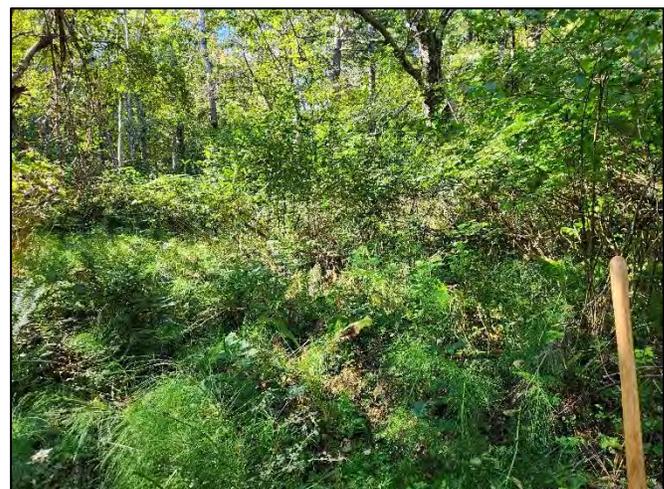
**Photo 12:** Conditions in middle of LHA basin / Wetland "A" area. (10-7-24)

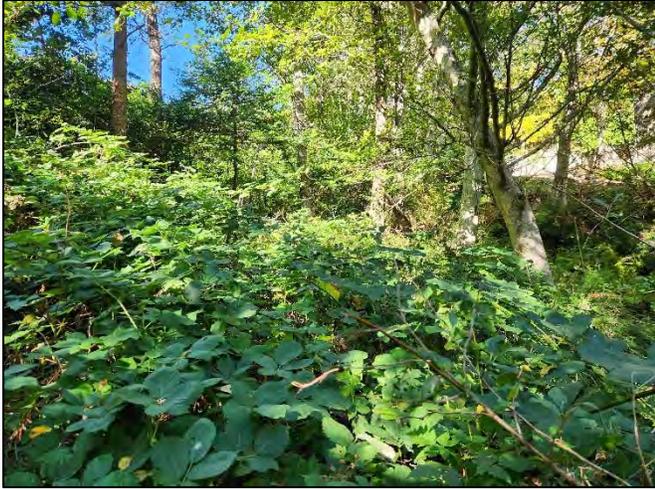
**Photo 13:** Within middle of LHA basin, looking North up brushy slope toward mapped SD outfall. (10-7-24)

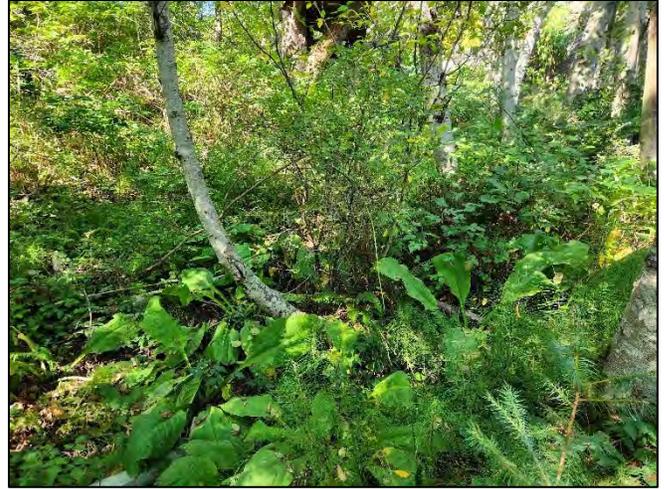
The convergent basin below the LHA slopes consists of lower surface grades leading into the low-lying Wetland “A” area. The transitional lower slope zone was covered in heavy brush and not accessed, but was viewed from within the basin bottom (Photos 11 & 12). We observed ground conditions becoming progressively moist to wet northeastward. Vegetation also changes to wet zone grasses and plants approaching the east site boundary (Photo 14) which is paralleled by a driveway embankment (Photo

**Photo 14:** Wet ground and plants concentrated along East margin of LHA basin. (10-7-24)

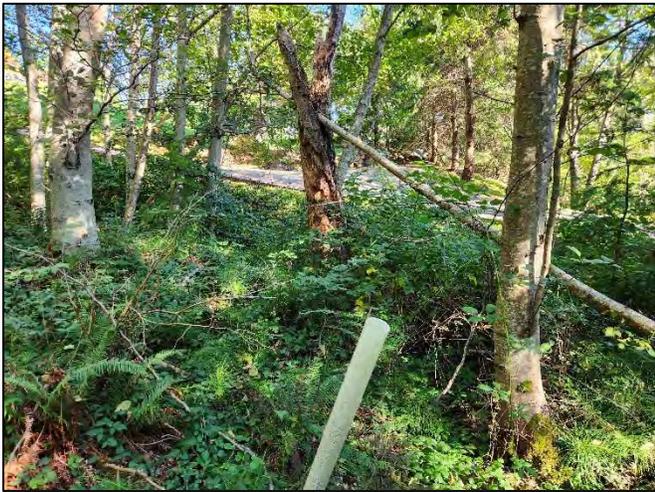
15) that effectively confines the basin on that side. At the low-point east margin of the basin, we found the mapped public Storm Drain inlet that leads into the Sea Pines Road system (Photo 16). City of Bellingham maps indicate an outfall for a public storm drain system from Viewcrest Drive located just uphill from the site's northeast corner (shown on Figure 2). We could not access this area from within the site (Photo 13). The presence of the mapped wetland extending well up the slope toward this outfall suggests the conditions are related. It is plausible, if not likely, that the SD outfall is a primary contributor to Wetland "A", and that the accumulation of water in this basin is controlled by the downhill inlet. We did not find or directly observe other seeps in the area.

**Photo 15:** Within east side of LHA basin, looking east toward SFR driveway embankment. (10-7-24)

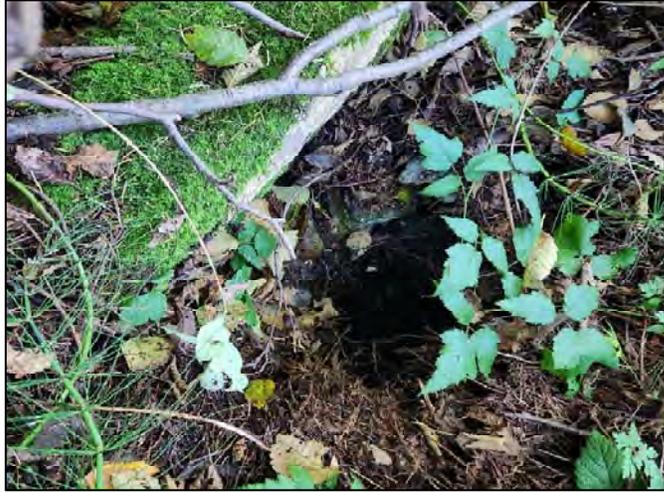
**Photo 16:** Found SD inlet at East edge of LHA basin and site, leads to Sea Pines Road utility. (10-7-24)

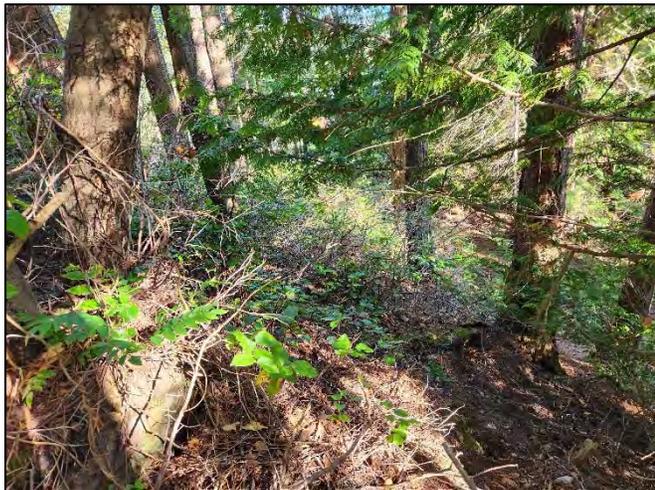
**Photo 17:** Moderate forested slope conditions at Lot 37 building zone, looking West. (10-7-24)

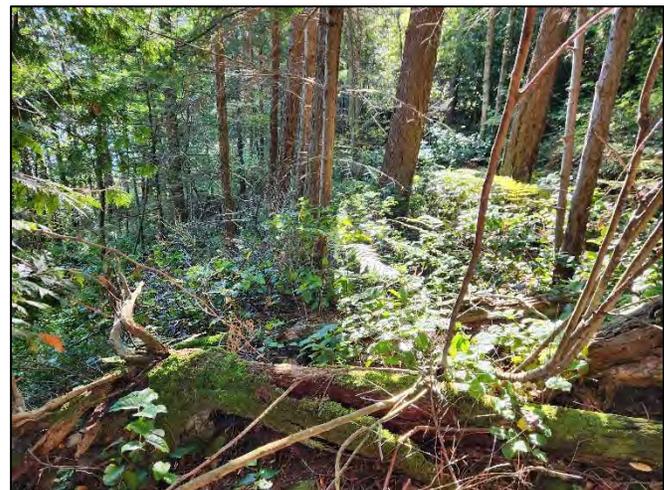
**Photo 18:** Moderate forested slope conditions at Lot 37 building zone, looking Southeast. (10-7-24)

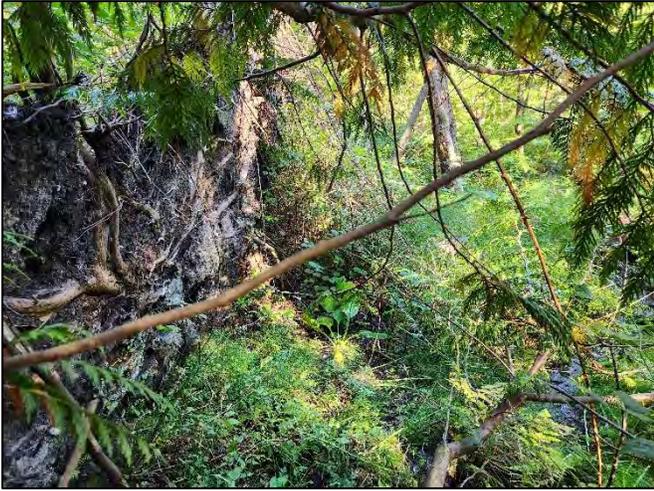
We located the top of the mapped wetland, finding wet ground exposed where a large tree had fallen in the past (Photo 19). Nearby rock exposures suggest bedrock is shallow in this area, limiting root depth and contributing to perched water conditions. We followed the upper half of the feature downhill until heavy brush became impassable. The feature was slightly lower compared to flanking slope areas, confining its extent. The feature typically had dark, moist to wet organic soils amid wet zone plants (Photo 20). Minor free water was present, although there was no consistent flow or channelization seen at the time of our visit. The lower end of Wetland "D" was found from below. At its terminus, the wet zone flora ends abruptly into typical brushy undergrowth approaching the lower slope (Photo 21). Along the nearby bluff slope crest, bedrock is exposed and patchy cover soils did not have signs of erosion from excess water flow (Photo 22). We interpret that any excess wet conditions emanating from the Wetland "D" feature are reabsorbed into the ground along the gentle upland grades before reaching the rocky bluff crest.

**Photo 19:** Uphill end of Wetland "D" with fallen tree remains and wet ground below. (10-7-24)

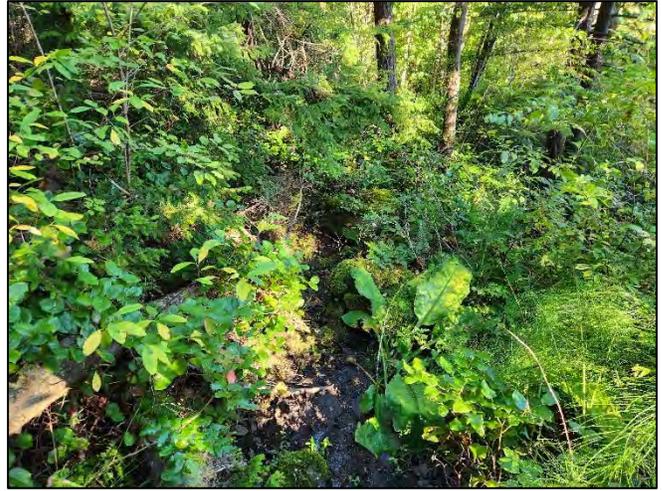
**Photo 20:** View down-gradient along strip of Wetland "D". (10-7-24)

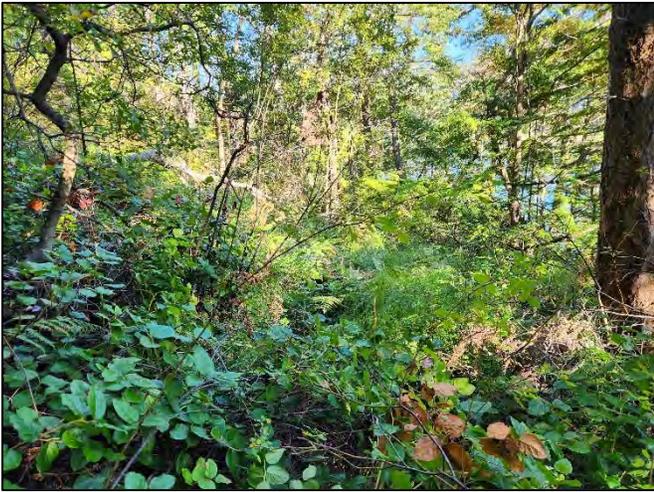
**Photo 21:** Downhill terminus of Wetland "D" above bluff slope. (10-7-24)

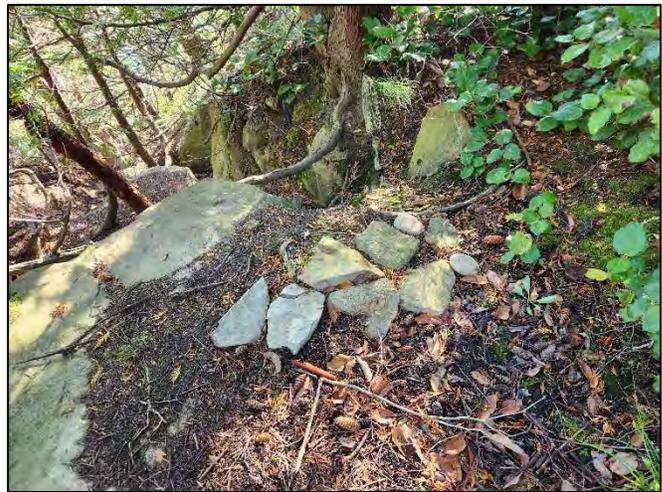
**Photo 22:** Rocky bluff slope crest near end of Wetland "D". (10-7-24)

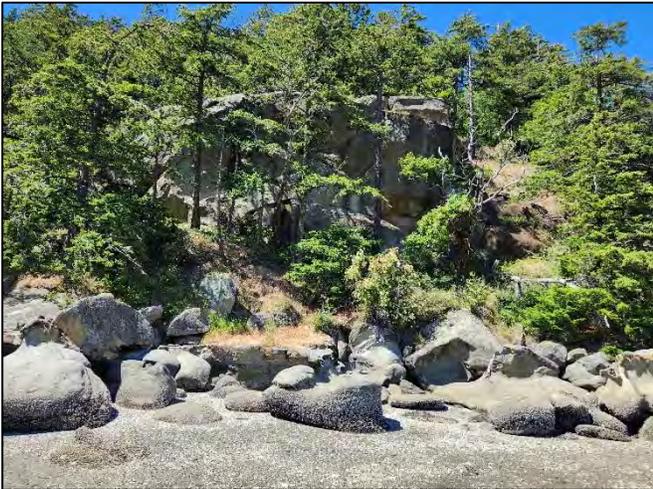
**Photo 1:** View of site shoreline from tidal zone at proposed dispersion area.

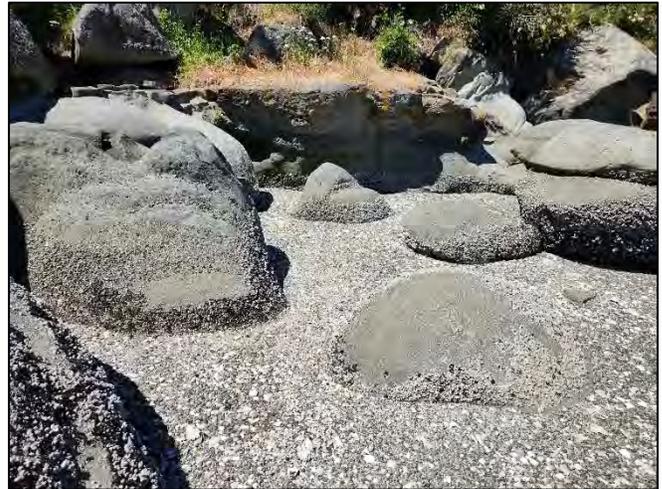
**Photo 2:** Dispersion is proposed atop the flat "table" outcrop situated among a rocky area.

- Design the shoreline Dispersion Tee so that it is sufficiently secured and resistant to damage from storm surge wave events.
  - Anchor the Dispersion Tee directly to the rock shelf by use of epoxied dowels and collars to the extent that it is not at risk of loss or dislodgement from a maximum potential storm wave magnitude.

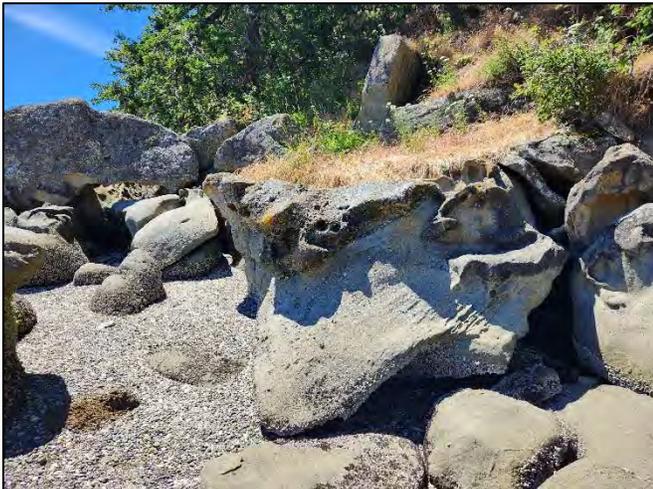
**Photo 3:** Profile view of dispersion outcrop and upper tidal conditions below.

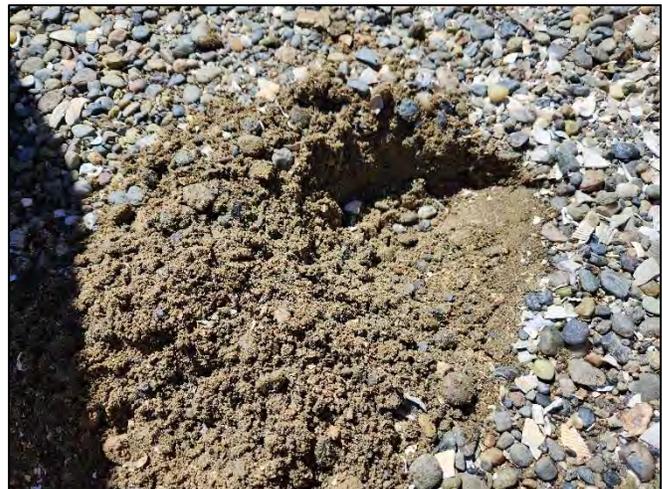
**Photo 4:** Upper tidal sediments consist of coarse-grained sand and gravel.

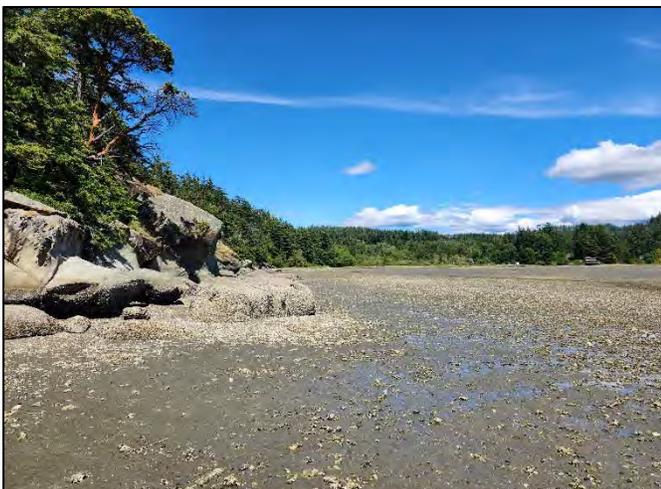
**Photo 5:** View to east from near dispersion area showing lower tidal conditions

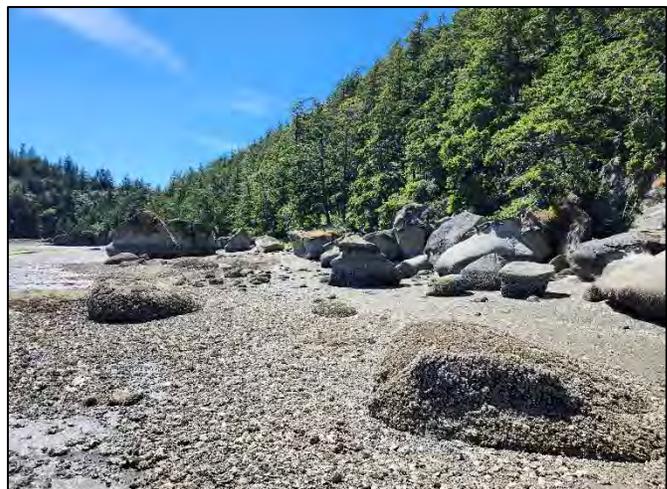
**Photo 6:** View to southwest from near dispersion area showing transition zone between upper and lower tidal areas.

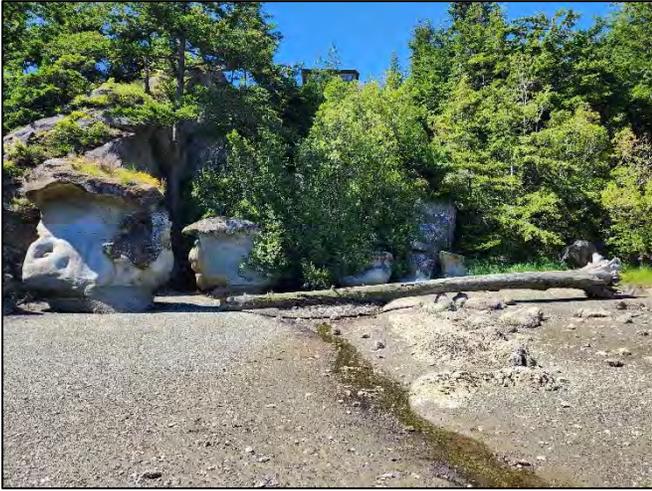
**Photo 7:** View of shoreline at location of existing stormwater release below Arbutus Place.

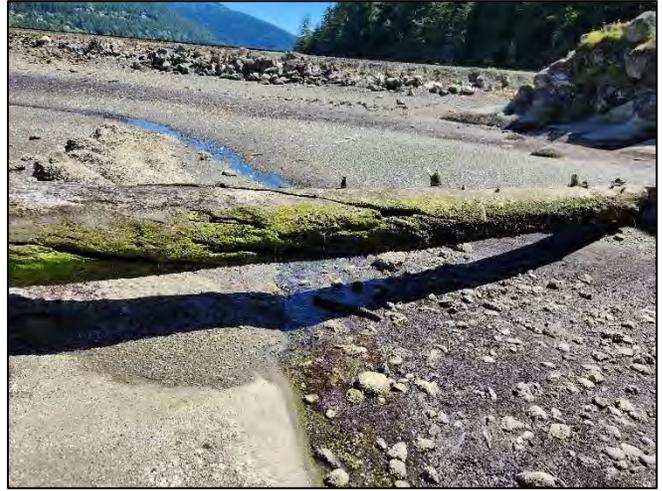
**Photo 8:** View out from shoreline next to emergence point of existing release.

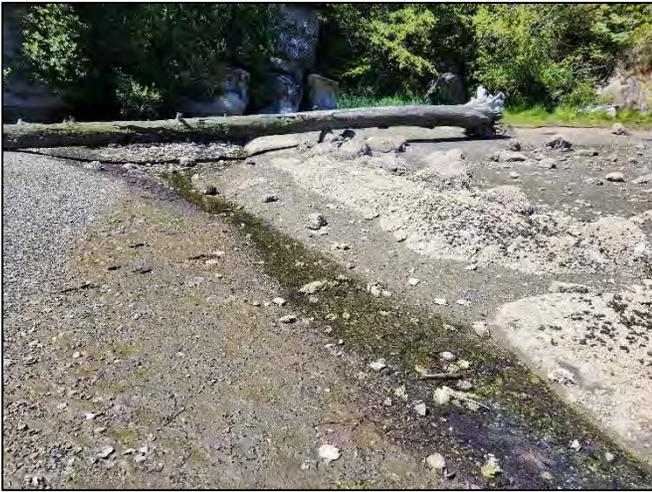
**Photo 9:** Closer view of flow channel conditions through upper tidal area.

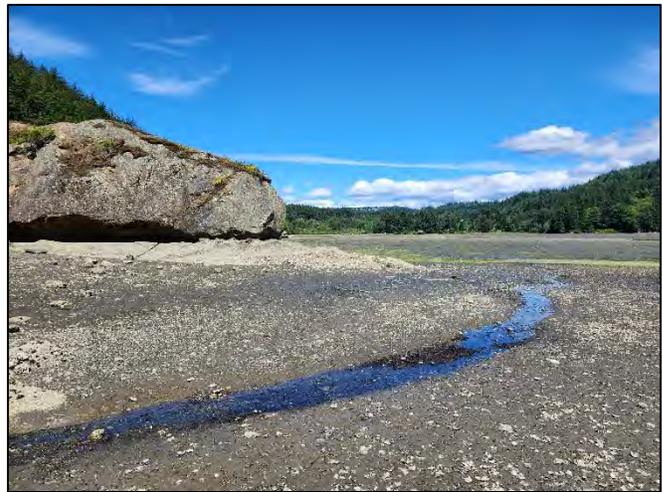
The existing outfall below Arbutus Place provides a comparison opportunity for potential impacts to tidal area conditions. Based on review of COB CityIQ GIS mapping of stormwater conveyance in the area, the Arbutus Place outfall appears to serve a cumulative extent larger than that of the project site. We have observed during shorefront reconnaissance, and by review of historical aerial photos, that associated effects to the upper tidal area from the Arbutus Place outfall are localized and relatively minor in nature after 43 years in service. No discernable impacts were seen to the main tidal extent past the local flow channel which dissipates progressively from the shoreline. This comparison location does not appear to have experienced impacts resulting in a loss of shoreline and tidal area function.

**Photo 10:** View of channel through transitional zone heading into lower tidal area where it becomes indistinguishable.
