Item 4.0 of “Adapting Woodstock” Charrette “Site Planning Topics & Reference Items”

Working With Water—Wetlands, the Creek, Bay Dynamics

Notes and Map by Tim Wahl, July 2008

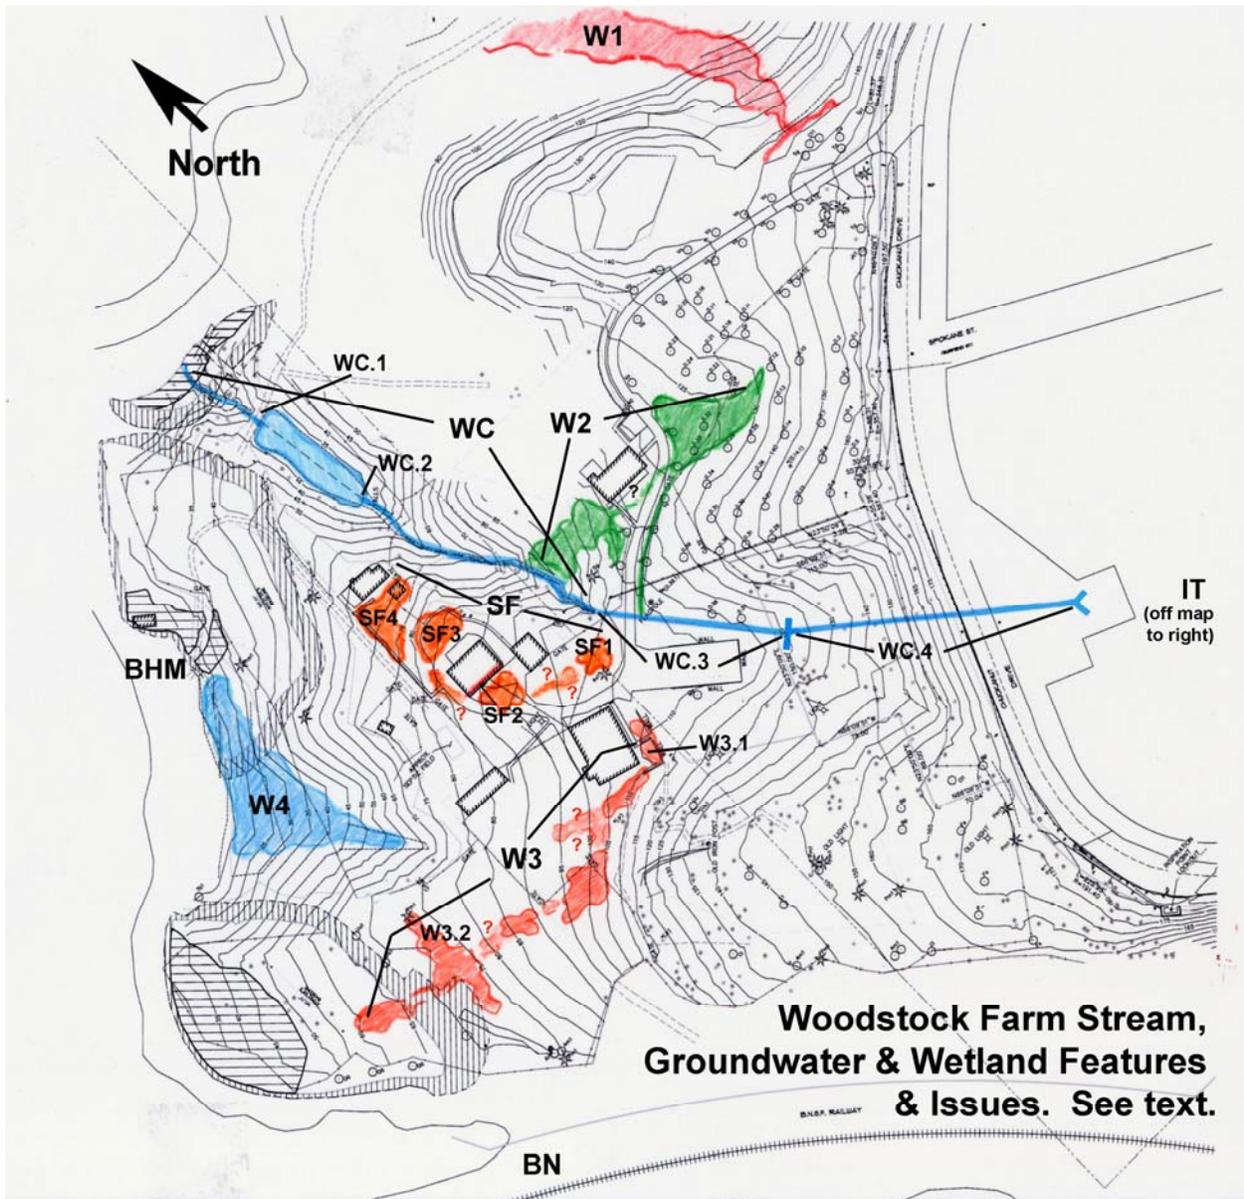
W1 Kopperdahl Wetland; Trail Renovation Issue

The switch-backing trail here is a former cat road constructed hurriedly by aspiring developer. Trail renovation requires a drainage system that essentially incorporates the hillside wetland flows moving down the draw. Like other narrow, forested wetlands this feature adds considerable biological diversity to the Woodstock site. This wetland should be protected and must be “worked with” creatively to dry-out the trail. While a few species could be added to enhance diversity, based on appropriate reference sites, the understory and herbaceous components are in good shape and fairly diverse.

W2 Orchard Spring & Cook’s House Wetlands; Driveway and Other Structural Issues

Water collects in the mowed basin opposite and E of the Cook’s House and is apparently discharged in a (probably partly collapsed) tile to the Cooks House wetland. The basin above the driveway has been historically grazed and altered (probably drained with tile) since the 1910s; as modified it comprises an important part of the historic character of the maintained orchard and grounds. Creation of a vernal pool could be explored. Water can be heard flowing from inside the Cook’s House basement. A portion of the peak discharge, probably resulting from tile failure, now flows along the upper edge of the driveway to and inlet at the sports court parking area, where it enters the creek culvert, one assumes. This flow along the driveway is likely charging the subgrade of the driveway, an undesirable state of affairs that should be corrected soon.

W3 Lower Bluff Seeps; Poorly Drained Areas around Gates-Lee House

Replacement of G-L House perimeter drains could eliminate a wet lawn problem at front door (W3.1, unusable during wet periods) and to relieve potential long term issues involving the house foundation... *Iris missouriensis* planted 2008 in pasture pockets W of “Chicken House lawn.” These seeps might be developed into wet meadow pockets and vernal pools as part of a designed landscape, for floral and biological interest. This system has been historically grazed and altered since the 1910s and, as modified, comprises an important part of the historic character of the Farm’s cultural landscape. Grass tennis court (W3.2) needs perimeter drainage for sustained use; it may have had such a system when constructed. Wet meadow pockets are visible outside regularly maintained areas cueing to *Juncus*. Preservation and enhancement of vernal pools and management of groundwater flows moving toward the extremely dry

W4 Boathouse Ravine Wetland

A relatively high quality forested wetland. Himalayan blackberries being removed from drier edges. *Viburnum trilobum* was added to buffer area. Former Gates' access road to the 1920s floating boathouse ran down this draw. Prehistoric wet-site artifacts of great interest but none found along OHWM. *Salicornia* and *Juncus* marsh at OHWM. 2006 inspection and dye tests with WCH Dept. indicate no septic discharges to this draw.

WC Open creek channel (WC), dammed pool (WC.1), seasonal waterfall (WC.2), lower culverted creek segment (WC.3), 1953 highway-standard creek culvert, WC.4

The Creek runs 6-9 months a year, and is valued as a source of gentle white noise and as a wildlife habitat feature. The potential for salmonid habitat is probably not significant; even with dam removal channel gradient is relatively steep, flows are low and fluctuating and a fish-impassible waterfall lies about 175' above the marine shoreline. The creek was culverted under Chuckanut Drive in 1953 or 1954 when a timber highway bridge was replaced with today's fill. A 36" culvert under the highway now connects with a 12" culvert running along the NE side of the sports court parking area to discharge into the open creek channel at the edge of the driveway. The discharge area below the driveway was seriously eroded during a creek overflow incident during the 1970s or 80s (?) when an object passing under Chuckanut blocked the 12" culvert in the junction box just above the sports court parking area. The eroded slopes at the 12" culvert discharge, while requiring stabilization, have remained remarkably stable after the overflow incident. Denis Bailey speculates there may be more than one culvert under segment WC4, although only one discharge is known. It is possible that an earlier Gates culvert under the original kitchen garden failed and was replaced by a second line by the Lees at the time of the 1953 highway construction. Apparent subsidence around the monkey-puzzle tree suggests underground instability due to ground water movement. Bailey has also wondered about a possible connection between the S barn wall and slab failures and old creek flows or flooding incidents.

SF Monkey-Puzzle Lawn Settling (SF1), Barn Slab Failure (SF2), Cowman's Cottage Area Bank Movements (SF4)

The concrete slab in front of the barn is failing and the S foundation wall of the barn basement is leaning to the N. Two structural engineers have looked at the situation and suggested monitoring. One felt action was needed immediately. Crack monitors are now in place on the barn wall, and indicate no movement over the past 18 months. (No failure trends or actual incidents are known.) Hydrostatic pressure is most certainly the cause of the barn wall movement, something which needs to be mitigated with sealing of the adjoining slab ASAP. Denis Bailey has speculated that there may be subsurface water movements from the old creek channel below the sports court parking area toward the barn slab/wall failure area. He also made note of the fact that the slab failure seemed to come after the plugged culvert incident described under WC, above. (Parks crews are implementing temporary water infiltration prevention actions this summer.) Taken with subsidence observed around the monkey-puzzle tree just N of the Gates-Lee House

and slumpage and soil heaving below the barn it is advisable to consider connected groundwater movements that may be influencing the entire S creek bank from the monkey-puzzle tree to the Cowman's Cottage. Below and N of the barn the old Gates dump (SF3, paved with a slab for parking by Ray Lee) is visibly slumping, the Cottage walkway slabs are heaving and an old shed at above the Cottage is breaking apart. Groundwater movements in this corridor are essential to understand with respect to the present septic fields in the area, as well what they mean for development of a new sewage treatment system elements for publicly-adapted Farm buildings.
