**GEOTECHNICAL INVESTIGATION
& GEOHAZARD REPORT
JONES EDGEMOOR ESTATE
PROPOSED 38-LOT PLAT DEVELOPMENT
VIEWCREST ROAD, BELLINGHAM, WA**

Submitted to Ann C Jones, Family LP
October 6, 2022

Subject: **Geotechnical Investigation & Geohazard Assessment**
Proposed 38-Lot Plat - Jones Edgemoor Estate
Viewcrest Road, Bellingham, WA

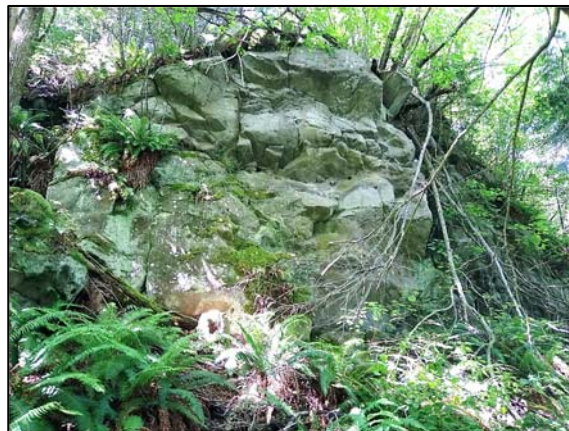
Photo 1: Bedrock Cliff Face; Northwest Slope

The cliff area along the northwest hill represents the greatest exposure and highest hazard potential for associated rock-fall (Photo 1, above). At its steepest point, the elevation drops about 37 feet over a horizontal distance of ~25 feet for an average slope ratio approaching 1:1.5 (H:V) along the cliff face. Grades range up to approximately vertical, and are locally overhanging on the variable outcrop faces. We observed these features to be highly influenced by the regularity and orientation of rock structures dictating their stability and character. Section 4.3 below provides a review of bedrock features and structures.

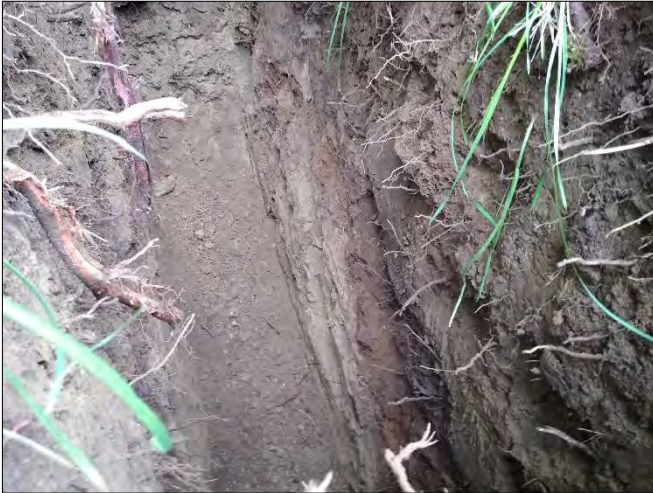
Uncontrolled Fill: Shallow materials, interpreted as non-native uncontrolled fill were found at one location (TP1, northeastern margin area) to approximately 3.5 feet bgs. The location coincides with an area of somewhat raised grade at the northern extent of the “East Road”, currently a primitive and overgrown off-road feature. Based on topographic indications, we suspect that similar fills may extend into the properties located to the east and west of TP1. The fill consisted of silt with sand (USCS Classification: ML) containing approximately 50% to 60% fines, was soft to medium stiff with depth, cohesive with low plasticity, and damp in the early summer season. The fill contained some chunks of asphalt, and was capped with about 0.7 feet of topsoil. A band of dark orange oxidation staining was observed from about 3.0 to 3.5 feet bgs near the base of the fill material.

Photo 1: TP1 Subsurface; Fill over Glacial Drift and Till

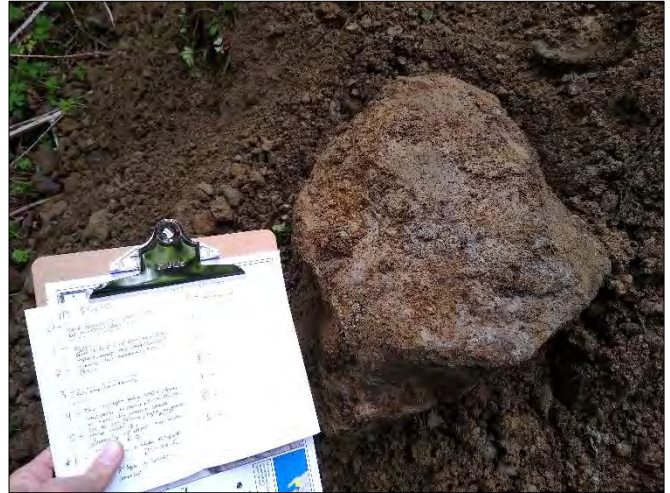
Photo 2: TP2; Excavated Boulder

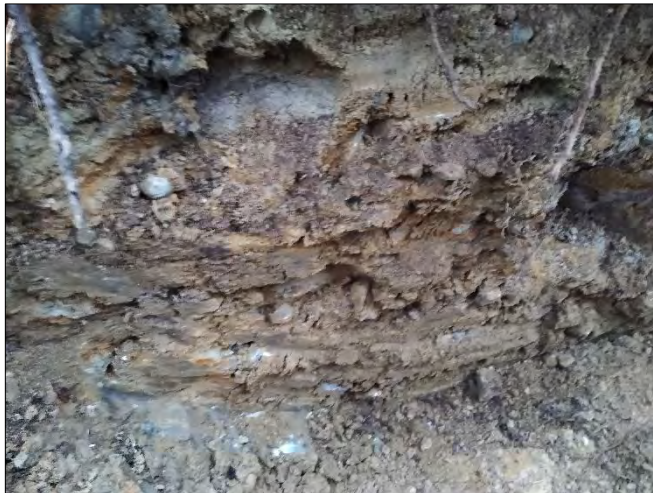
Photo 3: TP5; Redox Staining in Shallow Soil

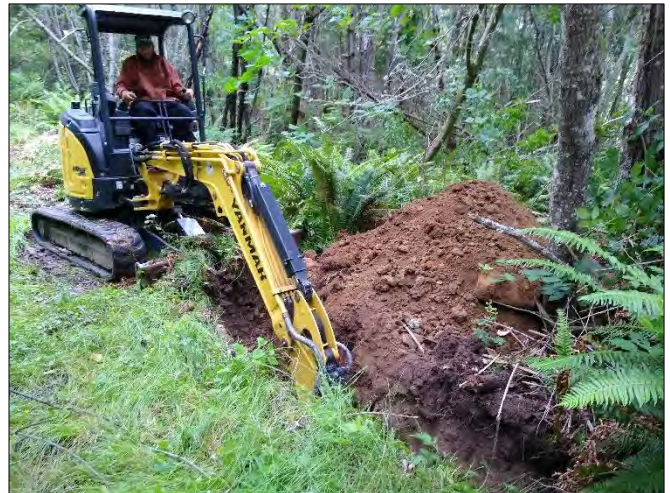
Photo 4: TP8 Location; Excavated Glacial Drift

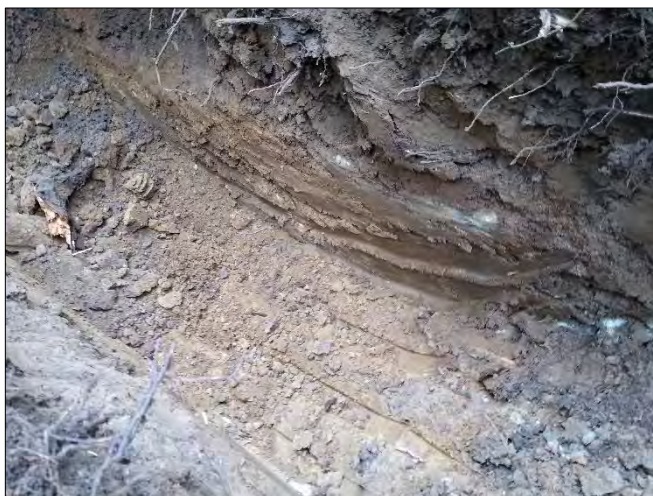
Photo 5: TP9; Oxidized Soil Horizon

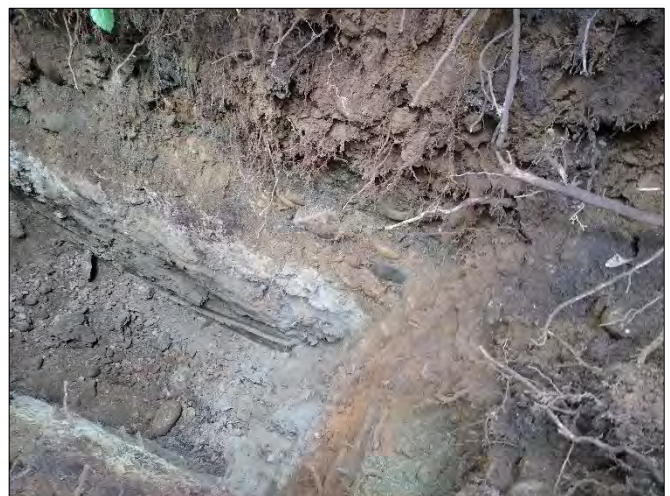
Photo 6: TP13; Thick Organic over Glacial Outwash and Dense Till

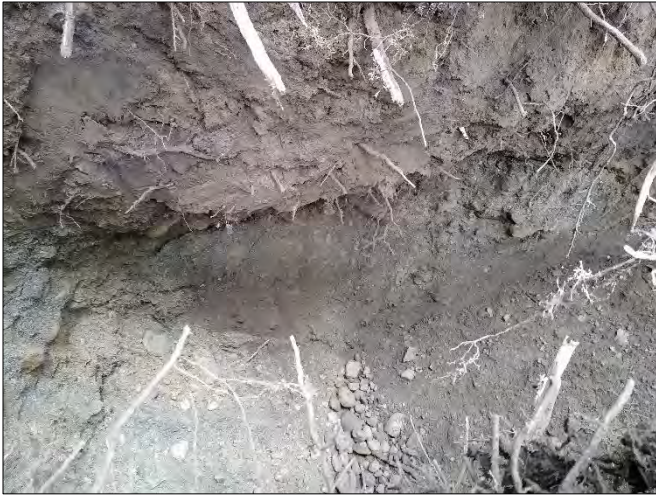
Photo 7: TP15; Thick Organic over Glacial Outwash

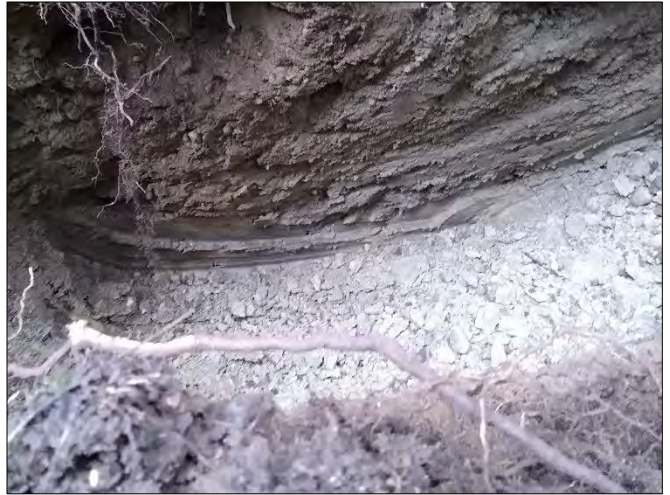
Photo 8: TP17; Dense Glacial Till at Base of Pit

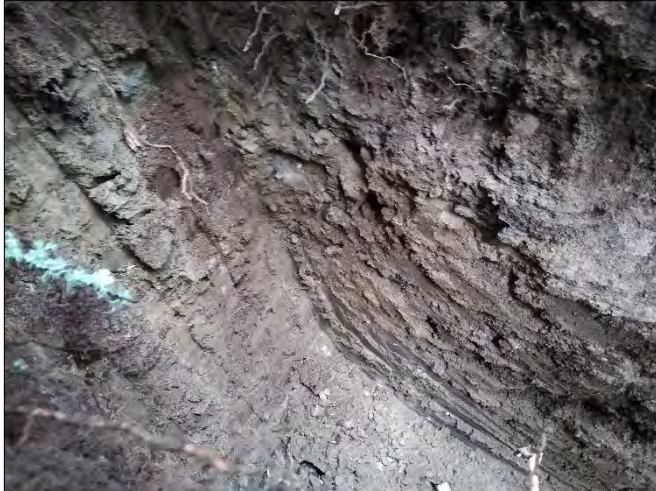
Photo 9: TP23; Glacial Drift over Dense Till

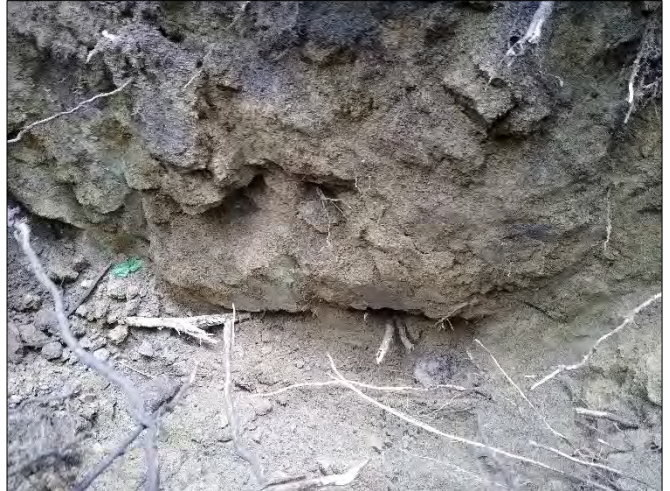
Soils that appeared to have been weathered-in-place (eluvium) were observed at the top of the outcrop in the northwest region of the site (TP25 and TP26). These soils appeared similar in character to the more frequently observed colluvium, but were made up almost entirely of poorly-graded medium sand (USCS Classification: SP), containing less than 5% fines. The SP soil was yellowish brown, non-plastic, non-cohesive, damp to moist, and loose to medium dense in the upper 3.5 feet before transitioning to the underlying weathering rind and bedrock at 4.0 feet bgs.

Photo 10: TP25; Sandy Eluvium Over Dense Sandstone Bedrock

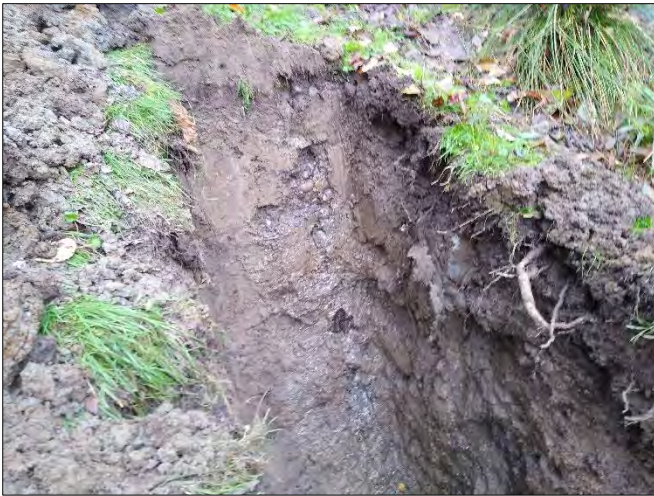
Photo 3: TP2 Seepage from North Pit-Wall

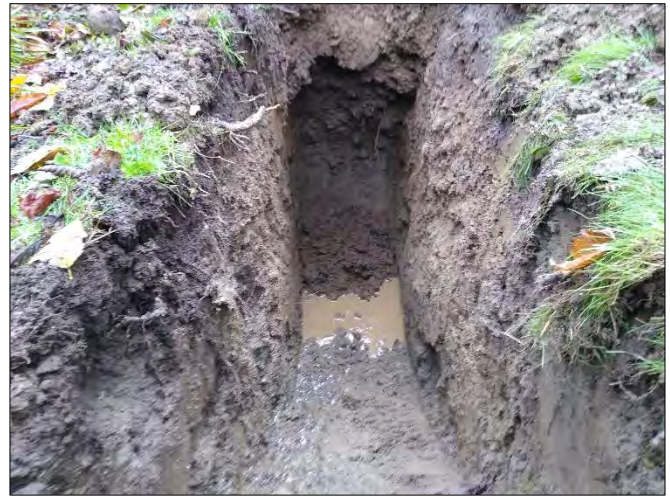
Photo 4: TP2 Caving on South Pit-Wall

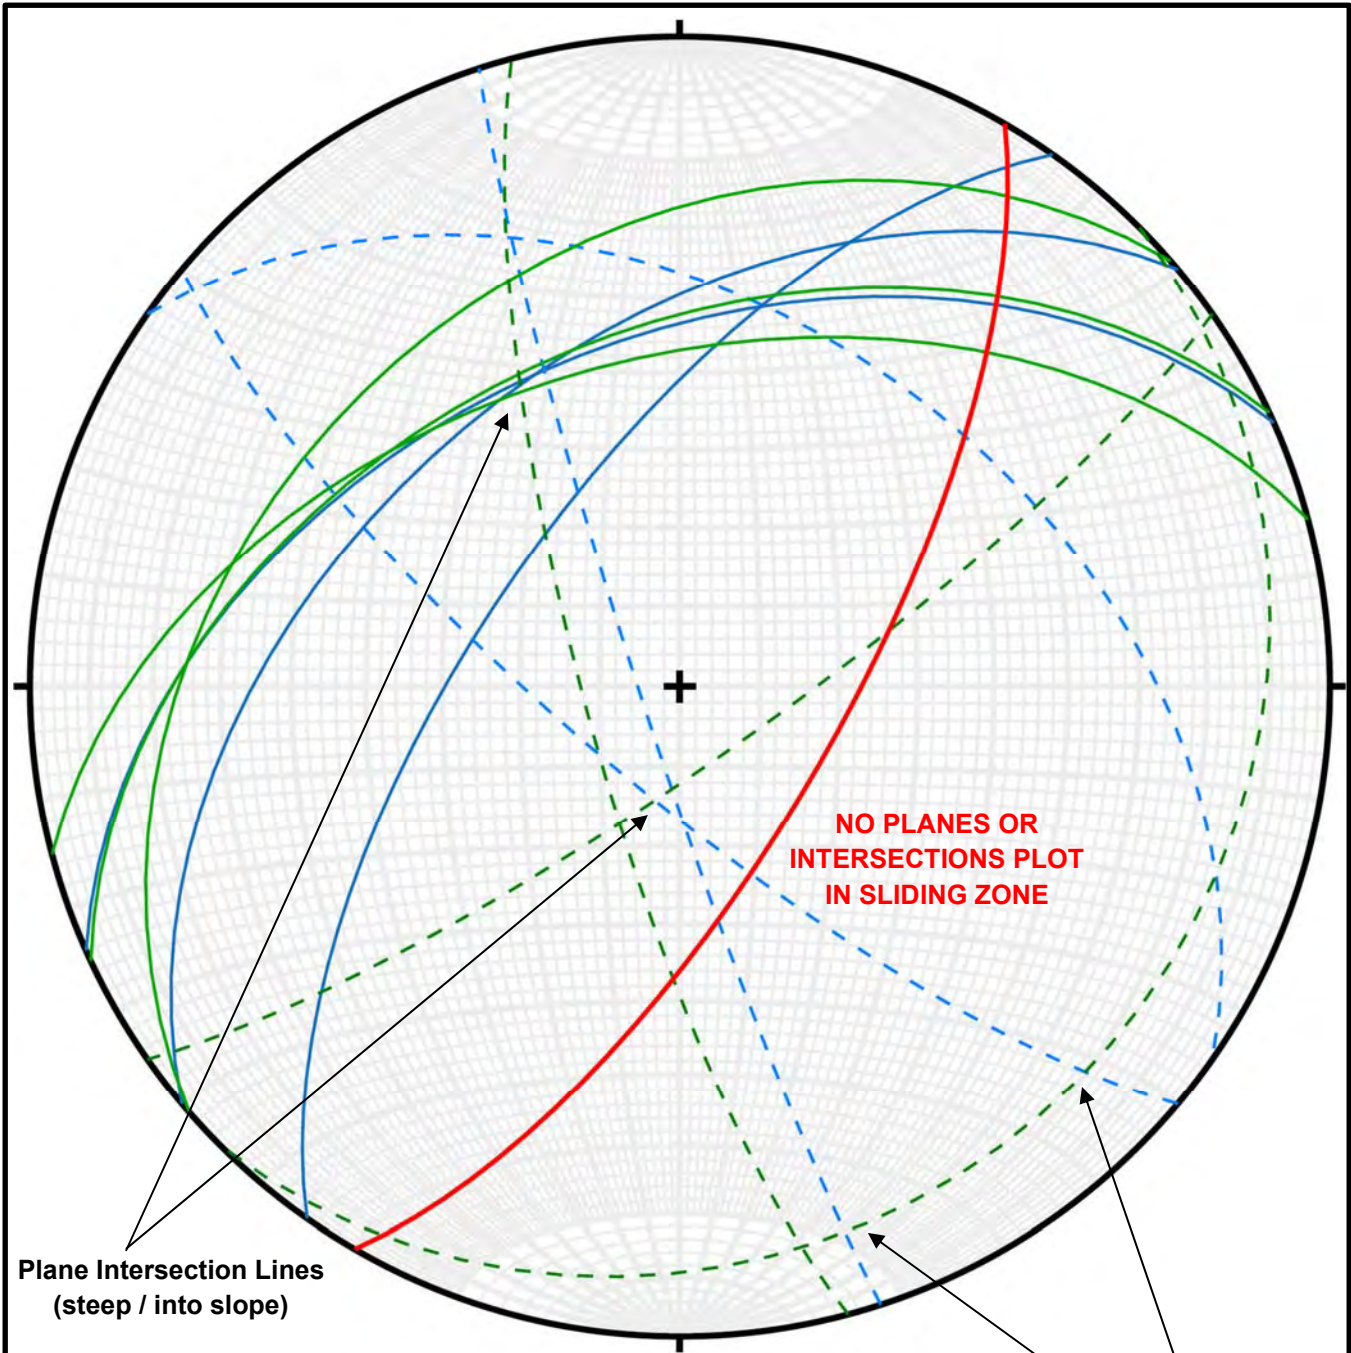
NO PLANES OR
INTERSECTIONS PLOT
IN SLIDING ZONE
