# **GEOTECHNICAL INVESTIGATION & GEOHAZARD REPORT JONES EDMOOR ESTATE PROPOSED 38-LOT PLAT DEVELOPMENT VIEWCREST ROAD, BELLINGHAM, WA**

Subject: **Geotechnical Investigation & Geohazard Assessment**  
**Proposed 38-Lot Plat - Jones Edgemoor Estate**  
Viewcrest Road, Bellingham, WA

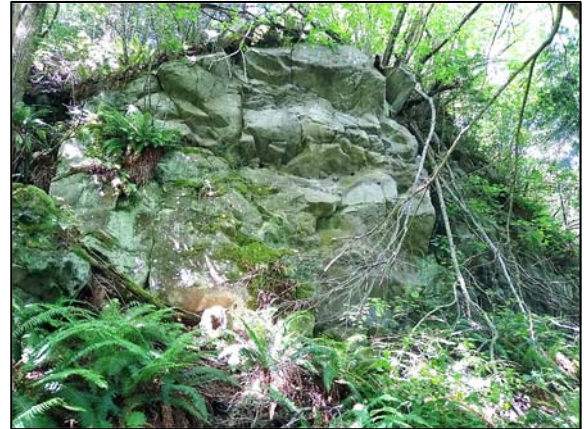
**Photo 1: Bedrock Cliff Face; Northwest Slope**

The opposite southeast side of the northwestern hill exhibits a steep or cliff-like face with prominent bedrock outcrops. Similar conditions are present to a lesser magnitude along the southeast faces of multiple smaller hills in the central project area. The cliff-formed faces are typically continuous for around 10 to 20 feet maximum and interspersed or bordered with vegetated steep slopes. Small scale rock-fall was observed along the southeastern side of two of the prominent ridge features in the central region of this area, interpreted to be occurring at a low rate of regularity. Detached bedrock blocks were not observed to have traveled far from their points of origin on the outcrops.

The cliff area along the northwest hill represents the greatest exposure and highest hazard potential for associated rock-fall (Photo 1, above). At its steepest point, the elevation drops about 37 feet over a horizontal distance of ~25 feet for an average slope ratio approaching 1:1.5 (H:V) along the cliff face. Grades range up to approximately vertical, and are locally overhanging on the variable outcrop faces. We observed these features to be highly influenced by the regularity and orientation of rock structures dictating their stability and character. Section 4.3 below provides a review of bedrock features and structures.

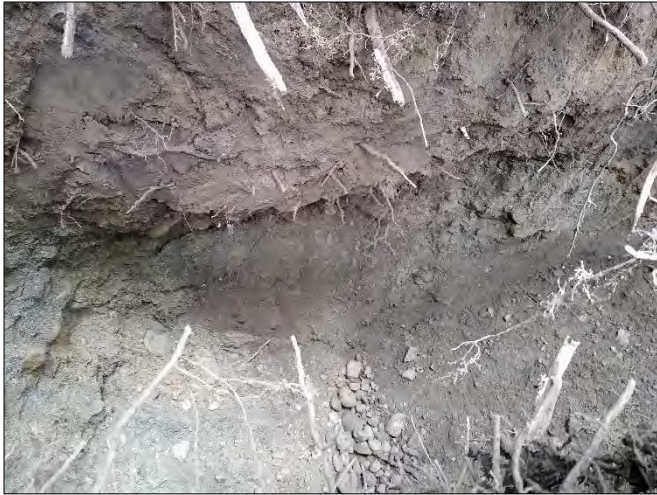
**Photo 7:** TP15; Thick Organic over Glacial Outwash

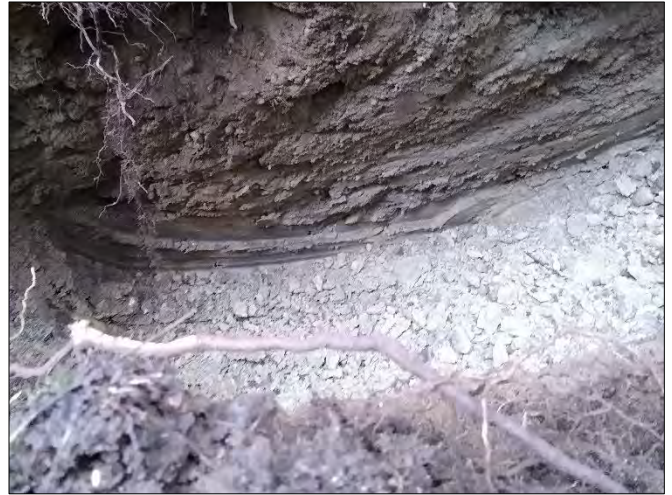
**Photo 8:** TP17; Dense Glacial Till at Base of Pit
