# **GEOTECHNICAL INVESTIGATION & GEOHAZARD REPORT JONES EDMOOR ESTATE PROPOSED 38-LOT PLAT DEVELOPMENT VIEWCREST ROAD, BELLINGHAM, WA**

Subject: **Geotechnical Investigation & Geohazard Assessment**  
**Proposed 38-Lot Plat - Jones Edgemoor Estate**  
Viewcrest Road, Bellingham, WA

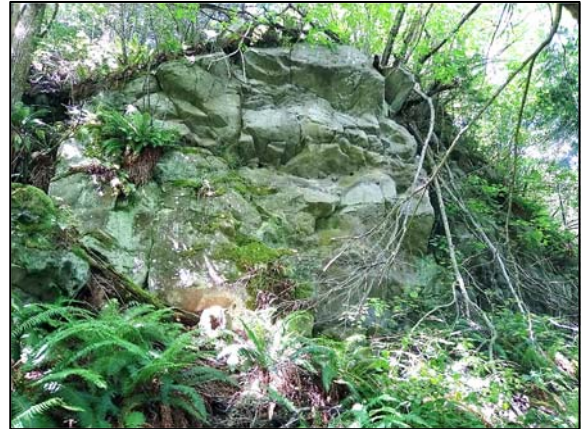
**Photo 1: Bedrock Cliff Face; Northwest Slope**

The cliff area along the northwest hill represents the greatest exposure and highest hazard potential for associated rock-fall (Photo 1, above). At its steepest point, the elevation drops about 37 feet over a horizontal distance of ~25 feet for an average slope ratio approaching 1:1.5 (H:V) along the cliff face. Grades range up to approximately vertical, and are locally overhanging on the variable outcrop faces. We observed these features to be highly influenced by the regularity and orientation of rock structures dictating their stability and character. Section 4.3 below provides a review of bedrock features and structures.

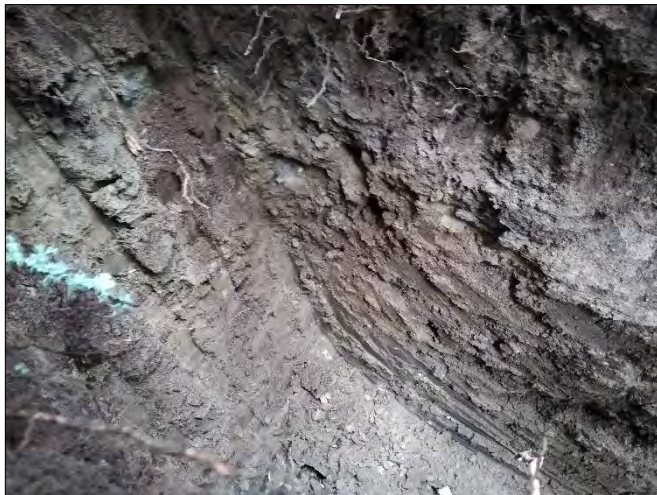
**Photo 9:** TP23; Glacial Drift over Dense Till

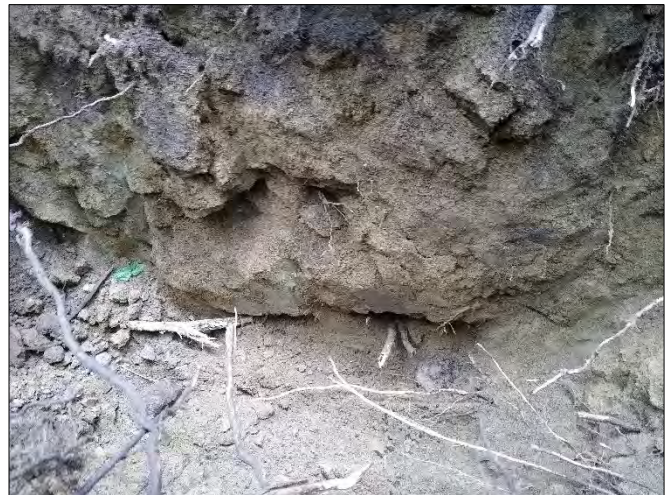
Soils that appeared to have been weathered-in-place (eluvium) were observed at the top of the outcrop in the northwest region of the site (TP25 and TP26). These soils appeared similar in character to the more frequently observed colluvium, but were made up almost entirely of poorly-graded medium sand (USCS Classification: SP), containing less than 5% fines. The SP soil was yellowish brown, non-plastic, non-cohesive, damp to moist, and loose to medium dense in the upper 3.5 feet before transitioning to the underlying weathering rind and bedrock at 4.0 feet bgs.

**Photo 10:** TP25; Sandy Eluvium Over Dense Sandstone Bedrock

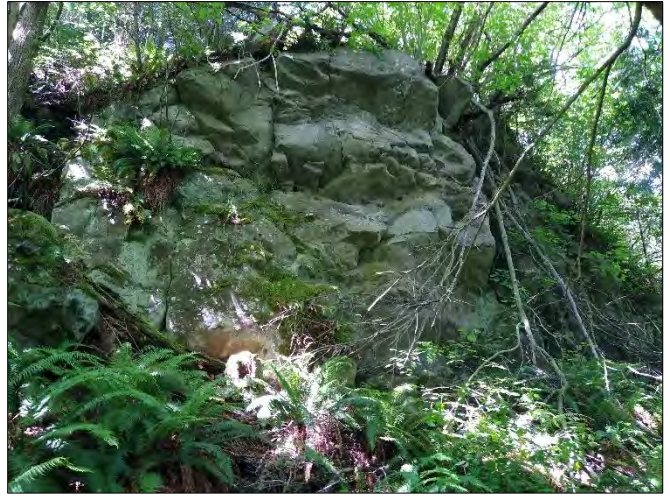
**Photo 2:** Southern Part of NW Bedrock Face

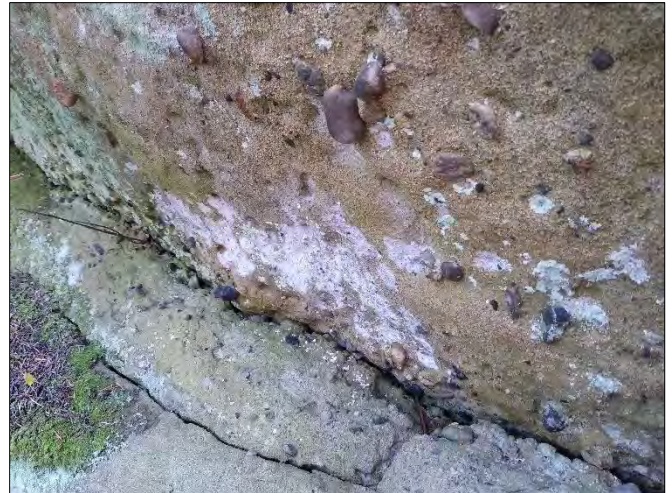
**Photo 10:** Conglomerate Bedrock Exposure; SW Project Area
