memorandum

subject Padden Creek Estuary Habitat Enhancements Project No. EN-38 - Final Feasibility Analysis

Attachment 2 – Final Phase I Environmental Site Assessment - Padden Creek Estuary Habitat Enhancements Project

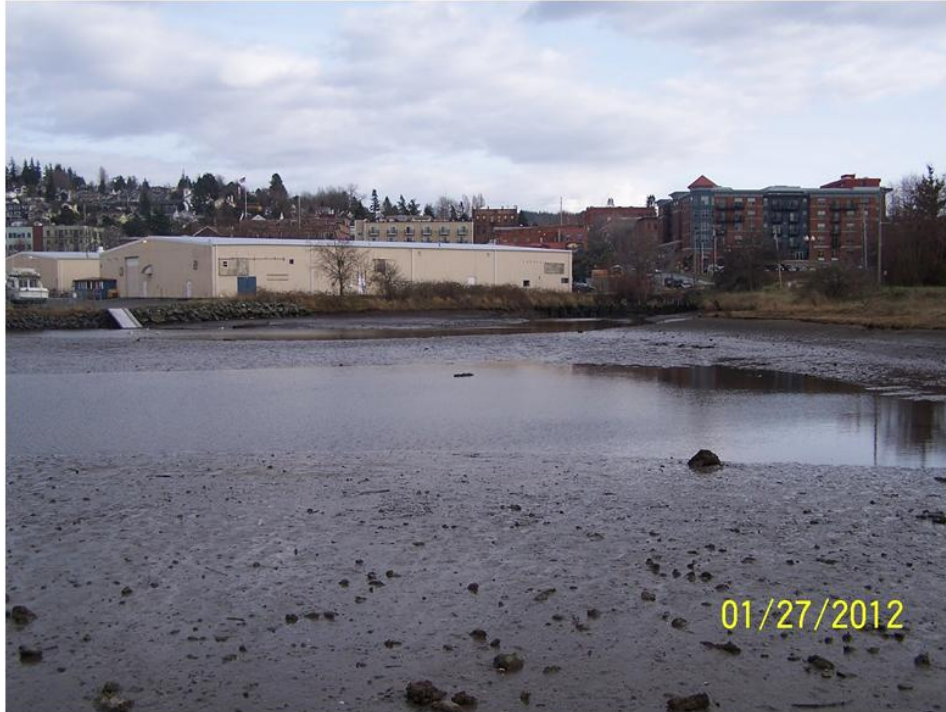
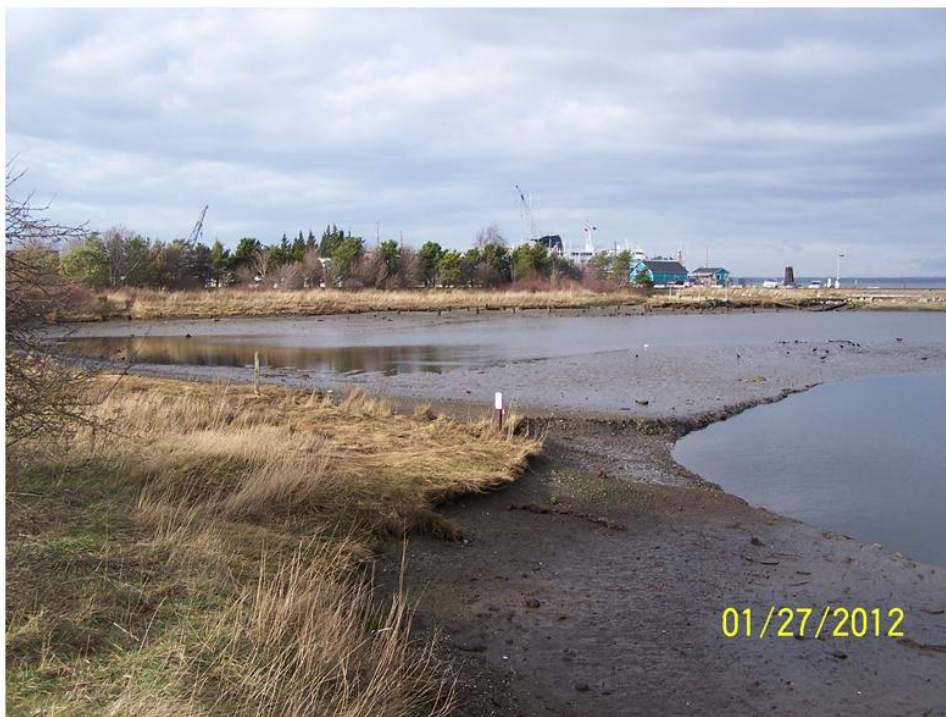
Figure 3. Photos of the subject property looking southeast (above) and northwest (below).

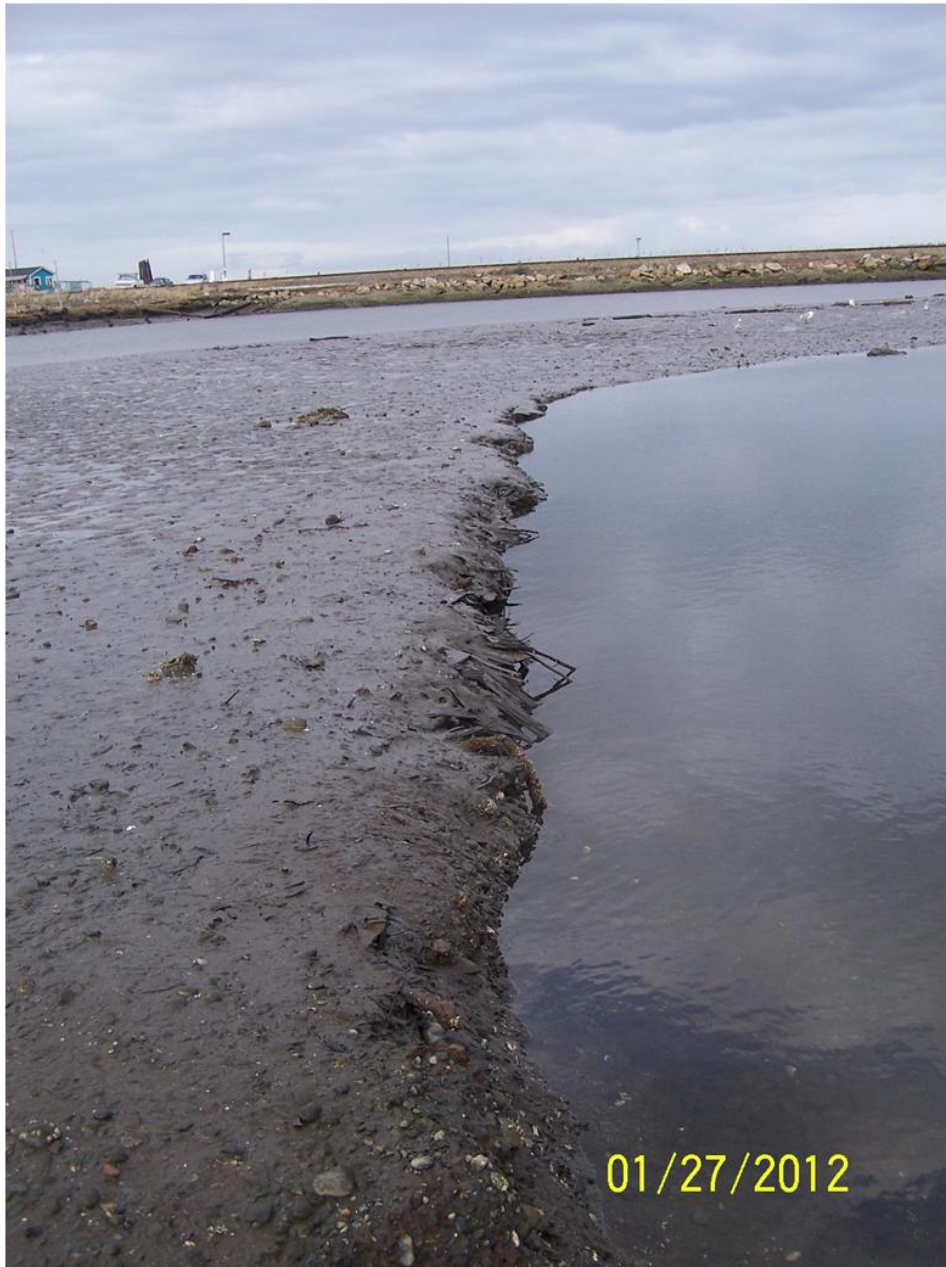
Ninety percent of the property is occupied by marine tidal mud flats. These mud flats had creosote pilings visible in several locations along the western shore and near the mouth of Padden Creek in the southeast corner. Wood shingles were visible in the center of the estuary, exposed through erosional action caused by down-cutting of Padden Creek through the mud, as well as some dumped chairs and urban trash (Figure 14 and 15). The upland portion of the property is located on the west and south sides and covered by undeveloped forest and grassland. Cresote pilings are located on the edge of the western shoreline on the subject property. The land north of the estuary is occupied by a BNSF rail line and there is rip-rap lining portions of the property boundary. The surface on the east side of the estuary is also rip-rapped with creosote pilings and bulkhead, and borders a paved industrial area primarily used for boat building, repair, maintenance, and storage.

Figure 14. Photo of the shingles layer in sediments on the subject property.

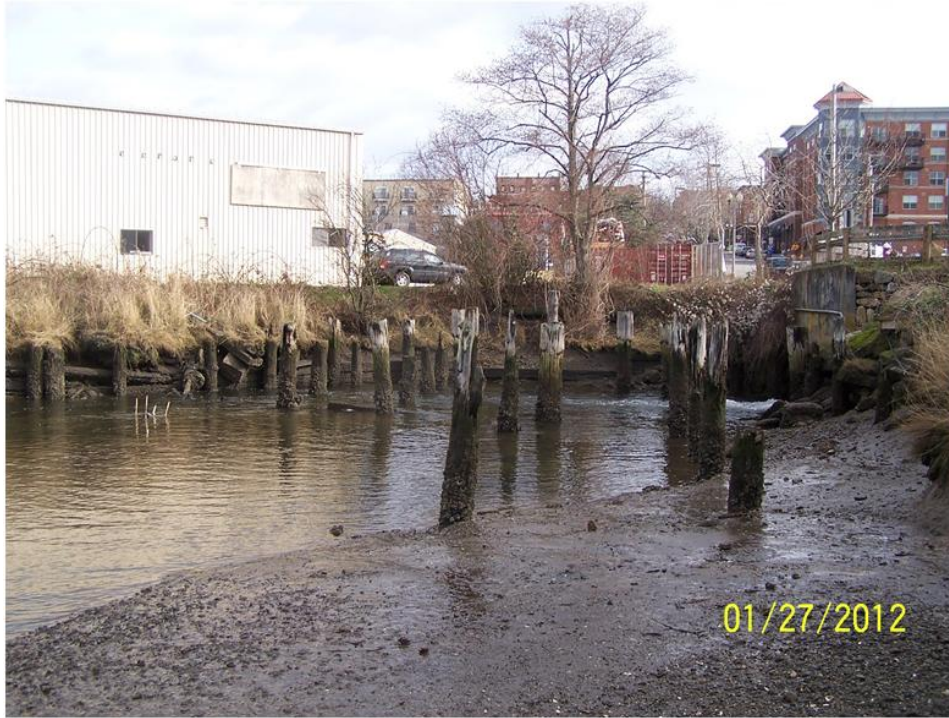
A series of approximately 30 creosote treated wood piles is located in the area waterward of the Harris Avenue box culvert. These piles generally extend to approximately +10 feet MLLW. On the east edge of the pile field is a failing creosoted wood retaining wall that has lost some of its upper lagging over time. Various types of debris are located in this portion of the estuary including old chairs and metal.

Figure 15. Photo of bulkhead and pilings in the southeast corner of the subject property (above) and urban trash in middle of estuary (below).

CR-1: A cluster of approximately 25 creosoted wood piles would be removed in the area immediately north of the Harris Avenue box culvert. These piles are fairly deteriorated and are serving no useful purpose. Several of the piles trend towards the west from the largest group. Some of these piles could be vibrated out to remove the full length of pile. However, several of these are quite rotten and may break; in which case the pile should be cut and fully removed above the mudline. This action is not a complicated or involved effort, as at least most of the piles can likely be reached from the adjacent uplands.
