# memorandum

subject Padden Creek Estuary Habitat Enhancements Project No. EN-38 - Final Feasibility Analysis

Attachment 2 – Final Phase I Environmental Site Assessment - Padden Creek Estuary Habitat Enhancements Project

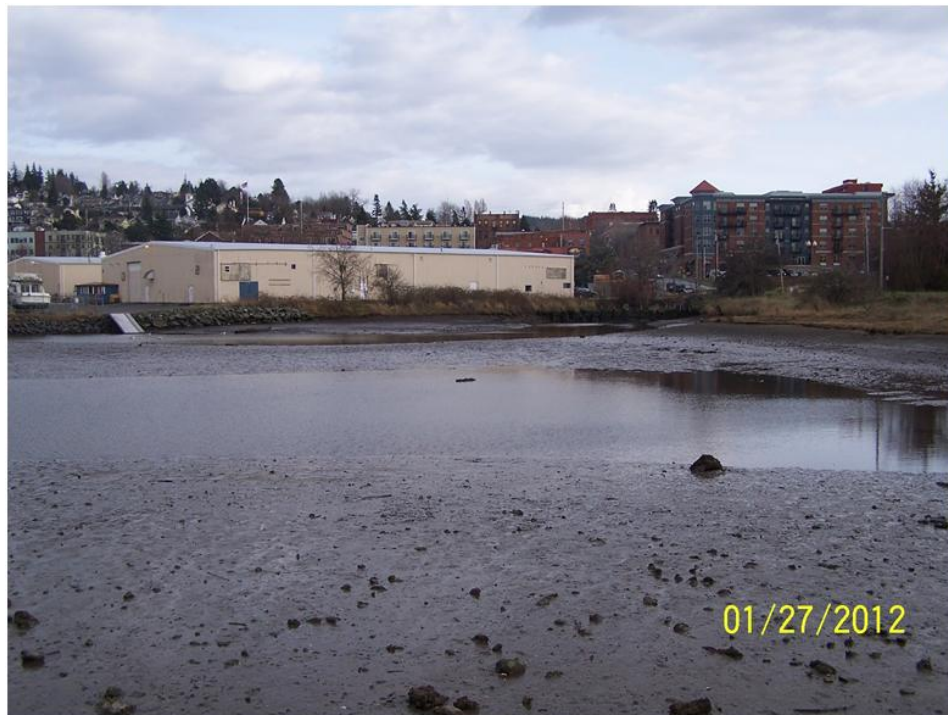
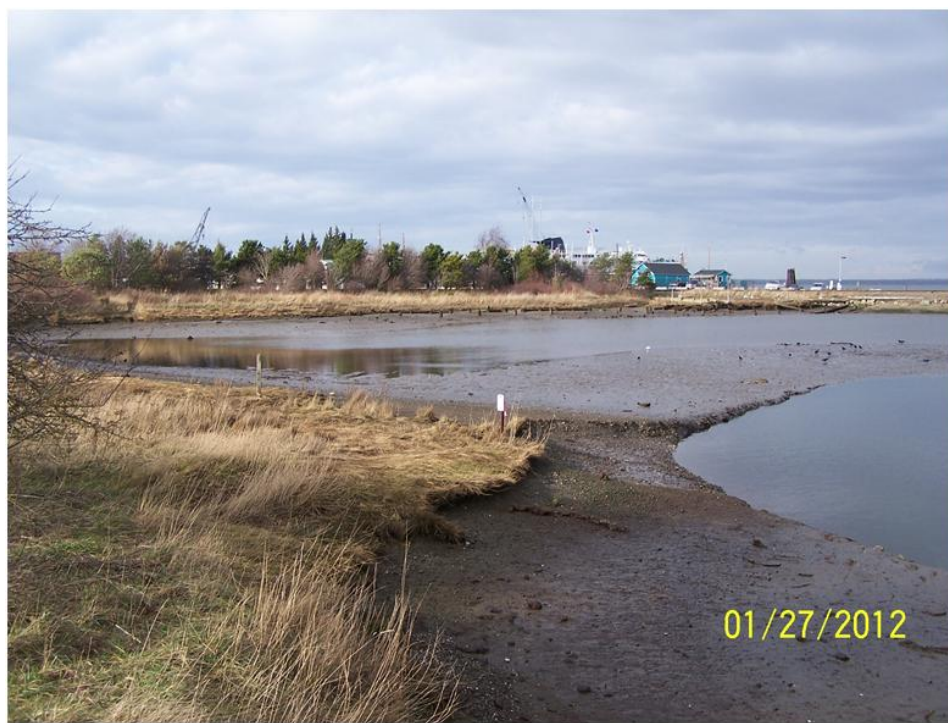
**Figure 3.** Photos of the subject property looking southeast (above) and northwest (below).
