date May 21, 2012

subject Padden Creek Estuary Habitat Enhancements Project No. EN-38 - Final Feasibility Analysis

Attachment 2 – Final Phase I Environmental Site Assessment - Padden Creek Estuary Habitat Enhancements Project

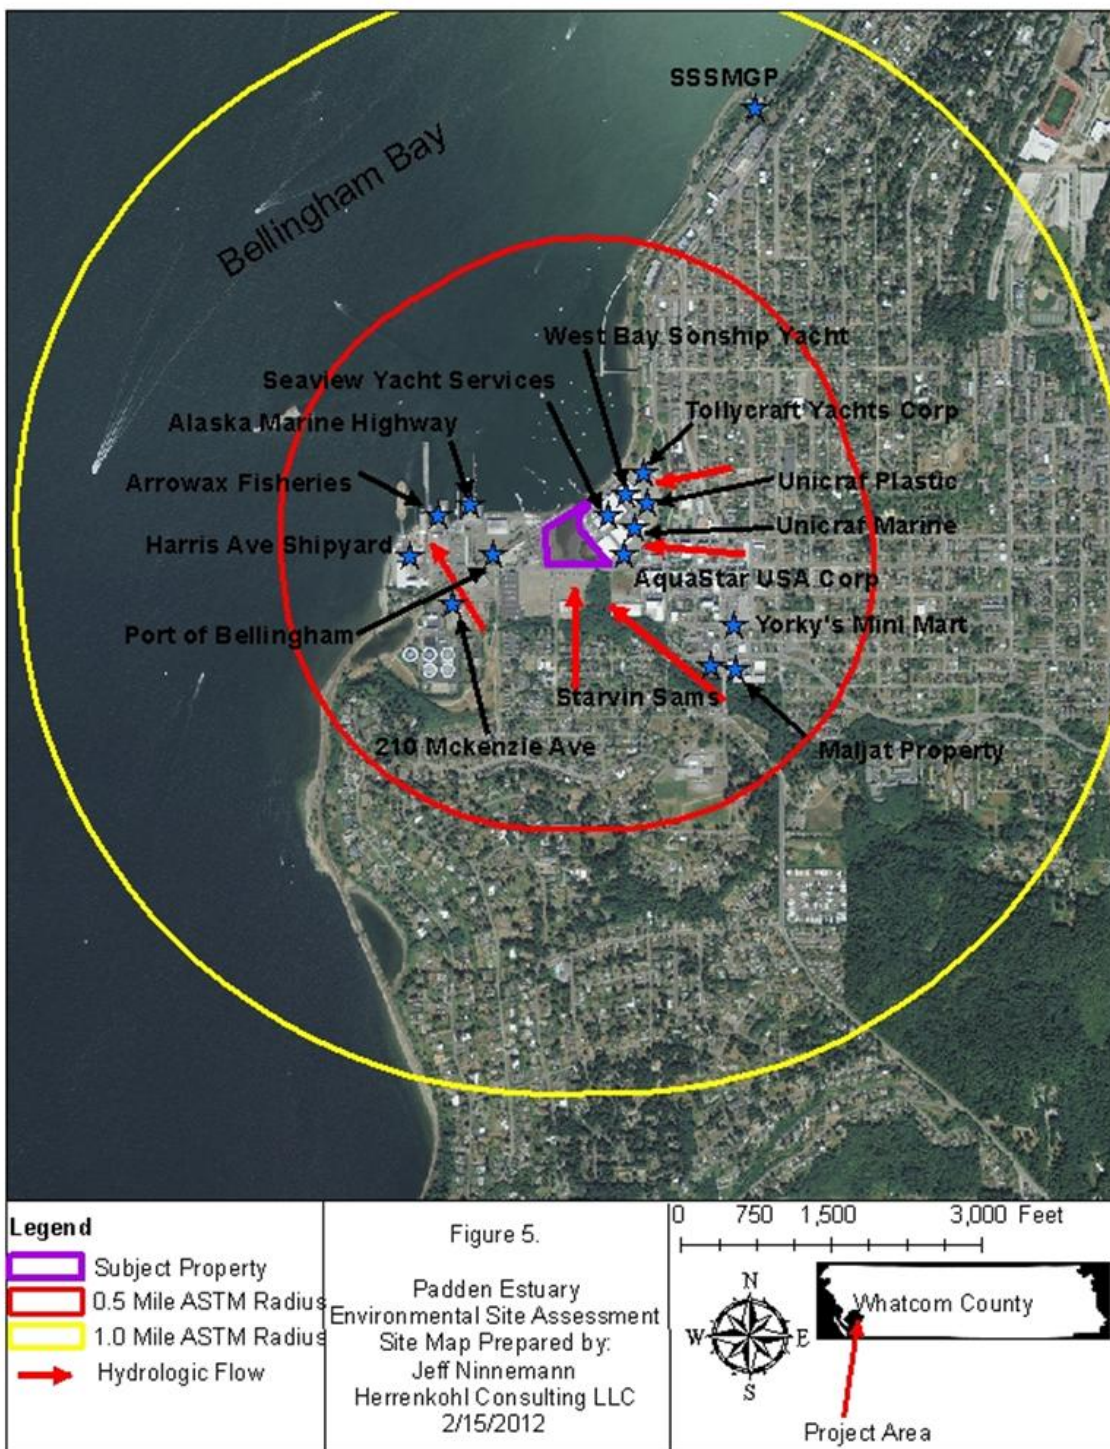
Historical records show that an iron works, foundry, and aluminum foundry existed across Harris Ave. from the subject property (Bellingham Iron Works) (Figure 6). Also, untreated stormwater runoff from downtown Fairhaven has been identified as an additional source of offsite contamination for the site. Surface water and stormwater flows off the streets and developed area of Fairhaven, enters Padden Creek, and then discharges through the subject property as it drains to Bellingham Bay.

Figure 5. Locations of potential onsite and offsite contamination sources.

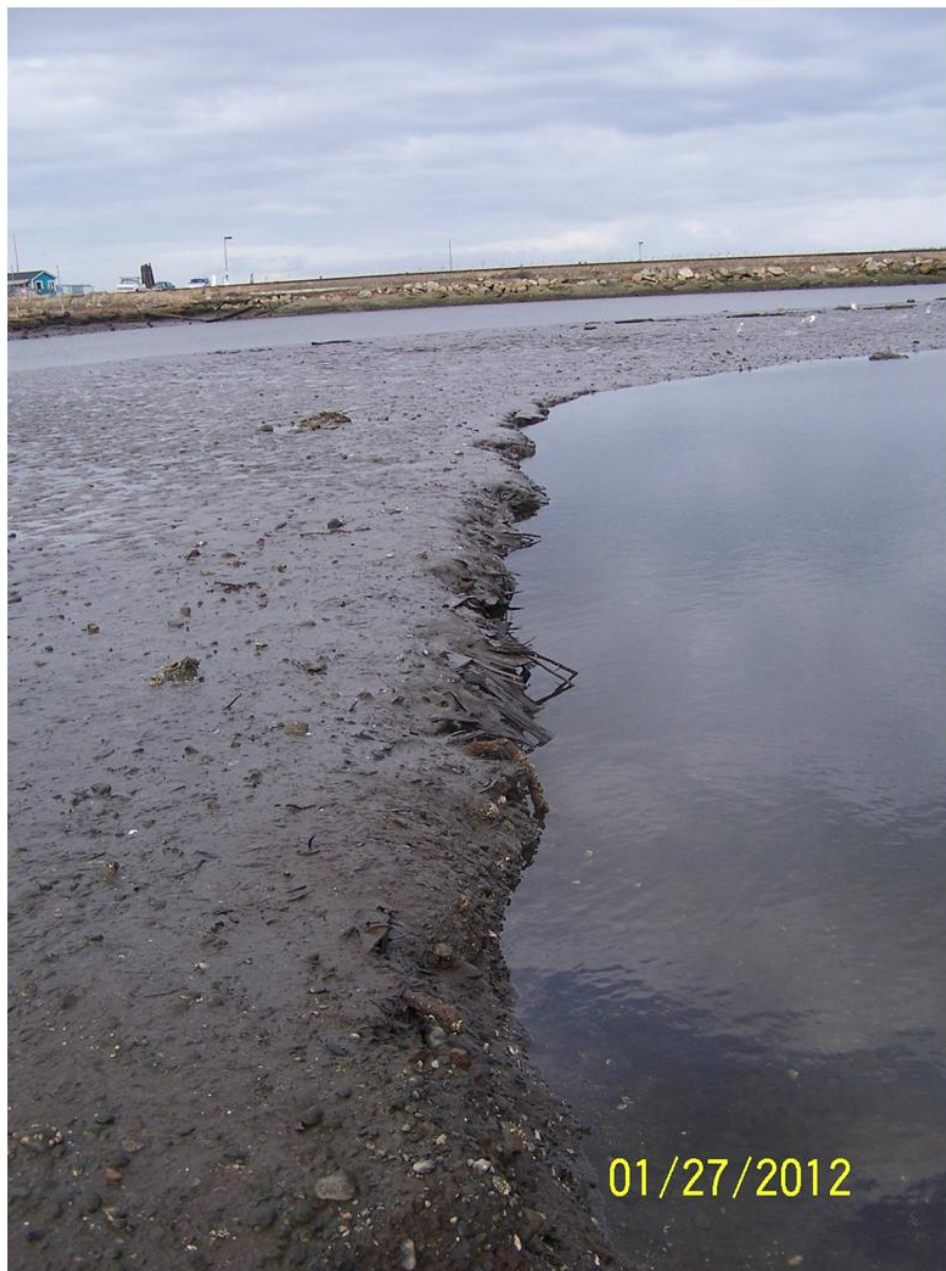
Ninety percent of the property is occupied by marine tidal mud flats. These mud flats had creosote pilings visible in several locations along the western shore and near the mouth of Padden Creek in the southeast corner. Wood shingles were visible in the center of the estuary, exposed through erosional action caused by down-cutting of Padden Creek through the mud, as well as some dumped chairs and urban trash (Figure 14 and 15). The upland portion of the property is located on the west and south sides and covered by undeveloped forest and grassland. Creosote pilings are located on the edge of the western shoreline on the subject property. The land north of the estuary is occupied by a BNSF rail line and there is rip-rap lining portions of the property boundary. The surface on the east side of the estuary is also rip-rapped with creosote pilings and bulkhead, and borders a paved industrial area primarily used for boat building, repair, maintenance, and storage.

Figure 14. Photo of the shingles layer in sediments on the subject property.

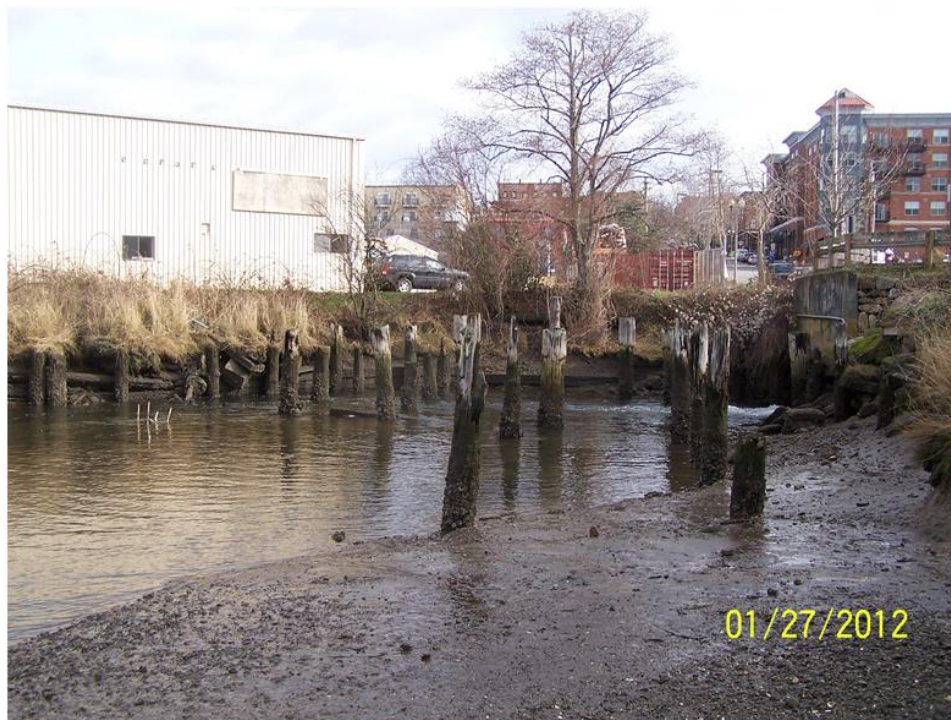
A series of approximately 30 creosote treated wood piles is located in the area waterward of the Harris Avenue box culvert. These piles generally extend to approximately +10 feet MLLW. On the east edge of the pile field is a failing creosoted wood retaining wall that has lost some of its upper lagging over time. Various types of debris are located in this portion of the estuary including old chairs and metal.

Figure 15. Photo of bulkhead and pilings in the southeast corner of the subject property (above) and urban trash in middle of estuary (below).

CR-1: A cluster of approximately 25 creosoted wood piles would be removed in the area immediately north of the Harris Avenue box culvert. These piles are fairly deteriorated and are serving no useful purpose. Several of the piles trend towards the west from the largest group. Some of these piles could be vibrated out to remove the full length of pile. However, several of these are quite rotten and may break; in which case the pile should be cut and fully removed above the mudline. This action is not a complicated or involved effort, as at least most of the piles can likely be reached from the adjacent uplands.
