Whatcom County Nearshore Habitat Restoration Prioritization

Prepared for: Whatcom County Marine Resources Committee

Coastal Geologic Services Inc.

June 27, 2007

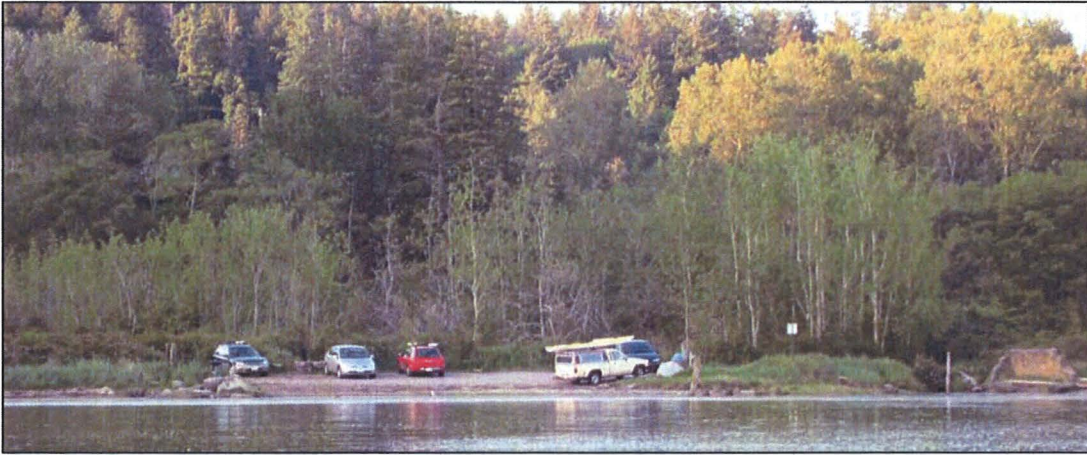
Figure 7. Restore backshore currently occupied by parking lot (CGS field photo).

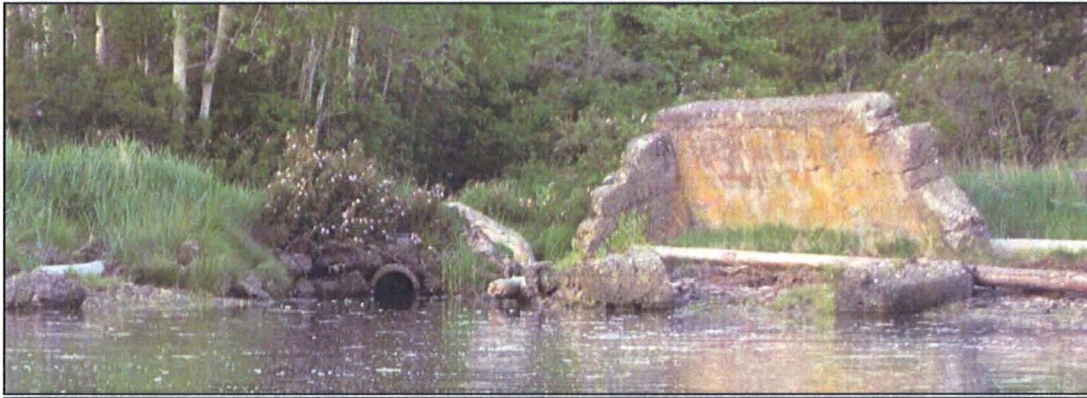
Figure 8. Remove relict concrete structure from backshore and enhance connectivity between backshore marsh/wetland and marine environment (CGS field photo).

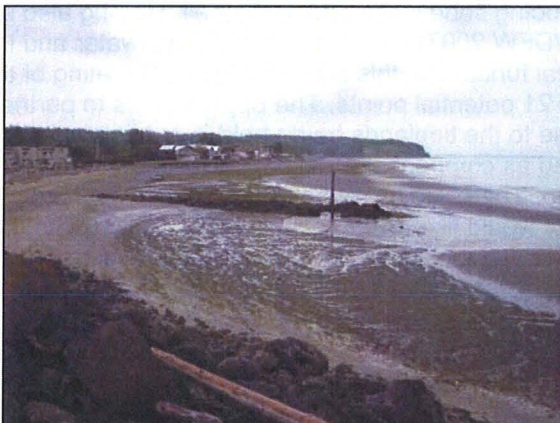
Figure 12. Looking east at armored culvert extending across shore (CGS field photo).

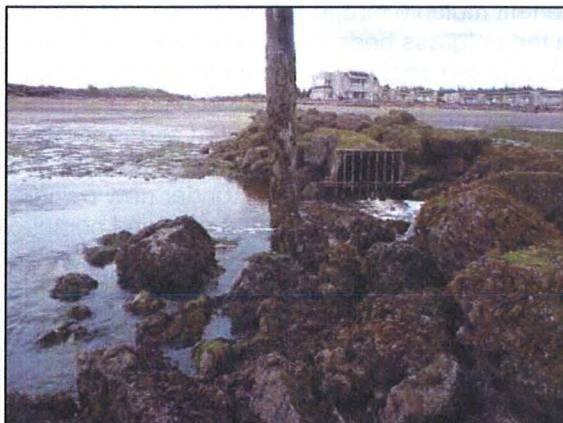
Figure 13. Culvert out-flow with considerable flow (CGS field photo).

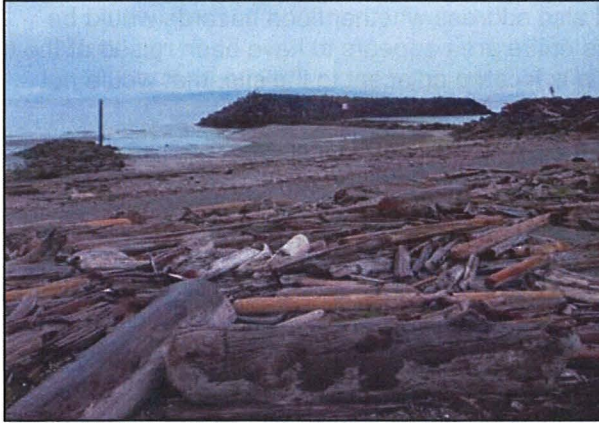
Figure 14. Culvert/stream buried beneath backshore east of Pt Roberts marina (CGS field photo).

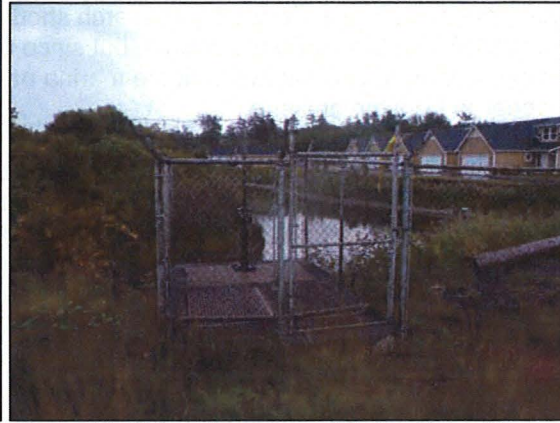
Figure 15. Tide gate and pond drained from Pt Roberts wetlands (CGS field photo).

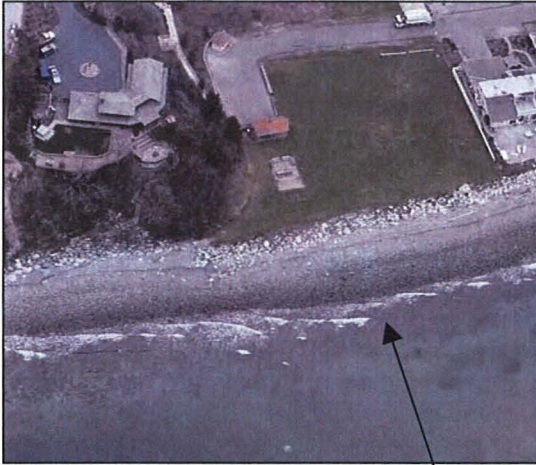
The rockery bulkhead extended well waterward of the adjacent bulkhead to the west and infringed on the upper intertidal beach (Figures 16 and 17). The site could be enhanced by removal of the rock and recreating a wider beach and backshore area. The site was filled to a higher elevation, likely during development of the marina, as shell fragments were observed in the eroding bank. An upper beach and backshore area would be created between retained (adjacent) bulkheads, resembling the upper part of a pocket beach. A small portion of the removed rock would likely be required for construction of return walls (running landward at the ends of adjacent bulkheads, designed to minimize end effects). These return walls would generally run landward along the property lines. The upper beach should also be nourished to aid in the reformation of lost forage fish spawning habitat area covered by riprap. Additional restoration recommendations for this site include enhancing the marine riparian area.

Figure 16. Air photo of Sunset Beach site, note toppled and infringing riprap at west end of site (Pictometry International Corp 2004)

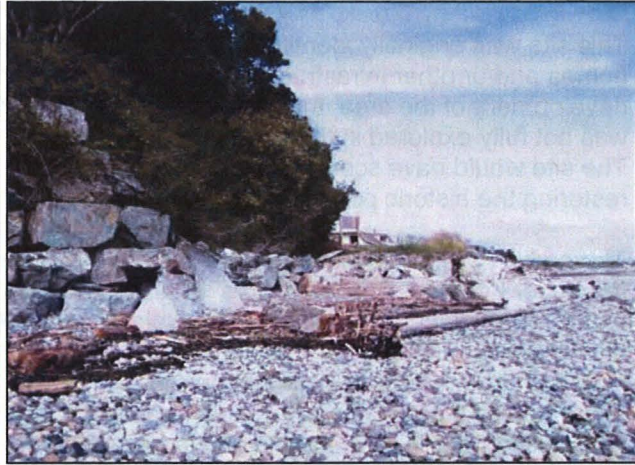
Figure 17. Infringing riprap at Sunset Beach (CGS field photo).

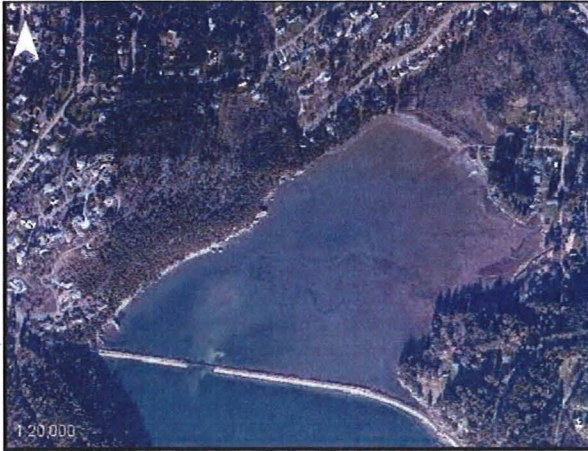
The causeway currently covers 153,040 sq ft of subtidal and intertidal area. The beach was historically composed of coarser material and apparently eelgrass beds were found throughout the inner shore of the Bay (Pers. Comm. T. Wahl 2007). Currently inner Chuckanut Bay beaches are comprised of relatively fine sediment (sands and silt) and patches of eelgrass are only found in the waterward end of the Bay. It is likely that if sedimentation rates continue at the current accelerated rate the Bay will experience further habitat degradation in the form of water quality issues, exceeded temperature thresholds for salmonids, and the progressive loss of intertidal area. It is likely that the tidal prism has already been substantially reduced in volume due to the accelerated sedimentation occurring within these shores. This process will likely be slowed by sea level rise, however, the native substrate of the beaches and the natural tidal hydrodynamics will not be recovered without restoration actions.

Figure 19. Aerial view of Chuckanut Bay causeway (Pictometry International Corp 2004).

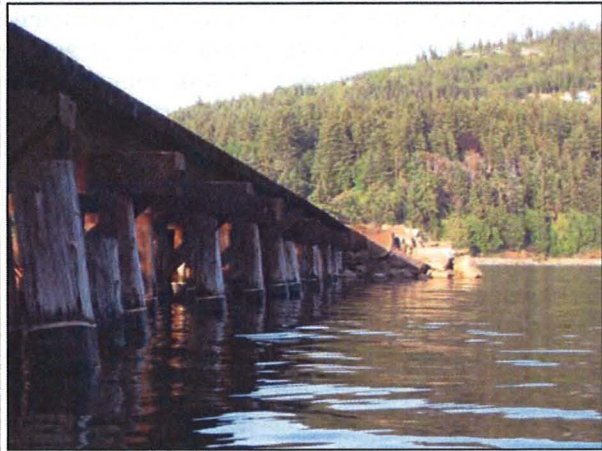
The causeway created additional shoreline along the revetment and the open shaded area beneath the causeway opening is the only access to the bay (Figure 20). The shading and additional riprap shoreline, provides an abrupt transition from shallow to deep water, likely increasing migrating juvenile salmonids' vulnerability to predation. The causeway opening was also constructed of heavily creosoted pilings, which likely adversely impacts water quality.

Figure 20. Chuckanut Bay causeway opening, creosote pilings (CGS field photo).

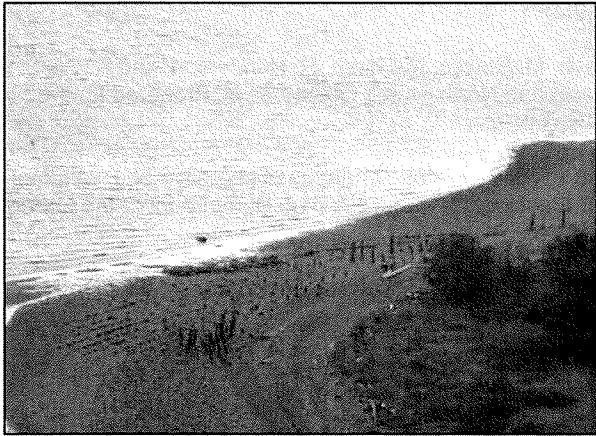
Removal of these relict items would restore intertidal habitat structure and ameliorate adverse impacts to water quality caused from the further decay and erosion of the slag and car parts. The field of over 100 relict piles would recover lost intertidal substrate, and enhance alongshore sediment transport that appears diminished due to wave attenuation caused by the piles and slag deposit. Juvenile salmonid migration pathways would likely also be enhanced as a result of the restoration. The cumulative targeted response of these actions was awarded 18 out of 45 points for these reasons.

Figure 21. Lily Point piling field (CGS field photo).

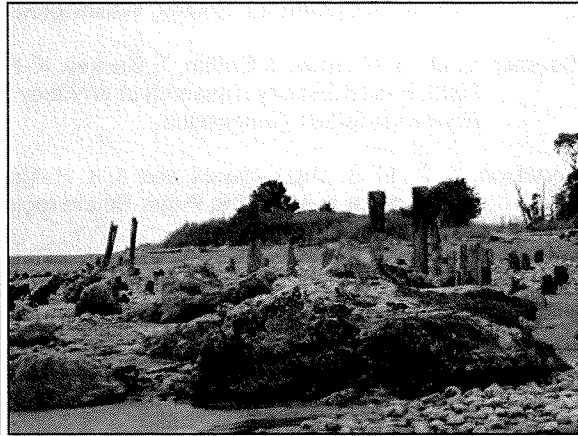
Figure 22. Slag deposits in lower beachface left from old cannery (CGS field photo).
