Restoration Programmatic for the State of Washington Specific Project Information Form

U.S. Army Corps of Engineers, Seattle District, Regulatory Branch

B. Applicant name (same as in JARPA): Craig Mueller, City of Bellingham

Waterbody: Padden Creek

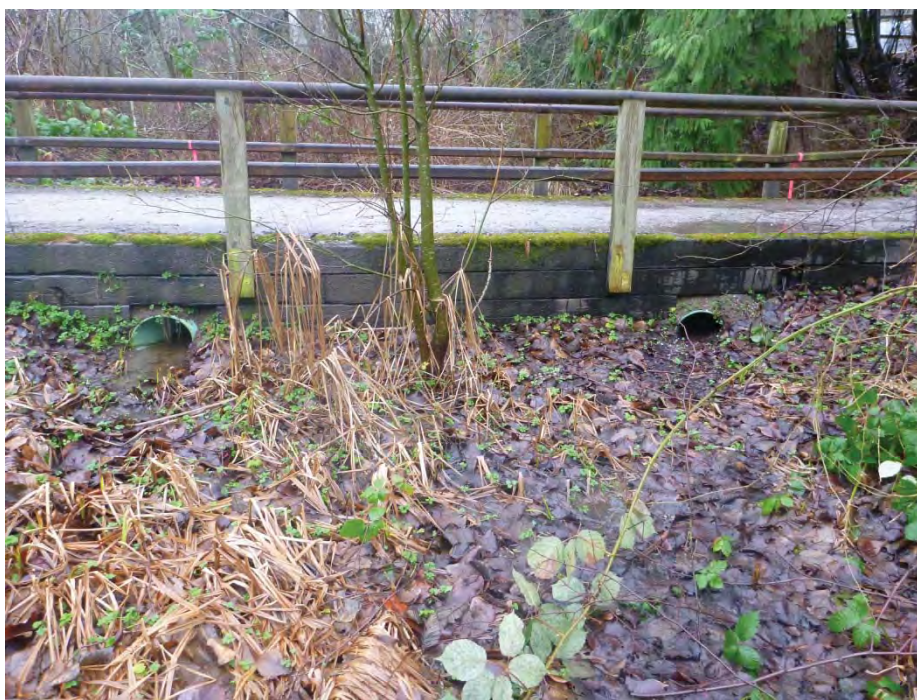
Photograph 5
Two culverts beneath walking trail that appear to have intermittent surface water connections between Wetlands A and B

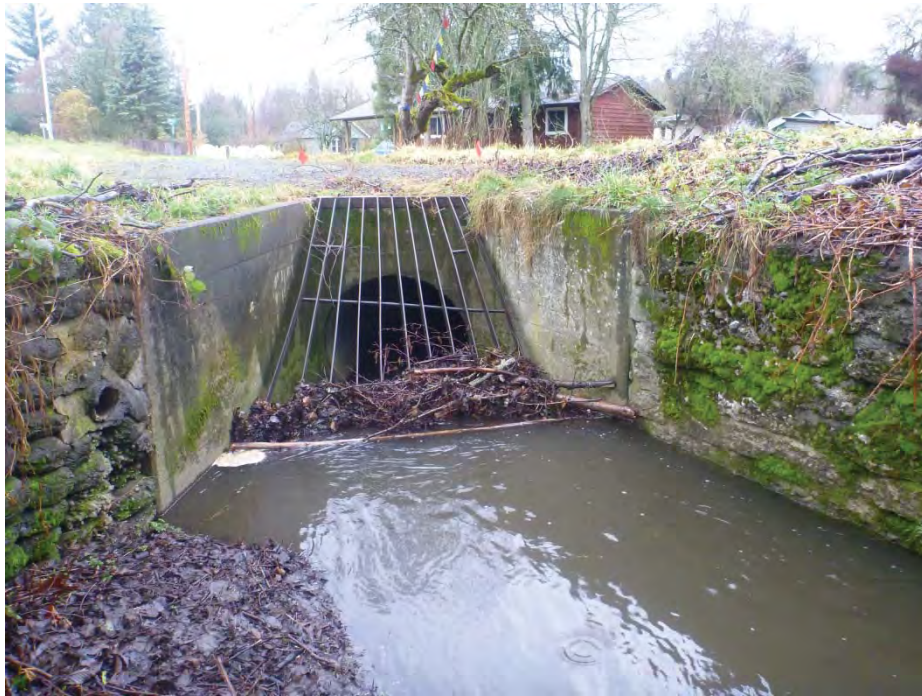
Photograph 7
Downstream culvert at eastern reach of Padden Creek

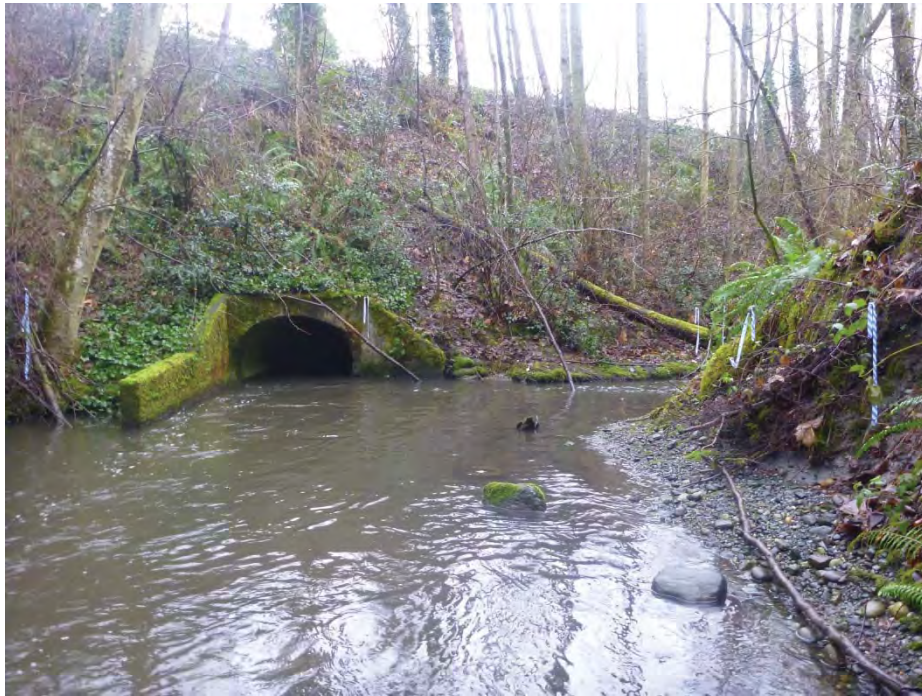
Photograph 9
Upstream culvert at eastern reach of Padden Creek, unnamed tributary to Padden Creek coming in from the right

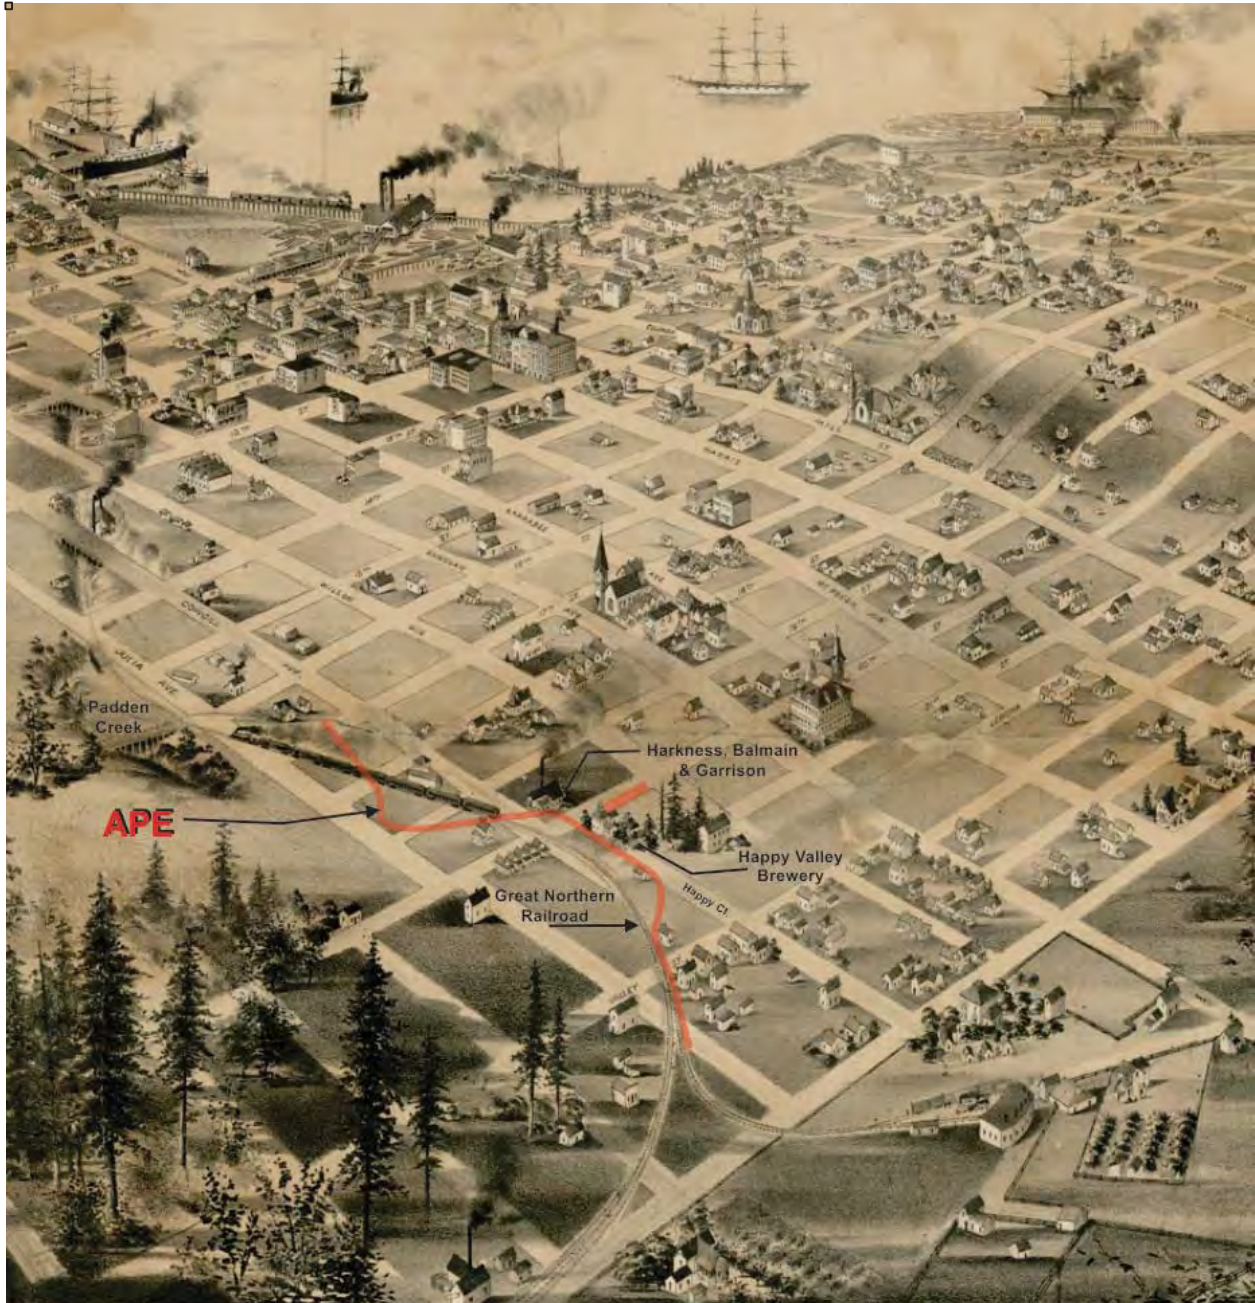
Figure 7. 1891 map of Fairhaven illustrating the APE in relation to the railroad grade, commercial businesses and Padden Creek (Fairhaven Land Co. 1891).

A Fairhaven Land Co. map from 1891 shows a stylized birds-eye view of the city, showing the APE in relation to Happy Valley businesses, the F & S railroad grade and a partially buried Padden Creek (Figure 7). Unfortunately the development boom was in vein as in late 1891 it was announced that Seattle had been chosen as the western terminus for Great Northern. In response, development in Fairhaven slowed dramatically and many of the town’s pioneers eventually sold their holdings and left town. Great Northern operated the original F & S line eventually tearing up the rails in 1903 (Bourasaw 2008). In 1912, ownership of the former F & S railroad grade was transferred to the Pacific Northwest Traction Company (PNTC) who operated the Interurban Electric Railway from 1912 to 1929 (Adams 1922). Bellingham Parks Department subsequently acquired and incorporated the former F & S rail grade into portions of SR 11 and created the Interurban Trail, which follows portions of the grade south through Fairhaven Park to Arroyo Park (Wessen 2005).

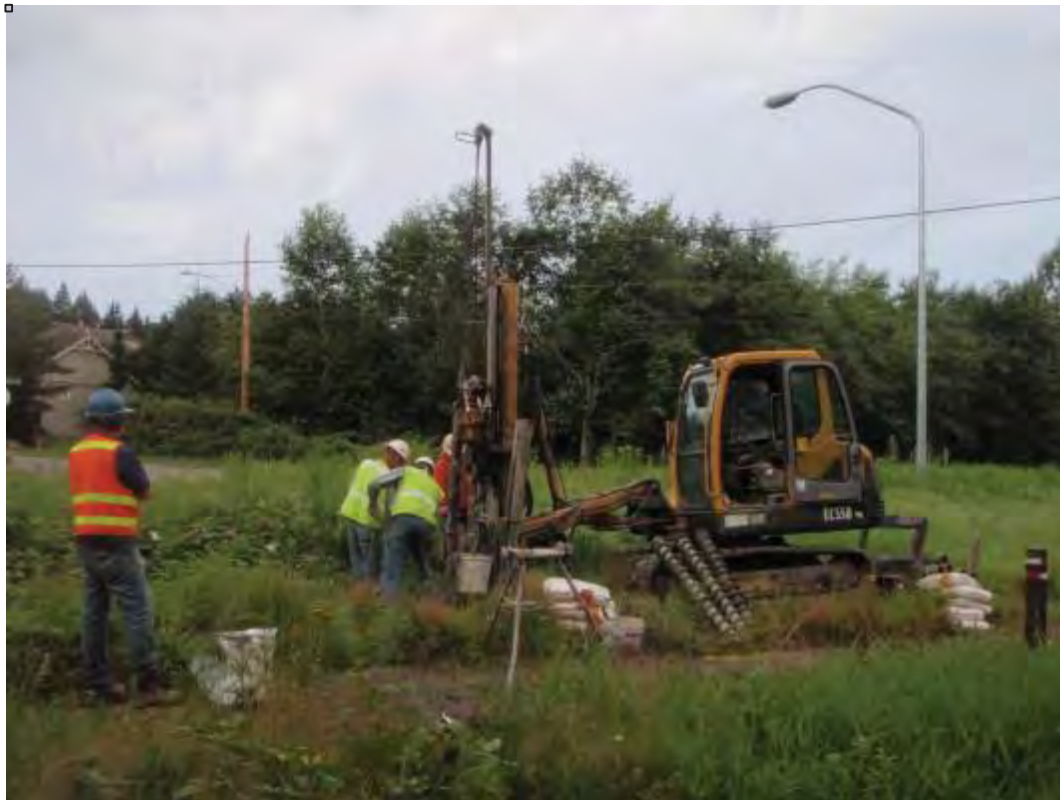
Figure 8. Auger excavating geotest borings along the eastern APE.

Field investigations for this project were conducted by DAR field director, Brett Meidinger. Field investigations consisted of archaeological monitoring and field survey. Archaeological monitoring was conducted on July 30, 31 and August 3, 2012 and included seven geotest bores and three backhoe trenches. Geotest boring was carried out using a hollow stem, 22.5 cm (9 in) diameter mechanical auger drill (Figure 8). The drill advances and 45 cm (18 in) sampling rods are pushed within the hollow center of the auger drill being driven into the underlying sediments collecting the sample within the rod (Figure 9). After the drill advanced the sampling rod was pulled out, opened, and examined for cultural material and buried soils by the monitor. The sampling rod was cleaned and returned into place within the auger drill. Additional sections of the auger drill were added as the machine advanced to depth. After each bore sampling was complete a bentonite mixture was pumped into the excavated bore location to backfill the hole created by the removed sediment.

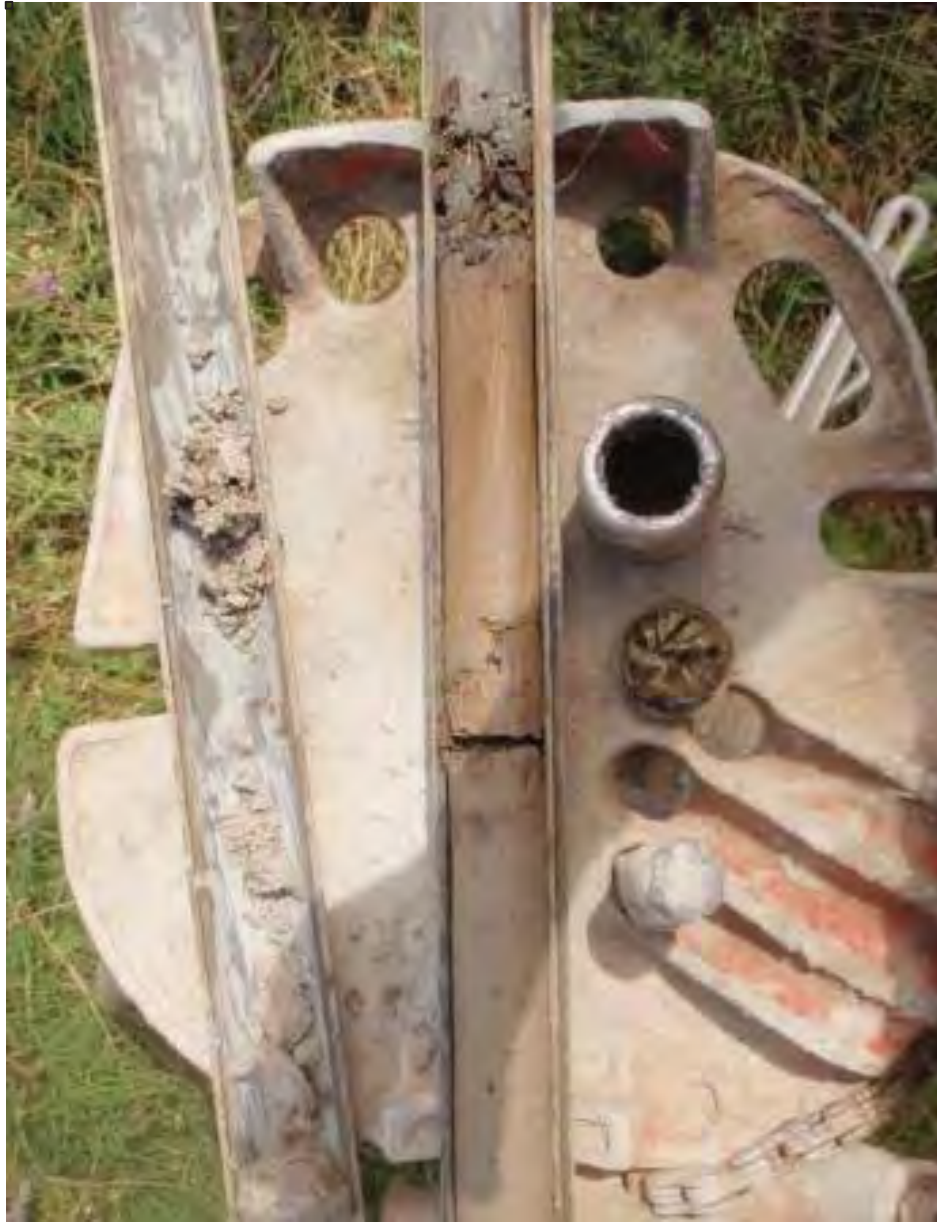
Figure 9. Geotest boring (B2) sample showing the upper sediments.

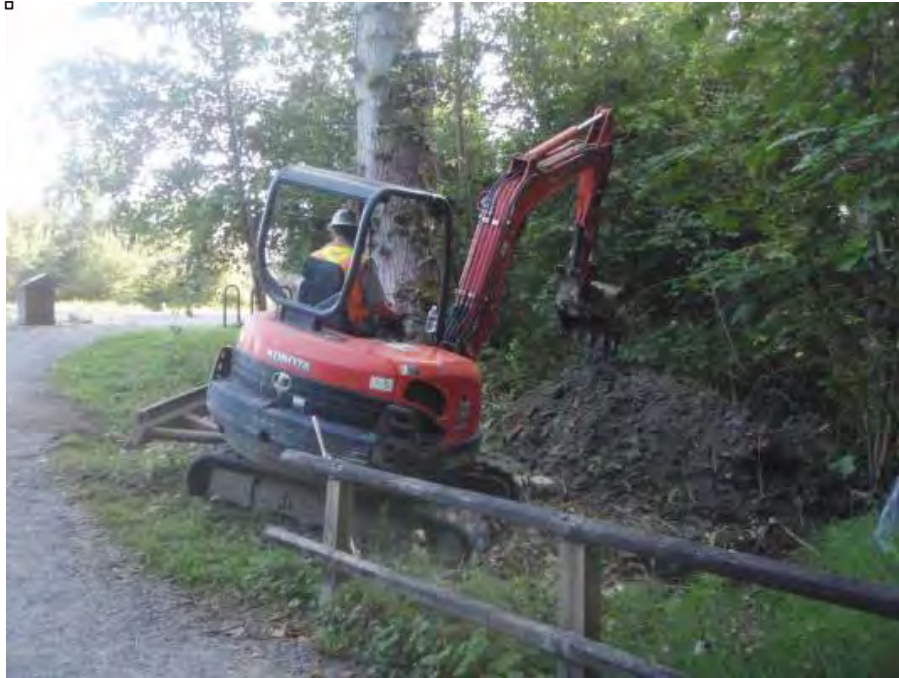
Figure 10. Backhoe excavating geotest trenches along the APE within the park.

Backhoe trenches were excavated using a mini backhoe using a flat 1 ft wide bucket (Figure 10). The excavated deposits were removed and piled next to the trench for later trench backfilling. The trench and spoils were also inspected for cultural materials and buried surfaces prior to the trench being backfilled.

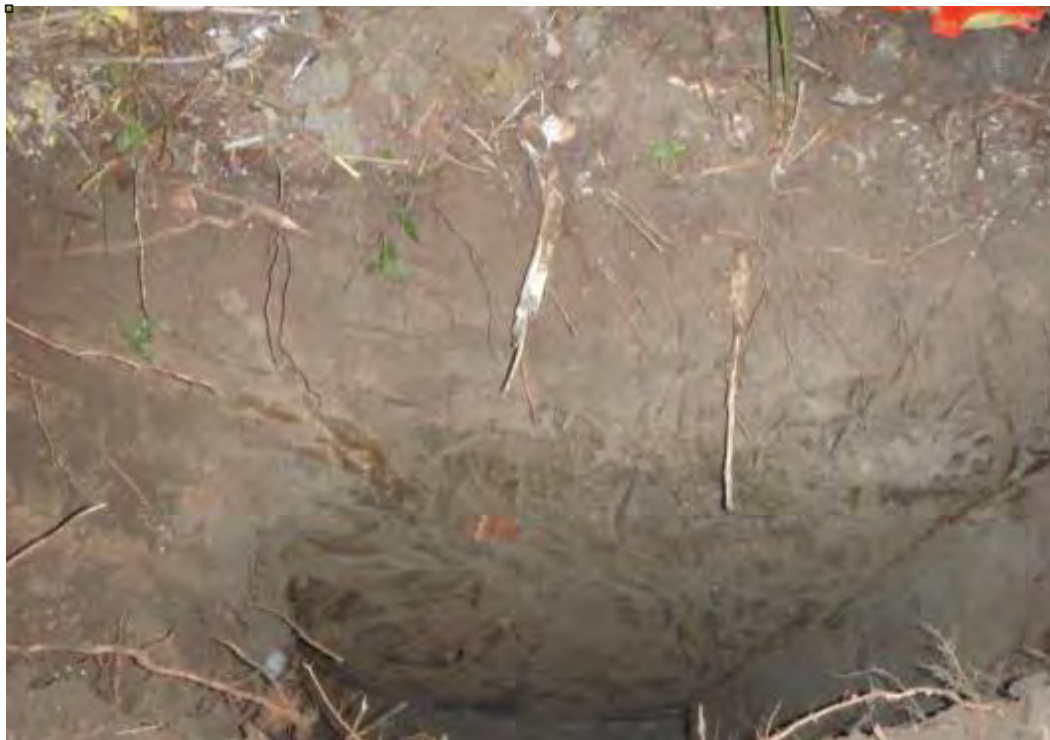
Figure 12. Geotest trench T2 (formerly T5) showing typical soils near wetland B.

Geotest trenches T1 and T3 were conducted between 20th and 22nd Street and T2 was excavated near the delineated wetland area in Arroyo Park. The trenches opened a wider excavation with visible trench wall profiles to depths of approximately 2.74 m (9 ft) and the sidewall profiles were examined for the presence of cultural material and buried surfaces. The resulting excavated backdirt was troweled through and examined, but it was not screened. A typical profile of the soils observed during geotest trenching can be seen in Figure 12.

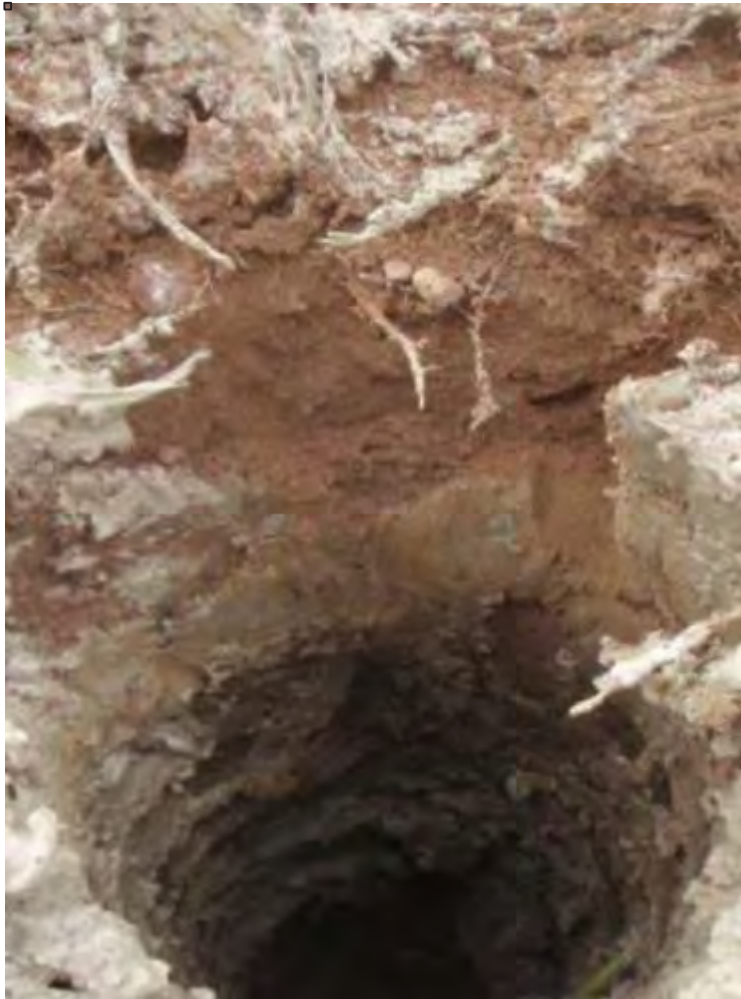
Figure 13. Shovel Probe 17 showing mottled fill deposits on top of a buried topsoil overlying graded glacial subsoils.

Shovel probe (SP) excavation of the western 198 m (675 ft) of the APE was precluded by the steeply sided slopes of the Padden Creek channel. Typically, SPs were excavated at approximately 10-15 m (32.8-49.2 ft) intervals along both sides of the proposed channel alignment; however, the interval was altered to avoid buried utilities and roadways. The majority of the SPs (n= 25) were excavated east of 20th Street and seven SPs were excavated west of 20th Street near the wetland area. The typical soils observed during shovel probe testing can be seen in Figure 13.

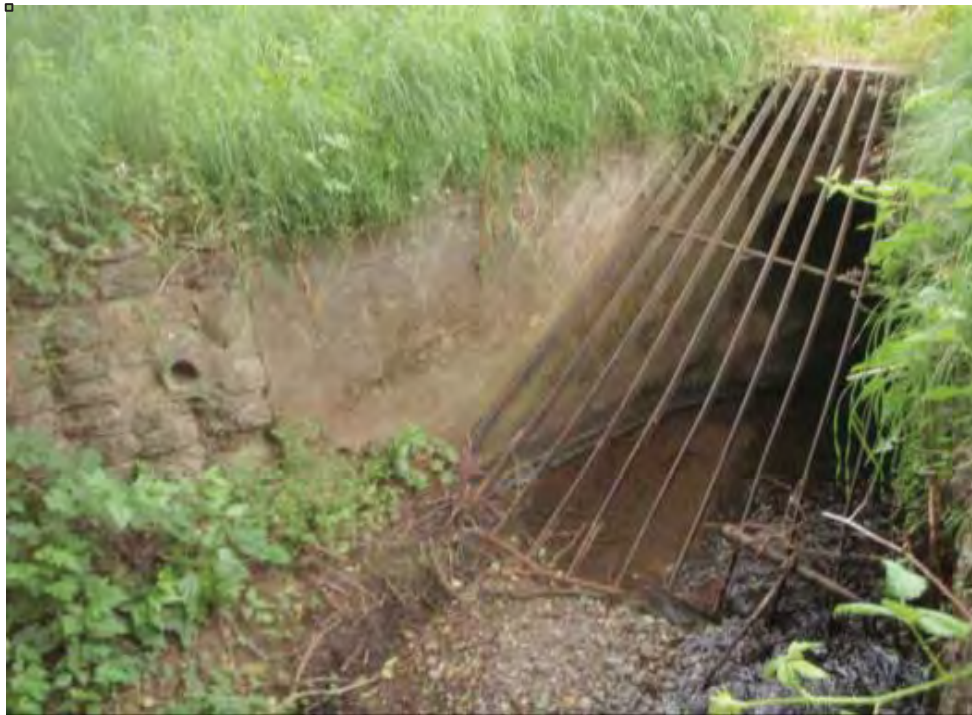
Figure 15. The upstream headwall, view southwest. Note the retaining wall reinforcement along the south wing wall.

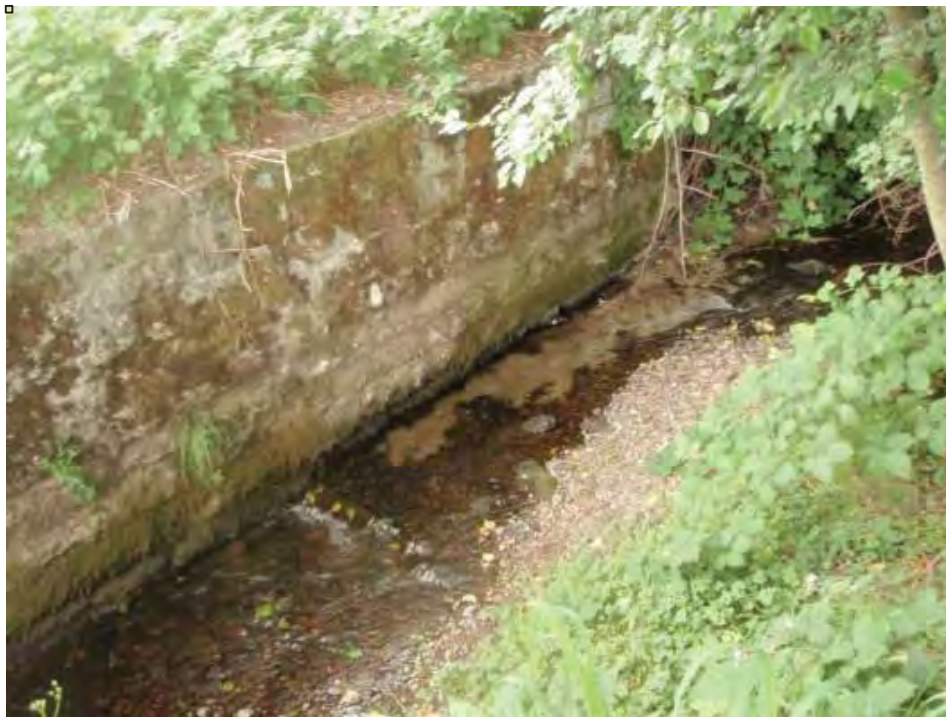
Figure 16. The north side of the upstream retaining wall, view northeast.

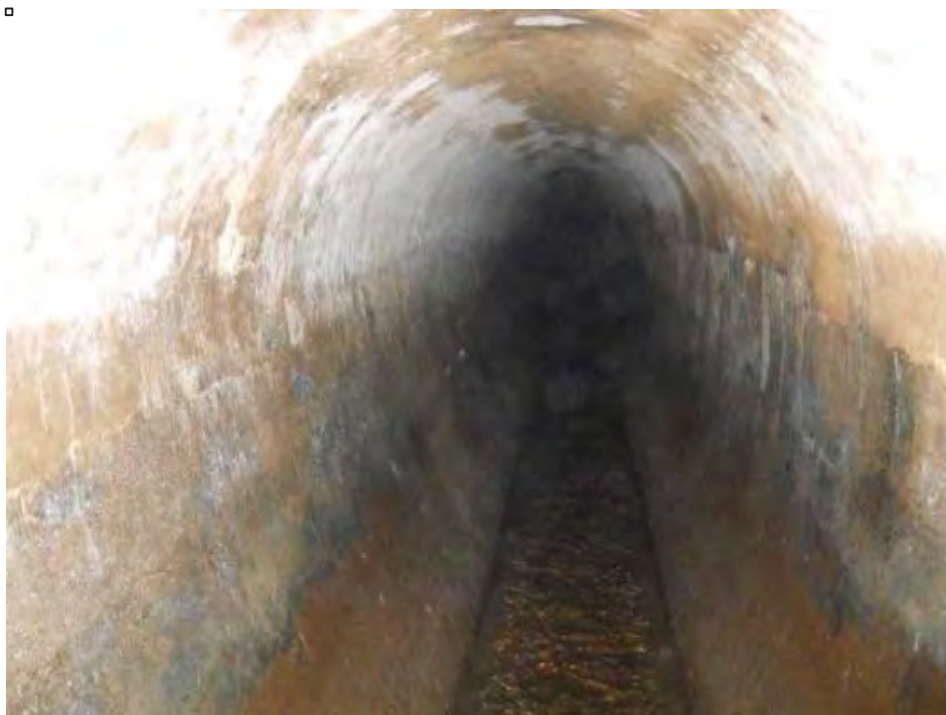
Figure 17. View of the interior of the tunnel (courtesy of Rick Lippold).

From the upstream headwall, Padden Creek is diverted into a tunnel (Figure 17). The tunnel is comprised of an approximately 250-foot long 5-foot diameter poured concrete culvert pipe at the entrance and exit of the system. In other locations, the tunnel is egg shaped, measuring 6-foot high by 4-foot wide, and is characterized by a 0.5-inch thick mortared brick lining. The tunnel has a notched base ranging from 4- to 5-inches wide and from 3- to 6-inches deep.

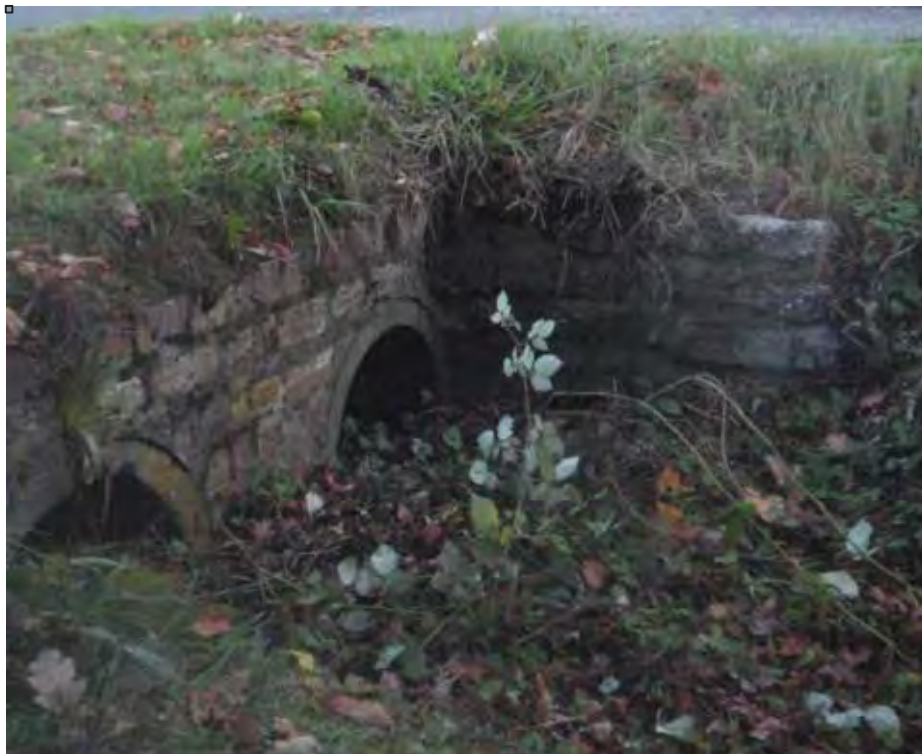
Figure 18. The culvert headwall, view southeast.

Padden Creek exits the Happy Valley Tunnel System at the downstream headwall located at Fairhaven Park approximately 100-feet southwest of 17th Street (Figure 19). The downstream headwall is an approximately 6.5-foot tall concrete arch facing with angled wing walls. To the east is the abandoned creek channel. Here, retaining walls extend for approximately 300-feet and along the north and south sides of channel bed (Figure 20). The retaining walls are sloped and constructed of stacked cast-in-place concrete bags. The retaining walls vary from 5- to 6-feet in height. The concrete reinforcement along the channel bed floor is sloped and overlaps as it follows the creek downstream and measures approximately 10-feet wide.

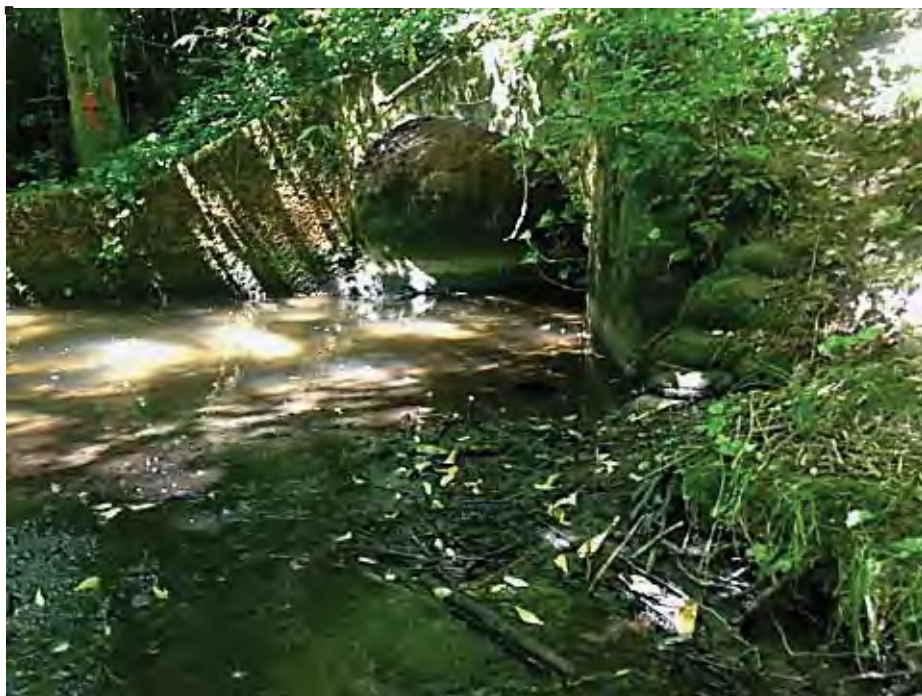
Figure 19. The downstream headwall, view northeast (courtesy of Aaron Hartvigsen, GeoEngineers Inc.). Note the retaining wall reinforcement along the southeast wing wall.

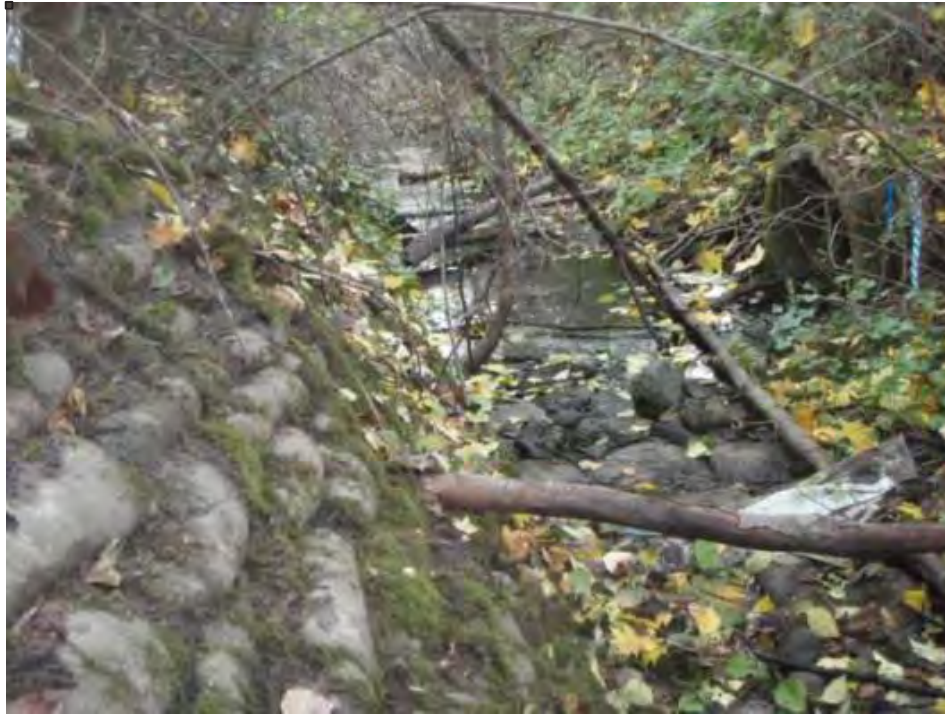
Figure 20. The downstream retaining wall along the creek channel banks and bed floor, view west.

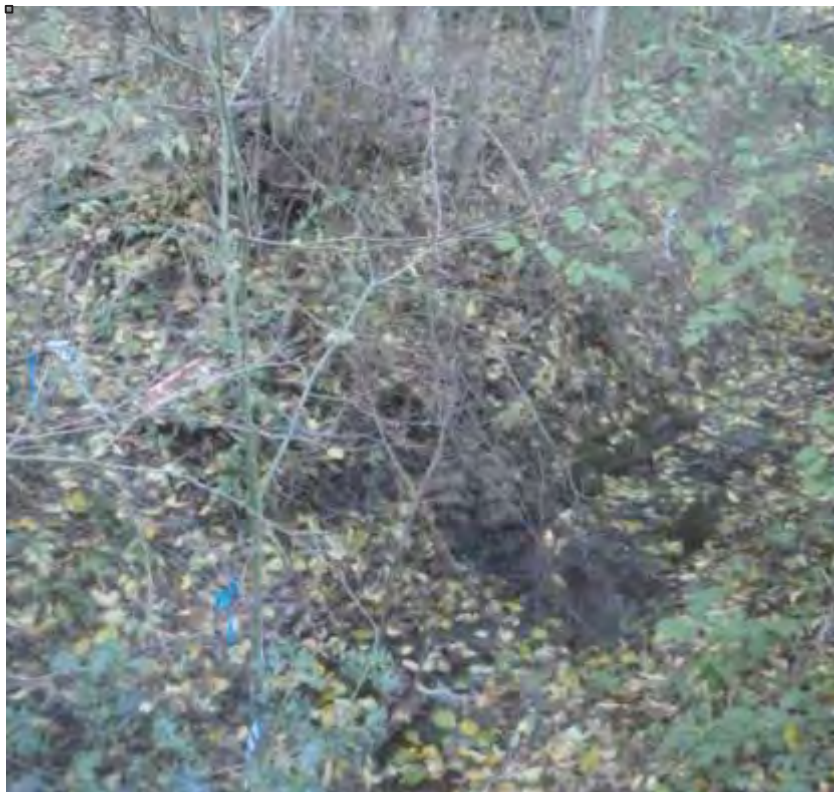
Figure 21. The F & S Railroad grade intersecting Padden Creek, view southwest. Note the channel retaining wall.

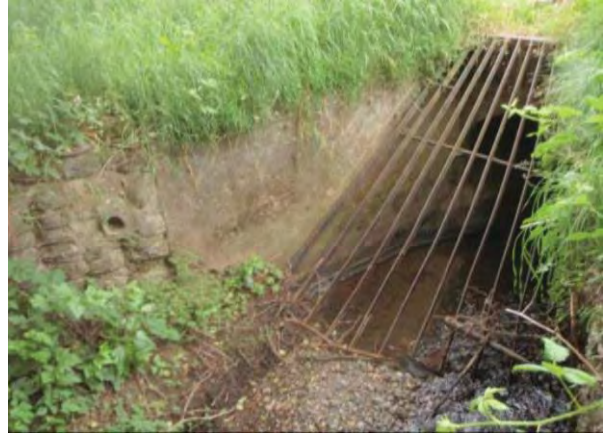
The upstream headwall, view southwest.
2012

Padden Creek enters the Happy Valley Tunnel System approximately 164-feet southeast of 22nd Street at the upstream headwall (Figure 15). The upstream headwall is a 6-foot tall poured concrete facing with angled wing walls and a metal grate that covers the tunnel opening. On the south wing wall, is a 60-inch diameter mortared concrete outfall pipe and a small section of the poured concrete has been repaired with stacked cast-in-place concrete bags that reach at least 10 courses high. At the north wing wall, a retaining wall extends southeasterly for an undetermined distance following the north side of the creek channel (Figure 16). The retaining wall is flat faced and characterized by its brick and mortared lining, measuring approximately 6 feet high and 1 foot thick. The base of the retaining wall is undercut by erosion in some areas along the creek waterline. The upstream headwall was reportedly upgraded sometime in the 1960s.

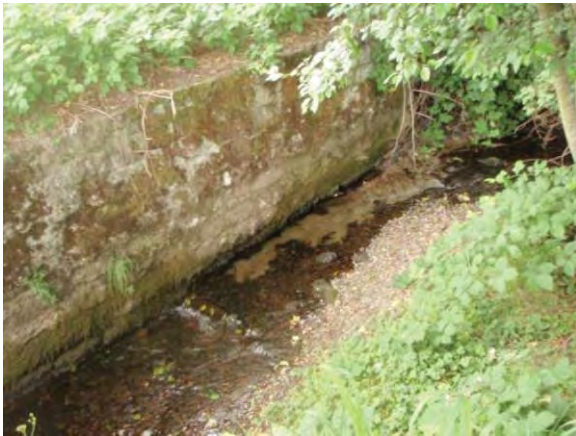
Note undercutting by erosion in some areas along the creek
waterline.
The base of the upstream retaining wall, view northeast.
2012

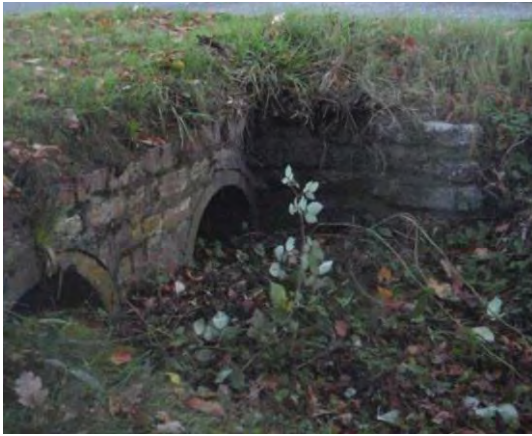
The culvert headwall located within an earthen drainage,
view southeast.

At the southeast corner of Happy Court and 22nd Street, Padden Creek is diverted beneath a culvert (Figure 18). The L-shaped culvert is comprised of three pipes that are flat faced and partially buried within an east to west oriented drainage ditch along the north side of a remnant Happy Court road alignment (see HPI). Two of the pipes measure 2-feet in diameter and drain east; and, the third pipe measures 1-foot in diameter and drains south. The headwall measures 2-feet in height and is 14-inches thick. The east face of the culvert headwall measures 9-feet in length and the south side wing wall measures 3-foot 7-inches. There was likely once a wing wall along the north side, however it has either been removed or has been buried due to slumping. The east wall of the culvert is covered by red brick facing with each brick measuring 3.5- by 8.5-inches being stacked at least 5 courses high.
