# **WHATCOM CREEK RESTORATION PROJECT REPORT: 2009**

**Associated with the  
Whatcom Creek Restoration Plan  
Developed for the June 10, 1999  
Olympic Pipe Line Gasoline Spill**

September 2010

Brenna Forester  
City of Bellingham  
Department of Public Works  
Environmental Resources Section  
Bellingham, WA

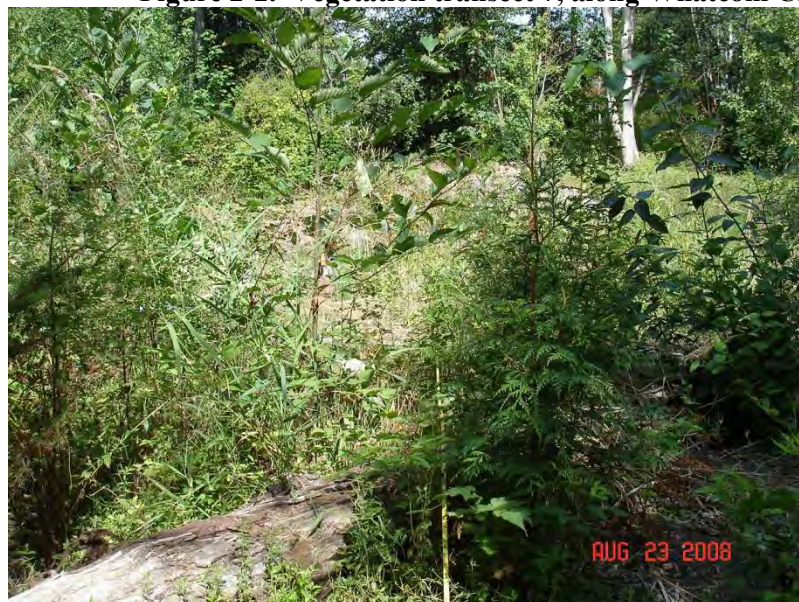
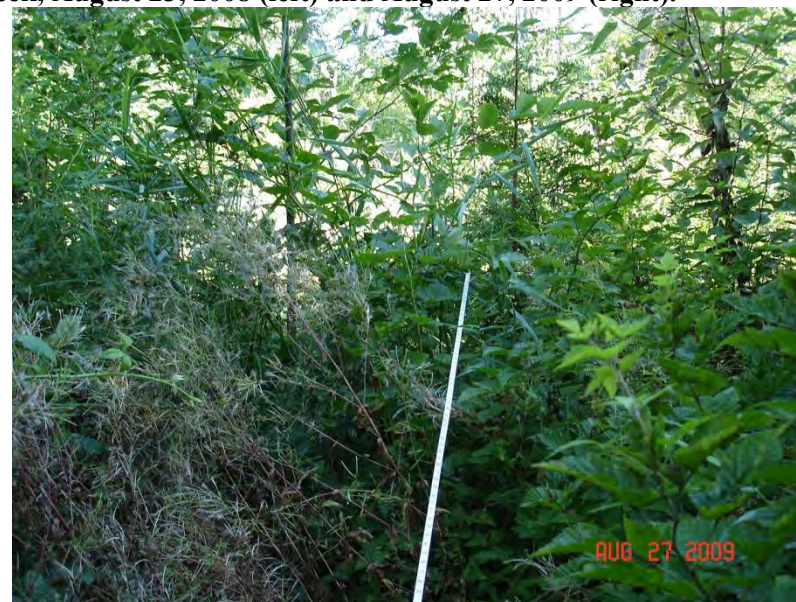
**Figure 2-2. Vegetation transect 7, along Whatcom Creek, August 23, 2008 (left) and August 27, 2009 (right).**

Beginning in 2008, a spherical concave densiometer was used to quantify canopy cover. Results from 2008 and 2009 surveys are presented in Table 2-4; 100% canopy cover would read 17.0 while 0% canopy cover would read 0.0. From 2008 to 2009, canopy cover has increased at 24 of 34 surveyed transects; 4 transects showed no change, while 6 transects had a loss of canopy cover. Average canopy cover has increased from 7.7 to 9.8, a 27% increase. At some transects (for example transects 7, 18, and 19) canopy cover has increased dramatically, with rapid growth of trees and shrubs from 2008 to 2009. Photos of two of these transects are presented in Figure 2-2 and 2-5.

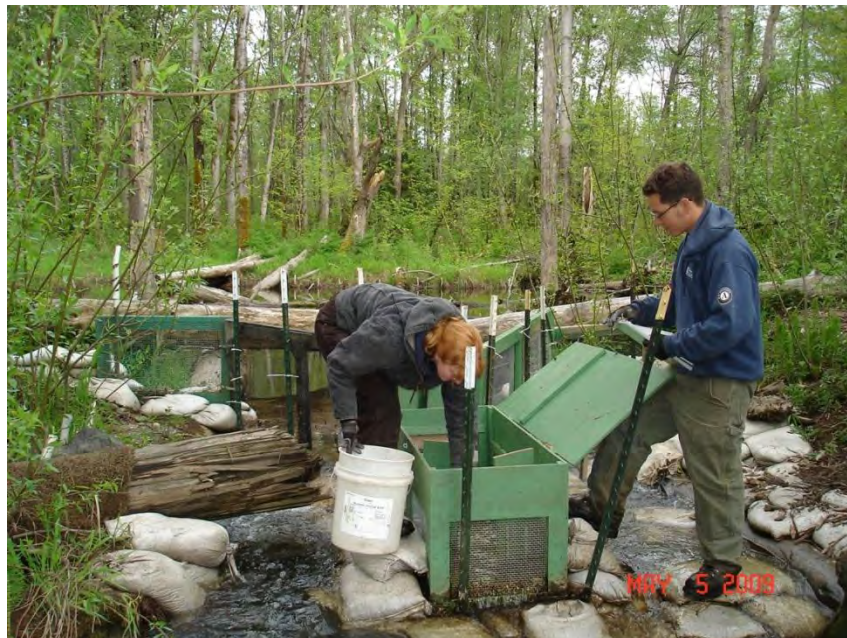
**Figure 2-7. WCC crew members checking the smolt trap for fish, May 5, 2009.**

A smolt trap is generally in place from mid-March to early June, or when low flows create insufficient water depth in the live box. In 2007, the trap was installed on March 28 and maintained until June 7 (72 days total). In 2009, the trap was installed on March 18 and maintained until May 26 (70 days total). Detailed methods are outlined in the *Whatcom Creek Restoration Project Report: 2007-2008* (Forester 2009). Recommended modifications to the trap and live box were instituted for the 2009 season.

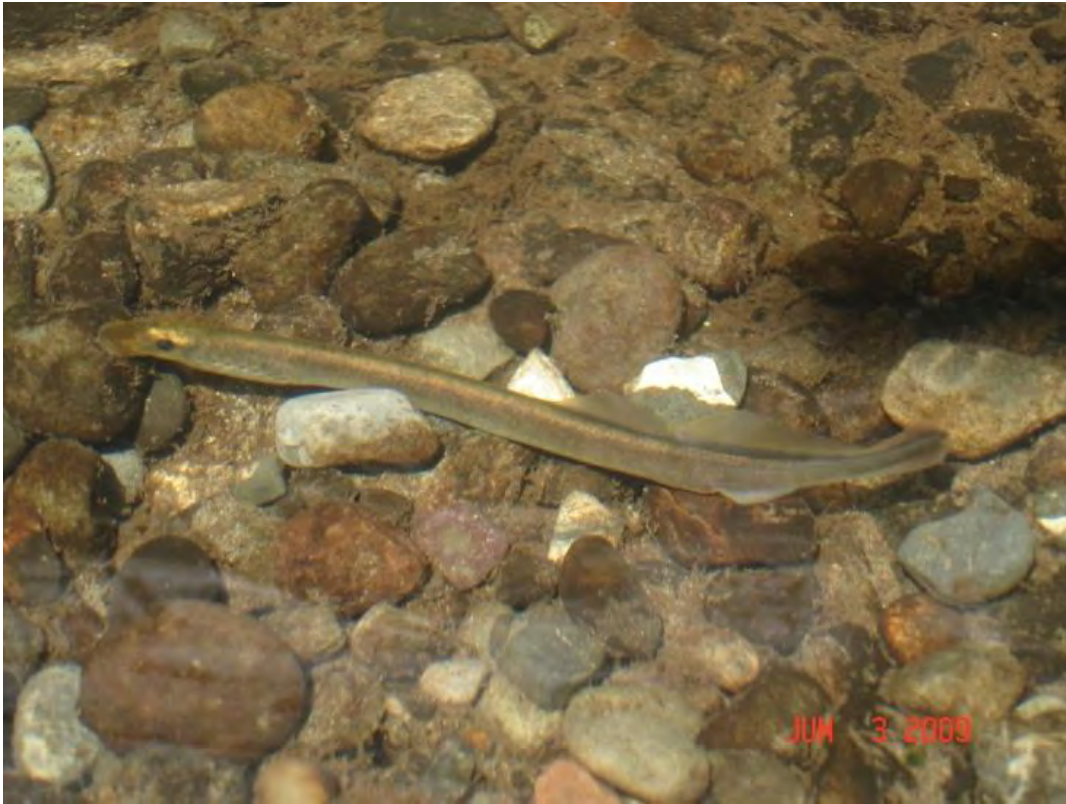
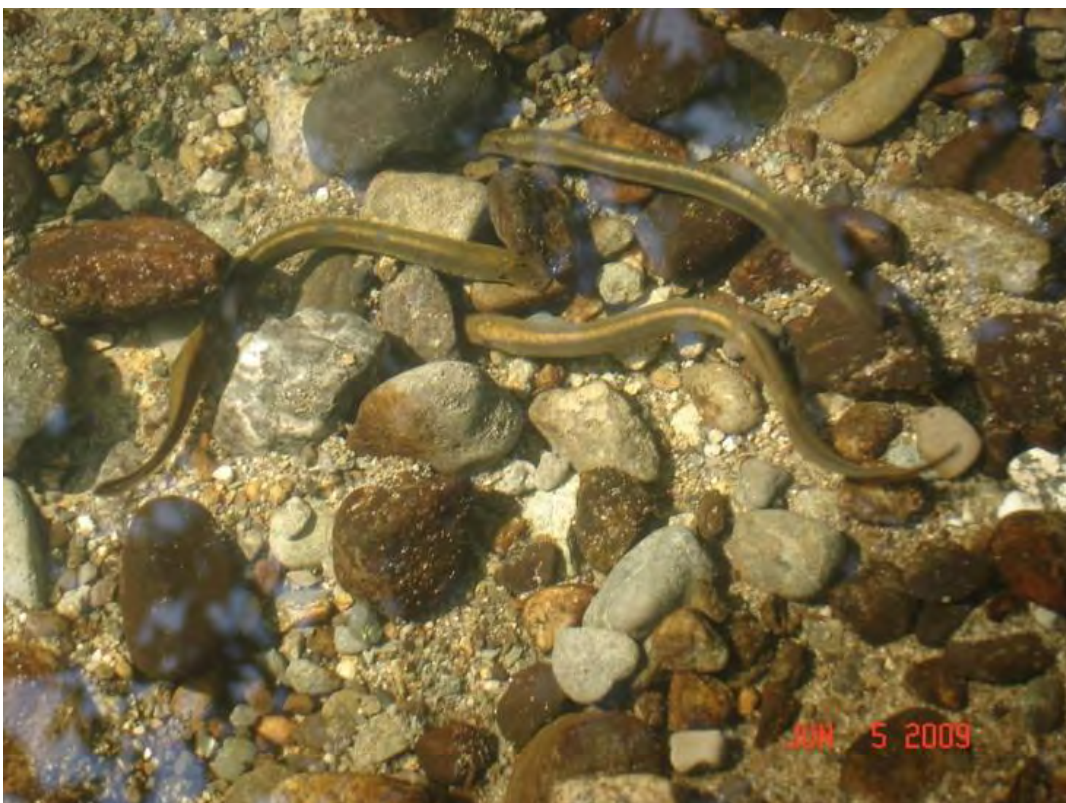
Native western brook lamprey (*Lampetra richardsoni*) were documented building redds and spawning in multiple areas of Cemetery Creek in 2009 (Figure 2-22). Three adult lamprey were first noted on June 3, 2009 in the area of fine gravel just upstream of the North Pond. On June 8, other spawning groups were located in the mainstem of Cemetery Creek, upstream of the West Pond. Western brook lamprey are a non-parasitic lamprey species that live their entire lives in freshwater. Mature adults do not feed, but only reproduce before dying. The larvae (ammocoetes) live as filter feeders in quiet backwater areas with silty bottoms. They have been documented to live up to 6 years in British Columbia (Wydoski and Whitney 2003). The Cemetery Creek system, with its many backwater areas and ponds with deep silty bottoms in combination with areas of fine spawning gravel, likely provides an ideal habitat for the maintenance and reproduction of western brook lamprey populations. It is hypothesized that western brook lamprey have distinct population groups since they are limited in their ability to make long-distance movements within river systems ([www.biologicaldiversity.org](http://www.biologicaldiversity.org)).

**Figure 2-22. Western brook lamprey building a redd in the Cemetery Creek channel, June 3 and 5, 2009. Size of these adults is approximately 6 inches.**

Staff should continue to watch for western brook lamprey spawning activity between the months of April and July, especially in areas of fine gravel in the Cemetery Creek channel. Care should be taken that redds are not disturbed or stepped on by staff; lamprey redds resemble small salmon redds (between 1 and 3 feet in diameter).

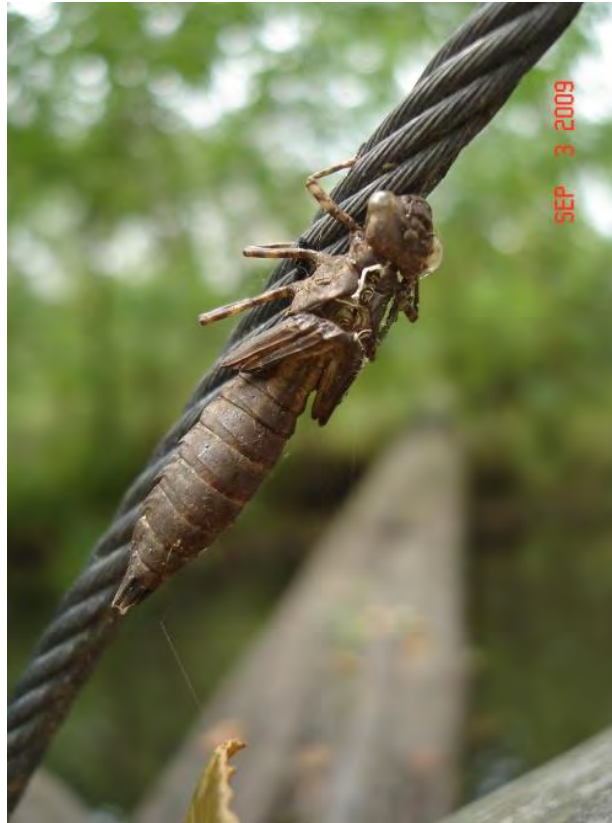
The pond system at Cemetery Creek is widely used by dragonflies and damselflies (order Odonata) for feeding and reproduction. Many of these insects are emerging from restoration site aquatic habitats, as larval casings are frequently found by staff on logs, emergent vegetation, and even large woody debris jam cabling (Figure 2-24). Documented species include northern bluet (*Enallagma annexum*, Figure 2-25), cardinal meadowhawk (*Sympetrum illota*, Figure 2-25), and California darner (*Rhionaeshna californica*).

**Figure 2-24. Dragonfly nymph casing on large woody debris cabling, Cemetery Creek, September 3, 2009.**

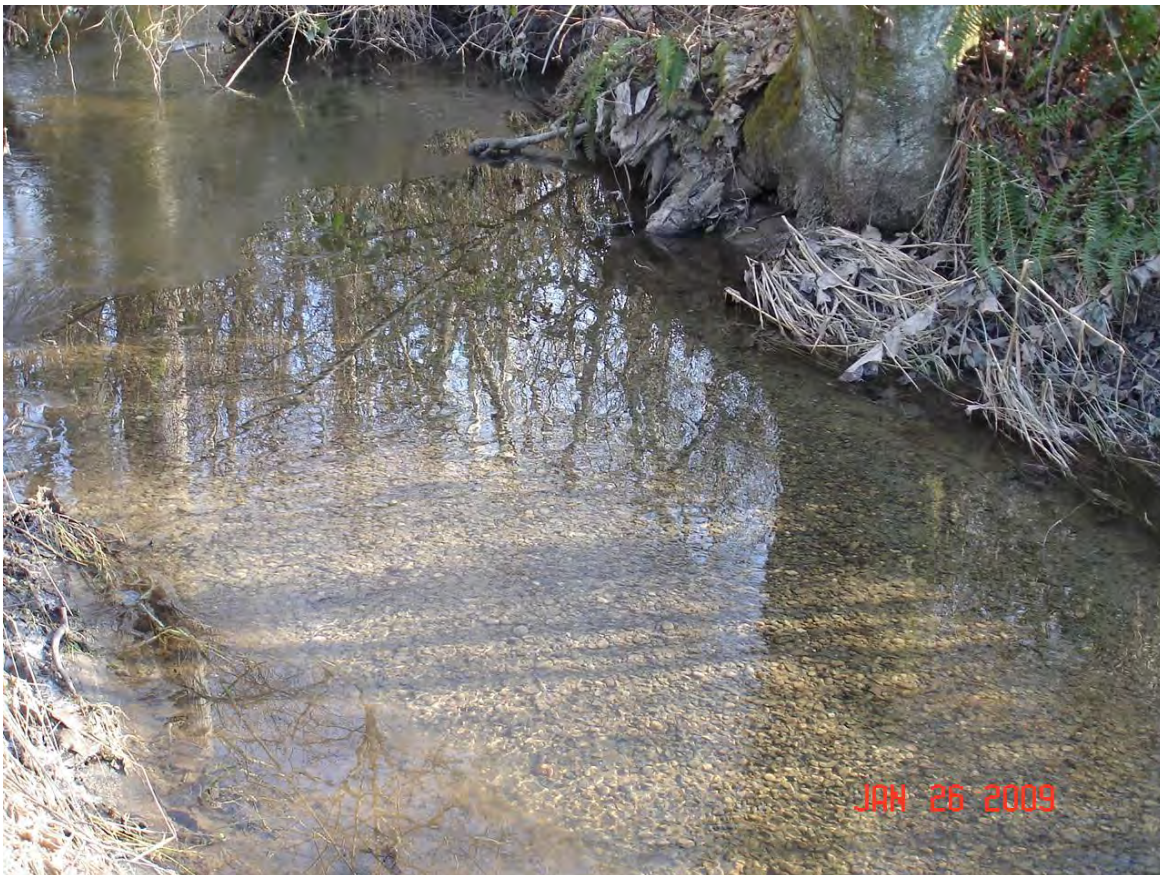
**Figure 3-9. Newly deposited spawning gravel patch at the upstream end of the restoration site, mainstem Cemetery Creek, January 26, 2009.**

- ✓ Reed canary grass should be pulled from the channel before the start of each spawning season. This invasive grass can bind spawning gravel in the channel, reducing habitat availability for spawning salmonids.

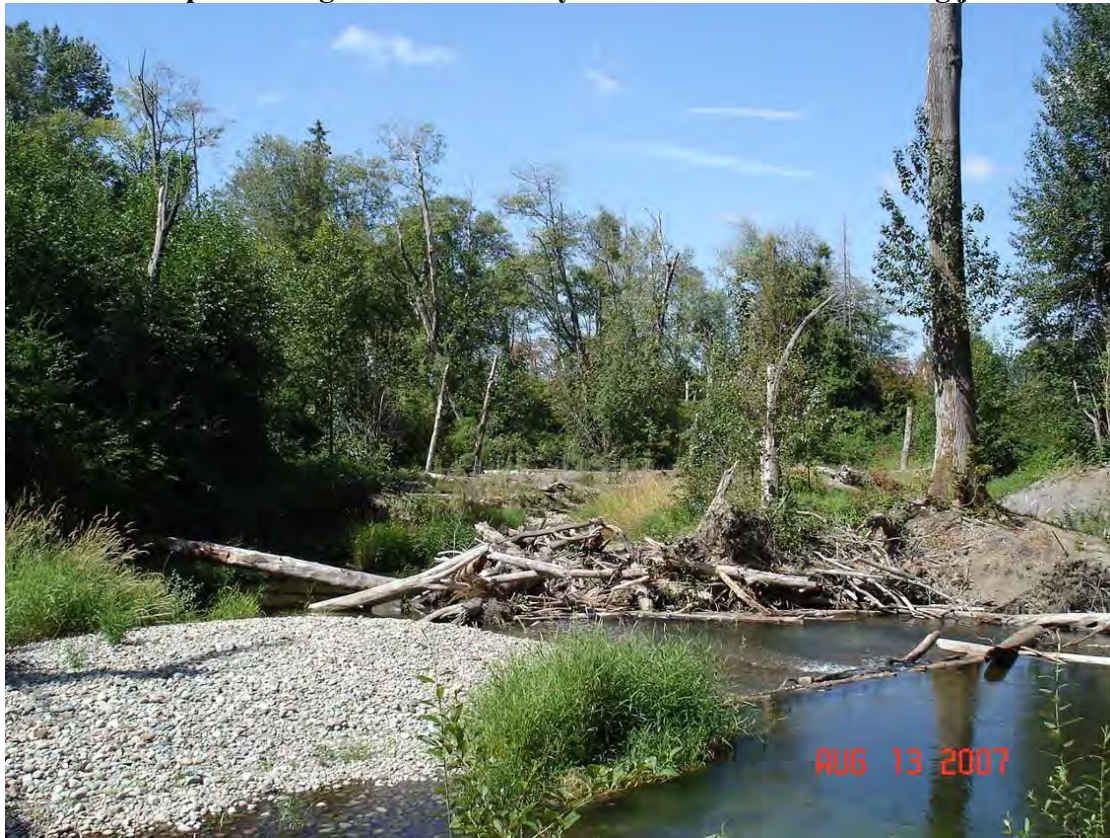
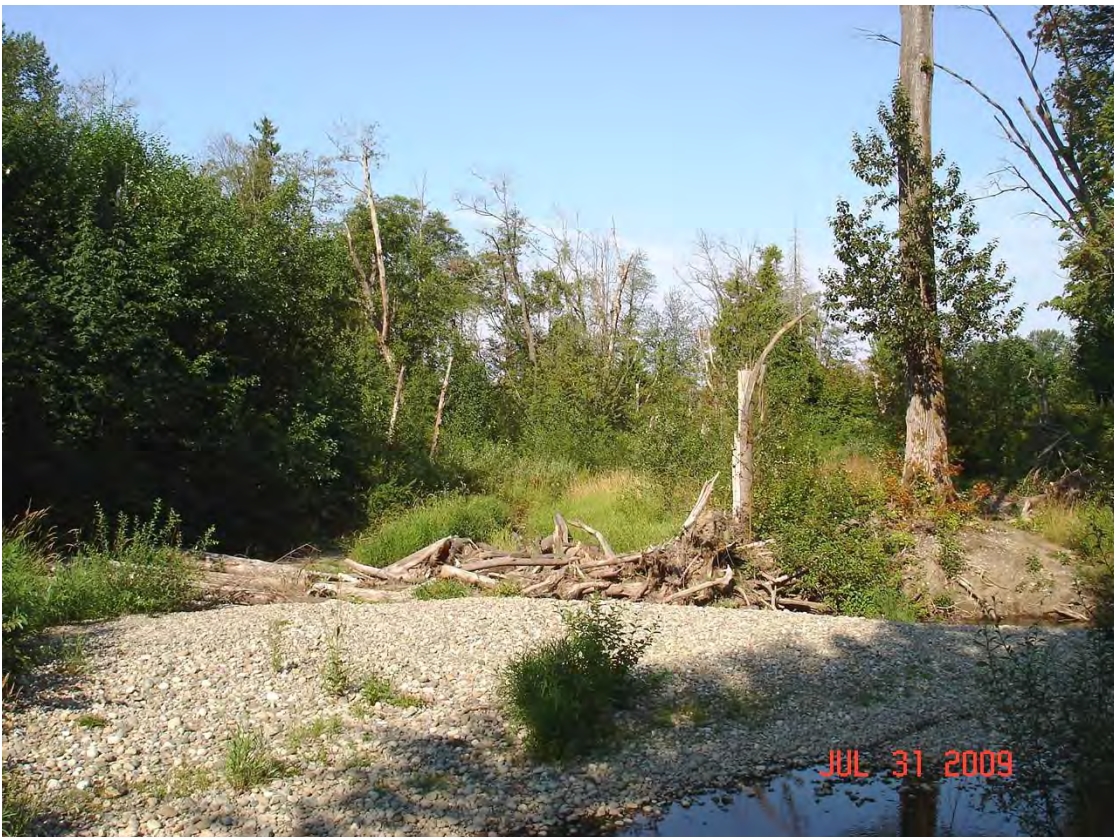
**Photopoints August 2007 and July 2009: 2a - Salmon Park log jam**
