City of Bellingham

Civic Athletic Complex
Consultant Team Investigation
And Observation Report

September 29, 2023

Prepared by:
RMC Architects, PLLC
1223 Railroad Avenue,
Bellingham, Washington 98225
360.676.7733

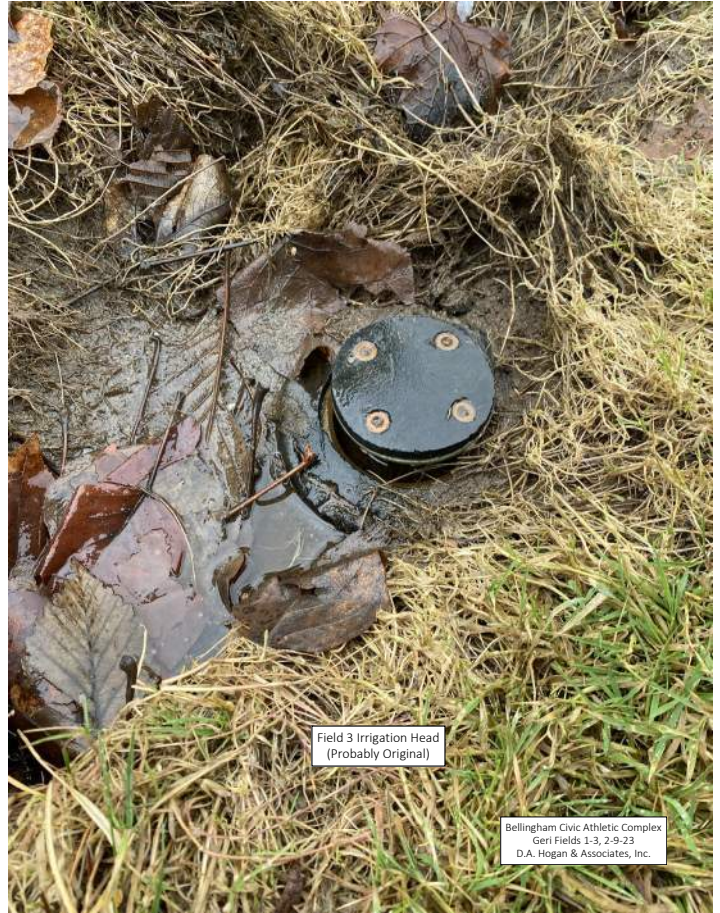
Field 3 Irrigation Head
(Probably Original)

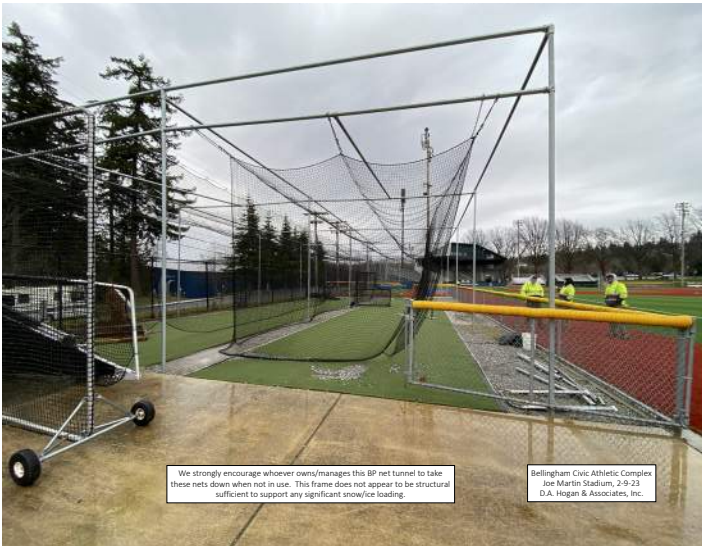
We strongly encourage whoever owns/manages this BP net tunnel to take these nets down when not in use. This frame does not appear to be structural sufficient to support any significant snow/ice loading.

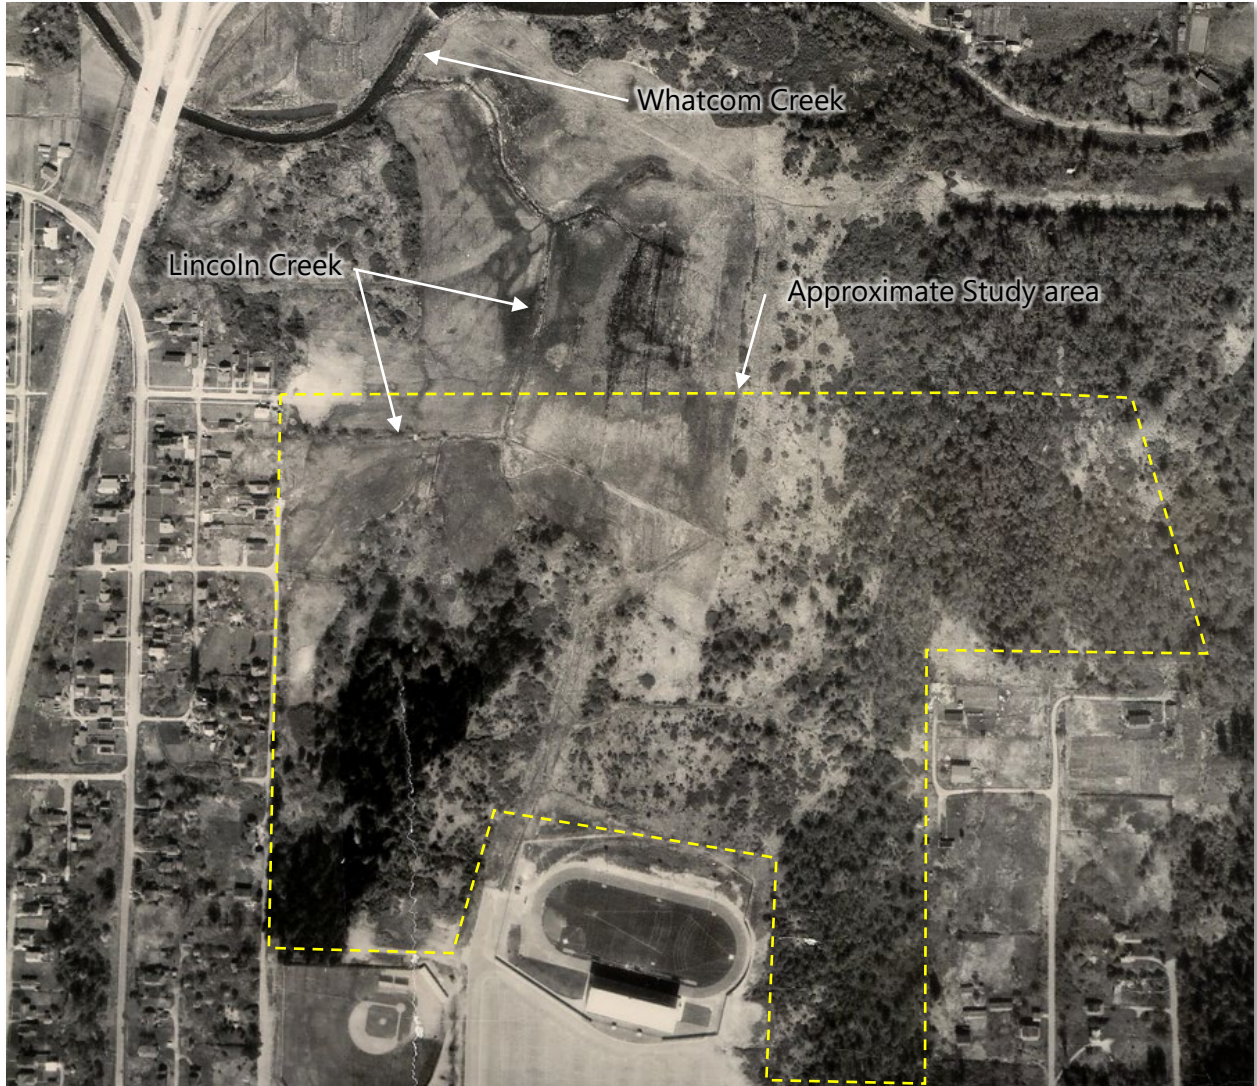
Photo 3. Historic photo of the study area, circa 1963 (City of Bellingham Historic Aerial Photographs). This map shows Lincoln Creek in a linear channel slightly further south than the current location. The creek was re-routed in the 1980s.

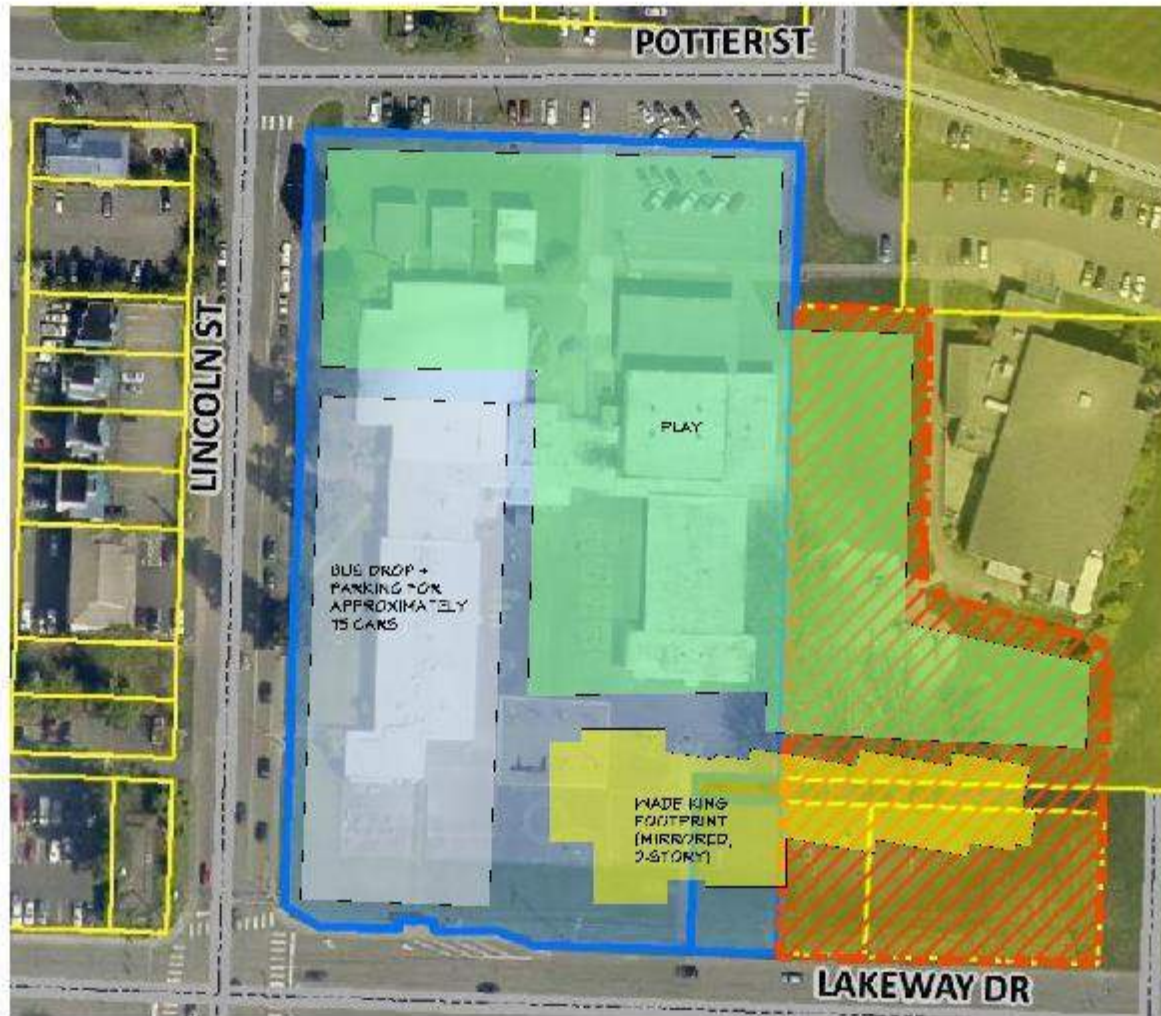
Phase 2 (WK Footprint) - Demo existing school; build parking & play
