STEWARDSHIP PLAN

CHUCKANUT COMMUNITY FOREST

BELLINGHAM, WASHINGTON

Prepared by
Herrera Environmental Consultants, Inc.

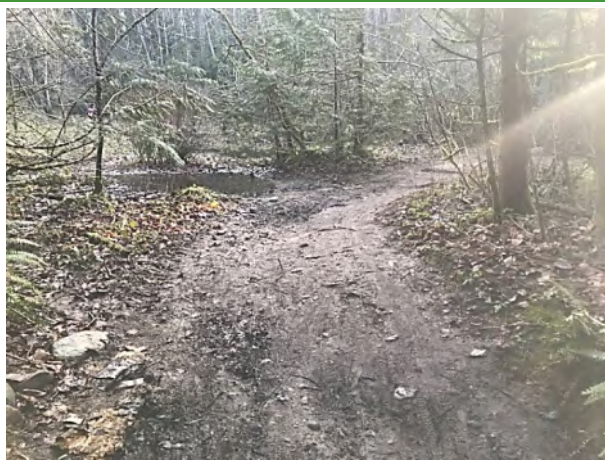
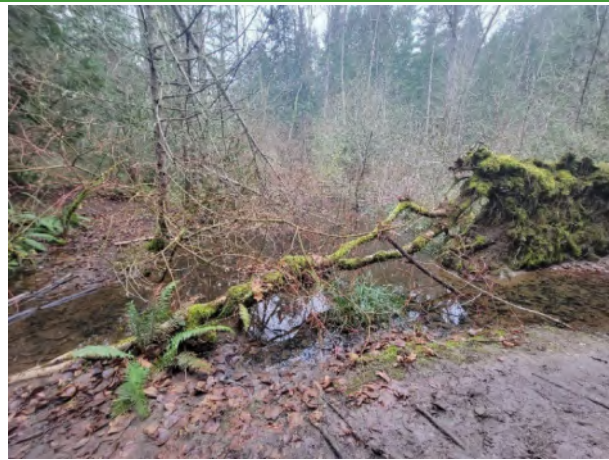
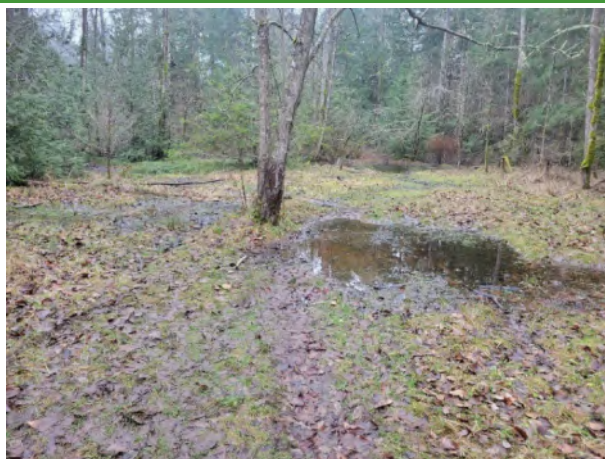
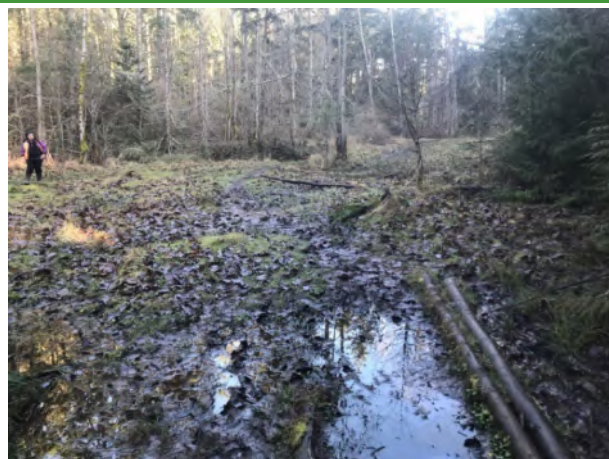
The City's proposal to utilize the existing roadbed, which constitutes a historical site disturbance near a former gravel yard, as a major cross-property trail connector between Fairhaven Park to the north and the Interurban Trail to the east is also recommended in the CCF's Baseline Report (Eissinger 2017) (Figure 7). However, one section of this roadbed trail was observed to intersect seasonal surface water flows from Wetland AY downslope to a small wetland on the south side of the trail (Photos 1 through 4). In order for the City to continue utilizing and improving this trail for major use, the installation of a culvert, bridge, or boardwalk structure or other low-impact development measures (such as a ballast rock base or "burrito") is recommended in order to preserve the seasonal surface water hydrologic connections while also minimizing impacts.

Wetlands AA, AX, and AY located at the site of a former gravel pit were observed to be highly disturbed by historical site use and by the current trail system (see Photos 1 through 4 in the [Area A: Improvement of Main Trail and Former Gravel Yard Restoration](#) subsection). Nonnative and invasive vegetation including creeping buttercup (*Ranunculus repens*), English ivy (*Hedera helix*), and English holly (*Ilex aquifolium*) were prevalent in these wetlands. The disturbed nature of these wetlands resulted in their lower rating as Category III wetlands. During Herrera's January and February 2022 site visits, a surface water connection was observed to flow downgradient from the gravel pit wetlands over the cross-roadbed trail to a small, delineated wetland and another suspected wetland area that had not been mapped within the adjacent historical gravel pit site area to the south. Invasive Himalayan blackberry (*Rubus armeniacus*) dominates the vegetation within the southern gravel pit site area.

The existing trails adjacent to and crossing through Wetlands AA, AY, and AZ are also directly impacting wetland hydrology, habitat, and buffer functions; and their removal is imperative for the site's recovery. Existing vegetation in this area is low functioning; and invasive nonnative species establishing within the exposed area should be removed and replaced with native tree, shrub, and herbaceous plant installations. A fence that does not impede wildlife migration, but that discourages pedestrian access from the trail into natural habitat areas, such as a two-rail fence (see the [Wildlife Habitat Protection](#) section below for more information) should be installed. This area, due to its historical land use and proposed process for its restoration, also presents an excellent educational opportunity. Accessible overlooks from the trail crossing toward the historical gravel pit areas to the north and south are possible locations for interpretative signage additions.

Nonnative and invasive Himalayan blackberry (*Rubus armeniacus*) dominates the vegetation in the adjacent depressional area to the south of the trail, also a remnant from former land use gravel extraction. Its removal and replacement with native plant installations is recommended; however, this work is not as critical as the recommended trail improvement and restoration of the wetlands to the north of the trail crossing.

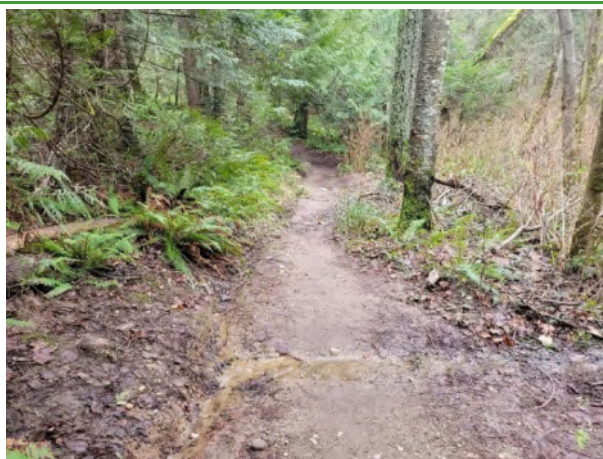
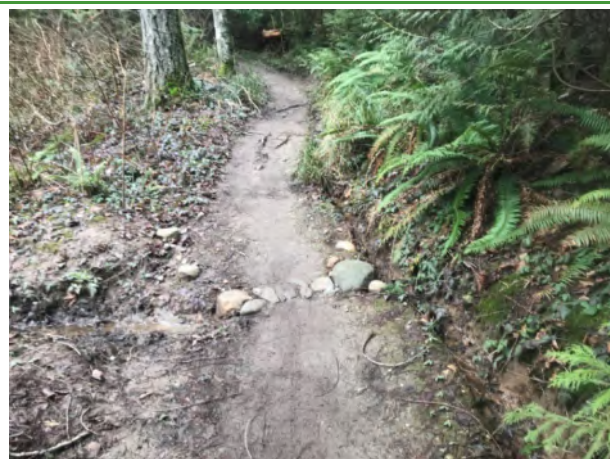
Current review of the CC1 and CC2 wetlands indicates that these areas should be combined as a single Category I mature forested wetland under City Environmental Critical Areas regulations with a standard designated protective buffer width of 190 feet. The existing trail, accessed from Chuckanut Drive North, which bisects the wetland, is impacting the system's natural hydrologic surface water connectivity (Photos 5 and 6). The highest level of preservation recommended for this area would be to remove the trail, as alternative trails connecting the View Crest trail access with the existing main roadbed trail to the northern portion of the site are already present.

At the time of site visits performed by Herrera biologists in January, February, and March of 2022, surface water was observed flowing over the trail bisecting the CC1 and CC2 wetland areas (see Photos 5 and 6 in the [Area B: Wetlands CC1 and CC2 Hydrology Connection Trail Crossing](#) subsection). Hydrophytic vegetation was observed growing next to both sides of the trail alignment, and a large contiguous area of saturated soils was also present to indicate wetland connectivity. Although these hydrology connections were observed during the wet season, ditching and the placement of rocks to serve as ad hoc measures for conveying surface water flows across and or adjacent to the trail indicate that saturated and or inundated conditions between the wetlands is frequent. For the purposes of designating protection and restoration priorities in this stewardship plan, it is recommended that the CC1 and CC2 wetland areas be recombined as one Category I mature forested wetland. Future restoration to minimize impacts along this section of the existing trail will require compliance with City critical areas protection and permitting regulations which will depend on further evaluation of problematic soils and hydrology indicators during the growing season (Environmental Laboratory 2010). Additional information regarding Herrera's review of hydrology connectivity within the CCF and adjacent area is included in the [Hydrologic Connections – Priority 3](#) subsection of the [Ecological Significance](#) section of this report.

Trail abandonment may be readily implemented through the installation of large logs, stumps with root wads, two-rail fencing, and dense native vegetation plantings. Herrera biologists, when in the eastern interurban trail network, noticed that a minor trail had apparently been abandoned as a natural circumstance of a fallen tree that had impeded easy pedestrian access. Signage alerting users to the sensitivity of the CC1/CC2 wetland complex and its associated wildlife habitat and therefore a need to restrict its access could also be installed in this location.

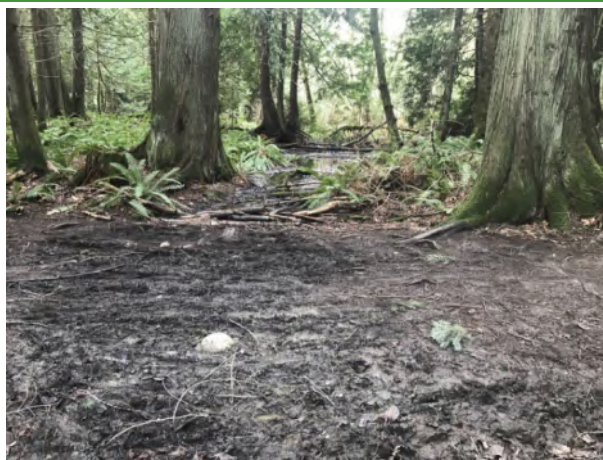
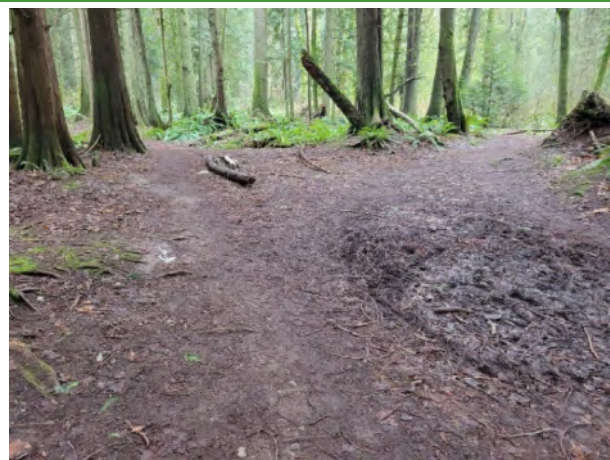
Seasonal surface water connectivity between the mature forested Category I Wetlands KK and JJ is at a crossroad on this portion of a well-used but oversized trail located within and adjacent to the CCF's eastern boundary (Figure 7; Photos 7 and 8). The installation of a culvert, bridge, or boardwalk structure, or other low-impact development measure (such as a ballast rock base or "burrito") is recommended, as well as reducing the overall width of the trail to 6 feet or less. Exposed soil areas outside of the 6-foot width should be revegetated with densely planted native shrubs and ground cover plants.

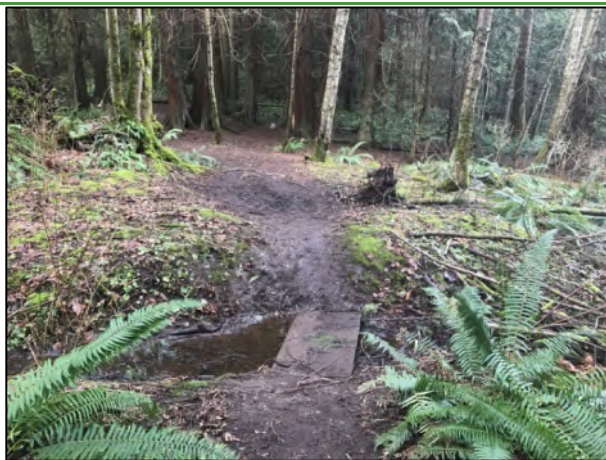
The existing ad hoc trail crossing at the southern end of Wetland KK, a Category I mature forested wetland, is recommended for removal. The proposed main trail loop does not include this portion of the site, and therefore trail-related impacts to Wetland KK and its associated buffers can be avoided. By eliminating this trail crossing, the total extent of the City's standard 190-foot-wide buffer designated to protect the wetland at this location can be restored and protected. To remove the trail and restore the area to a natural state, the procedure outlined in [Method for Trail Removal](#) below should be followed. Photo 9 shows the existing trail at the southern end of Wetland KK that is recommended for removal.

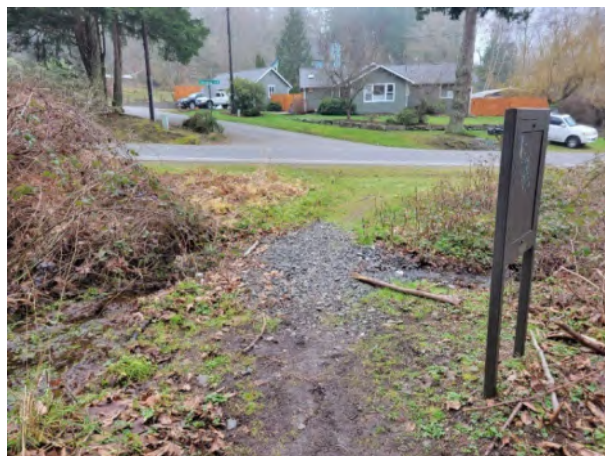
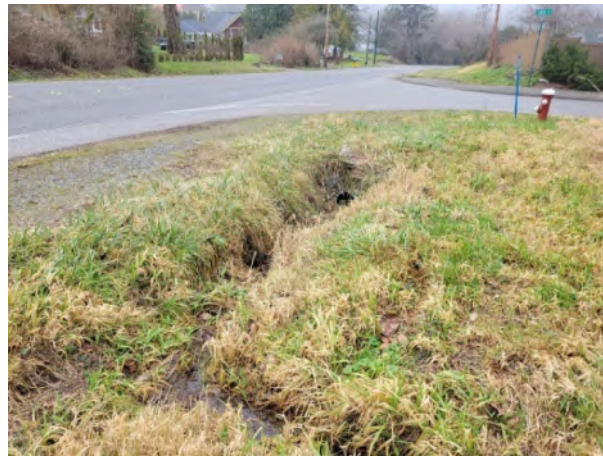
The existing access to the CCF from Chuckanut Drive and across from 16th Street crosses a piped segment of a ditch that discharges seasonal surface water flows from the Category I mature forested Wetland CC1 to a storm water drainage system within the Padden Creek subbasin (Figure 7; Photos 10 and 11). Although not formally delineated, a degraded reed canarygrass dominated Palustrine Emergent (PEM) wetland that parallels the ditch extends north to the road corner. This area needs restoration to improve the diversity of native vegetation and appropriate sizing of the existing conveyance pipe should be evaluated to ensure that site hydrology is managed. A new trail corridor that would provide connectivity along Chuckanut Drive between View Crest Road and 16th Street is recommended for consideration to support the removal of existing trails that surround and directly impact Wetland CC1 at the site. Improvements along the new roadside trail corridor to provide additional parking are also recommended.

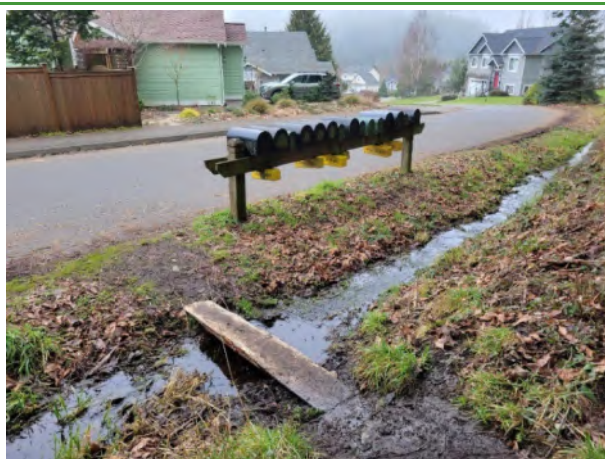
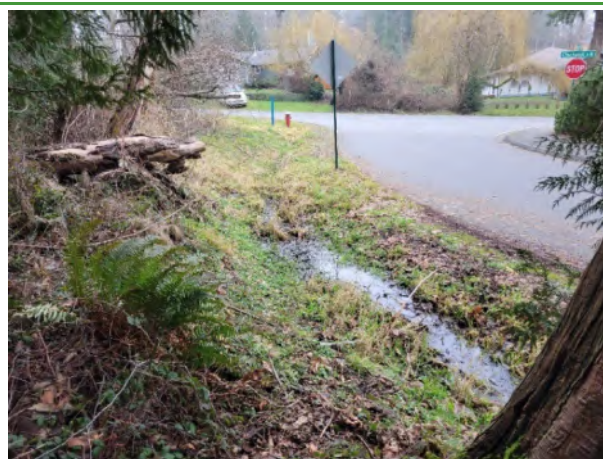
The existing pedestrian access into the CCF from the residential community at the east end of 16th Street is encumbered by an open roadside ditch that conveys seasonal surface water flows west from the corner of Chuckanut Drive (Figure 7; Photos 12 and 13). Crossing of the ditch, which is currently spanned by a single wood plank to provide ad hoc trail access, should be improved through the installation of a properly-sized culvert pipe (12-inch diameter, minimum).

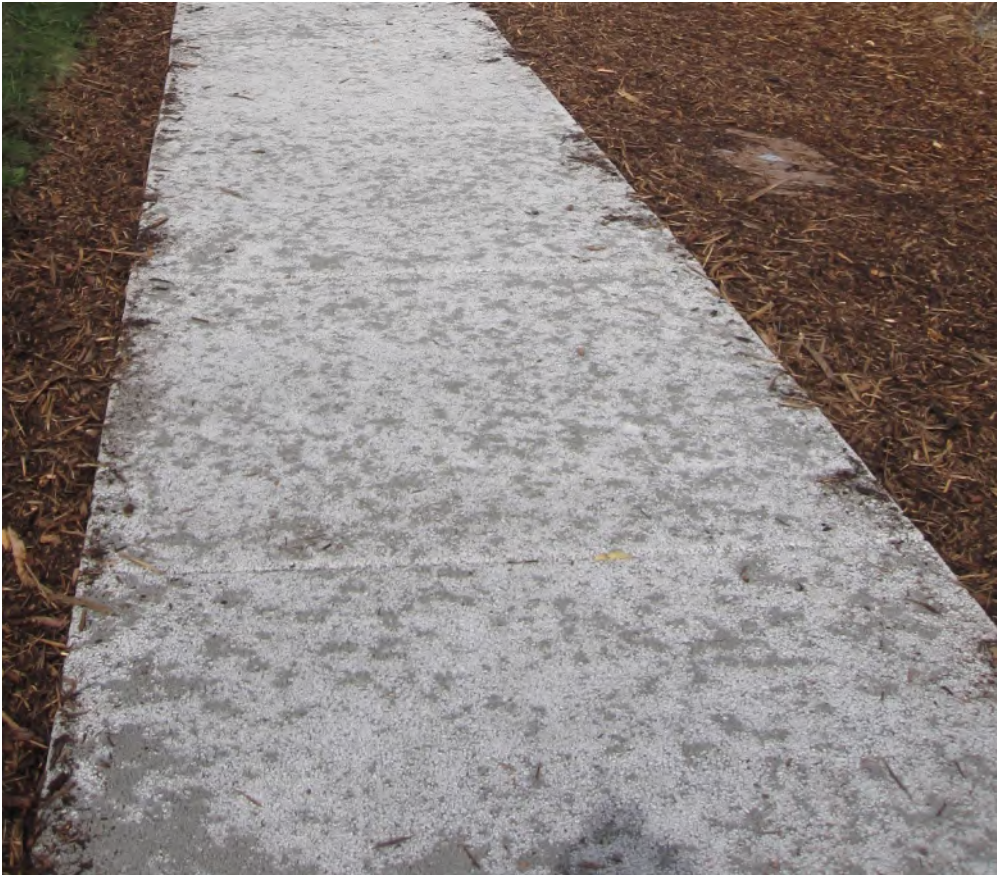
Photo 14. Pervious Concrete Trail, Westridge Place, Bellingham, Washington.

Trails in the highest traffic locations can be paved with a hard and durable surface such as asphalt (such as the segments of the Whatcom Creek trail from Railroad Avenue to Ellis), or concrete (such as a typical sidewalk). In some cases where the soil and site conditions are appropriate, a hard-surface trail can be made pervious (such as the trail from Westridge Place to Magrath Road near Northridge Park; see Photo 14).

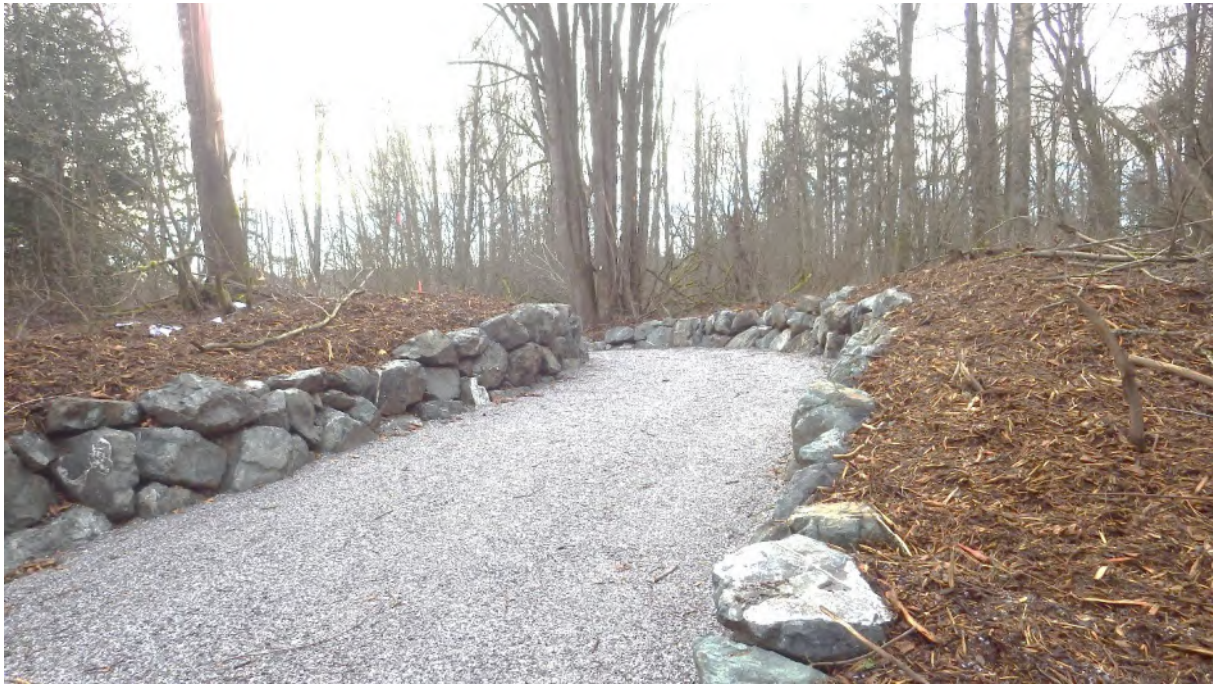
Photo 15. Typical Crushed Limestone Trail from Herrera's Design at Julianna Park, Bellingham, Washington.

The City's standard plan (Drawing 2505.1) for limestone shared-use paths can be found here: <https://cob.org/wp-content/uploads/02505.01-typical-trail-section.pdf>. An example of this type of trail is shown below in Photo 15. Managers should weigh the needs for city maintenance, ADA accessibility, and recreational users against the importance of preserving ecosystem functions within the CCF before installing this type of high impact trail.

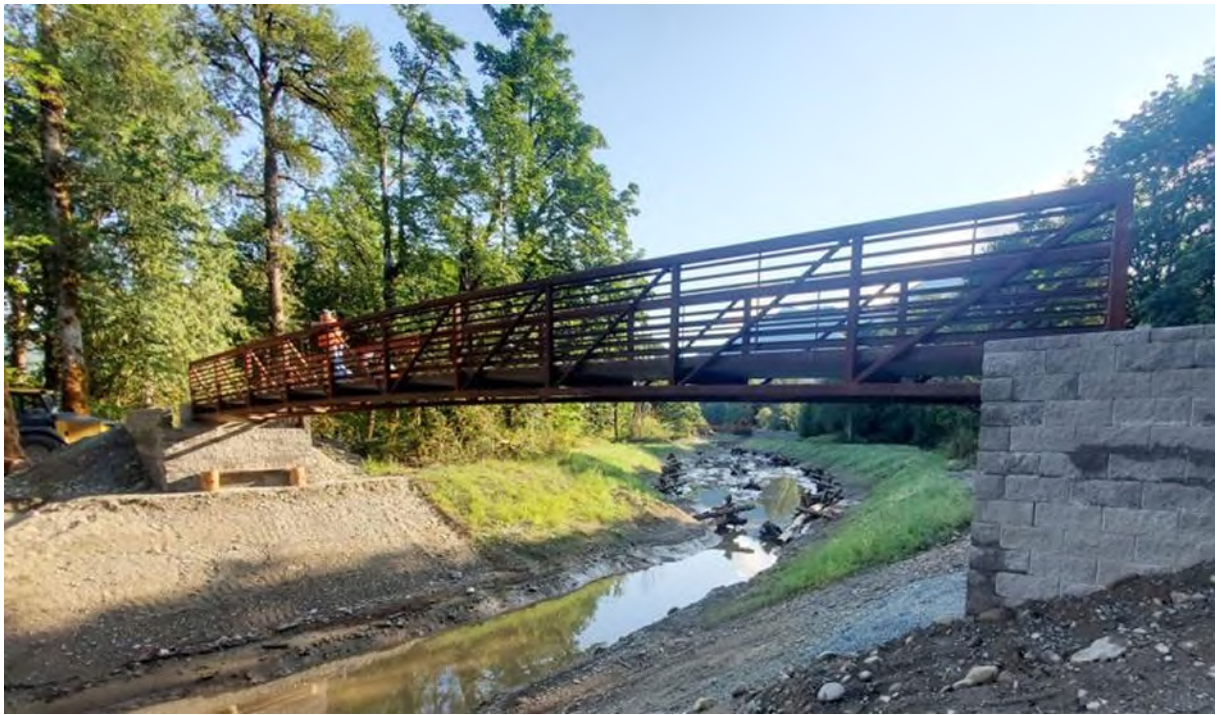
Photo 16. Example Pre-Fabricated Pedestrian Bridge from Herrera's Design at Presentin Park, Marblemount, Washington.

The preferred method to cross wetlands or streams with a trail is with a bridge or boardwalk structure. Several vendors (such as Contech or Big R) provide pre-fabricated pedestrian bridges that meet the City of Bellingham's standards for crossing streams. Using a pre-fabricated bridge is typically the most cost-effective approach to providing stream crossings when compared to a custom-designed and site-fabricated bridge; see Photo 16.

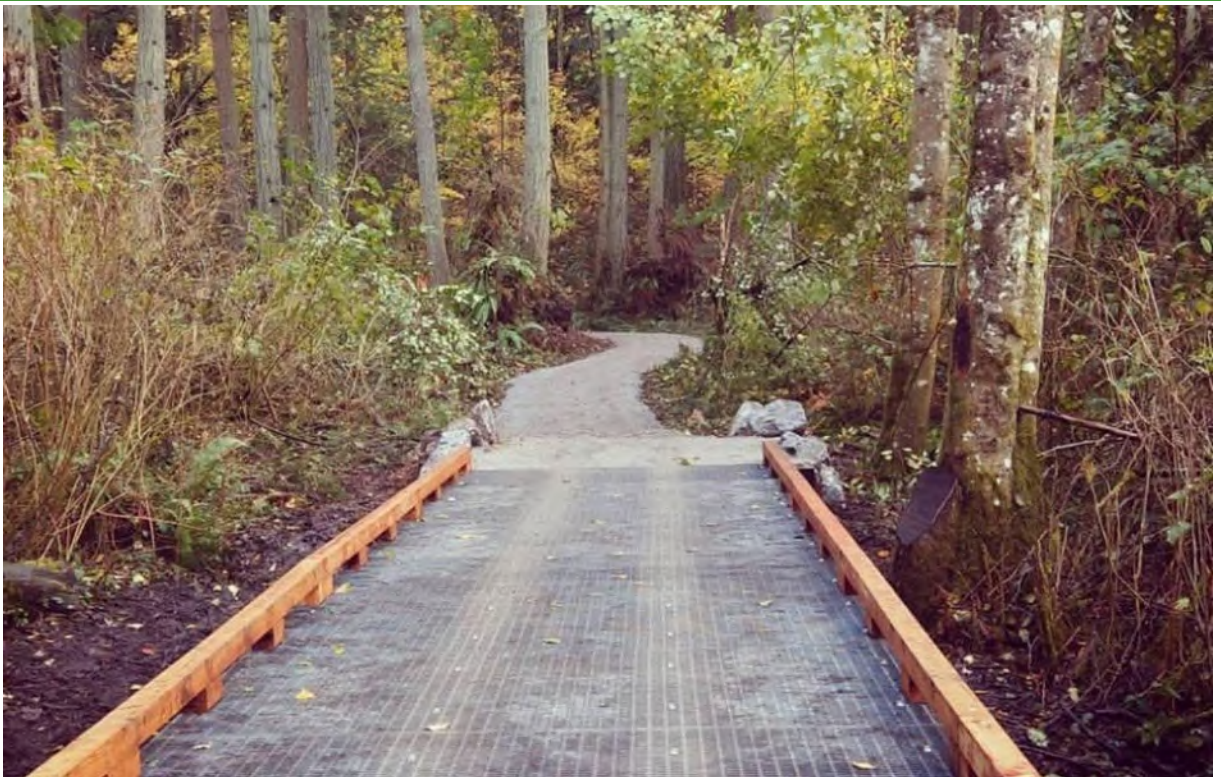
Photo 17. Example Wetland Boardwalk Design from Herrera's Work at Fairhaven Park Adjacent to the Site, Bellingham, Washington.

Boardwalks with open grating can be built on pin piles or other low-impact pier foundations within wetlands and largely avoid impacts requiring mitigation; see Photo 17.

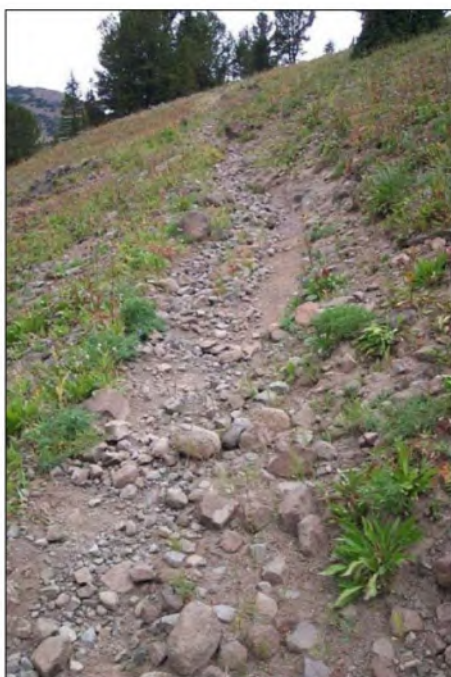
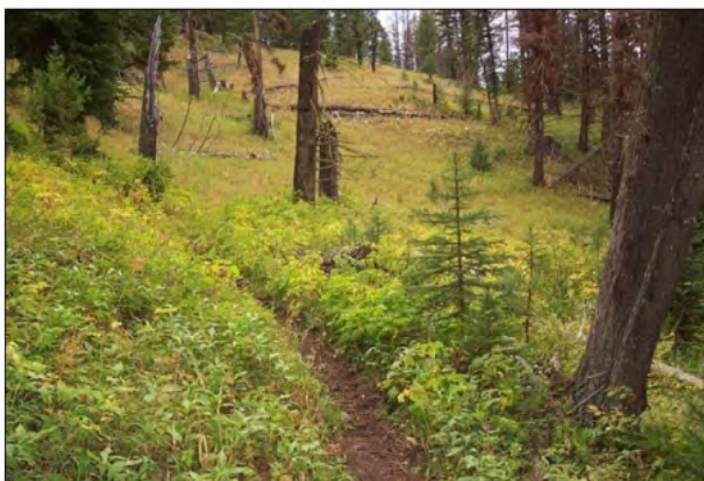
Figure 10. Trail Class 2 Example Photographs, USFS.

TC2 – Tread: Tread continuous and discernible, but narrow and rough.

In addition to the City of Seattle reference above, the USFS Trail Class Matrix (<https://www.fs.fed.us/recreation/programs/trail-management/documents/trailfundamentals/National_Trail_Class_Matrix_10_16_2008.pdf>) can be useful in classifying less formal trails. The existing narrow footpaths on the site are a combination of Trail Class 2 and 3, as shown in Figures 10 and 11.

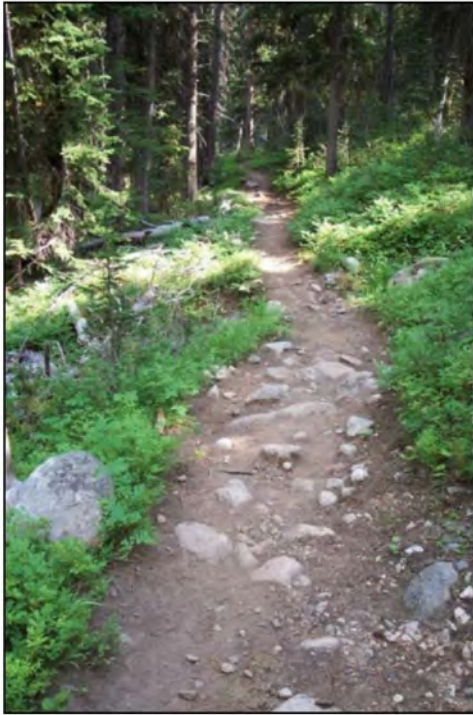
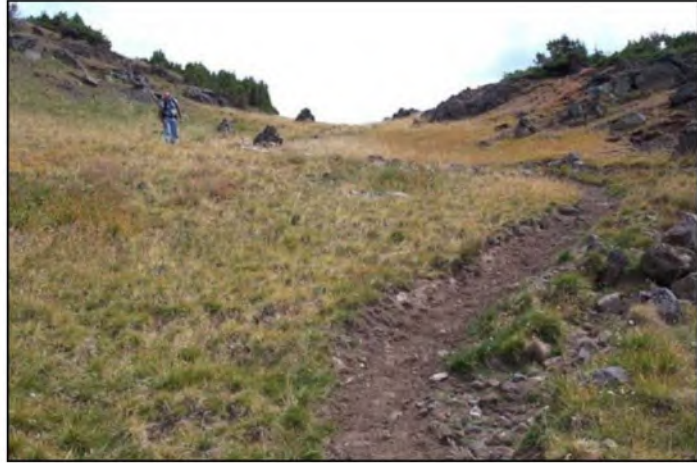
Figure 11. Trail Class 3 Example Photographs, USFS.

TC3 – Tread: Tread continuous and obvious.

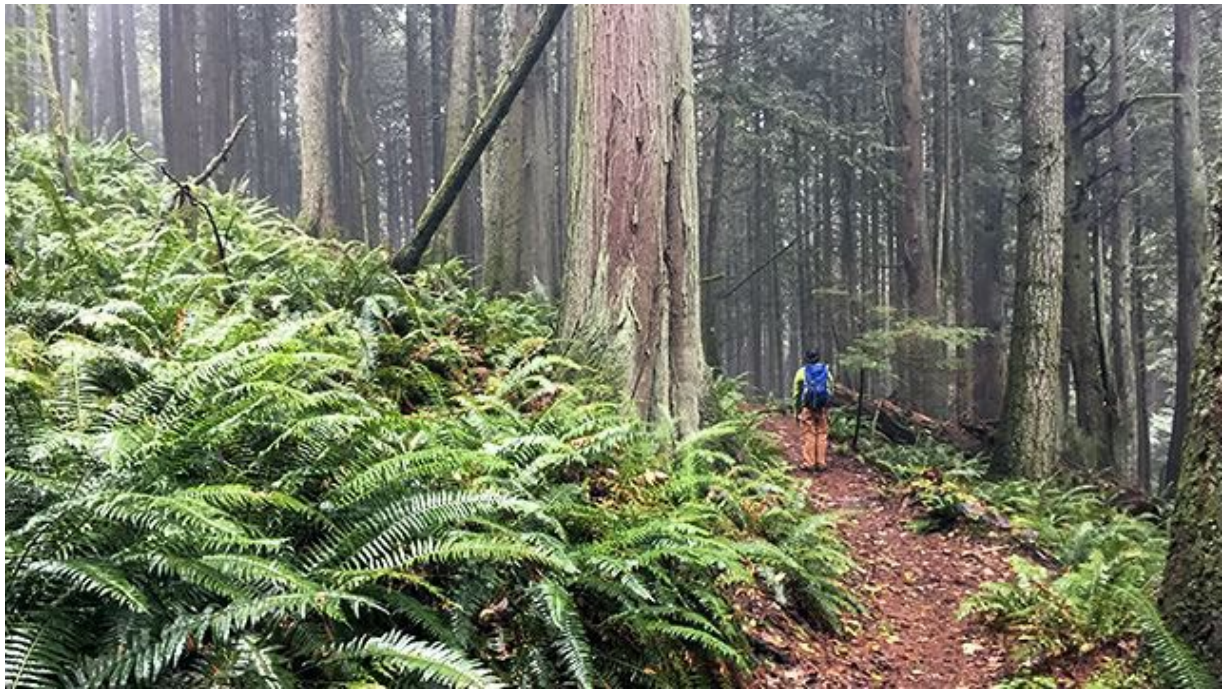
The images below show examples of Trail Class 3 narrow foot paths in the Chuckanut mountains.

Photo 18. Trail Class 3 Chuckanut Mountains Example Photograph, Whatcom County Parks & Recreation.

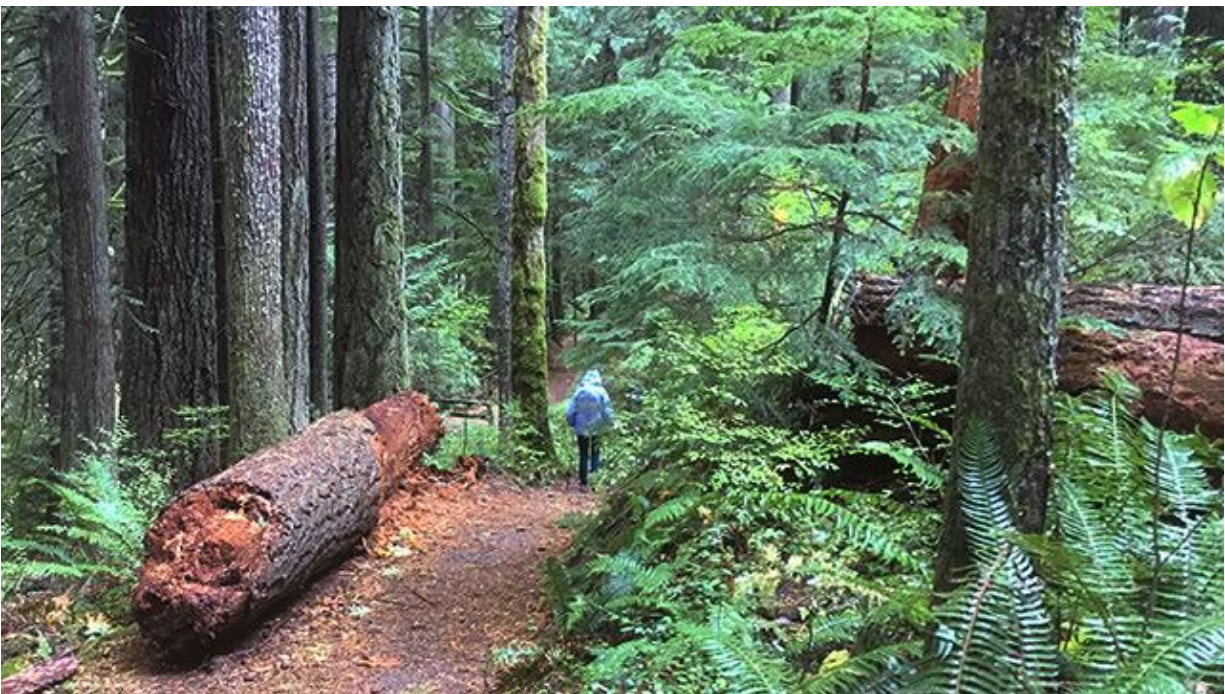
Photo 19. Trail Class 3 Stimpson Nature Reserve Example Photograph, Whatcom County Parks & Recreation.

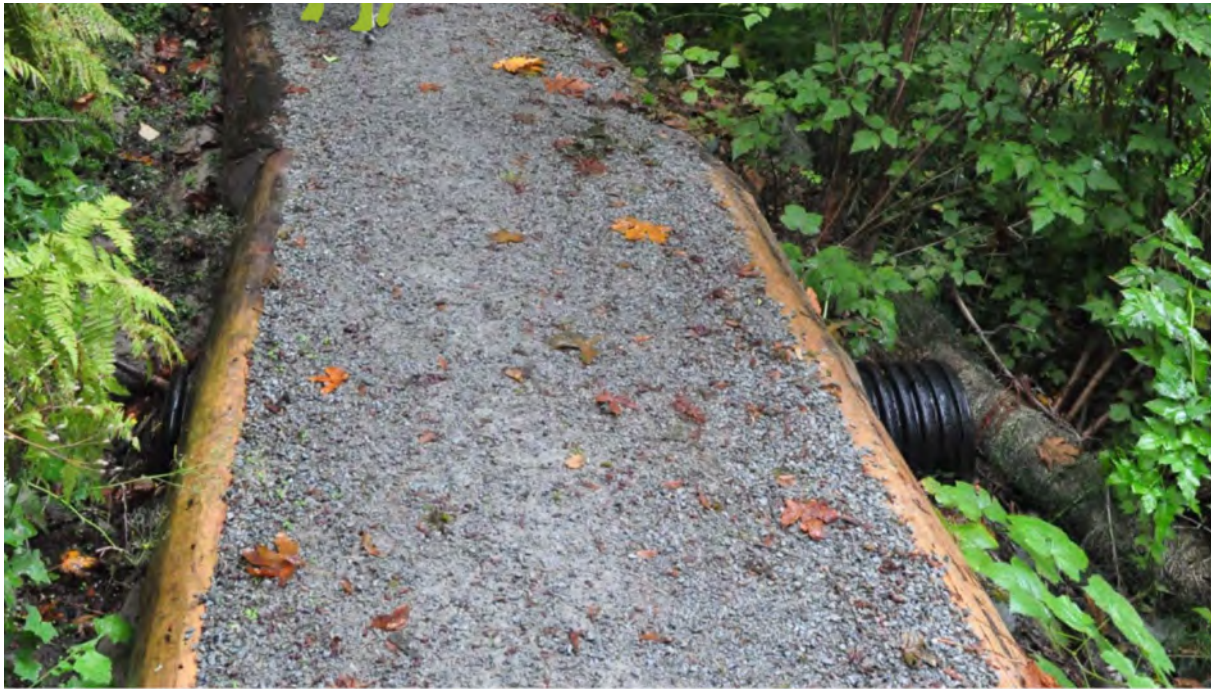
Photo 20. Example Culvert Installation Under a Trail.

To convey shallow concentrated flows, a simple culvert can be used (see Photo 20 for an example).

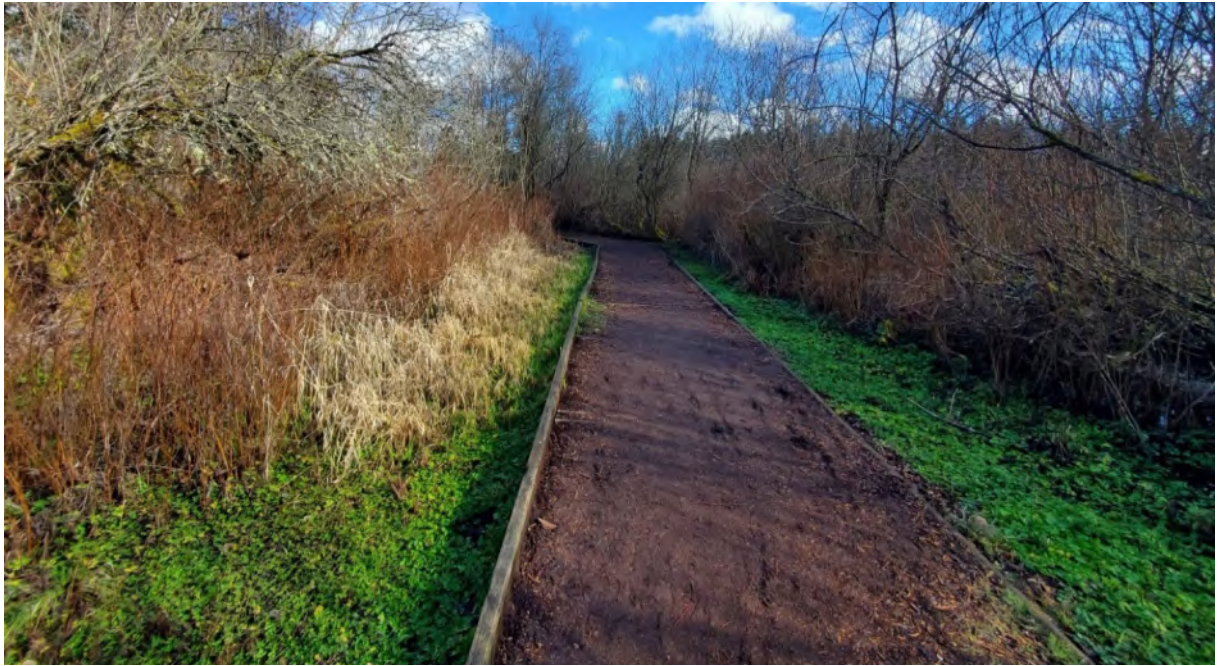
Photo 21. Wildlife Separation and Habitat Protection with Dense Vegetation.

Two techniques for separating people from wildlife and protecting habitat include fencing and dense native vegetation installations, such as are shown below in Photos 21 and 22. The fencing shown in the images is two-rail fence, as per City of Bellingham Drawing 2840.06. Along with this fencing, a “Stay on Trail” sign per City of Bellingham Drawing 10430.10 should also be installed. Both of these can be found here: <<https://cob.org/gov/rules/standards/park-design-standards>>.

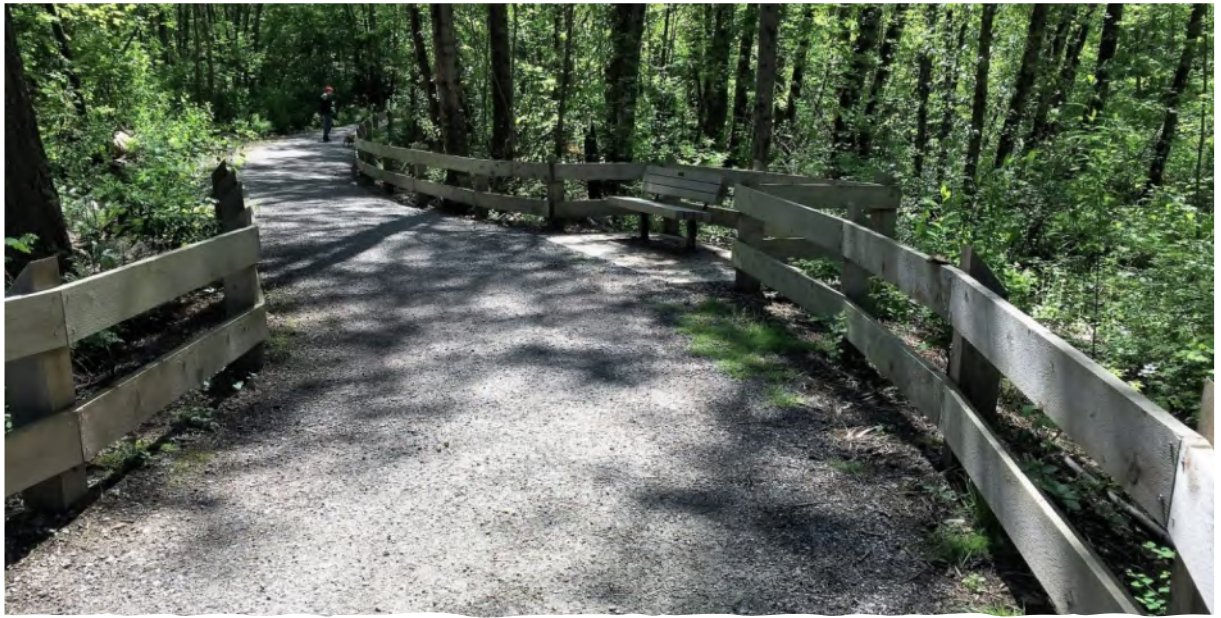
Photo 22. Wildlife Separation and Habitat Protection with Two-Rail Fence.

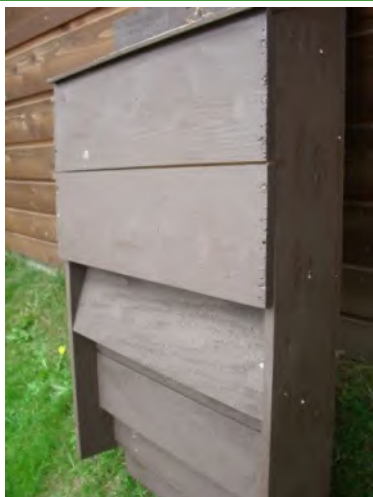
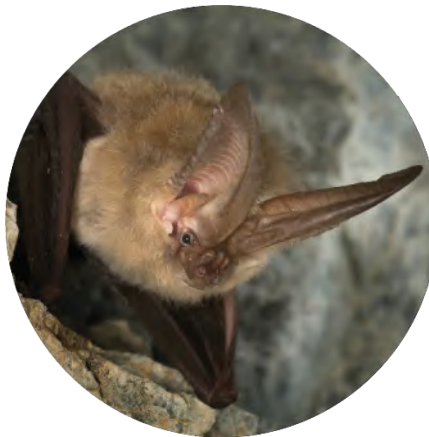
Bat Houses Provide Refuge for Area Bats.

foraging habitat for many species. Roosting habitat, while best provided by natural forest processes, may be supplemented by adding special habitat features, such as bat boxes, to encourage bat roosts and nesting boxes for birds which can increase opportunities for various wildlife in the near term, presumably while recruitment of these structures is developing naturally under proper forest management. Underplanting with native species should be targeted to areas where understory vegetation was sparse. Plants that provide high value for wildlife forage, such as beaked hazelnut (*Corylus cornuta*) can be used to increase forage opportunities throughout the CCF.
