MF Nooksack River Fish Passage Two-Year Monitoring: Topographic and Photographic Analysis

Channel Profiles

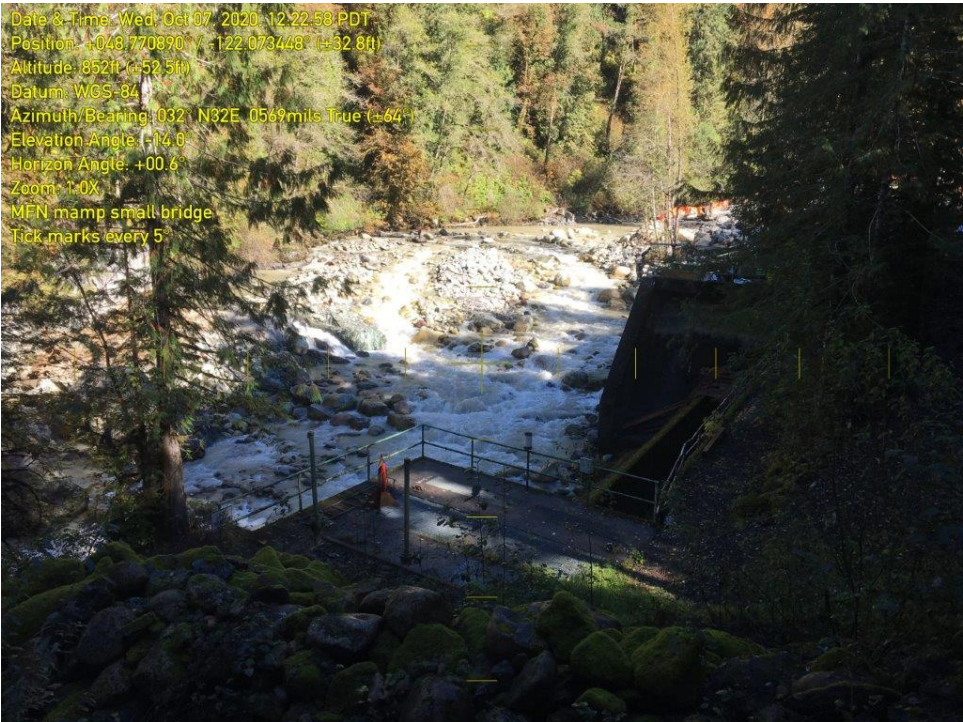
October 2020

Roadway near time lapse camera (“Small Bridge” on map)

Photograph taken looking upstream from the roadway at the approximate timelapse camera location

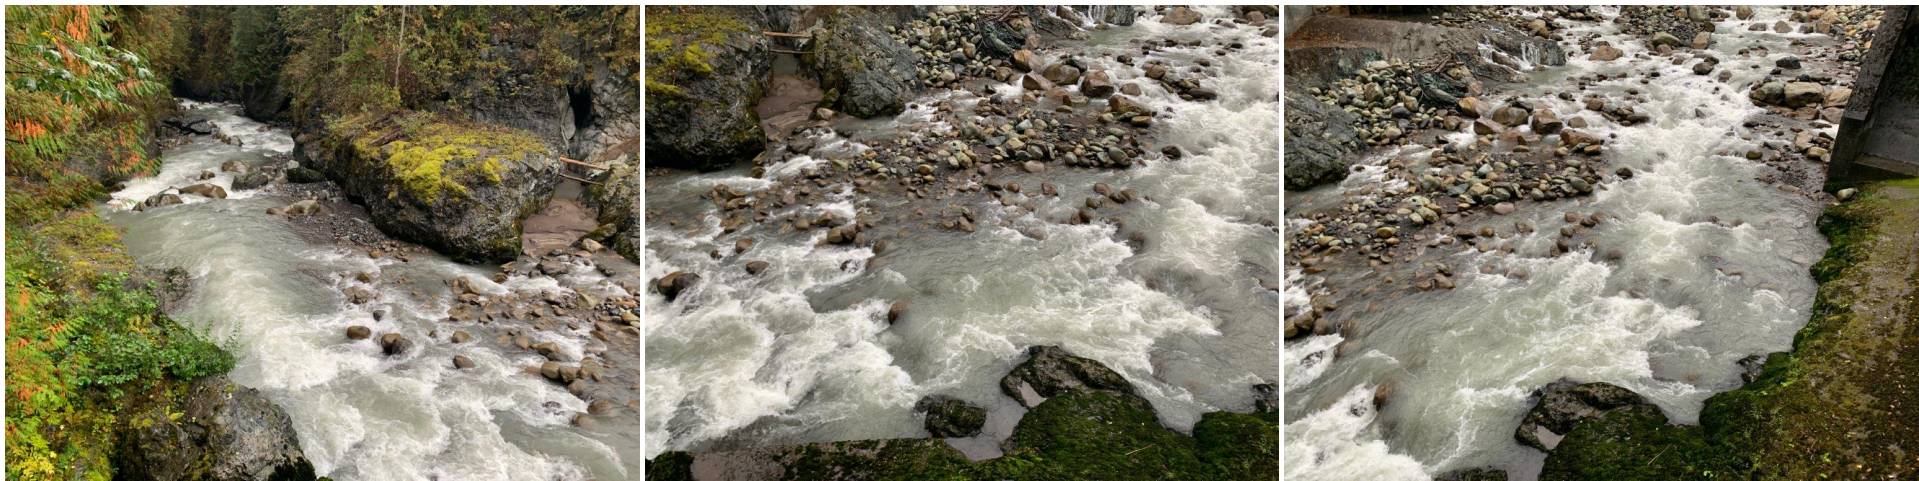
September 2021

Left Bank Location 1 (LB1)

Photographs taken looking downstream (left), perpendicular to flow (center) and upstream (right) at the photograph location marker

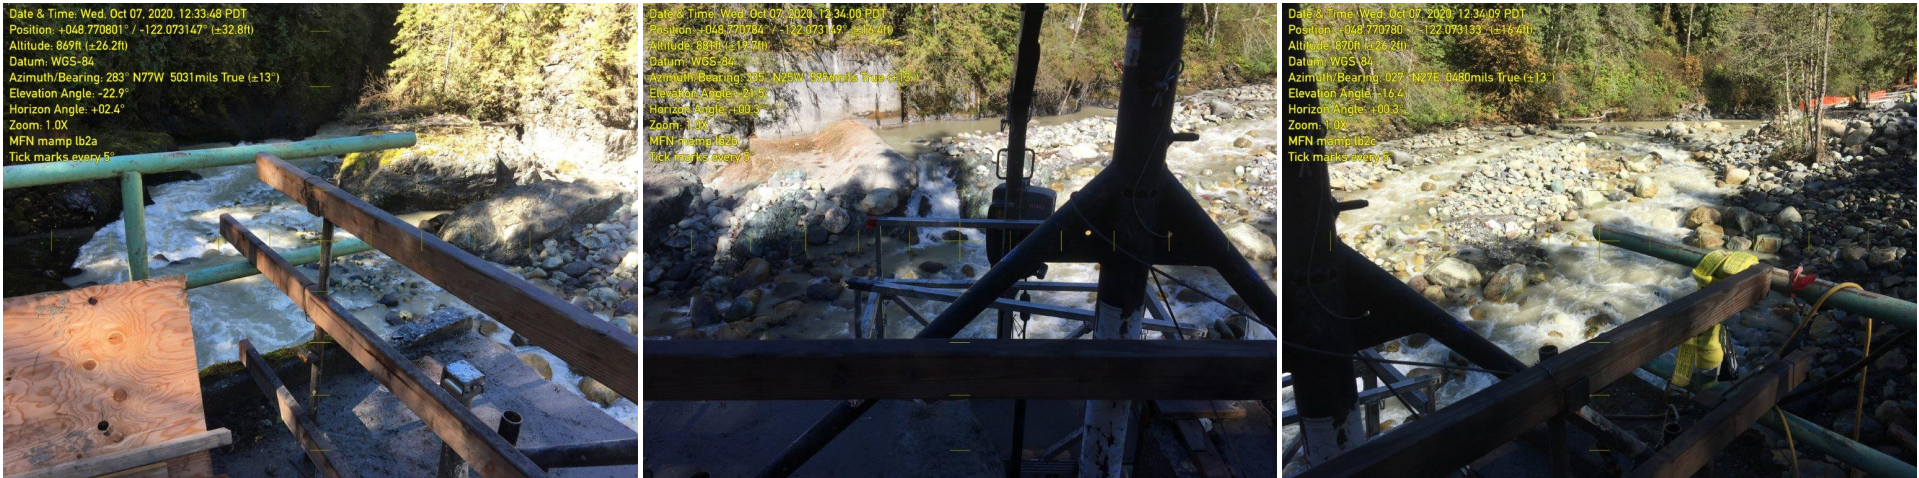
October 2020

Left Bank Location 2 (LB2)

Photographs taken looking downstream (left), perpendicular to flow (center) and upstream (right) at the photograph location marker

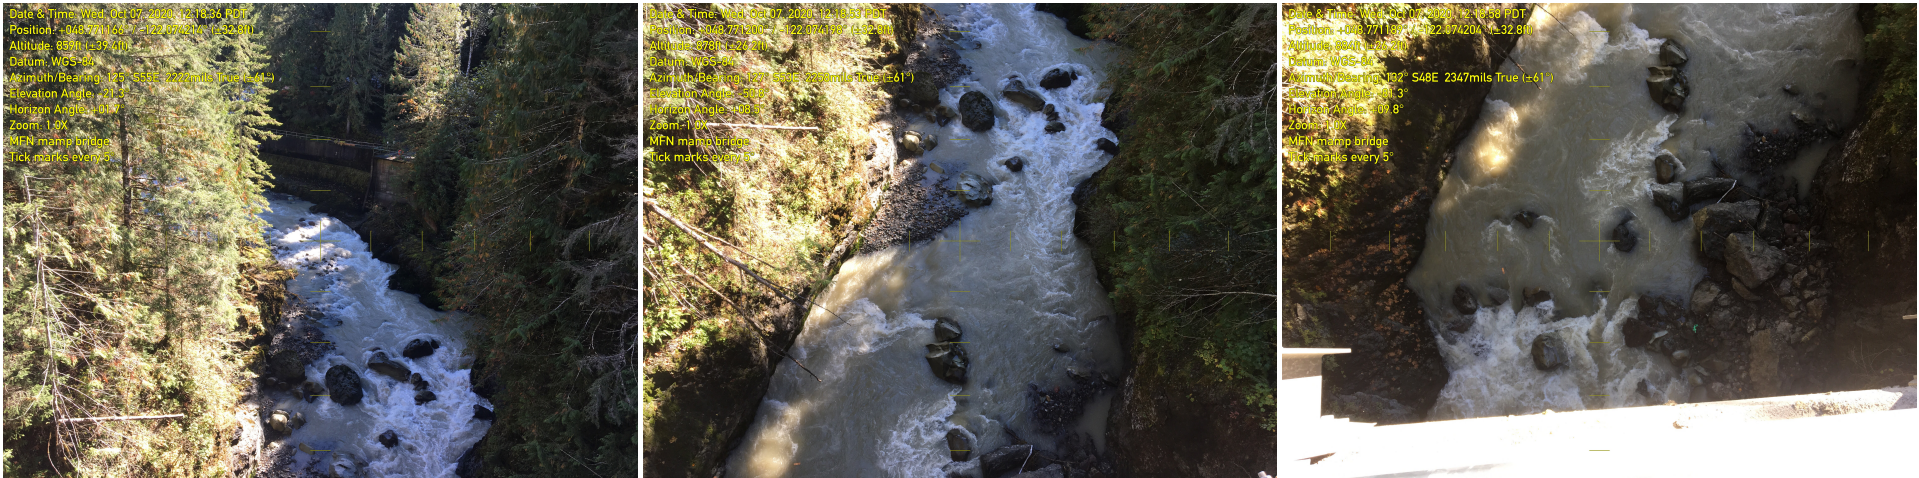
October 2020

Bridge Upstream Location (Bridge US)

Photographs taken from the bridge center railing looking at the upstream horizon (left), upstream oblique (center) and directly below bridge (right)

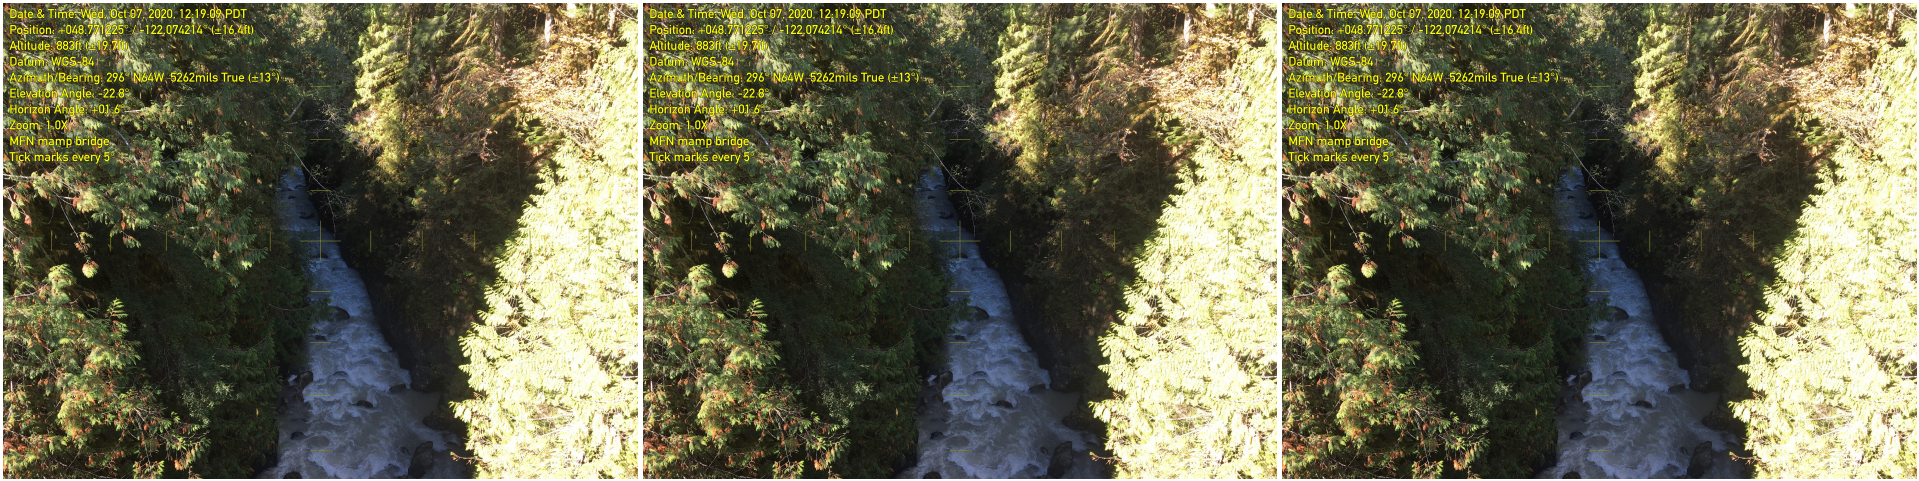
October 2020

Bridge Downstream Location (Bridge DS)

Photographs taken from the bridge center railing looking at the downstream horizon (left), downstream oblique (center) and directly below bridge (right)

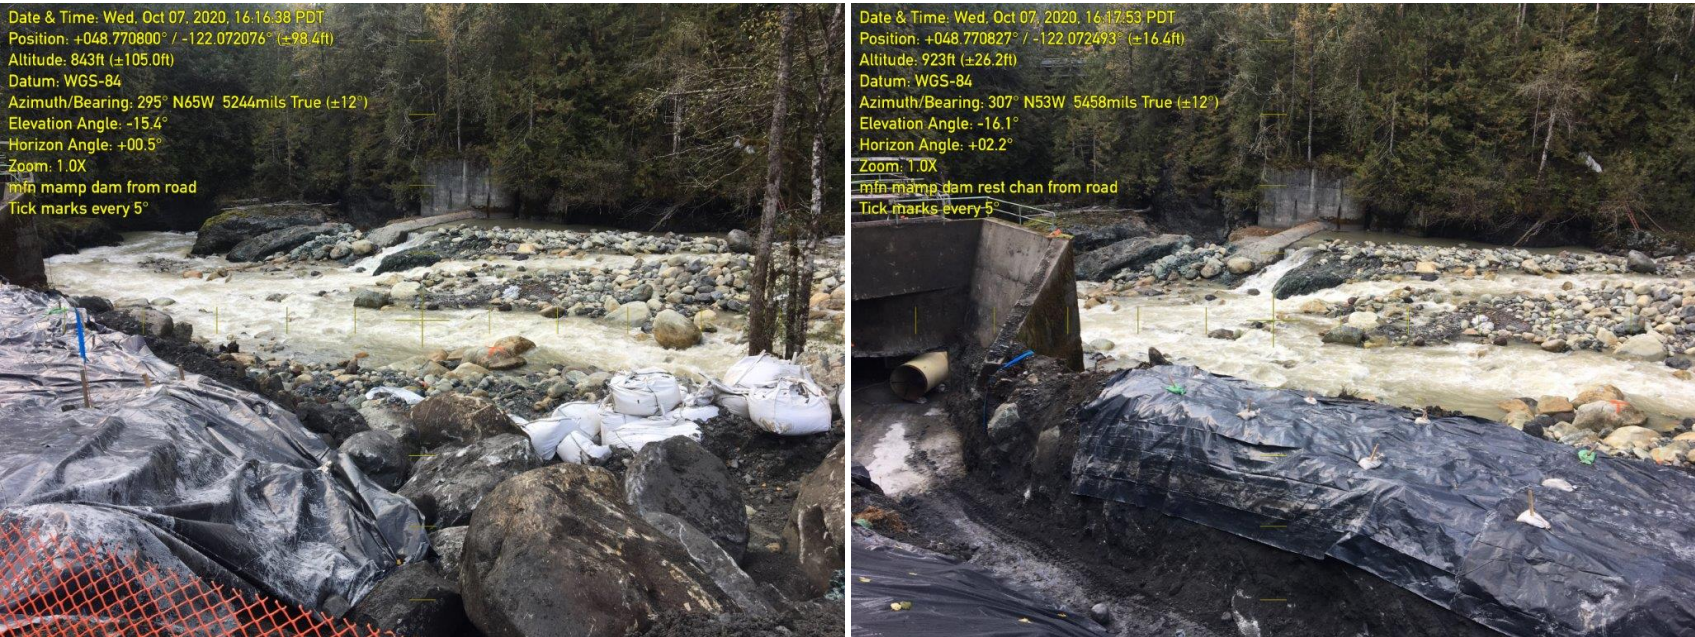
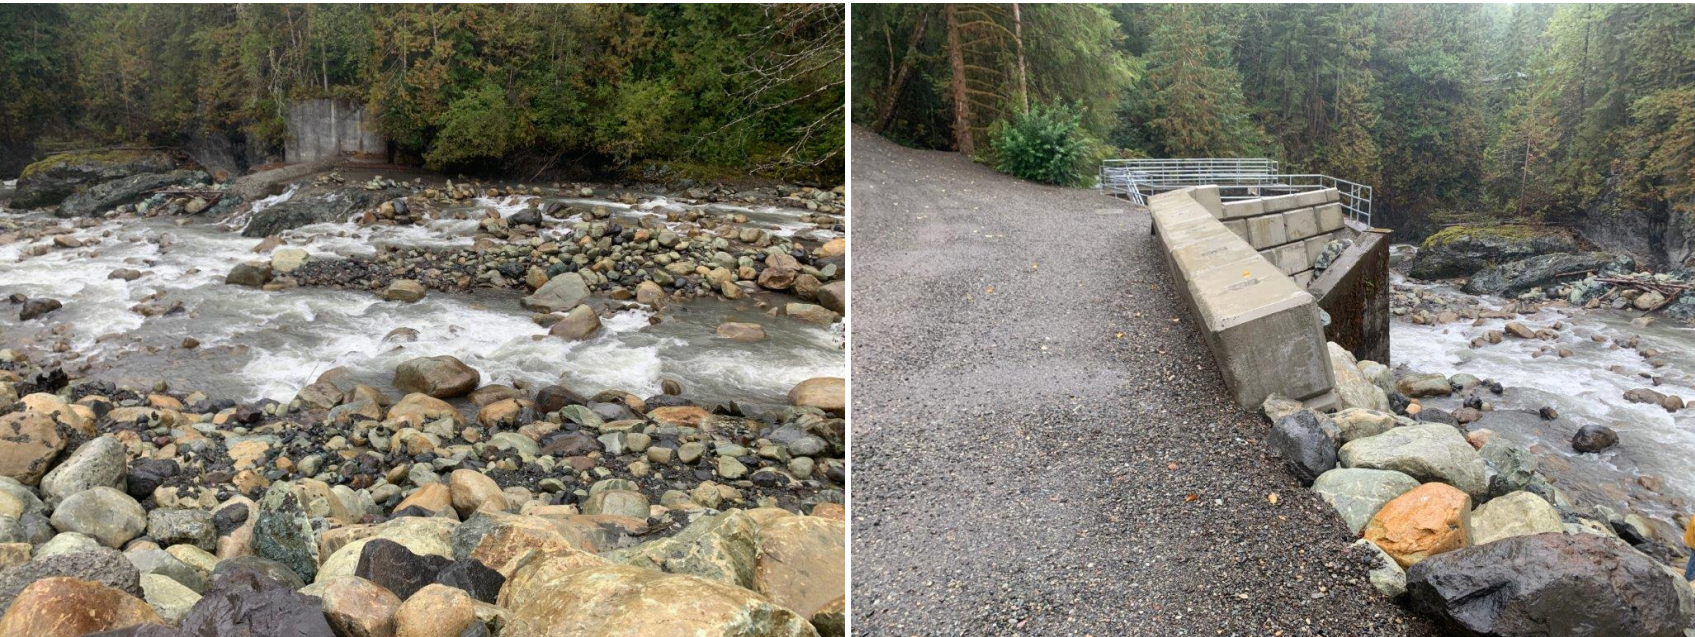
Overview from Road

Photographs taken looking downstream from construction roadway

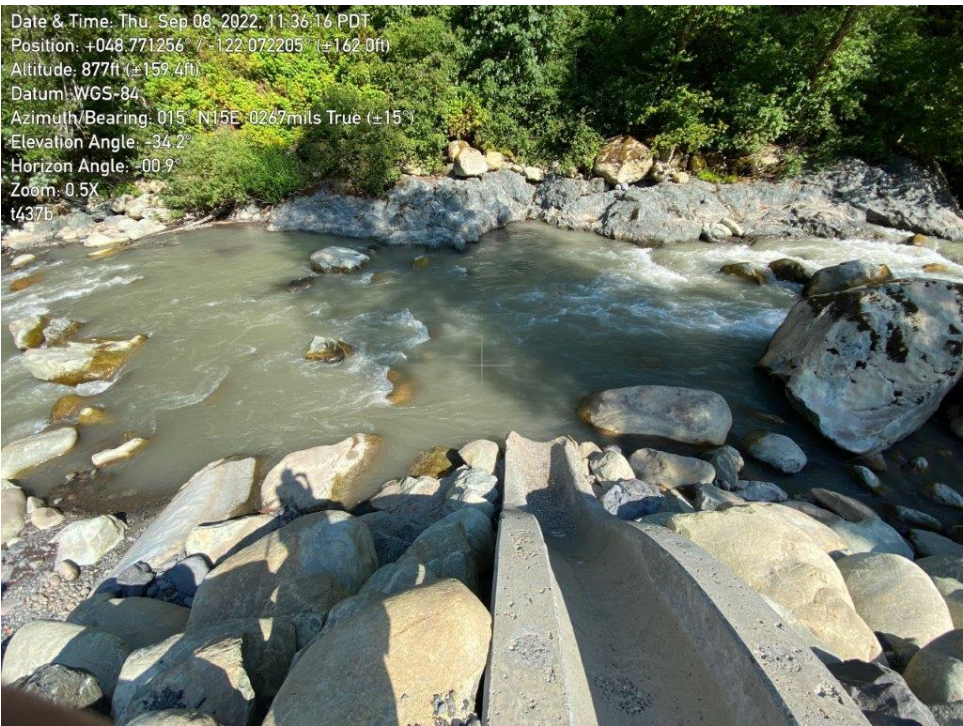
September 2022

Fishway Outfall Slide (Transect 437 on map)

Photograph taken looking down at fishway outfall slide from Transect 437 marker

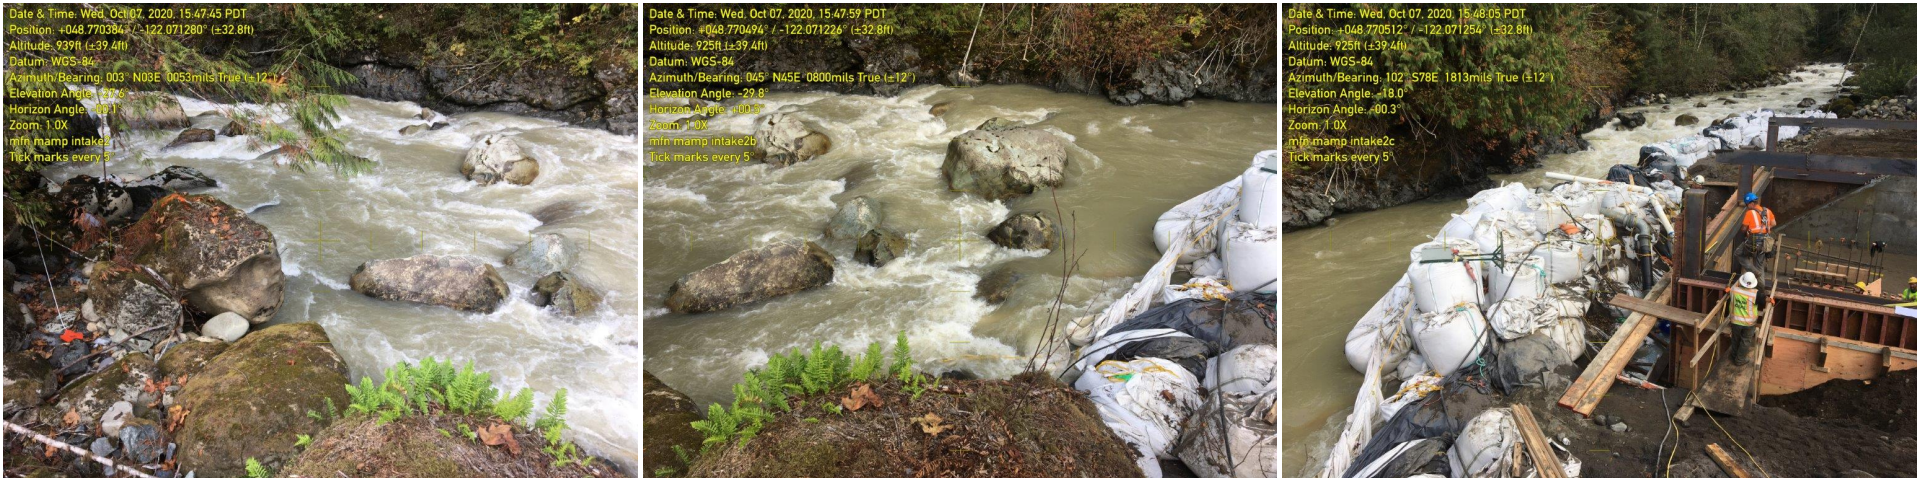
October 2020

Intake 2

Photographs taken looking downstream (left), perpendicular to flow (center) and upstream (right) at the photograph location marker

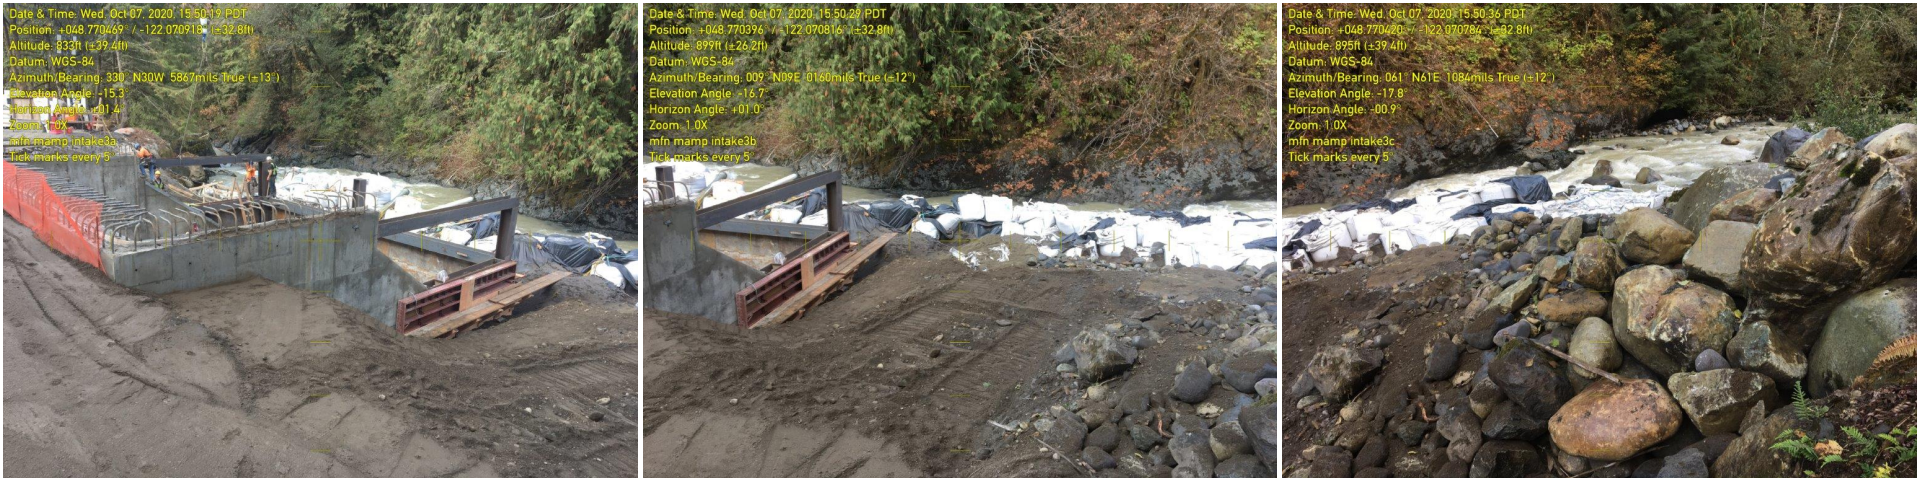
October 2020

Intake 3

Photographs taken looking downstream (left), perpendicular to flow (center) and upstream (right) at the photograph location marker

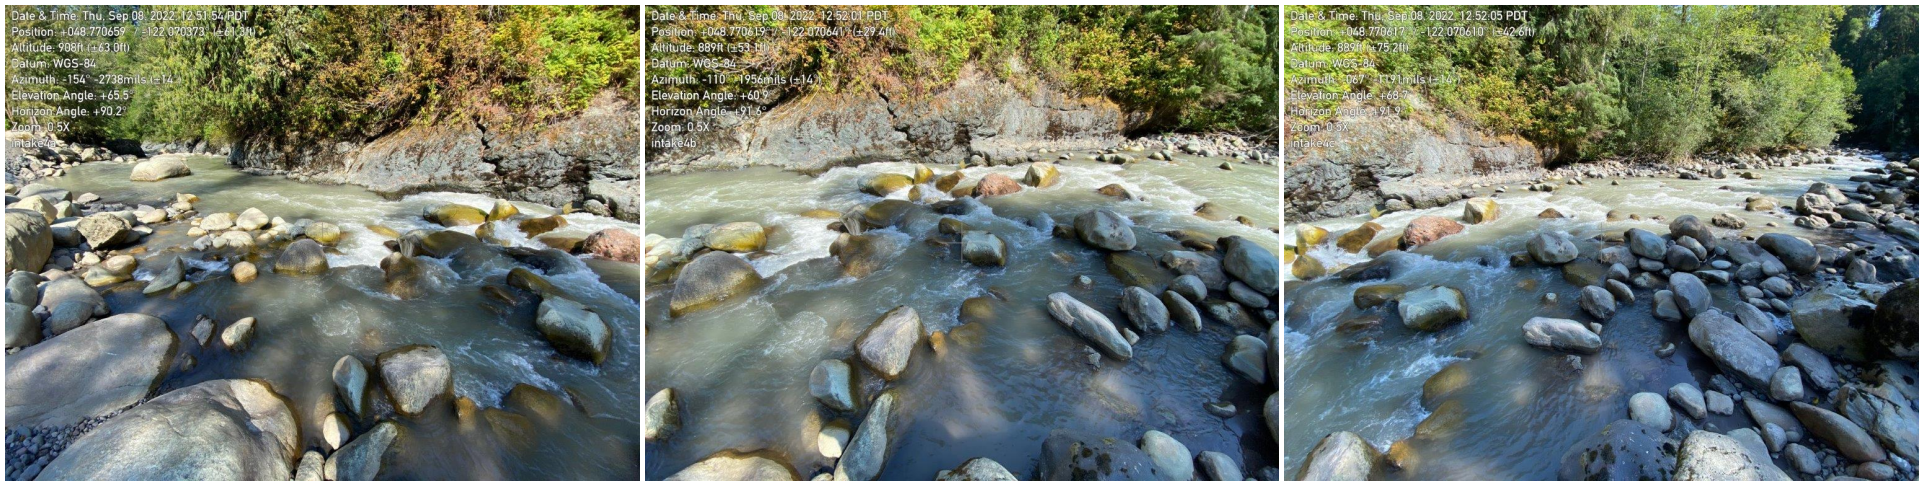
September 2022

Intake 4

Photographs taken looking downstream (left), perpendicular to flow (center) and upstream (right) at the photograph location marker

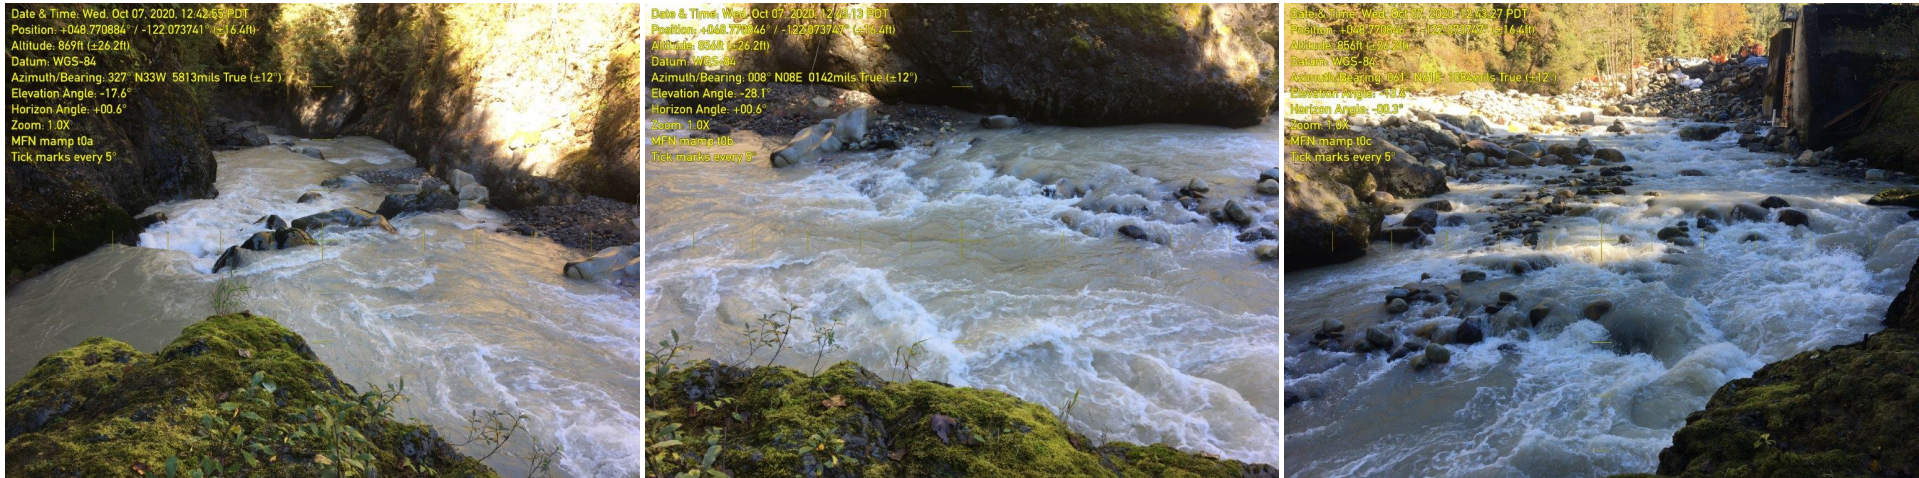
October 2020

Transect 0

Photographs taken looking downstream (left), perpendicular to flow (center) and upstream (right) at the transect location marker

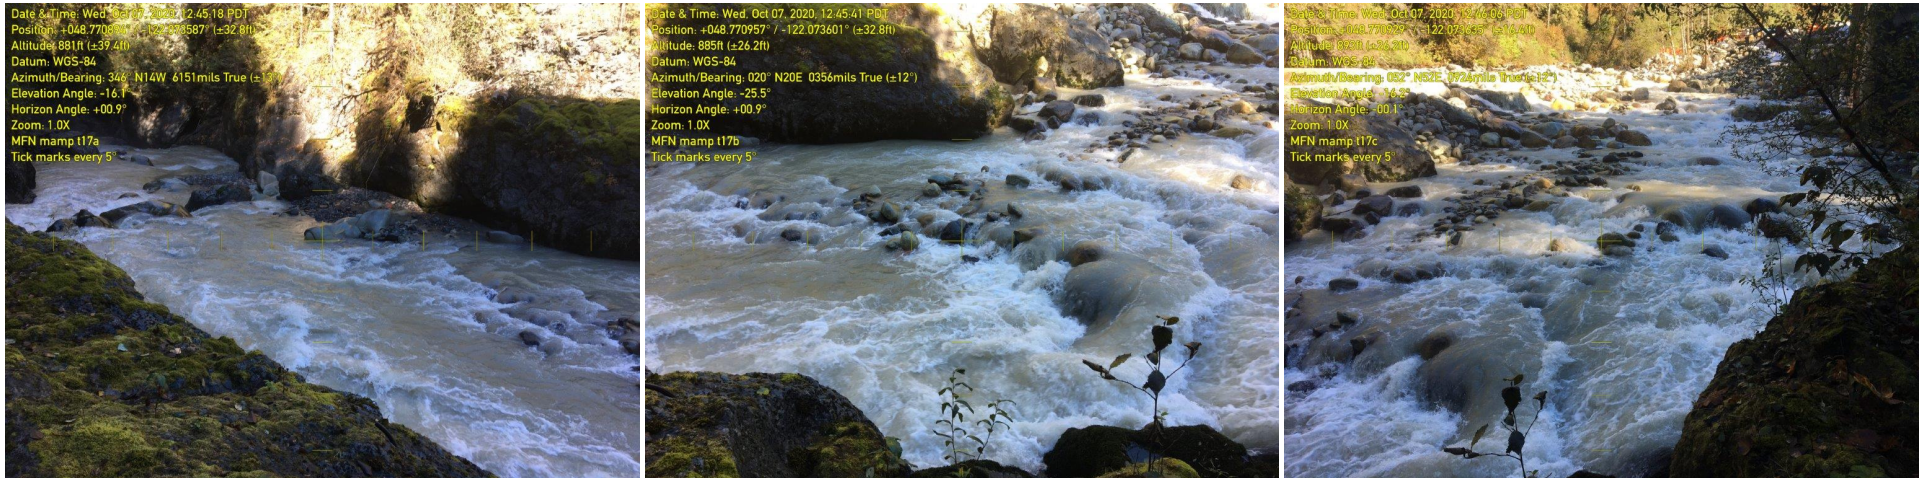
October 2020

Transect 17

Photographs taken looking downstream (left), perpendicular to flow (center) and upstream (right) at the transect location marker

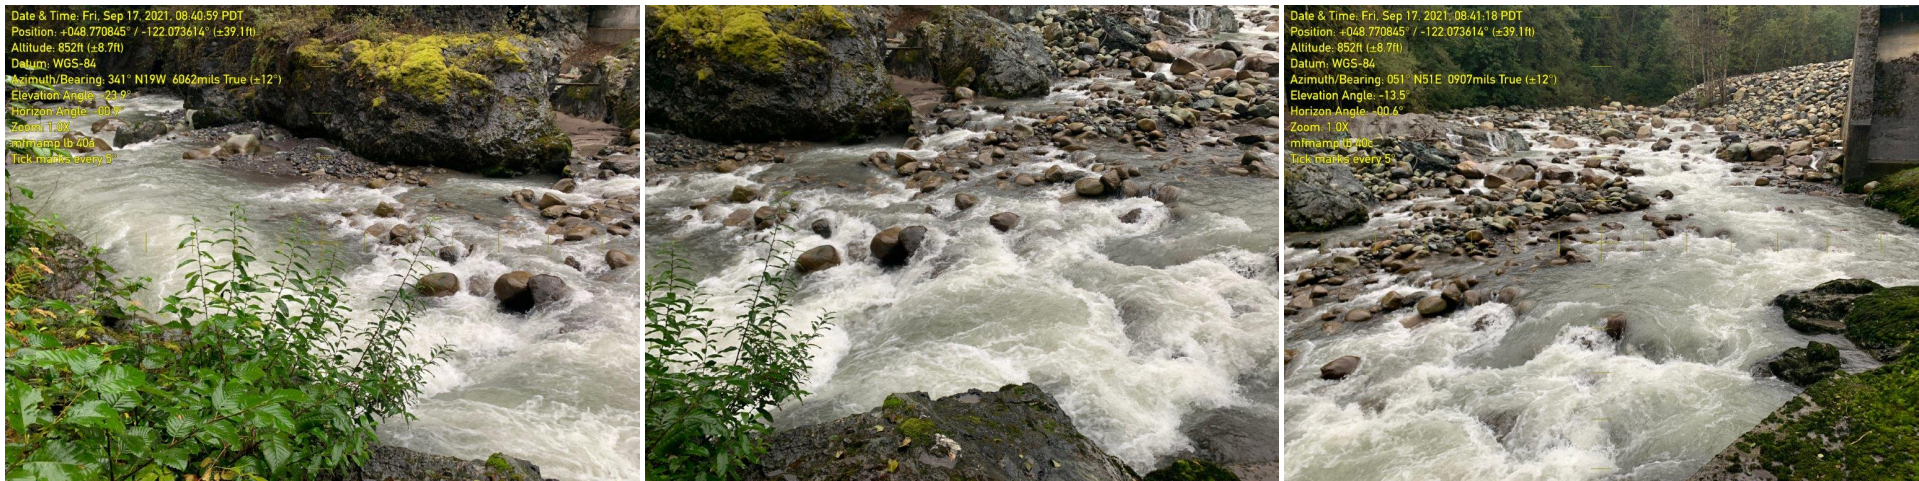
September 2021

Transect 40

Photographs taken looking downstream (left), perpendicular to flow (center) and upstream (right) at the transect location marker

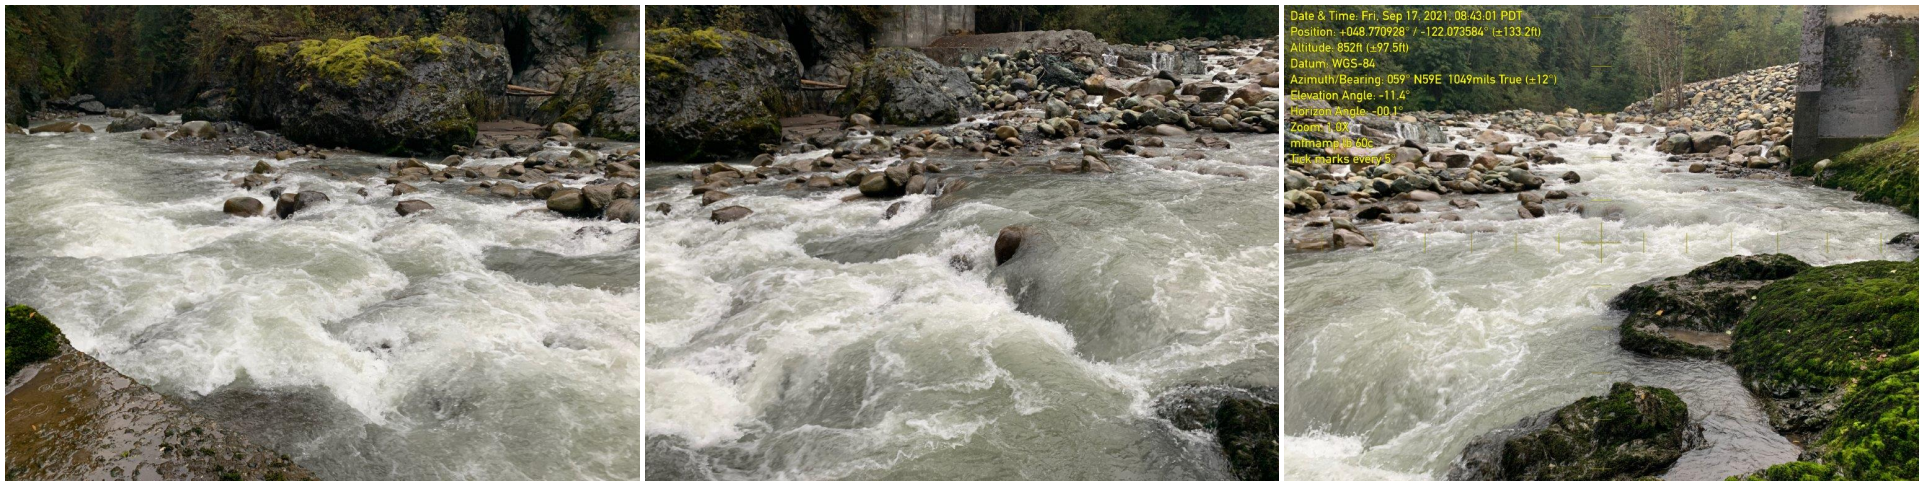
September 2021

Transect 62

Photographs taken looking downstream (left), perpendicular to flow (center) and upstream (right) at the transect location marker

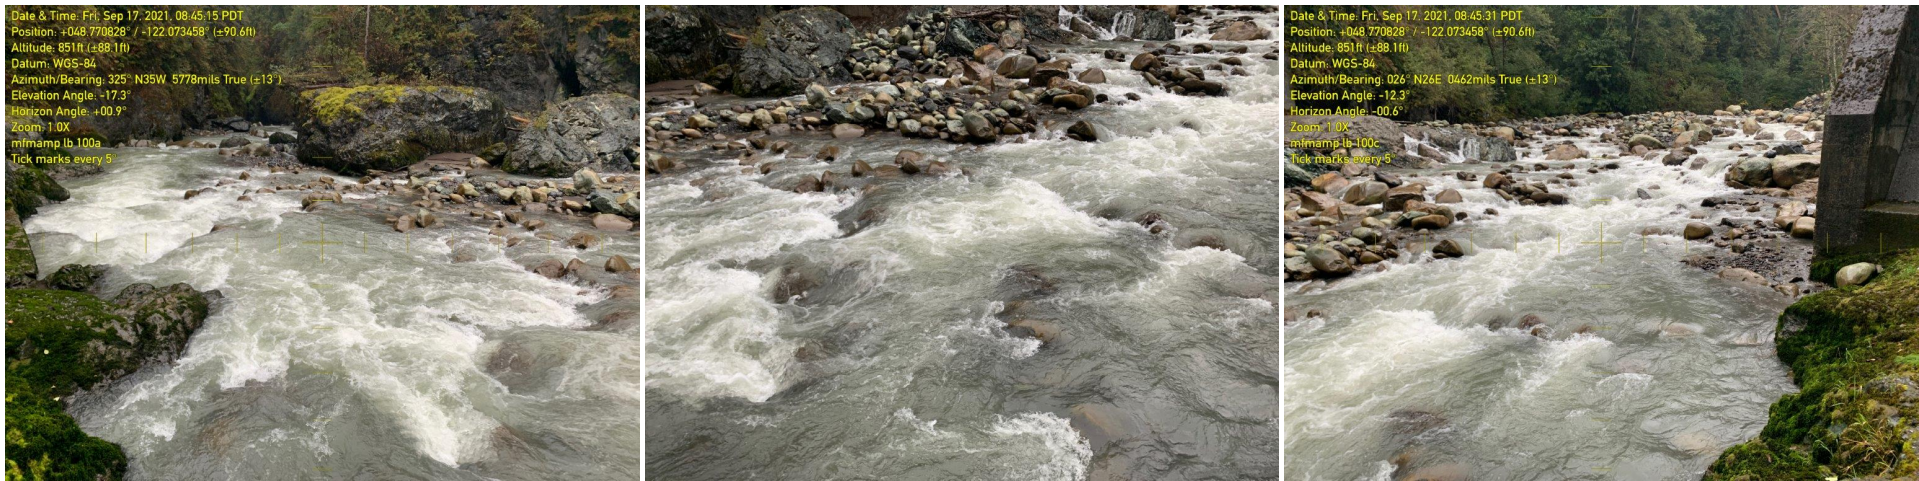
September 2021

Transect 100

Photographs taken looking downstream (left), perpendicular to flow (center) and upstream (right) at the transect location marker

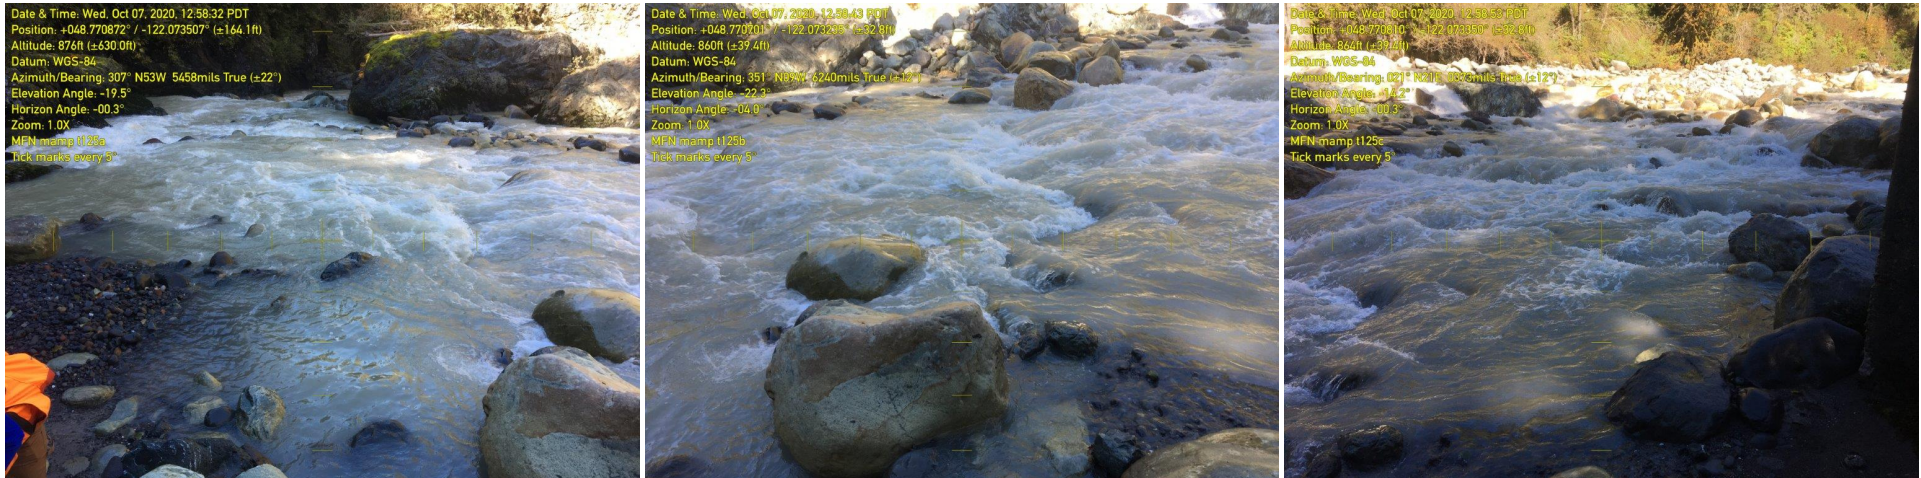
October 2020

Transect 125

Photographs taken looking downstream (left), perpendicular to flow (center) and upstream (right) at the transect location marker

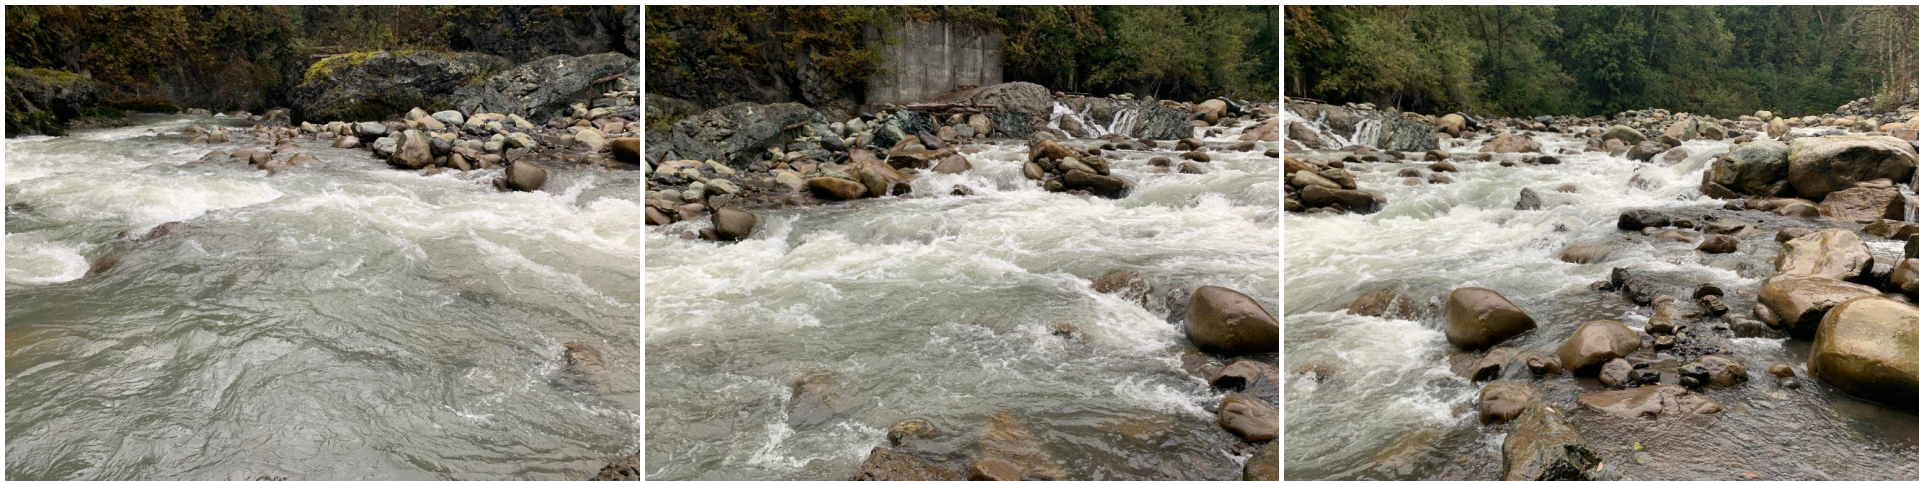
September 2021

Transect 141

Photographs taken looking downstream (left), perpendicular to flow (center) and upstream (right) at the transect location marker

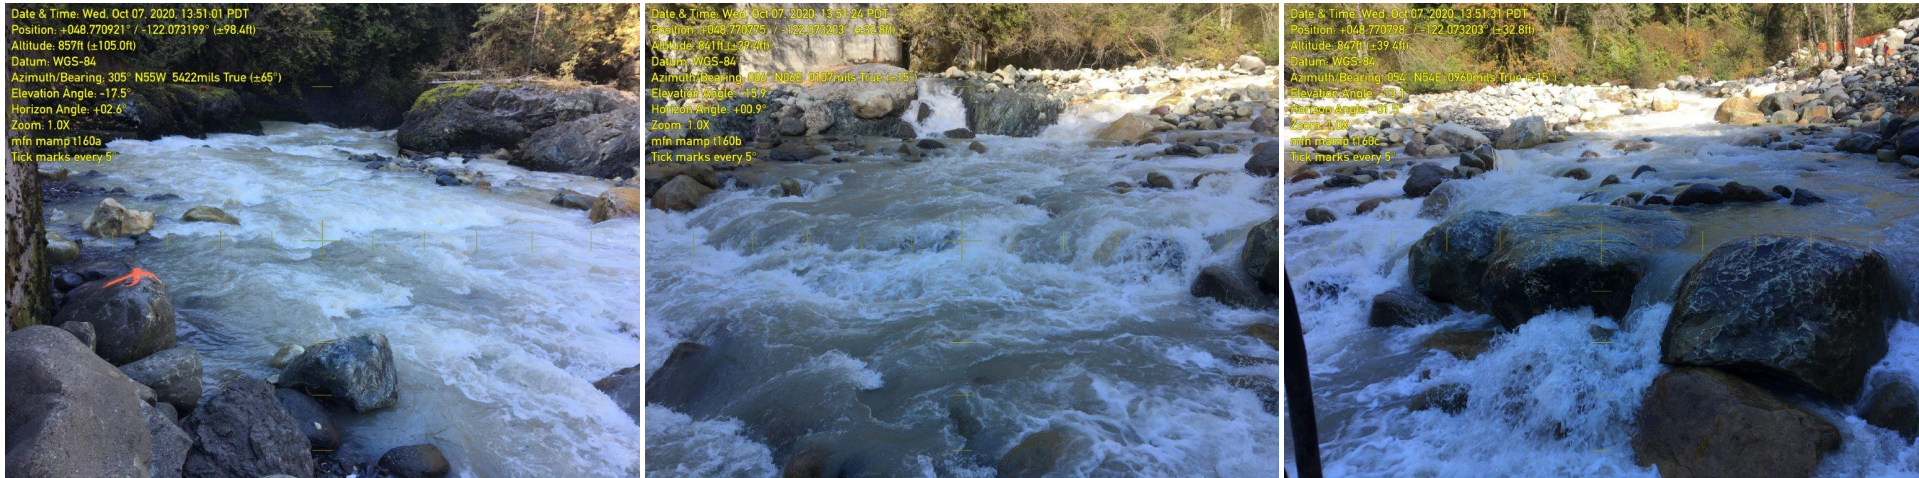
October 2020

Transect 160

Photographs taken looking downstream (left), perpendicular to flow (center) and upstream (right) at the transect location marker

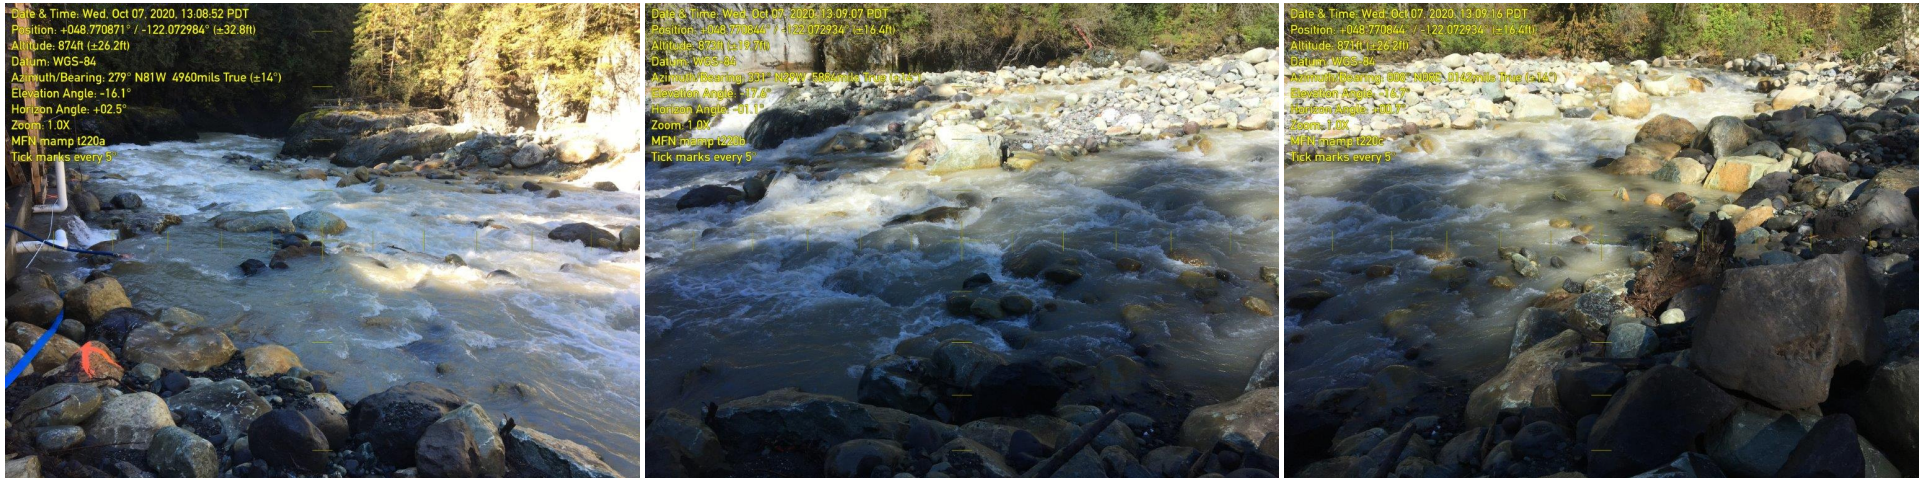
October 2020

Transect 220

Photographs taken looking downstream (left), perpendicular to flow (center) and upstream (right) at the transect location marker

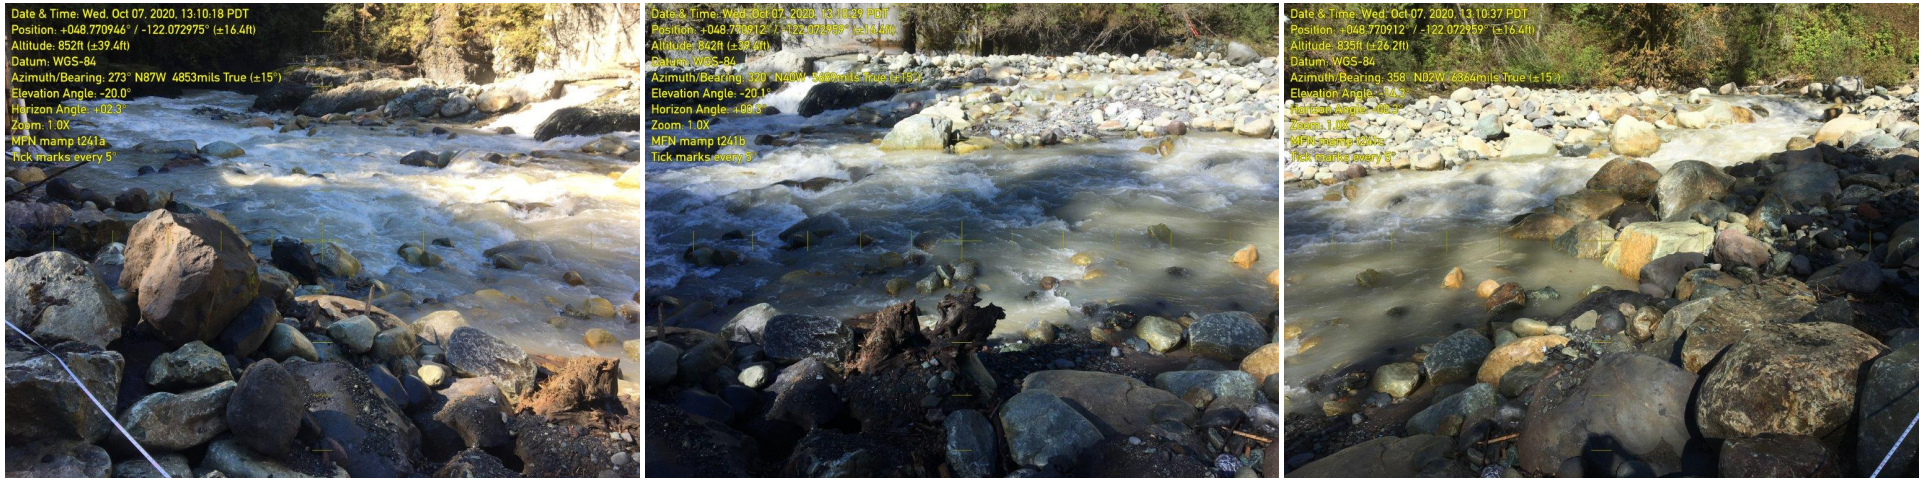
October 2020

Transect 241

Photographs taken looking downstream (left), perpendicular to flow (center) and upstream (right) at the transect location marker

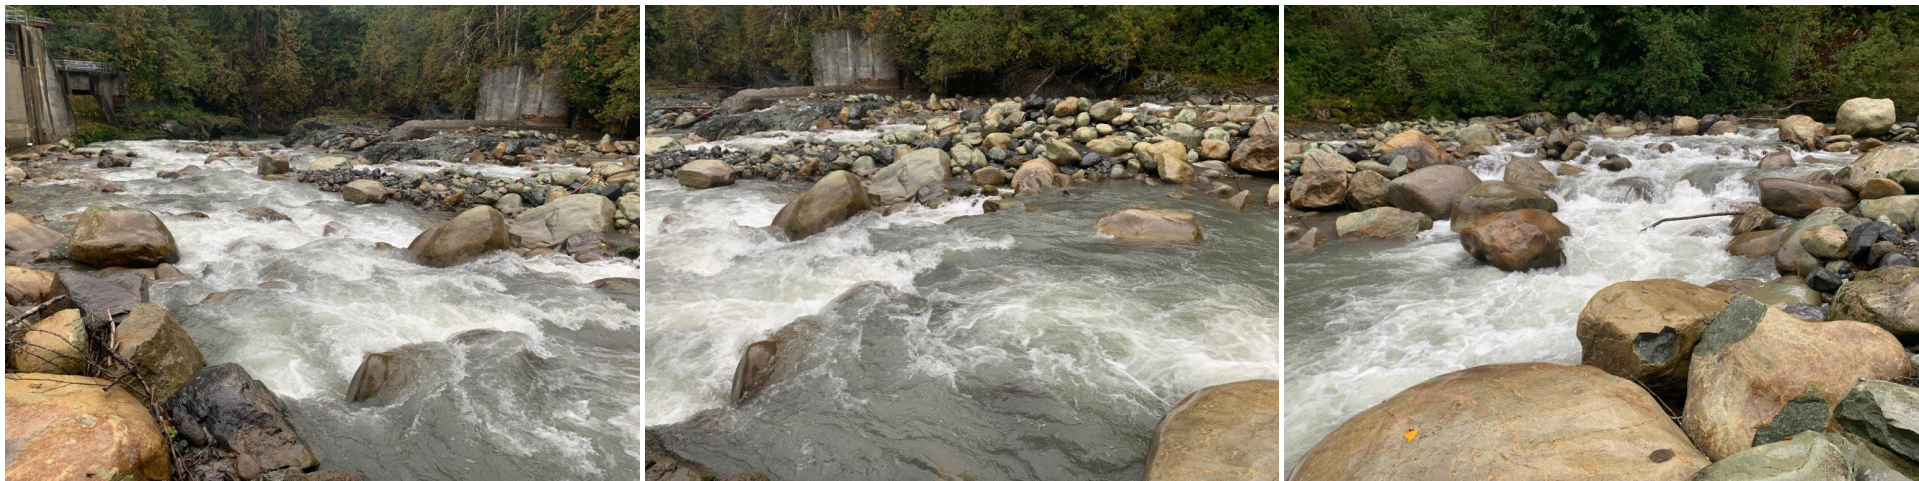
September 2021

Transect 320

Photographs taken looking downstream (left), perpendicular to flow (center) and upstream (right) at the transect location marker

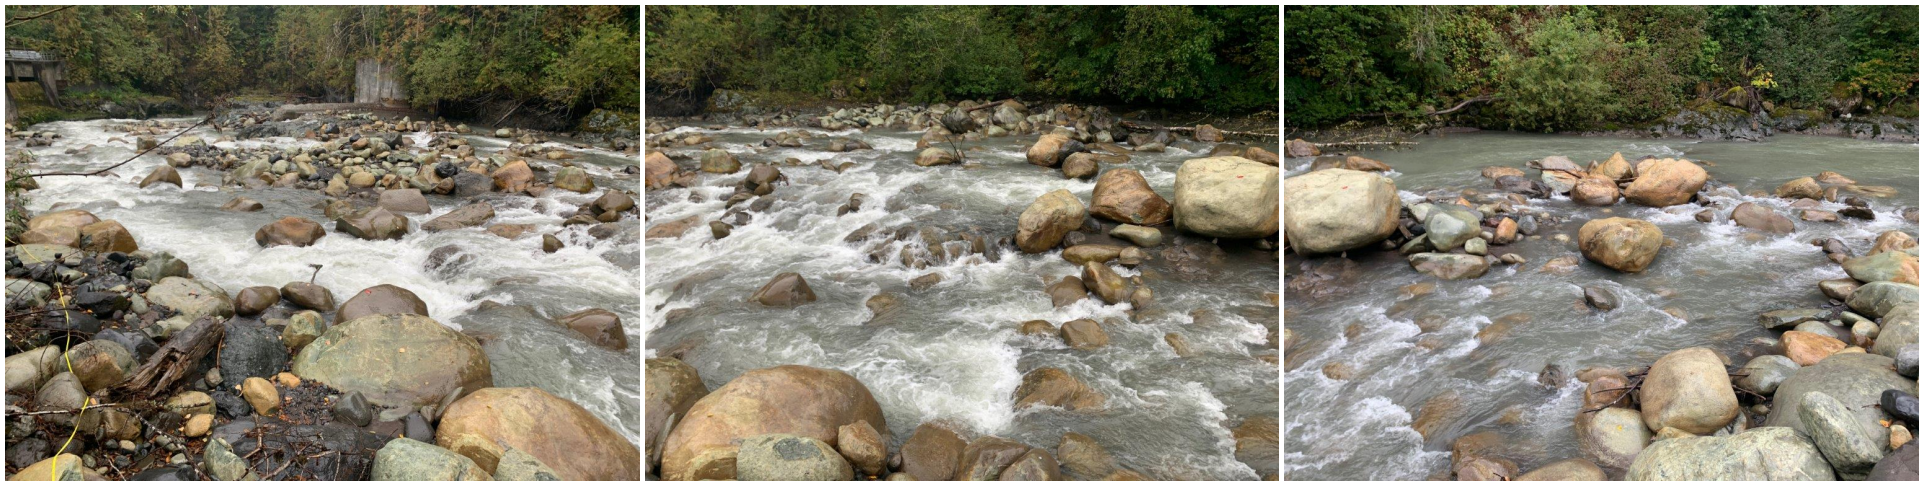
Transect 380

Photographs taken looking downstream (left), perpendicular to flow (center) and upstream (right) at the transect location marker

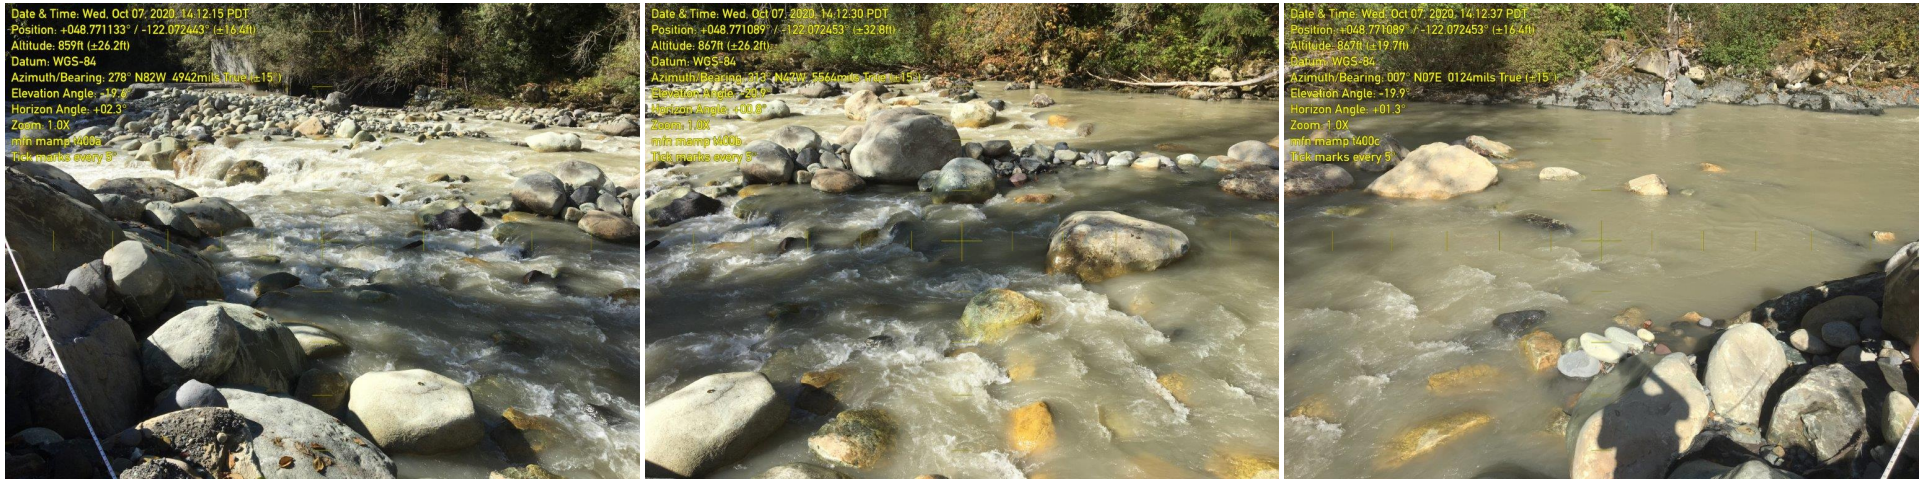
Transect 400

Photographs taken looking downstream (left), perpendicular to flow (center) and upstream (right) at the transect location marker
