MF Nooksack River Fish Passage Two-Year Monitoring: Topographic and Photographic Analysis

Channel Profiles

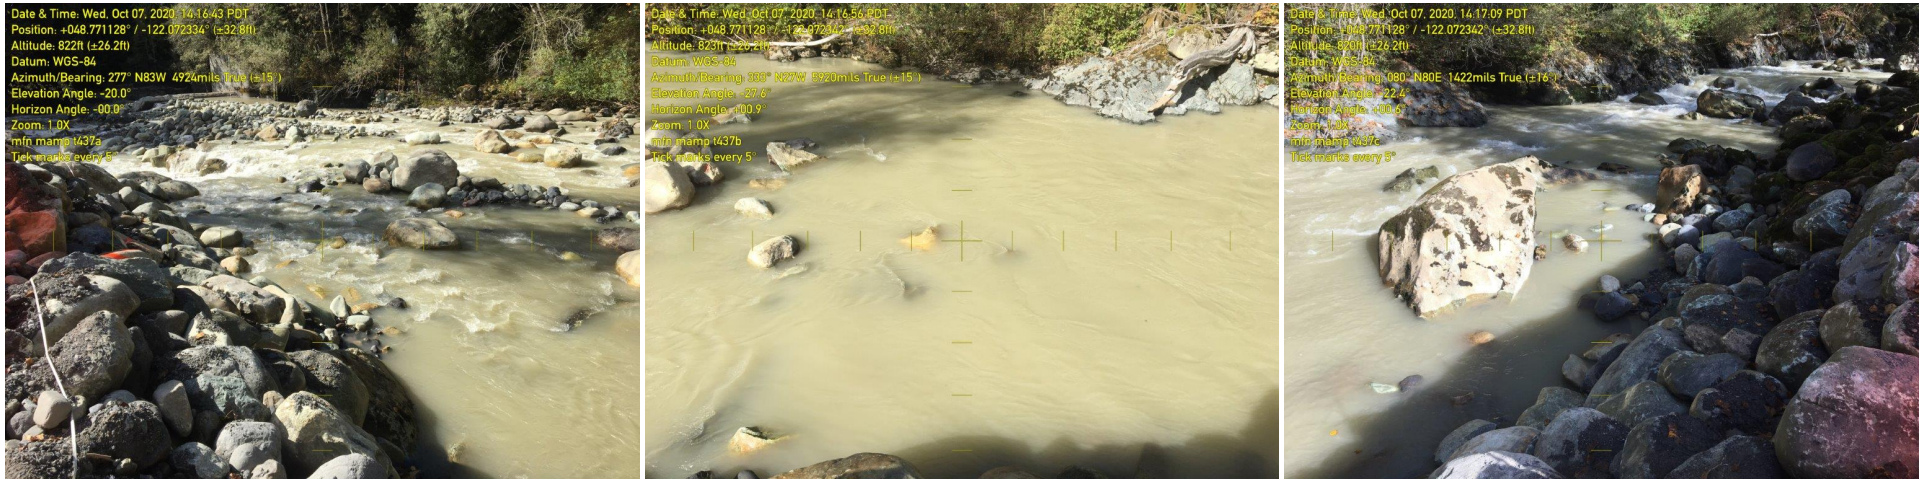
October 2020

Transect 437

Photographs taken looking downstream (left), perpendicular to flow (center) and upstream (right) at the transect location marker

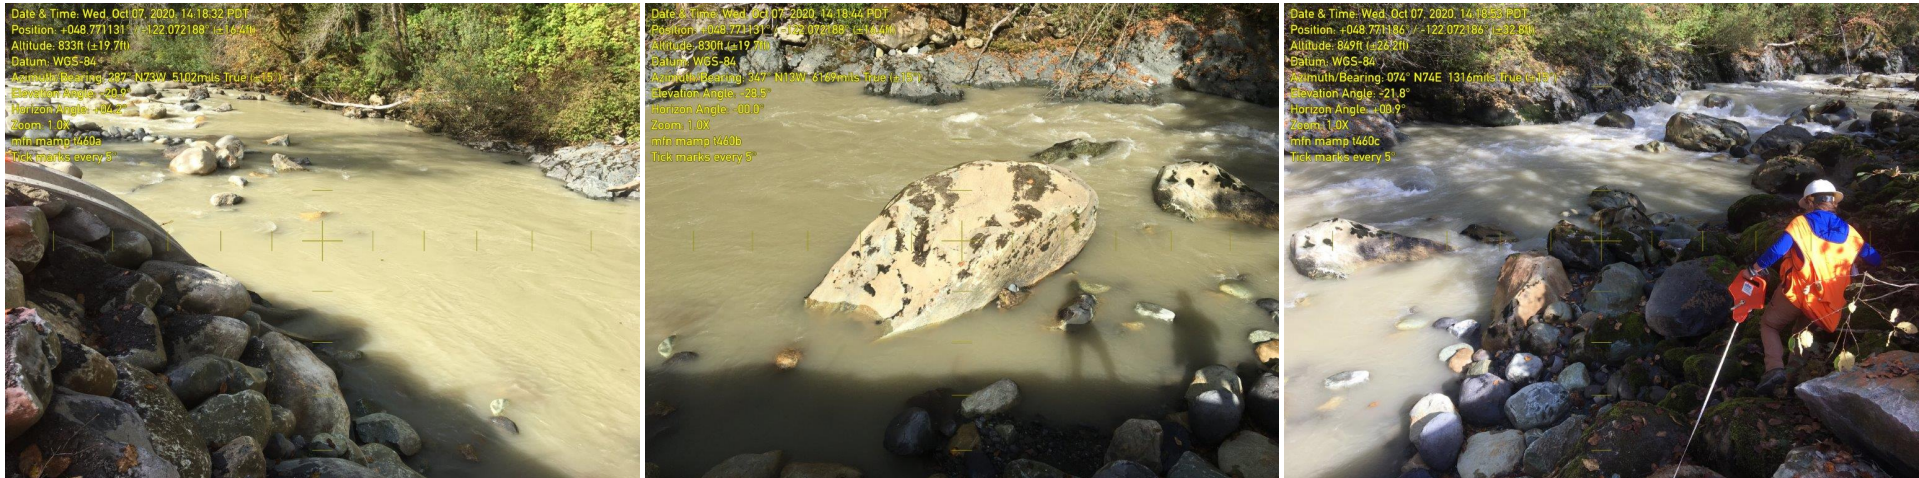
October 2020

Transect 460

Photographs taken looking downstream (left), perpendicular to flow (center) and upstream (right) at the transect location marker

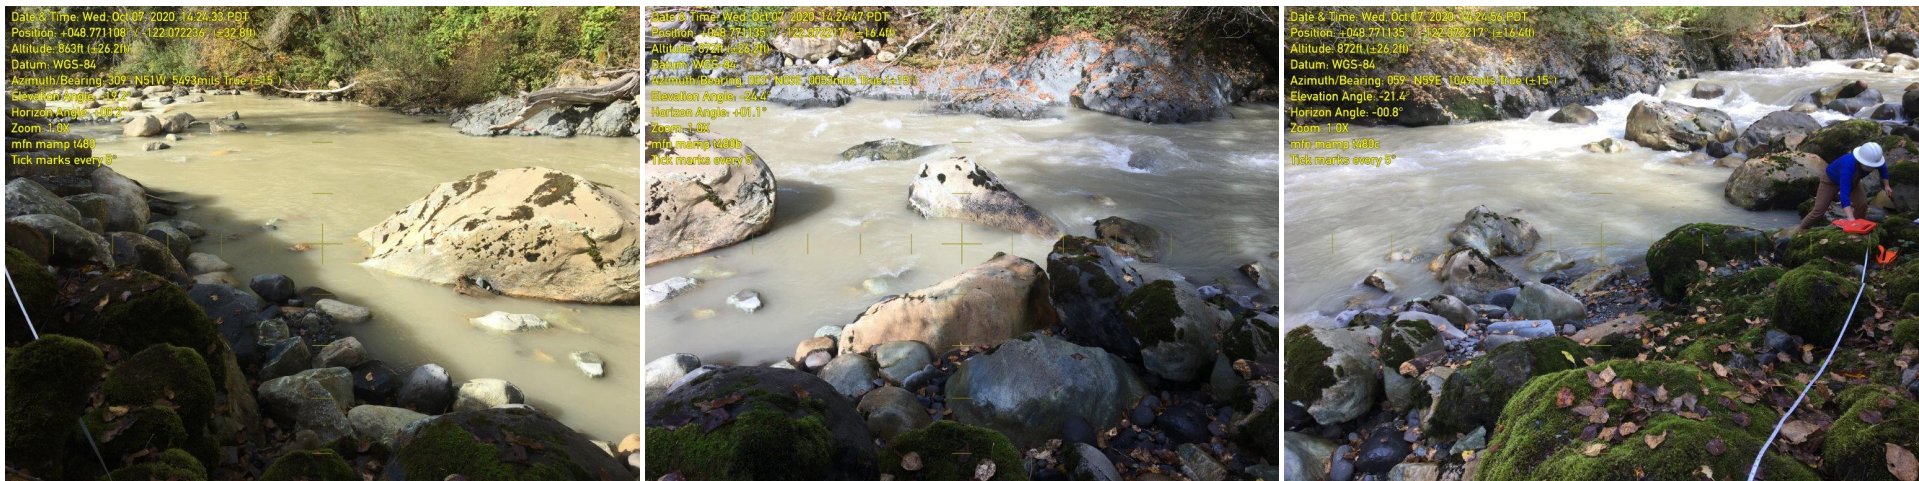
October 2020

Transect 480

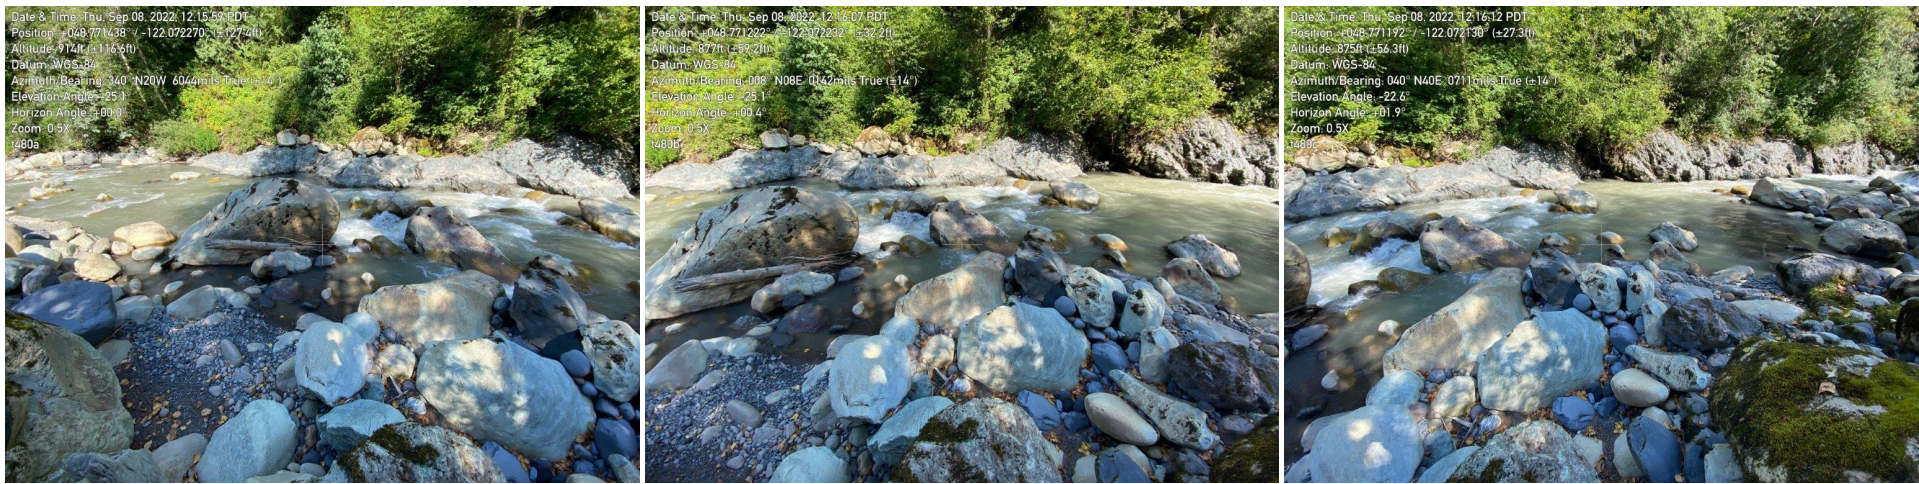
Photographs taken looking downstream (left), perpendicular to flow (center) and upstream (right) at the transect location marker

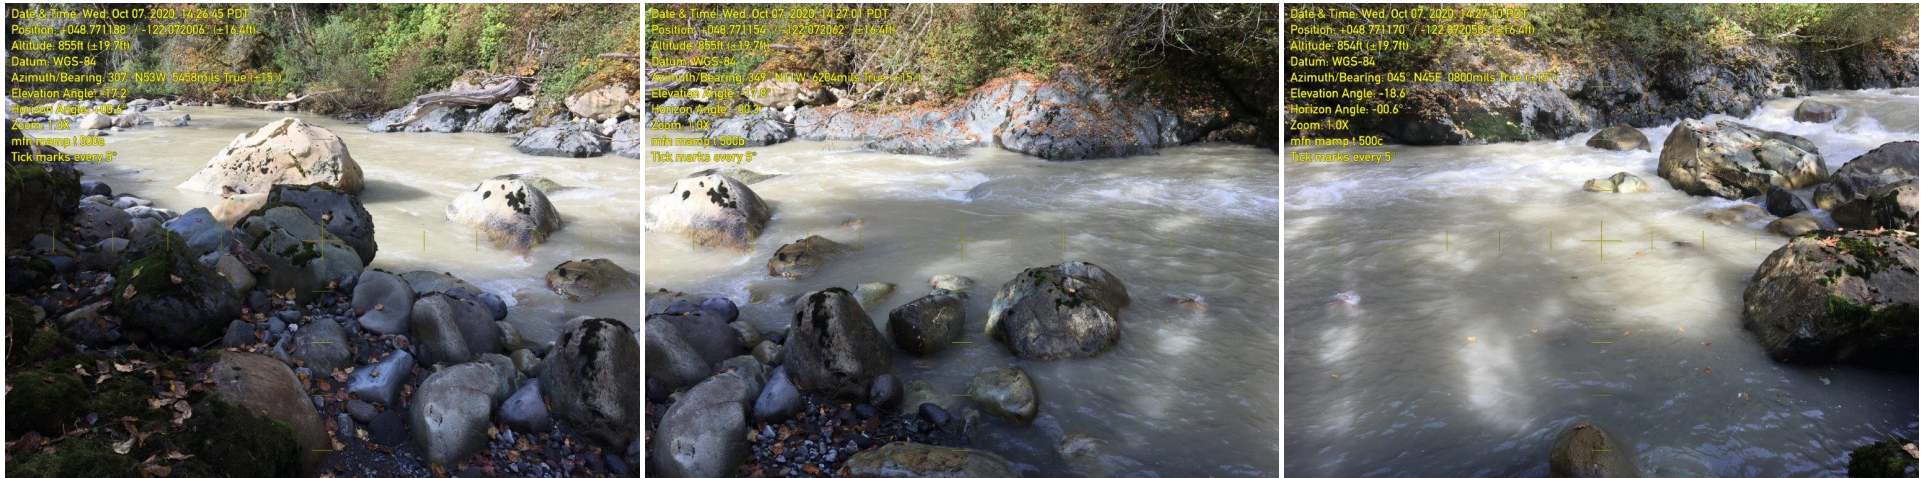
October 2020

Transect 500

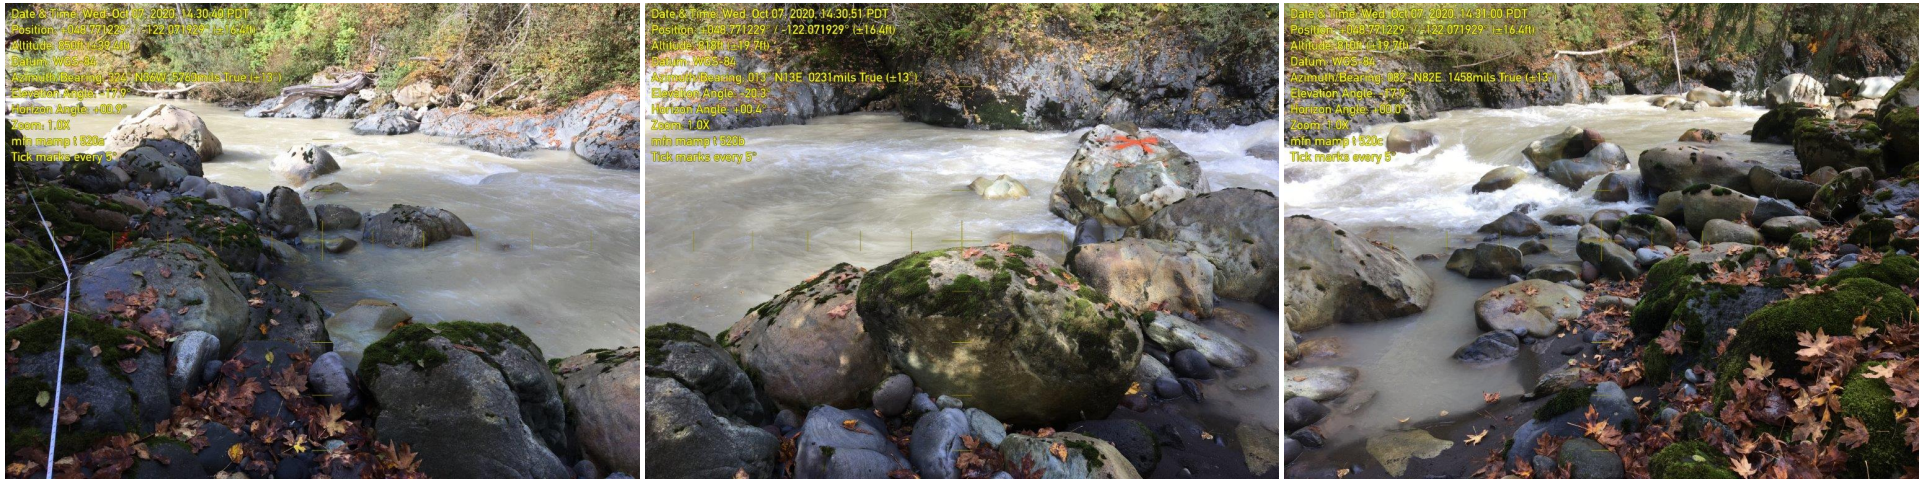
October 2020

Photographs taken looking downstream (left), perpendicular to flow (center) and upstream (right) at the transect location marker

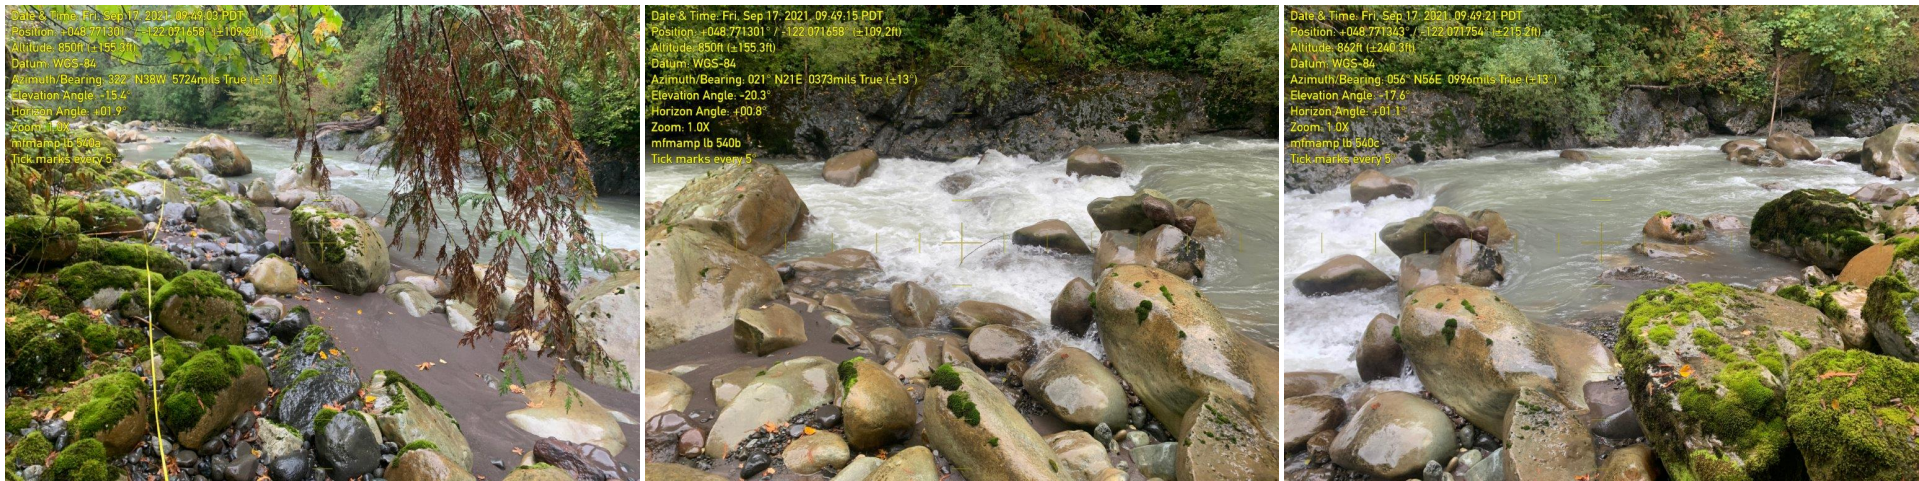
September 2021

Photographs taken looking downstream (left), perpendicular to flow (center) and upstream (right) at the transect location marker

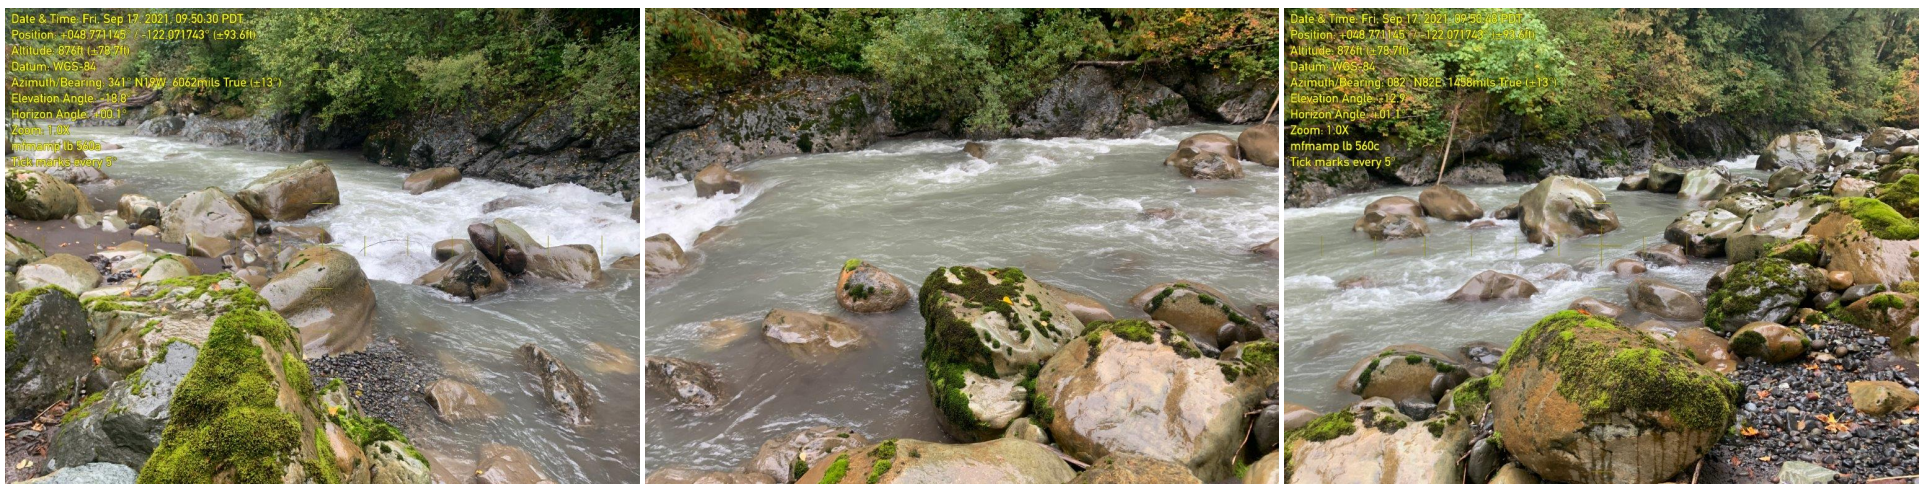
Transect 560

Photographs taken looking downstream (left), perpendicular to flow (center) and upstream (right) at the transect location marker

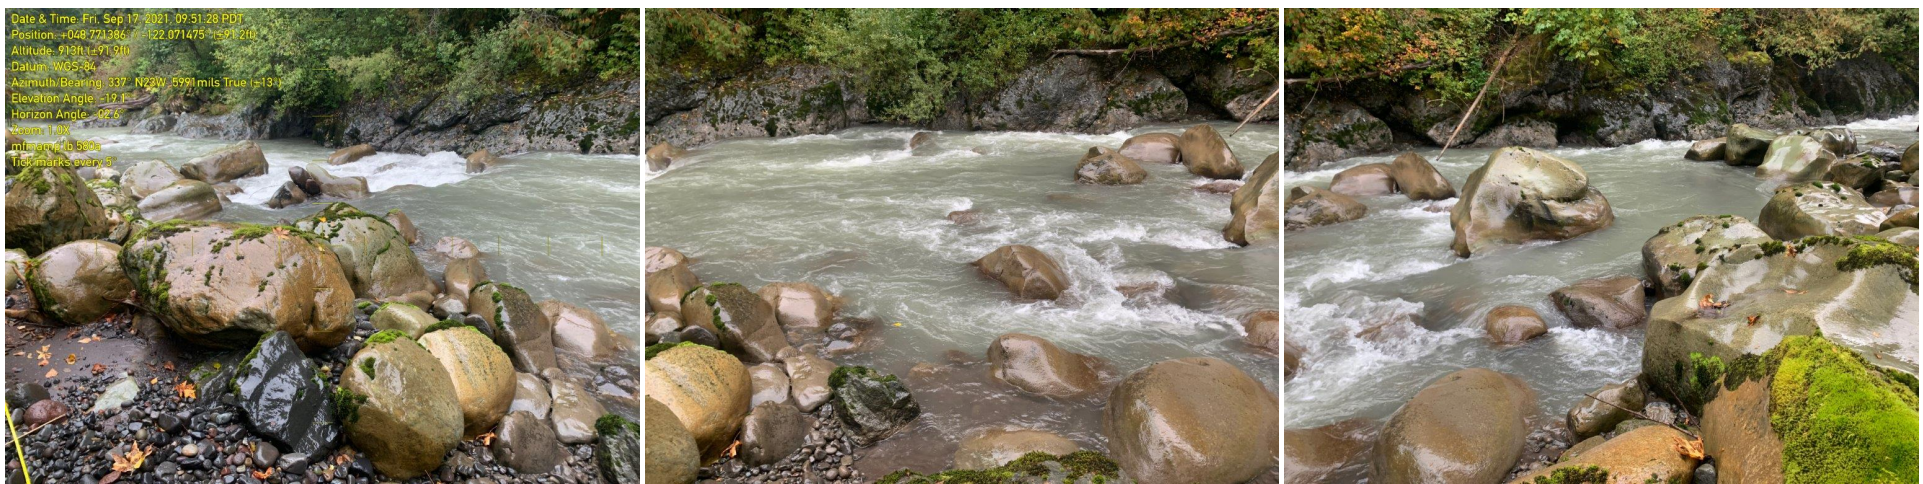
Transect 580

Photographs taken looking downstream (left), perpendicular to flow (center) and upstream (right) at the transect location marker

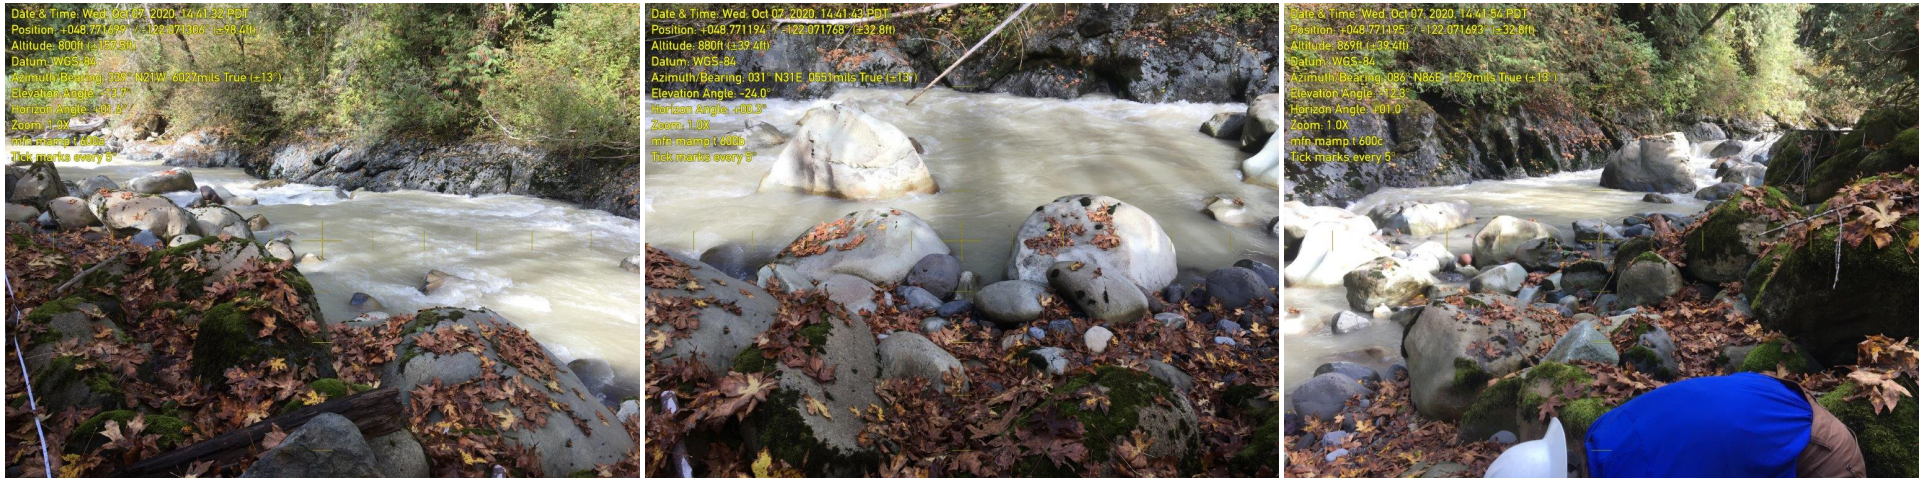
October 2020

Photographs taken looking downstream (left), perpendicular to flow (center) and upstream (right) at the transect location marker

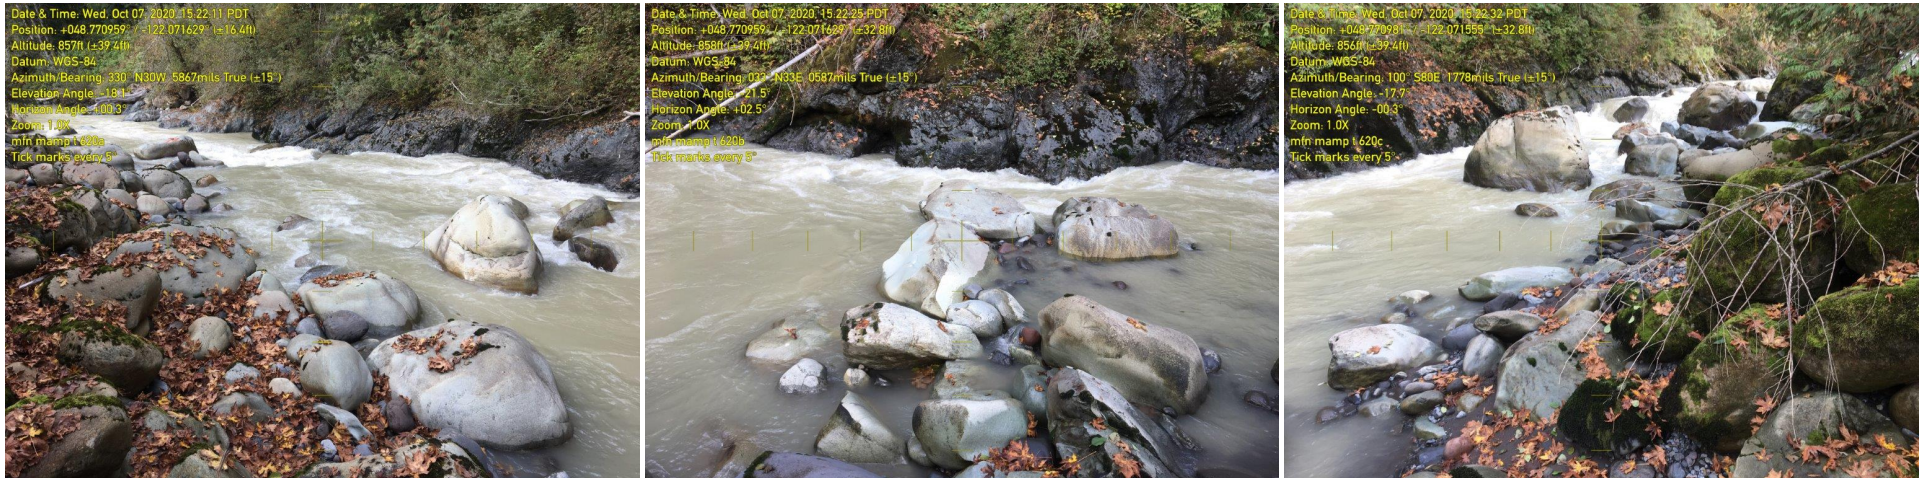
October 2020

Photographs taken looking downstream (left), perpendicular to flow (center) and upstream (right) at the transect location marker

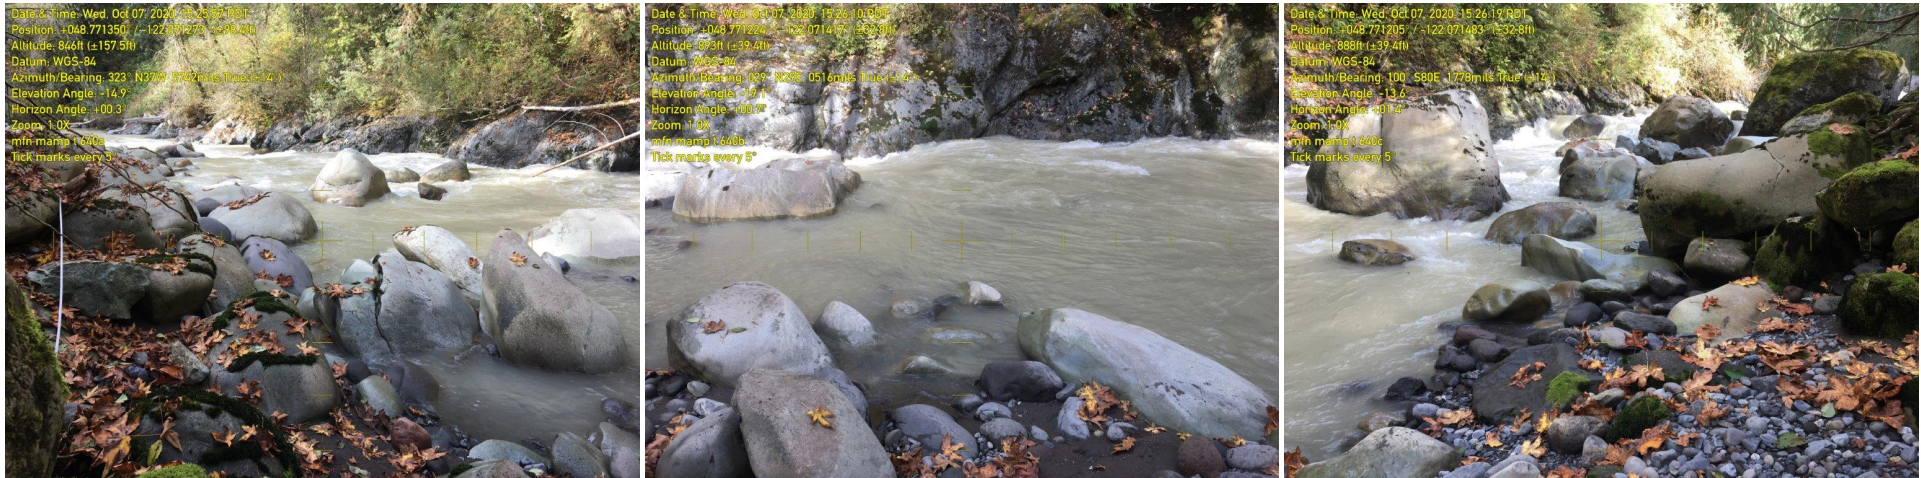
October 2020

Photographs taken looking downstream (left), perpendicular to flow (center) and upstream (right) at the transect location marker

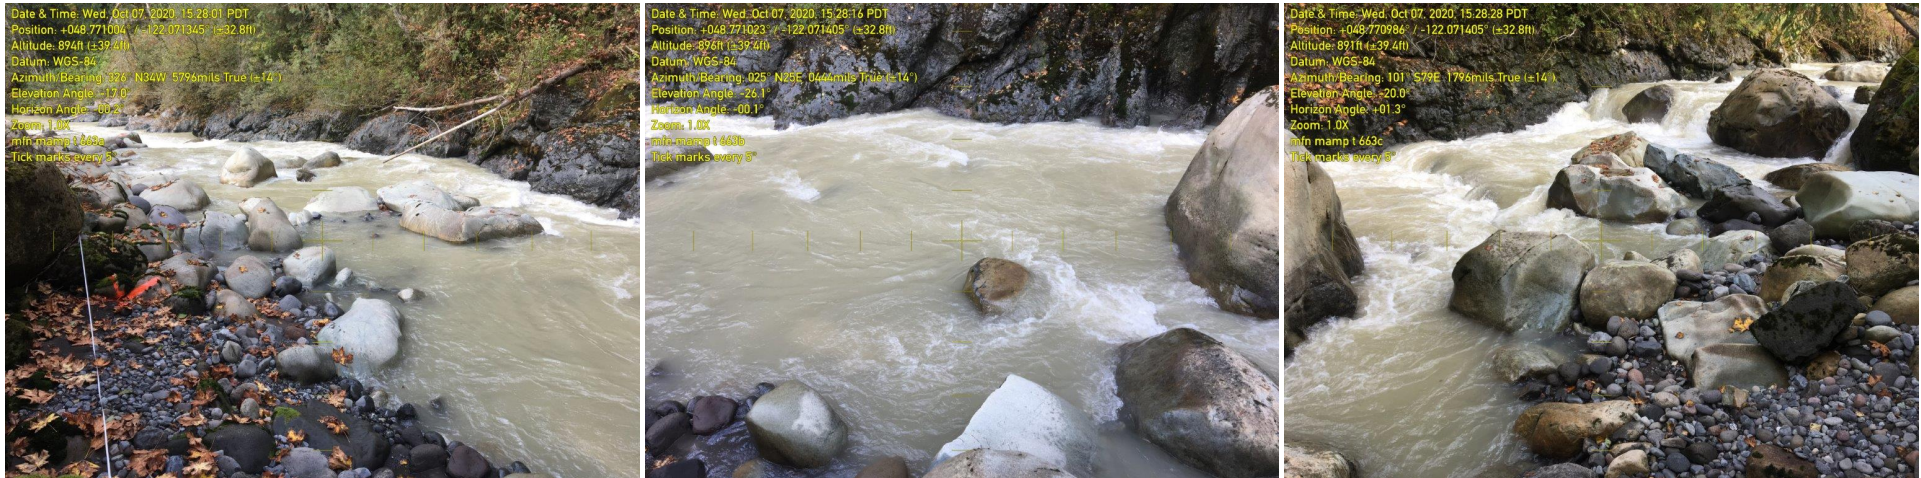
October 2020

Photographs taken looking downstream (left), perpendicular to flow (center) and upstream (right) at the transect location marker

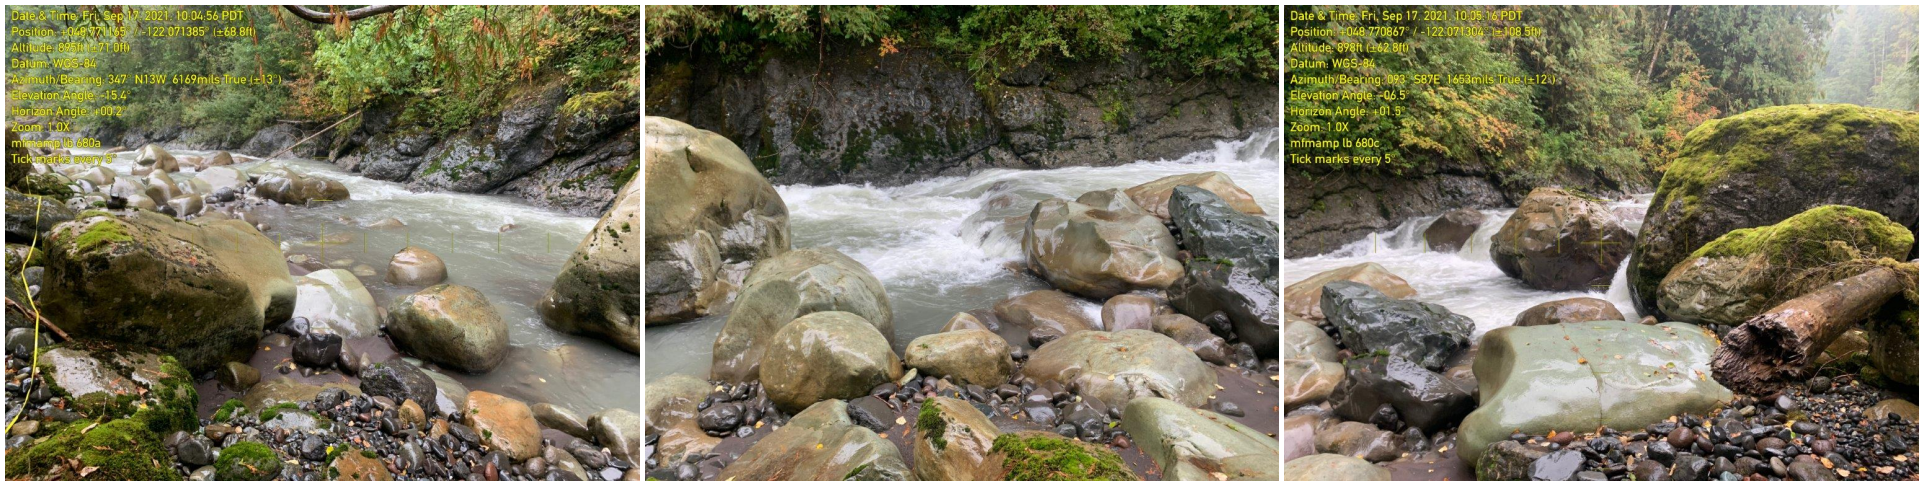
September 2021

Photographs taken looking downstream (left), perpendicular to flow (center) and upstream (right) at the transect location marker

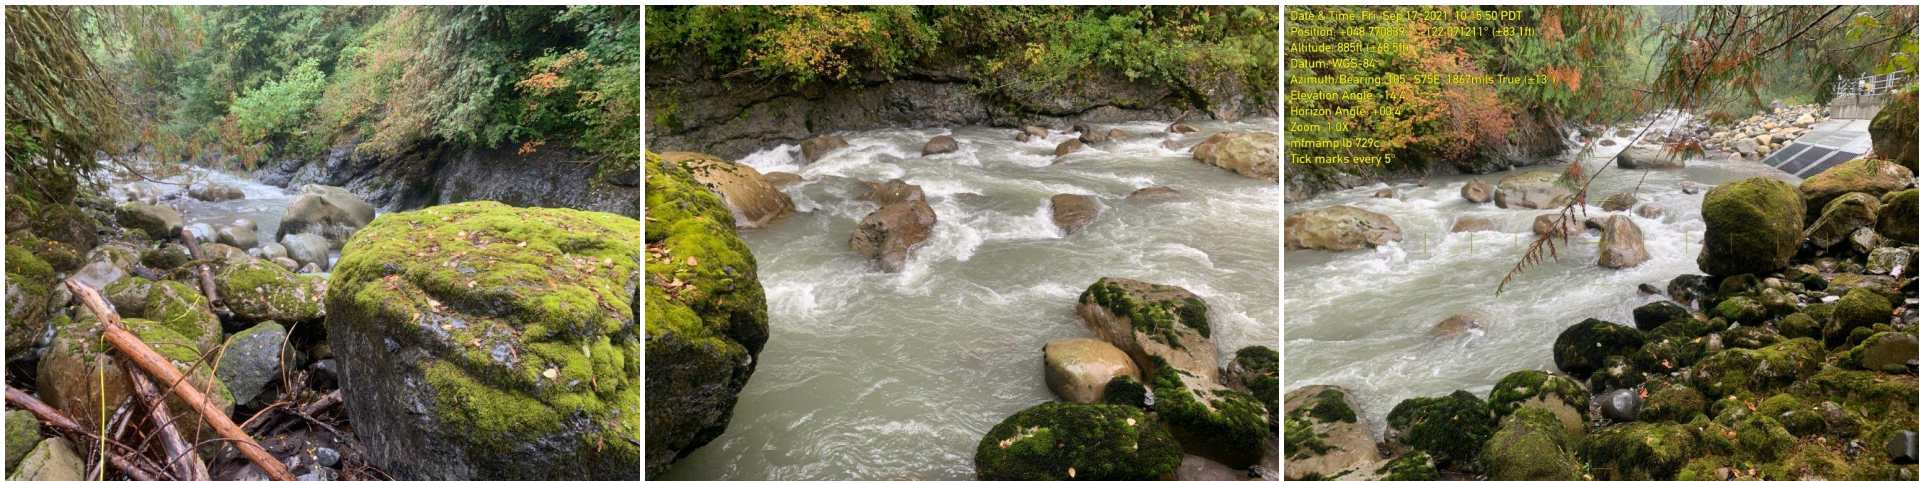
September 2021

Photographs taken looking downstream (left), perpendicular to flow (center) and upstream (right) at the transect location marker

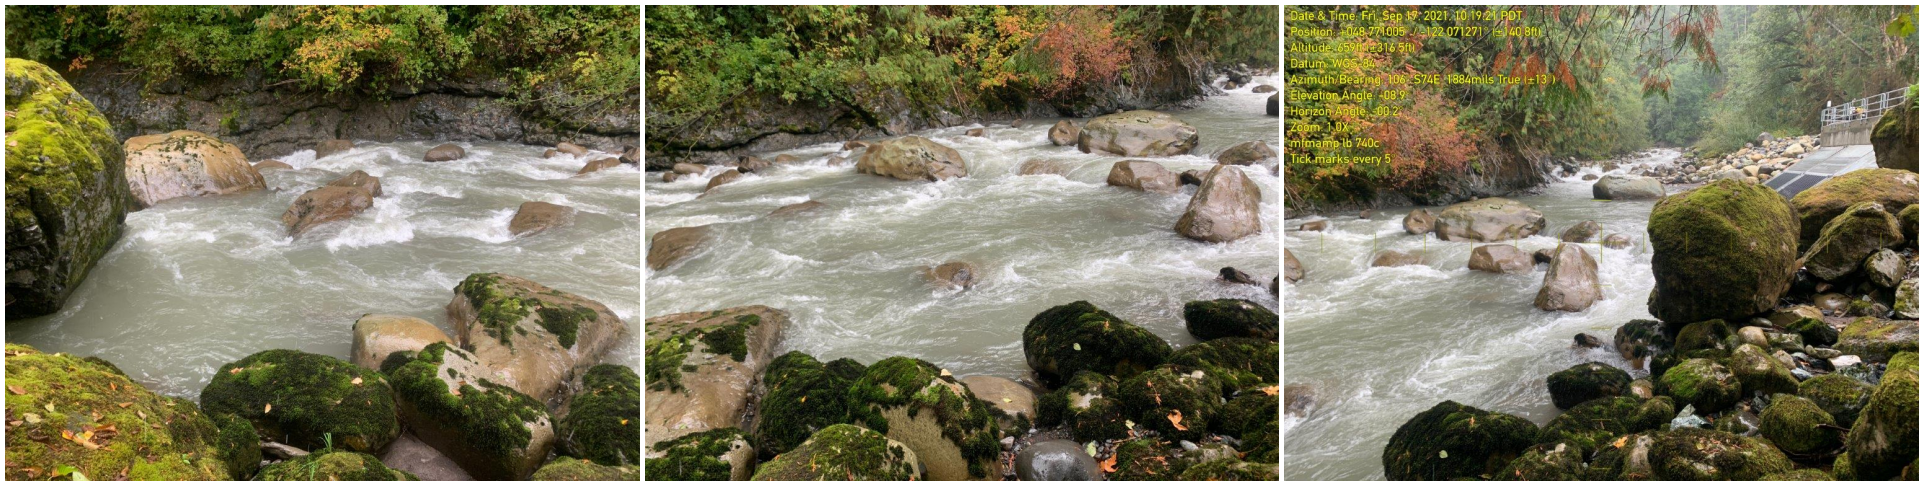
September 2021

Photographs taken looking downstream (left), perpendicular to flow (center) and upstream (right) at the transect location marker
