# SQUALICUM CREEK WATERSHED CHANNEL MIGRATION ZONE MAPPING TECHNICAL REPORT

Prepared for the City of Bellingham Department of Public Works  
September 13, 2016

**RE: Squalicum Creek and Associated Tributary Channel Migration Zone Mapping**  
Whatcom County, Washington

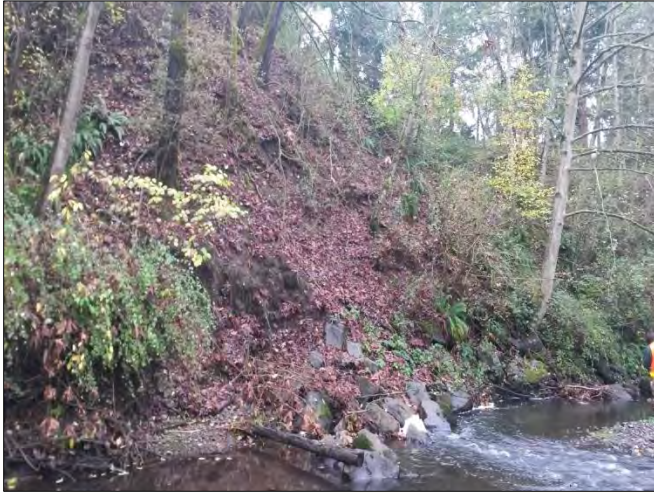
**Photo 1:** Active Erosion site, partially armored.

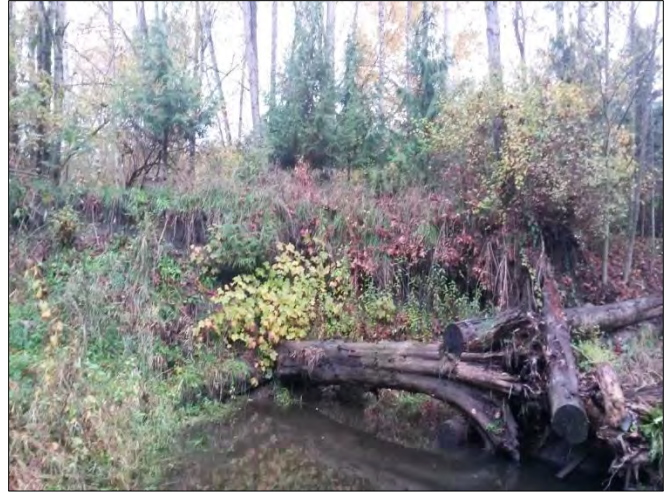
**Photo 2:** Installed LWD near mouth.

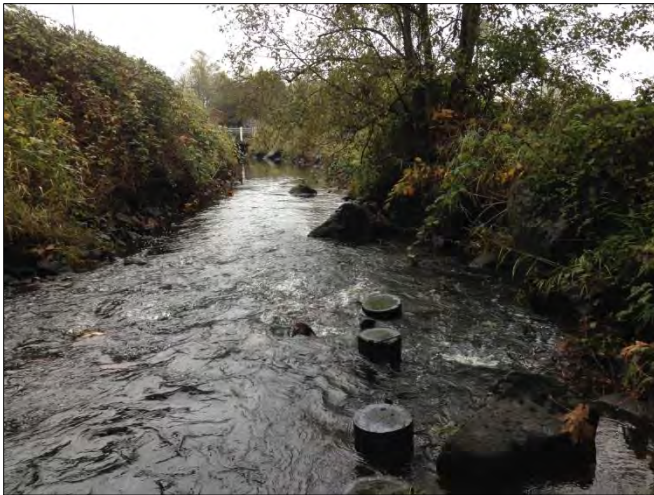
**Photo 3:** Armored banks with blackberry.

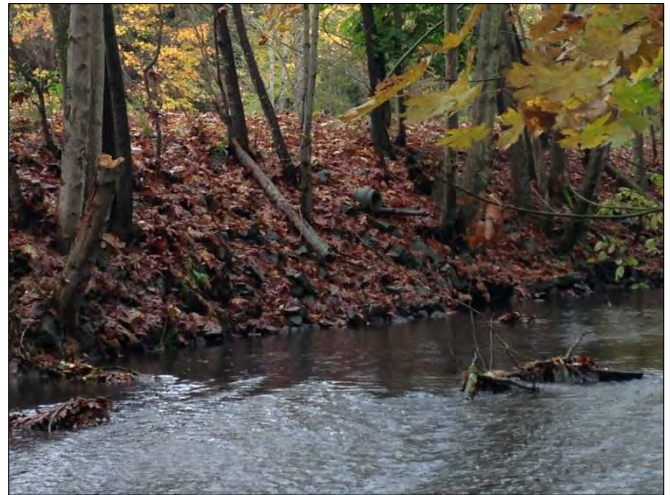
**Photo 4:** Relict bank armoring.

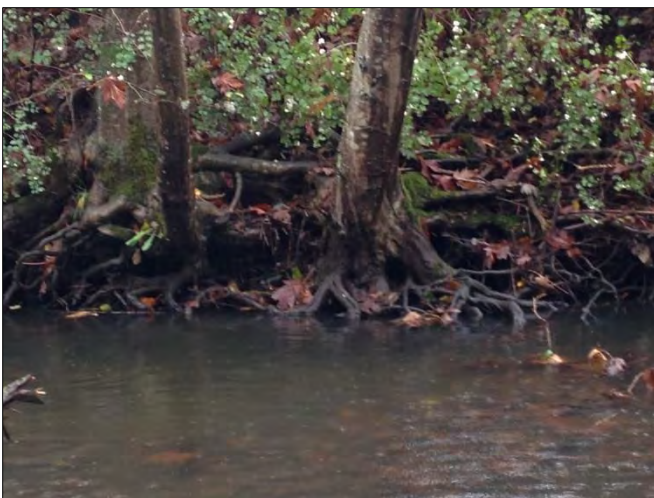
**Photo 5:** Undercut banks below maturing alders.

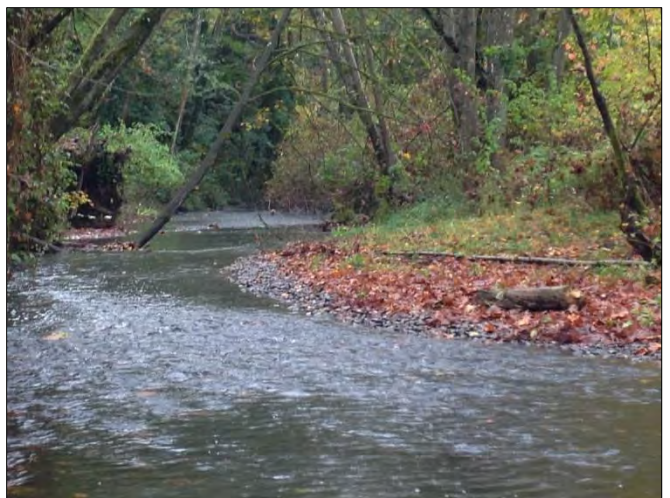
**Photo 6:** Wide banks of Lower Squalicum with gravel.

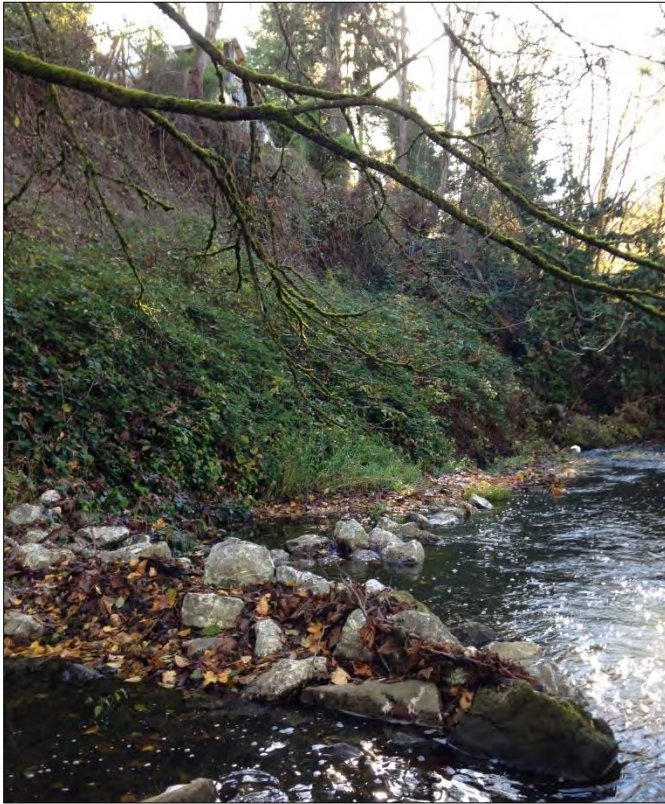
**Photo 7:** "Wing dam" with severe erosion in background.

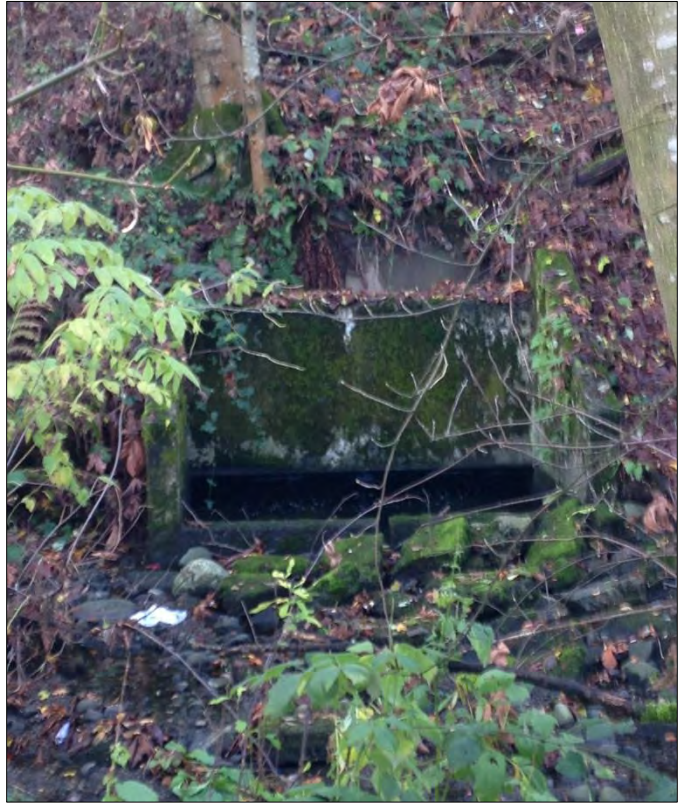
**Photo 8:** Relict stormwater feature.

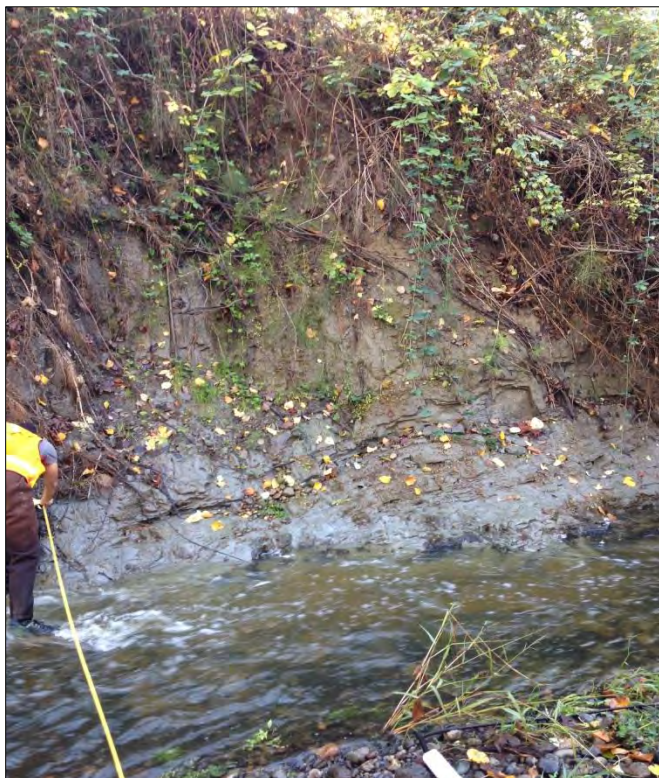
**Photo 9:** Glaciomarine drift "clayey" banks.

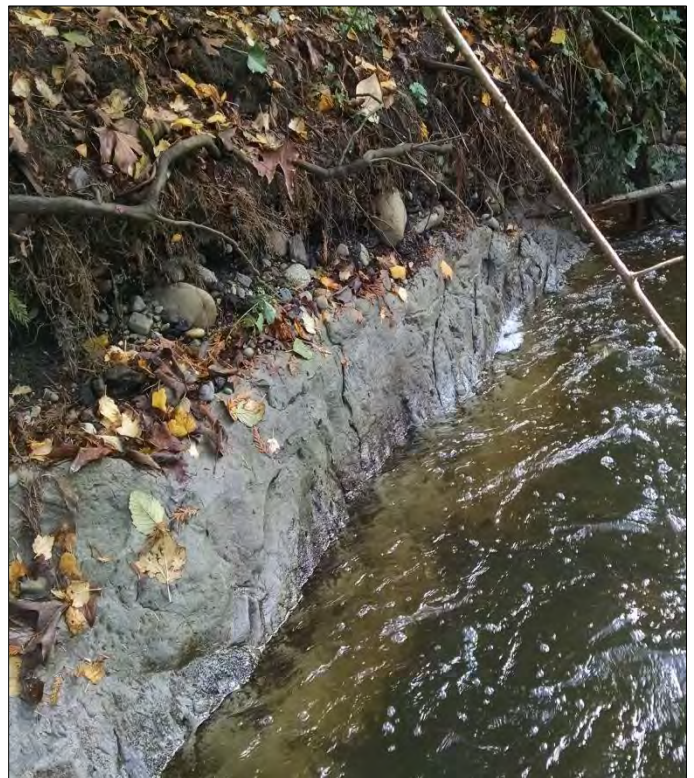
**Photo 10:** Glaciomarine drift bank demonstrating "resistance" to erosion.

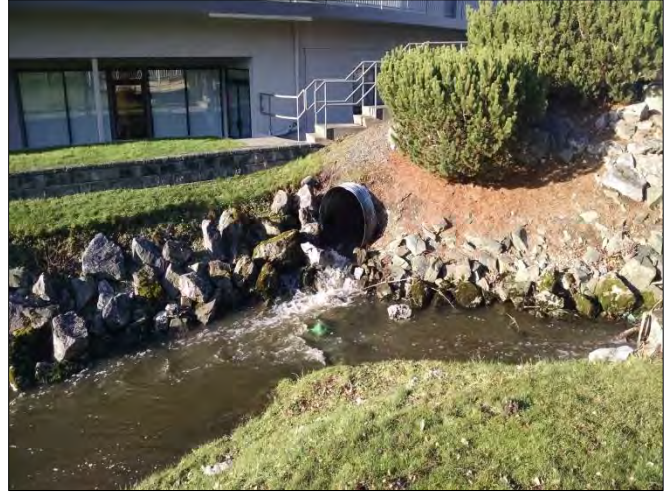
**Photo 12:** Culvert "mouth" of tributaries.

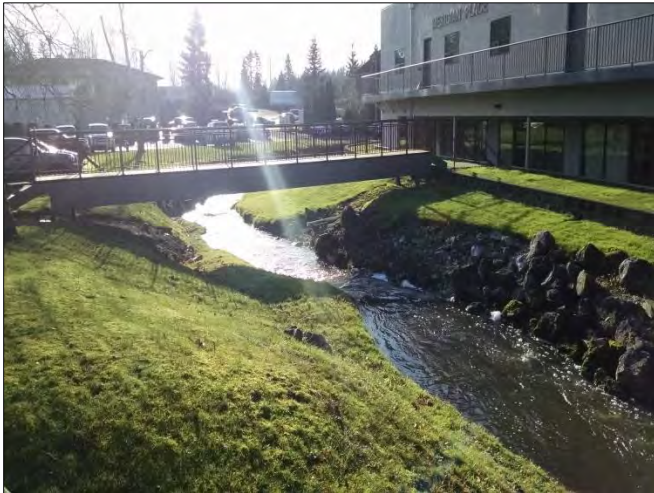
**Photo 13:** Banks lacking vegetation near I-5.

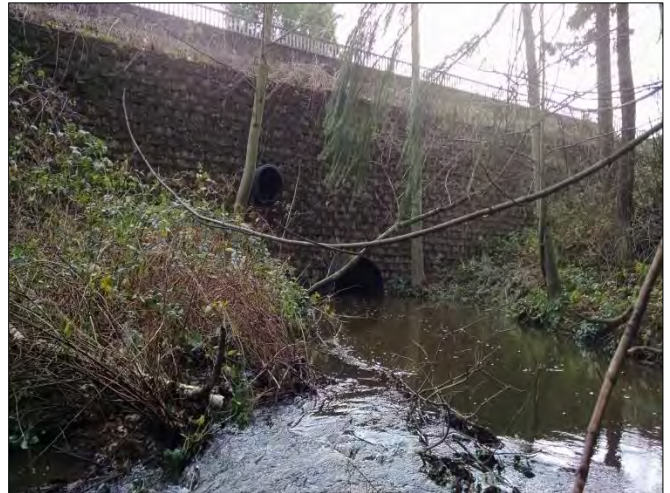
**Photo 14:** Culvert wetland near Bakerview Rd.

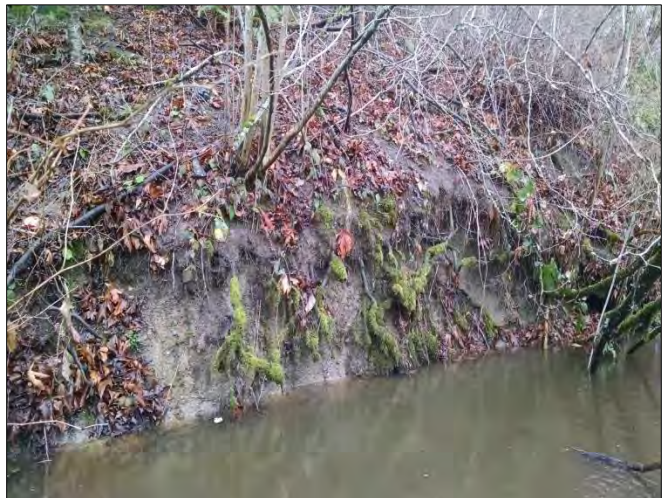
**Photo 16:** Bank erosion in reach B-5.

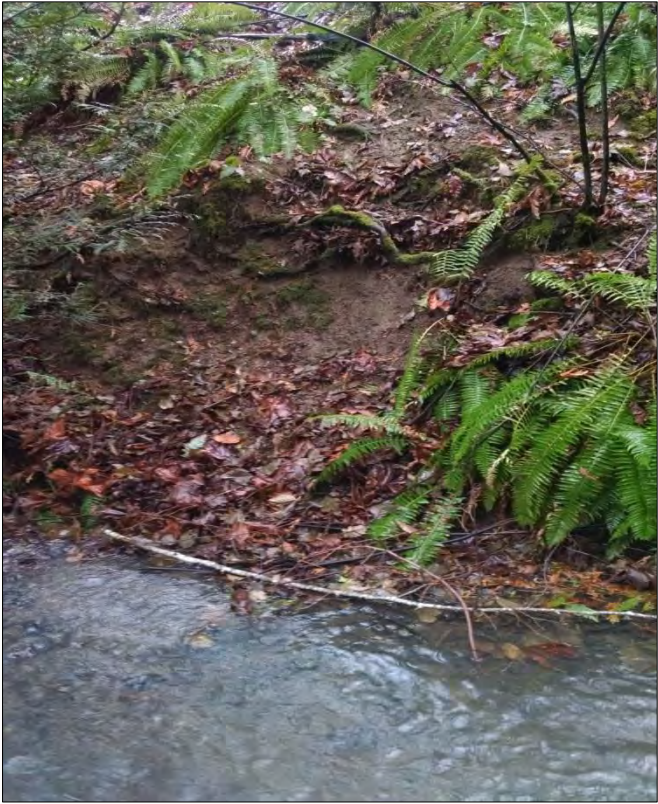
**Photo 17:** Evidence of later erosion.

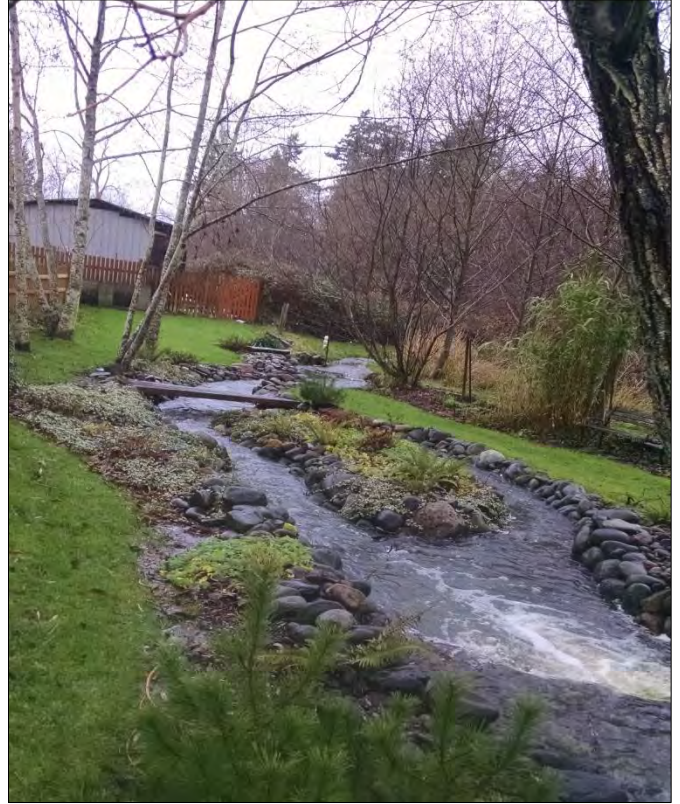
**Photo 18:** Channel modification on private property.

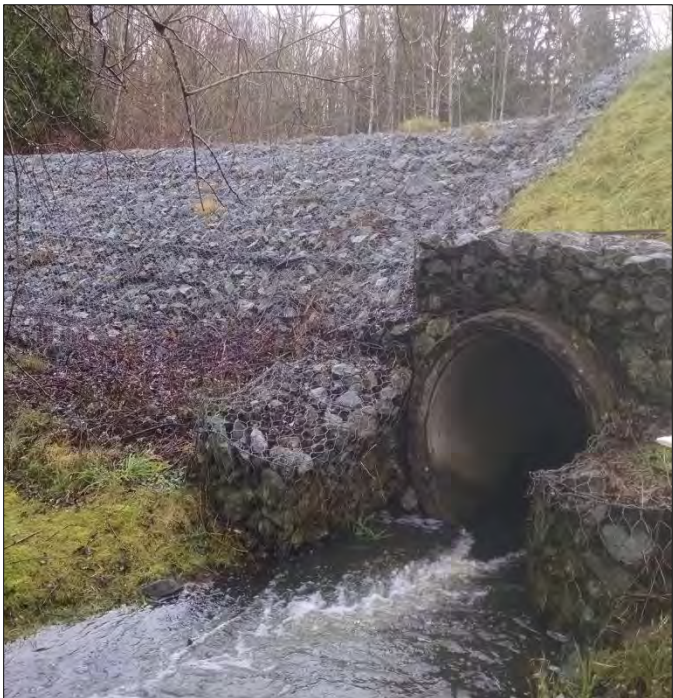
**Photo 19:** Stormwater control structure.

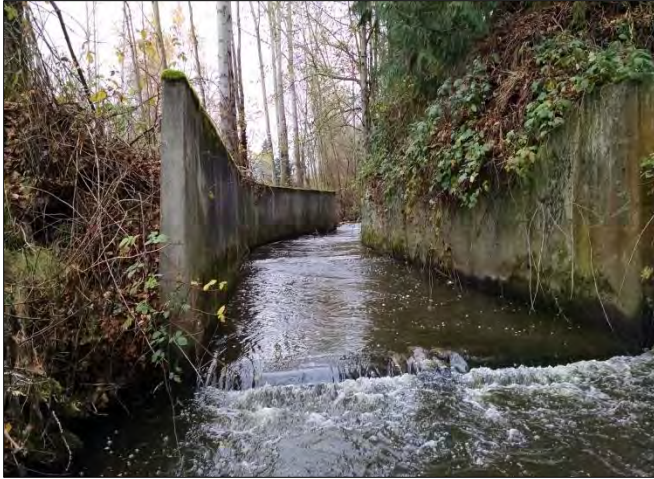
**Photo 21:** Bank modifications upstream of Baker Ck.

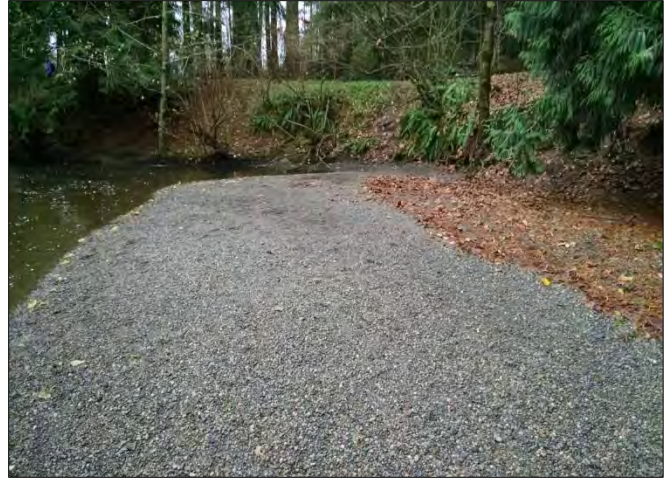
**Photo 22:** Gravel flood terrace in Cornwall Park.

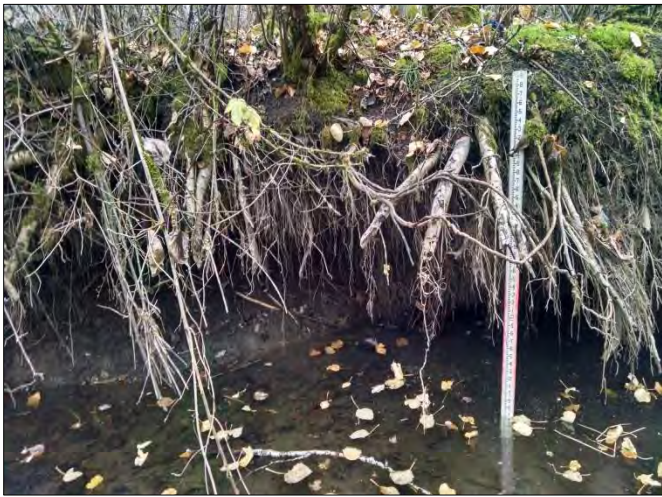
**Photo 23:** Severe undercut bank behind Hospital.

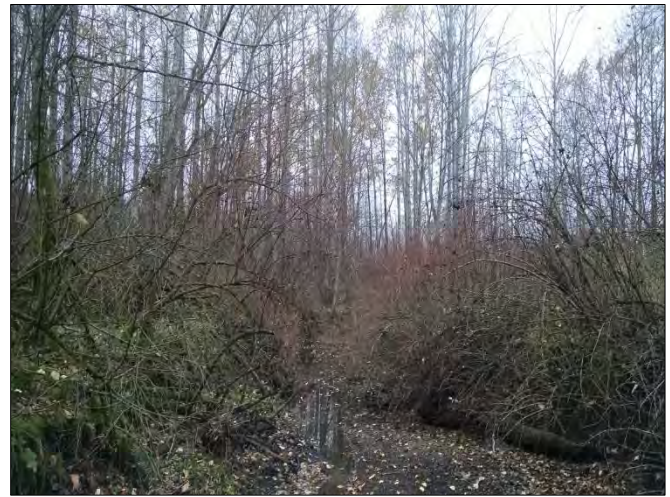
**Photo 24:** Thick underbrush, bank erosion.

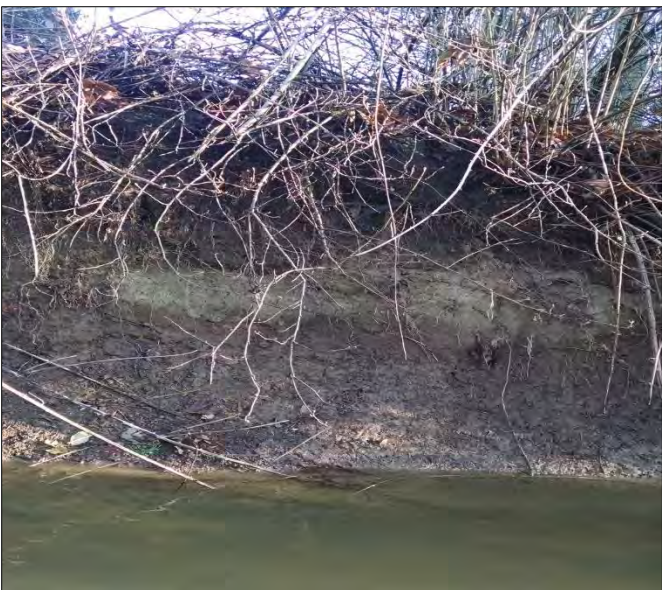
**Photo 25:** Active erosion in D-6.
